DIVISION OF DRINKING WATER
Marie E. Owens, P.E.
Director

August 20, 2020

Subject: **Inspection Report**, Johnson Well No. 1 (WS005) Inspection and 160K Tank (ST002) and 250K Gordon Creek No. 1 (ST003) Tank Repair Inspection; Highland Subdivision Water System, System #15005, File #7100

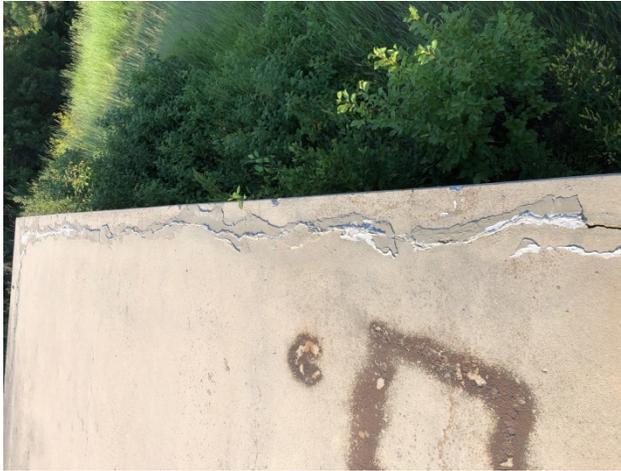
Photo 1
Tanks cracks prior to patch (ST002)

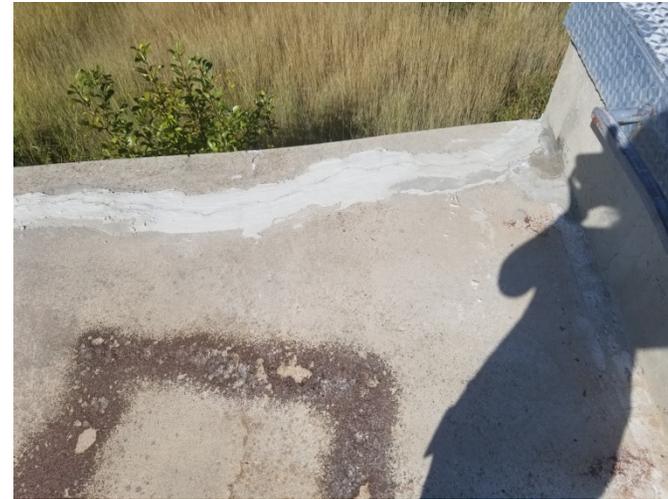
Photo 2
Repairs with fresh cracks (ST002)

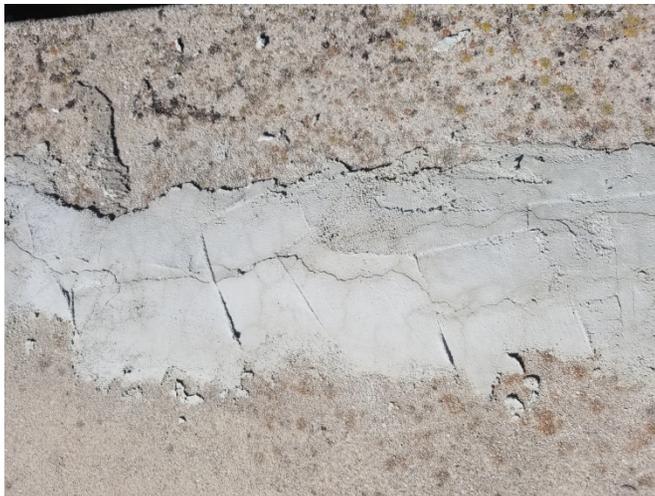
The majority of the cracks on 160k Tank (ST002) appear to have been correctly repaired. Photo number 3 shows the southern corner of the tank where surface cracks have reappeared on the recent patch. Division staff discussed with water system staff how the cracks should be repaired with a more elastic patch to ensure a proper seal is maintained over the crack.

Photo 3
Repairs with fresh cracks (ST002)

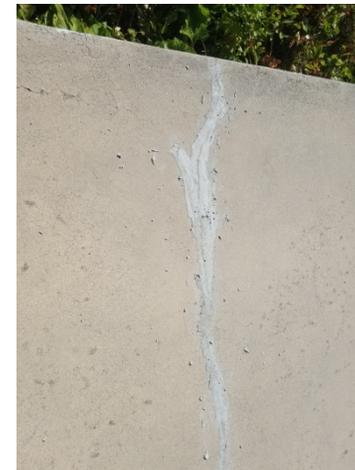
Photo 4
Repairs with fresh cracks (ST002)

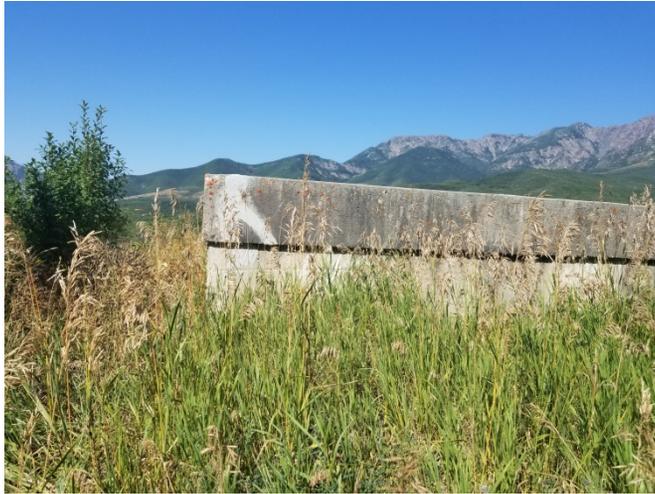
Photo 5
Repairs with fresh cracks (ST002)

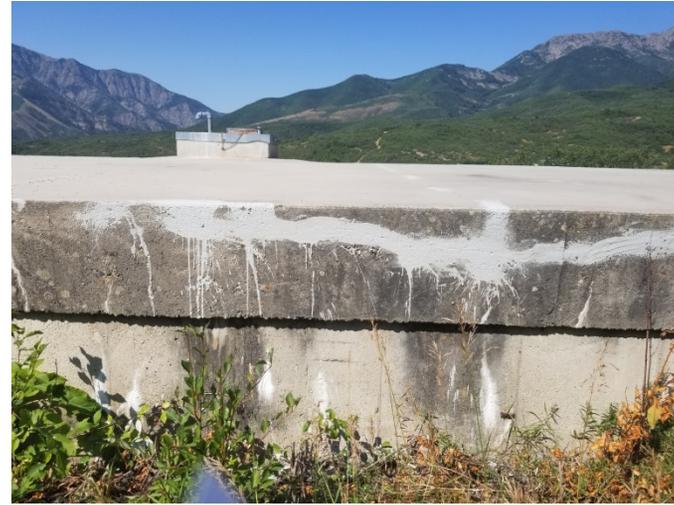
Photo 6
Repairs with fresh cracks (ST002)

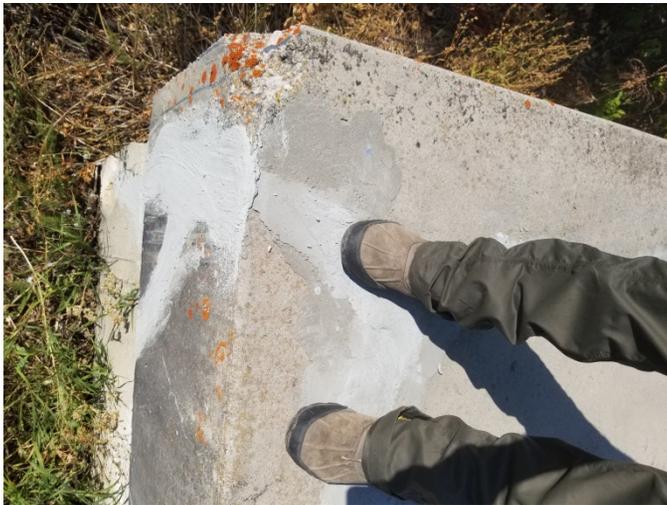
Photo 7
Repairs with fresh cracks (ST002)

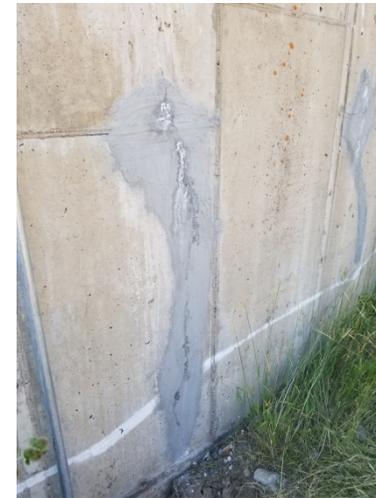
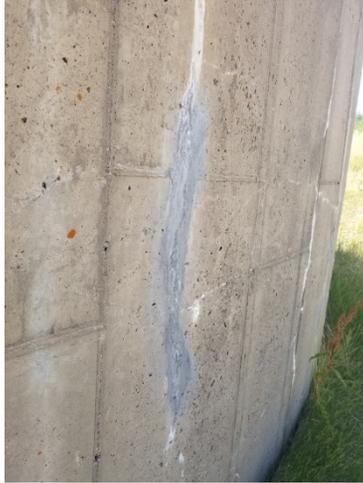
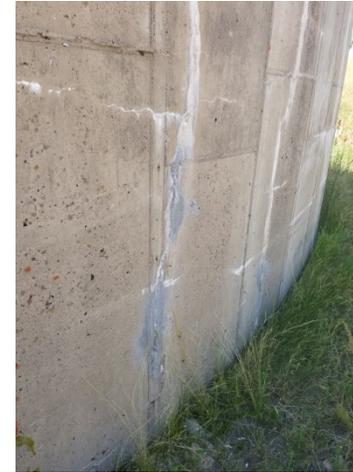
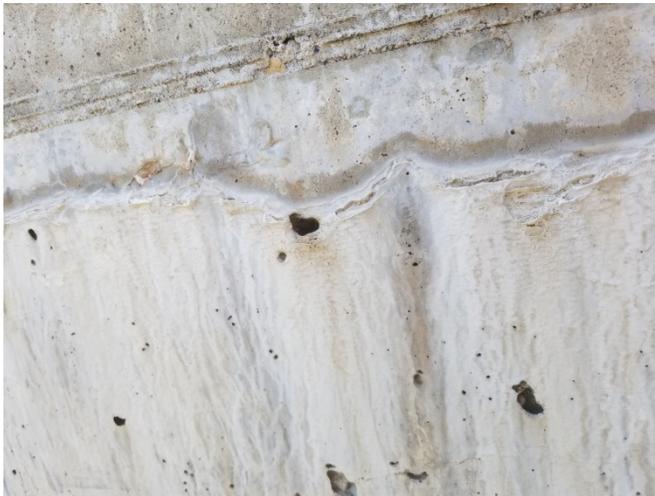
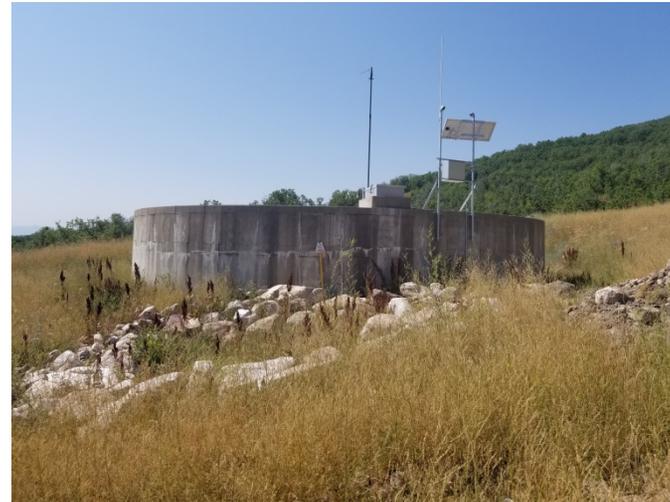
The repairs on 250K Gordon Creek No. 1 (ST003) were already showing signs of seepage stains. Division staff discussed how these stains are clear evidence that surface repairs from the outside are insufficient to repair cracks and that these cracks must be repaired from inside the tank. See photos 8 through 12 for photo documentation of the repairs as witnessed by Division staff on August 4, 2020.

In addition, the Division will be modifying the IPS violation code for 250K Gordon Creek No. 1 (ST003) to V017 [STORAGE TANK SUBJECT TO CONTAMINATION DUE TO UNSEALED

OPENINGS ON TANK ROOF OR SIDEWALLS] per R309-545-6(1) and 545-9(1) due to the excessive seepage documented at the site during the August 4, 2020 inspection.

Photo 8
Repairs with fresh seepage signs (ST003)

Photo 9
Repairs with fresh seepage signs (ST003)

Photo 10
Repairs with fresh seepage signs (ST003)

Photo 11
Repairs with fresh seepage signs (ST003)

Photo 12
Gordon Creek 250k No 1(ST003)

Division staff detailed how any repairs inside the tank met the definition of a Drinking Water Project as defined in Rule R309-500-5(1) as any of the project that includes the construction of, addition to, or modification of a public drinking water facility that may affect the quality or quantity of water delivered. Drinking Water projects must have Division plan approval before construction and receive an Operating Permit from the Division before being placed into service.

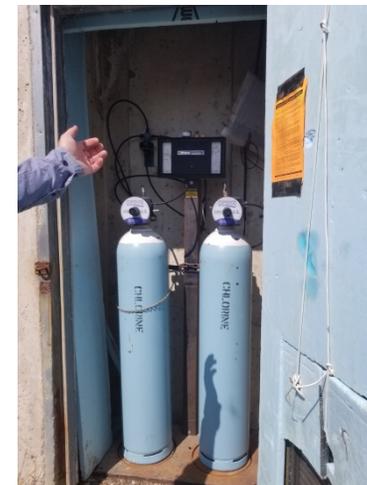
Division staff inspected the Gordon Creek Chlorinator (TP002) during the August 4, 2020 site inspection. Staff witnessed the installed automatic switch over on the chlorinator, see photo 16. The installation of this equipment addresses the existing IPS deficiency TD001, for lacking continuous disinfection automatic switch over.

Photo 16
Gordon Creek Chlorinator (TP002) new automatic switch over

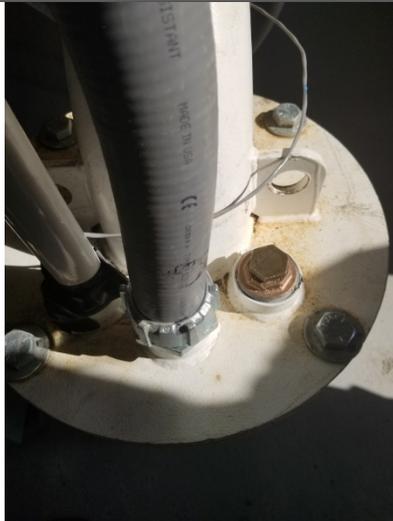
1. Well head casing vent capped
 - a. Photo 23 shows the well head casing vent bolted at the time of the inspection. Division staff recommended the installation of a casing vent to ensure more efficient pumping of the well.

Photo 23
Johnson Well No1 (WS005) well head casing vent recommendation

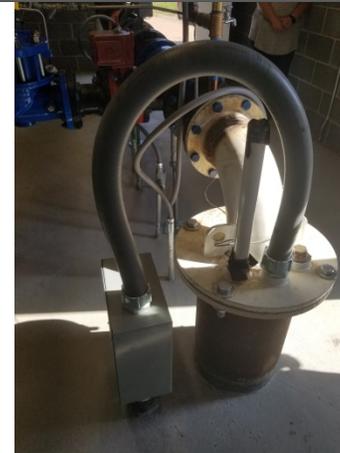
2. Transducer piping not secured on well head
 - a. Photo 24 shows the temporary piping and taping placed on the well head transducer slot of the well head that was witnessed by Division staff at the time of the inspection.

Photo 24
Johnson Well No1 (WS005) transducer piping not secure

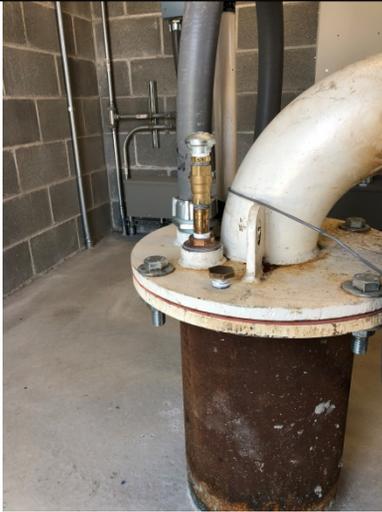
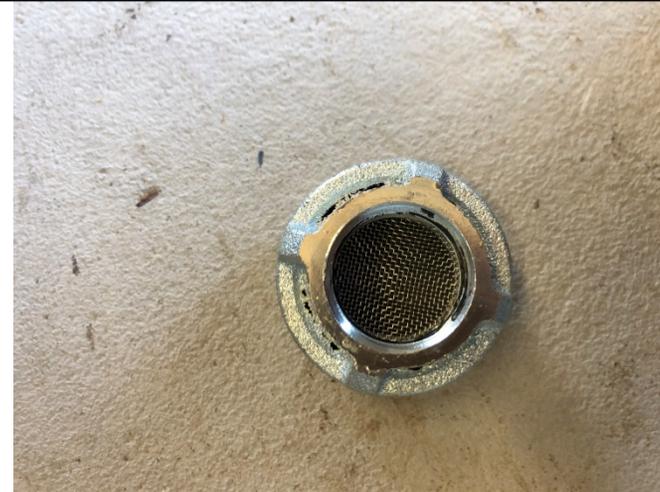
Photo 25
Johnson Well No1 (WS005) well head casing installed (8/5/20)

Photo 26
Well casing vent screen (8/5/20)

- b. Photos 25 and 26 show the installation of a well casing vent per Division recommendation. This photo documentation was supplied to the Division on 8/5/20.

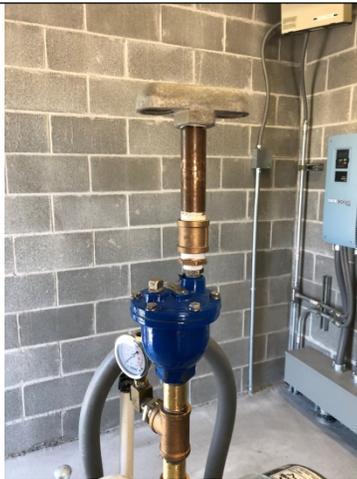
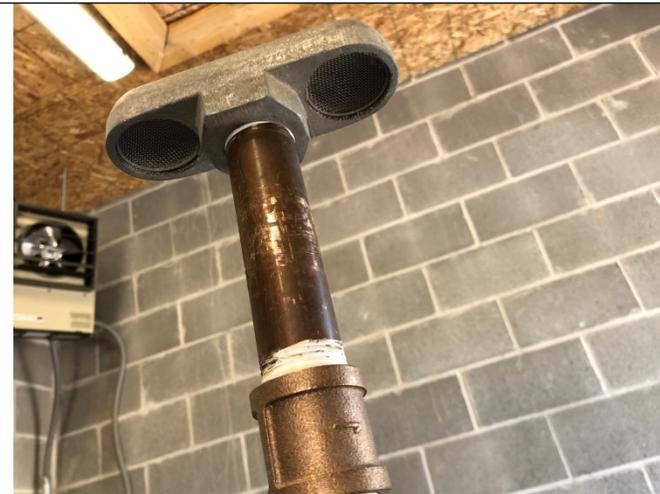
Photo 27
Johnson Well No1 (WS005) discharge line vent (8/5/20)

Photo 28
Discharge vent line replaced (8/5/20)

- b. Photos 27 and 28 show the replacement made per staff recommendation on 8/5/20 by email photo documentation

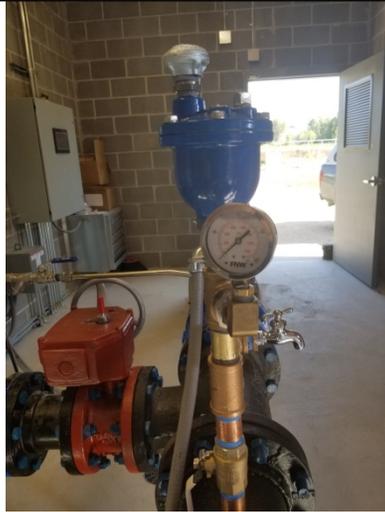
3. Inadequate venting on discharge piping
 - a. Photo 29 shows the single vent cap that had inadequate spacing that was witnessed by Division staff at the time of the inspection.

Original Johnson Well No1 (WS005) discharge line vent, needed vent gap cleared

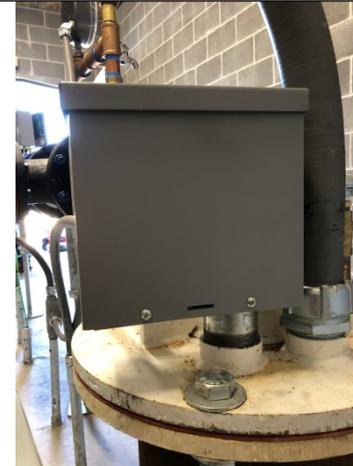
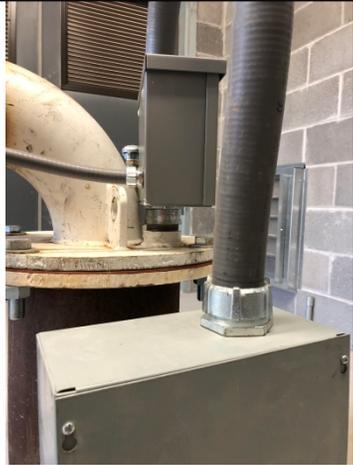
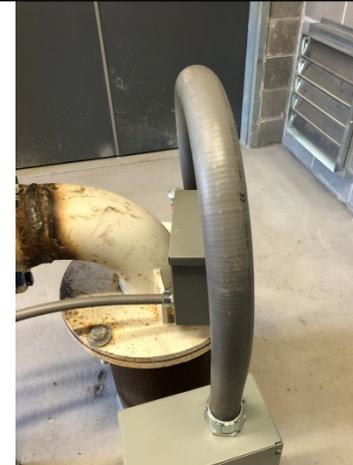
Photo 36
Johnson Well No1 (WS005) Transducer installed 8/7/20

Johnson Well No1 (WS005) Transducer installed 8/7/20

- b. Photos 36 through 38 show the transducer installed on the well head and all the connections sealed appropriately per photo documentation supplied on 8/7/20.
