SECOND FIVE-YEAR REVIEW REPORT FOR
KENNECOTT (SOUTH ZONE) SUPERFUND
ALTERNATIVE SITE
SALT LAKE COUNTY & TOOELE COUNTY, UTAH

Utah Department of Environmental Quality
Division of Environmental Response & Remediation
Salt Lake City, Utah

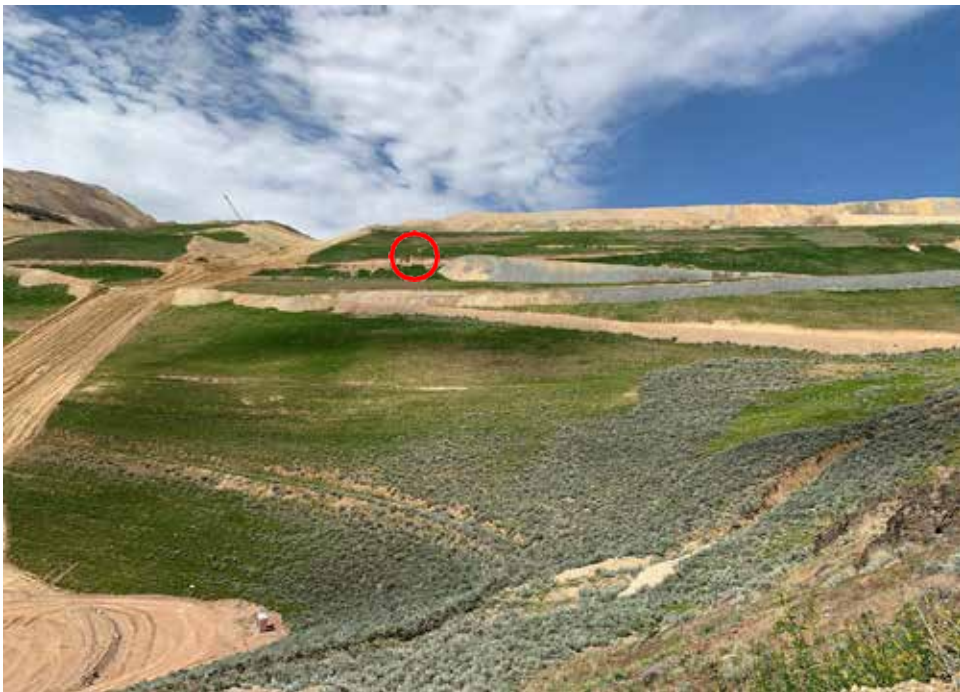
Photo 2 - Pictured is the reclaimed eastern embankment of the Bingham Canyon Waste Rock Dump. Located along the left side of the photo is the excavated alignment for the new Bingham Mine Ore Conveyor. Located just below the top of the dump (red circle), above the first road cut and right of the new conveyor is an erosional gully, RTKC has been requested to repair, which resulted from a 2013 high intensity storm event.

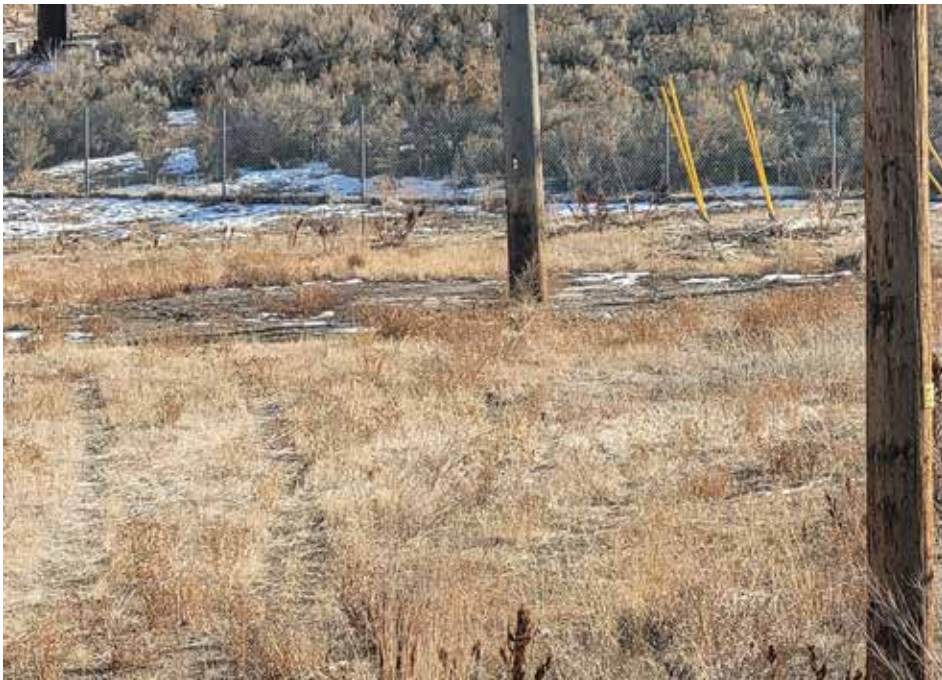
Photo 12 - Pictured south of the Bingham Creek Channel, north of the Trans Jordan Landfill's (TJL) fence line, is an area previously impacted by storm water runoff in the early 2000s. This portion of the Bingham Creek Floodplain was repaired by the operator at the TJL. Re-vegetation efforts have been successful though there remains a bare patch around the utility pole in the background.

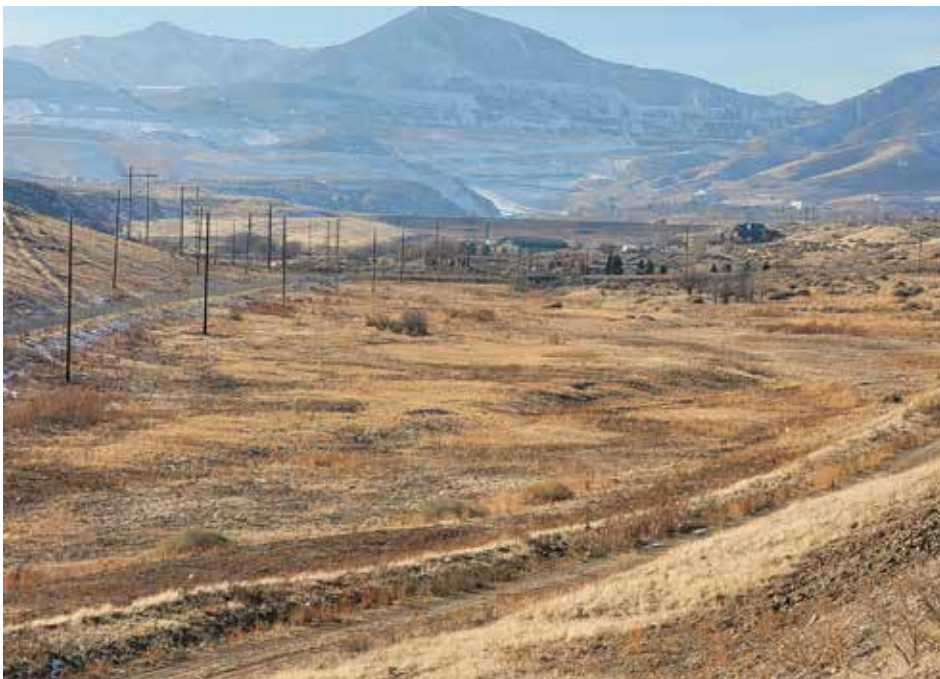
Photo 14 - Pictured is the western extent of the Bingham Creek Channel and floodplain looking back to SH-111. Surfaces are well vegetated, fairly flat (no discernible channel invert), and no flowing water was observed. The photo was taken near the western extent of the Bingham Flats area now part of Oquirrh Park, a commercial development by LHM - Daybreak Communities.

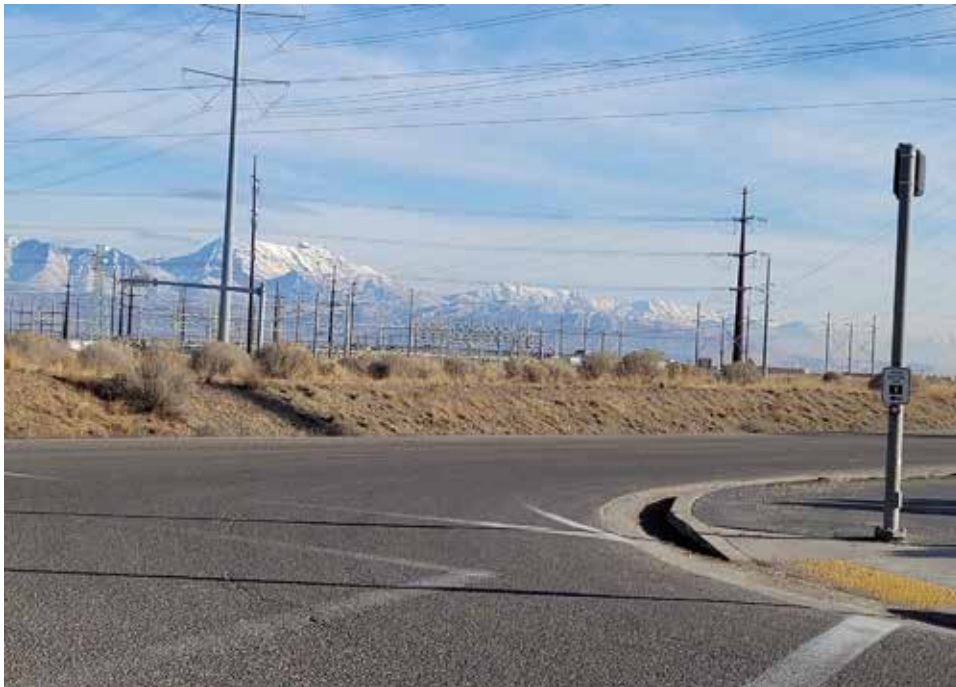
Photo 18 - Pictured is the Mountain View Corridor roadway intersection with Old Bingham Highway. The vegetated soil (center background) is a repository that was constructed by UDOT during the Mountain View Corridor construction. UDOT consolidated and covered rail bedding material (slag) and soils with concentrations of lead above 2000 mg/kg and arsenic above 100 mg/kg from the historic 1960s DRG Rail Corridor. The repository is well vegetated and stable.

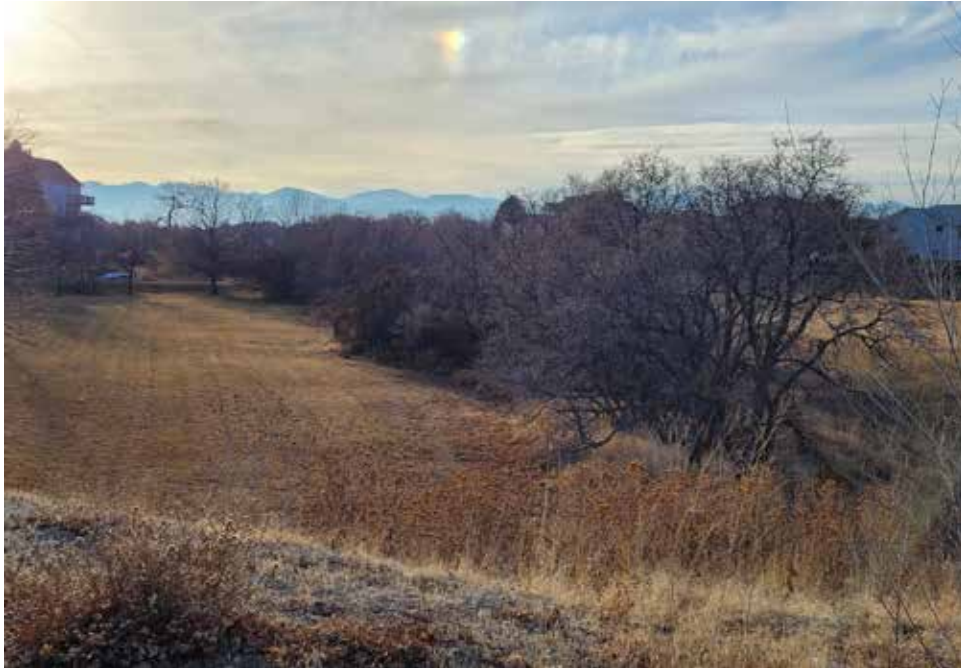
Photo 27 - Pictured upgradient and west of 4000 West is the Bingham Creek Channel (bounded by the scrub oak). The Channel traverses through the neighborhood park. The Channel is well vegetated, which has not changed since the last FYR. No water was observed in the Channel nor was any erosion observed along the Channel.

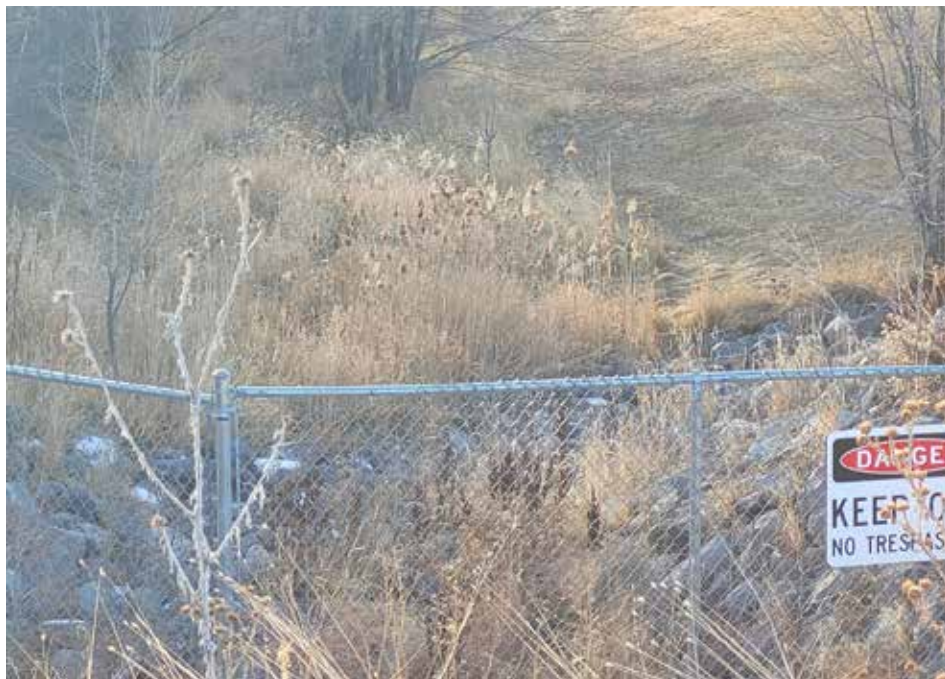
Photo 28 - Pictured is the Bingham Creek Channel just upgradient of the culvert under 4000 West. The Channel is well rip-rapped above the culvert. No water was observed in the Channel nor was any erosion observed along the Channel.

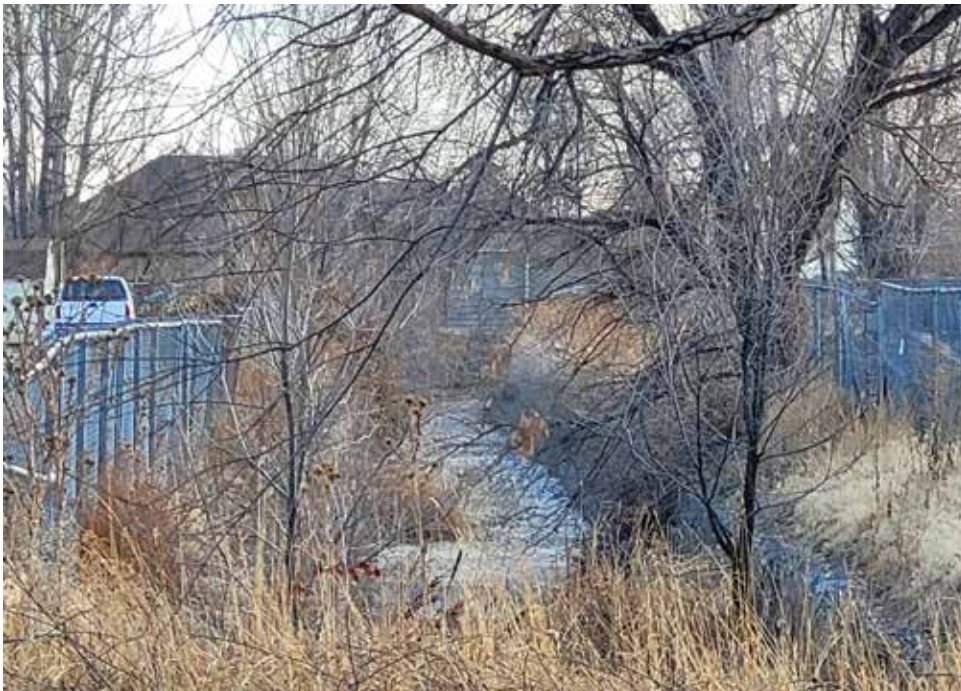
Photo 32 - Pictured south and upgradient of Haun Drive is the Bingham Creek Channel, which is cement lined. The Channel through a residential development which predates the Bingham Creek Phase I & III cleanups. The Channel characteristics have not changed since the last FYR. No water was observed in the Channel nor was any erosion observed along the Channel.

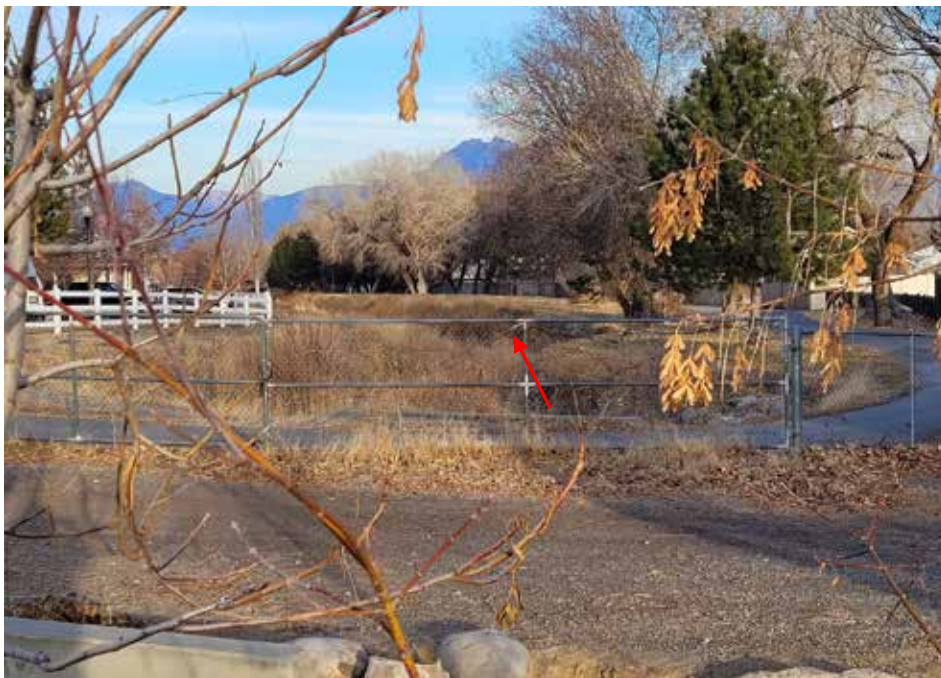
Photo 34 - Pictured east and downgradient of 2200 West is the Bingham Creek Channel (red arrow) as it traverses northeast, south of the West Jordan senior assisted living facility (out of frame, upper left quadrant) and the residential parcels (upper right quadrant). West Jordan maintains a trail along the Channel. The Channel has not been changed since the last FYR, it is still well vegetated and defined. No water was observed in the Channel nor was any erosion observed along the Channel.

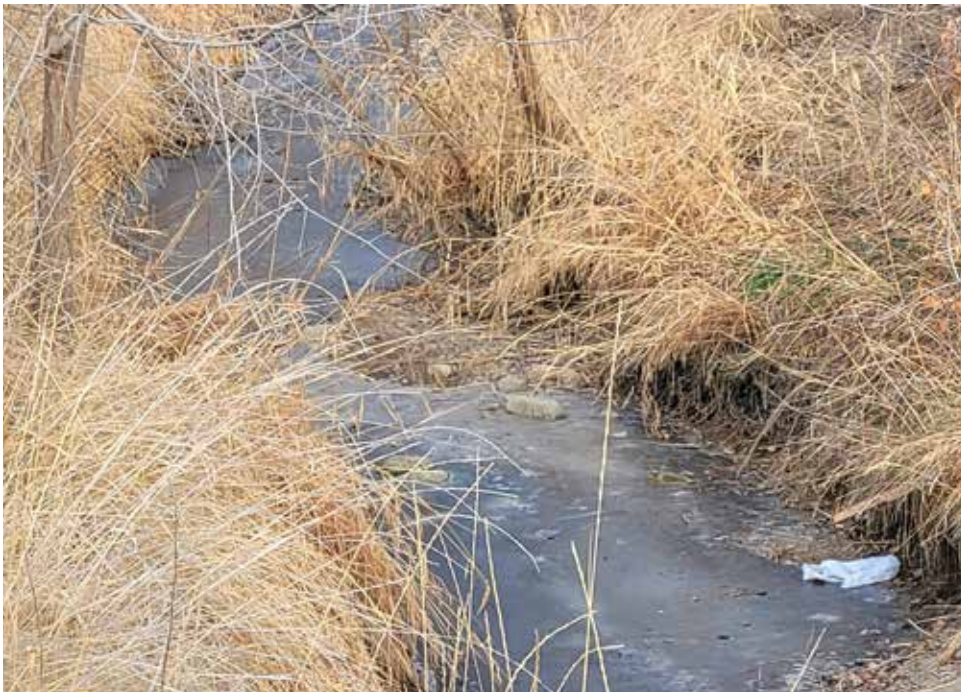
Photo 36 - Pictured east and downgradient of the Sugar Factory Road box culvert is the Bingham Creek Channel. Frozen water may be evidence of localized springs or may be ponded water from recent snow melt. The Channel embankments are well vegetated and appeared stable. Further east of this location the embankments get steeper and the City of West Jordan intends to stabilize the embankments in the future.

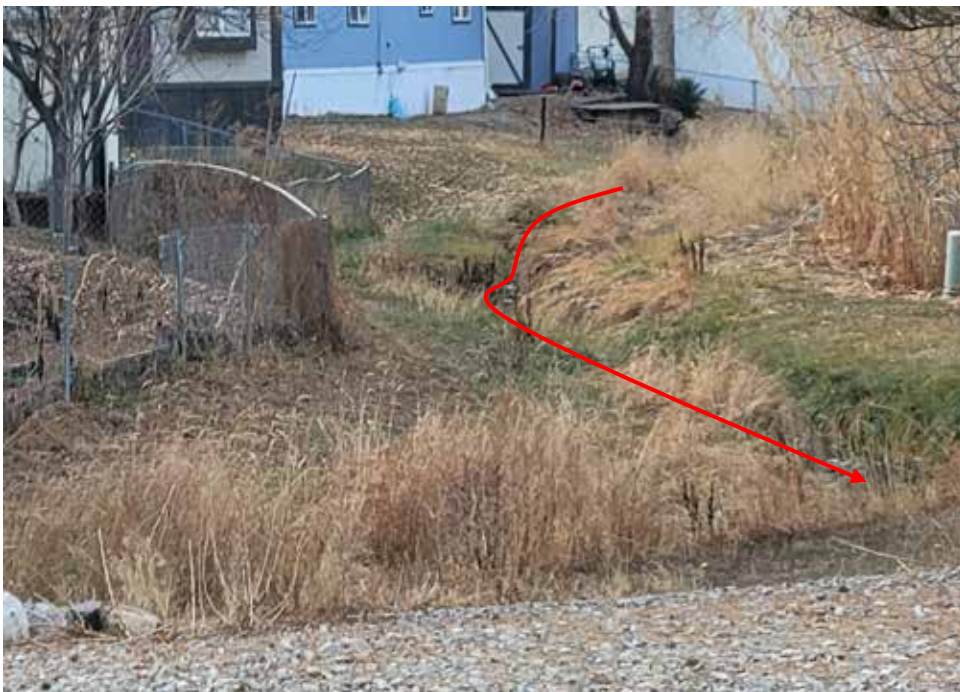
Photo 38 - Pictured west and upgradient of 1500 West is the Bingham Creek Channel (red arrow) at the downgradient end of the Brookside Mobile Home Park. The Channel characteristics have not changed since the last FYR. No erosion or eroded sediment/soils were observed. Channel embankments are well vegetated with grasses.

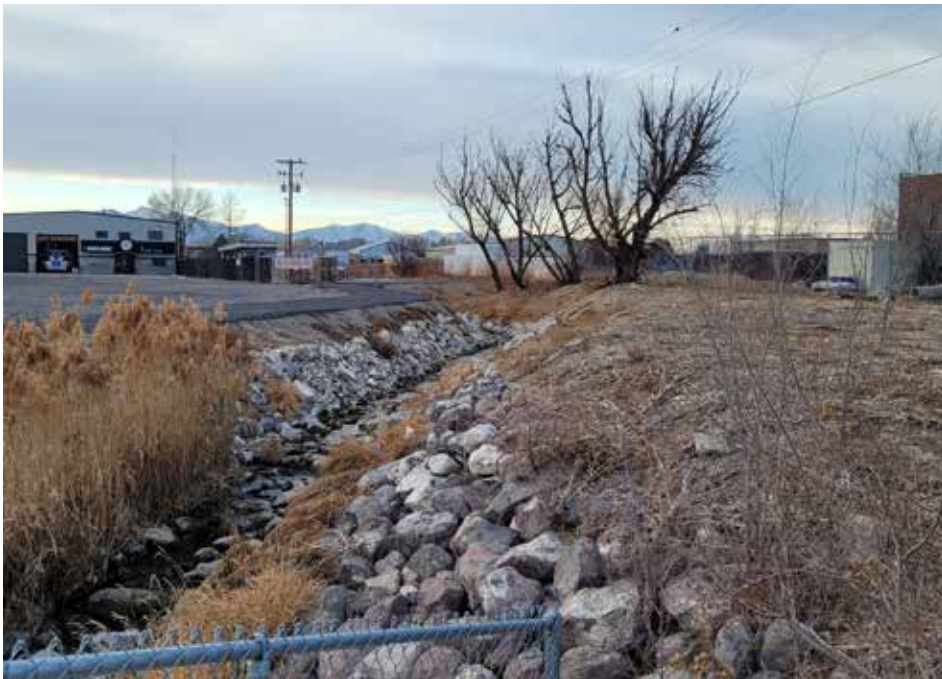
Photo 40 - Pictured west and upgradient of 1300 West is the Bingham Creek Channel. As noted, in 2019 SLCO FC increased the flood control capacity of the Channel, reconstructing it with rip-rap to stabilize the slopes. No erosion or eroded sediment/soils were observed, water was observed.

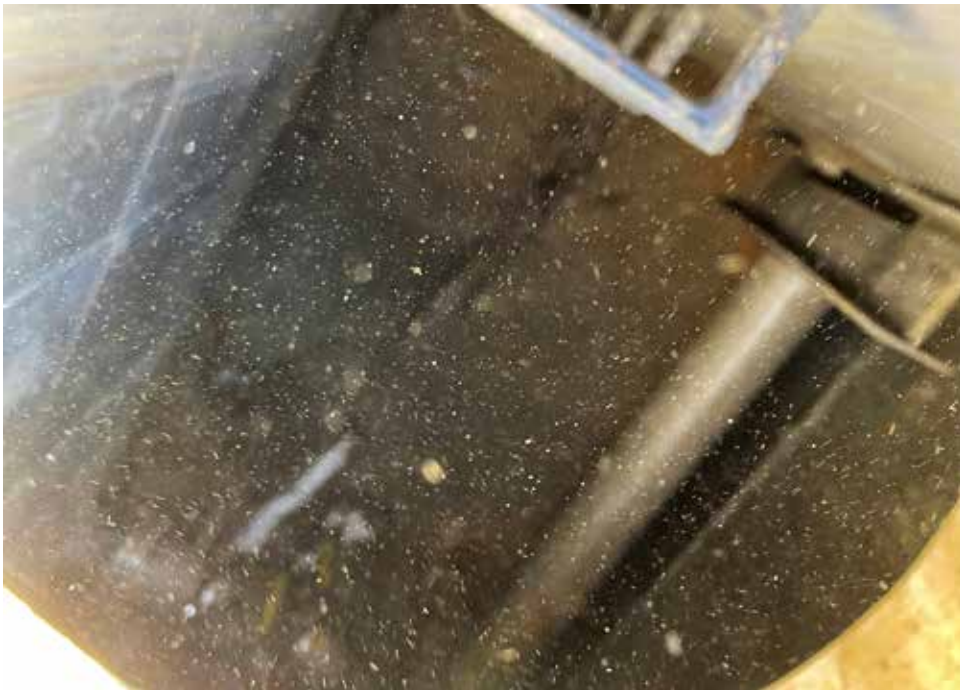
Photo 50 - Pictured is the pipe used to convey water from BSG2787 to the Tailings Pipeline. The sump box is equipped with metering to alarm the RTKC computer system of rising water, and is designed to collect water if there is a break in the pipe. No water was observed in the sump box.

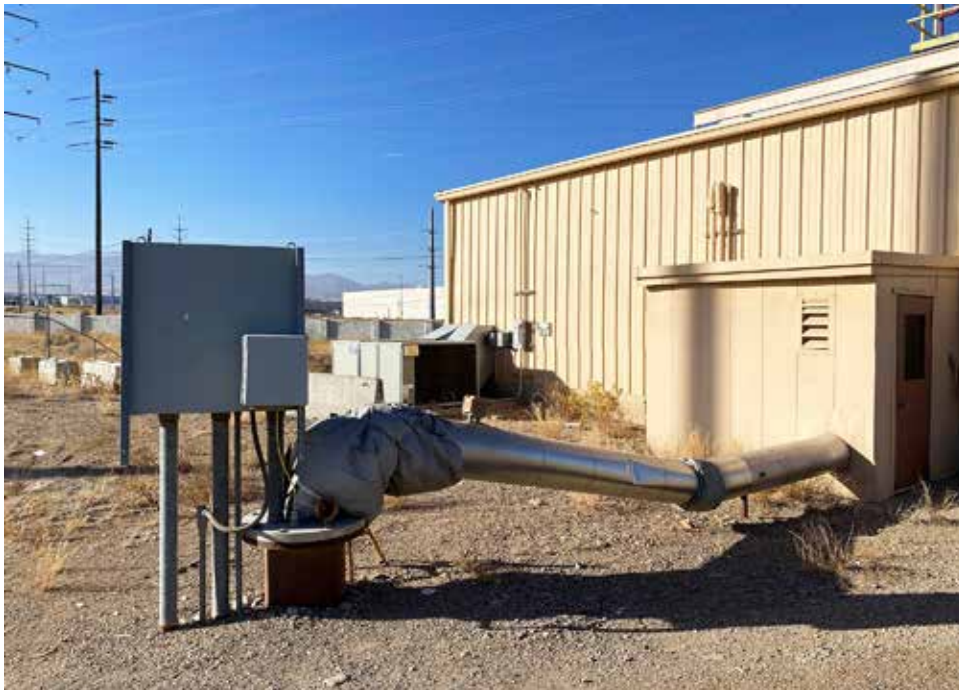
Photo 54 - Pictured is the well head, casing, and pipe, as well as the housing for Barrier Well #BFG1200 (or K109). No leaks were observed.

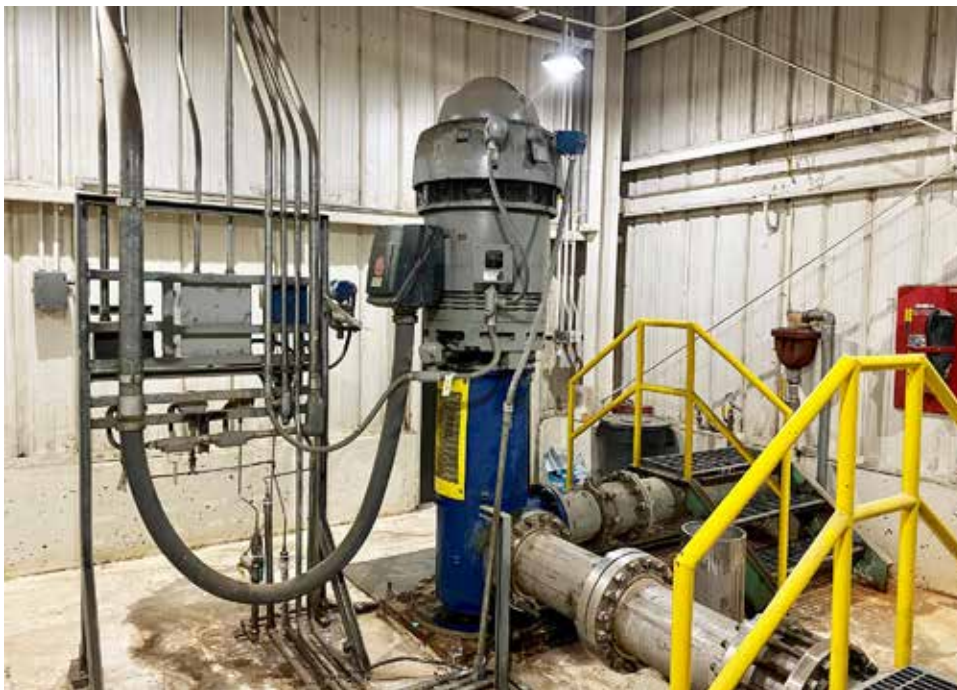
Photo 56 - Pictured is the well pump, piping and metering equipment for BFG1200. No signs of leakage were observed.

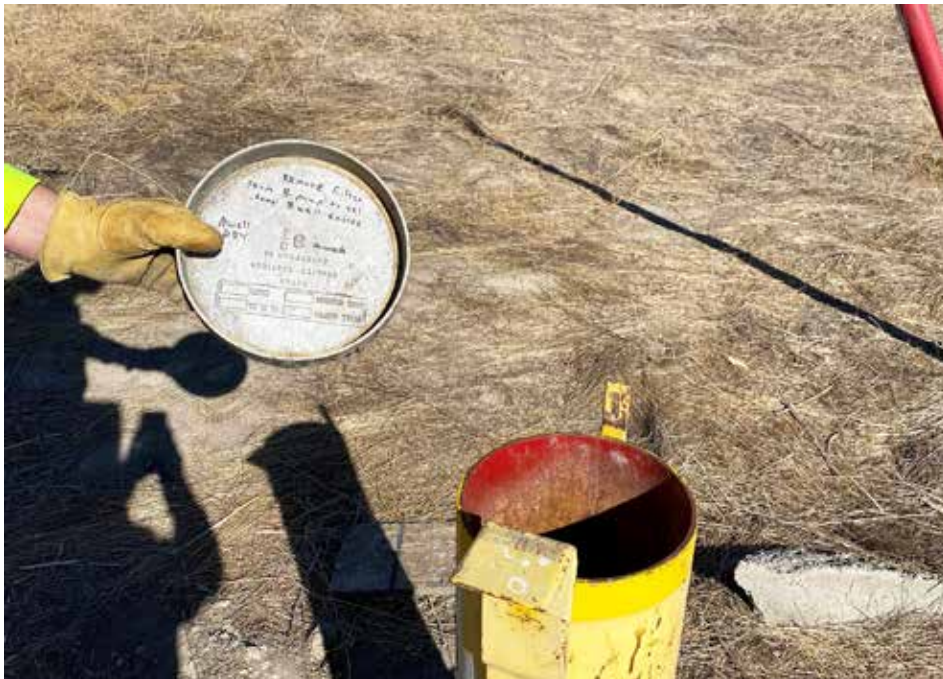
Photo 60 - Pictured is the vertical casing for Compliance Monitoring Well #BSG1135. The casing is secured by the depicted cap and a lock. Each of the three 2-inch monitoring well completions are inside the casing. Each compliance well (10 in total) are a triple completion with each completion (A, B, and C) screened at different vertical heights within the aquifer. BSG1135 is located southeast of the Zone A Plume north of 11800 South and west of Mountain View Corridor.

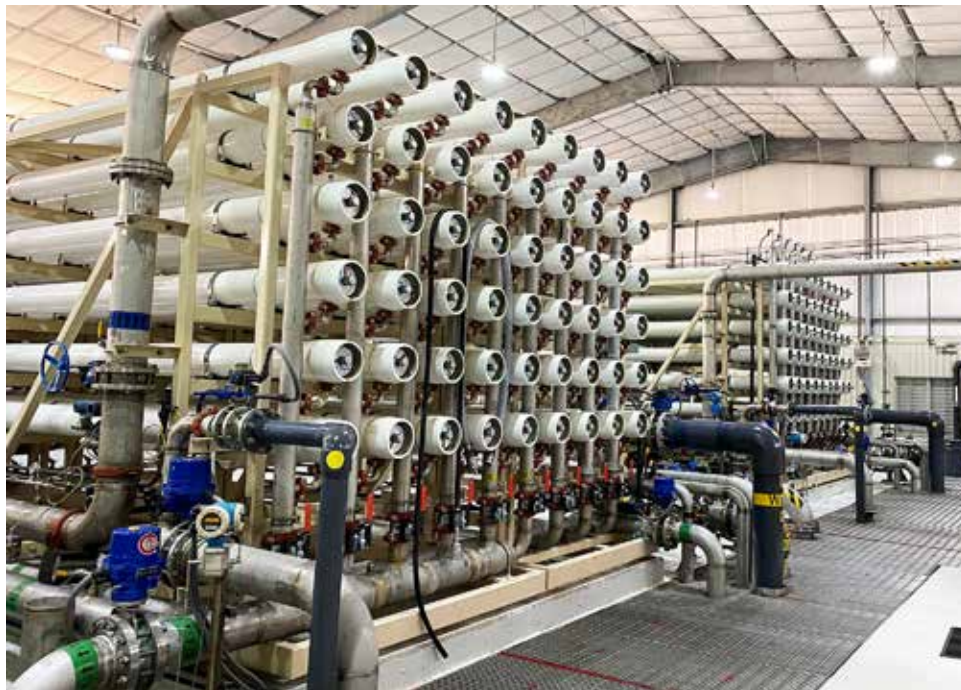
Photo 68 - Pictured are the two RO membrane treatment skids each capable of treating 1,500 gallons per minute (gpm). Each skid consists of two treatment stages, the concentrate or byproduct of the first stage becomes the feed water for the second stage. Each treatment skid is able maintained to have a recovery efficiency of approximately 75%. Each white PVC horizontal vessel holds 7 RO membrane units. No leaks were detected.

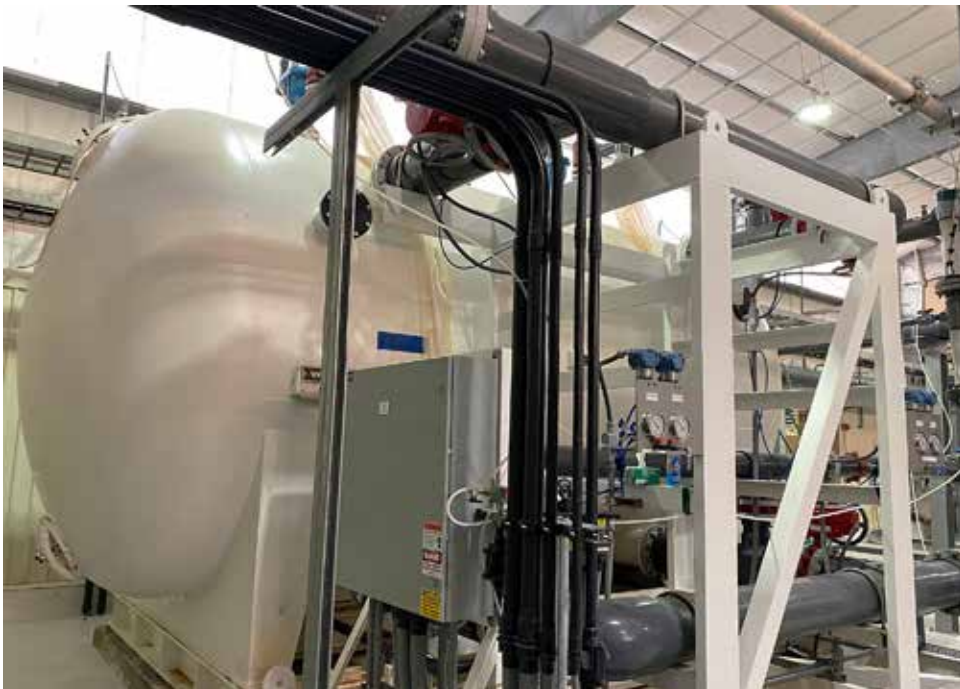
Photo 70 - Pictured is another view of the manganese filtration vessel. No leaks were detected.

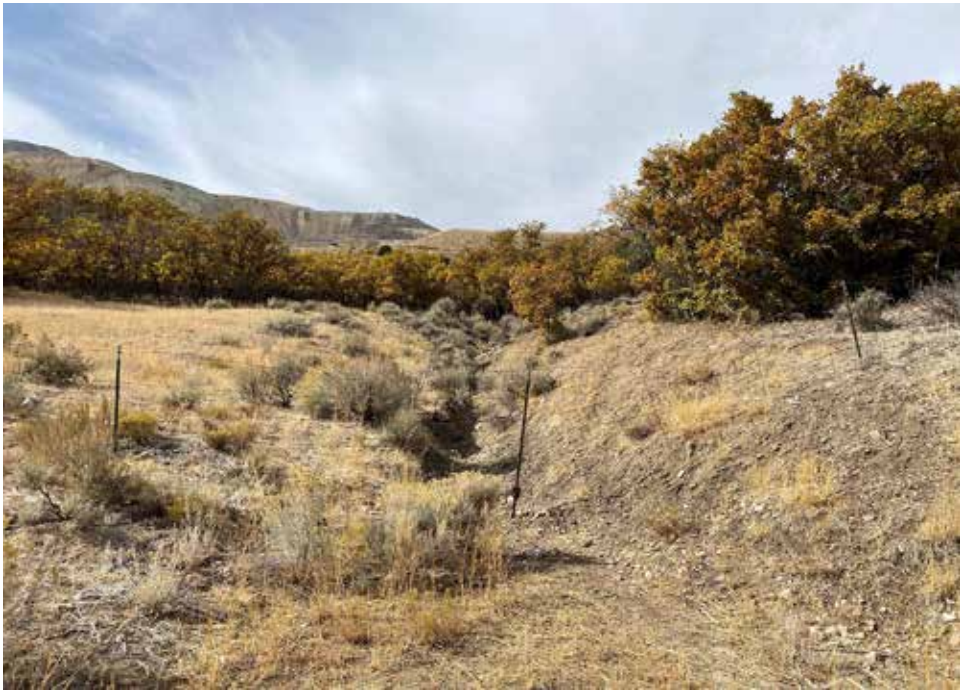
Photo 74 - Pictured is Yosemite Drainage just above the SLCO road in Butterfield Canyon. The Yosemite Drainage is incised along this lower stretch and has previously been impacted by releases of waste rock sediment from the South Waste Rock Dump located in the upper reach of the Yosemite Drainage. The Yosemite Drainage channel is well vegetated with sagebrush, rabbitbrush and grasses but the bottom is comprised of gravelly silt. No signs of recent erosion were observed.

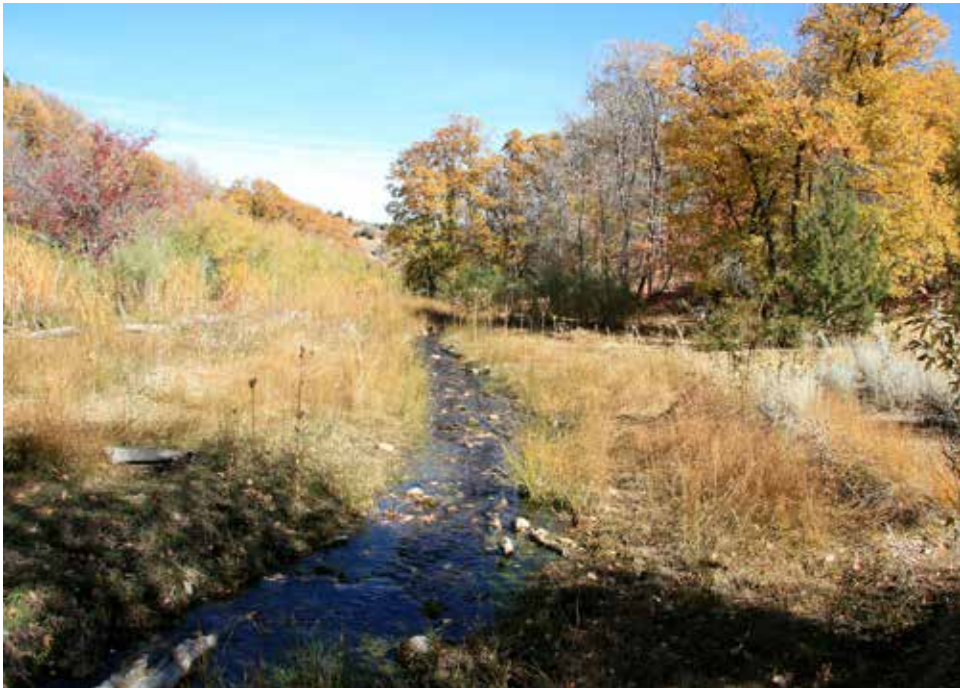
Photo 84 - Pictured is a segment of Butterfield Creek Channel with a shallower channel invert and wider flood plain. In locations where there is a wider floodplain in the Canyon, there tends to be more grasses, willows and tamarisk. No signs of recent erosion were observed.

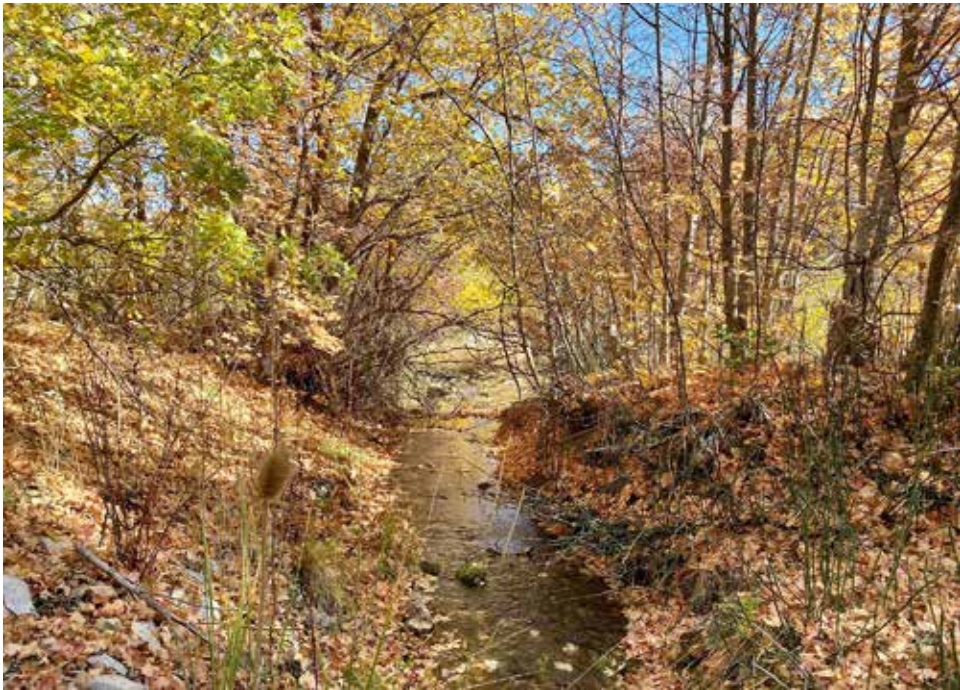
Photo 88 - Pictured is another segment of Butterfield Creek Channel. At times the cottonwoods and aspens in this stretch provide some canopy cover which adds to leaf litter in fall and have stabilized the embankments. No signs of recent erosion were observed.

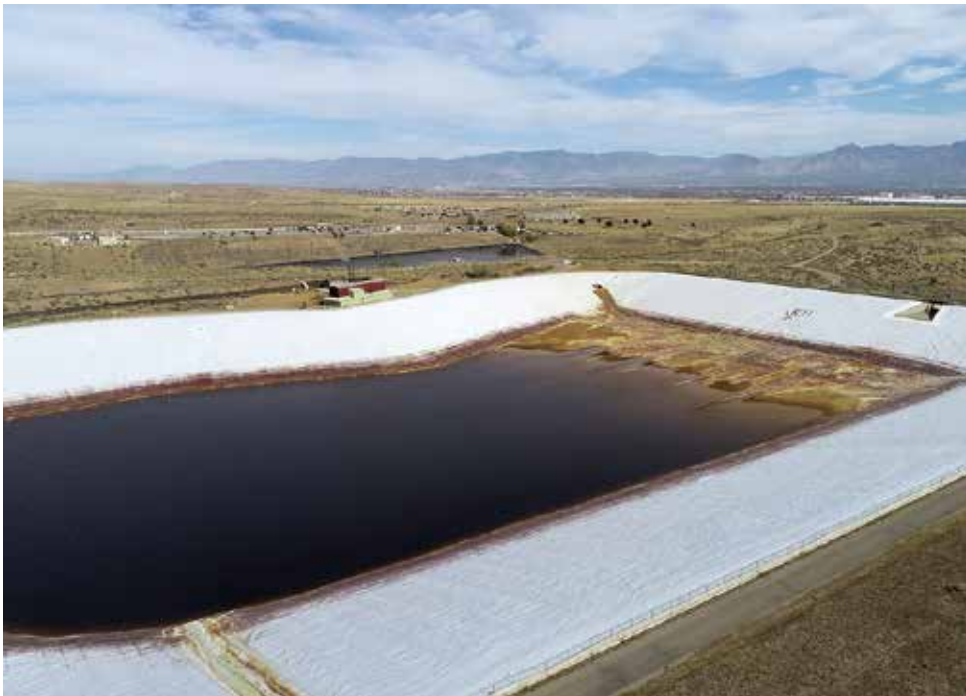
Photo 116 - Pictured is an aerial view of Zone 2 of the Large Bingham Reservoir. Water storage was observed below the high water line, indicative of smaller volumes of acid mine drainage and other waters from mine requiring storage prior to disposal. Water from the two zones is sent to the Waste Water Disposal Pump Station for conveyance to RTKC's North Tailings Impoundment for disposal.

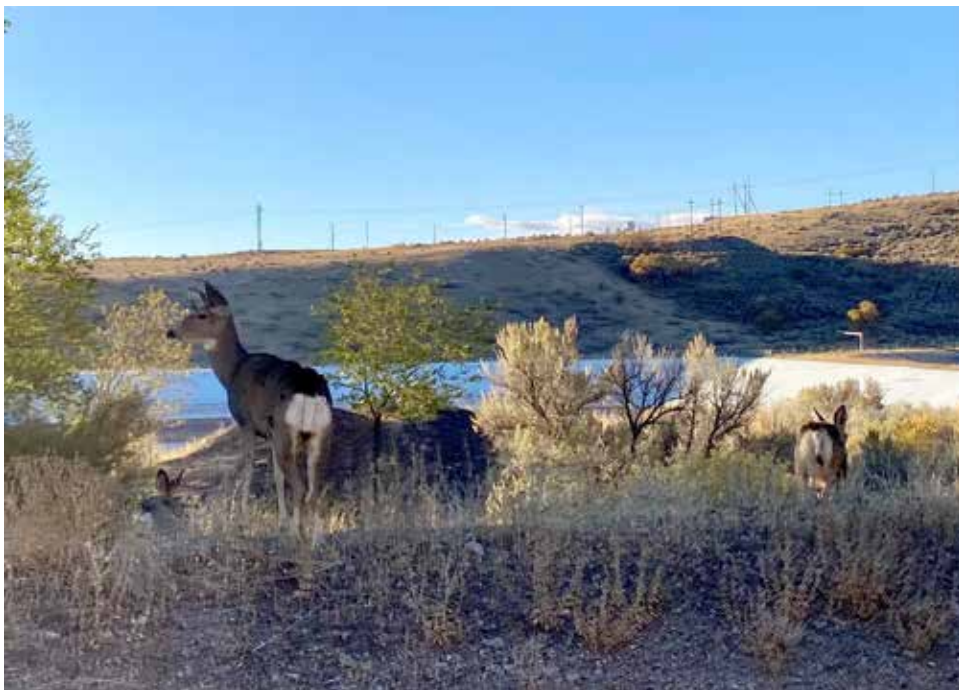
Photo 122 - Pictured are Mule Deer above the Large Bingham Reservoir. Keeping deer out of Reservoir is a high chain link fence. Sometimes deer breach the fence and have been observed in the Reservoir which then requires RTKC to inspect the upper liner on the surface for tears.

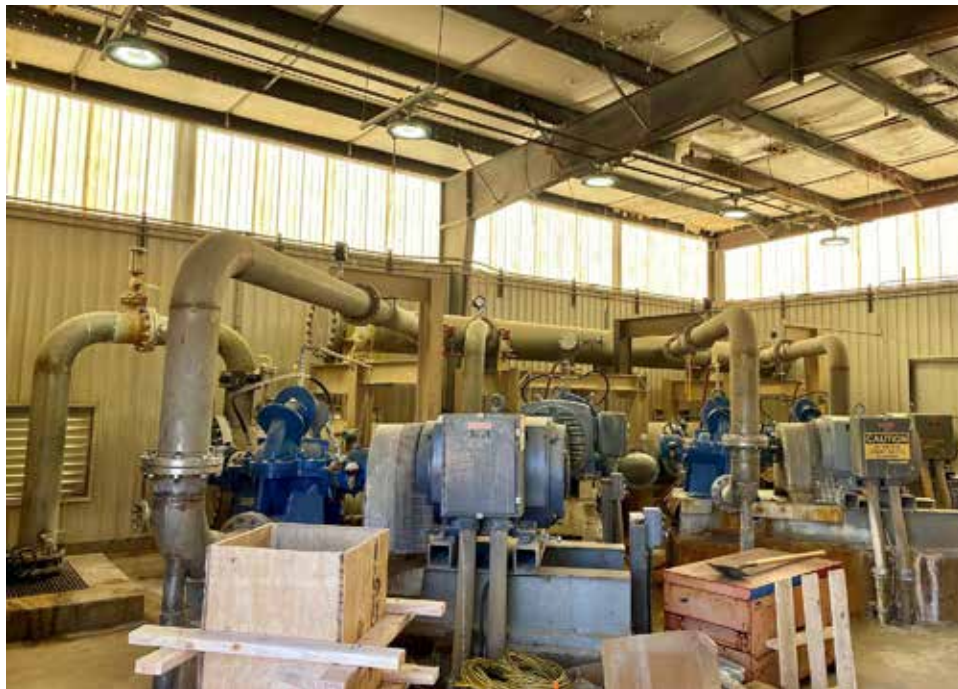
Photo 126 - Pictured is the interior of the WWDPS where the pumps to lift water to the Tailings Pipeline (OU15) are located. No leaks were detected.

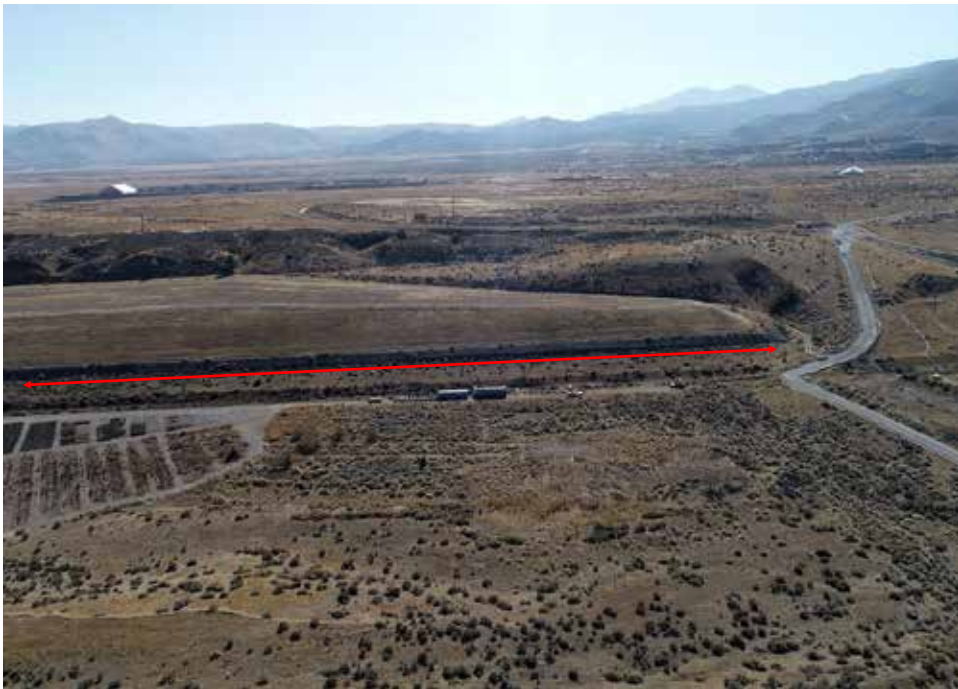
Photo 131 - Pictured is an aerial view of the ARCO Tails Repository's northern embankment. Concrete cribbing (above the red arrow) is used at the base to stabilize the embankment. No changes to the area were observed since last FYR. The land to the south is owned by RTKC.

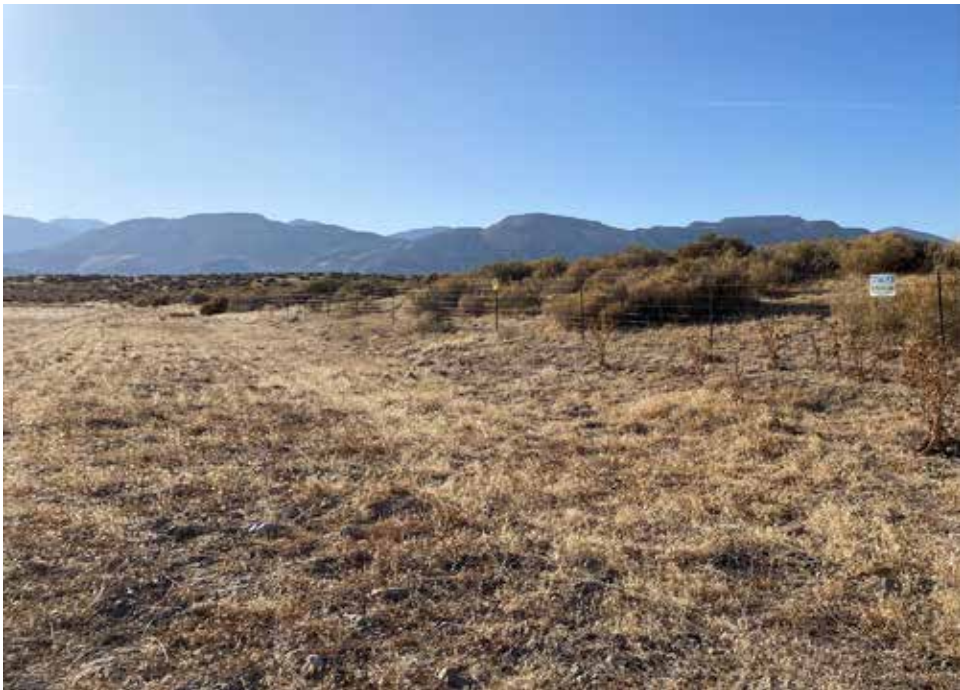
Photo 144 - Pictured is a section of the eastern perimeter fence securing the Lark Tails area. Soils are stable and well vegetated. No erosion was observed.

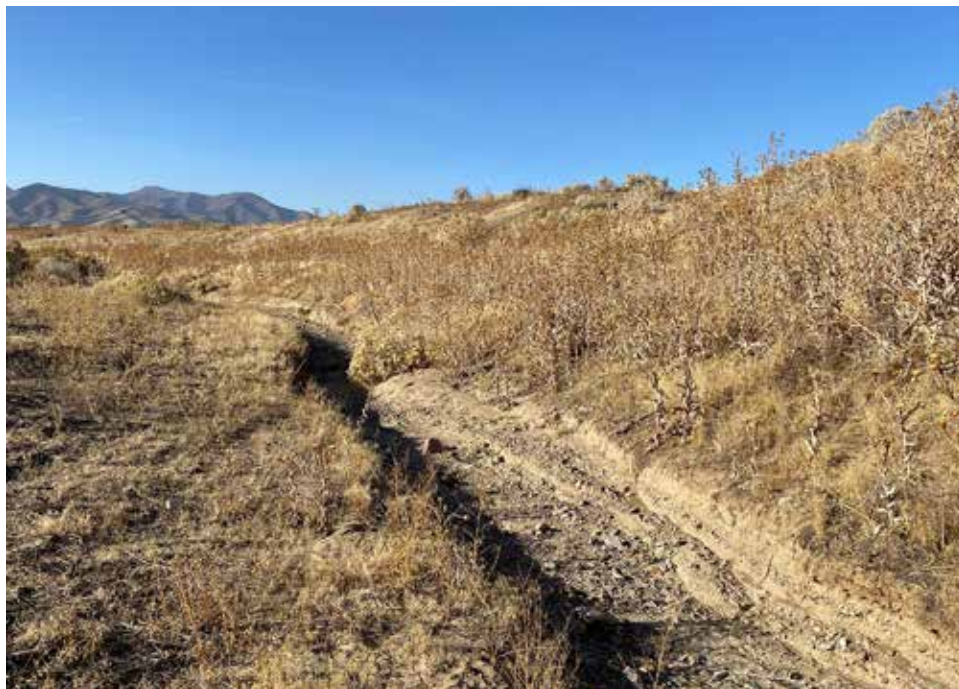
Photo 154 - Pictured is the Midas Creek Channel looking west from the location in photo 153. Soils comprising the bottom of the Creek Channel are silty-sand with some gravel, and stable. No undercutting of the embankment was observed, no erosion was observed. The floodplain is more extensive and well vegetated compared to the Channel itself.

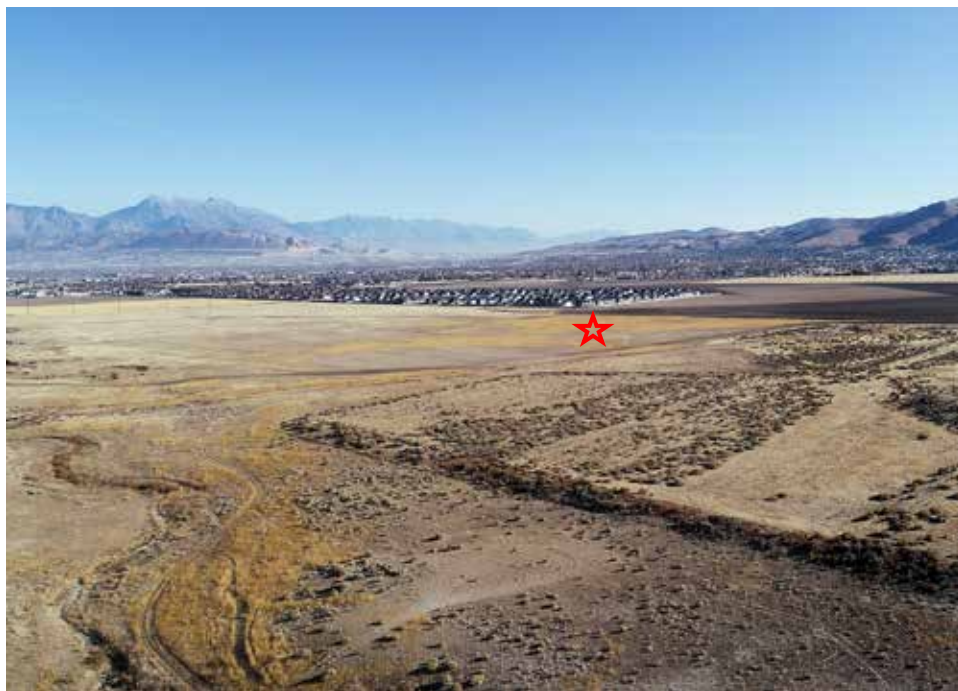
Photo 160 - Pictured is an aerial view near the northeast corner of the Lark Tails area and Midas Creek Channel. The red star denotes the historical location of the Southeast Tails area at OU6. Edge Homes is constructing a residential development east of the Southeast Tails area. The property east of OU6 prior to being transferred to SLR by RTKC was accessed to determine if soils exceed the site KUALs, RTKC did perform some further removal work for soils above the KUALs.

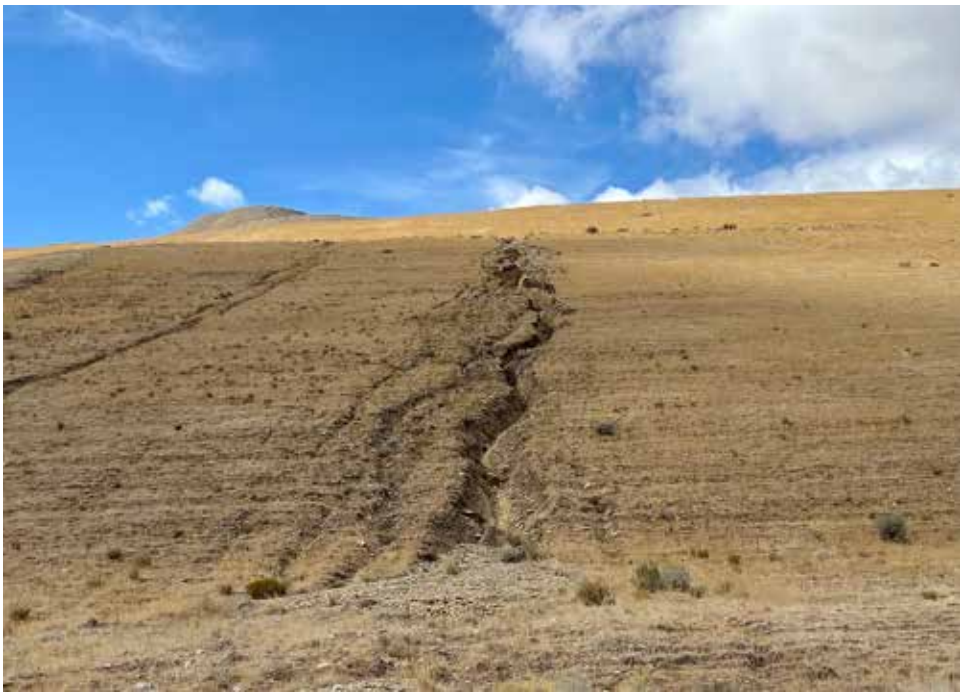
Photo 189 - Pictured is a section of one of the lower rail dumps of the Bingham Mine Eastside Waste Rock Dumps located in the Bluewater 1 Drainage. The rail dump was constructed in a manner that can facilitate erosional gullies along the dump's slope as depicted here. RTKC periodically repairs the erosional gullies.

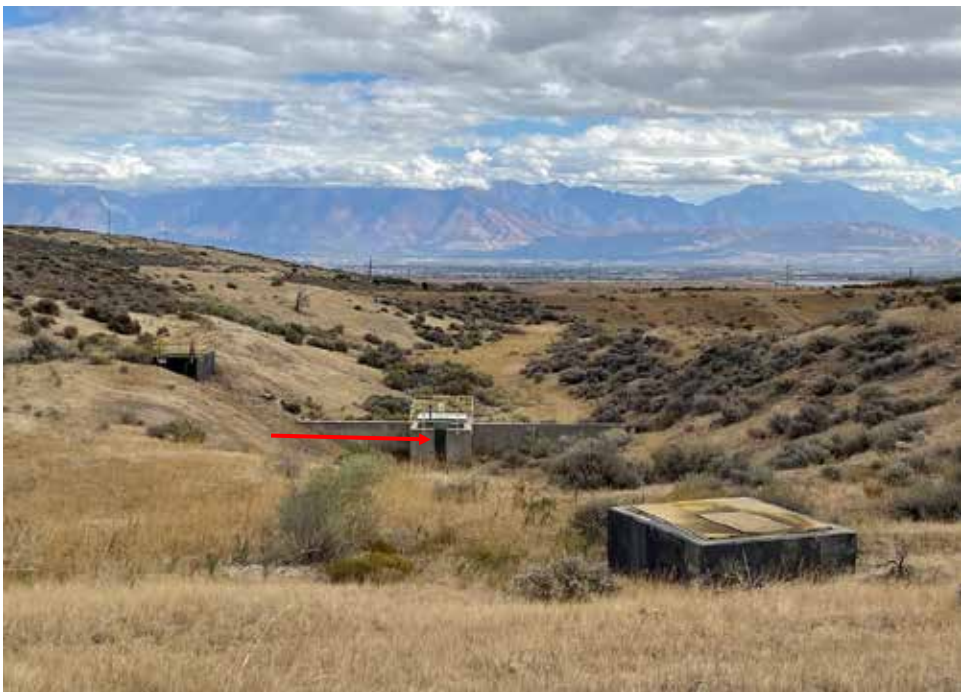
Photo 191 - Pictured is a closeup of the Lower Bluewater 1 Cutoff Wall. Both cutoff walls in Bluewater I were observed to be free of debris and no sediment buildup. The red arrow denotes the storm water runoff sump for the lower wall.

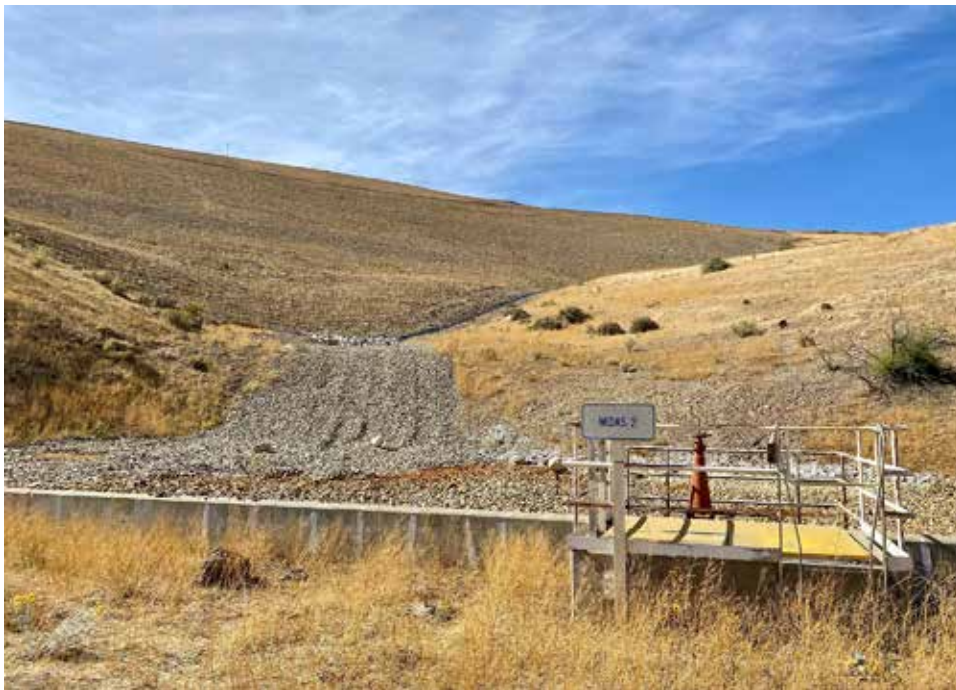
Photo 195 - Pictured is the Midas 2 Cutoff Wall located in the northern portion of the Midas drainage. The gravel bed is used to help dissipate the energy of storm water runoff from the upgradient sediment basin and to facilitate drainage to the cutoff wall surface water sump. The Midas 2 Cutoff Wall appeared to be in good condition.
