SECOND FIVE-YEAR REVIEW REPORT FOR
KENNECOTT (SOUTH ZONE) SUPERFUND
ALTERNATIVE SITE
SALT LAKE COUNTY & TOOELE COUNTY, UTAH

Utah Department of Environmental Quality
Division of Environmental Response & Remediation
Salt Lake City, Utah

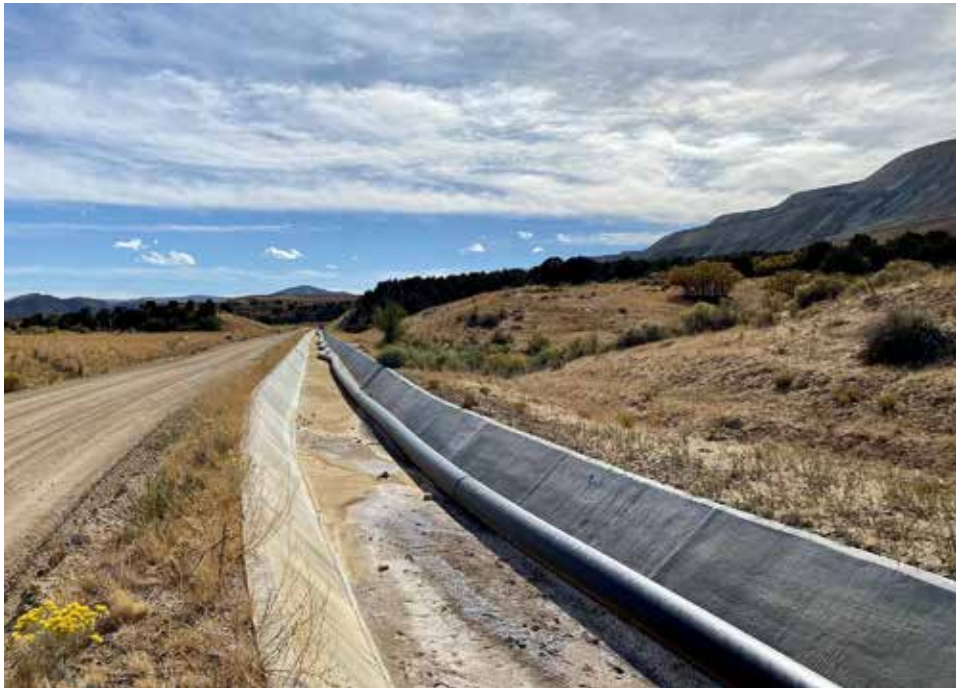
Photo 197 - Pictured is a close up of the cement lined canal and the Water Collection System HDPE pipe. Water and sediment in the canal tend to be indicative of localized storm water runoff. RTKC has not reported any operational issues with pipeline.
