SEVENTH FIVE-YEAR REVIEW REPORT FOR ROSE PARK SLUDGE PIT SUPERFUND SITE SALT LAKE COUNTY, UTAH

Utah Department of Environmental Quality
Division of Environmental Response and Remediation
For
U.S. Environmental Protection Agency
Region 8
DENVER, COLORADO

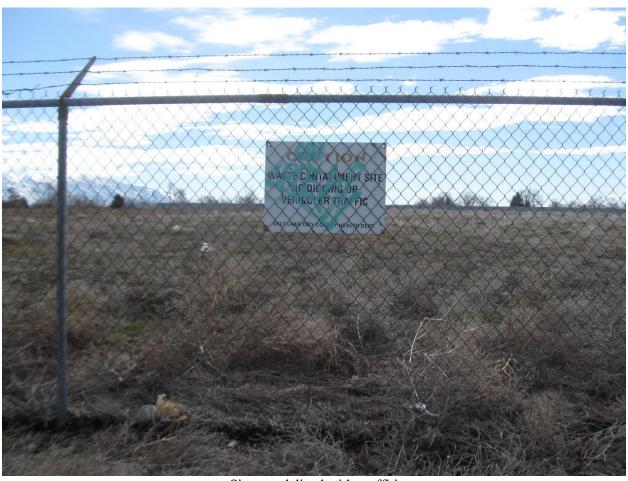
With the exception of one sign that had been vandalized with graffiti, signs informing the public that the Site is a waste contamination Site and digging and vehicle traffic are not allowed were found to be legible and in good condition. The sign that had been vandalized with graffiti was located on the Site's northern fence line.

Sign vandalized with graffiti

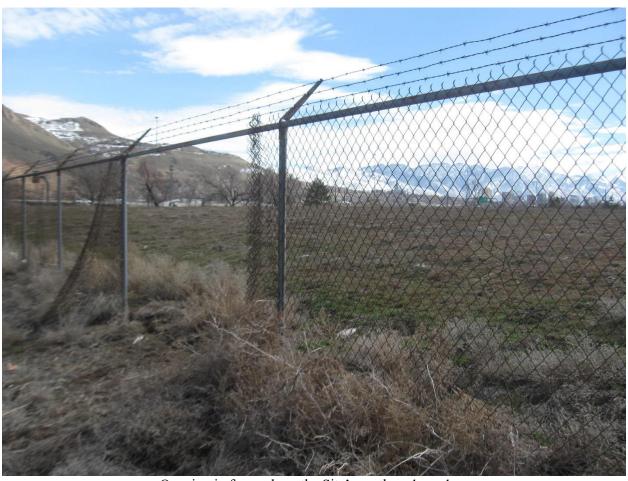
The inspection found all monitoring wells were properly secured/locked and in good condition. The chain link fence had been cut and rolled back to create an opening at two separate locations along the Site's north boundary. These opening are not deemed to be an immediate threat to the integrity of the cap since vehicle access points located along 1200 West are restricted by fences and barricades that are adjacent to the Site.

Opening in fence along the Site's northern boundary

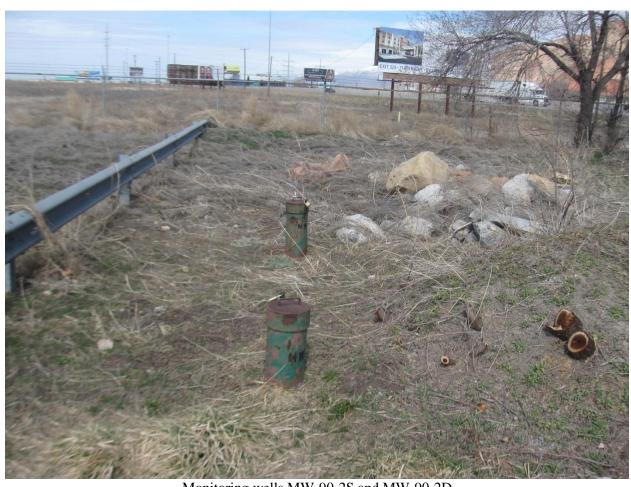
Monitoring wells MW-90-2S and MW-90-2D

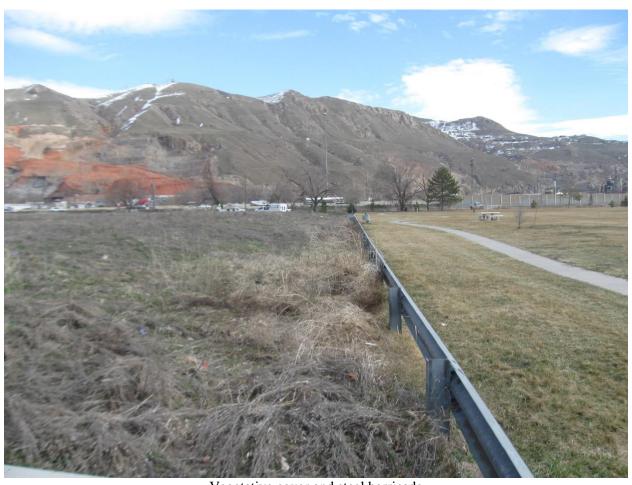
The cap, which supports a variety of grasses and weeds, was observed to be in good condition and prevents exposure to the wastes contained in the repository. Surface water appeared to be draining off the cap with no signs of erosion or ponding on the cap's surface. No trees or shrubs were growing on the cap. However, signs of burrowing animals on and around the cap were observed during the inspection. These burrows were small and not deemed to be a threat to the integrity of the cap since no evidence of waste material was observed.

Vegetative cover and steel barricade

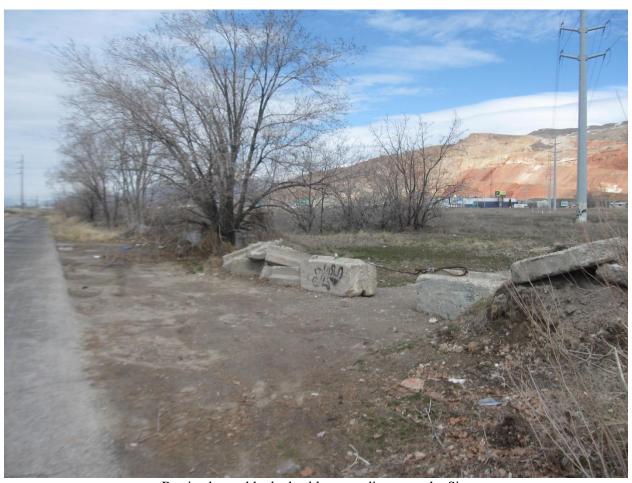
Barricades and locked cable gate adjacent to the Site
