# **Appendix I**

## **Site Inspection Photos and Observations**

**I. OU3 Herriman Agricultural Properties**

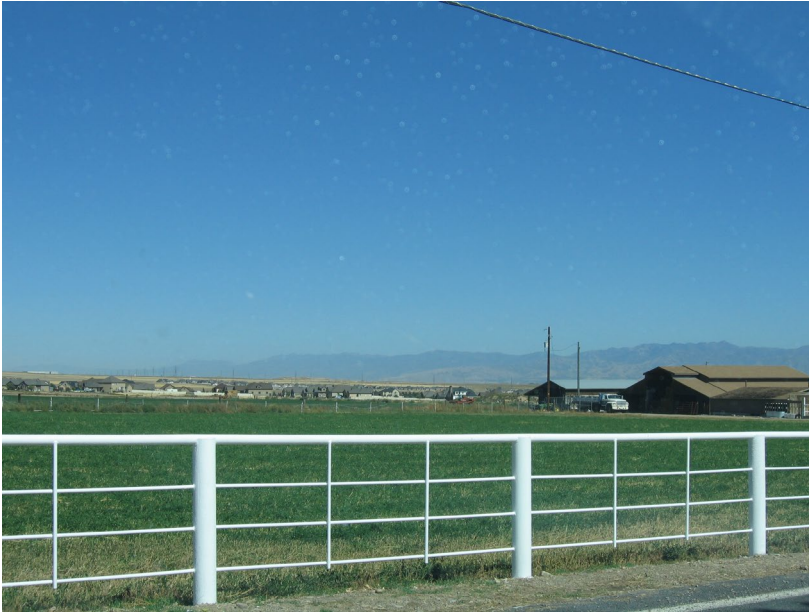
**Figure No. 1:** Typical agricultural property in use in the Community of Herriman.

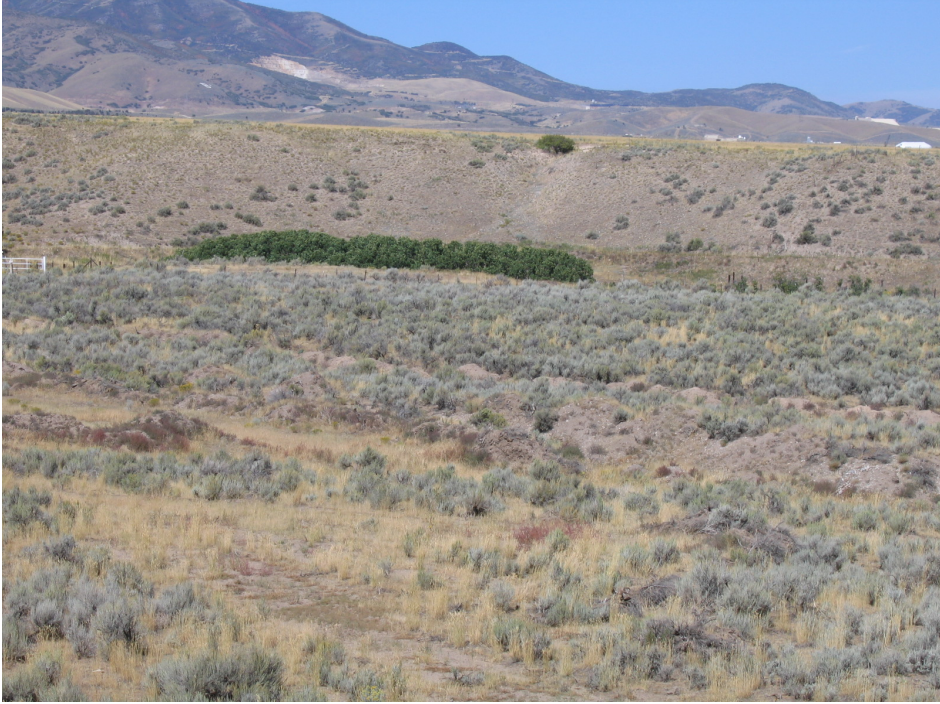
**Figure No. 3:** Pictured is a section of agricultural land not being farmed. As noted, native and weedy vegetation begins to become more prevalent as the cover vegetation when fields are left to fallow. The patch of dark green vegetation demarks the alignment of Butterfield Creek which is a losing stream in this stretch.

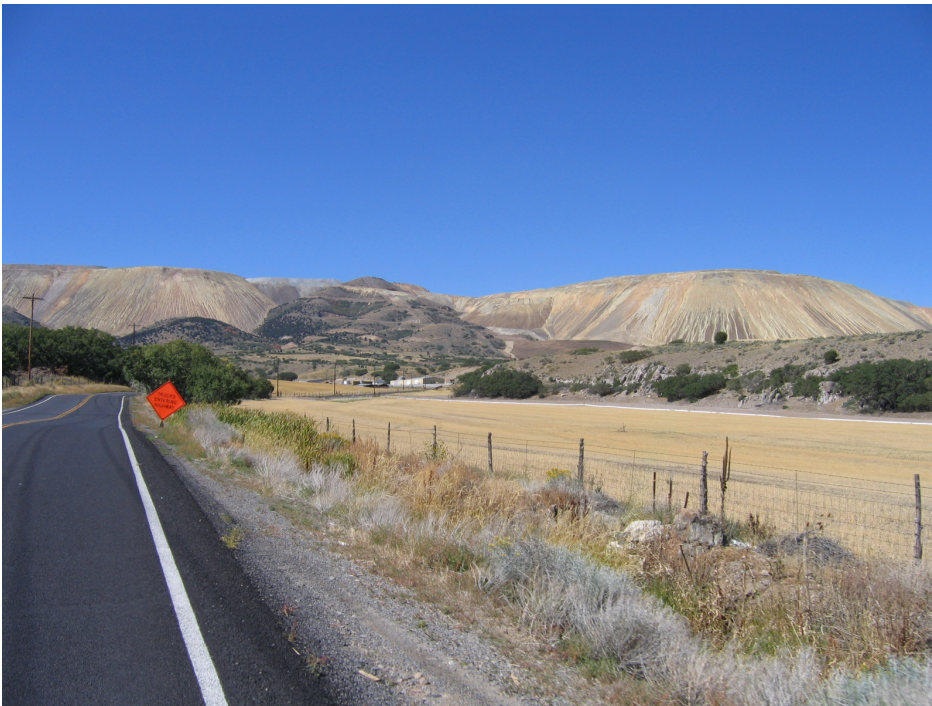
**Figure No. 4:** Pictured is the western extent of the draw associated with Butterfield Creek and the Bingham Mine waste rock dumps in the background. Pictured are farm lands associated with HAG001.

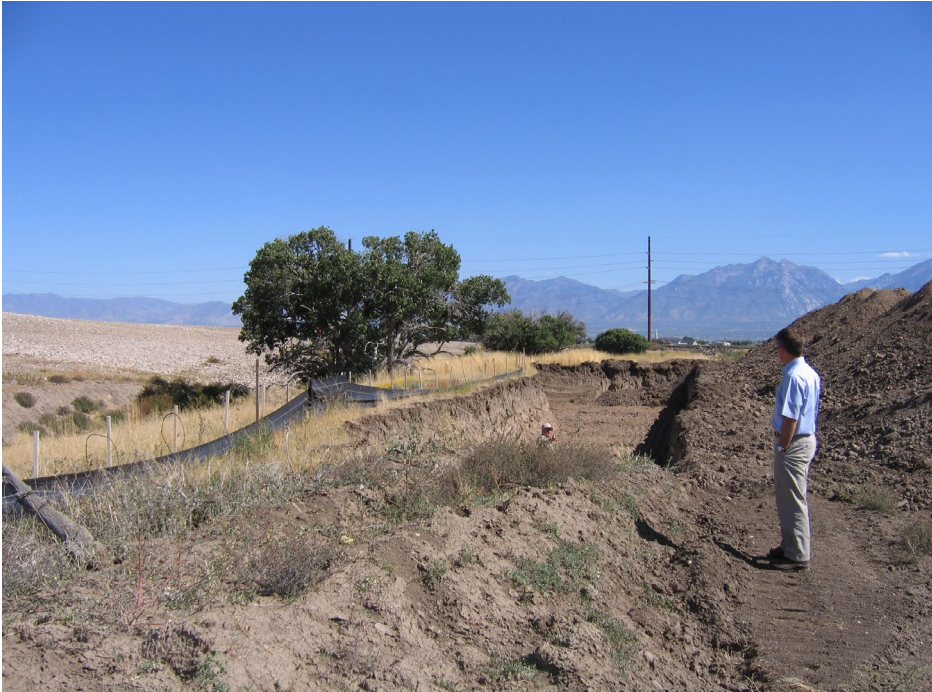
**Figure No. 5:** Blackhawk development excavation trench or pit.

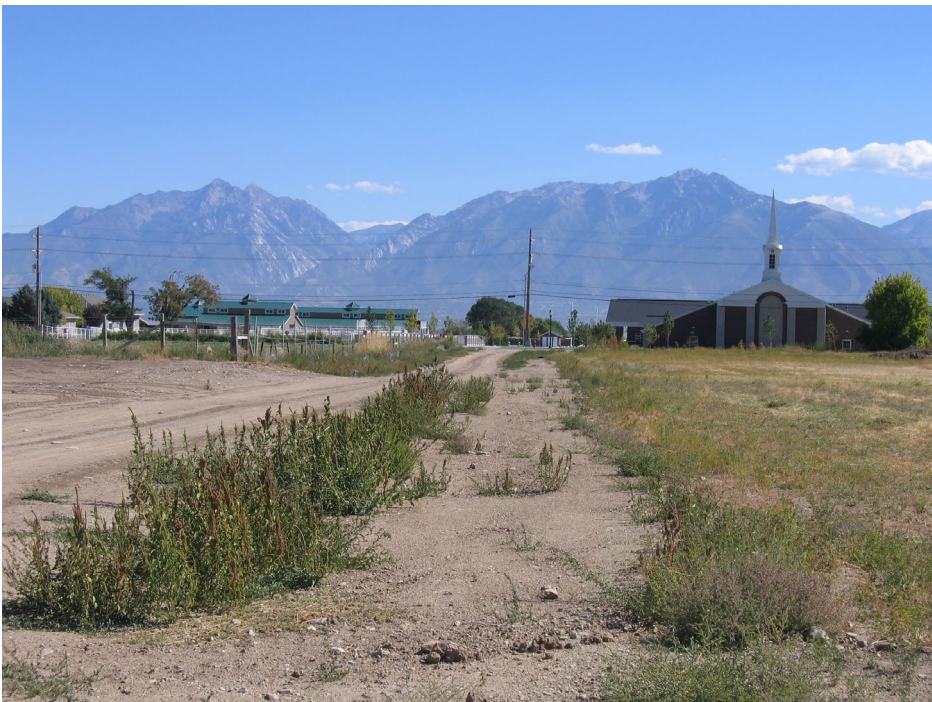
**Figure No. 6:** Alignment of buried flood control/storm water sewer conduit near 6000 West.

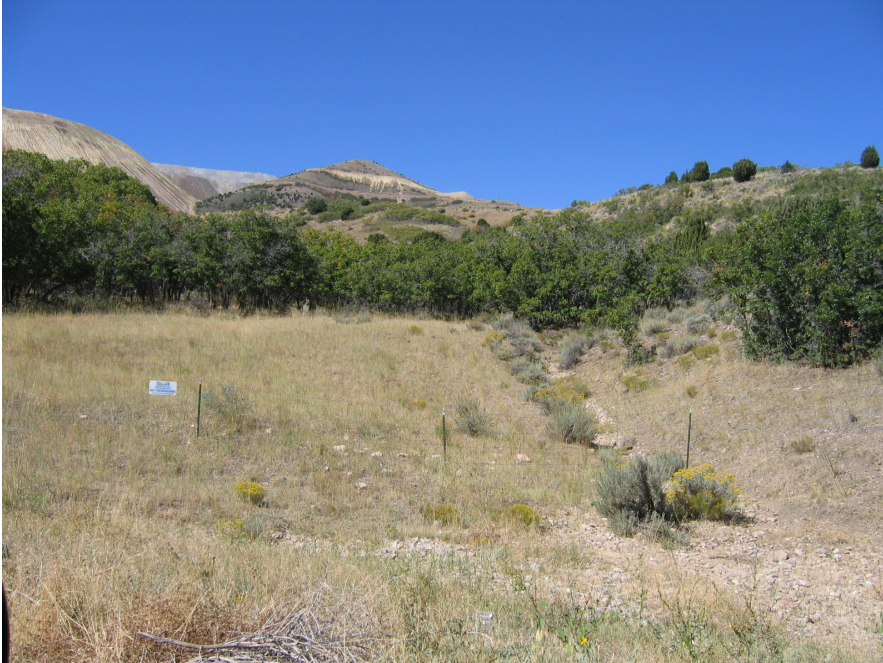
**Figure No. 7:** Pictured is the area of the confluence of Yosemite drainage and Butterfield Canyon north of the County road (1 year and 2 months after a release from the Yosemite Waste Rock Dump in the upper reaches of the drainage, See Appendix D).

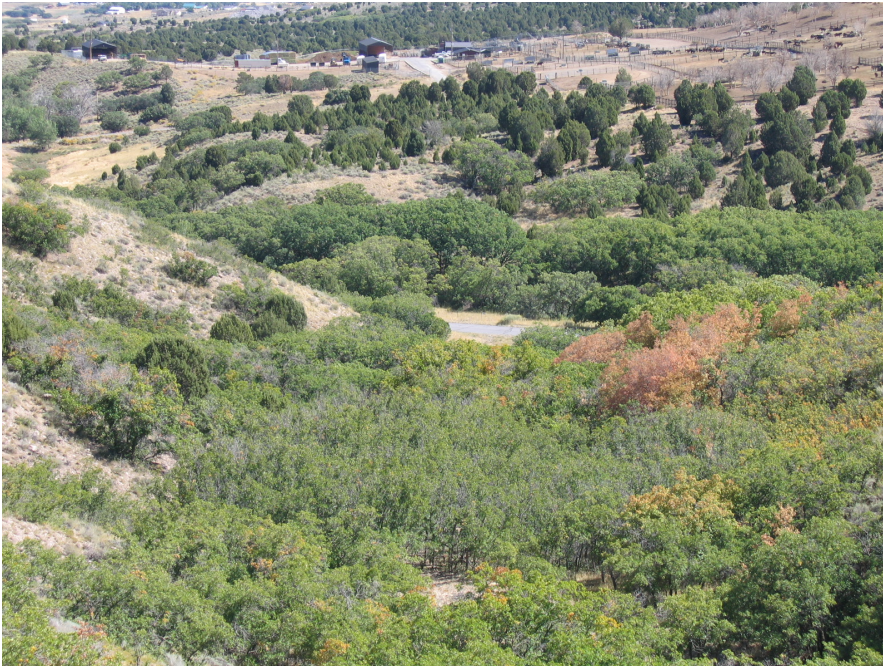
**Figure No. 8:** Lower Yosemite drainage from above the confluence location with Butterfield Canyon.

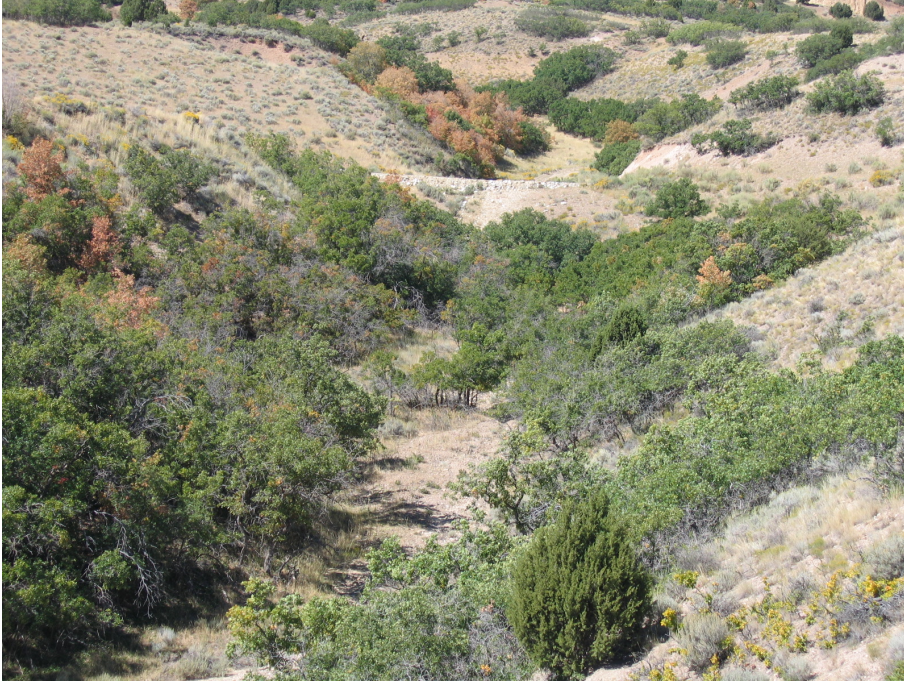
**Figure No. 9:** Up-gradient storm water catch basin (a portion of the Eastside Collection System) in upper Yosemite drainage.

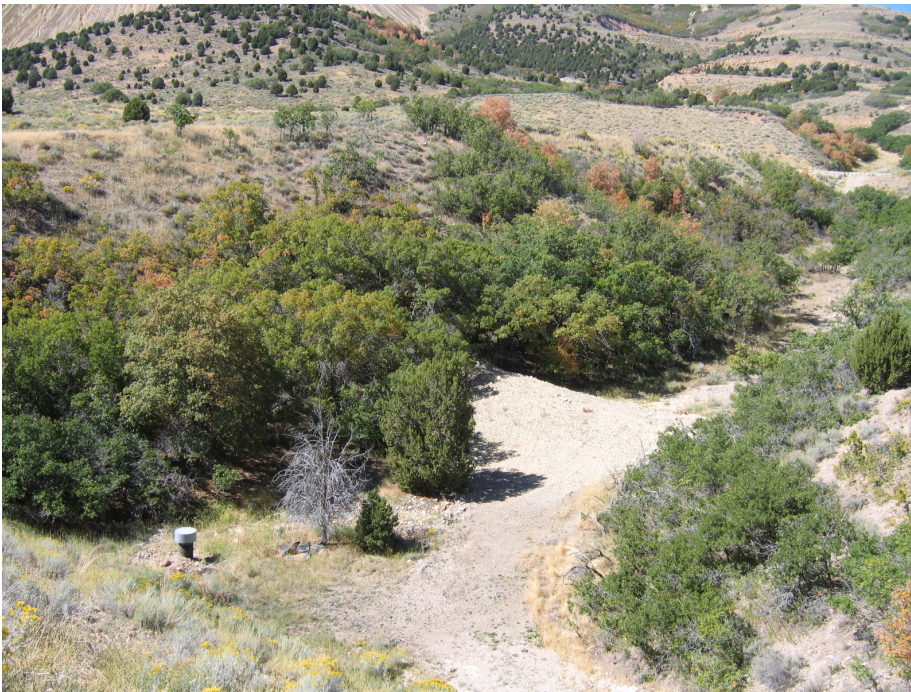
**Figure No. 10:** Pictured is the upper reach of Yosemite drainage. Note the reconstructed drain near the base of the dam. This area is a desilting basin and the drain allows decant water to flow down Yosemite drainage.

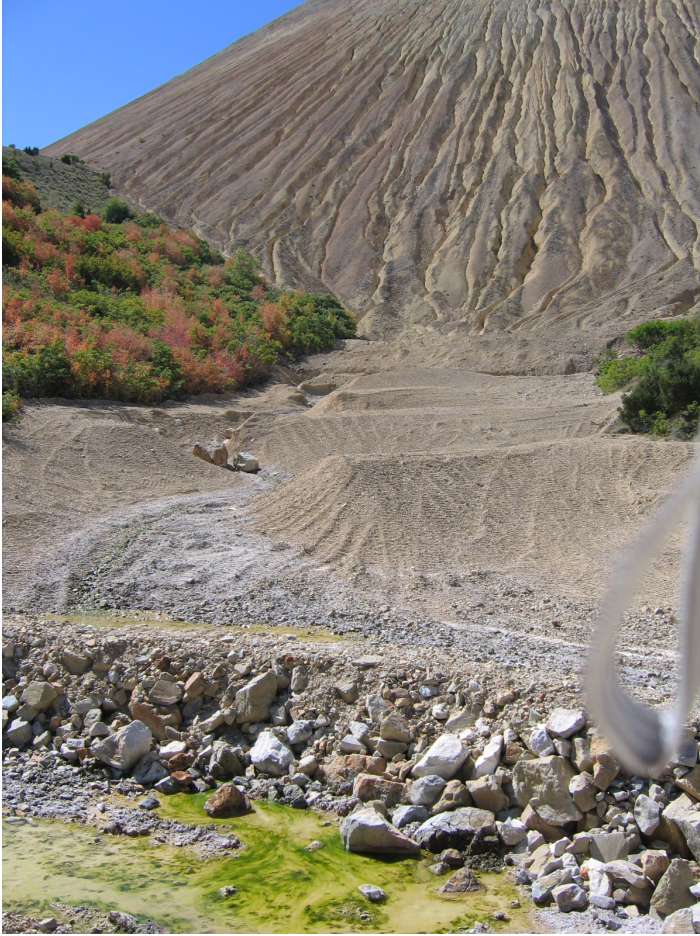
**Figure No. 11:** Base of Yosemite waste rock dump and reconstructed sedimentation traps.

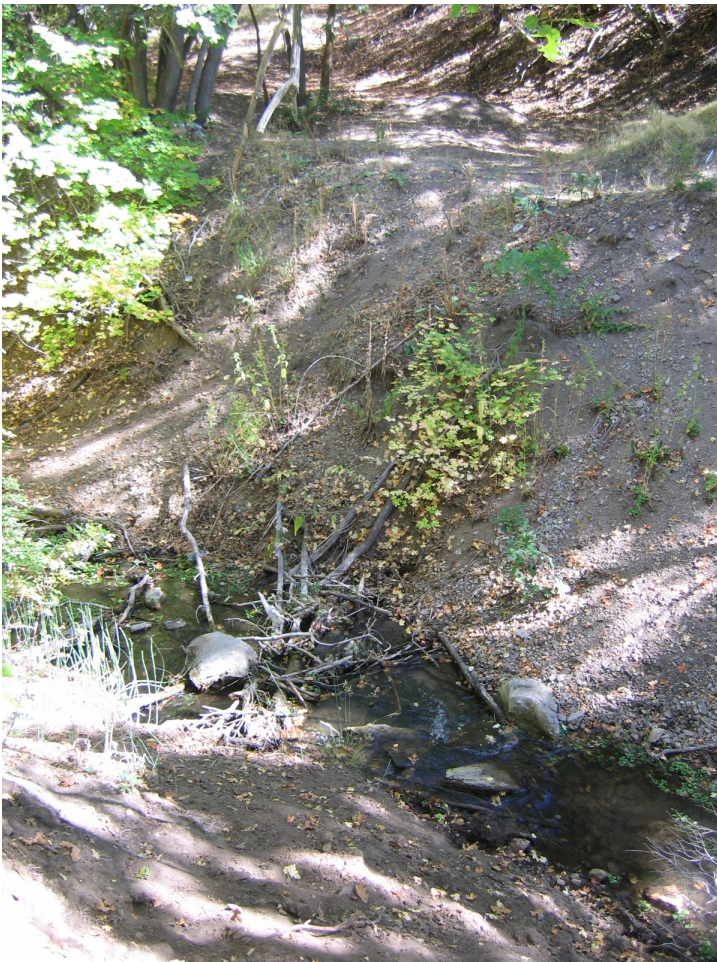
**Figure No. 14:** Pictured is Butterfield Creek channel up-gradient of the Yosemite drainage confluence.

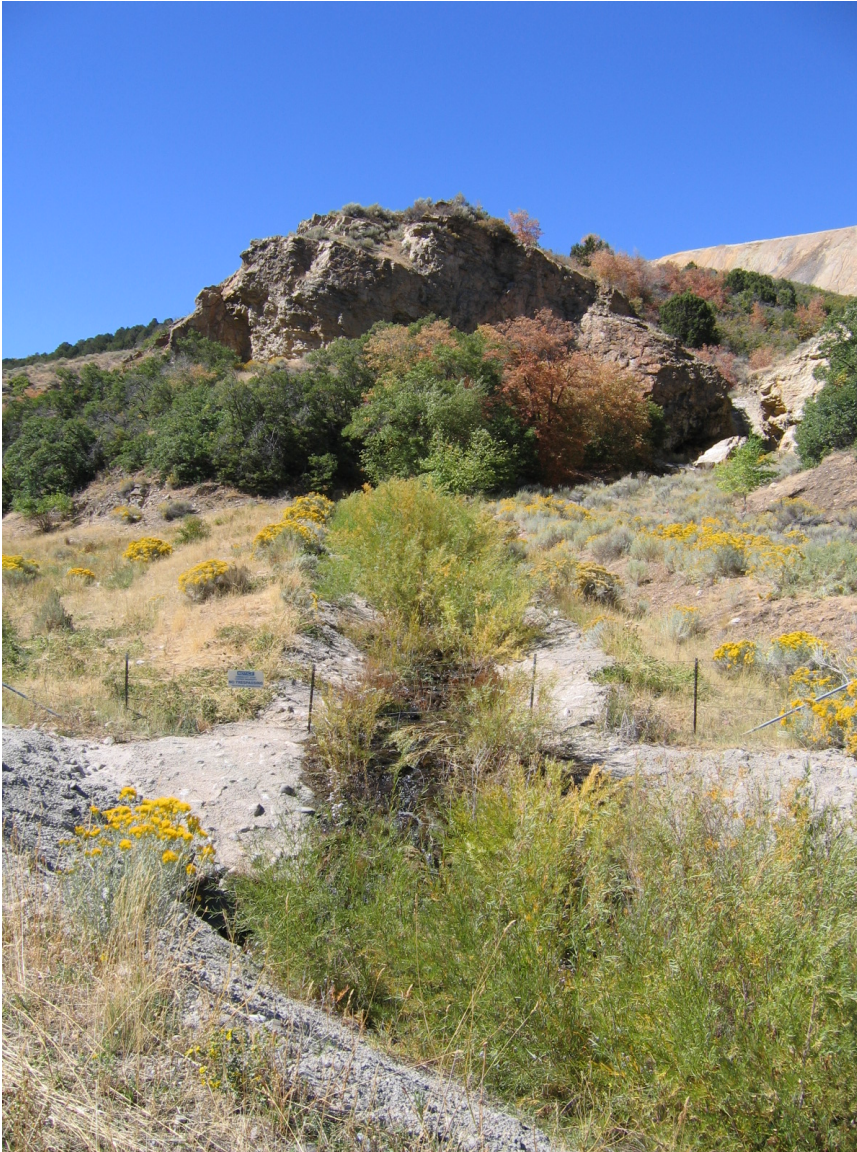
**Figure No. 15:** Pictured is the adit drain of the Butterfield Mine Tunnel (adit is near rock outcrop). Waste rock was removed from around and near this portal during the removal action.

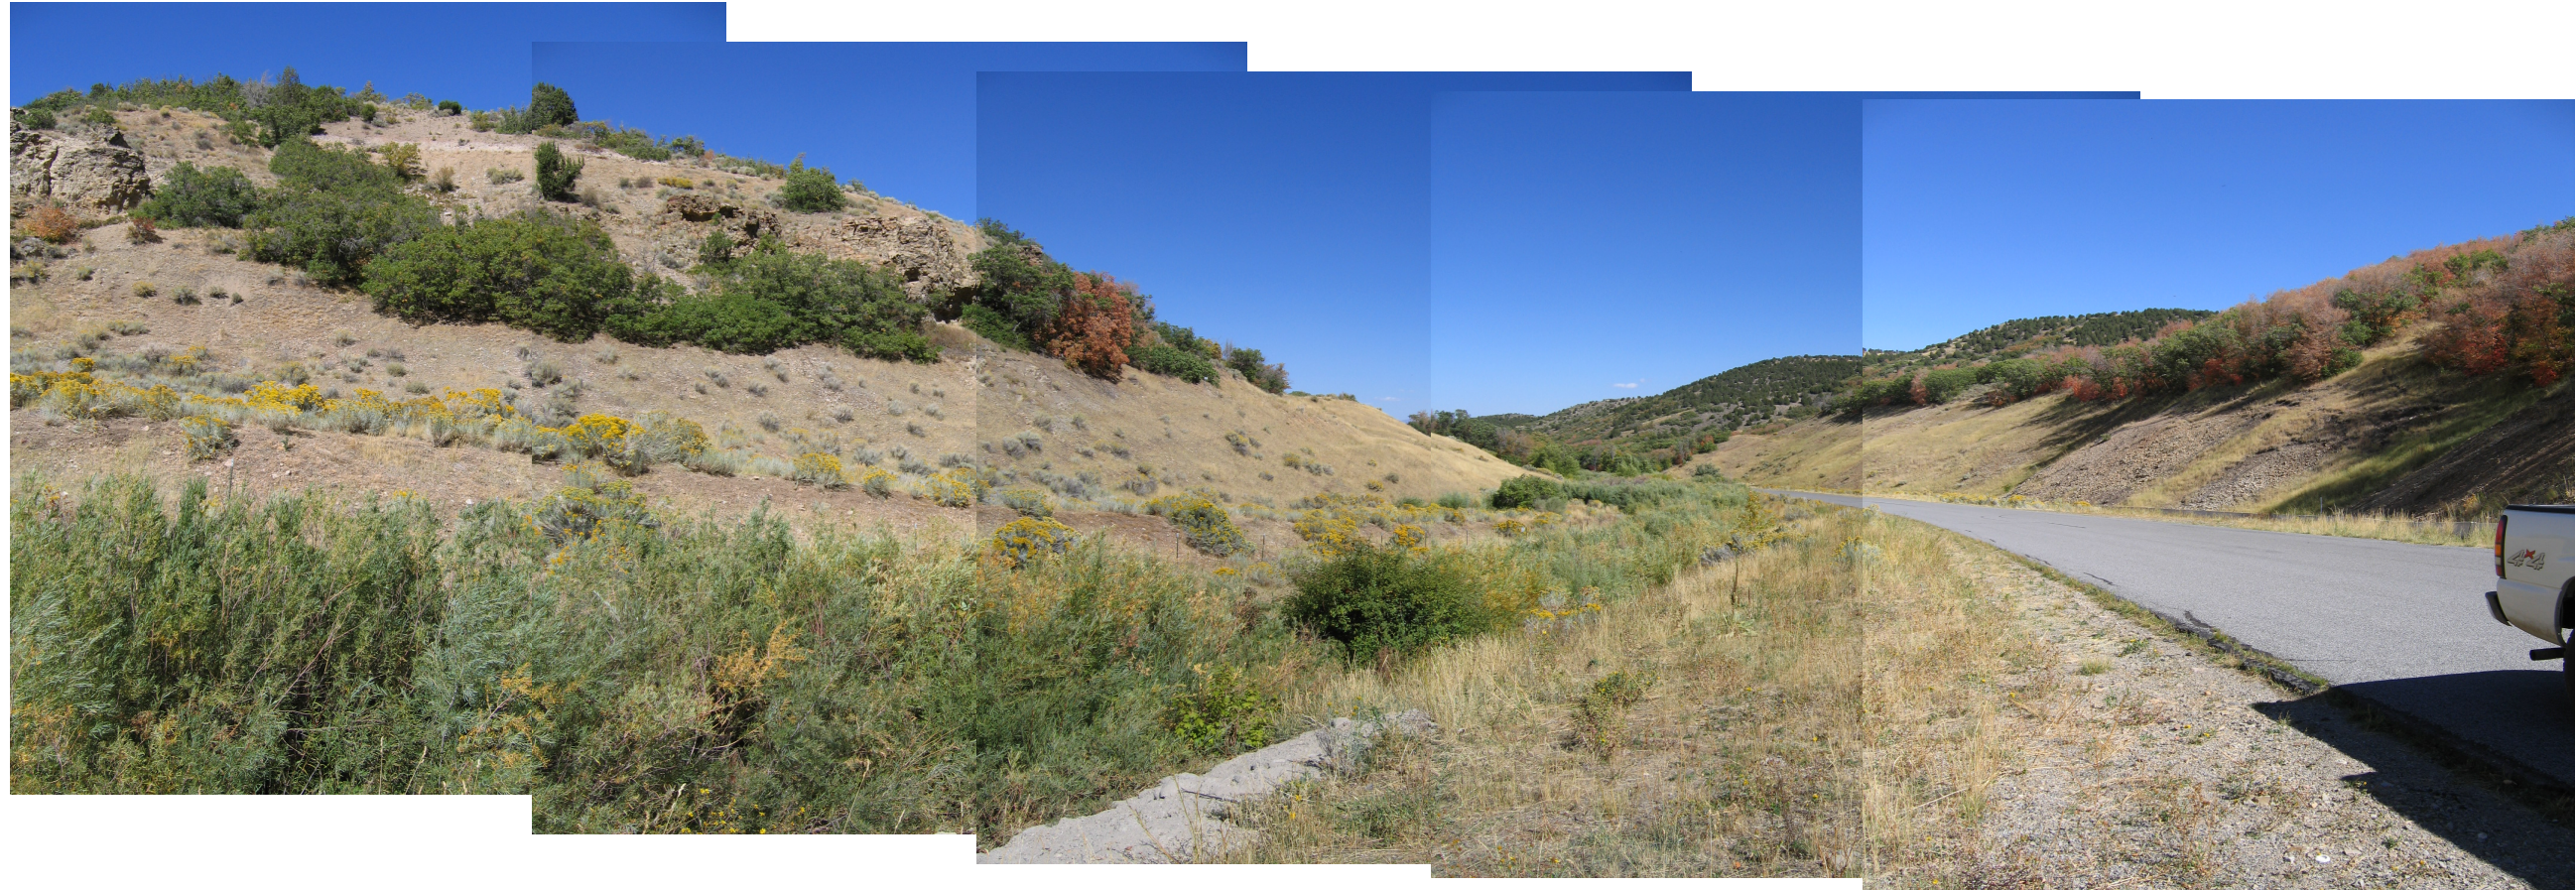
**Figure No. 16:** Pictured in this panorama is Butterfield Canyon just below the Butterfield Mine Tunnel. This is the area from where waste rock was removed.

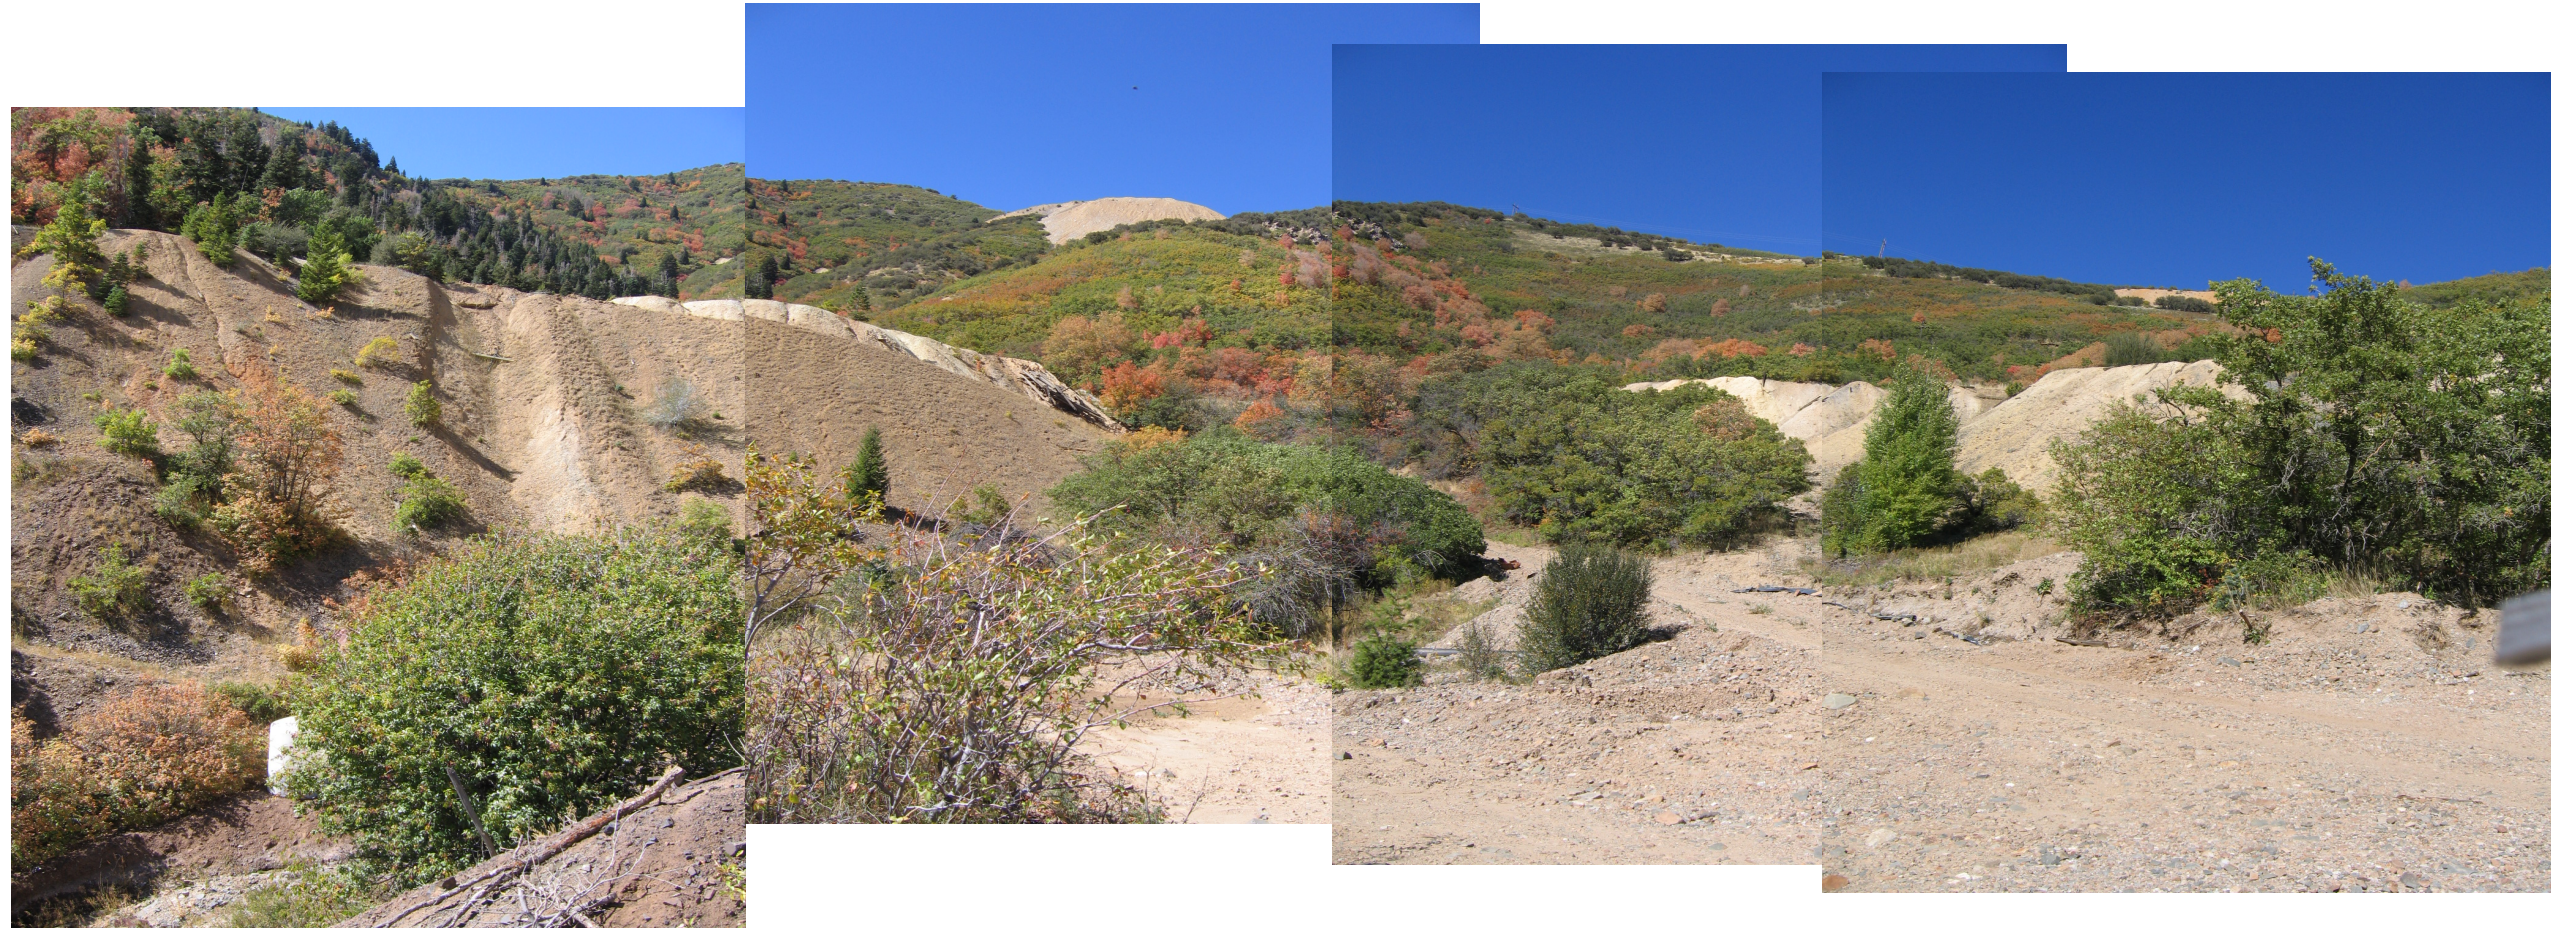
**Figure No. 17:** Pictured is the Queen Mine in Queen's drainage. This series of panorama photos try to show the extent of tailings and waste rock piles remaining in place.

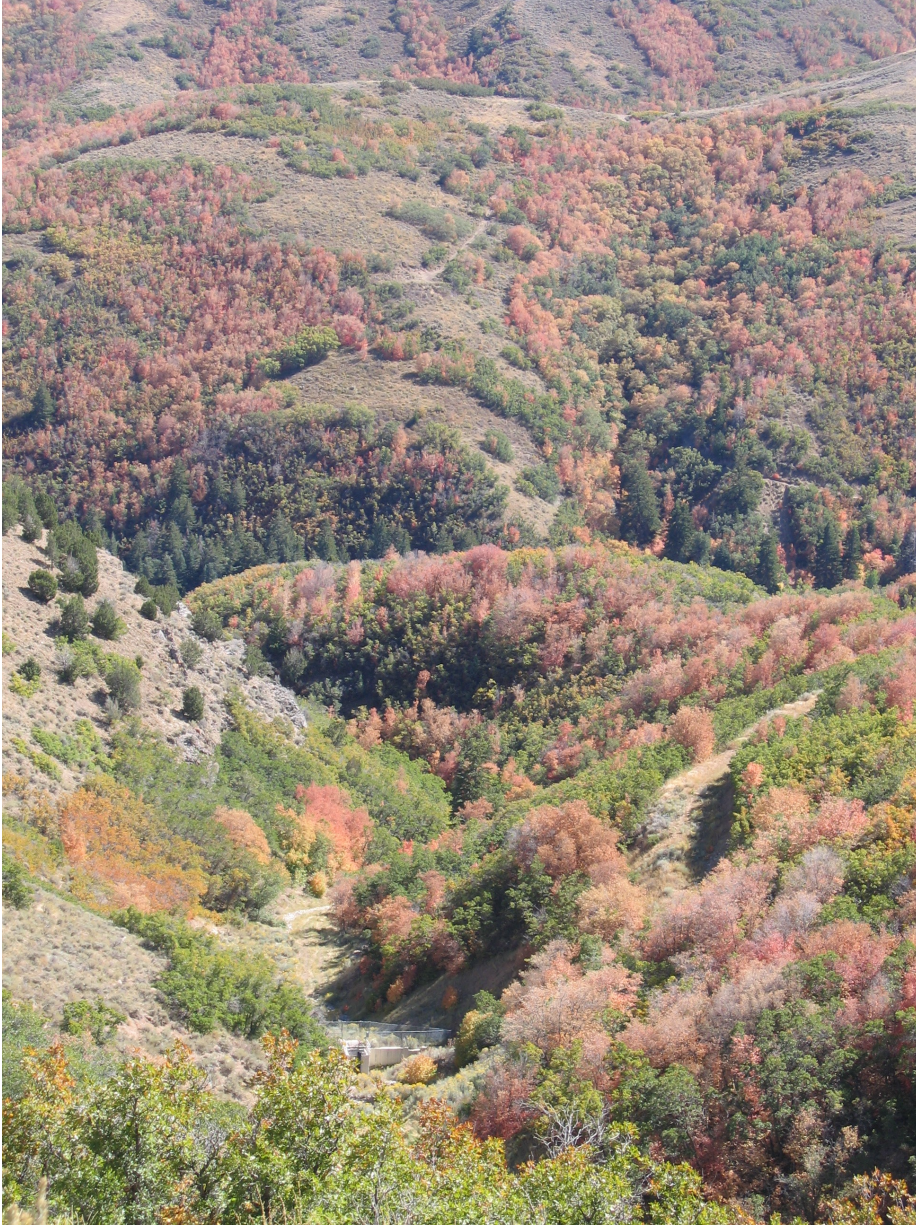
**Figure No. 18:** Queen drainage just below the Queen Mine site. Pictured is the Eastside Collection System cut-off wall (concrete structure in the first clearing). In the distance and at the base of the drainage is Butterfield Canyon recreational area. Photo was taken from approximately the same vantage point as Figure No. 17.

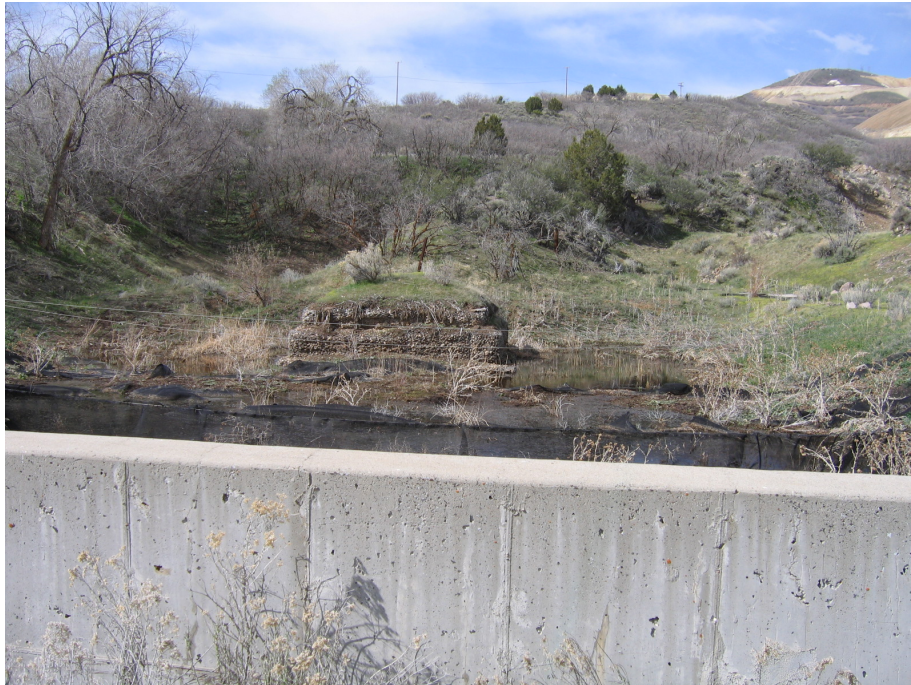
**Figure No. 19:** Pictured is the Lower Keystone Drainage and cutoff wall. Early response work tried an experimental surface sulfide reducing bioreactor wetland near the wall (black sheeting material) to address surface flows with elevated sulfate; which subsequently was assessed unsuccessful. This cutoff wall is part of the larger Eastside Collection System, which manages potentially mine impacted waters filtering through the up gradient alluvium and flowing surface water. The Eastside Collection System is operated in compliance with a State of Utah Groundwater Pollution Protection permit.

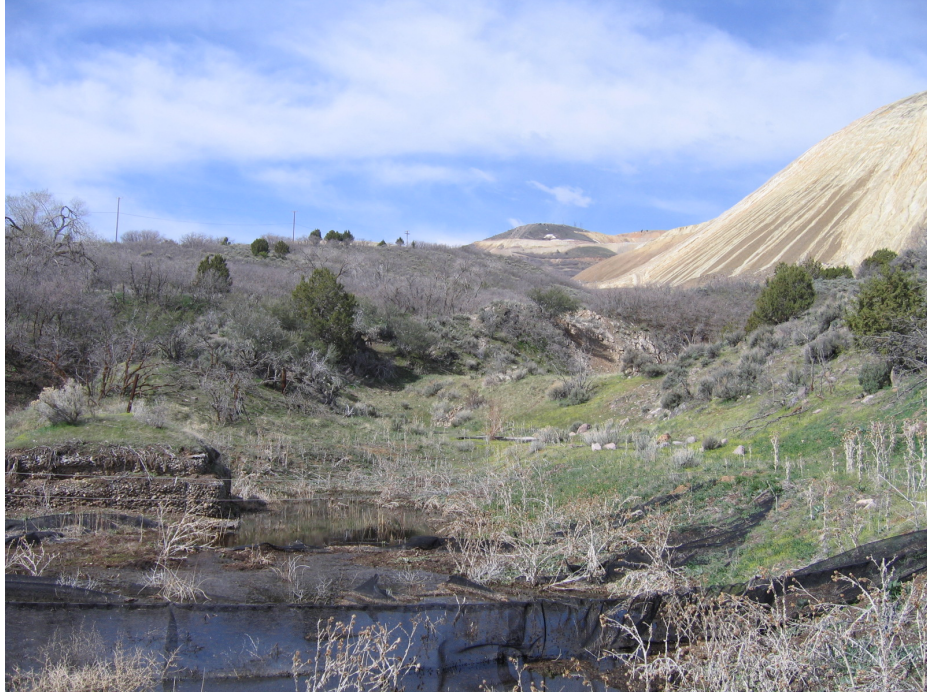
**Figure No. 20:** View is westerly up lower Keystone Drainage up gradient from the Mascotte Tunnel.

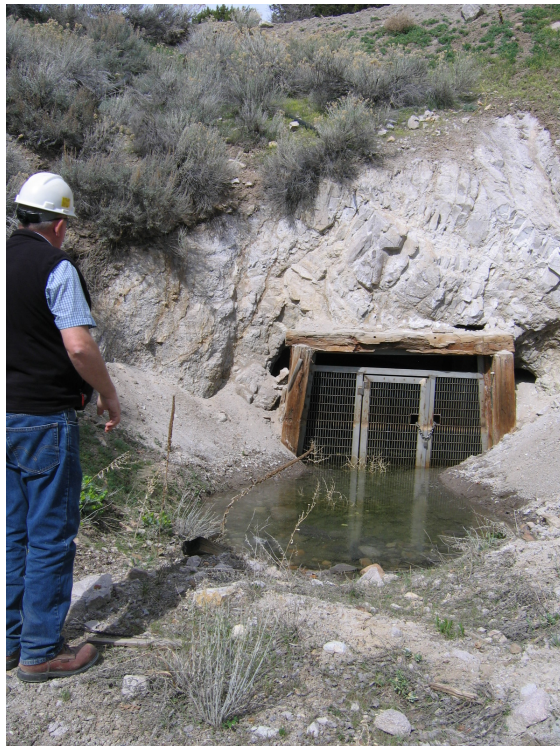
**Figure No. 21:** Pictured is the Mascotte Tunnel portal, half submerged. The Tunnel is no longer used for ore haulage capacity, but is used to transport water away from the deeper tunnel workings. Mr. Brian Vinton noted that the visible bedrock near the portal is well weathered and crumbly (as can be attested to the fine grand sand left and right of the portal frame).

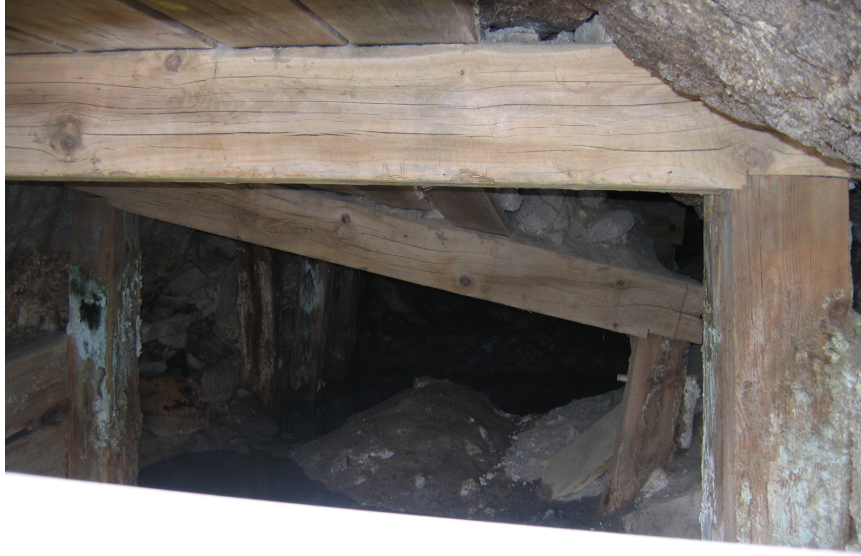
**Figure No. 22:** Pictured is the Mascotte Tunnel working just inside from the portal. The cribbing along this tunnel is wooden and in sections is in disrepair but the tunnel still produces water. The Mascotte Tunnel is down gradient from the Lower Keystone Drainage and cutoff wall.

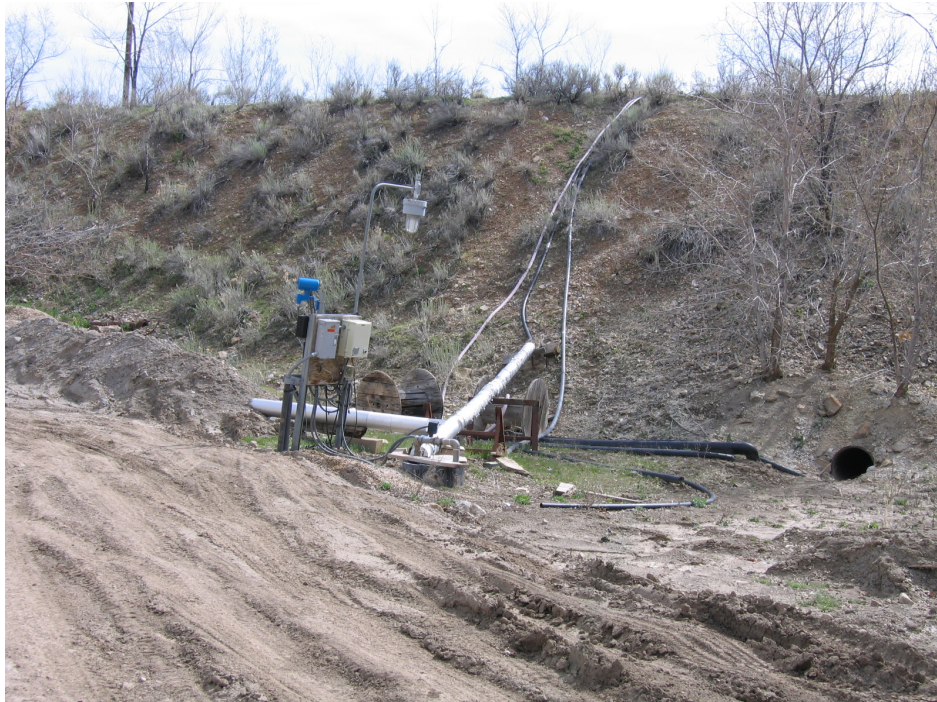
**Figure No. 23:** Pictured is the sump structure where tunnel produced along the length of the Mascotte Tunnel reports to be pumped to the water management facilities of Kennecott.

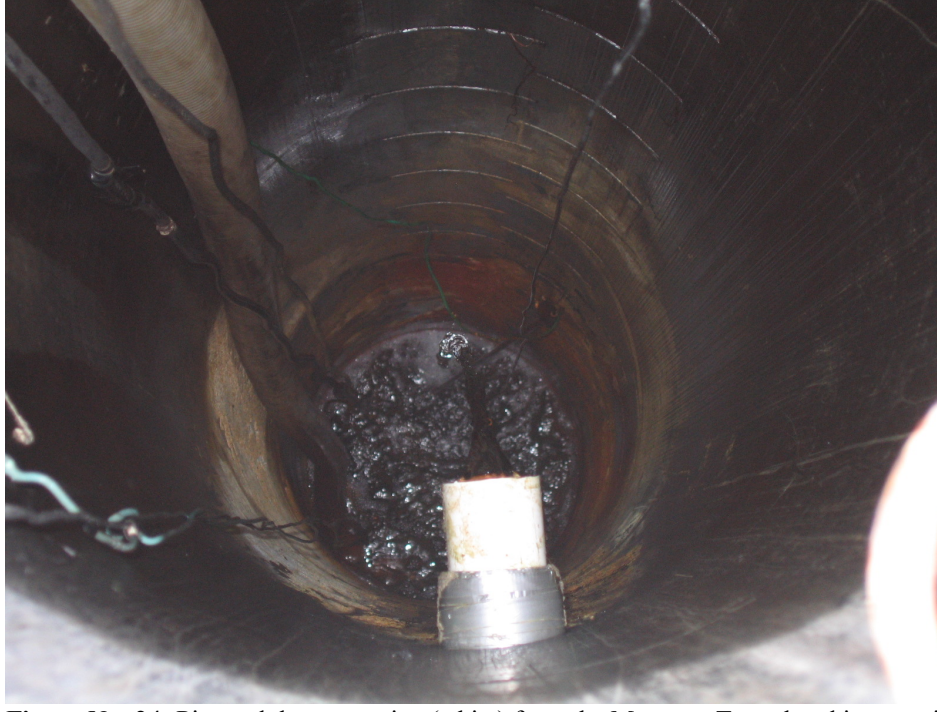
**Figure No. 24:** Pictured the water pipe (white) from the Mascotte Tunnel and its associated sump, water quality is okay for the copper extraction process.

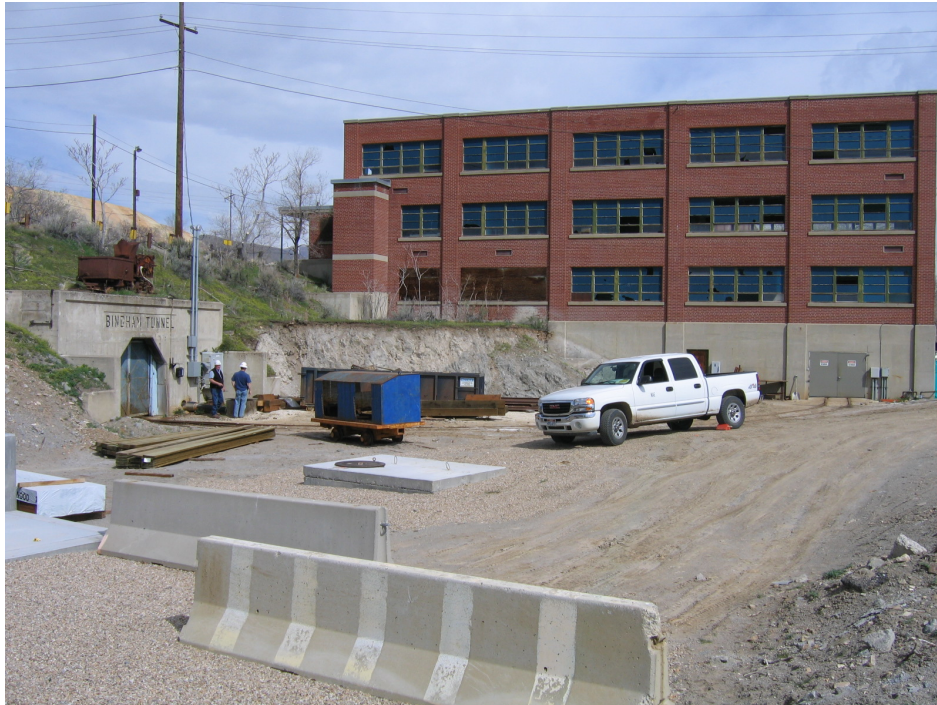
**Figure No. 25:** Pictured is the Bingham Tunnel portal and staging area near the USSRM administration building. The Bingham Tunnel is approximately 100 yards to the north of the Mascotte Tunnel. Mr. Kelly Payne and Mr. Brian Vinton are beside the tunnel portal.

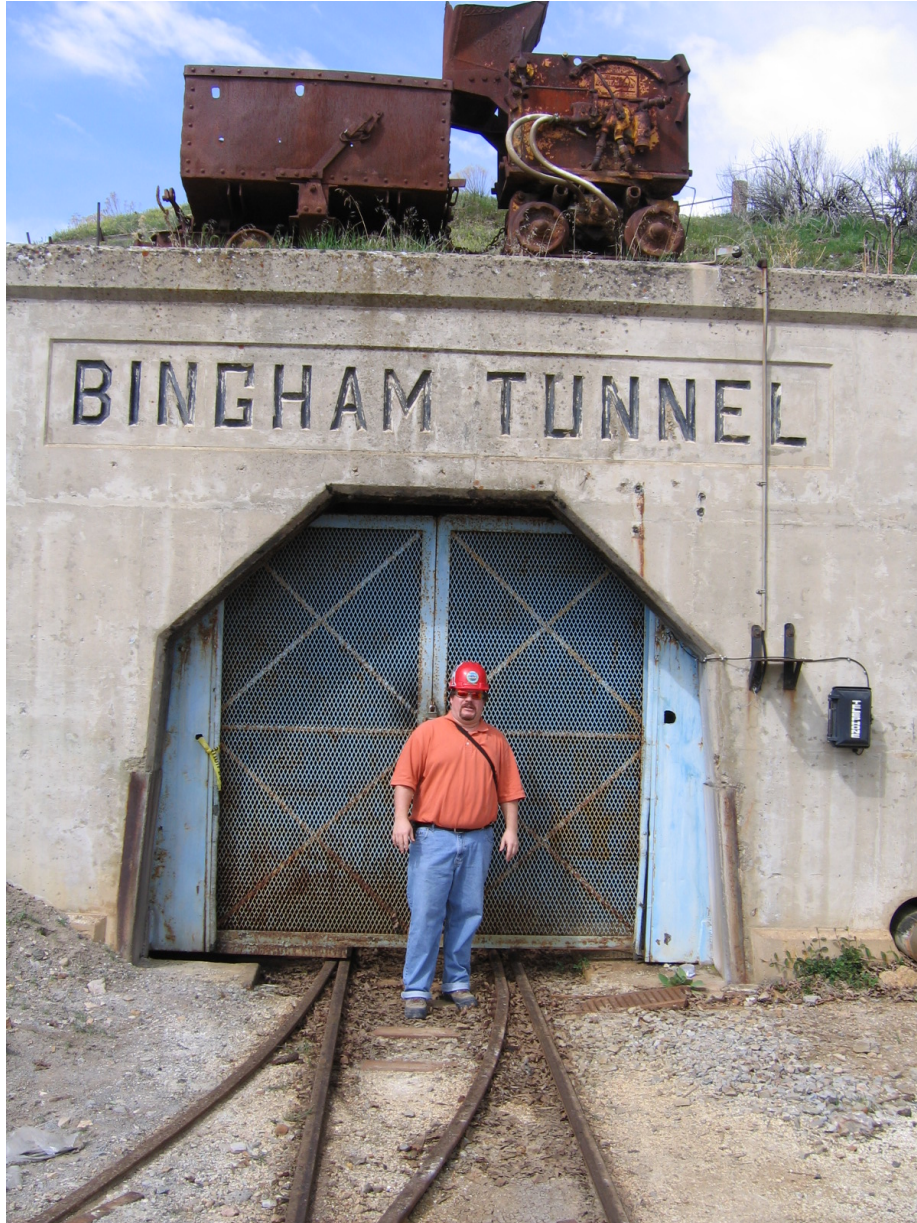
**Figure No. 26:** Mr. Douglas Bacon (UDEQ project manager) is pictured at the entrance of the Bingham Tunnel. Located in the lower right corner of the photo is a pipe that delivers Lark Shaft water (the Bingham Tunnel intersects the Lark Shaft) to the water management control facilities of Kennecott. The Bingham Tunnel is used today to help dewater the Bingham Canyon Pit; water is taken from the tunnel to another location nearby and then sent via pipe to the water management facilities of Kennecott.

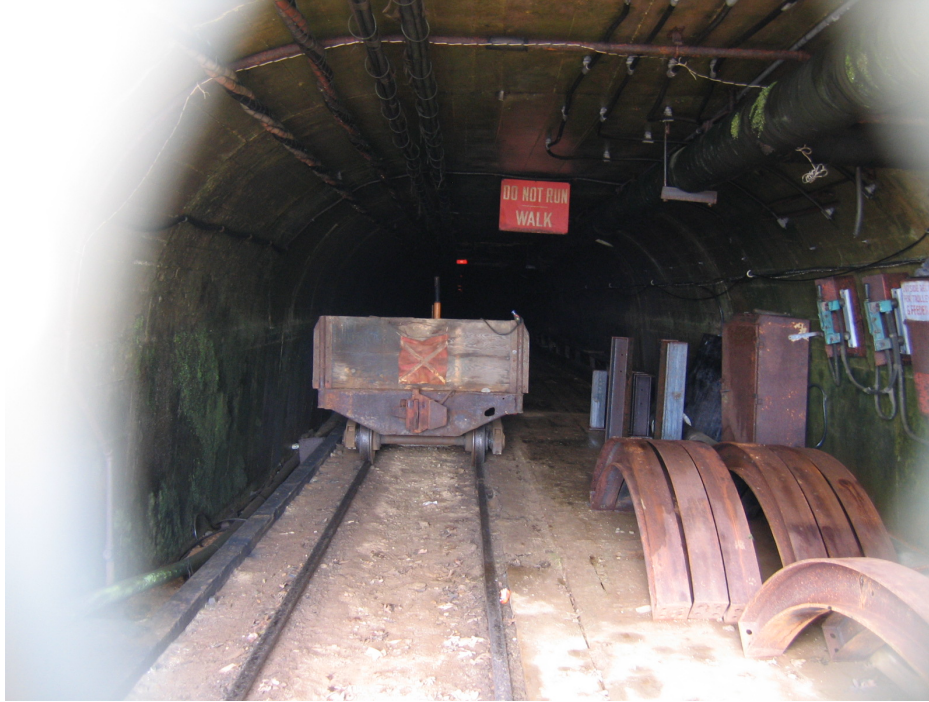
**Figure No. 27:** Pictured is the Bingham Tunnel just inside from the portal. Immediately to the right of the arched cribbing material is a tunnel that leads to the basement of the USSRM administration building. The tunnel is currently undergoing repair to replace some slipping sections of the cribbing. The waste rock produced from drilling this tunnel and the Mascotte Tunnel was the source of the waste rock found at Lark.

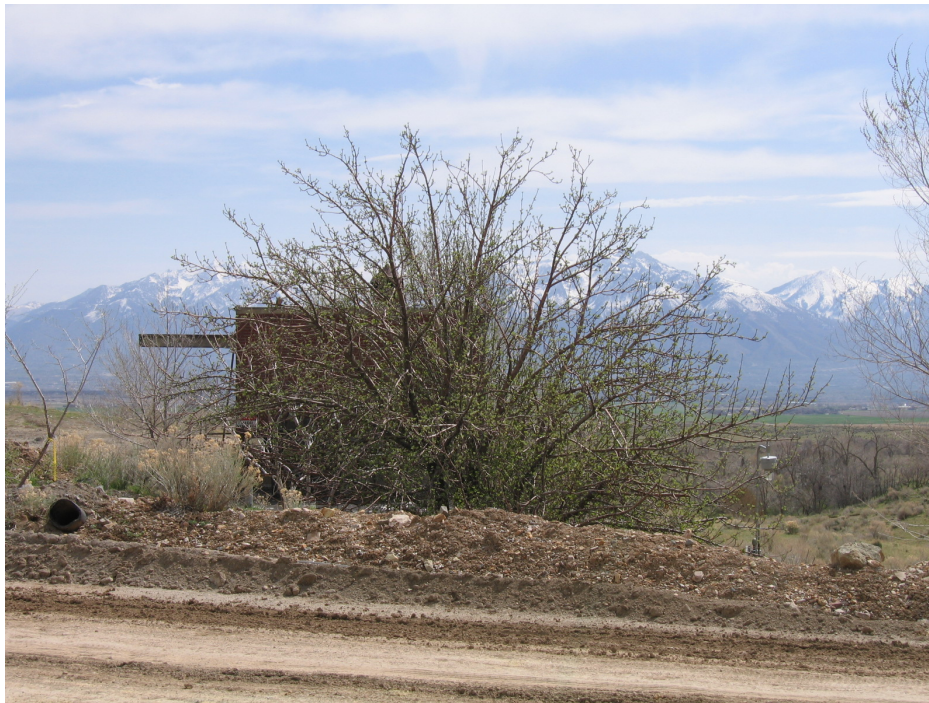
**Figure No. 28:** Pictured is the Apple Tree sump (behind the apple tree). At the base of the tree is a drop box where Bingham Creek Tunnel and Lark Shaft water combine and are piped to Kennecott's water management facilities near Copperton.

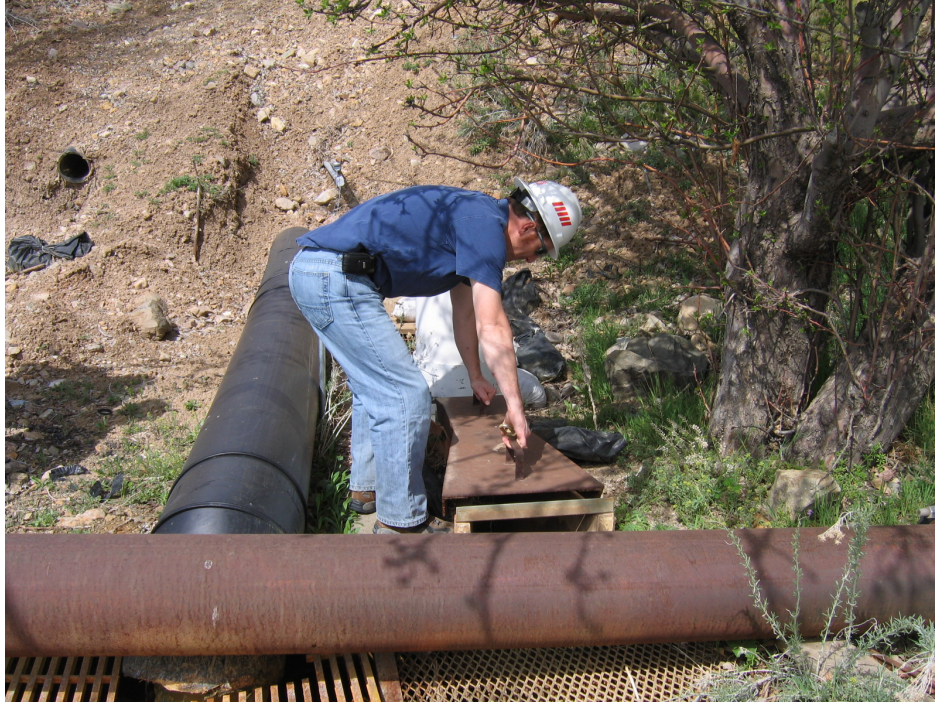
**Figure No. 29:** Mr. Kelly Payne is checking the historic flume that used to transport Bingham Tunnel water to the water management drop box; now the black HDPE pipe does.

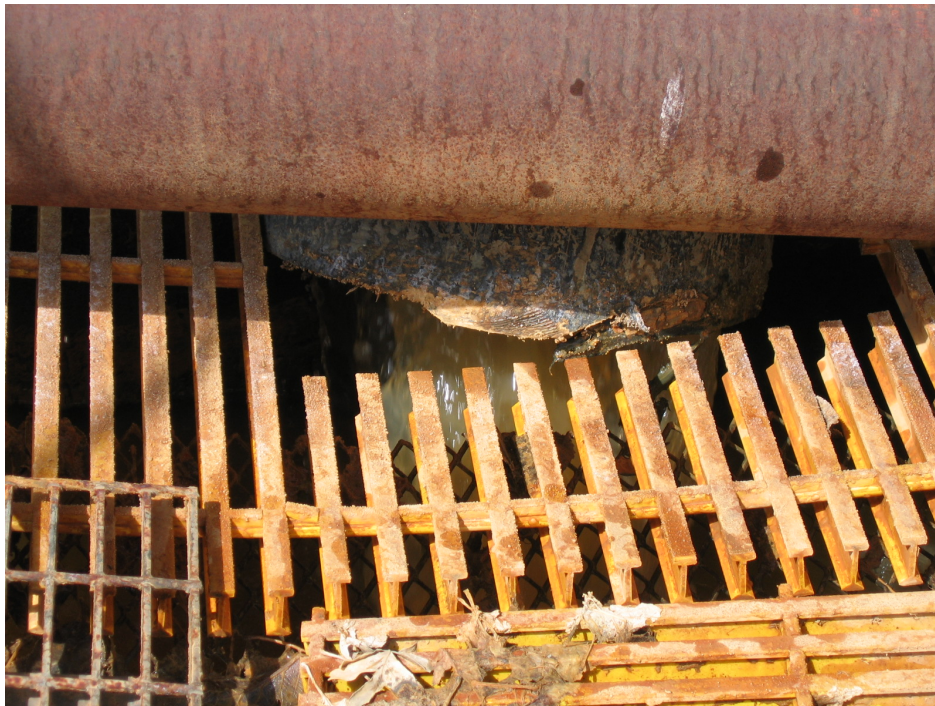
**Figure No. 30:** Though difficult to make out the pale yellowish colored water is derived from the Bingham Tunnel.
