# **Appendix I**

## **Site Inspection Photos and Observations**

**I. OU3 Herriman Agricultural Properties**

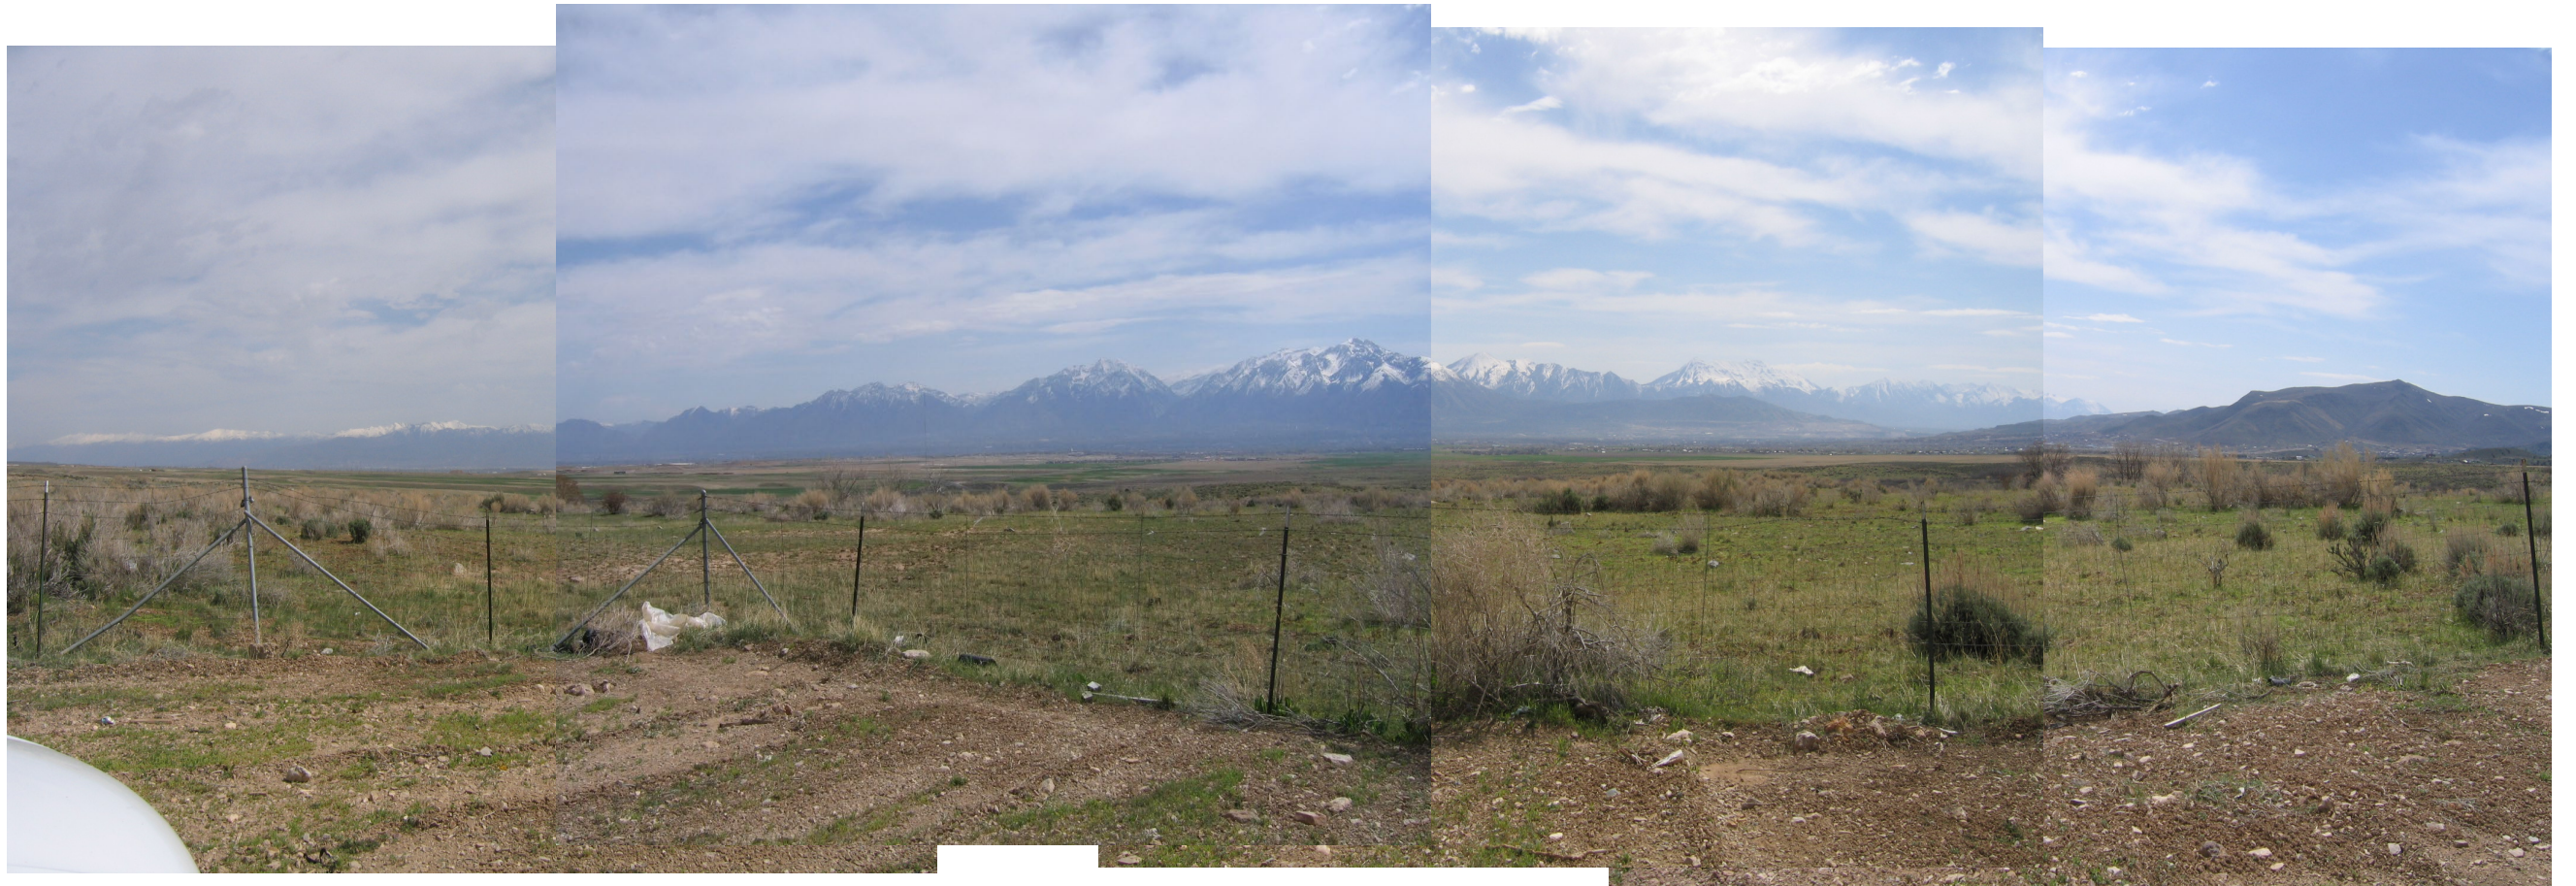
**Figure No. 33:** Pictured is the area of the North Dump near the USSRM facilities. The North Dump was removed and the land was reclaimed and seeded.

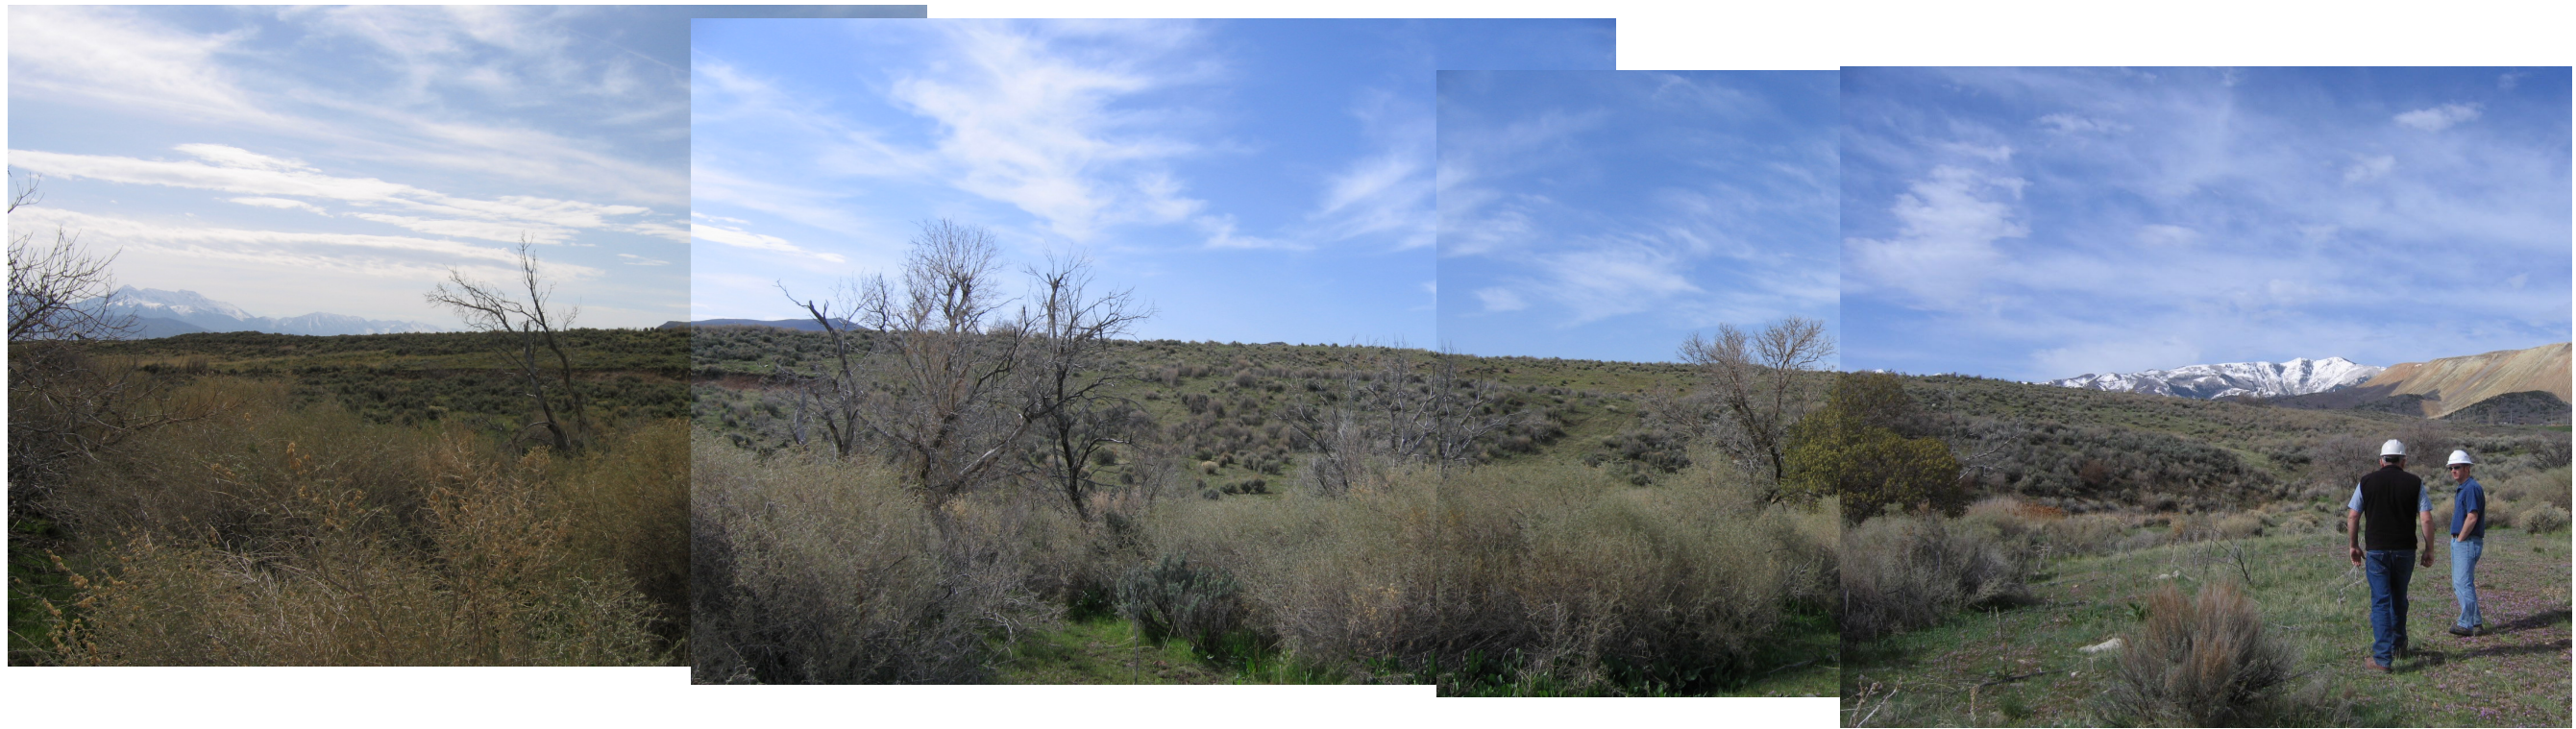
**Figure No. 34:** Pictured is the ridge line where once stood the Long Dump (of the Lark Waste Rock site). The Long Dump was near the historic lower Lark town site (figures 34&35). Near the base of this ridge line is the Experimental Wetlands area.

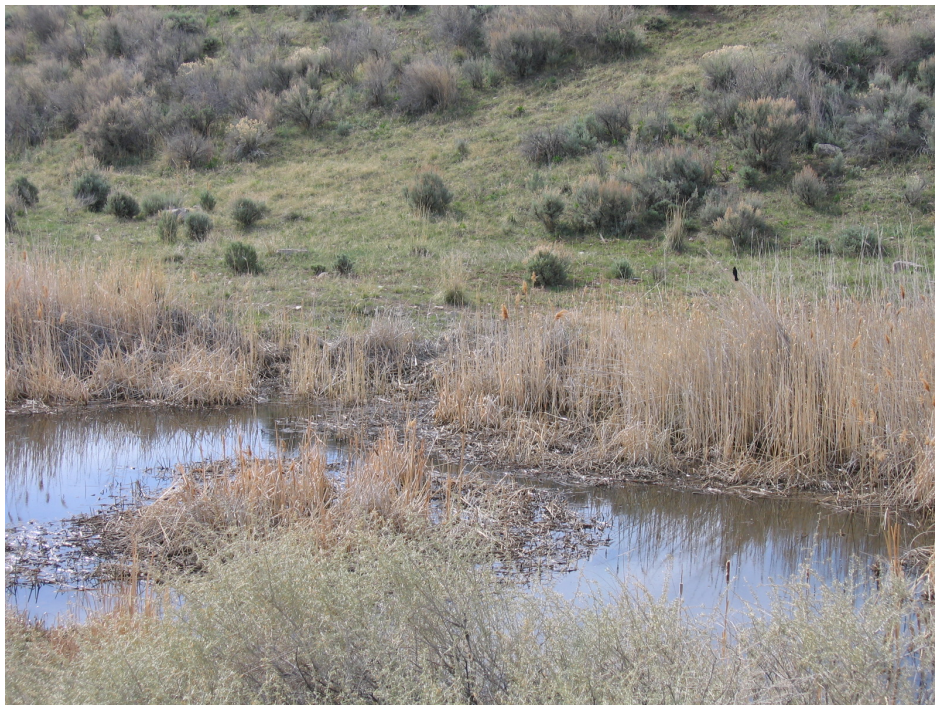
**Figure No. 36:** Pictured are ponds 3&4 of the Lark experimental wetlands. Though no longer active as a wetland treatment unit, wildlife has begun to make use of the wetlands (note the red-winged blackbird in the cattails). Other wildlife was observed during the inspection. The two ponds are separated by a zone of biological active material to help to reduce sulfate concentrations (though again it is noted that the ponds are not being maintained as a treatment unit).

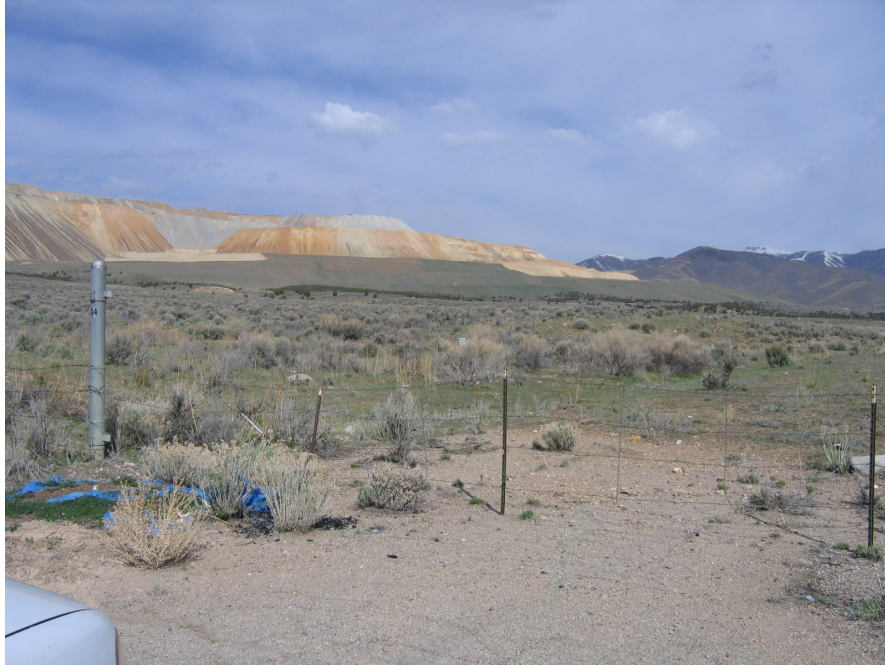
**Figure No. 41:** Pictured is the Randolph Peterson Gate area (though the historical gate is gone). This area was located slightly northeast of the Lark Waste Rock removal area, just off of Rt. 111 Southwest of the Midas Creek Silos area. The area was well vegetated with grasses and sage brush.

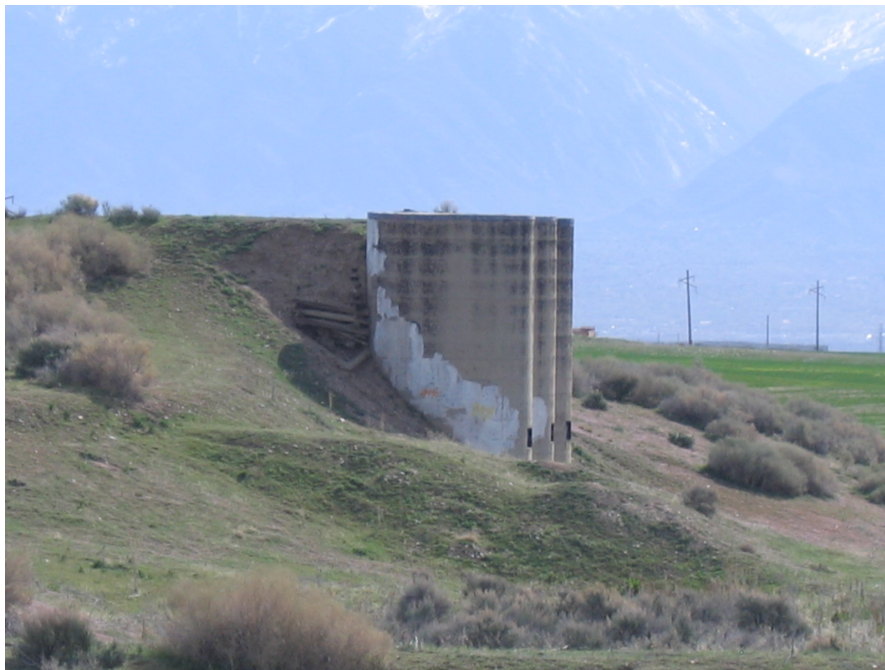
**Figure No. 42:** Pictured is the Midas Creek Silos area (Figure No. 46 is of the right side, or south side, of this area). Some removal action was performed in this area where once the Mascotte Ditch, Bastian Ditch and Midas Creek came together. The silos are still used for grain storage on a periodic basis and are visible from Rt. 111 (from where the photo was taken).

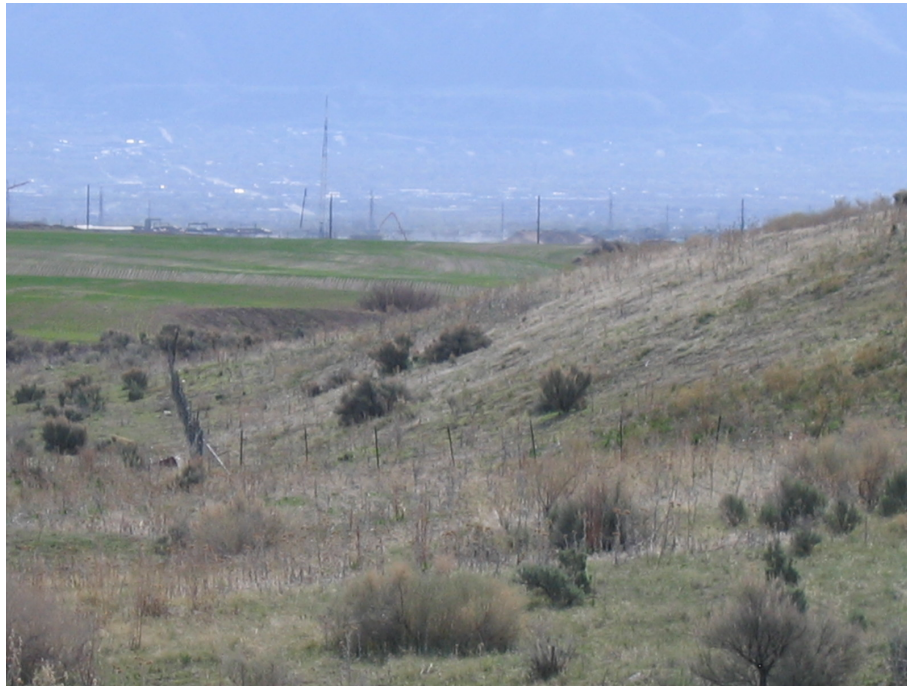
**Figure No. 43:** Pictured is the embankment and fence of the Lark Tailings reclamation area. To the north or left of the fence is farm land within the Midas Creek drainage. Off in the distance is the construction of a local high school for the Jordan School District along 6000 West (Photo taken from Rt. 111).

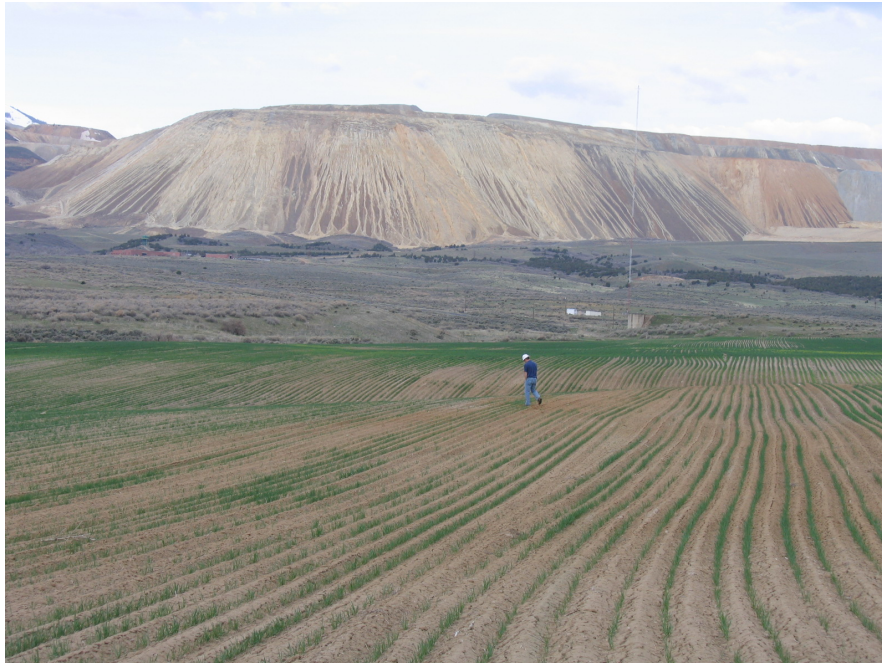
**Figure No. 44:** Pictured is Mr. Kelly Payne walking in an area suspected to be the confluence of the Bastian Ditch and the Mascotte Ditch, note discolored soils. Some cemented material similar to tailings was found as a chunk by Mr. Payne of which the lead concentration was less than 250 mg/kg and the arsenic was less than 50 mg/kg per XRF measurement. The farm land is to the north of Midas Creek; Midas Creek is situated between Lark Tailings area (denoted by sage brush) and the farm land. Note the Midas Creek Silos in the background; Rt. 111 is near the white shed.

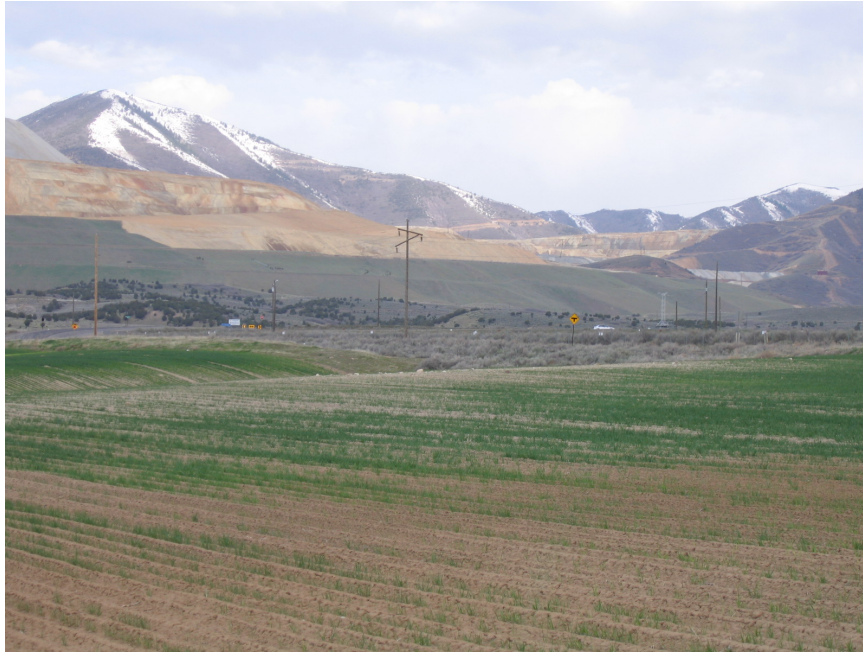
**Figure No. 45:** Near the intersection of Rt. 111 and 11800 South is a depression just south of 11800 South. Across from the depression is a yellow “T” caution road sign. This is the suspected alignment of the Bastian Ditch prior to turning west and heading back toward the Midas Creek Silos area.

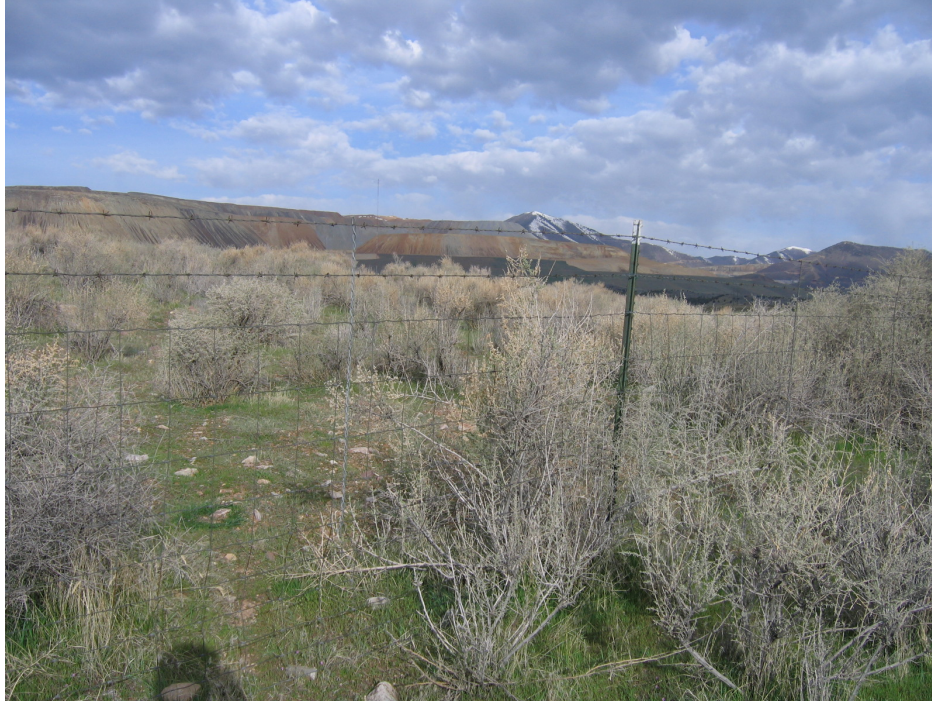
**Figure No. 49:** Pictured above Midas Creek is the fencing material running along the northern (pictured), eastern, southern and western boundaries of the Lark Tailings reclamation area. The fence is approximately 6 foot with two strings of barbed wired at the top.

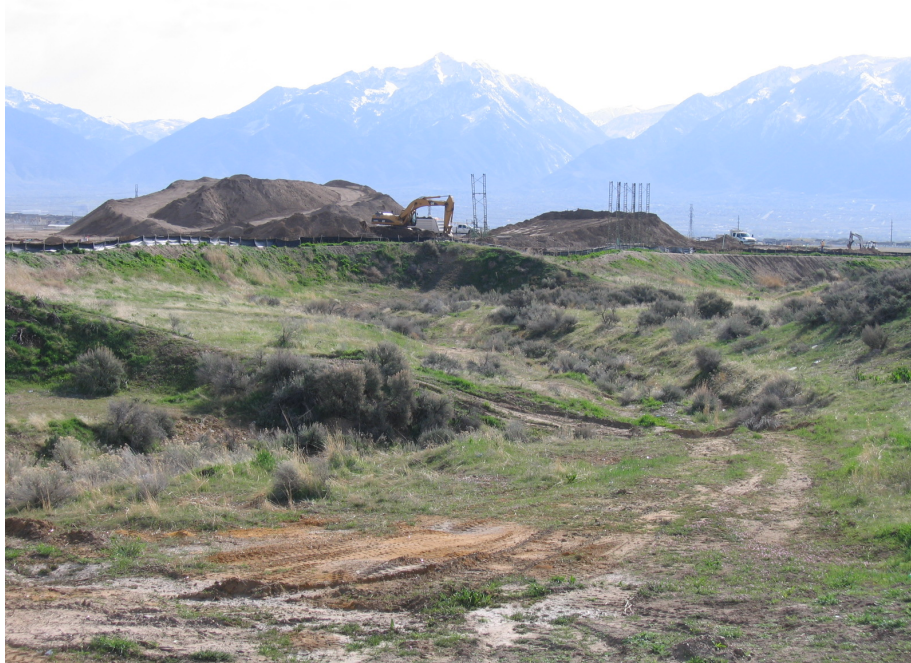
**Figure No. 55:** Pictured is Midas Creek after crossing 6000 West, just to the south of the new high school construction project. Some discolored soils were visible in the creek channel. Out of the frame to the right (south) is a pasture lot that is growing hay or alfalfa, Midas Creek channel follows the silt fencing lining the northern embankment and boundary of the channel.

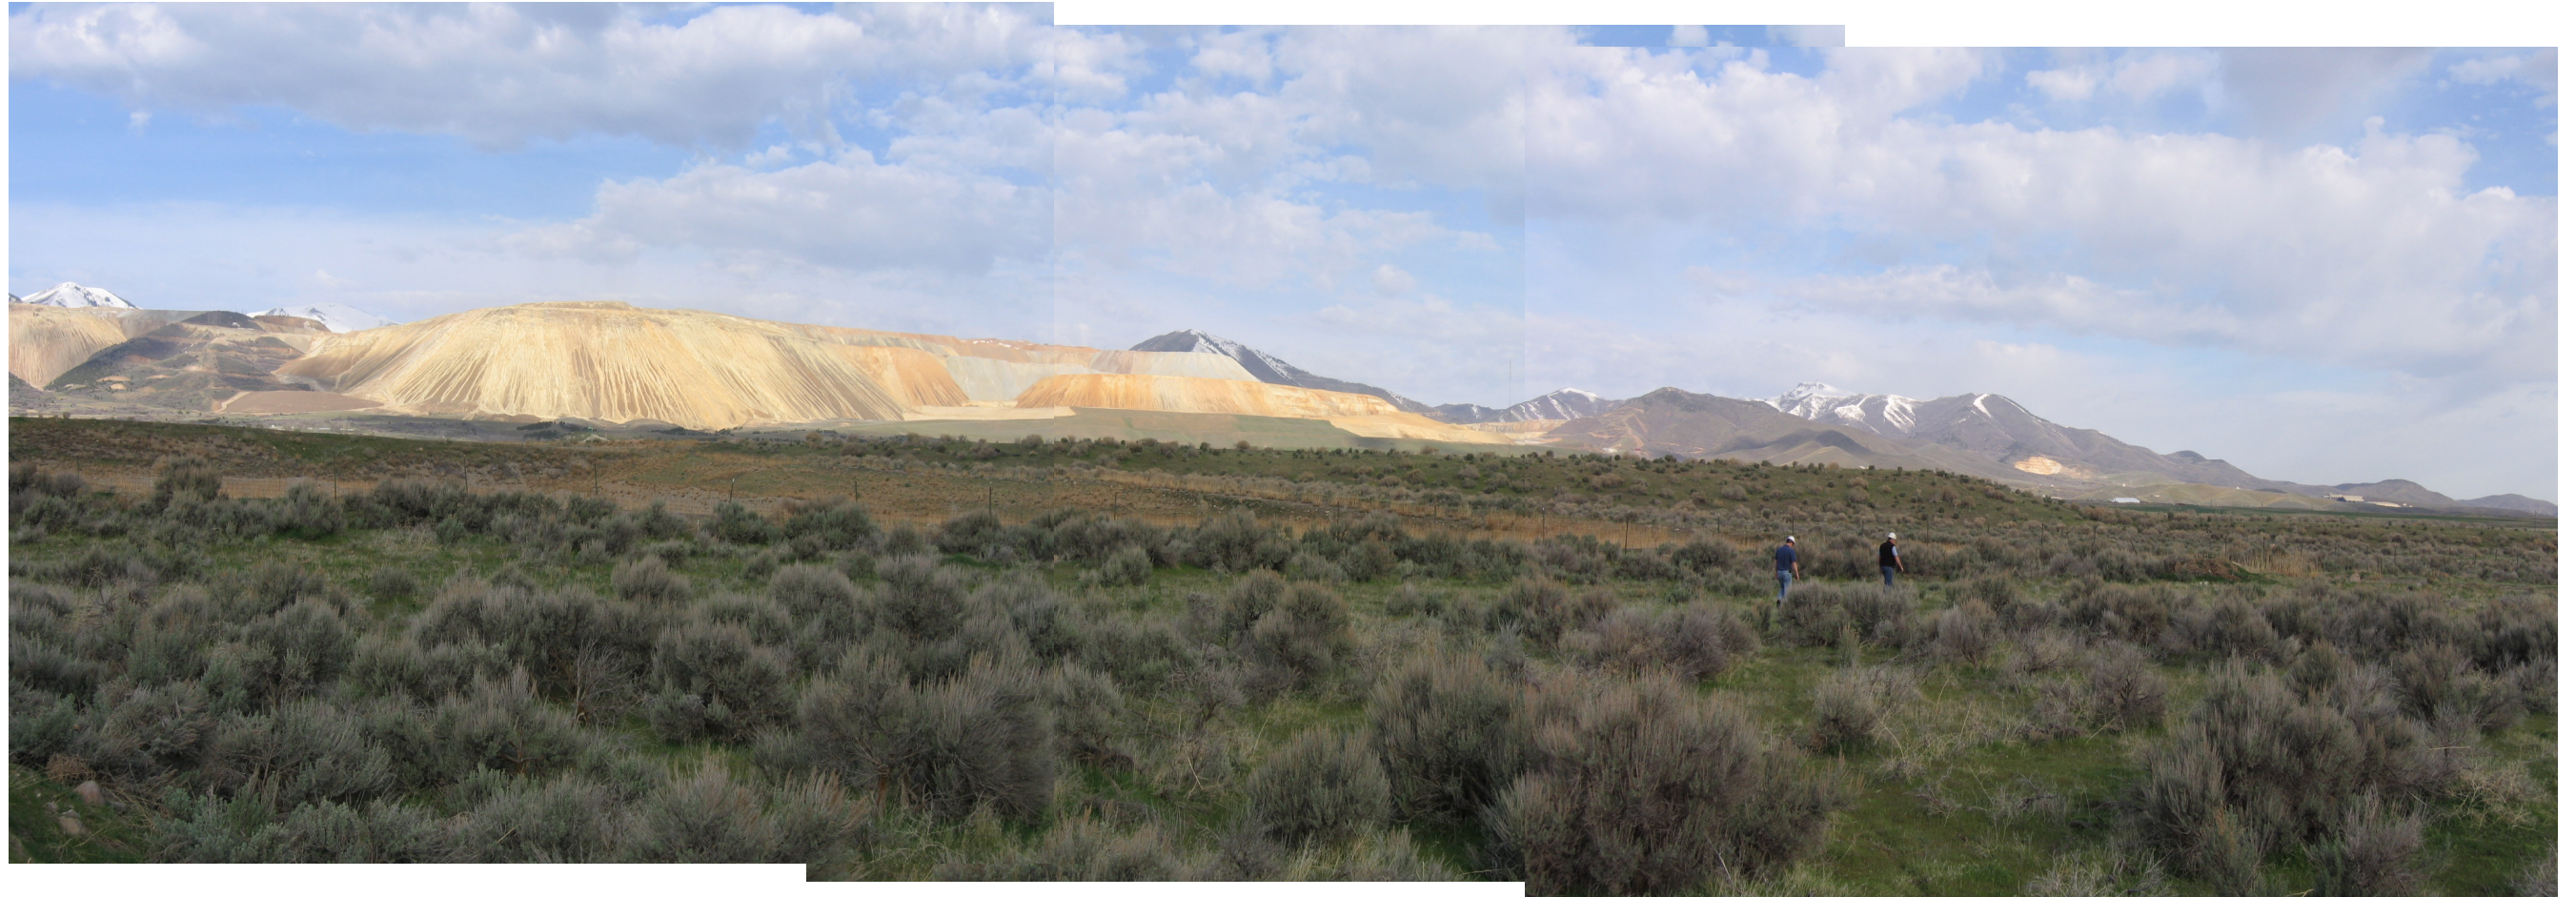
**Figure No. 58:** Pictured is the southeast corner of the Lark Tailings reclamation area, photo taken from a portion of the Southeast Area cleanup site where there was observable distressed vegetation during response work at the site. Mr. Brian Vinton and Mr. Kelly Payne are walking through the Southeast Area. Behind the sage brush in the foreground in the left side of the panorama is an area that Kennecott Land constructed a lined water reservoir to serve the purpose of storing dust suppression water during the use of the haul road from where the panorama was taken.

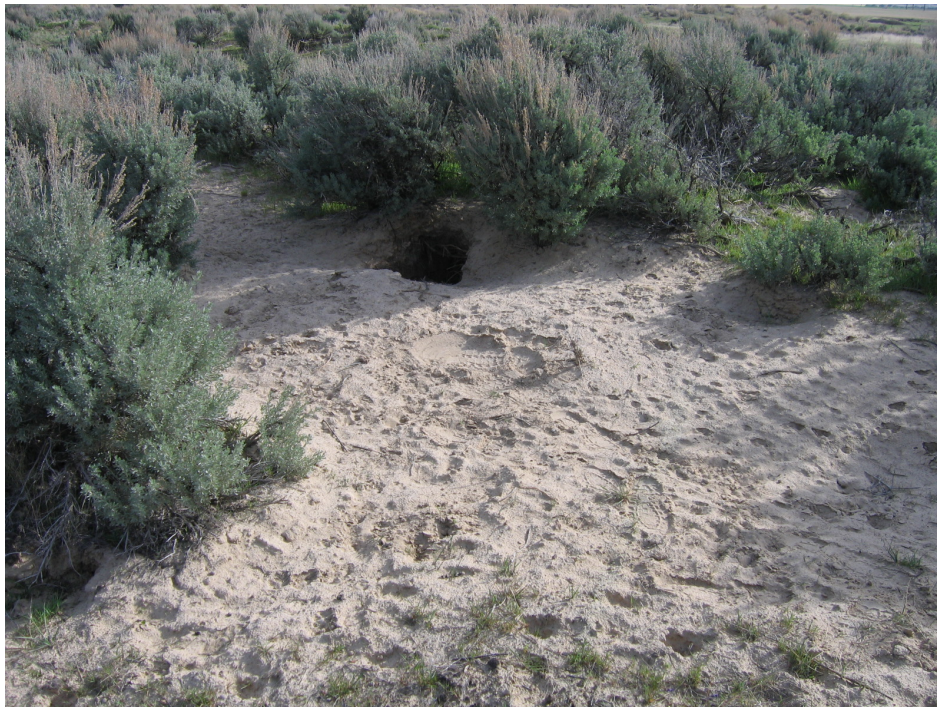
**Figure No. 60:** Pictured is a rabbit hole located within the fenced area of the Lark Tailings reclamation site, immediately west of the Southeast Area. Jack rabbits have moved into the area and this is a location where they have brought up tailings to the surface.

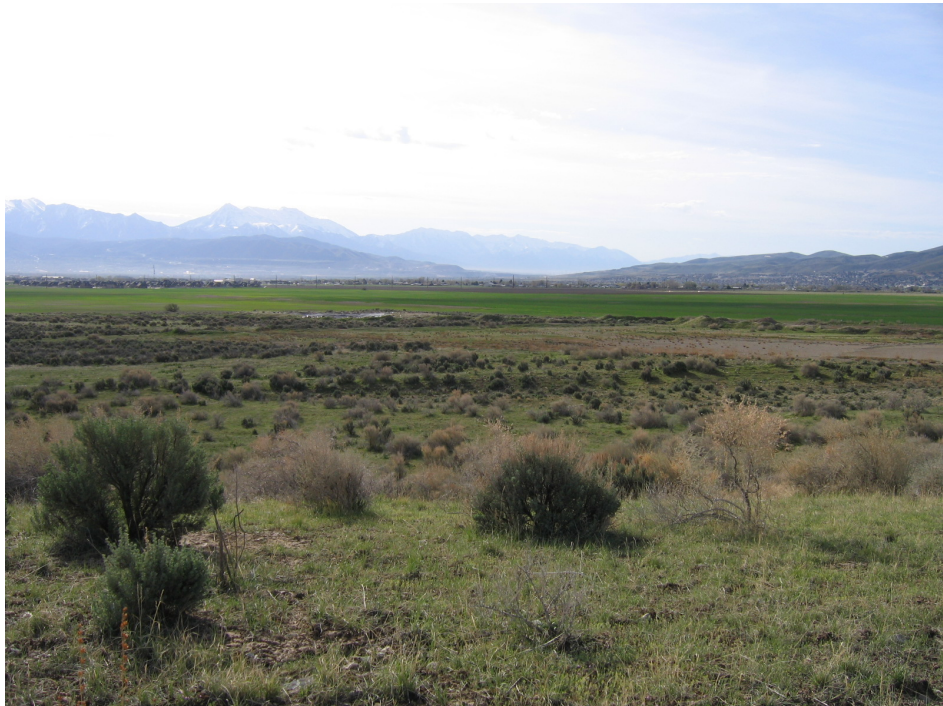
**Figure No. 62:** Pictured is the Southeast Area from on top of the Lark Tailings reclamation area's leading edge to its southeast embankment. The scarring and lack of vegetation is due to the haul road construction activities of Kennecott Land.

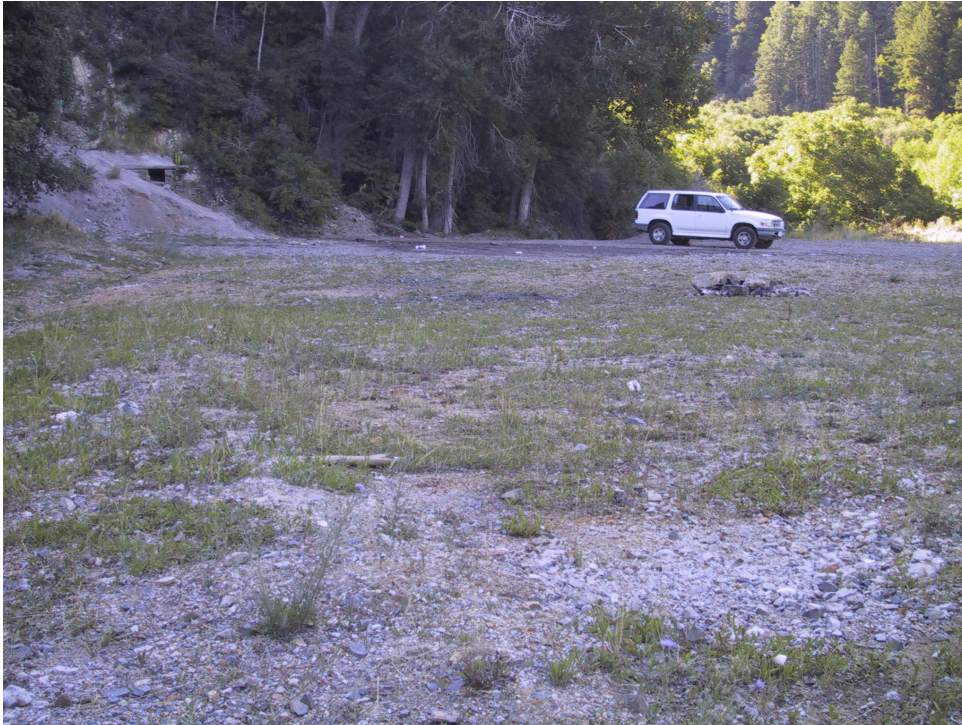
**Figure No. 67:** Pictured is the top of the Water Supply Tunnel Dump from near the top edge of the western embankment and drainage pipe. Surface revegetation was beginning to have some success.

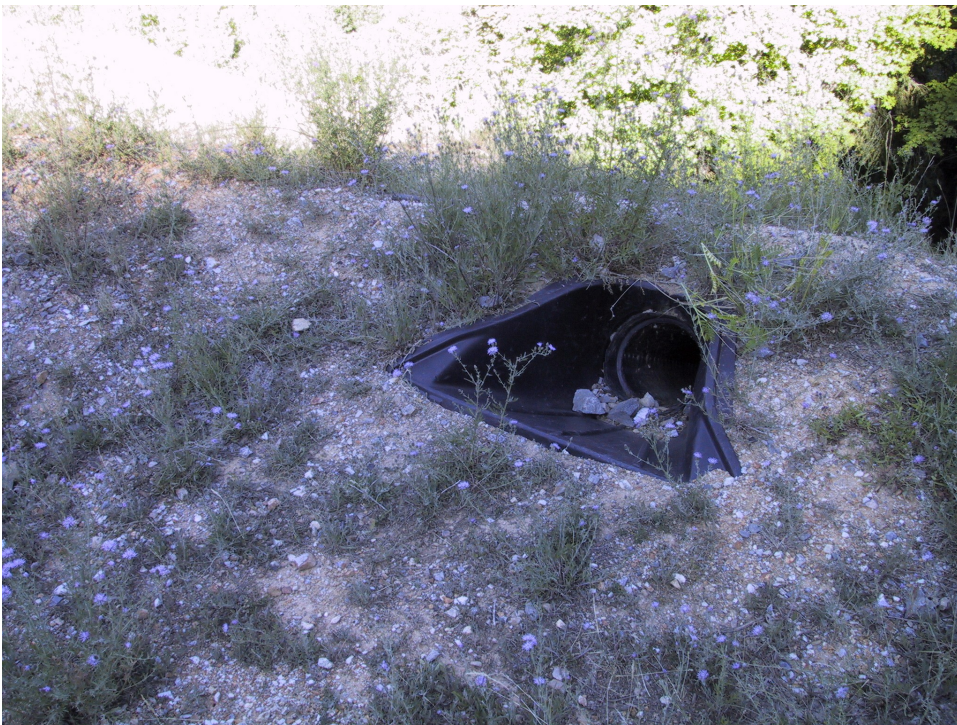
**Figure No. 73:** Pictured is the drain/catch basin for surface water flowing from the Water Supply Tunnel across the top of the Dump surface. In 2006 this catch basin was seen to be undercut by excessive water pushed out from the tunnel during its reconstruction.

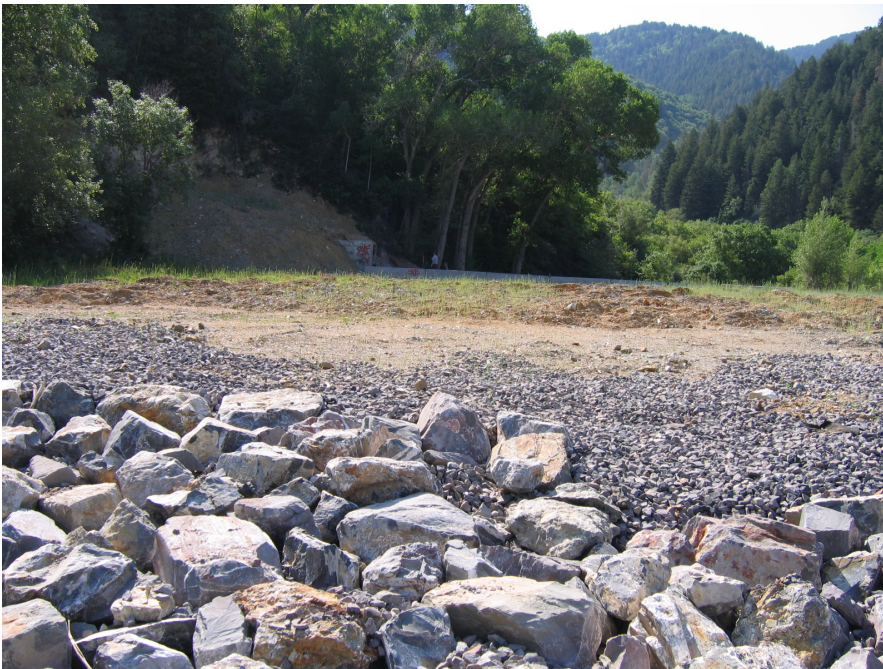
**Figure No. 75:** Pictured is the top of the Water Supply Tunnel Dump from near the top edge of the western embankment and newly reconstructed drainage channel. Surface revegetation was beginning to show better success.

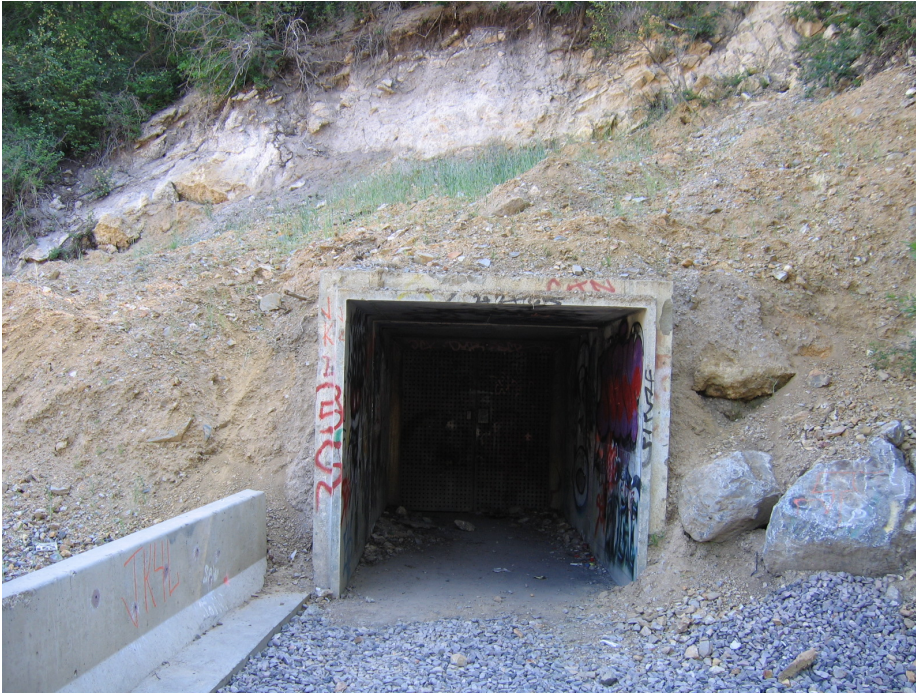
**Figure No. 76:** Pictured is the Water Supply Tunnel portal post reconstruction. A pipe inside the tunnel (since reconstruction) takes surface water produced from inside the tunnel's reaches down off the Dump and directs the flow into the local irrigation company's system (see Figure 41). A more solid steel door is inset from the concrete portal opening to allow access by the mine operators, but not the public.

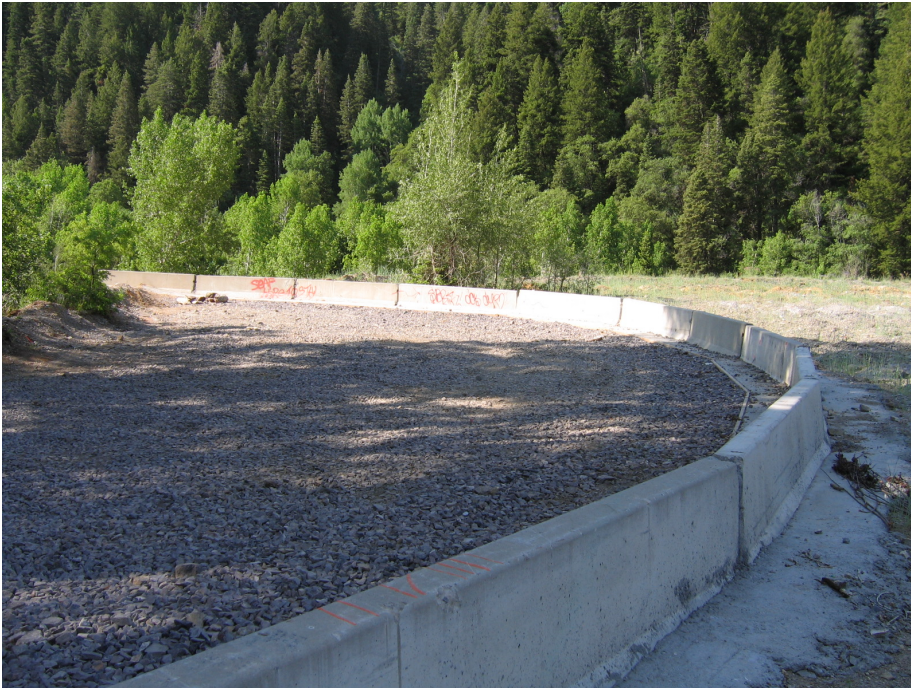
**Figure No. 77:** Pictured is the series of Jersey Barriers keyed into a concrete base from the tunnel portal to the eastern slope of the Water Supply Tunnel Dump. As of 2007 these barriers are used to keep the public from driving onto the  $\frac{3}{4}$  of the Water Supply Tunnel Dump's top surface. This barrier was installed to facilitate the revegetation effort.

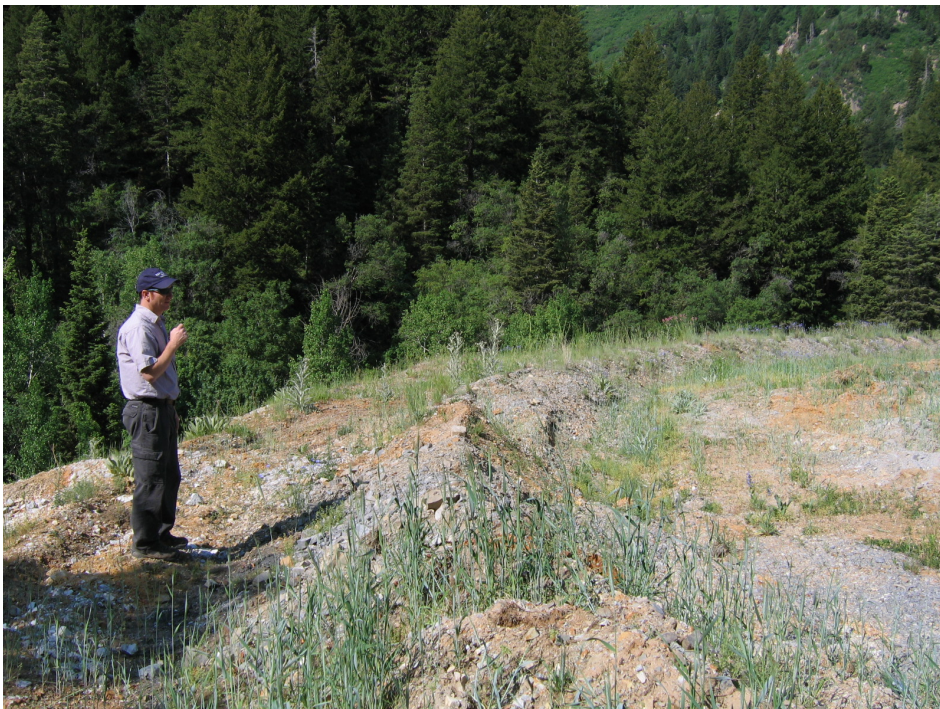
**Figure No. 79:** Pictured is the water control berm located near the edge of the Water Supply Tunnel Dump's southern embankment (Kelly Payne – Kennecott Project Manager is also pictured). Note the vegetative cover compared to that shown in Figure No. 72 of the August 2005 inspection.
