**THIRD FIVE-YEAR REVIEW REPORT FOR
BOUNTIFUL/WOODS CROSS 5TH S. PCE PLUME SUPERFUND SITE
DAVIS COUNTY, UTAH**

Prepared by

Division of Environmental Response and Remediation

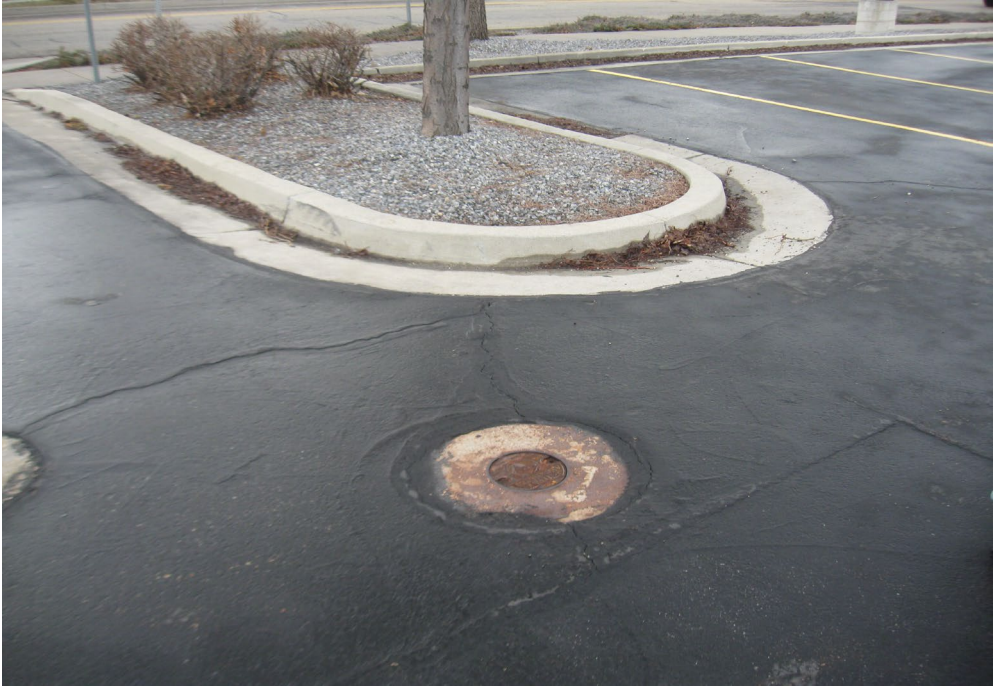
PHOTOGRAPHIC LOG	
Inspection Date: March 22, 2023		Bountiful Third FYR Site Inspection	
Photo No.1	Date: 3/22/23

Description:OU1 Source Area HMW17D

- The yield around HMW-17D has been significantly decreased by amendment injections, even with an attempt at redevelopment in fall of 2021, making recent sampling at this location very difficult. Continue to monitor conditions at HMW-17D to see if yield improves. If yield does not improve, evaluate if surrounding wells provide adequate information in this area.

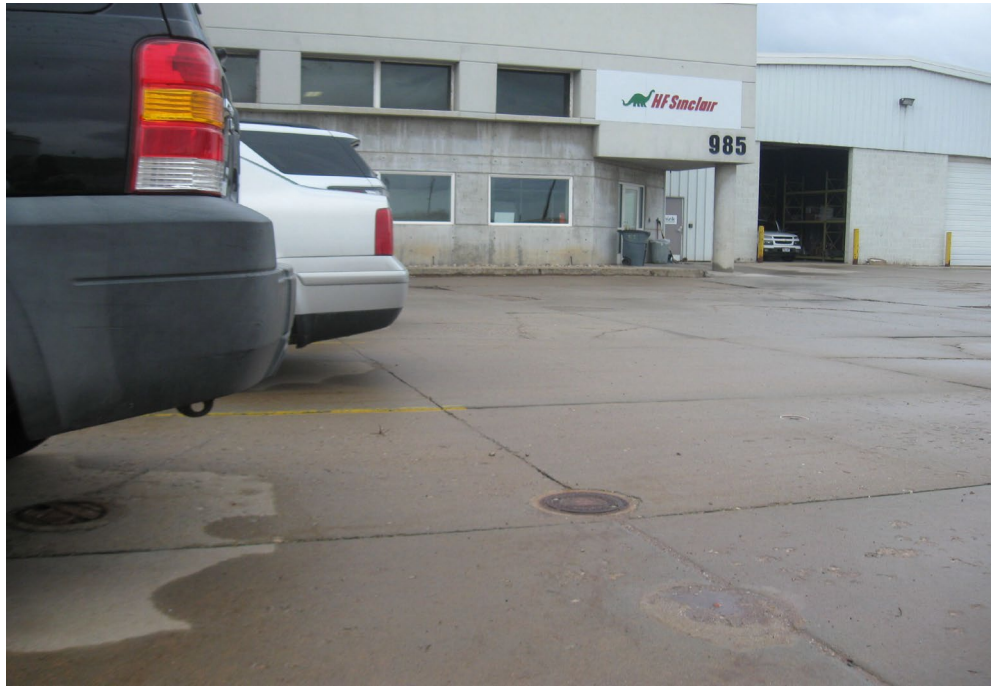
Photo No.3 Date: 3/22/23

Description:
OU1 Biobarrier 3a

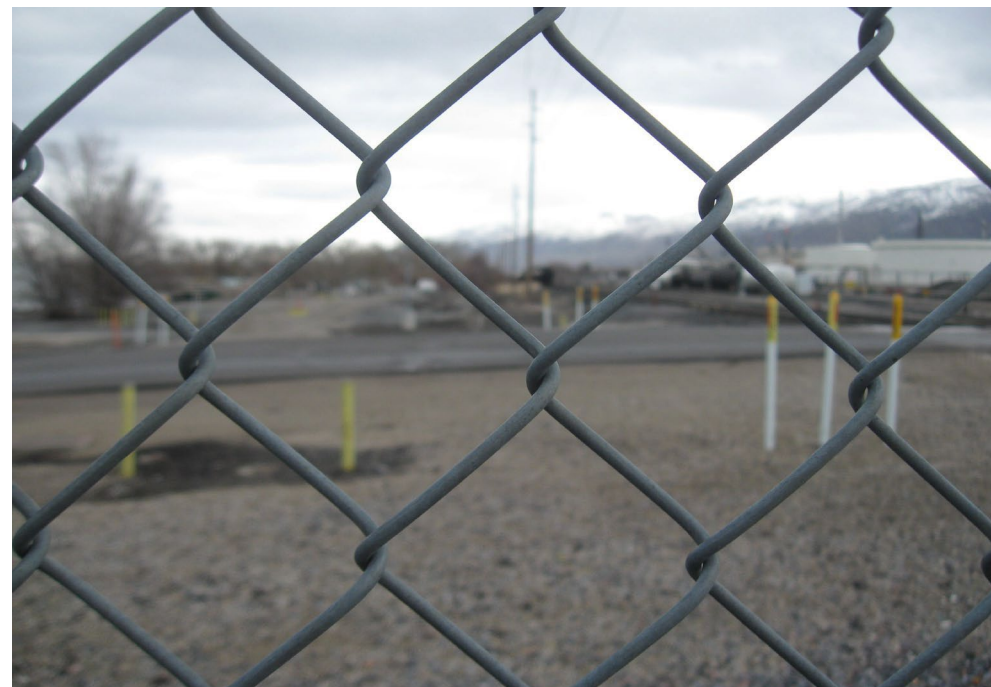
Photo No.4 Date: 3/22/23

Description:
OU1 Biobarrier 3b

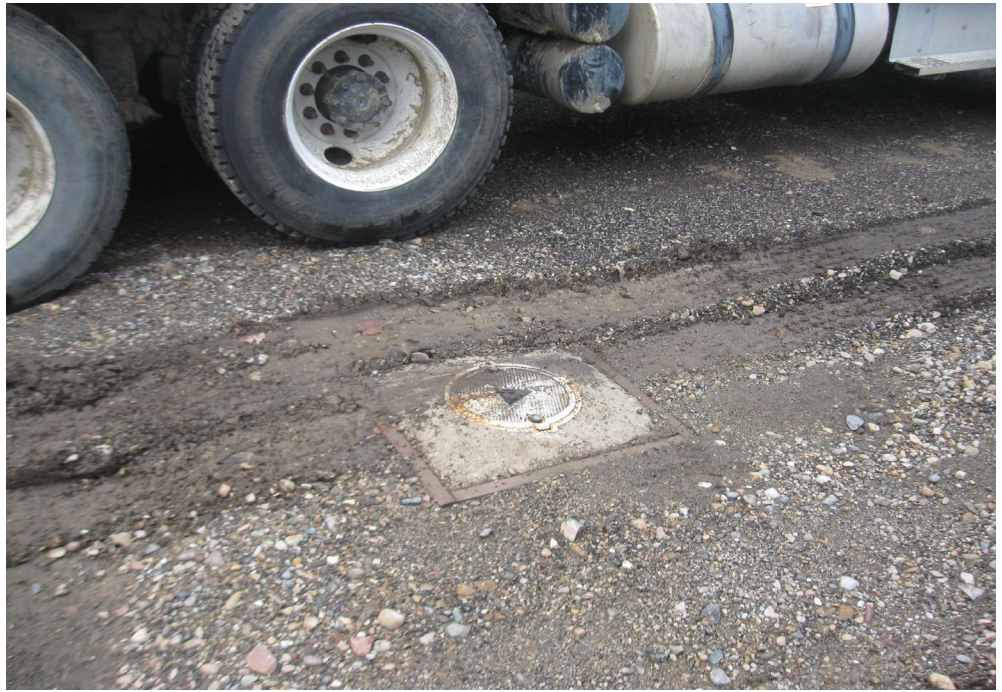
Photo
No.5

Description:
OU1/HMW-39S
Furthest extent of
OU1Plume

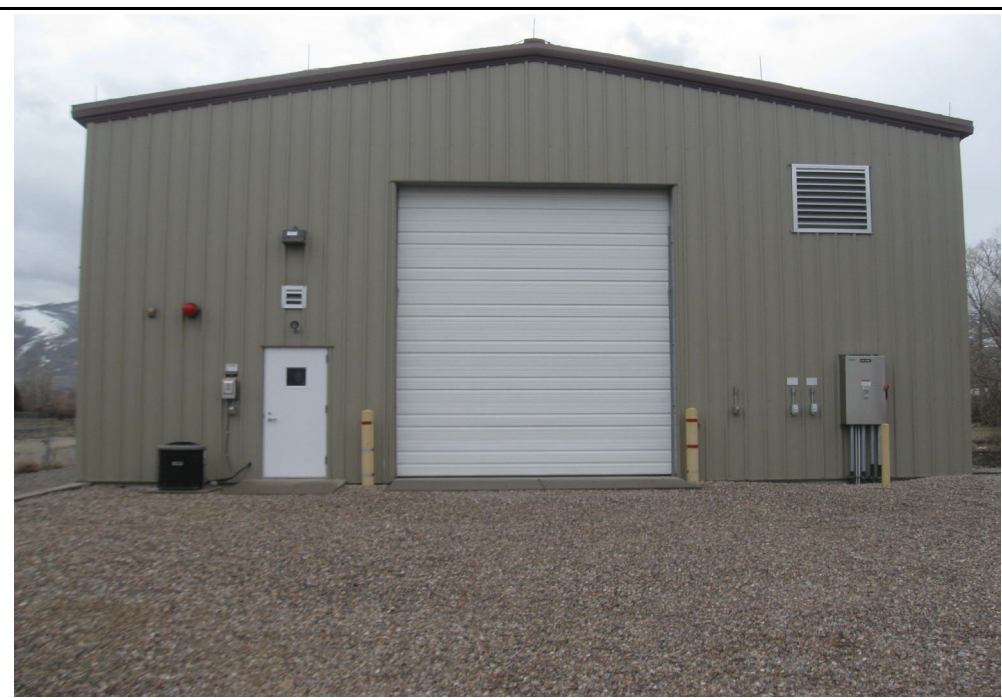
Photo
No.6

Description:
OU2
Treatment Building

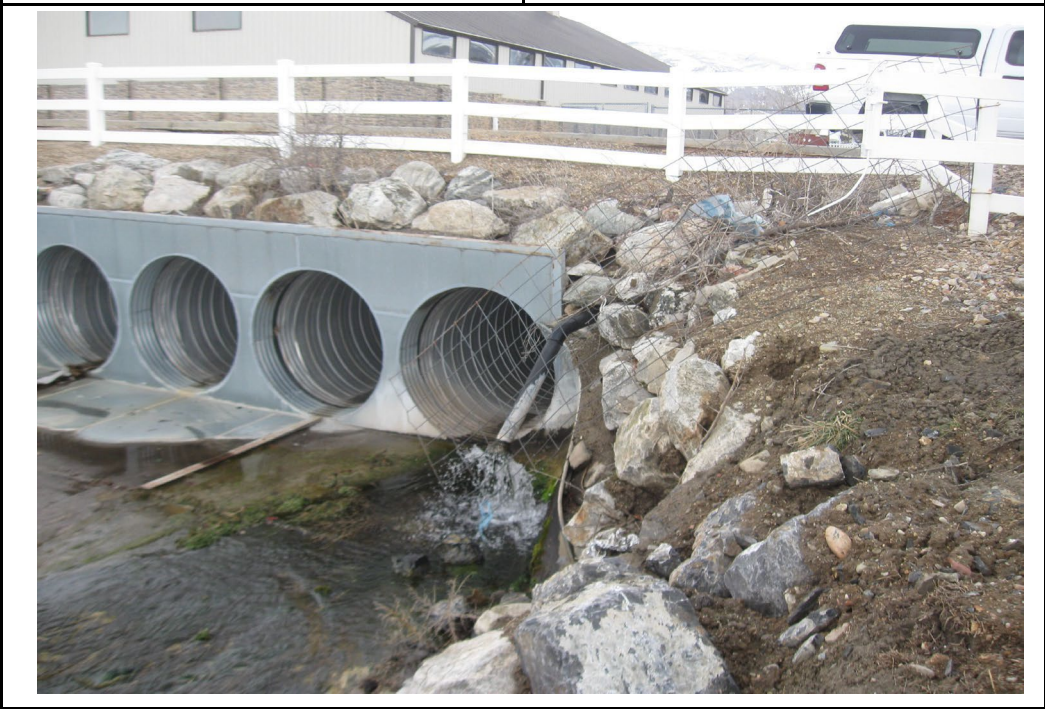
Description:
A-1 Canal Discharge

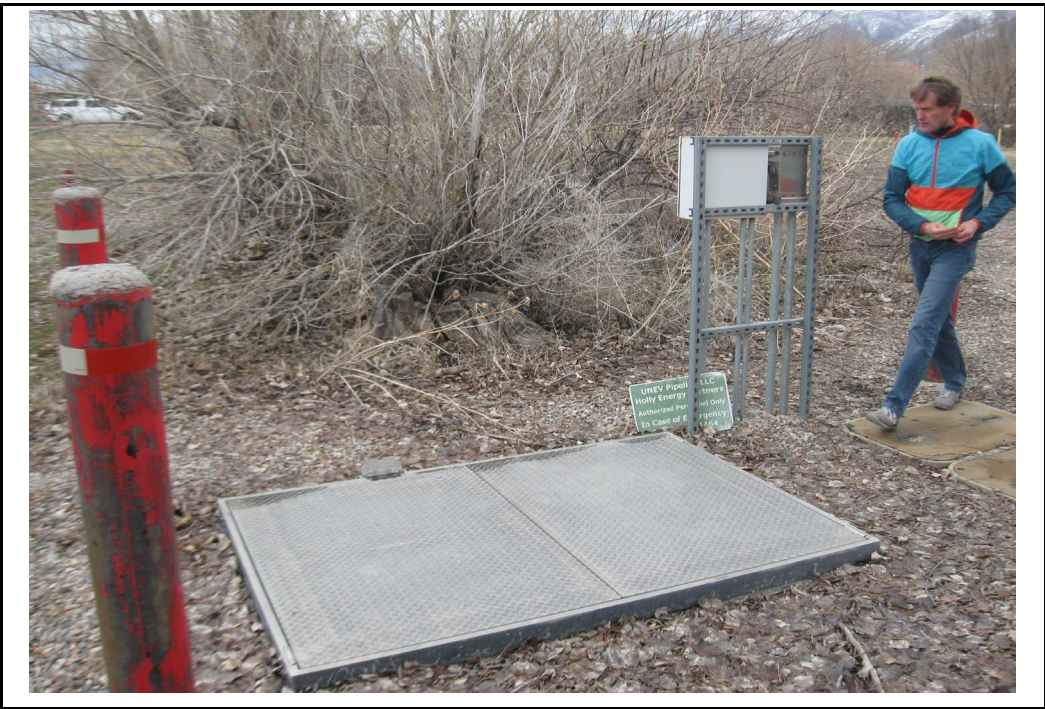
Photo
No.8

Description:
OU2 EW-3

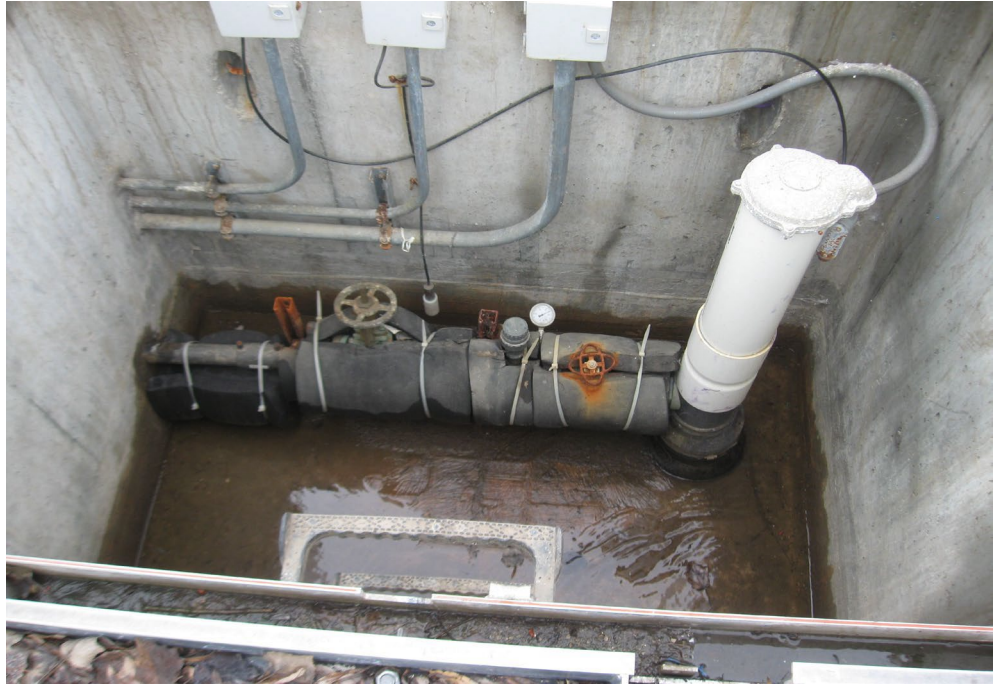
Description:
OU2- EW-2
Well Vault

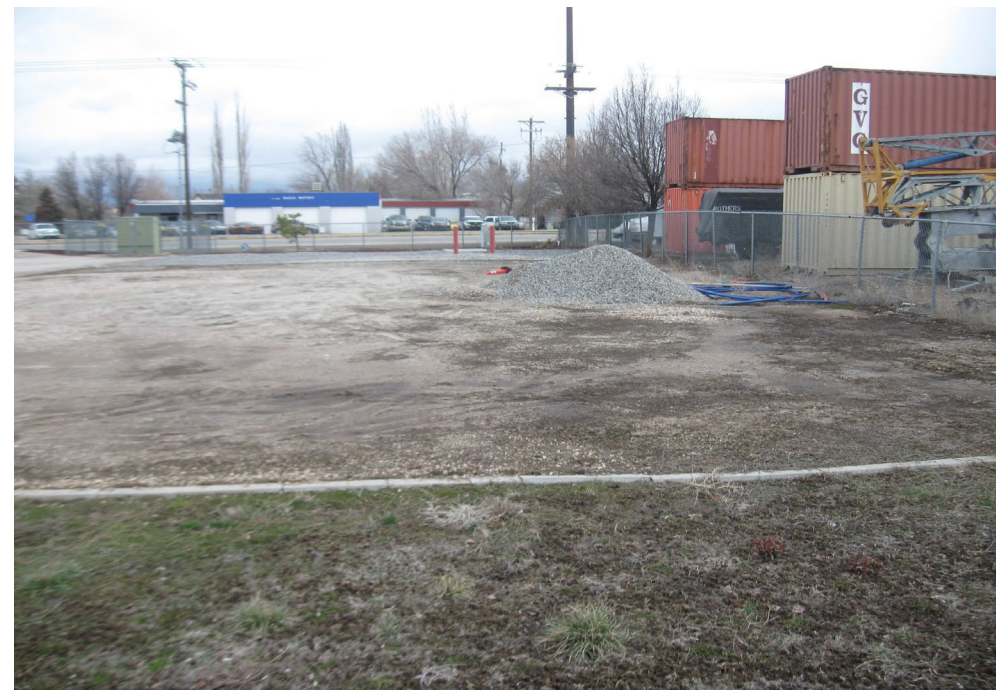
Photo
No.10

Description:
OU2- EW-5

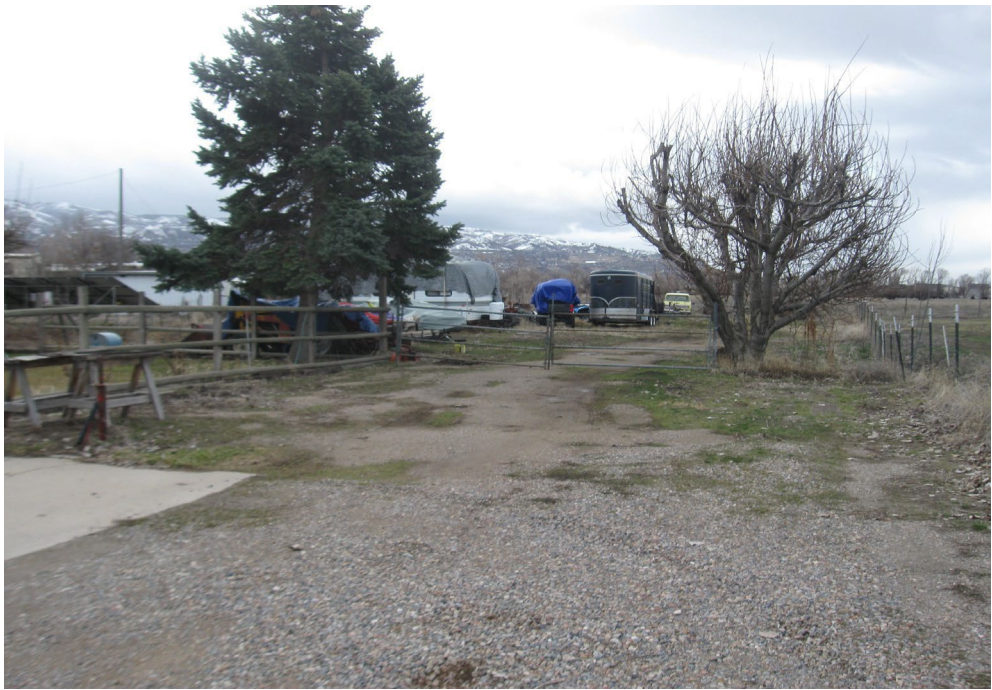
The domestic well DW-27, which is used for residential supply, has had intermittent PCE results above the MCL since 2016 (the maximum being 6.7 µg/L in 2020), which calls into question the protectiveness of the remedy for OU2. However, with installation of the new extraction well, EW-5, that was brought online in June 2020, the PCE concentration at DW-27 appears to be decreasing, with the preliminary PCE concentration observed at that well (3.2 µg/L) in 2022 being below the MCL. Additionally, the owners of this well have been offered a connection to the municipal water supply but have declined, as they indicated they preferred well water. They were interviewed for this FYR and indicated that there is a filter on the tap in the house, though they were not sure of its efficacy.

Description:
OU2
Gertsch Property
DW-27

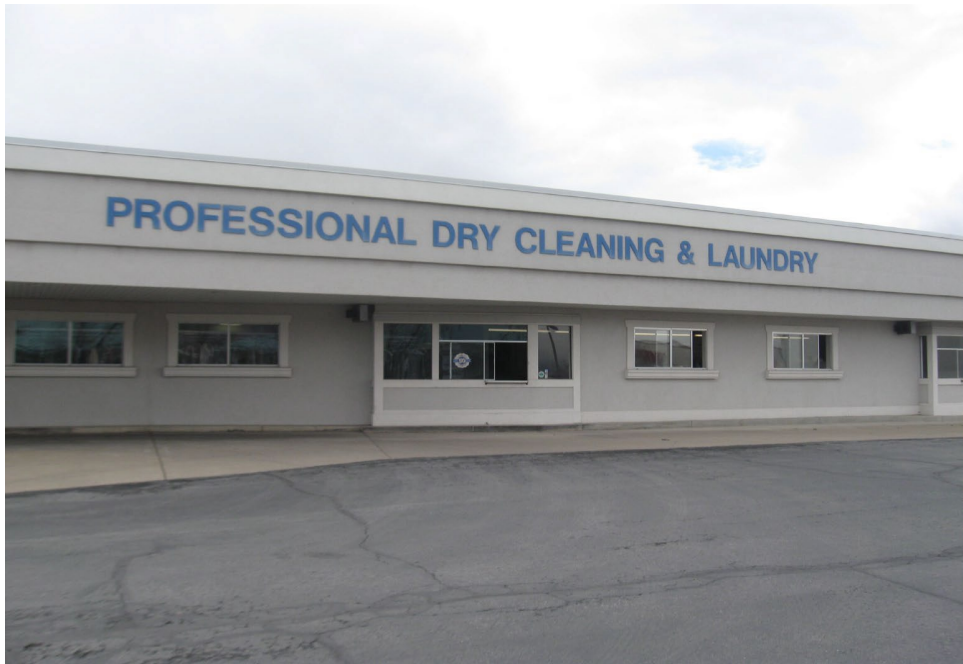
Photo
No.12

Description:
OU2 Source Area
Bountiful Family
Cleaners

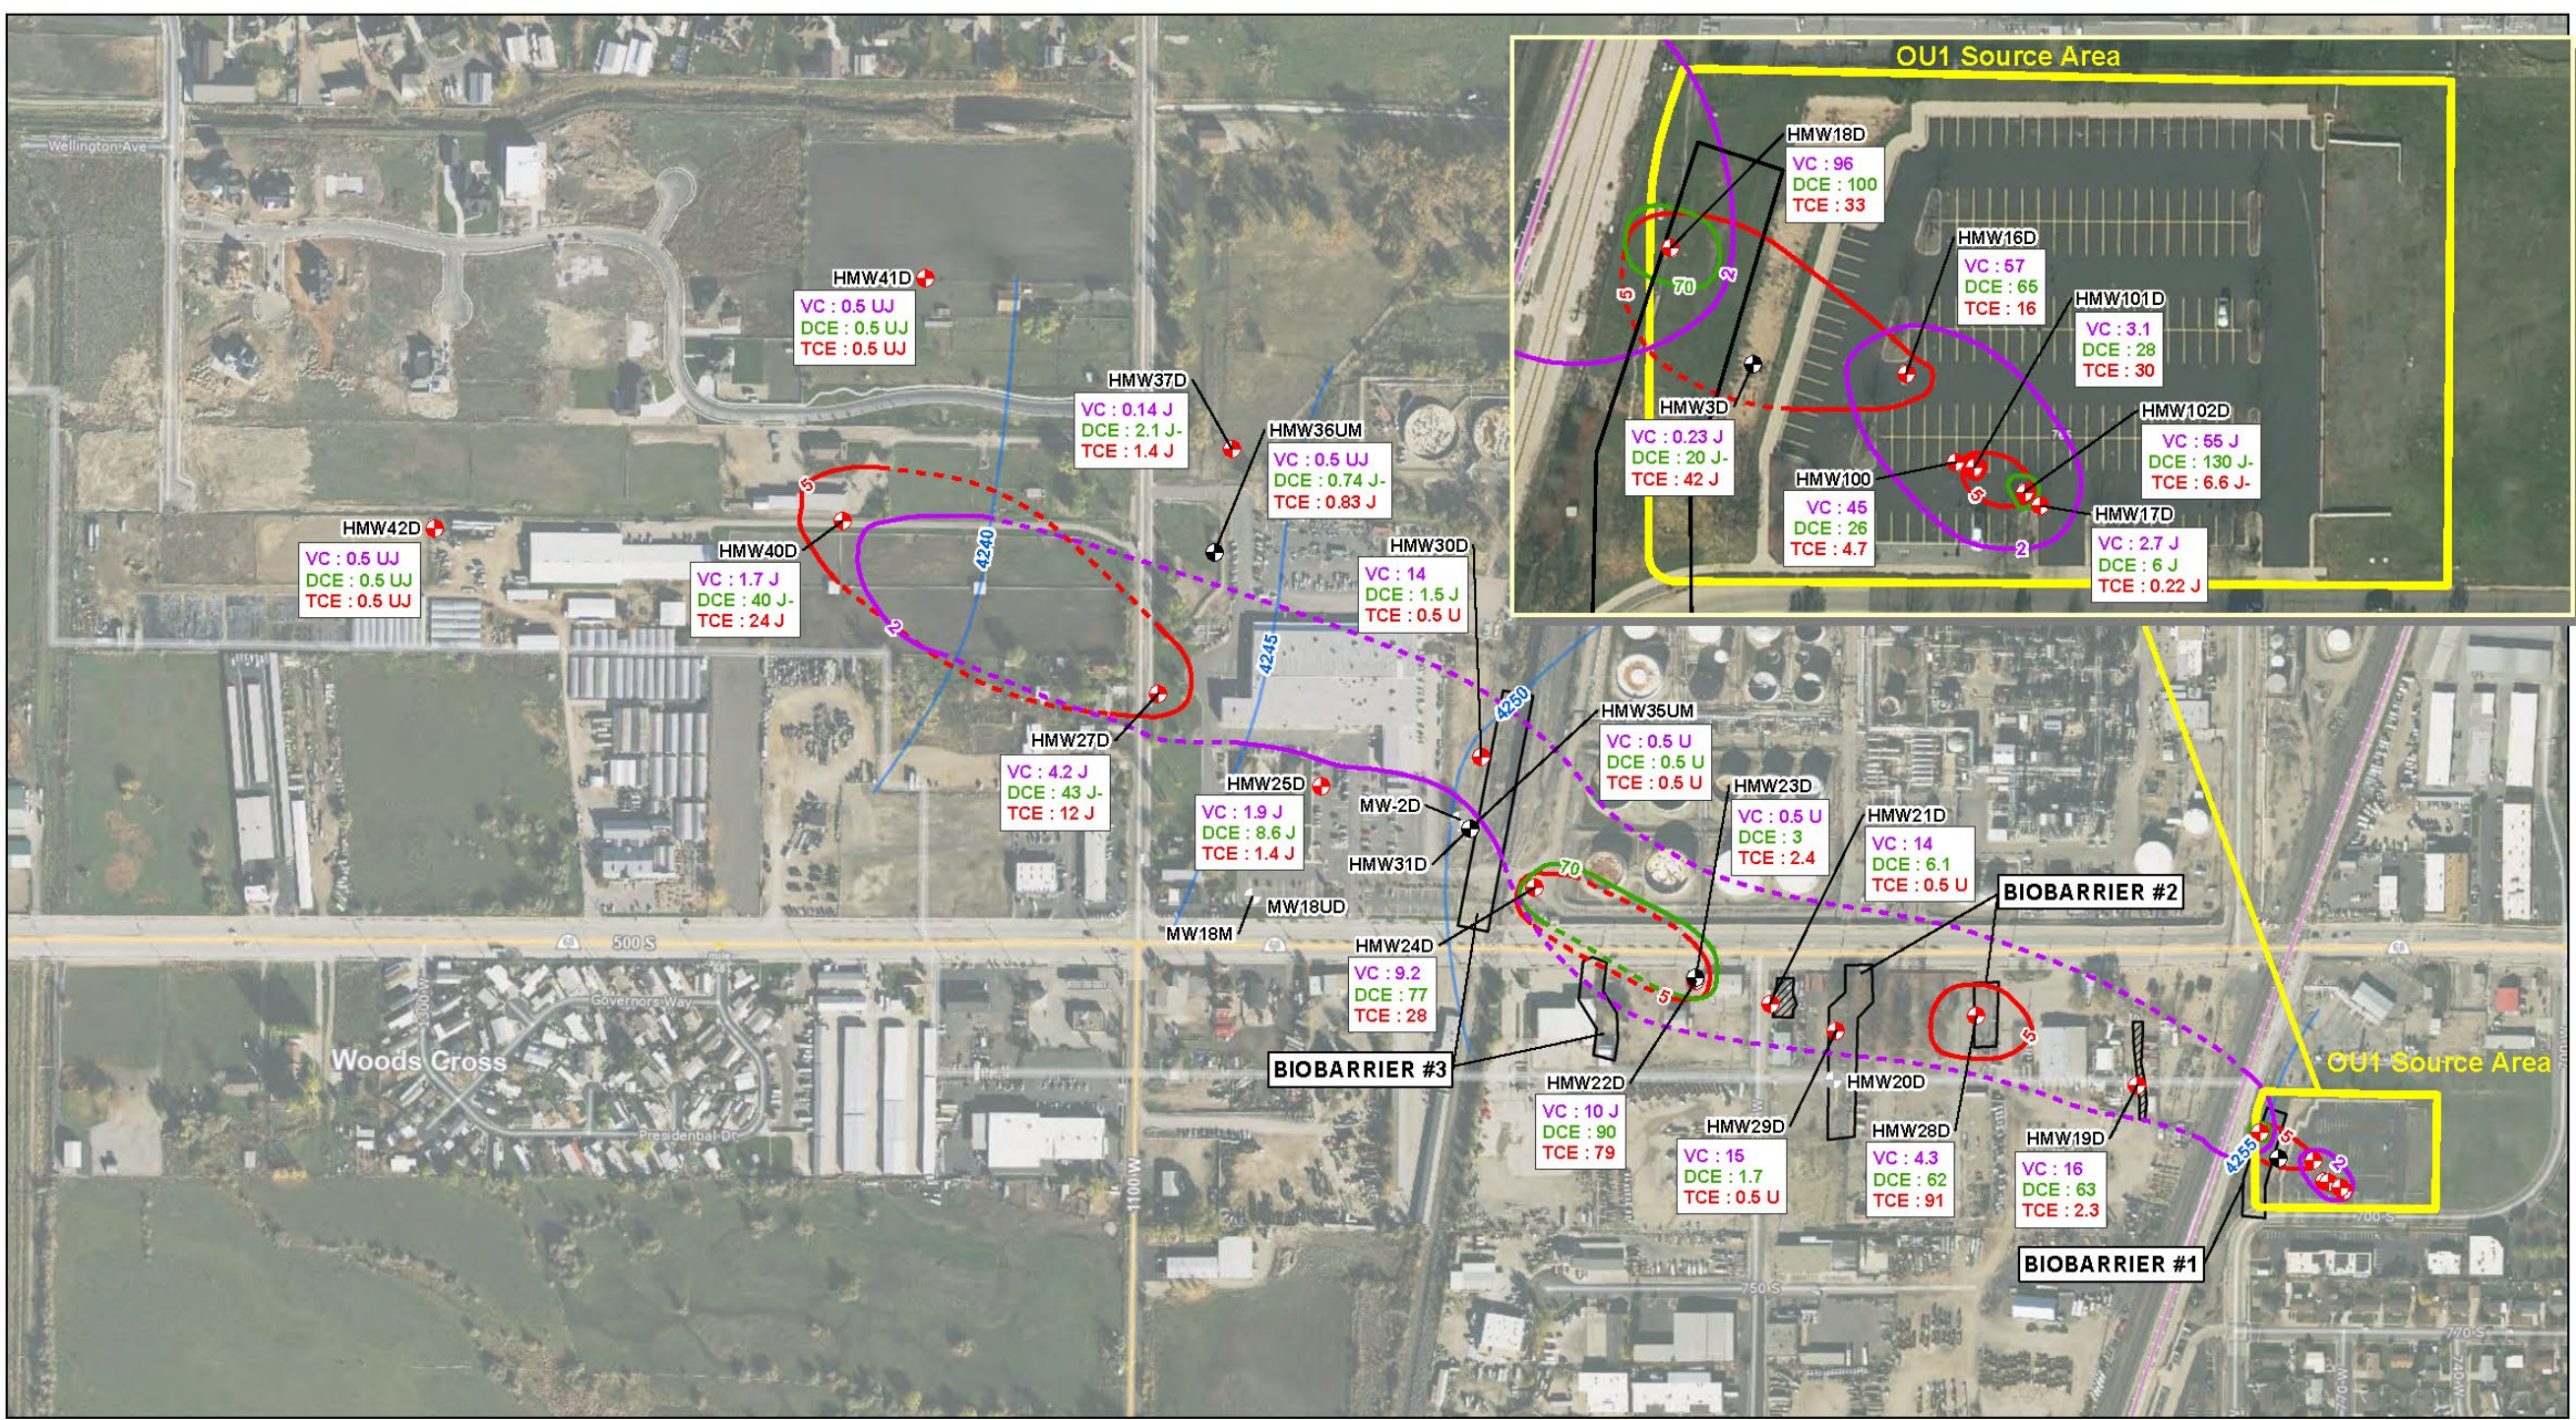
Figure H-5:
Extent of Trichloroethene, CIS-1,2-Dichloroethene, and Vinyl Chloride in the Deep Aquifer - OU1
Bountiful/Woods Cross
5th South PCE Plume
Operable Unit 1
Taken from the 2021 (13th) Annual Monitoring Report

The concentration of TCE in the deep zone is higher than the concentration observed in the shallow zone; however, concentrations of both cis-1,2-DCE and vinyl chloride are relatively the same in the deep zone as in the shallow zone. In the source area, the highest TCE concentration in 2021 was 42 $\mu\text{g/L}$, observed in well HMW-3D (Figure H-5); however, this is much lower than the TCE concentrations observed above 1,000 $\mu\text{g/L}$ in the source area in 2008, e.g., HMW-17D had a TCE concentration of 1,500 $\mu\text{g/L}$ in 2008. The TCE concentration at HMW-17D in 2021, subsequent to the 2020 amendment injections, was 6.6 $\mu\text{g/L}$ and the cis-1,2-DCE concentration was 130 $\mu\text{g/L}$, which is the highest concentration observed in the deep zone in 2021. This suggests that the 2020 amendment injection has been successful at augmenting biodegradation in this hot spot.

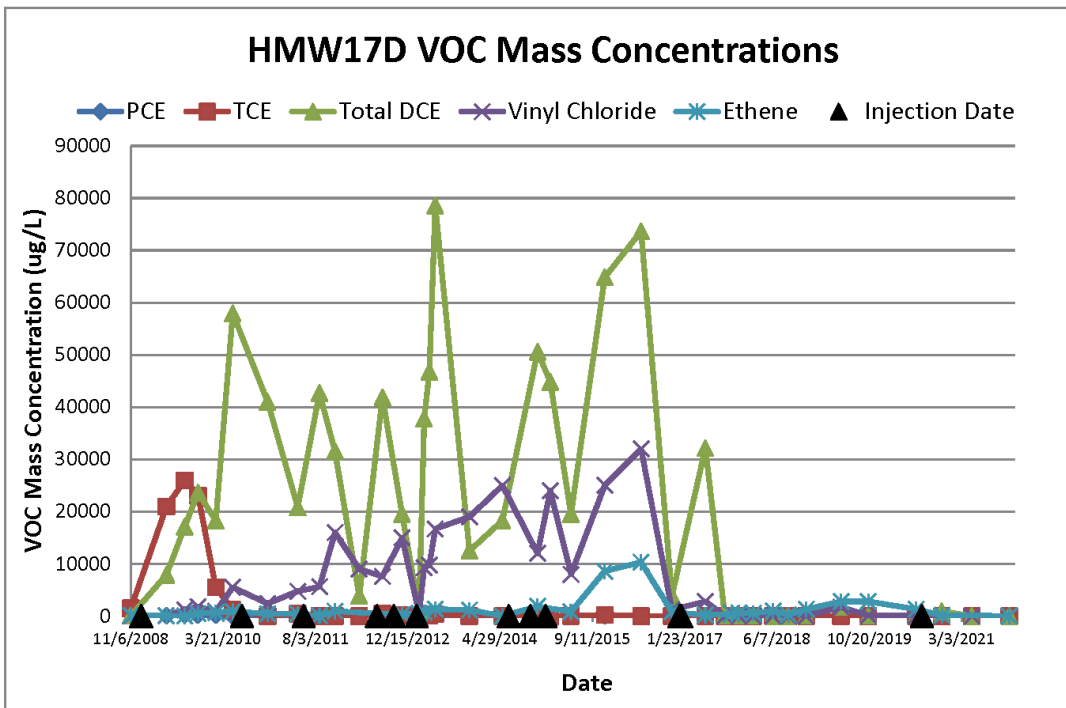
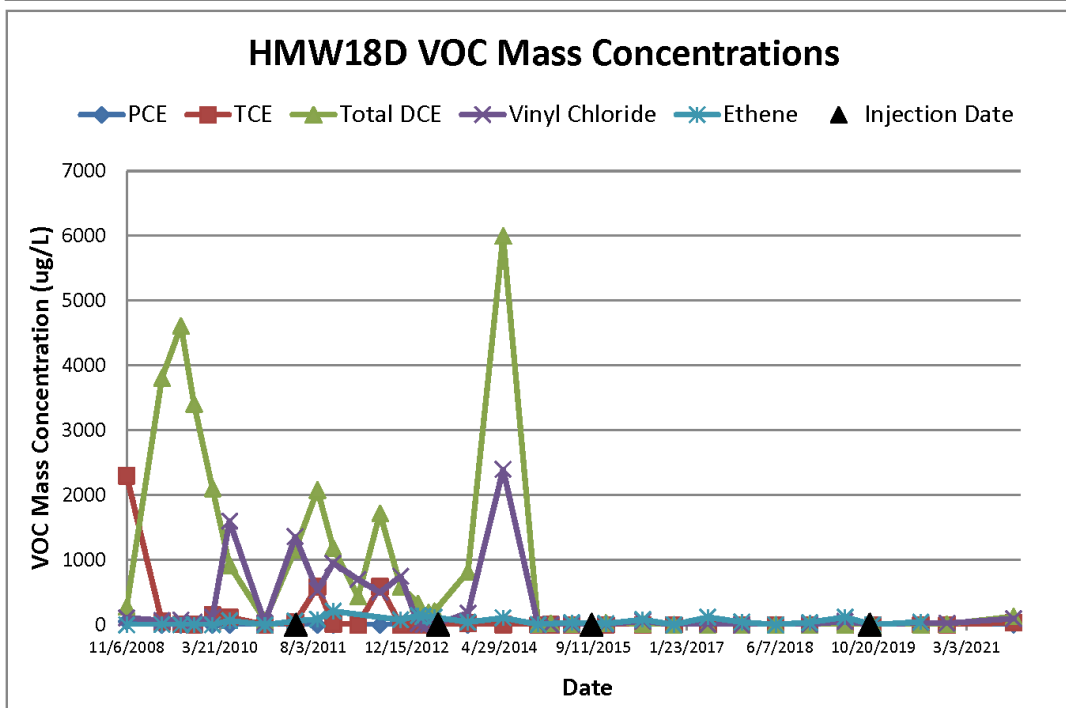
Figure H-6: VOC Concentration Over Time in Monitoring Wells HMW-17D and HMW-18D

permeability enhancement activities. Furthermore, with the exception of one location in the deep zone, total CAH concentrations in both the shallow and the deep zones are below the action level of 200 µg/L, indicating that additional amendment injections will not likely be necessary. However, it may be necessary in the future to evaluate alternative approaches to decrease vinyl chloride to below the action level, as it appears that the degradation of vinyl chloride may have stalled.

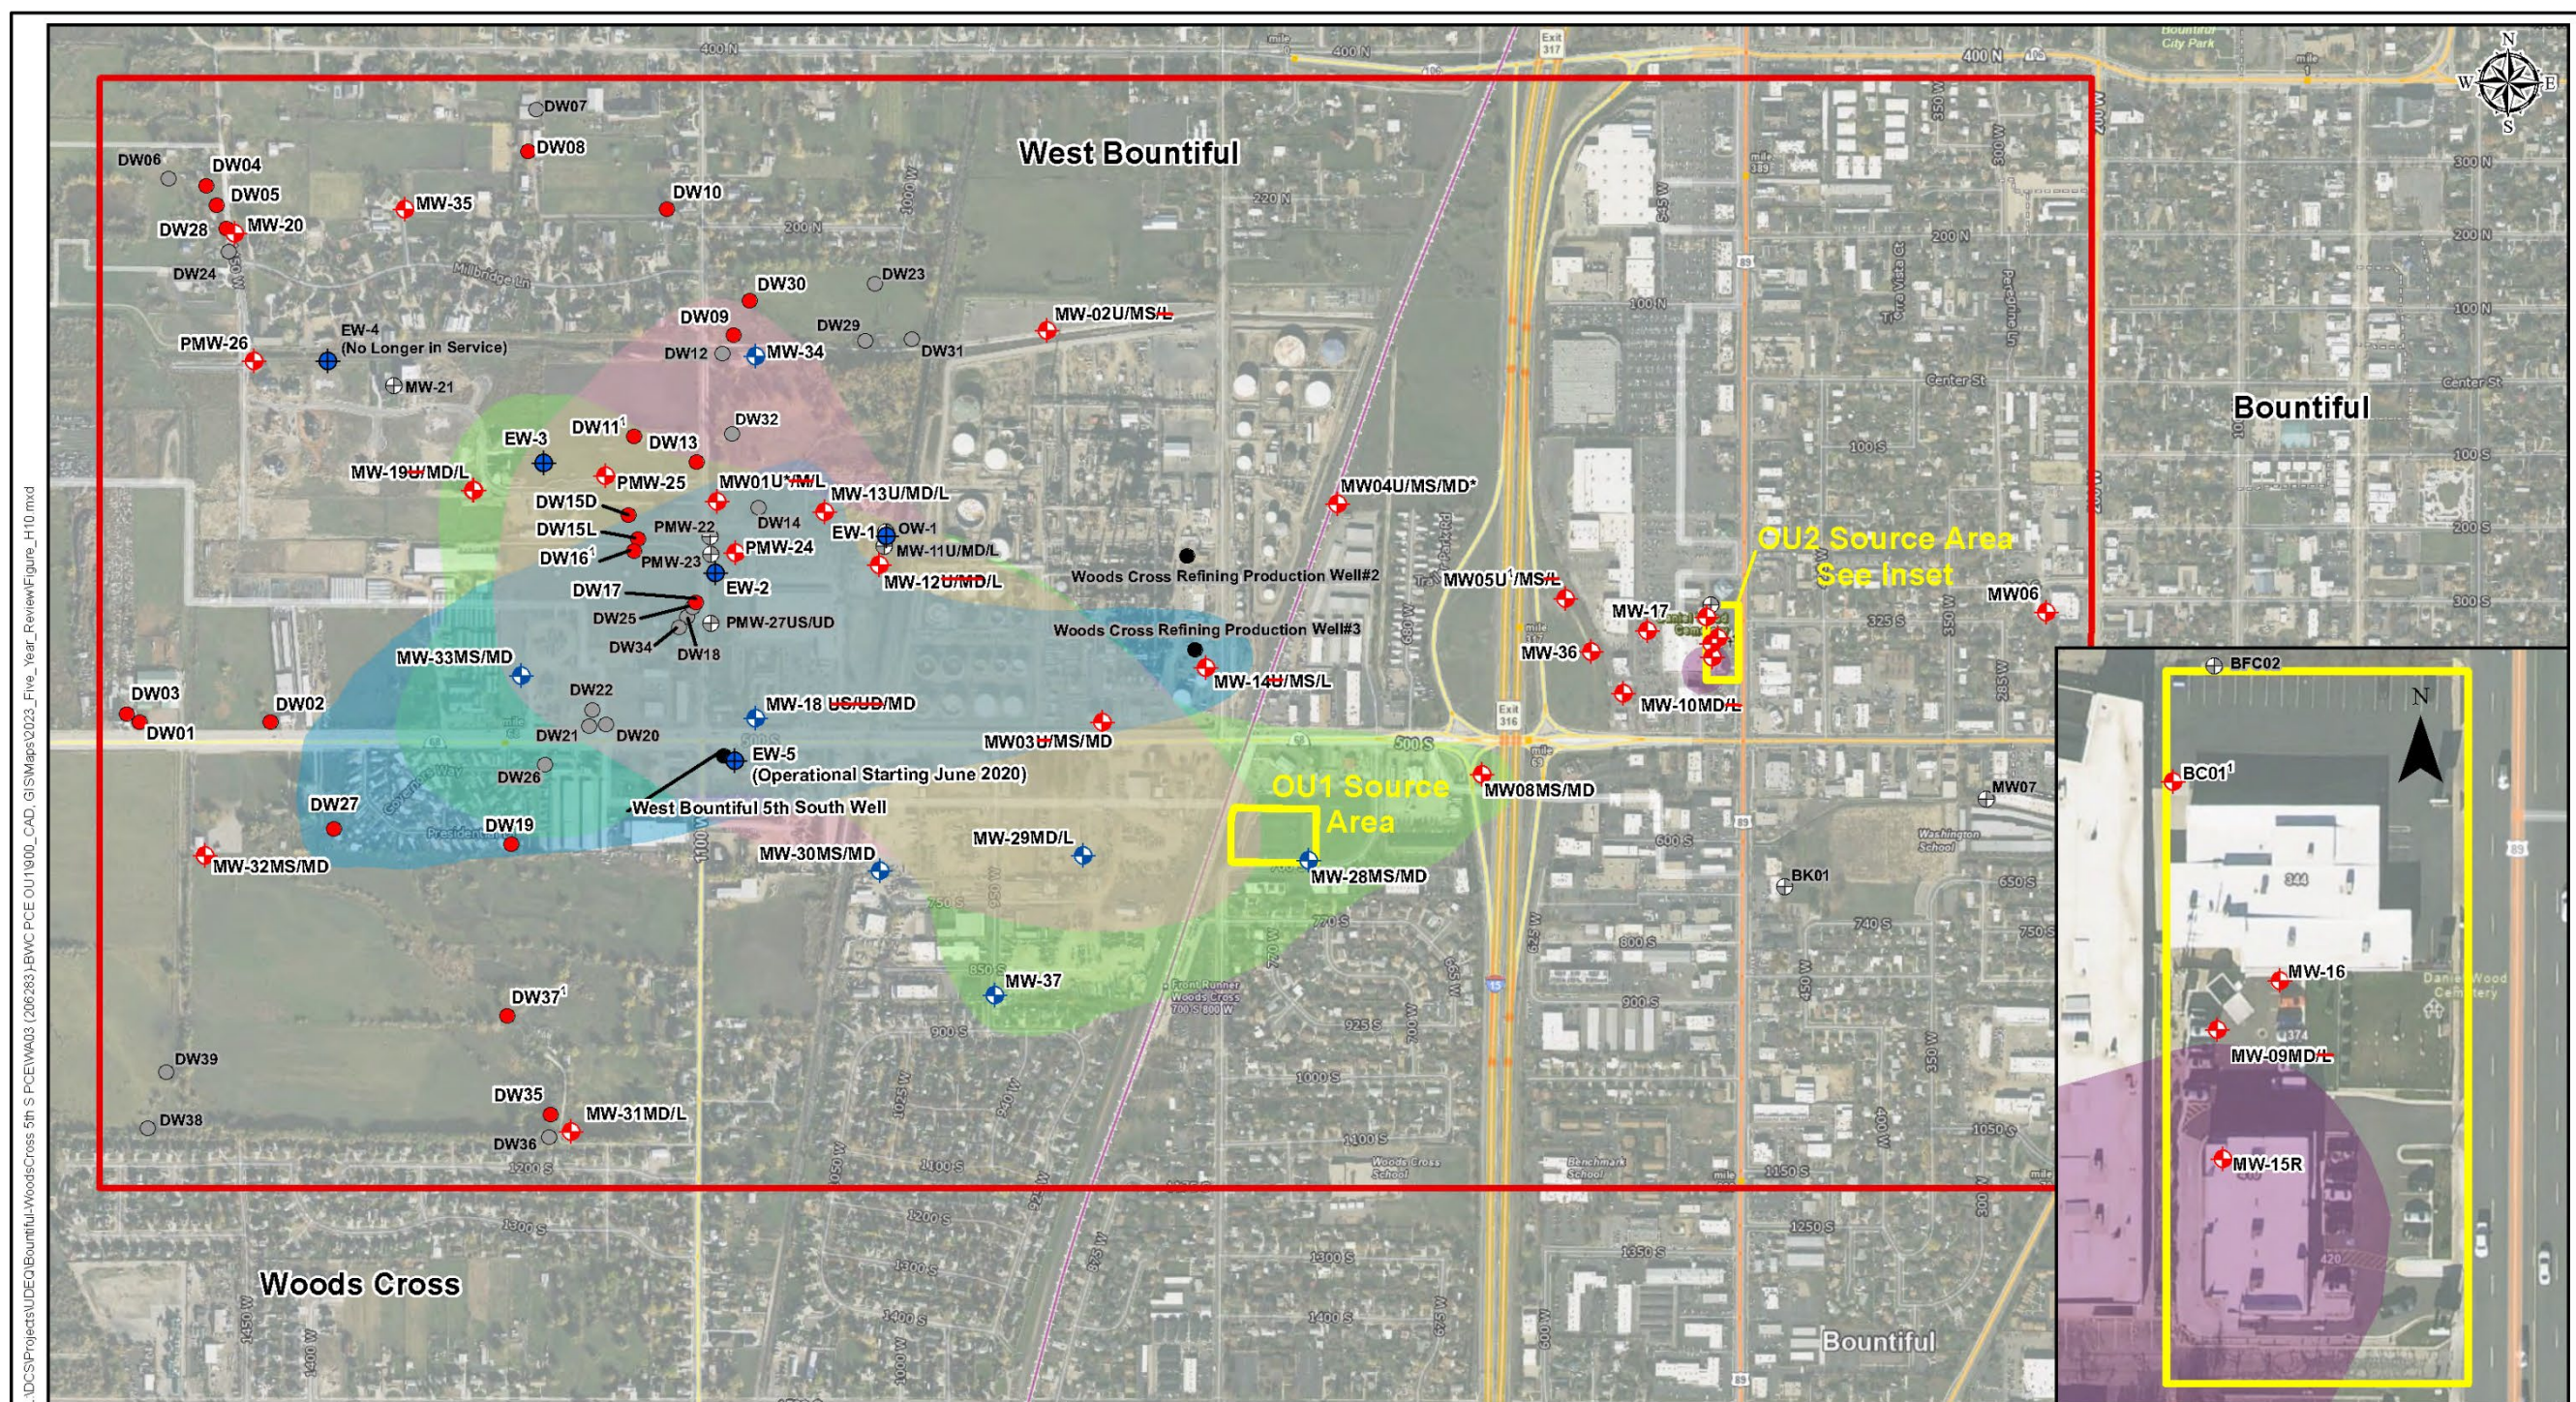
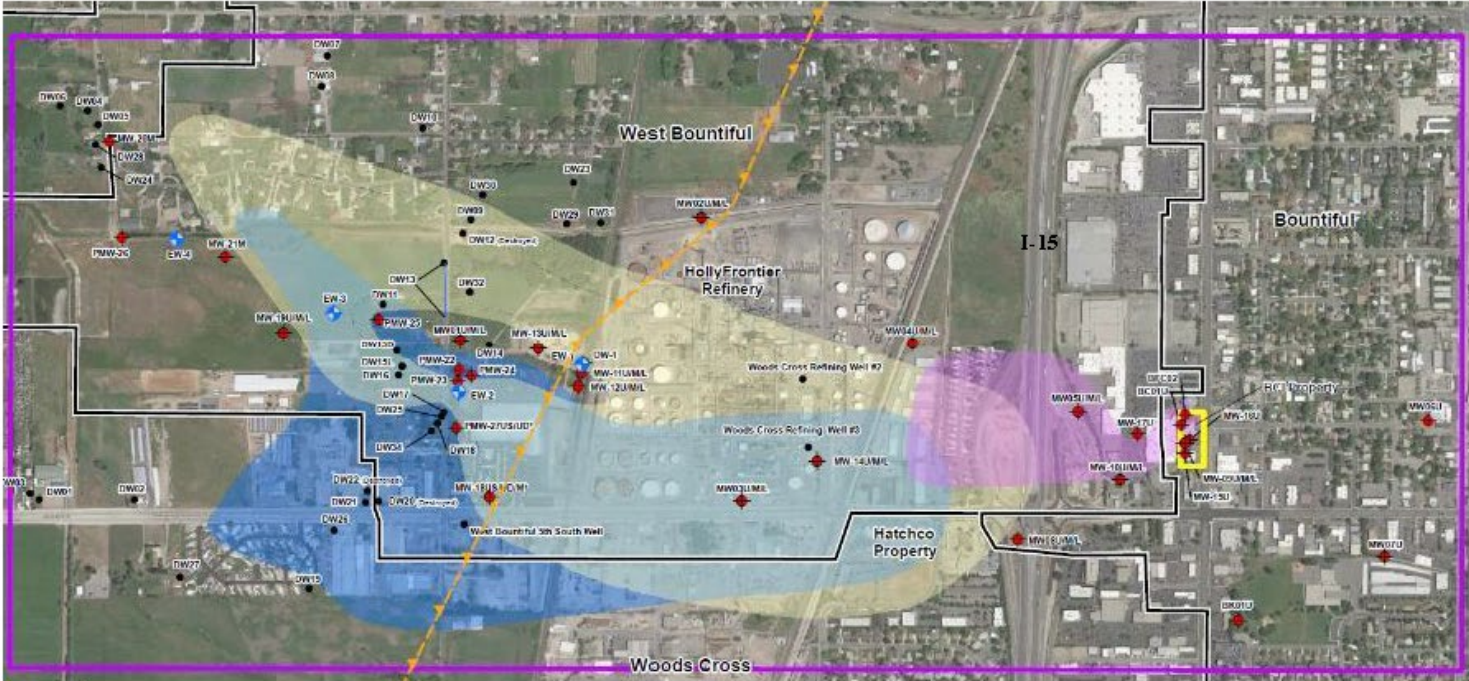
Figure H-11: OU2 Dissolved PCE Plume A cross All Surficial Aquifer Zones – September 2016

PCE plume maps for 2021 compared to 2016 are presented in Figure H-10 and Figure H-11, respectively. Comparison of the maps shows that the most obvious change observed in 2021 is the sharp decrease in the extent of the PCE plume in the upper zone (Figure H-10). The PCE footprint has also decreased to a lesser extent in the middle zone and lower zone since 2016, and additional wells continue to define the plumes in both zones to the southwest. Water level data from 2021 indicates that the GWTS appears to induce hydraulic gradients near the extraction wells that affect middle zone hydraulic gradients in a way that is likely to prevent dissolved PCE migration to the west, northwest, and southwest (with the addition of EW-5) in the pumping area. As of 2022, all groundwater sampling at OU2 occurs in the spring, during the period of seasonal high groundwater levels.
