5.9 SWMU 14: BUILDING S-108 (FORMER MOTOR POOL)

Figure 5.9-1
Site Map
SWMU 14 - Building S-108
(Former Motor Pool) as Remodeled, 1988
 Tooele Army Depot - South Area
 Prepared by: Ebasco Services Incorporated

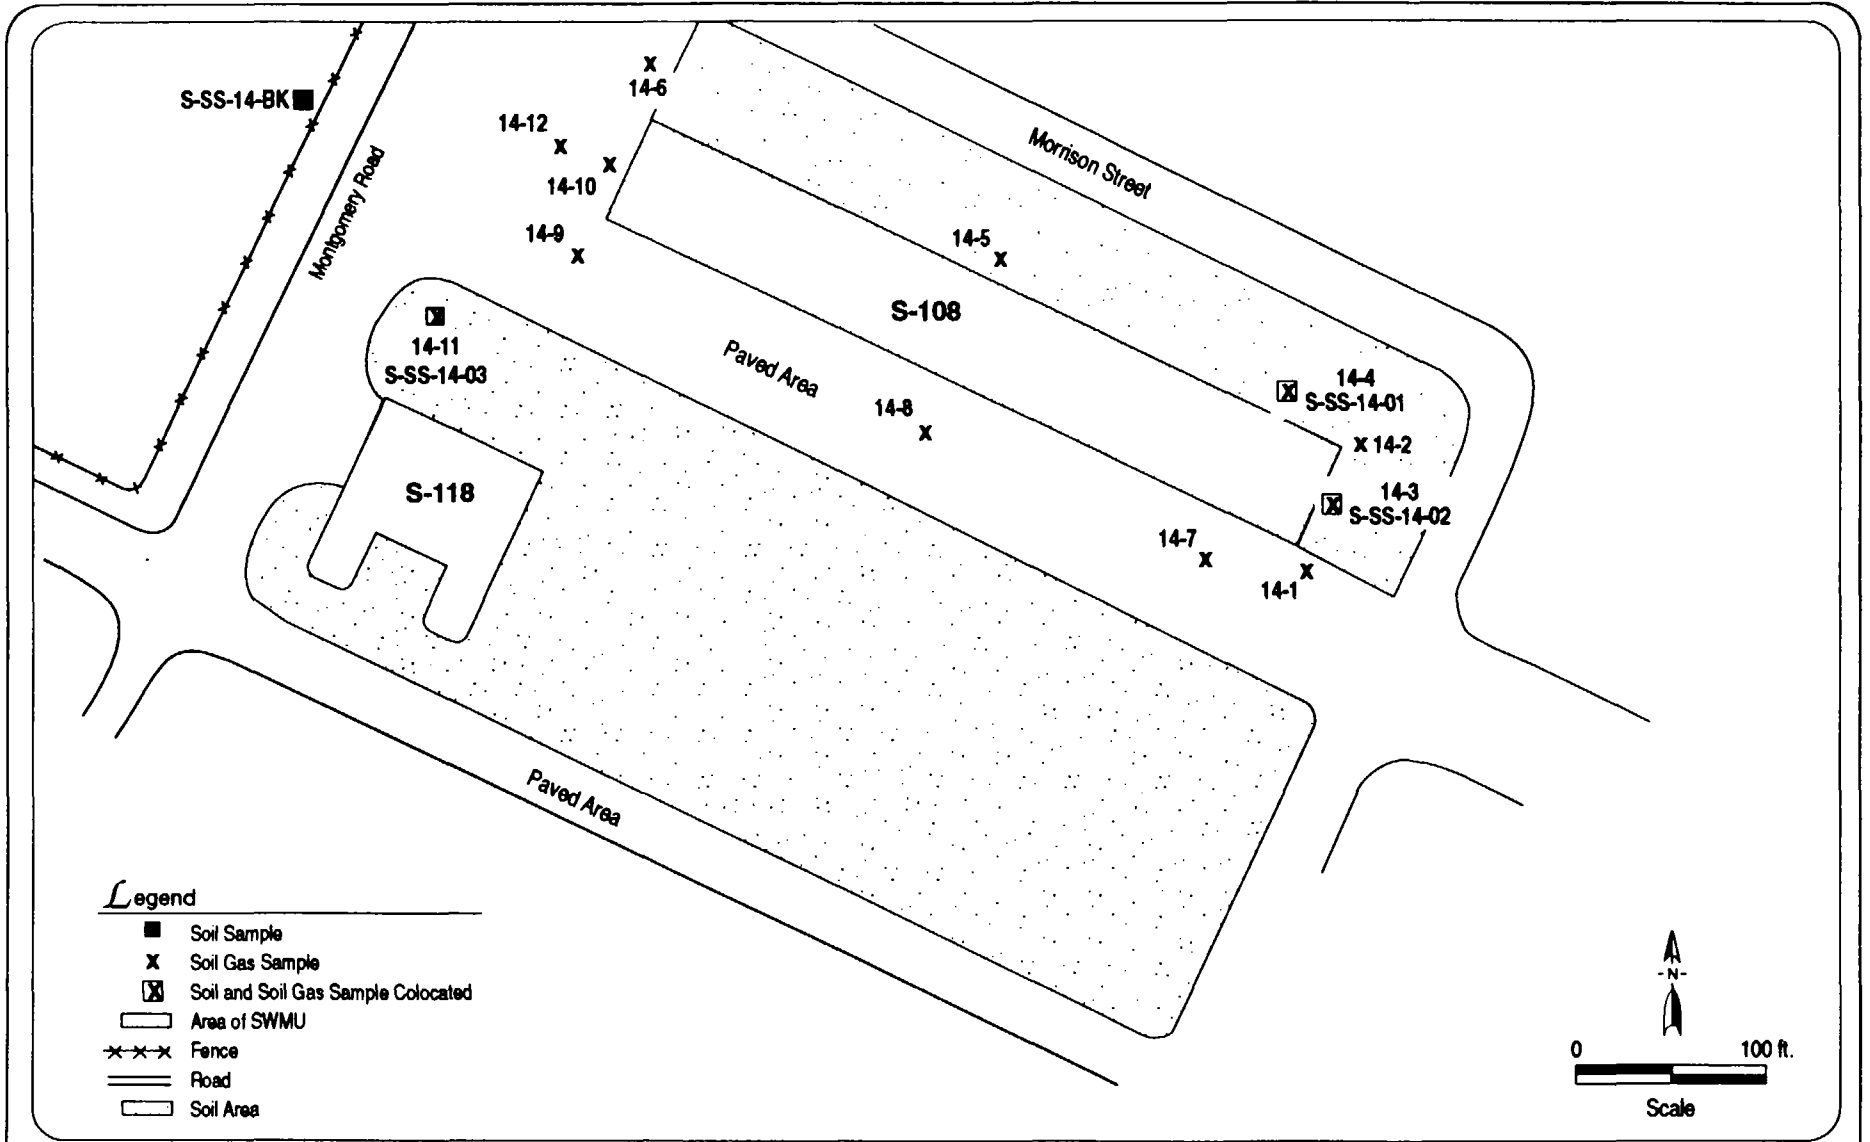
Building S-108 is located in the administration area and currently houses the Chemical Surety Office (Figure 5.9-1). This building was previously named S-108, but was renumbered 5108 in 1991. A hard-packed gravel apron and parking lot surround the building. The building was formerly a motor pool area where spills of petroleum products, solvents, and oils may have occurred (USAEHA 1986). The Installation Assessment (USATHAMA 1979) also reported that this building was once used for processing M12 (machine gun) links and for welding. Potential contaminants from this operation may include hydrochloric, chromic, and phosphoric acids and metal dust.

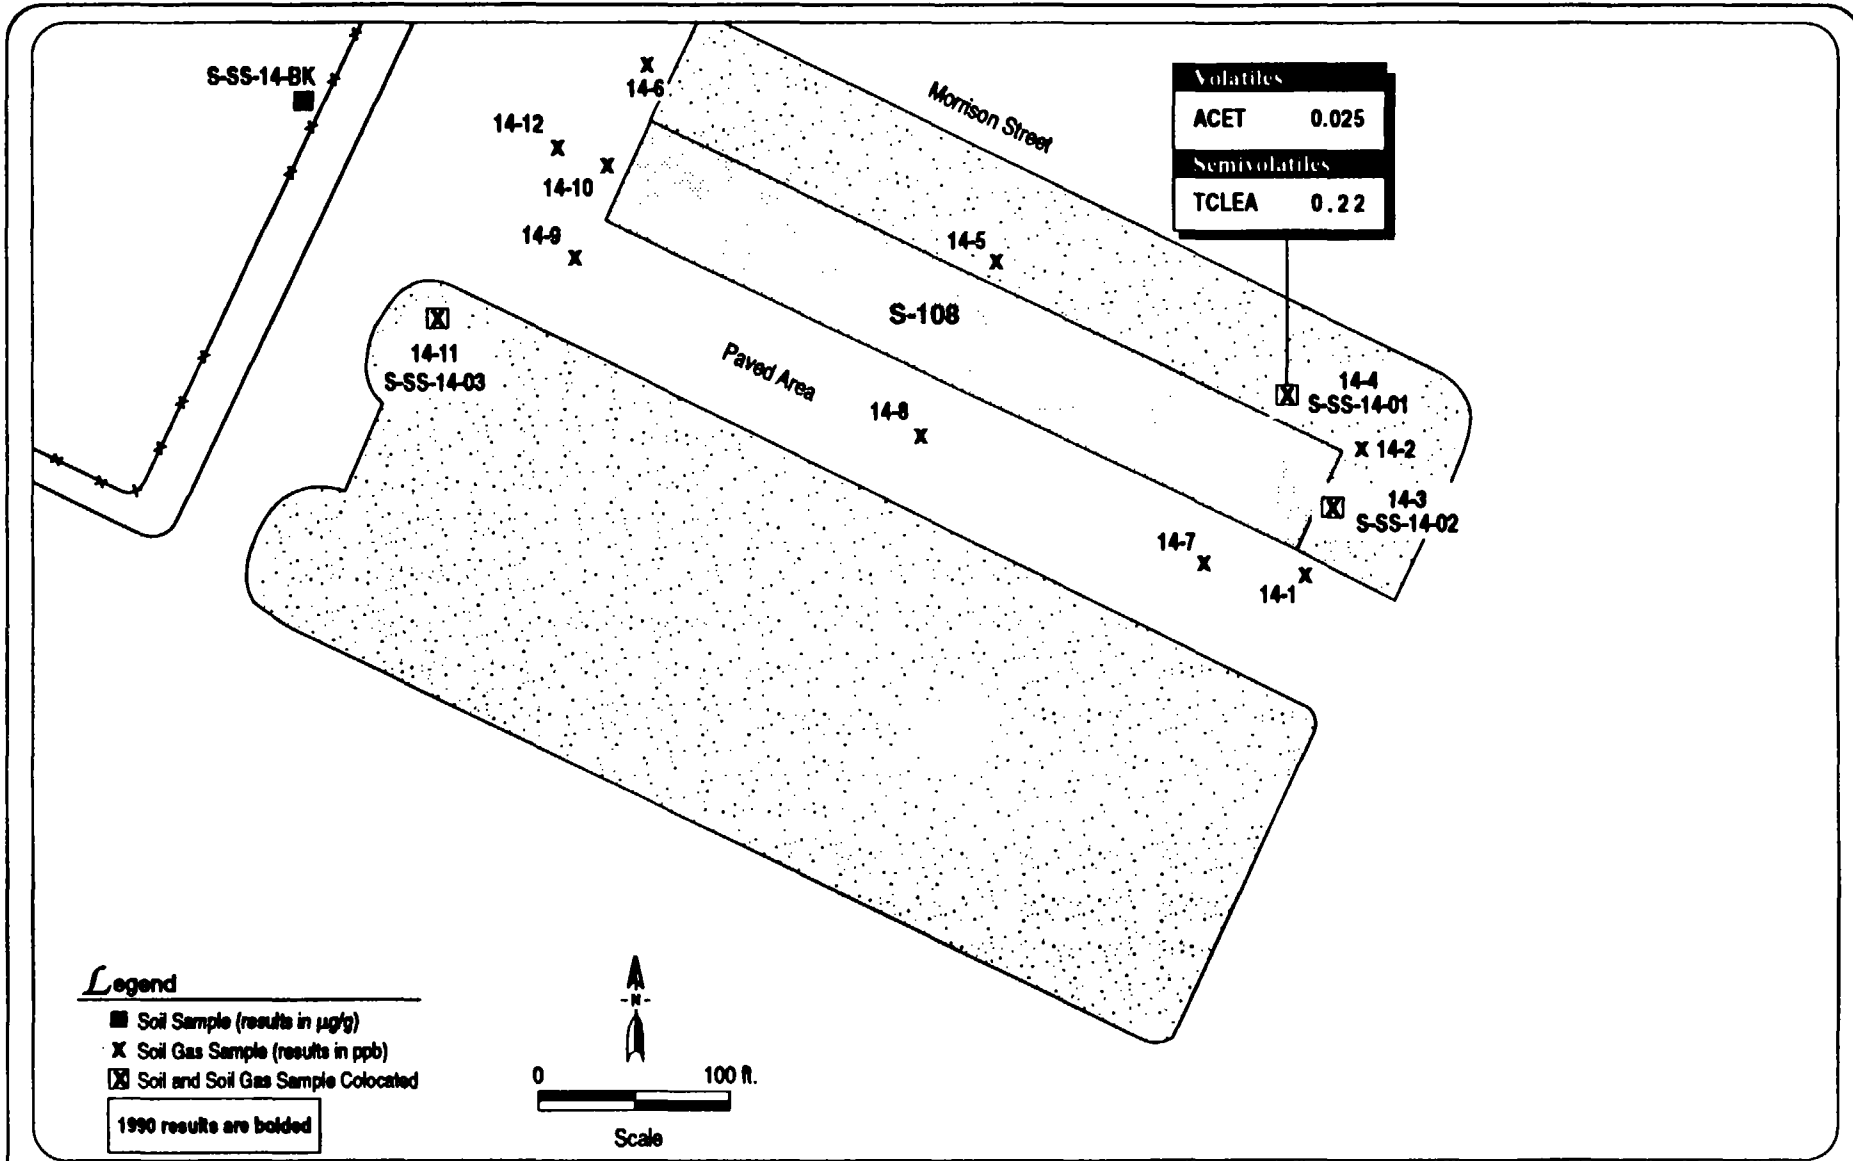
Figure 5.9-2
SWMU 14 - Building S-108
(Former Motor Pool) as Remodeled, 1988
Organics

Although low levels of fuel-related organic compounds and chlorinated solvents were detected in soil gas samples, these compounds were not identified in soil samples. Trichloroethylene recoveries in MS/MSD samples corresponding to soil samples S-SS-14-01, 02, and 03 were outside the 95 percent confidence limit (Section 3.10). Therefore, the contamination assessment is based on qualified volatile organics results. However, the semivolatiles and TPH in soil confirm the absence of significant contamination at SWMU 14. No semivolatiles were detected. Only one soil sample showed a detection of TPH and this detection was at a low concentration. The soil gas compounds and the low-concentration TPH detection are probably related to the present use of this area as a parking lot. Acetone was also detected at low concentrations in each soil sample, indicating possible laboratory contamination since acetone is commonly used in laboratories as a glassware rinse. Since groundwater in the area is 280 ft or more below the surface, it is unlikely that groundwater has been affected by this site.

No further investigations are recommended at SWMU 14. Analytical results indicated low level organic contamination of soil, which is probably associated with the parking lot. These low levels of organics have little potential of infiltrating to groundwater.

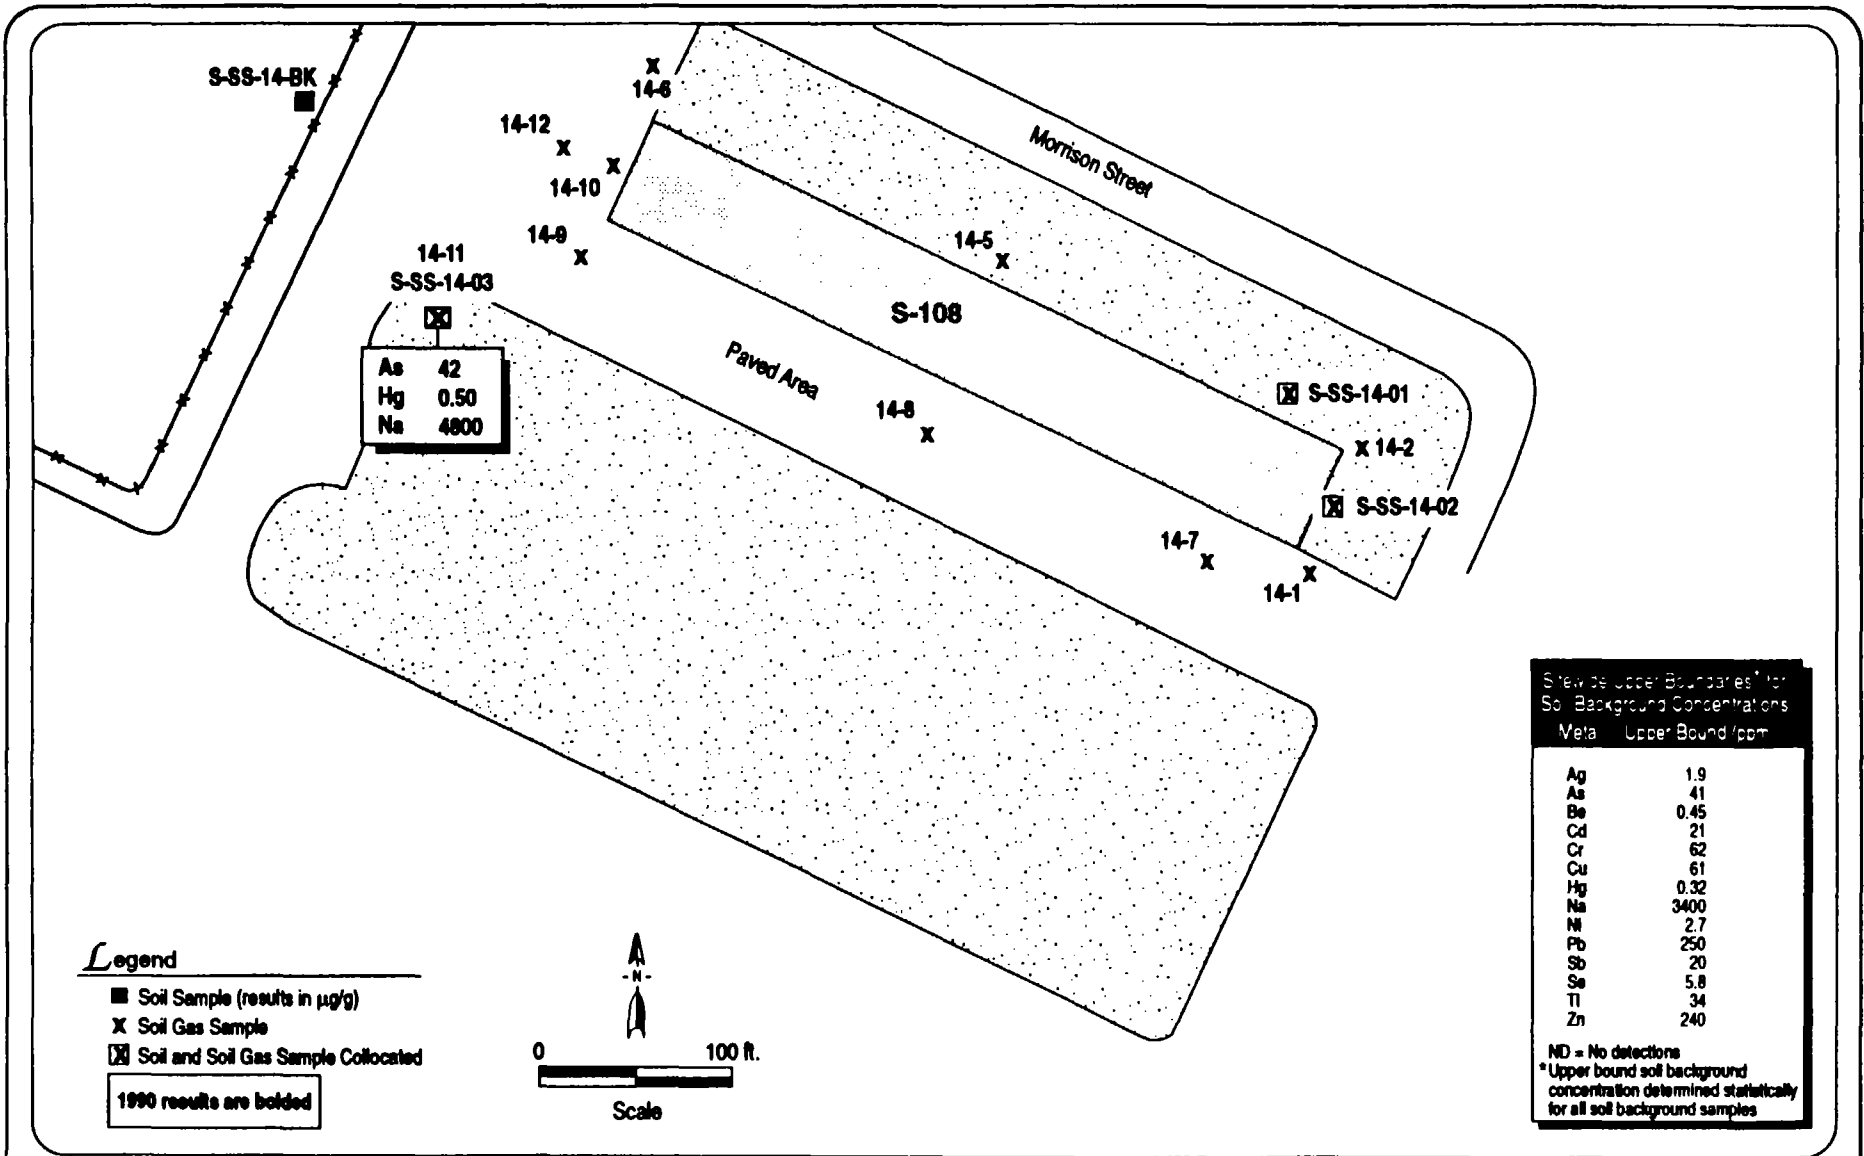
Figure 5.9-3
SWMU 14 - Building S-108
(Former Motor Pool) as Remodeled, 1988
Metals

Arsenic, mercury, and sodium were slightly above background levels in one sample (S-SS-14-03). These concentrations may reflect natural variation in soils or low level contamination. However, these metals are not likely to be related to any releases from a former motor pool building and are more likely to occur naturally in the soil.

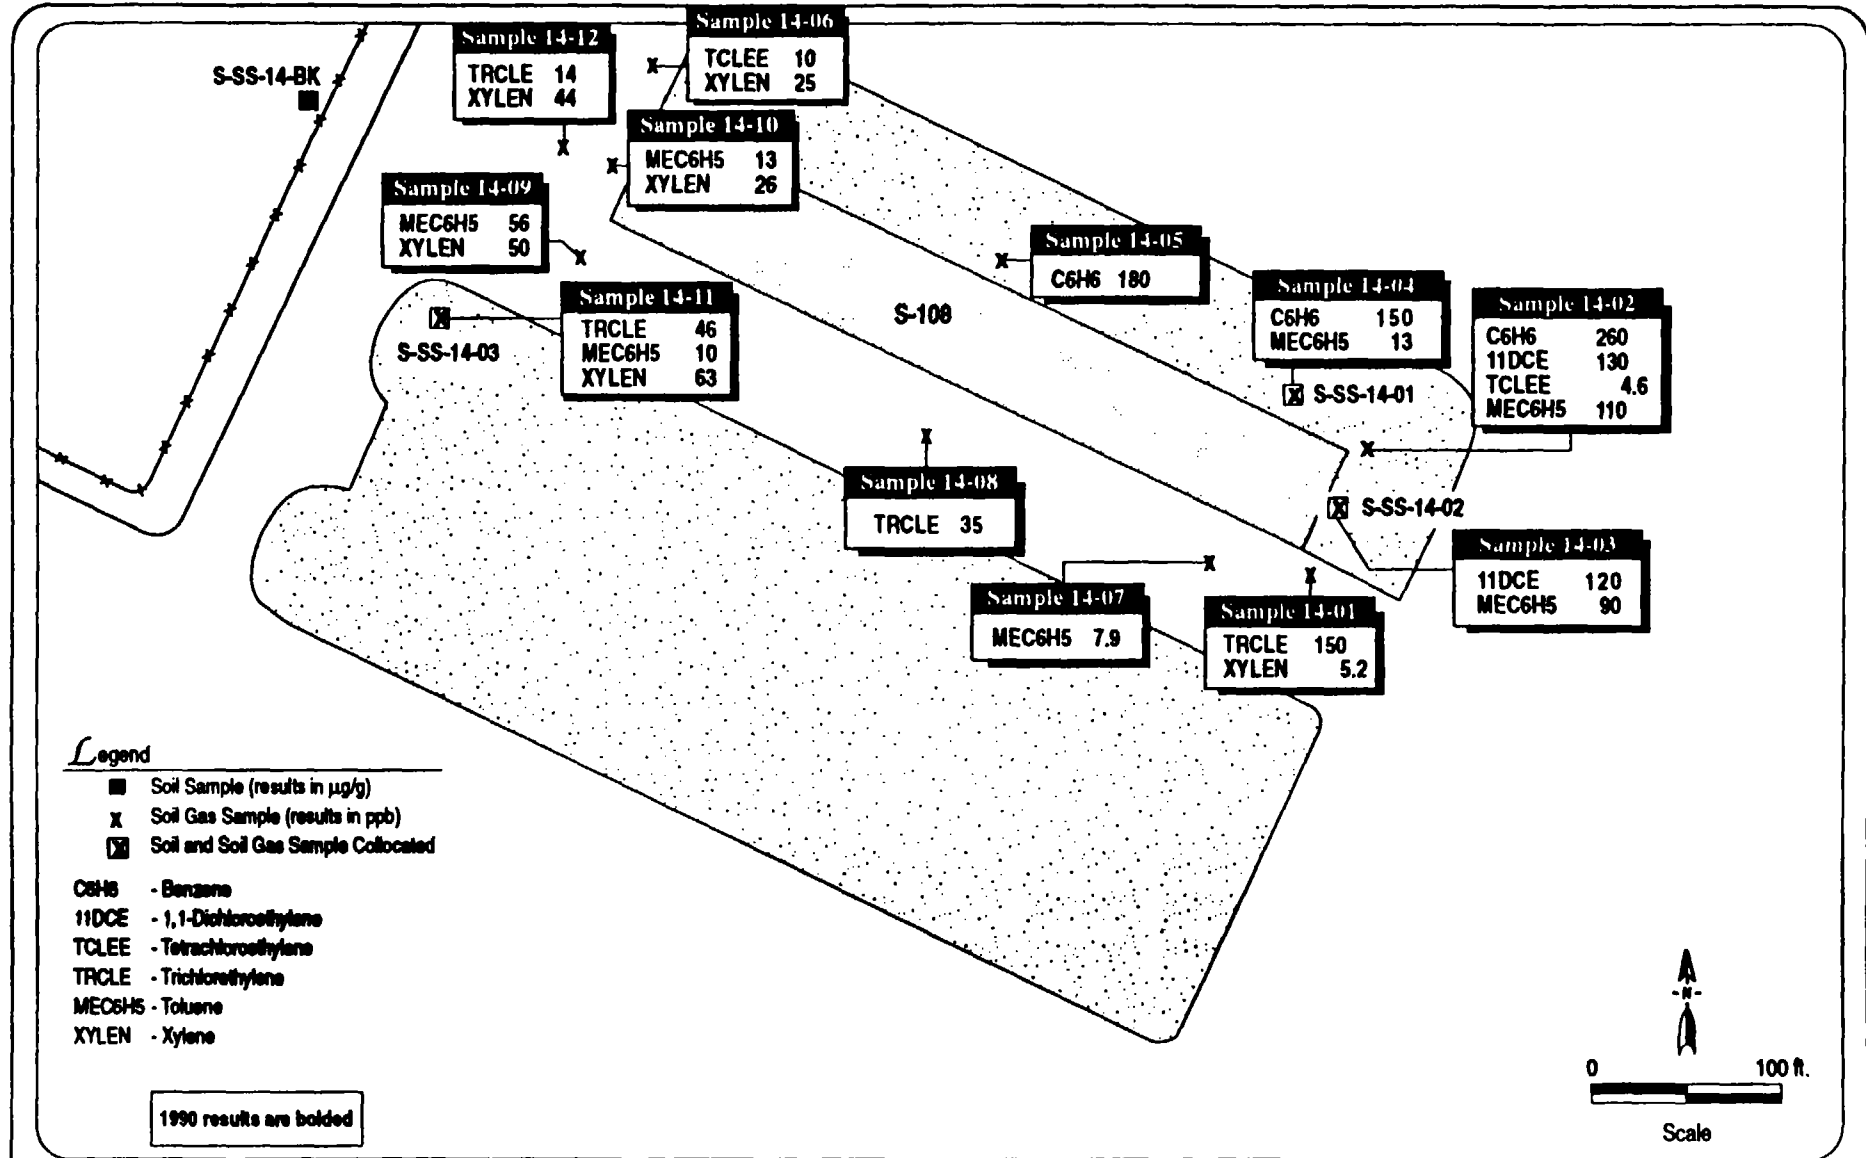
Figure 5.9-4
 SWMU 14 - Building S-108
 (Former Motor Pool) as Remodeled, 1988
 Soil Gas Detections

Soil gas analyses indicated low concentrations (less than 500 parts per billion) of fuel- and solvent-related volatile organics. Benzene was detected at the highest concentration, but toluene was detected most frequently. Fuel-related volatile organic compounds were detected in every sampled location, with the highest concentrations east and northeast of Building 5108.
