PROJECT MEMORANDUM

To: Mark McCune, P.E., Steve Cheney, P.E., UPRR
From: Carol Ravano, P.E.
Job No.: 4294.0
Date: 21 October 2013
Subject: Great Salt Lake Causeway East Culvert- Results of Diving Inspection, 11 October 2013

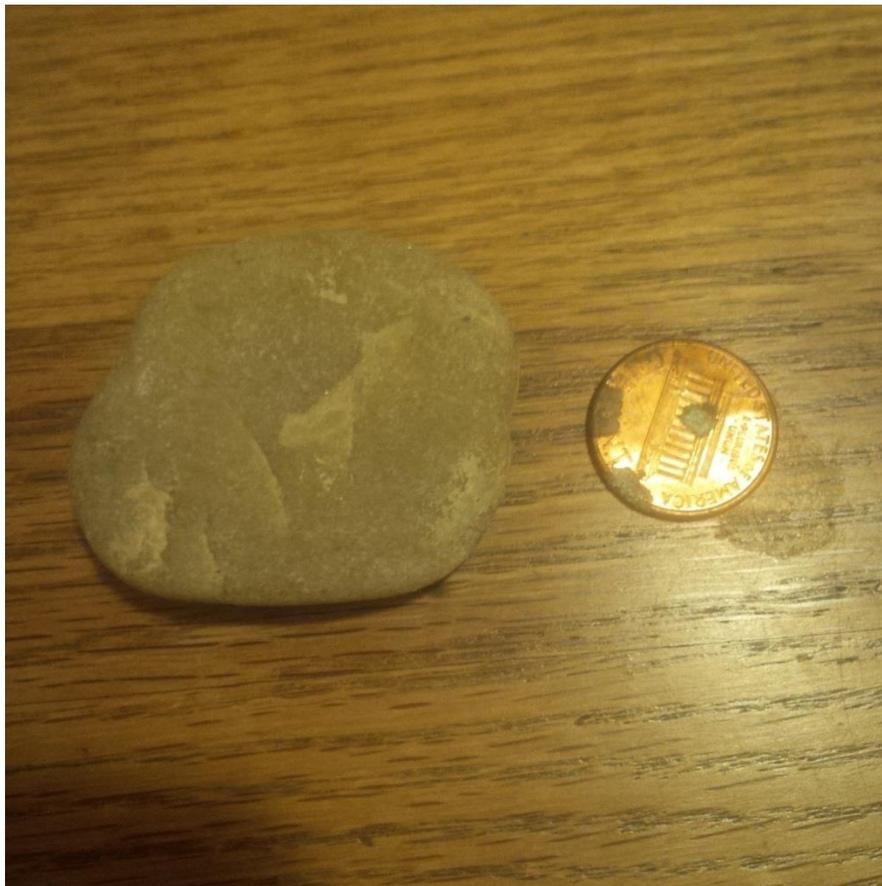
Similar to what we observed in March 2013, during this dive, we noted a pile of smaller rock, less than 6 inches in diameter, at the base of the crack in the west sidewall. The observations of the diver are similar to what was described above at the base of the crack on the east sidewall. This material is presumed to have come into the culvert through the open crack

Photo 1- Sample of rounded rock taken from pile at base of crack in the west sidewall of the East Culvert. This is presumed to be original backfill material.

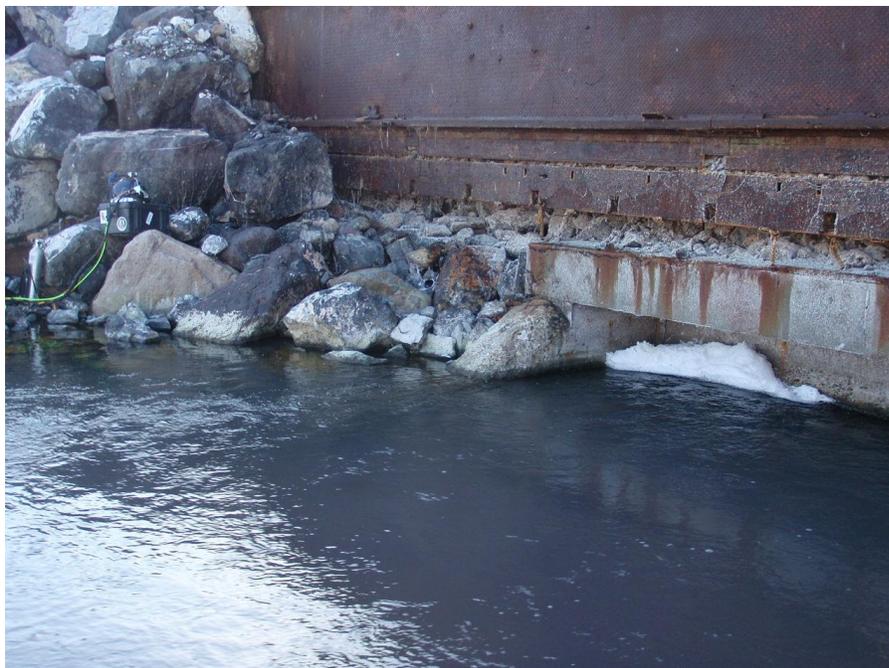
Photo 2-View of North Side of East Culvert. The water level is approximately 1.5 to 2 feet lower than in March 2013

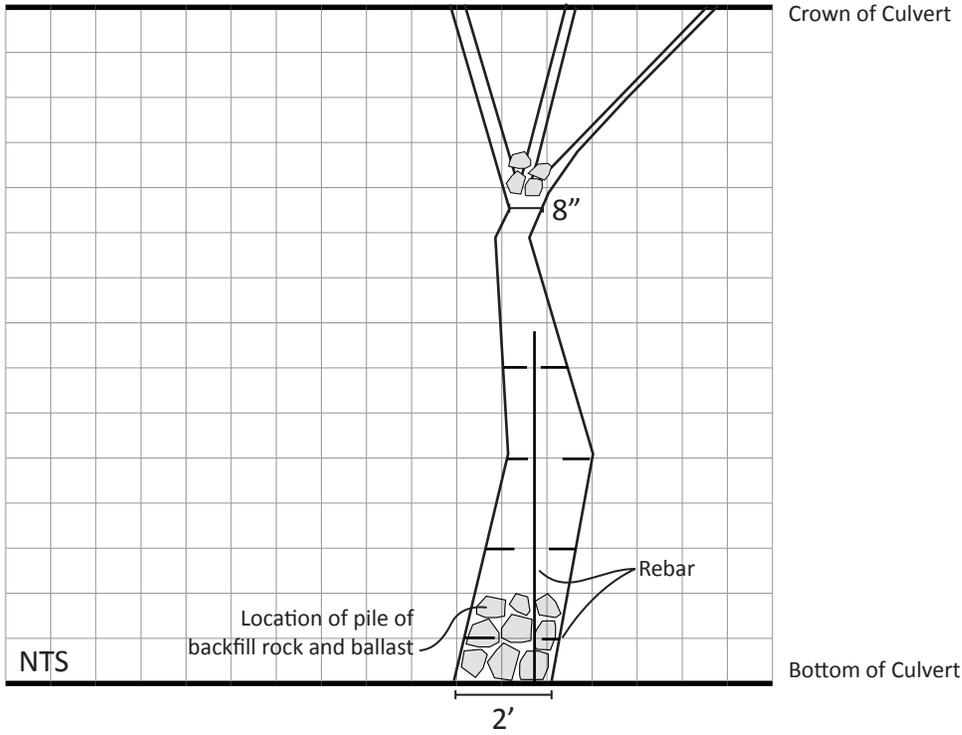
WEST SIDEWALL

Opposite the crack in the east sidewall, there is a crack in the west sidewall which appears to have widened since the March 2013 dive. The crack is approximately 2 feet wide at the base and greater than 12 inches deep. This crack divides into 3 smaller cracks, spaced approximately 2 to 3 feet apart, at about 10 feet up from the culvert bottom. Where the main crack divides into the smaller cracks, there are loose blocks of concrete, less than 1 foot in diameter.

During the dive, the diver also noted that the crack does continue through the 45 degree chamfers that are located at the intersections of the sidewalls and the crown and bottom of the culvert, making it a continuous crack around the entire perimeter of the culvert.

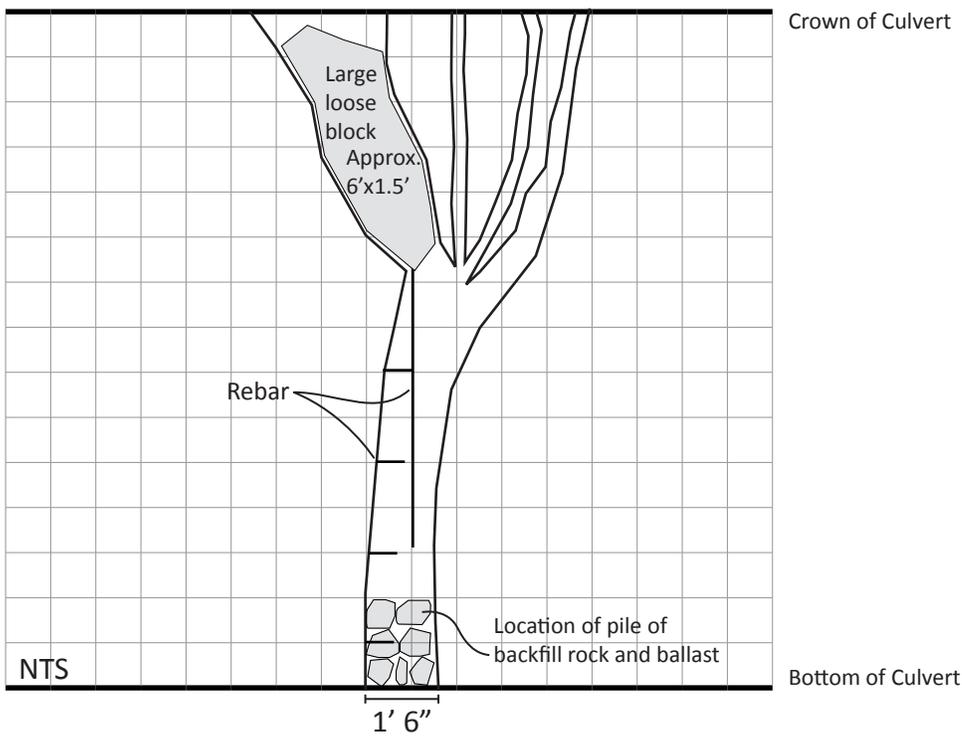
EAST SIDEWALL

During the 11 October 2013 dive, the following observations were made regarding the crack in the east sidewall: There is an existing crack located in the east sidewall, approximately 30 feet in from the north culvert entrance that was first noted in July 2005. Over the years, the crack has increased in width and it is now 18-inches wide and greater than 12 inches deep; the concrete sidewall has continued to spall and there is exposed, corroding rebar present in the crack. As of March 2013, the crack on the east sidewall had split at the top (approx. 10 foot level) into 2 separate cracks. During this 11 October 2013 dive, the diver noted that there are now 4 separate cracks at the top of this crack and that the size and number of loose concrete blocks has increased. The diver described this crack as looking like a tree, with the large open crack as the trunk and then the branches at the top. The loose concrete blocks are located where the cracks diverge from the main trunk.

One of the loose blocks on the east sidewall, located where the cracks diverge, was described by the diver as approximately 6 feet high and 18 inches wide. Just below this block, there were several smaller blocks of loose concrete, less than one foot in diameter. The large block weighs approximately one ton, but because of the buoyant force of the super saline water, the diver was able to move the block around.

As the diver was attempting to scale the cracks in the east sidewall to reach the crown, smaller pieces of the concrete (less than 6 inches in size), broke off in his hand. The diver also noted that there are parallel cracks that continue from the above described crack, through the 45 degree chamfer that is located at the intersection of the sidewall and the crown, and across the culvert crown, connecting with the major crack on the west sidewall, which is described below. Because the water clarity was good during this dive, we were able to see the bubbles which formed at each of the crack lines, indicating that there is a slight offset between the cracks.
