Department of Environmental Quality

DIVISION OF SOLID AND HAZARDOUS WASTE Scott T. Anderson Director

RE: Landfill Inspection

Karl Lund CD Landfill Post Closure Inspection Photographs April 4, 2013

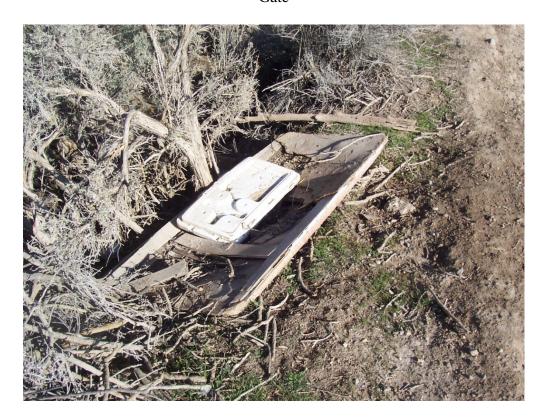
Cooler lid and old door at the gate

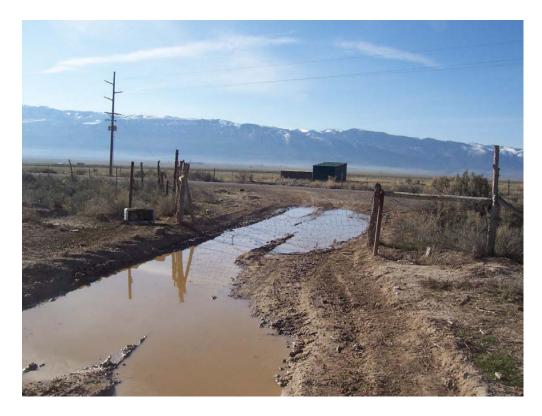
| Facility Name Karl Lund - Westside CD Landfill | County Sanpete |
|--|---|
| No secure gate, just a farm road wire gate | 6. DRAINAGE / EROSION |

Unsecure gate with cooler dumped nearby

- 1. The concrete debris accumulated onsite, to be used as rip-rap along the entire ditch at the edge of the landfill, has not been placed as required.
- Several piles of construction and demolition debris and other types of waste have not been covered or they have been placed on top of the landfill cover. Part III, Section C of the permit requires that the cover be maintained. The uncovered waste must be covered as required by the permit.
- 3. The gate to the landfill is not secure, allowing access at any time to the site. Waste is accumulating near the gate. The steel posts and cable at the entrance to the closed landfill should be used to secure the property.

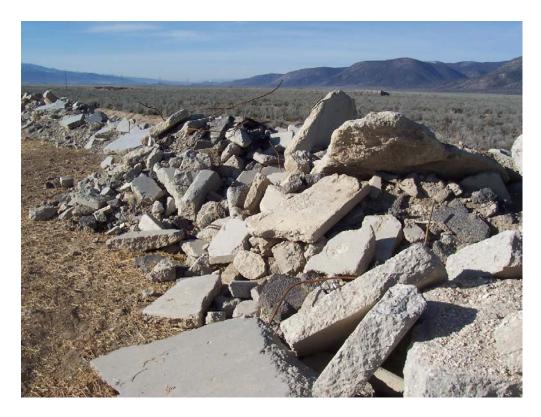
Waste asphalt intermixed with concrete debris

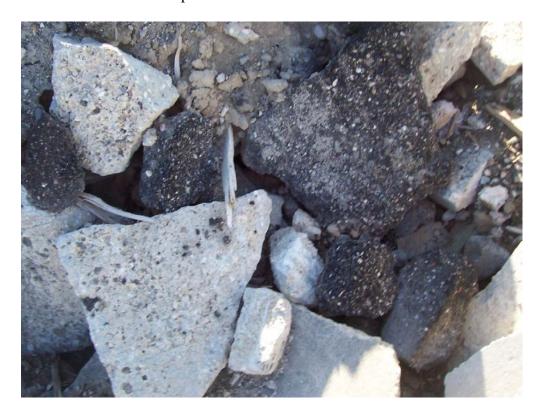
Close up of asphalt debris

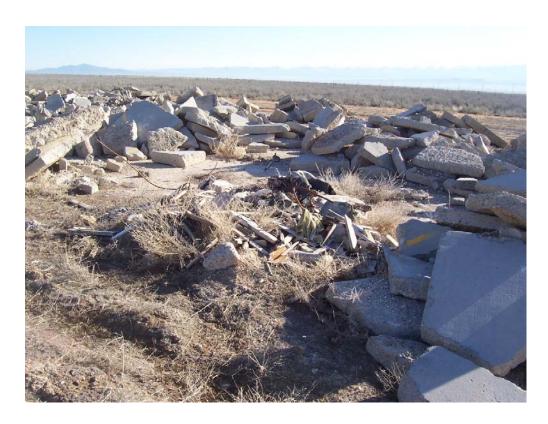
| Date: 4/4/13 Facility Name: Karl Lund | - Westside CD Landfill |
|---|---|
| Wood fence, caste iron pipe, etc. waste observed amongs the | 11.5 Heatment Certification |
| concrete debris | 11 A Paint Piles Test Possite |

Exposed CD waste with in the concrete debris

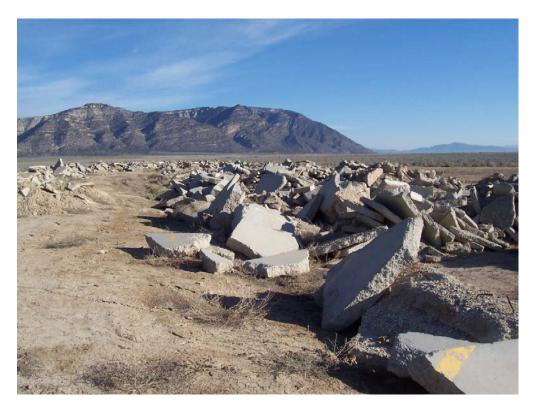
Concrete debris

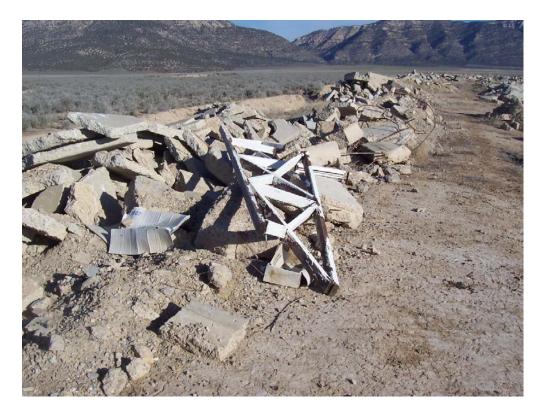
Concrete debris

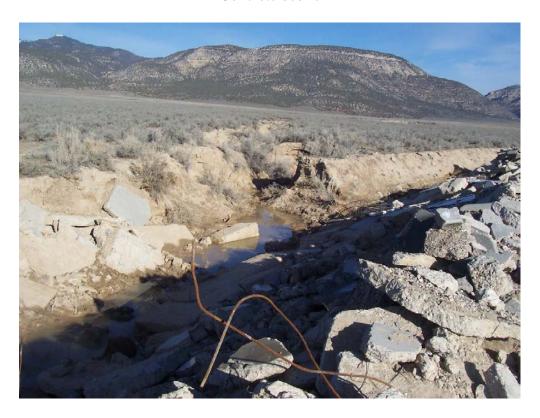
Rebuilt channel with concrete debris

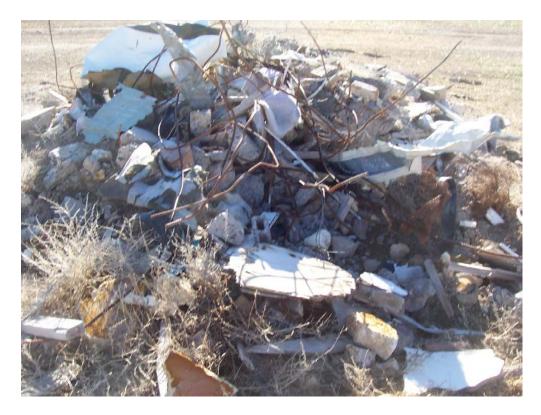
| Date: 4/4/13 Facility Name: Karl Lund | - Westside CD Landfill |
|---|---|
| Several areas of CD waste at the surface | |

CD waste at the landfill

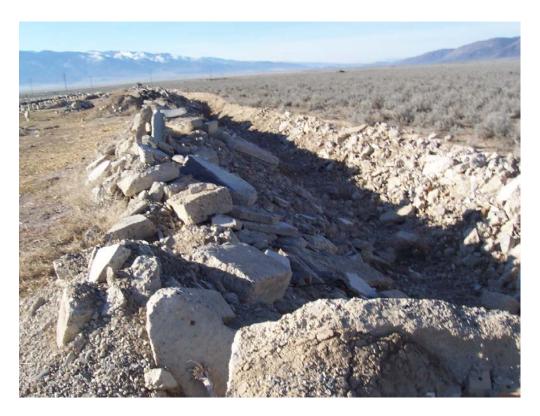
Channel with concrete placed as rip-rap

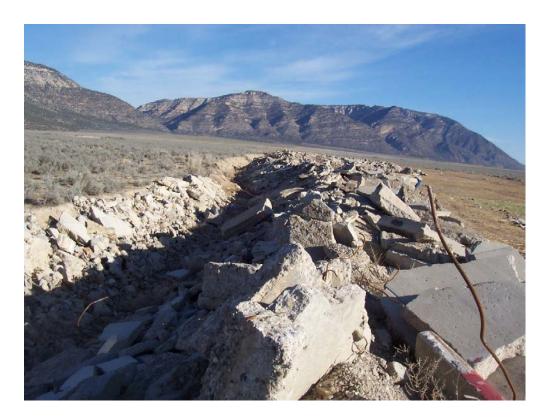
Channel with concrete placed as rip-rap

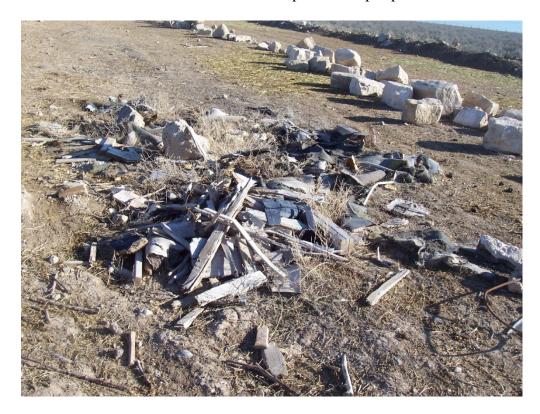
Exposed CD waste

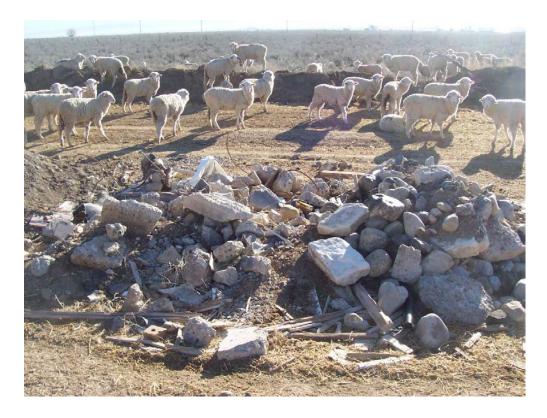
Exposed CD waste

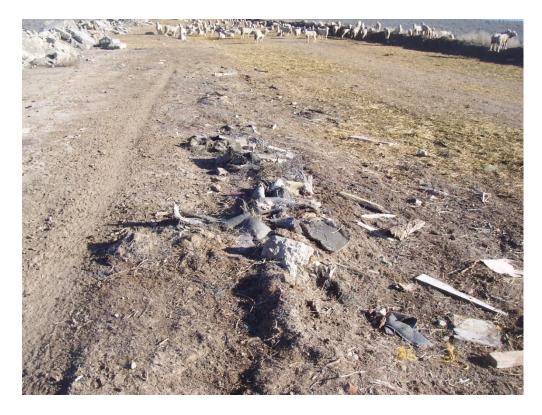
Exposed CD waste

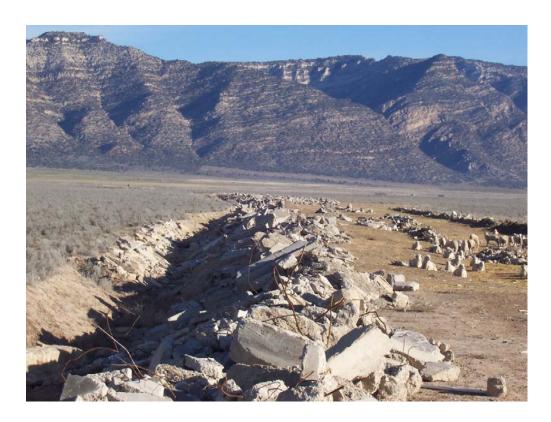
Concrete debris with channel

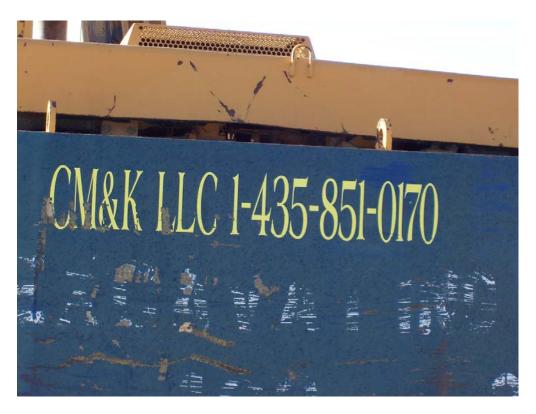
Equipment onsite

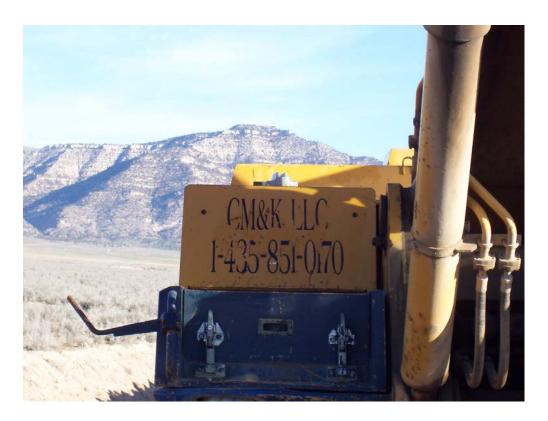
Equipment onsite

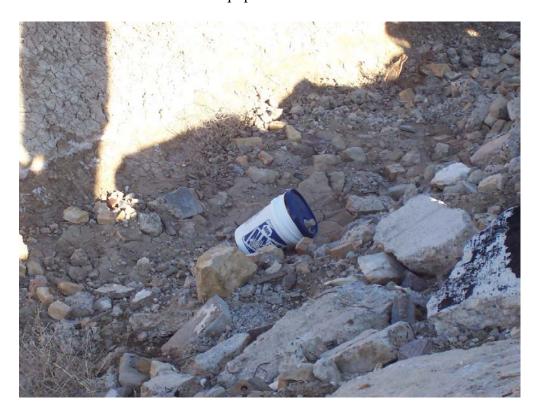
Lubricant container in the channel

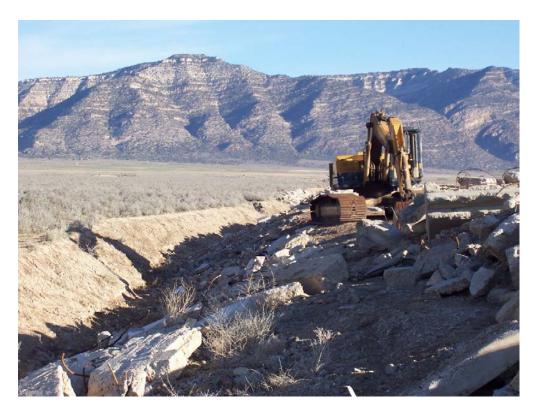
Equipment with concrete rip-rap on east side of channel

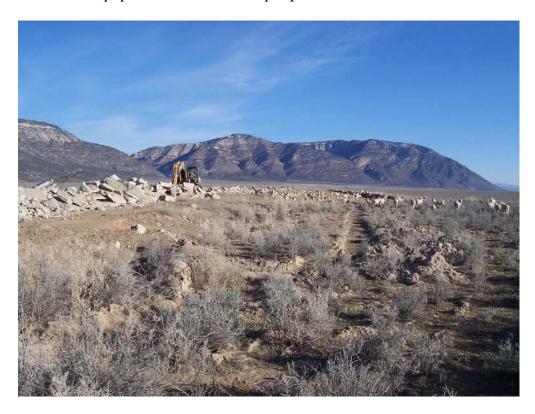
Northwest view of the landfill

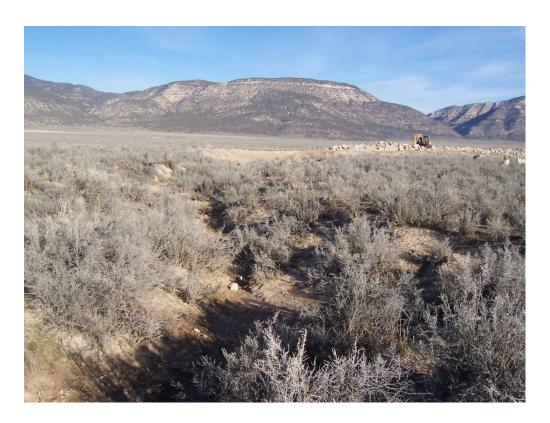
Landfill from a distance

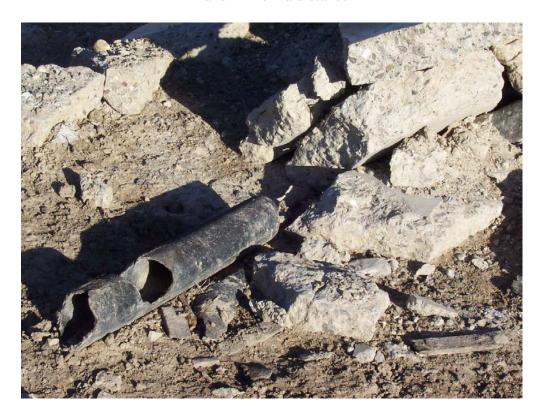
Waste cast iron pipe within the concrete debris
