DERR Yosemite Release Inspection Report

MEMORANDUM

SUBJECT: July 27, 2007 Yosemite Dump Release Due to Storm Event

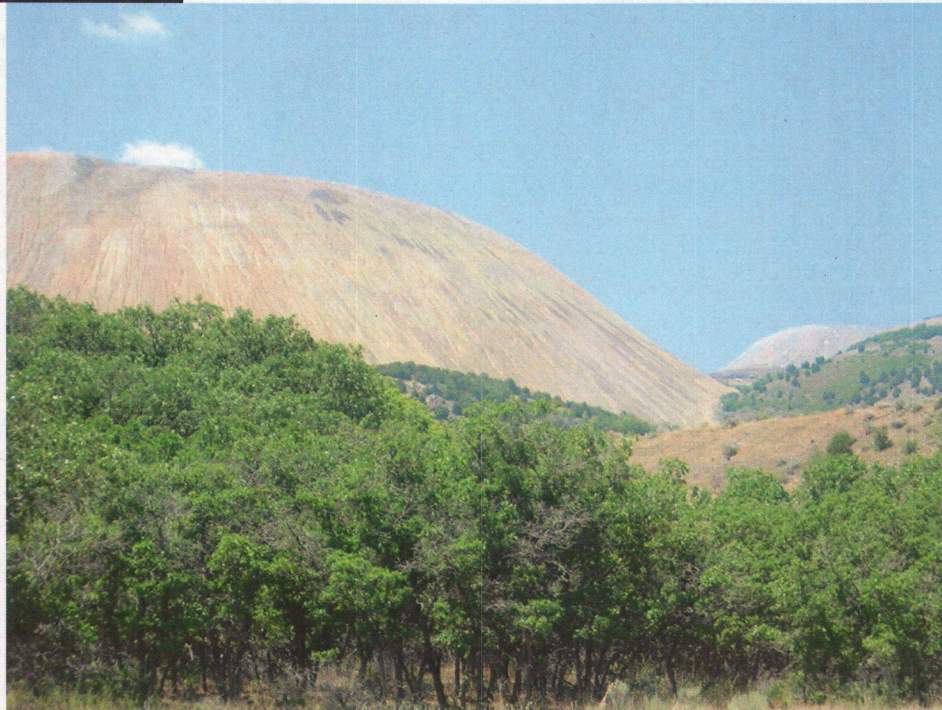
Photo No. 1 – Pictured is the eastern face of the Yosemite Dump. From the County Road in Butterfield Canyon, rills and gullies on the dump face were visible.

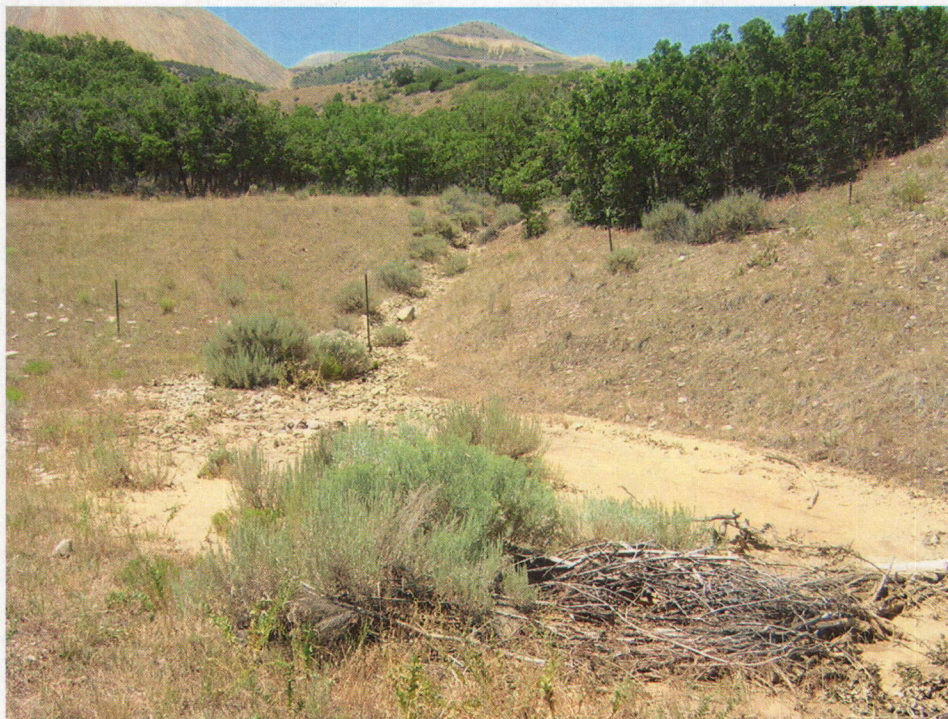
Photo No. 2 – Pictured is the drainage channel in the lower section of Yosemite Drainage. Note the stands of sage brush (or rabbit brush) and the tufts of standing grass amongst the dump material runoff (yellowish/coffee colored sands).

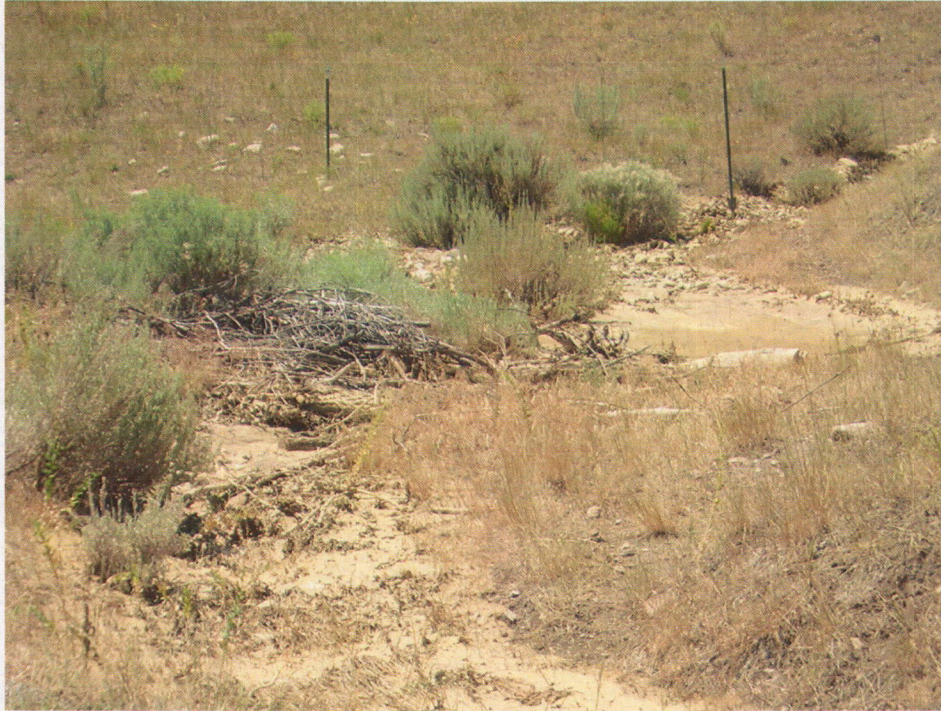
Photo No. 3 – Pictured is the same section of the lower Yosemite Drainage pictured in Photo No. 2 from a different angle. As noted, the tufts of grass and stands of sage brush (or rabbit brush) appeared to be intact, though in some locations matted by the runoff dump material.

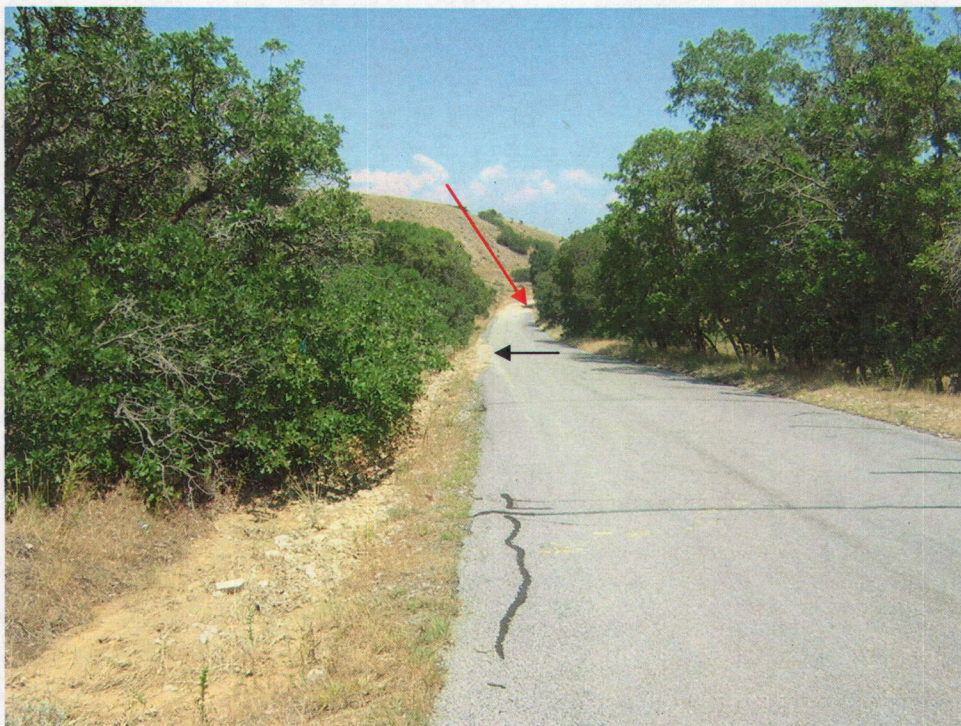
Photo No. 4 – Pictured is the County Road viewed from the lower section of Yosemite Drainage. The Black arrow points out a location where runoff material skirted onto the road surface. The Red arrow points out the location (approximately 300 feet to the east) that the runoff flow (storm water / dump material) crossed the County Road. Note that for the most part the runoff was contained to the north side of the County Road.

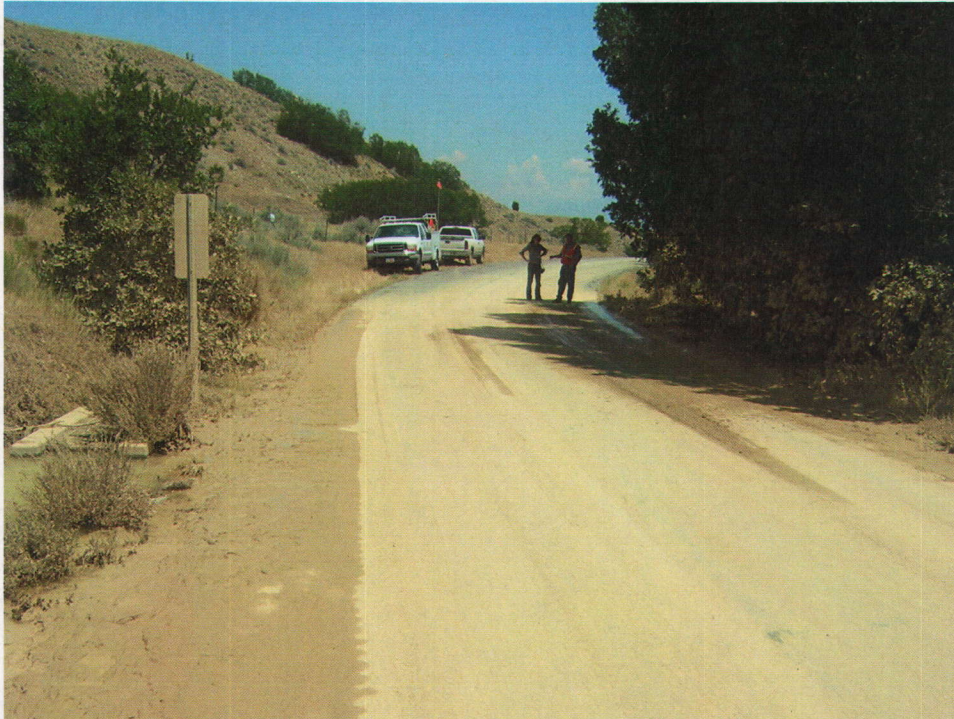
- 6) As observed, the storm water flow surpassed the capacity of and blocked the County constructed culvert, migrated across the County Road and into the constructed drainage channel leading to Butterfield Creek. The roadway had dump material deposited onto its surface within an area horizontally confined (east/west) to about 10 to 20 feet; depositional thickness was approximately 0.5 to 1.0 inches. There was deposited dump material amongst the stand of trees along the south side of the County Road which progressively decreases in volume in a westerly trend.

Photo No. 5 – Pictured is a lower (in elevation) section of the County Road in Butterfield Canyon, where because of a blockage in the underlying culvert (inlet pictured to the forefront of the street sign) the runoff flow (storm water / dump material) from Yosemite Drainage crossed to the south side of the County Road and into the County constructed drainage channel to Butterfield Creek. The two persons in the shadow of the trees are Ms. Peacy and Mr. Vinton. Note the stagnant water surrounding the inlet to the County constructed culvert.

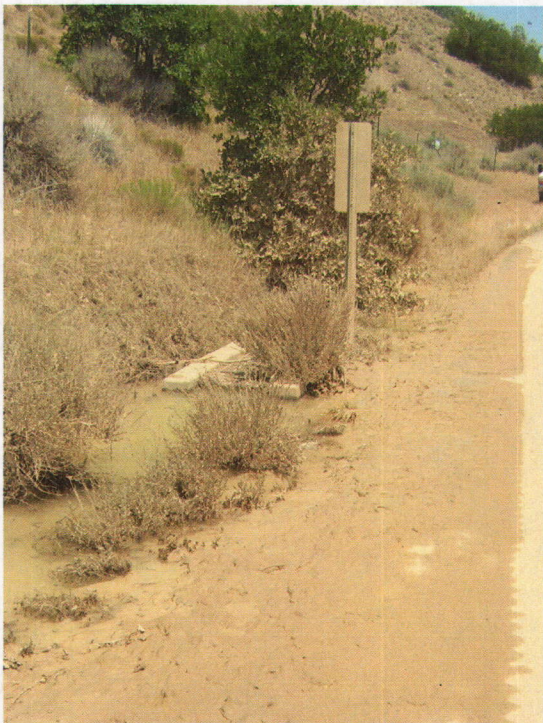
Photo No. 6 – Pictured is the north side of the County Road and the County constructed culvert inlet. Note the stagnant water and dump material deposited along the side of the road.

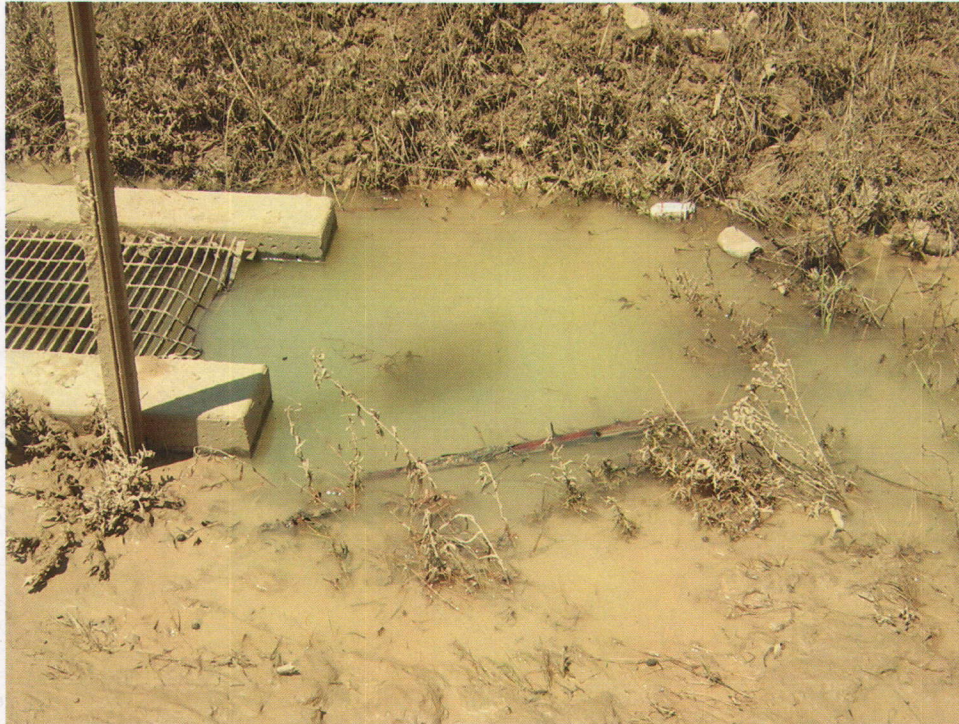
Photo No. 7 – The stagnant water surrounding the County constructed culvert was visually observed to be opaque and high in total suspended solids. The dump material matted nearby vegetation but the vegetation was still not uprooted.

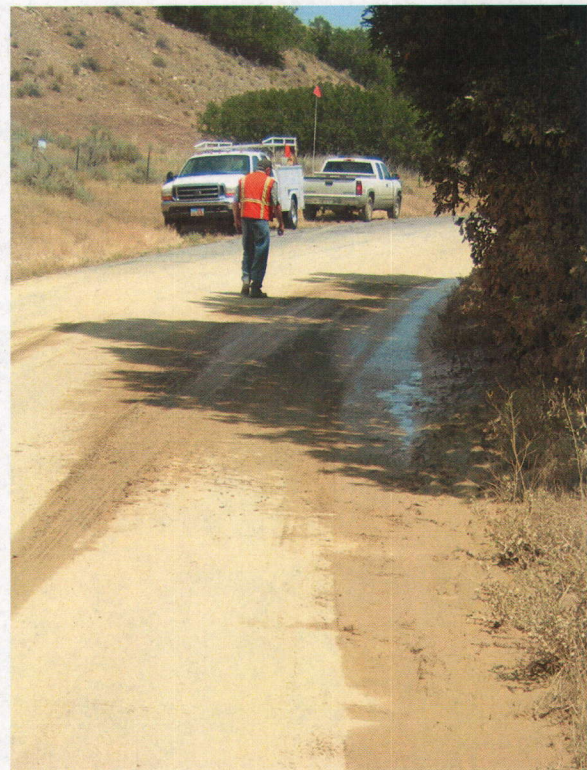
Photo No. 8 – Pictured is the south side of the County Road (the individual in the back ground is Mr. Vinton). The road surface had dump material dried on it. There was significant buildup of dump material (0.5 to 1.0 inches in depth); however the deposited material was not consistently distributed.

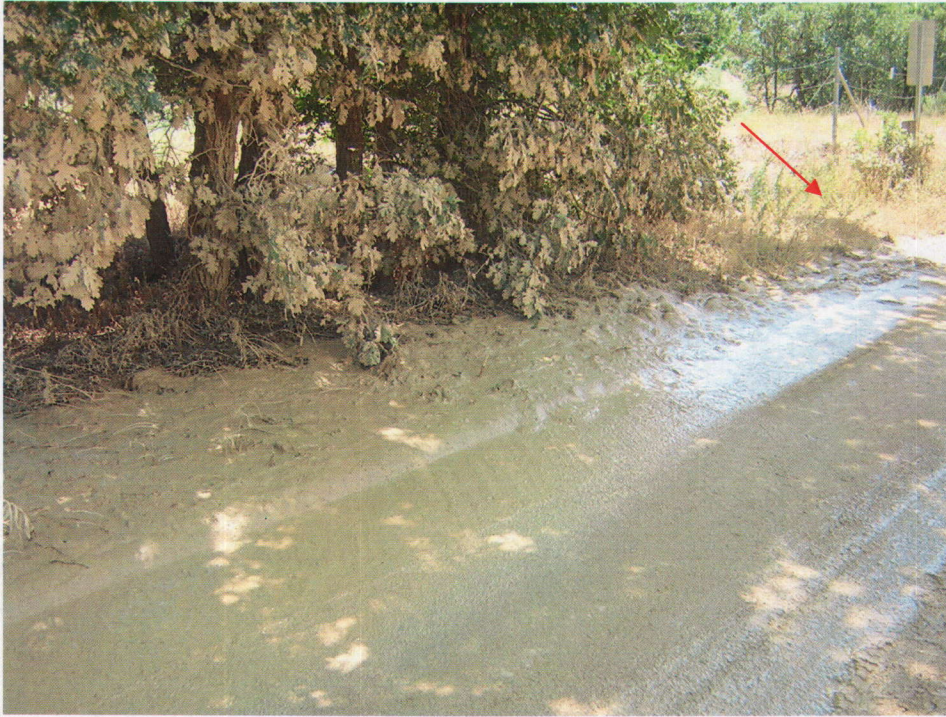
Photo No. 9 – Pictured is the south side of the County Road in Butterfield Canyon with the stand of trees noted earlier. Note the dump material and its deposition along the side of the road. In a westerly trend toward the County constructed drainage channel to Butterfield Creek (red arrow) the amount of dump material becomes less.

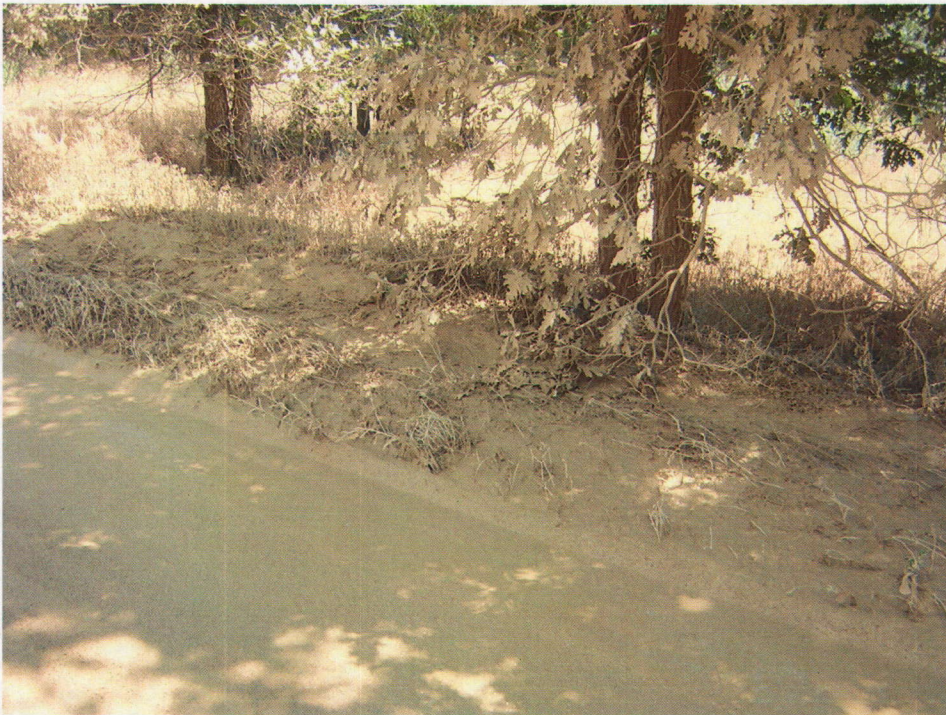
Photo No. 10 – From the same vantage point as Photo No. 9 (but looking southeast from the County Road), one can view the distribution of dump material. Note that even though matted significantly, the vegetation along the south side of the road (grasses predominantly) were not uprooted.

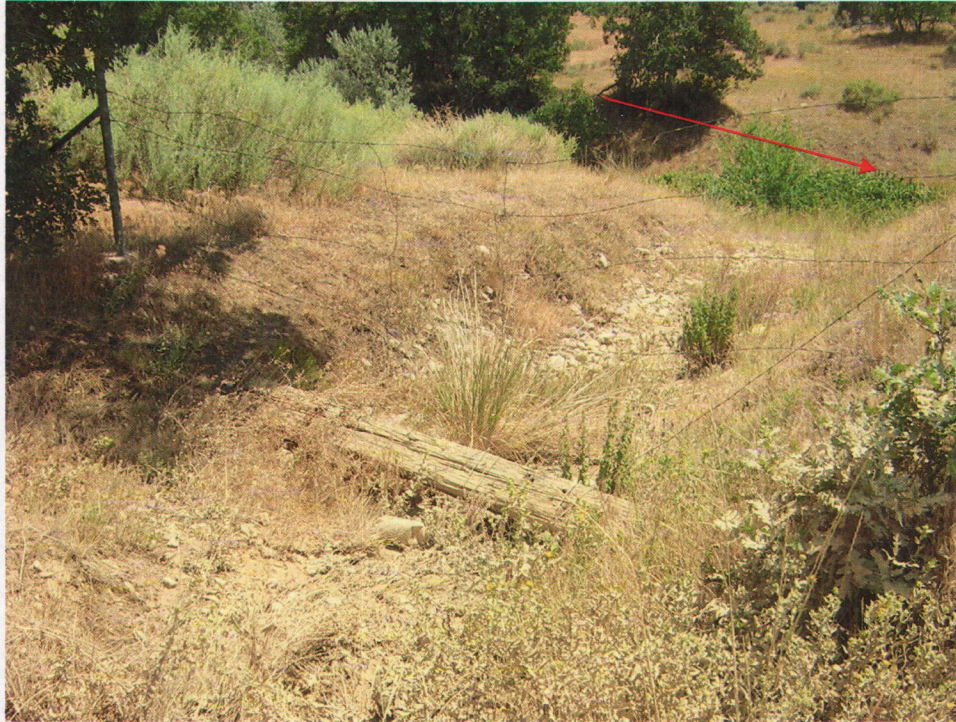
Photo No. 11 – Pictured is the County constructed drainage channel leading from the outlet of the County constructed culvert underlying the County Road in Butterfield Canyon. The outlet for the culvert was (when pictured) buried. The vegetation in the channel appeared to be relatively intact, with some matting due to deposited dump material. The riprap in the lower section of this channel also appeared to be intact. Butterfield Creek channel is denoted by the red arrow.

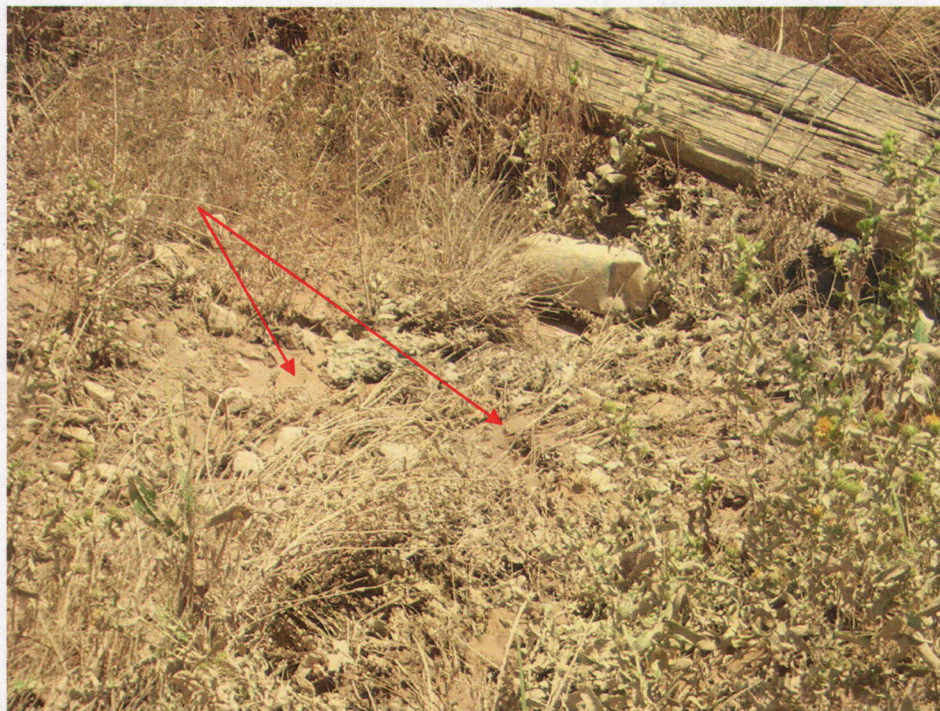
Photo No. 12 – Pictured is the approximate location of the outlet to the County constructed culvert. Photo was taken to again document the condition of existing grasses and other vegetation located along the spill pathway. Note the deposition of dump material (coffee color when wet), red arrows.

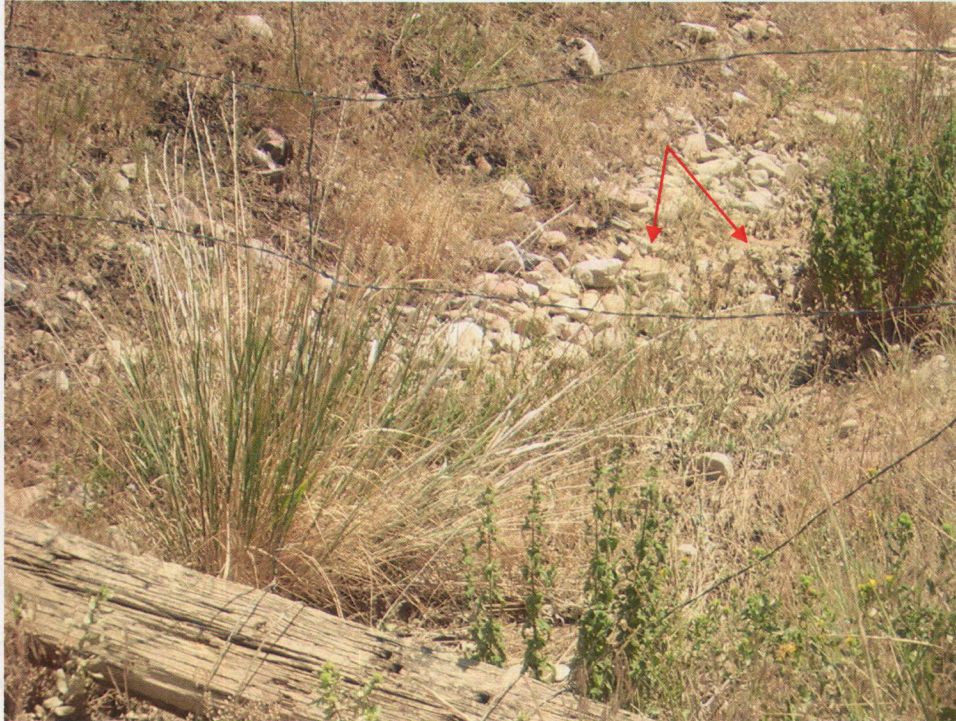
- 7) Similar to the lower section of Yosemite Drainage, the drainage channel to Butterfield Creek on the south side of the County Road had stands of vegetation matted with dump material, but not uprooted. There was limited vegetative debris observed, but as noted by Mr. Vinton the County culvert was blocked. Riprap in the drainage channel was still in place but had dump material within the spaces between the rocks.

Photo No. 13 – Pictured is the County constructed drainage channel just below the outlet structure for the culvert. Note the established vegetation and intact riprap. Also note the limited distribution of dump material (coffee color) located between the rocks comprising the riprap cover (red arrows).
