UTAH DIVISION OF WATER QUALITY

SW ENERGY CORP.  
Government Smoot No. 3 Well  
IN GRAND COUNTY, UT

RESPONSE TO NOTICE OF  
VIOLATION AND ORDER  
Docket No. 114-08

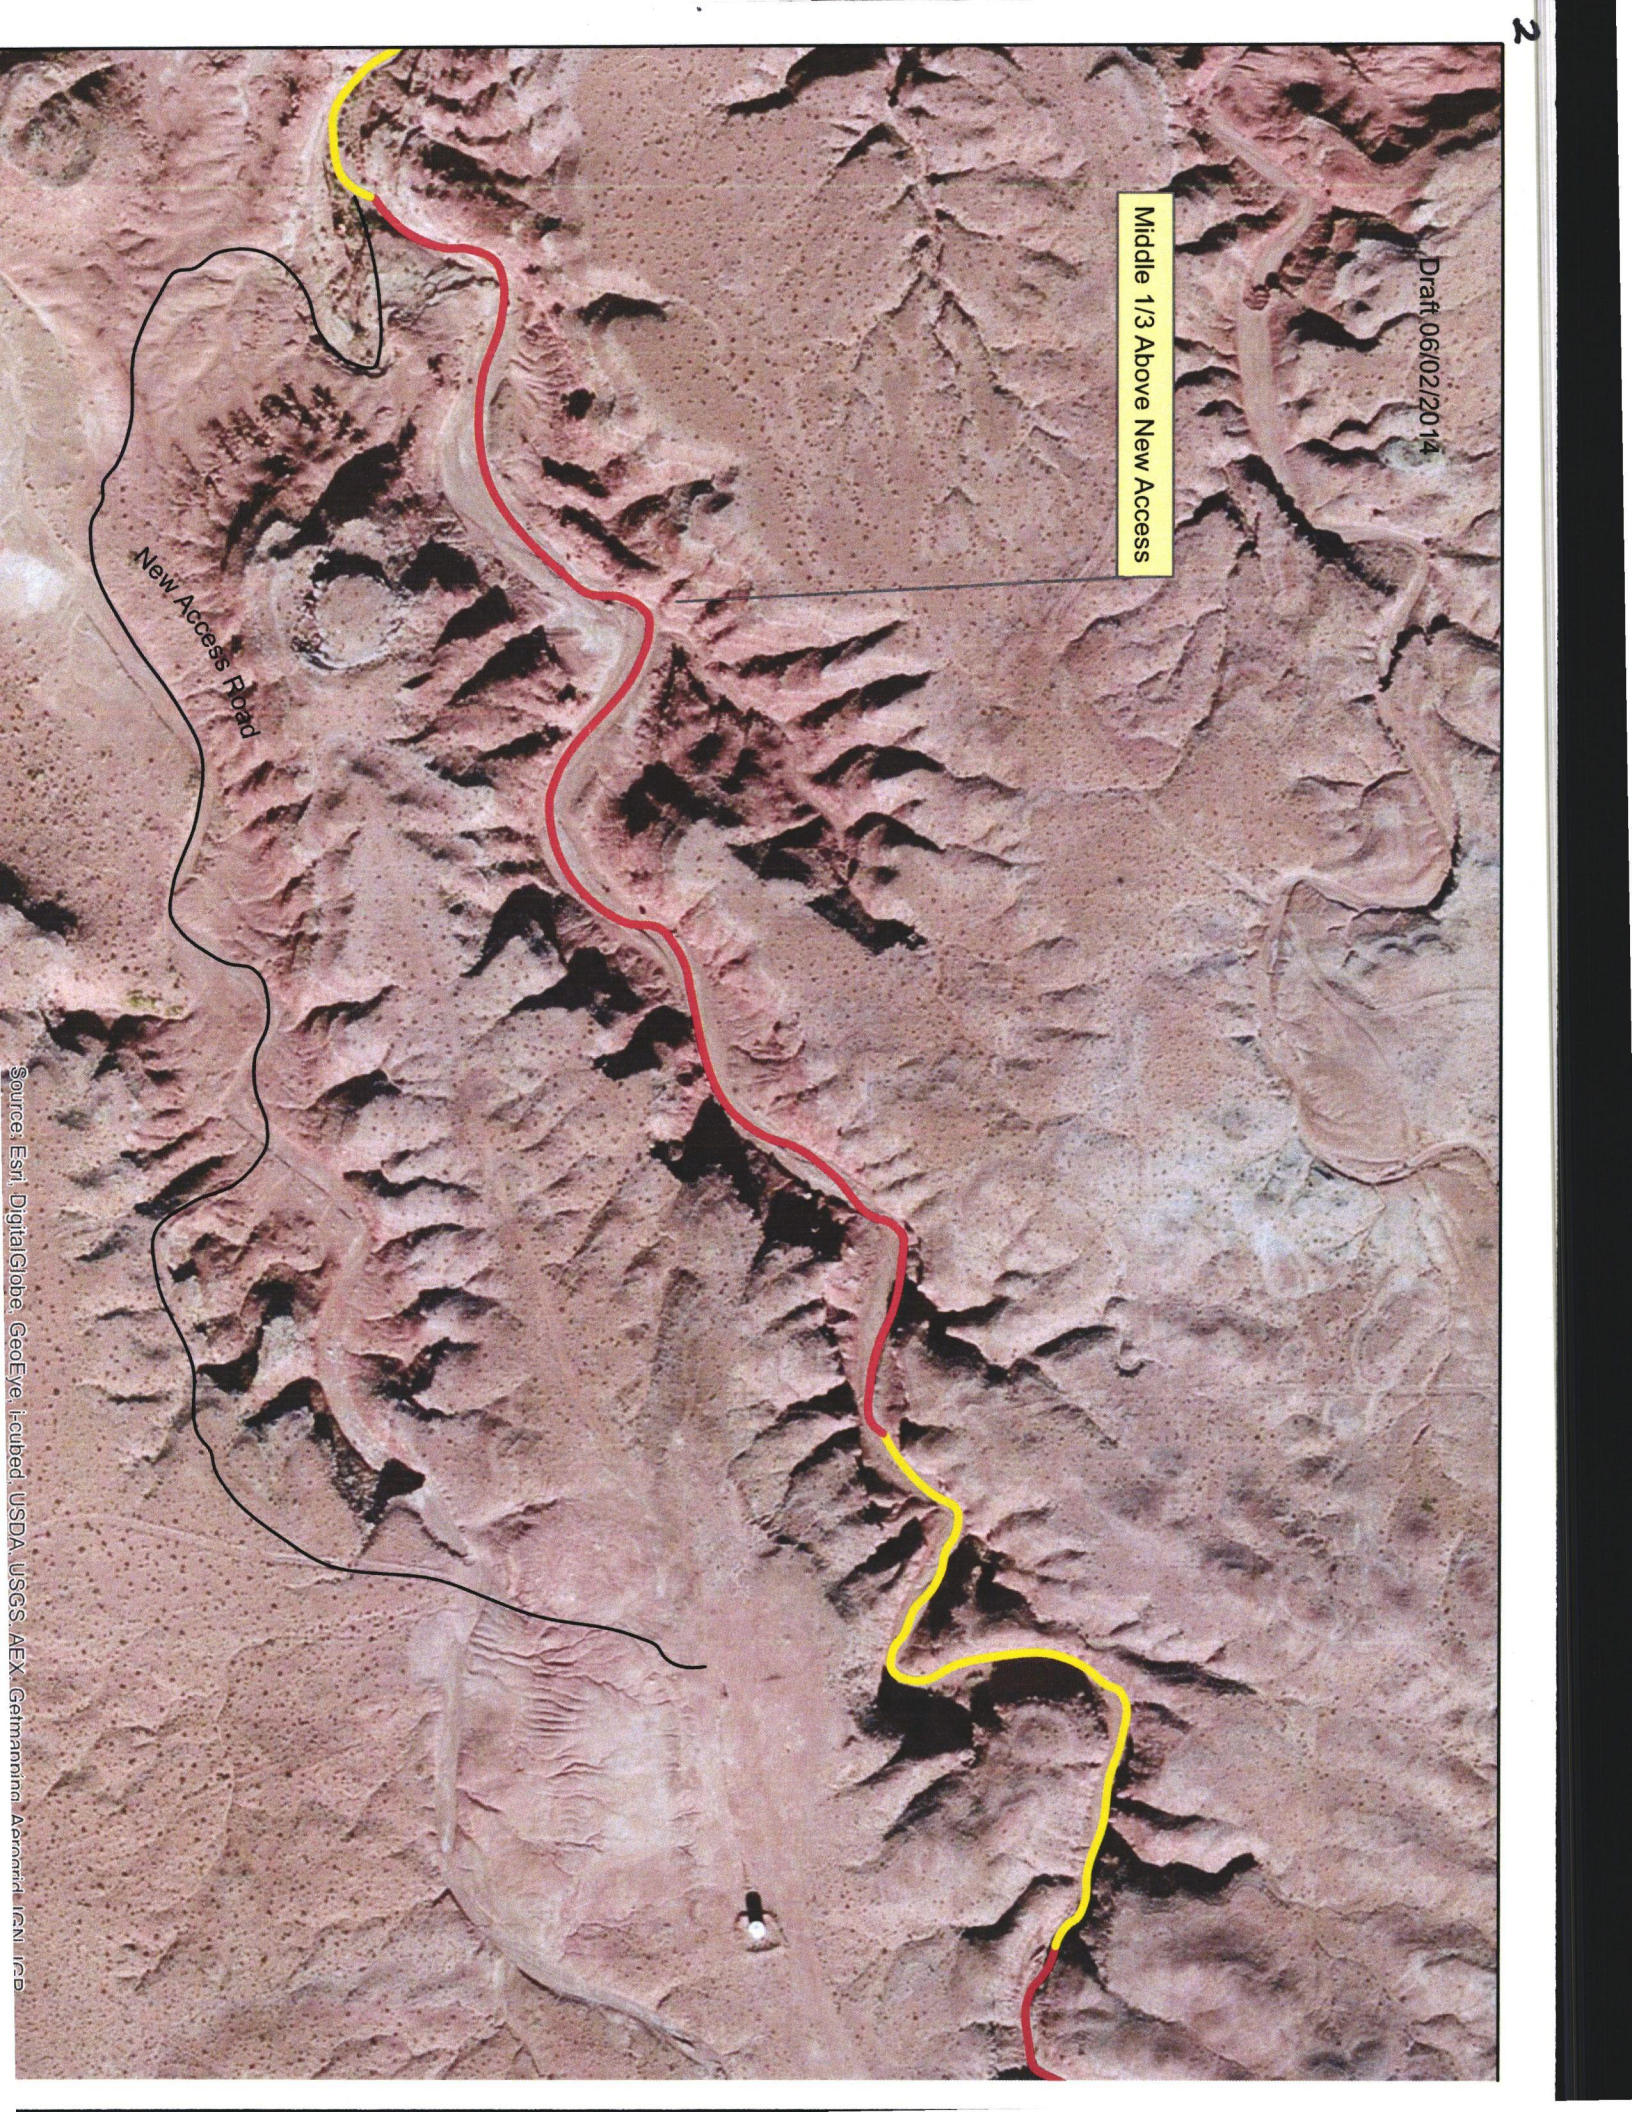
Middle 1/3 Above New Access

New Access Road

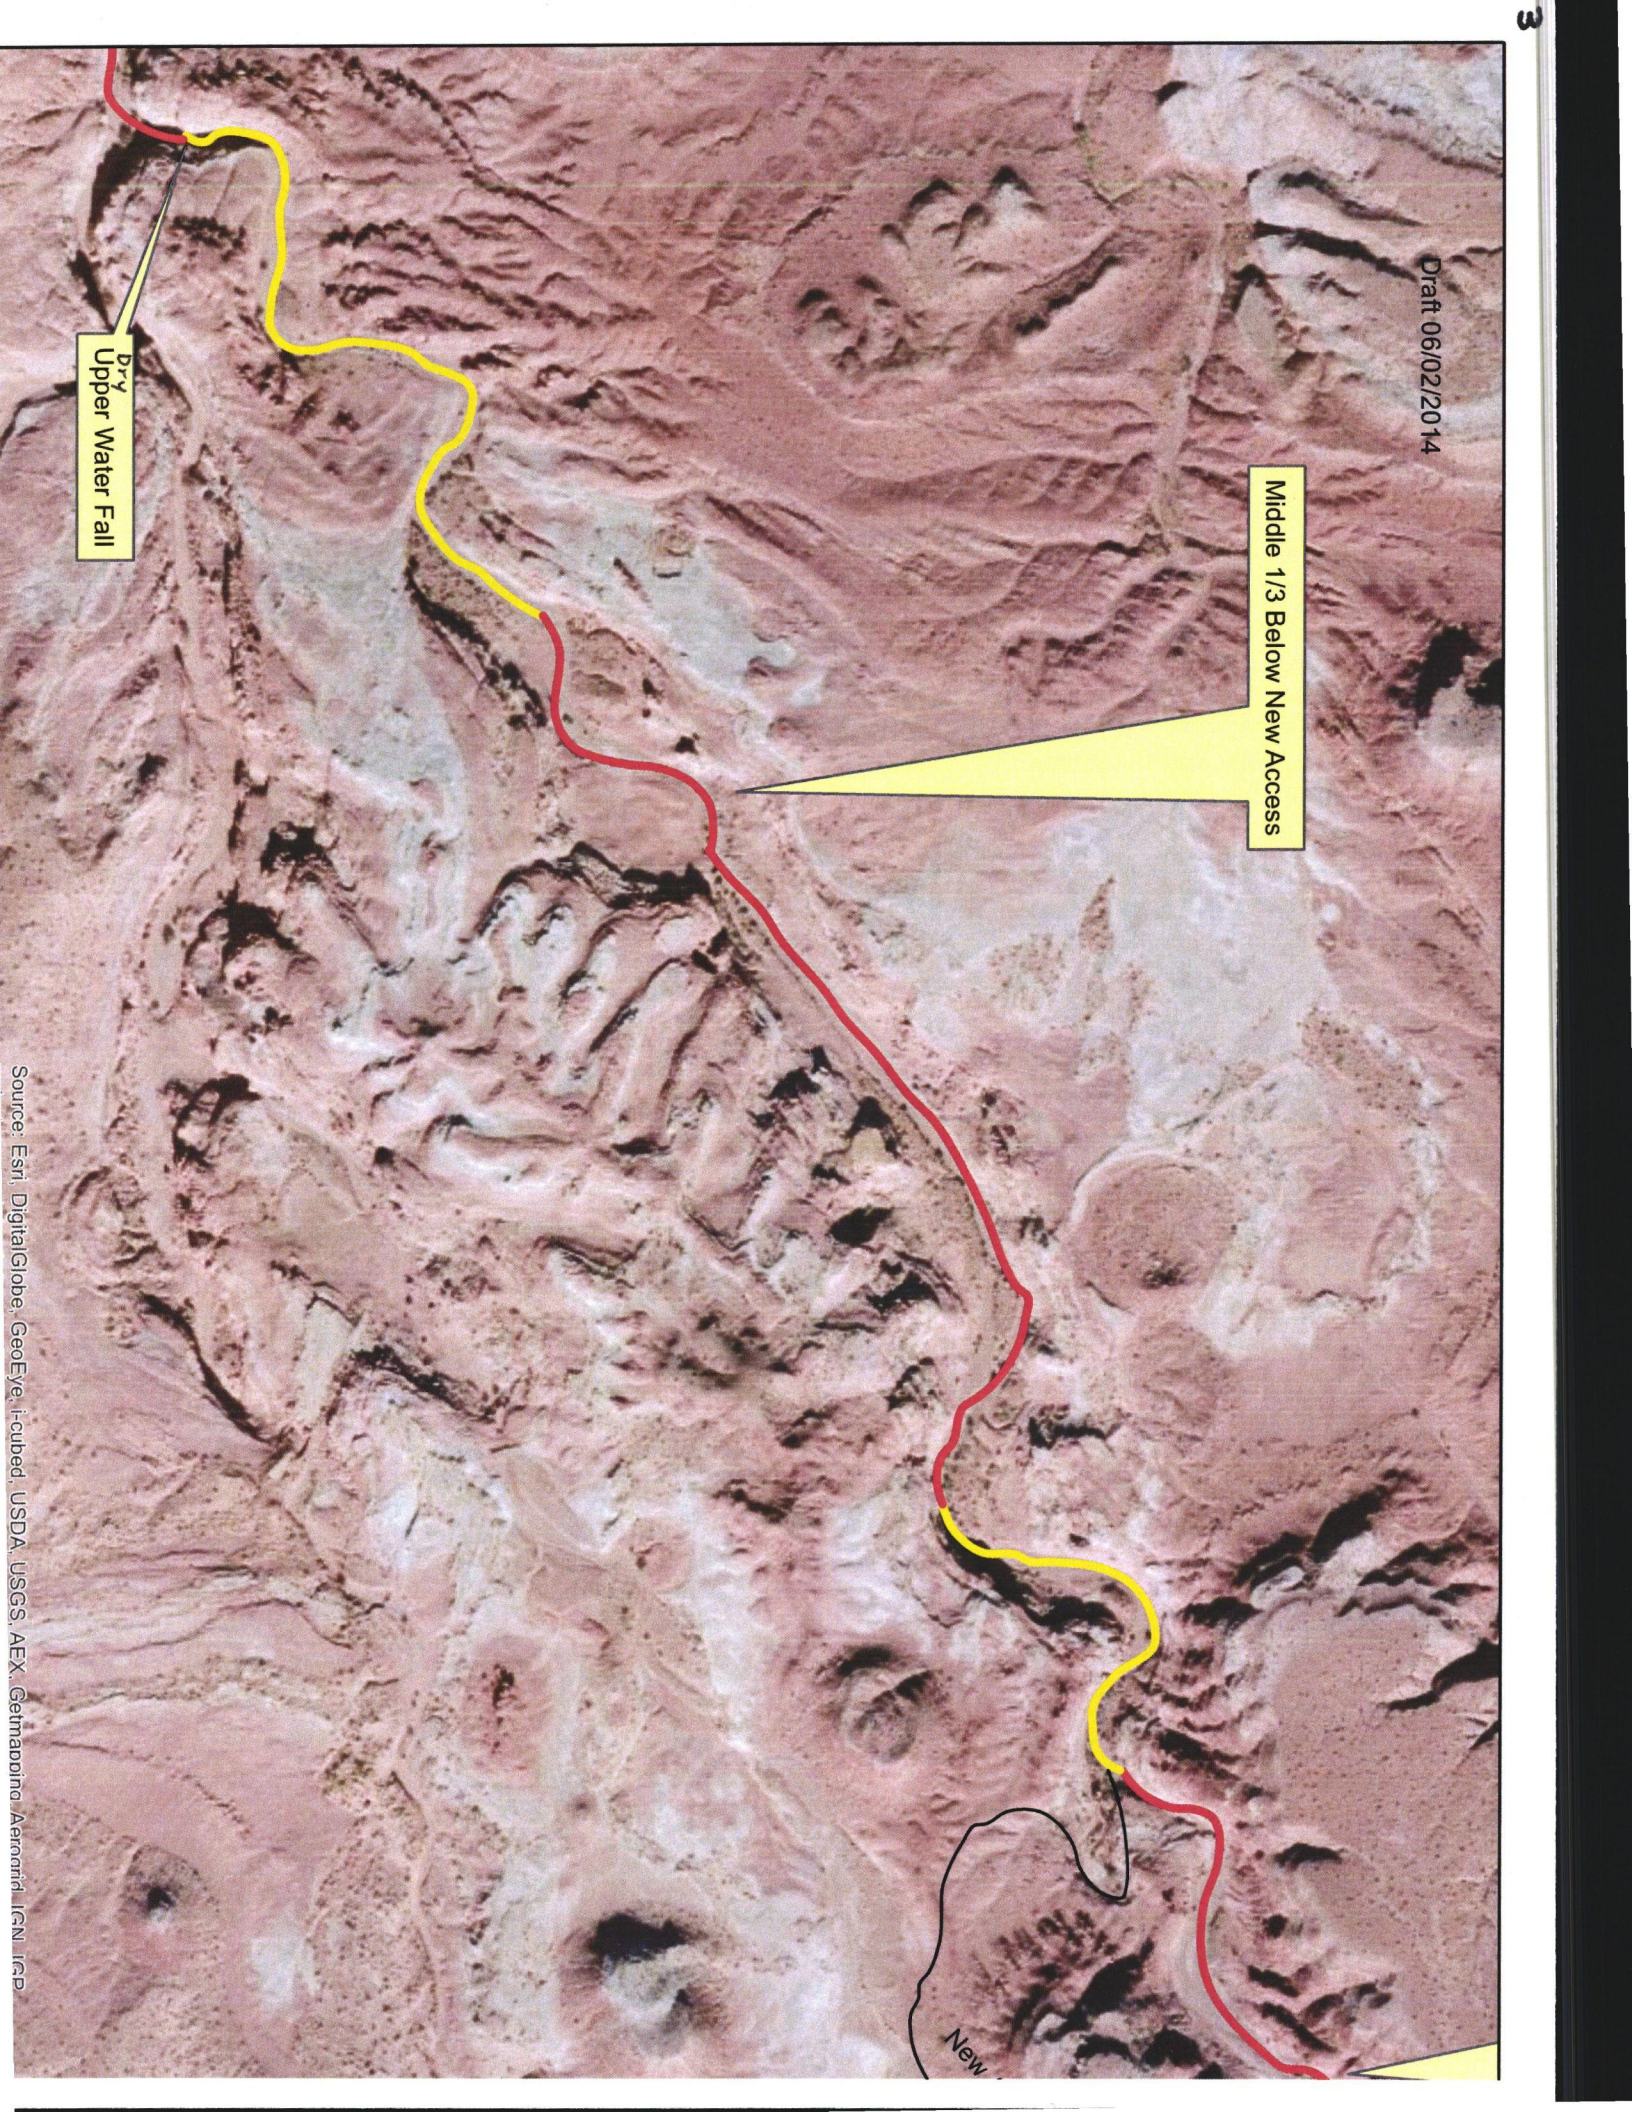
Middle 1/3 Below New Access

Dry Upper Water Fall

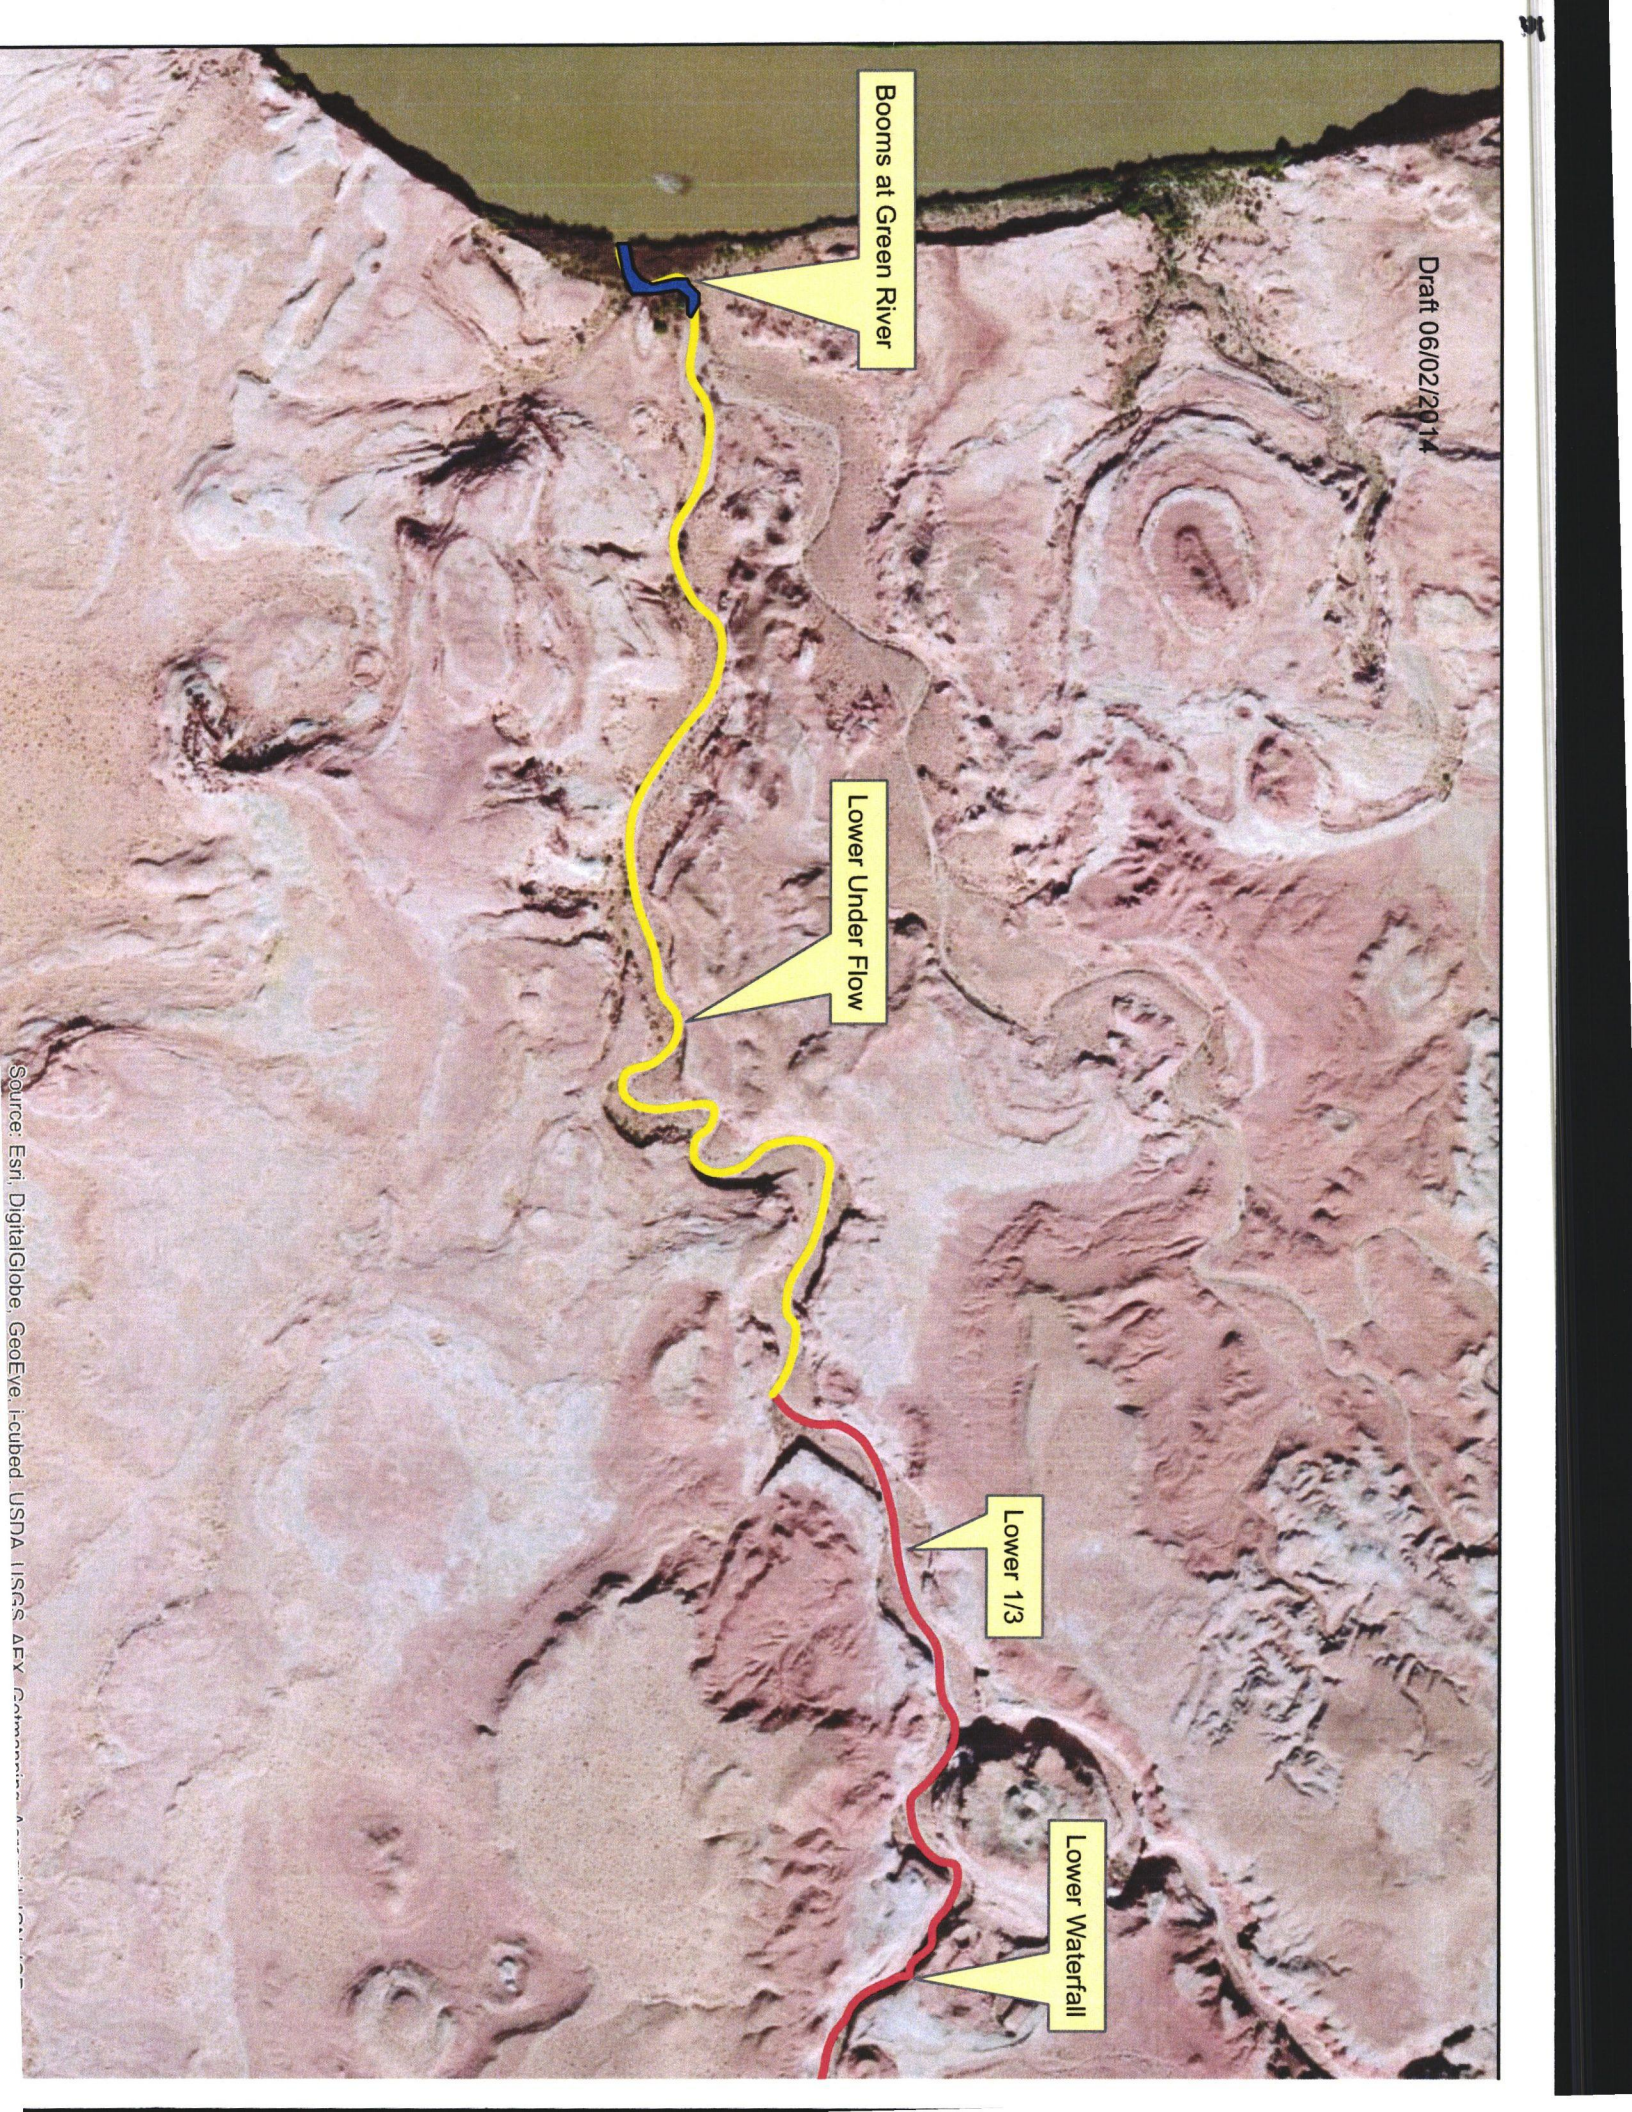
Lower 1/3

Booms at Green River

Lower Under Flow

Lower Waterfall
