MEMORANDUM

DRC-2019-010131

SUBJECT: Review of the Energy Fuels Resources (USA) Inc., White Mesa Uranium Mill, Blanding, Utah June 27, 2019 Source Assessment Report for MW-11 and MW-24 Ground Water Discharge Permit No. UGW370004 (Permit)

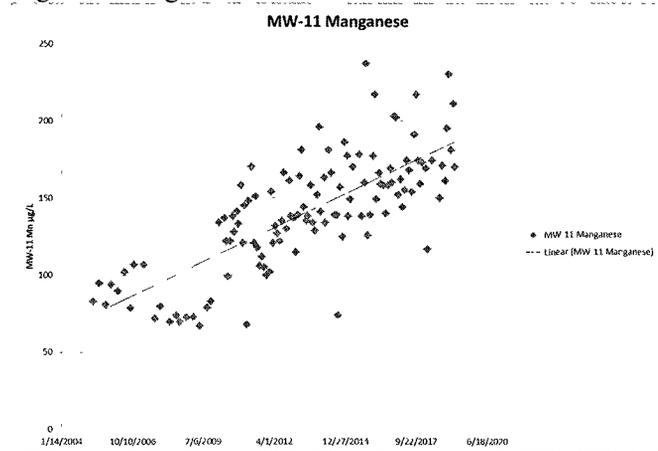
Figure - Manganese Data Plot of Historical Data at MW-11

Per review of the data plot for MW-11 manganese, it appears that an ongoing increasing trend has been occurring since installation of the monitoring well and was identified at the time of the background report.

**MW-11 (Manganese)** – DWMRC notes that manganese concentrations in MW-11 have been indicating an increasing trend since the beginning of monitoring for the parameter at the monitoring well. DWMRC notes that the trend is more evident starting in 2012 when a new laboratory and more sensitive methods of analysis were implemented. Per the SAR, the complete historical dataset for Mn shows a normal distribution of data. A review of other indicator parameters does not indicate that the increasing Mn or decreasing pH is being caused by the release of tailings solution. Monitoring well MW-11 was part of the University of Utah Study and findings indicated that the monitoring well was unaffected by Mill activities. The SAR discusses that the increasing trend is potentially related to dissolution of manganese in clays and carbonate minerals in the aquifer in the region of MW-11.

Per DWMRC review, these findings are consistent with previous EFR SAR's and it does not appear that the GWCL exceedances and/or manganese trends at monitoring well MW-11 are being caused by mill activities. Based on the increasing trend, adjustment of the GWCL for manganese in the Permit is appropriate.

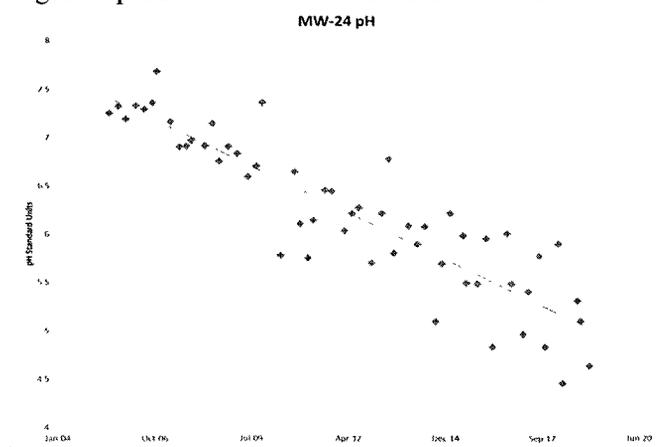
Figure - pH Data Plot of Historical Data at MW-24

**MW-24 (Beryllium, Cadmium, Nickel, Thallium, Fluoride, pH)** – DWMRC notes that beryllium, cadmium, nickel, thallium and fluoride are showing increasing trends at MW-24 and that pH is showing a significant decreasing trend. Recent pH values at MW-24 have been as low as 4.45. The SAR discusses that the rising concentrations of metals is potentially due to desorption of minerals from hydrous ferric oxides due to decreasing pH and/or the dissolution clay and sulfide minerals in the Brushy Basin and Burro Canyon Formations. Based on review of the groundwater data, including tailings wastewater indicator parameters the SAR discusses that the trends do not appear to be associated with Mill activities; however, recent increasing trends for certain parameters has resulted in out-of-compliance status warrants further investigation. A proposed path forward is found below in the Conclusion section of this memorandum.

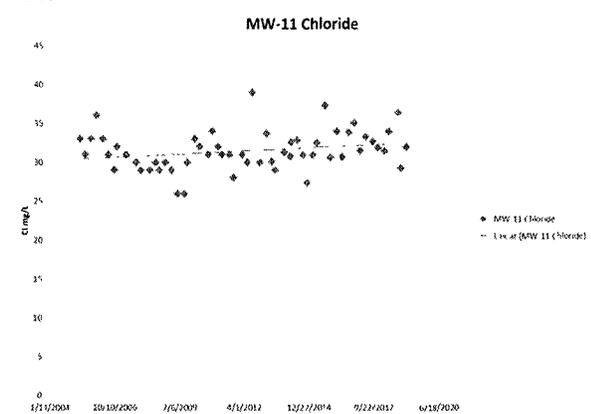
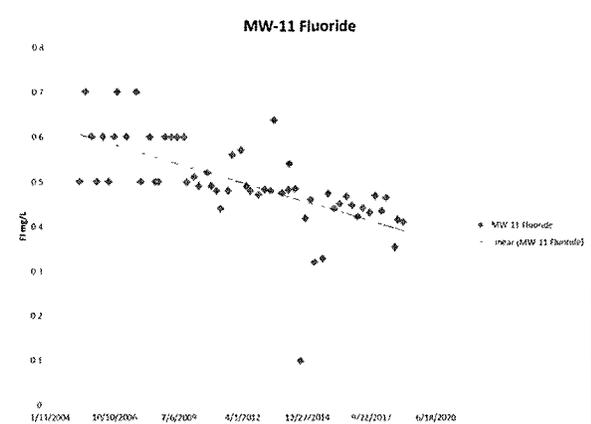
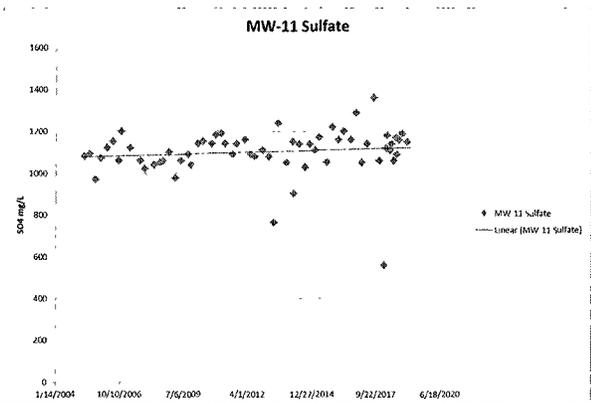
**MW-11**

MW-11 DWMRC Analysis: Chloride Flat, Fluoride Decreasing, Sulfate Flat, Uranium Increasing (Note that if uranium is plotted starting in 2012 there is no trend. Per review of the indicator parameters for MW-11 it does not appear that trends or concentrations are indicative of a tailings wastewater release to the groundwater. Per review of other monitoring parameters at MW-11 it is noted that pH is showing a slight decreasing trend, no other trends noted in the data.

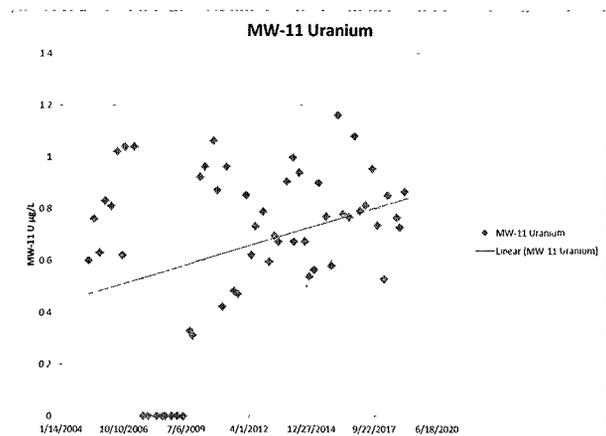
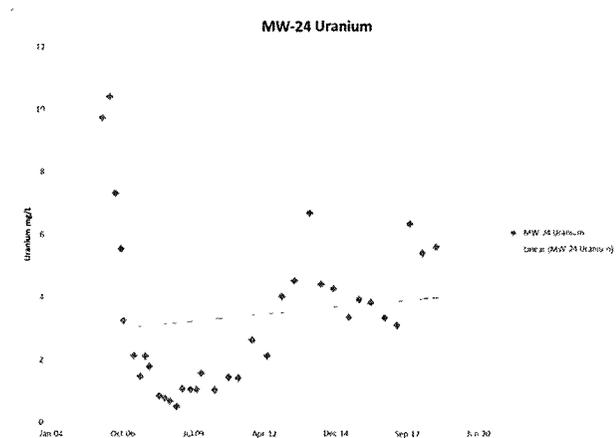
MW-24 DWMRC Analysis: Chloride Flat, Sulfate Flat, Uranium Increasing (Early data appears unreliable in the data set). Field pH is showing a strong decreasing trend, MW-24 has been noted to have higher percentages of pyrite and other sulfuric minerals in core materials than other cores examined. Per review of indicator parameters and other parameters in MW-24, it does not appear that groundwater is impacted by the release of tailings wastewater.
