MEMORANDUM

SUBJECT: Review of the Energy Fuels Resources (USA) Inc. (EFR), White Mesa Uranium Mill, Blanding, Utah October 19, 2020 Source Assessment Report for Selenium and Uranium in Monitoring Well MW-28  
Ground Water Discharge Permit No. UGW370004 (Permit)

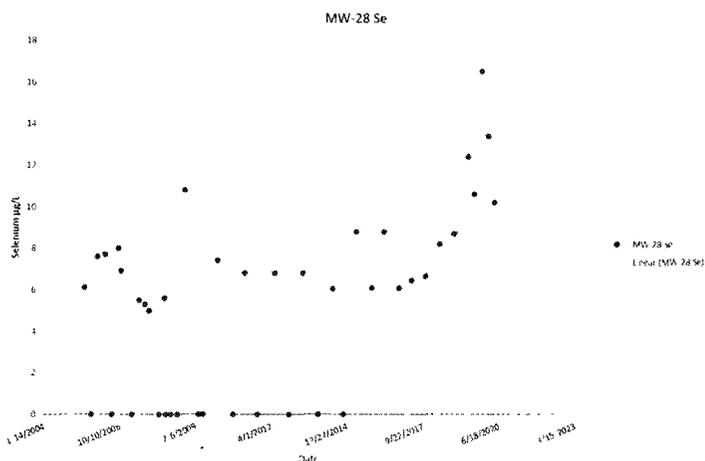
Selenium Data Plot of Historical Data at MW-28

Both data sets show an inflection (rising trend) beginning post 2017.

**Selenium** – The SAR notes that selenium concentrations in MW-28 are relatively low for the site. The time series plots show variability in selenium concentrations prior to 2012 and an increase in concentrations following the 2014 damage and repair. A point of inflection is apparent showing an increasing trend post 2017. The SAR discusses that this trend is likely associated with the mobilization of naturally occurring selenium in the formation by nitrate from the nitrate/chloride plume, oxidation of selenium-bearing pyrite by nitrate, and generally elevated selenium concentrations within the nitrate/chloride plume.

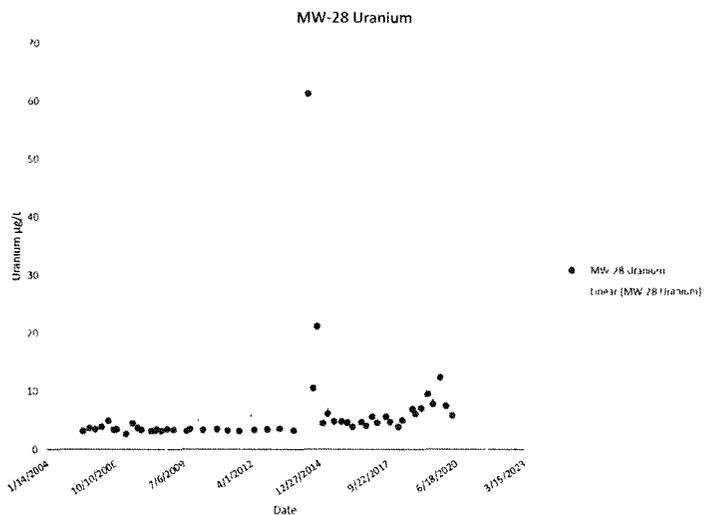
Uranium Data Plot of Historical Data at MW-28

**Uranium** – The SAR notes that uranium concentrations in MW-28 are relatively low for the site. A spike in concentrations is noted in 2014 associated with the well damage and repair. There is a point of inflection apparent in the post 2017 data where an increasing trend is evident. The SAR discusses that this trend is likely due to mobilization of naturally occurring uranium in the formation by nitrate in the nitrate/chloride plume, increased mobility of naturally occurring uranium resulting from increased bicarbonate.

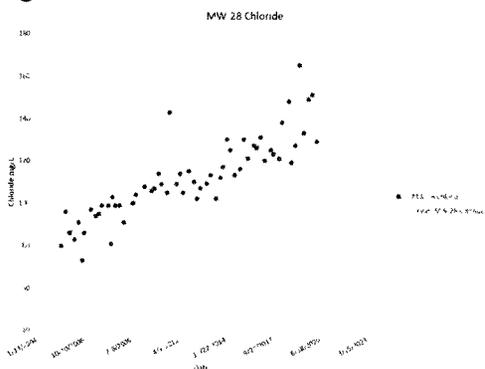
Figure – Chloride Plot of Historical Data at MW-28 – Increasing Trend

The use of chloride as an indicator parameter in the case of monitoring well MW-28 is complicated by the fact that MW-28 appears to be impacted by the nitrate/chloride plume, and chloride is therefore increasing and is not a reliable primary indicator of cell leakage for MW-28. Chloride at monitoring well MW-28 is now showing a significant increasing trend.

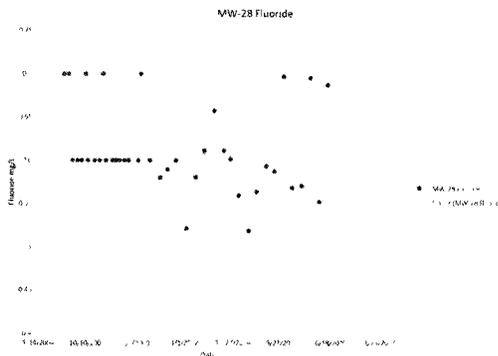
Figure – Fluoride Plot of Historical Data at MW-28 – Decreasing Trend

Fluoride concentrations were decreasing at the time of the Background Report and continue to show a decreasing trend.

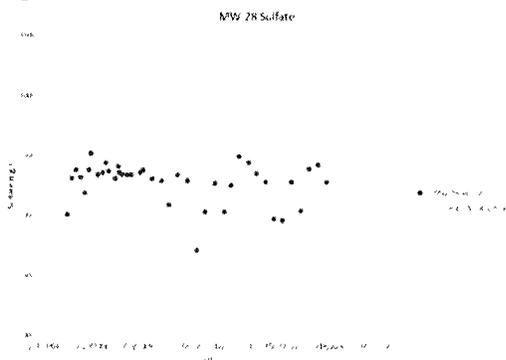
Figure – Sulfate Plot of Historical Data at MW-28 – Decreasing Trend

Sulfate concentrations in MW-28 exhibit a slight decreasing trend.
