DIVISION OF WASTE MANAGEMENT AND RADIATION CONTROL

MEMORANDUM

SUBJECT: Review of the Energy Fuels Resources (USA) Inc. (EFR), White Mesa Uranium Mill, Blanding, Utah September 27, 2023, Source Assessment Report for Selenium in Monitoring Well MW-11 and pH in Monitoring Well MW-37 Ground Water Discharge Permit No. UGW370004 (Permit)

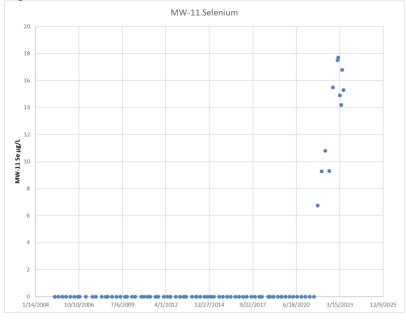
Figure 1 – Historical Selenium Data Plot at MW-11

The selenium data set in MW-11 depicts a significantly increasing trend since first testing over the reporting limit during the 4th Quarter 2021 sampling event.

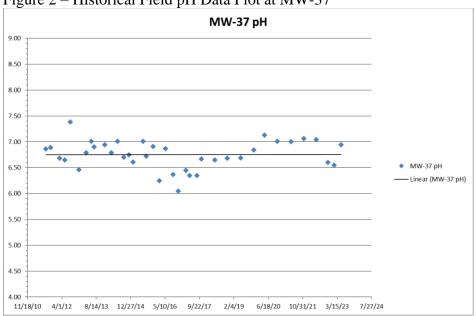
Figure 2 – Historical Field pH Data Plot at MW-37

The field pH data set in MW-37 does not exhibit a significant decreasing trend and exhibits a non-parametric distribution.

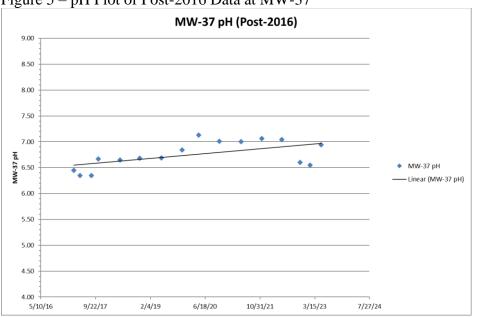
Figure 5 – pH Plot of Post-2016 Data at MW-37

The SAR notes that pH at MW-37 was decreasing prior to 2016 and may have resulted from pyrite oxidation, since visible pyrite was noted in the drilling log. After 2016, the stable to increasing pH trend (reflected in most of the MW-series wells) cannot result from TMS seepage mixing into groundwater since the TMS solutions have a very low pH. The field pH data set in MW-37 does not exhibit a significant decreasing trend and exhibits a non-parametric distribution as shown in Figure 2.

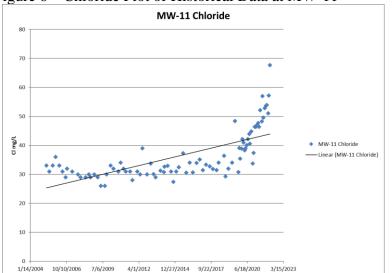
Figure 6 – Chloride Plot of Historical Data at MW-11

Per the SAR, the increase in chloride has occurred "only since about 2018, correlates to an increase in nitrate, and is due to the migration of the nitrate/chloride plume towards MW-11."

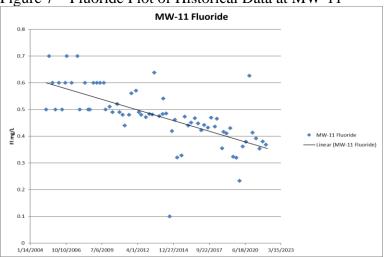
Figure 7 – Fluoride Plot of Historical Data at MW-11

Fluoride is highly concentrated in tailings wastewater. Literature and transport modeling has shown fluoride to be highly mobile in the vadose zone and groundwater beneath the tailing cells. Per the figure below, fluoride is showing a decreasing concentration trend in MW-11 indicating that MW-11 is not impacted by potential seepage from the TMS.

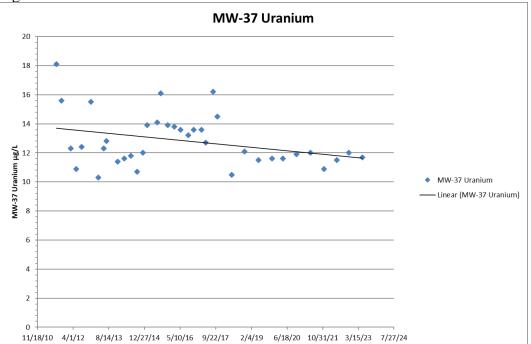
Mann-Kendall test results included in the SAR show that no significant trends exist for MW-37 indicator parameters. Linear regression test results for normally distributed constituents, chloride and uranium show a decreasing trend in chloride (Figure 10) and a significantly decreasing trend in uranium (Figure 9), indicating that there has been no impact to MW-37 from potential TMS seepage.
