# Site Characterization Summary & Remediation Plan Milepost 174.5 Release Site

Chevron Pipe Line Company Salt Lake Pump Station Salt Lake City, Utah Bellaire, Texas

July 2010

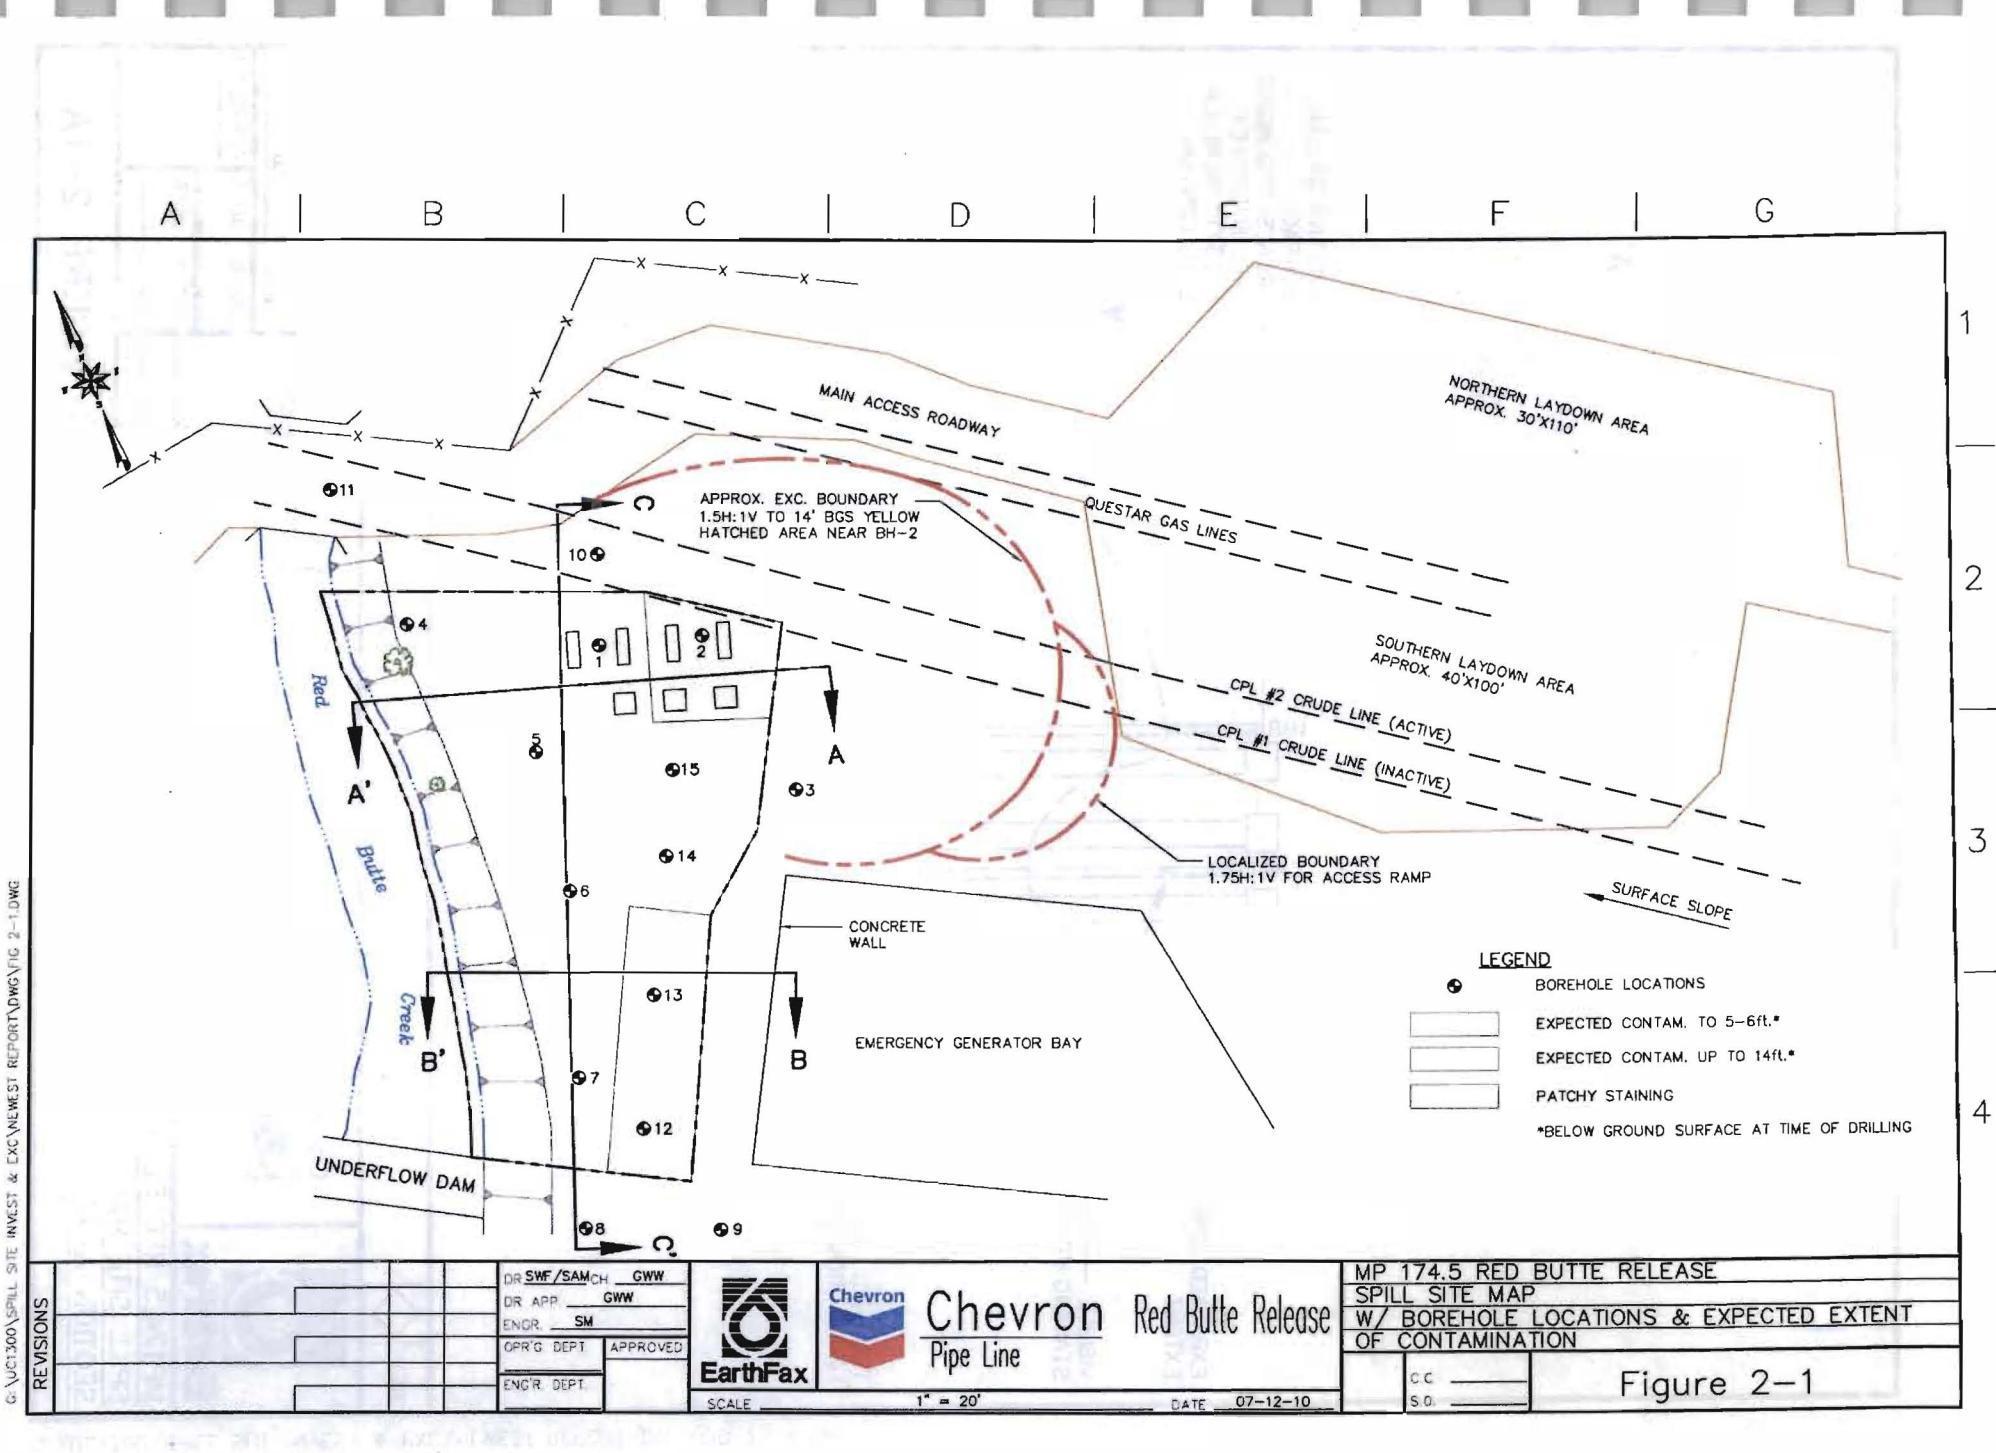
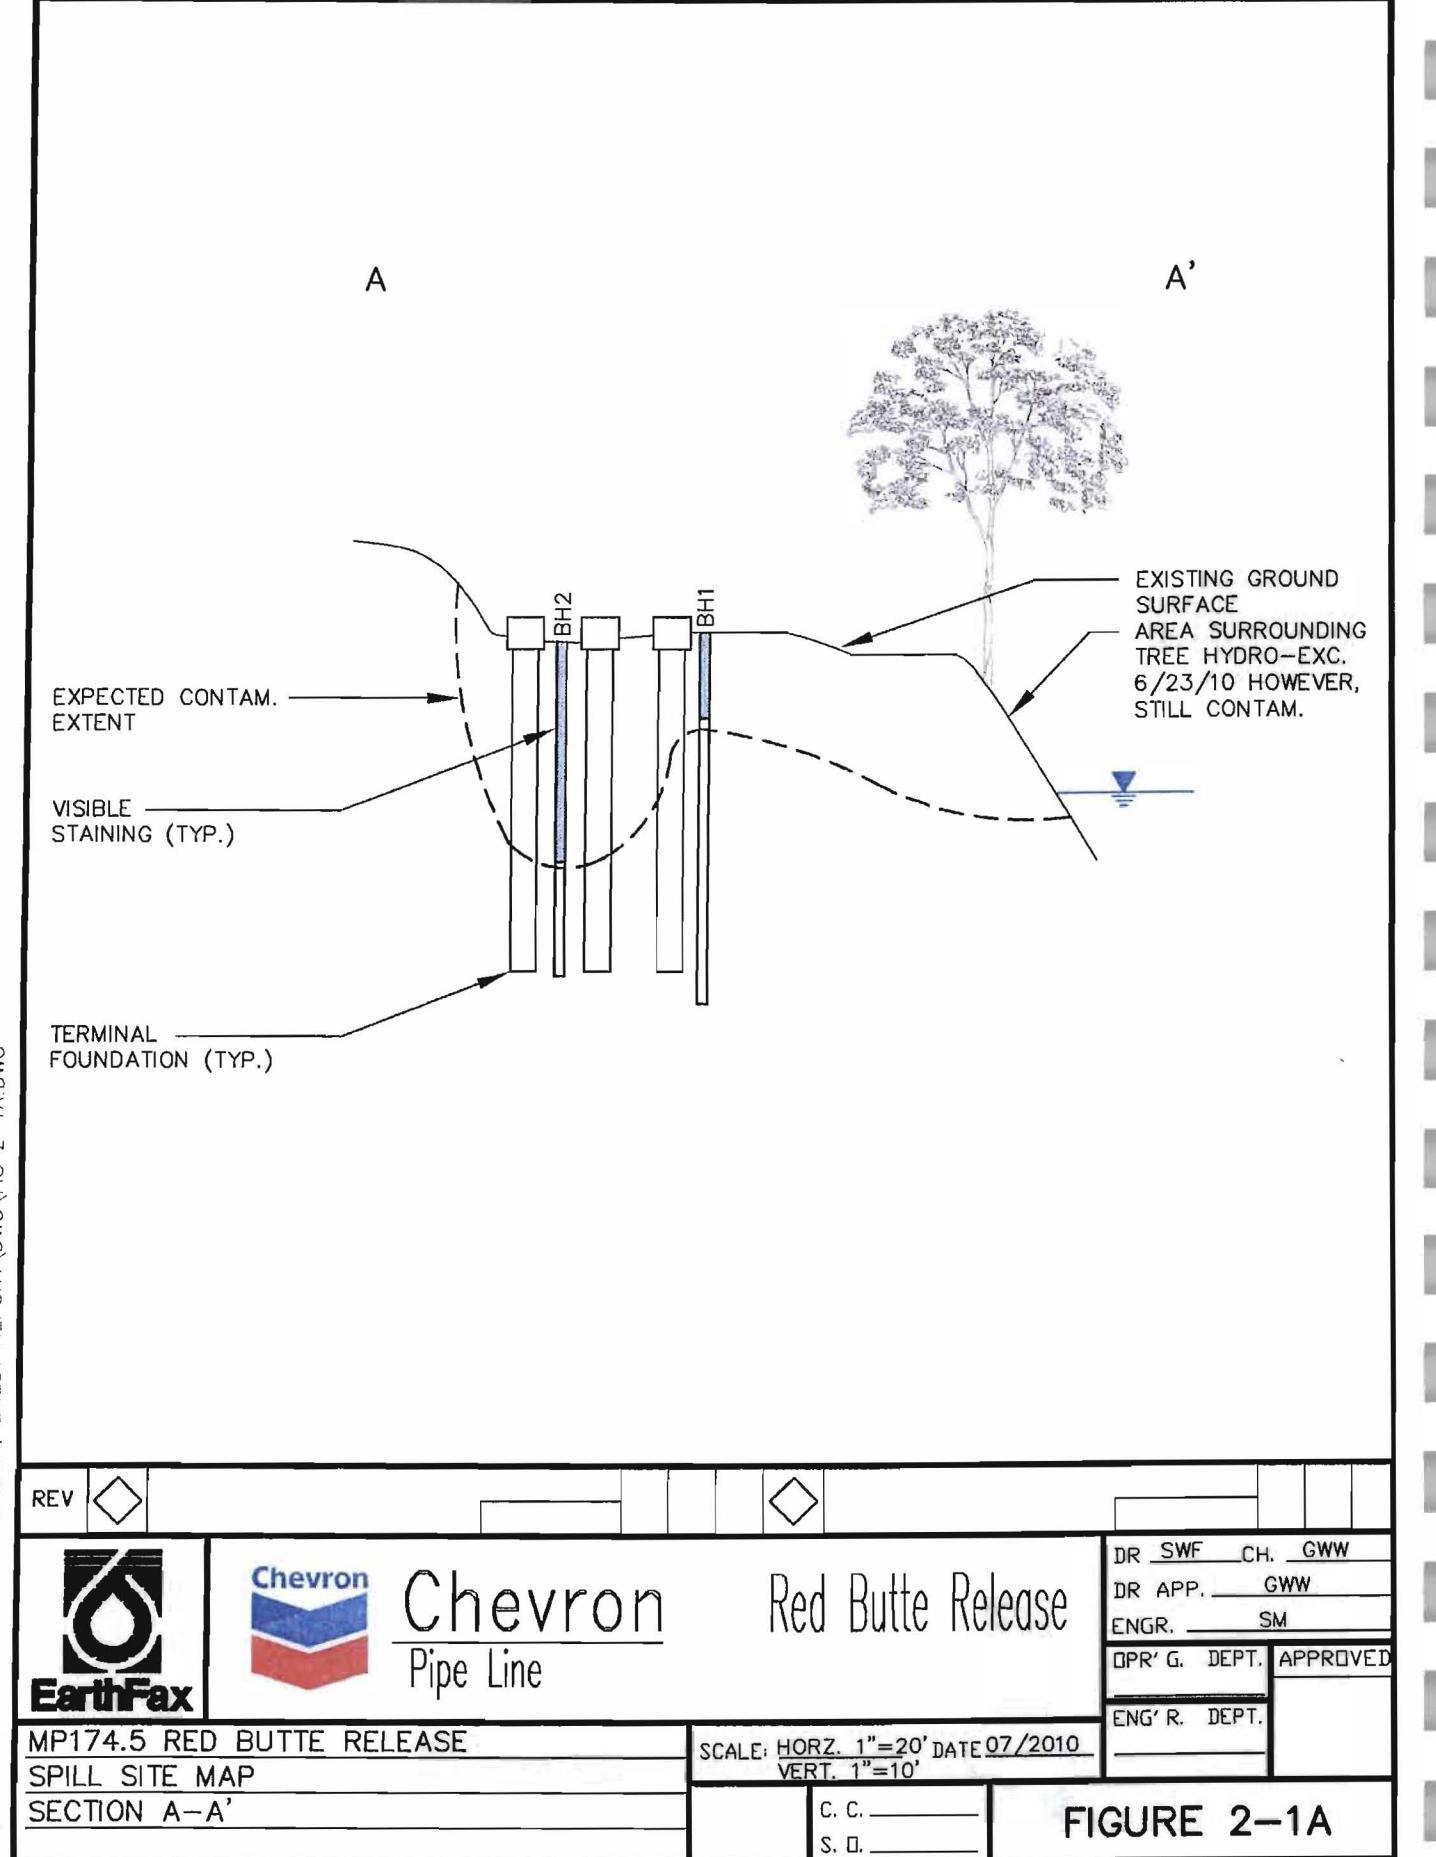
G: \UC1300\SPILL SITE INVEST & EXC\NEWEST REPORT\DWG\FIG 2-1A.DWG

The characterization of the spill site was performed by drilling exploratory boreholes at the locations shown in the attached Figure 2-1. These boreholes were drilled with a tractormounted geoprobe rig (BH1-BH10), with a backhoe (BH11), or by hand with a bucket auger (BH12-BH15) during the week of June 21, 2010. The soils recovered were analyzed in the field for organic vapors using an organic vapor analyzer ("OVA") and samples were collected and submitted for laboratory analyses. Laboratory samples were collected as soon as clean soils were encountered in each boring as indicated by observations of soil staining or organic vapor content.

Based on observations made during the drilling, it appears as if the crude oil is present in the soil roughly 12-14 feet below the ground surface (at the time of drilling) near the leak point at the electrical towers and 5-6 feet below the ground surface at the southern end of the pool location (see Figure 2-1). Three borings were installed uphill and south of the known contarninated area to assess whether the contamination had migrated off-site. Based on the observations made of these boreholes as well as observations made of the pipeline repair excavation, it appears as if the crude <u>did not</u> significantly migrate off site to the north, east, or south. However, based on soil staining and observations of excavations made at the level of the river, it is apparent that the crude oil migrated westerly through the soil down to Red Butte Creek.

Though a soil boring could not be safely drilled between the existing excavation at the crude pool location and the emergency generator bays, patchy crude staining was observed on the face of the excavation and is only expected to extend several feet toward the generator bays in the location shown on Figure 2-1.

- Excavation slopes will need to be benched/sloped at 1.5H:1V as required by OSHA for Type C soils in the northern (power terminal tower area) section where excavation depths are deeper and contamination is known to extend below the level of the river. The extent of the excavation at this slope can be seen on Figure 2-1 along with the extent of an access ramp excavated at 1.75H:1V. As seen on the figure, maintaining this slope will require exposing the Chevron crude pipelines in the area surrounding the excavation. Place supports under the pipe as directed by CPL to provide structural support for the pipelines as the excavation progresses.

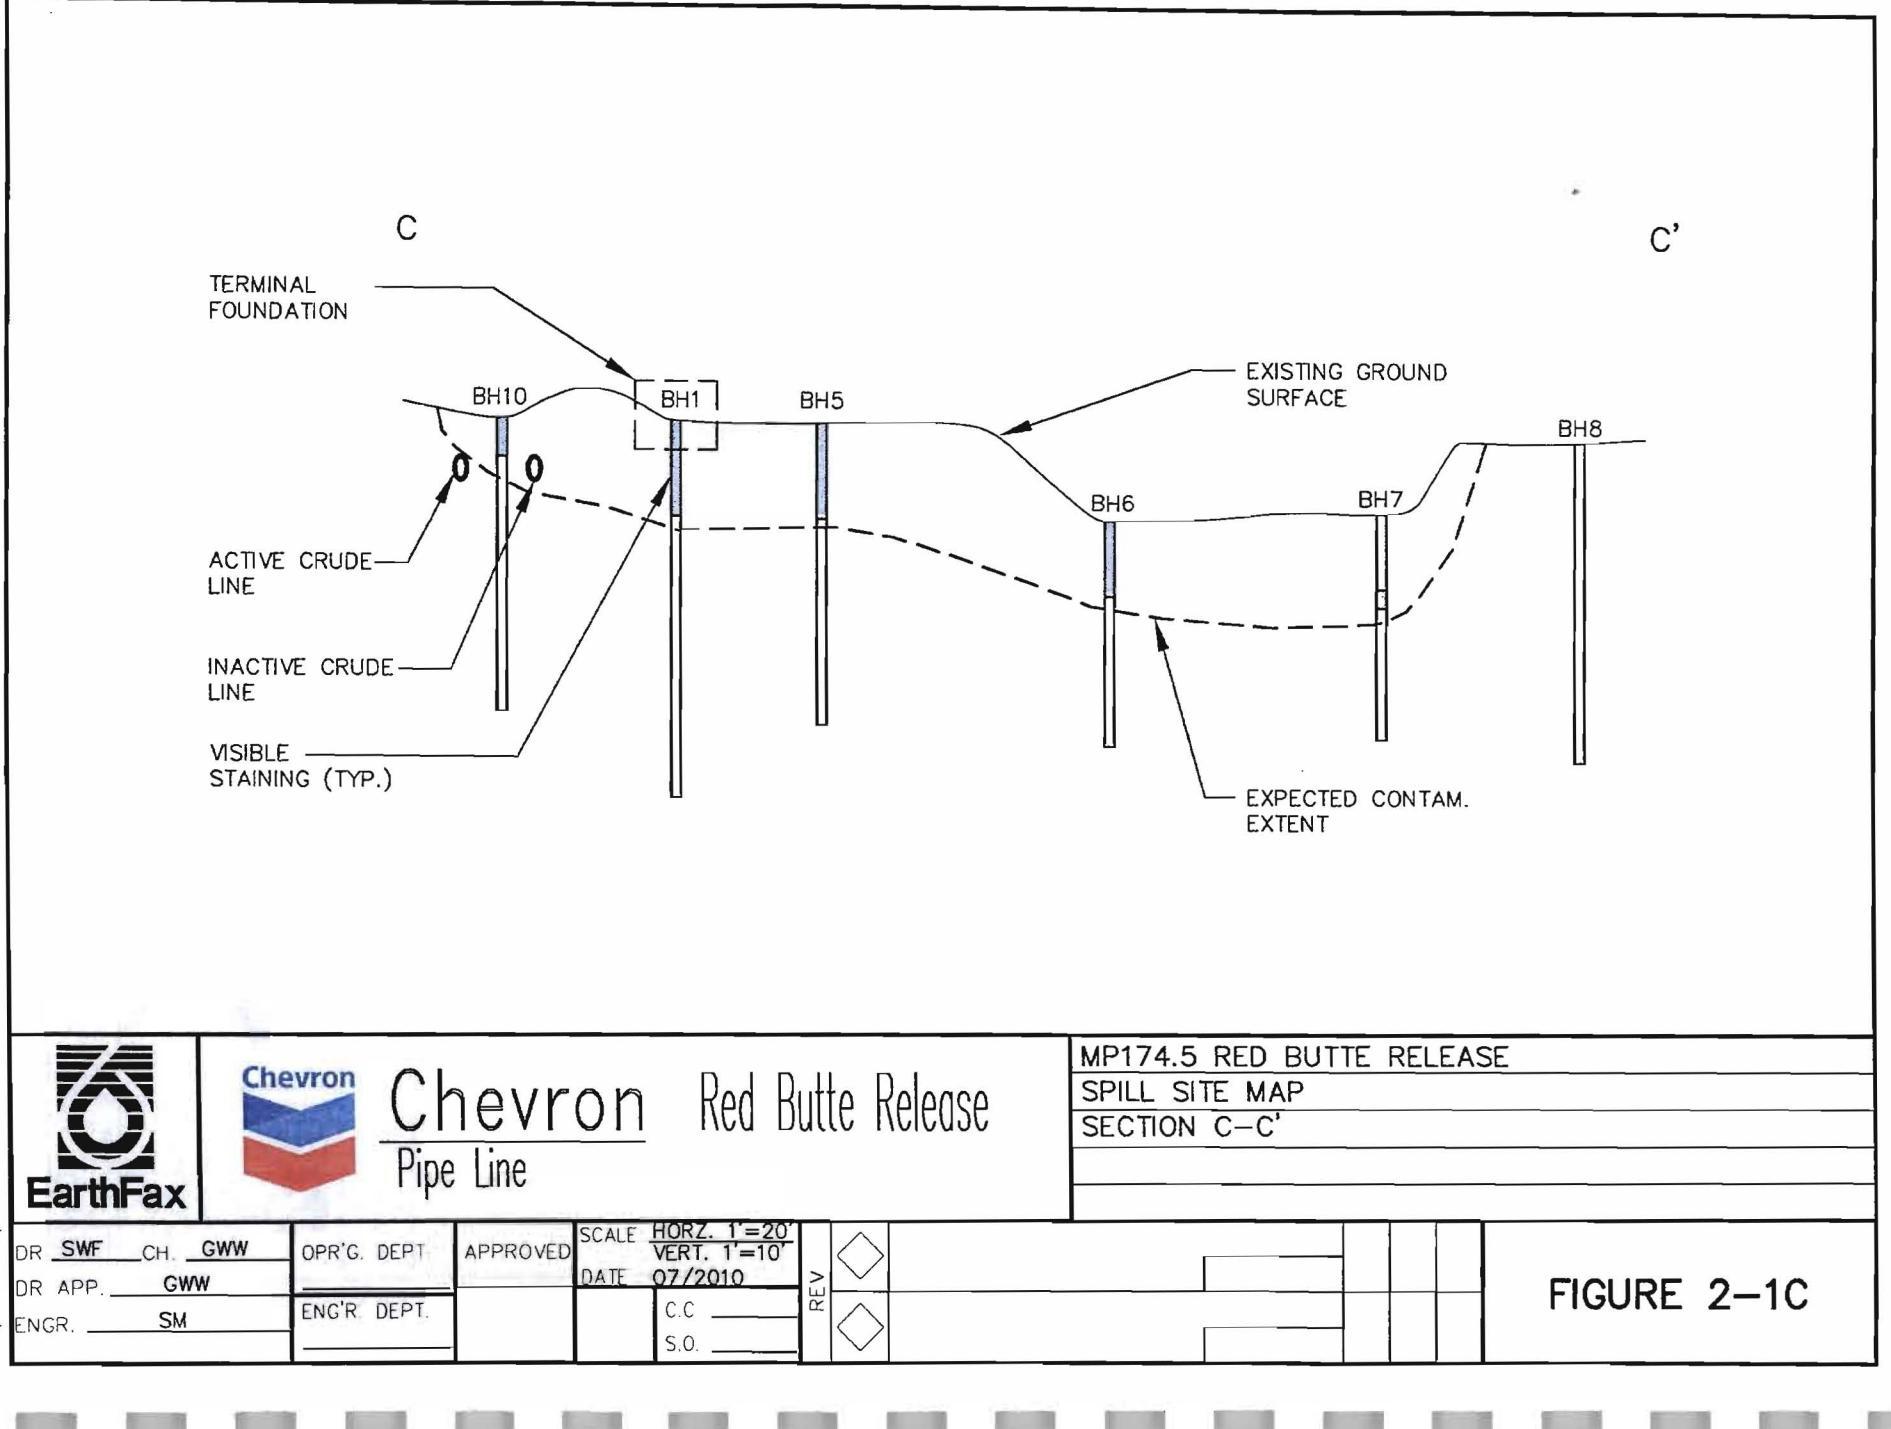
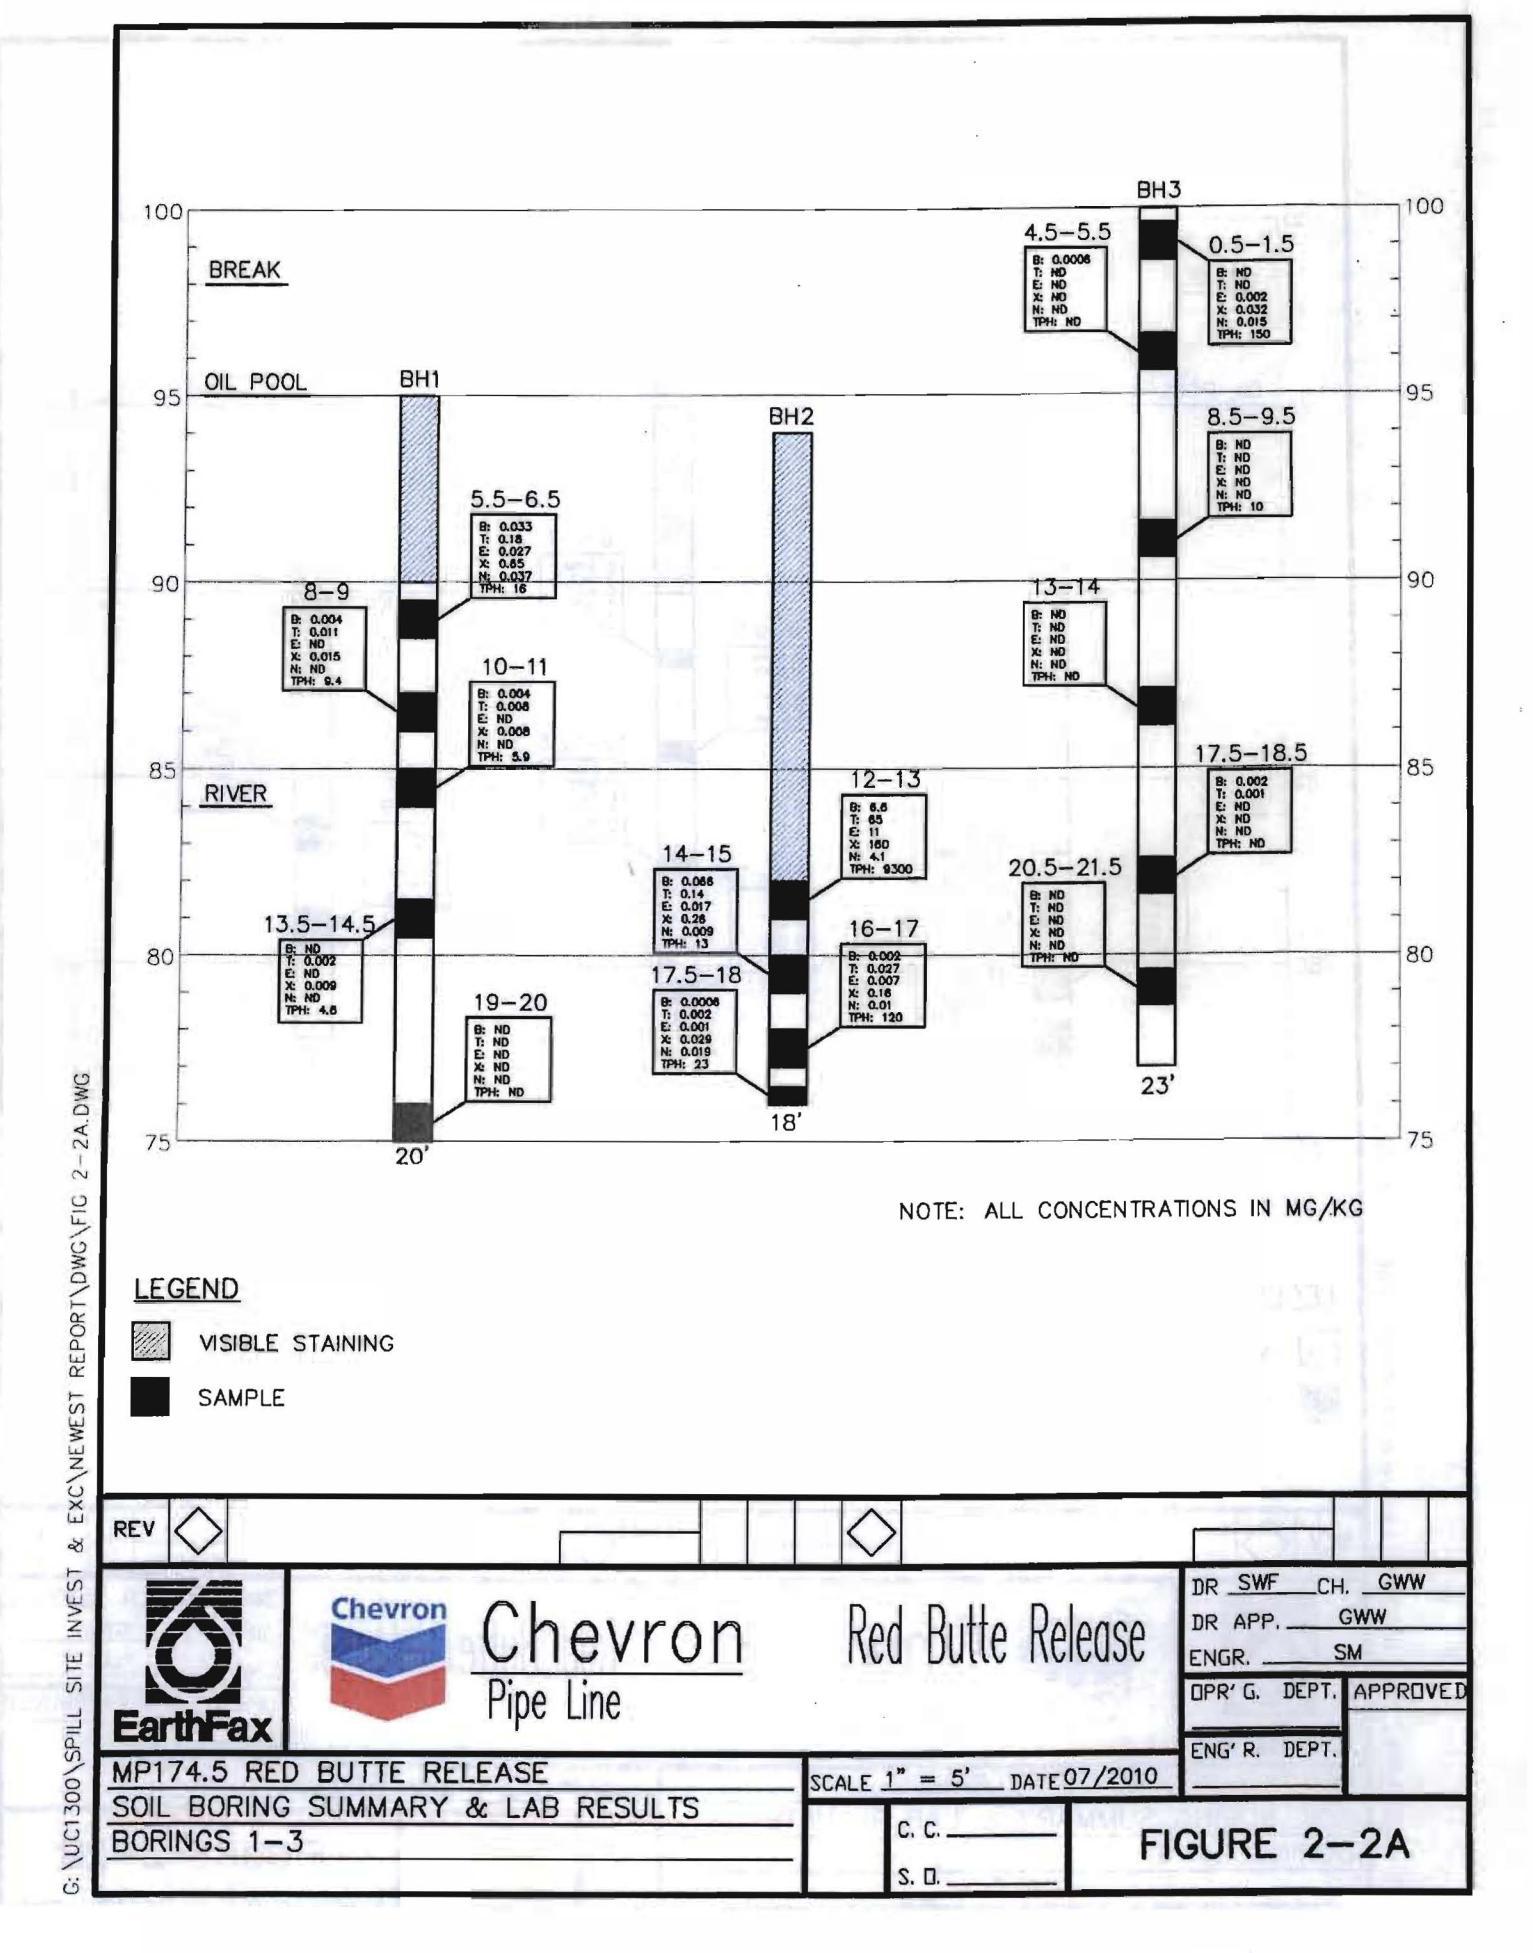
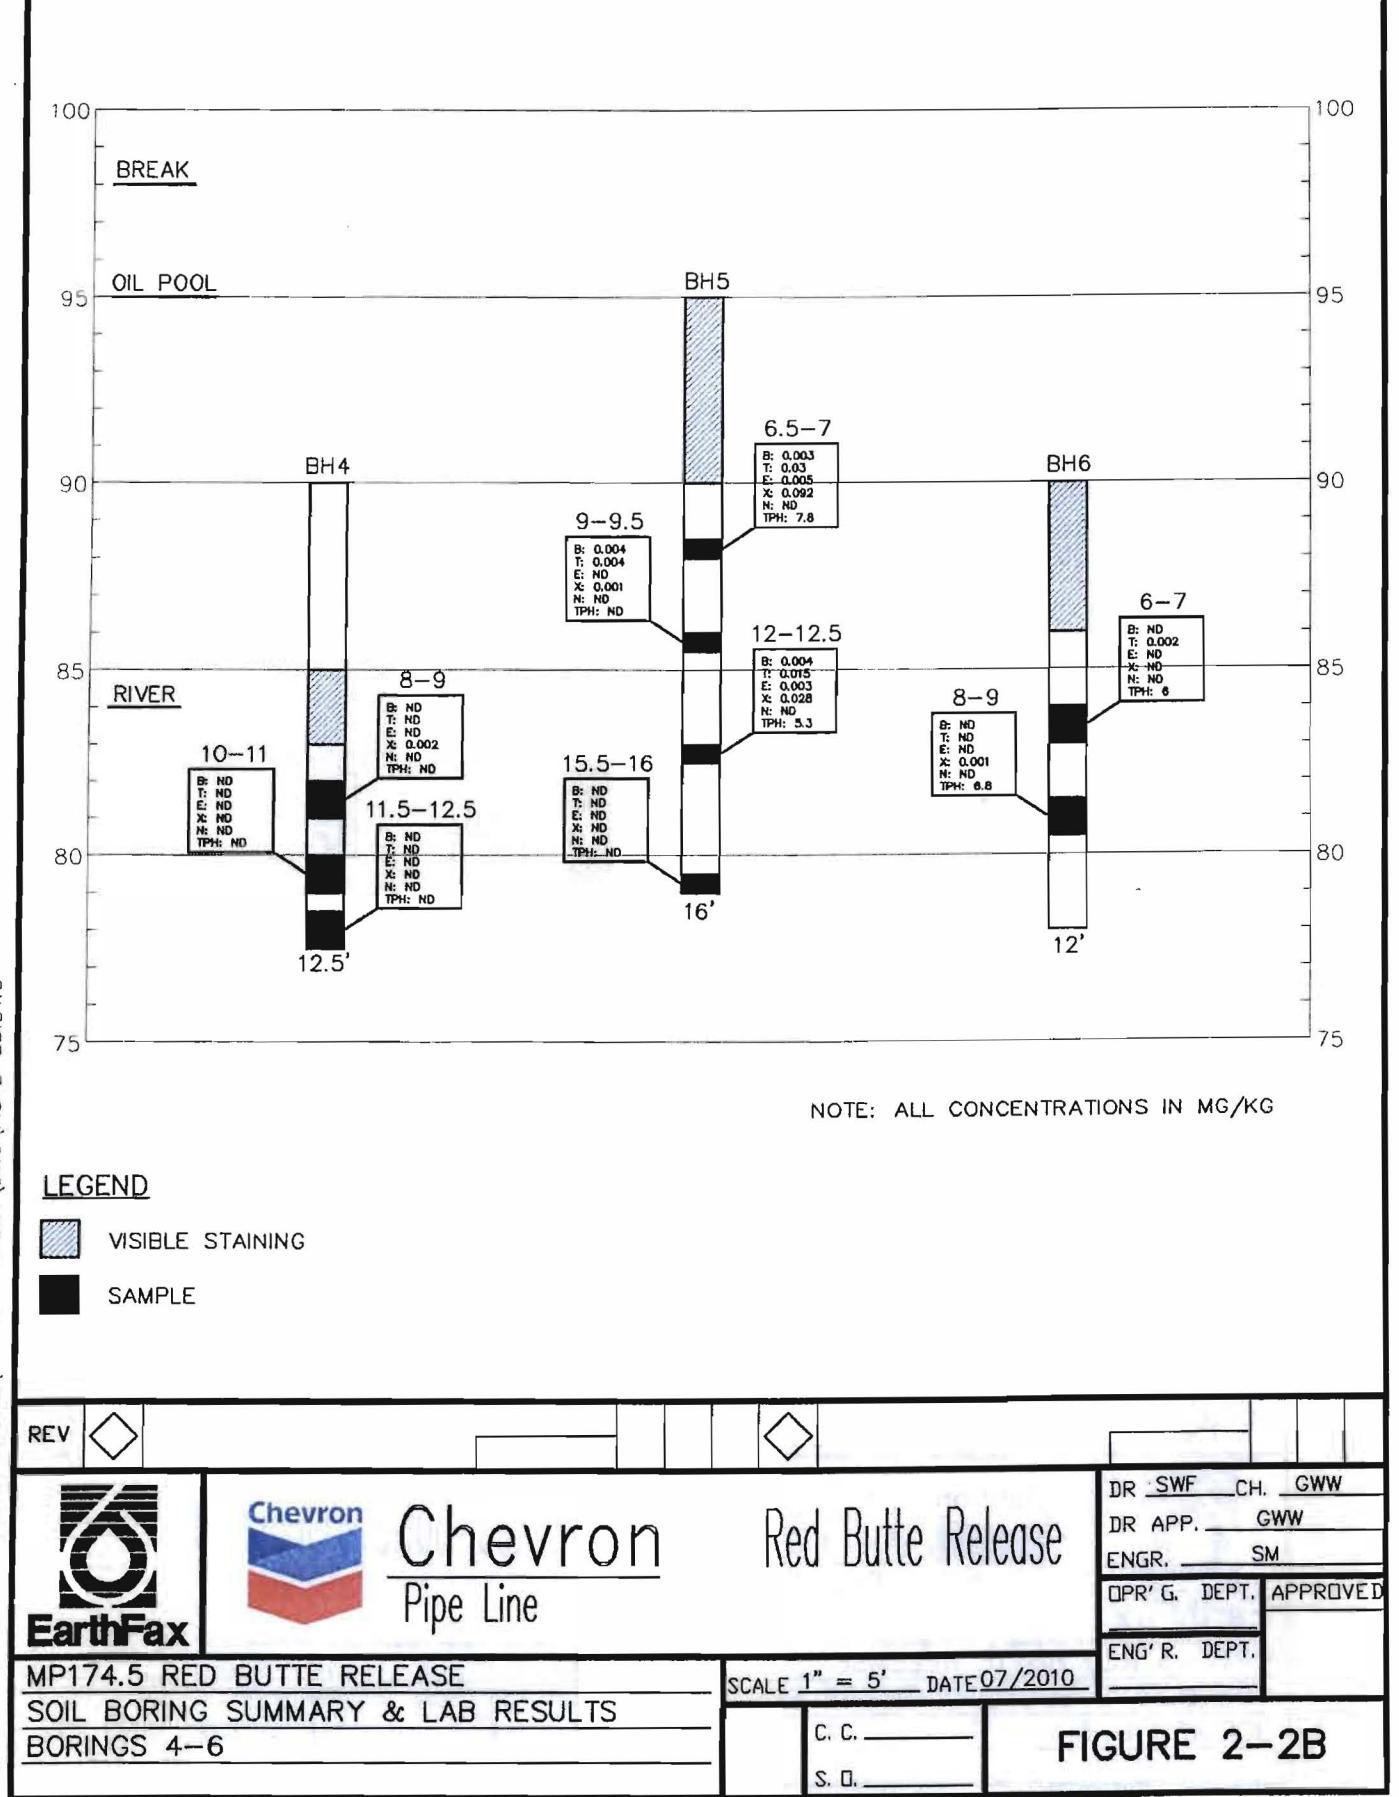
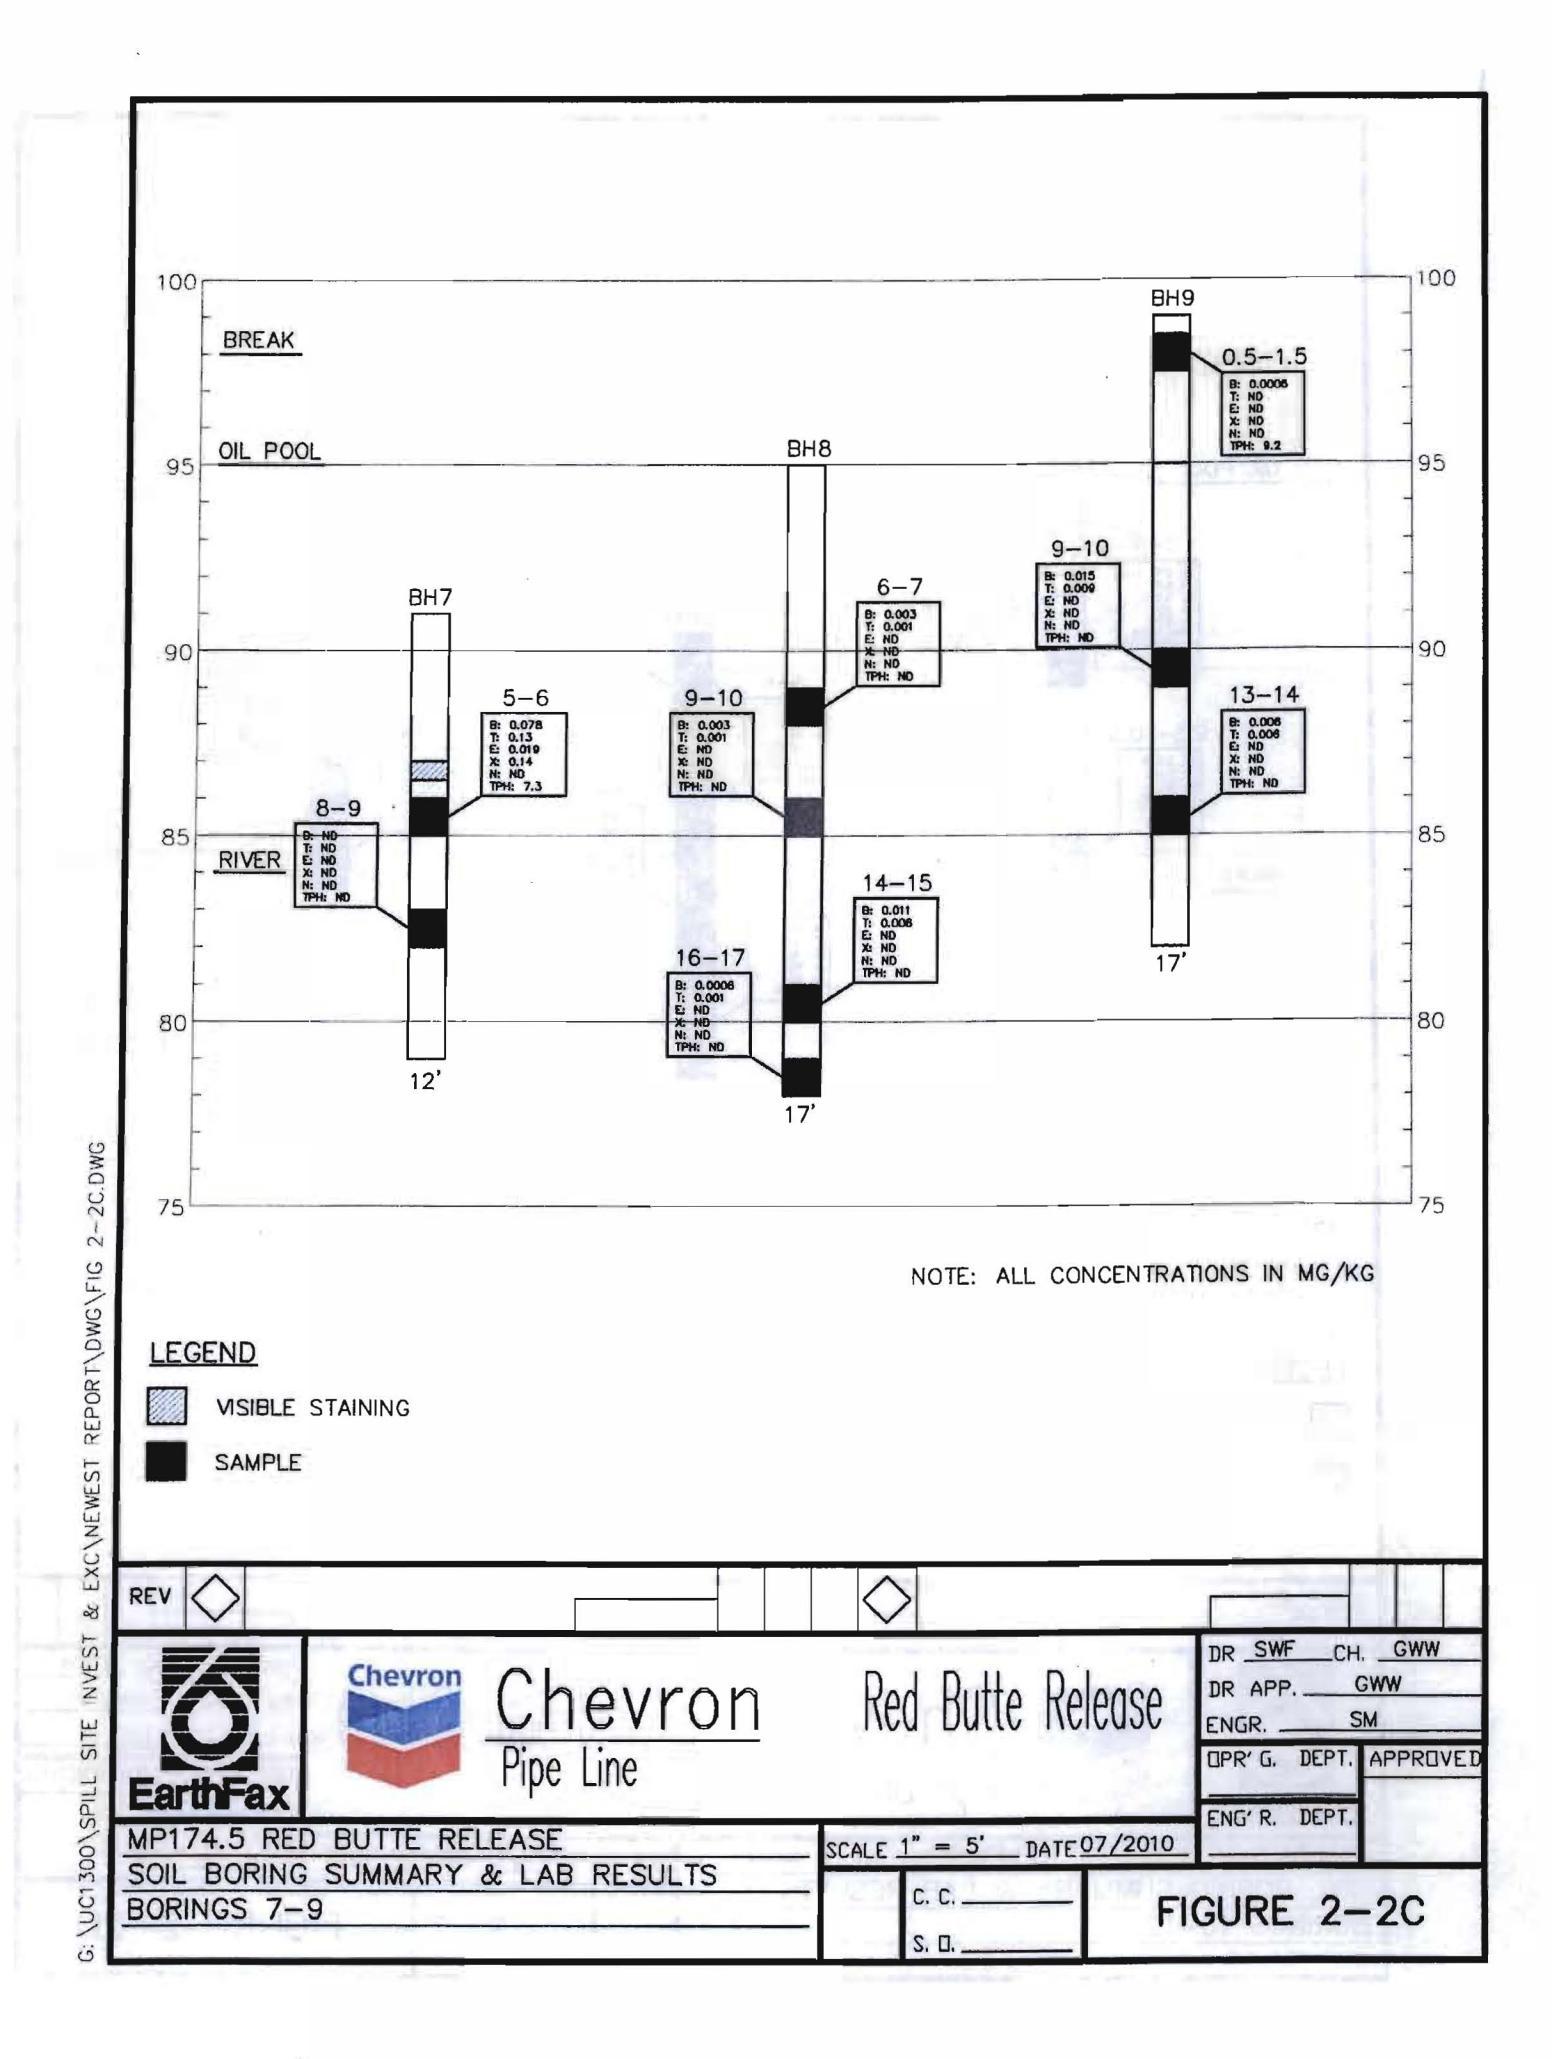
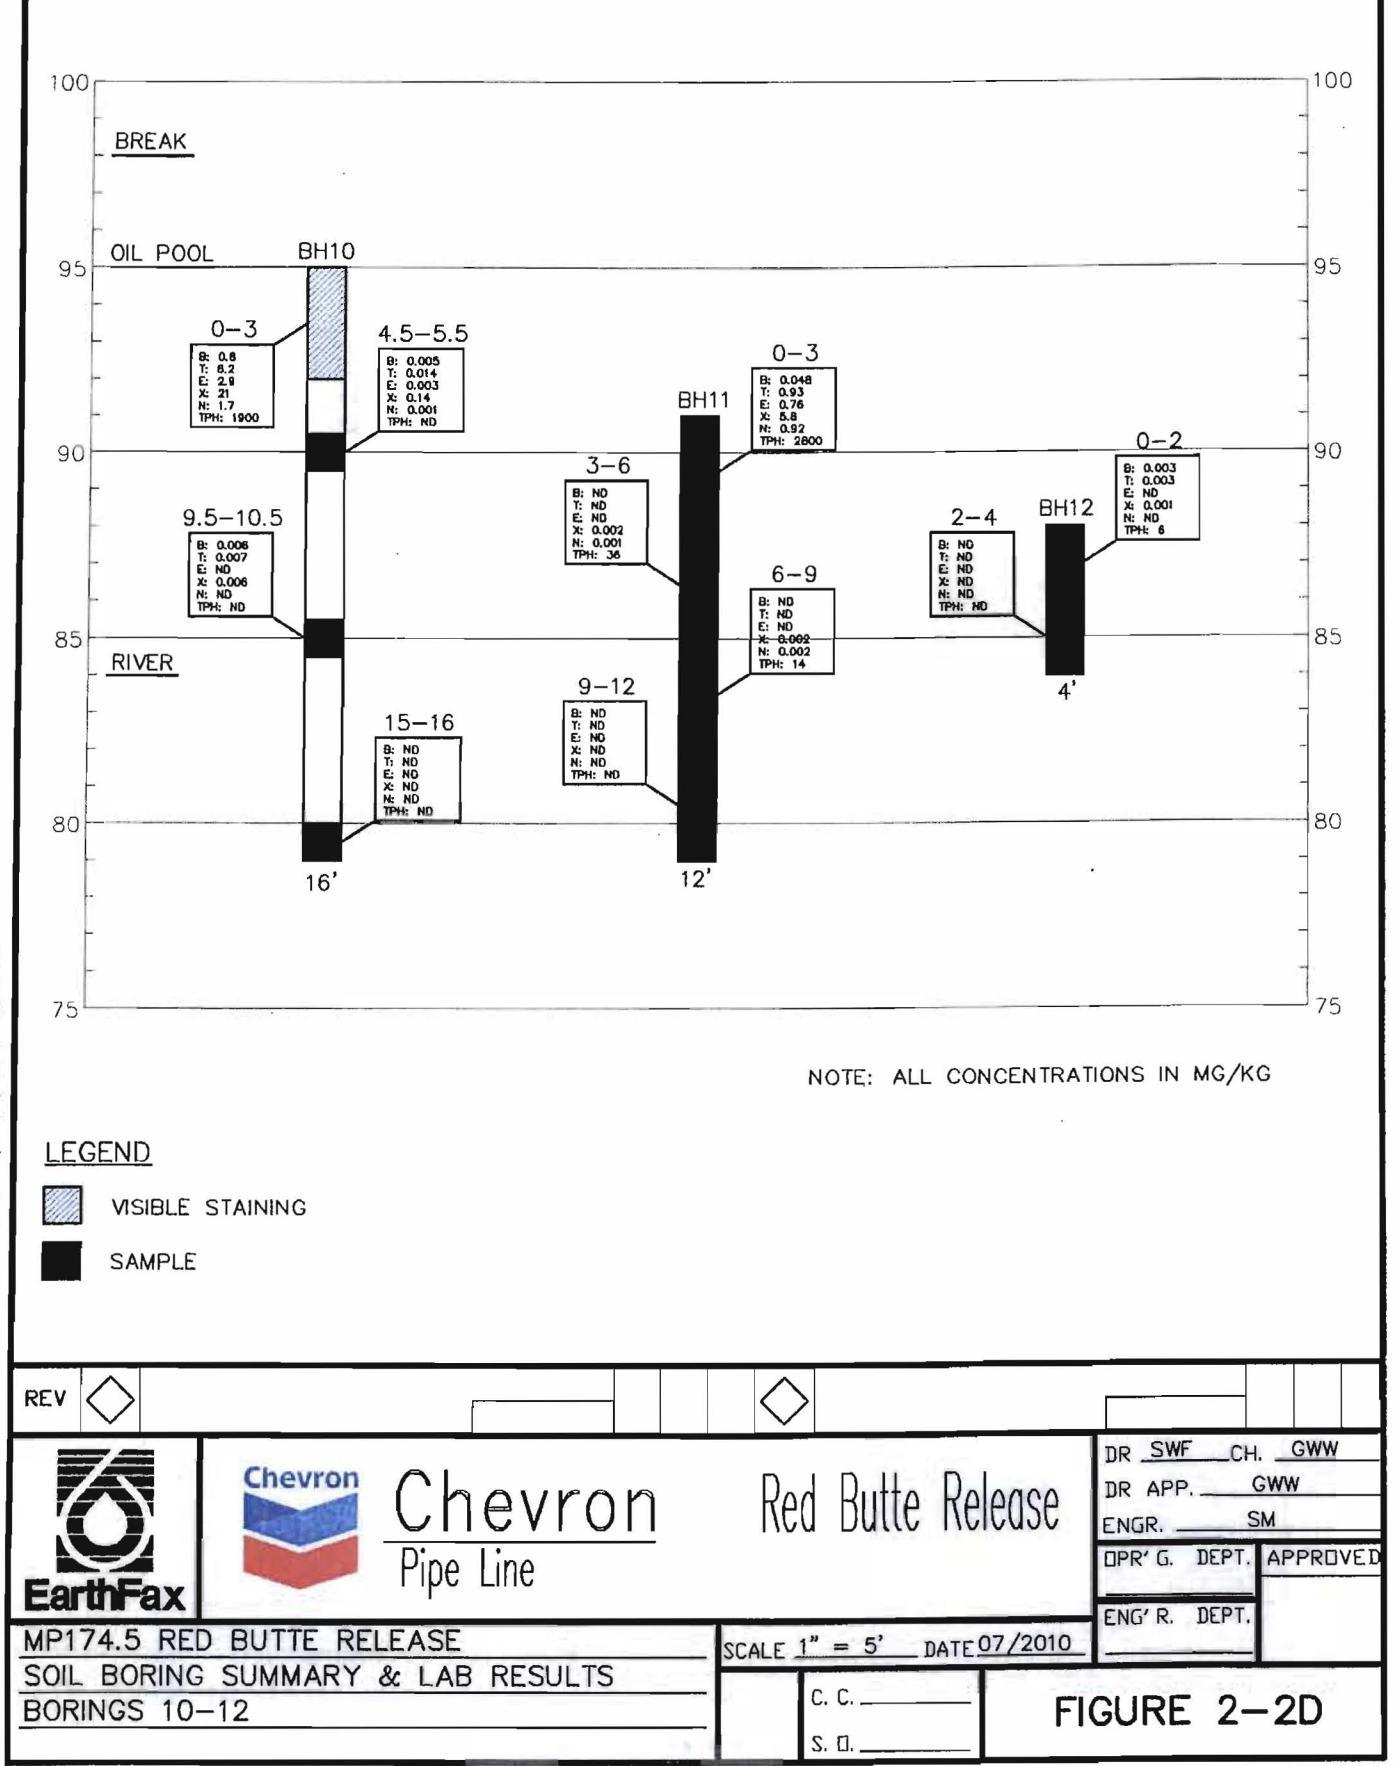
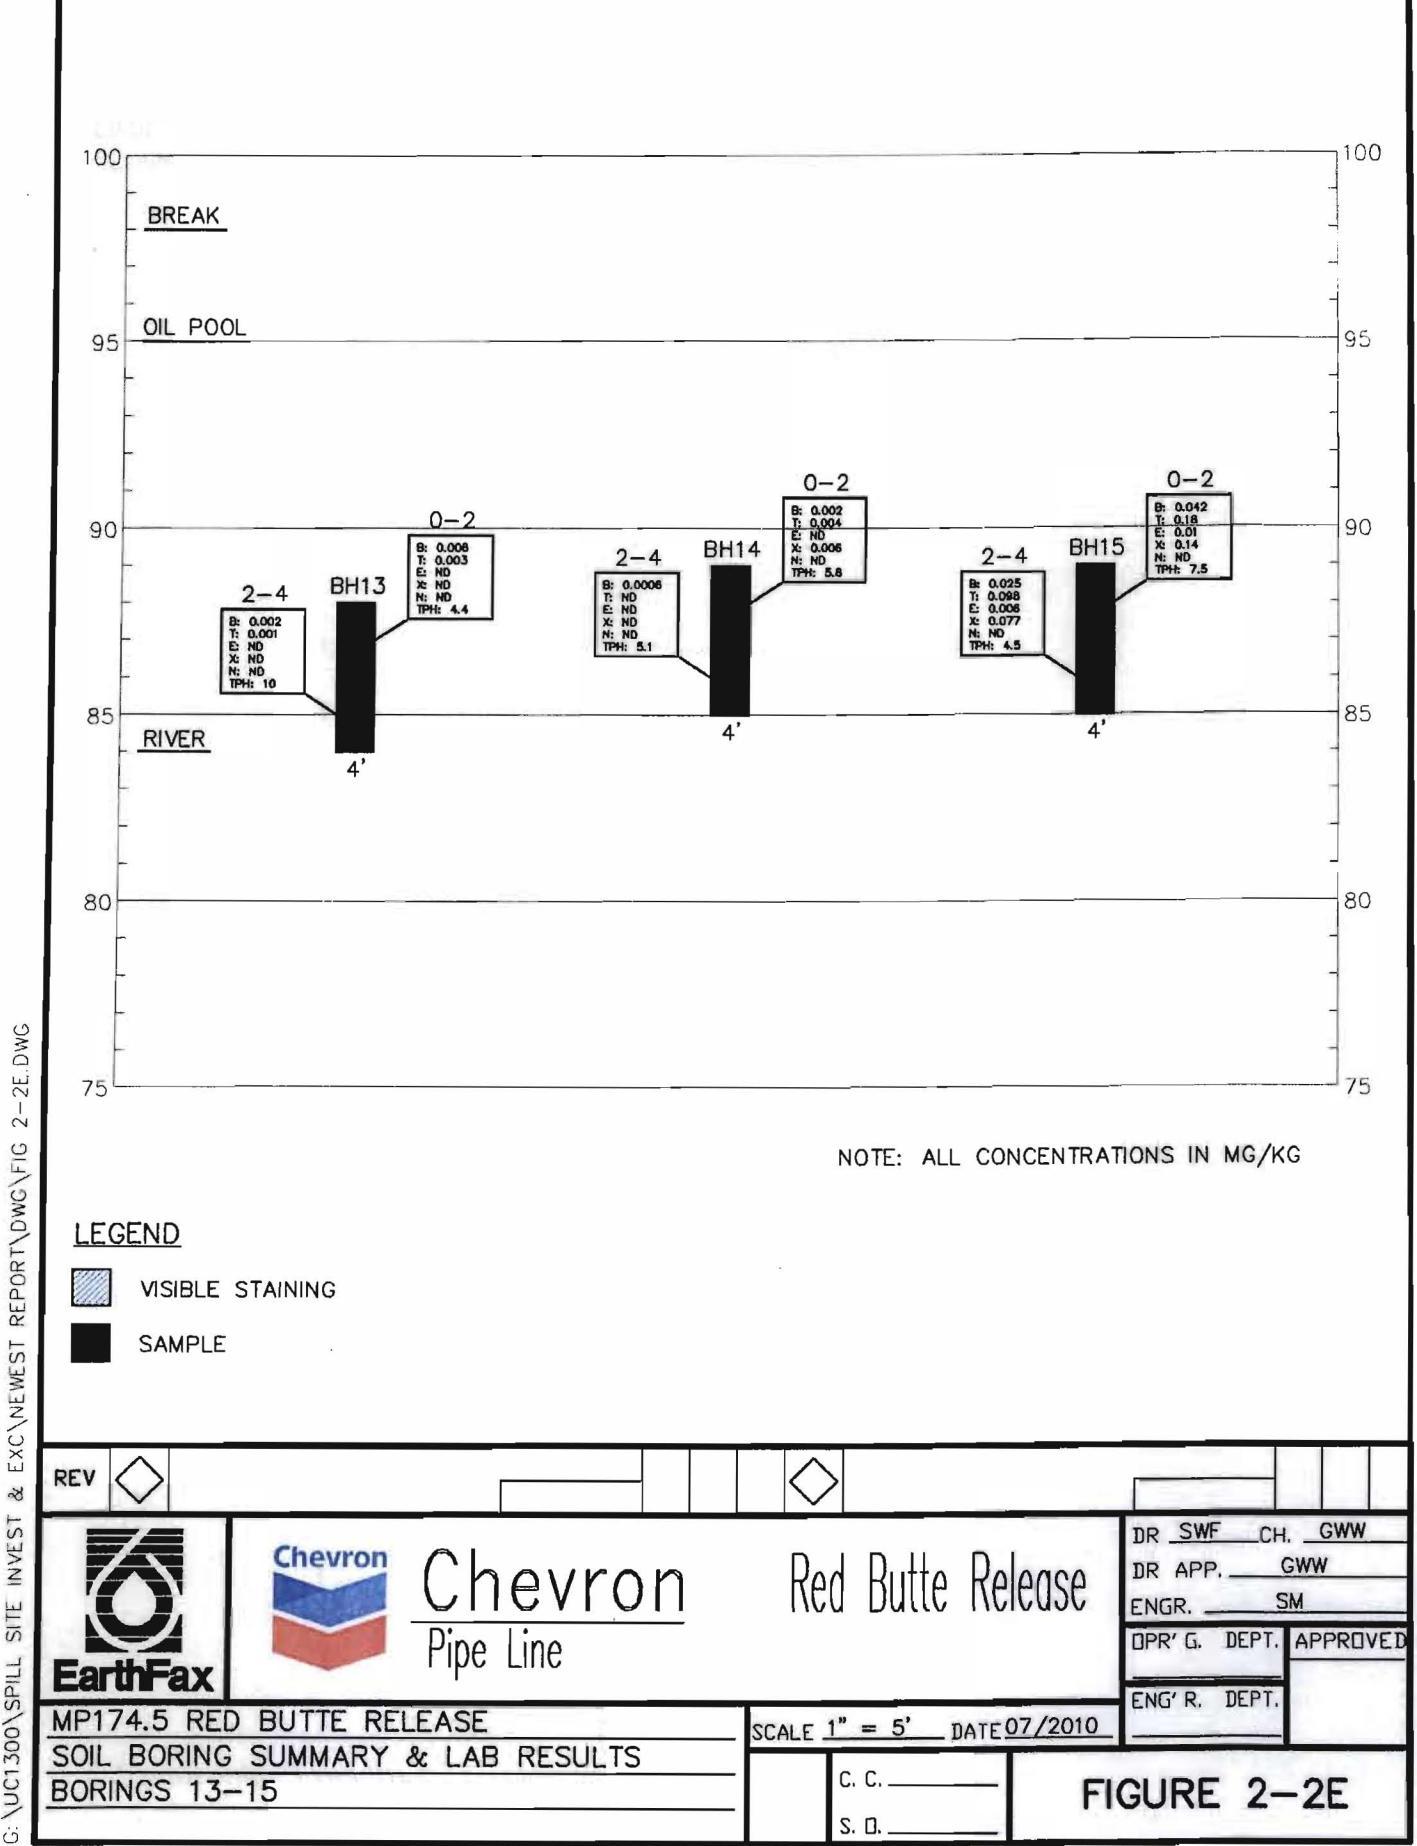
Following is a summary of the findings for each borehole. Figure 2-2 shows each boring at its respective elevation with the extent of visible staining, sample locations, and analytical laboratory results for these samples. This figure also includes the elevation of the ground surface at the leak point, crude pool, and Red Butte Creek. The logs for each boring with OVA readings and laboratory analytical results can be found in Appendices A and B, respectively.

- BH-1: Located between two power terminal foundations, drilled to 20 ft (level of deep foundations supporting terminal). Visible crude staining to 5.5 ft.
- BH-2: Located between two power terminal foundations, drilled to refusal at 18 ft.
  Visible crude staining to 12 ft with a strong hydrocarbon odor present to 14 ft.

- BH-4: Located near the bridge over Red Butte Creek, below the crude "channel" present during the release, drilled to refusal at 12.5 ft. Visible crude staining from 5-7 ft (0-5 ft already excavated and replaced).

- BH-5: Located along the crest of the slope to Red Butte Creek, drilled to 16 ft. Visible crude staining to 5.5 ft.
- BH-6: Located near the crest of the slope to Red Butte Creek in the bottom of an excavation performed to expose concrete covering the RMP transmission lines, drilled to 12 ft. Visible crude staining to 4 ft.
