Section 319 Nonpoint Source Pollution Control Program
Watershed Project Final Report

Jordan River Murray Taylorsville
Improvement Project

FY2018

Salt Lake County
Watershed Planning and Restoration Program

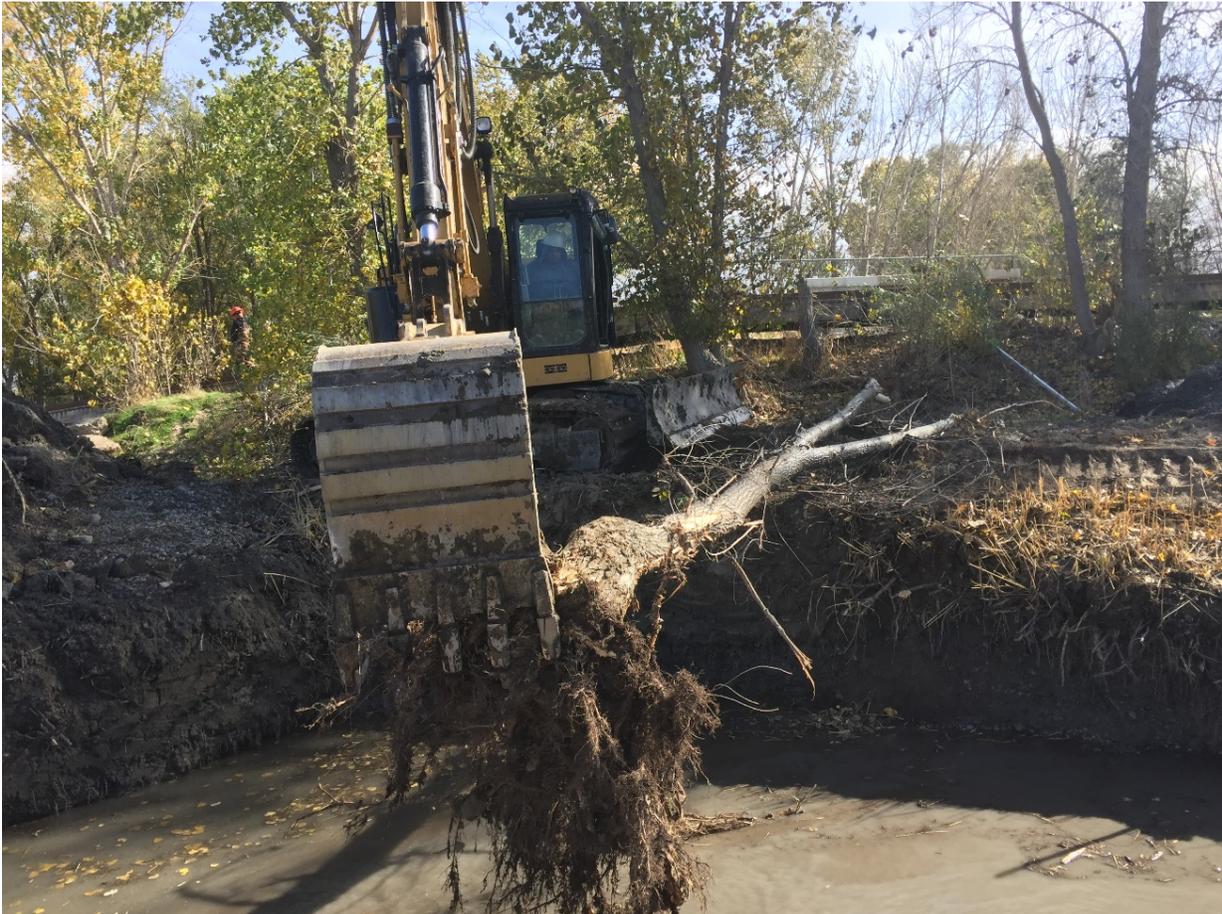
Figure 1: Phase 1 Toe wood structure install on the Jordan River

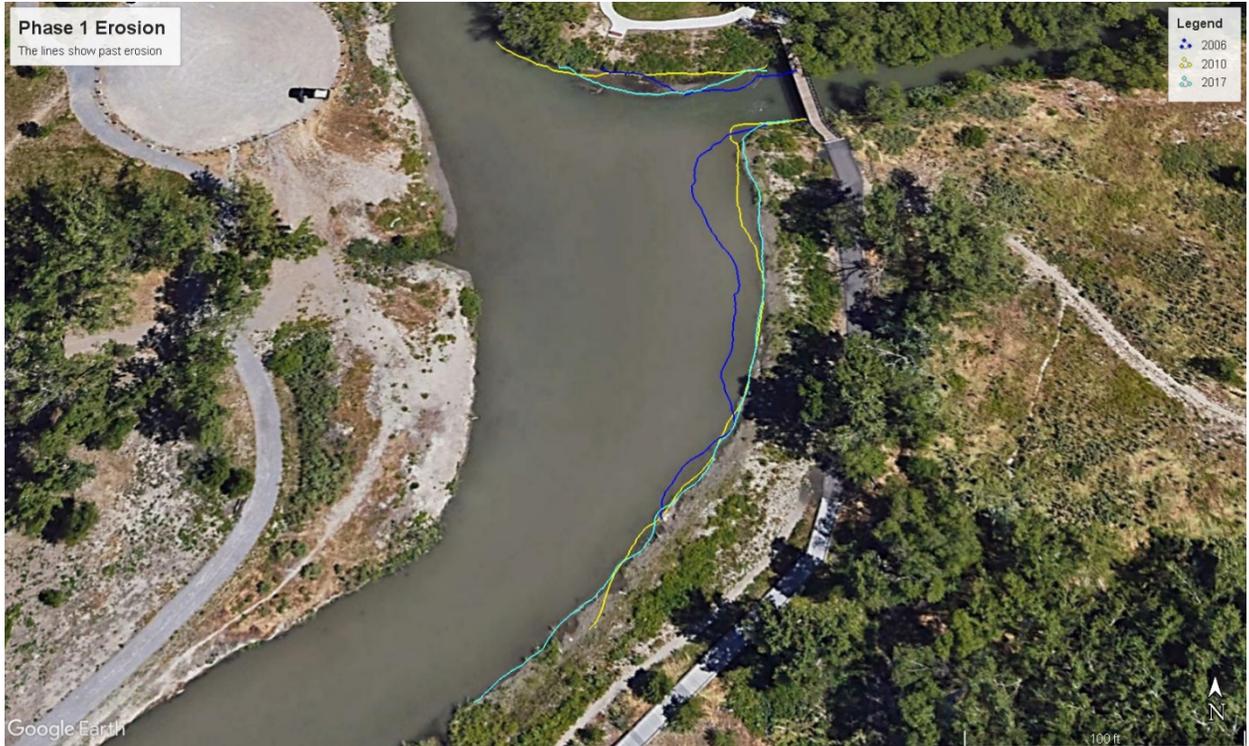
Figure 2: Phase 1 with digitized banks from past years to show the erosions progression

Phase 1 (Figure 2) of the JRMT project had seen up to 38 feet of erosion along the east bank from 2006 to 2015 which caused a large amount of sediment to enter and remain in the river exacerbating the sediment, nutrient and DO issues along this segment. Construction in phase 1 added twelve feet of floodplain to the east bank that had disappeared due to erosion. The east bank is maintaining a healthy and thriving riparian community composed of native vegetation that has seen very little disruption from multiple bankfull events.

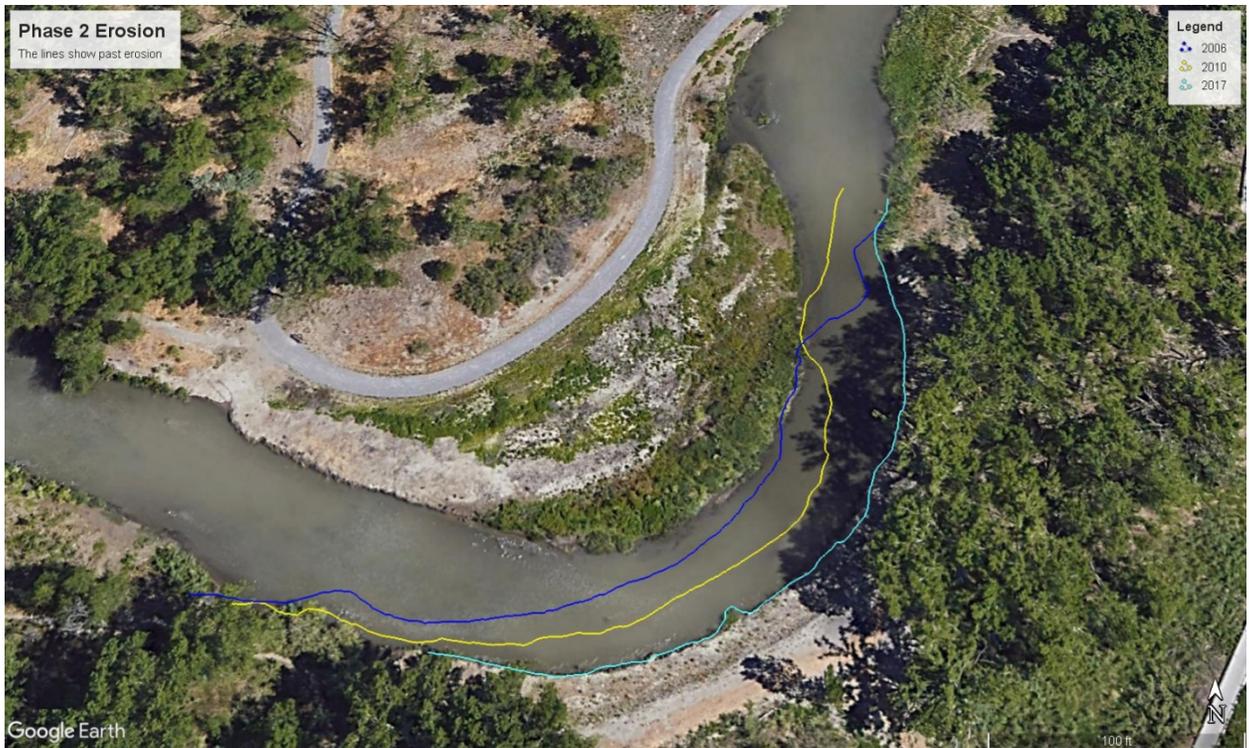
Figure 3: Phase 2 with digitized banks from past years to show the erosions progression

Phase 2 of the JRMT project (Figure 3) had seen over 50 feet of erosion between 2006 and 2016 which forced the east bank of the Jordan River to move into one of the last native cottonwood stands along the river. Since construction finished in 2016 the erosion that was occurring along the east bank has halted and the floodplain that was built along the west bank is functioning as a normal floodplain should allowing sediments to deposit along the floodplain during bankfull, and larger, events. The west bank has seen a natural floodplain continue to develop in size while supporting a large stand of native plants that were planted by the WPRP in the riparian community. The halt of erosion along the east bank and the continued growth of the floodplain along the west bank has decreased the bankfull width in this phase of the project increasing the velocity of the river and ushering sediments that were once deposited along the river bed at normal flow to move on to the floodplain and further down river and into the detention basin.

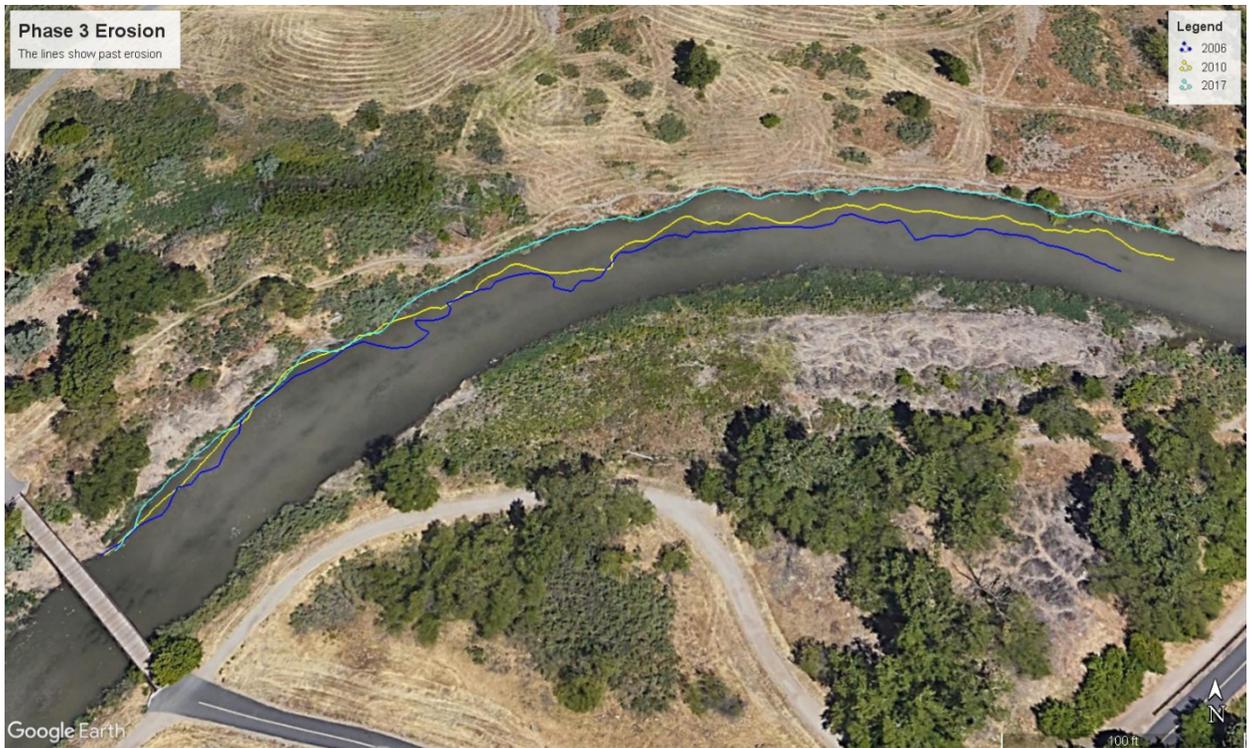
Figure 4: Phase 3 with digitized banks from past years to show the erosions progression

Phase 3 the largest segment of this project (Figure 4) had seen up to 35 feet of the bank erode into the river from 2006 to 2017 causing an increase in sediments entering the river through this section, exacerbating the issues with sediment transport in this segment of the Jordan river. When construction was completed in this section in 2017 the erosion that was occurring was halted and the floodplain that was constructed is acting as expected allowing the rivers bankfull events to inundate the floodplain, slowing down the velocity of the river and allowing sediments to fall out of the water column. The construction on this phase has caused the bankfull width to decrease which is causing the velocity of the water to increase in the low flow channel and normal flows and keep the sediment that would fall out of the water column in this area to deposit on the floodplain in high flow events or pass through this segment of the project.

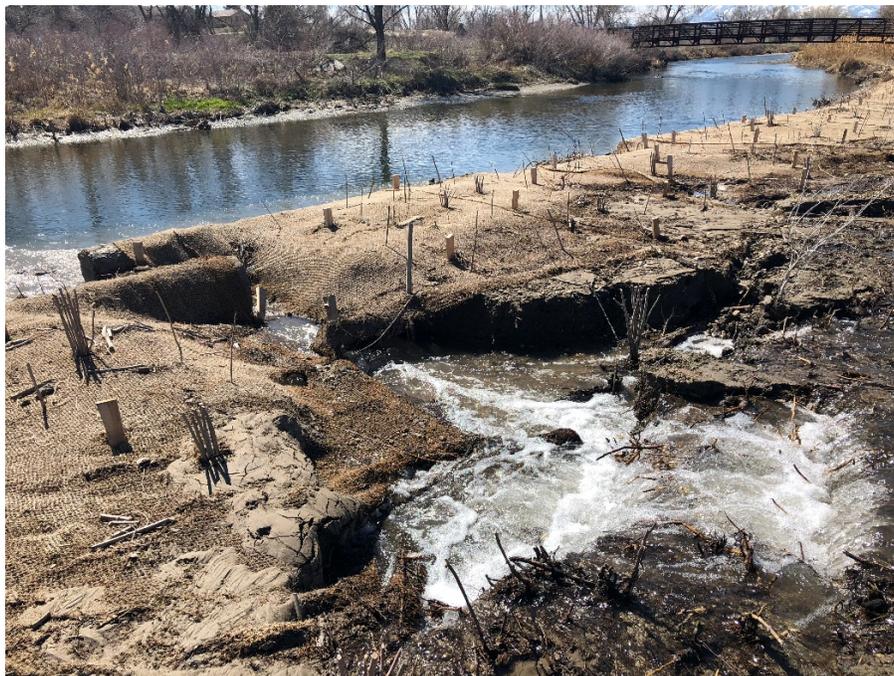
- After construction and planting of phase 3 Taylorsville-Bennion Improvement District purged one of their wells that drained into a storm drain that abruptly ended in a wetland just west of our project. As the wetland filled it began to empty into the Jordan River through Phase 3 and eroded a large area from the wetlands to the river (See figure 3) including pushing one of the toe-wood logs out three feet into the Jordan River. This erosion threatened to cause severe damage to phase 3, if the river reached bankfull erosion could have easily occurred behind the other toe wood structures and causing them to fail. The issue was fixed immediately and a long-term solution for the inadequate drainage has been found.

Figure 6: Erosion through Phase 3 from storm drain west of the project

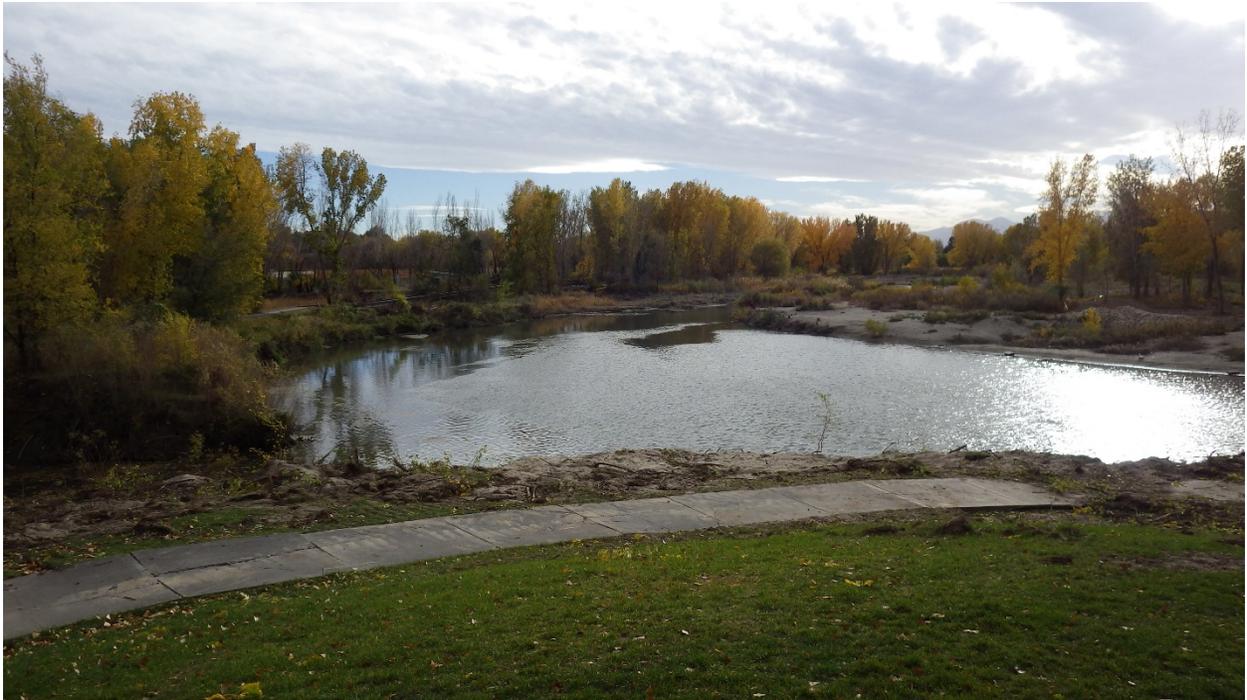
Figure 7: Phase 1 Pre-Construction

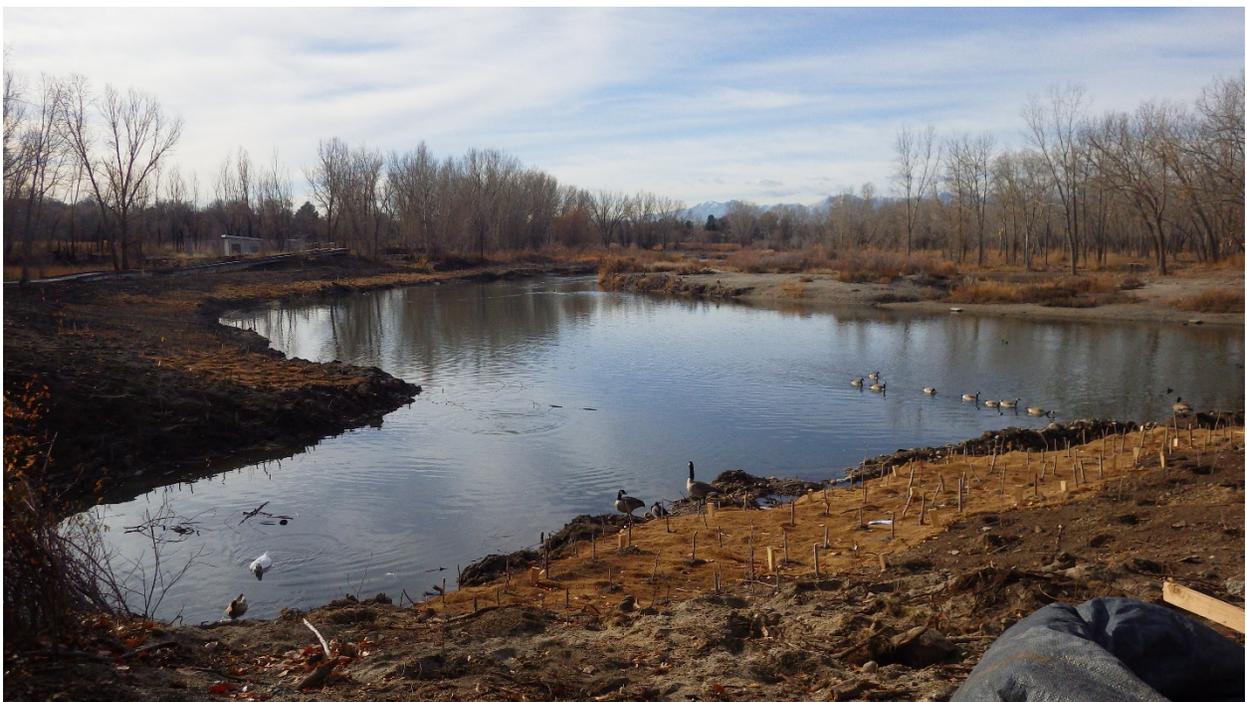
Figure 8: Phase 1 After construction

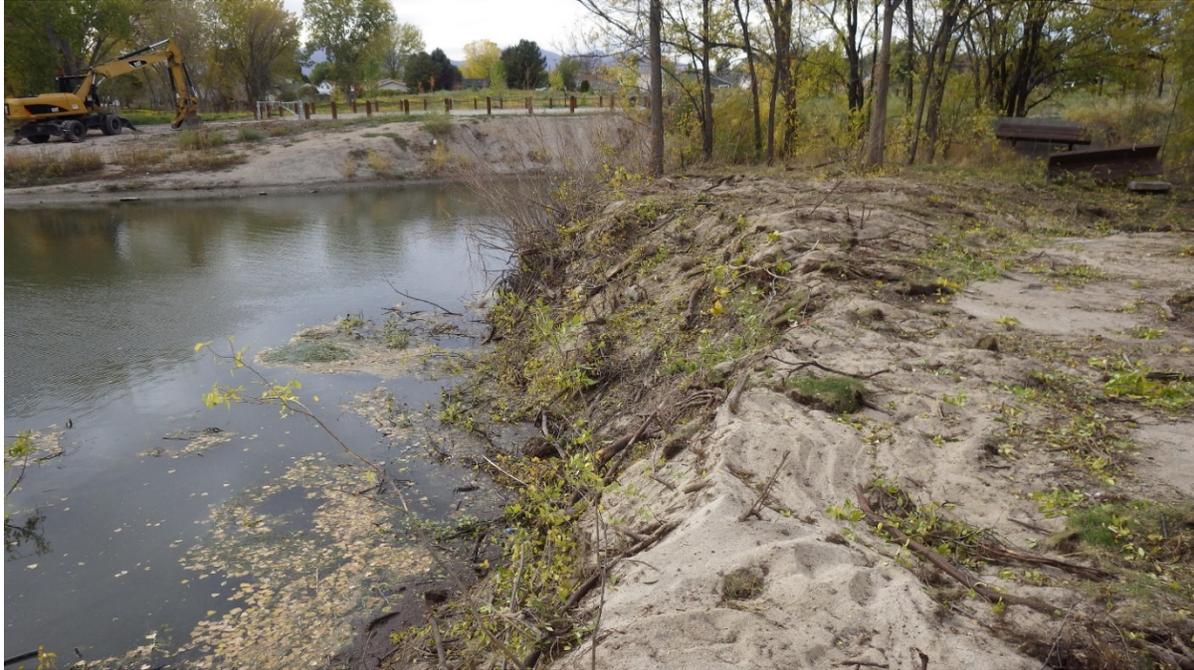
Figure 9: North end of Phase 1 pre-construction

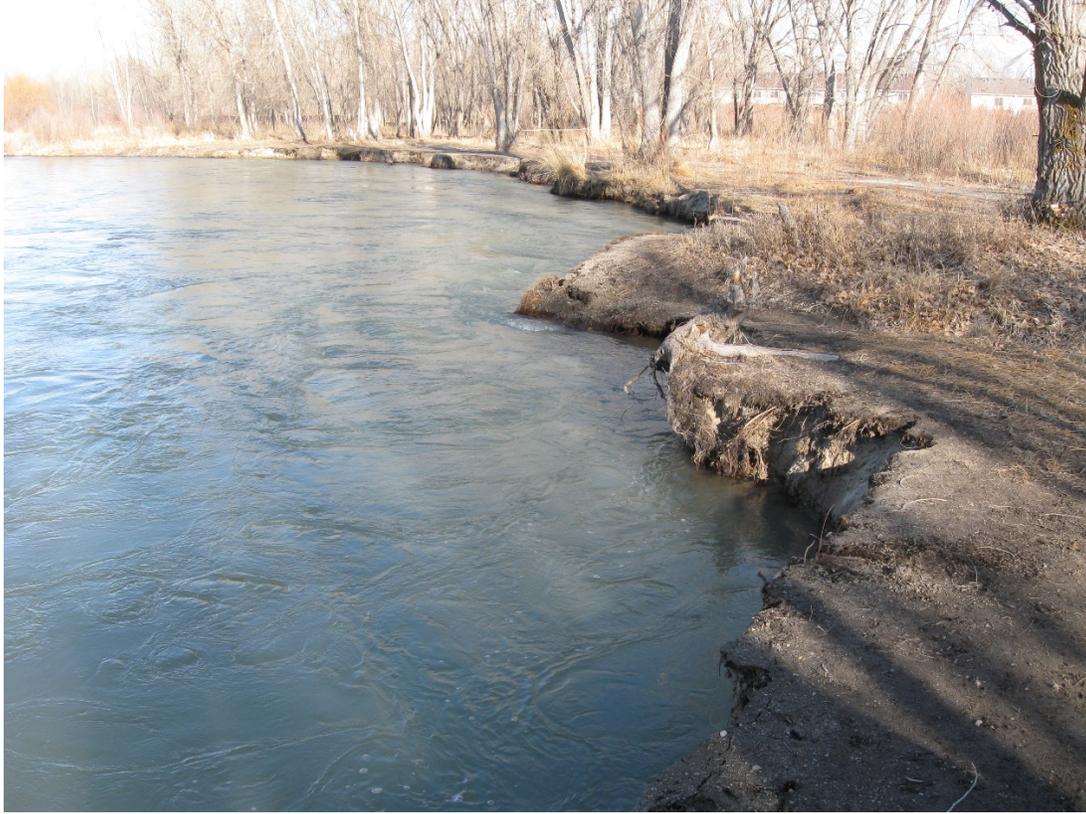
Figure 13: Bankfull flow before construction looking downstream

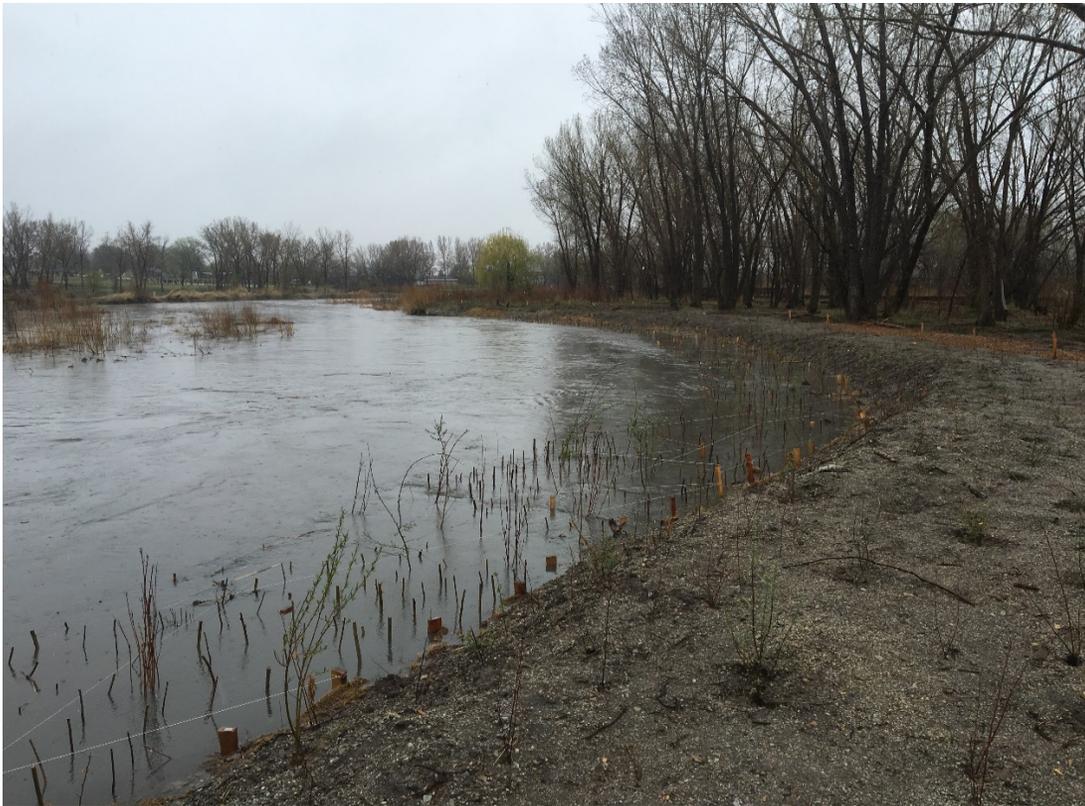
Figure 14: Bankfull flow after construction looking downstream

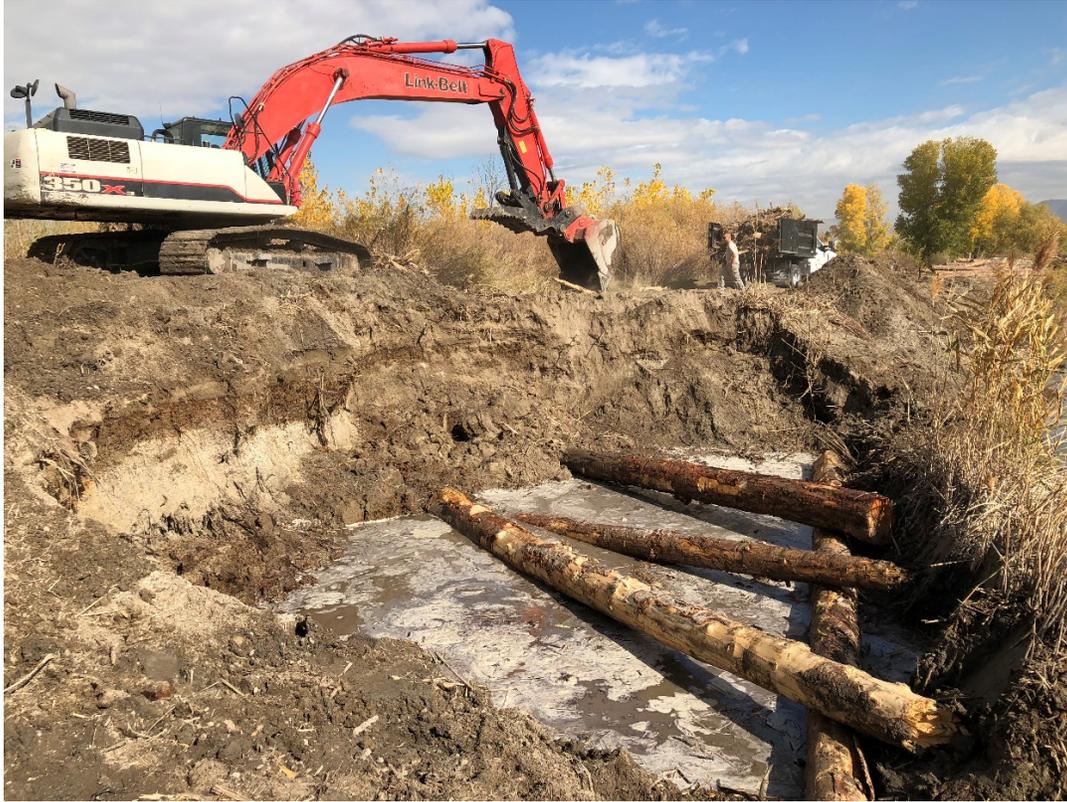
Figure 19: Phase 3 Toe Wood installation

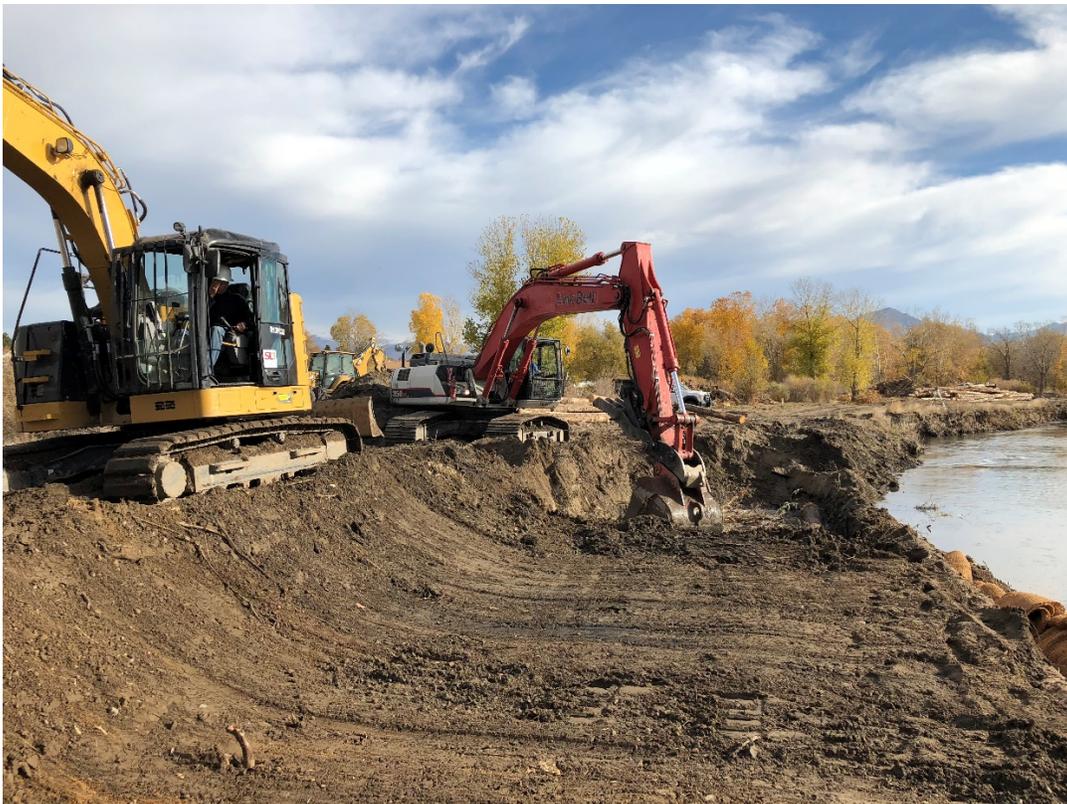
Figure 20: Phase 3 Toe Wood install and bank grading

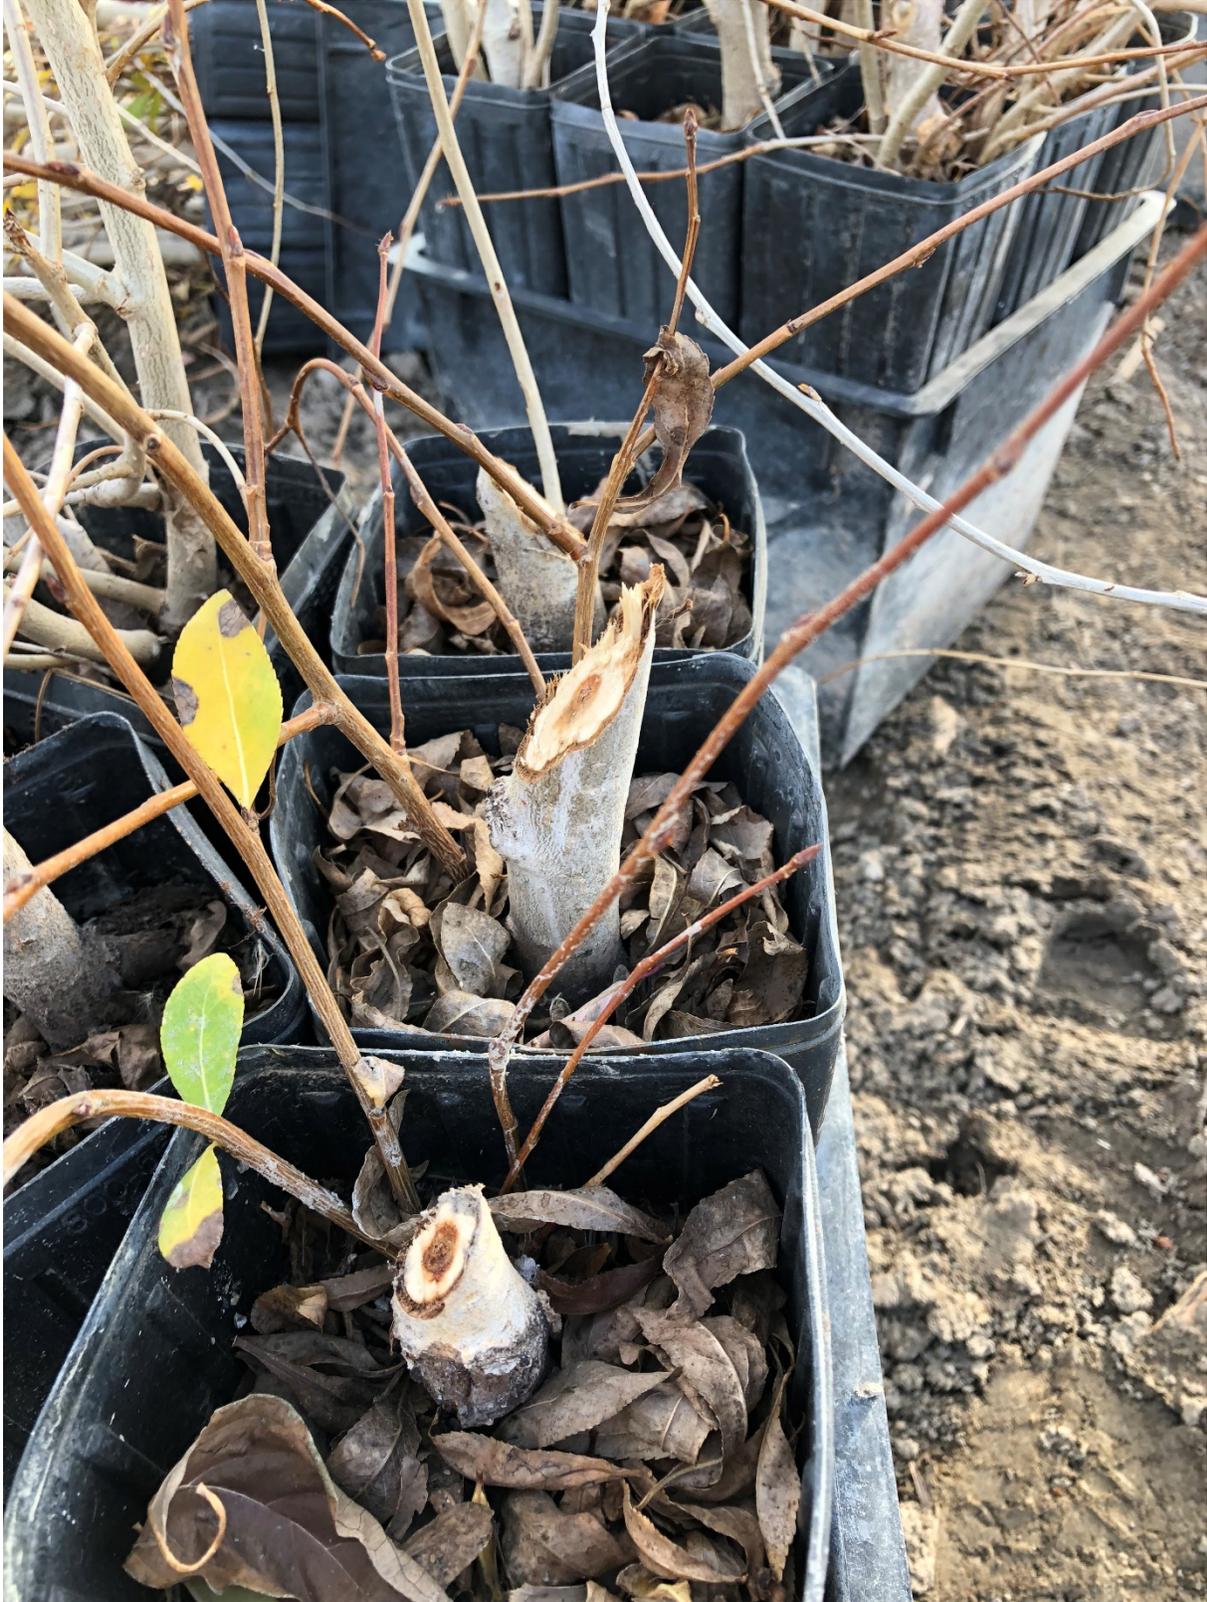
- During planting on phase 3 we lost multiple potted trees to beavers, they were still planted and are showing signs of new growth. (See figure 23 in Appendix A)

Figure 23: Beaver Damage to cottonwood trees before planting
