UTAH DEPARTMENT of
ENVIRONMENTAL QUALITY
**DRINKING
WATER**

Water System Facilities Sanitary Surveys-2018 Part 2

Storage Tanks

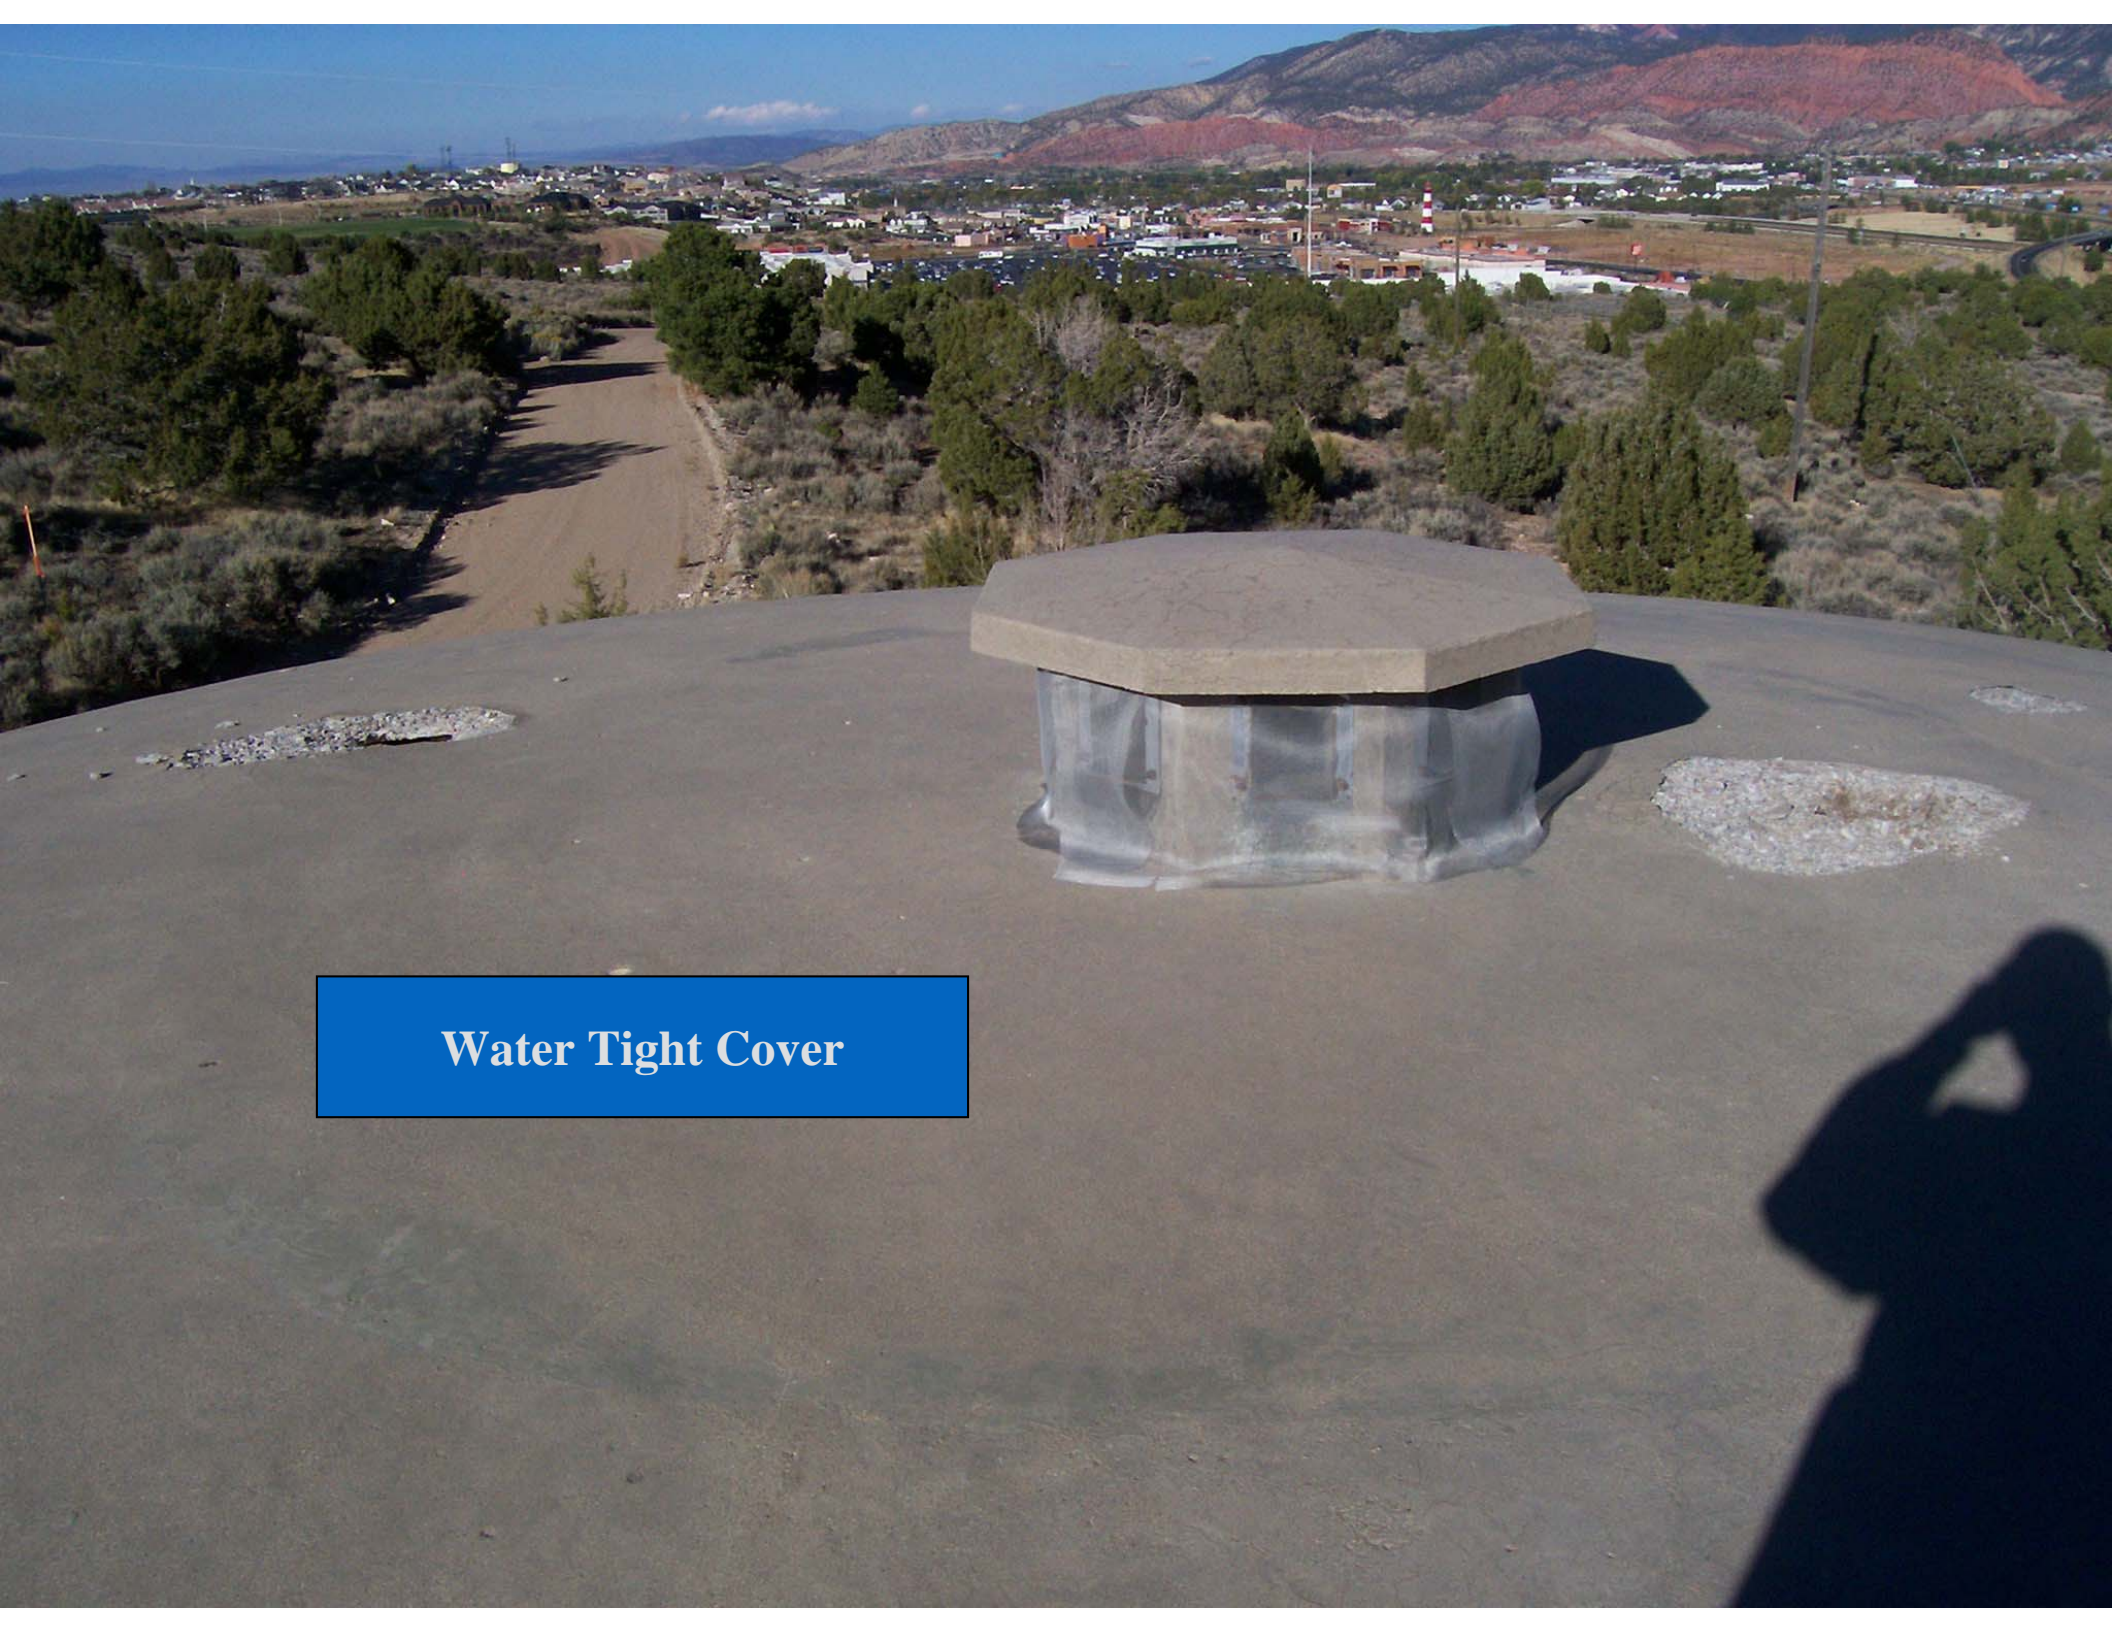
Cover Sloped to drain

Water Tight Roof & Cover

Area Sloped so Water Will Drain Away

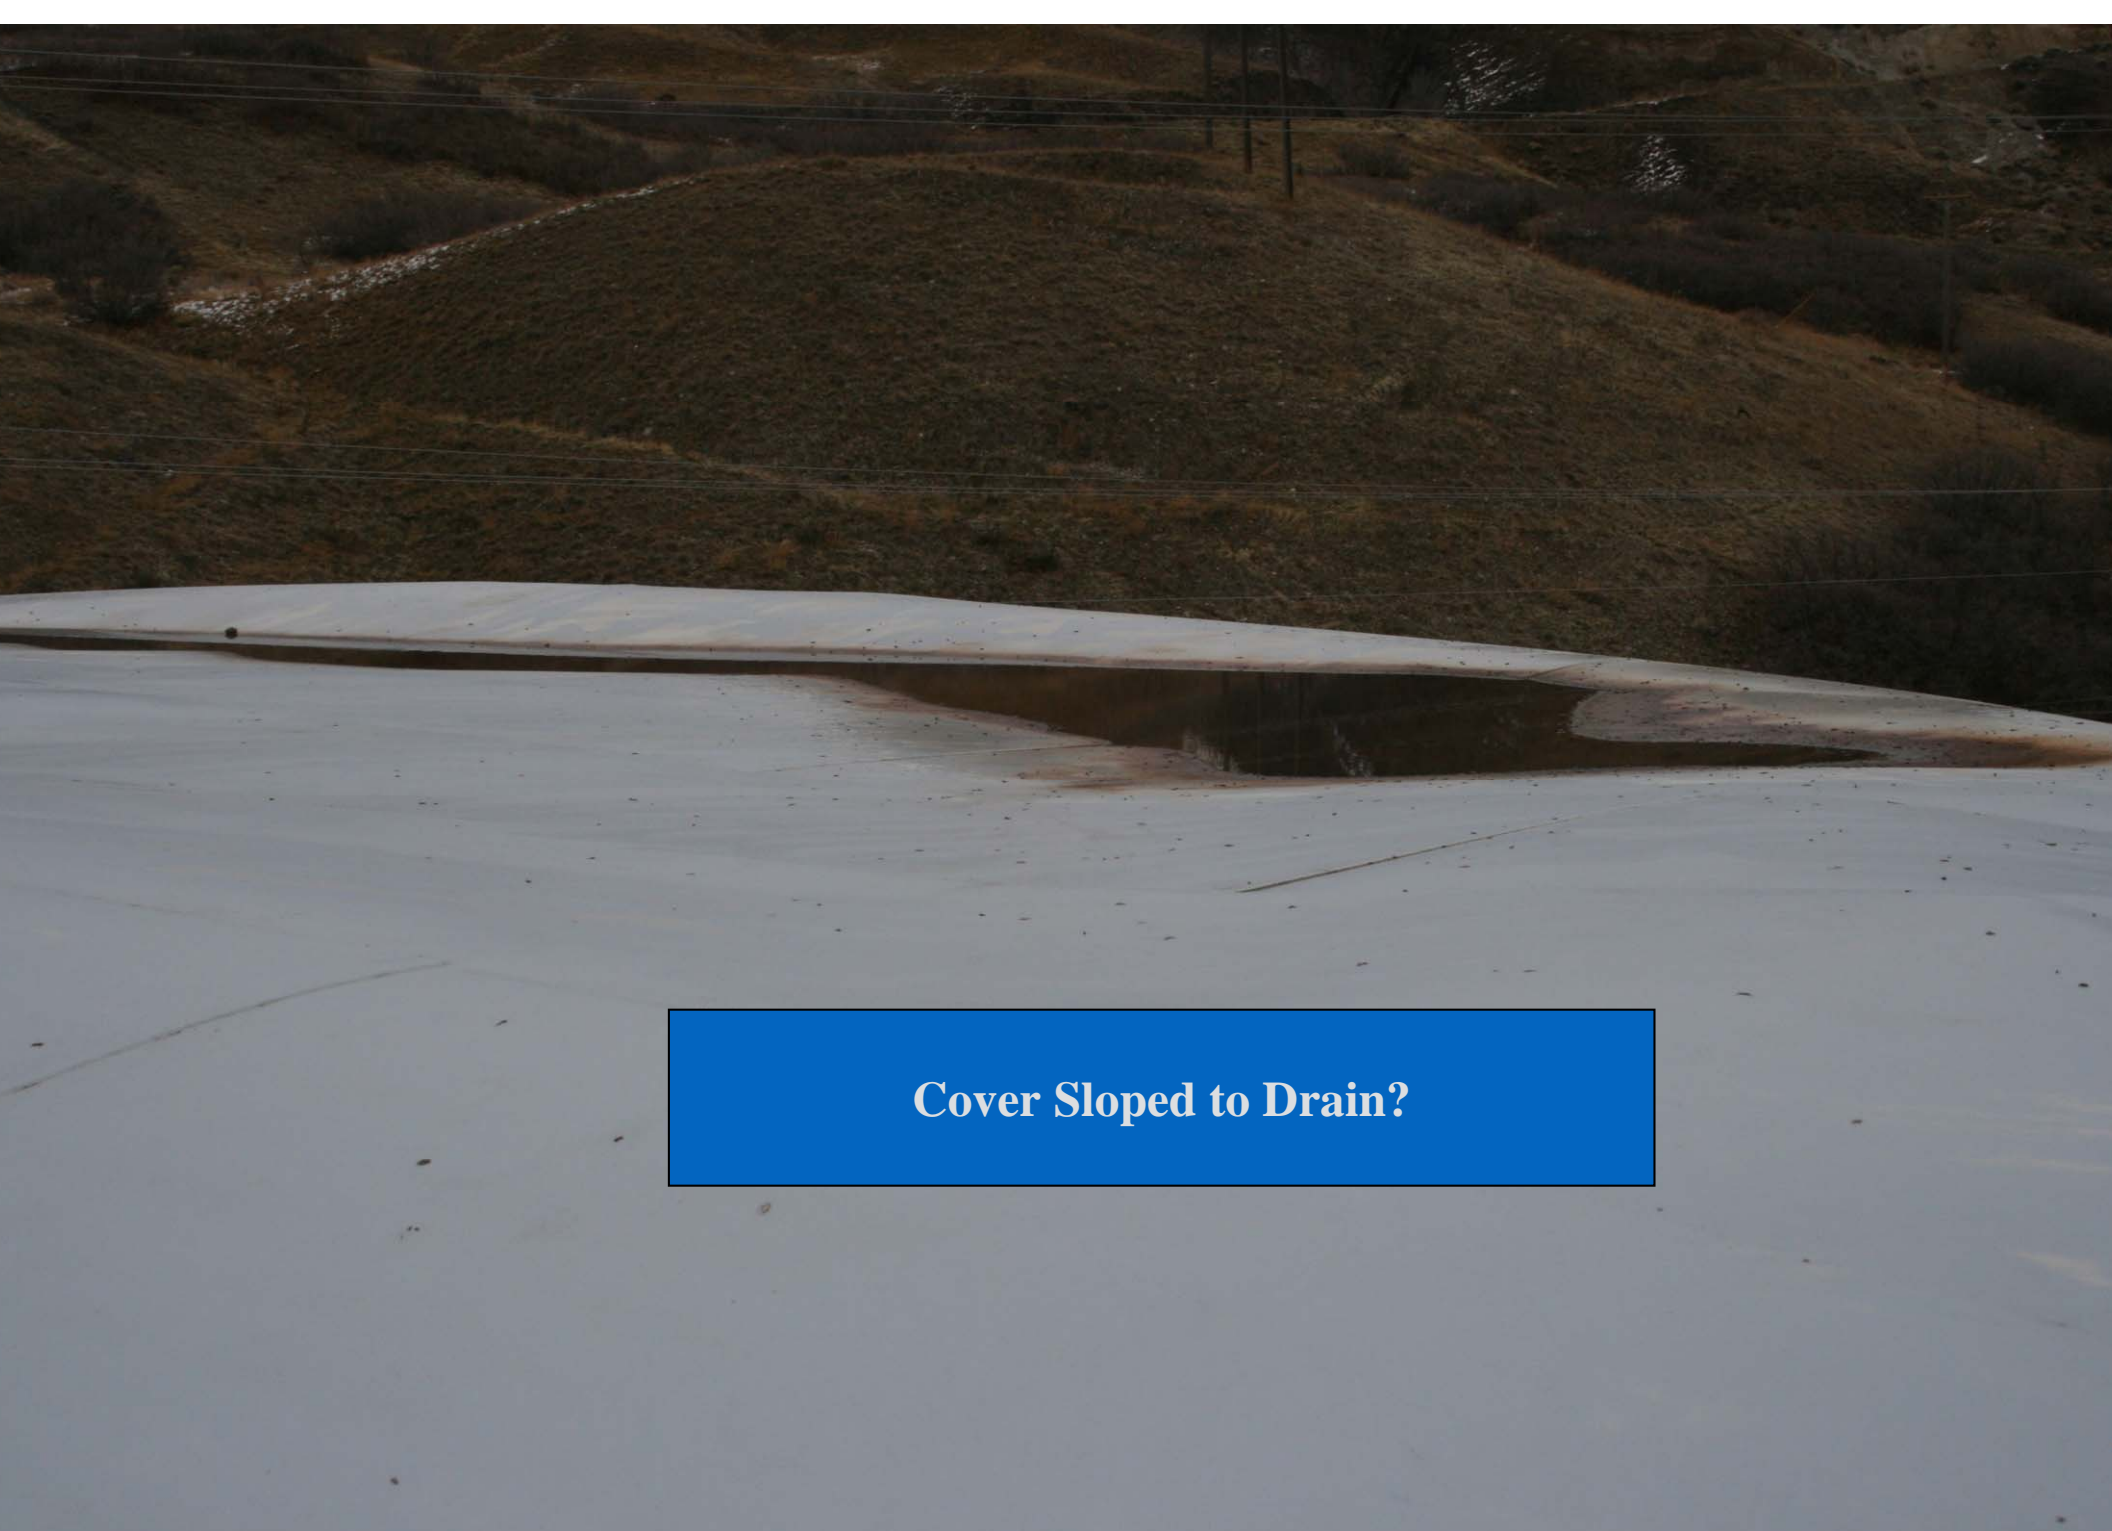
Water Tight Cover

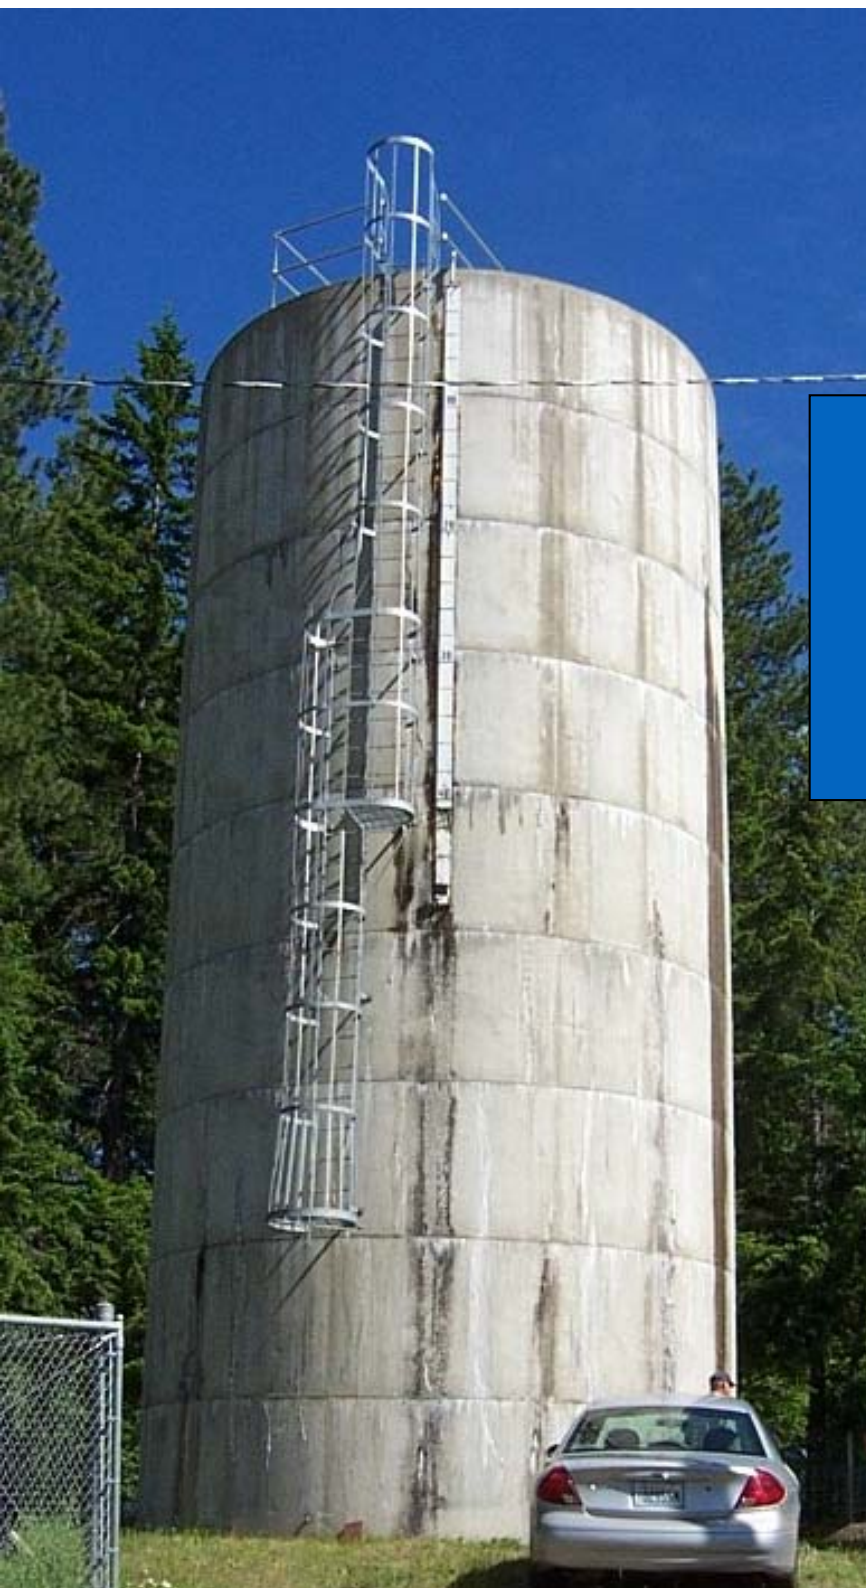
Access Ladders

**Which one is
Safe to climb?**

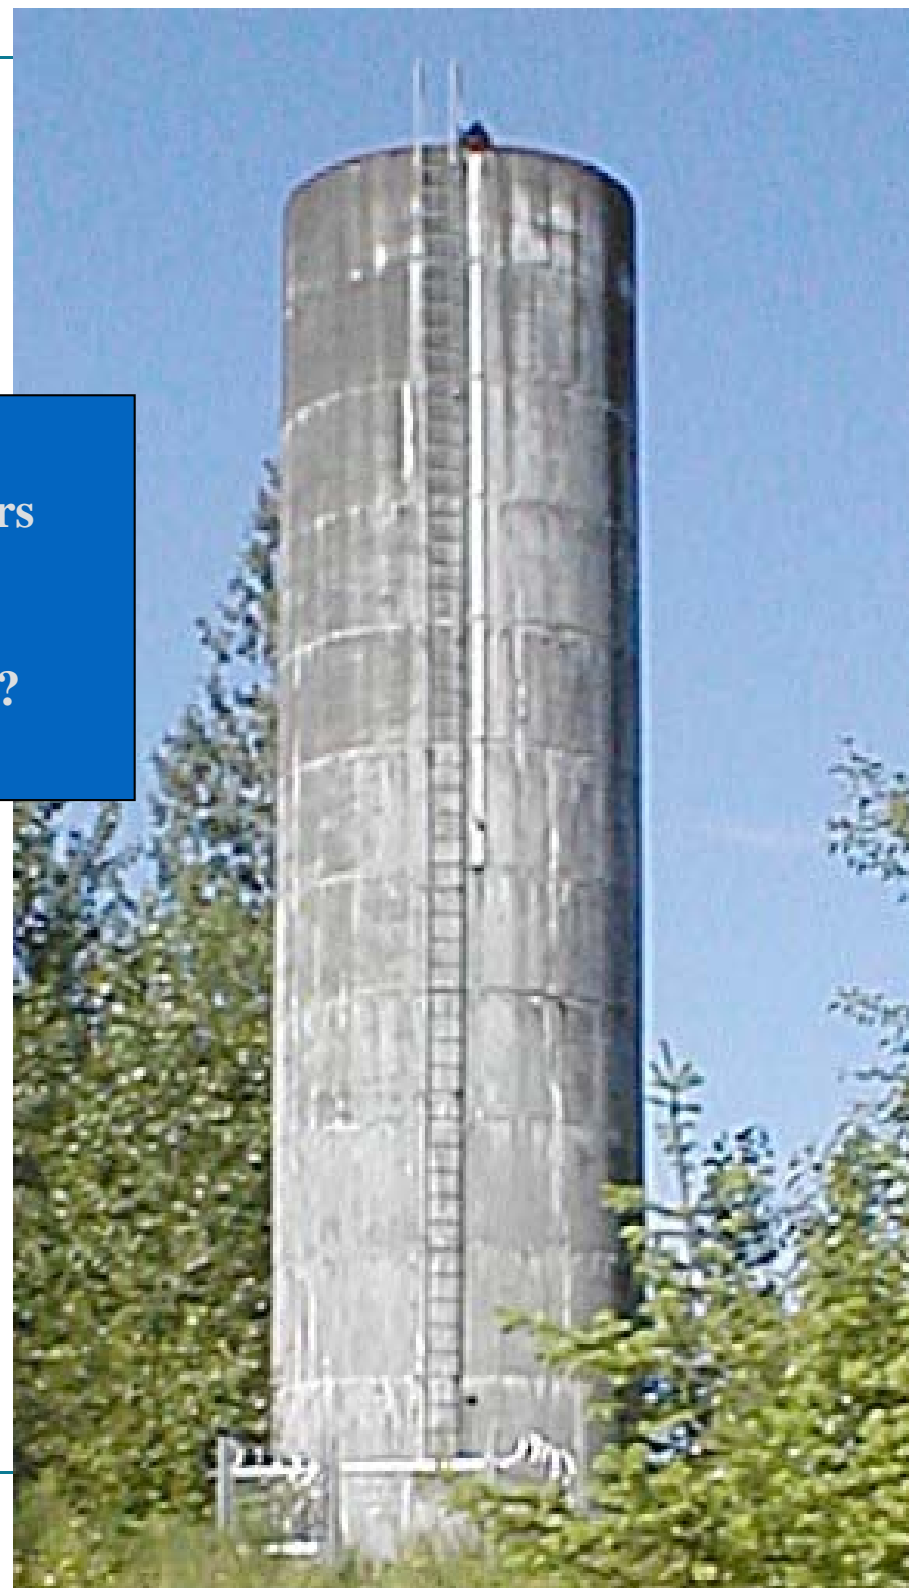
**At Least 3' extension
Above cap**

Distance away from bottom of tank

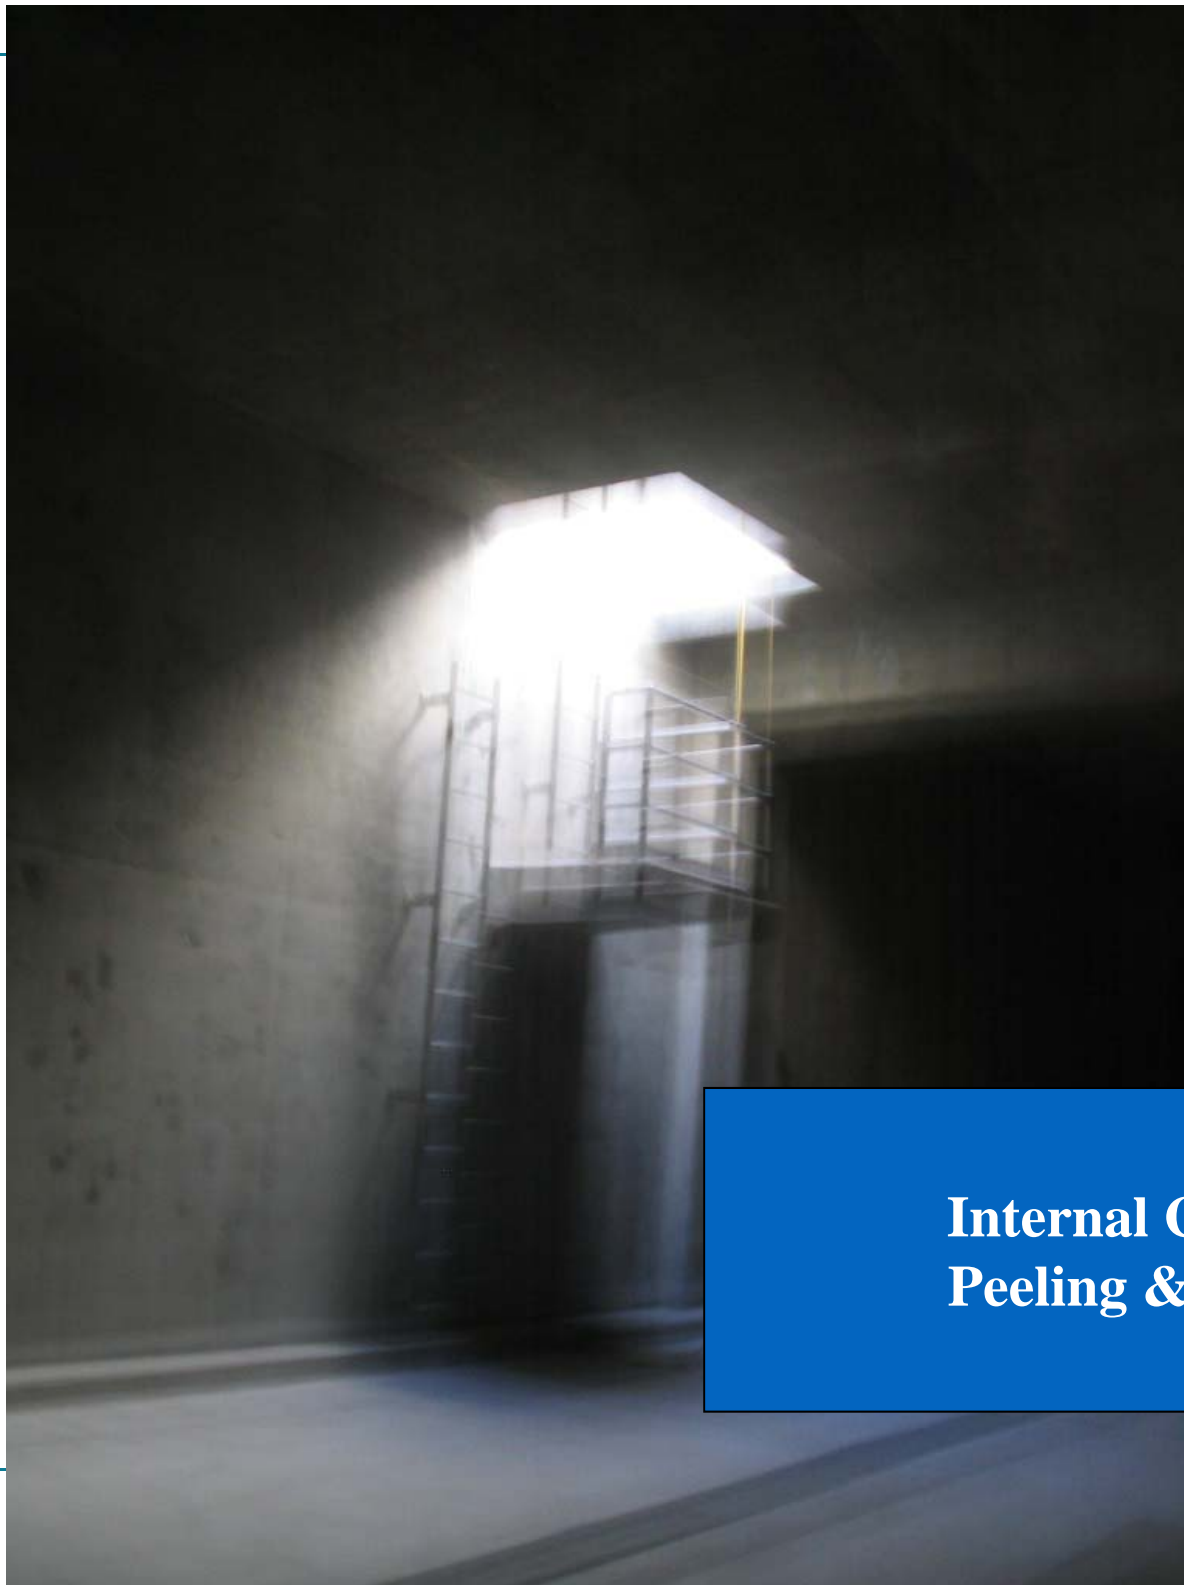
Internal Coatings Peeling & Cracks

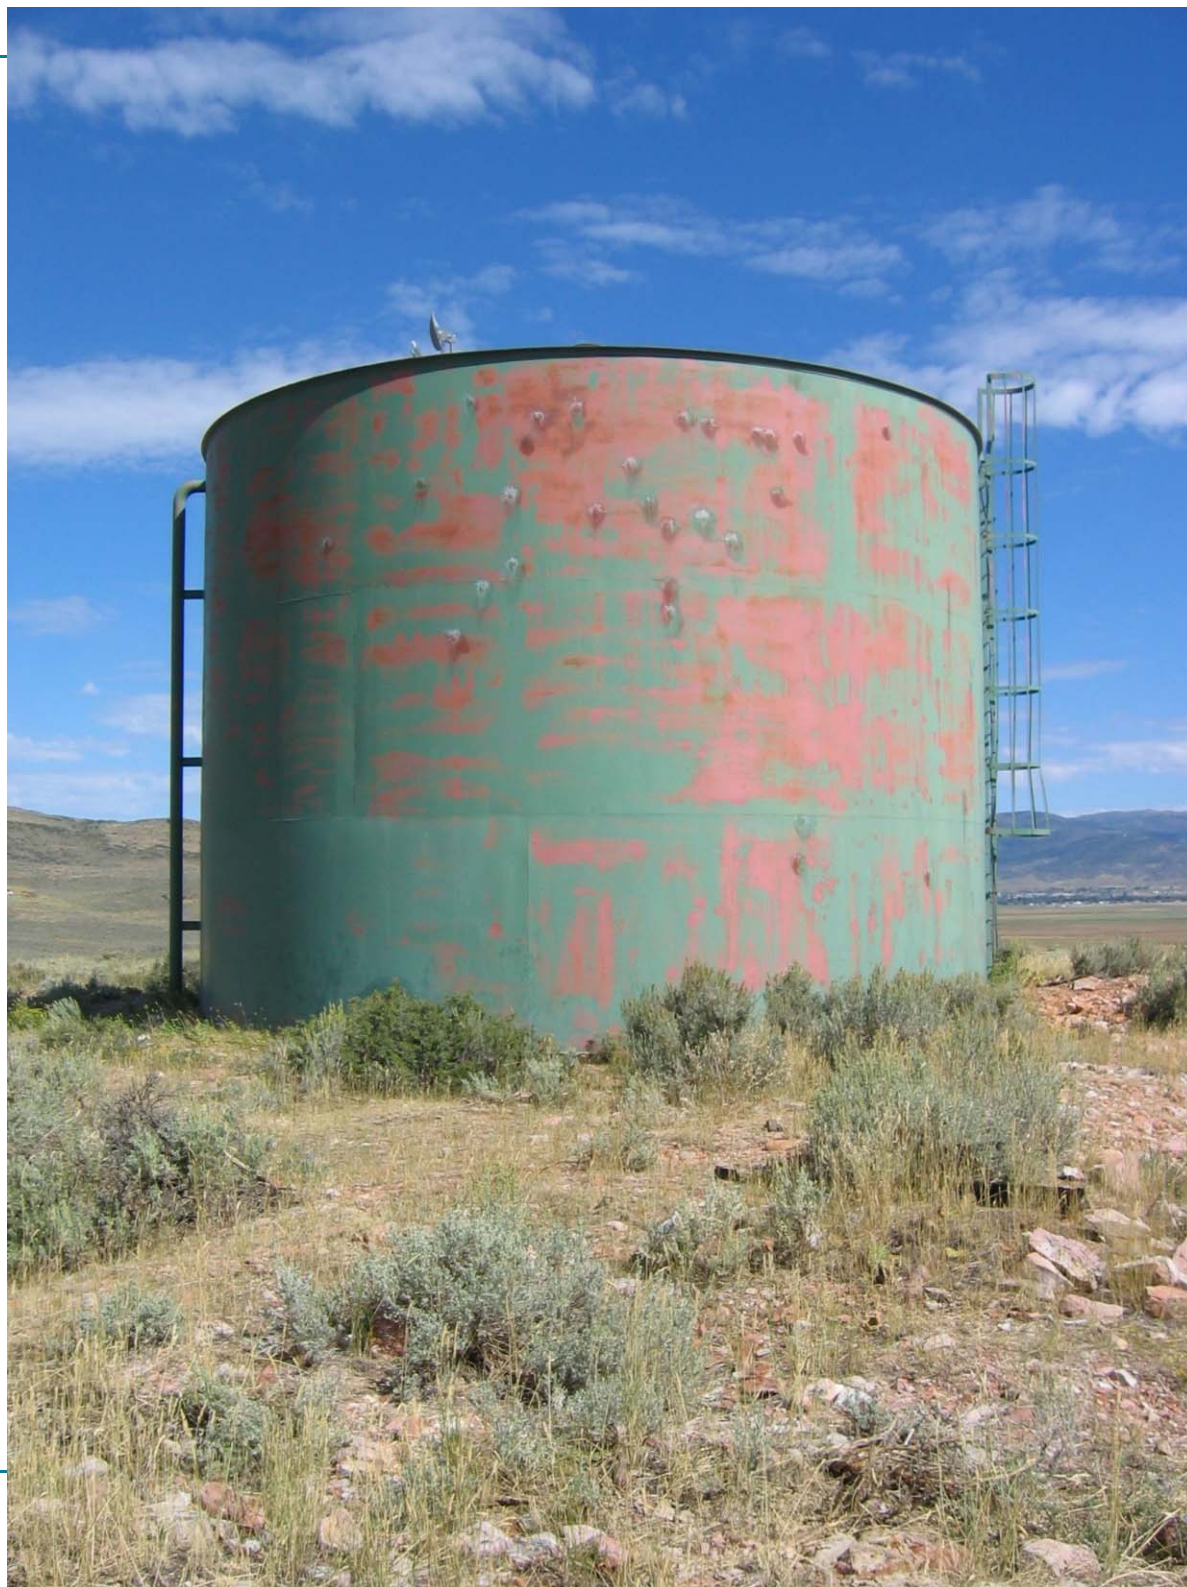
**Electrolysis
Bottom of Tank**

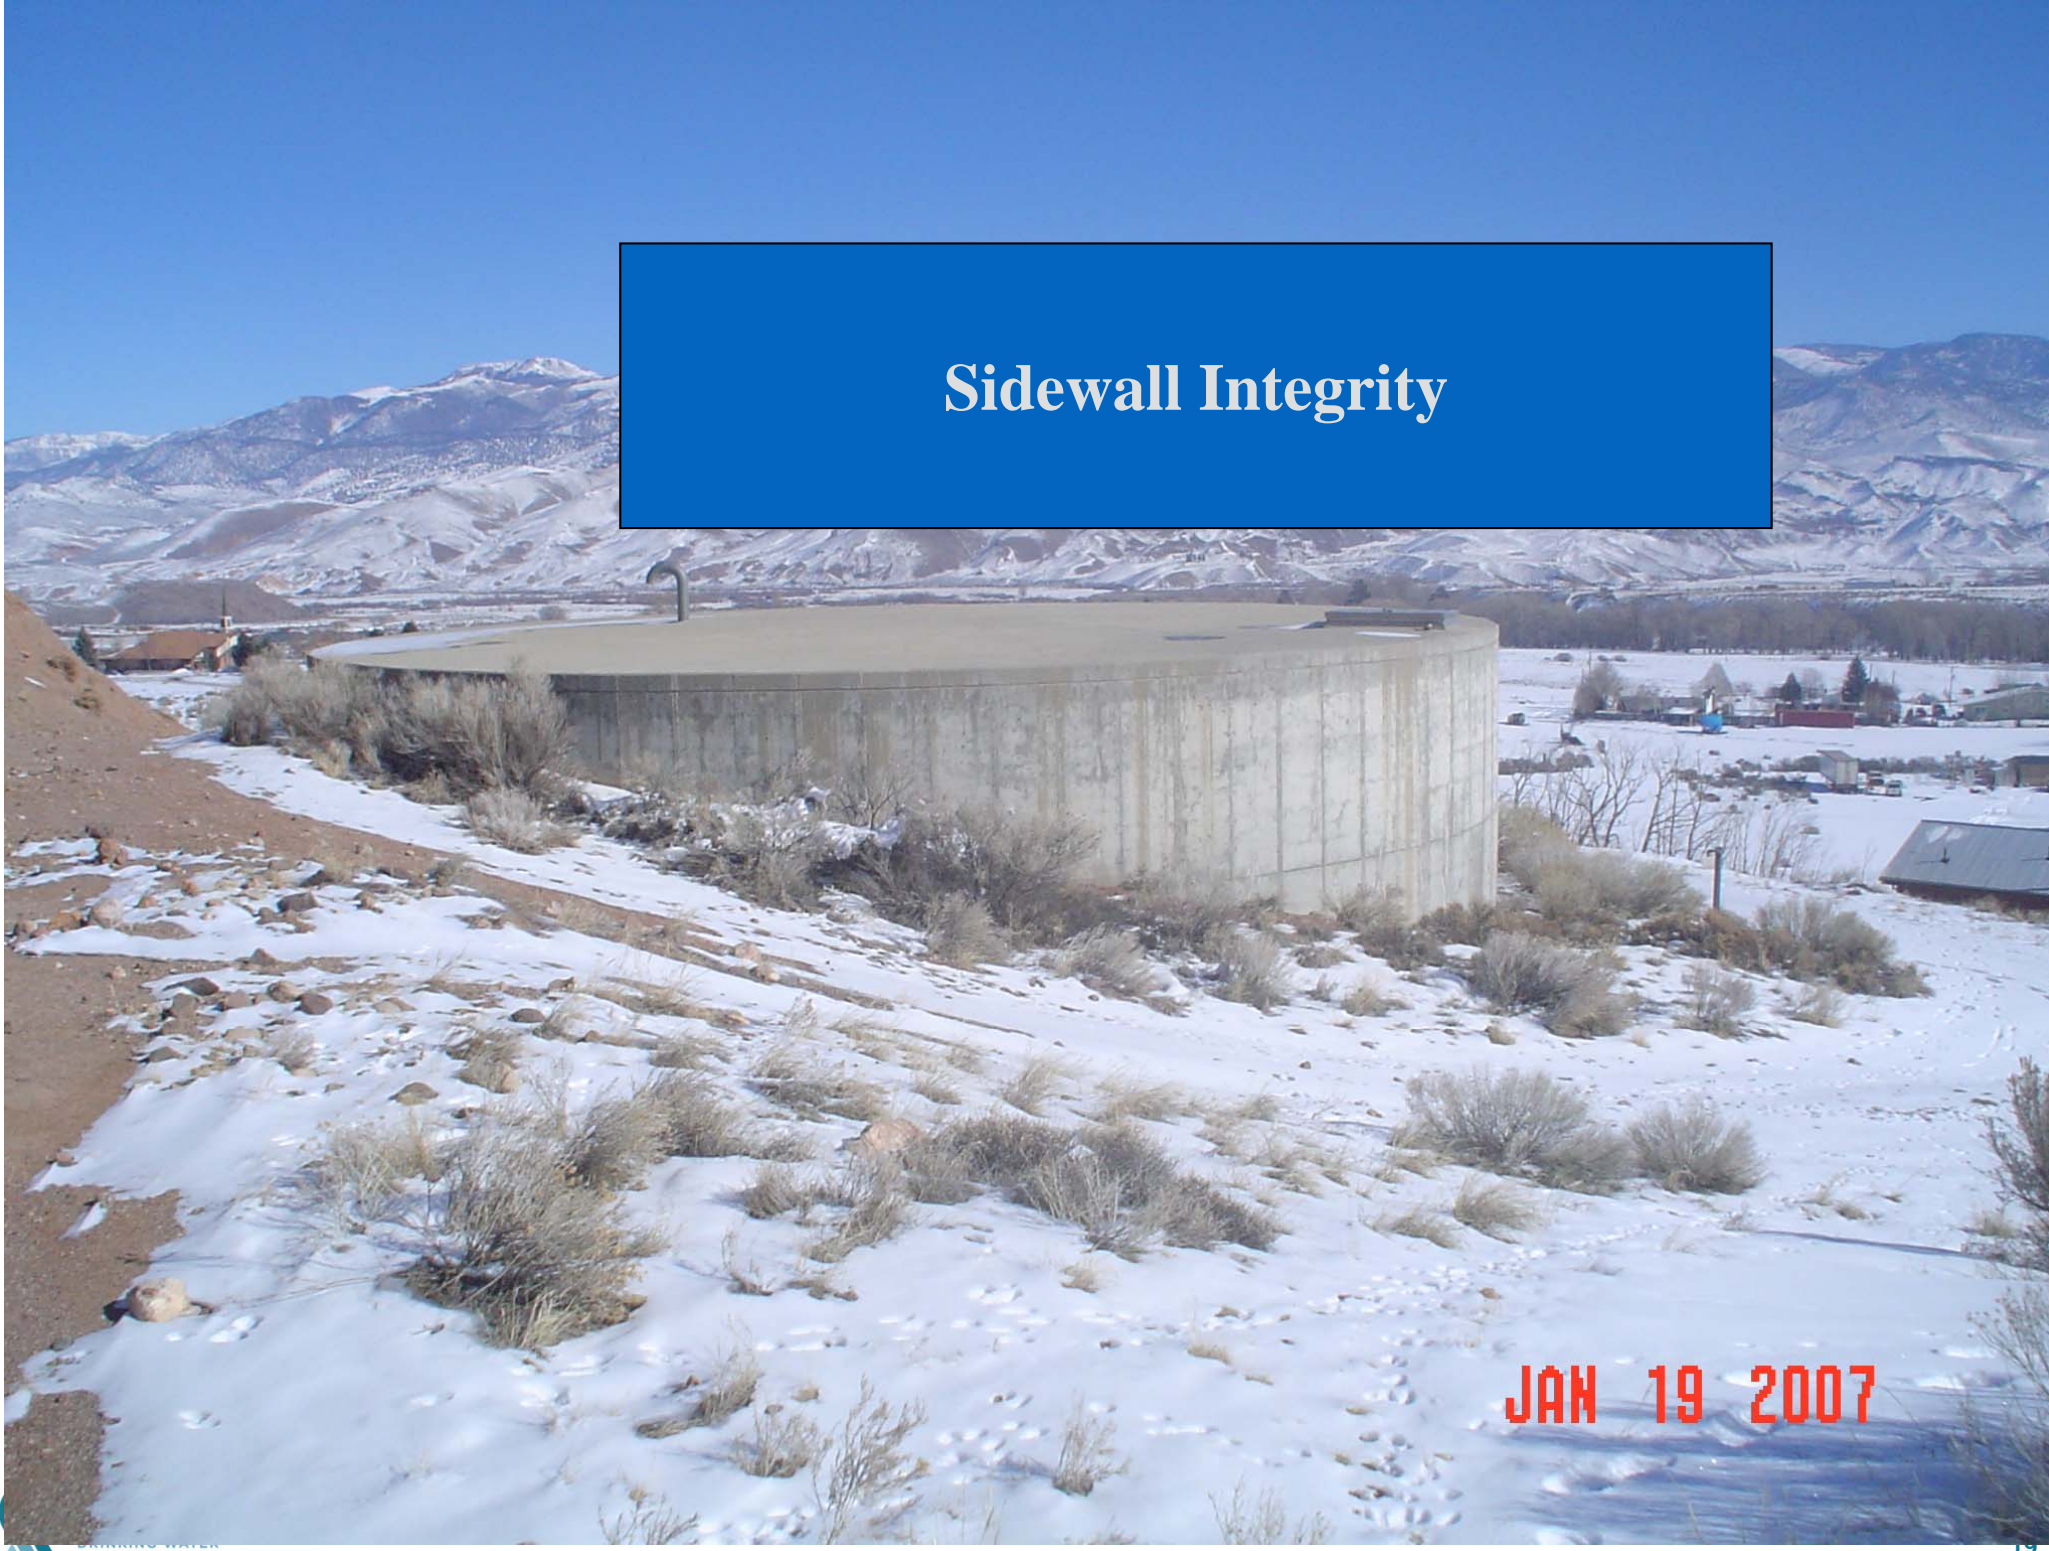
A photograph of a concrete wall, likely a dam or retaining wall, showing signs of weathering and water damage. The wall is made of large concrete blocks with visible horizontal joints. There are several vertical and diagonal cracks, some of which appear to be filled with a lighter material. The surface is discolored with various shades of gray, brown, and white, suggesting moisture and possibly mold or mineral deposits. At the top of the wall, there is a circular structure, possibly a vent or a small tunnel entrance, which is partially covered by a dark, curved object. The background is a clear blue sky.

Sidewall Integrity

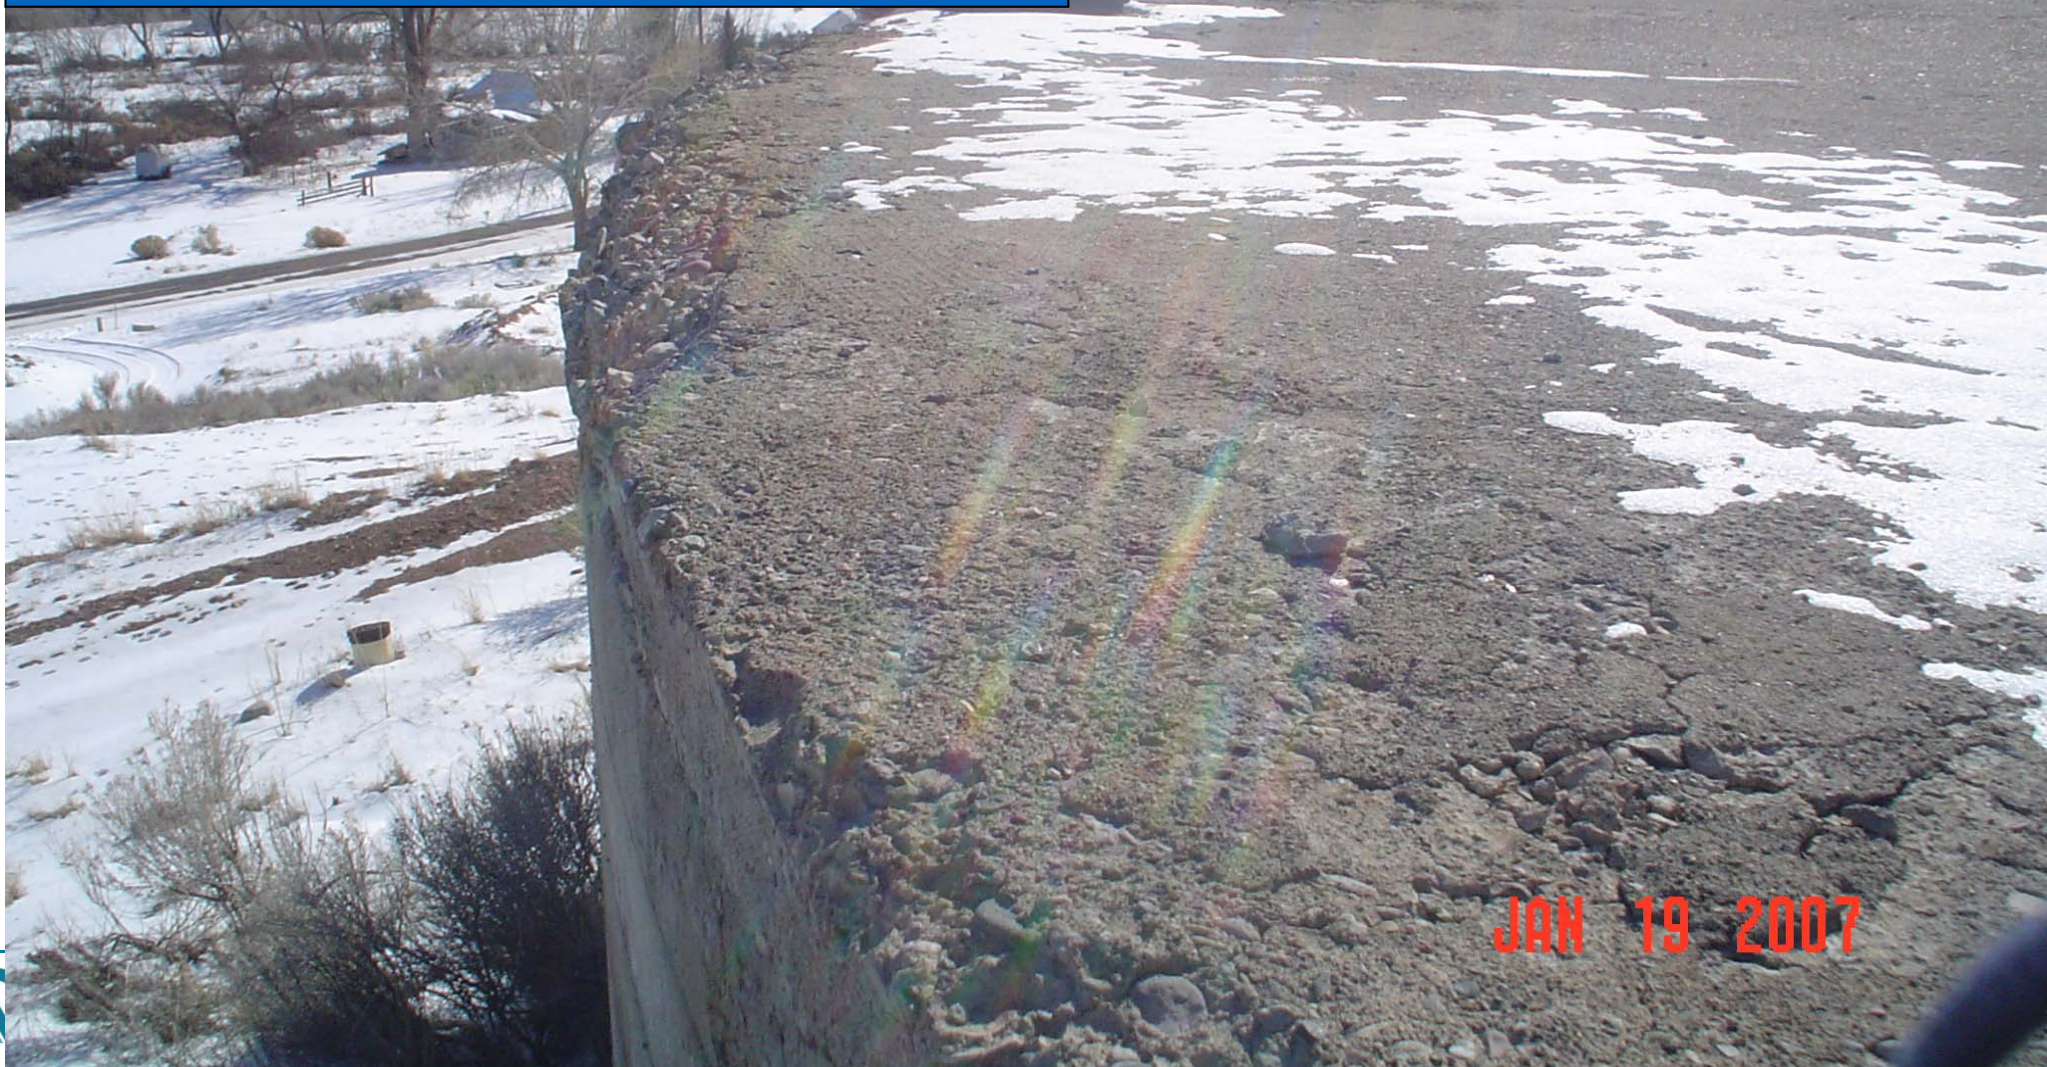
Deterioration/Spaulding

Evidence /Actual Leakage

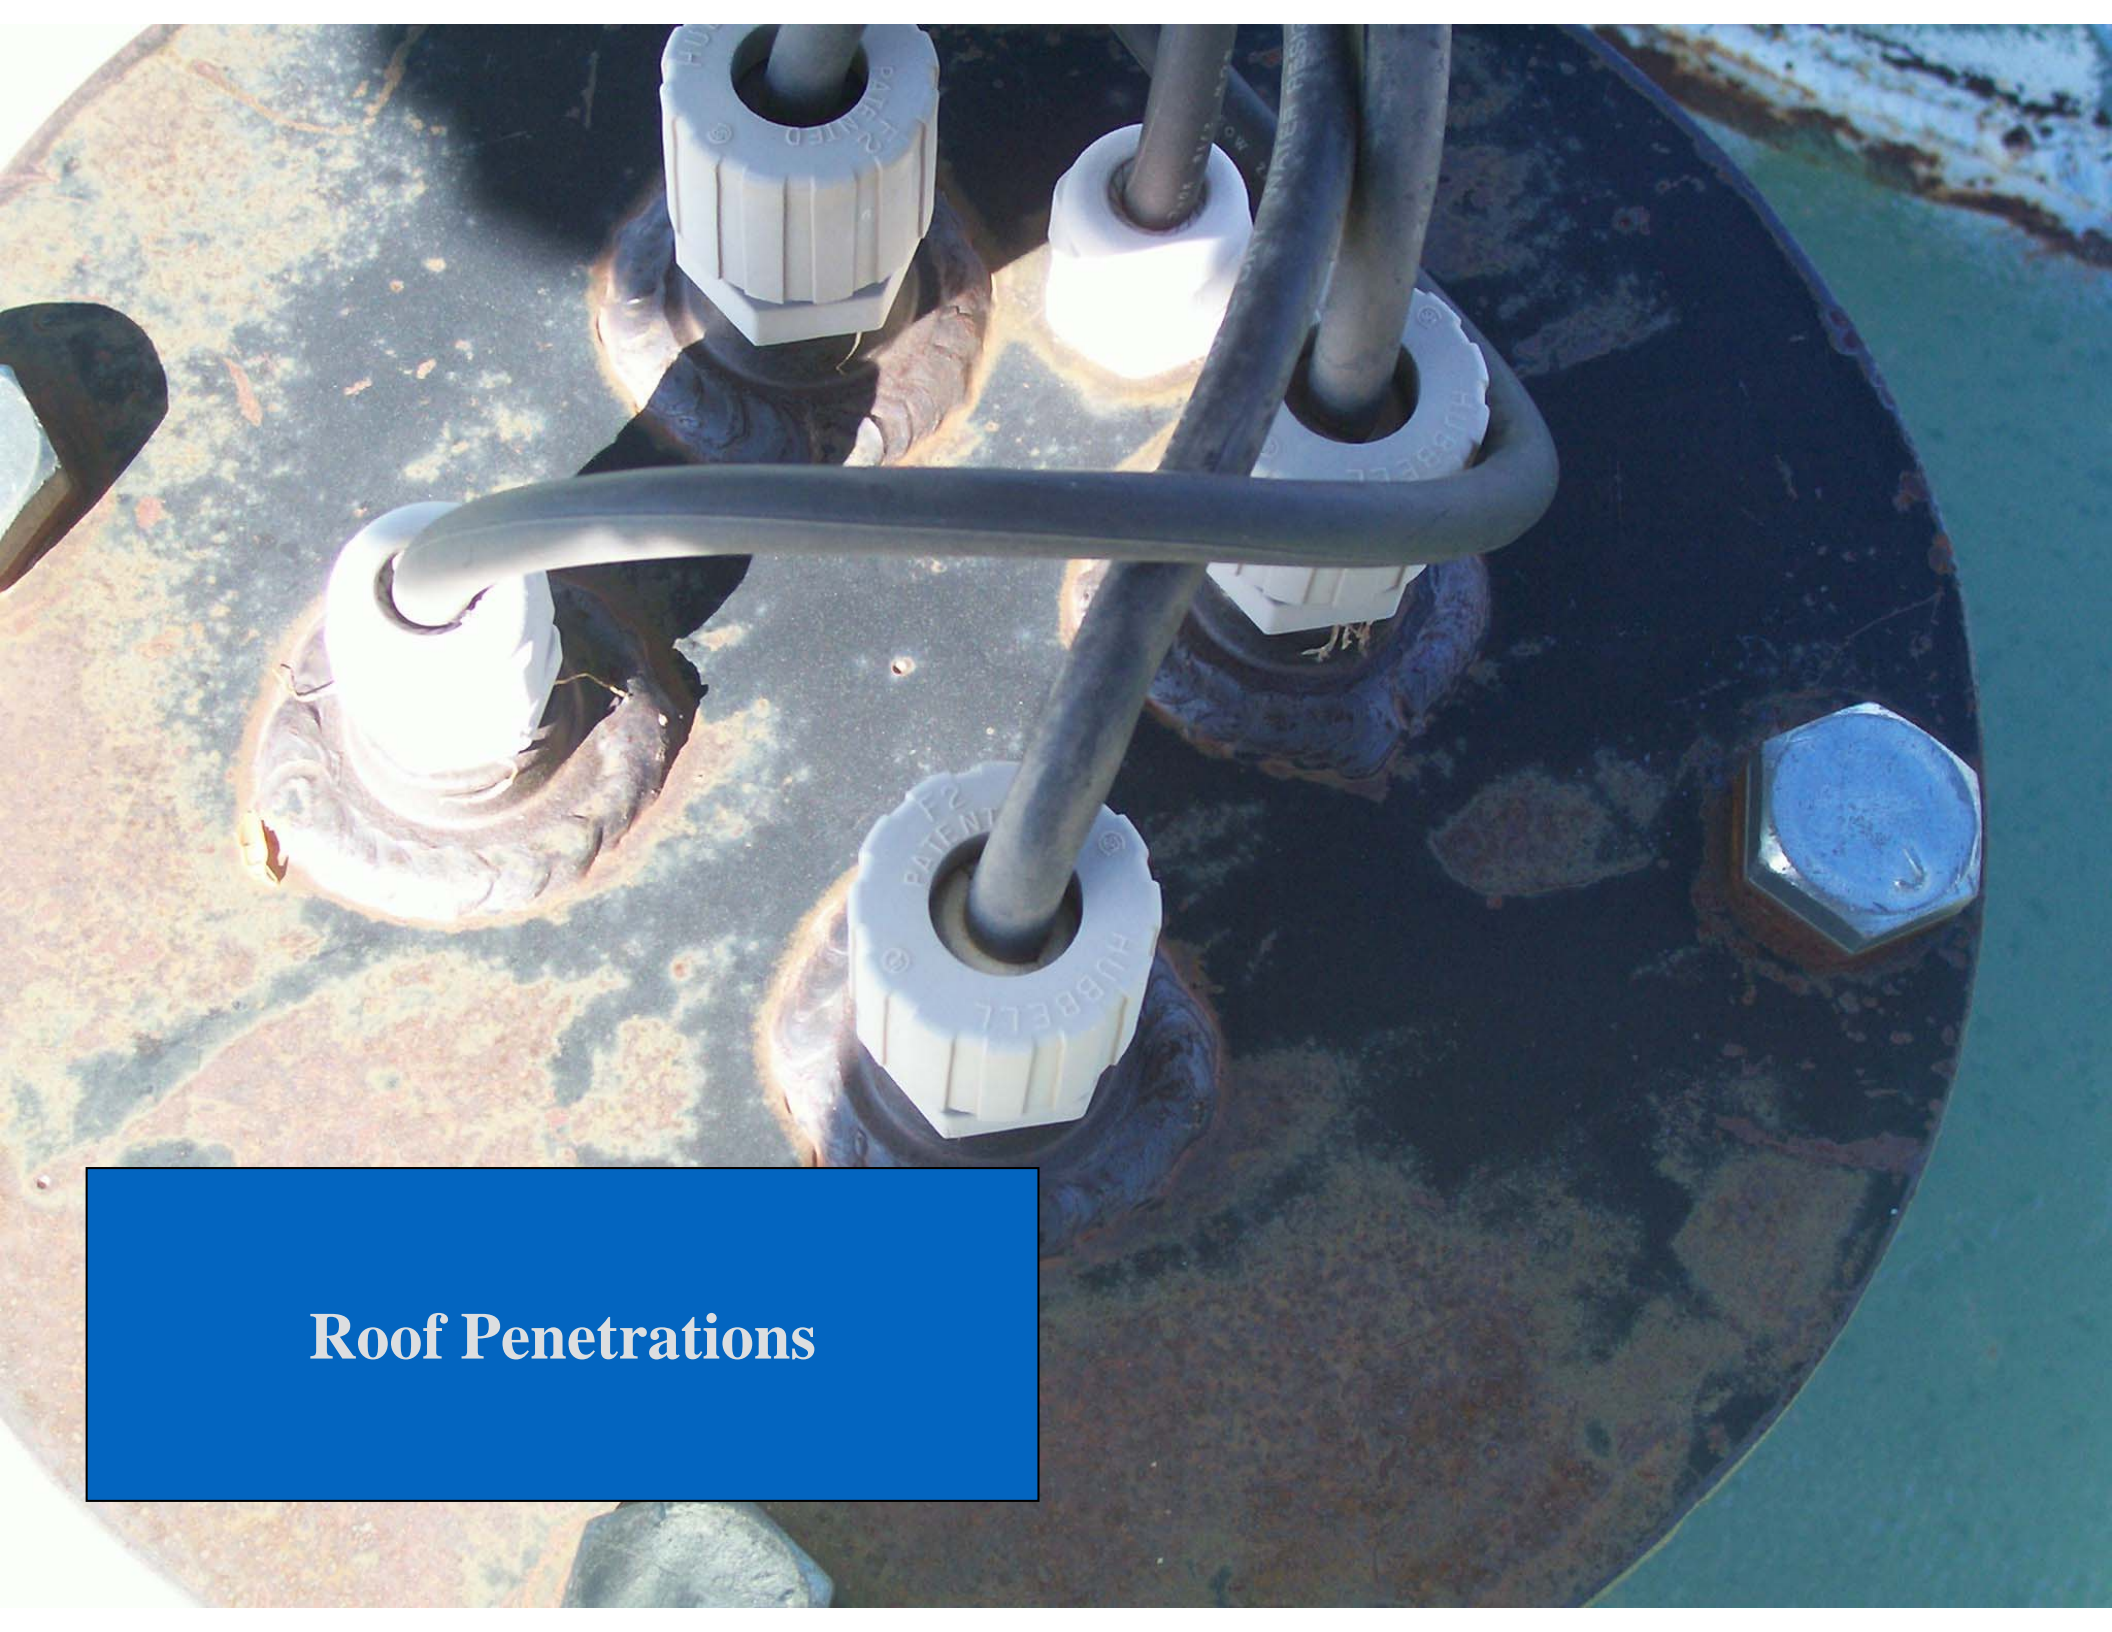
Roof Penetrations

A photograph showing a close-up of a rusty, brown metal roof penetration. A red pen is placed horizontally next to a small hole in the metal to provide a sense of scale. The metal surface is heavily corroded and shows signs of wear. In the background, a concrete surface and some rebar are visible.

Unsealed Roof Penetrations
