UTAH DEPARTMENT of
ENVIRONMENTAL QUALITY
**DRINKING
WATER**

Water System Facilities Sanitary Surveys-2018 Part 2

Storage Tanks

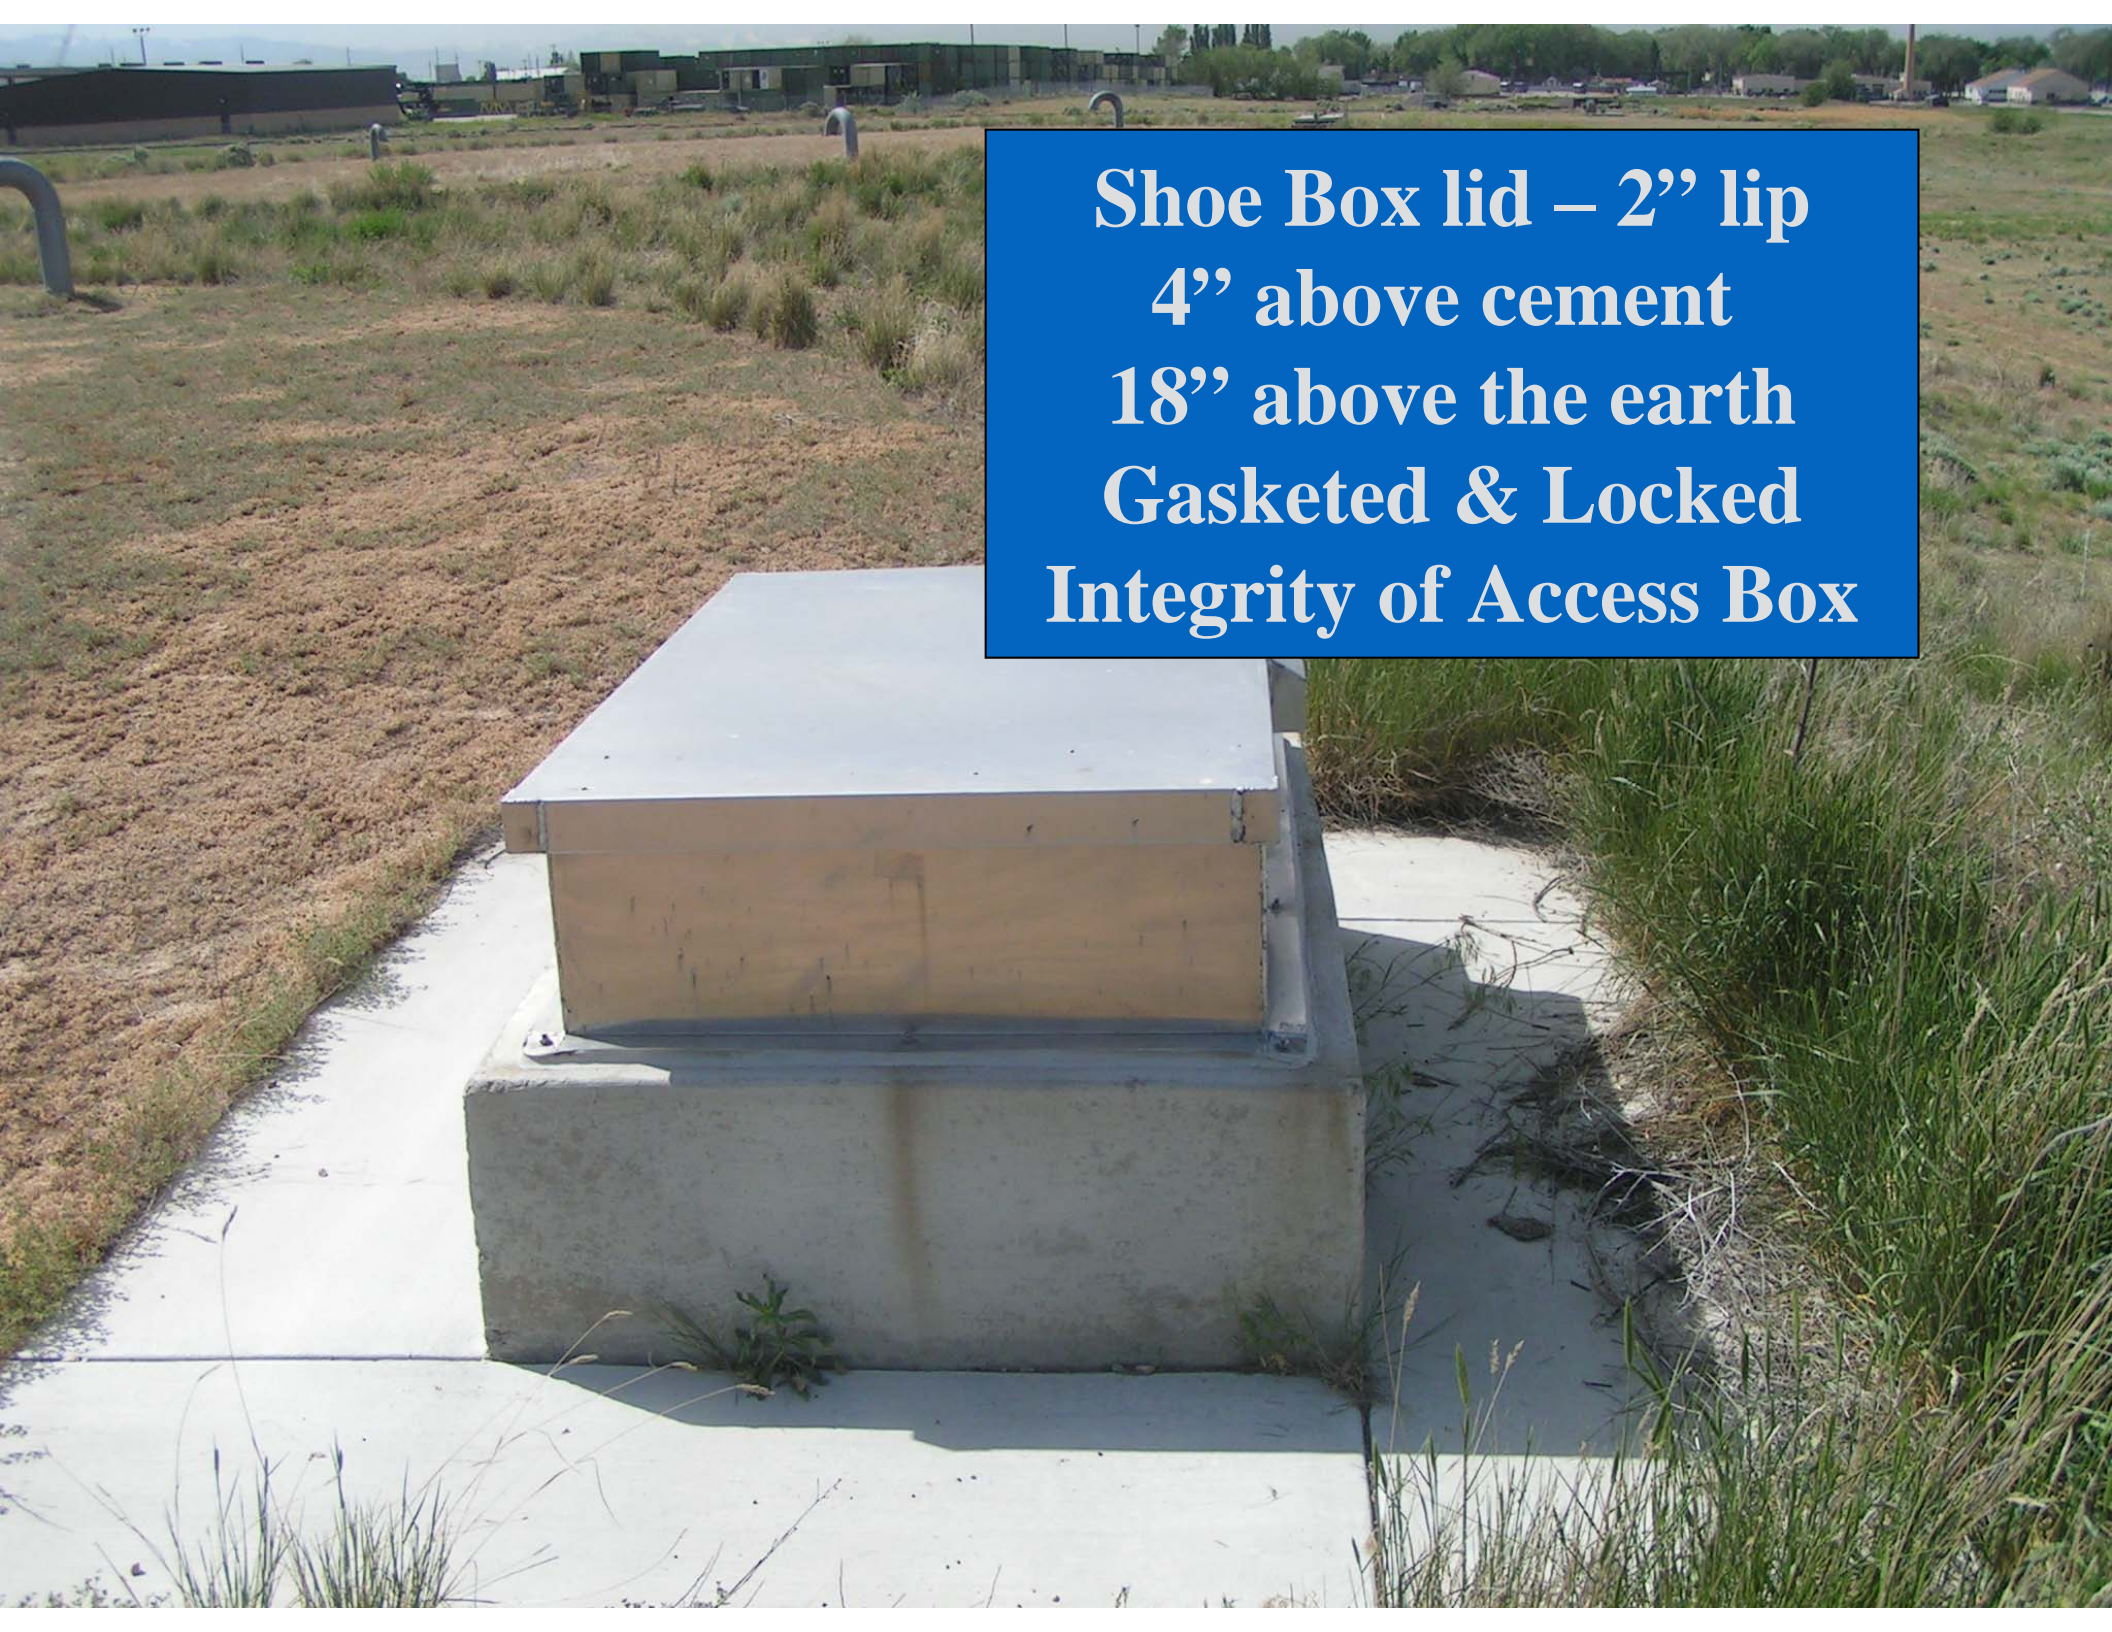
A photograph of a metal shoe box lid mounted on a concrete base in a field. The lid is a rectangular metal box with a flat top and a visible lip. It is mounted on a concrete base that is partially embedded in the ground. The surrounding area is a dry, grassy field with some taller grasses on the right. In the background, there are some industrial buildings and a fence line.

**Shoe Box lid – 2” lip
4” above cement
18” above the earth
Gasketed & Locked
Integrity of Access Box**

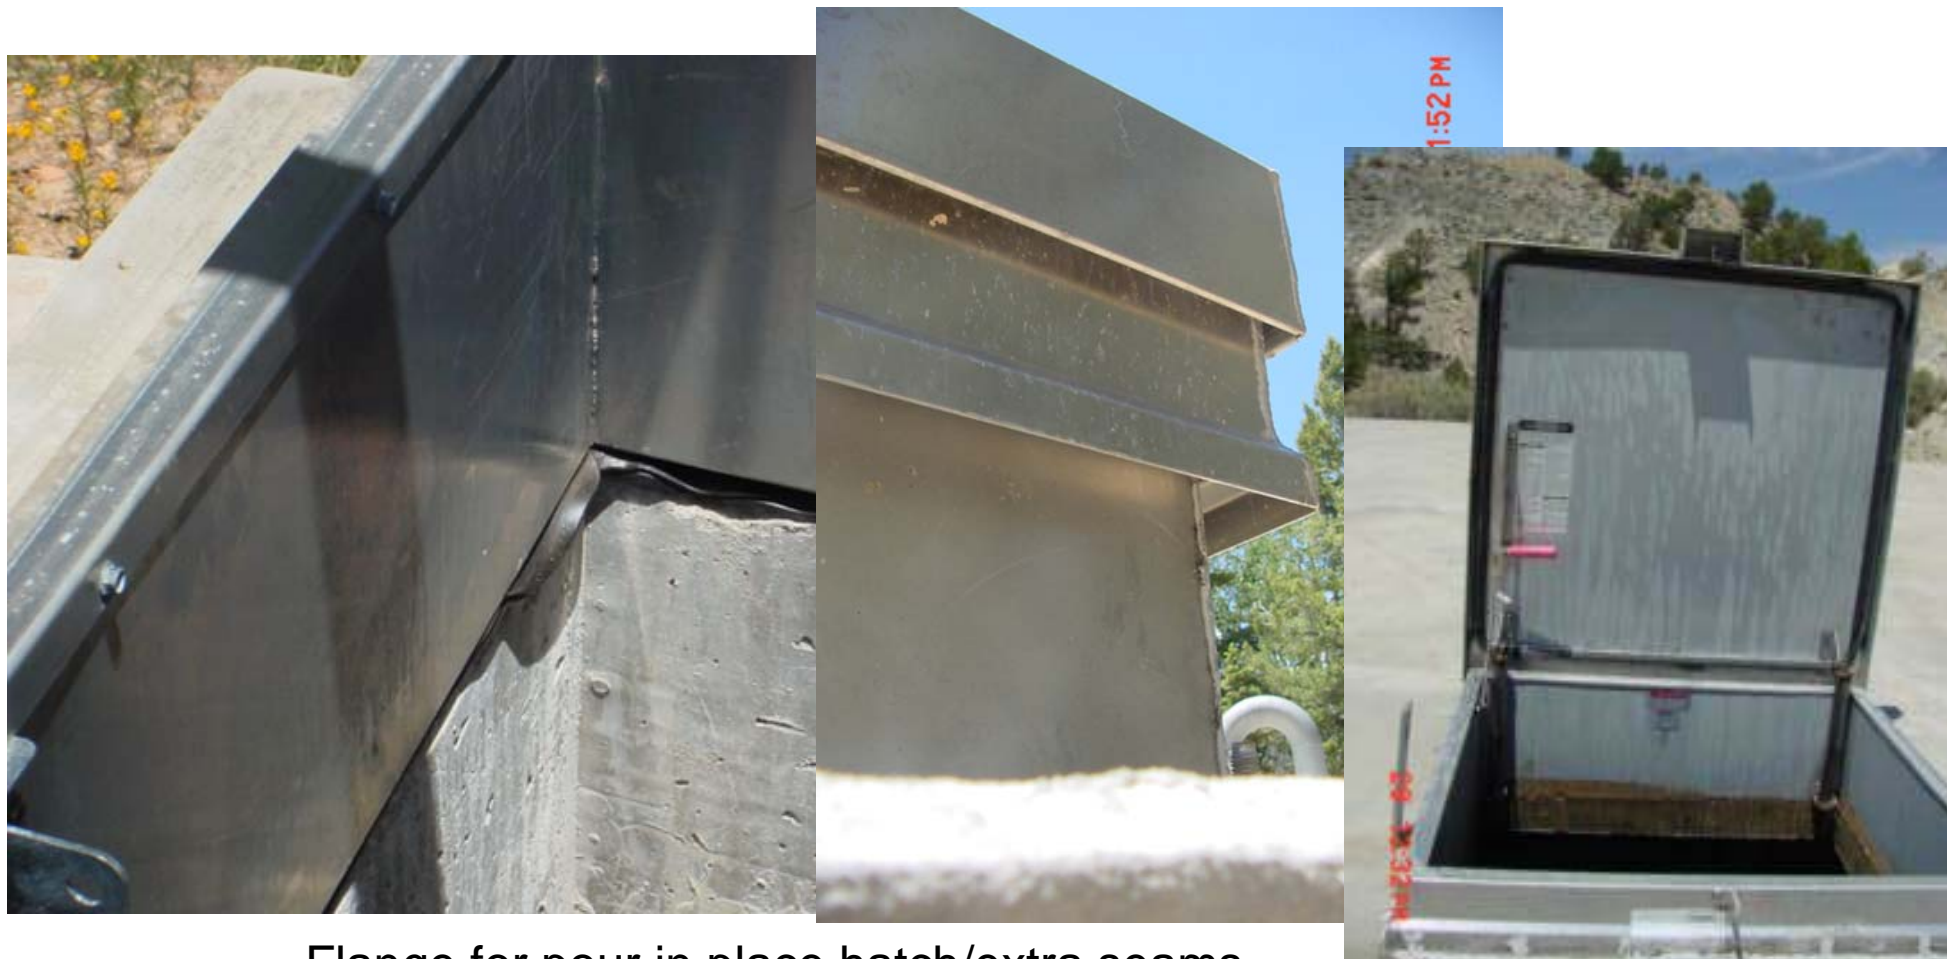
Flange for pour in place hatch/extra seams

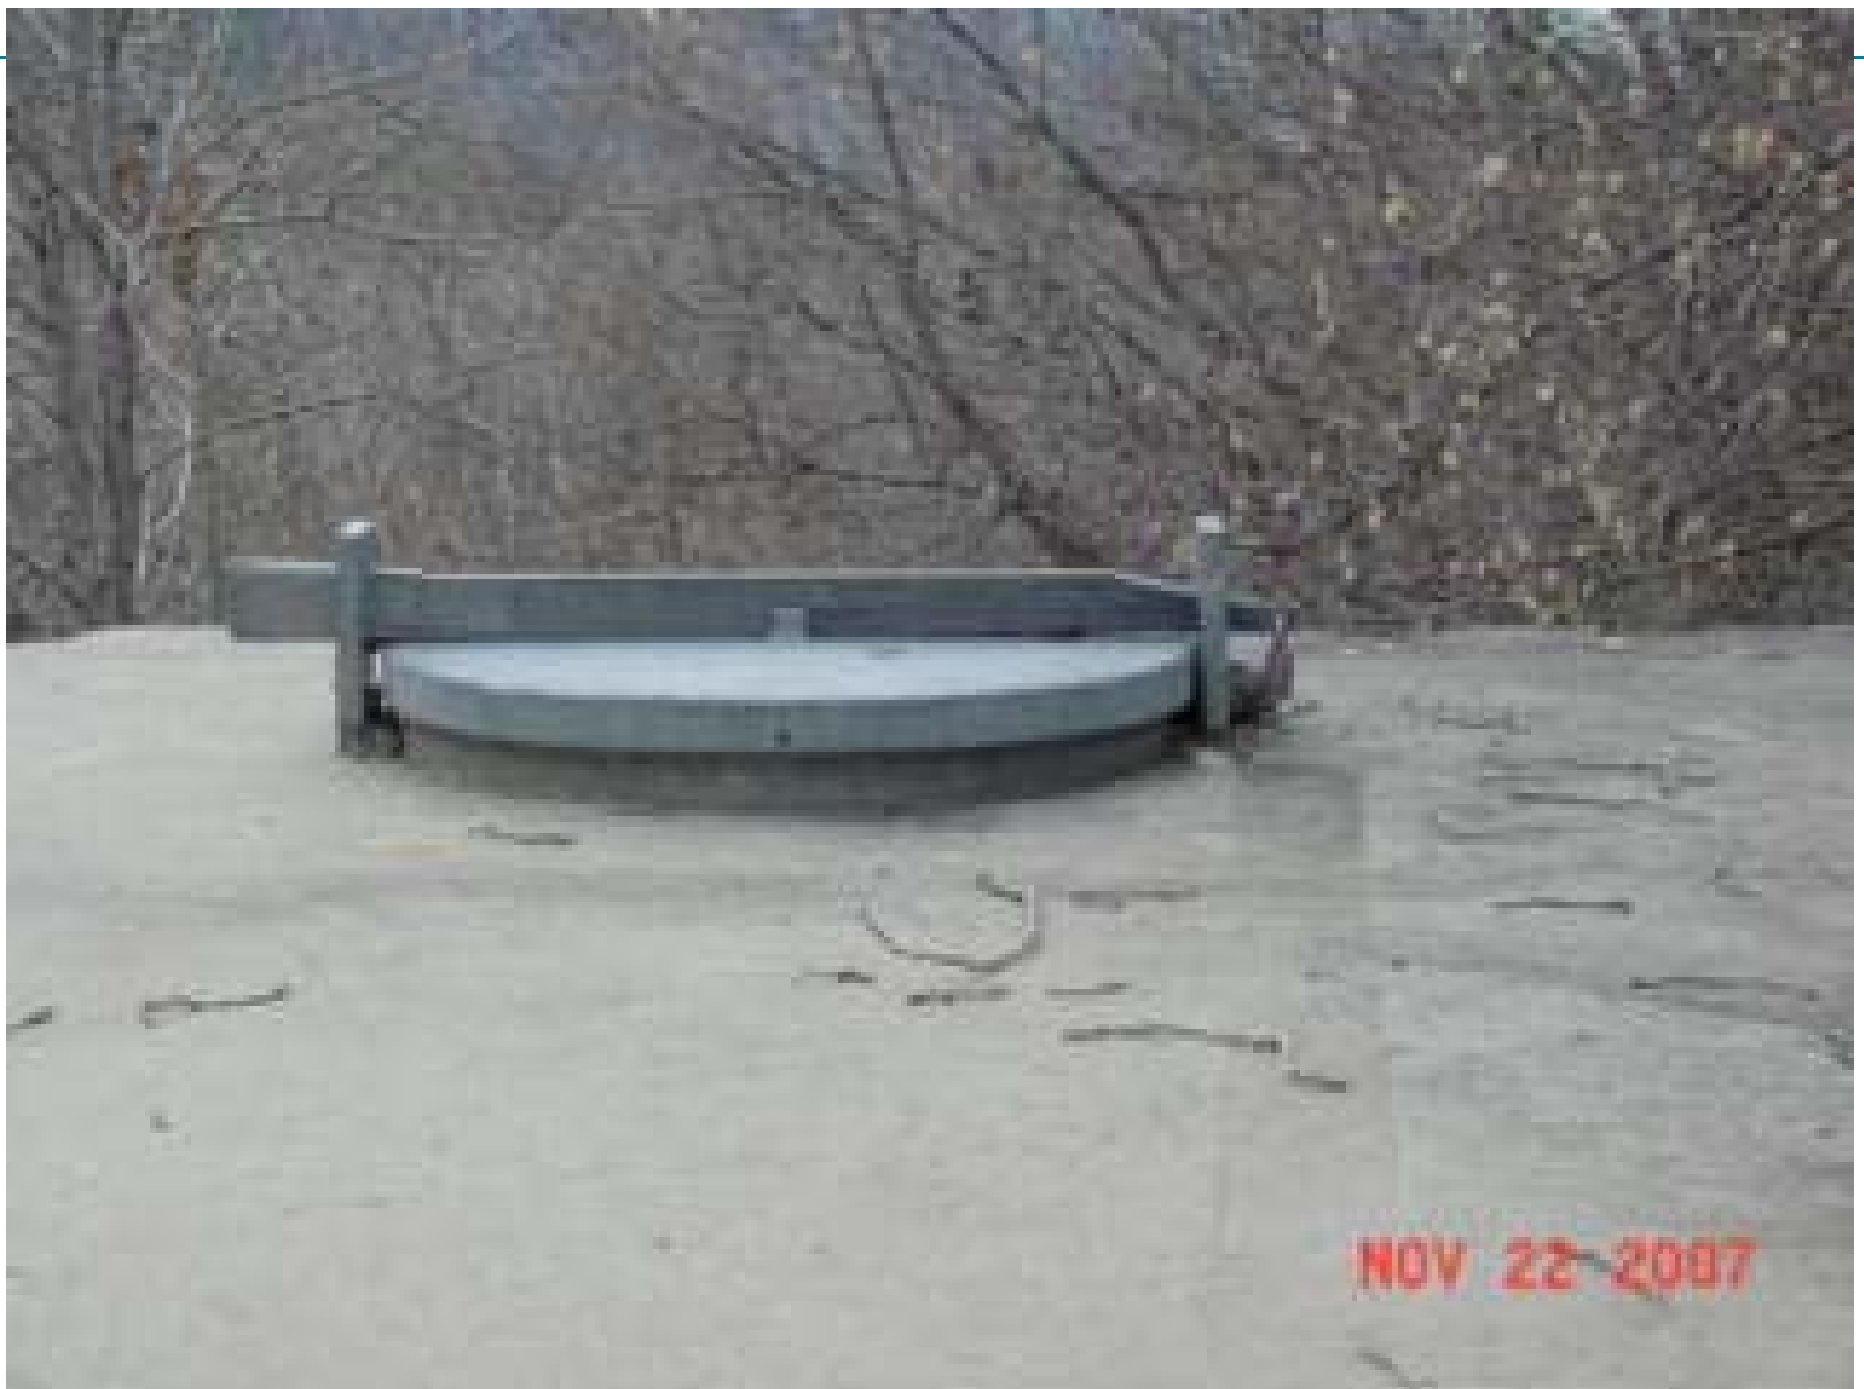
Improper Access Opening

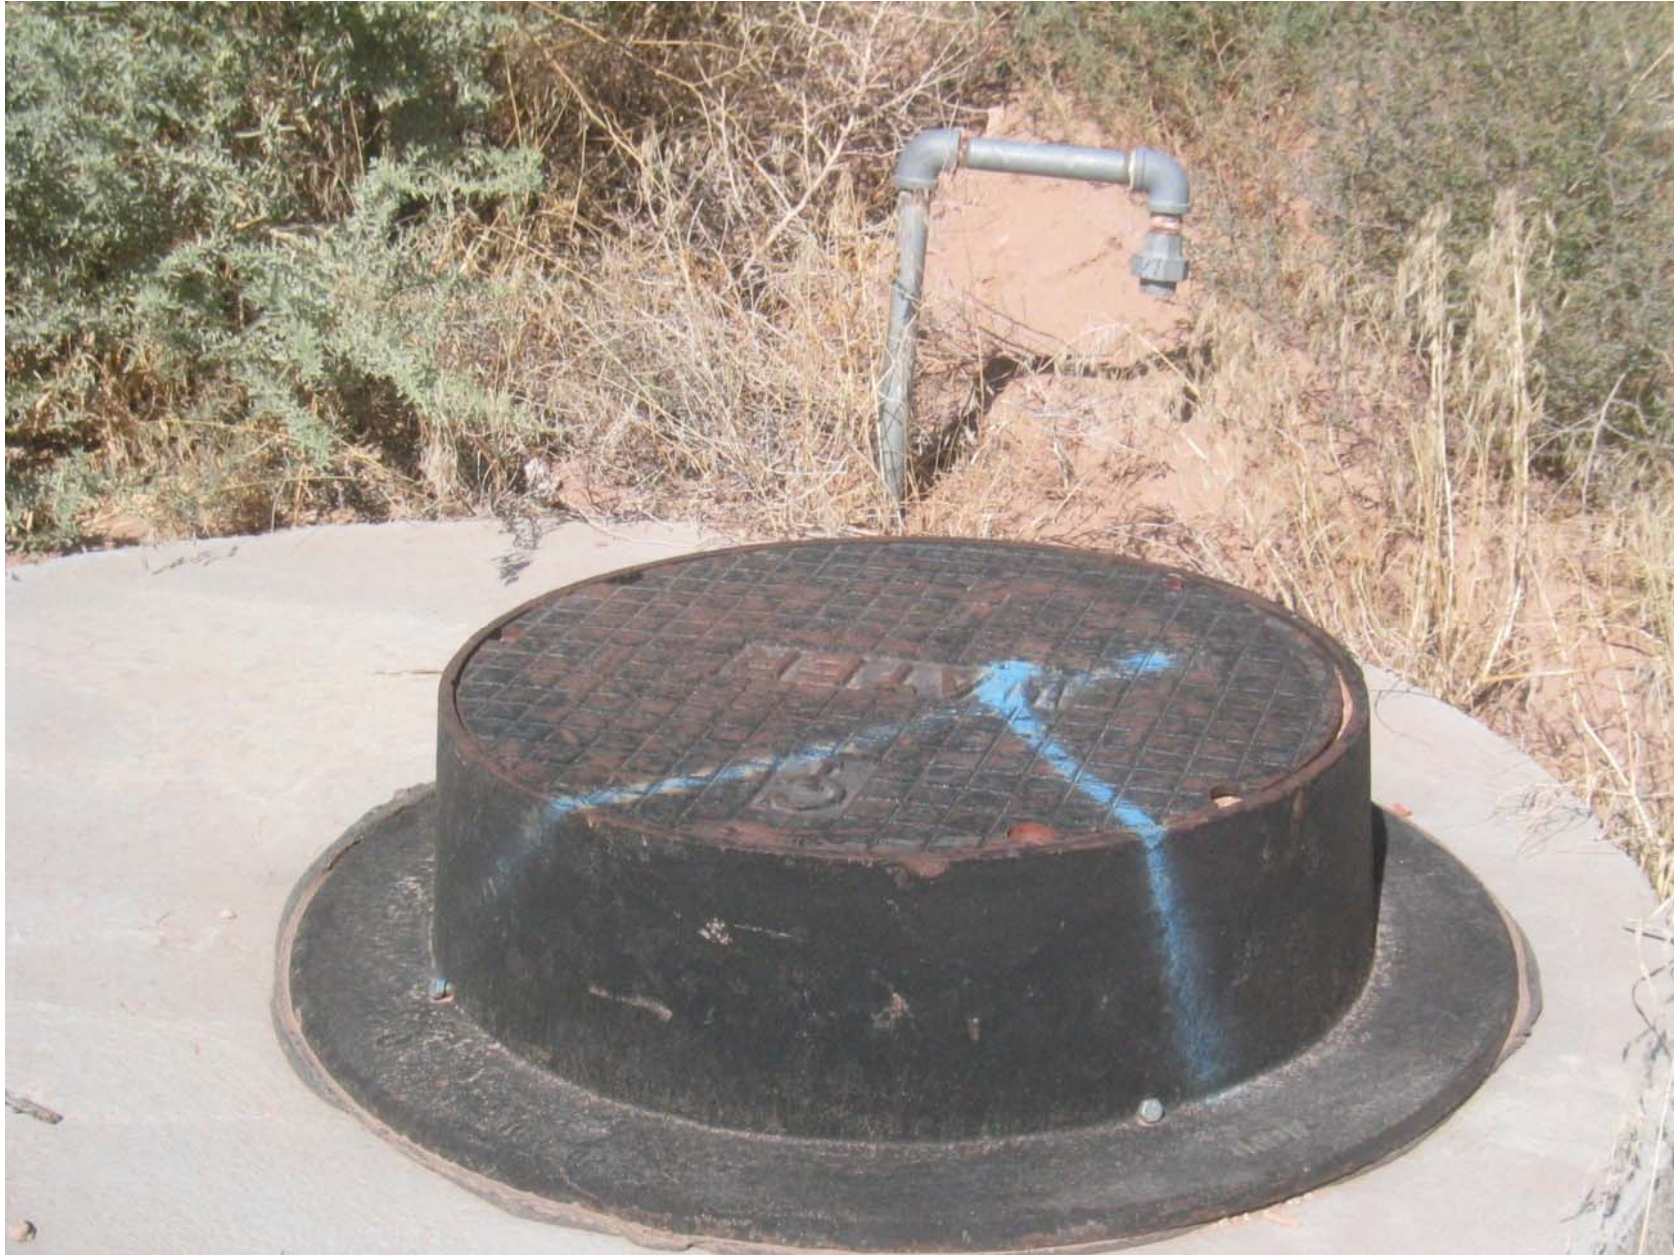
Improper Access Opening

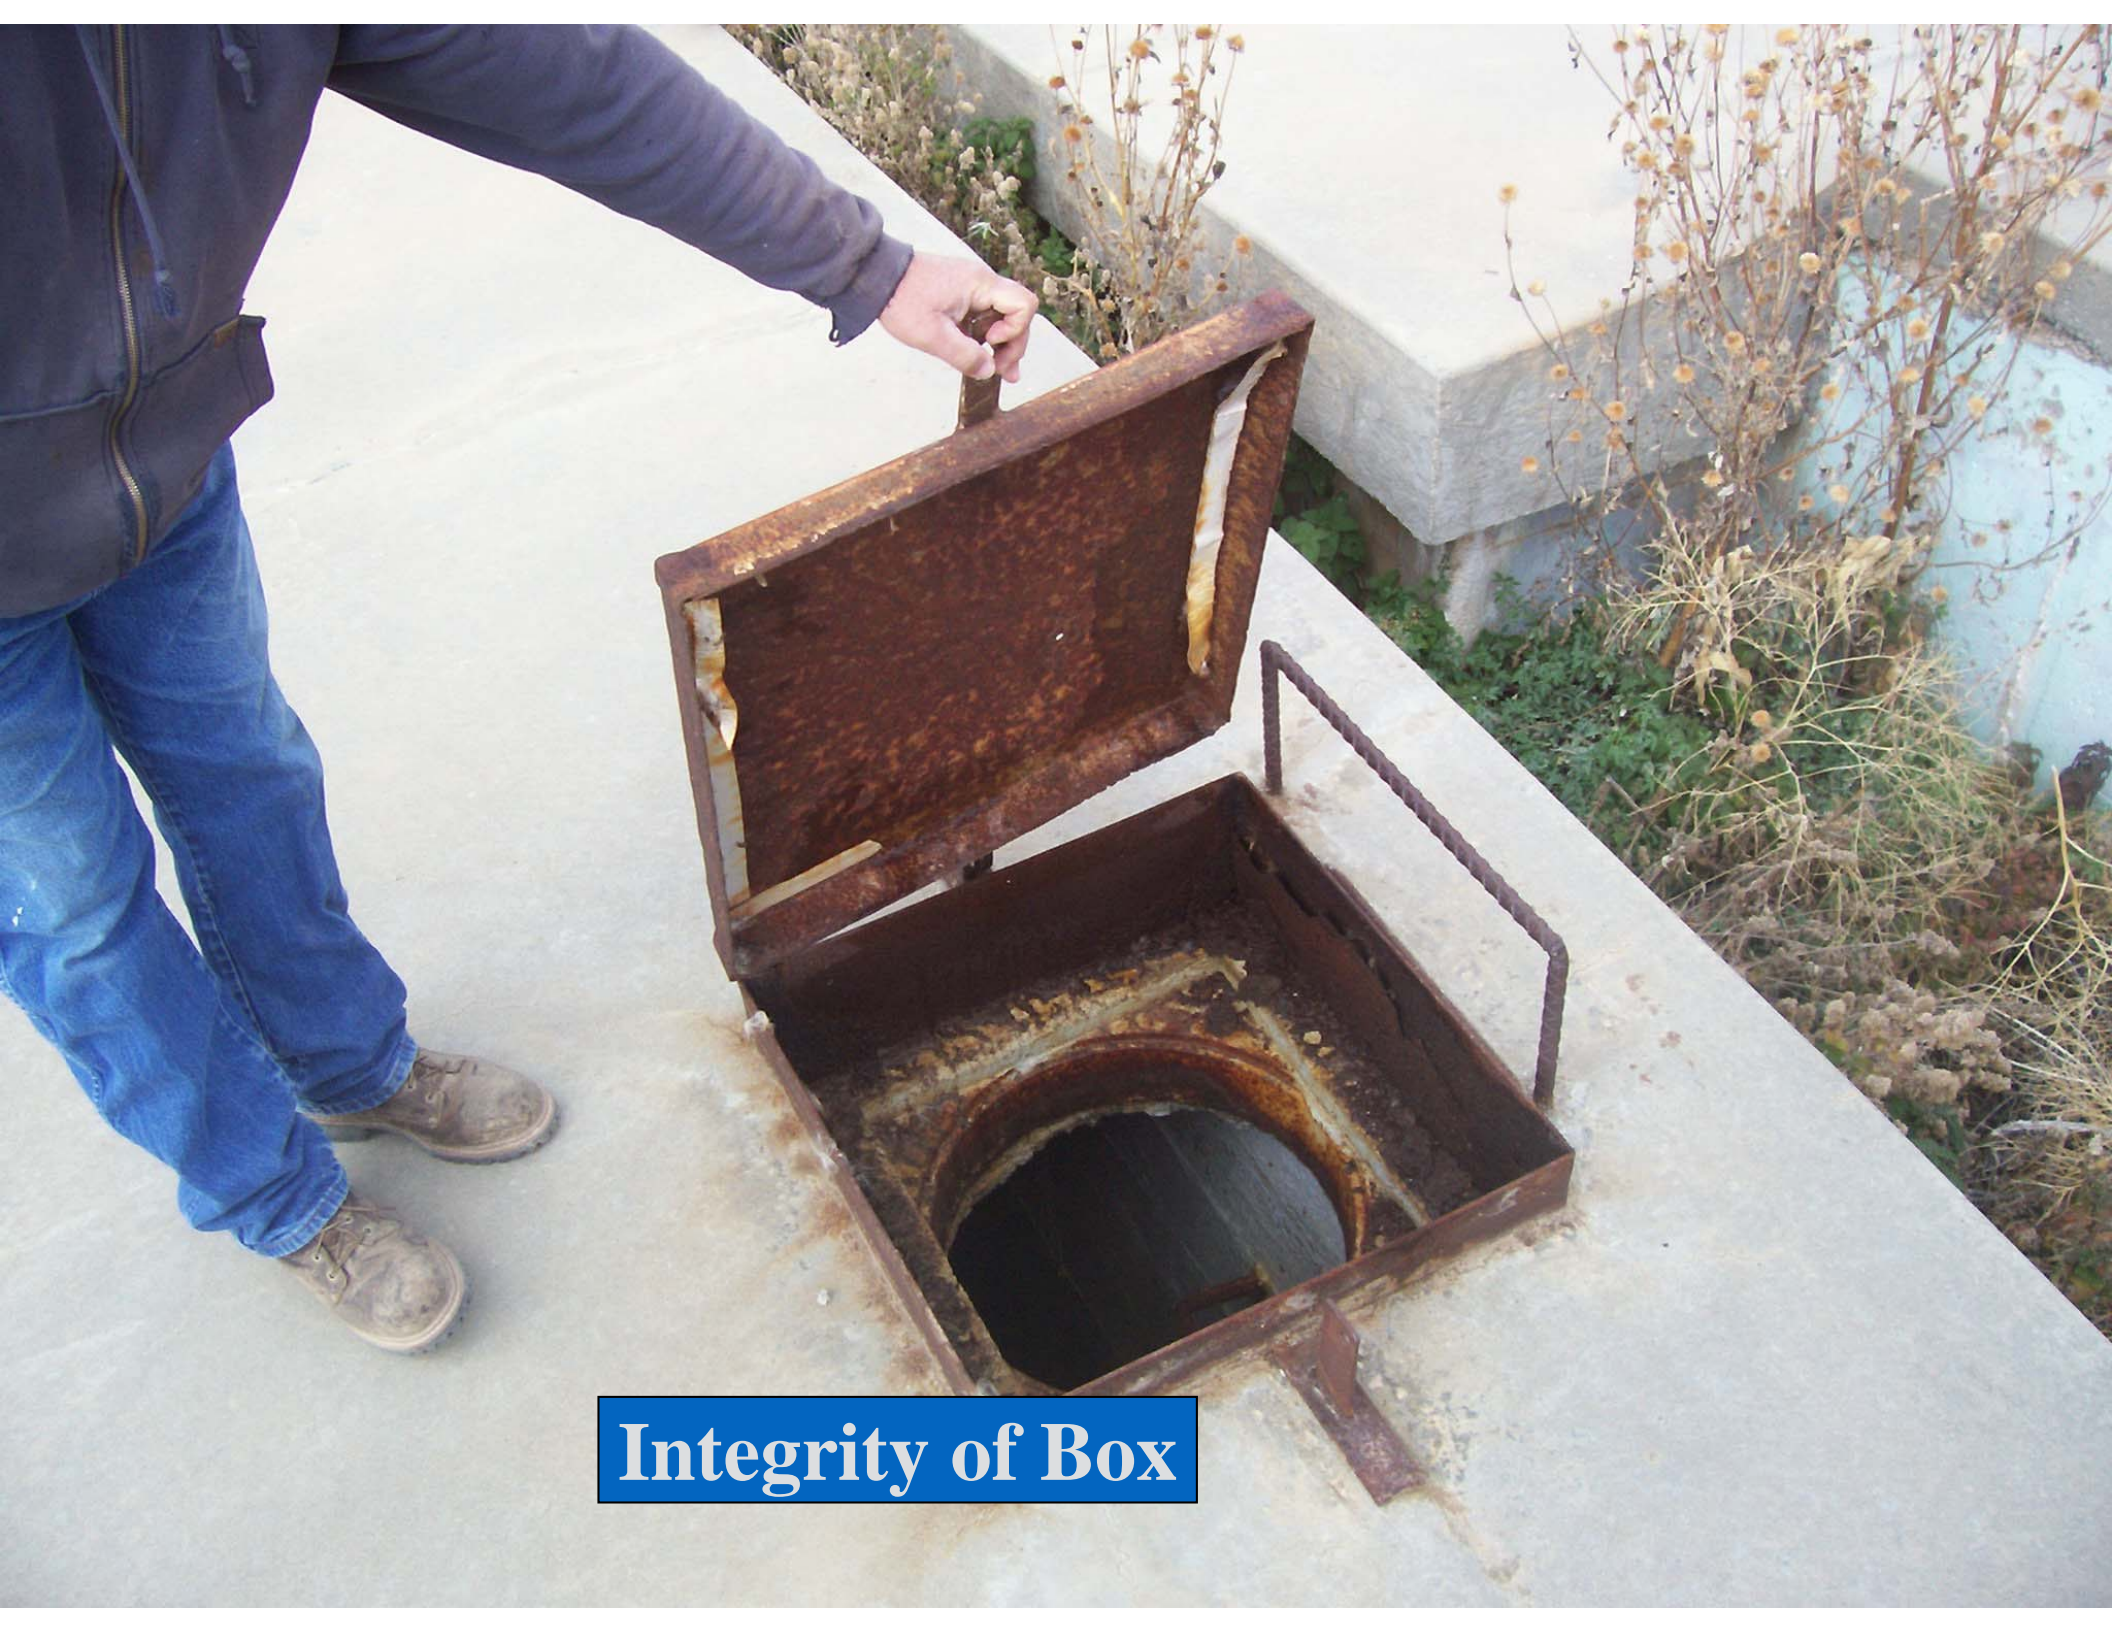
Integrity of Box

**Unsealed Bolt Hole
No Gasket**

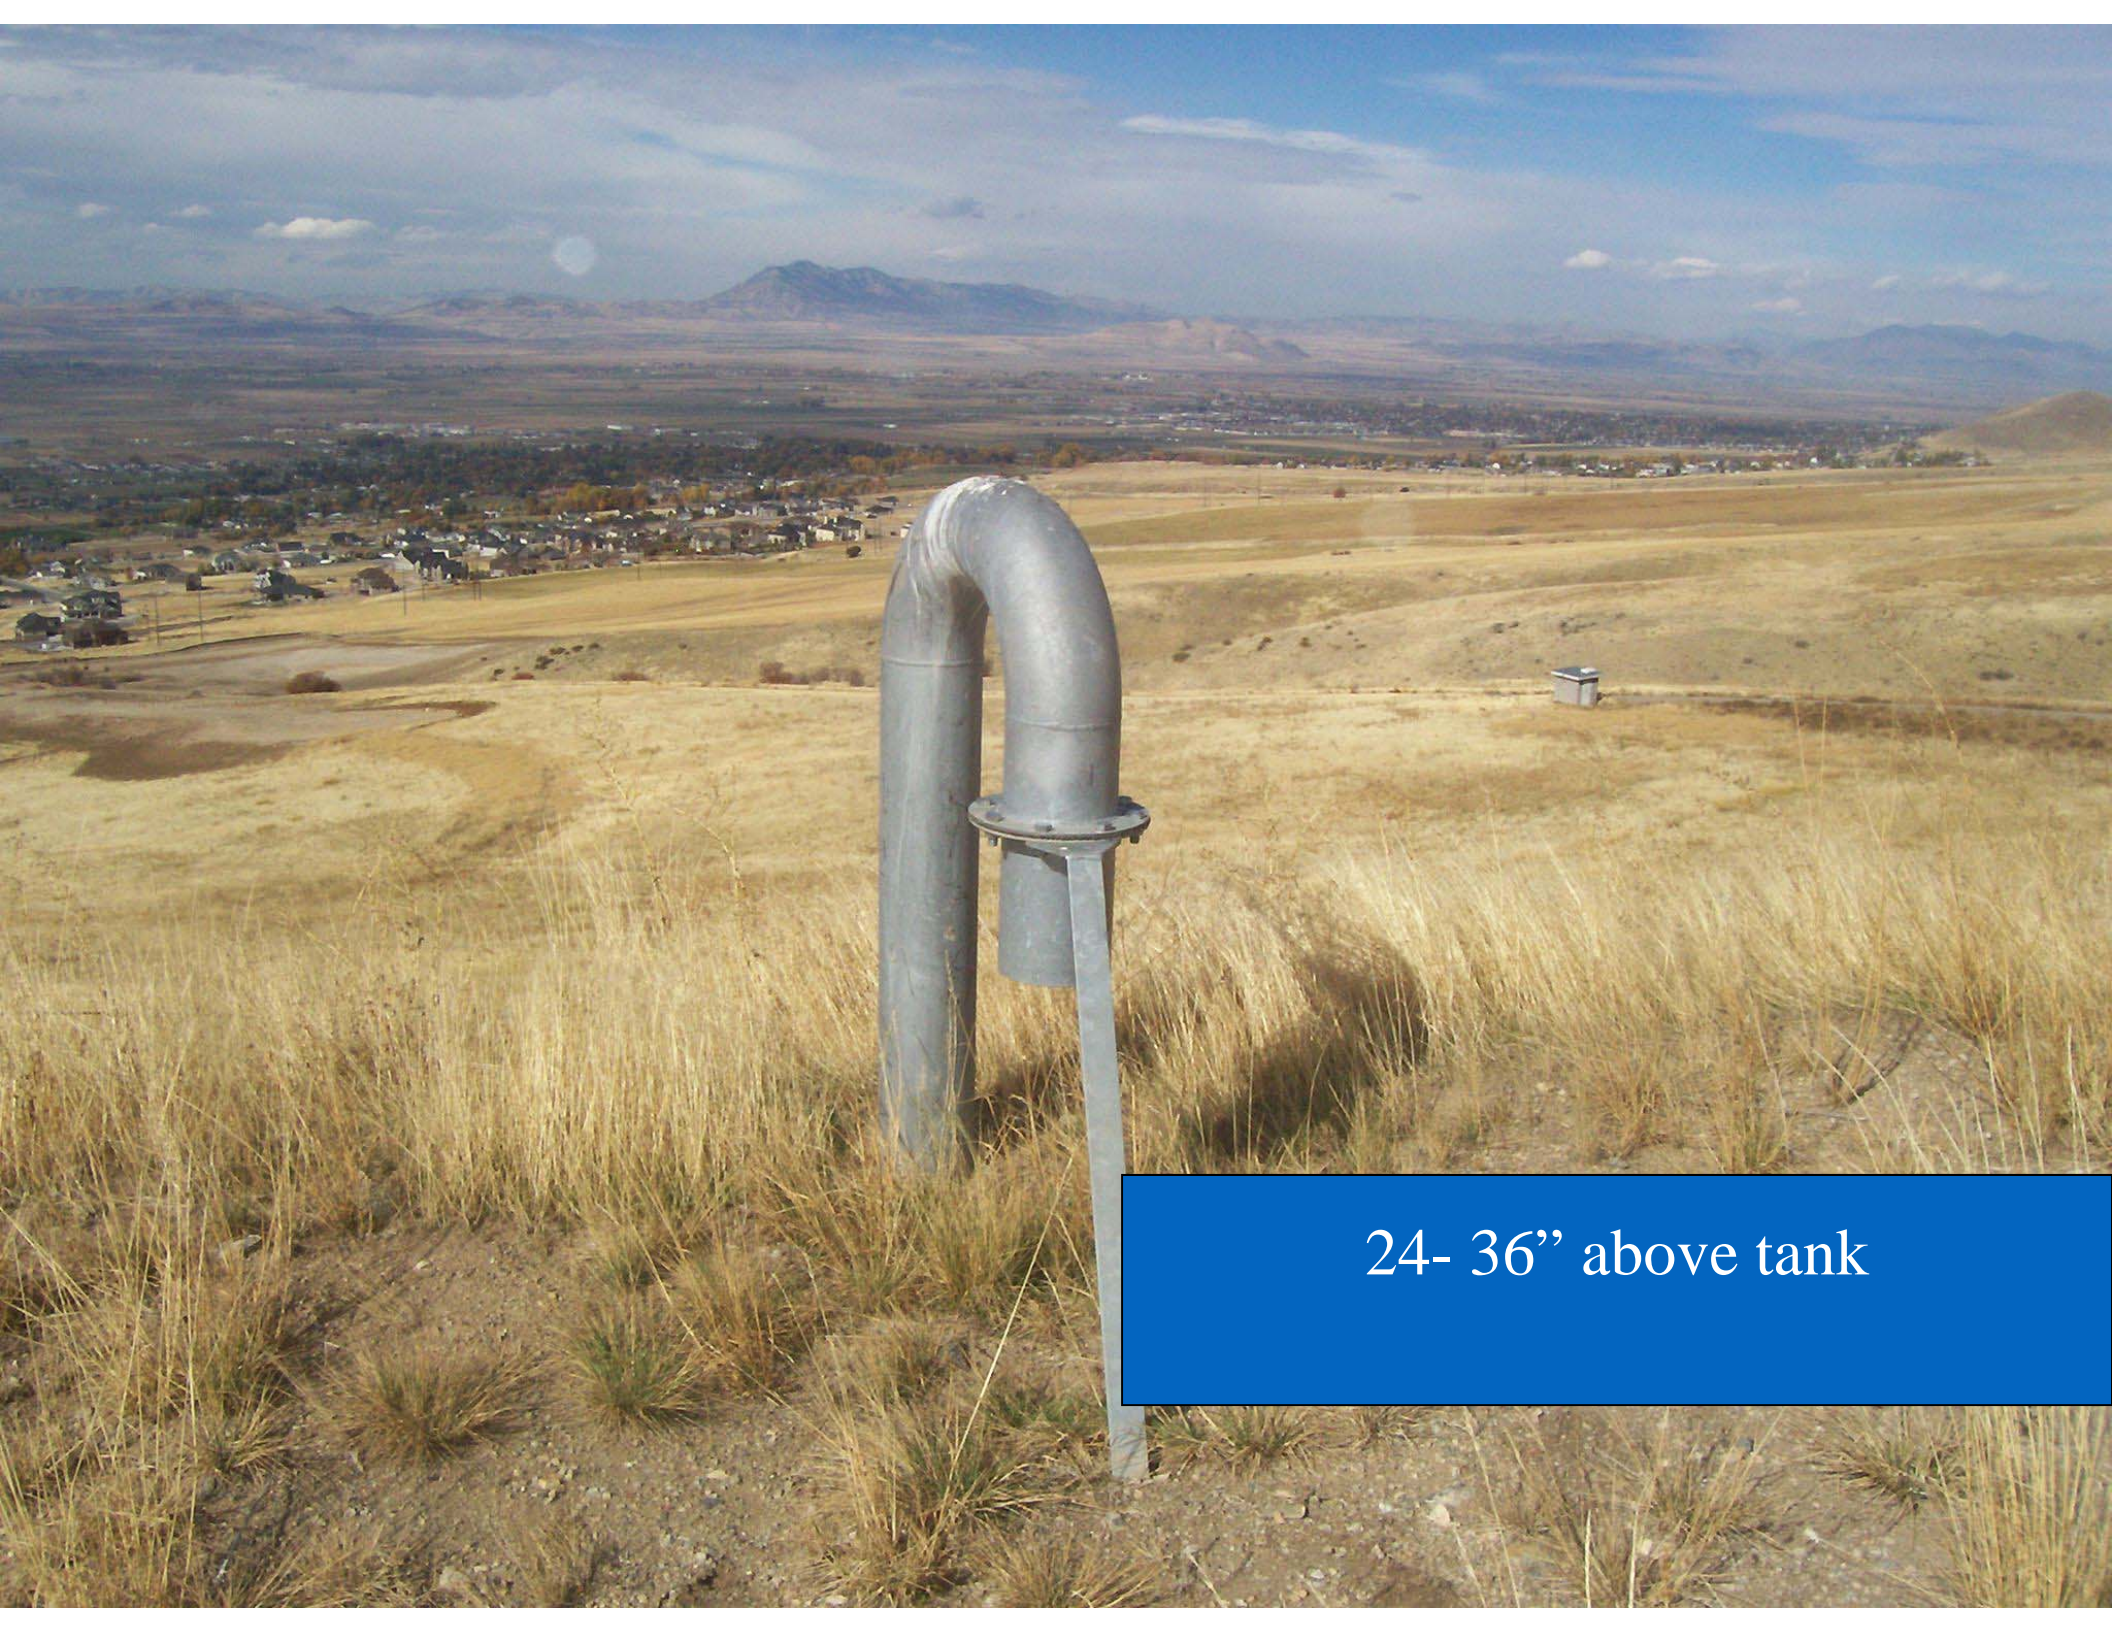
24- 36" above tank

Good Protector Screen

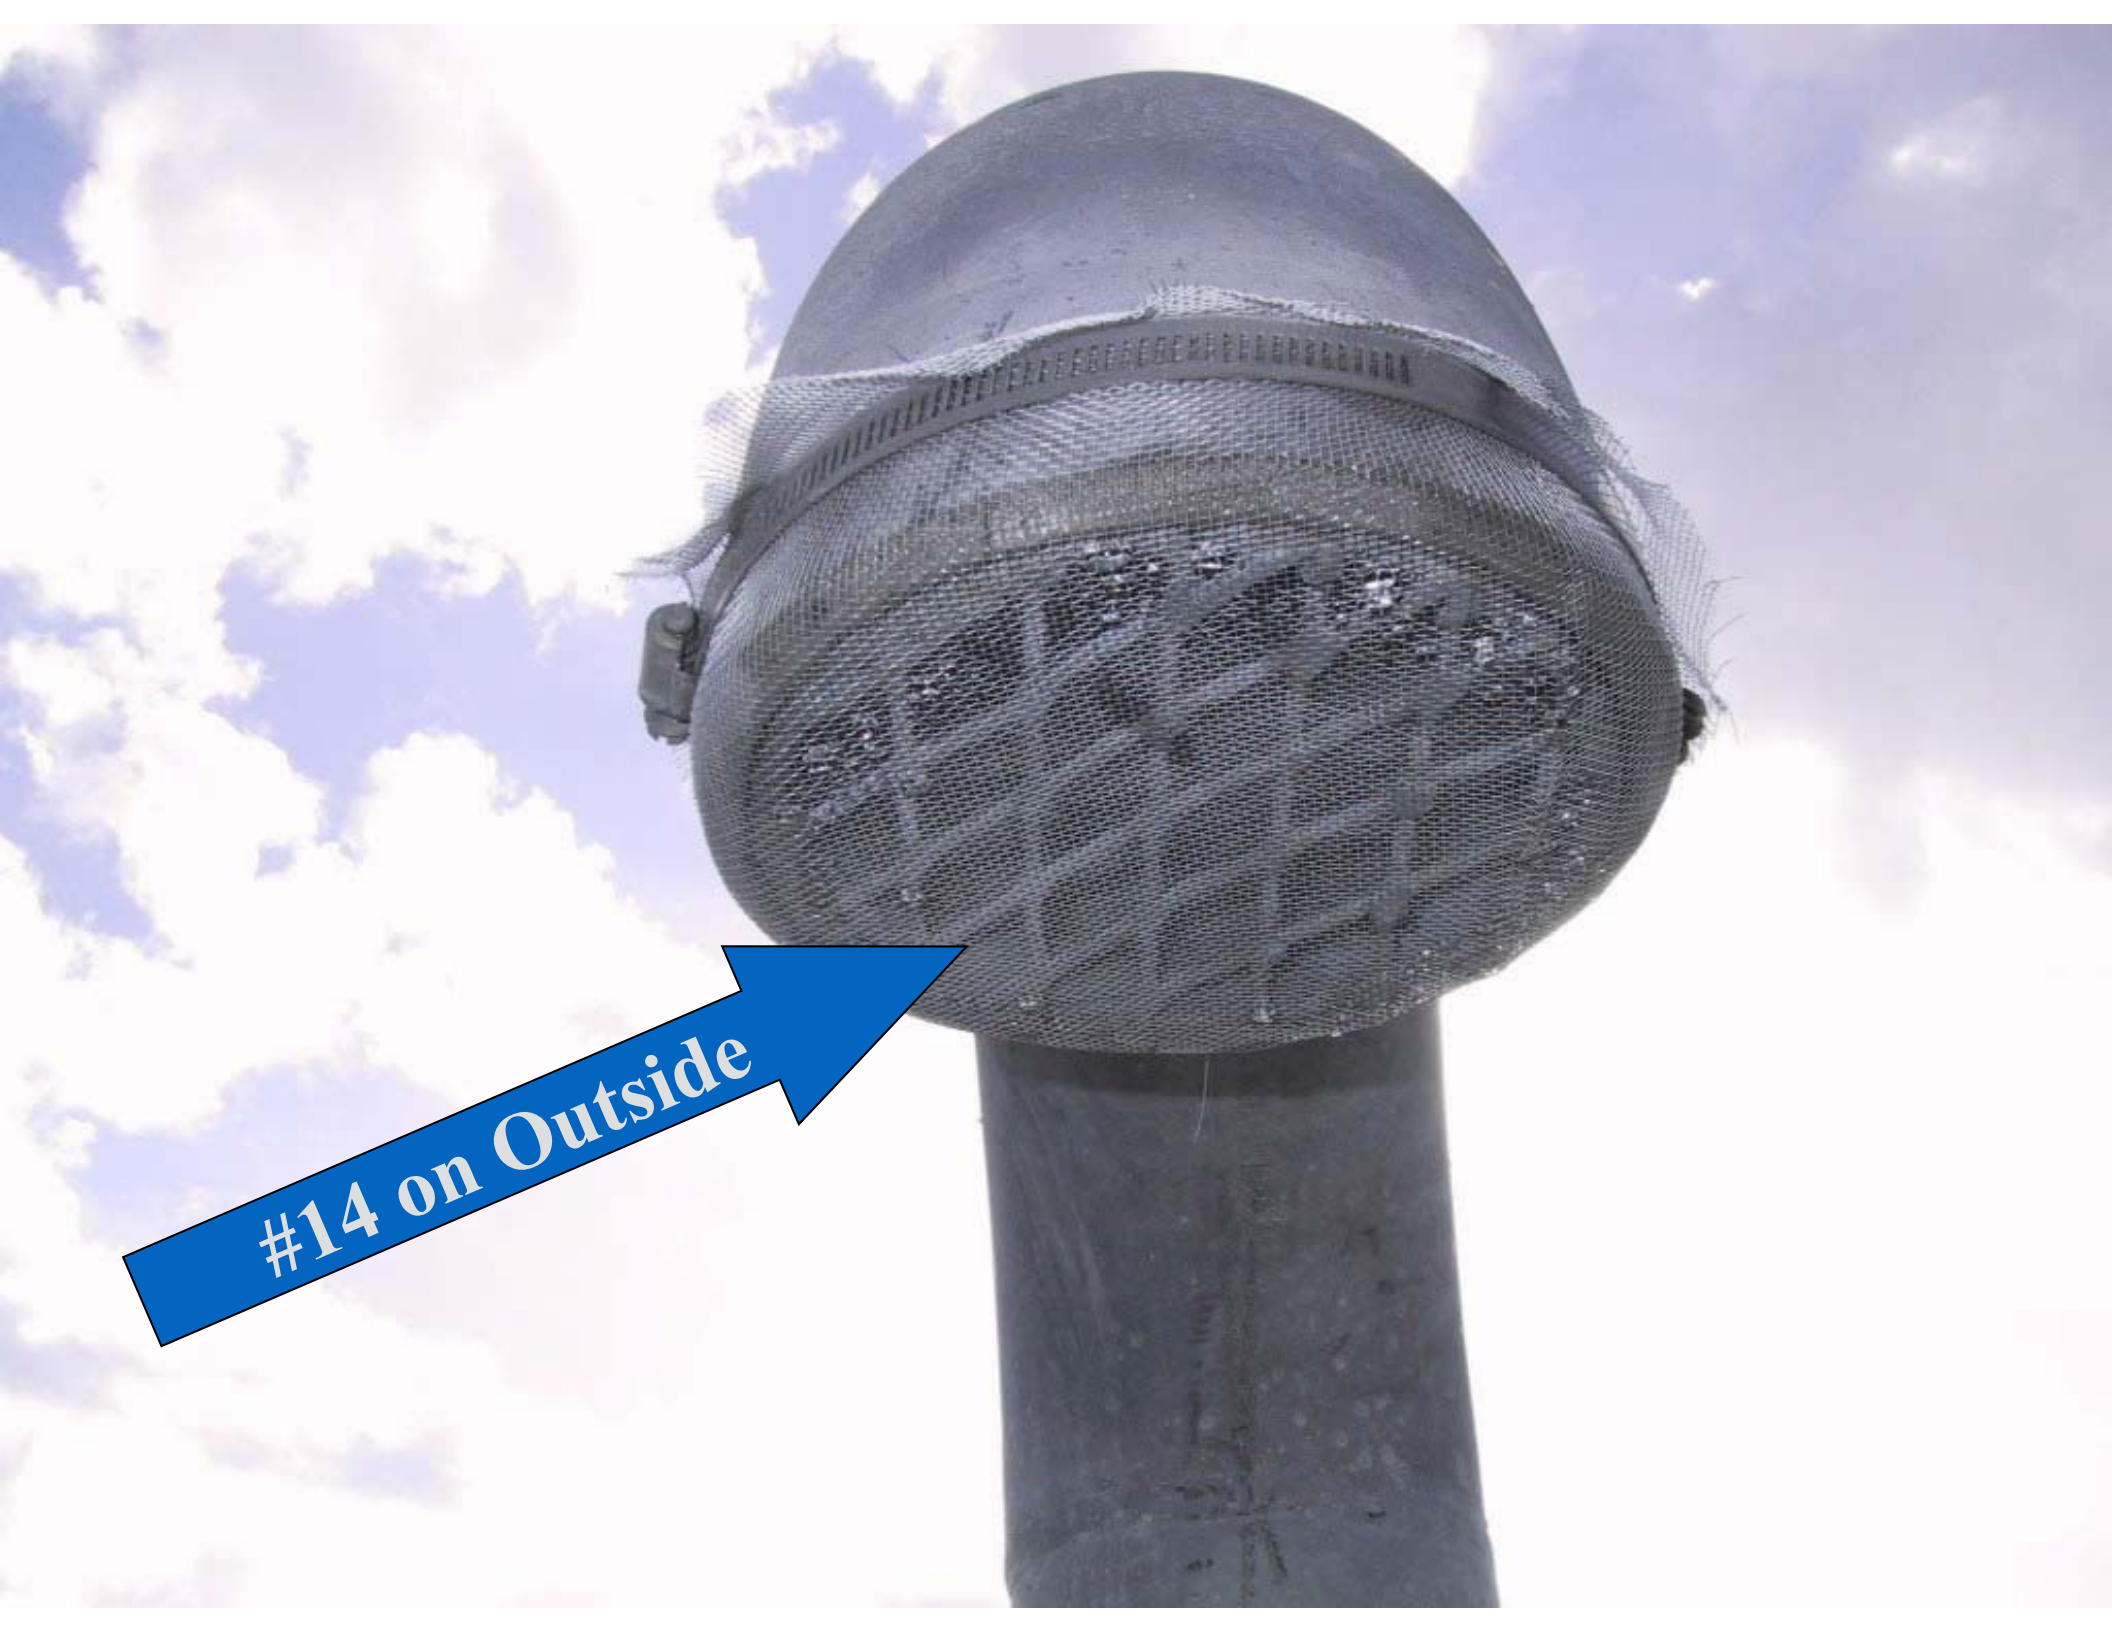
#14 on Outside

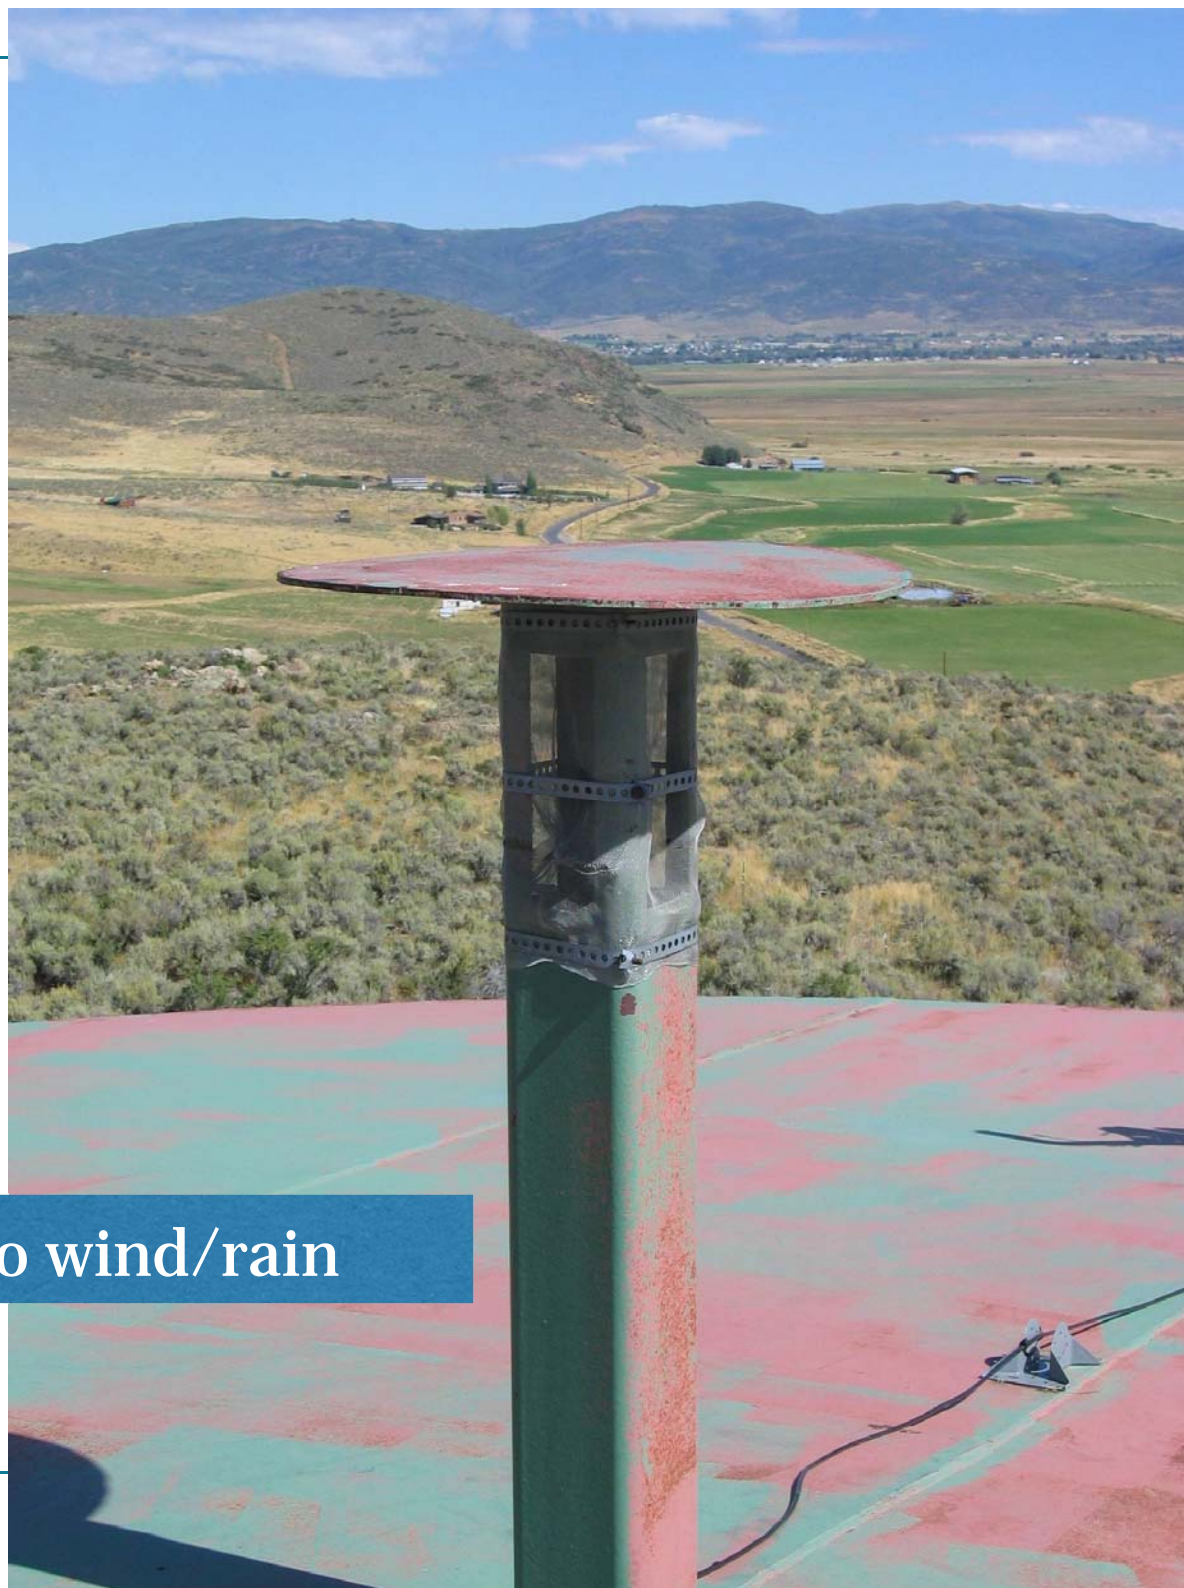
Exposed to wind/rain

A cylindrical metal vent with a conical roof is mounted on a metal roof. The vent has a dark, perforated body and a light-colored, conical top. The roof is made of light-colored metal panels. There is some rust and debris around the base of the vent.

Exposed to wind/Rain
