UTAH DEPARTMENT of
ENVIRONMENTAL QUALITY
**DRINKING
WATER**

Water System Facilities Sanitary Surveys-2018 Part 2

Storage Tanks

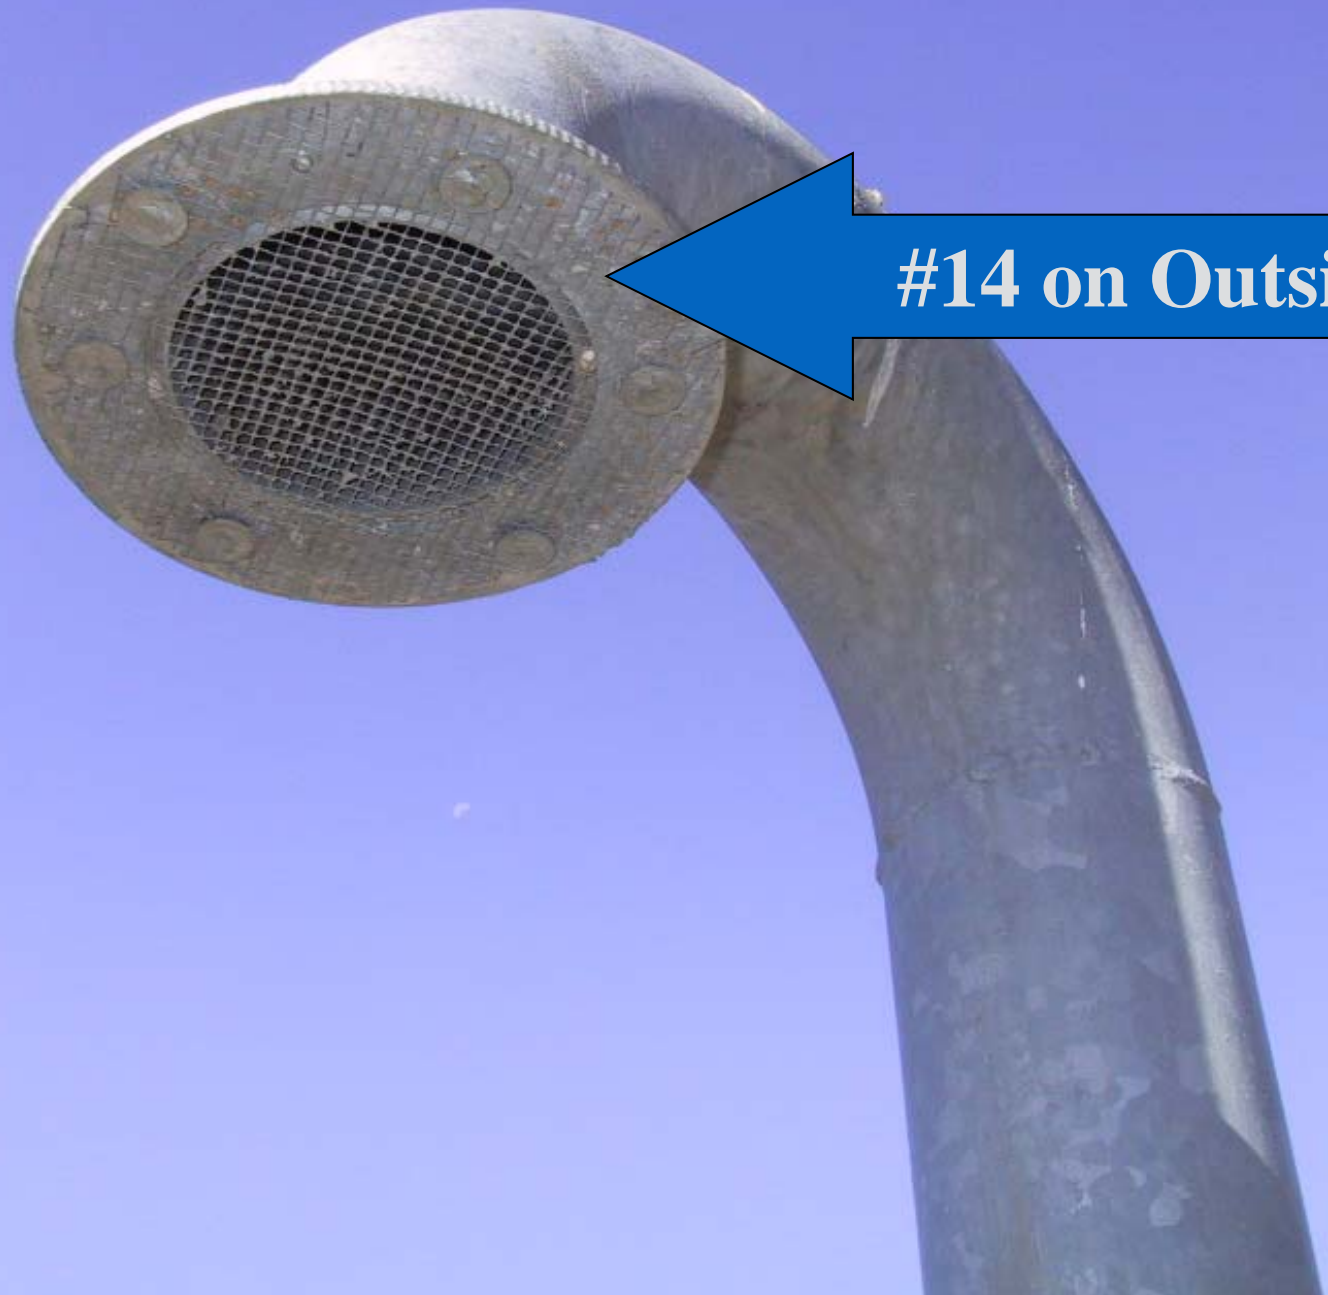
#14 on Outside

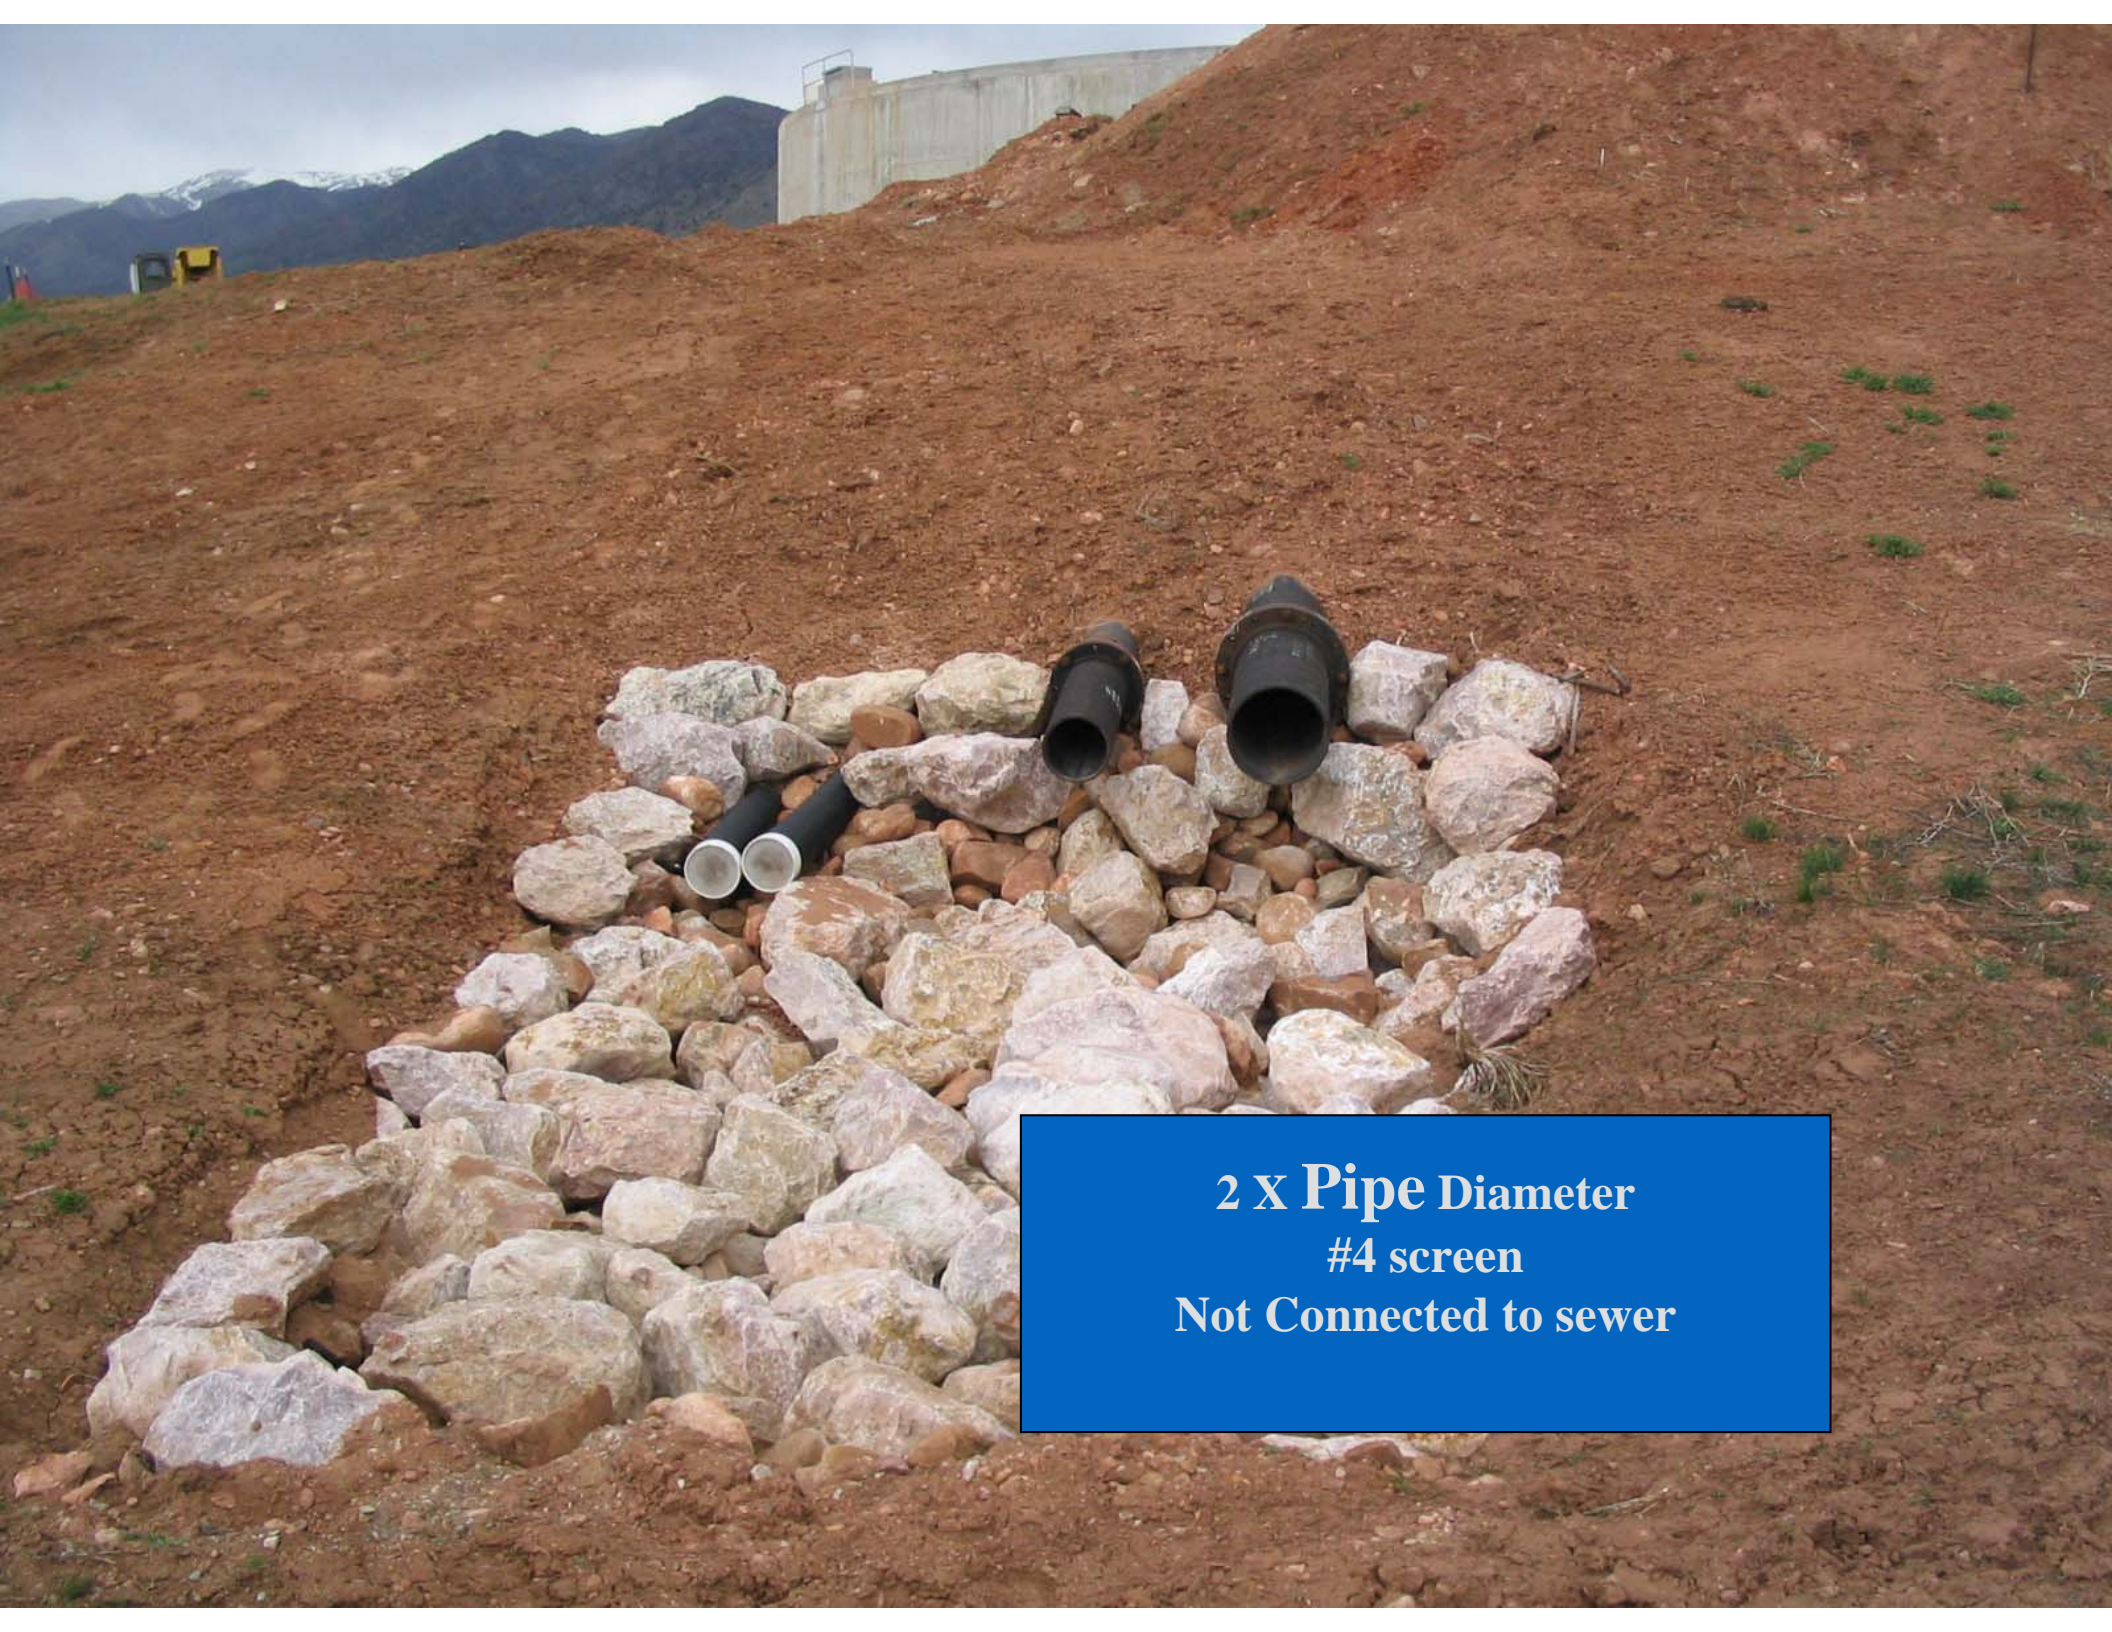
2 x Pipe Diameter
#4 screen
Not Connected to sewer

Combination Overflow/Drain
12" free fall

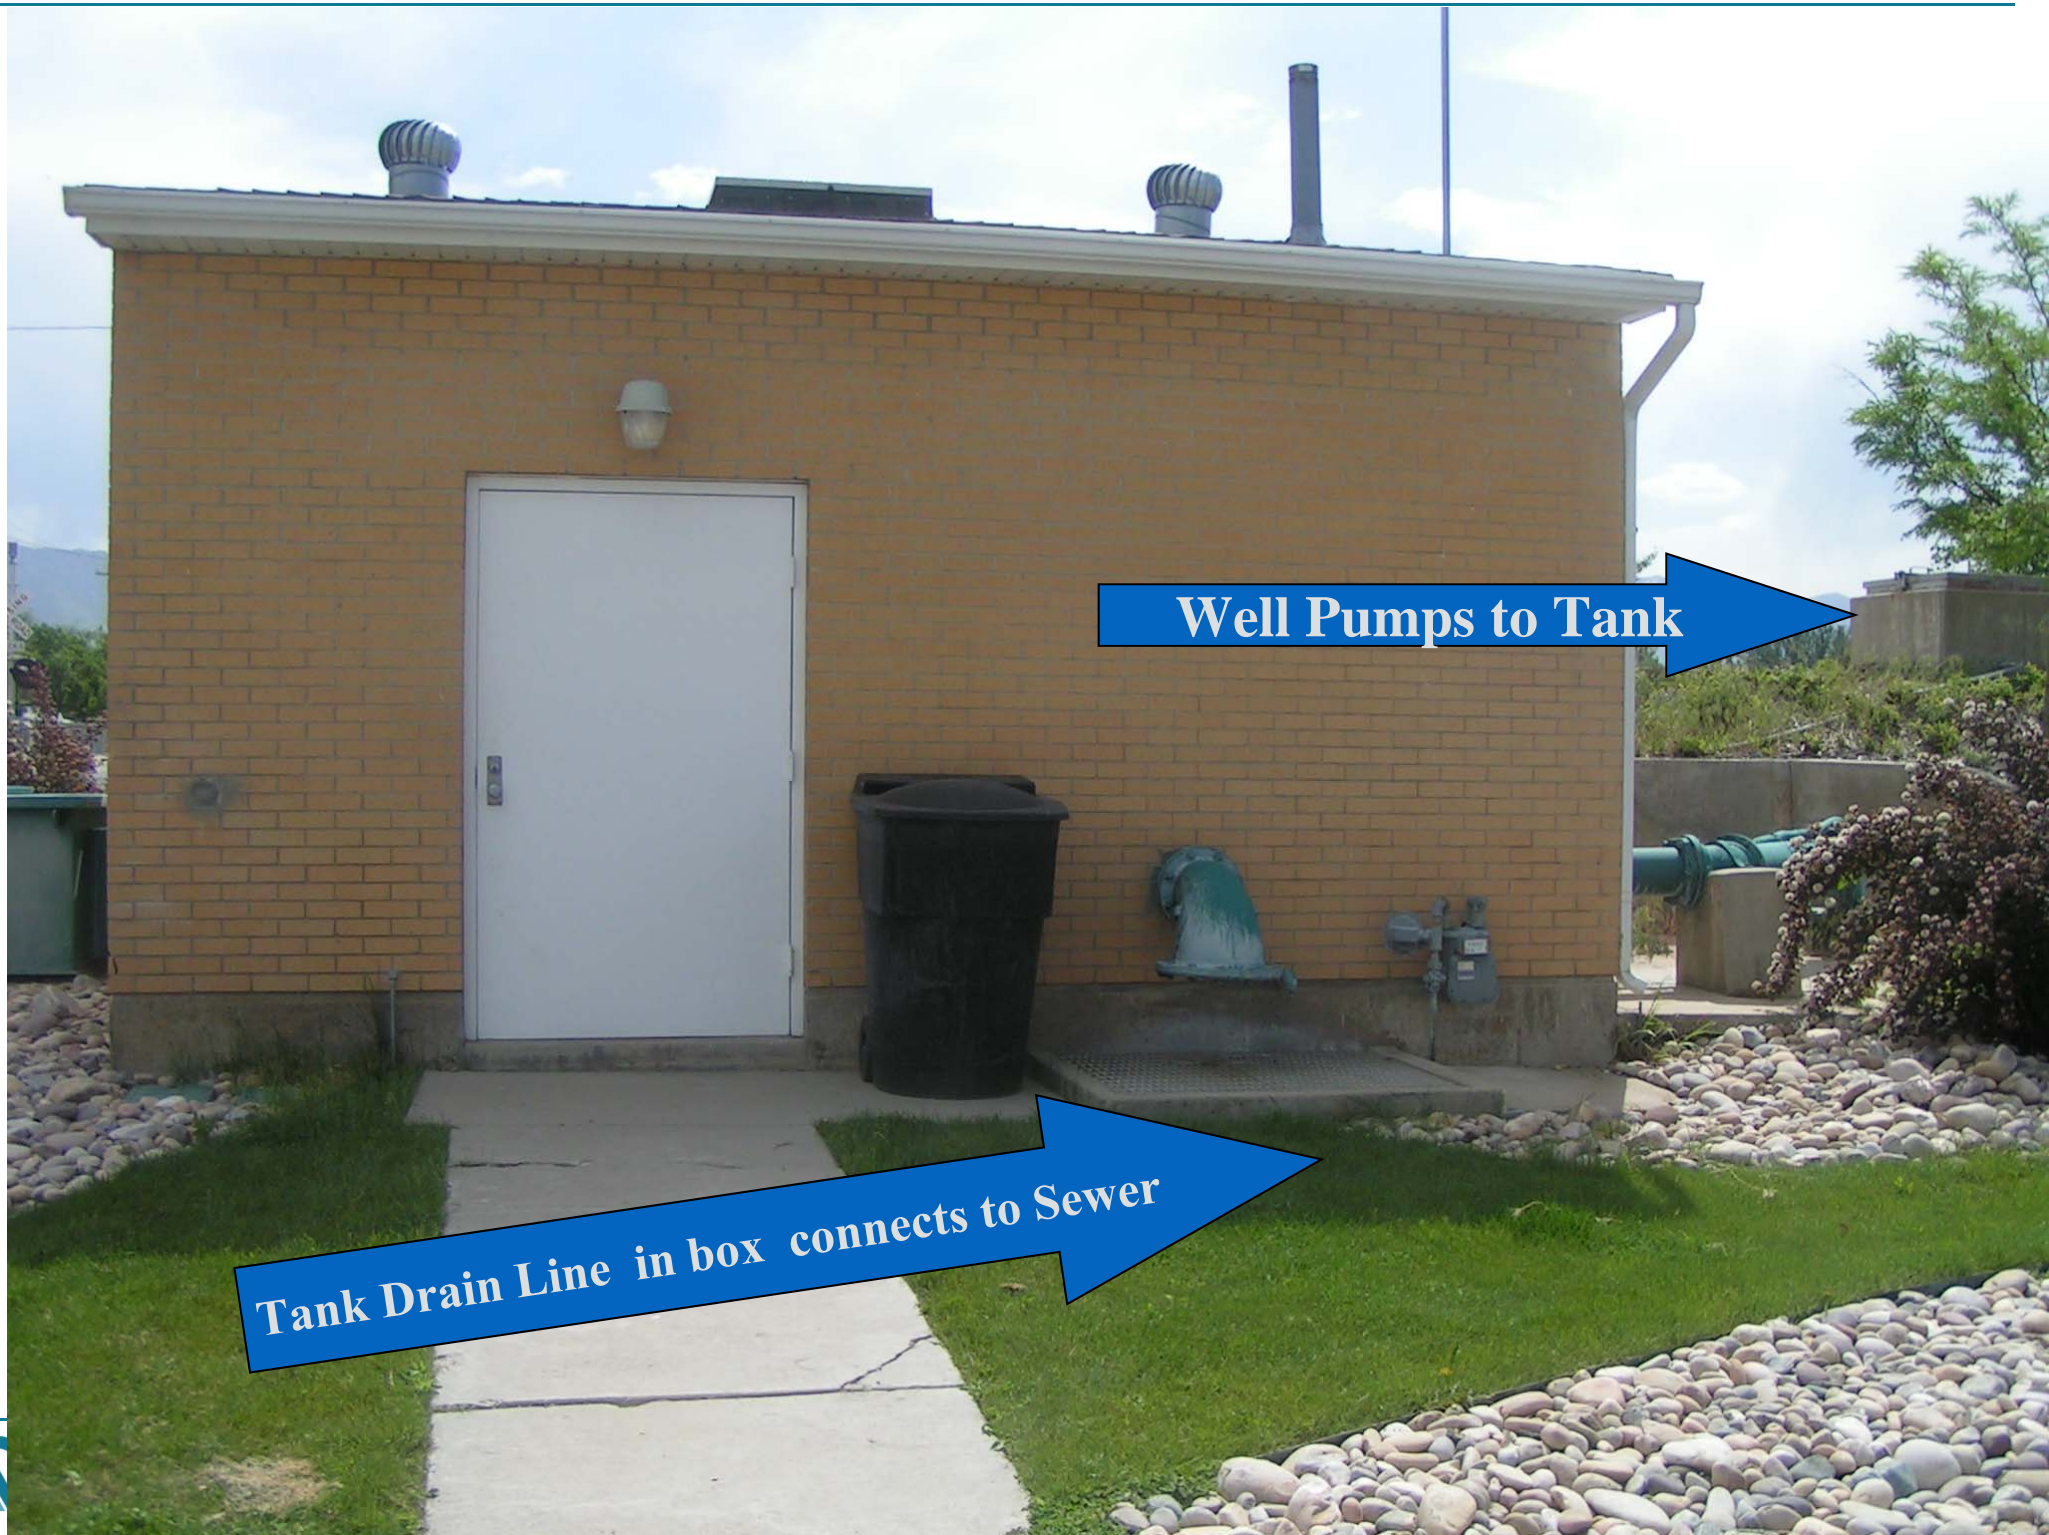
Well Pumps to Tank

Tank Drain Line in box connects to Sewer

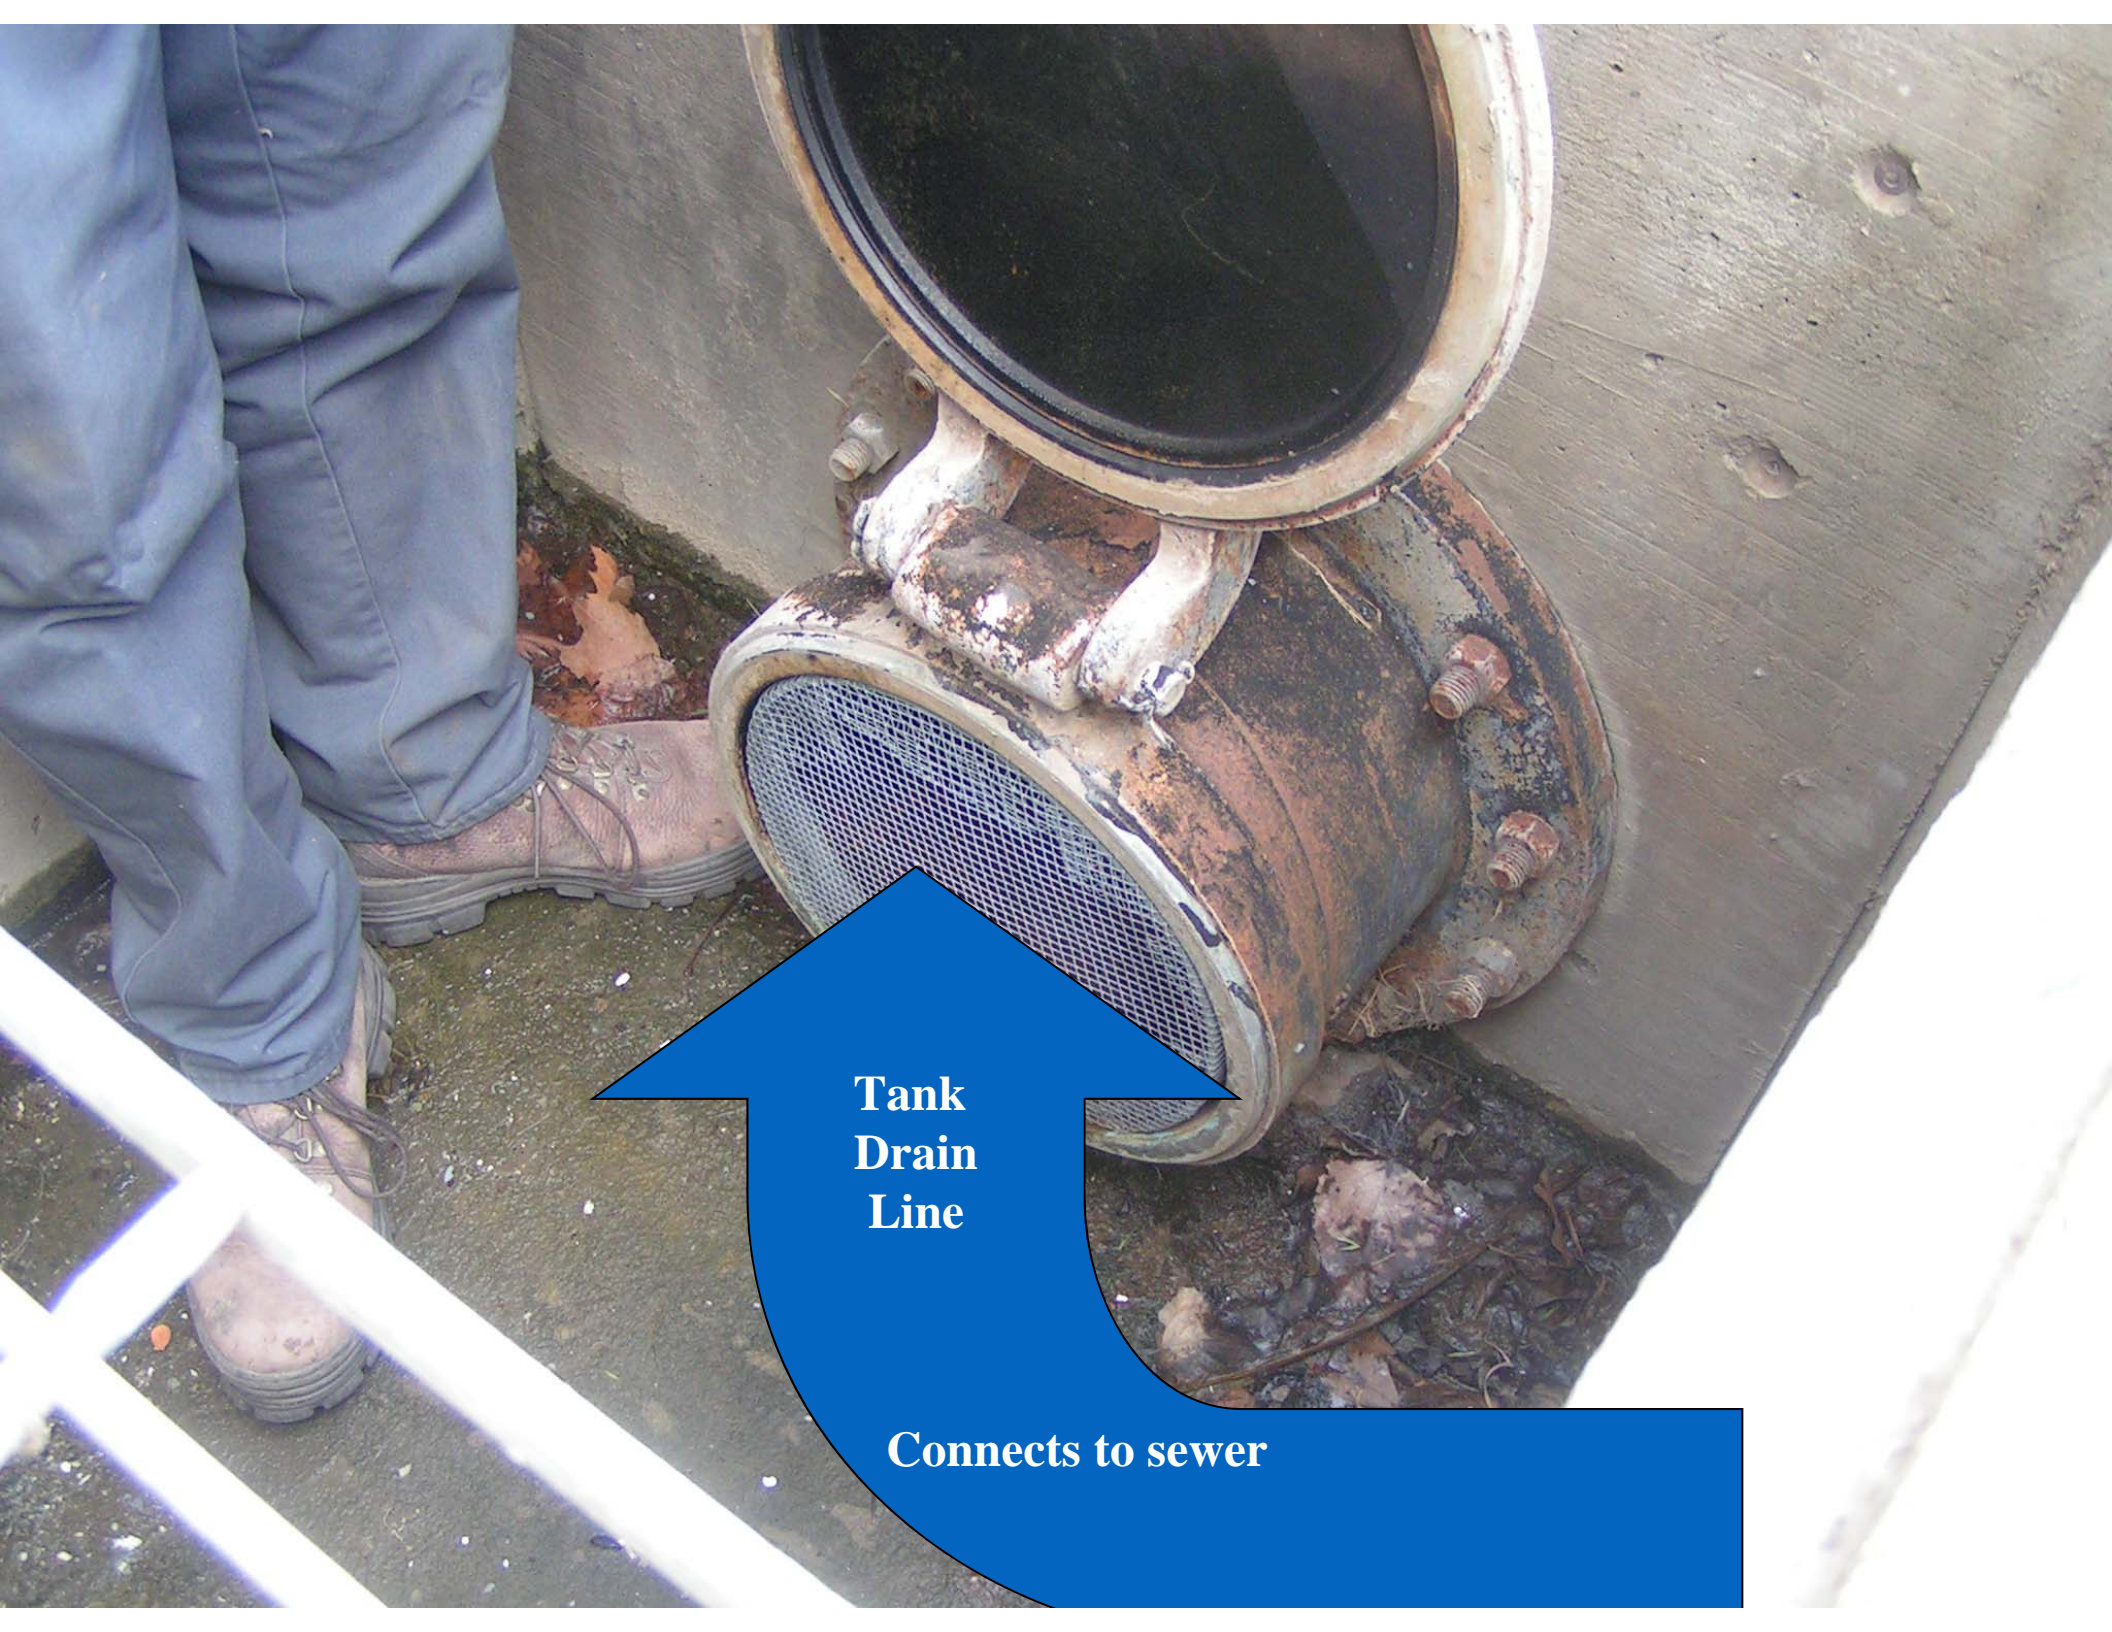
**Tank
Drain
Line**

Connects to sewer

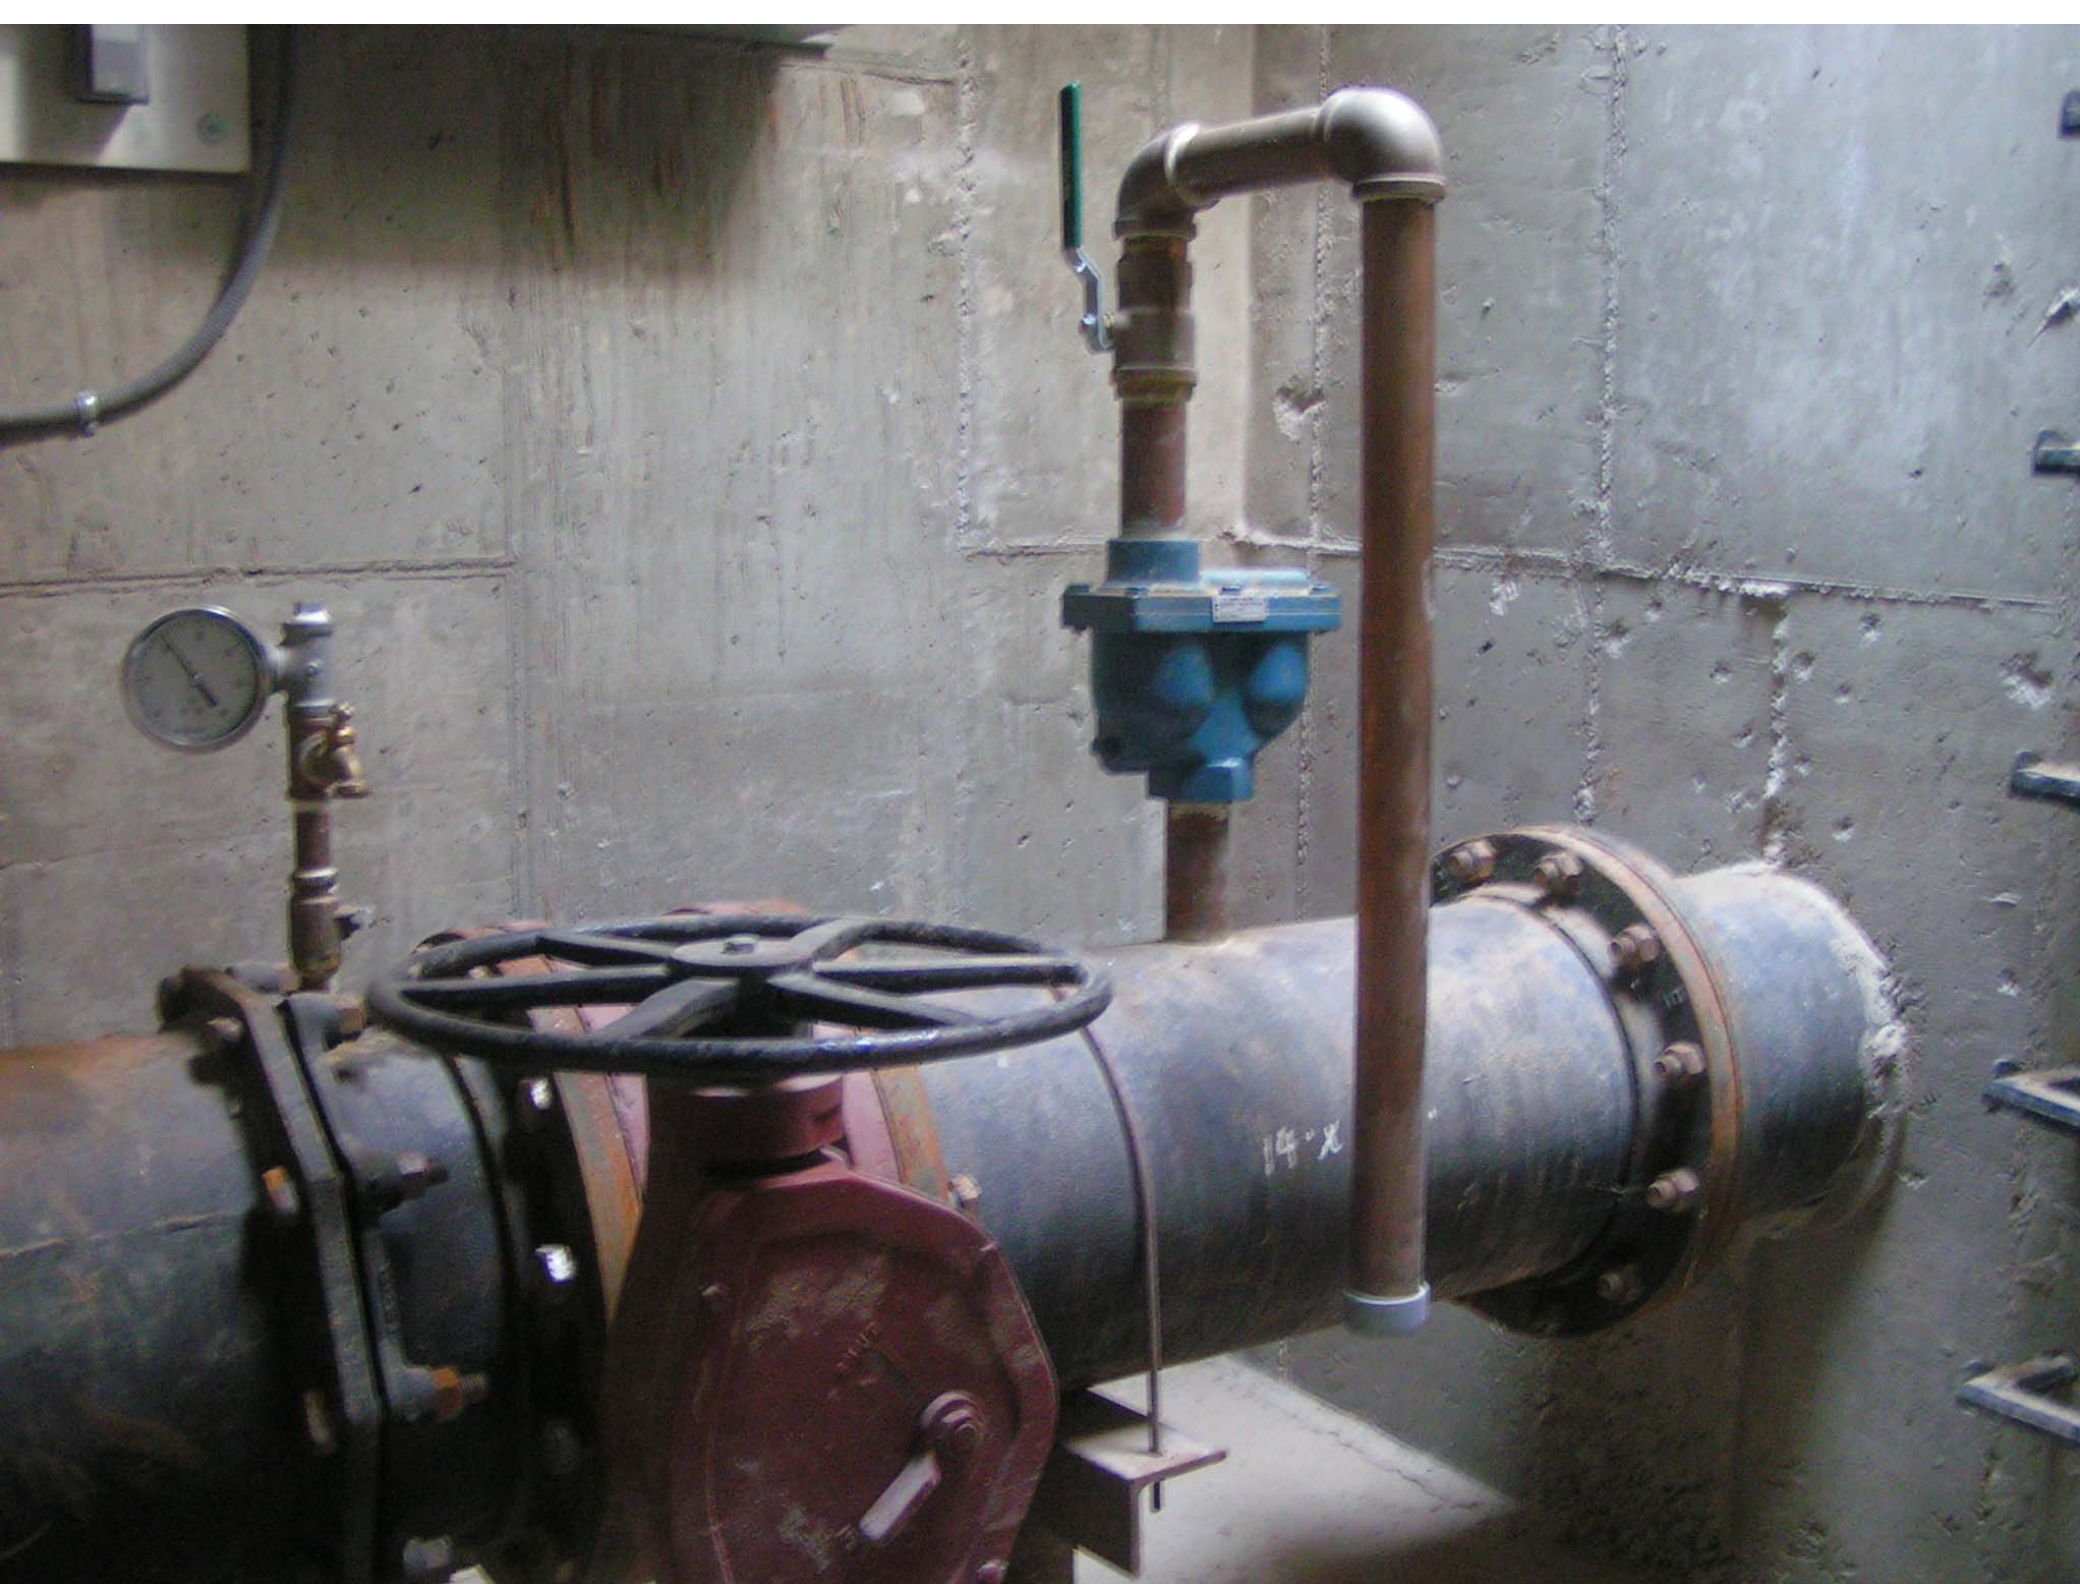
#14 Mesh

A close-up photograph of a metal mesh air vent. The vent is a cylindrical metal pipe with a white plastic or rubber cap at the end, which has a circular opening covered by a silver-colored metal mesh. The vent is positioned on a dark, heavily textured surface, possibly a piece of machinery or a large pipe, which shows signs of rust and wear. A blue text box is overlaid on the image, containing the text "#14 required on air vents".

#14 required on air vents

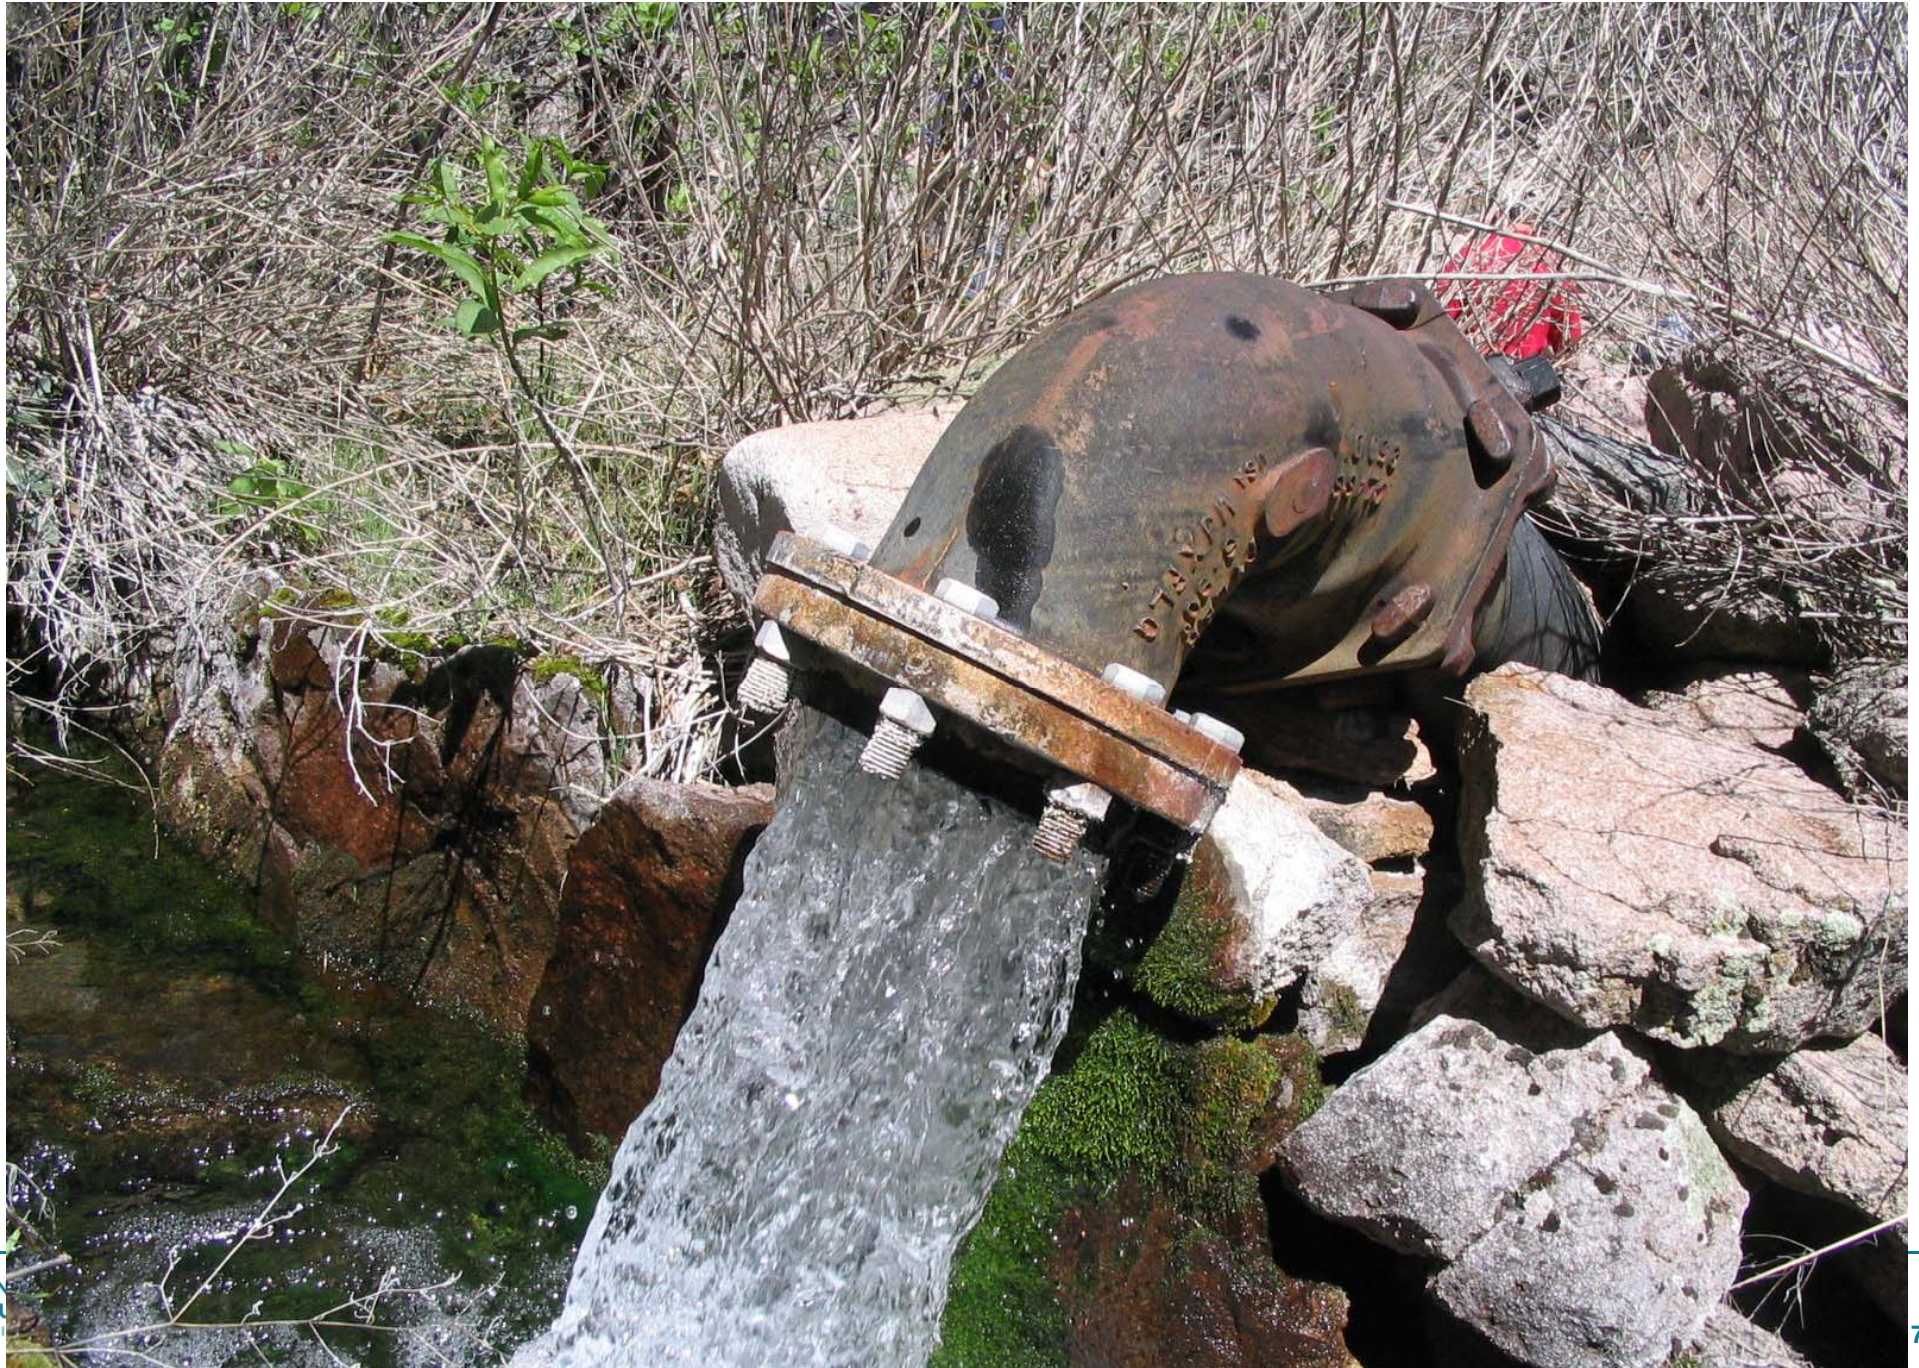
A photograph of industrial equipment inside a concrete enclosure. The ceiling is made of corrugated metal with several orange lifting straps hanging from it. A bright, yellowish light fixture is mounted on the ceiling. The equipment consists of various pipes, valves, and a large red pressure relief blow off. A blue arrow points from the text 'Pressure Relief Blow Off' to the blow off. The equipment is mounted on a concrete wall. A small electrical control box is visible on the left wall.

Pressure Relief Blow Off

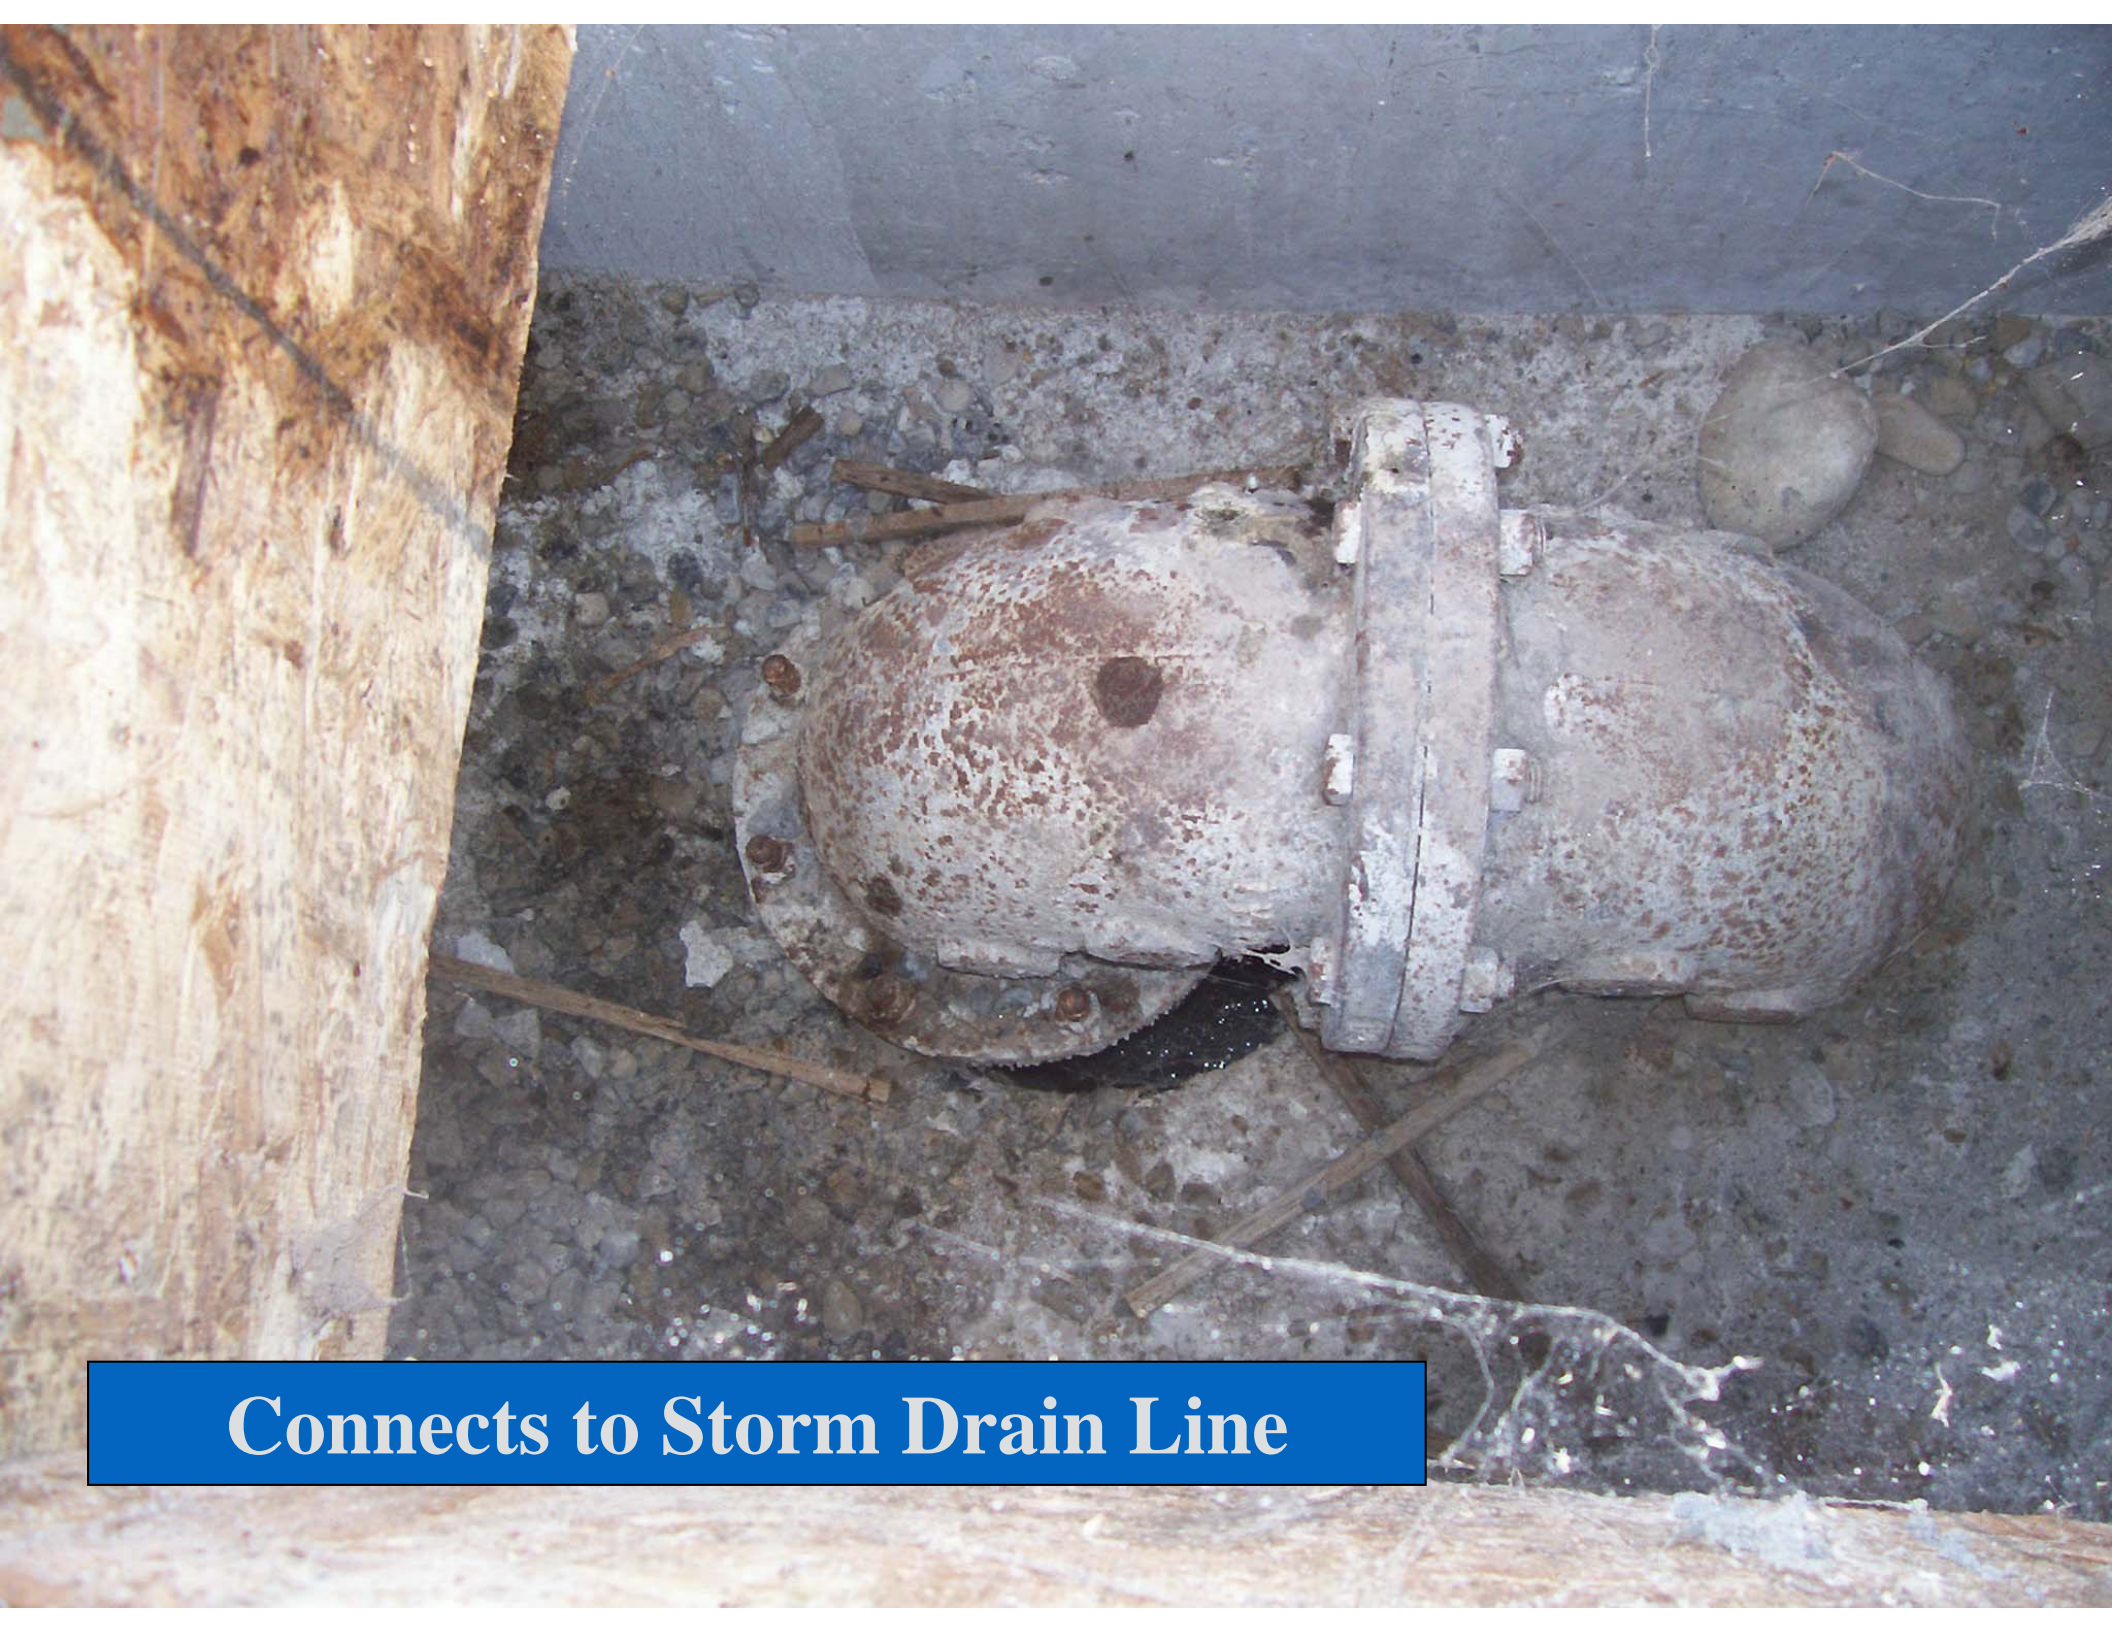
Terminates in Buried Pit

Connects to Storm Drain Line
