UTAH DEPARTMENT of
ENVIRONMENTAL QUALITY
**DRINKING
WATER**

Water System Facilities Sanitary Surveys-2018 Part 2

Storage Tanks

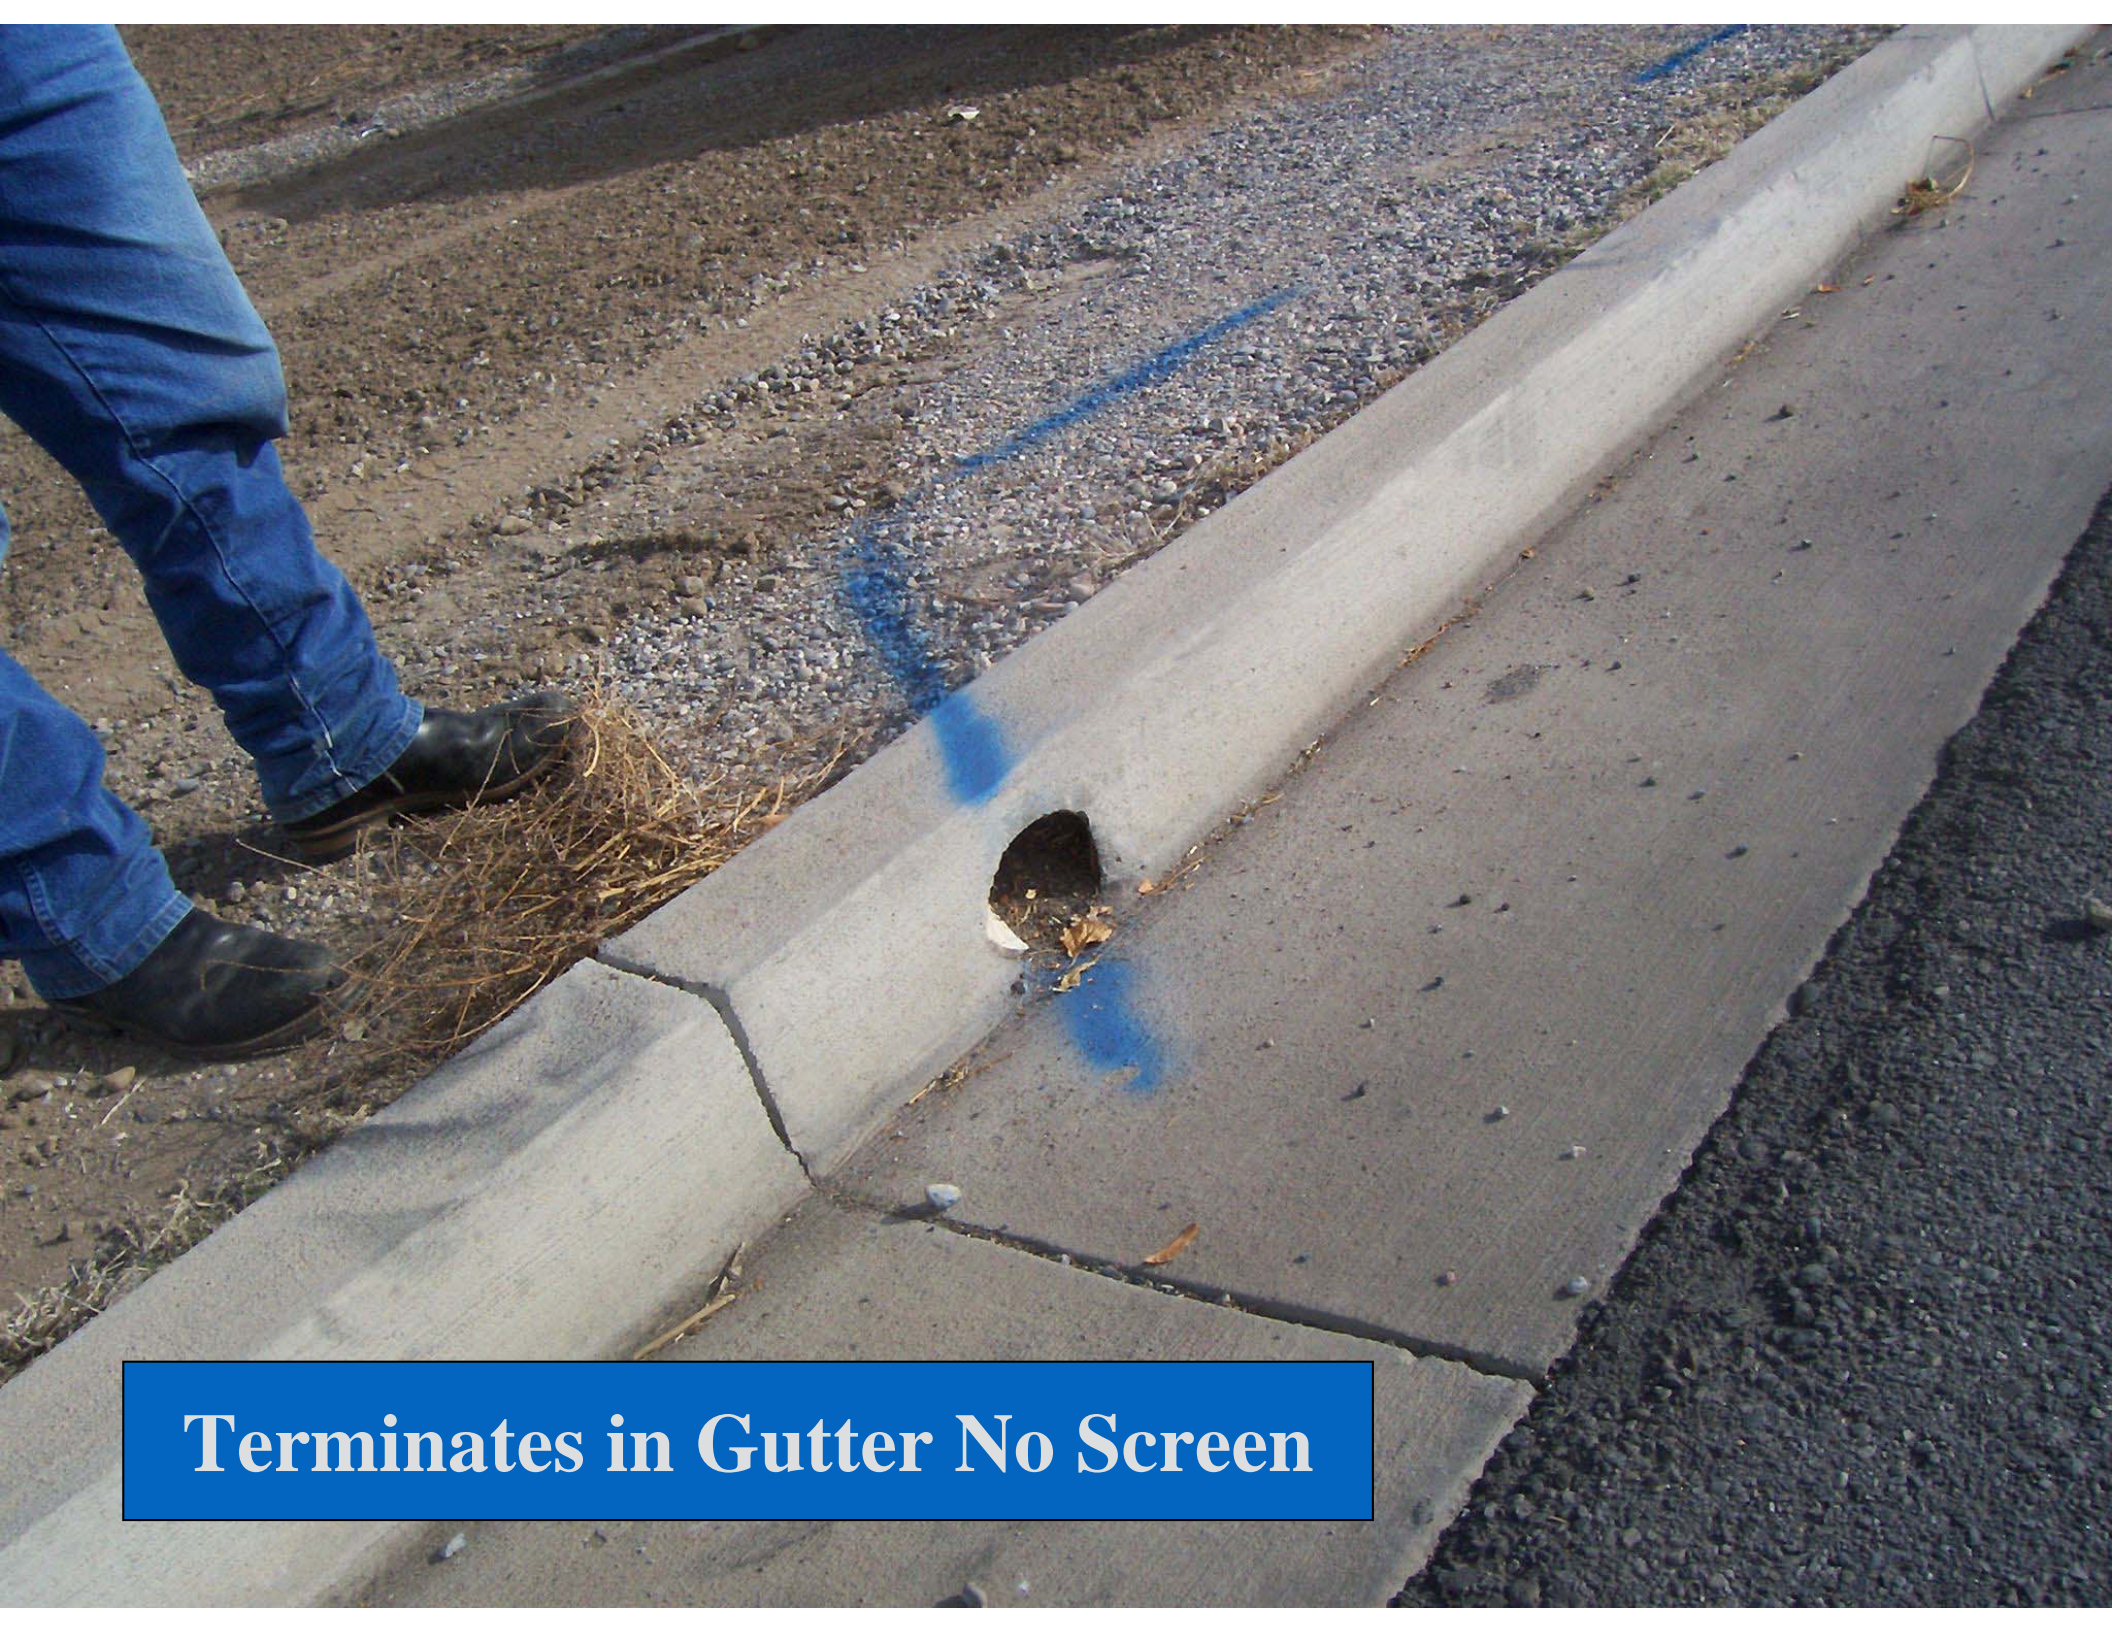
Terminates in Gutter No Screen
