**FOURTH FIVE-YEAR REVIEW REPORT FOR
EUREKA MILLS SUPERFUND SITE
JUAB COUNTY, UTAH**

**Utah Department of Environmental Quality
Division of Environmental Response and Remediation**

**U.S. Environmental Protection Agency
Region 8
Denver, CO**

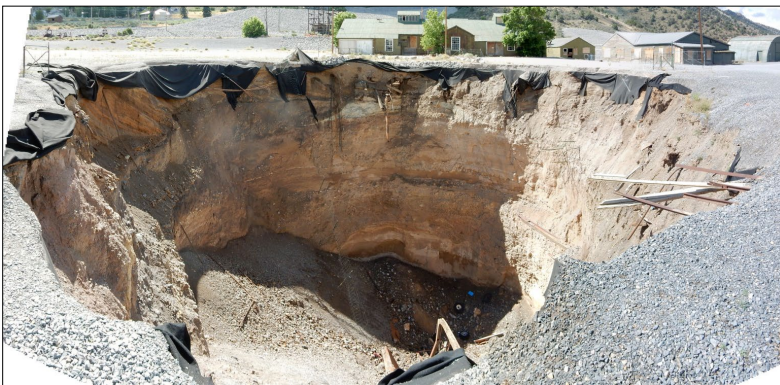
Subsidence in the waste rock at the shaft location was noted in 2016 and had grown to 100 ft diameter and 80 ft deep by spring 2017. Spectrum Engineering was contracted by AMRP to design a safeguard for the subsidence. Through coordination with the landowner, the City of Eureka, Utah DERR, US EPA, and AMRP, a design was developed to fill the subsidence hole with material from a nearby repository of contaminated soil. The design included a reinforced concrete plug at the bottom and recapping of the disturbed area.

Aerial image, June 2017.

Nelco Contractors of Price, Utah was awarded the contract for the project. The work included: installation of a one-foot thick, reinforced concrete plug approximately 30' x 100' near the bottom of the subsidence hole; excavation, haulage, and dumping of approximately 12,831 cubic yards of contaminated waste soil for backfill from a repository located 1,000 ft from the site; and installation of a protective cap consisting of 16,000 sf geotextile and 440 cy crushed limestone.

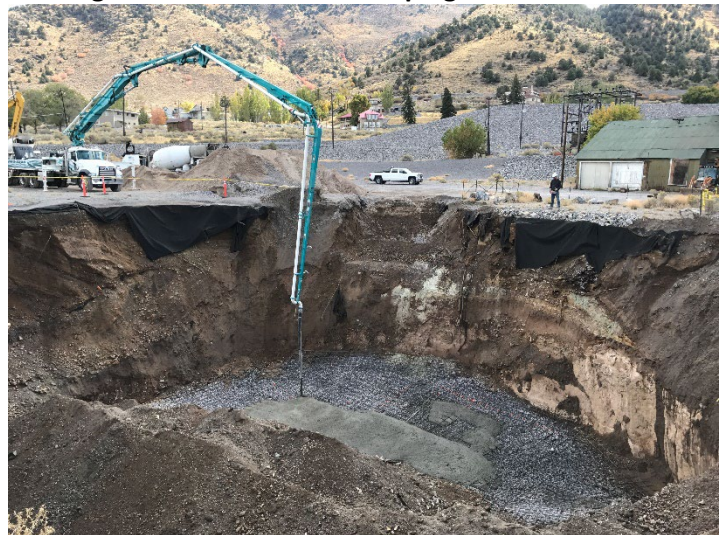
Below: Chief No. 1 subsidence during reclamation.
Pouring the reinforced concrete plug.

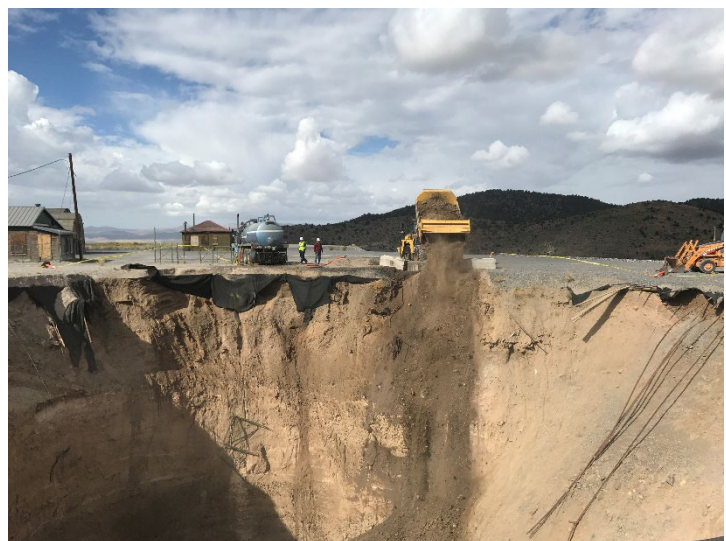
Backfilling the subsidence hole.

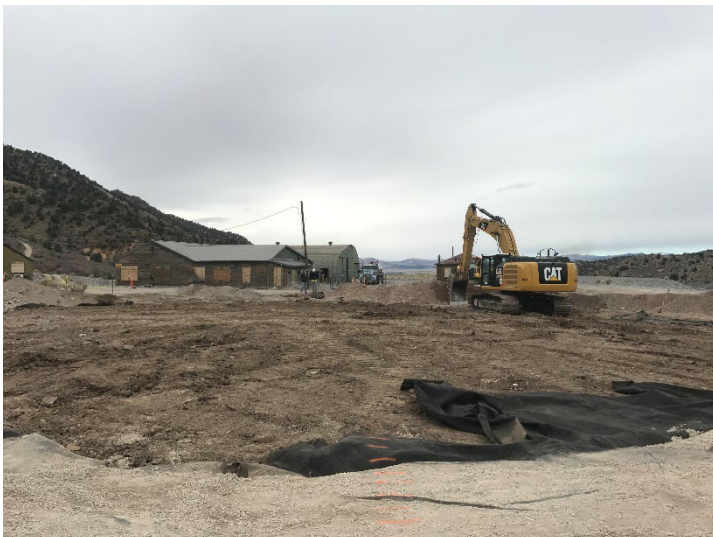
Backfill complete. Preparing to replace cap of geotextile and crushed limestone.

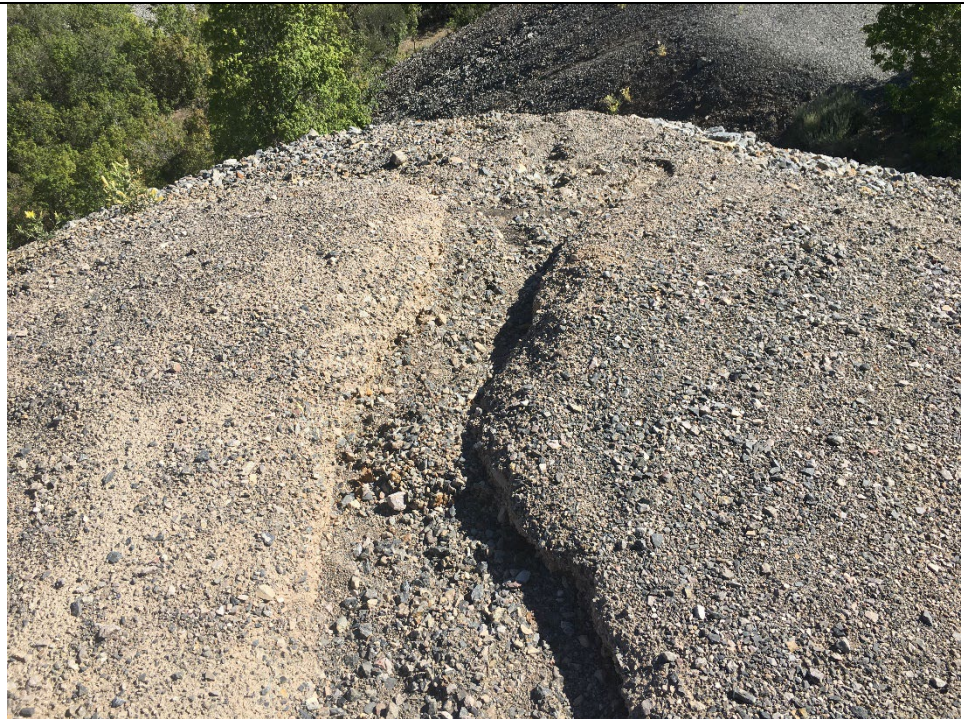
Photo 2

Erosion Rill observed on the northeast corner of the Upper Godiva Mine Waste Pile

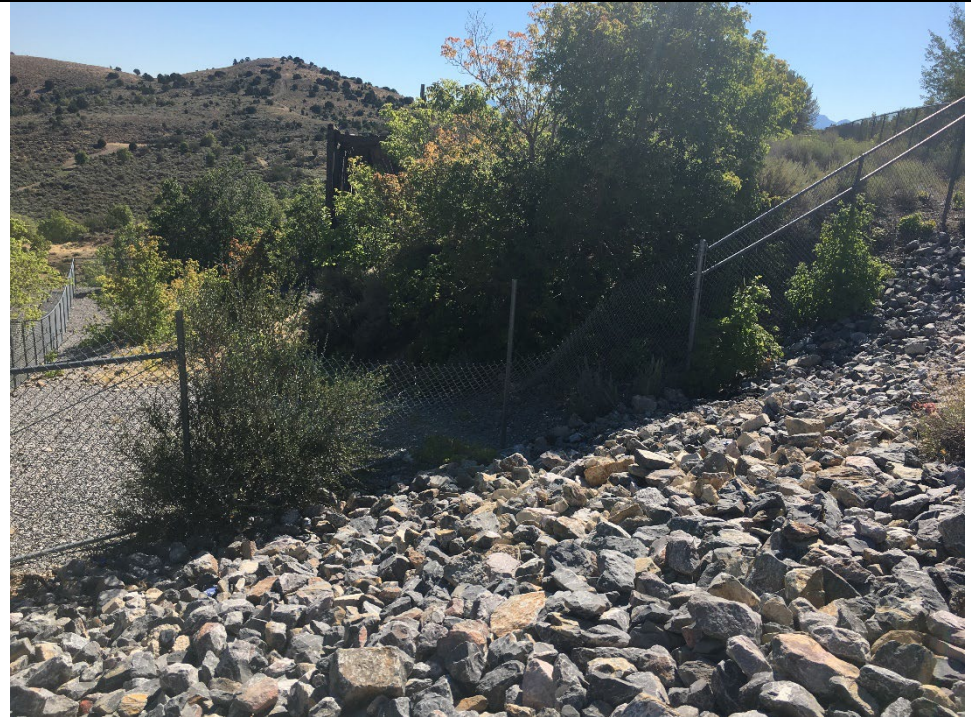
Photo 4

Observed damage to
the west fence at the
Godiva Shaft

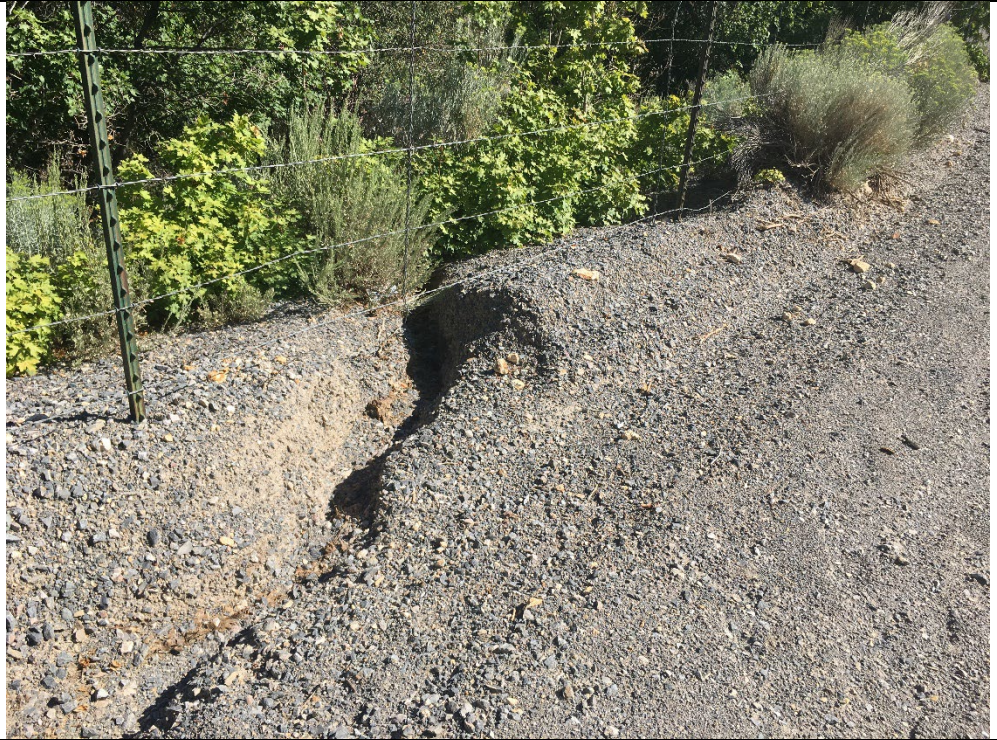
Photo 5

Erosion rill on north side of access road to May Day and Godiva Mines.

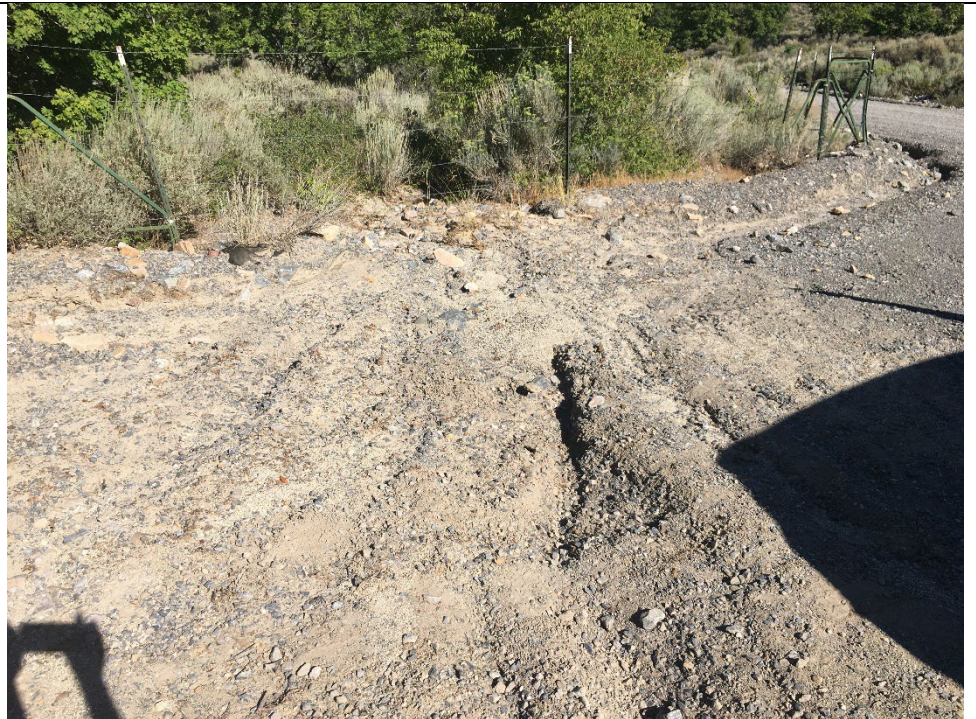
Photo 6

Erosion rill at northwest corner of Knightsville Road and the access road to May Day and Godiva Mines.

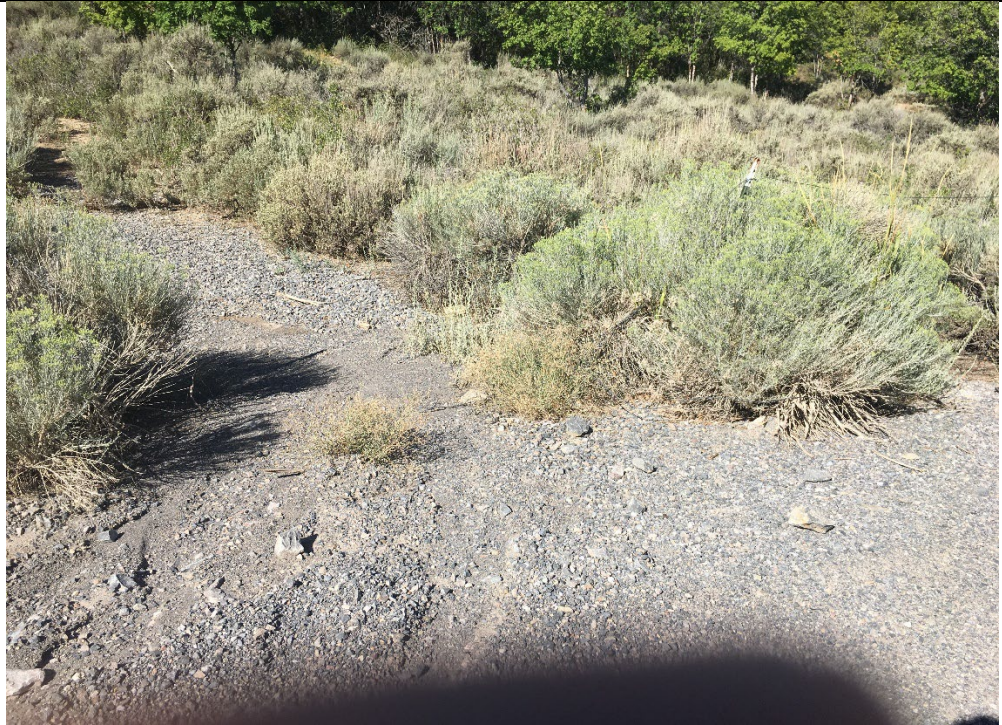
Photo 7

Damaged/missing wire fencing on the west side of Knightsville Road.

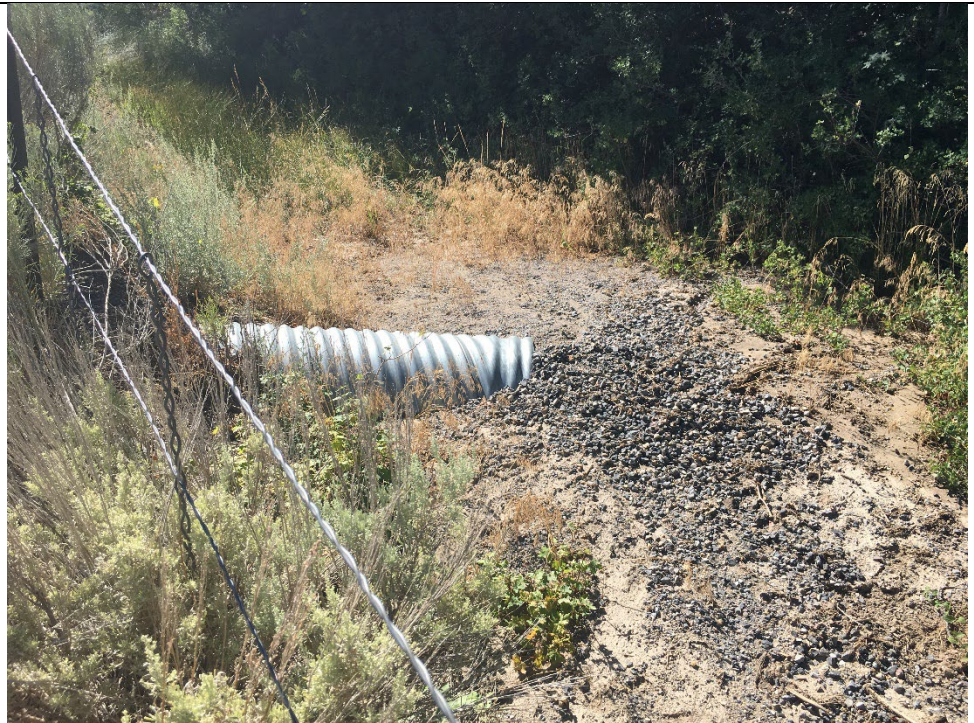
Photo 8

Debris blocking the culvert on the west side of Knightsville Road.

- A small gravel blockage was noted on the west side of the drainage culvert underneath the road. Juab County is responsible for the maintenance of Knightsville Road and repairs will be completed by September 2023.
- Substantial amounts of vegetation, including small trees and bushes, were observed in the Upper and Lower Eureka Gulches. The DERR will work with Eureka to spray the Upper and Lower portions of the Eureka Gulch with herbicide in the fall of 2023 and remove dead vegetation in the spring of 2024.
- Inform property owner of prohibition on residential use, including RV parking.

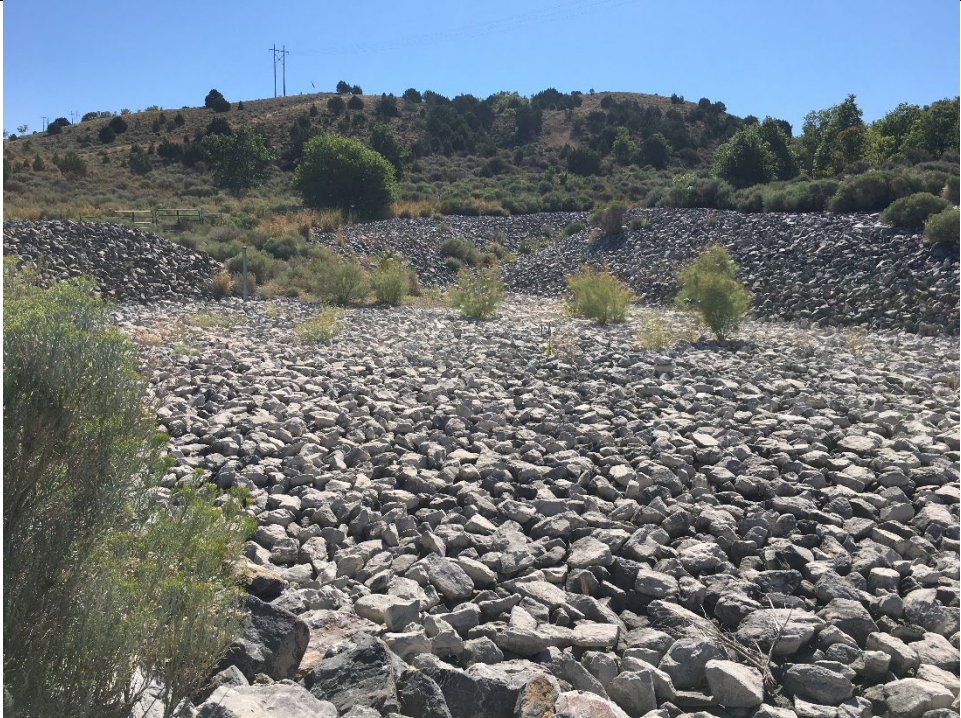
Eureka Mills		Photo 9
Date: 08/17/2022

View: South		
<p>Observed vegetation in Sedimentation Pond KC-1.</p>

Vegetative growth was noted at multiple RAS and drainage areas. Although generally minor at the time of the inspection, the vegetation should be monitored closely during subsequent Site inspections and a contractor should be hired to spray the areas with herbicide to remove the shrubs if the vegetative growth becomes more substantial in the future.

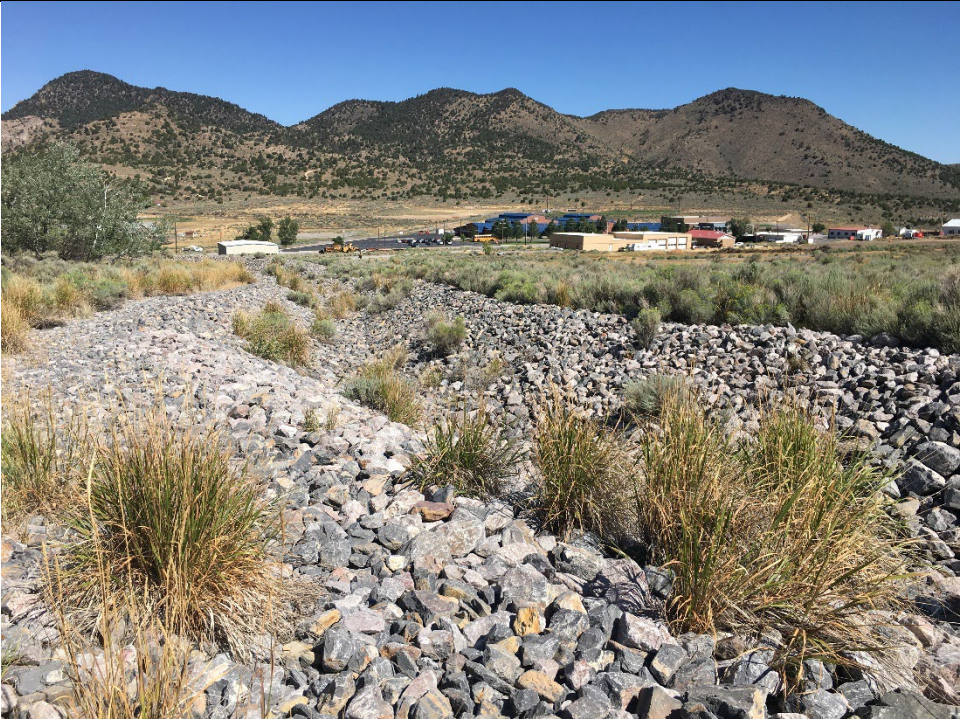
Eureka Mills		Photo 10
Date: 08/17/2022

View: North		
<p>Vegetation in the drainage channel between KC-1 and KC-2 Sedimentation Ponds.</p>

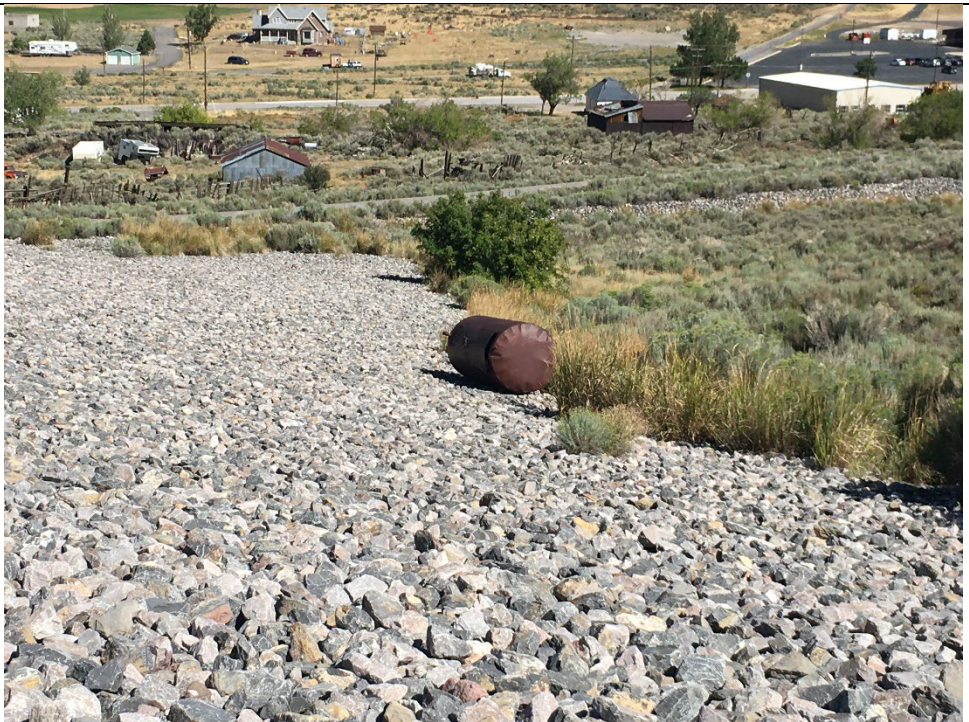
Rusted storage tank at the east side of Chief Mine No. 2.

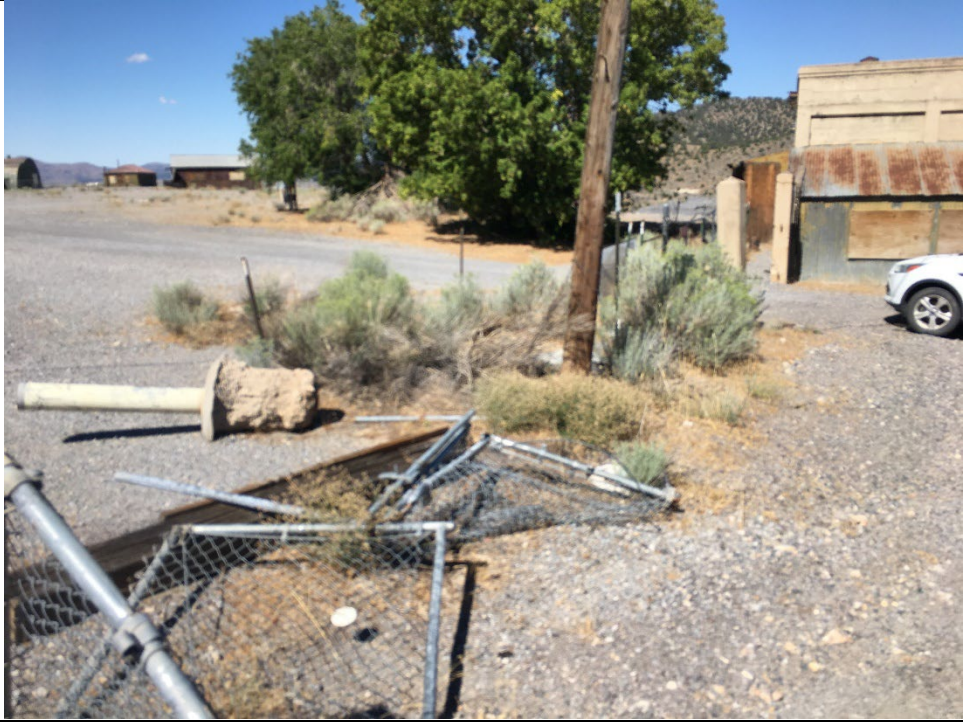
Eureka Mills	Photo 13
Date: 08/17/2022

View: Northwest	
<p>Damaged fence at Chief Mine #1.</p>

- Repairs will need to be made to the east fence at Chief Mine #1. The damaged fence allows potential trespassing onto the property and the capped areas of Chief Mine #1. The DERR will discuss the damage to the fence at Chief Mine #1 with the property owner. Repairs will be completed by September 2024.

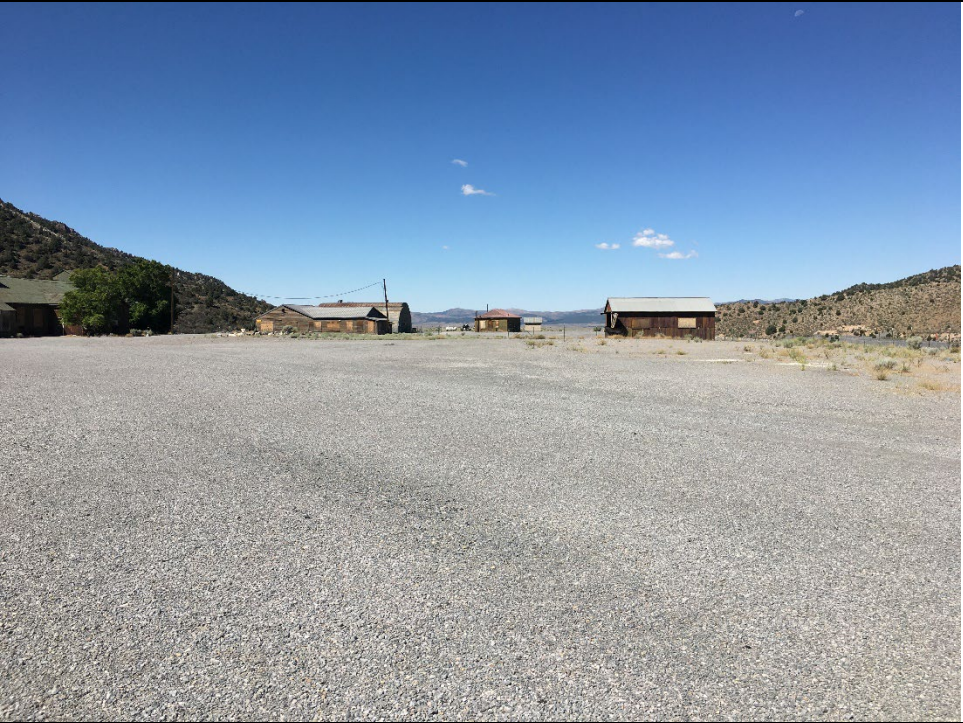
Eureka Mills	Photo 14
Date: 08/17/2022

View: West	
<p>Cap at Chief Mine #1. Location of the former sinkhole identified in 2018 Five-Year Review is at center of photo.</p>

Other Findings #2: A sinkhole associated with mining activities was observed on the eastern surface of the Chief Mine No. 1 Waste Pile. The sinkhole collapsed the armored cap and waste tailings soils beneath the cap into the abandoned mine shaft below the ground surface. The sinkhole was an oblong shape and measured at 100 feet by 30 feet and 80 feet deep. The Utah Department of Natural Resources, Division of Oil, Gas and Mining, Abandoned Mine Reclamation Program, in coordination with Eureka, DERR, and EPA, contracted the work to repair and close the sinkhole. An engineering proposal was developed by Spectrum Engineering to place a reinforced concrete plug near the bottom of the sinkhole and backfilled the remainder of the subsidence area with 12,831 cubic yards of soils removed from the Open Cell. The cap was then repaired with the installation of 16,000 square feet of geotextile fabric and covered with 440 cubic yards of crushed limestone. The work was completed in October 2018 and a summary of the activity is included as Appendix D of this report.

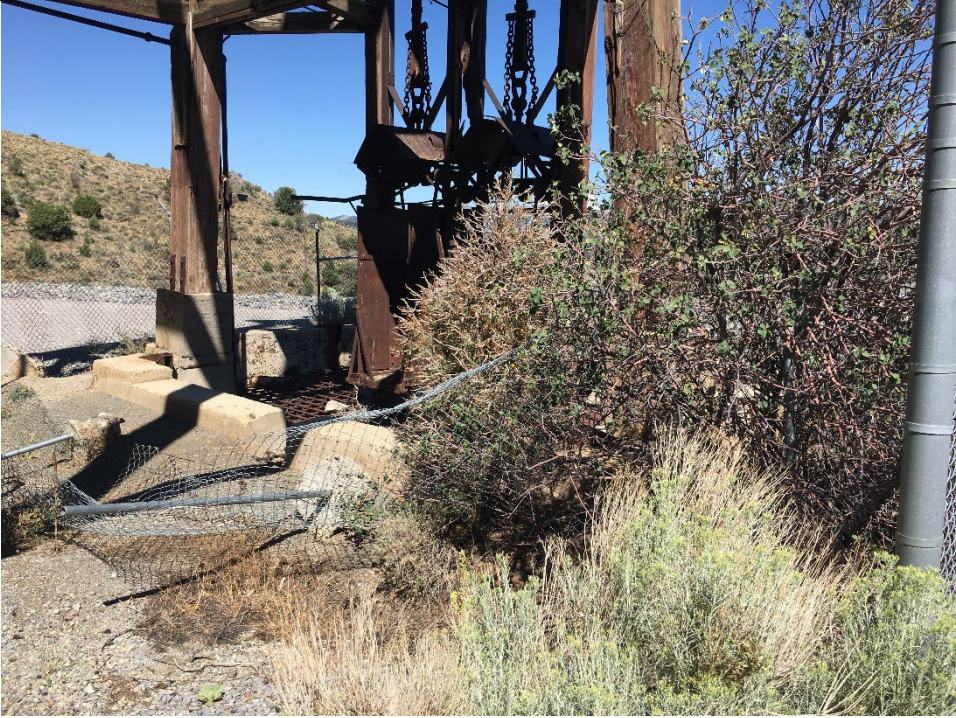
Eureka Mills	Photo 15
Date: 08/17/2022

View: West	
<p>Damaged/missing fencing at the Eagle/Blue Bell Mine Shaft.</p>

- Repair the chainlink fencing along the east side of the Eagle Blue Bell Mine Waste Pile head frame. The damaged fence allows for trespass into the mine shaft area. Although the mine shaft was closed by the Utah Division of Oil, Gas and Mining, Abandoned Mine Program, hazards still exist in the area. Repairs will be made by September 2024.

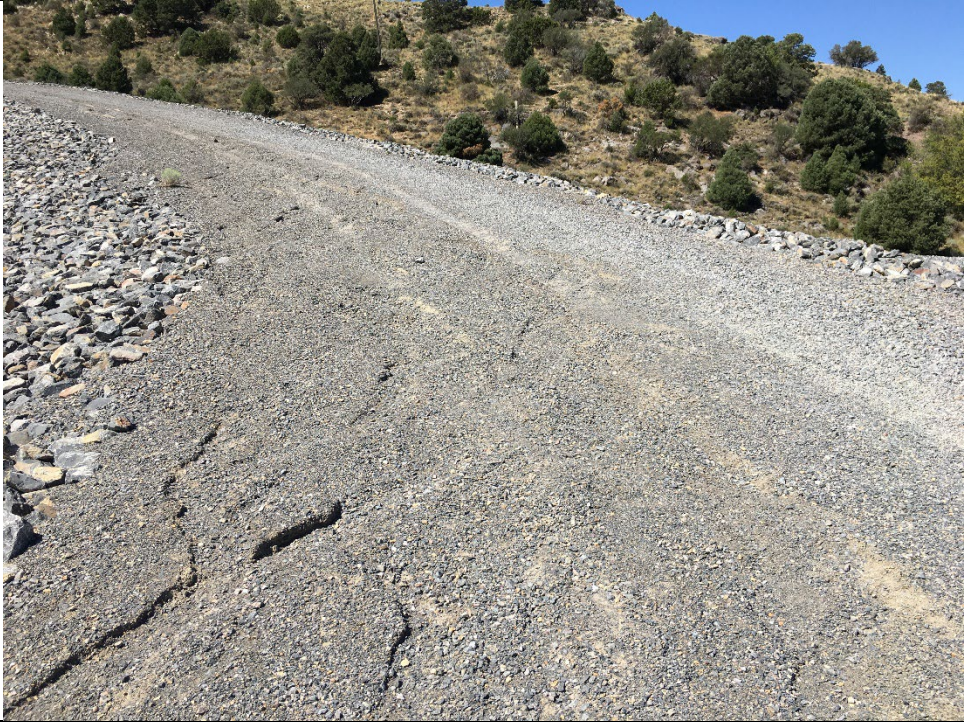
Eureka Mills		Photo 17
Date: 08/17/2022

View: Southwest		
<p>Erosion rills in the access road leading up to Eagle/Blue Bell.</p>

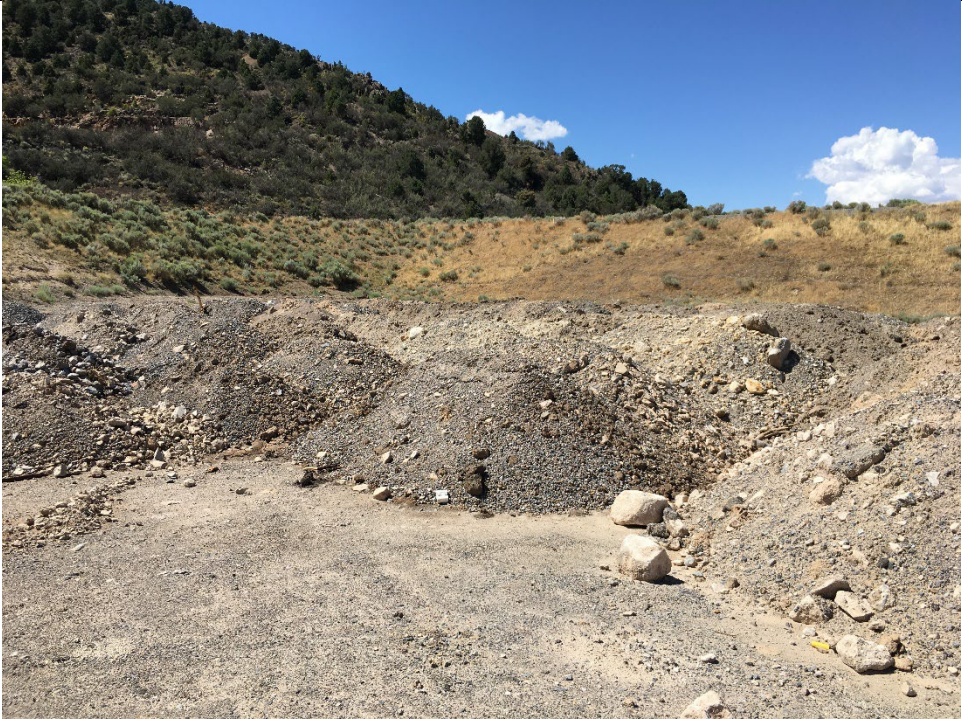
Eureka Mills		Photo 21
Date: 08/17/2022

View: Southwest		
Soil piles staged inside the Open Cell. Staging of soils is not consistent with compaction and grading requirements for soil in the Open Cell.

The inspection found that the RASs, including the capped mine waste piles, drainages, sediment ponds, and haul/access roads, were in generally good condition and remain protective of human health and the environment. However, there were several areas of concern identified during the Site inspection that will need to be addressed during the next five-year period. Within the Open Cell, the inspection found approximately 45-50 piles of soil that had not been properly graded or compacted. The DERR also identified what appeared to be construction debris

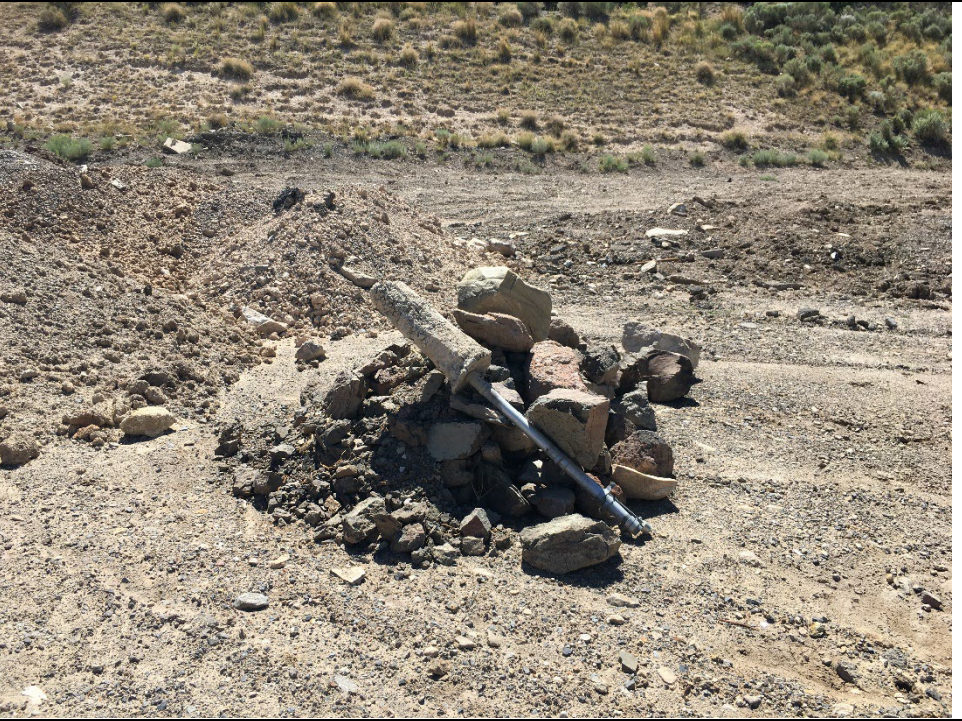
Eureka Mills		Photo 22
Date: 08/17/2022

View: South		
Construction debris including asphalt, cement, and a steel pole dumped in the Open Cell.

improperly disposed of in the Open Cell. The gate at the top of the Open Cell appeared damaged and in need of repair which may have lead to illegal dumping within the Open Cell. The drain line leading from the decontamination pad at the Open Cell was not functioning properly. Lynn Elliott believed the drain line has collapsed at a location beneath the access road, prohibiting water inside the decontamination pad from properly draining. Following the inspection, the DERR coordinated with Lynn Elliott and Drew Froula with concerns regarding the condition of the Open Cell. Lynn Elliott stated the construction debris was likely the result of illegal dumping and the City would remove the the steel posts for proper disposal in the municipal landfill. The City also coordinated with contractors for Dominion Energy to remove asphalt and concrete from the piles for proper off-site disposal and to grade and compact the soil piles. Information from Trent Hamada and Randy Johnson with Dominion Energy confirmed the removal of asphalt and concrete from the soil piles for off-site disposal and that the soil piles were properly graded and compacted in October 2022. The DERR continues to work with the city to address the needed repairs to the gate and decontamination pad. The repairs to the decontamination pad are being addressed through a work assignment with the Level of Effort (LOE) contractor and are scheduled for completion in the fall of 2023. The gate repairs will be made in the fall of 2023.

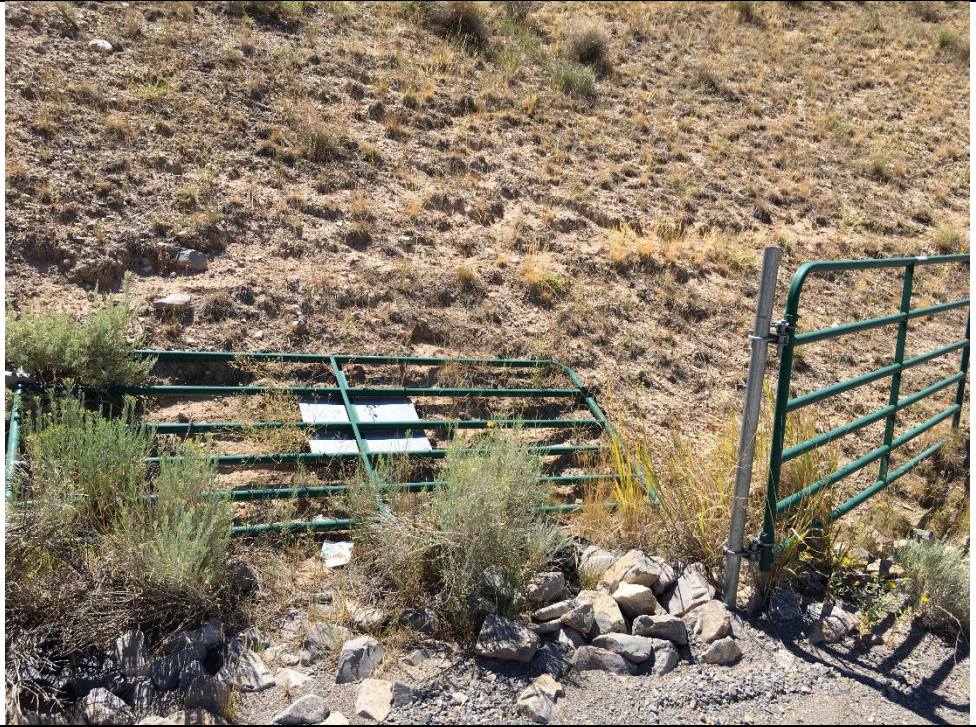
Damage to the fence at the top of the Open Cell.

- Repair the gate at the top of the Open Cell. The current damaged condition of the gate allows for trespass and illegal dumping of potentially unauthorized wastes in the Open Cell. The gate will be repaired by September 2024.

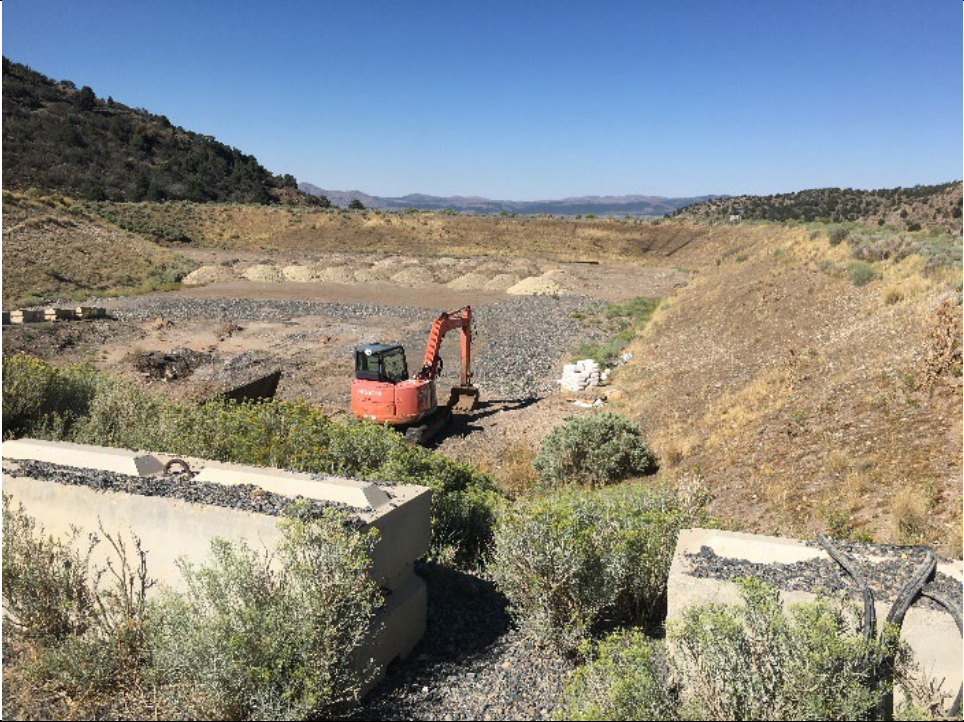
Eureka Mills		Photo 29
Date: 09/02/2022

View: West		
<p>View of the Open Cell. Additional soil piles have been added to the Open Cell with no effort to compact or grade the soils.</p>

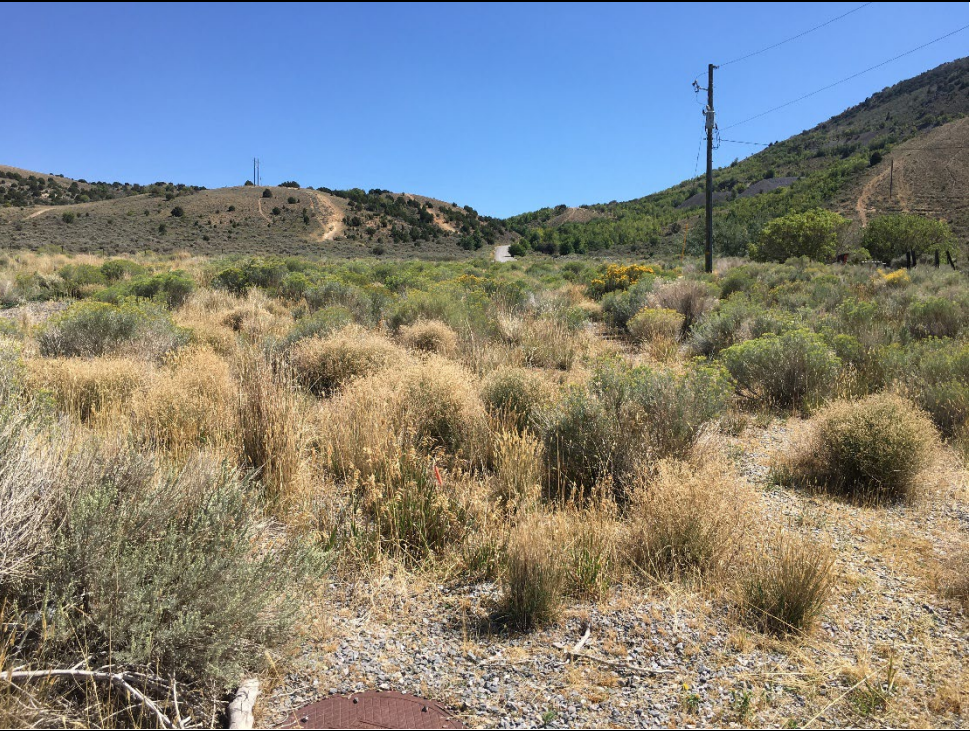
Eureka Mills		Photo 30
Date: 09/02/2022

View: South		
<p>View south from Manhole 5 (at bottom) along Knightsville Drainage. Vegetation prevented the DERR from finding other manhole locations.</p>

The inspection also found dense vegetation including brush and small trees within the Upper and Lower Eureka Gulches. Maintaining the gulches clear of debris and vegetation is the responsibility of the city of Eureka. The dense vegetation was noted during the previous 2021 inspection and did not appear to have been properly sprayed with herbicide. The issue was brought up with Lynn Elliott and Drew Froula during the September 2nd inspection and the DERR will continue to work with Eureka to clear the gulches.

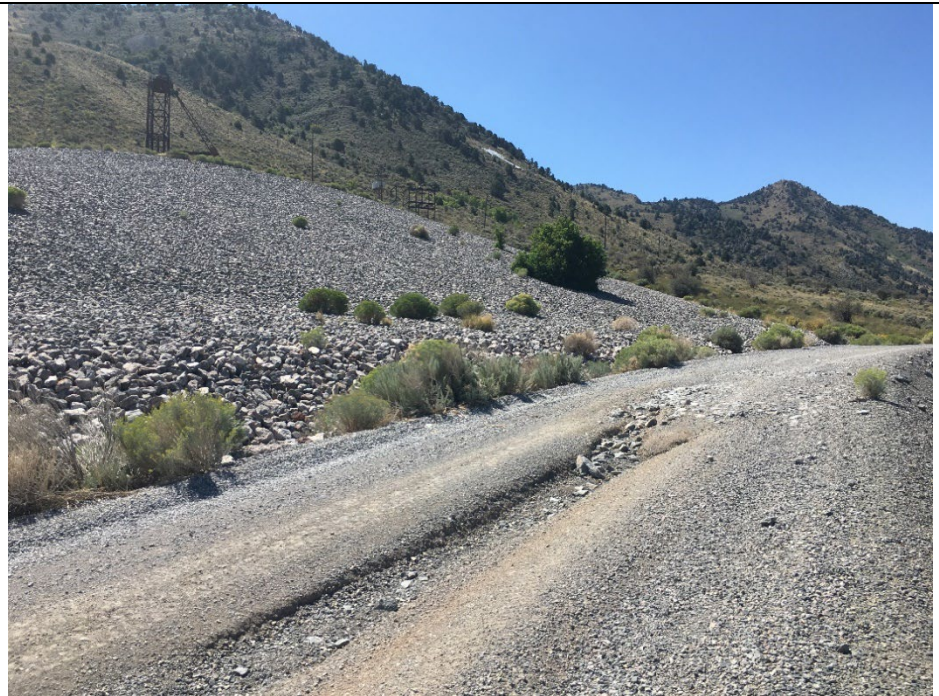
Photo 32

Deep erosion channel in the Chief Mill Site No.1 Access Road at the base of Chief Mine No.2 waste pile.

Deep erosion rills were observed at two locations along the Chief Mill Site No.1 Access Road (Haul Road), the first at the base of the Chief Mine No. 2 Waste Pile and a second rill near the Gardner Canyon sedimentation ponds. The DERR will develop a scope of work to procure a contractor to conduct the maintenance repairs and anticipates that the work should be completed in the fall of 2023.

- Deep erosion rills with some areas of exposed marker barriers were observed at two locations along the Chief Mill Site No. 1 access road, the first at the base of the Chief Mine No. 2 Waste Pile and a second rill near the Gardner Canyon sedimentation ponds. The DERR will work to develop contracts for the repair work. Repairs to the Haul Road will be completed by November 2023.

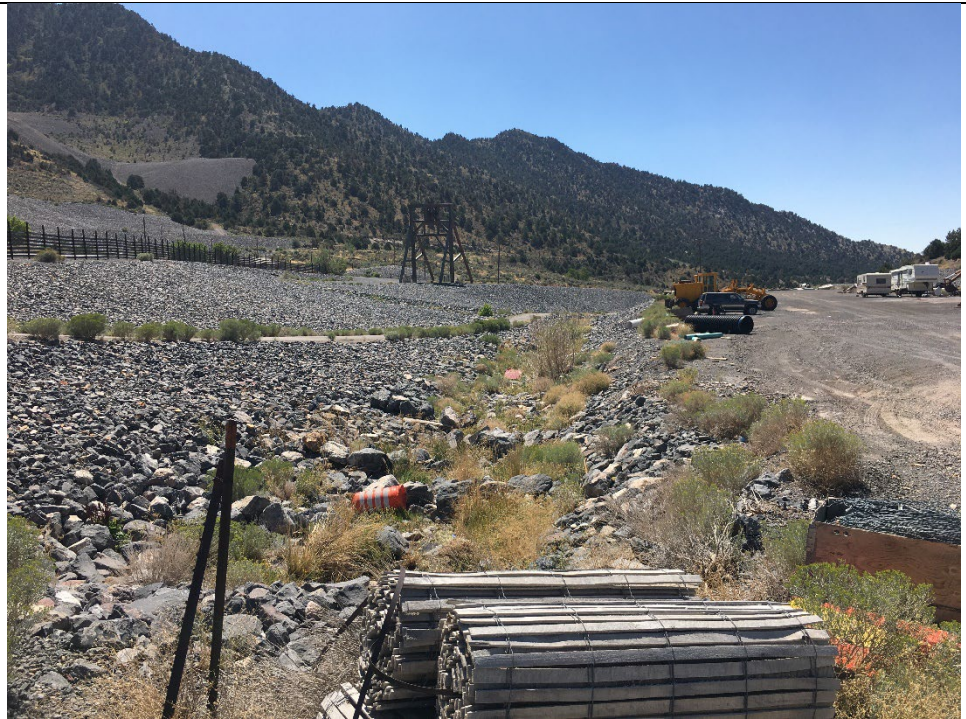
Photo 38

Lower Eureka Gulch through the City Yard. Debris and vegetation visible in the gulch.

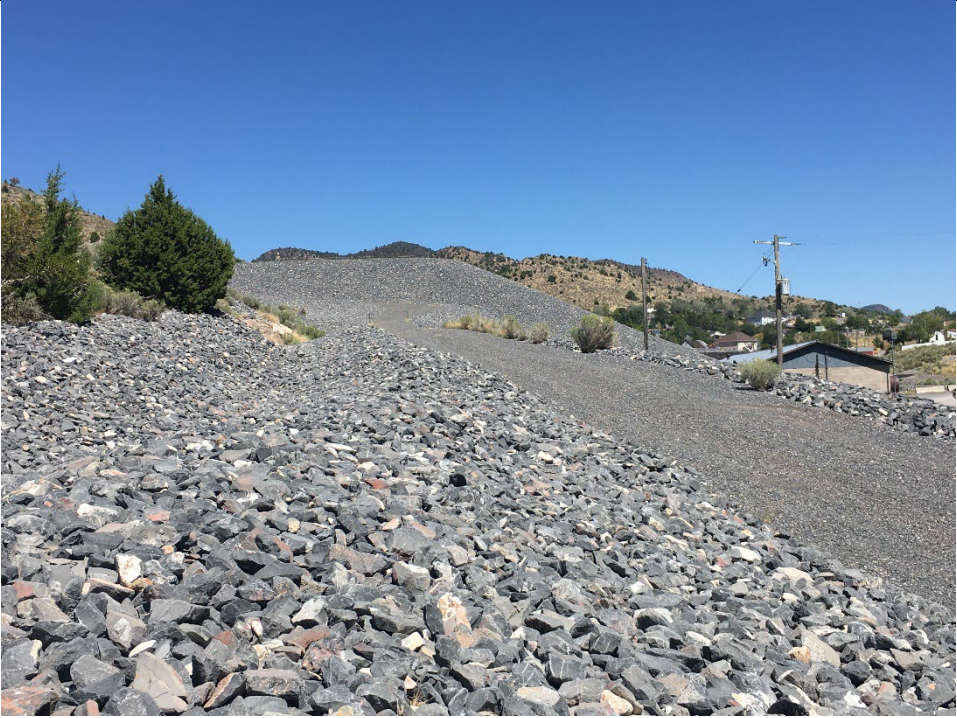
Eureka Mills		Photo 39
Date: 09/02/2022

View: Northeast		
<p>Access road leading up to the Bullion Beck and Gemini Mine Waste piles. Gate at the top of the access road was reportedly locked and locks changed.</p>

- The locks to several gates, notably gates to the Chief Mine #1, Snowflake Mine Waste Pile, Gemini Mine Waste Pile and the Bullion Beck Mill and Mine Waste Pile areas were reportedly removed and replaced by the property owners, prohibiting access to these areas for the inspection. The DERR and EPA will need to work with the property owners to restore access to these locations by September 2023.
