*File: IUC Cell 4A
Rnd 1 Interrog.
Resp.*

Re: Cell 4A Lining System Design Report, Response to DRC Request for Additional Information – Round 1 Interrogatory, Cell 4A Design.

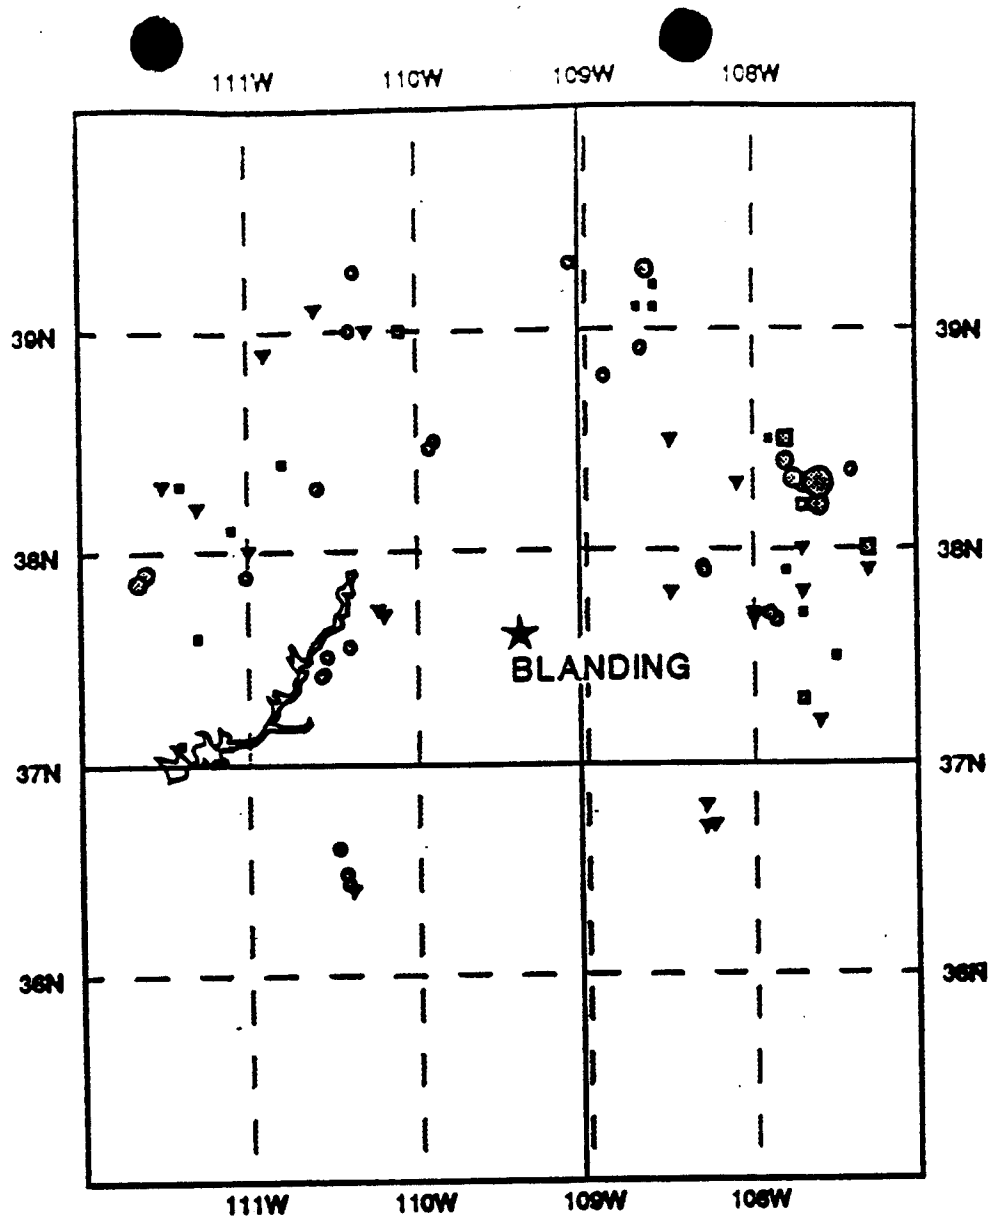
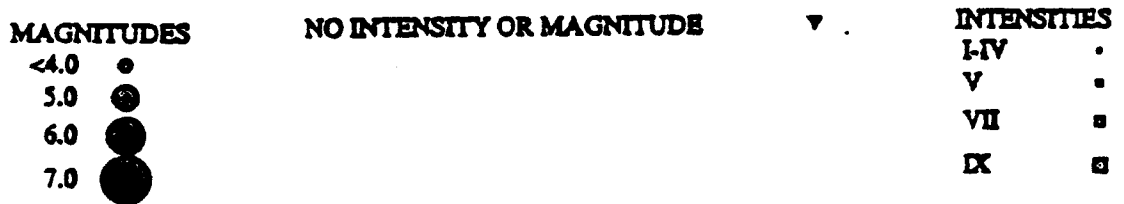
UMETCO MINERALS CORPORATION
 WHITE MESA PROJECT
SEISMICITY
 200KM AROUND
 BLANDING UTAH
 JUNE, 1988 FIGURE A-4

Only 63 non-duplicative epicenters have been recorded within a 120 mile (200 km) radius of the project area (Figure A-4). Of these, 50 had an intensity IV or less (or unrecorded) and two were recorded as intensity VI. The nearest event occurred in the Glen Canyon National Recreation Area approximately 38 miles (63 km) west-northwest of the project area. The next closest event occurred approximately 53 miles (88 km) to the northeast. Just east of Durango, Colorado, approximately 99 miles (159 km) due east of the project area, an event having local intensity of V was recorded on August 29, 1941 (Hadsell, 1968). It is very doubtful that these events would have been felt in the vicinity of Blanding.

103 EARTHQUAKES PLOTTED

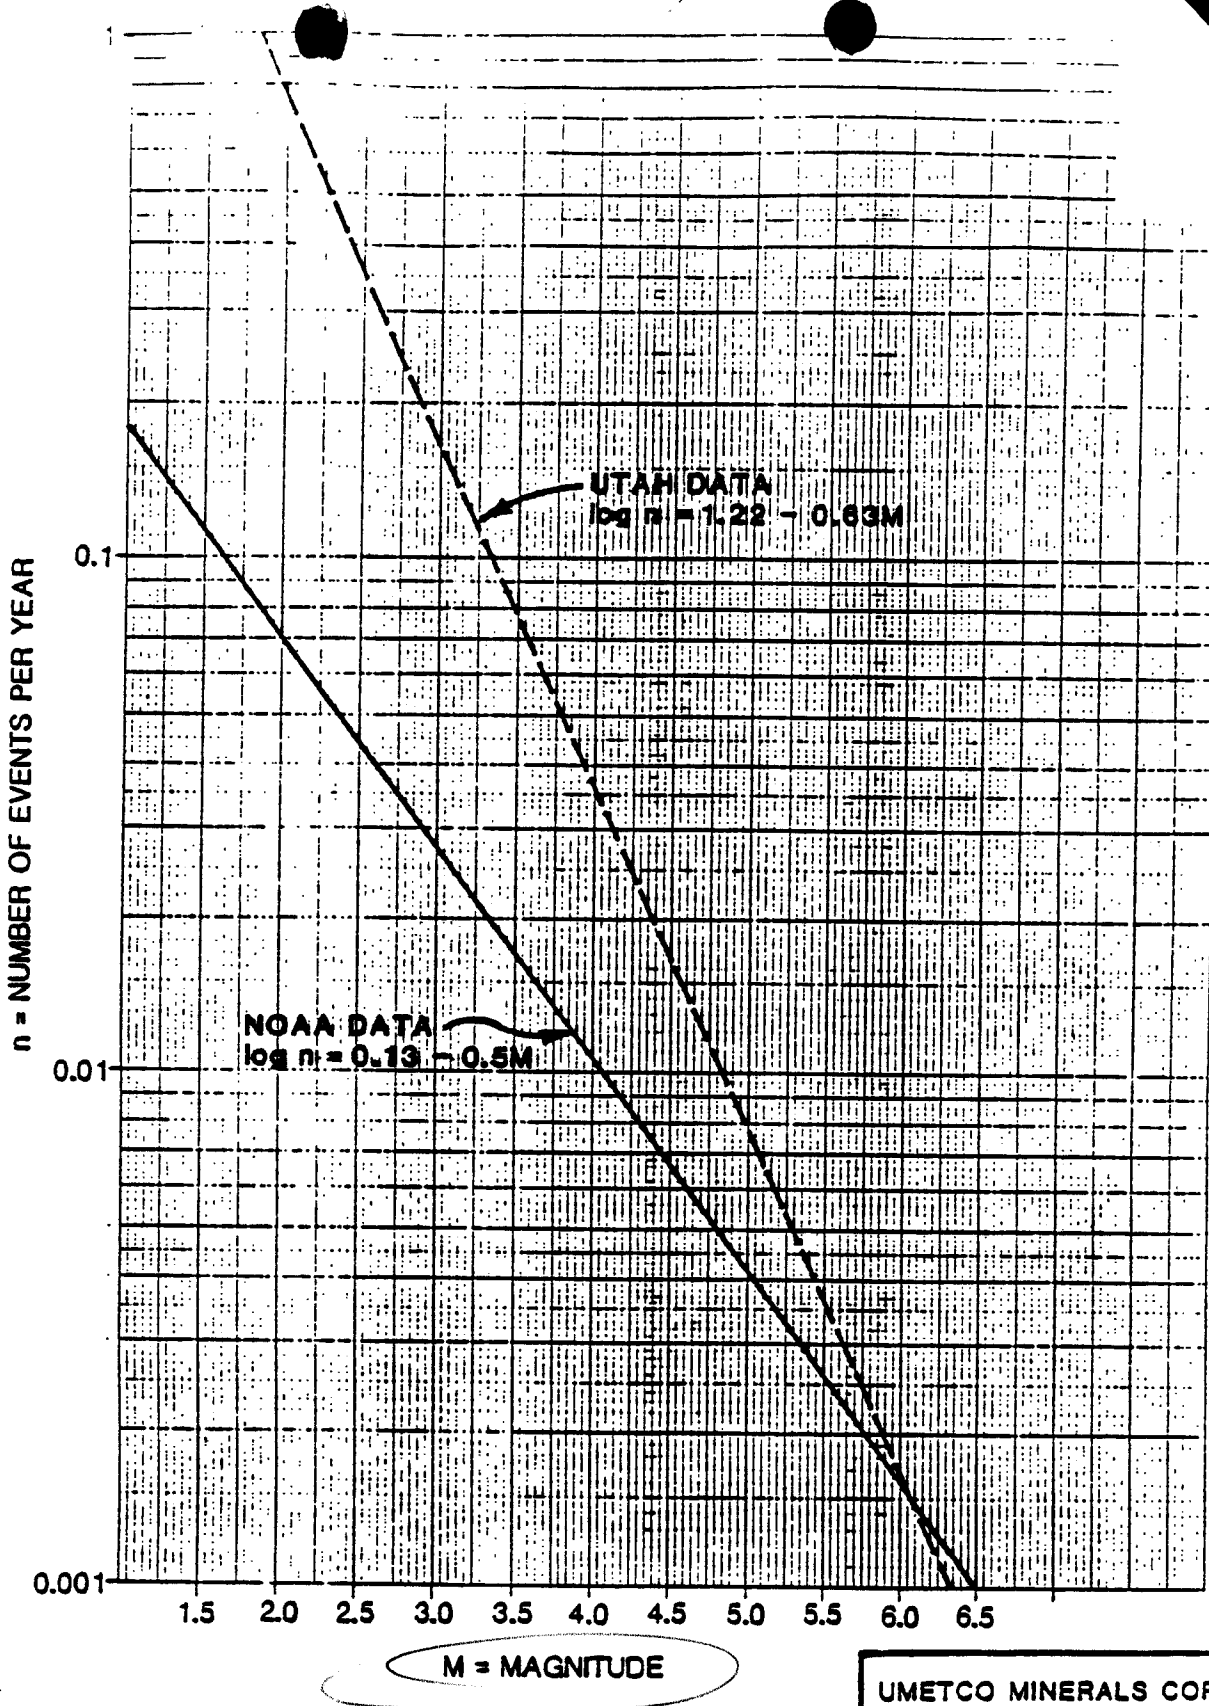
JUNE, 1988 FIGURE A-7

COVERS AREA WITHIN A 75 KM
 RADIUS OF THE PROJECT SITE

UMETCO MINERALS CORPORATION
 WHITE MESA PROJECT
 MAGNITUDE / FREQUENCY
 RELATIONSHIP

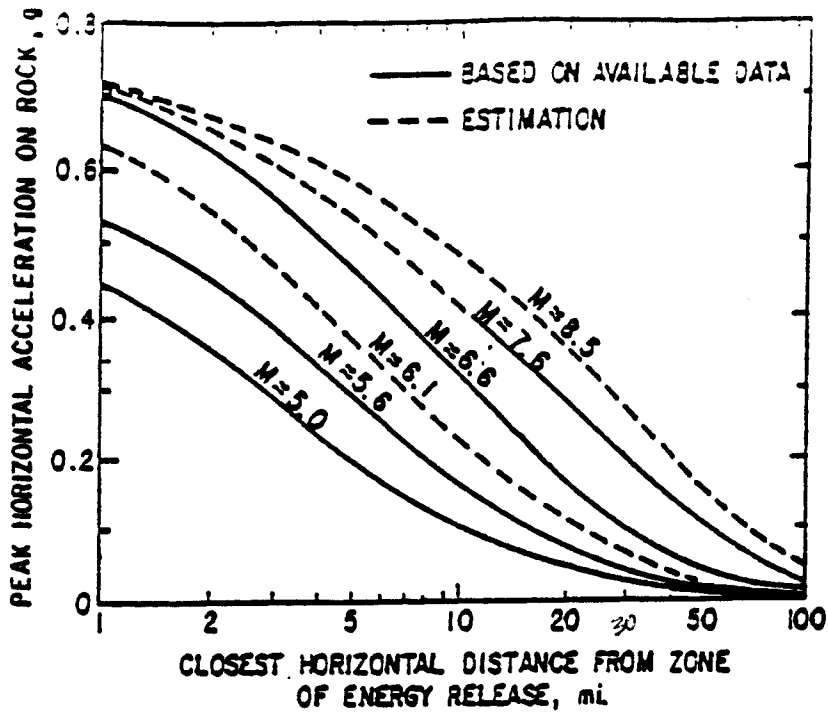
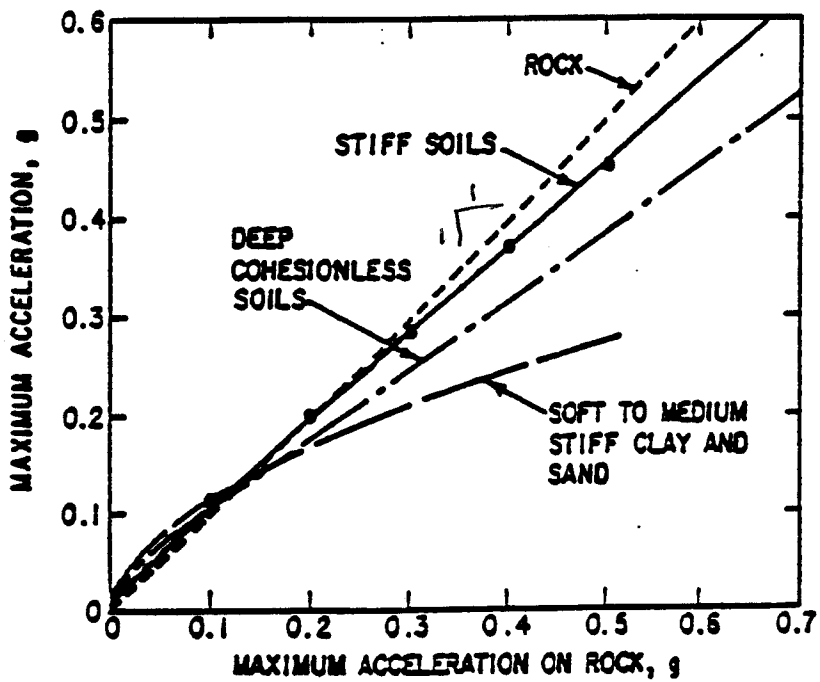
(From Seed and Idriss, 1982)

UMETCO MINERALS CORPORATION
 WHITE MESA PROJECT
 GROUND ACCELERATION
 CURVES

Ground motions at the White Mesa project site resulting from an maximum credible earthquake (MCE) on the fault discussed can be estimated from attenuation curves established by Seed and Idriss (1982). The graph in Figure A-9 indicates an estimated peak horizontal acceleration at a distance of 57 km from the epicenter would be 0.07g.

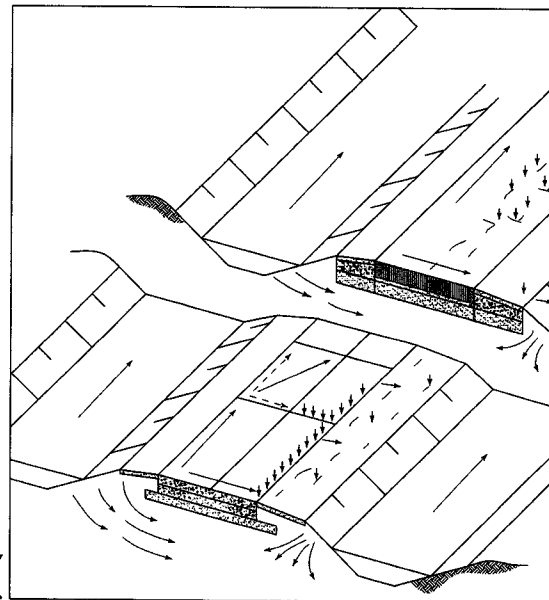
Points of water entry into highway pavement structural sections.

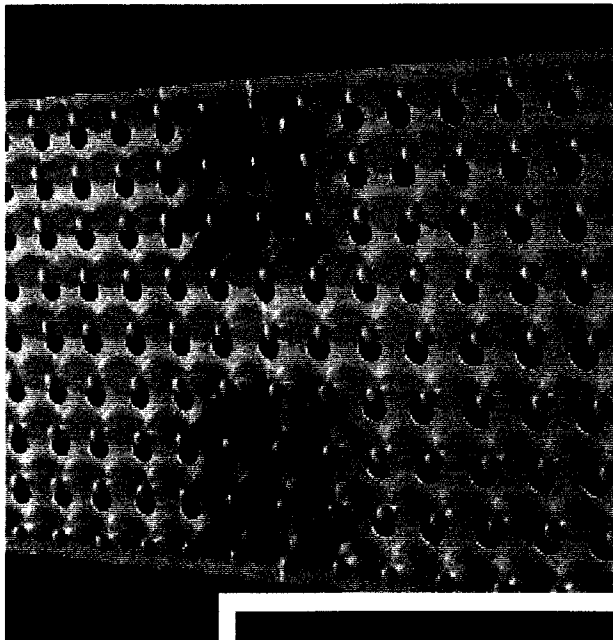
The snap-lock coupling provides a smooth and positive joint to connect rolls of STRIPDRAIN Geocomposite Pavement Edge Drains for increased flow efficiency.

The snap-lock coupling creates a positive connection between sections—providing high resistance to joint pull-apart and planar alignment—to ensure efficient flow characteristics and soil-tight connections.

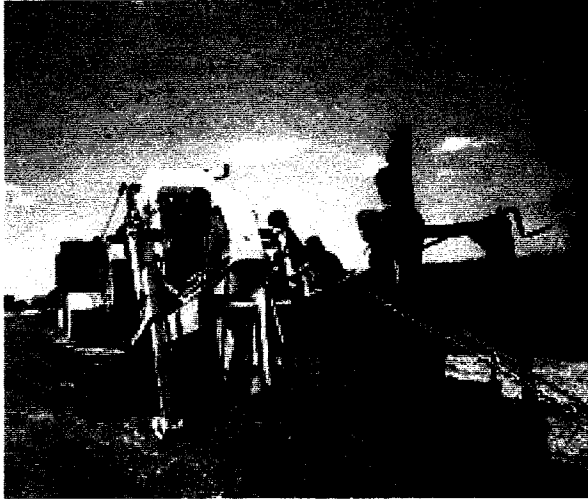
Conventional trenching equipment with placement boot makes installation fast and economical.

Wheel-type trenchers are suitable for excavation and placement of STRIPDRAIN in pavement edge drain applications (trench width and depth varies by job condition). It is furnished in rolls that are unrolled along the open trench, placed in a vertical position against the pavement edge and then backfilled.

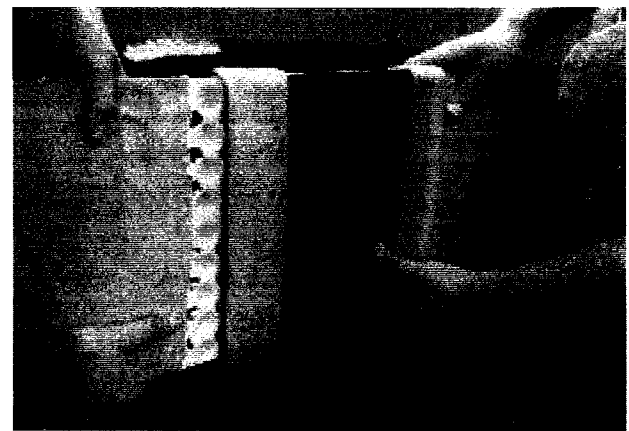
Soil-tight end outlet and side outlet fittings provide efficient discharge of ground water.
