APPENDIX H
RIPRAP DURABILITY

REPORT
FOR
SEQUOYAH FUELS CORPORATION
DISPOSAL CELL PROJECT

SOUTER QUARRY
RIP RAP SUITABILITY STUDY

**CMB Report 05-001:
Results of Slope Protection
Material Investigation of Souter
Construction Company, Souter
Quarry, Gore, OK, for the US
Army Engineer District, Tulsa**

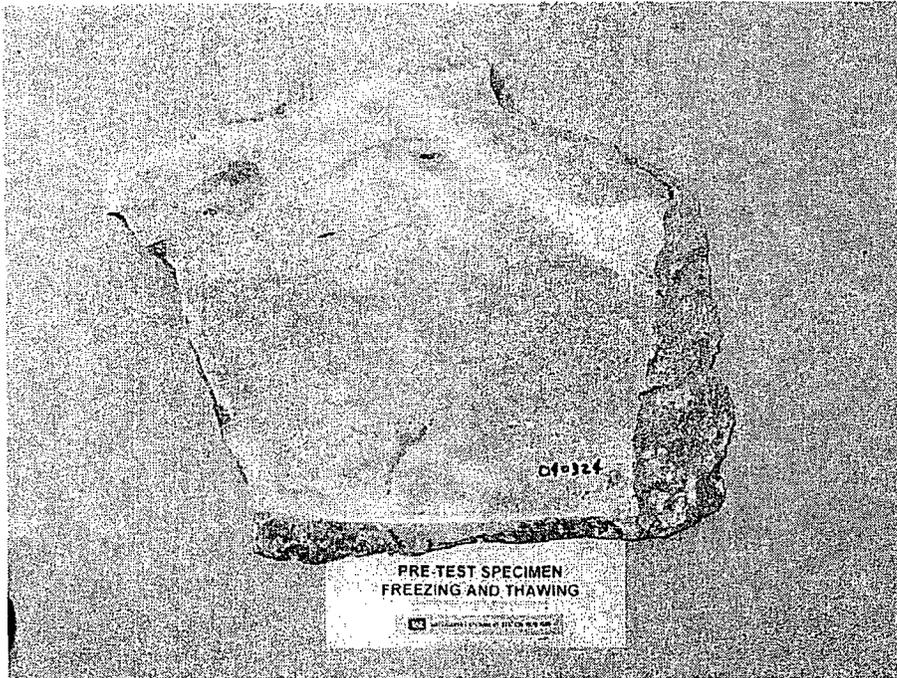
Photograph 1. Stone 040324a before subjected to 20 cycles of freezing and thawing.

The results of the resistance to cycles of freezing and thawing test, CRD-C 144, indicated the stones exhibited a loss of only 2.6% following 20 cycles of freezing and thawing. Photographs of the pre-test condition and post-test condition of each test slab are enclosed in Appendix B.

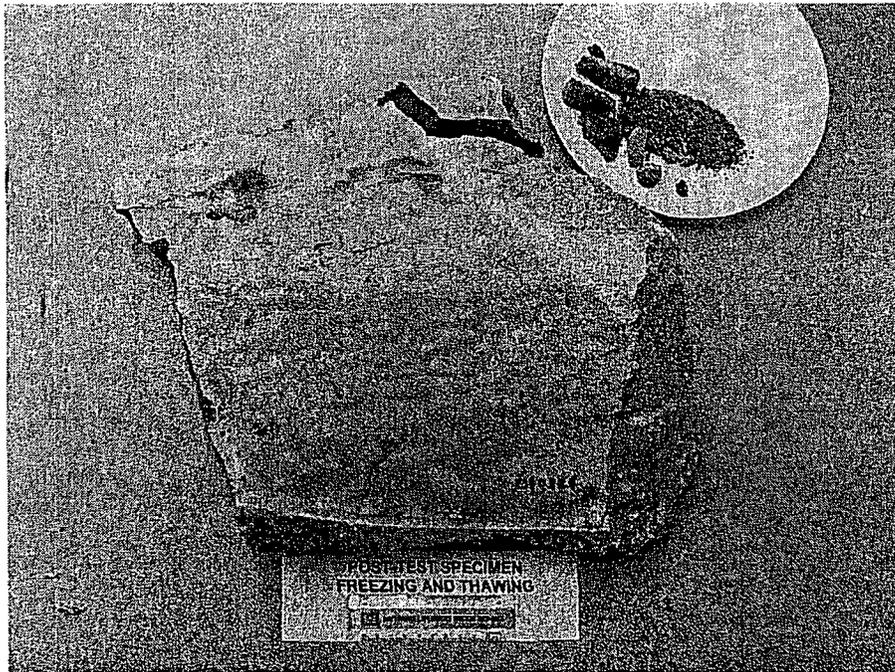
Photograph 2. Stone 040324a after exposed to 20 cycles of freezing and thawing. Results are based upon largest remaining piece.

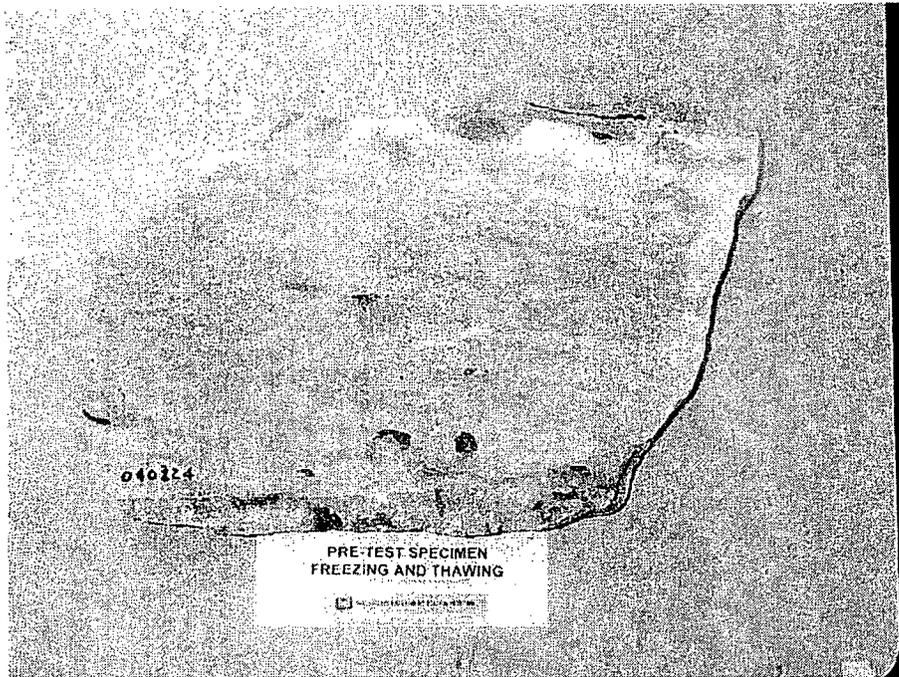
Photograph 3. Stone 040324b before subjected to 20 cycles of freezing and thawing.

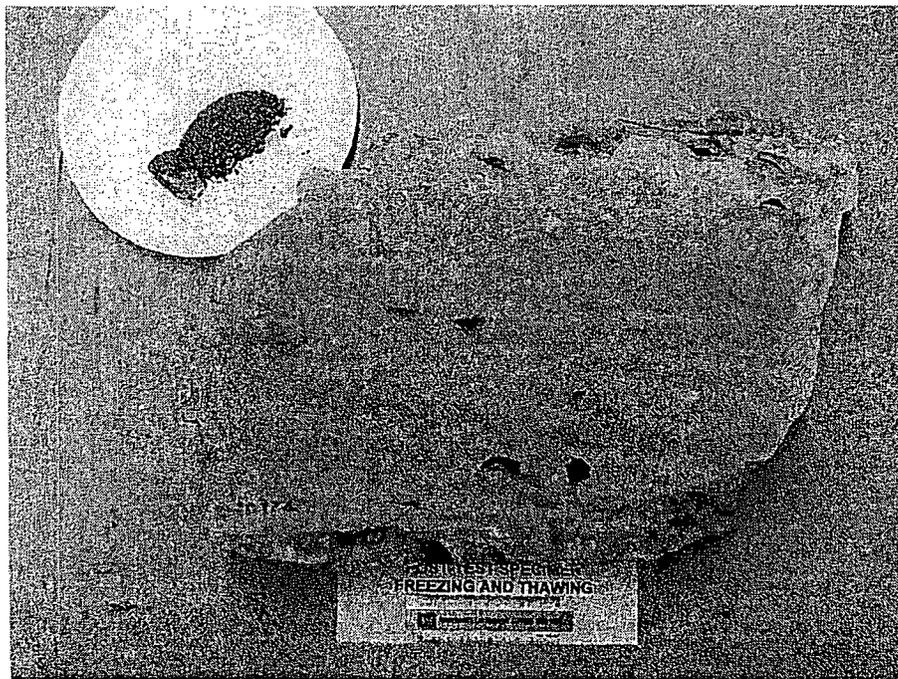
Photograph 4. Stone 040324b after exposed to 20 cycles of freezing and thawing.

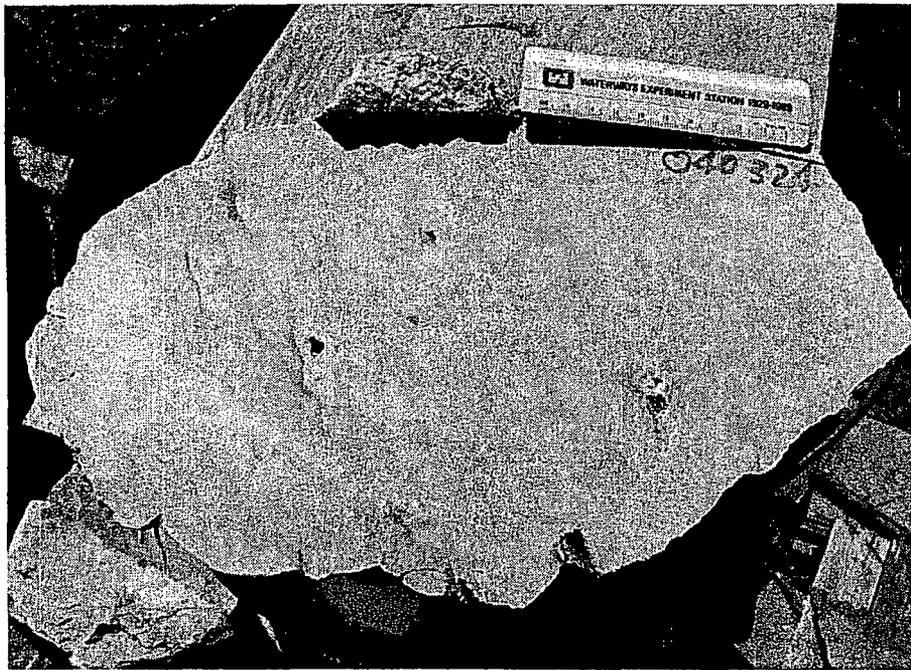
1. Sample 040324 is a large boulder-sized gray rock (Figure 1). The rock appeared to be a fine-grained fossiliferous limestone with a few vuggy holes partially filled with more coarse-grained crystals of calcite.

Figure 1. Photograph of rock sample CMB No. 040324

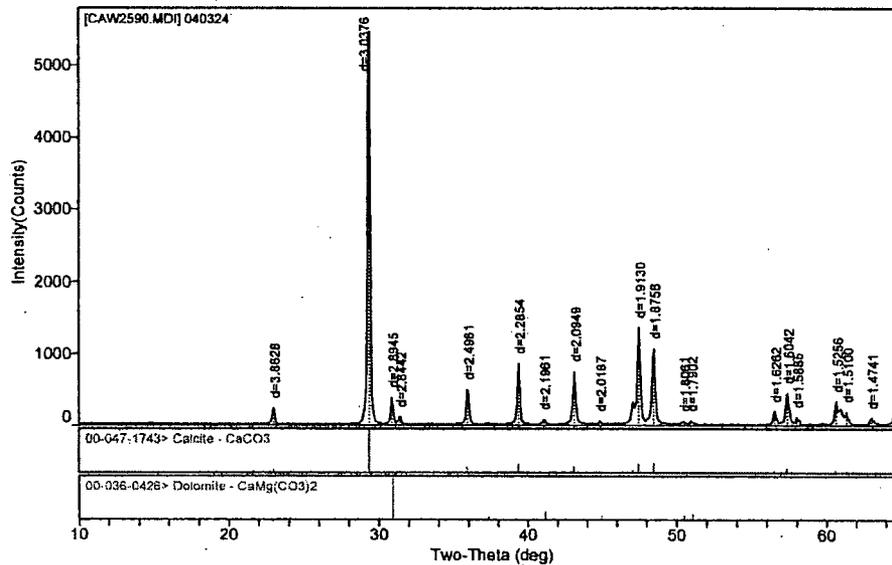
3. The XRD pattern of the sample is given in Figure 1. The sample is principally calcite with minor dolomite present. The presence of clay minerals was not observed.

Figure 1. X-ray diffraction pattern of bulk sample of sample 040324.

4. The mineralogy of the sample as determined by XRD analysis does not indicate that there would be any phases present that would cause a problem if the rock was subjected to freezing and thawing conditions.

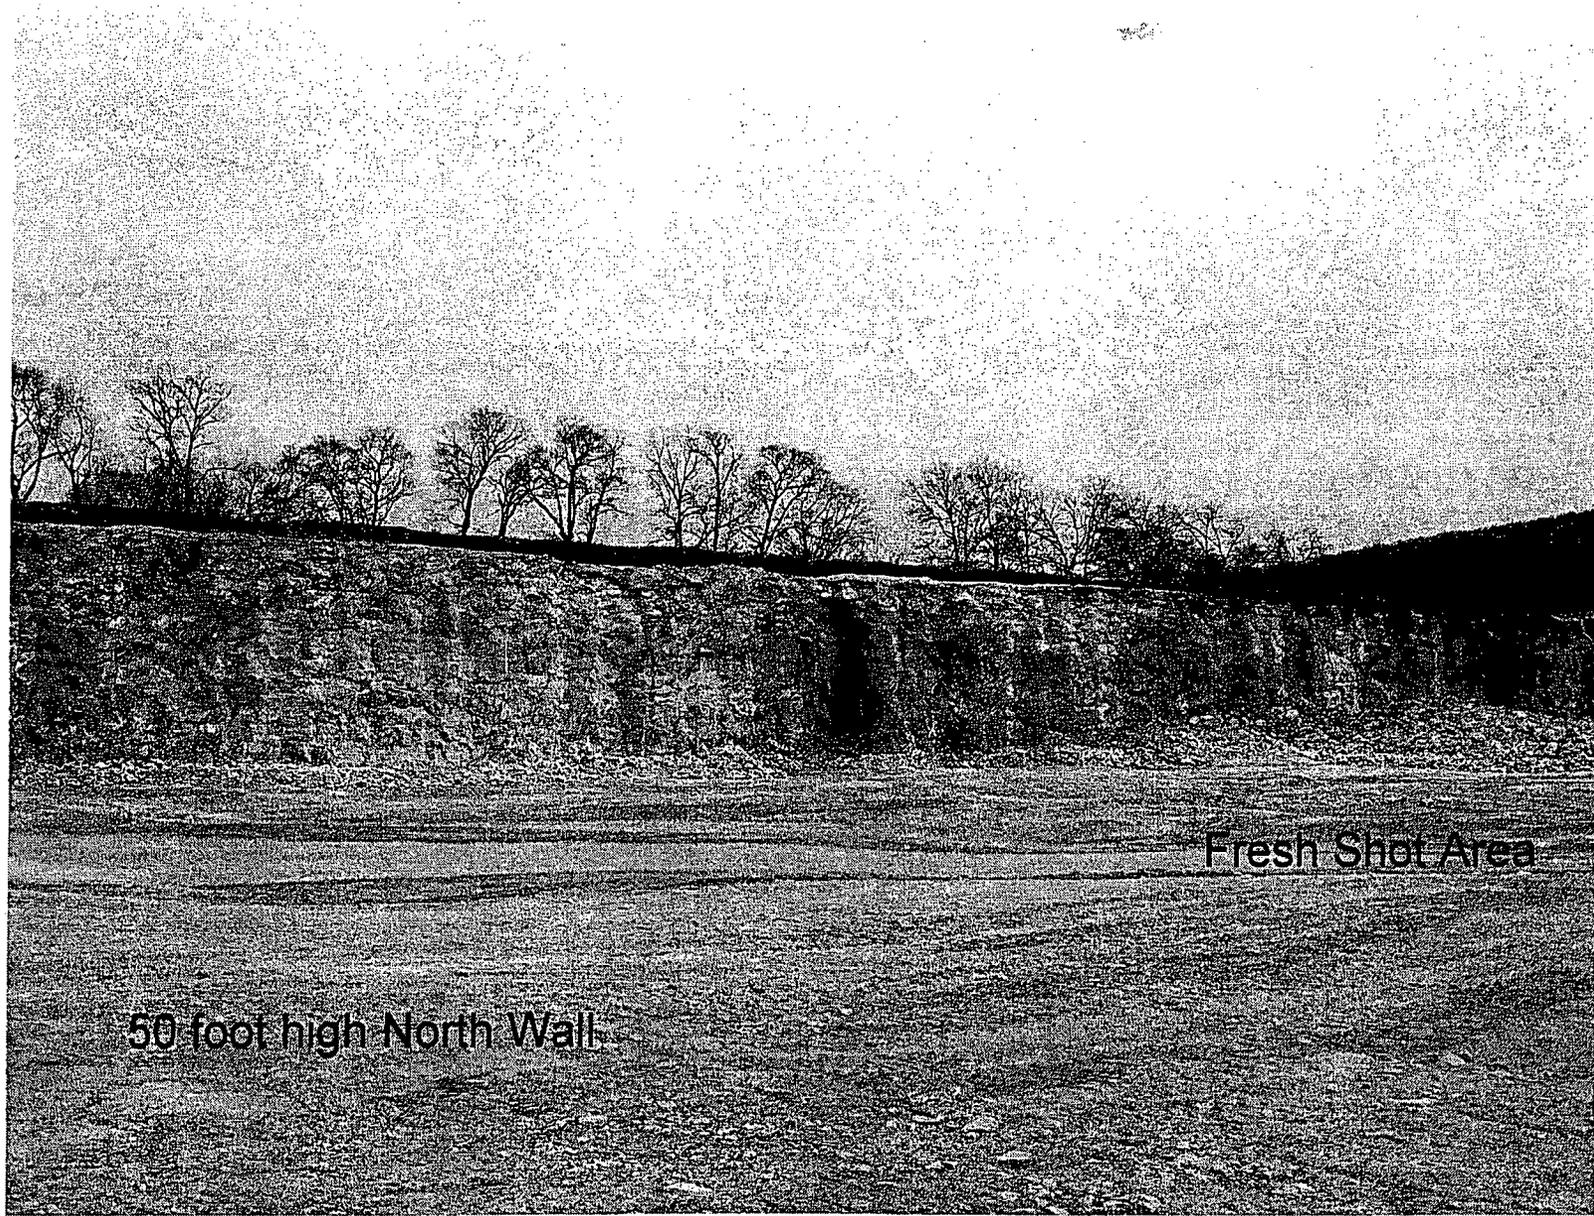
50 foot high North Wall

Fresh Shot Area

A fresh shot along the north quarry wall was performed a few days prior to this study which provided a cleaner wall of stone to work with. Several photos of the north wall have been included as Figure C-1 and C-2 in Appendix C. The cleaner wall improved the surface visibility and aided in identifying bedding planes, stylolites, vugs, and dolomitic lenses. Very few visible stylolites were present along this section of the north wall rock face that was accessible near the base of the highwall. Furthermore, there were no dolomitic lenses or large vugs that had been filled with clays or other impurities near the base of the highwall. The few irregular bedding planes present had no pattern and were mostly found near the top surface of the highwall. The only significant visible feature found along the northeast portion of the quarry face was the abundance of vugs located in one, ten foot by ten foot, area of the face. The vugs were approximately 10 to 25mm in size and the majority appeared to be clean, i.e., very little to no calcite crystals or clay buildup within the vugs. The vugs were spaced irregularly, ten to twenty-four inches apart. A section diagram has been prepared on a photo taken from the northeast corner wall and is included as Figure C-3. This diagram shows the location of the vuggy area and the irregular bedding planes near the top surface. Figures C-4, C-5, C-6 and C-7 show details and close ups of the vug area. The remainder of the north wall to the west, as well as the west wall itself, was also inspected for stylolites. It was evident from this inspection that very thin striations and discolored bands (possibly stylolites), less than 9.5mm thick became more visible along the west wall and appeared to be clustered in areas making it very difficult to measure any type of spacing. Since this area of the quarry is not intended to be used for the riprap on the SFC project, the measurement of stylolite spacing was not attempted along this wall.

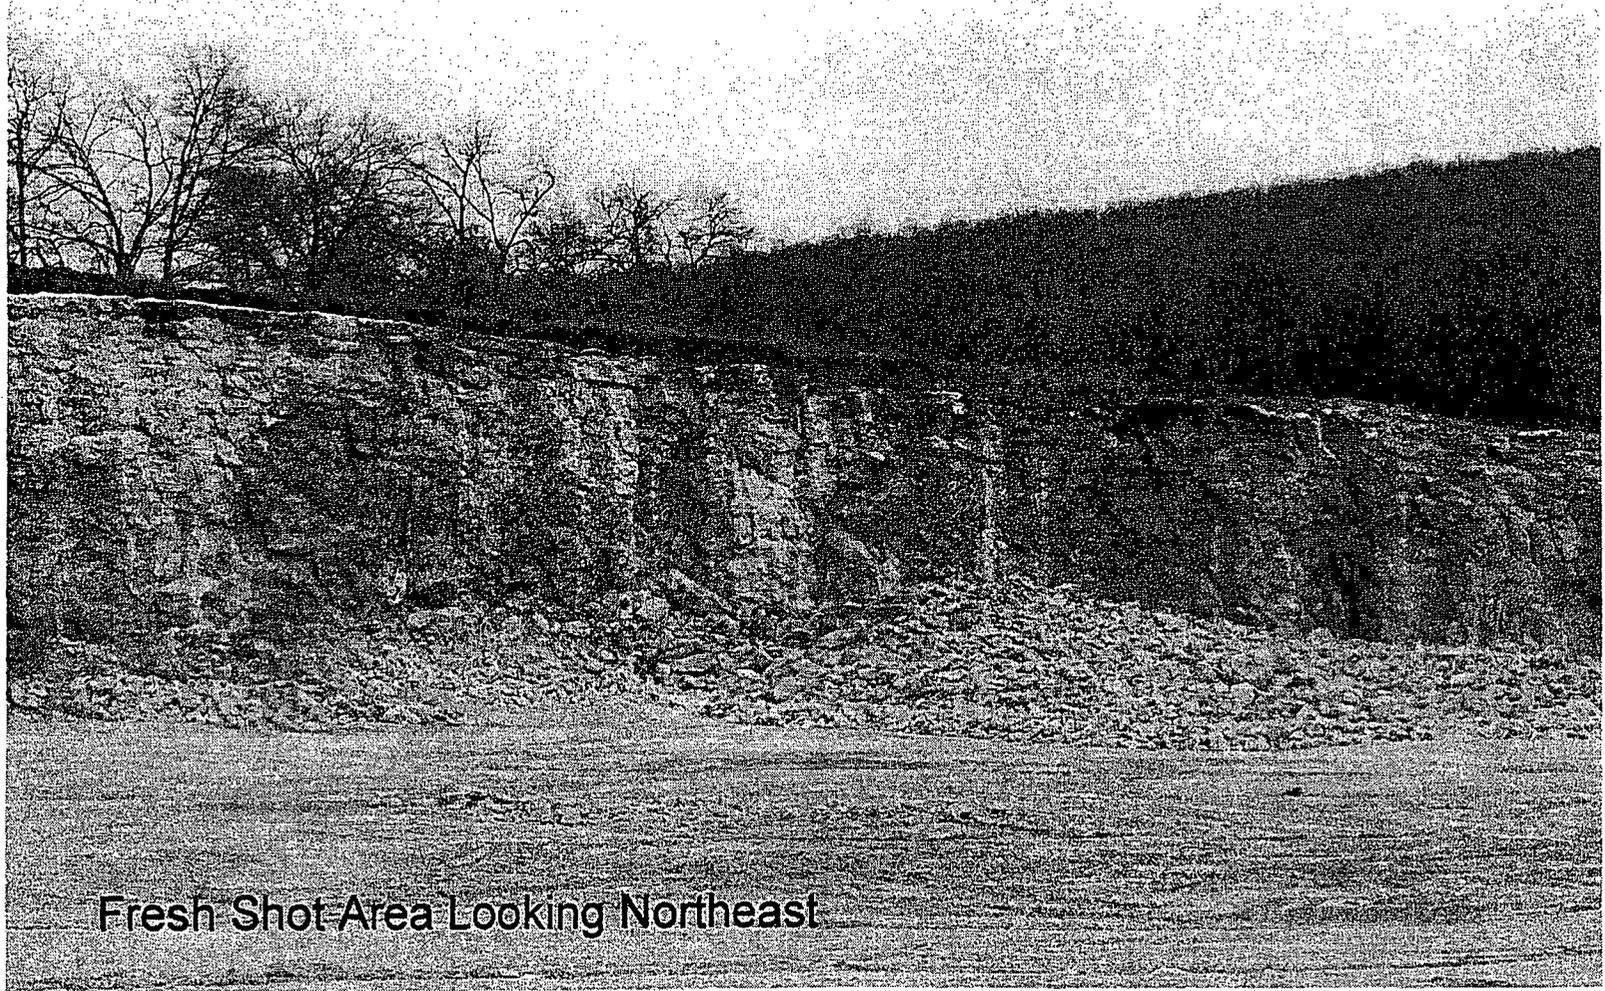
Figure C-2

Fresh Shot Area Looking Northeast

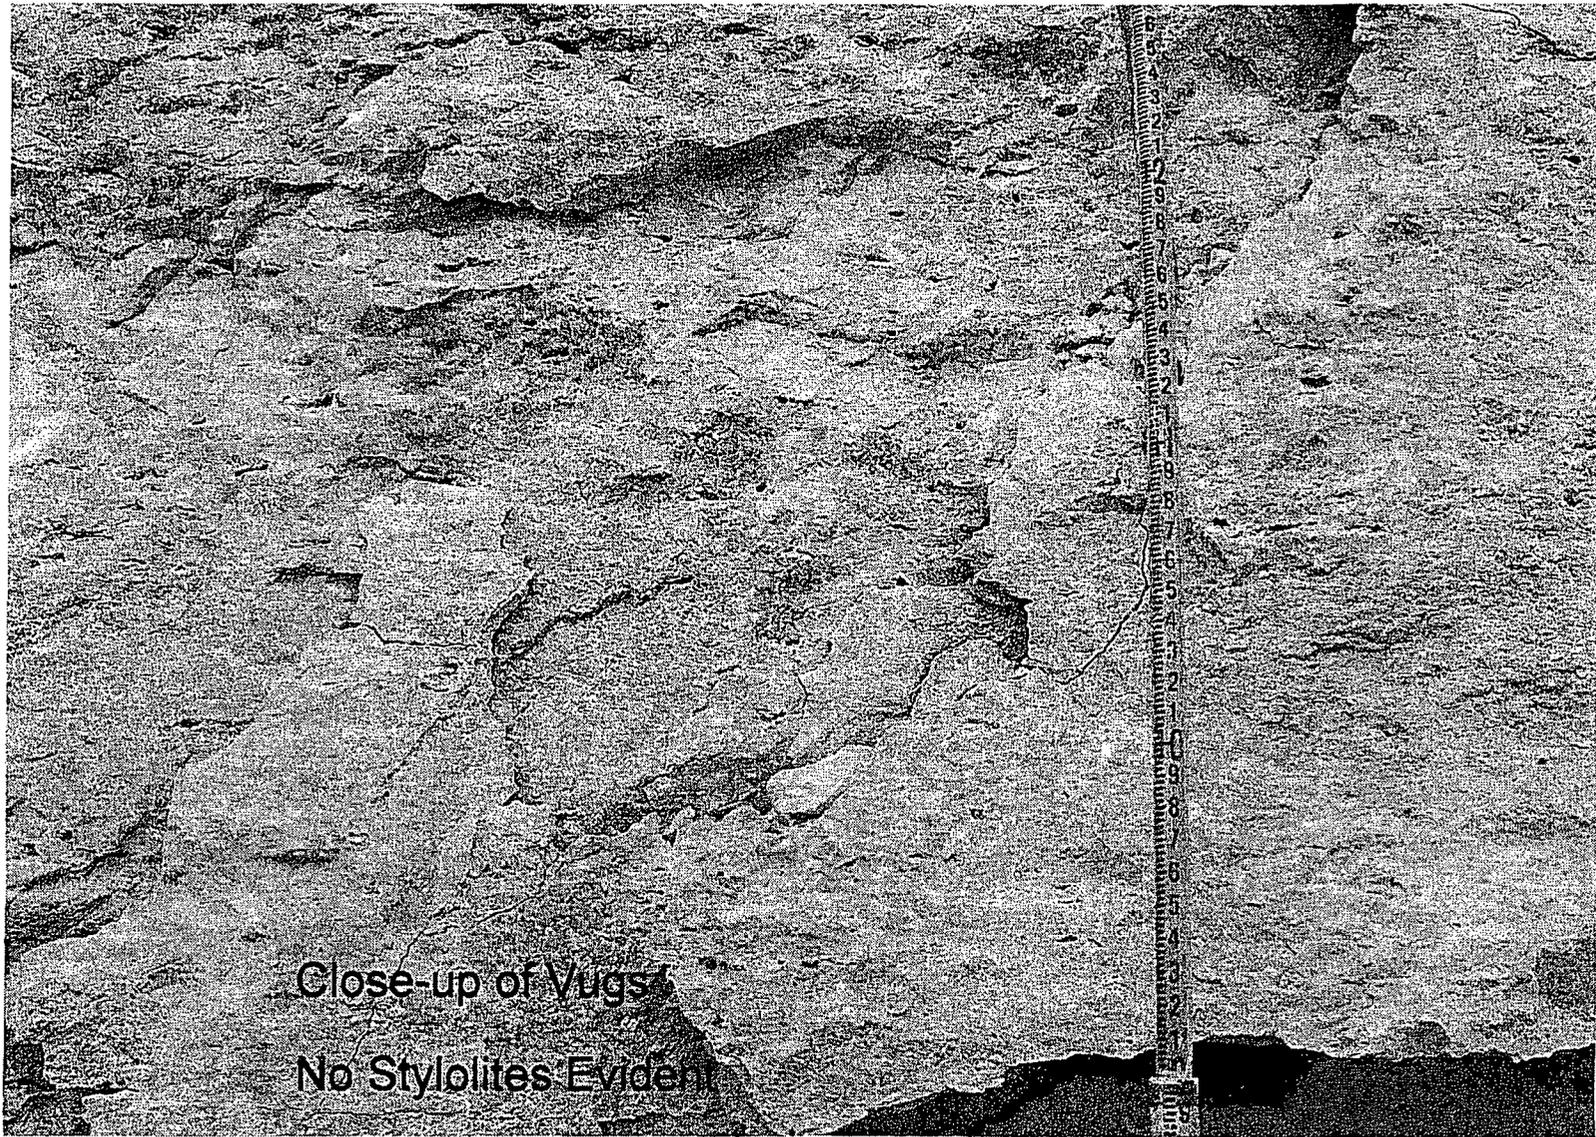
Figure C-6

Close-up of Vugs
No Stylolites Evident

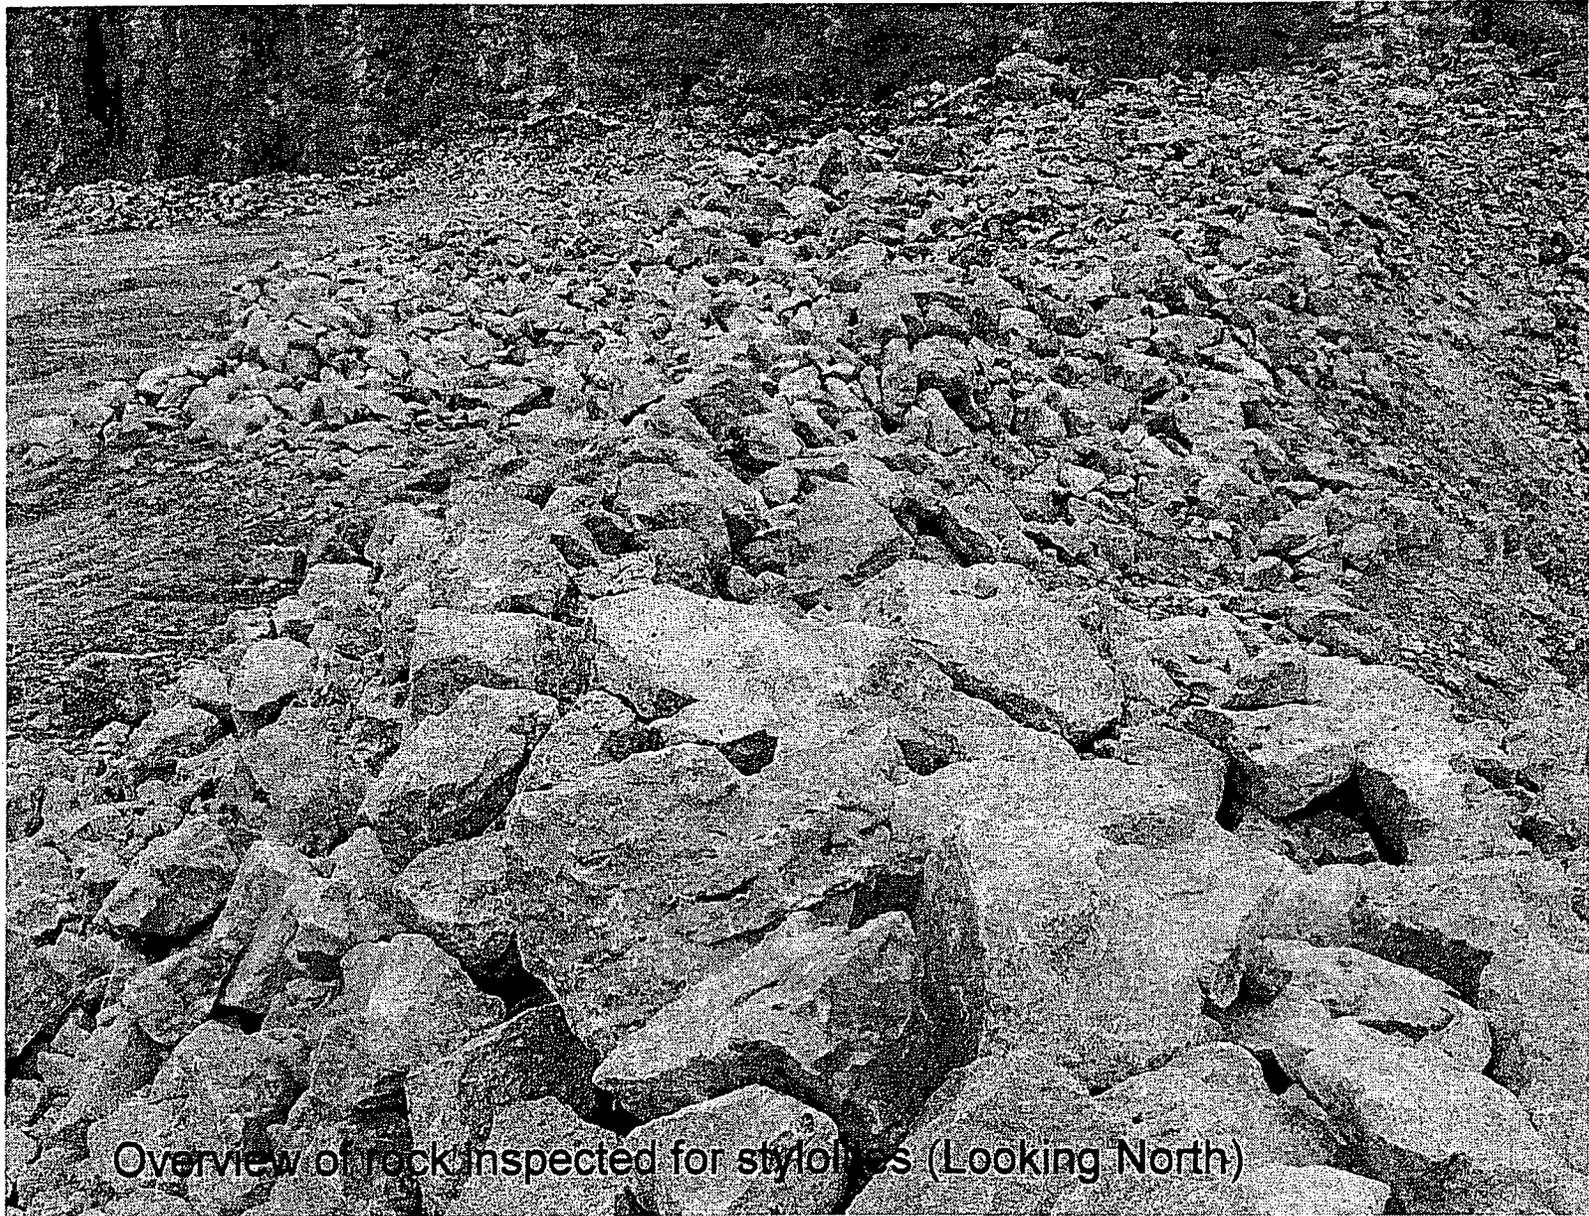
Figure D-4

Overview of rock inspected for stylolites (Looking North)

An inspection was conducted of the rock shot from the north wall of the northeast corner face with the intention of identifying stone to measure stylolite spacing. Several hundred feet of fresh shot-rock was on the ground along the northeast corner area. It was very difficult to find any stone with regular surface features that resembled stylolites. There were several stones that contained thin discolored bands that blend into the surrounding stone surface which may be stylolites. Occasionally, a stone was found with a tint of dolomitic clay-like material or very thin stylolite staining on a stone surface. However, without cutting the stones, I could not determine for certain that these discolorations were actually stylolites. The absence of discernable stylolites prevented the recording of any spacing measurements. Very few vugs were found in the shot rock at the base of the wall. The vugs that were identified in the shot rock were less than 25mm and lined with a thin veneer of calcite crystals with little or no dolomitic clay present. Appendix D has several photos of individual stones found along this area. Again, the absence of visible stylolites, bedding planes and dolomitic clay impurities prevented meaningful recording of these features. Several representative stones were collected from the shot rock in the area of interest for petrographic examination, and for absorption, specific gravity, sodium sulfate soundness, and abrasion analyses. The results of these analyses have been included as Appendix E.

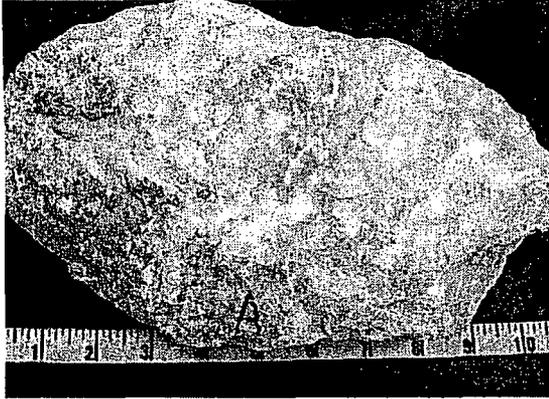
Figure 1. Rock Fragment A.

Samples A, B, and C are essentially identical (Figure 1, 2, and 3). The rock represented by the samples is a moderately hard, moderately dense, mottled pinkish-beige, white to light beige, and gray, limestone (Figure 4). No vugs, open fissures, large voids, or significant cavities are observed. No well-defined bedding planes or seams are detected; however, variations in color and grain size reveal non-planar bands (Figure 5) that broadly resemble bedding. Parallel, gray and grayish white bands and lenses occur sporadically. Dark gray layers up to 1 mm thick resemble poorly-formed stylolites; these features are rare. Calcite-filled, 'healed' fractures (Figure 6) up to 1 mm across intersect the bands at a steep angle, and are fairly frequent.

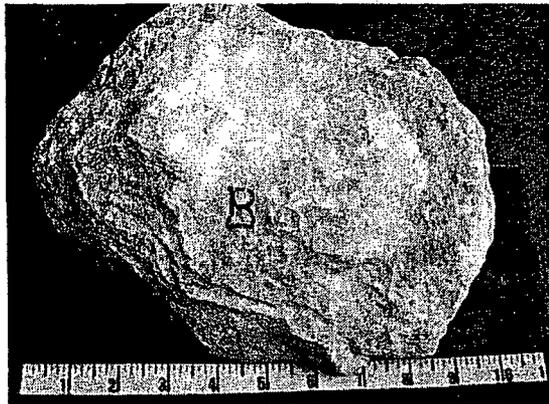
Figure 2. Rock Fragment B.

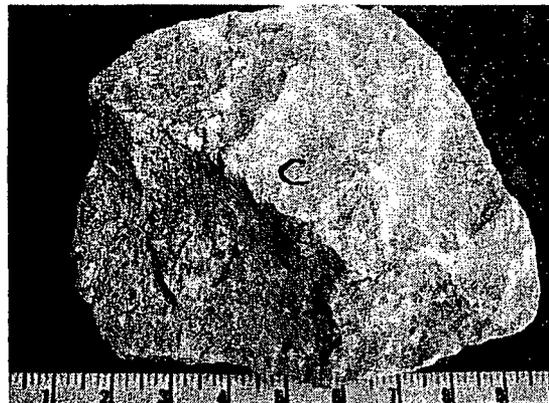
Figure 3. Rock Fragment C.

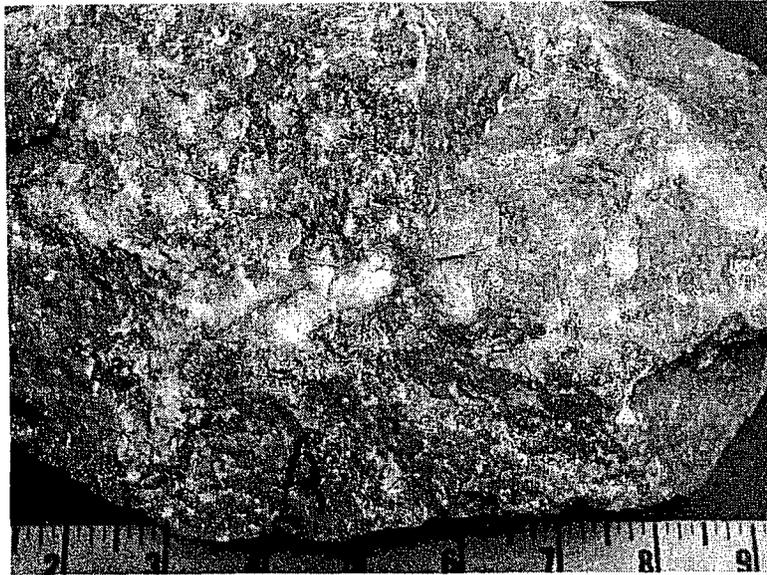
Figure 4. After washing, the Rock Fragment A is shown to be mottled pinkish-beige, gray and white.

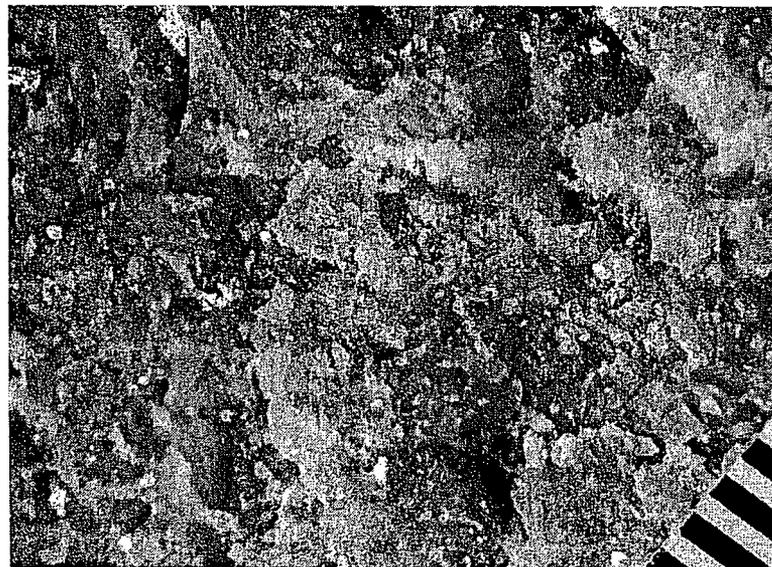
Figure 7. The pinkish-beige portions consist of medium to coarse-grained calcite that contains inclusions of hematite 'dust.' Millimeter scale.

The rock is a calcitic, fossiliferous limestone. The pinkish-beige portions of the stone (Figure 7) are mainly composed of interlocking crystals of medium to coarse-grained calcite (average crystal size of 1 to 3 mm). The white to pale-beige portions of the stone consist of fine-grained calcite. Pyrite is observed in trace amounts, less than 1 percent by volume, and occurs as small crystals and clumps of crystals scattered throughout the limestone (Figure 8). Hematite occurs in trace amounts as minute inclusions ('dust') within the calcite crystals in the pinkish-beige portions of the limestone (Figure 9). The gray portions of the limestone are softer and contain variable amounts of clay or clay-size siliceous minerals (Figures 10 and 11). Overall, the amount of soft, clay-size minerals is minor (estimated at less than 3 percent). Further analysis by X-ray diffraction (XRD) would be needed to identify these minerals.

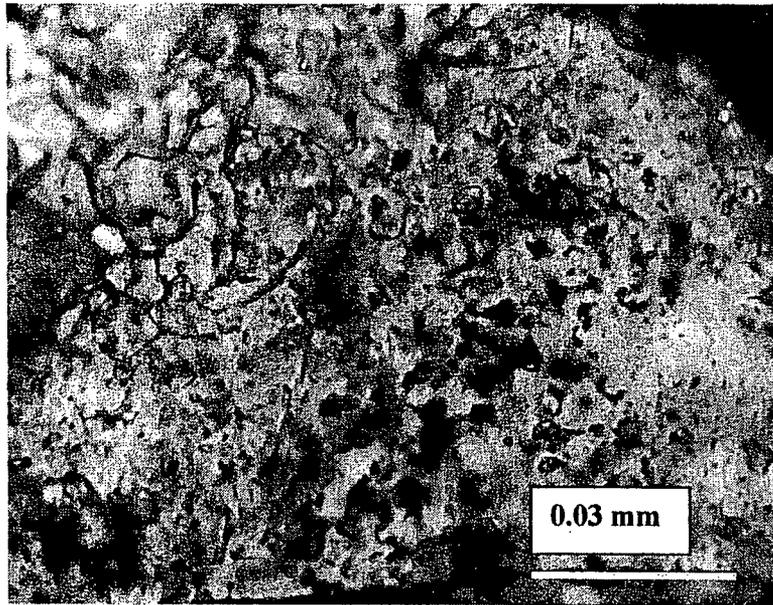
Figure 9. Cross-polarized light image showing small, red, hematite inclusions in calcite.

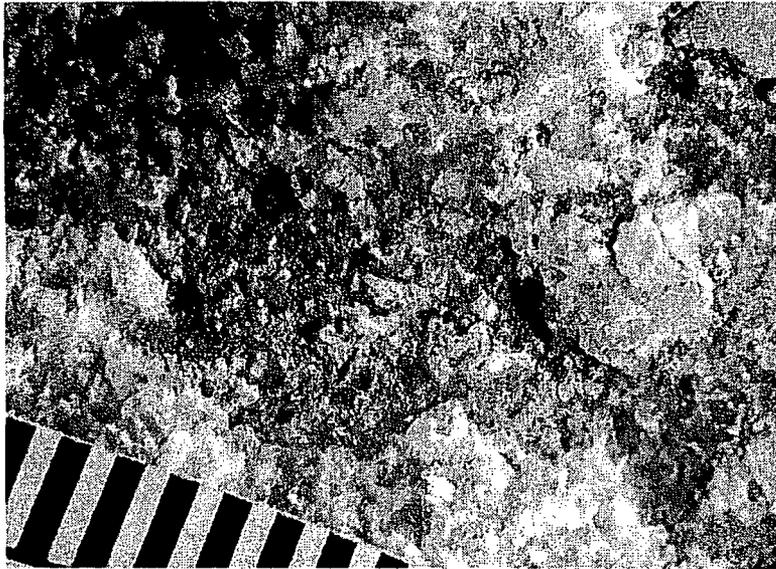
Figure 10. Gray portions of the limestone are soft clay or clay-size minerals. Millimeter scale.

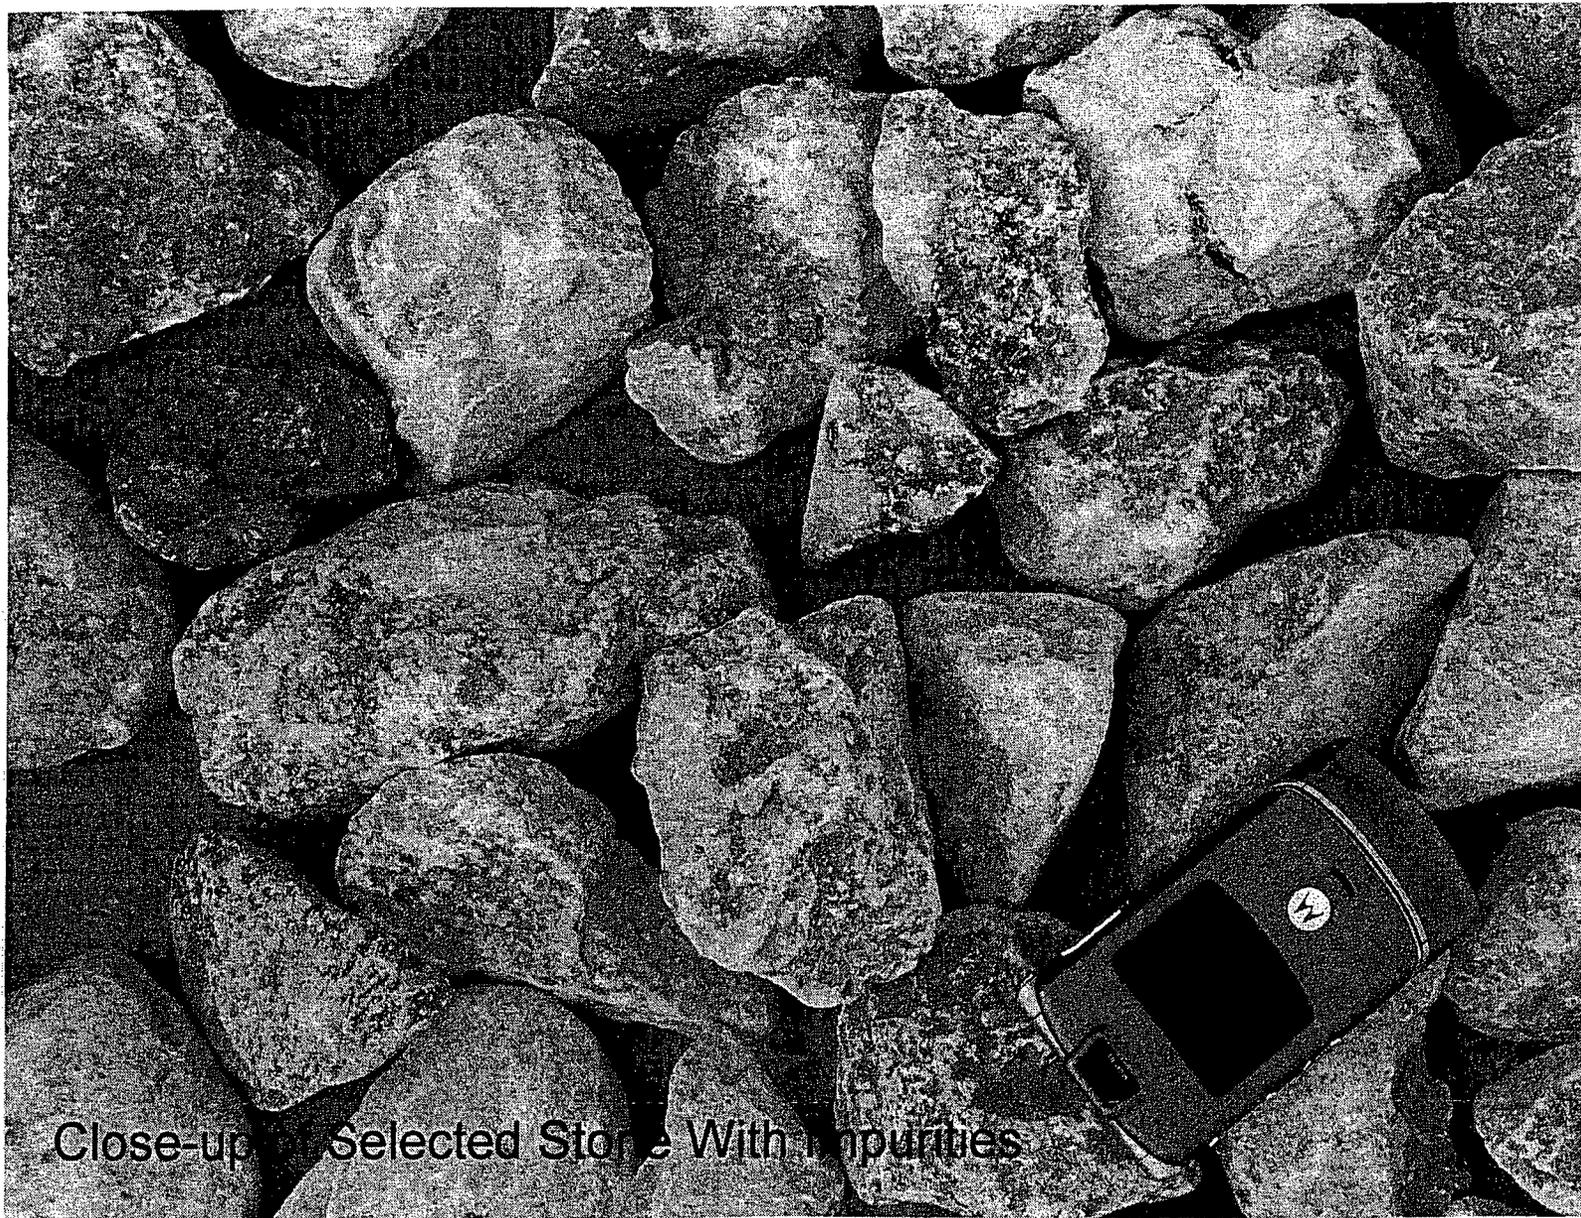
Figure F-3

Close-up of Selected Stone With Impurities

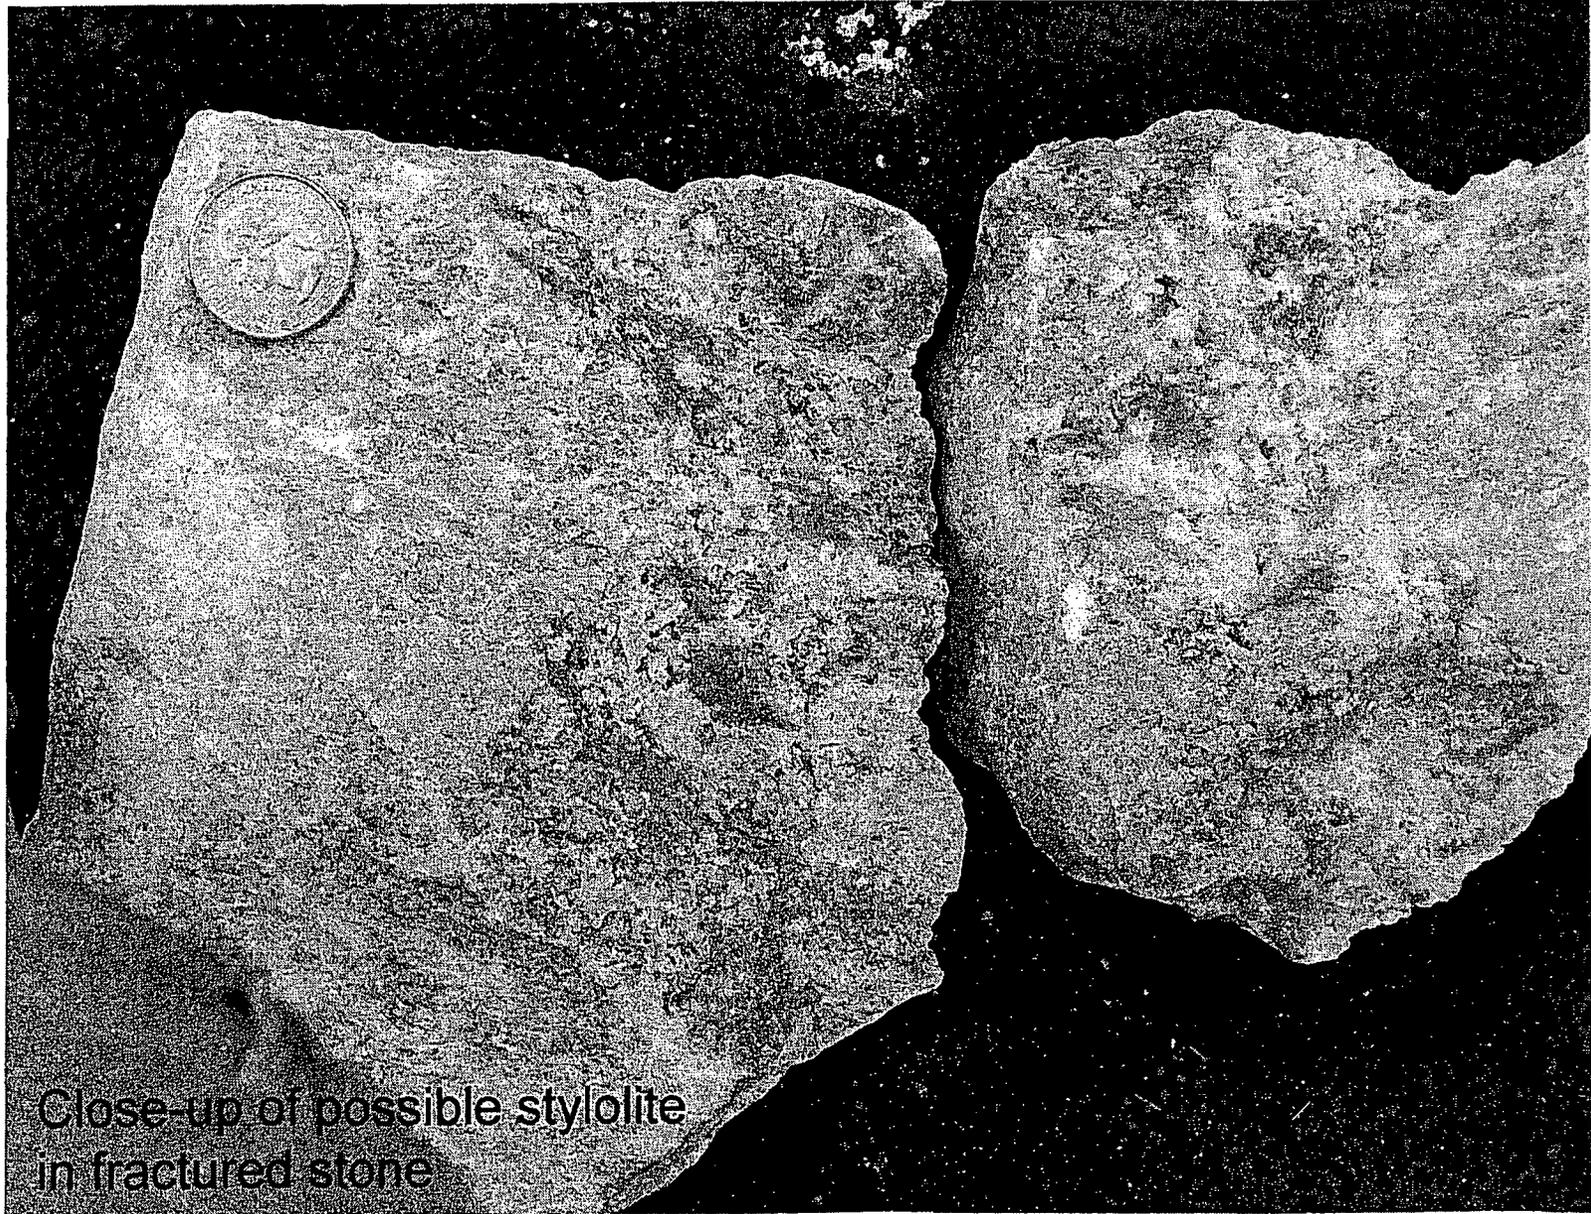
Figure F-4

Close-up of possible stylolite
in fractured stone
