**Utah Water Quality Task Force Meeting
Minutes**

October 20th, 2016 9:30-11:30
Utah Division of Water Quality
195 N. 1950 W.
Salt Lake City, Utah

Utah's Efforts to Address Harmful Algal Blooms

TIBBLE FORK DAM SEDIMENT RELEASE

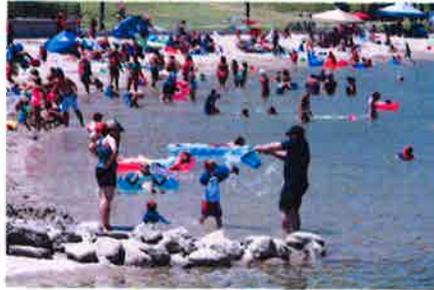
2016 cHABs in Utah Waters

- ❑ Blackridge Reservoir
- ❑ Mantua Reservoir
- ❑ Payson Lakes (n=4)
- ❑ Scofield Reservoir
- ❑ Utah Lake
- ❑ Farmington Bay
- ❑ Upper Box Cr. Reservoir

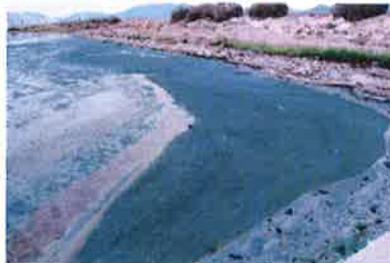
Utah Lake Closure

DANGER

LAKE CLOSED due to toxic algae

KEEP OUT OF LAKE

SALT LAKE CITY - Public health officials have decided to close Utah Lake, effective immediately, due to a large, harmful algal bloom that may pose a serious health risk to the public and animals. The Utah Department of Health (UDHD) and Utah County Health Department (UCHD) say lab results for samples collected by the Utah Department of Environmental Quality (DEQ) show the concentration of algal cells in the water are three times the threshold for closing a body of water.

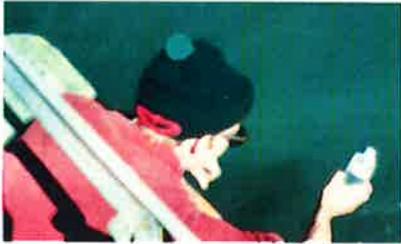
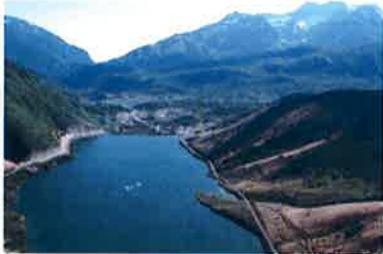
Nutrient Reduction Success: Deer Creek Reservoir

Deer Creek Reservoir Algal Blooms (1970s)

Deer Creek Reservoir Algal Blooms (1990s)

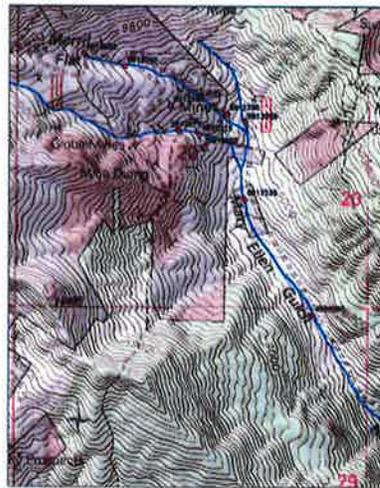
- Uncovered tailings piles remain outside of several mines
- Some mines are discharging contaminated groundwater
- Some streams flowing over tailings, dissolving metals
- Contaminated water and sediment flowing directly into streams
- Primary contaminants of concern are Arsenic, Cadmium, Copper, Lead, Mercury and Zinc

Map of Mary Ellen Gulch, American Fork Canyon

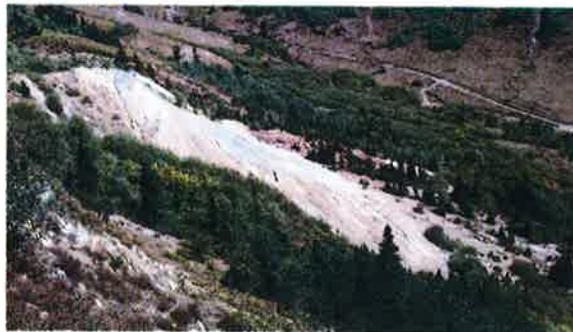
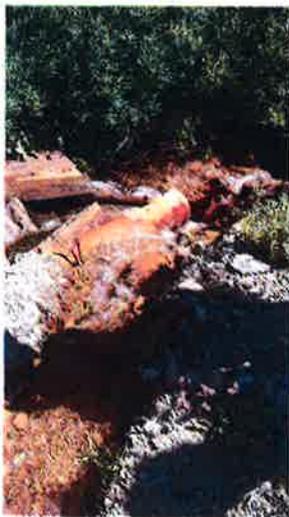
Acid mine drainage and tailings pile, Live Yankee Mine, American Fork Canyon

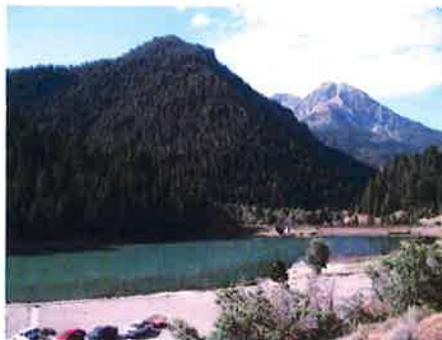
- Dam built in 1966 for flood control and sediment retention
- Dam is currently being seismically upgraded and raised 15 feet to increase water storage
- Stores approximately 258 acre-feet of water (~ 385 ac. ft. after upgrade)
- About 14 acres in size (23 after upgrade)
- Construction began in June 2016 and will be completed in December 2016

Tibble Fork Reservoir prior to construction

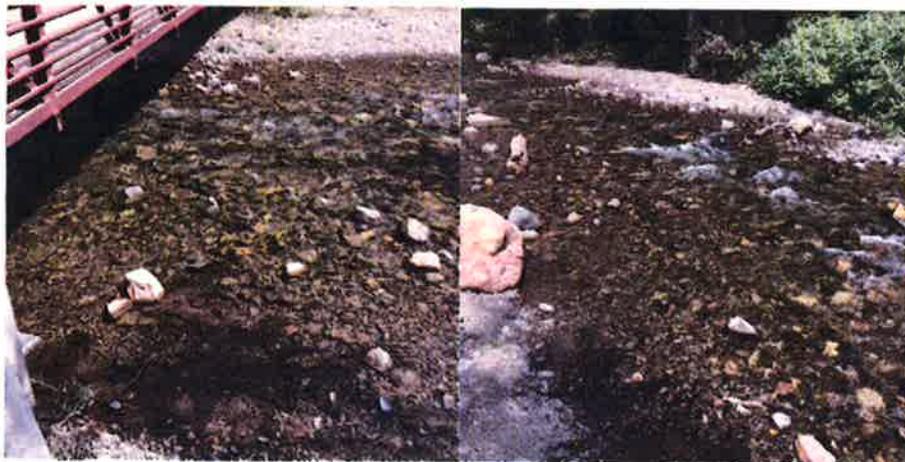
Water Quality Above Dam, 23 Aug 16

North Fork of American Fork River above Tibble Fork Reservoir

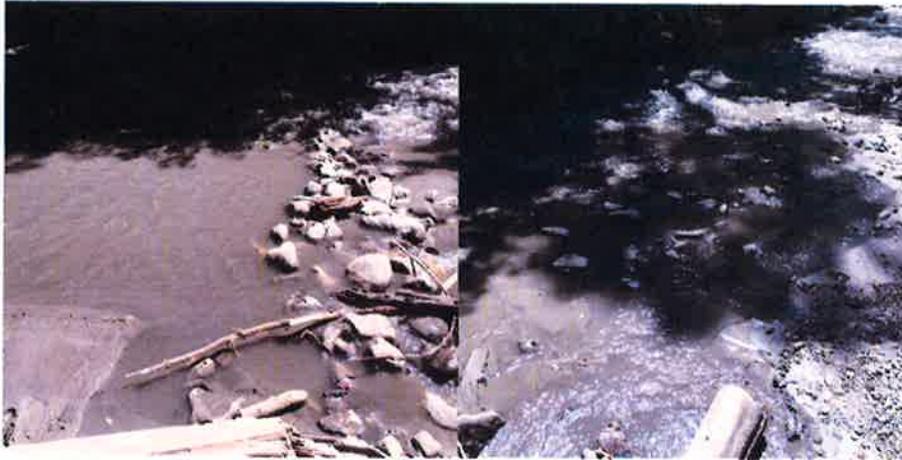
Water Quality Below Dam, 23 Aug 16

North Fork of American Fork River below Tibble Fork Dam

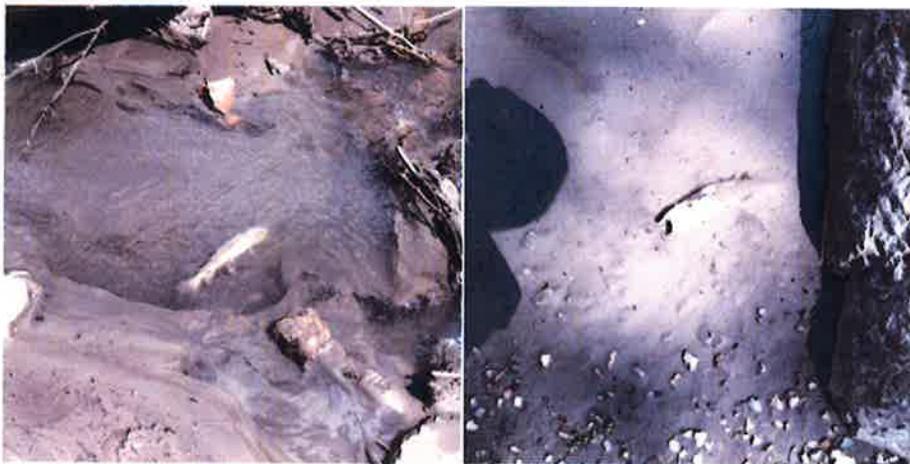
Fish Kill Below Dam

Dead trout in North Fork American Fork River below Tibble Fork Dam

- To make these repairs a drawdown was required, and during this drawdown approximately 8700 cubic yards of sediment was discharged from the reservoir resulting in a fish kill of approximately 5,250 trout.

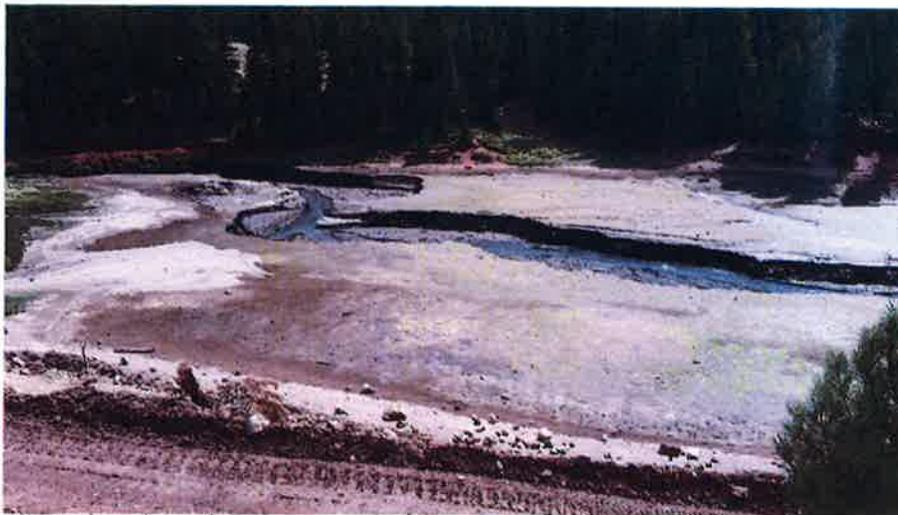
Erosion of sediment in lake bed

North Fork of American Fork River flowing through bottom of Tibble Fork Reservoir

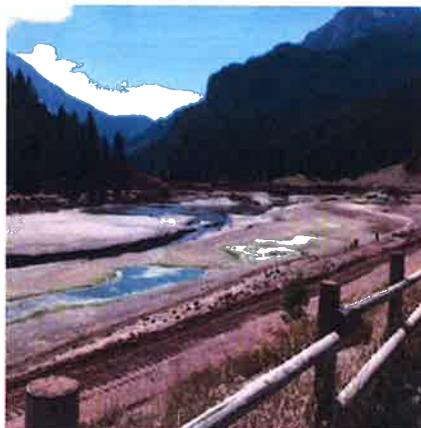
Dam Construction at Tybble Fork Reservoir

- Tibble fork Dam is currently being upgraded to become more seismically stable, and to be able to double the storage capacity of the reservoir. This construction should be completed by mid-December of 2016.
