NAVAJO LAKE

Limnological Assessment of Water Quality

Utah Division of Water Quality

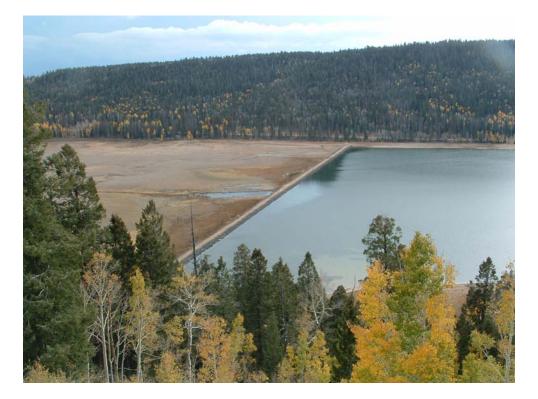
Photo 1. View of Navajo Lake and dike.

The dike has been raised in stages beginning in about 1933. It was last raised to 5.2 m (17 ft) in 1945. The dike allows the lake to be maintained near 4 to 5 m (13-16 ft) deep; however evaporation and seepage, and release of irrigation water via a pipe outlet, still drop the water level a few feet below the dike spillway level by late summer in most years.

Navajo Lake was created several thousand years ago after a lava flow cut off the natural surface flow of the uppermost part of Duck Creek in the Sevier River Drainage. The lake is unique in that groundwater accounts for most of the inflow and all of the outflow. Sinks located on the east end of the lake are the principal outlets; no surface outflow exists for the lake. Sinkholes in the east end of the lake drained the lake completely in low water years before construction of a north-south dike, just west of major sinkholes on the east end of the lake basin (see Photo 1).

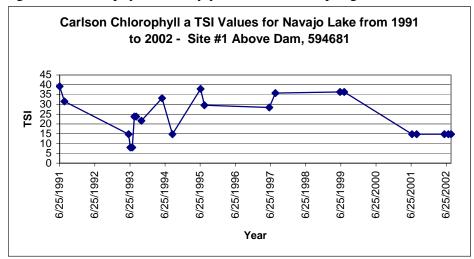
Figure 1. Chlorophyll a TSI by year for three sampling locations.

The Carlson Trophic Status Index is often used to classify or predict the productivity of a lake compared to typical lakes and is determined by three indicators, chlorophyll a, secchi depth and total phosphorus concentrations. The latter two are typically used as surrogates for the most important indicator of lake productivity which is chlorophyll a. Historically, TSI values for Navajo Lake have demonstrated that it is primarily an oligotrophic lake, with very little primary production in the form of phytoplankton (measured as chlorophyll a). The Clean Lakes Study determined that total phosphorus is sufficient to support higher phytoplankton growth but that long winters and a short growing season may limit their growth. Typically, the TSI values for TP indicate the lake to be somewhat mesotrophic while the chlorophyll a TSI demonstrates a predominantly oligotrophic system. Figure 1 summarizes the chlorophyll a TSIs for all available data at the three sampling locations.
