Red Leaf Resources
Southwest #1 Project Area
Supplemental Seep and Spring Inventory
May 2013

Prepared for:
Red Leaf Resources, Inc.
10808 South River Front Parkway
Suite 200
South Jordan, UT 84095-5956
801.878.800

Prepared by:
JBR Environmental Consultants, Inc.
8160 South Highland Drive
Sandy, UT 84093
801.943.4144

August 2013

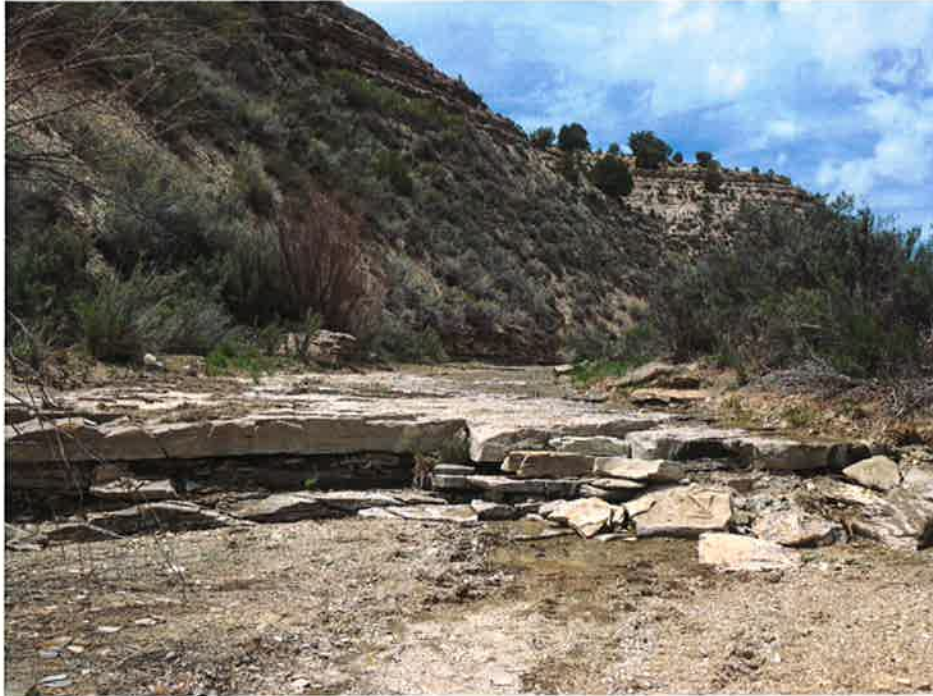
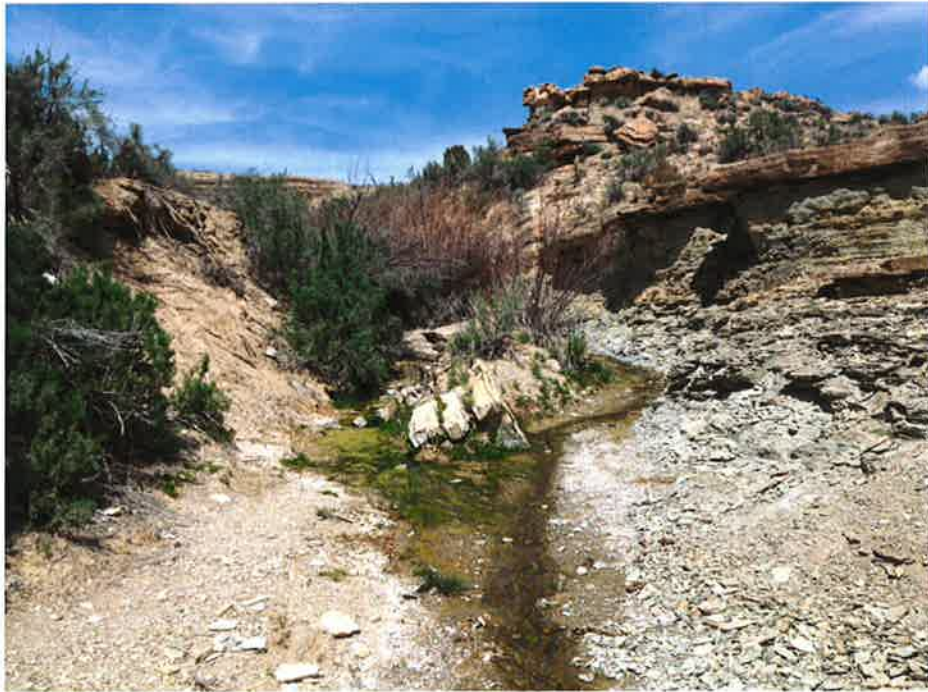
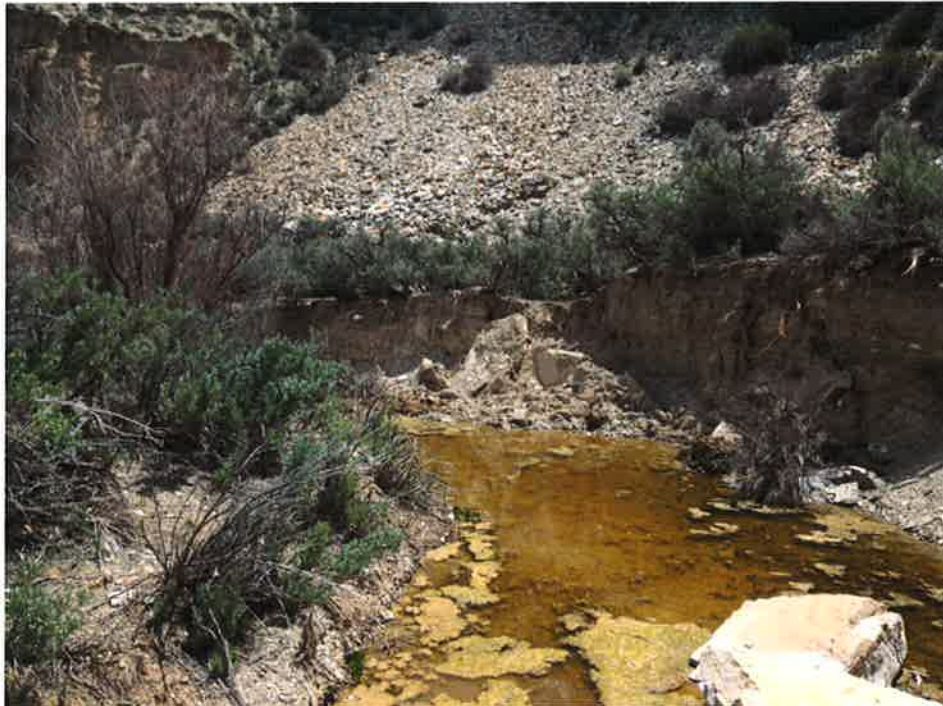
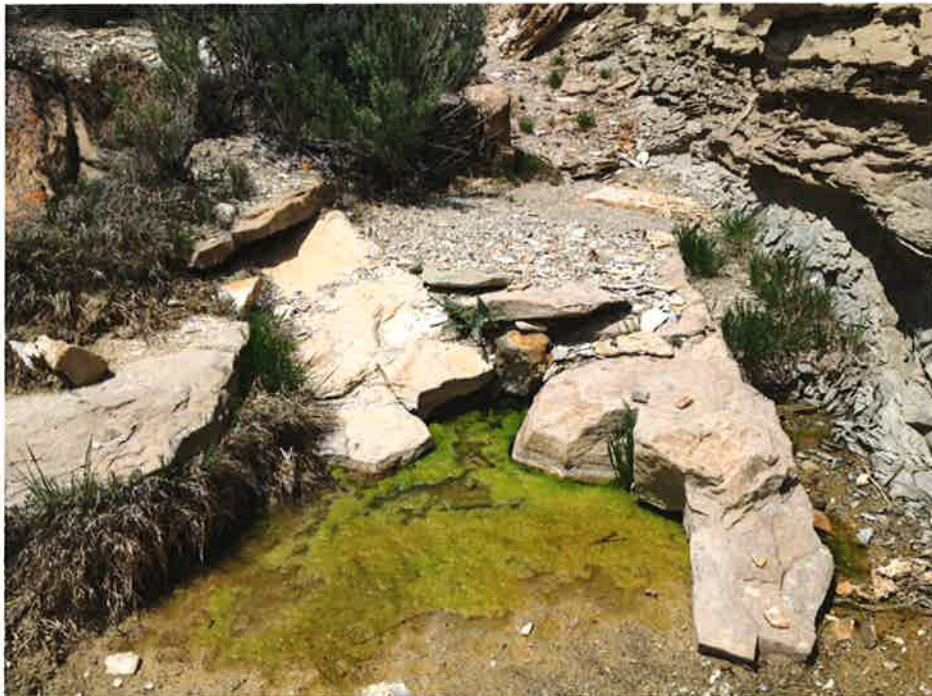
This was the largest spring located within the Klondike Canyon system. It can be noted that the first emergence of water from this spring was approximately 100 yards further up the drainage channel in May 2013 than it was in October 2012. This spring initially surfaced in the bottom of the main tributary channel draining from the west to the east into Sweet Water Canyon and surfaced within the stream channel at an interface between alluvium and the Parachute Creek Formation. There was no development, and there is no water right on file with the State Engineer's Office.

At sample time (1245), water was flowing at approximately 0.42 gpm, measured using the bucket method. Flow resurfaced and went subsurface again several times within approximately 3,900 feet before going subsurface for the last time. The flow did not increase downstream or progress for a sufficient distance to support perennial stream flows in the downstream channel. There were a few tamarisk and small areas of sedges within the 300 feet; however, water was confined to the stream bottom and in most areas there was only a substrate of bedrock and gravel. Temperature was 11.8°C, pH was 8.21, and conductivity was 2.52 mS. See photos 1 – 4 in **Appendix A**.

Photo 1 Klondike Canyon Spring – 01 looking up canyon

Photo 2 Klondike Canyon Spring – 01 looking up canyon

Photo 3 Klondike Canyon Spring – 01 looking down canyon

Photo 4 Klondike Canyon Spring – 01 looking down canyon

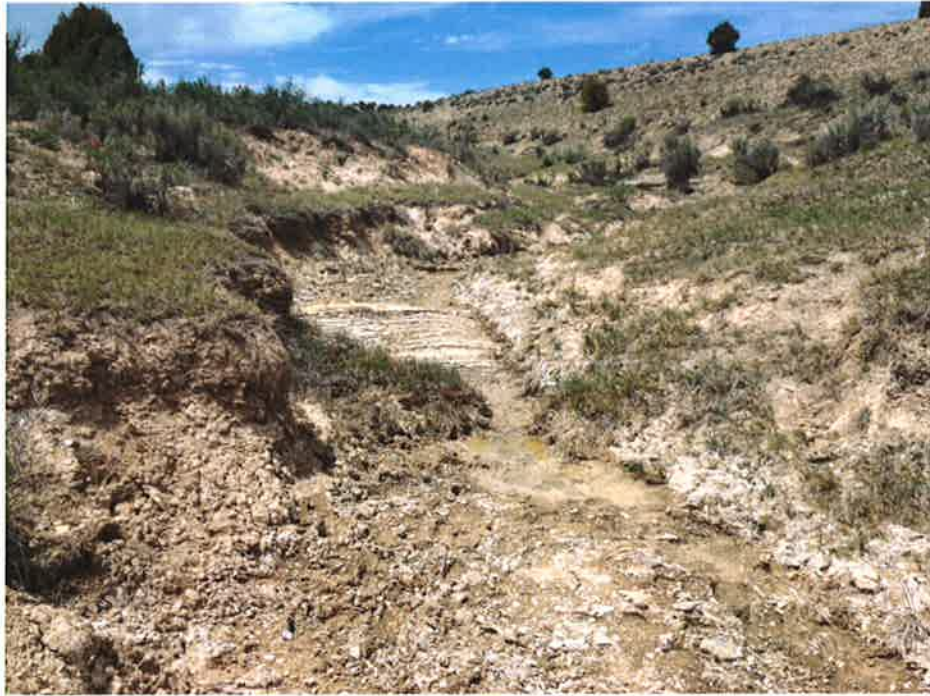
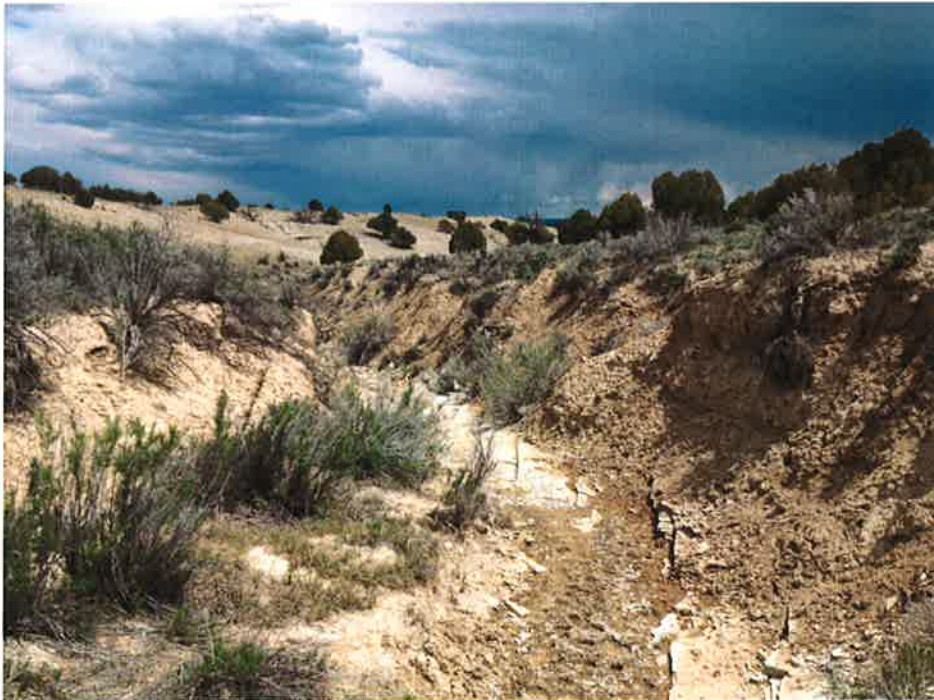
This spring (formally designated as Klondike Canyon seep-2) was a spring that also appeared to issue from an interface between alluvium and the Parachute Creek Formation. It can be noted that the first emergence of water from this spring was approximately 50 yards further up the drainage channel in May 2013 than it was in October 2012. Surface water was present intermittently (i.e., resurfaced and went subsurface again several times) within approximately 2,100 feet before going subsurface for the last time. There was no development, and there is no water right on file with the State Engineer's Office.

There was some evidence of wildlife usage but no vegetation due to its location (bedrock and gravel). At sample time (1350), flow was not observed; there were only saturated conditions and small shallow pools in the drainage bottom. The temperature was 19.5°C, pH was 8.71, and conductivity was 1.07 mS. See photos 5 – 6 in **Appendix A**.

Photo 5 Klondike Canyon Spring – 02 looking down canyon

Photo 6 Klondike Canyon Spring – 02 looking up canyon

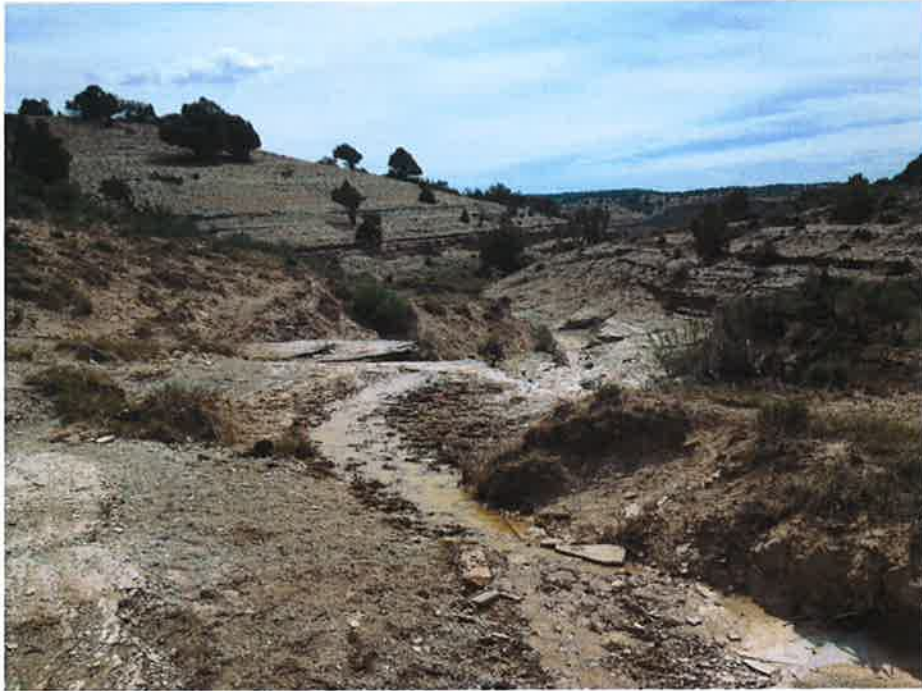
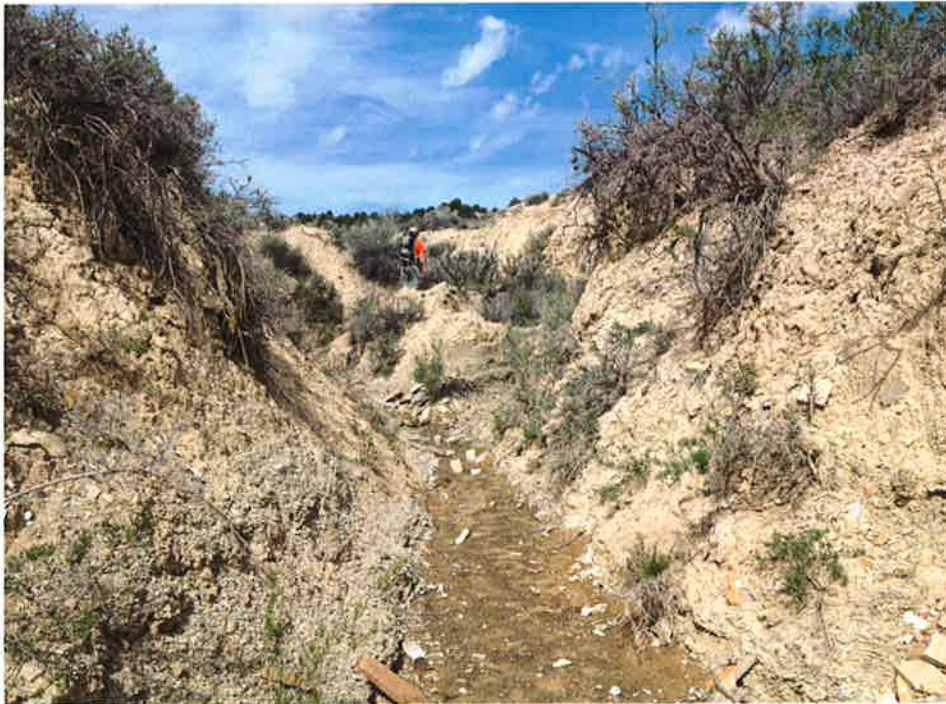
spring that issued from an interface between alluvium and the Parachute Creek Formation. Surface water was present intermittently (i.e., resurfaced and went subsurface again several times) within approximately 2,200 feet before going subsurface for the last time. There was no development, and there is no water right on file with the State Engineer's Office.

There was some evidence of wildlife use but only minimal vegetation (tamarisk, grasses, and sedges at some locations). Cliff habitat was present in the surrounding area. Flow was not measured at this spring during sampling time (1035) as only saturated conditions or small shallow pools were present. The temperature was 23.7°C, pH was 8.46, and conductivity was 2.58 mS. See photos 7 – 8 in **Appendix A**.

Photo 7 Klondike Canyon Spring – 03 looking down canyon

Photo 8 Klondike Canyon Spring – 03 looking up canyon

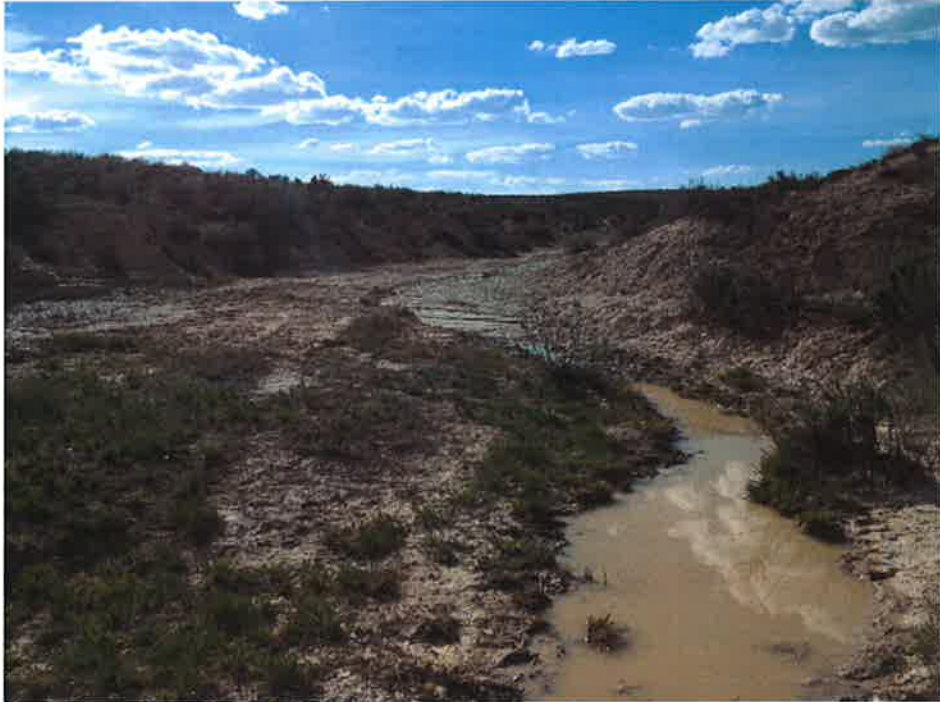
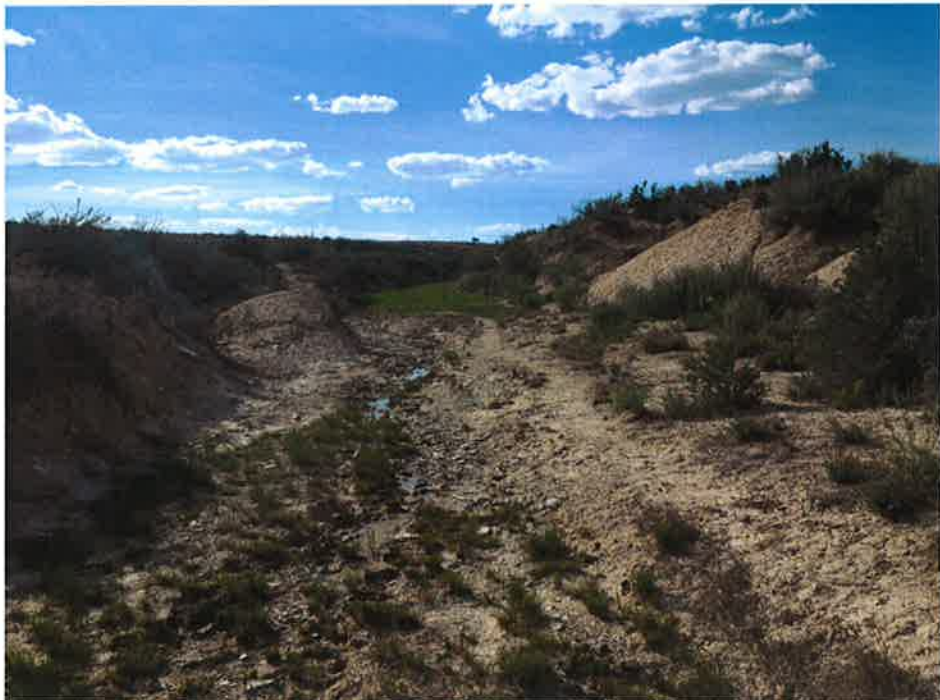
This spring site (formally designated as Potential Seep-02), was a spring that issued from an interface between alluvium and the Parachute Creek Formation. Flow resurfaced and went subsurface again several times within approximately 1,400 feet before going subsurface for the last time. There was no development, and there is no water right on file with the State Engineer's Office.

There was some evidence of wildlife use but no changes in vegetation except for a higher concentration of grass. Flow was measured at 0.52 gpm at this spring during sampling time (1730). The temperature was 22.4°C, pH was 9.13, and conductivity was 2.54 mS. See photos 9 – 10 in **Appendix A**.

Photo 9 Reservoir Canyon Spring – 01 looking down canyon

Photo 10 Reservoir Canyon Spring – 01 looking up canyon

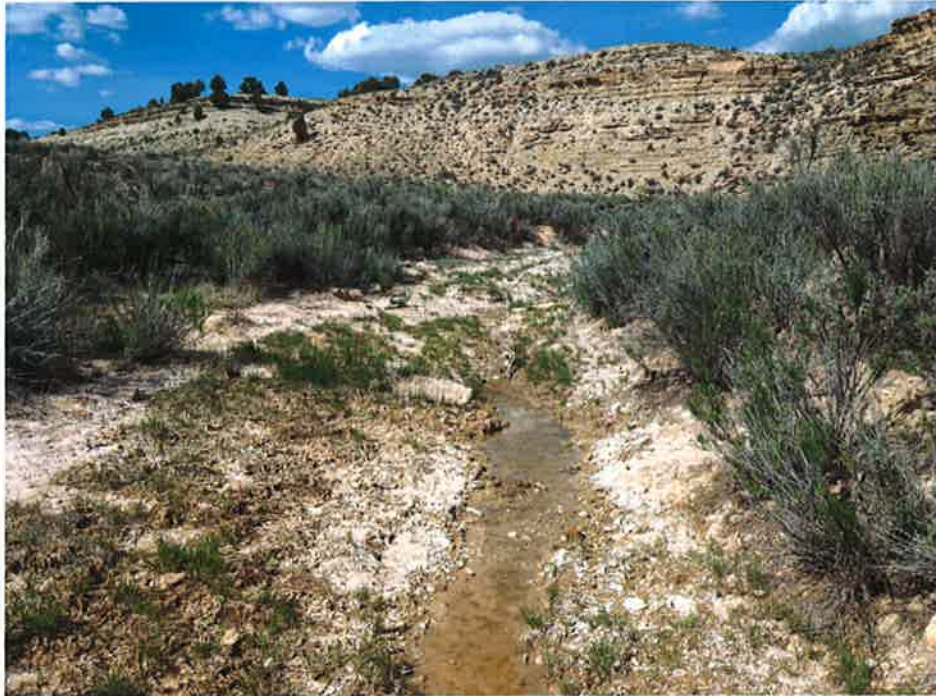
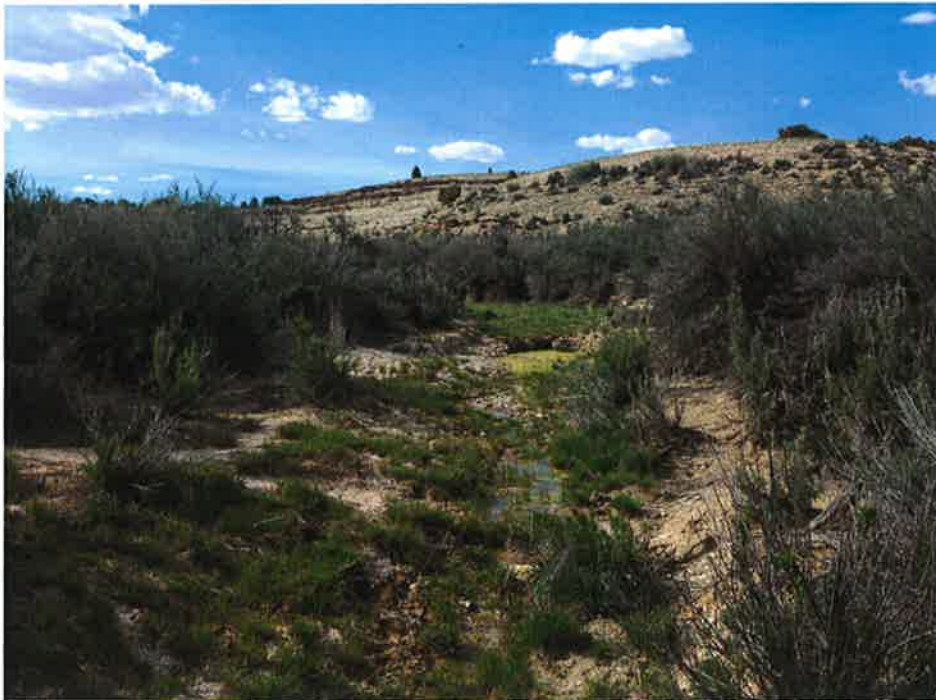
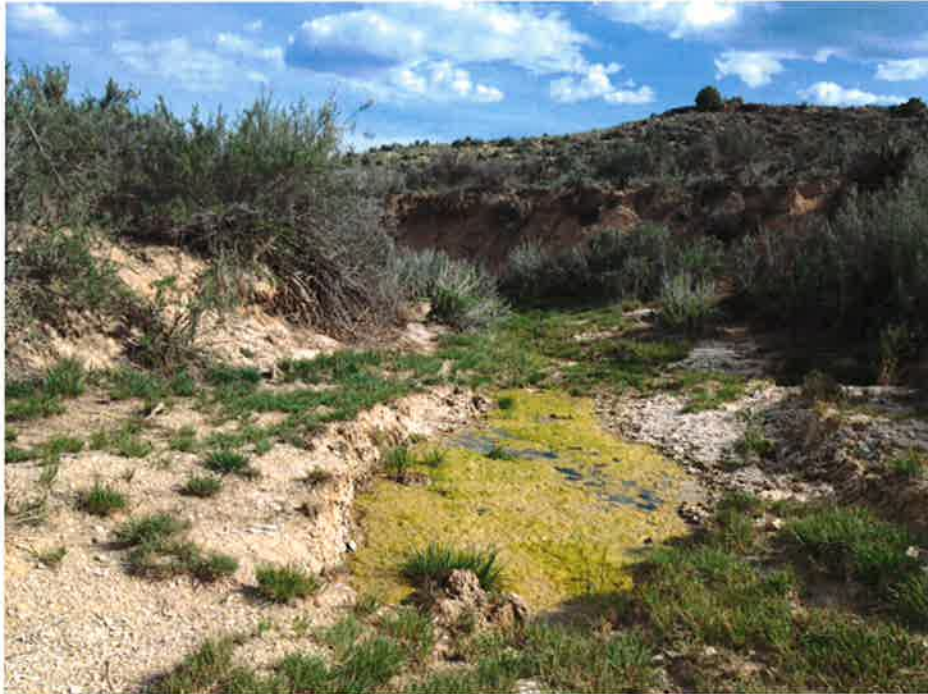
This spring site (formally designated as two separate potential seeps, Potential Seep-03a and Potential Seep-03b), was a spring that issued from an interface between alluvium and the Parachute Creek Formation. Surface water was present intermittently (i.e., resurfaced and went subsurface again a couple of times) within approximately 50 feet before going subsurface for the last time. There was no development, and there is no water right on file with the State Engineer's Office.

There was some evidence of wildlife use but no changes in vegetation except for a higher concentration of grass. Flow was not measured at this spring during sampling time (1730) as only saturated conditions or small shallow pools were present. The temperature was 20.0°C, pH was 8.59, and conductivity was 2.30 mS. See photos 11 – 13 in **Appendix A**.

Photo 11 Reservoir Canyon Spring – 02 looking up canyon

Photo 12 Reservoir Canyon Spring – 02 looking up canyon

Photo 13 Klondike Canyon Spring – 02 looking up canyon

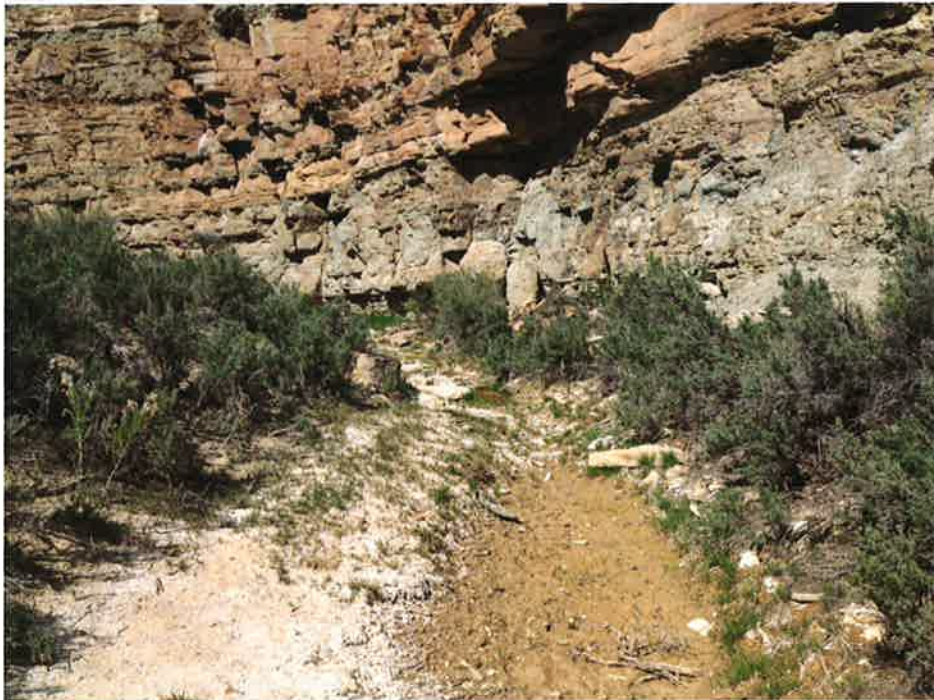
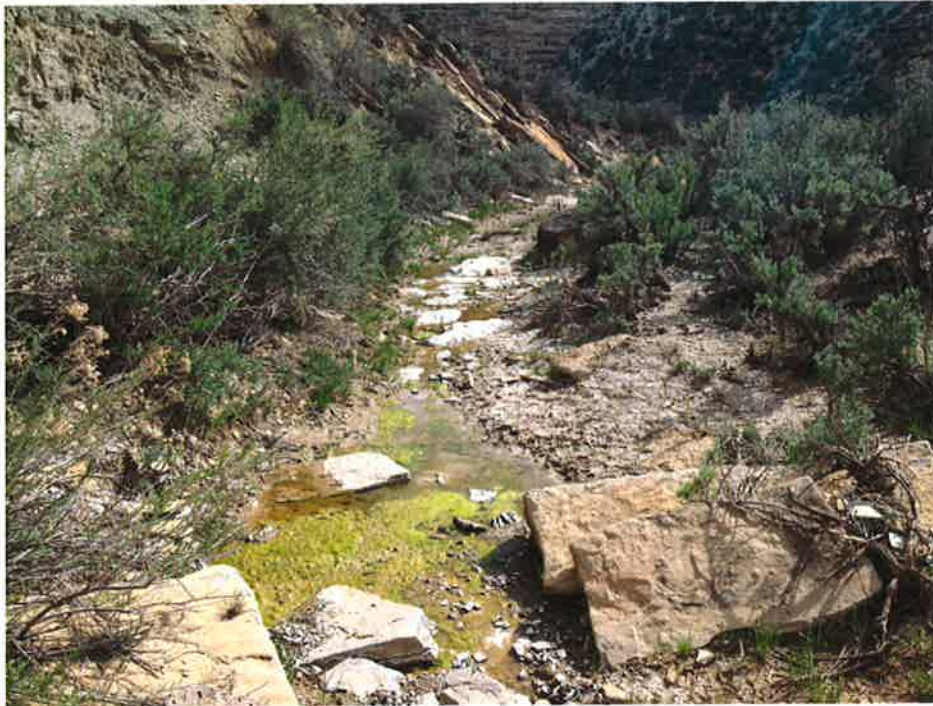
Klondike Canyon Seep-03f, and Potential Seep-04, was a spring that issued from an interface between alluvium and the Parachute Creek Formation. There was an area of continuous surface water (saturated soil and shallow pools) for approximately 50 feet, where the water then went subsurface. There was no development, and there is no water right on file with the State Engineer's Office.

There was some evidence of wildlife use but no changes in vegetation except for a higher concentration of grass. Flow was not measured at this spring during sampling time (1700) as there was no visible flow (i.e., only saturated conditions or small shallow pools were present). The temperature was 26.0°C, pH was 9.74, and conductivity was 3.50 mS. See photos 14 – 15 in **Appendix A**.

Photo 14 Reservoir Canyon Spring – 03 looking up canyon

Photo 15 Reservoir Canyon Spring – 03 looking up canyon

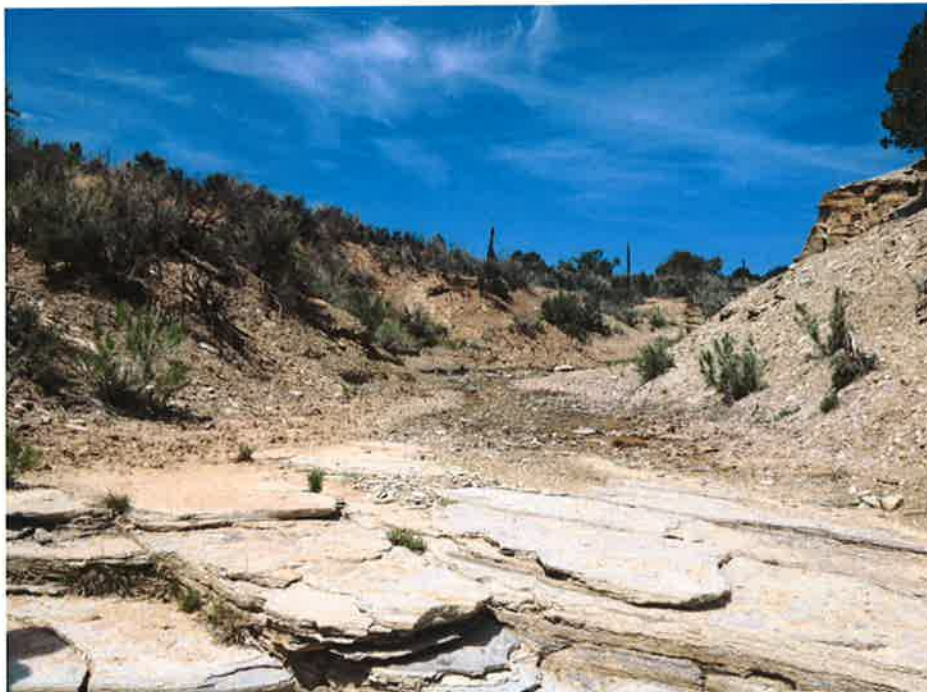
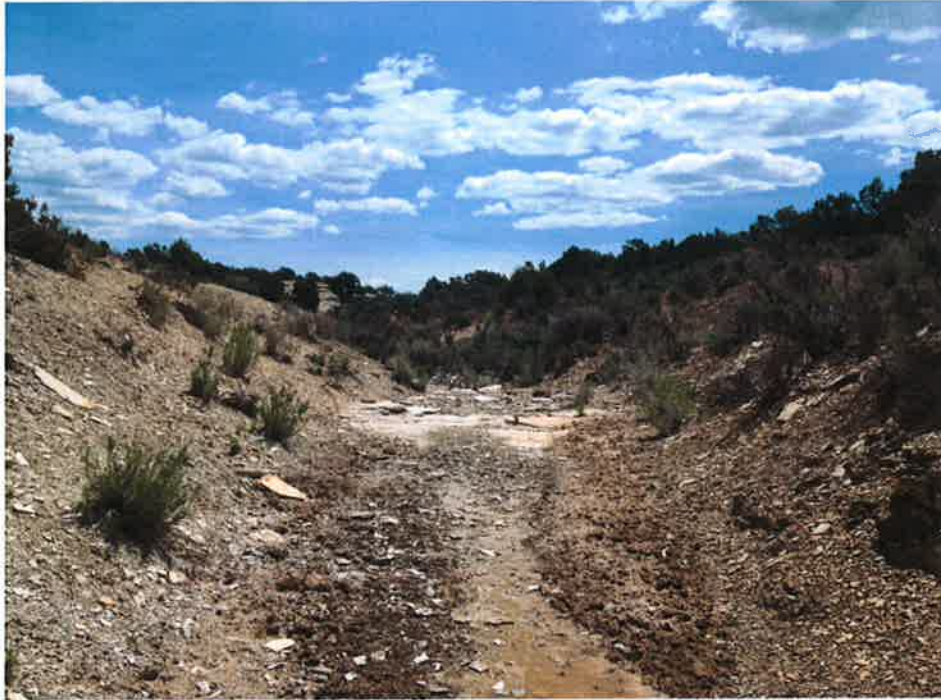
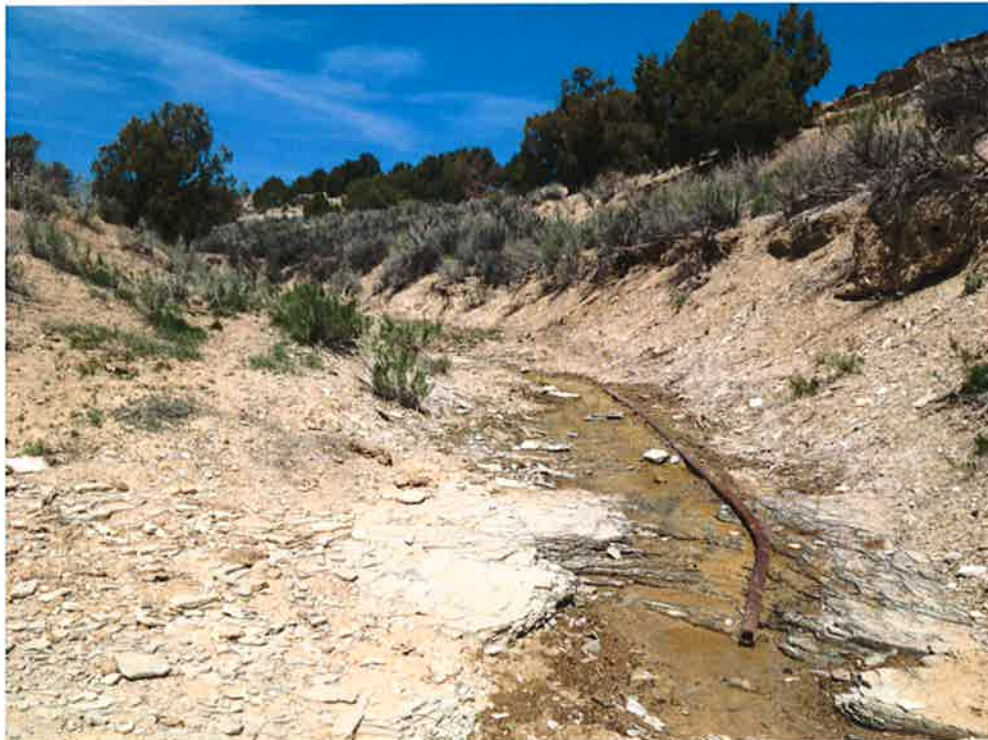
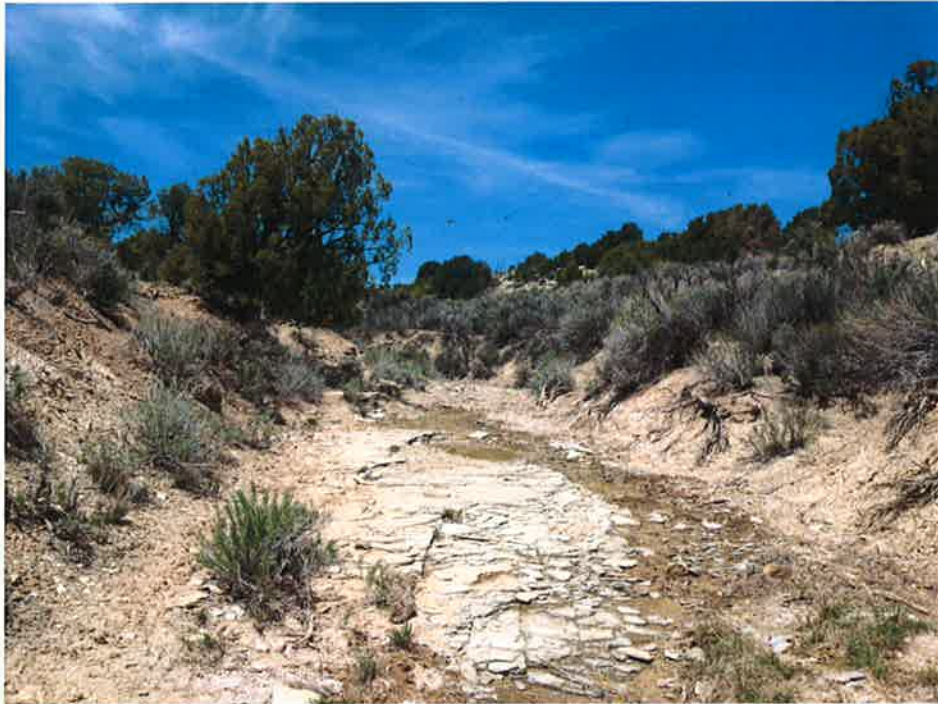
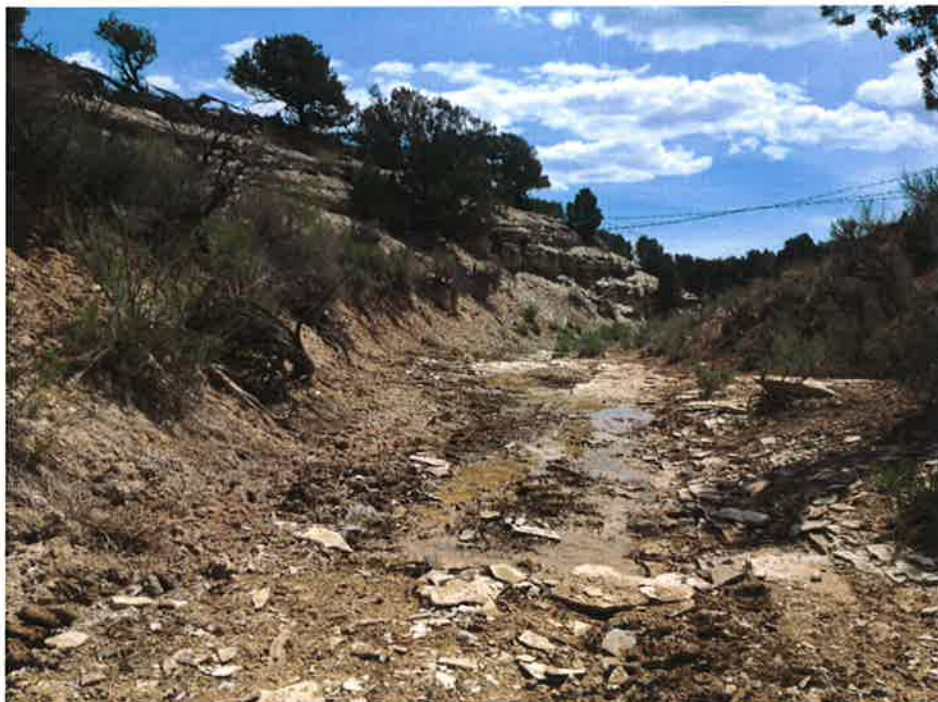
This seep discharged from a shale bedrock outcrop at a small drop in the stream channel. There was in situ bedding of the Parachute Creek Member located immediately in the channel and on the surrounding drainage walls.

In the channel bottom was an old pipe that may have been associated with some previous development of this spring. There is a water right record on file for this spring with the State Engineer's Office. There was no riparian or wetland vegetation associated with the site, as water was confined to an area of the streambed with bedrock.

There was some evidence of wildlife use, deer tracks, but no changes in vegetation. Flow was not measured at this spring during sampling time (1220) as only saturated conditions or small shallow pools were present. The temperature was 25.4°C, pH was 8.55, and conductivity was 4.56 mS. See photos 16 – 20 in **Appendix A**.

Photo 16 Indian Ridge Canyon Spring – 01 looking up canyon

Photo 17 Indian Ridge Canyon Spring – 01 looking down canyon

Photo 18 Indian Ridge Canyon Spring – 01 looking up canyon

Photo 19 Indian Ridge Canyon Spring – 01 looking up canyon

Photo 20 Indian Ridge Canyon Spring – 01 looking down canyon

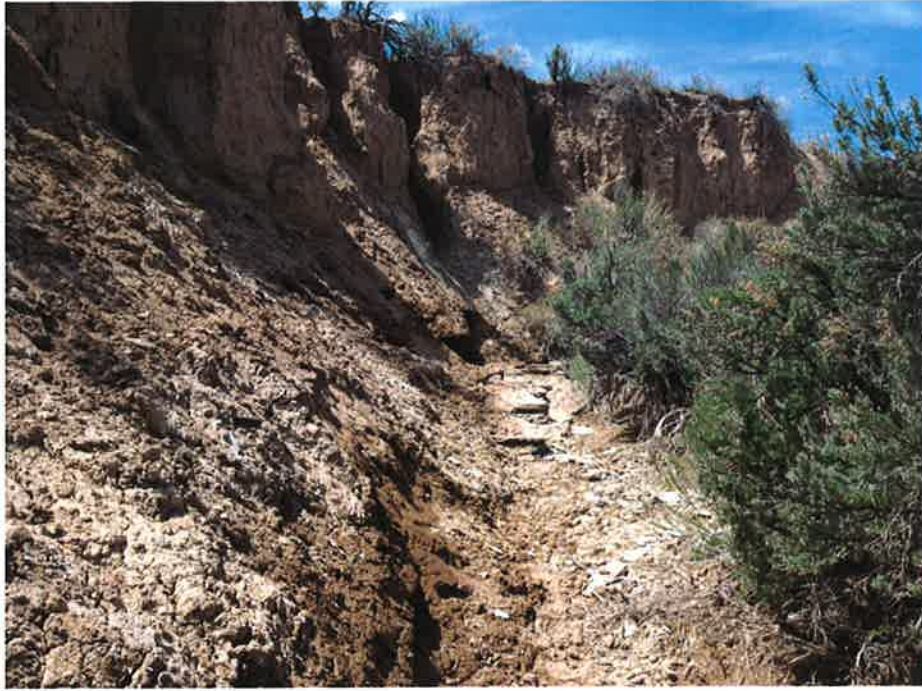
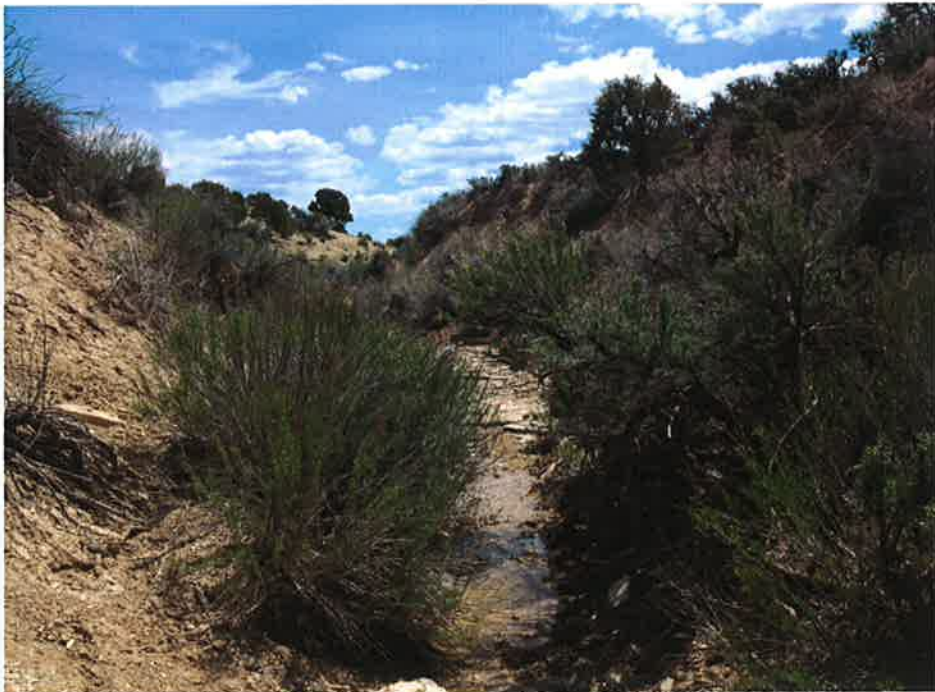
This spring site (formerly designated as Potential Seep-05), was a spring that issued from an interface between alluvium and the Parachute Creek Formation. There was no development, and there is no water right on file with the State Engineer's Office.

There was evidence of wildlife in form of numerous mule deer tracks, but no changes in vegetation. Flow was not measured at this spring during sampling time (1230) as only saturated conditions or small shallow pools were present. Water resurfaced and went

subsurface again several times within approximately 240 feet before going subsurface for the last time. The temperature was 20.5°C, pH was 7.97, and conductivity was 4.20 mS. See photos 21 – 22 in **Appendix A**.

Photo 21 Indian Ridge Canyon Spring – 02 looking up canyon

Photo 22 Indian Ridge Canyon Spring – 02 looking up canyon
