## **2.0 FACILITY DESCRIPTION**

### **2.1.1 General Description of the Bacchus Facility**

### 2.2.2 HS-1

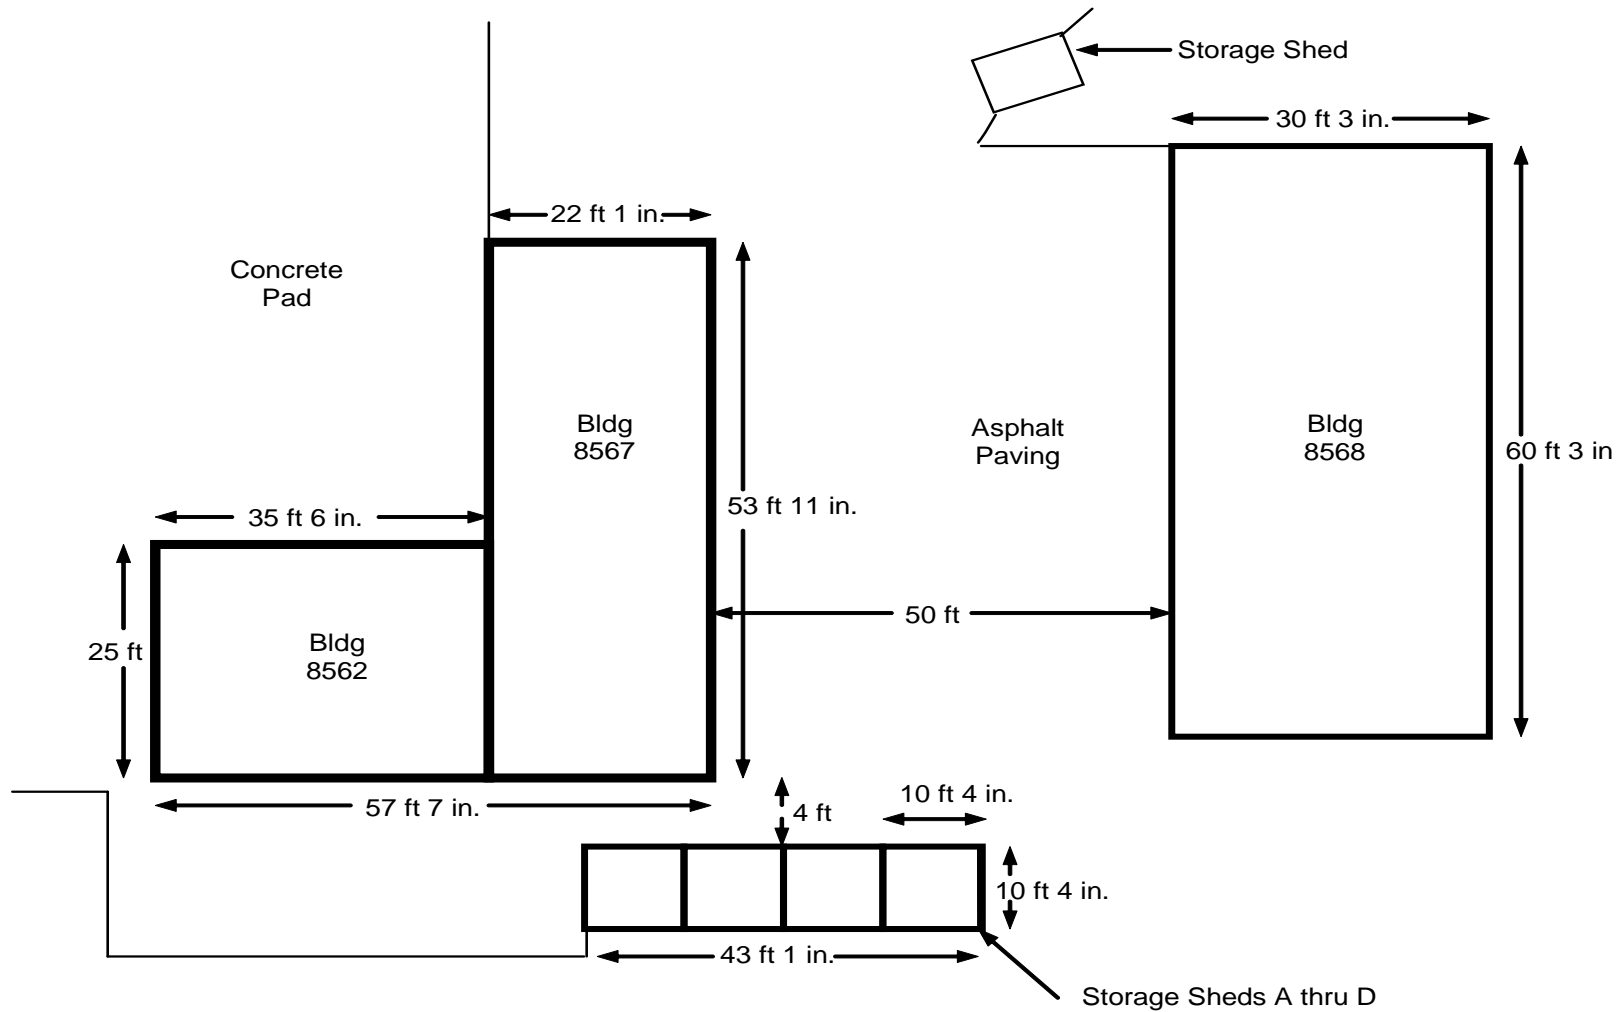
**Figure 2-2.2**  
**HS-1 Building Complex**

The four wood-framed sheds each having approximate dimensions 10'4" x 10' 4" located to the south of Building 8567 (Figure 2-2.2). Actual dimensions vary slightly for each shed. The sheds are designated A, B, C and D. Shed B is used to store hazardous waste. Sheds A and C are used to store supplies. Shed D is a mechanical room for the facility. Storage capacity for Shed B is 450 gallons. The sheds have a concrete floor with no secondary containment.

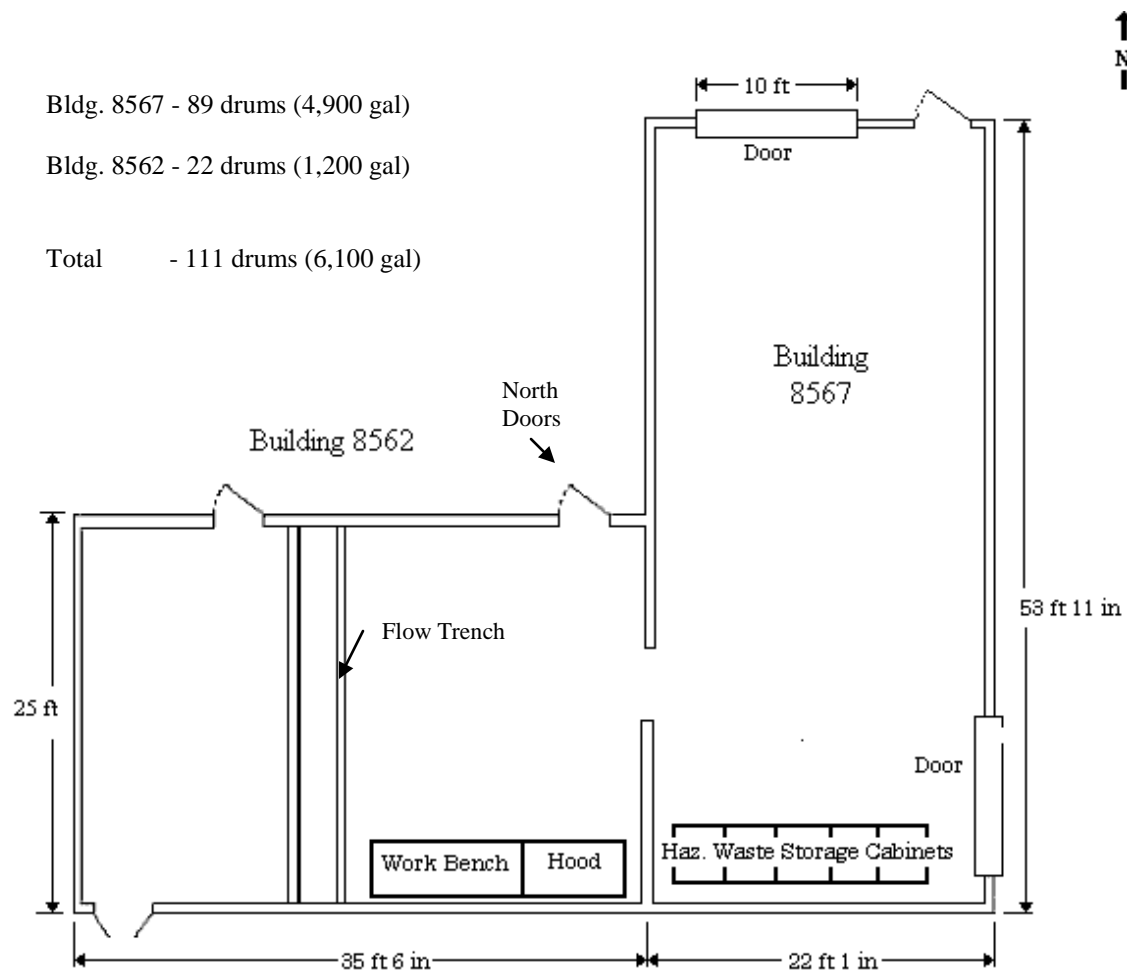
**Figure 2-2.4**  
**Bldg. 8562 and 8567 Drum Storage**

Building 8562 (Figure 2-2.4) is divided by a wall into two separate rooms. The west half of the building is office space, and the east half is a work area. No hazardous wastes are stored in the office area. The entire building is equipped with heat and lighting.

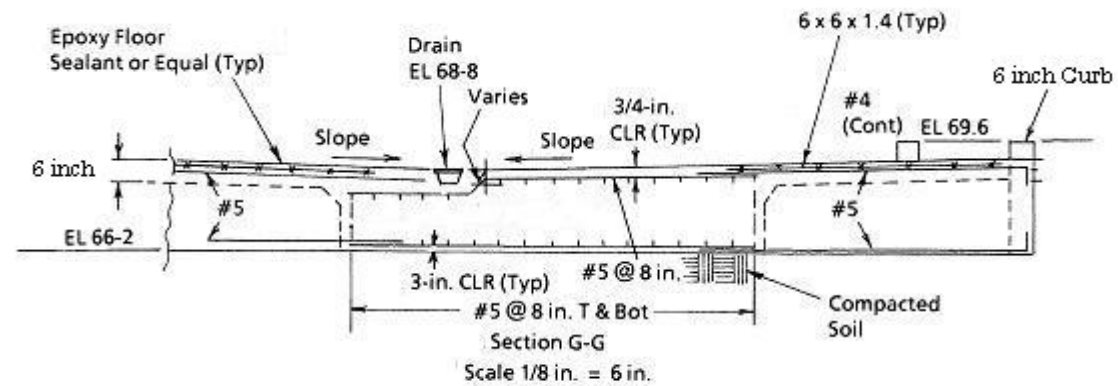
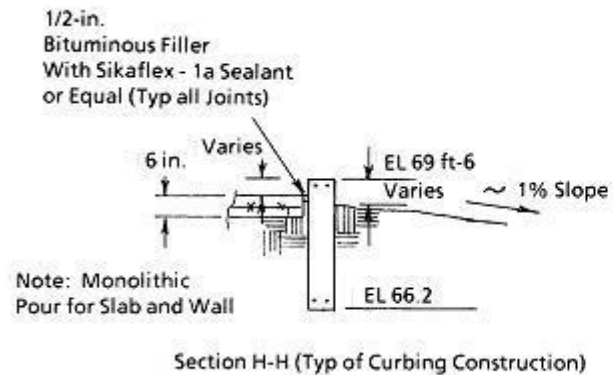
**Figure 2-2.5**  
**Bldg 8562 Floor Details**

The floor in the work area was constructed using a monolithic cast concrete slab with a 6" curb on the South and North walls (Figure 2-2.5). The inside dimensions of the work area are 24' x 20'. The main concern for liquid containment is to ensure that liquids will be contained, and not released through the north personnel door. The area adjacent the personnel door is approximately 0.12' higher than the surrounding floor area. The floor forms the secondary containment in the area west of the personnel door with a liquid collection trench forming the low point of the containment. The dimensions of the containment are approximately 12' x 24' x 0.12'. The volume of this area can be approximated by taking half of the volume for the containment rectangle described above, or 17 ft<sup>3</sup>. The room also has a floor trench, which is an architectural feature from the previous occupancy of the building. The average dimensions of the trench are 0.4' deep, 0.5' width and 24' long for a volume of 5 ft<sup>3</sup>. The total volume contained in the trench and area west of the personnel door is 22 ft<sup>3</sup>. Using 7.48 gallons per cubic foot, the containment will hold approximately 165 gallons.

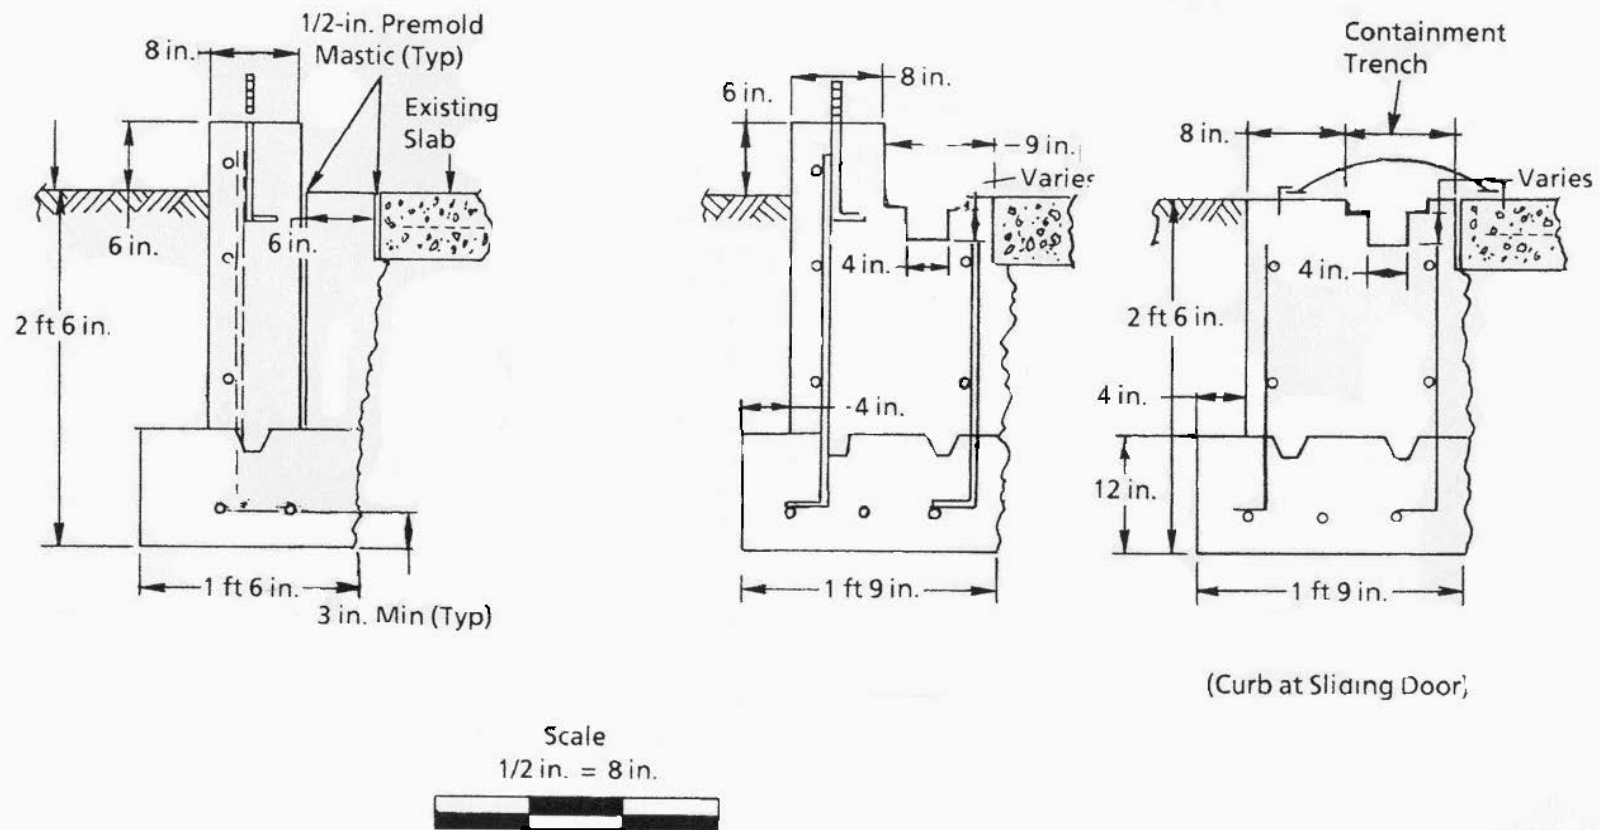
**Figure 2-2.6**  
**Bldg 8567 Floor/Curbing**

Building 8567 is an enclosed structure, built on a monolithic cement pad surrounded by a minimum 6" curb on all sides (Figure 2.2-6). The inside dimensions of this building are 21' x 52'. The floor slopes to the north and east. Any liquids released will be contained and collected along the north and east side of the building. The average depth along the north wall is 0.30'. The average depth along the east wall is 0.25'. To conservatively determine the containment capacity the size of the containment will be estimated based on a depth of 0.25' along both the north and east wall. The width will be 21' along the north wall, 35' along the east wall and will cover approximately one-half the room using a line which bisects the room running from the northwest corner to a point approximately 35' along the east wall. The 35-foot distance along the east wall is the floor elevation where liquids could start to flow through the door into the work area of Building 8562.

The volume for this area is  $\frac{1}{2}$  the length x the width x the depth or  $\frac{1}{2} (.25') (21') (35') = 92 \text{ ft}^3$ . Using 7.48 gallons per cubic foot, the containment will hold approximately 690 gallons.

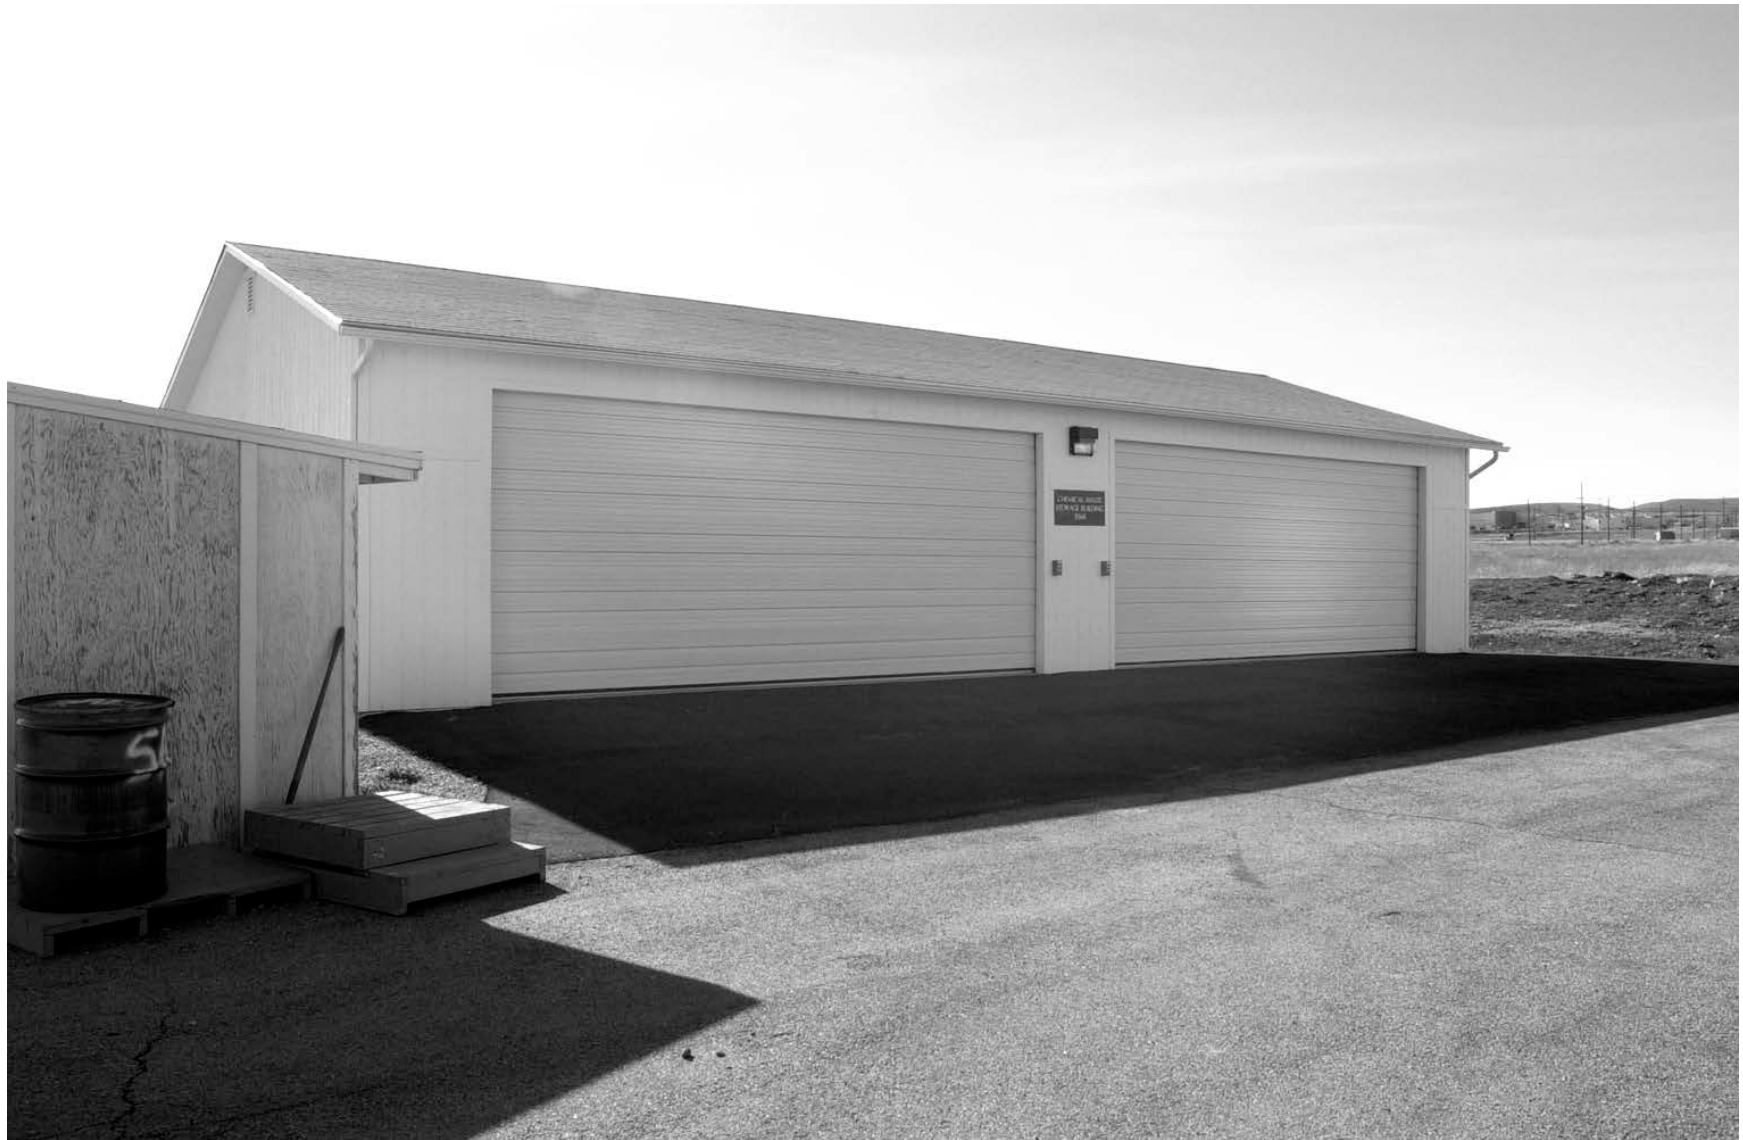
**Figure 2-2.7**  
**Bldg 8568 Hazardous Waste Storage Building**

Building 8568 (Figure 2-2.7 and 2-2.8) is an enclosed wood-framed structure fitted with two large overhead doors. It measures 30' wide x 60' long. Storage capacity is 9,350 gallons. The concrete floor in this building has no secondary containment. It is used to store both RCRA and non-RCRA wastes. RCRA liquid wastes may be stored in Building 8568 only if the containers are stored on pallets that provide secondary-containment or packaged as lab packs containing chemically compatible absorbent material in sufficient quantity to absorb the total liquid contents.

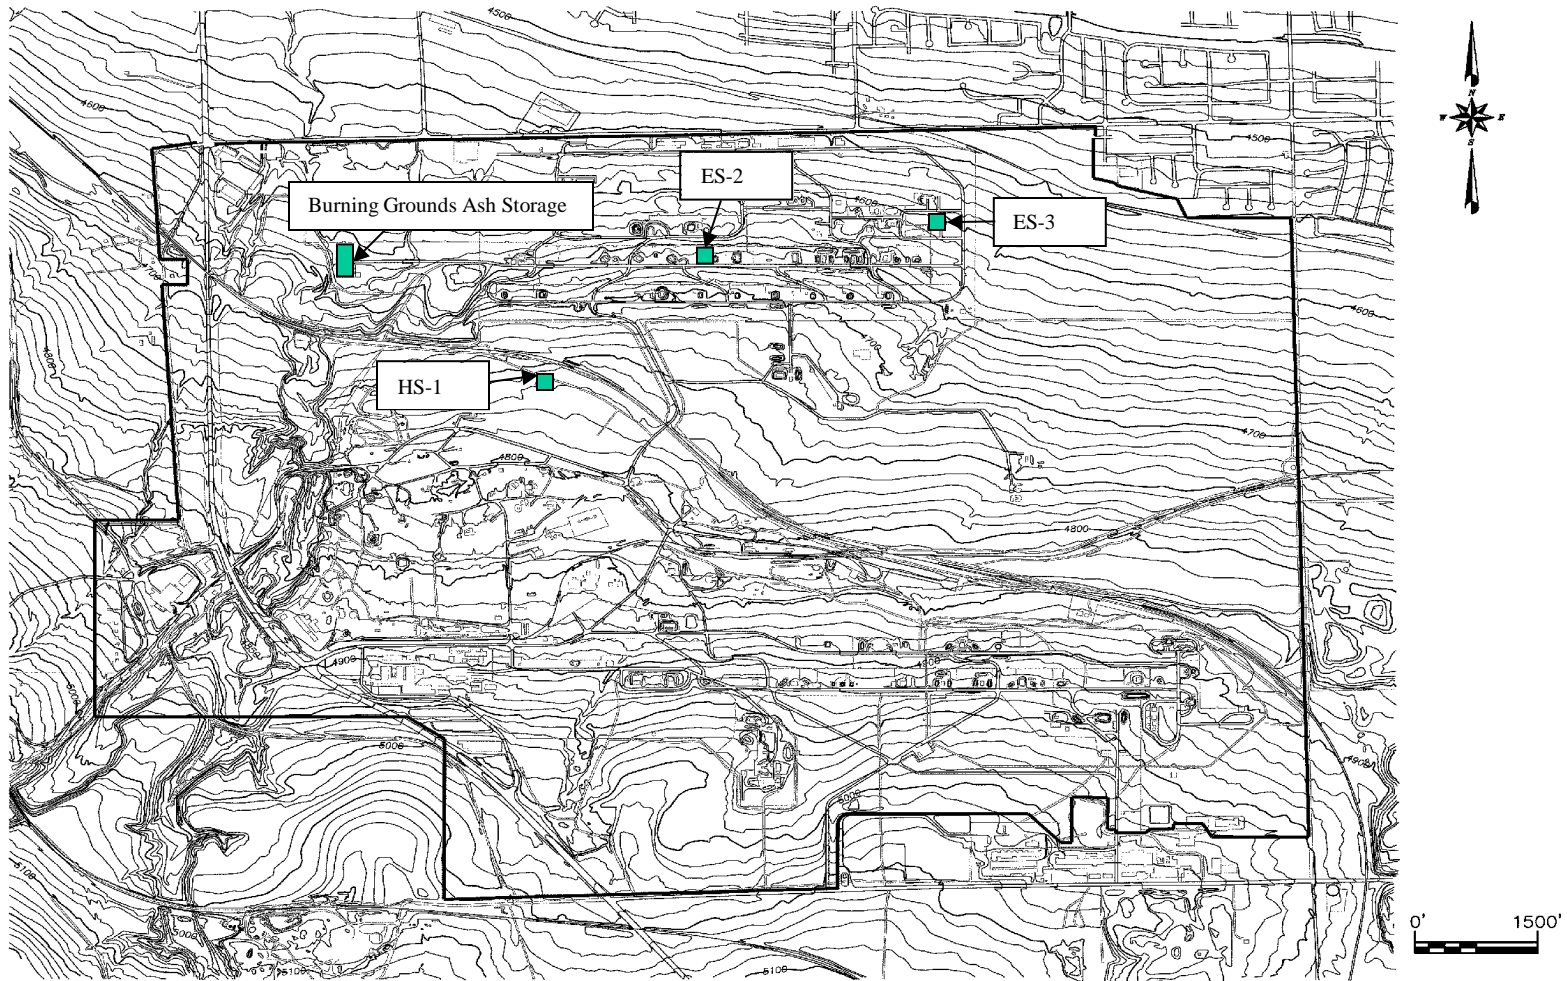
**Figure 2-5.10**  
**ATK-Bacchus Topographic Map**

A topographic map is presented showing the various Bacchus facilities: Plant 1, NIROP, and Bacchus West in Figure 2-5.10. The map shows plant facilities, security fences and gates, and the hazardous waste management facilities. The topographic map includes:

- Surface contours
- Surface water flow and drainage barriers

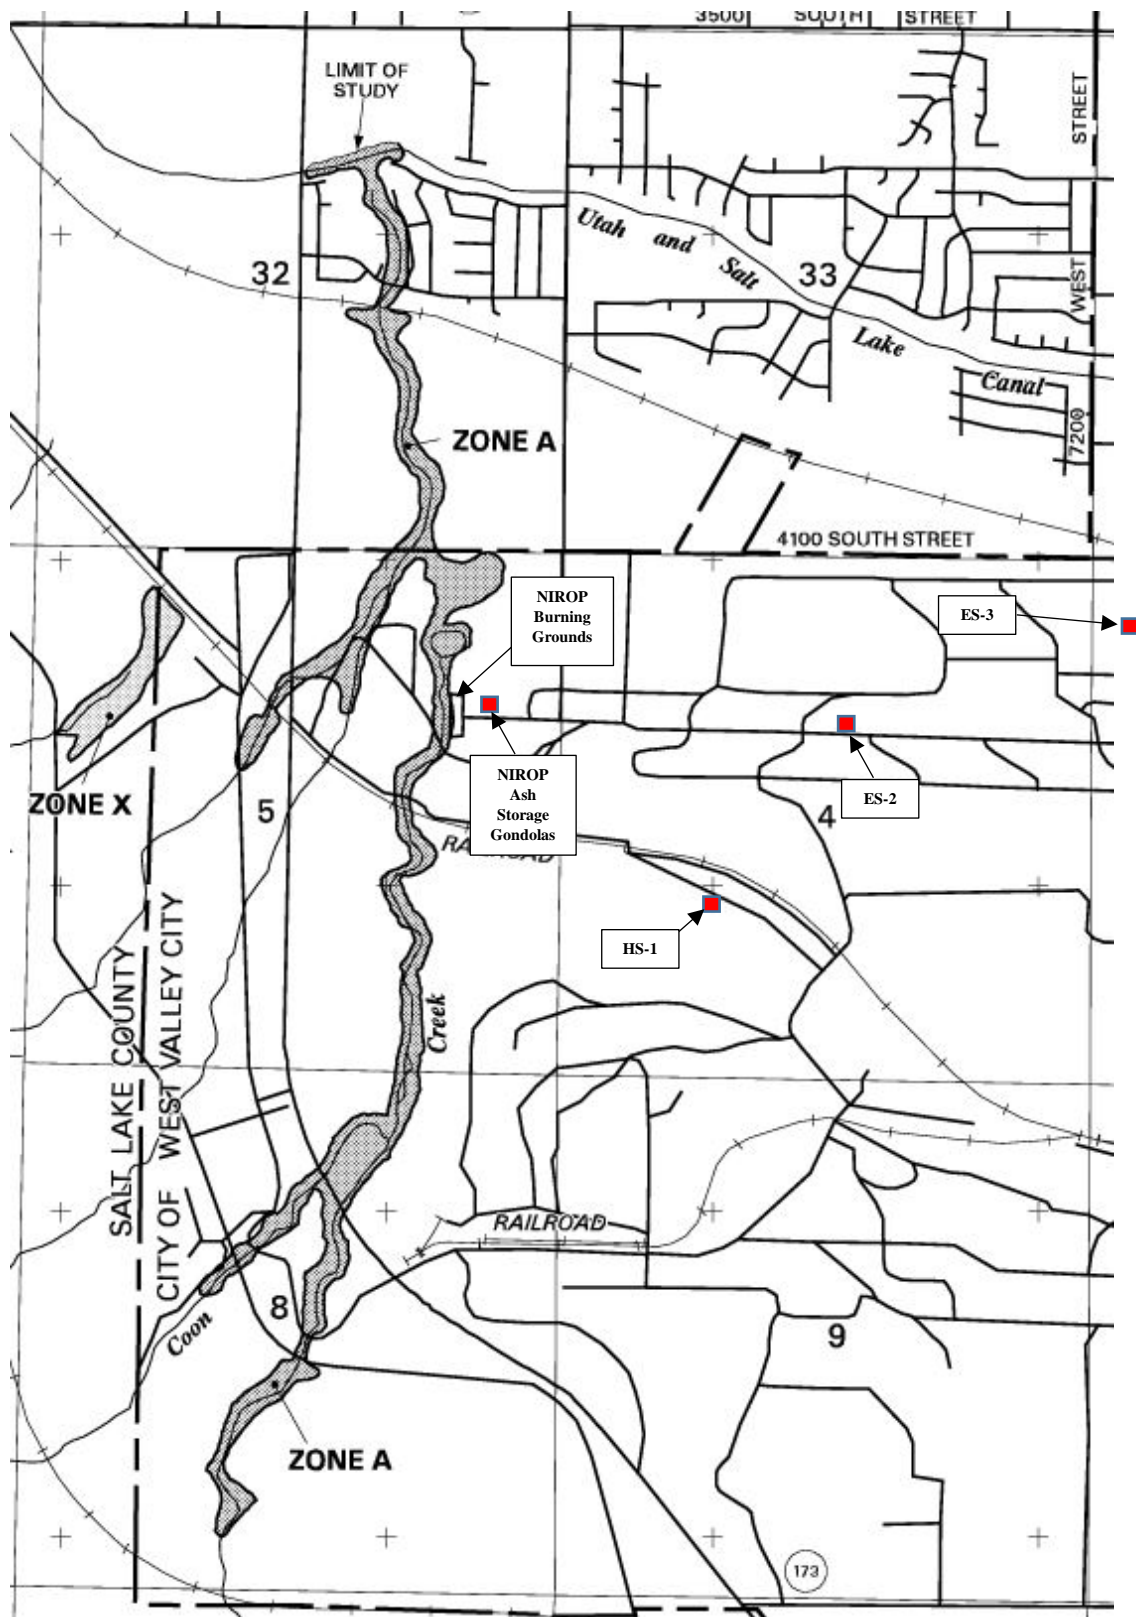
**Figure 2-5.11**

A copy of the portion of the FEMA Flood Insurance Rate Map for the area of the facility that includes HS-1, ES-2, ES-3, and the NIROP Burning Grounds is presented in Figure 2-5.11. HS-1 on Plant 1 is not located within or immediately adjacent to a 100-year floodplain (Zone A designation).

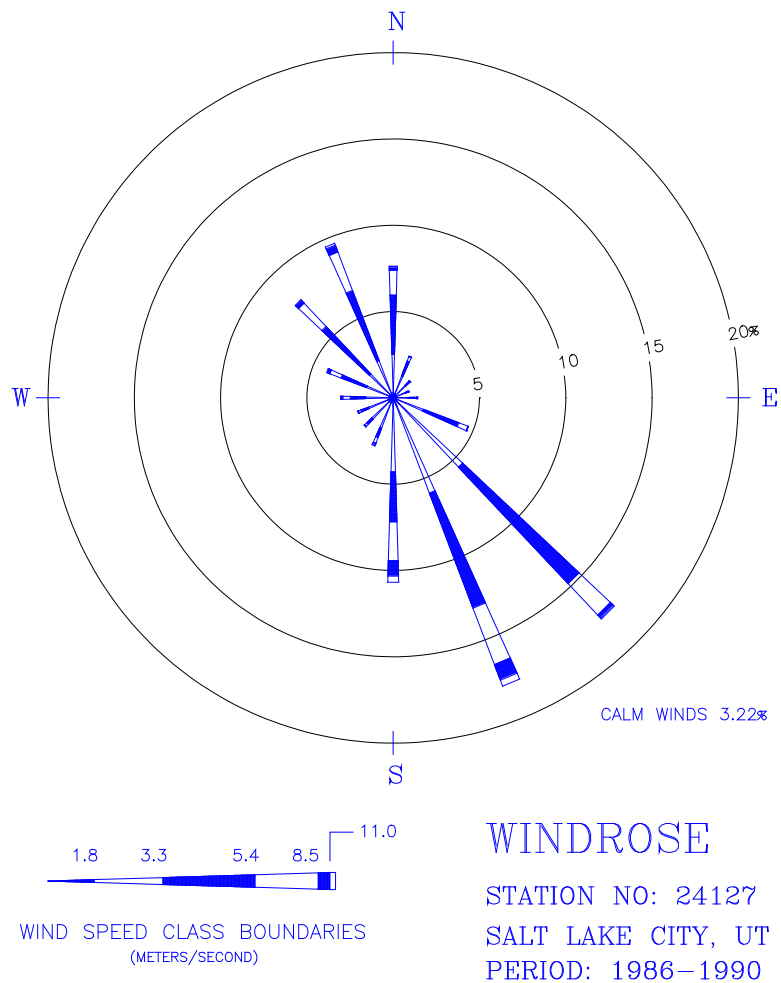
**Figure 2-5.1<sup>29</sup>**  
**Salt Lake City Area Windrose**

The wind rose (Figure 2-5.12) for the Salt Lake area shows the frequency of winds, in percent by direction and speed, and indicates the average wind speed in miles per hour. The predominant wind direction is from the south with an average wind speed between 8.9 and 11.3 mph. The next most prominent wind direction is from the north with an average wind speed of 7.9 to 8.8 mph.

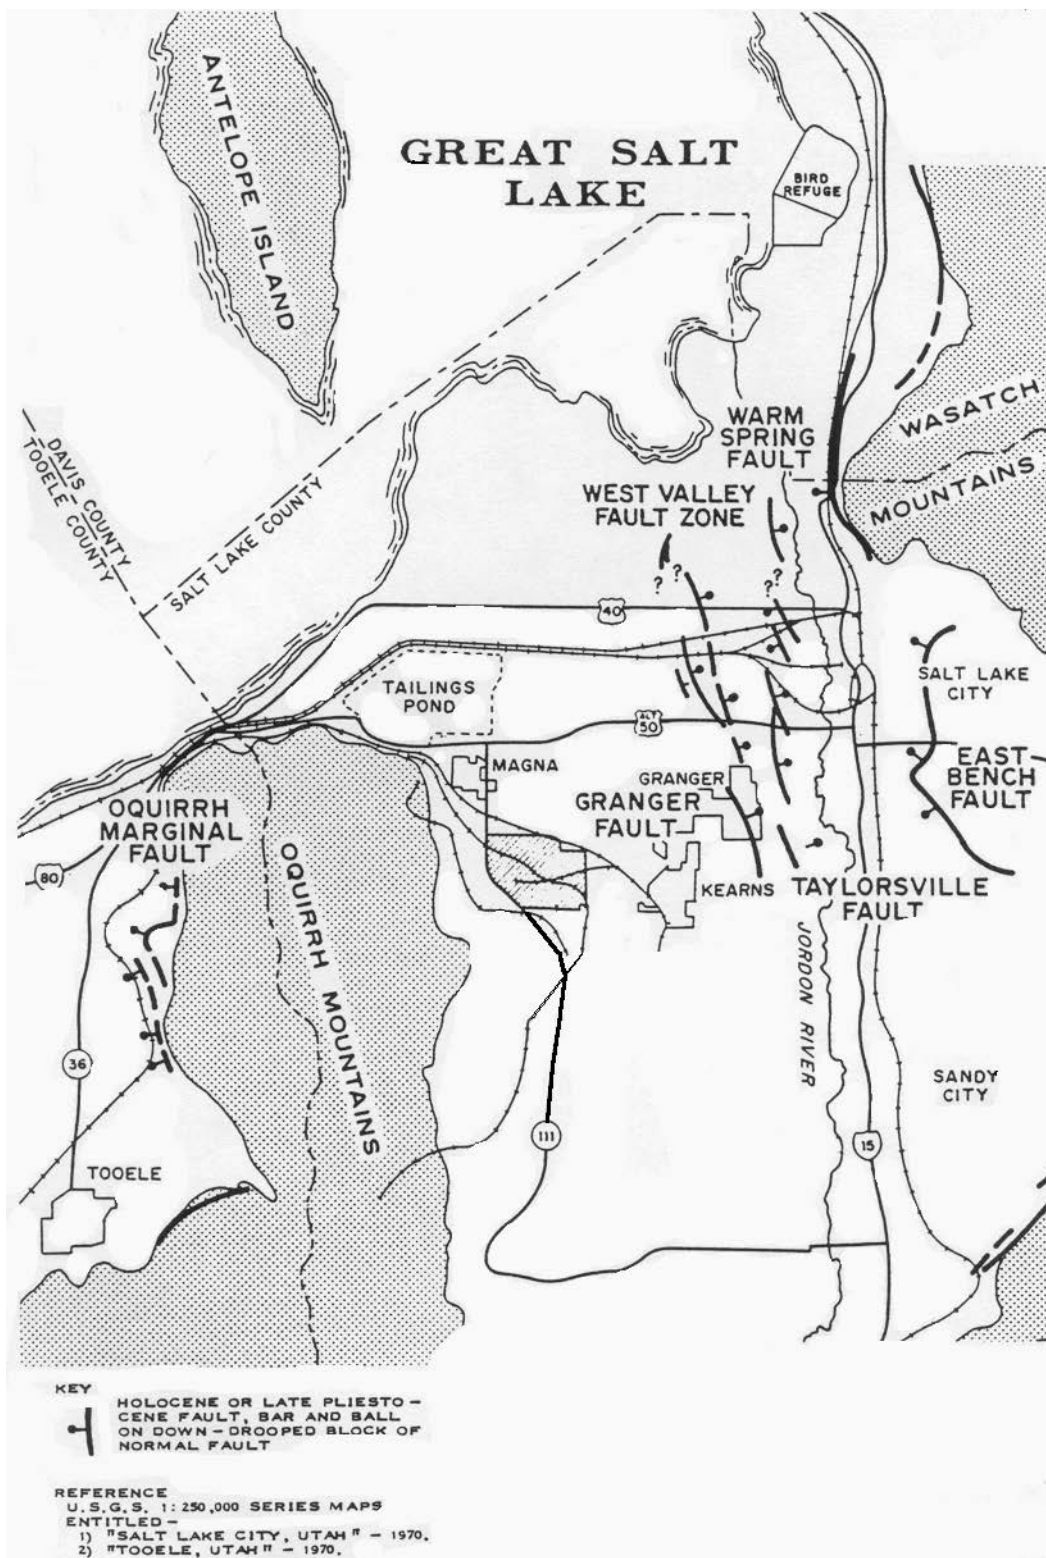
**Figure 2-5.13**  
**Salt Lake City Area Geologic Faults**

The only documented sympathetic and antithetic faulting in the Salt Lake Valley near the facility is the West Valley Fault Zone (Figure 2-5.13 and 2-5.14). The faults in this zone primarily dip toward the east in antithetic response to weakness in the valley sediments caused by movement along the Salt Lake City section of the Wasatch Fault Line. No documentation is present to suggest that the West Valley Fault Zone is tectonic in nature (basement controlled).

The Granger fault, as named by Marine and Price (1964) and evaluated by Keaton and others (1987), is the nearest Holocene age fault with possible recent displacement. It is located about five miles east-northeast of the site. The Granger and Taylorsville faults to the east comprise the West Valley Fault Zone (Figure 2-5.13).
