SUBJECT: Site Management Plan  
 MJK Fabrication Facility  
 791 South 9300 West  
 Ogden, Utah

**SITE MANAGEMENT PLAN  
MJK FABRICATION  
791 SOUTH 9300 WEST  
OGDEN, UTAH**

**Project No. 2229-001**

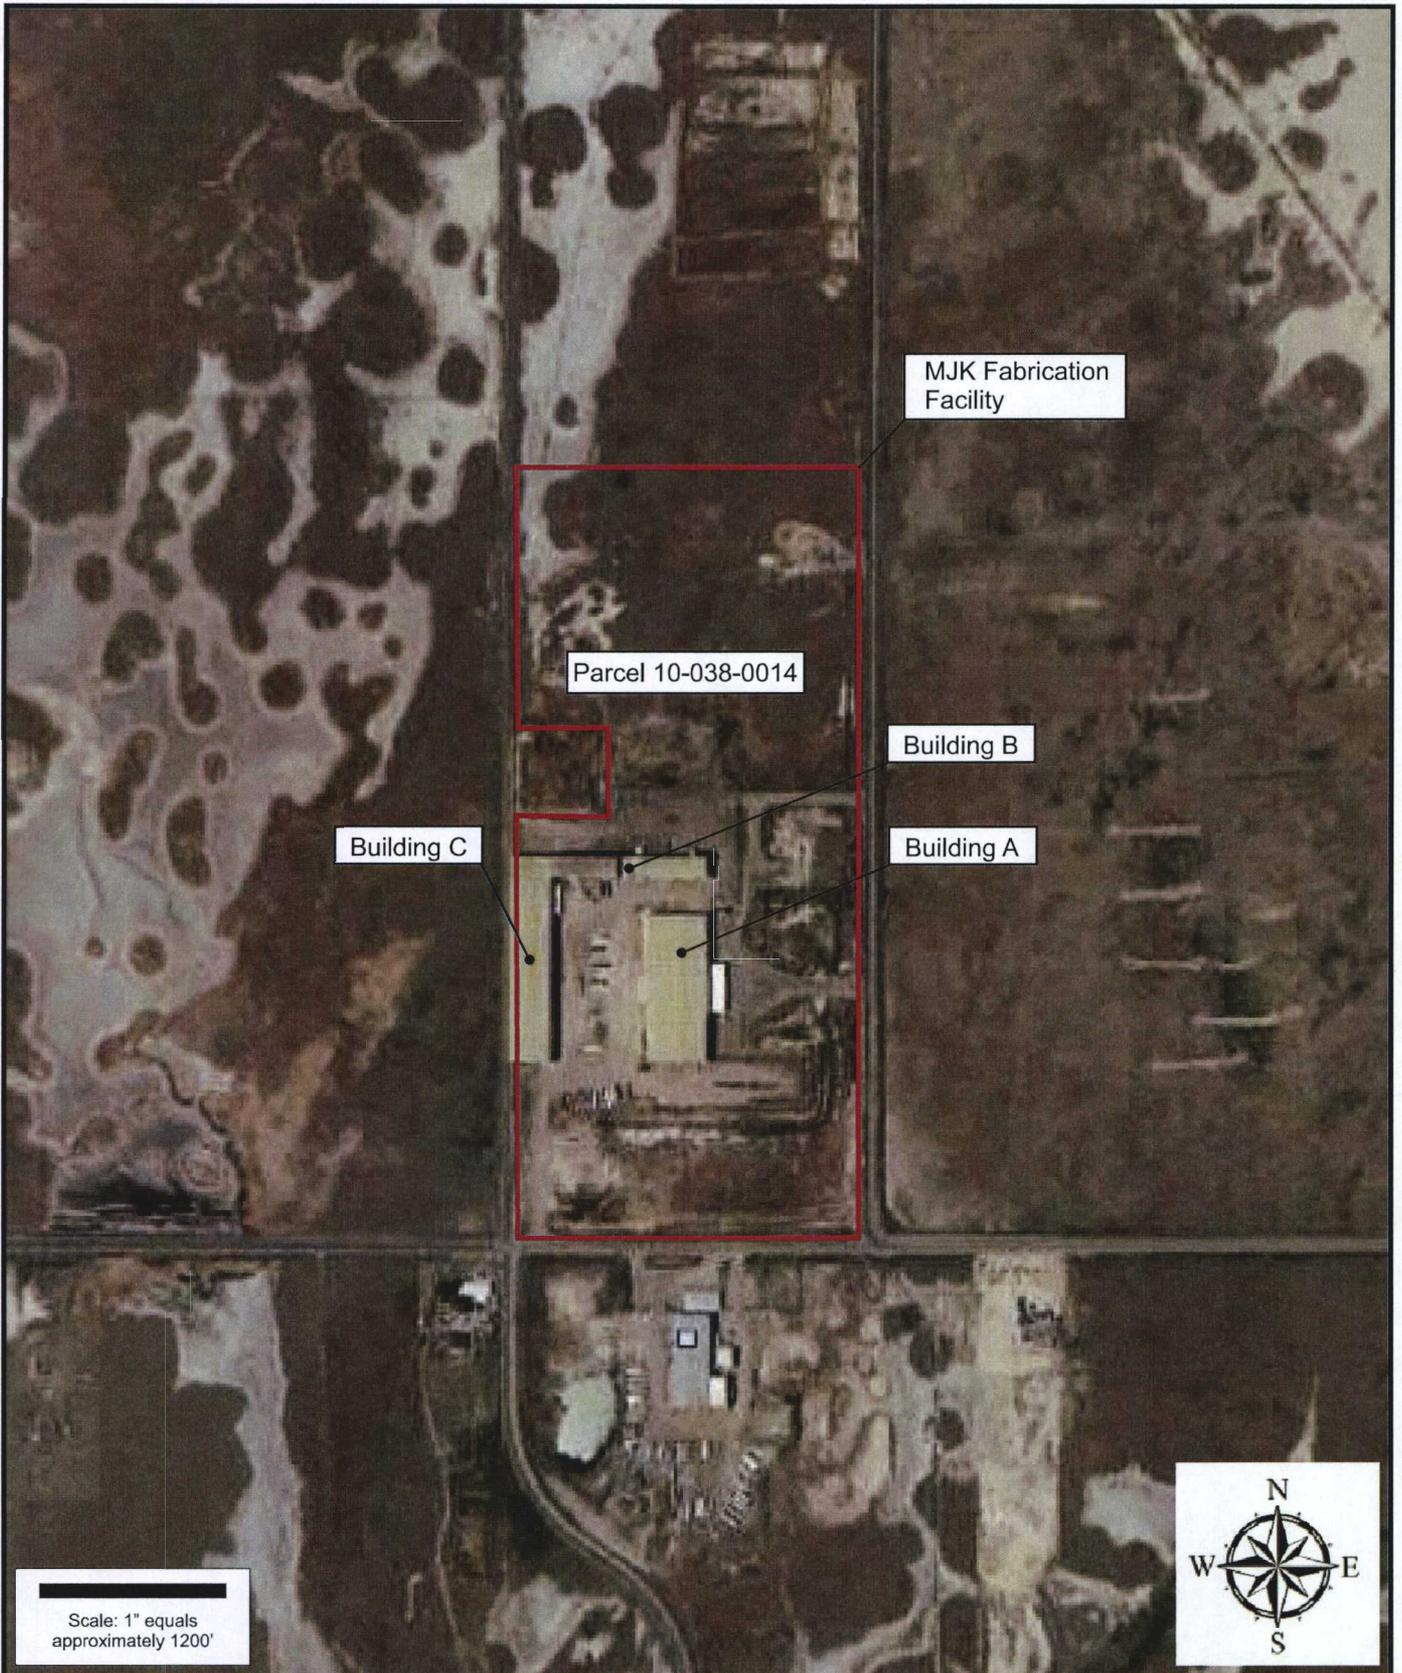
FIGURE 2

**FACILITY PARCEL MAP**

A Facility Location Map and Facility Parcel Map are presented as Figures 1 and 2, respectively.

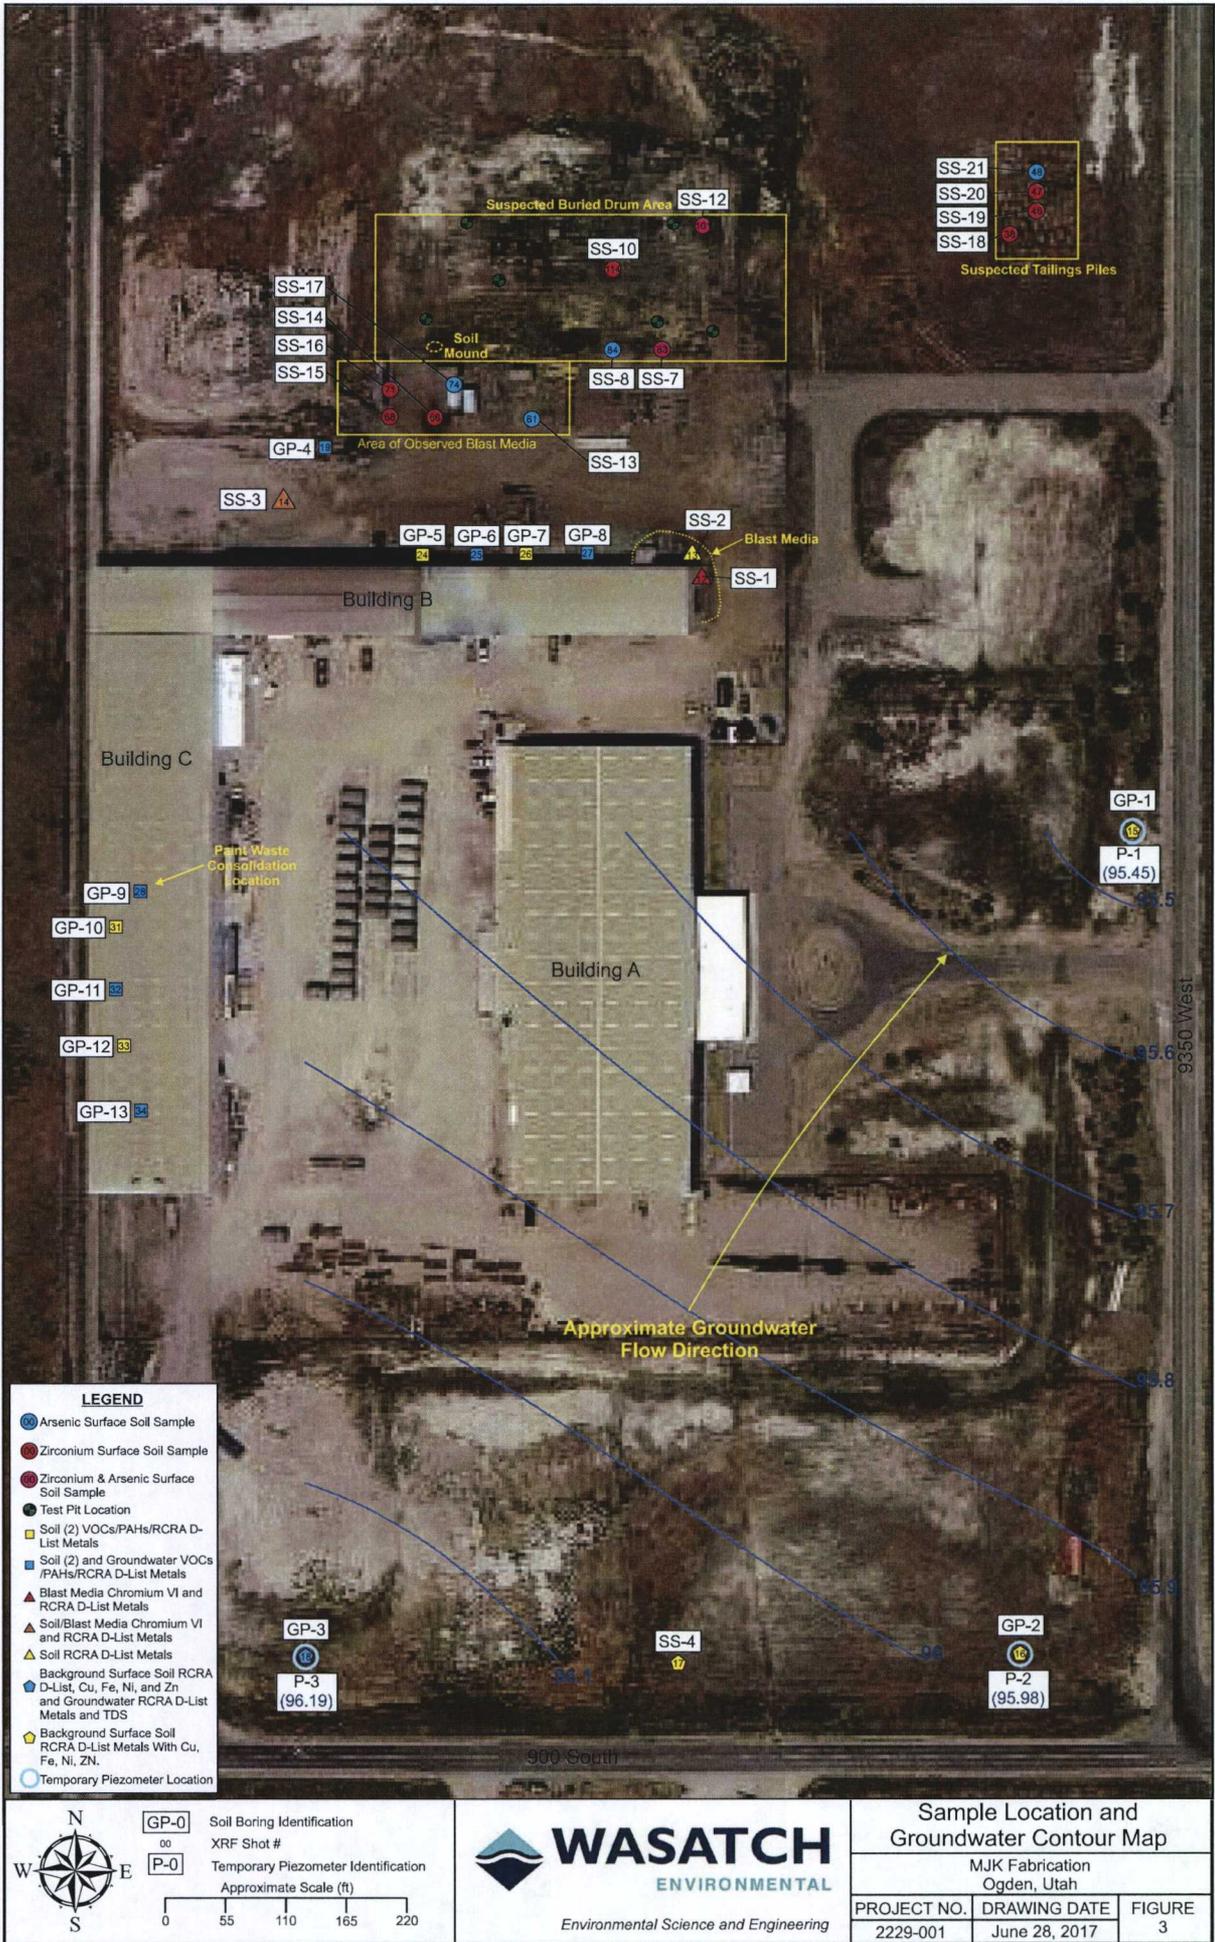
Figure 3 – Sample Location and Groundwater Contour Map

In May 2017, Wasatch conducted the following subsurface investigation activities in the area of Building B as depicted on Figure 3:

In May 2017, Wasatch conducted the following subsurface investigation activities inside Building C as depicted on Figure 3:

Additionally, four surficial background soil samples (GP-1, GP-2, GP-3, and SS-4) were collected from the southern and eastern portions of the subject property in areas with no prior suspected activities (see Figure 3). Temporary piezometers were set in three of these borings (see Figure 3). Top-of-casing elevations were surveyed and depth to groundwater measurements were obtained from three of the temporary piezometers in order to determine groundwater flow direction. Wasatch determined that the groundwater flow direction was to the northeast.
