ATTACHMENT 12

LANDFILL 5 FACILITY DESCRIPTION

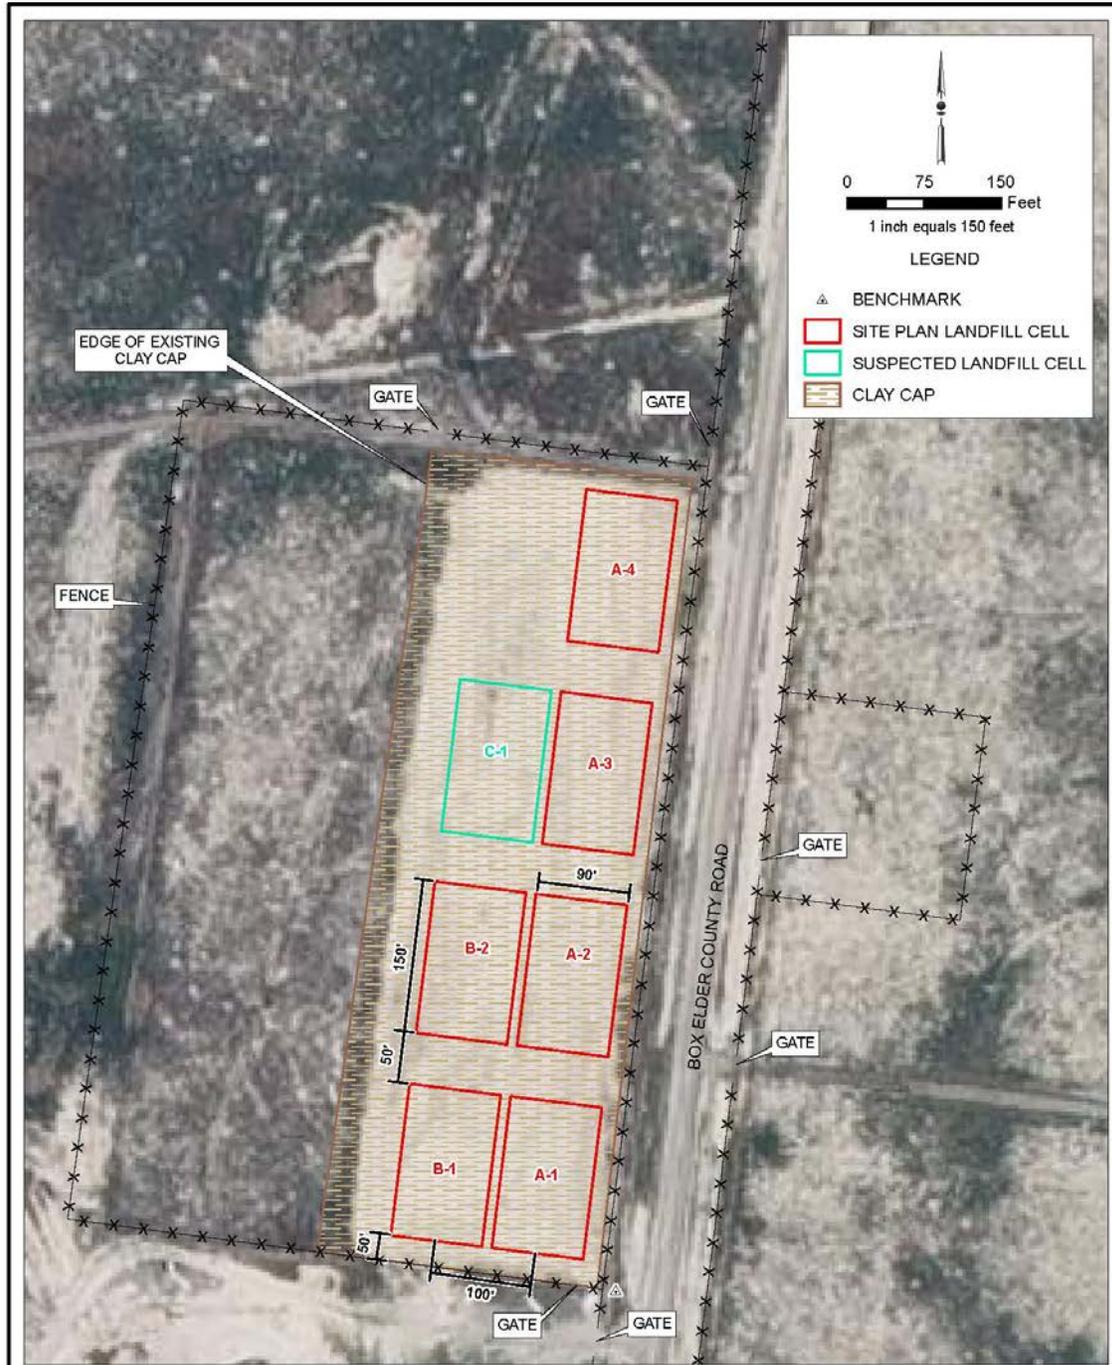
Figure 1
LANDFILL 5 SITE PLAN
UTAH TEST AND TRAINING RANGE

Historical records for Landfill 5 and the disposal cell geometry are provided in the Closure Plan (CH2M HILL, 1988). As presented in Figure 1, the Closure Plan describes six separate, unlined cells with cell dimensions of approximately 90 feet by 150 feet. Existing landfill records do not identify any markers used to survey the coordinates of the landfill cells. As a result, the locations of the cells beneath the cap were poorly delineated before a geophysical survey was conducted in 2003. According to the Closure Plan, no bottom liners were installed because of the arid climate, soil conditions, and the containerization of liquid wastes. A silt and clay layer, 10 to 25 feet thick, was observed in four shallow boreholes drilled around the perimeter of the landfill, and field permeability tests indicated that soils below depths of 200 feet had relatively low permeability coefficients of generally less than 20 feet per year (2×10^5 centimeters per second [cm/sec]).

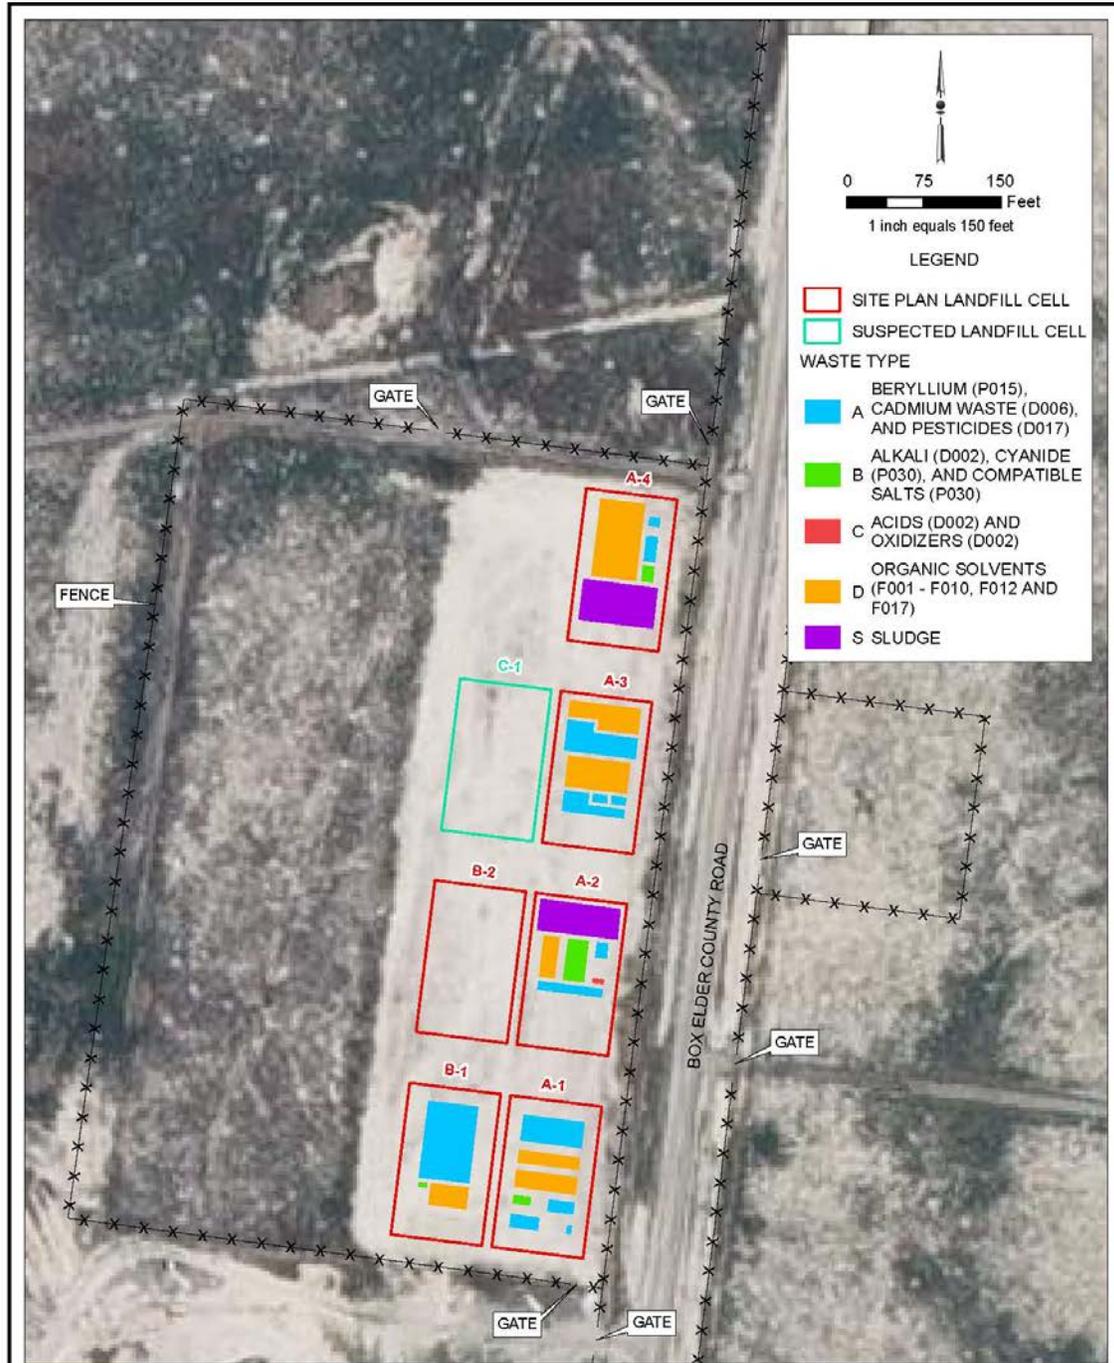
Figure 2
LANDFILL 5 WASTE LOCATION MAP-UPPER LEVEL
 UTAH TEST AND TRAINING RANGE

As-built drawings of Landfill 5 show each cell was excavated to a depth of 15 feet bgs and is composed of two layers of waste material. Each layer is specified as being the depth of a 55-gallon drum (about 3 feet). The two layers are separated by 3 feet of native soil. Drums containing similar wastes were given a designated code letter ranging from A to D and were buried together within each cell layer. Wastes with different code letters were separated vertically and horizontally by at least 3 feet of native fill. Once a cell reached capacity, an additional 5 feet of native soil were used as top cover. The waste codes included the following types of waste:

- A—Beryllium (P015), Cadmium Waste (D006) and Pesticides (D017)
- B—Alkali (D002), Cyanide (P030) and Compatible Salts (P030)
- C—Acids (D002) and Oxidizers (D002)
- D—Organic Solvents (F001–F010, F012 and F017)

The disposal locations of the waste types in each cell as presented in the Closure Plan for the upper and lower layers of the landfill are shown in Figures 2 and 3. In addition to the waste type codes A to D, Figures 2 and 3 also show the disposal location of industrial wastewater treatment plant (IWTP) sludge.

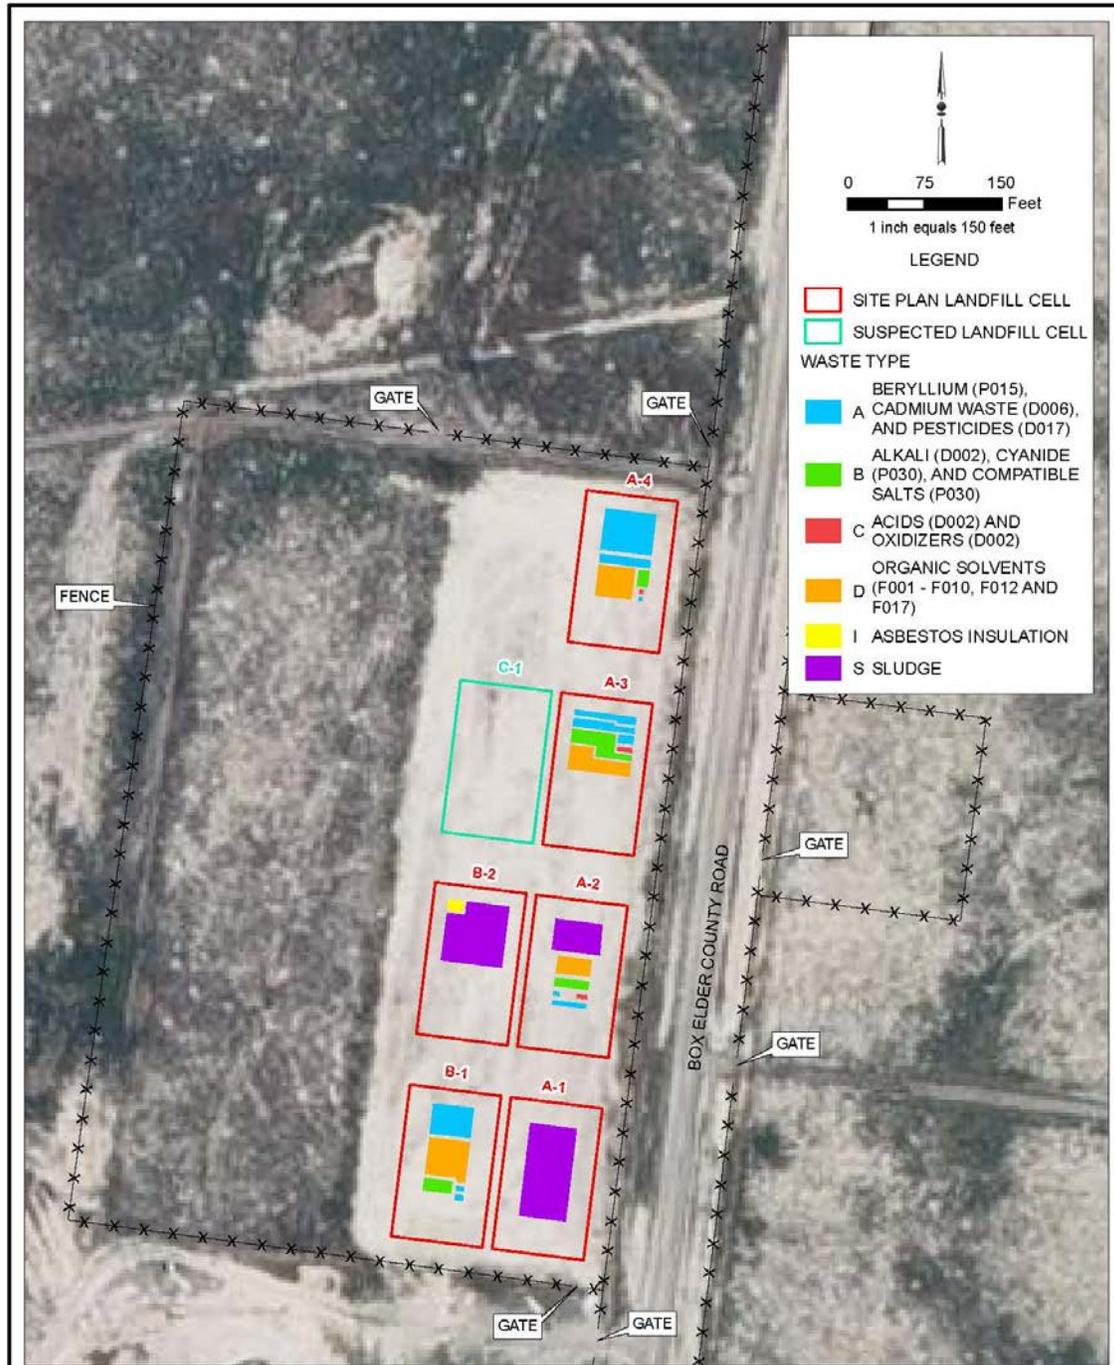
Figure 3
LANDFILL 5 WASTE LOCATION MAP-LOWER LEVEL
 UTAH TEST AND TRAINING RANGE
