Subject: Closure Report, Lacey's Lake Pond Area
Ground Water Discharge Permit No. UGW150002
PacifiCorp, Huntington Power Plant

Closure Report Lacey's Lake Pond Area

PacifiCorp Huntington Power Plant

December 2011

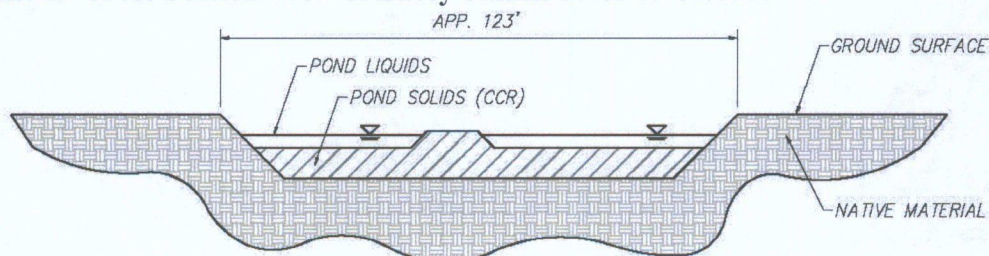
Schematic 1. Cross Section View of Lacey's Lake Prior to Closure

These waste streams previously directed to Lacey's Lake contain high solids concentrations, both dissolved and suspended. Suspended solids are primarily ash or coal combustion residuals (CCR). This solid material would accumulate in Lacey's Lake requiring periodic removal. This was accomplished using a long arm reach excavator capable of dredging sludge from all but the center of the pond, as shown in Photographs 1 and 2 in Attachment A. This dredged material was then staged adjacent to the pond for drying prior to transport to the on-site Class III Industrial Waste Landfill for disposal. The schematic below depicts the cross section configuration of Lacey's Lake prior to closure.

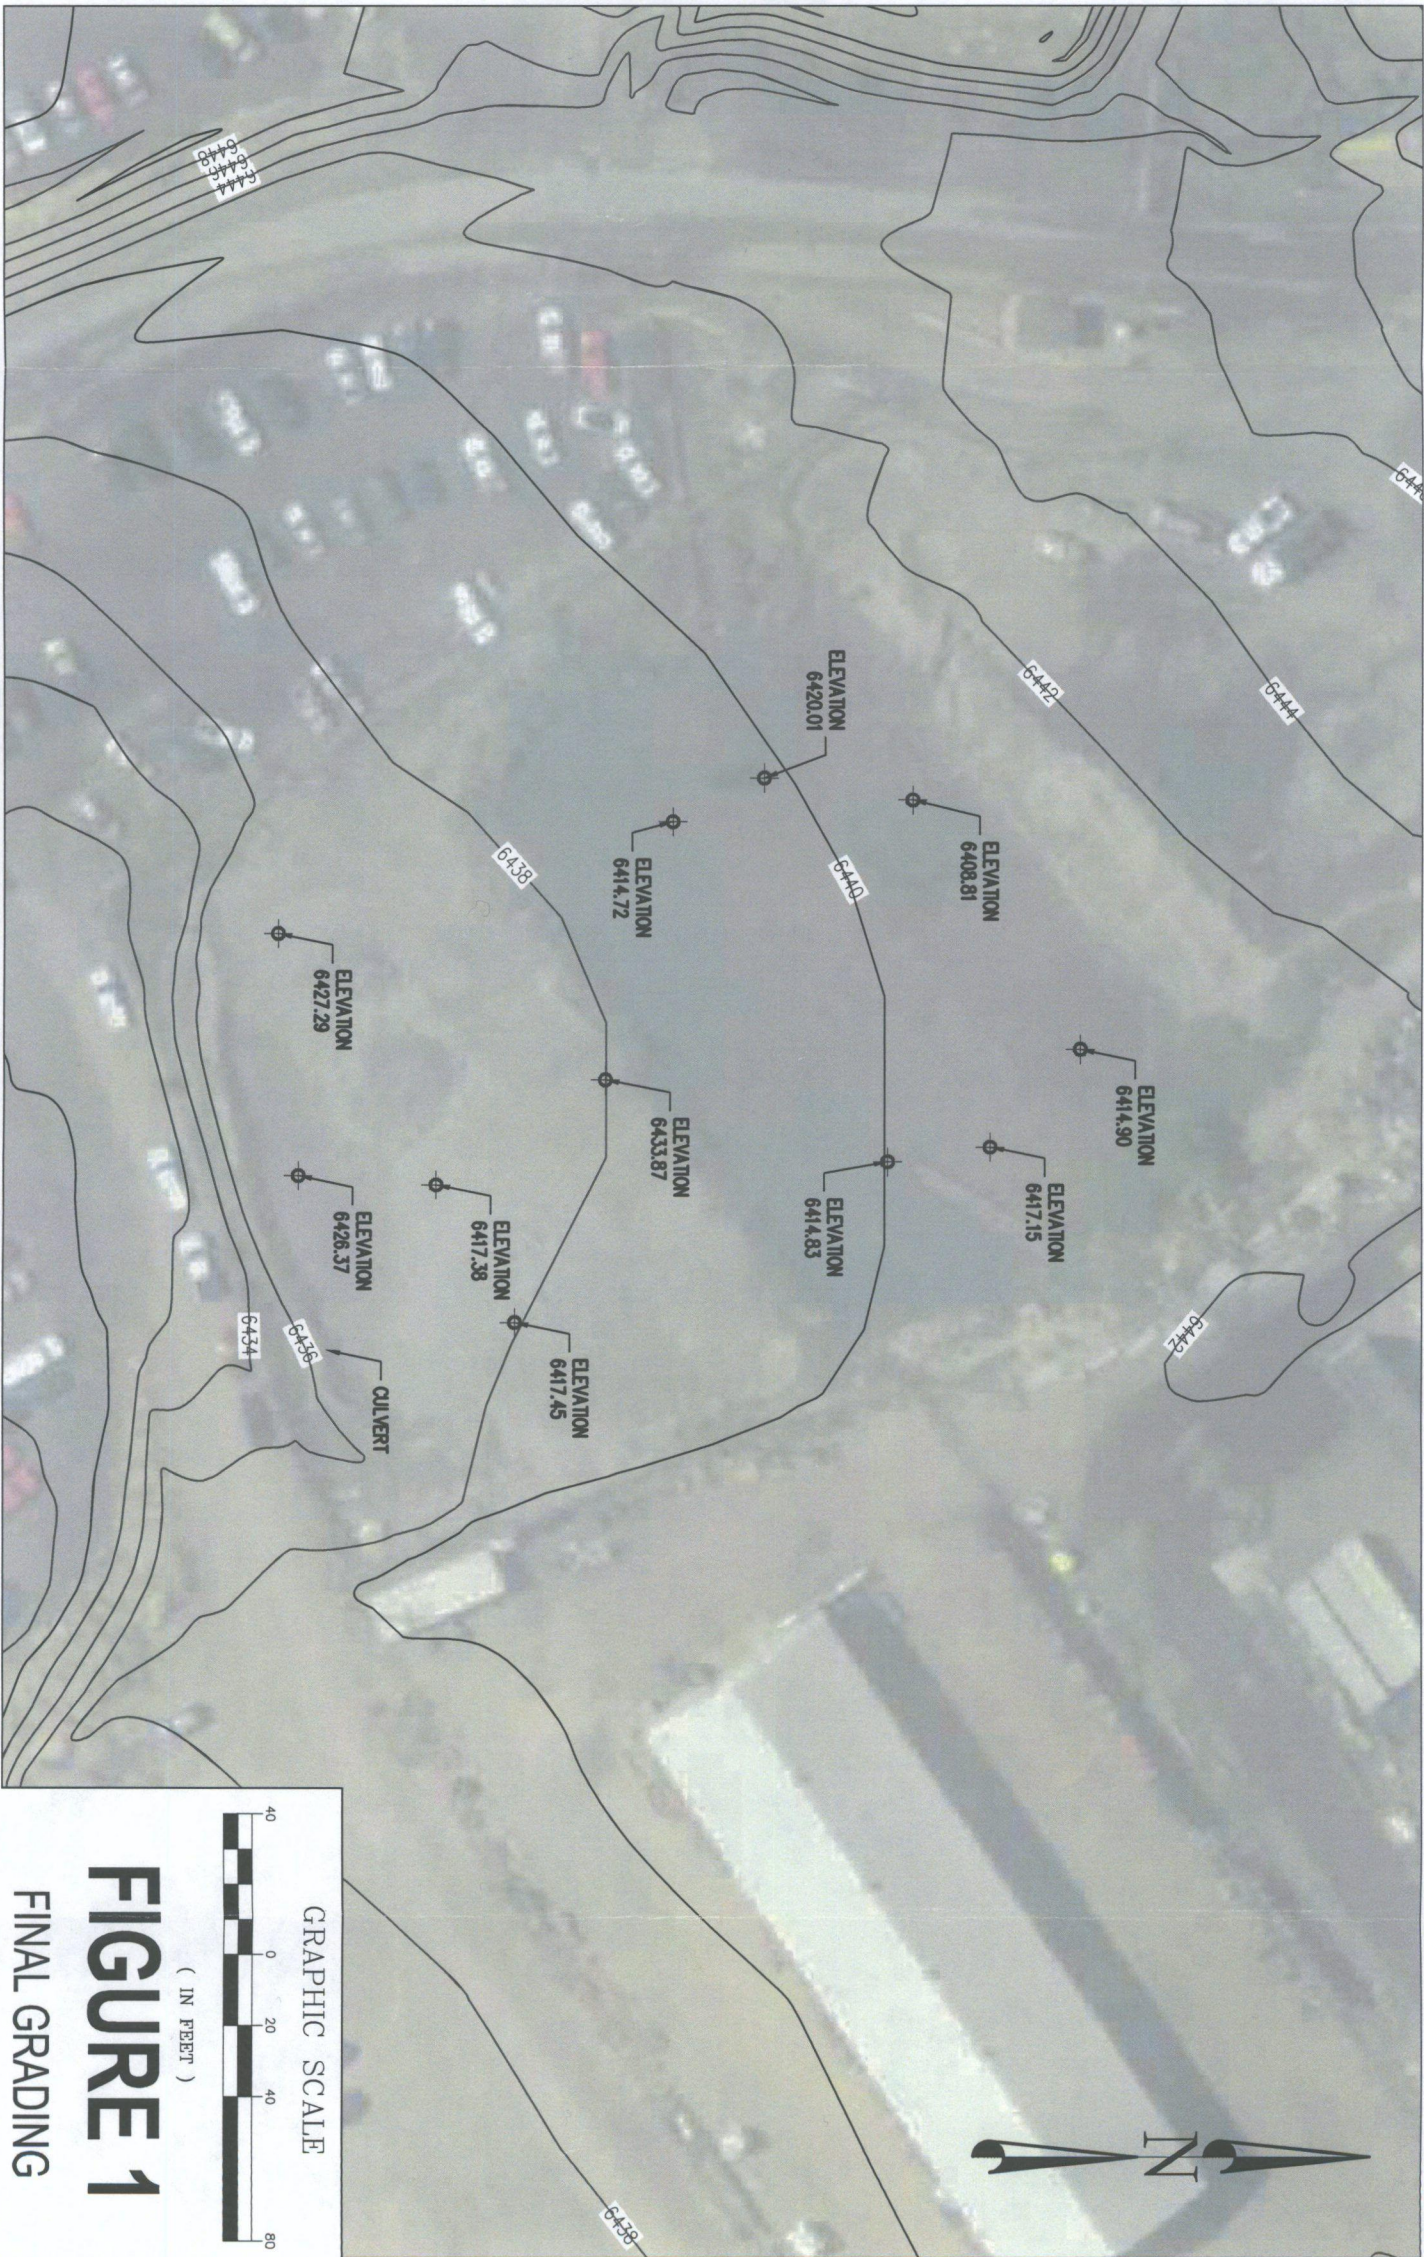
GRAPHIC SCALE
(IN FEET)
FIGURE 1
FINAL GRADING

On October 31, 2011, Nielson Construction, URS and Huntington staff inspected the site and determined that removal of waste material from Lacey's Lake and adjacent waste handling areas was completed. The approximate elevation at the base of the excavated areas were measured using an automatic level. These approximate elevations are shown in Figure 1.

place the backfill material directly in the former pond area where it was then graded and compacted in a series of lifts to the required 90% compaction. Placement of backfill material was completed at the end of November 2011. Photographs 23 and 24 in Attachment A show the final site grade after completion of site restoration activity. The approximate final grade follows the surrounding topography and is depicted in Figure 1. This final grade provides positive drainage with a surface slope of approximately two percent.

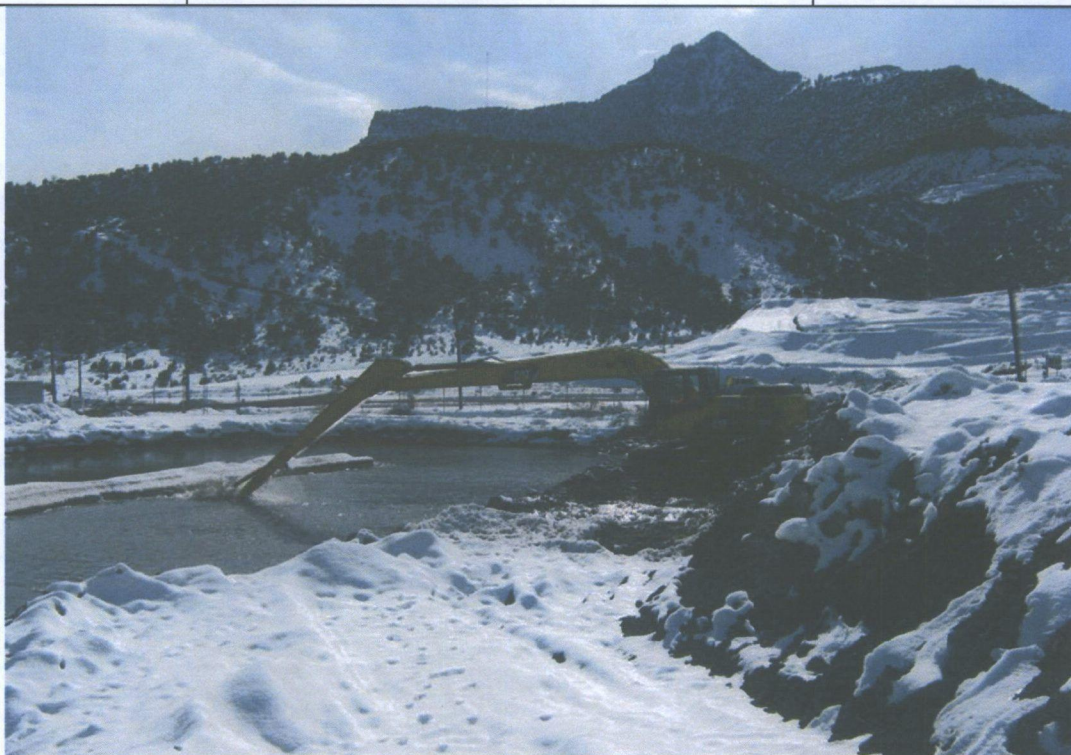
1

View of Lacey's Lake looking South during sludge removal dredging prior to closure.

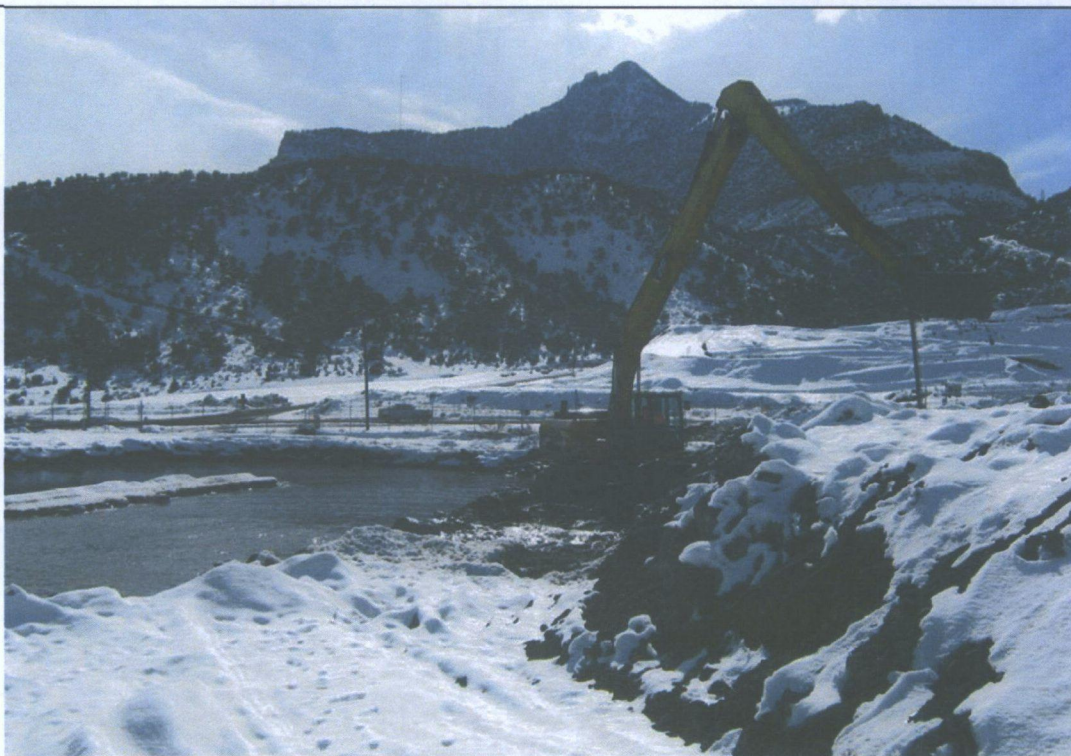
2

View of Lacey's Lake looking South during sludge removal dredging prior to closure.

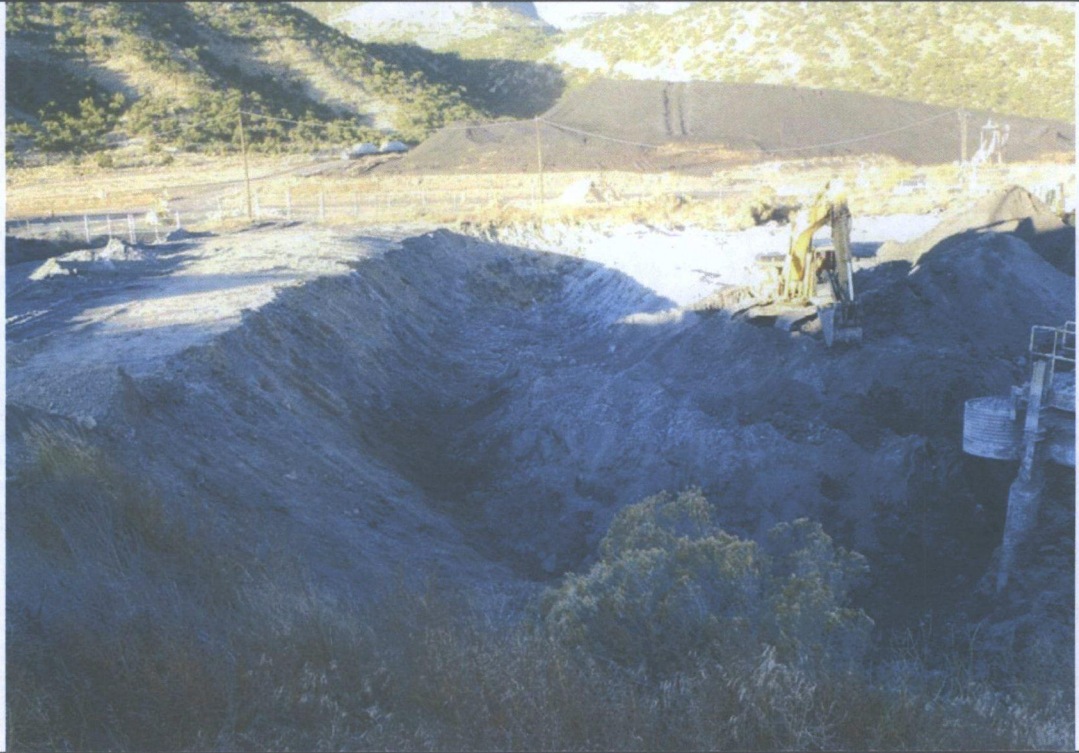
3

View of Lacey's Lake during initial waste removal activity during closure.

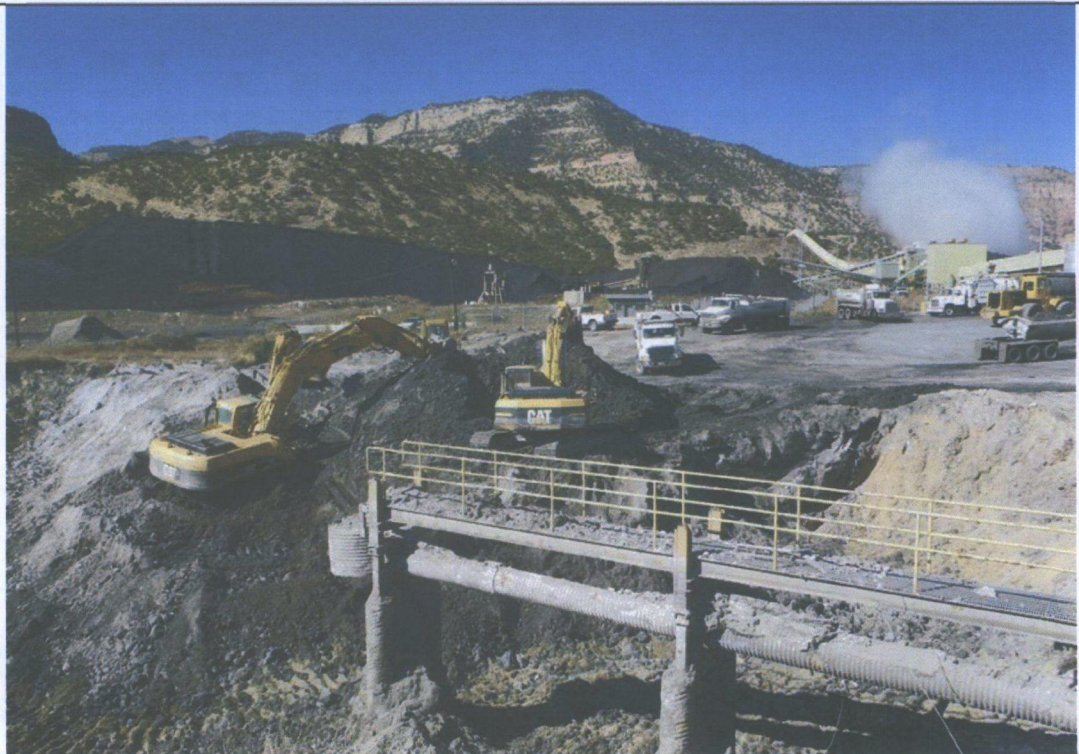
4

View of Lacey's Lake during initial waste removal activity during closure.

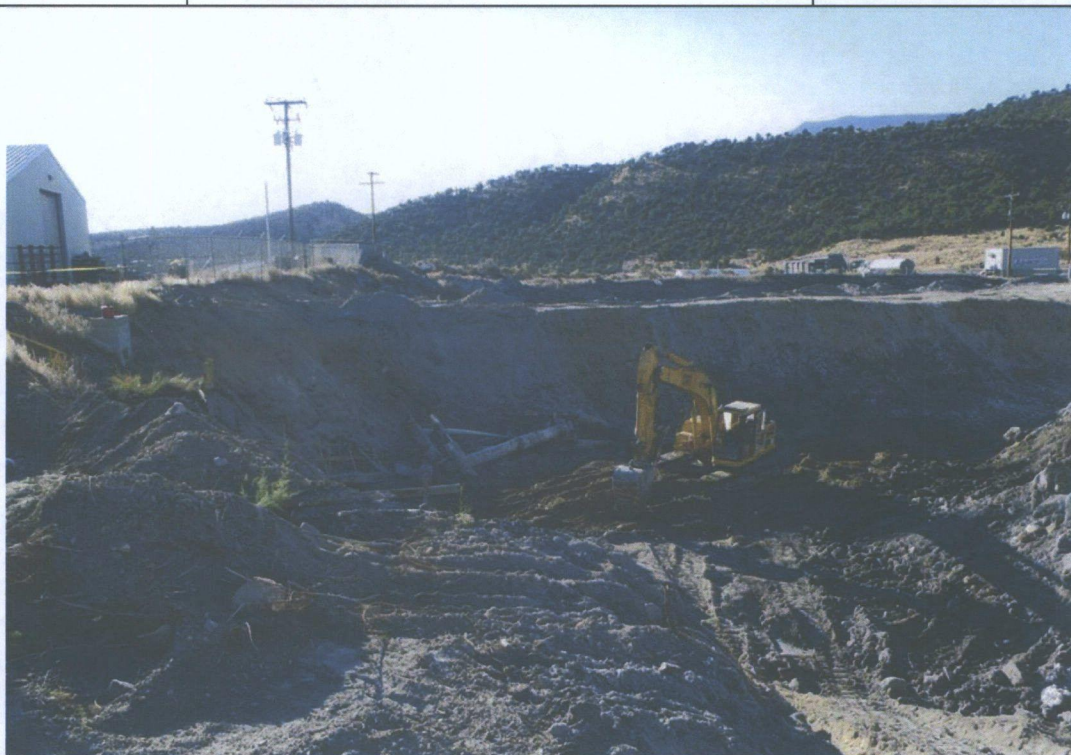
5

View of Lacey's Lake during waste removal activity.

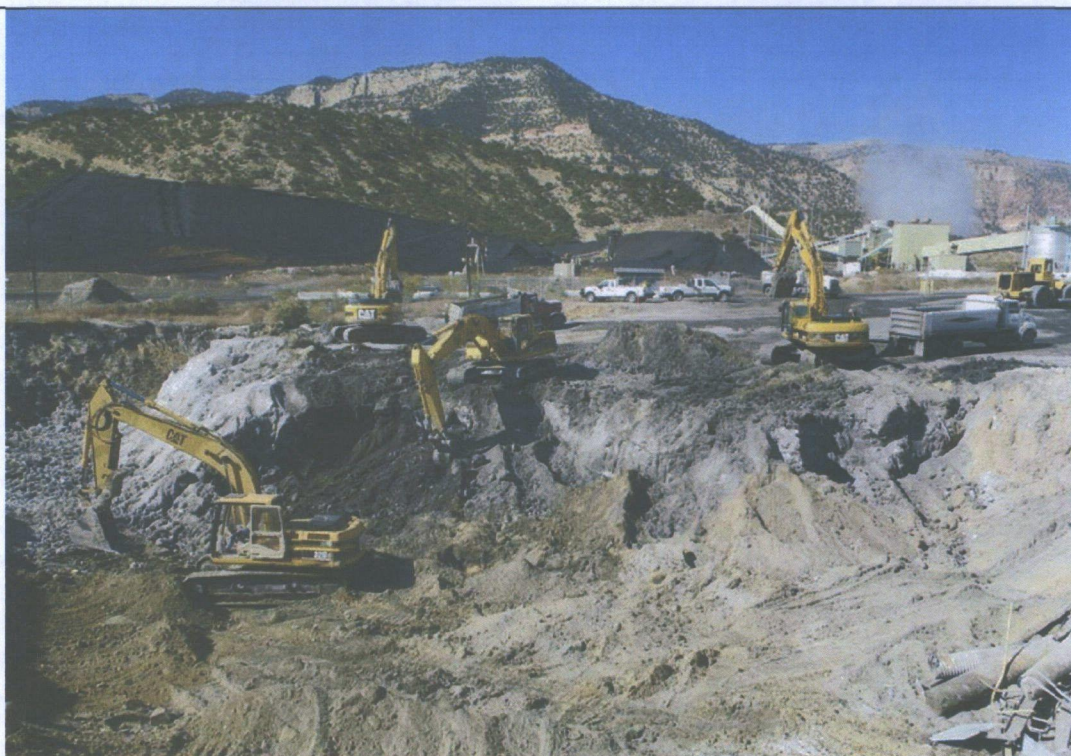
6

View of Lacey's Lake during waste removal activity.

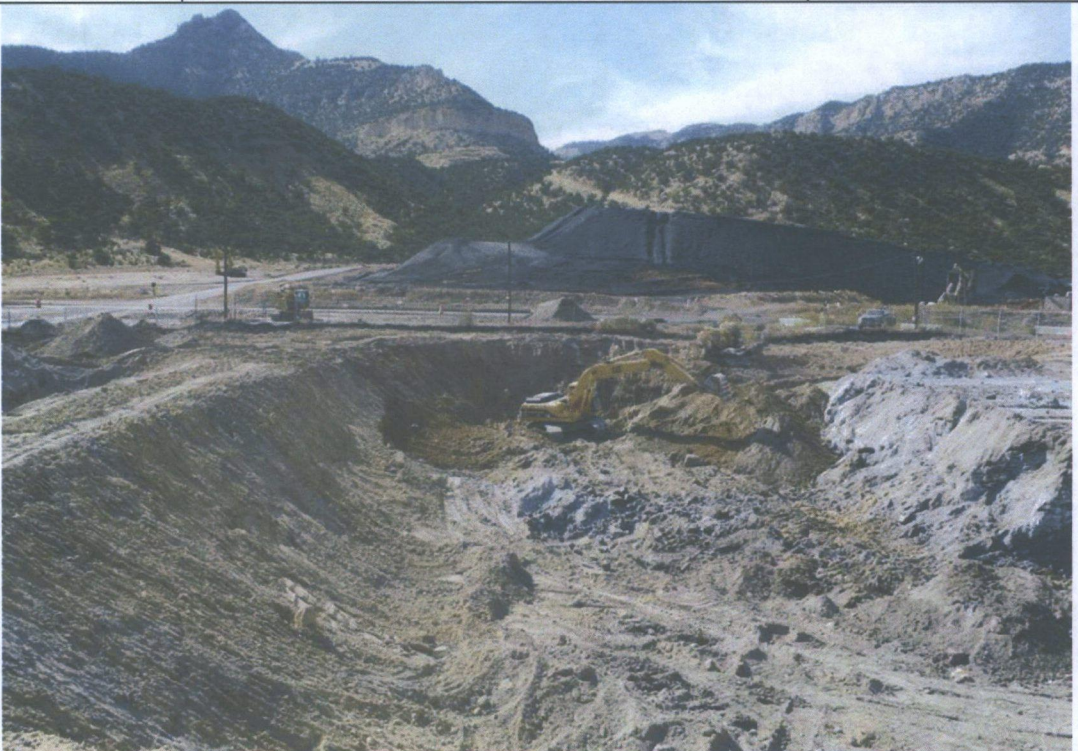
Client Name: PacifiCorp		Site Location: Huntington Power Plant	Project No. 24585242
Photo No. 7	Date: 10/24/11

Direction Photo Taken: West			
Description: View of Lacey's Lake during waste removal activity.

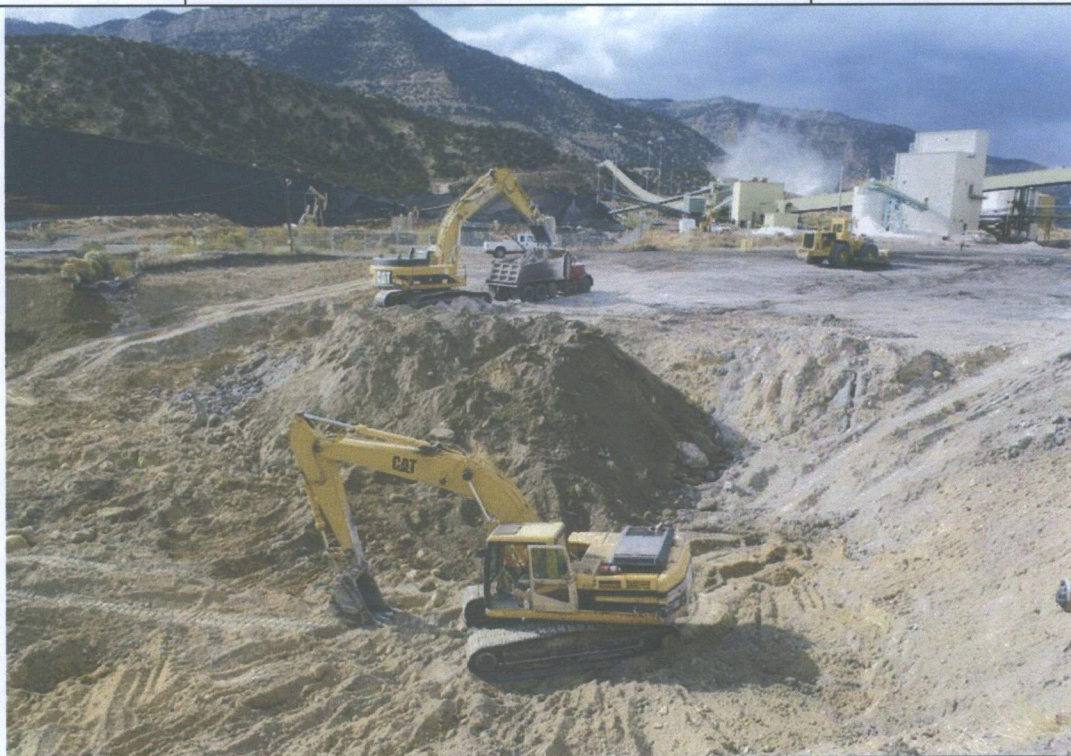
9

View of Lacey's Lake during waste removal activity.

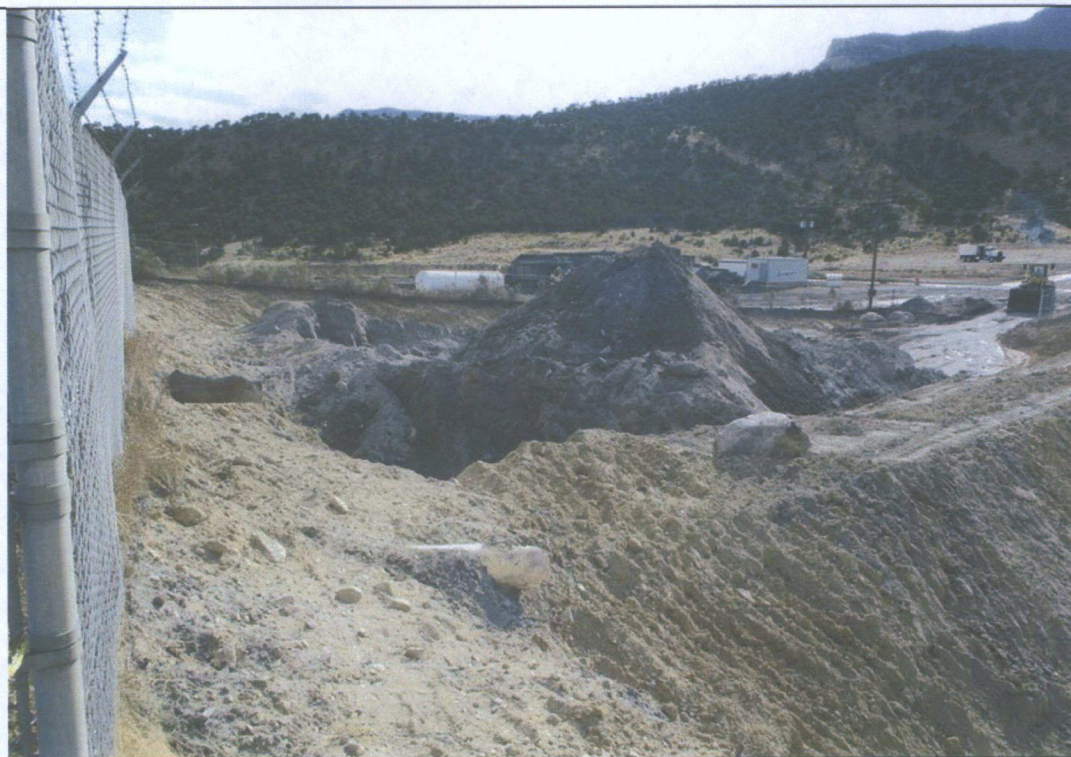
10

View of fly ash drying area south of Lacey's Lake during waste removal activity.

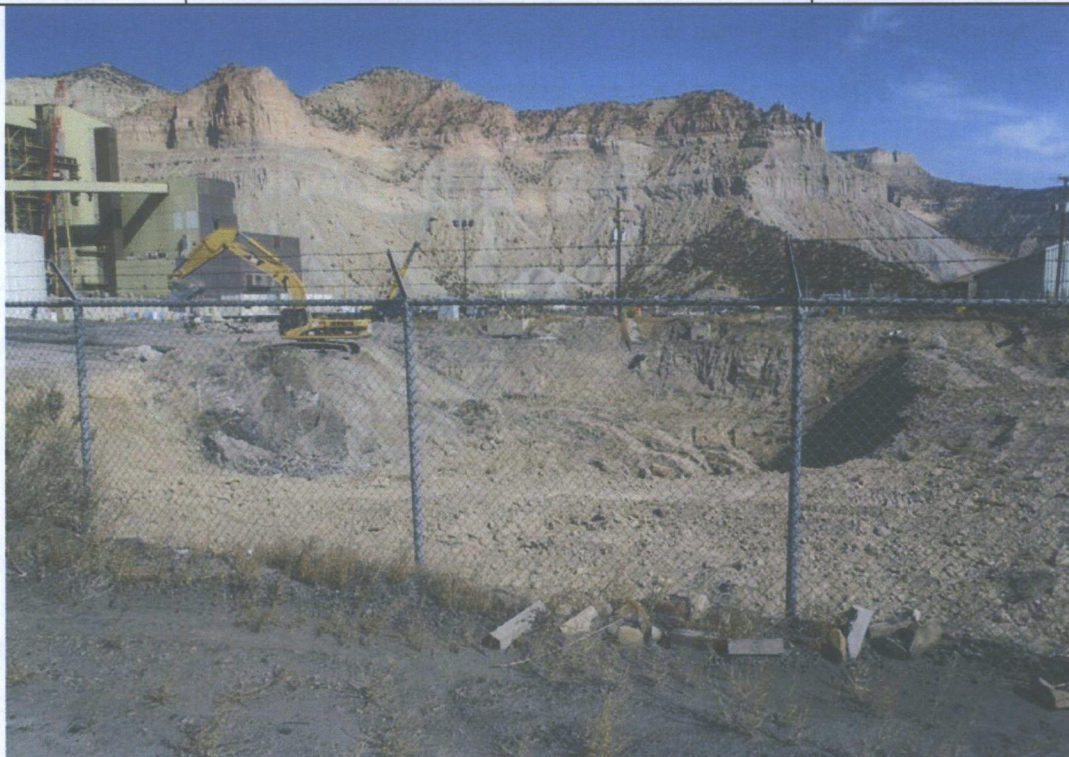
11

View of Lacey's Lake during waste removal activity.

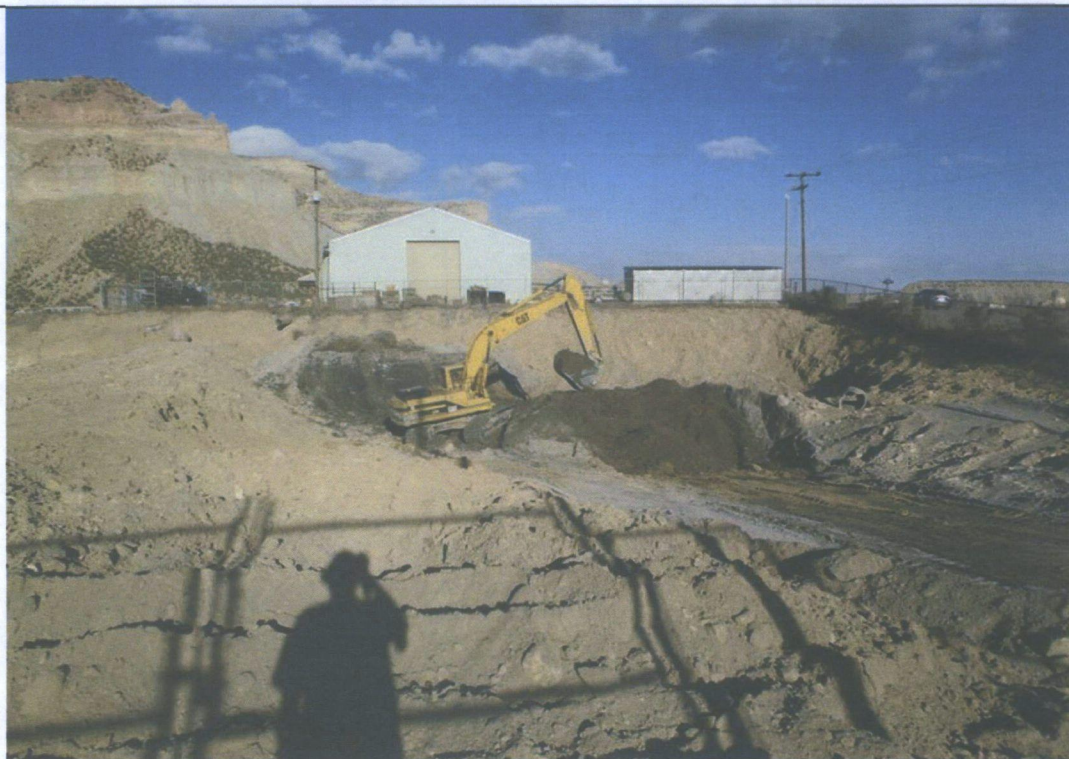
12

View of fly ash drying area south of Lacey's Lake during waste removal activity.

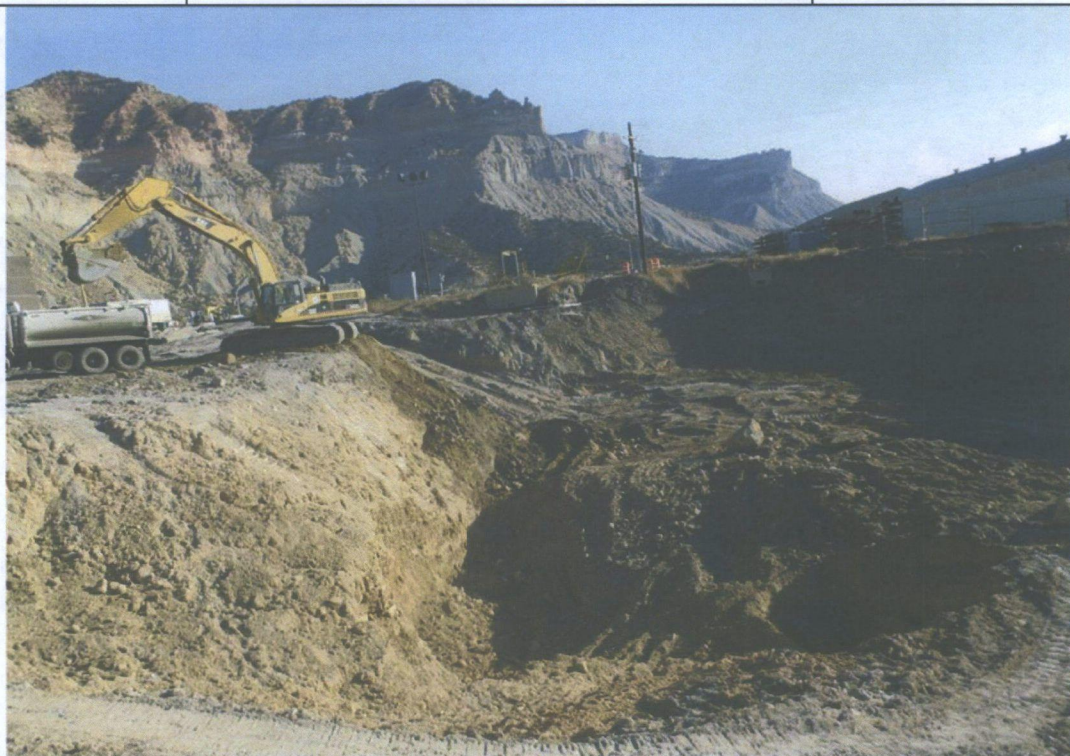
13

View of Lacey's Lake during waste removal activity.

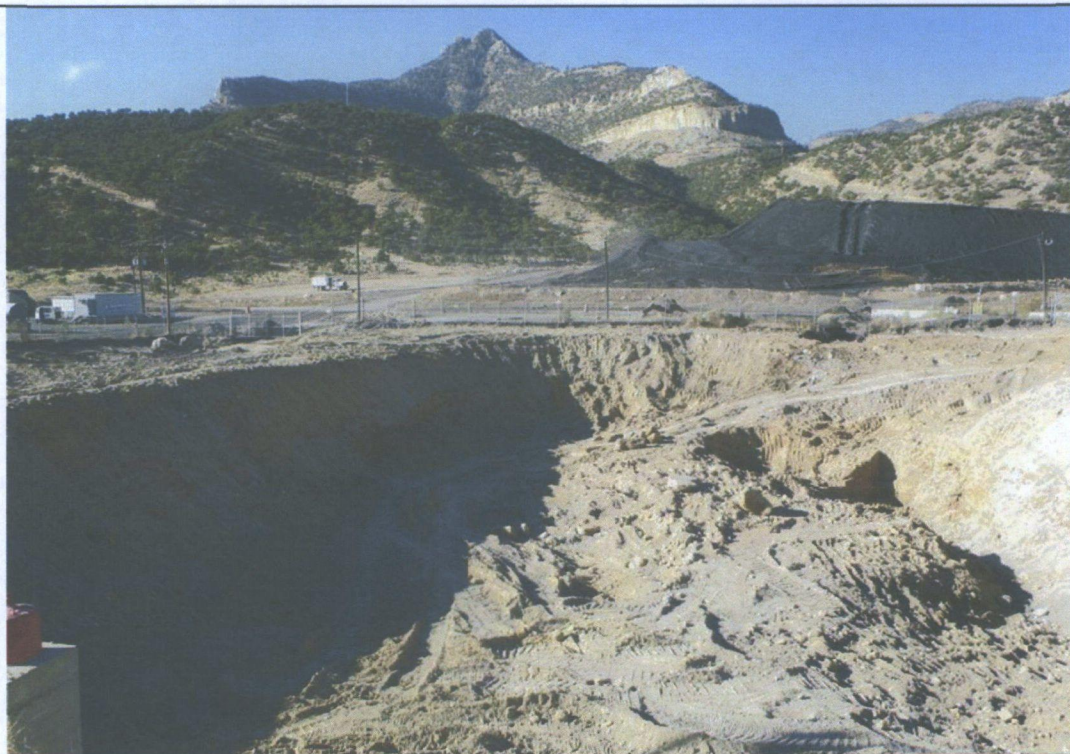
14

View of Lacey's Lake during waste removal activity.

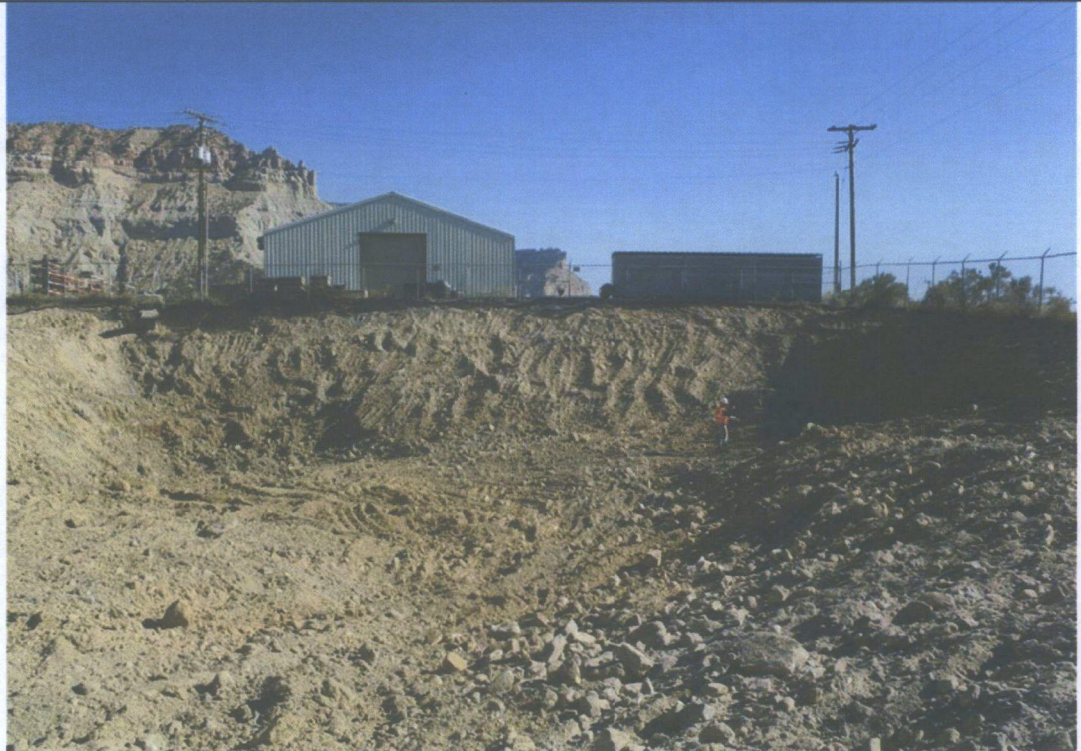
15

View of fly ash drying area south of Lacey's Lake during waste removal activity.

Note the individual collecting elevation survey data at the approximate location of the three foot diameter culvert.

During excavation a large diameter culvert was observed in the southeast corner of the excavation. The culvert was approximately three feet in diameter and appeared to be designed to convey stormwater under the access road to the south although the terminal end of the culvert was not located. Based on site observations the culvert appeared to be at approximately the same elevation as surrounding native material. However, the surrounding native material and culvert had been buried by ash material in the past and was not anticipated prior to closure activity. This culvert may have inadvertently served as a conduit for contaminant migration in the horizontal flow direction thereby accelerating contaminant migration to the south toward groundwater monitoring location HSW-1. The culvert was plugged with concrete prior to site restoration in the area to prevent potential future migration of groundwater and/or contaminants in the subsurface.

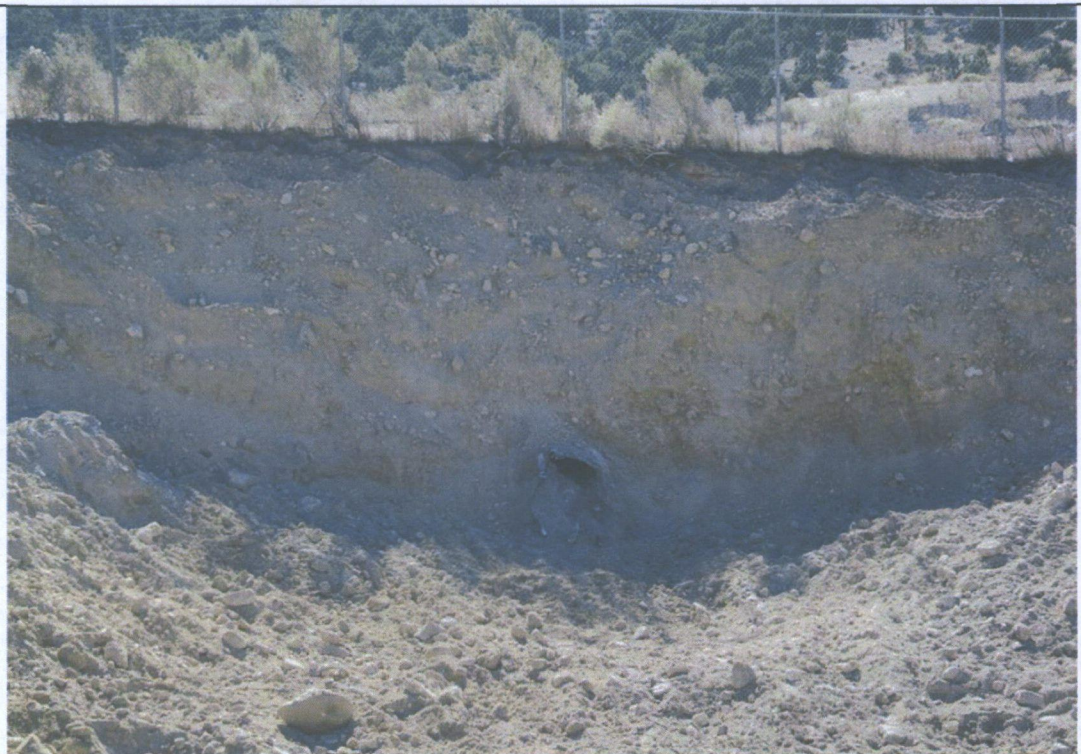
16

View of the large diameter culvert located at the south end of the fly ash drying area south of Lacey's Lake.

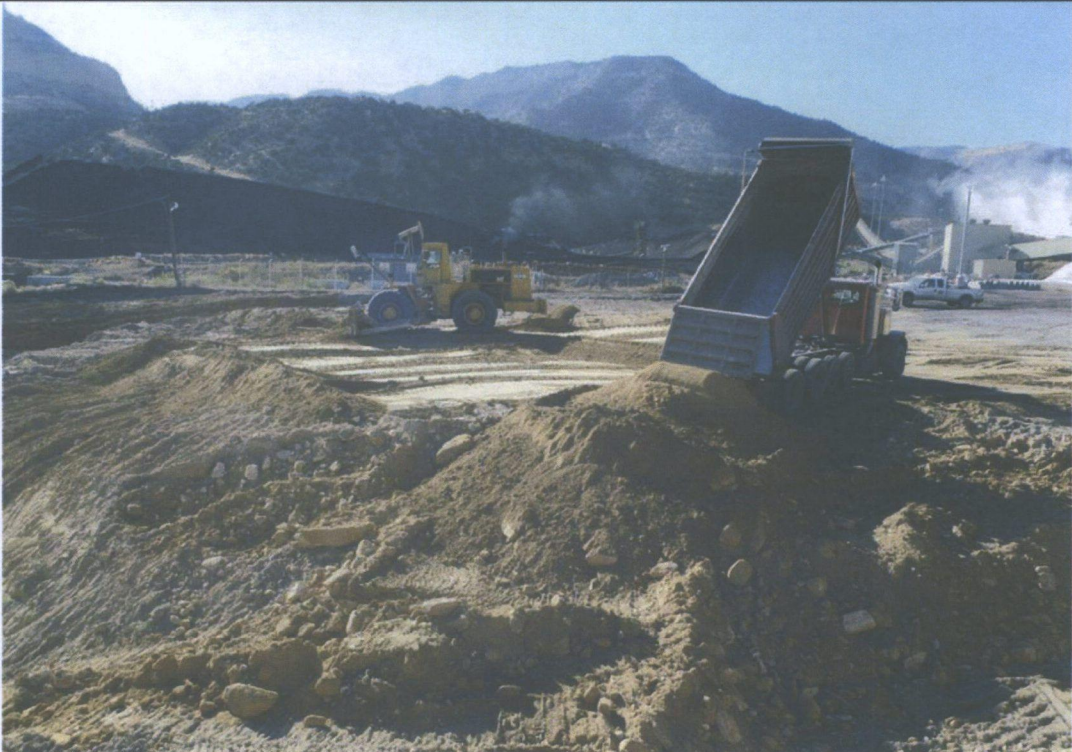
Client Name: PacifiCorp		Site Location: Huntington Power Plant	Project No. 24585242
Photo No. 17	Date: 10/31/11

Direction Photo Taken: Northwest			
Description: View of Lacey's Lake during site restoration activity.

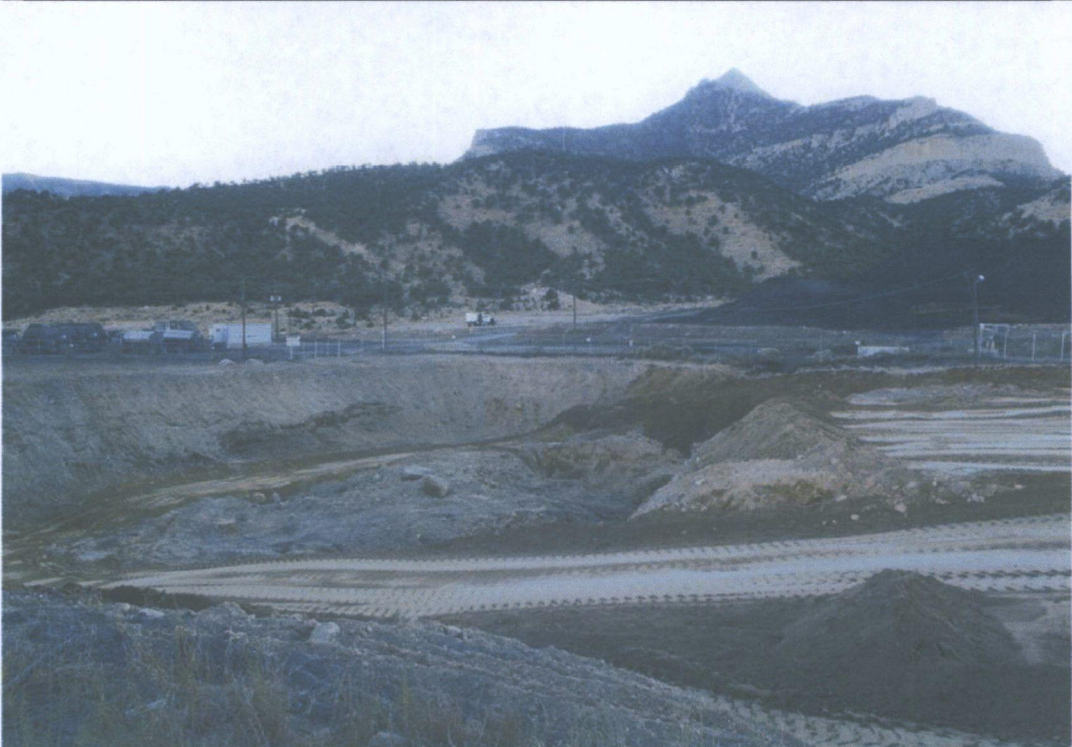
Photo No. 18	Date: 10/31/11

Direction Photo Taken: Southwest		
Description: View of Lacey's Lake during site restoration activity.

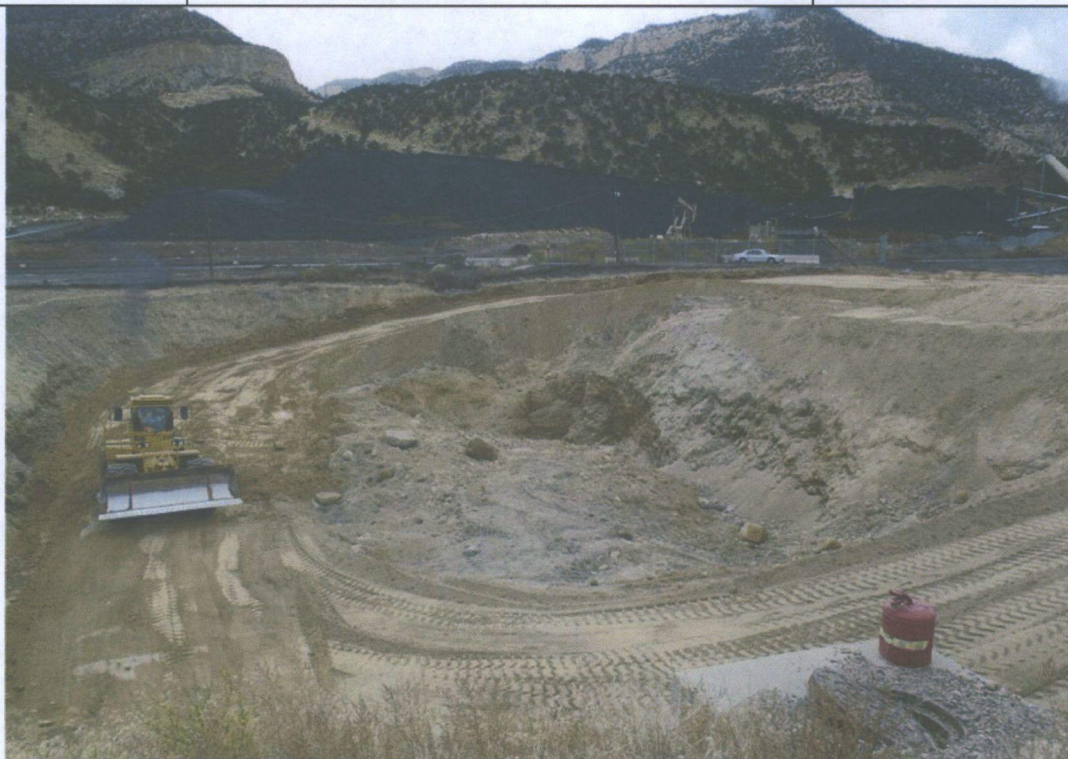
19

View of Lacey's Lake during site restoration activity.

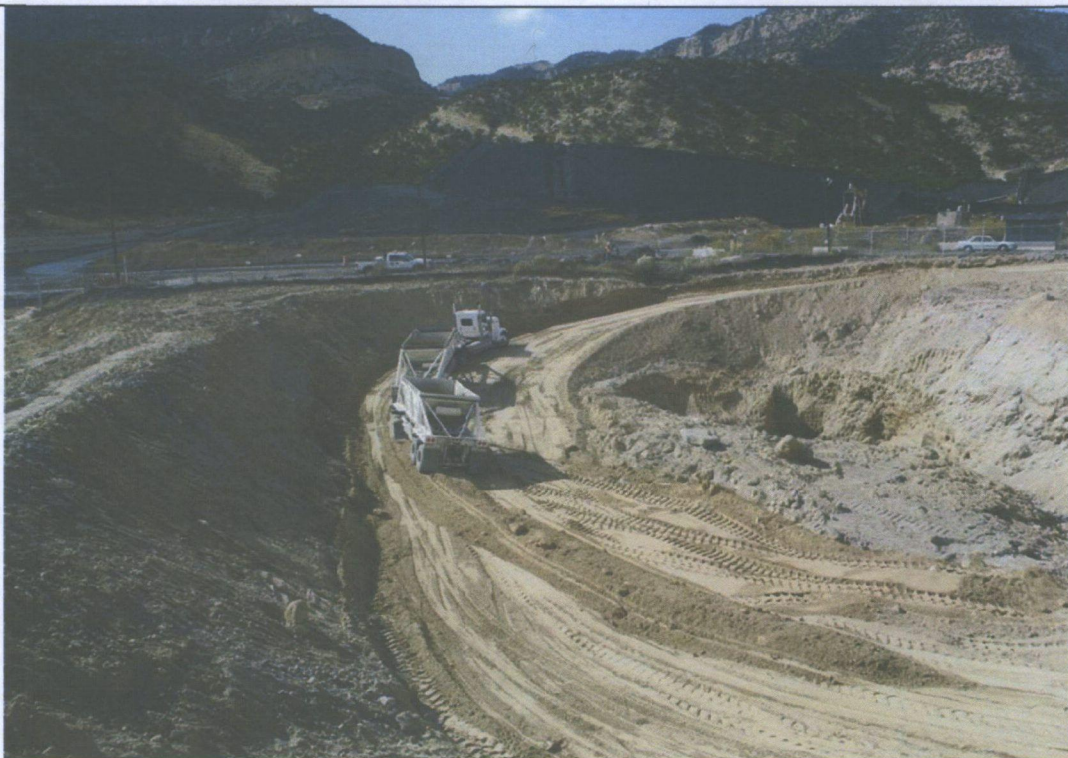
20

View of Lacey's Lake during site restoration activity.

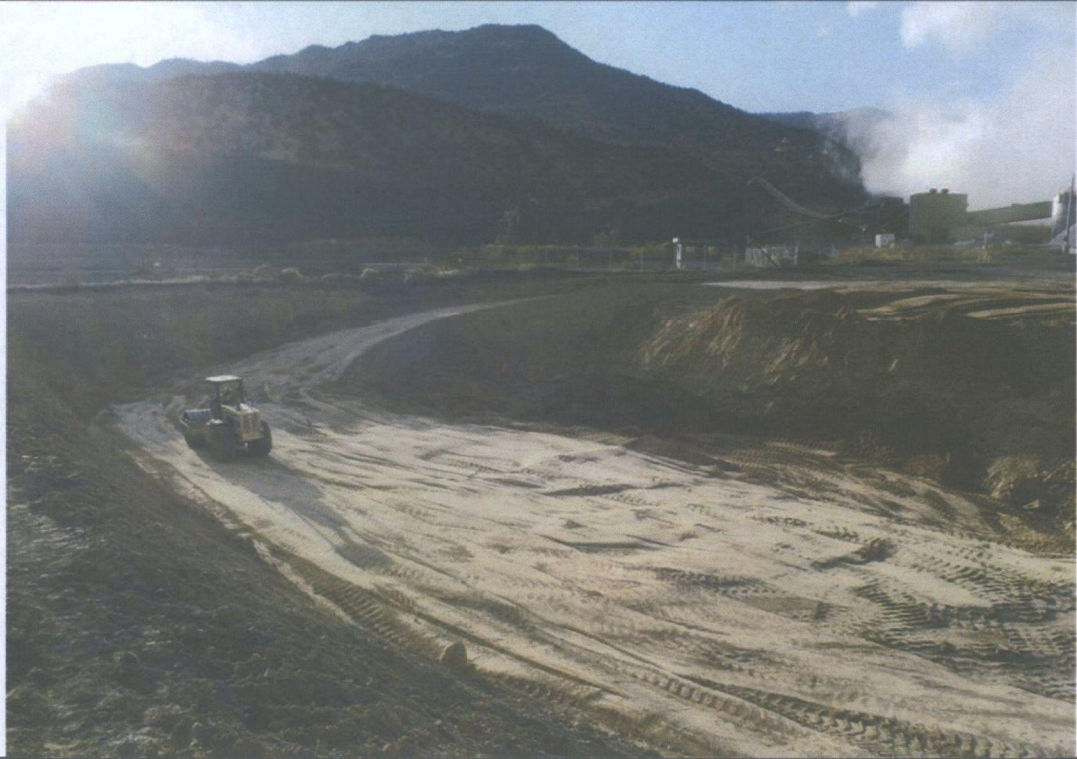
21

View of Lacey's Lake during site restoration activity.

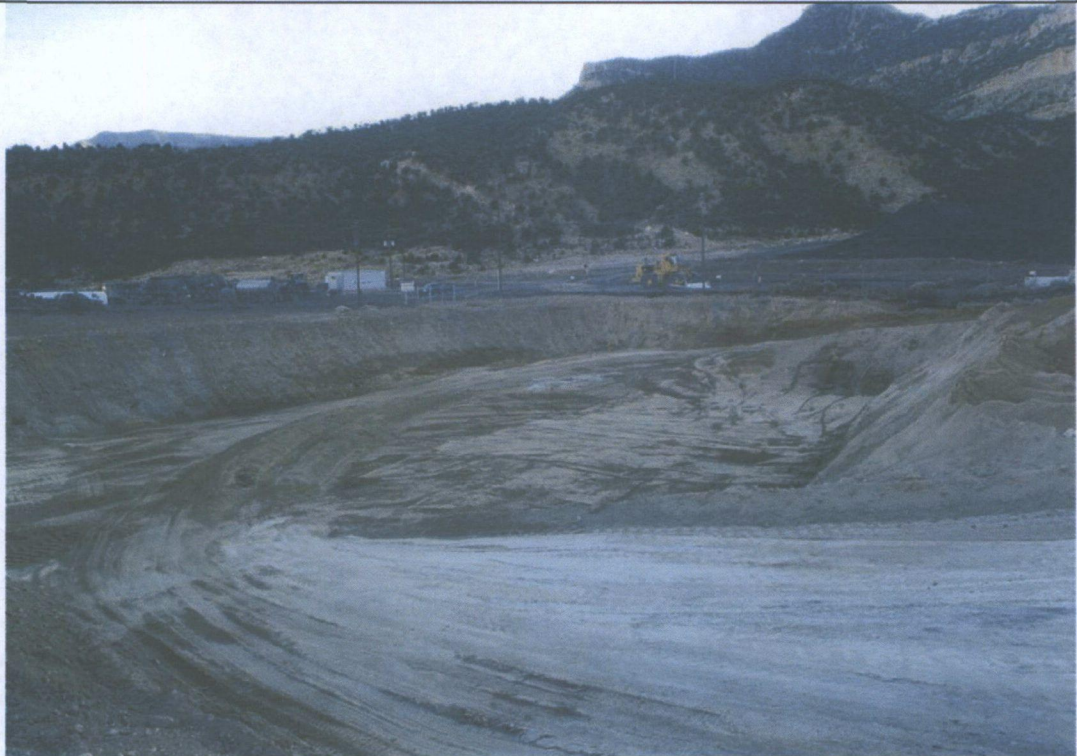
22

View of Lacey's Lake during site restoration activity.

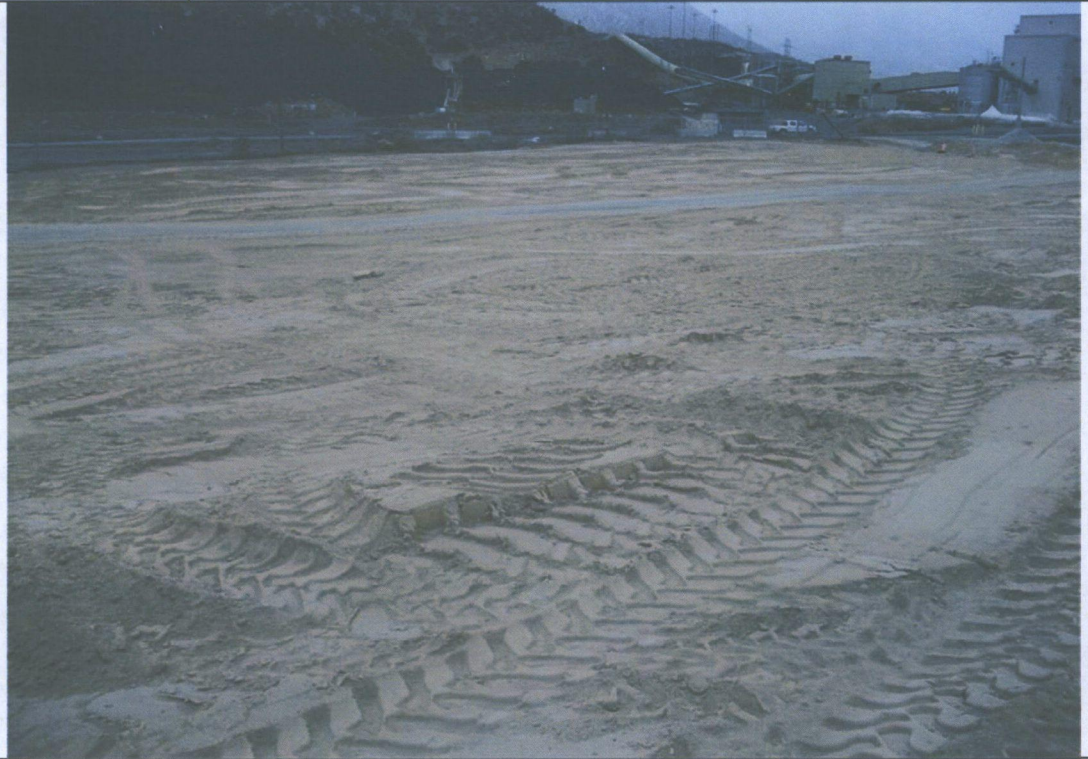
23

View of Lacey's Lake post closure activity.
