Subject: Closure Report, Lacey's Lake Pond Area
Ground Water Discharge Permit No. UGW150002
PacifiCorp, Huntington Power Plant

Closure Report Lacey's Lake Pond Area

PacifiCorp Huntington Power Plant

December 2011

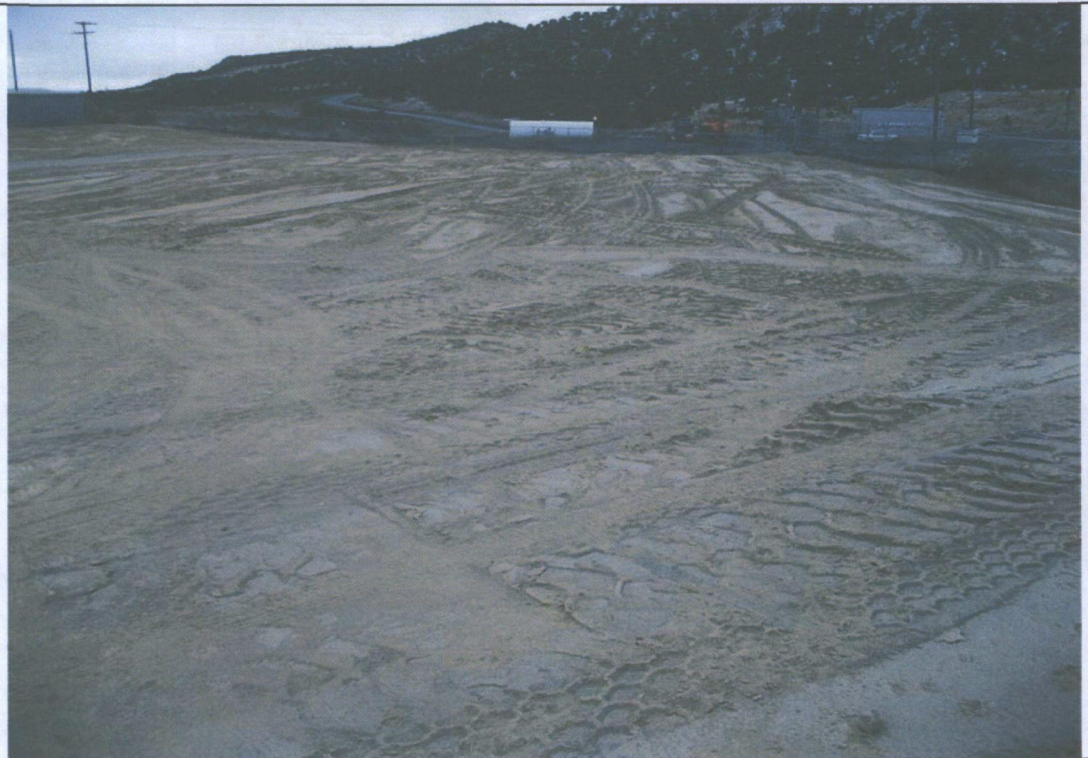
place the backfill material directly in the former pond area where it was then graded and compacted in a series of lifts to the required 90% compaction. Placement of backfill material was completed at the end of November 2011. Photographs 23 and 24 in Attachment A show the final site grade after completion of site restoration activity. The approximate final grade follows the surrounding topography and is depicted in Figure 1. This final grade provides positive drainage with a surface slope of approximately two percent.

View of Lacey's Lake post closure activity.
