Memorandum

Subject: Confirmation of CCR Removal Efforts for the Huntington Power Plant Wastewater Pond (aka Holding Basin)

Photograph Log

General Information	Project Number: 60429408	Project Name: Wastewater Pond CCR Removal	
	Client: PacifiCorp Energy		
	Location: Huntington Power Plant, Huntington , Utah		
	Field Investigator: Wil Pineda and Rick J. Cox

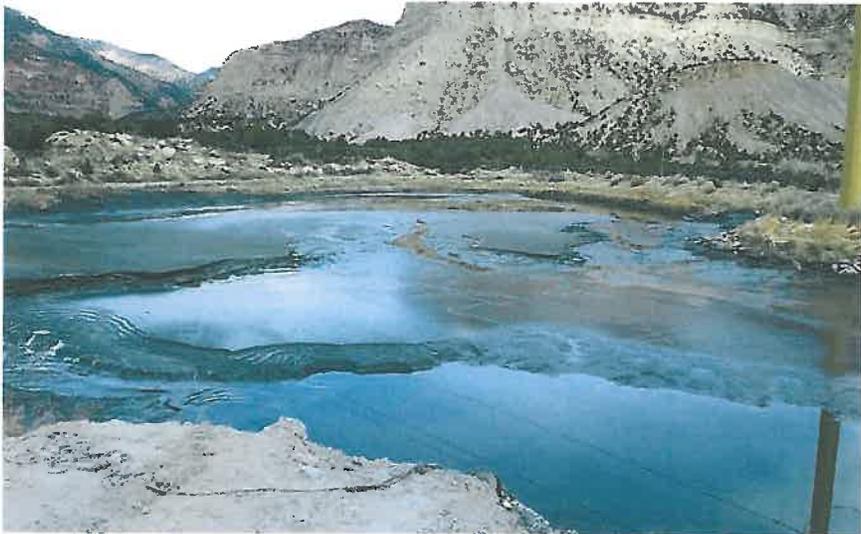
Photographs	Photograph: 1

Description: Wastewater pond prior to cleaning activities facing northeast.

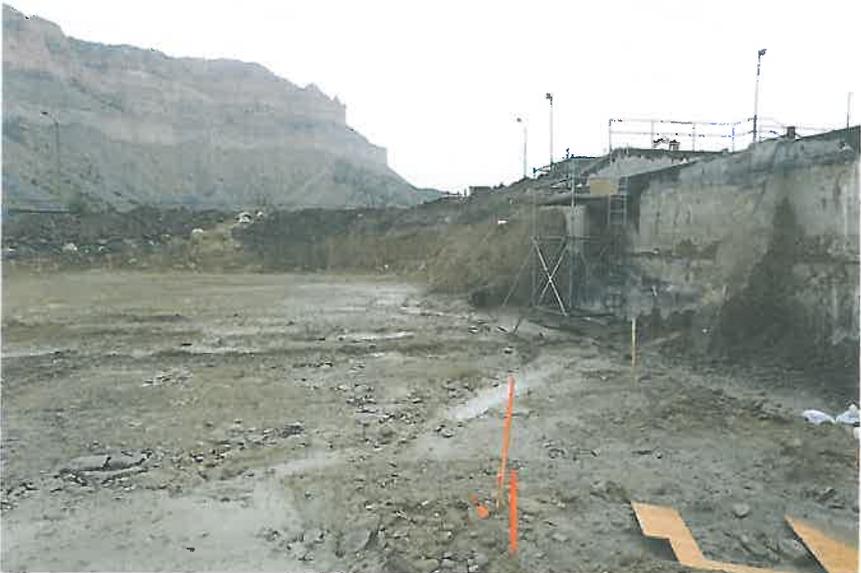
Photographs	Photograph: 2

Description: Former wastewater pond area facing east. Area cleared of CCR in preparation for WWB 2 concrete structure. 8-7-2015

A major cleaning event was conducted between August and October 2015 to remove accumulated sediment and CCR from the Wastewater Pond. URS staff visited the Huntington Power Plant on August 7, 2015 to confirm that CCR had been removed from the proposed footprint of WWB2 prior to foundation preparation for the new structure. Refer to Photo 2 in the attached Photograph Log.

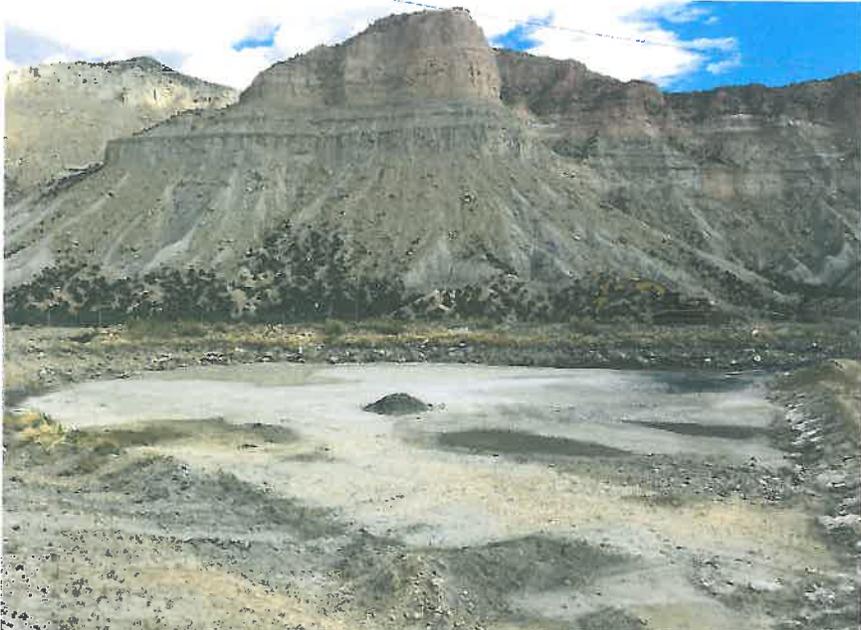
Photographs	<p>Photograph: 3</p> <p>Description:</p> <p>Former wastewater pond area facing east. Area cleaned except for <1/8" thick layer of CCR in some areas.</p> <p>9-29-2015</p>

URS visited the site again on September 29 and October 6, 2015 to observe the cleaning activities and removal of CCR as the project progressed. The final site visit by URS to confirm pond cleaning was on October 13, 2015. Refer to the Photograph Log for photos taken during each site visit.

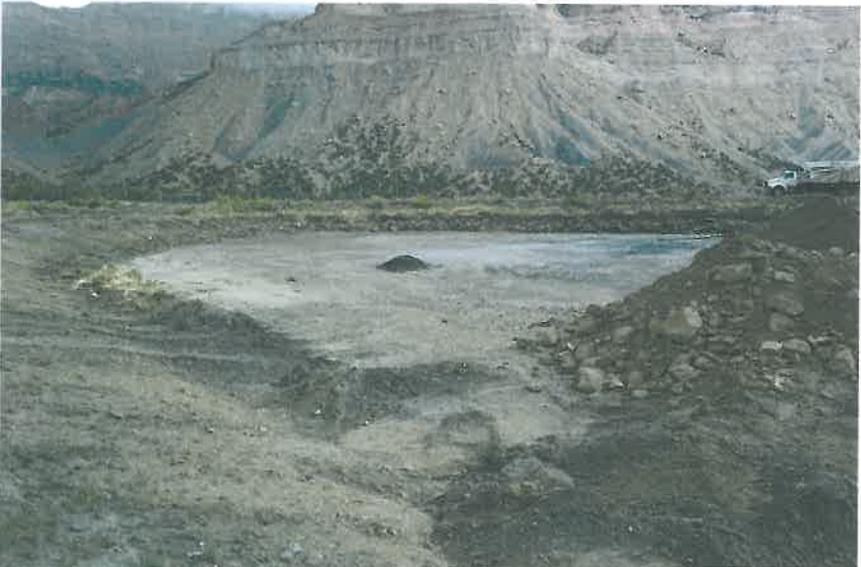
<p>Photograph: 4</p> <p>Description:</p> <p>Former wastewater pond area facing east. Same condition as 9-29-15 with exception that fill has been stockpiled for the WWB2 structure and drying pad.</p> <p>10-6-2015</p>

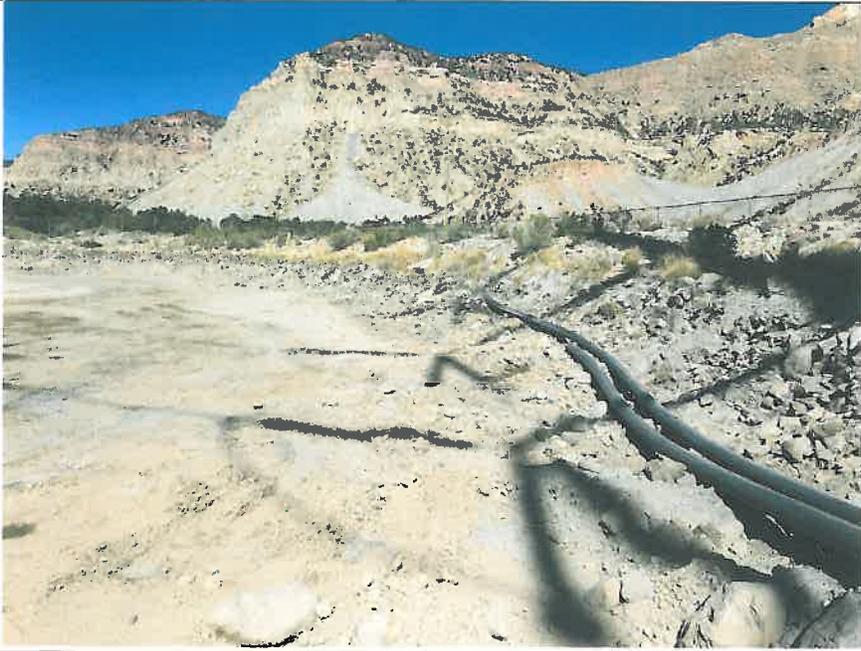
Photographs	<p>Photograph: 5</p> <p>Description:</p> <p>Former wastewater pond area facing west. Pond embankment and floor completely cleaned.</p> <p>10-13-2015</p>

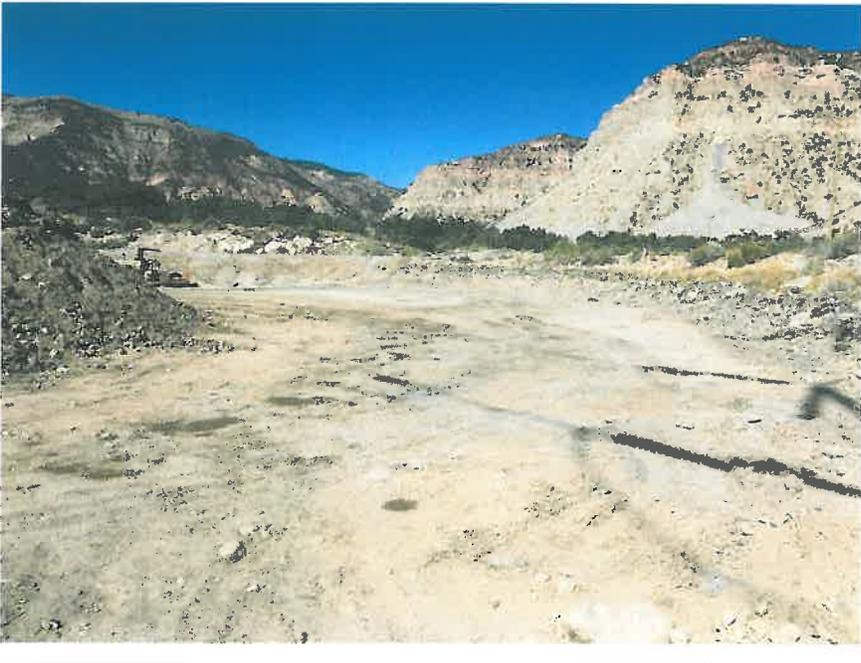
Photographs	<p>Photograph: 6</p> <p>Description:</p> <p>Former wastewater pond area facing southwest. Pond embankment and floor completely cleaned.</p> <p>10-13-2015</p>

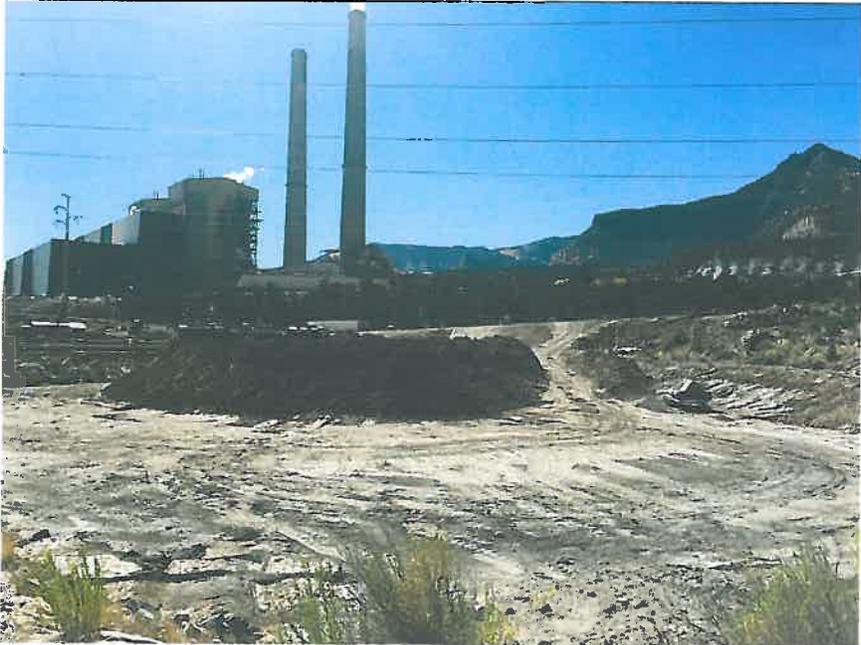
Photographs	<p>Photograph: 7</p> <p>Description:</p> <p>Former wastewater pond area facing south. Pond embankment and floor completely cleaned. Stockpile is the location for the new drying pad.</p> <p>10-13-2015</p>

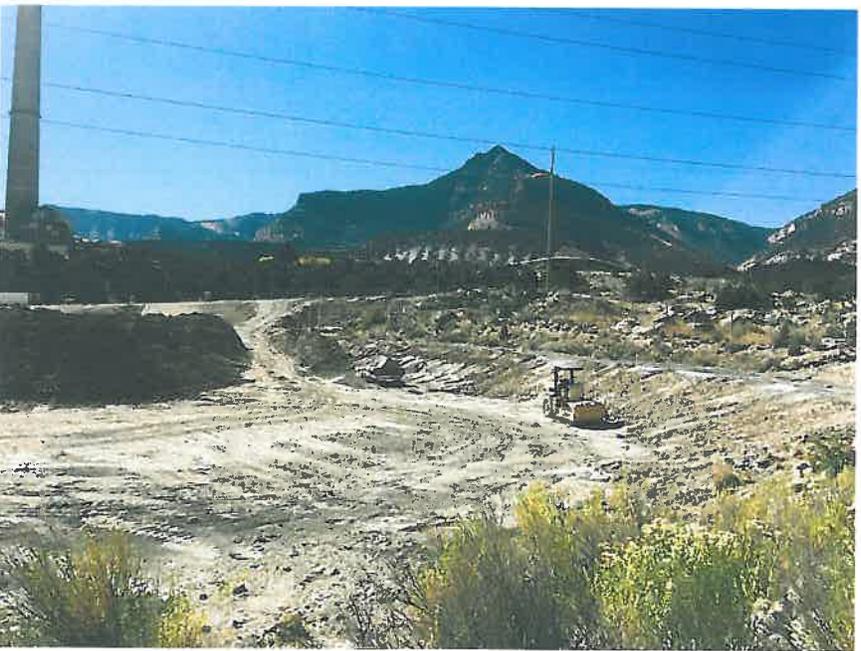
Photographs	<p>Photograph: 8</p> <p>Description:</p> <p>Former wastewater pond area facing southwest. Pond embankment and floor completely cleaned.</p> <p>10-13-2015</p>
