June 7, 2017

Re: Contaminant Investigation and Corrective Action Plan; Transwest Pick-A-Part, 3586 North 2000 West, Farr West, UT 84404

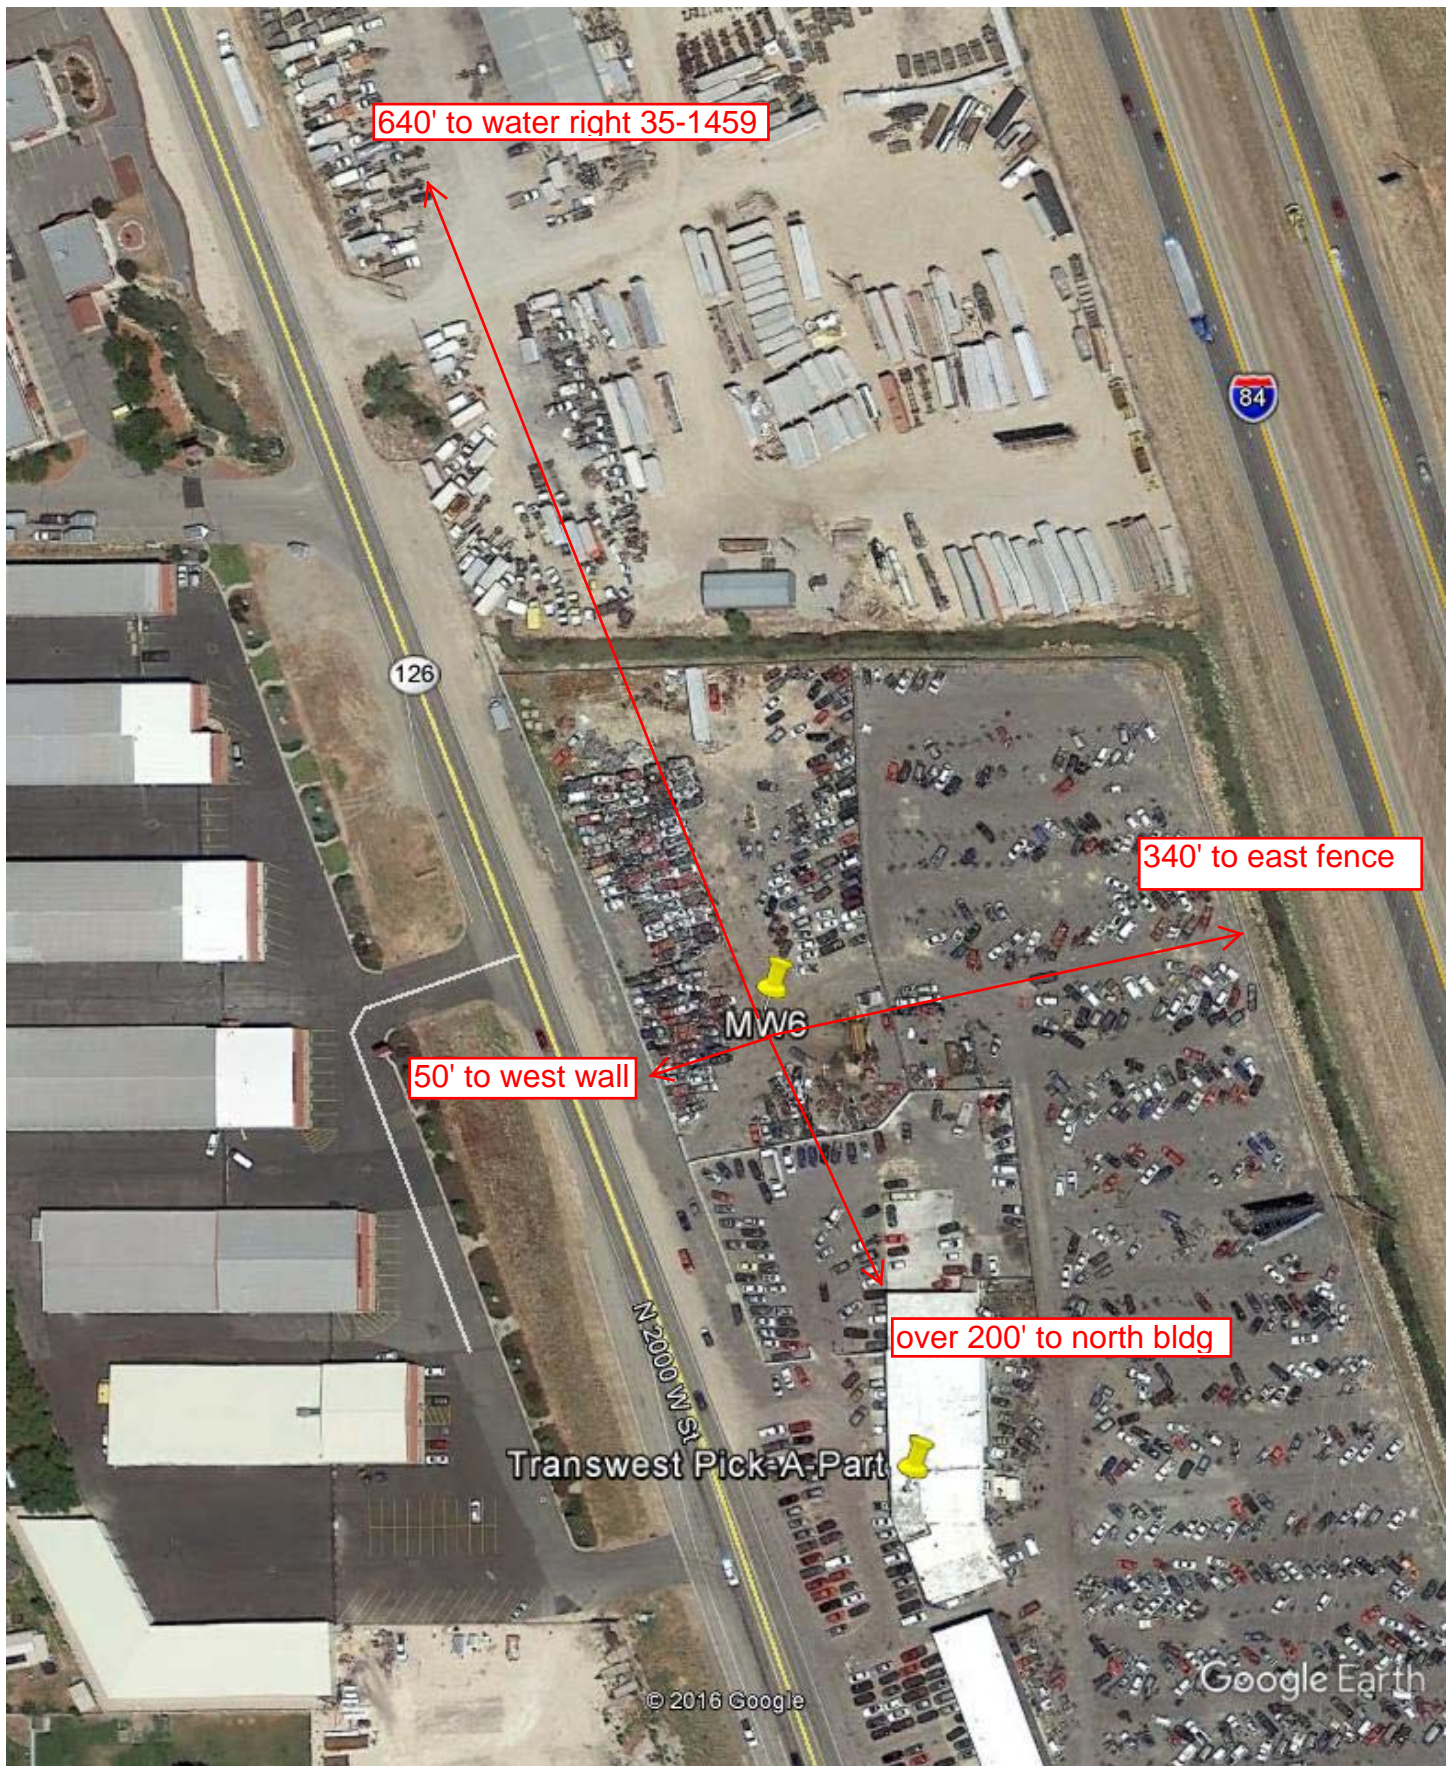
Product # A17-1983 Fig # 9

Notes  
3586 N. 2000 W. Farr West, UT  
DRO in groundwater, measured  
in mg/L as of 22 May 2017.

The plume of diesel fuel contaminated groundwater has been investigated in an area around MW6, estimated at approximately 1,460 ft<sup>2</sup>. The plume is does not appear to be connected directly to either the crusher or the moved AST. The plume seems to originate from a random spill. The plume area is estimated at 34 x 55 feet, with the long axis southeast to northwest. See figure 9, Appendix A.

The DRO plume appears to radiate from the area around MW6, moving slightly to the northwest. The plume does not reach beyond down gradient MW9.
