# **CHAPTER 3**

## **Coarse Particulate Organic Matter Measurements in the Jordan River and its Major Tributaries, 2010 – 2015**

**Theron Miller**

**Wasatch Front Water Quality Council**

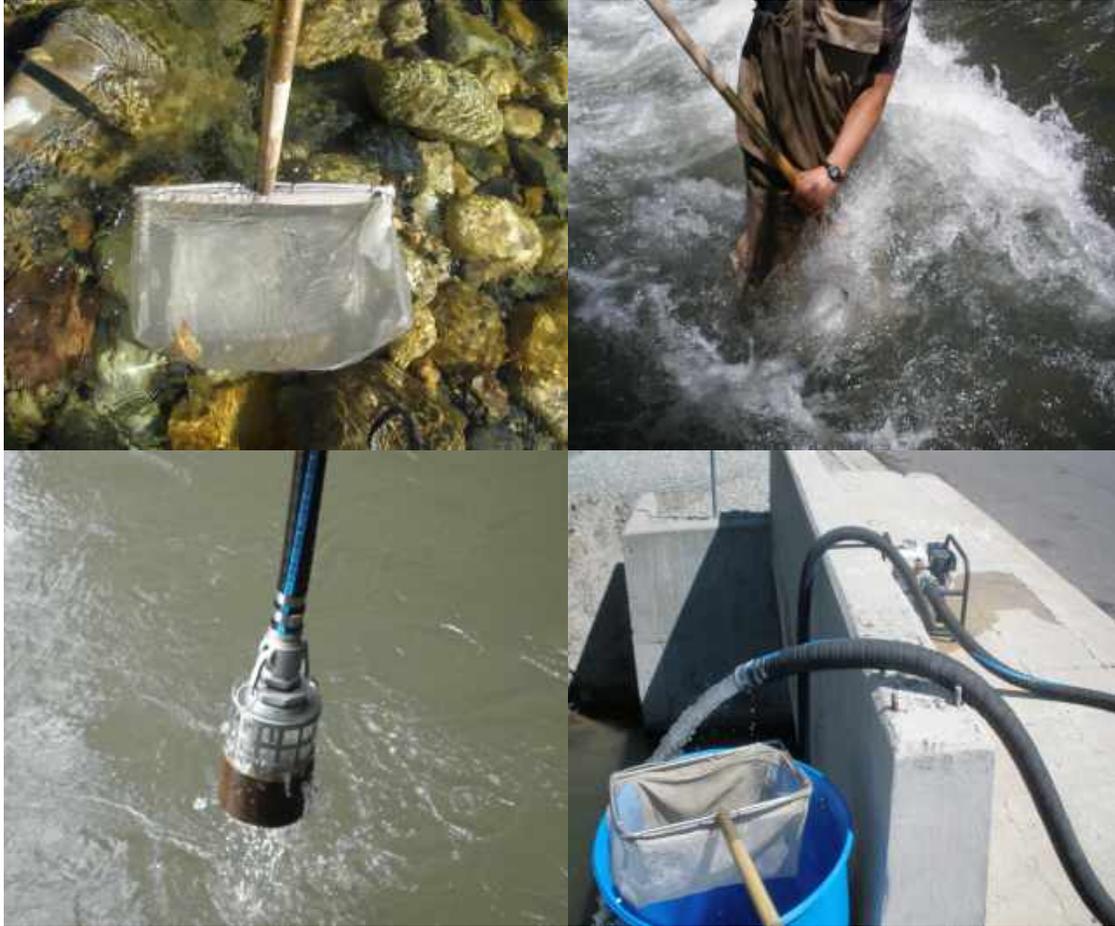
Figure 40. Photographs illustrating the two techniques used for sampling coarse particulate organic matter. With either technique the water was initially filtered through the same net, followed by screening with a 1-mm soil sieve.

During relatively low-flow (non-spring runoff) conditions (< approximately 300 CFS), samples were collected with a standard 10 x 18-inch sweep net. The only mesh available during 2010 to 2012 was 500  $\mu\text{m}$  whereas the standard separation between FPOM (VSS) and CPOM is defined using a 1 mm mesh size. Therefore, samples were immediately rinsed in a 1 mm- mesh soil sieve for accurate separation of particle sizes. At each site, samples were collected at  $\frac{1}{4}$ ,  $\frac{1}{2}$  and  $\frac{3}{4}$  distance across a perpendicular transect. Where or when the stream depth was > approximately 30 cm, and floating debris was visible, samples were collected with the net at the surface and with the net resting on the bottom in order to collect floating debris as well as bed load and suspended material. The top and bottom samples were composited when collected. In addition, samples collected at  $\frac{1}{4}$ ,  $\frac{1}{2}$  and  $\frac{3}{4}$  distance across the stream were composited and this process was performed in triplicate. The duration of sample collection was timed in order to calculate the load and the duration of each “set” was adjusted in order to collect sufficient sample for accurate measurement as well as to limit sample volume to < approximately 200 g dry weight to facilitate sample handling, drying and combustion in the laboratory. Concentration or mass of the organic debris was determined by dividing the sample mass by the product of the stream velocity x net dimensions x sampling duration. During high flows or during the autumn leaf fall, typical duration of net placement was 10 to 30 seconds. During low flow conditions of winter and summer, net placement was extended to 60 seconds or more in order to collect sufficient sample volume. During high flow conditions (> approximately 300 CFS), we used a 3-inch trash pump. About  $\frac{1}{2}$  of the cross-linkages of the intake screen were removed to facilitate the uptake of the debris. The intake screen was weighted with approximately 40-pounds of steel plates to ensure that the screen remained on the stream bottom. Sample collections from the surface were not performed during these high flows because the turbulence caused sufficient mixing that the leaf material was rapidly saturated and was assumed to be distributed randomly throughout the water column. Also, because of this homogeneity, sample collection was only

performed near the center of the channel. The discharge volume from the pump was measured using a 55-gallon barrel and each of triplicate samples included ten volumes (550 gallons) of water. Similarly, this material was sieved using the 1 mm soil sieve to collect the CPOM fraction.

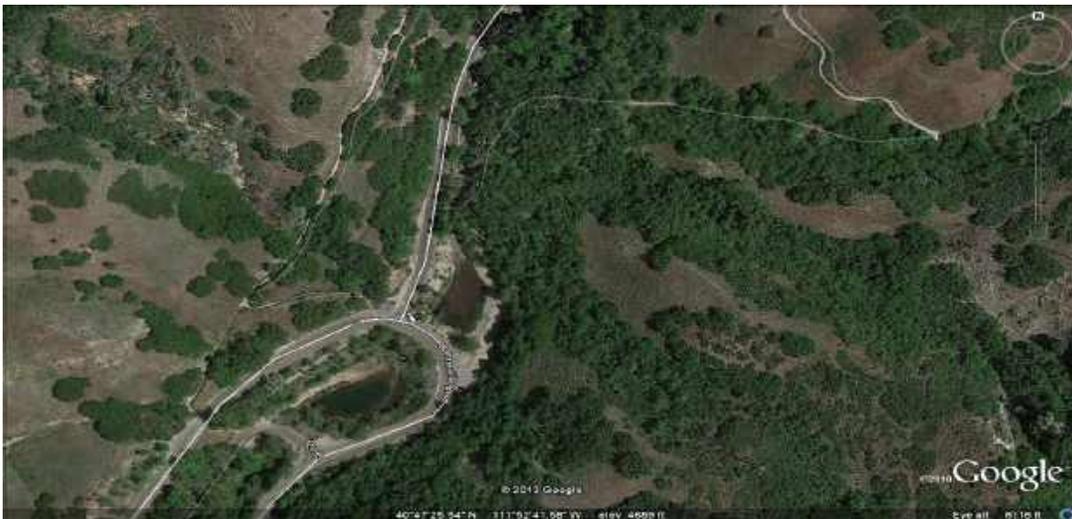
Figure 42. Image depicting the two small debris basins located near the mouth of City Creek Canyon.

City Creek is a small tributary that flows out of City Creek Canyon. At the mouth of the canyon, approximately 0.5 mile upstream from Memory Grove, there are two small ponds, approximately 1/4 acre in size (Figure 3). Despite their small size, we chose to sample upstream and downstream in 2010 to evaluate the ability of these small basins to remove CPOM. Figure 4 illustrates the effectiveness of CPOM removal during this relative low flow year.
