Utah Department of Environmental Quality
Division of Water Quality
TMDL Section
Thistle Creek TMDL

EPA Approval: July 9, 2007

THISTLE CREEK TMDL

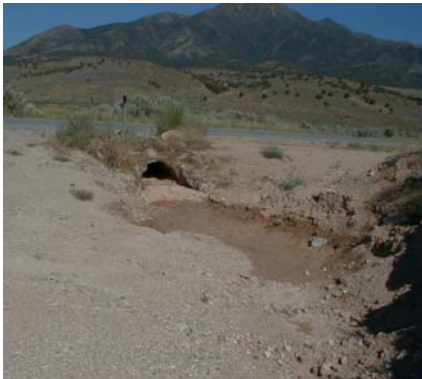
Photo 1. About 8% of the sub-watershed has severe to highly erosive soils.

Soils range from sandy and very sandy loams in the bottomlands to stony clay loams in the uplands. About 8% of the sub-watershed has soils identified as highly to severely erosive. Many of these soils are associated with steep slopes.

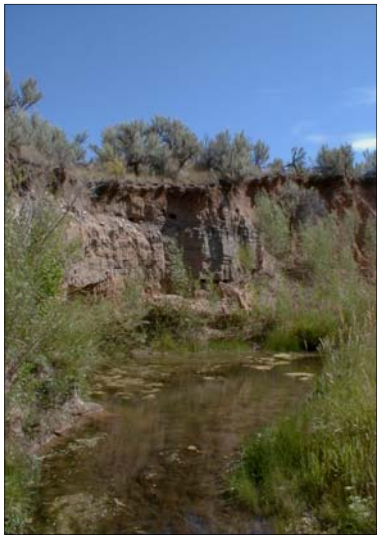
Photo 2. Excess sediment impairing the cold water fish habitat in Thistle Creek.

Excess sediment is impairing Thistle Creek's cold water fisheries beneficial use. Excess sediment can impair spawning success, egg survival to emergence, rearing habitat, and food availability.

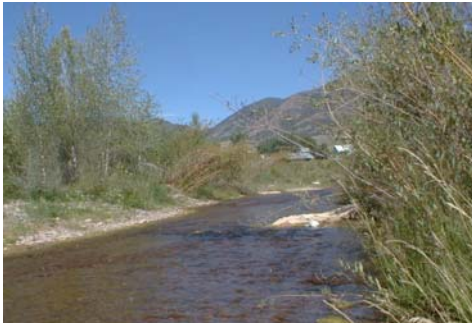
Figure 2 . Fish numbers before and after stream restoration

Figure 2 displays data on fish populations that was collected before and after a stream restoration project illustrating the effects of sediment on game fish populations.

Before the restoration, 250 fish per mile were counted. Within a year after restoration 1,250 fish per mile were tallied. Figure 3 shows how fish biomass responded to stream restoration projects. Trout biomass is one of the defined targets/endpoints identified for determining attainment of beneficial uses.

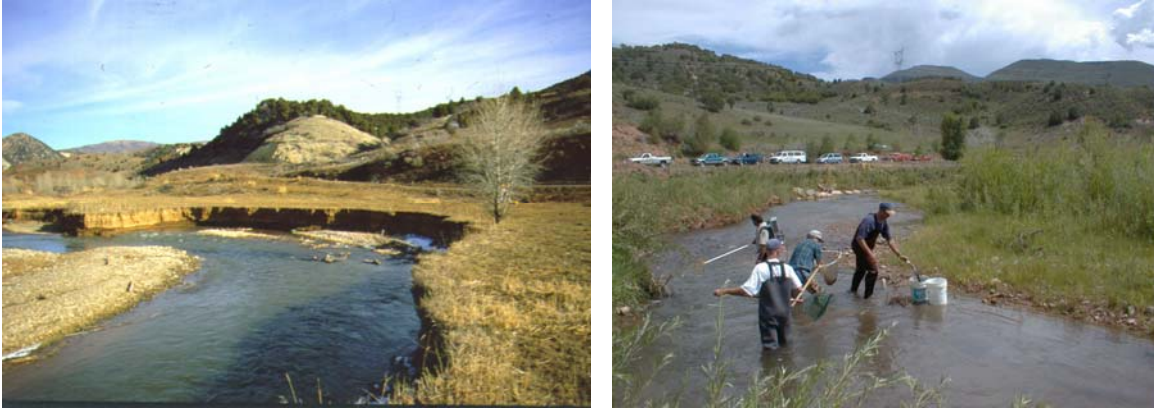
Photo 4. Before restoration (left) the fish count was 250 per mile on this reach of lower Thistle Creek. In a different view but the same reach, one year after restoration (right), numbers rose to 1,250 fish per mile.

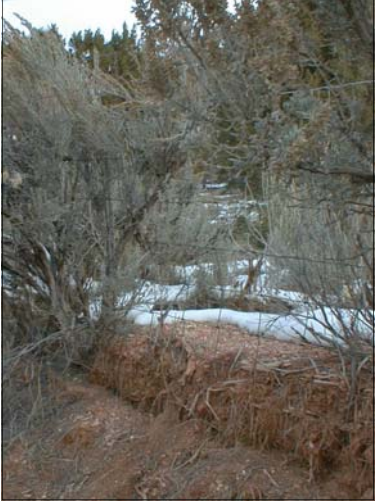
Photo 5. Highly erosive soils and the reduced ability of upland plant communities to hold soil in place are major contributors of sediment to the stream.

Past and current management practices have affected the upland plant communities by favoring shrub and tree growth, leaving the highly erosive soil surface exposed to sheet and rill erosion. The understory production of grass and herbaceous plants was measured at 37 to 40 pounds of plant material per acre on an area targeted for improvement. On adjacent land that had been treated, plant production was increased 10-fold, ranging from 250 to 500 pounds/acre.

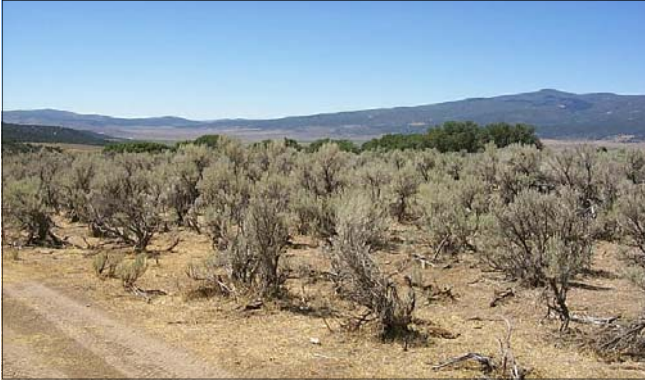
Photo 6. The suppressed presence of grasses and broad-leaved plants in upland plant communities exposes more soil to erosion.

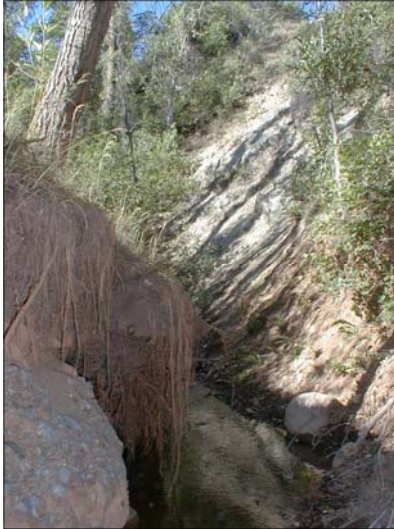
Photo 7. Unstable streambanks on this tributary contribute 5,000 tons of sediment annually to Thistle Creek . The 1983 floods likely initiated the this on-going sediment source.

In 1983, the Thistle Slide dammed Thistle Creek and subsequently flooded the small community of Thistle. The affects of that event still influence stream channel instability today. The 1983 flood waters scoured and downcut parts of the upper Thistle Creek channel, leaving a broad, oversized stream channel with raw cutbanks. In the lower reaches, as Thistle Lake backed

up the channel, thick deposits of sediment were deposited. After the lake receded, the stream channel eroded through these deposits in route to its confluence with Soldier Creek.

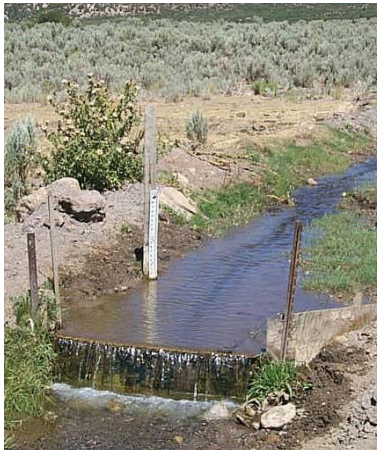
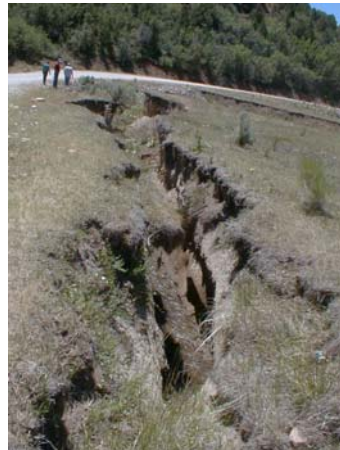
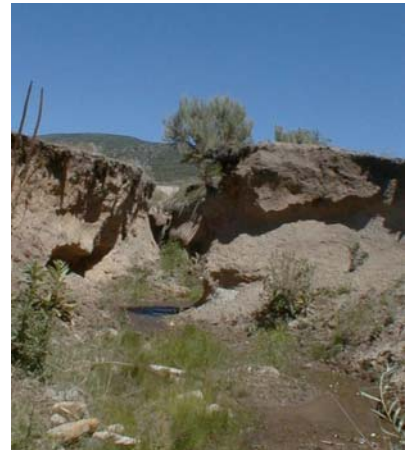
Photo 8. Diverted irrigation water (left) cut a new channel over 300 feet long and up to 15 feet deep (center). At the diversion's confluence with Thistle Creek (right), it is conservatively estimated to yield over 2,000 tons of sediment per mile annually.

Past and current stream channel management practices including channelization, irrigation diversions and irrigation return flows continue to introduce sediment into the stream channel.
