# **UPPER SEVIER RIVER**

## **Total Maximum Daily Load and Water Quality Management Plan**

Utah Division of Water Quality

EPA Approval Date: August 4, 2004

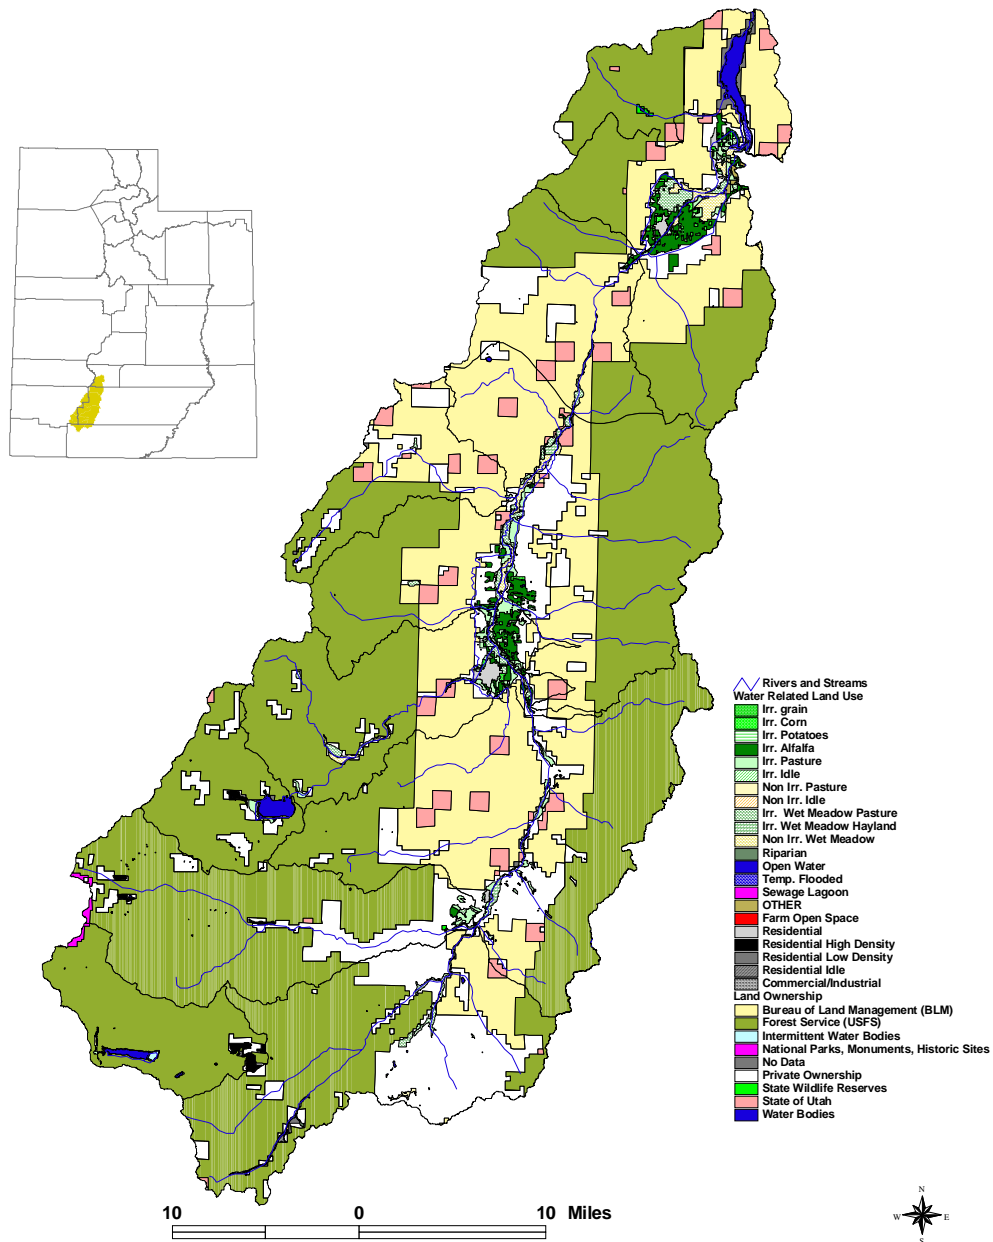
Map 1.

## Landownership and Water Related Land Use in the Upper Sevier River Watershed

Land under agricultural production represents only 3% of the land cover in the watershed and occupies lower elevation fields and meadows concentrated near rivers and streams (Map 1) . Water related land use data (Table 3) from the Division of Water Resources details the land cover associated with crop irrigation and municipal water use and development. In the Upper Sevier River watershed, the dominant agricultural crop is alfalfa. Combined with pastures and wet meadows utilized for grazing, land cover associated with cattle production comprise 64% by acreage of water related land uses.

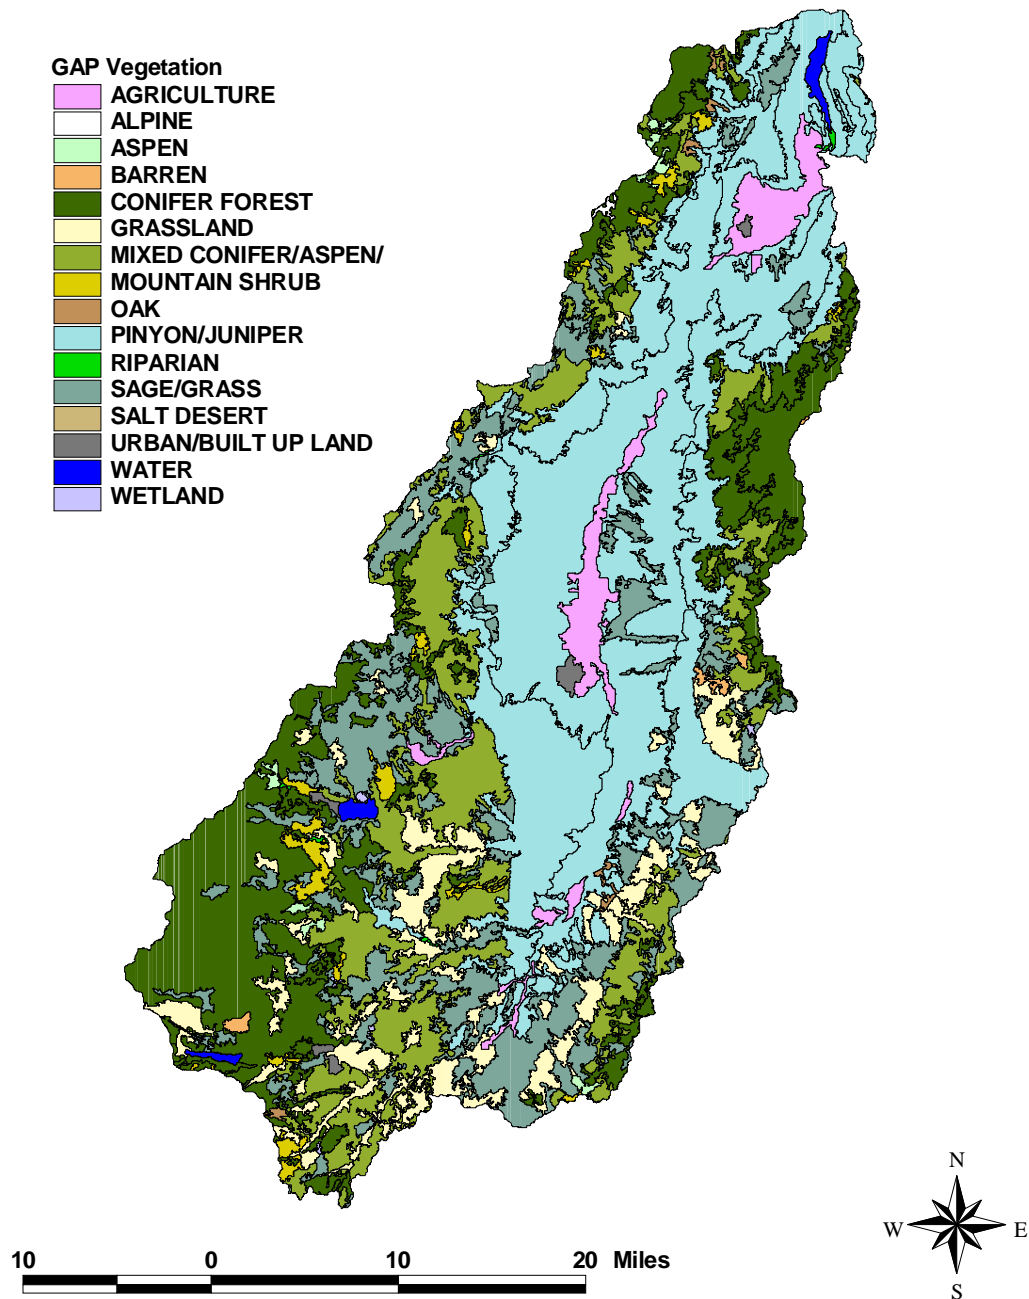
Map 2.

## Vegetation in the Upper Sevier River Watershed

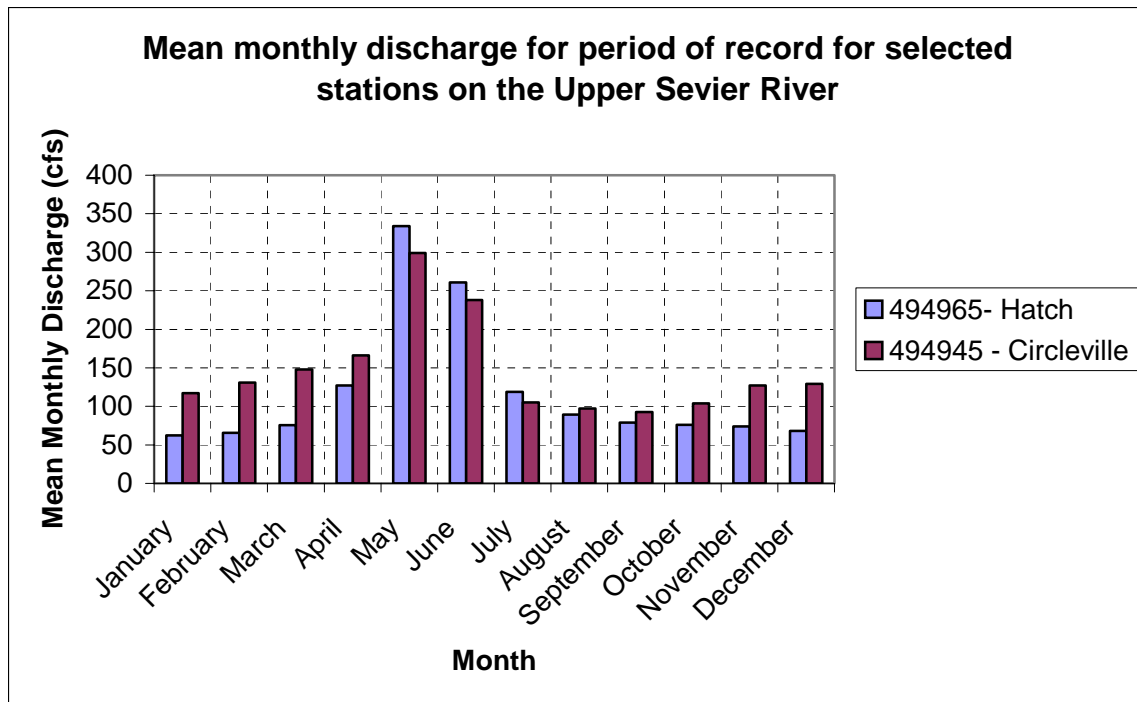
Figure 1. Mean monthly discharge for selected stations on the Upper Sevier River.

Available flow data for the Upper Sevier River are summarized in Figure 1. which shows the mean monthly discharge for two stations on the river located near Hatch in the upper watershed and the lower river in Circleville Canyon. With the exception of the irrigation season, flows are greater at the downstream station near Circleville. An average of approximately 68,400 acre-ft of water is diverted from the river and its tributaries in the Panguitch Valley during the irrigation season. According to a study by the Utah Department of Natural Resources (1993), of this irrigation water, approximately 33% or 22,950 acre-feet is consumed by crops. The remaining irrigation water discharges to streams and groundwater as tailwater, valley fill recharge and leakage from canals (11,110 acre-ft, 21,500 acre-ft, and 12,840 acre-ft, respectively). With the exception of a small stream section near Hatch, the length of the Upper Sevier River through Panguitch Valley is a gaining stream. The river is heavily influenced by irrigation diversions particularly near Panguitch, where several complete diversions are operated (see Map 3).

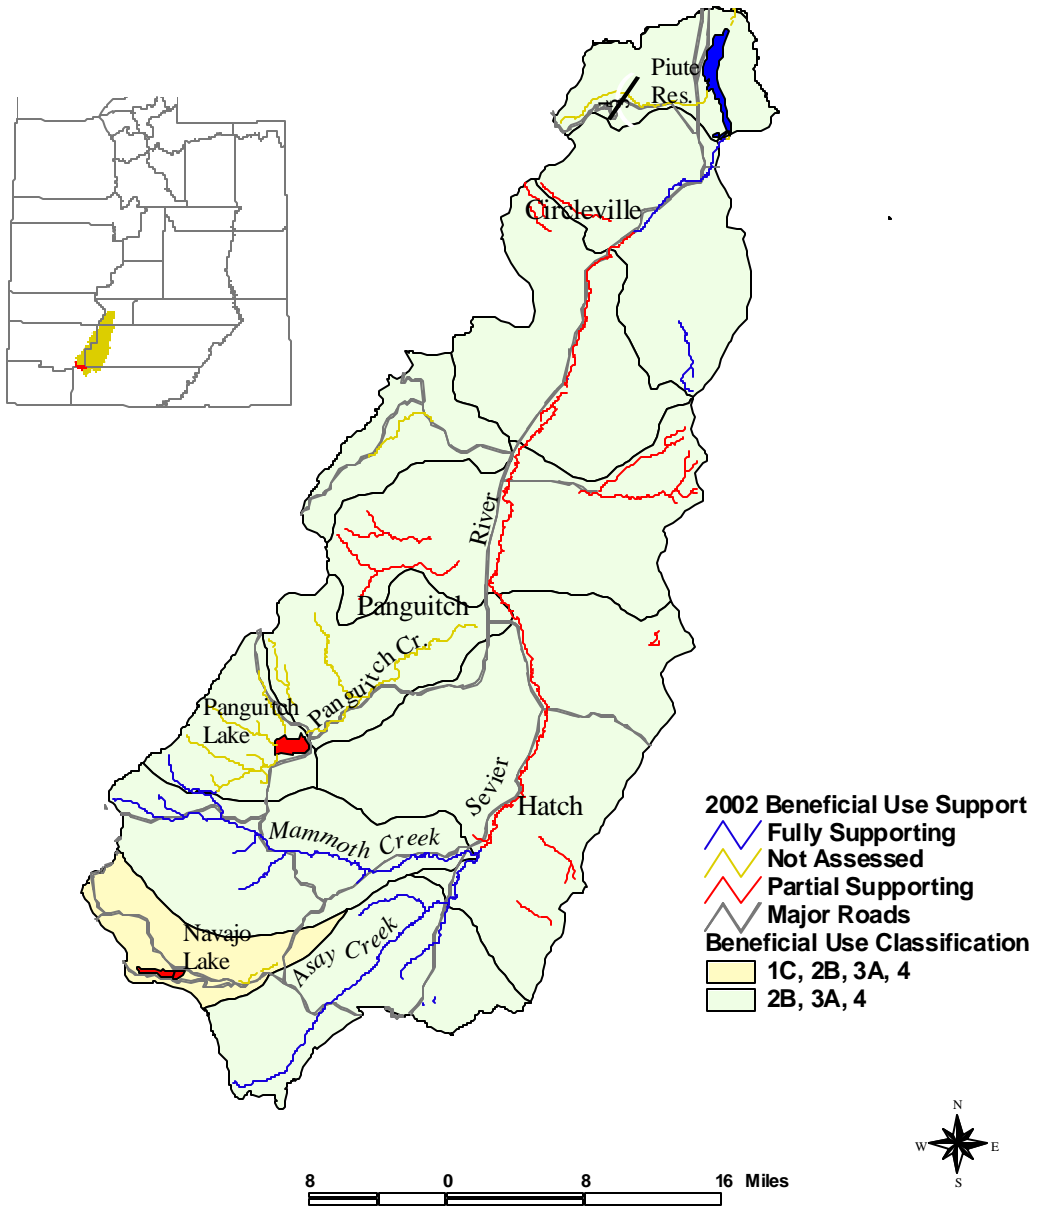
Map 4.

## Beneficial Use Classification and Support Status (2002) for the Upper Sevier River Watershed

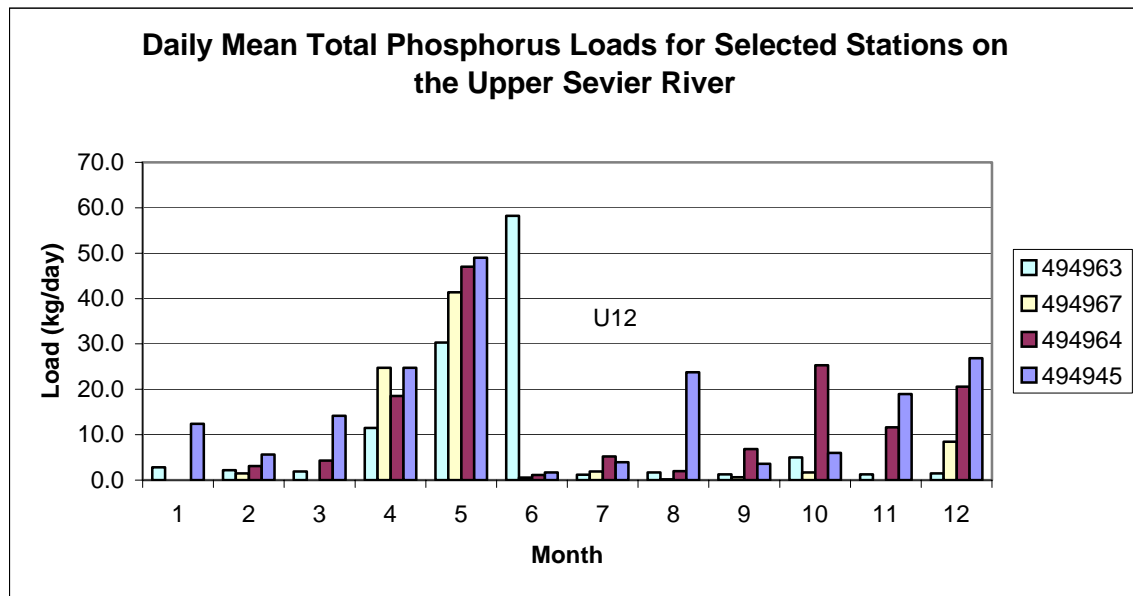
Figure 3. Mean TP loads for selected stations on the Upper Sevier River.

Mean total phosphorus concentrations and loads were calculated by sorting data by month and obtaining monthly averages (see Appendix B for summaries). Figure 3 indicates that loads are highest during April and May, which corresponds with the spring runoff. The sharp drop in loading in the middle and lower river during June may reflect the effect of irrigation diversions reducing flows and concentrations due to land application. Loads remain low in the upper river the remainder of the year while higher loads in the lower river reflect irrigation return flows and streambank erosion from higher fall stream flows. In addition, levels may increase in downstream reaches as a result of over-wintering of livestock in the Panguitch Valley.

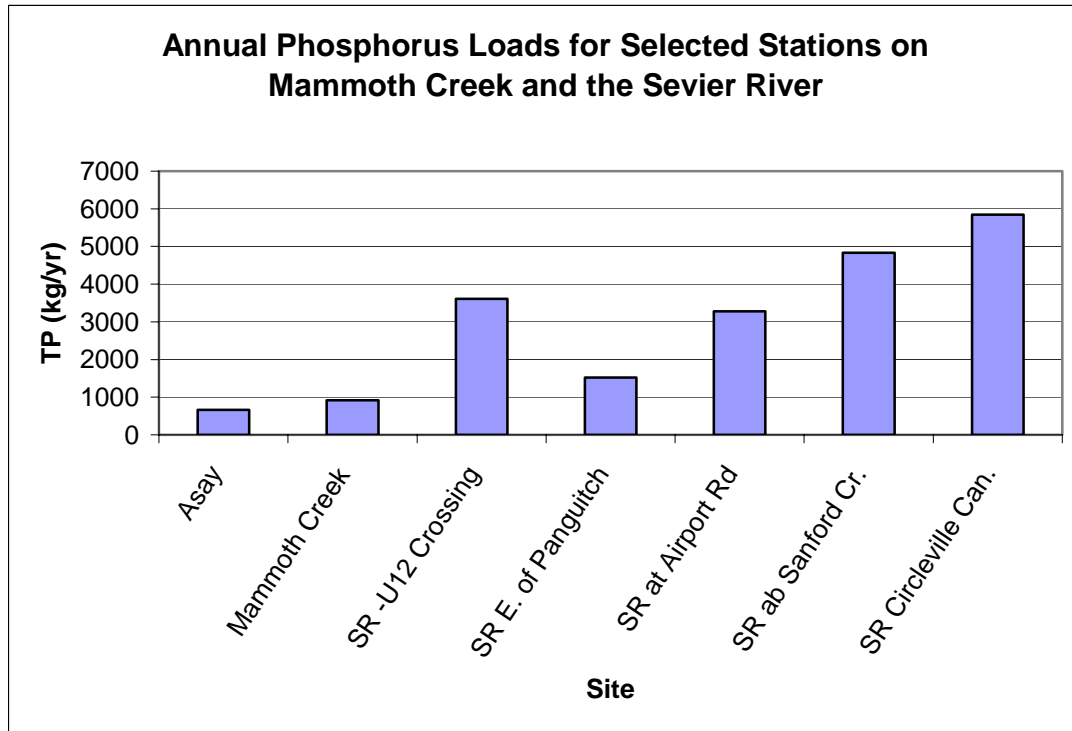
Figure 4. Annual TP loads for selected stations.

Annual loads (see Figure 4.) were calculated by averaging monthly loads and multiplying by 365 days in the year. In general, loads increase with downstream reach. The exception to this trend occurs at 494963 (Sevier River at U12 Crossing) in June which may be due to higher flows in this reach which is located upstream from major irrigation diversions. The site 494966 (Sevier River East of Panguitch) is located below a major diversion which accounts for the lower TP loads observed at this site.

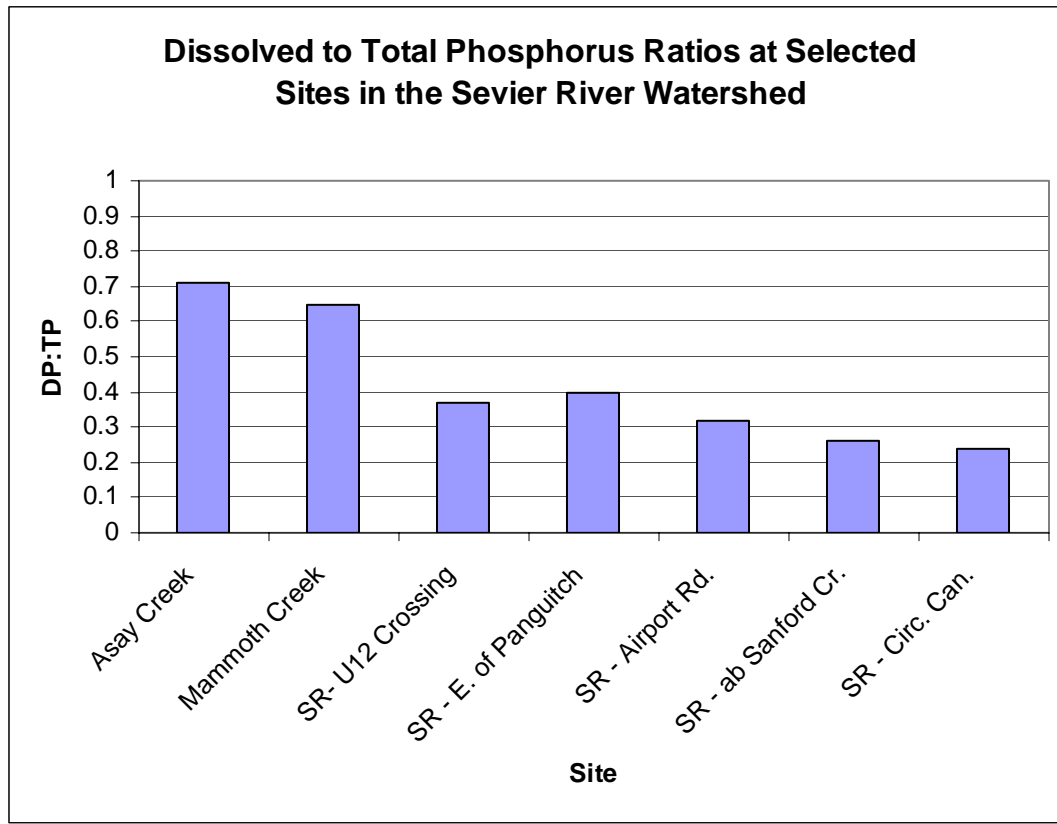
Figure 5. Dissolved and total phosphorus ratios.

Dissolved phosphorus appears in surface waters usually from sources of organic nutrient enrichment such as a wastewater treatment plant, animal feedlot waste, or other point source discharge. Examination of ratios of dissolved to total phosphorus concentrations can be used to indicate whether sources are predominantly organic in nature as is the case when high ratios are found in surface water. Ratios were calculated for selected sites on the Upper Sevier River, Asay and Mammoth Creeks and are presented in Figure 5.

Ratios of DP to TP were low (0.24) in the lower river suggesting that TP was not readily bioavailable but adhered to soil or sediment particles. Conversely ratios in Mammoth and Asay Creeks were high (0.65) indicating organic enrichment related to sources such as the Mammoth Fish Hatchery, grazing and high numbers of septic systems from home development in both the Asay and Mammoth creek watersheds.

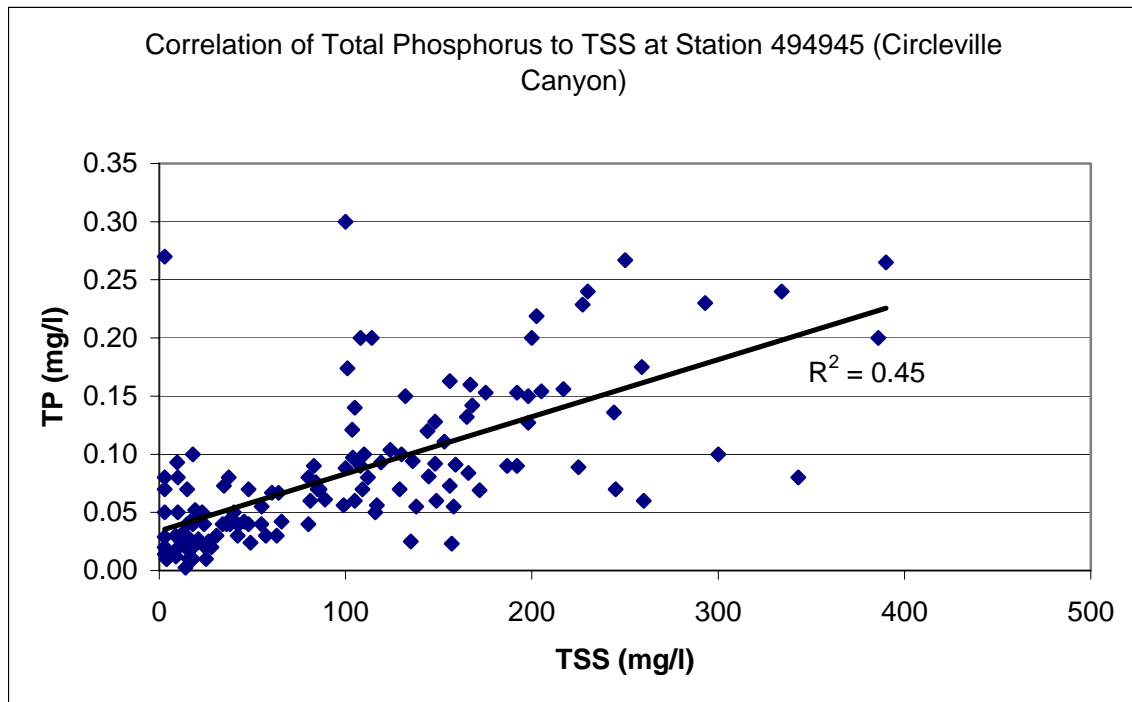
Figure 6. Correlation of TP to TSS at station 494945.

In addition to dissolved to total phosphorus ratios, correlations between TP and Total Suspended Solids (TSS) were graphed (see Figure 6). While the relationship between TSS and TP is not particularly strong for the entire dataset ( $R^2 = .45$ ) the majority of high phosphorus measurements ( $> 0.05$  mg/l) occur when TSS is also high. Analysis of the dataset for Asay Creek (494990) reveals a similar relationship between TSS and TP ( $R^2 = 0.49$ ) while Mammoth Creek ( $R^2 = 0.002$ ) did not bear a relationship, thus indicating that TP concentrations are not likely a function of sediment-borne phosphorus, but primarily organic in nature.

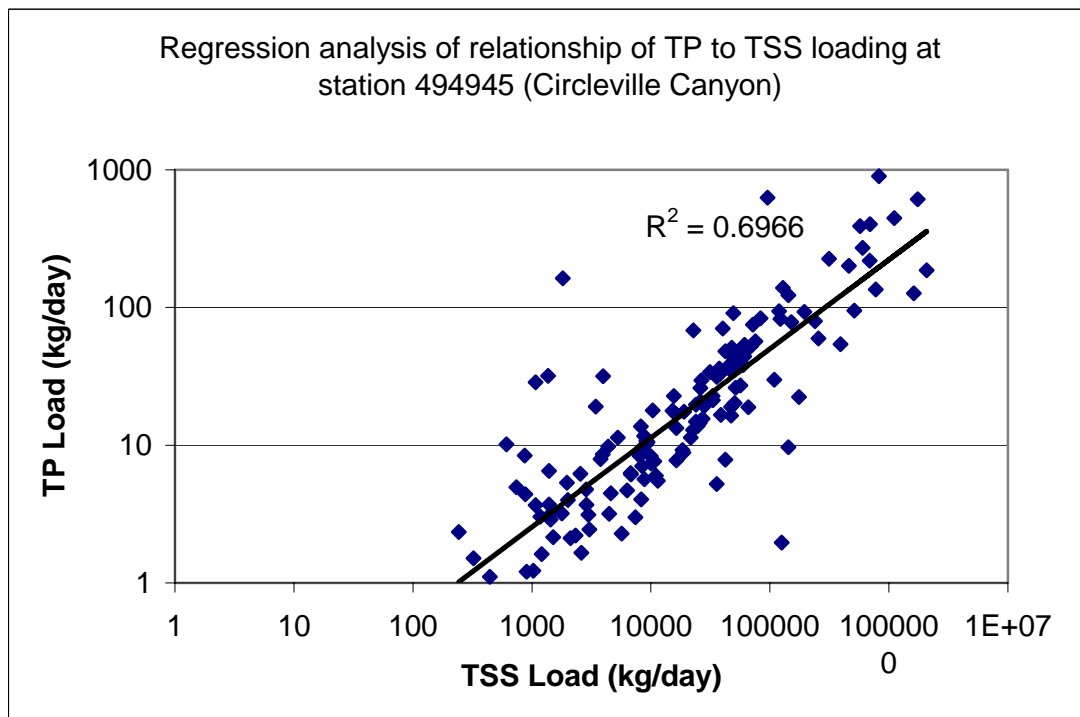
Figure 7. Regression analysis of TP and TSS Loads for Station 494945.

In addition, regression analysis of the relationship between TP load and TSS load (Figure 7) provides stronger evidence that high loads of TP are flow related and associated with high sediment loads.

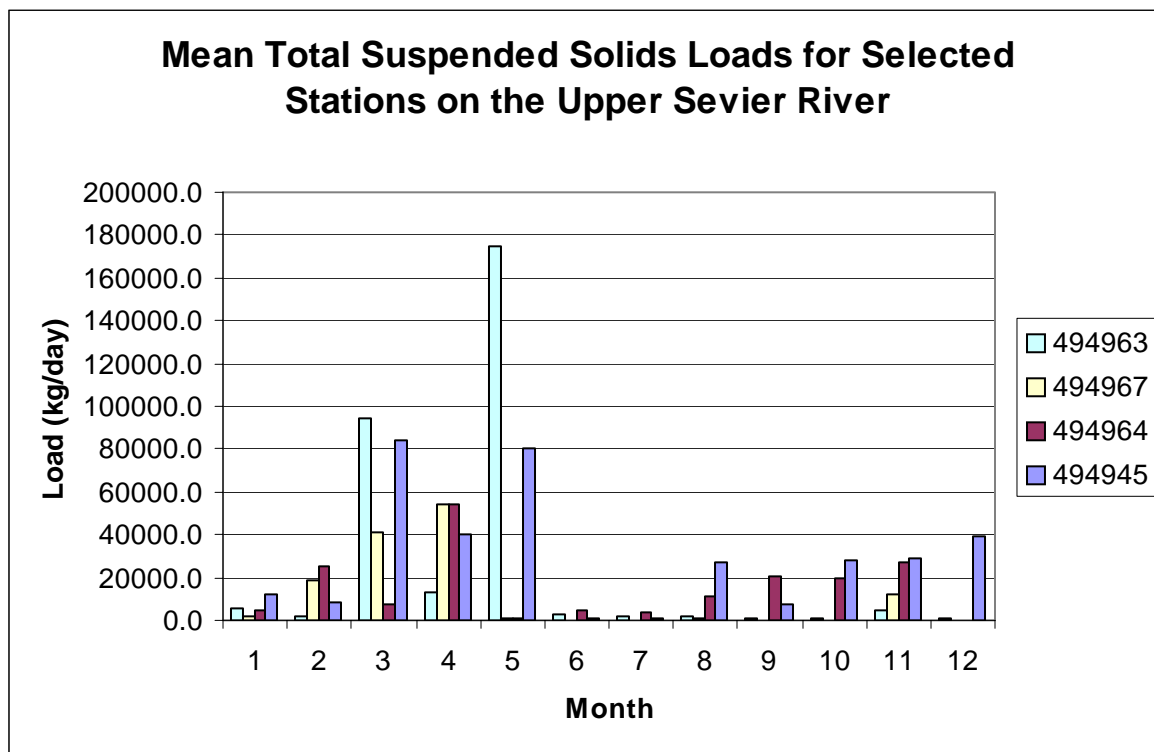
Figure 8. TSS loads at selected stations on the Upper Sevier River

Mean total suspended solids (TSS) concentrations and loads were calculated by sorting data by month and obtaining monthly averages (see Appendix B for summaries). Figure 8 indicates that loads are highest during April and May, which corresponds with the spring runoff. The sharp drop in loading in the middle and lower river during June may reflect the effect of irrigation diversions reducing flows and concentrations due to land application of river water. Loads remain low in the upper river the remainder of the year while higher loads in the lower river reflect irrigation return flows and streambank erosion from higher fall stream flows.

As is typical of stream with snowmelt dominated hydrograph, TSS values generally peak in the months of spring runoff as tributary inflows and bank erosion from high flows contribute sediment to the system. A notable exception can be seen in May values, where irrigation withdrawals not only effect discharge but the TSS load. Peaks in TSS load early in March and April may be a result of low elevation snowmelt mobilizing sediment from valley bottoms and foothill rangeland. The lower river (represented by 494964 and 494945), exhibits an increase in TSS load as stream flows increase in the lower river after irrigation season. In this situation, streambank and in- channel erosion is most likely occurring from increased flows from groundwater recharge and fall storm events. However, analysis of the correlation between flow and TSS concentrations for the period of record at 494945 did not show TSS to be well correlated to flow ( $R^2 = .28$ )

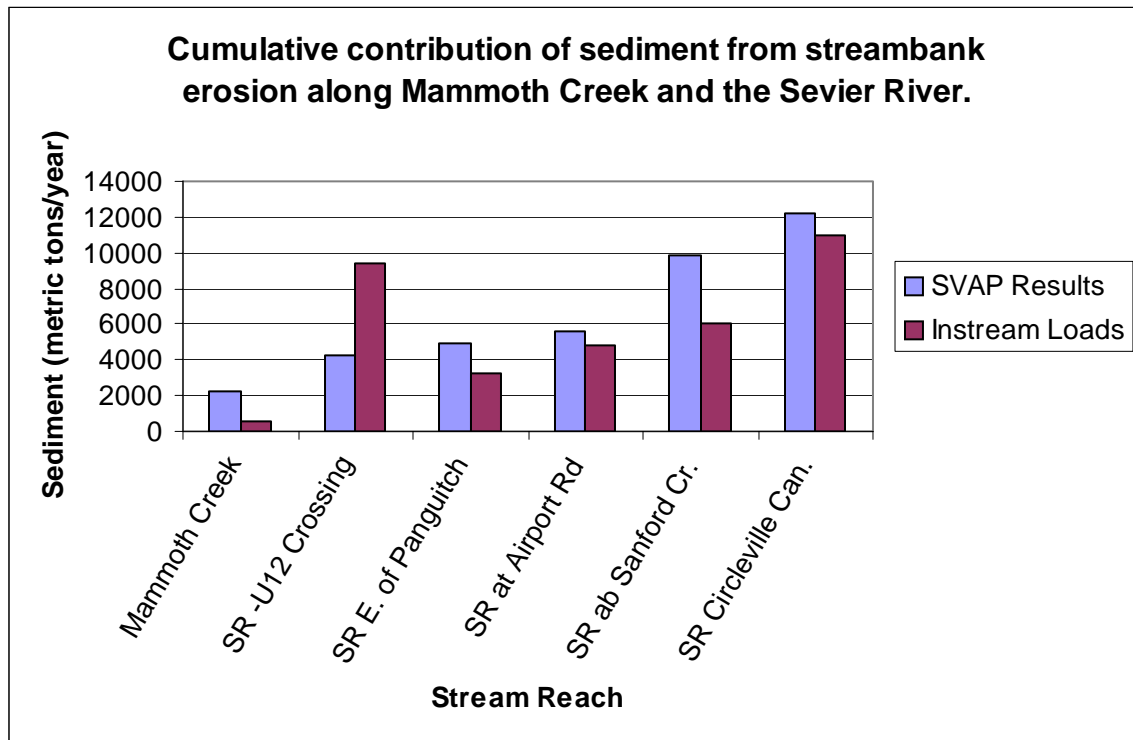
Figure 9. Estimated sediment loads from streambank erosion.

Relative increases in sediment as TSS as measured in instream loads from water quality data mirror the increases predicted during the survey using SECI protocol. While the SECI estimates the total amount of sediment delivered to the stream from the volume of material being lost each year, TSS only measures the suspended fraction of sediment transported in the stream. The estimates of streambank erosion would be expected to be higher since not all of the material entering a stream would be suspended in the water column but comprise bed load as well. Since the SECI survey was incomplete and did not include other tributaries we would expect the sediment contribution to be much greater. The site at SR at U12 crossing exhibited extremely high TSS values in the 2001-02 intensive sampling season which is responsible for the spike in TSS load at this site. In addition, numerous irrigation withdrawals in the area upstream of Panguitch may regulate the amount of TSS in the river since in some cases the withdrawals are complete dry dams and the water is flooded onto fields to the east of the Valley. The monitoring station 494966 (Sevier River East of Panguitch) is one such site, located below a complete diversion which had resulted in lower observed stream flow and loads for both TSS and phosphorus.

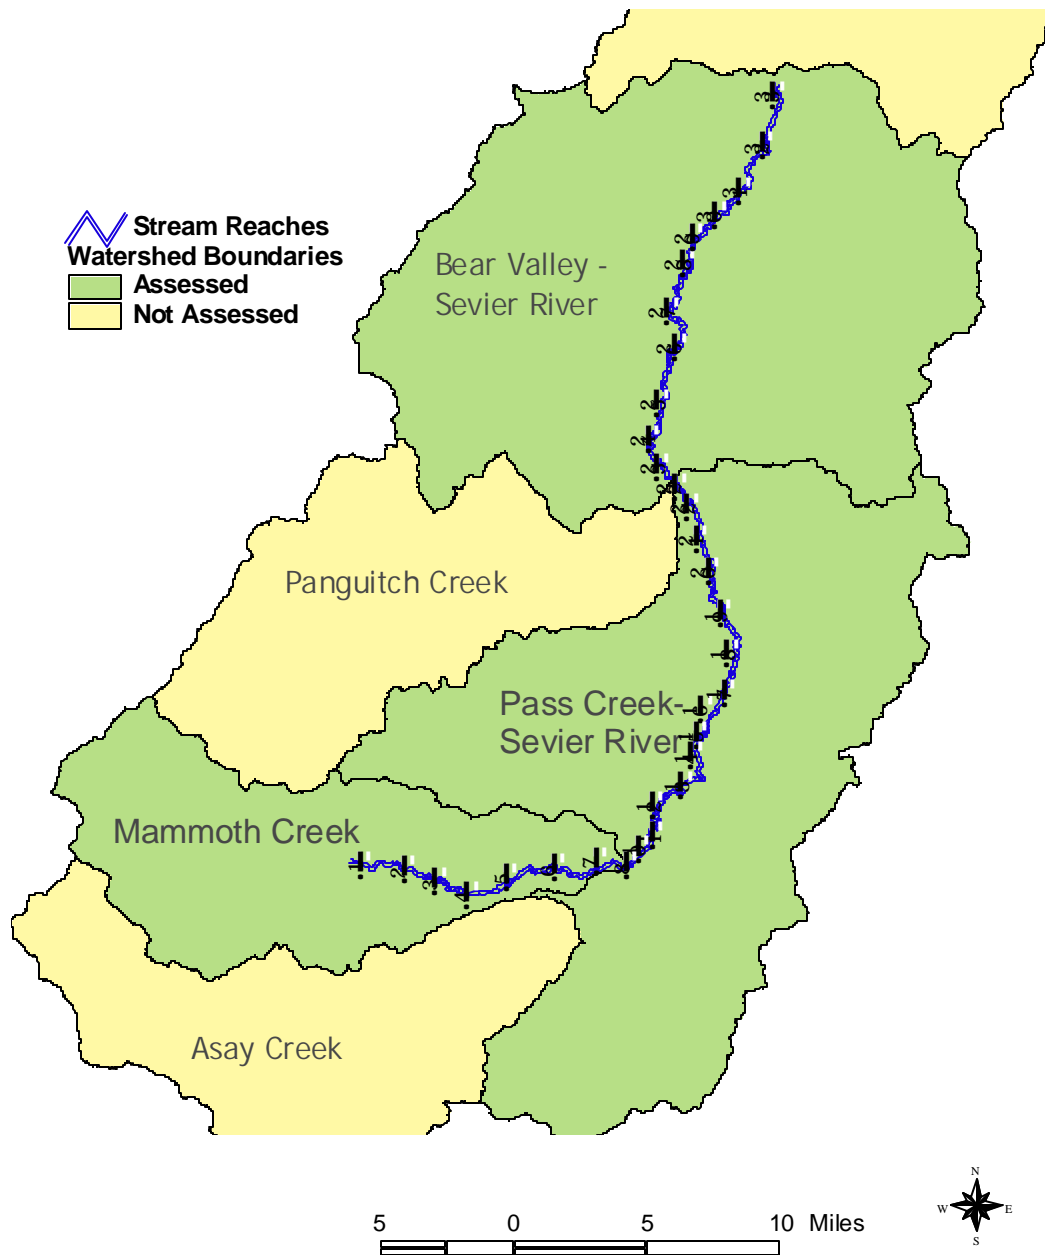
Map 5.

An extensive survey using the Stream Visualization Assessment Protocol or SVAP (USDA, 1998 ) was completed in October of 2002 on a total of 65 stream miles on the Upper Sevier River and Mammoth Creek (see Map 5). Selected results pertaining to streambank condition are contained in Table 12. In addition to SVAP additional erosion information was derived using the Streambank Erosion Condition Index or SECI (USDA,). SECI is essentially an erosion hazard index used to estimate bank erosion in

Stream reaches assessed using the Stream Visual Assessment Protocol

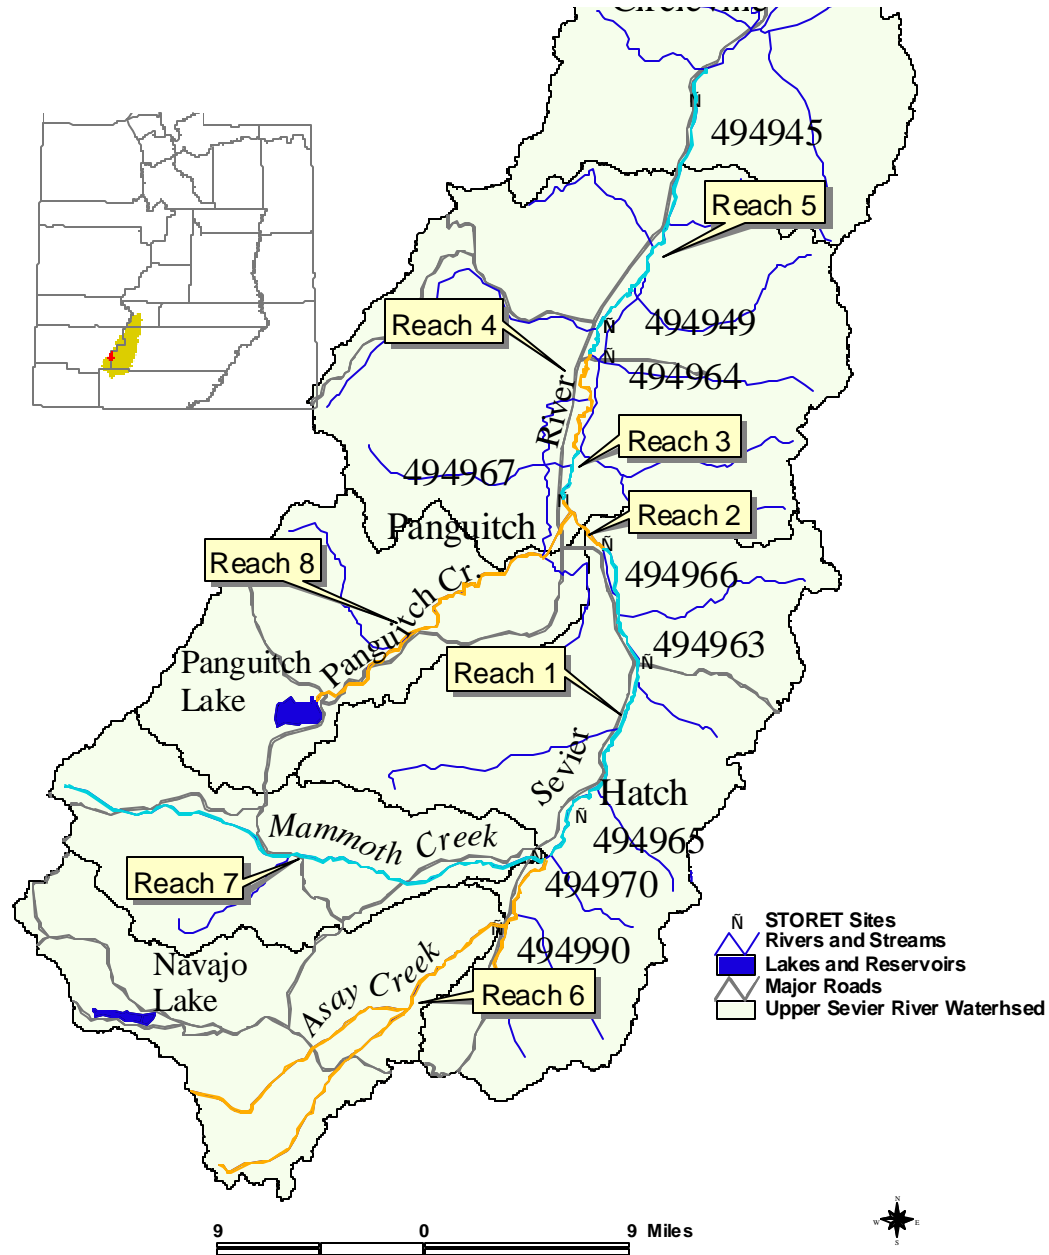
Map 6.

**Reaches assessed for cattle numbers and loading estimates.**

Overall, it was estimated that approximately 2037 kg/year of total phosphorus is attributed to the presence of cattle in the Sevier River upstream of Circleville Canyon. The load from grazing sources represents approximately 35% of the total measured annual load at the lowest STORET station of 494945. Table 14 summarizes the monthly load contribution from cattle in each reach (Note: Panguitch Creek was not included in the assessment since the stream is diverted into sprinkler systems during the majority of

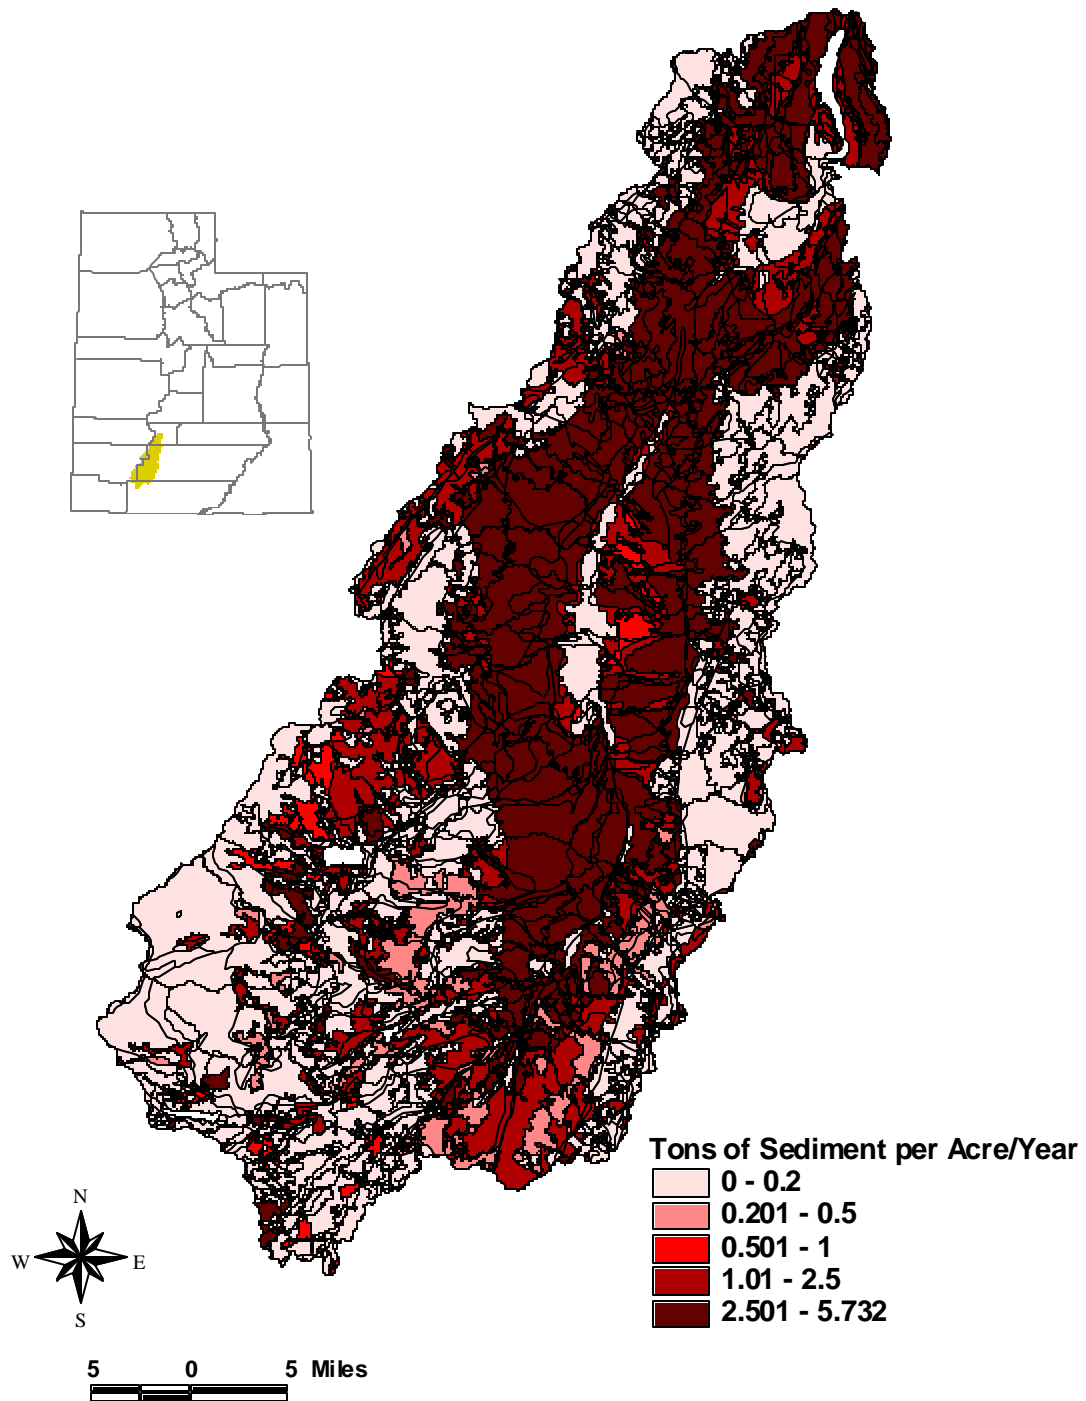
**Map 7. Sediment delivery rates (USLE model results)**

The erosion results of USLE (before applying the SDR) are displayed in Map 7 in tons of sediment per acre per year. Area with the highest rates of erosion occur in the foothill rangeland where soils are highly erodible, conditions are arid and ground cover poor.
