CHAPTER 4

**Coarse Particulate Organic Matter Measurements in the
Jordan River and its Major Tributaries, 2010 - 2012**

Draft Report

Jordan River/Farmington Bay Water Quality Council

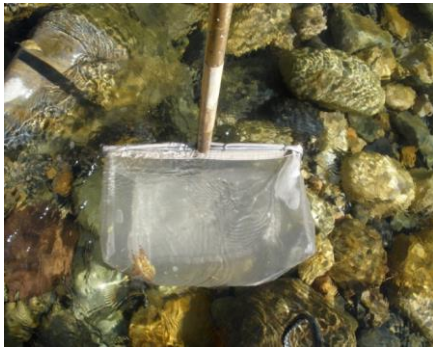
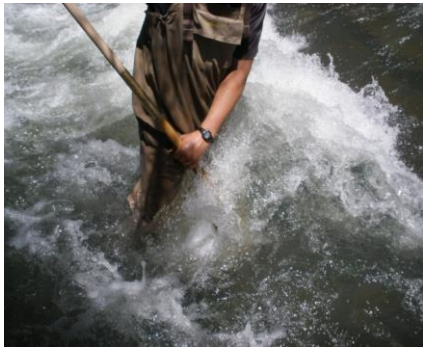
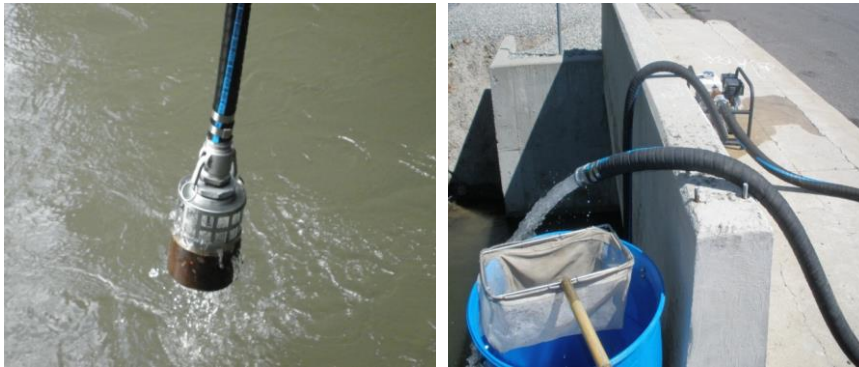
Figure 1. Photographs illustrating the two techniques used for sampling coarse particulate organic matter. With either technique the water was initially filtered through the same net, followed by screening with a 1-mm soil sieve.

During relatively low-flow (non-spring runoff) conditions (< approximately 300 CFS), samples were collected with a standard 10 inch x 18 inch sweep net, obtained from Wildlife Supply Company. The only mesh available during 2010 to 2012 was 500 μm whereas the standard separation between FPOM (VSS) and CPOM is defined using a 1 mm mesh size. Therefore, samples were immediately rinsed in a 1 mm- mesh soil sieve for accurate separation of particle sizes. At each site, samples were collected at $\frac{1}{4}$, $\frac{1}{2}$ and $\frac{3}{4}$ distance across a perpendicular transect. Where or when the stream depth was > approximately 30 cm, and floating debris was visible, samples were collected with the net at the surface and with the net resting on the bottom in order to collect floating debris as well as bed load and suspended material. The top and bottom samples were composited when collected. In addition, samples collected at $\frac{1}{4}$, $\frac{1}{2}$ and $\frac{3}{4}$ distance across the stream were composited and this process was performed in triplicate. The duration of sample collection was timed in order to calculate the load and the duration of each “set” was adjusted in order to collect sufficient sample for accurate measurement as well as to limit sample volume to < approximately 200 g dry weight to facilitate sample handling, drying and combustion in the laboratory. Concentration or mass of the organic debris was determined by dividing the sample mass by the product of the stream

velocity x net dimensions x sampling duration. During high flows or during the autumn leaf fall, typical duration of net placement was 10 to 30 seconds. During low flow conditions of winter and summer, net placement was extended to 60 seconds or more in order to collect sufficient sample volume. During high flow conditions (> approximately 300 CFS), we used a 3-inch trash pump. About ½ of the cross-linkages of the intake screen were removed to facilitate the uptake of the debris. The intake screen was weighted with approximately 40-pounds of steel plates to ensure that the screen remained on the stream bottom. Sample collections from the surface were not performed during these high flows because the turbulence caused sufficient mixing that the leaf material was rapidly saturated and was assumed to be distributed randomly throughout the water column. Also, because of this homogeneity, sample collection was only performed near the center of the channel. The discharge volume from the pump was measured using a 55-gallon barrel and each of triplicate samples included ten volumes (550 gallons) of water. Similarly this material was sieved using the 1 mm soil sieve to collect the CPOM fraction.

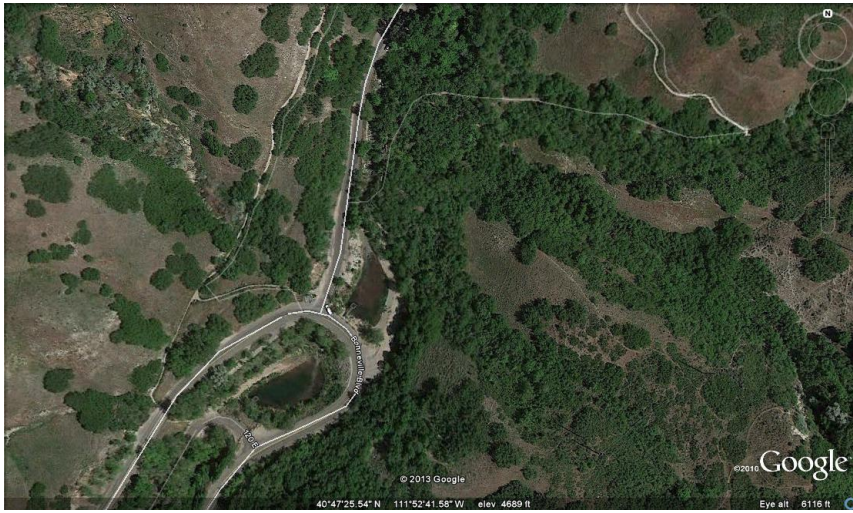
Figure 3. Image depicting the two small debris basins located near the mouth of City Creek Canyon.

City Creek is a small tributary that flows out of City Creek Canyon. At the mouth of the canyon, approximately 0.5 mile upstream from Memory Grove, there are two small ponds, approximately 1/4 acre in size (Figure 3). Despite their small size, we chose to sample upstream and downstream in 2010 to evaluate the ability of these small basins to remove CPOM. Figure 4 illustrates the effectiveness of CPOM removal during this relative low flow year.

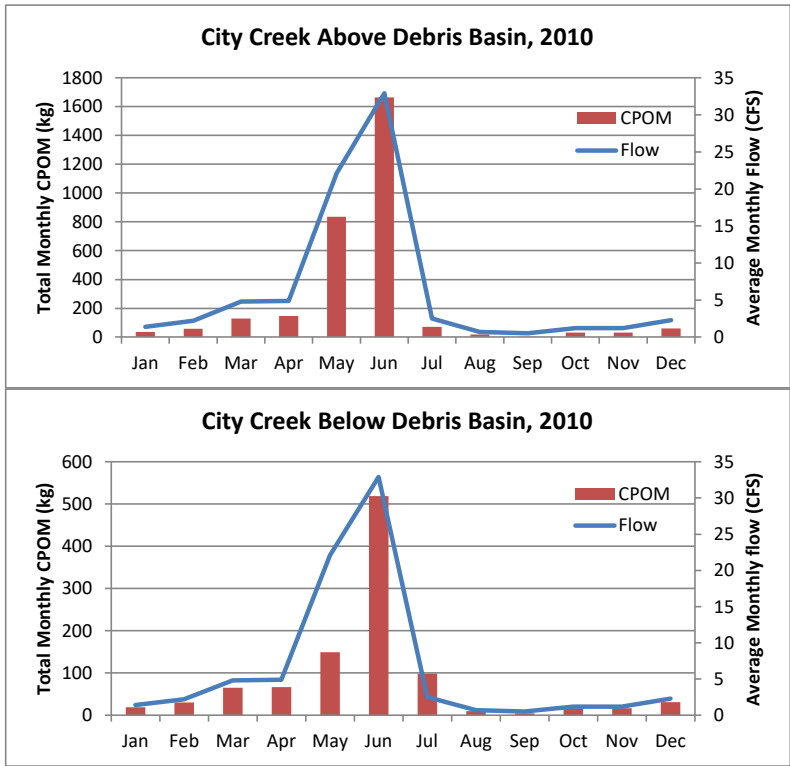
Figure 4. Monthly CPOM values in City Creek during 2010. Top: Samples collected approximately 100 m upstream from the debris basins; Bottom: Samples collected approximate 50 m downstream from the basins.

The two small debris basins reduced the CPOM load by about 2/3. This suggests that if these debris basins are maintained that substantial quantities of the CPOM can be removed and prevented from settling in and affecting downstream segments. Data collected during 2011 and 2012 are illustrated in Figure 5. During these years sampling was only performed at a point downstream from both debris basins. Because City Creek is directed to an underground culvert not far below Memory Grove, we feel that samples collected from this location provide an estimate of CPOM that is delivered to the Lower Jordan River near North Temple Street.

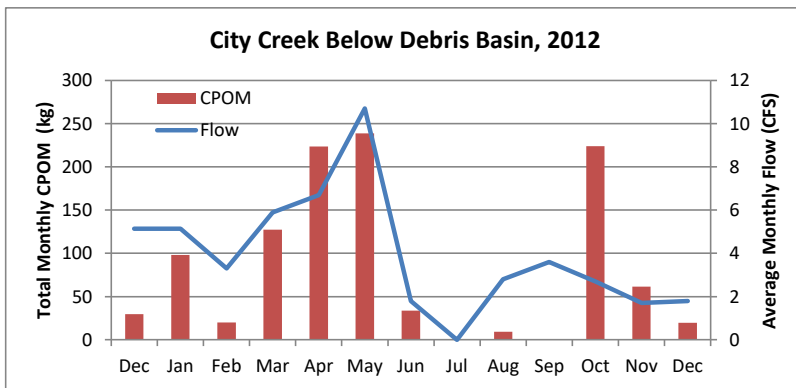
Figure 5. Monthly measurements of CPOM during 2011 and 2012 in City Creek. Samples were collected downstream from the small debris basins in Memory Grove.

It should be noted that rainfall and snowpack during 2010 was near the long-term average for the Wasatch front. Rainfall and snowpack during 2011 was approximately 30% above average while that for 2012 was about 30% below average. Therefore, the CPOM load during 2011 above the debris basins was likely much larger than that delivered in 2010, further suggesting that the debris basins were quite effective in reducing organic matter loads to the Jordan River. The CPOM loads during 2012 was predictably low.

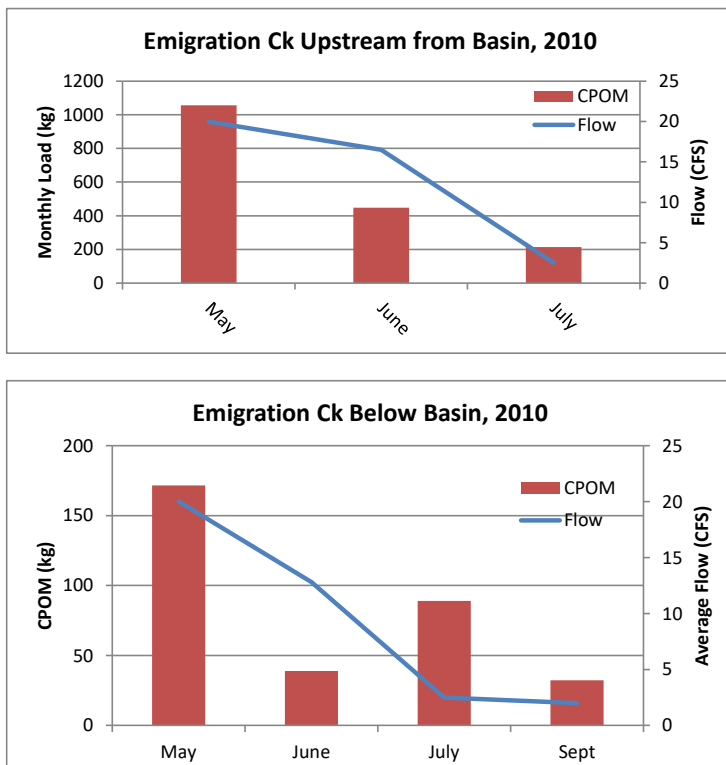
Figure 6. Monthly measurements of CPOM during 2011 and 2012 in Emigration Creek.

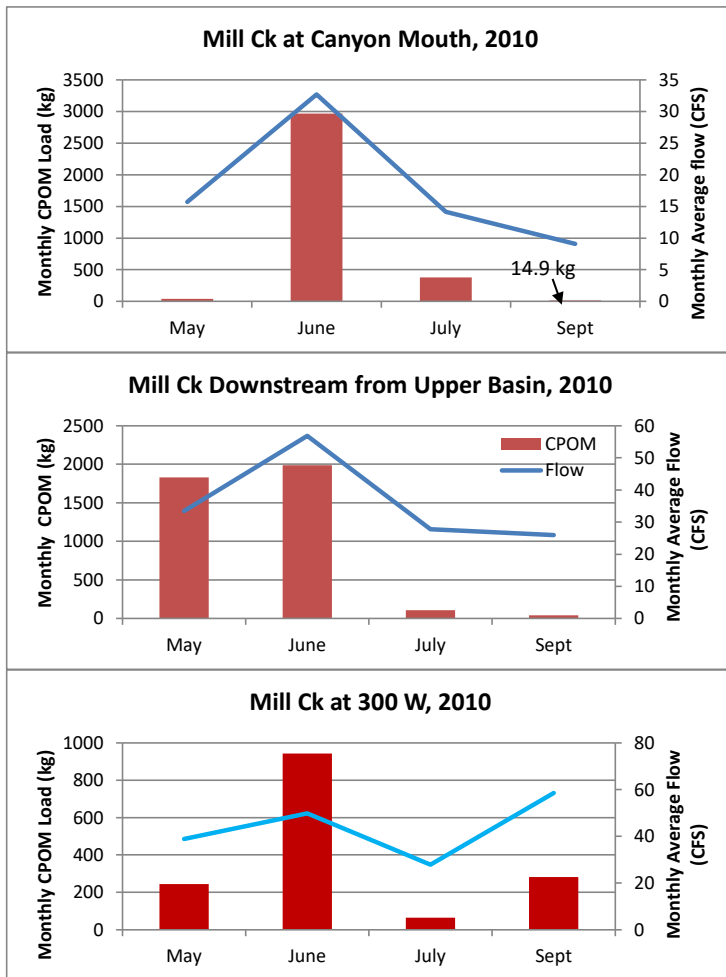
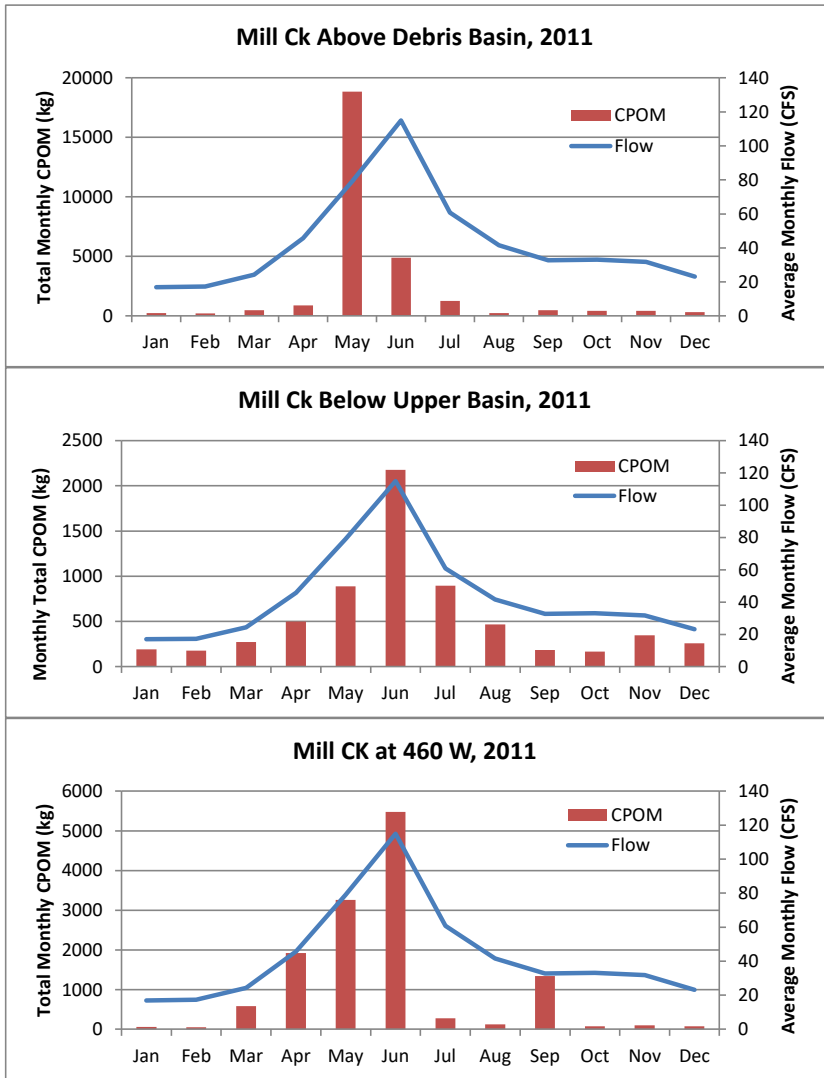
Figure 7. Monthly measurements of CPOM during 2011 and 2012 in Mill Creek.

Figure 7. Continued. The unexpected high value in May above the debris basin was due to the collection of a large stick in the sweep net.

Mill Creek is another small tributary to the Jordan River. It forms the next canyon south of Parleys Canyon. Again, it had similar flows and contains two smaller debris basins, although they are located about 3 and 4 miles out from the canyon mouth. The stream intermittently flows above ground and through underground culverts. Figure 7 illustrates the 2010 data collected upstream and downstream from the 1300 E basin.

The debris basins again significantly reduced the amount of CPOM that is delivered to the Jordan River.

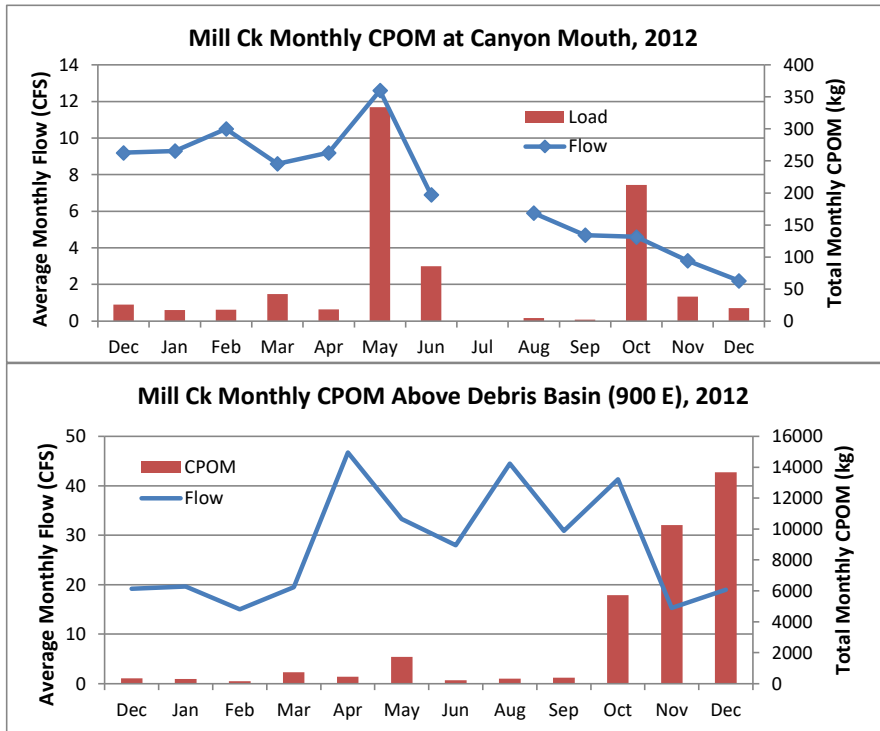
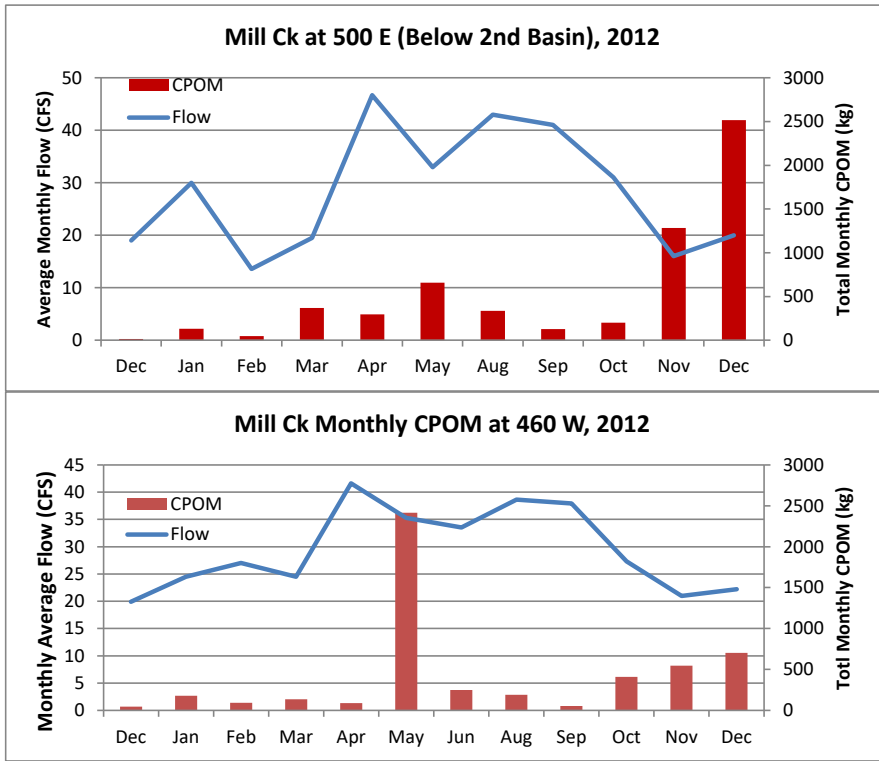
Figure 8. Monthly flow and CPOM values at four sites in Mill Creek during 2012. Mill Creek has two debris basins, immediately downstream from 900 E and immediately upstream from 500 E. Note the large increase in CPOM at 900 E and 500 E in October November and December, despite the low seasonal flow.

Figure 8, Continued. Monthly flow and CPOM values for Mill Creek during 2012.

Similar samples were collected during 2012 (Figure 8). It should be noted that rainfall and snowpack were much less than average, resulting in considerably less flows than during 2011. These low flows led to predictably low CPOM values at the canyon mouth. The channel gains consider flow as it travels toward the Jordan River. There are unusually high levels of CPOM above the 900 E debris basin even though flows are minimal. In addition, CPOM levels were elevated for the last three months. The fact that flows were diminished suggests that material was delivered anthropogenically at a location between the mouth of the canyon and 900 E.

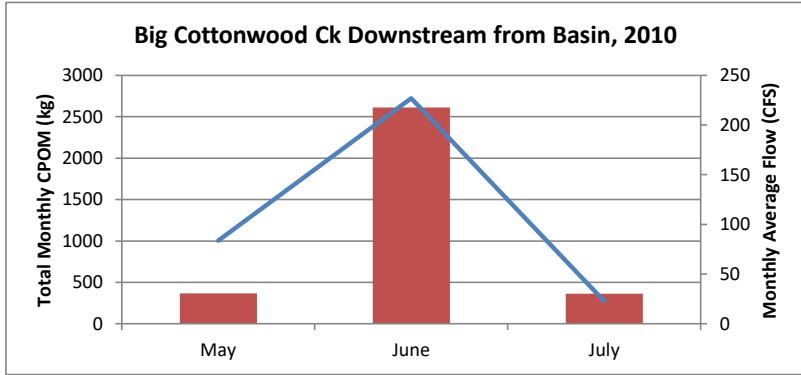
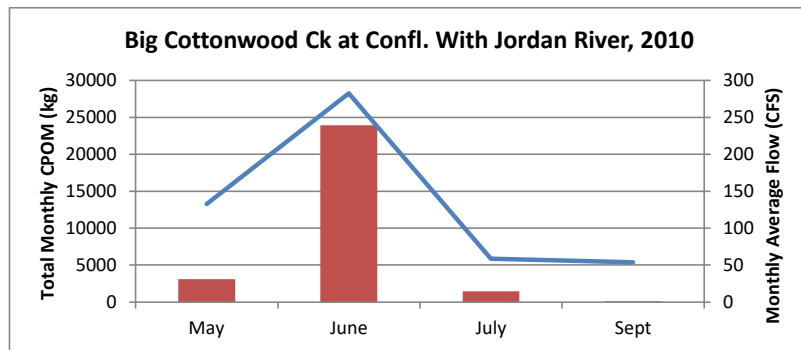
Figure 9. Flow and CPOM at selected sites along Big Cottonwood Creek during 2010, 2011, and 2012. The debris basin was located approximately 800 m (1/2 mile) below the canyon mouth.

While the inflow delivered an estimated 40,000 kg during June, the outflow from the basin only carried 2,500 kg during June, a reduction of 94% (Figure 9b.). This reveals the effectiveness of debris basins if they provide sufficient residence time and are maintained. Despite the observed effectiveness of the debris basin during spring of 2010, Big Cottonwood Creek acquired considerable CPOM downstream of the debris basin (up to 25,000 kg during June) as it flowed through the urbanized section of the creek. This sampling site was located immediately upstream from the confluence of Big Cottonwood Ck and the Jordan River, indicating that this large load entered the Jordan River.

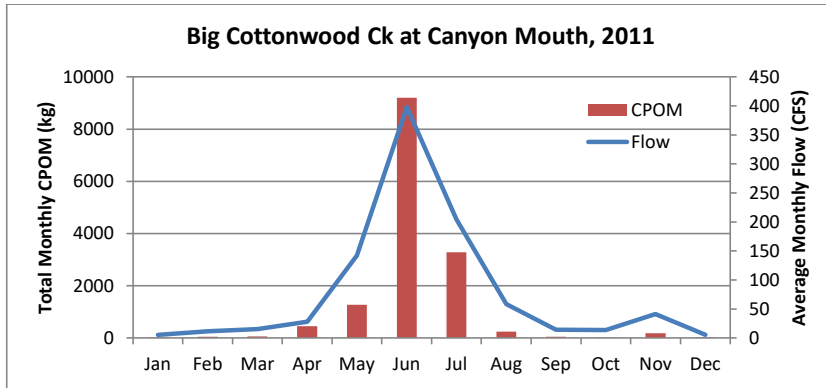
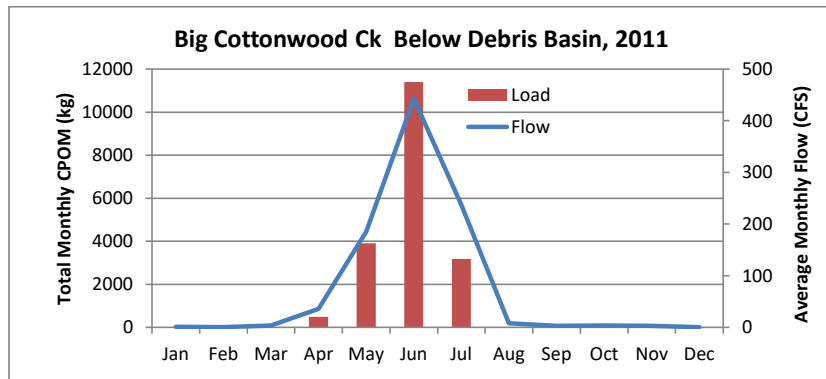
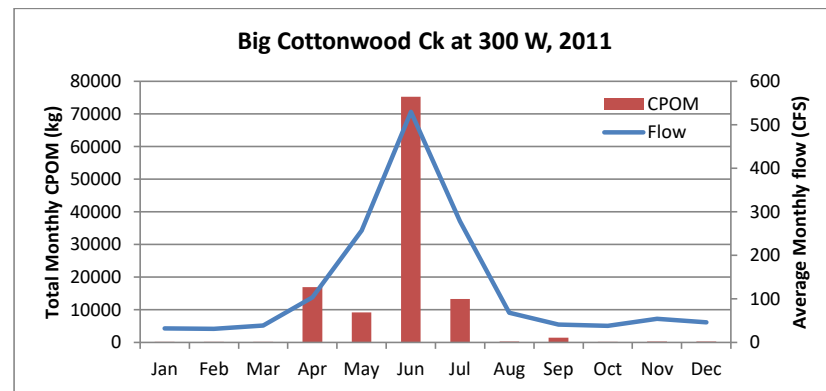
Figure 9. Continued. Note in Figure 9 f. CPOM values for Oct. Nov. and Dec. were very low (13, 5 and 2.2 kg respectively).

Flows were substantially greater during the greater snowpack year of 2011 (Figure 9, d., e. and f.). Yet, there was an unexpected lower load of CPOM. The CPOM samples for June were collected on June 8, which was relatively early on the ascending limb of the hydrograph during this specific year. This would have been before the creek reached or exceeded bankfull, whereby much more leaf and grass material that would have been deposited during the previous fall would be mobilized and transported by the creek. Also notable, the debris basin was ineffective in removing CPOM during this period. It is likely that either the increased flow did not provide adequate retention time, and/or the debris basin was relatively full of sediment and had not been dredged prior to the 2011 runoff season. Most notable, as with 2010, there was significant accrual of CPOM between the debris basin, and 300 W. The estimated CPOM load for the month at 300 W (and was undoubtedly delivered to the Jordan River) was near 75,000 kg (Figure 9 f.). This sample was collected about two weeks after sampling was performed at the canyon mouth which was very close to the timing of peak flows in Big Cottonwood Creek. Flows during 2012 were substantially below average. The channel was completely dewatered by June at the canyon mouth and by May at the site below the debris basin. There were measurable flows at 300 W, which included a moderate amount of CPOM during May and June. The flow further diminished throughout the remainder of the year and this low flow undoubtedly contributed to the very low CPOM measurements, even through the months of leaf litter falling during September, October and November-suggesting that much of the leaf litter fell on the banks.

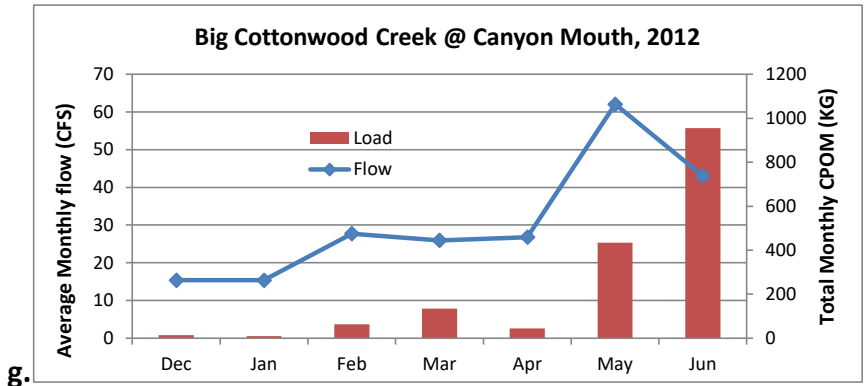
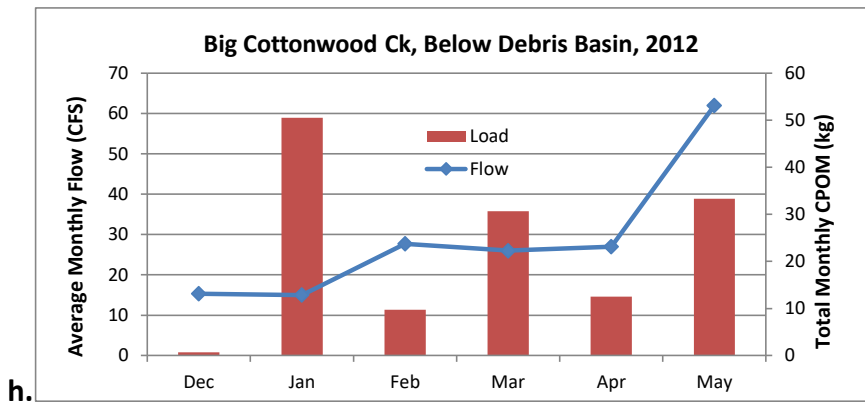
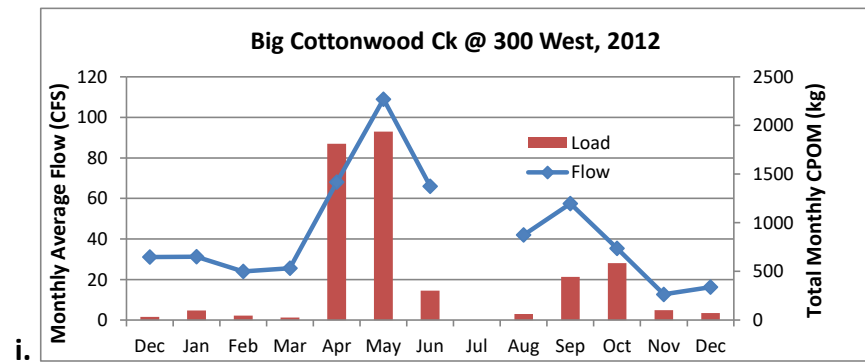
Figure 9, Continued. Note, the creek was totally dewatered immediately below the debris basin after May, but then some return flows occurred by fall and continued carrying CPOM.

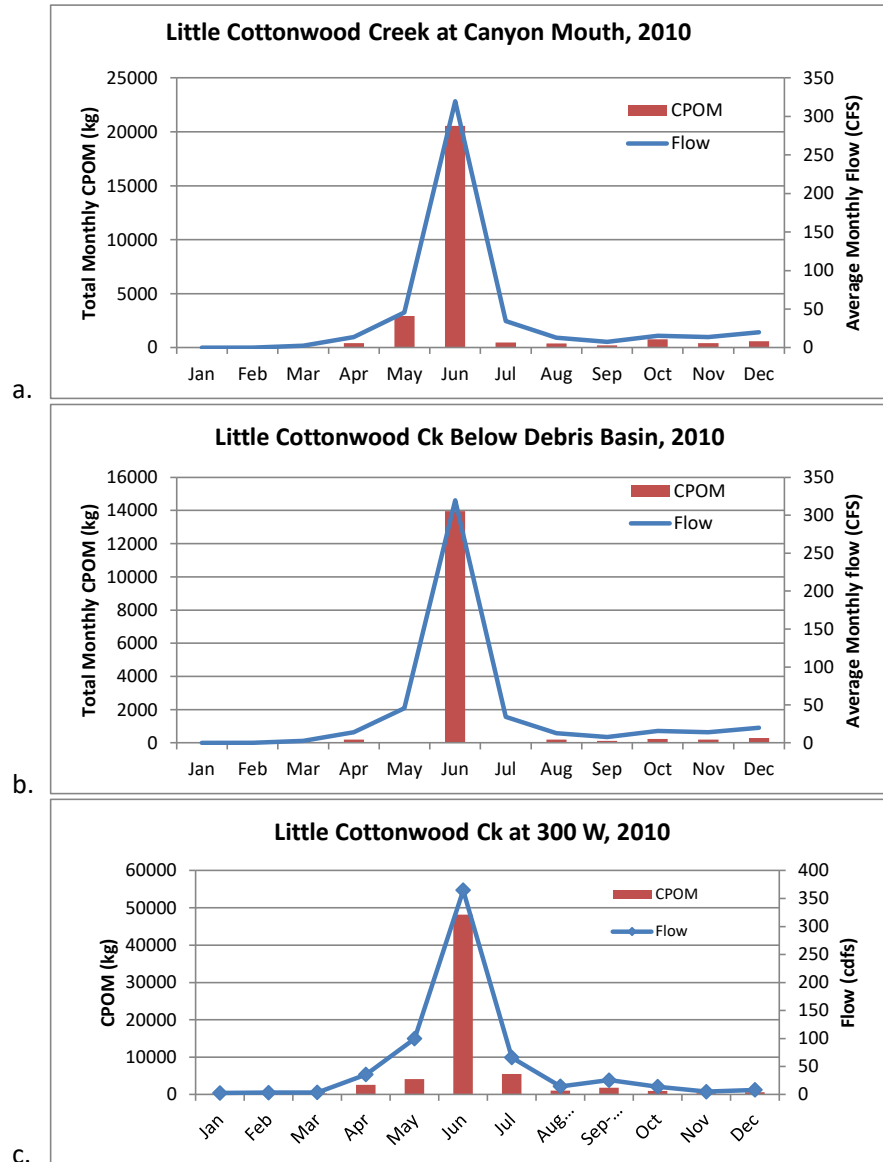
Figure 10. Flow and CPOM at selected sites along Little Cottonwood Creek. The debris basin was relatively small (approximately 0.5 hectare; 1 acre) located approximately 800 m (1/2 mile) below the canyon mouth.

Little Cottonwood Creek behaved very similar to Big Cottonwood Creek. There is a small debris basin located just upstream from the diversion at the canyon mouth. This debris basin removed approximately $\frac{1}{2}$ of the CPOM coming out of the canyon during 2010 (Figure 10). The snowpack was slightly below average during the 2010 spring with peak flows occurring during June. During 2011, runoff included much higher peak flow and this flow was sustained through both

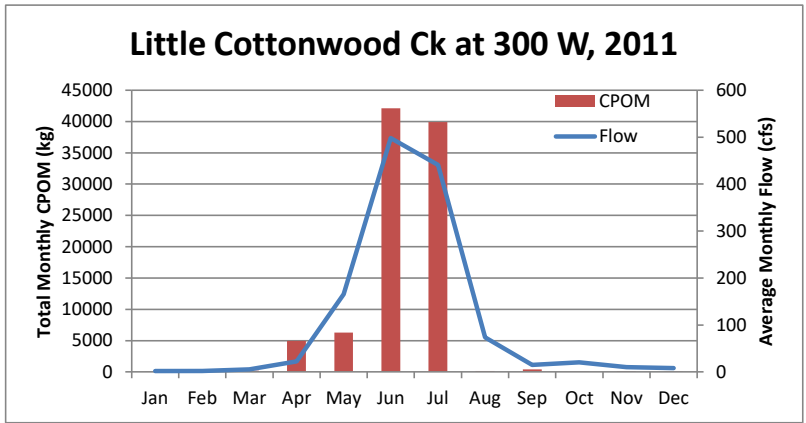
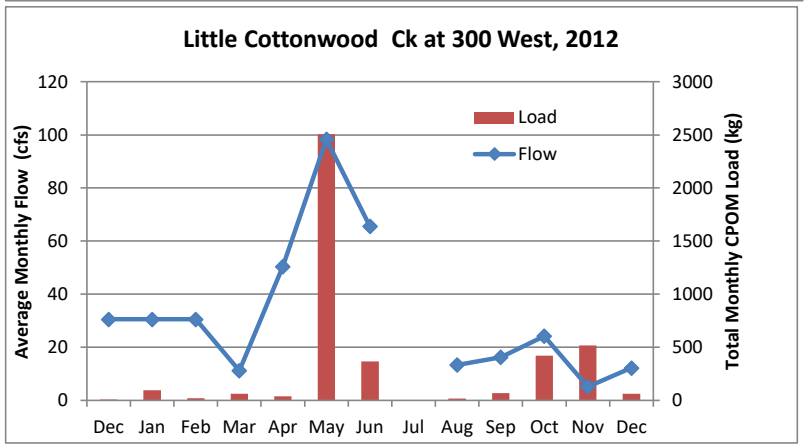
Figure 10, d and e. CPOM measurements and mean monthly flow at 300 W, approximately 800 m (0.5 mile) upstream from the confluence with the Jordan River. Note difference in axis scales between 2011 and 2012 graphs.

June and July. 2012 was another low snowpack, low runoff year which resulted in much lower CPOM loading that during 2011. CPOM loads were directly correlated to flows and notably the fall loading that had occurred in Mill Creek and City Creek was not observed or was greatly diminished in both Little Cottonwood and Big Cottonwood Creeks. This may have been due to the timing of sampling or perhaps also due to the relatively low flows of late summer and fall of 2012. Also as with Big Cottonwood Creek there are many 10s of thousands of kg of CPOM

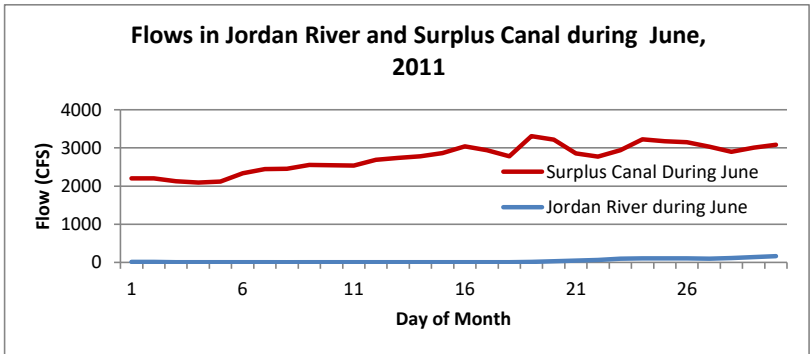
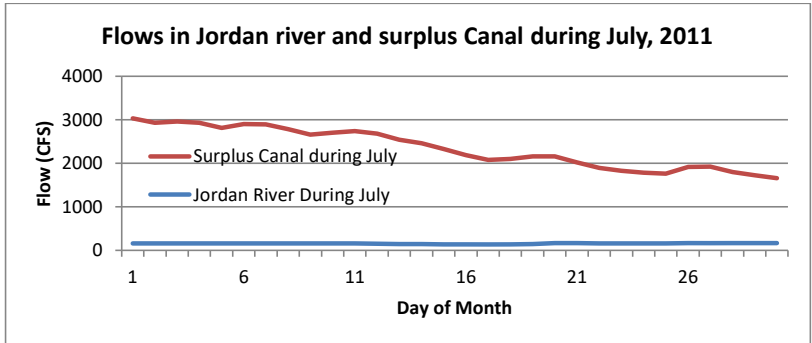
Figure 11. A comparison of flows measured in the Surplus Canal at the SLC International Airport and the Jordan River at 1700 S, during June (a) and July (b).

There are two distinct flow regimes associated with the 2012 season. The first is that the greatest flows during 2012 occurred from the end of January through April. Note that peak flows occurred in February and March, as more water was released from Utah Lake to provide additional capacity for possible additional high runoff flows in 2012. However, spring runoff flows were much lower than expected prompting the water managers to change their management strategy and begin conserving water in Utah Lake, thus altering and restricting normal seasonal flows. Indeed, by June, when flows are normally peaking, they were very much less than 2011 values and had fallen to a stable range near 175 CFS at 1700 S (Figure 13). It is also informative to provide similar detailed daily flow for the months June and July. These are included in Figure 14. Comparison with Figure 11 reveals the dramatic differences in flow regime that can occur from year to year.

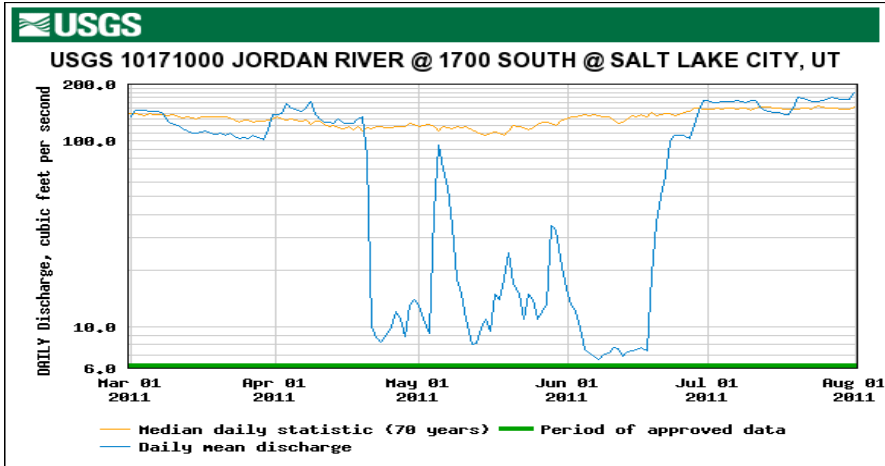
Figure 12. USGS flow data recorded at 1700 S from March through July, 2011. Note how flow was restricted during the peak runoff months of May and June.

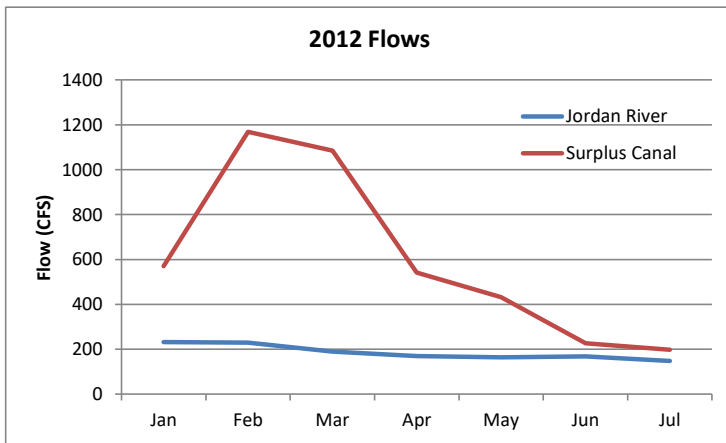
Figure 13. Mean monthly flows in the Surplus Canal and in the Jordan River at 1700 S During 2012. Note unusual peak flows occurred during February and March rather than during normal timing for spring runoff. See text for more details.

An example of a low water year is the 2012 year (Figure 13). Snow pack during the 2011/2012 winter was at about 70% of average. This led to a much lower runoff and hence a much lower proportion of the Jordan River was diverted to the Surplus Canal. As a result, the CPOM loads were also much lower than the 2011 year (see below).

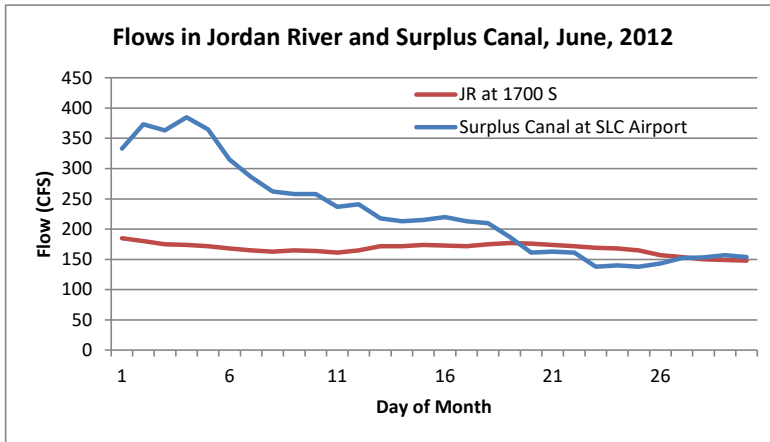
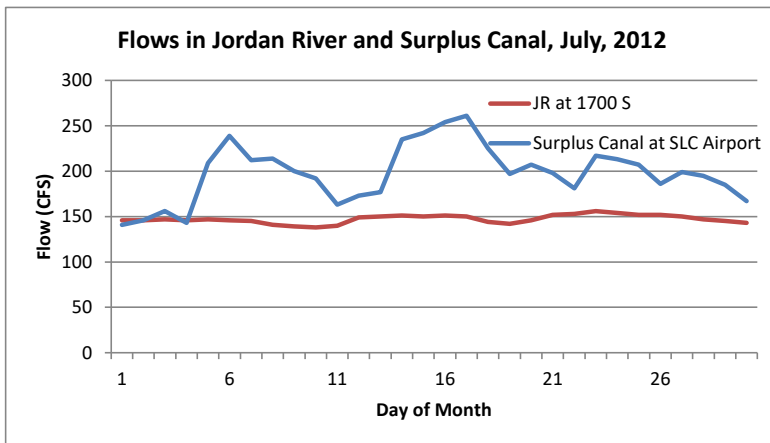
Figure 14. USGS flow recordings in the Jordan River at 1700 S and the Surplus Canal during June (a) and July (b) of 2012.

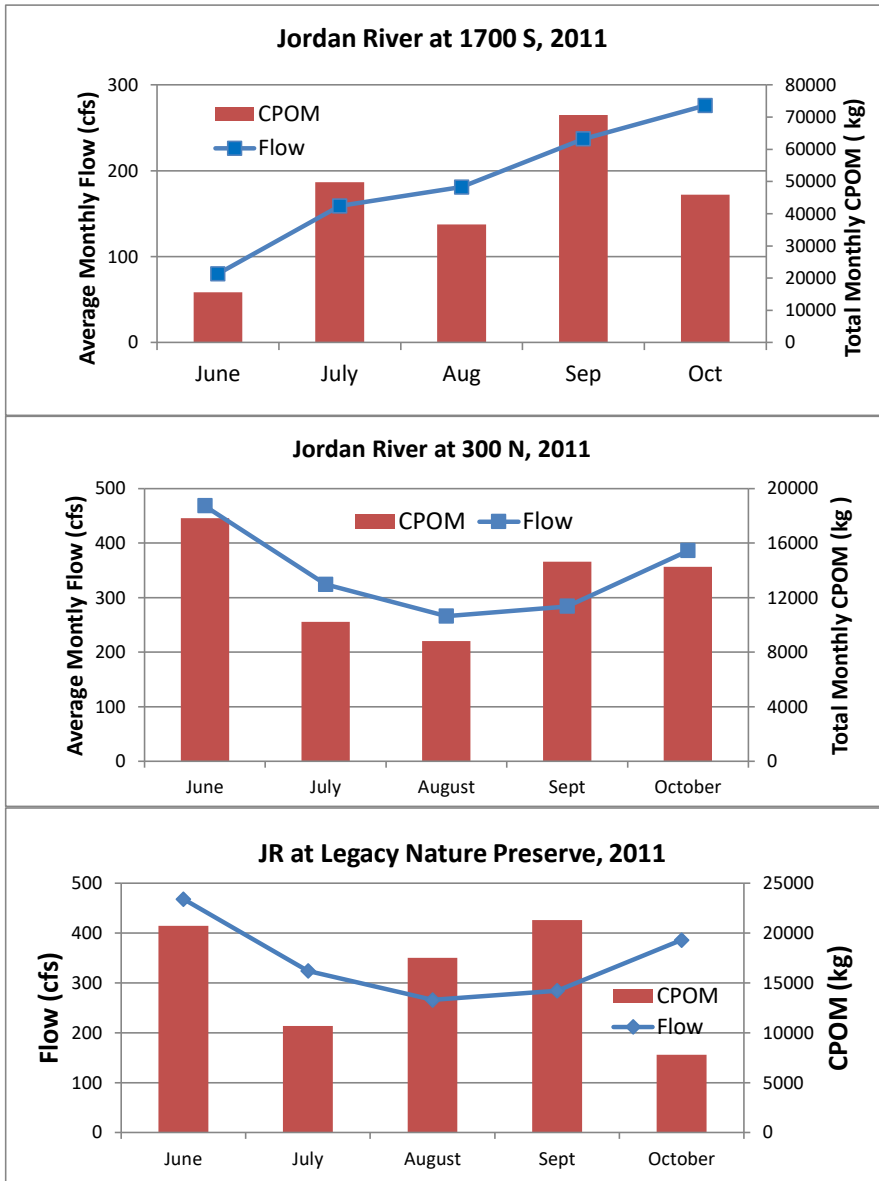
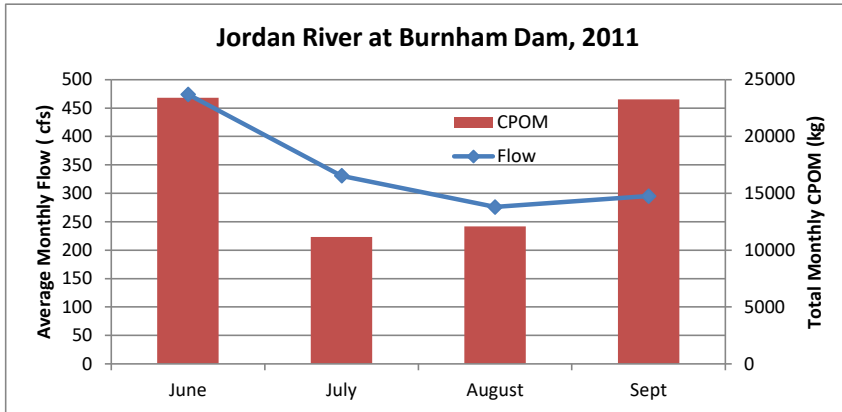
Figure 15. Flow and CPOM measurements made at 1700 S (a.), 300 N (b.), and Burnham Dam (c.) during 2011. Flow measurement data was collected from the Salt Lake County gage at 500 N.

Figure 15. Continued.

CPOM loads responded as expected to these different flow regimes. Flow and CPOM loads in the Jordan River during 2011 are illustrated in Figure 15. CPOM loads were generally correlated to flows. Some notable characteristics include; 1) Total flows (combined Surplus Canal and the 1700 S flows) remained near or above 3000 CFS for about 3 weeks during June and July (Figure 11). Yet, a greater proportion of water was allowed down the Jordan River channel starting on about June 23 and continuing throughout July. This greater flow down the channel apparently carried a greater load of CPOM, even though total flow began to diminish after the first week in July. This is likely related to the point made above, wherein the bottom discharge of the diversion dam leading to the lower Jordan River is carrying a disproportionate higher load of CPOM relative to the actual total flow because the CPOM is primarily being carried as bedload and hence is more easily directed to the bottom release of the gate leading to the river channel. Contrarily, the flow diverted to the Surplus Canal flows over the top of the weir which is about 2 m above the stream bottom. Overall, several hundred thousand kg of CPOM were likely transported to the lower Jordan River.

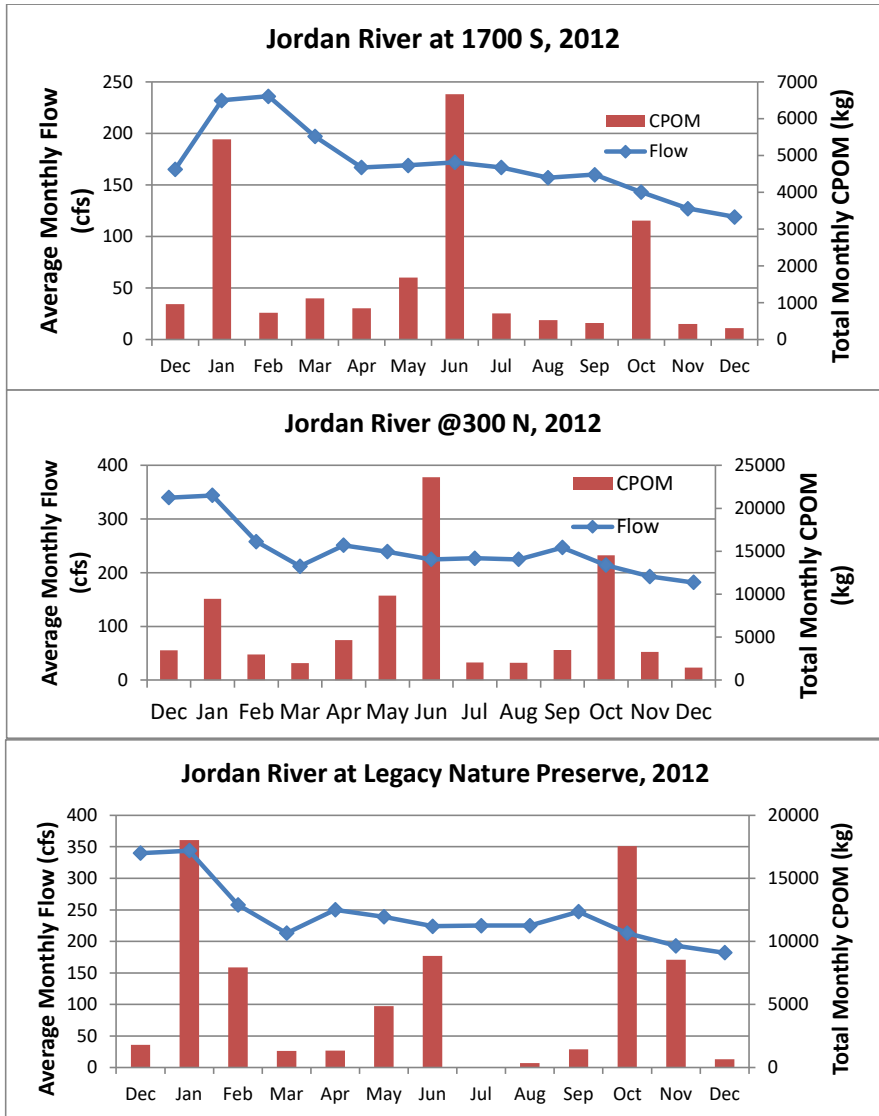
Figure 16. Monthly measurements of flow and CPOM at 1700 S (a.), 300 N (b.) and Legacy Nature Preserve (c.) during 2012. During the higher flow periods of January, February and March, and during August, September and October, CPOM samples were collected twice monthly.

During 2012 the sampling effort was increased to include monthly samples. Overall flows were much less than during 2011, although similar flow-related patterns of CPOM were observed during 2012 (Figure 16). Again, despite the diversion of the majority of the flows, a considerably elevated load of CPOM was associated with the increase in spring flows. For example, there were two CPOM samples collected during January, 2012. The first was collected January 5, when total flows (1700 S and Surplus Canal flows totaled 595 CFS) and the CPOM load was measured at 1.2 mg/ft^3 at 1700 S. If flows had been sustained at this value, the total CPOM load for January would have been 511 kg. However, the second CPOM sample was collected on January 25, one day after flows had increased by 50% to 879 CFS. These were the highest flows experienced by the river since the spring of 2011 and hence it is likely that this increase had begun to pick up additional CPOM lying in backwaters or on the banks. If this flow and CPOM load had been sustained for the entire month of January, the total monthly CPOM load would have been estimated to be 10,367 kg. The mean of these two values was actually 5,439 kg (Figure 16), perhaps an accurate reflection of actual January loads. These data further support the idea that, although the great majority of water is diverted to the Surplus Canal during high flows, there are considerable quantities of CPOM that continue moving down the channel.

In turn, and contrary to the January peak in CPOM, the June CPOM peak was likely due to the natural runoff and increase in CPOM loading from the tributaries (Figures 8, 9 and 10). CPOM values measured during autumn were elevated once again and were correlated to the annual leaf fall from riparian zones along tributaries, storm drains and the main stem. Notably, these autumn values were quite similar to those measured during 2011 – as was the actual stream flow.

Except for the June samples of 2012, CPOM loads downstream from 1700 S fell considerably, indicating that large quantities settled out of the water column. There was very little change in CPOM between Legacy Nature Preserve and Burnham Dam. Overall, however, it is apparent that the CPOM loading during 2012 was much lower than 2011 and this was most likely due to the general lower flow conditions.
