Summary Report for Dissolved Oxygen Monitoring in the Jordan River, Salt Lake County, Utah

**Utah Department of Environmental Quality,
Division of Water Quality**

SWCA Environmental Consultants

April 2016

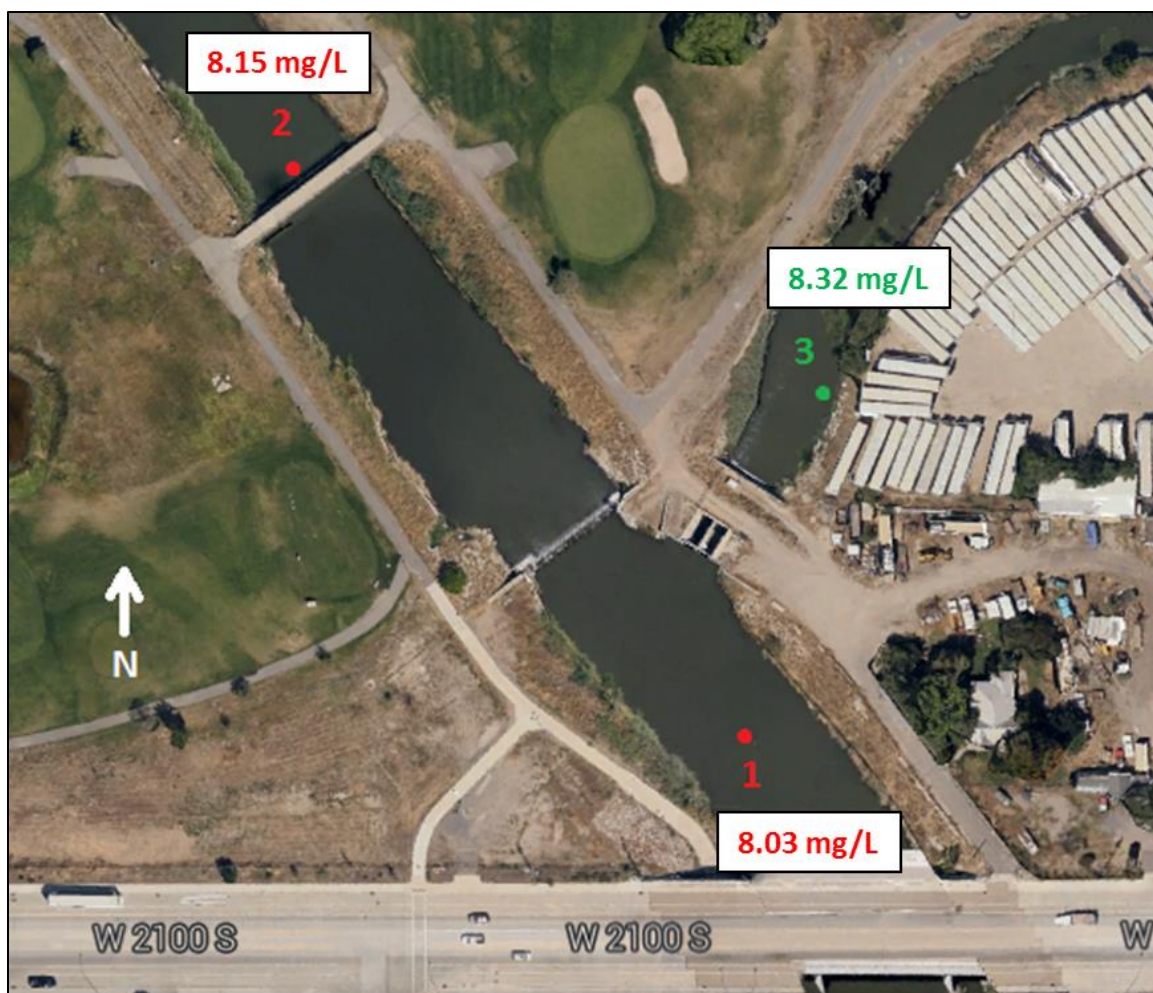
Figure 4. Additional sampling locations and dissolved oxygen measurements during Profiling Event #1 (SWCA 2014b).

What is consistent is a drop in DO between 3300 South and 2100 South during every sampling event, with DO decreasing in values ranging from 0.18 mg/L in July to 3.46 mg/L in June. This decrease occurs despite the effect of reaeration by the radial gates at the Surplus Canal diversion (Figure 4). The consistent drop between these two sites indicates a DO sink between the two locations. Considering that the only major tributary to the Jordan River between these two sites is Mill Creek, **it is possible that the creek is contributing low DO water or high DO-demanding substances to the Jordan River.** There is some visual evidence of such a contribution (Figure 5), **but additional measurements are needed to support this hypothesis.** The evidence of a lack of mixing of the dark plume with the river is contrary to the evidence of a well-mixed river observed with the data and may be due to temperature differences.

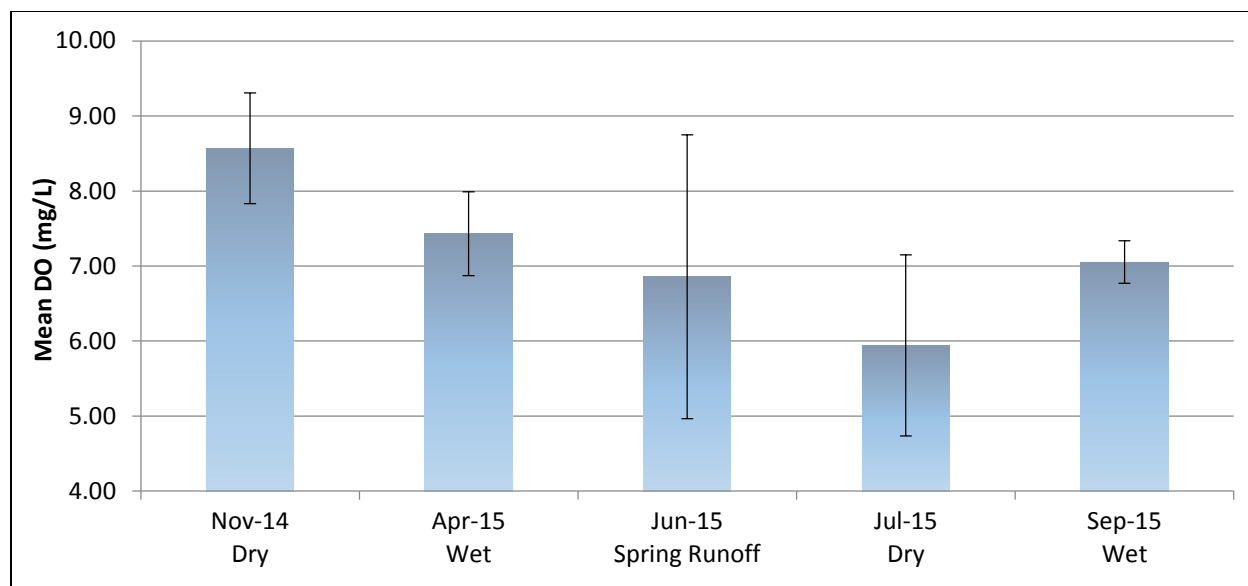
Figure 6. Mean dissolved oxygen by sampling event across all sites. Bars represent one standard deviation from the mean.

When examined by type of sampling event, mean DO (across all sites) was highest during the dry November sampling event (8.57 mg/L) and lowest during the dry July sampling event (5.94 mg/L) (Figure 6). This pattern holds when examining data at each site during each event (Figure 7). Across all sites, DO is generally highest in the dry November sampling event and lowest during the dry July sampling event (see Figure 7). These results indicate that **storm events are not solely responsible for decreases in DO concentration**. Low DO concentrations may occur during storm events but may also occur during dry baseflow periods of the warmer summer months as well.

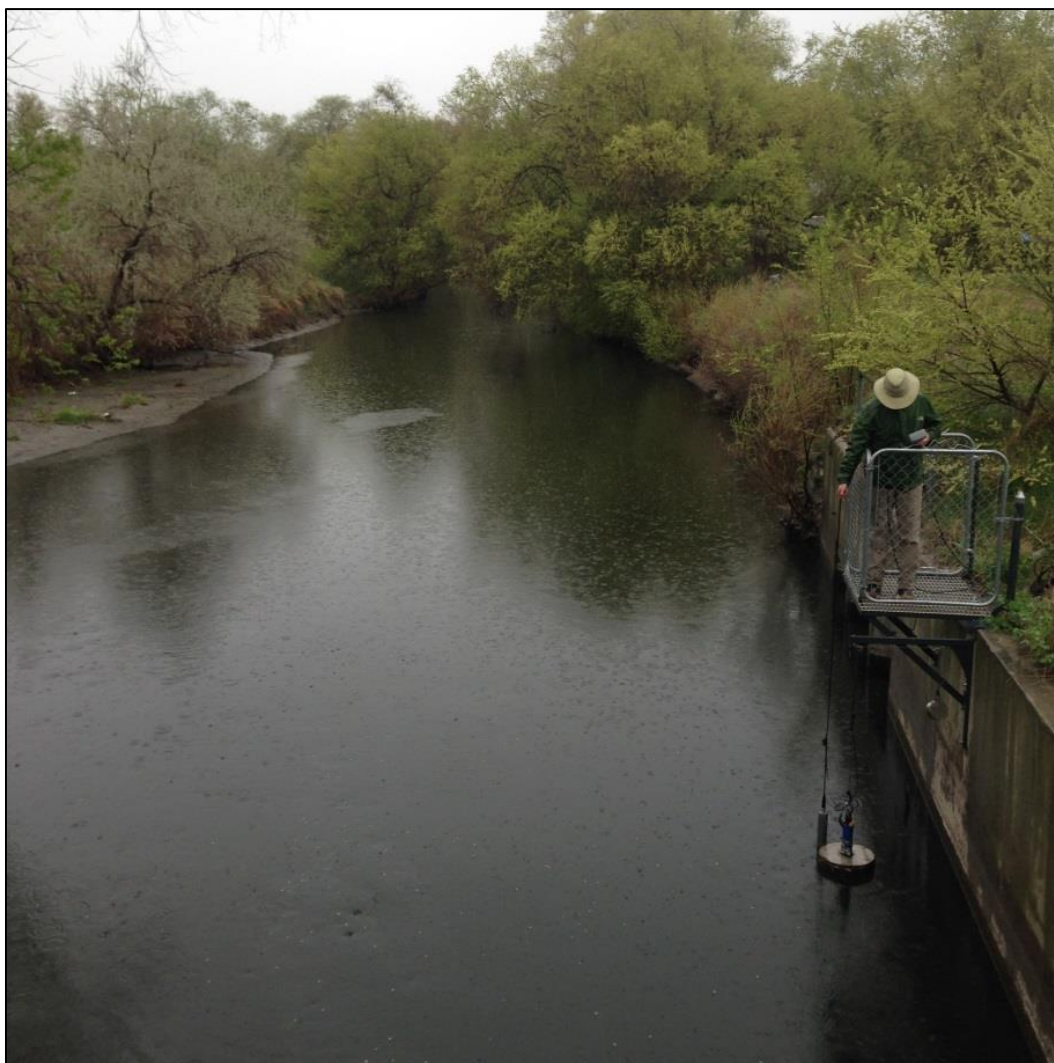
Figure 8. Dissolved oxygen measurement near the JR/FBWQC probe at the 800 South site.

Five of the DO profiling sampling locations (3300 South, 2100 South, 800 South, 300 North, and Center Street) are co-located with the Jordan River/Farmington Bay Water Quality Council (JR/FBWQC) in situ water quality probes (see Figures A-1 through A-4 in Appendix A), allowing for direct comparison between manual DO measurements and in situ probe measurements (Figure 8).

Large differences were observed between manual DO measurements and JR/FBWQC probe measurements at most sites when comparisons were possible (Table 3). The relative percent difference between manual measurements and JR/FBWQC probe measurements ranged from 2% to 52% and averaged approximately 18%. **Manual DO measurements were on average, approximately 1.5 mg/L lower than adjacent in situ probes.** This large difference in measurements may be due to calibration issues or sensor drift, or perhaps to the influence of algae on the sensor housings (Figure 9). The latter hypothesis is plausible because JR/FBWQC probes generally measured *higher* than SWCA's probes, an expected result if there were a localized increased flux of oxygen to the probes from algal photosynthesis on the sensor housing. **This hypothesis could further be supported through nighttime measurements,** where the expected result would be that JR/FBWQC probes would measure *lower* DO concentrations than SWCA's probes, due to increased localized respiration from algae on the sensor housings.

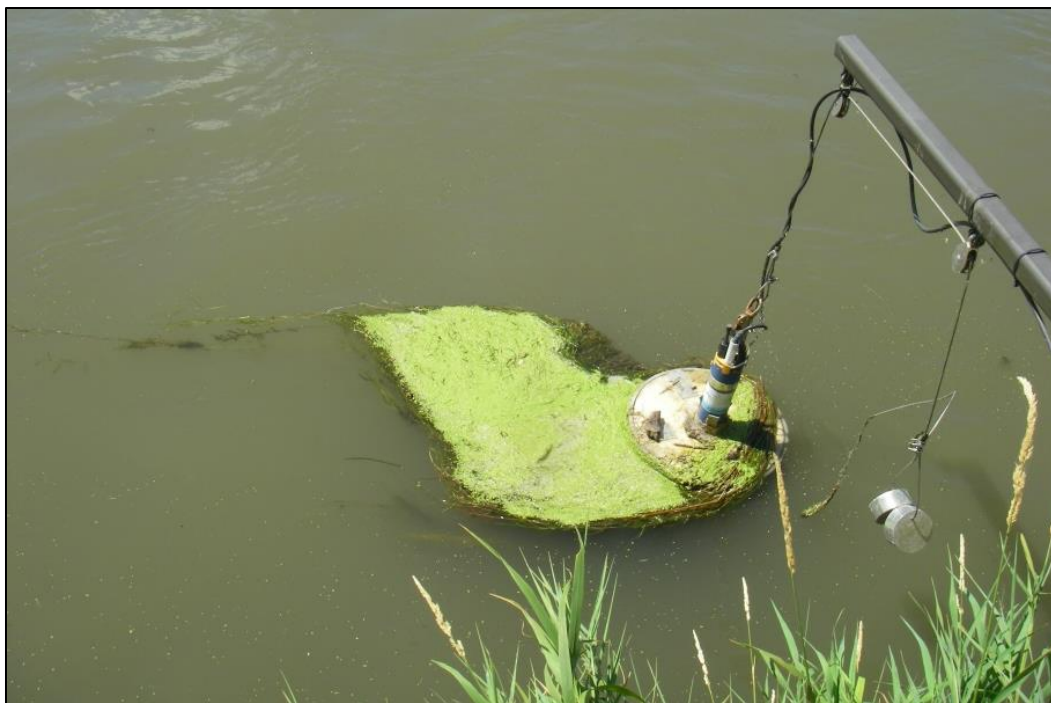
Figure 9. Jordan River/Farmington Bay Water Quality Council probe located at 2100 South.

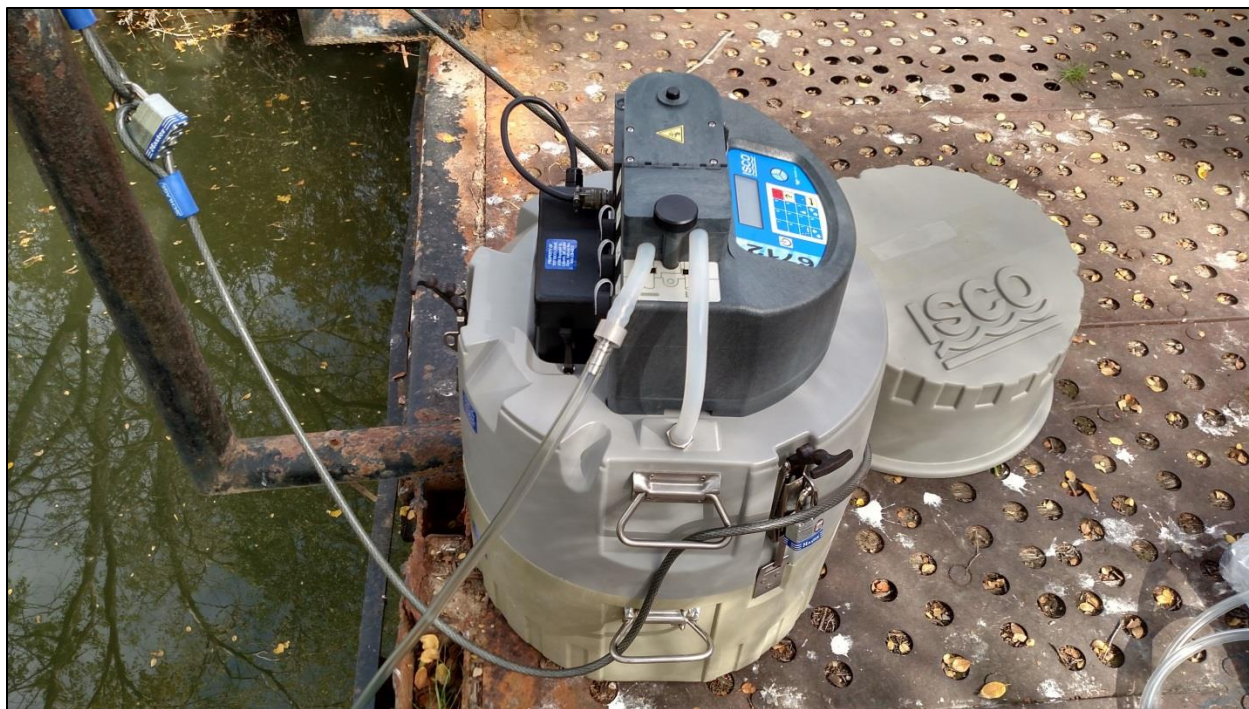
Figure 10. Teledyne Isco autosampler stationed at Little Cottonwood Creek to capture data during the October 18–19, 2015, storm.

Two stormwater sampling events were conducted at two sites along the Jordan River: 1) Mill Creek and 2) Little Cottonwood Creek in April and October of 2015 (Figures A-3 and A-4 in Appendix A). Stormwater sampling at a third site (stormwater outfall at 600 South) was planned; however, due to logistics and the magnitude of the storm event, sampling did not occur on either occasion (see SWCA 2015e and SWCA 2015f for details). For a full description of sampling procedures, please see the SAP (SWCA 2014a) and associated memoranda (SWCA 2015e, SWCA 2015f). Briefly, for each event Teledyne Isco autosamplers were set up at the two locations (Figure 10) and programmed based on the expected duration of the storm. Samples were collected the following day and transported on ice to American West Analytical Laboratories for analysis.

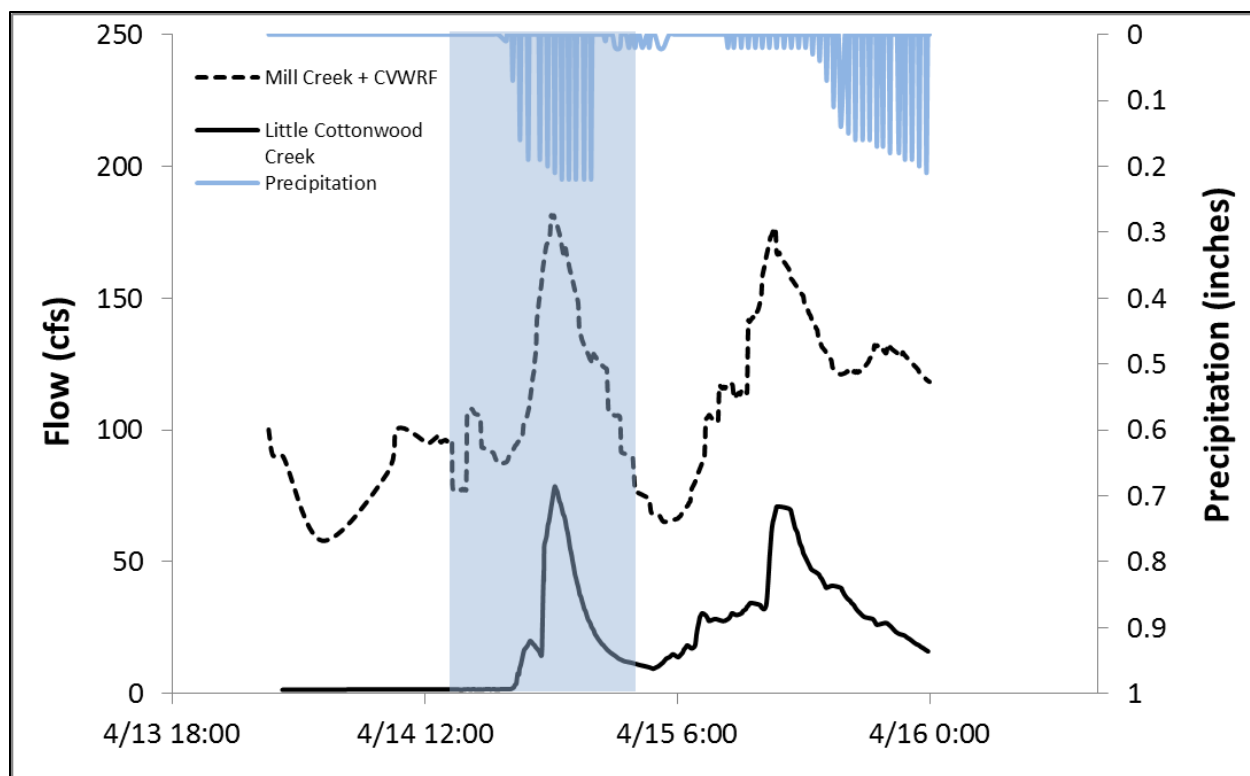
Figure 11. Hydrographs and hyetographs for the April 14–15, 2015, storm event. The shaded region represents the time period of water chemistry sampling.

The first stormwater sampling event occurred April 14–15, 2015. The storm event initially consisted of rainfall (approximately 0.2 inch per hour) but transitioned into snowfall throughout the night (Figure 11). The second stormwater sampling event occurred October 18–19, 2015. The storm event consisted of light rainfall (approximately 0.04 inch per hour), with a total event accumulation of 0.22 inch (Figure 12). Maximum flows during the April event were 77 cubic feet per second (cfs) for Little Cottonwood Creek and 179 cfs for Mill Creek. For the October event, maximum flows were 70 cfs for Little Cottonwood Creek and 137 cfs for Mill Creek. Discharge from the CVWRF accounts for nearly half of the flow in Mill Creek; otherwise, the flows in the two creeks are very similar.

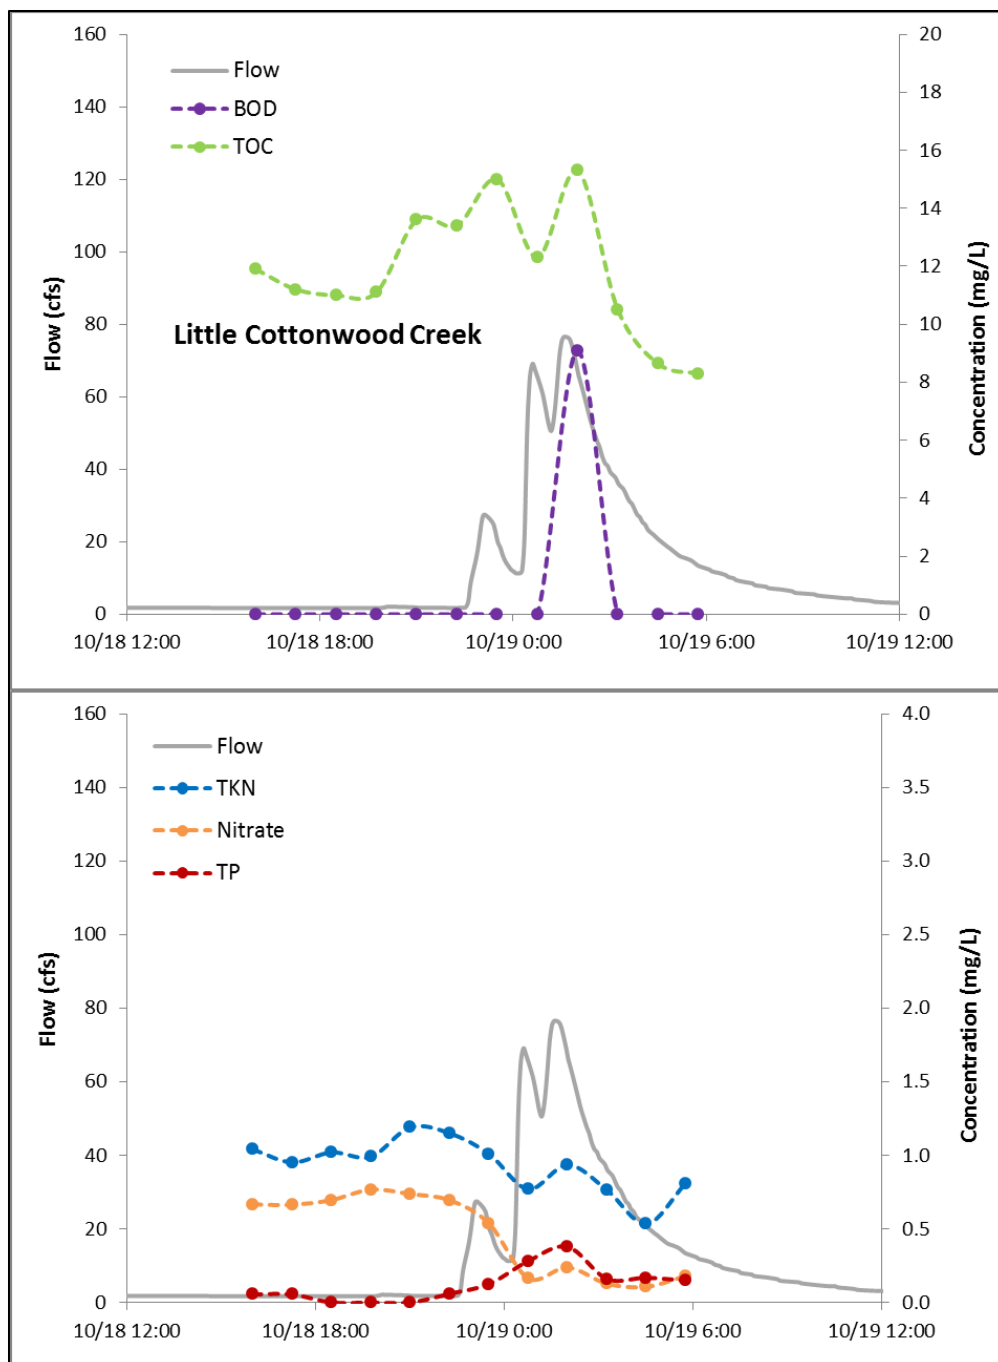
Figure 14. Hydrographs and pollutographs for the October 18–19, 2015, storm event for Little Cottonwood Creek. Where points are displayed as 0 on the concentration axes, they were below the detection limit. All cBOD sample concentrations were lower than detection limits and are not displayed.

Generally speaking, Mill Creek exhibited higher concentrations of most analytes, including total TKN, NO_3/NO_2 , and TP (Figure 14 and 15). The exception was TOC, for which Little Cottonwood Creek had higher concentrations. Note that all values for cBOD from Mill Creek and Little Cottonwood Creek were reported as below detection limits, and BOD in both tributaries was detected in only one sample per tributary.

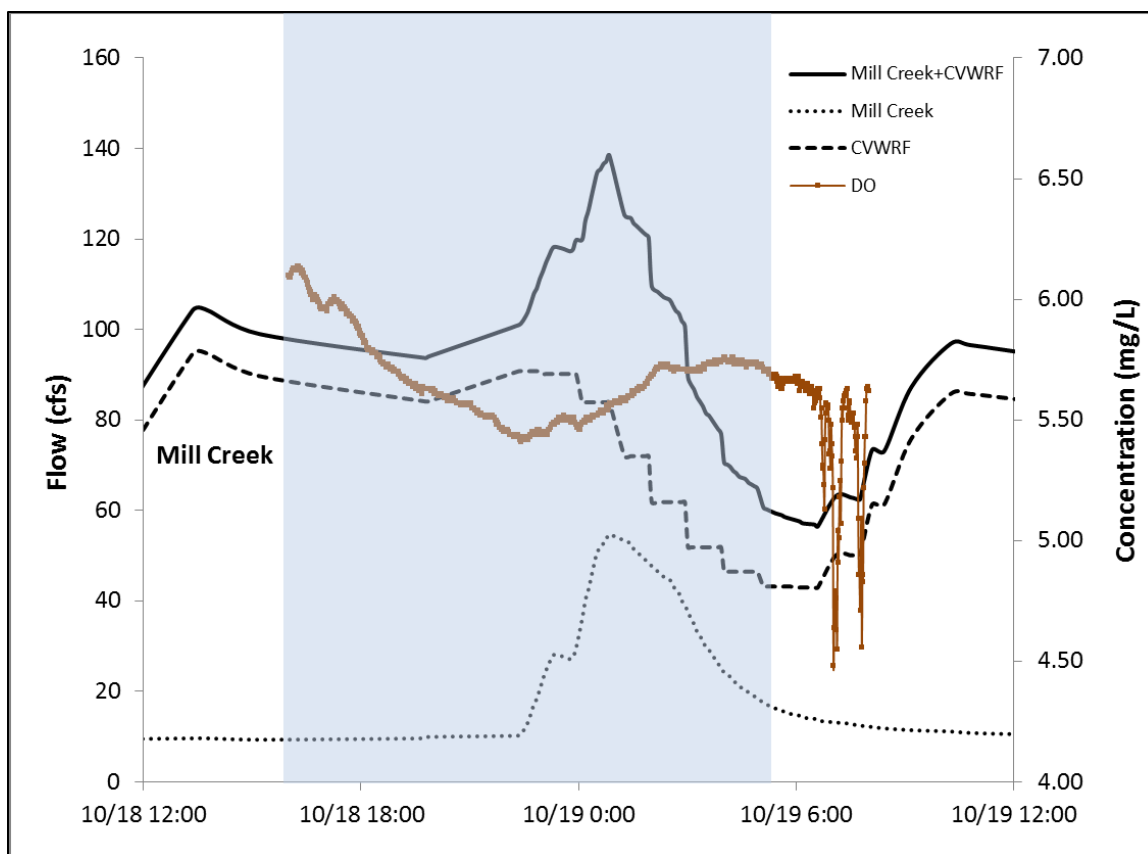
Figure 16. Dissolved oxygen for the October 18–19, 2015, storm event for Mill Creek.

An INW DO2 Sensor was installed at the Mill Creek site to record continuous DO throughout the October storm event. DO in Mill Creek exhibited a decrease until approximately midnight when it began a steady increase (Figure 16). The decrease in DO is expected as a part of the diurnal cycle; however, the increase in DO before daylight hours is somewhat surprising and could be attributed to increased aeration as a result of the increased flow in Mill Creek during the storm event. It is also possible that DO is increasing because discharge from the CVWRF is decreasing. DO also exhibited significant decreases during the latter part of the sampling period when CVWRF discharge is increasing. (Unfortunately, no analyte data were available during this time.) Despite these observations, it is important to note that there are many factors affecting DO cycling in streams, and, without additional data, it is difficult to pinpoint exact causes for DO behavior.

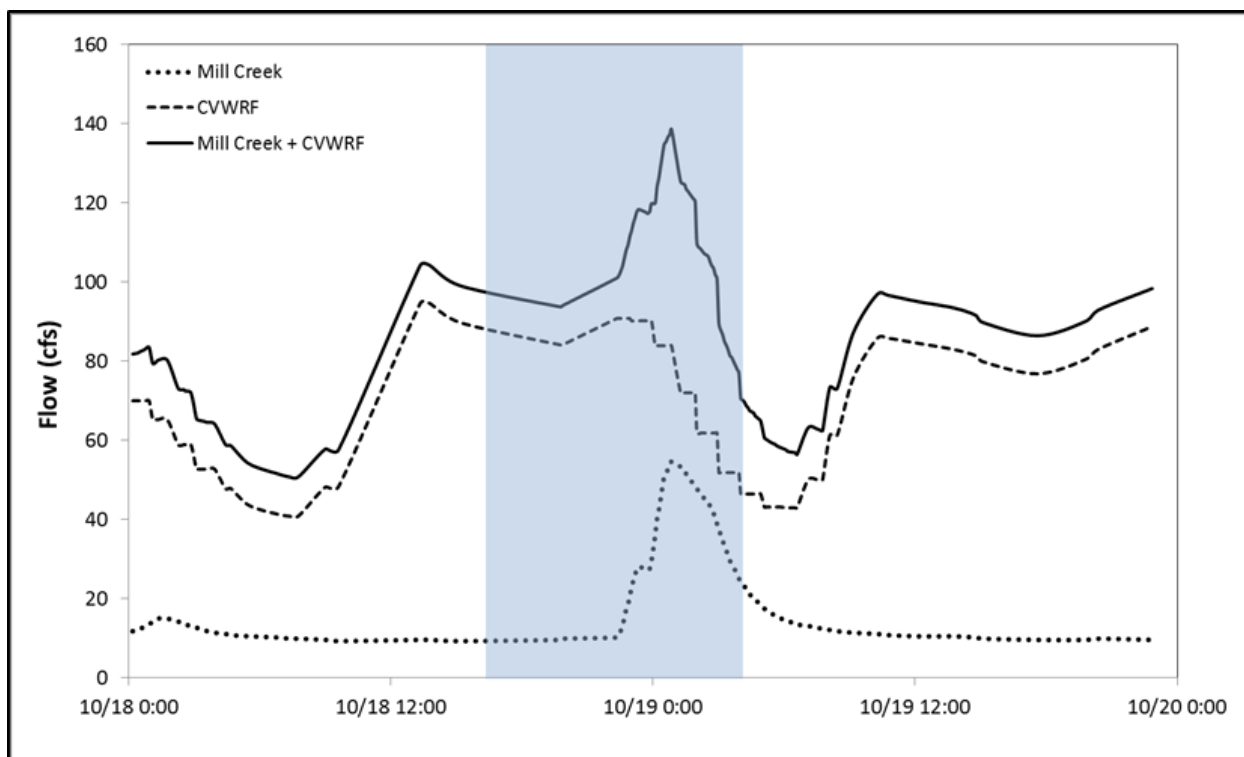
Figure 17. Hydrographs for the October 18–19, 2015, storm event. The shaded region represents the time period of water sampling. Mill Creek + CVWRF represents flow at the sampling site. Flow data were obtained from Salt Lake County and the CVWRF.

Discharge from the CVWRF on October 18 and October 19 was irregular and appeared to occur in pulses. It more than doubled the flow in Mill Creek at the sampling site (Figure 17). When analytes in Mill Creek were examined in relation to discharge from the CVWRF, significant positive relationships were present between nitrate and discharge ($R^2 = 0.75902$, $P \leq 0.05$) and between TP and discharge TP ($R^2 = 0.74576$, $P \leq 0.05$). Significant relationships were not present between TKN and discharge and between TOC and discharge (Figure 18). It appears that the peak in TOC was largely driven by the increase in flow in Mill Creek from the storm rather than discharge from the CVWRF (see Figure 15).

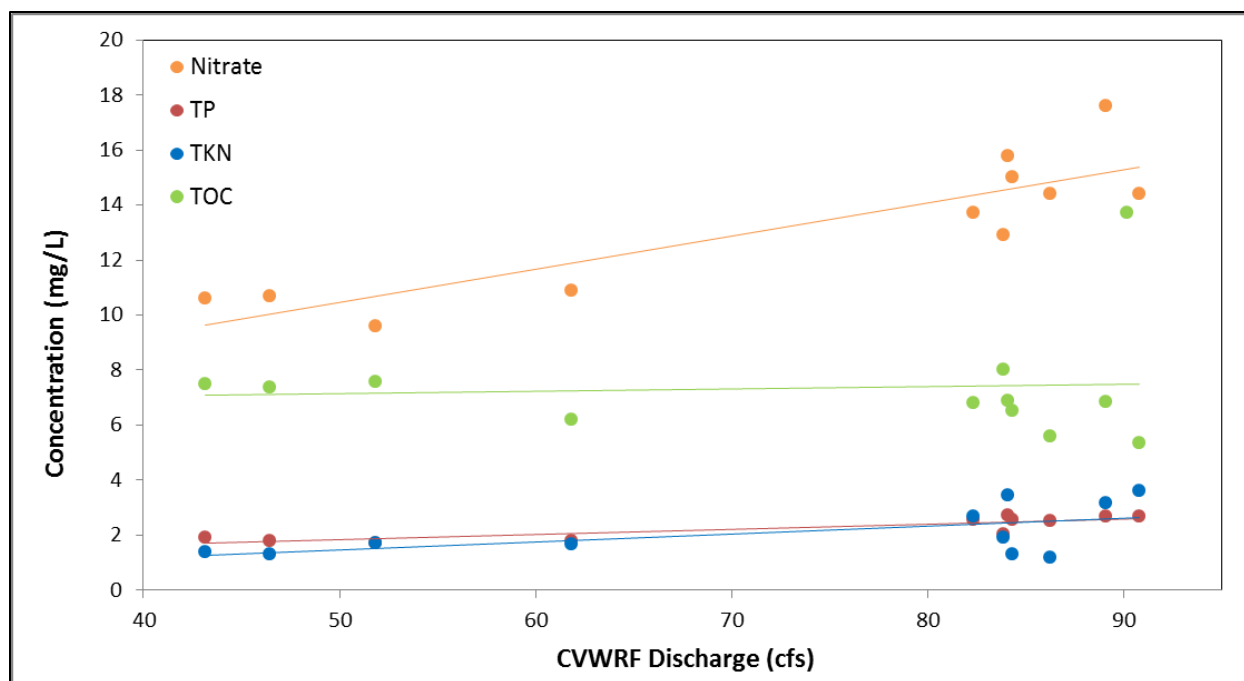
Figure 18. Regression analysis for four analytes in Mill Creek and discharge from the CVWRF.

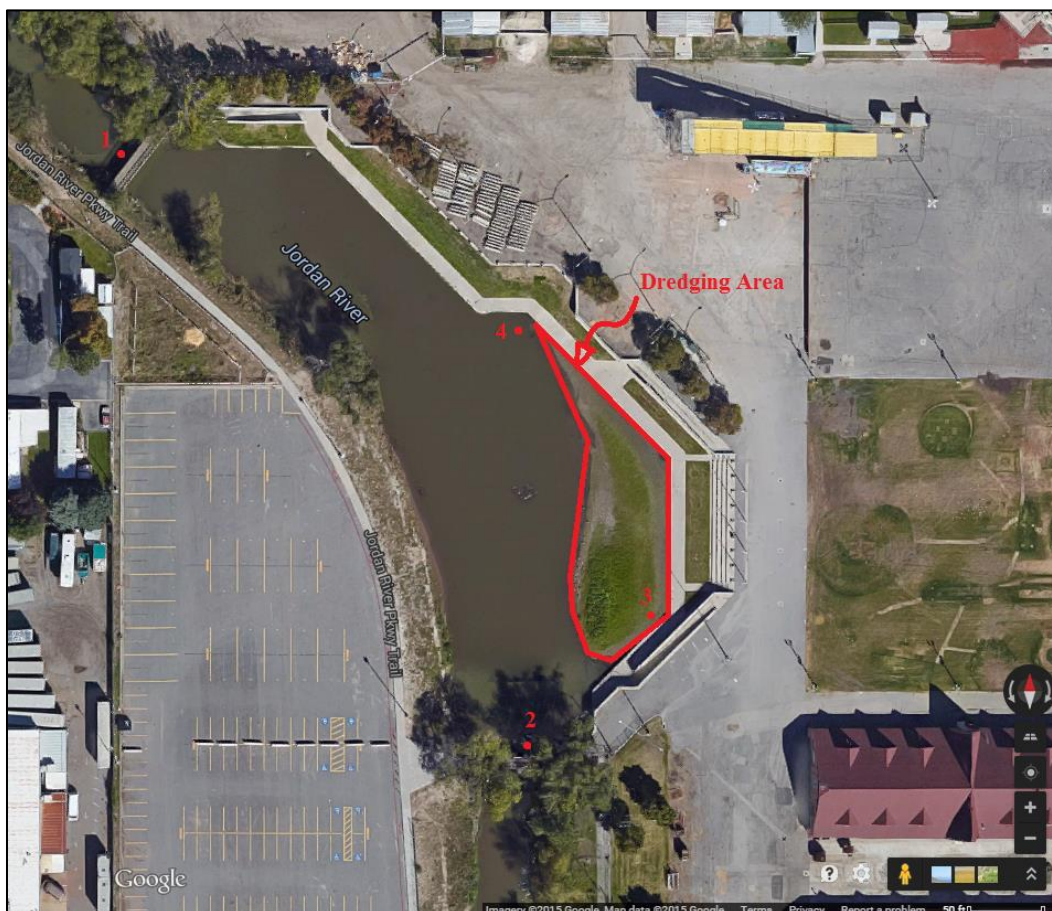
Figure 19. Aerial imagery overview of dredging site at Utah State Fairpark. Numbered points are the four sampling locations, with numbers referring to order of sampling.

DO monitoring during a dredging event on the Jordan River occurred on March 4, 2015, at the Utah State Fairpark. For a full description of sampling methodology for the dredging event, please see the associated memorandum (SWCA 2015g). Prior to sampling at the dredging operation, a sample was taken at the pedestrian bridge just south of North Temple to establish a baseline measurement. DO was then sampled from four locations in the vicinity of the dredging operation (Figure 19). The first sample was taken approximately 350 feet downstream of the dredging site at a Jordan River Parkway pedestrian bridge. The second sample was taken approximately 100 feet upstream of the dredging site, also at a pedestrian bridge. The third sample was taken within 5 feet of the active dredging. For this third sampling location, baseline measurements were recorded *before* the sediment was agitated by the dredging backhoe. After those measurements were recorded, the backhoe operator scooped up sediment within 5 feet of the DO probe, and more measurements were recorded to observe changes in water chemistry from sediment agitation (Figure 20). Measurements were continually observed until water chemistry parameters returned to baseline numbers. To account for potential backwater effects, a sample was taken at the fourth sampling location just downstream of the dredging site, in a backwater area similar to the third sampling point but relatively undisturbed by the dredging activity. According to operators on-site, the goal of the dredging operation was to remove approximately 4 vertical feet of sediment from the river.

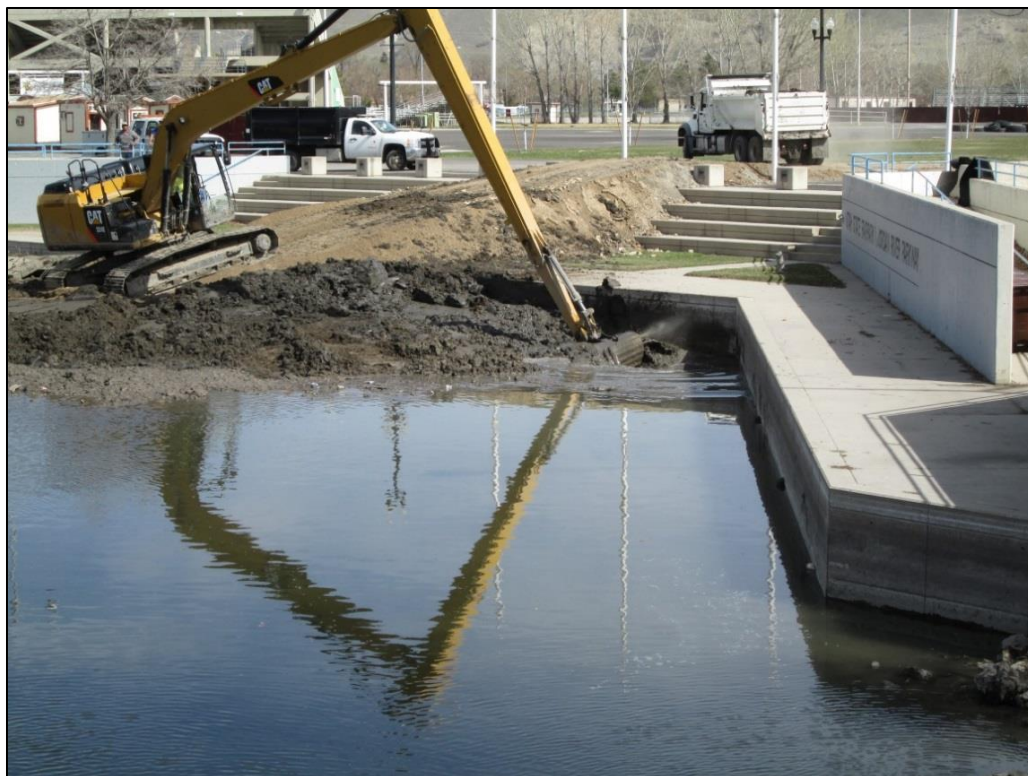
Figure 20. Dredging action at sampling location 3, view from sampling location 2.

Data collected during this event are shown in Table 6 and indicate a significant reduction in water quality from sediment suspension. This impact was highly localized, however; it was only apparent within approximately 20 feet of dredging activities, which is possibly due to dredging occurring outside the main flowpath of the river, limiting the amount of sediment transported downstream. Additionally, the operators were careful not to disturb too much sediment in the main flowpath of the river. Closer to the dredging activity, **suspended sediment reduced DO concentrations by up to 3.4 mg/L (from 6.30 mg/L to 2.91 mg/L) in a matter of seconds, but, when left undisturbed, DO concentrations returned to baseline conditions after the sediment disturbance within 5 minutes.**

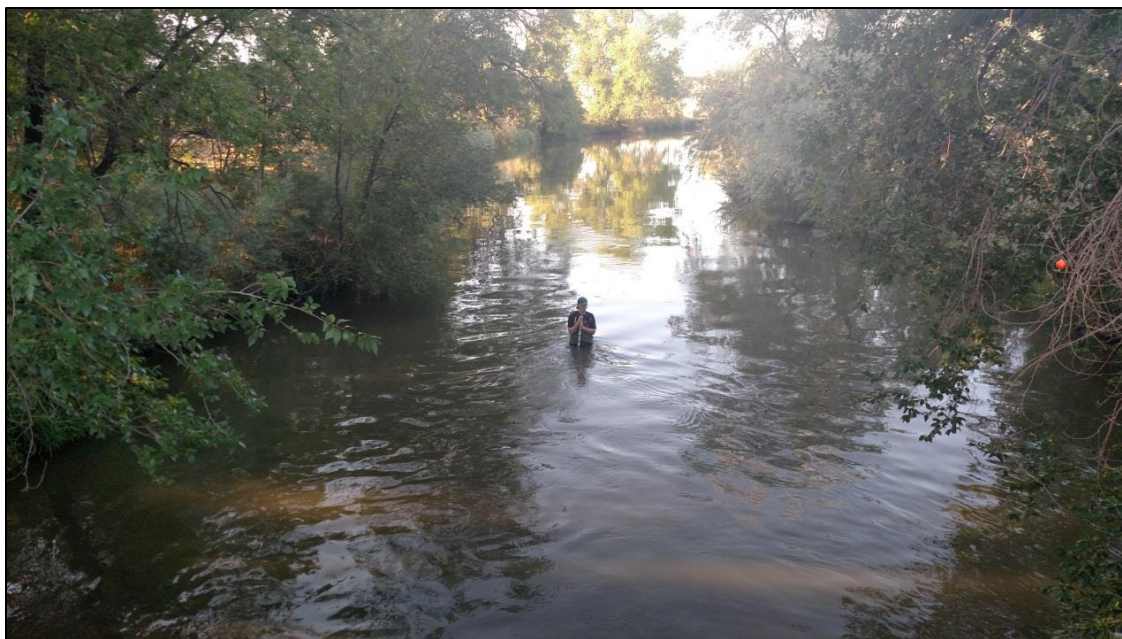
Figure 21. 1700 South site, view facing upstream.

Sampling Location	Rationale
1700 South	Mostly gravel bed
800 South	Intermediate bed sediment between gravel and organic
Redwood Road*	Predominantly organic with some gravels
