# Total Maximum Daily Load for *Escherichia coli* (*E. coli*) in the Fremont River Watershed

Prepared by  
Utah Department of Environmental Quality  
Division of Water Quality

Utah Department of Environmental Quality  
 Division of Water Quality  
 Fremont River TMDL

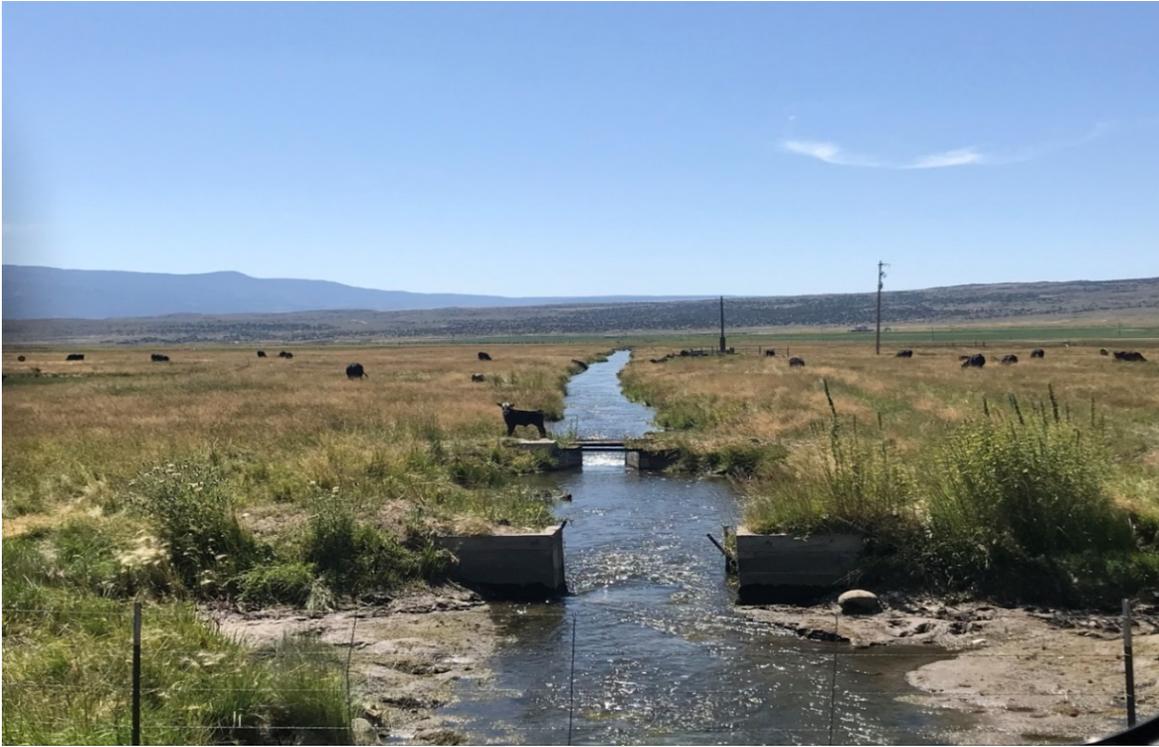
Figure 12. Image of 4955310: Spring Creek at U24 Crossing, September 2019

Spring Creek originates at a spring located on a valley margin 2.5 miles north of Loa, Utah. The stream is diverted numerous times along its seven-mile length until it reaches the confluence with the Fremont River. Flow from the spring is a constant 13 cfs. By the time Spring Creek reaches the Highway 24 crossing south of Loa, it has flow rates that vary between four cfs during irrigation diversion and 22 cfs during spring runoff. The stream follows generally the same course as the one surveyed in the late 1800s, but considerable straightening and diverting have occurred since that time. The creek carries a substantial amount of irrigation return flow. It is bordered by irrigated pastures that are often grazed by cattle, sheep, and wildlife.

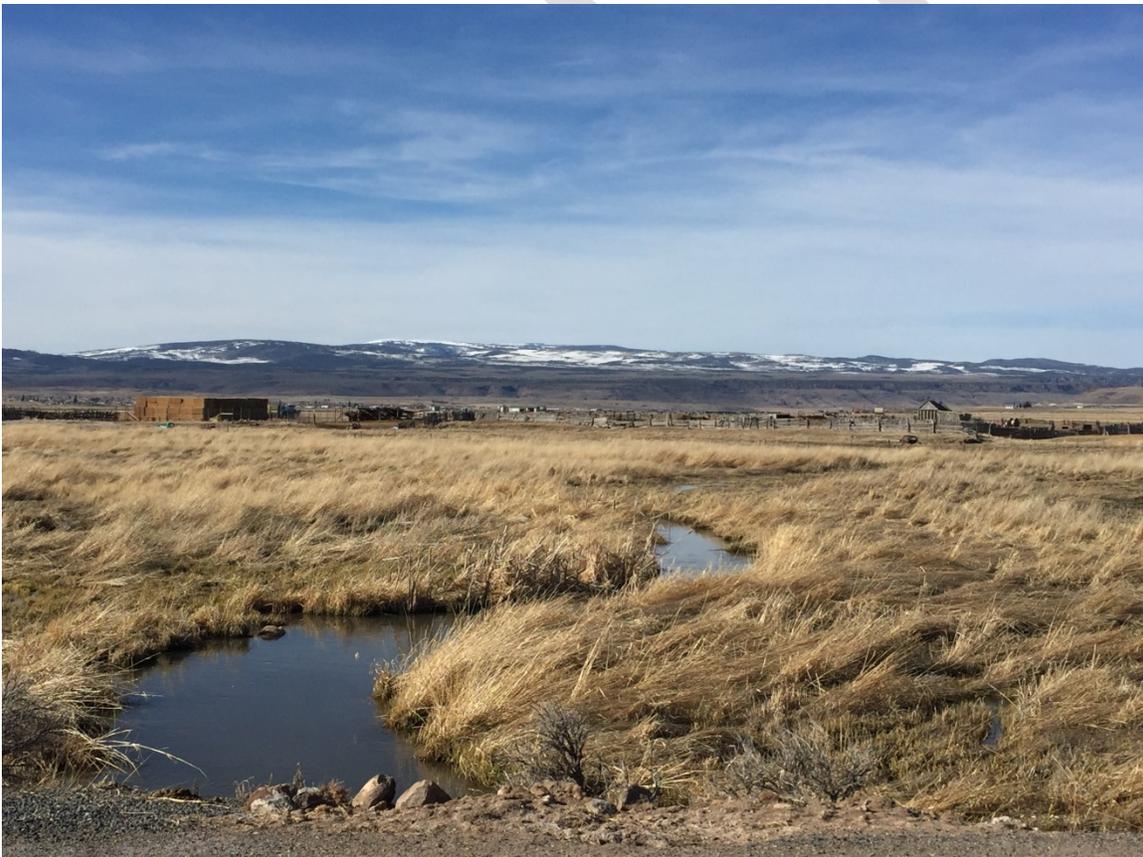
Figure 14. Image of 4955330: Fremont River at Big Rocks Road

The Fremont River channel between Mill Meadow Reservoir and Spring Creek is generally dry most of the year as water is held in the reservoir or diverted just below the reservoir for irrigation. The confluence of the Fremont River and Spring Creek is less than a mile upstream of this monitoring location. Spring Creek contributes a majority of the flow, with the slight addition of some springs and irrigation return flows. This site has the potential to be dry at times throughout the year depending on upstream water diversion and use. Flow slows as it moves through this marshy area. Thirty-five percent of *E. coli* samples collected from 2016-2018 exceeded the maximum criterion recreation use standard (Figure 14).

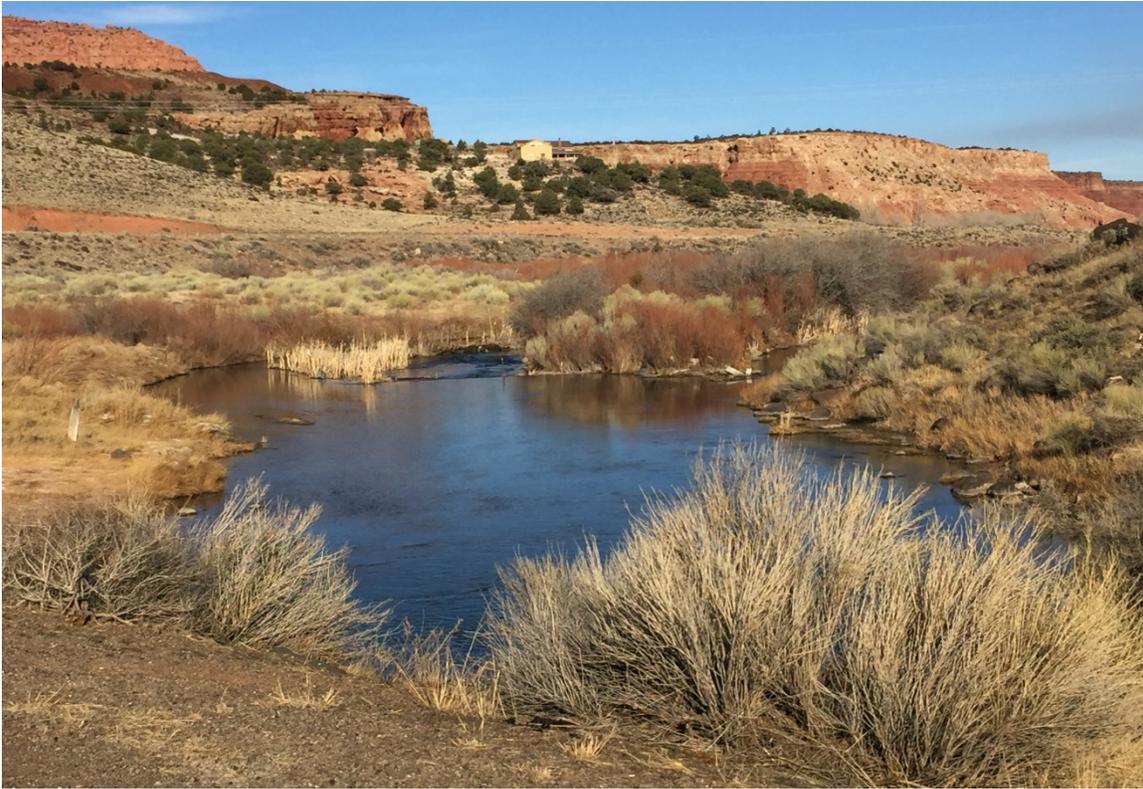
Figure 16. Image of 4954380: Fremont River at Bicknell

This is the uppermost monitoring location in the impaired Fremont-3 AU. Even when upstream monitoring locations have *E. coli* exceedances, the concentrations usually drop below the water quality standard at this Bicknell location. Of 32 samples collected between 2016 and 2018, only two exceeded the maximum standard (6%) (
