TMDL Water Quality Study of **Echo Creek Watershed, Utah**

Approval Date: August 4, 2006

Utah Department of Environmental Quality
Division of Water Quality
288 N 1460 W
Salt Lake City, UT 84116

Echo Creek TMDL

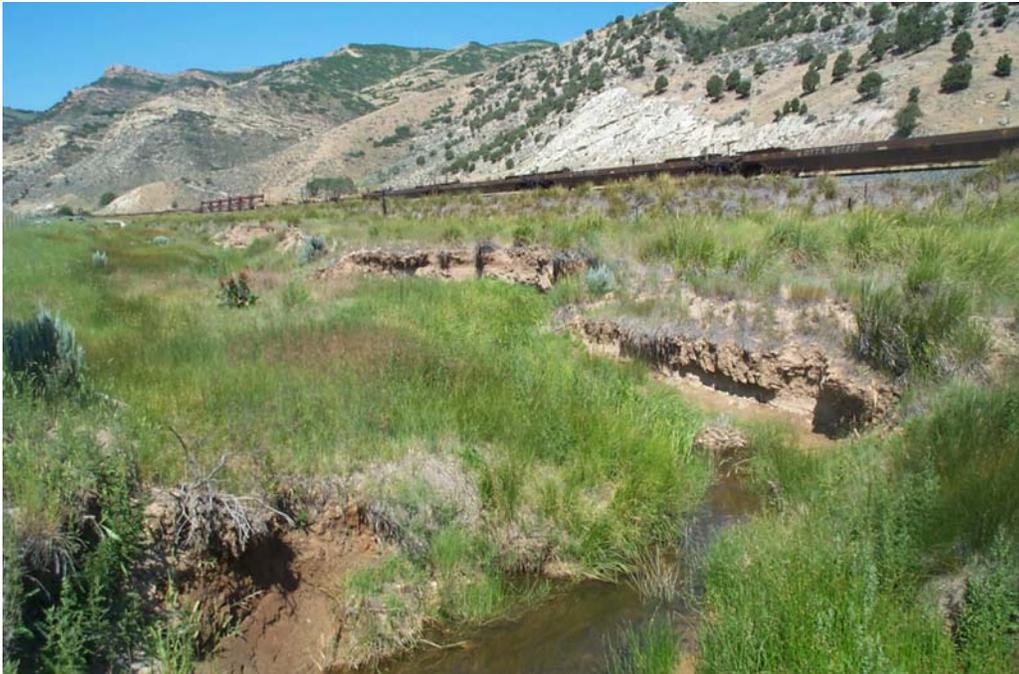
Figure 1-1. Present day photo of Echo Creek. The railroad has constricted the meanders of the stream and it has responded by down cutting. Notice the absence of woody riparian vegetation and eroding banks.

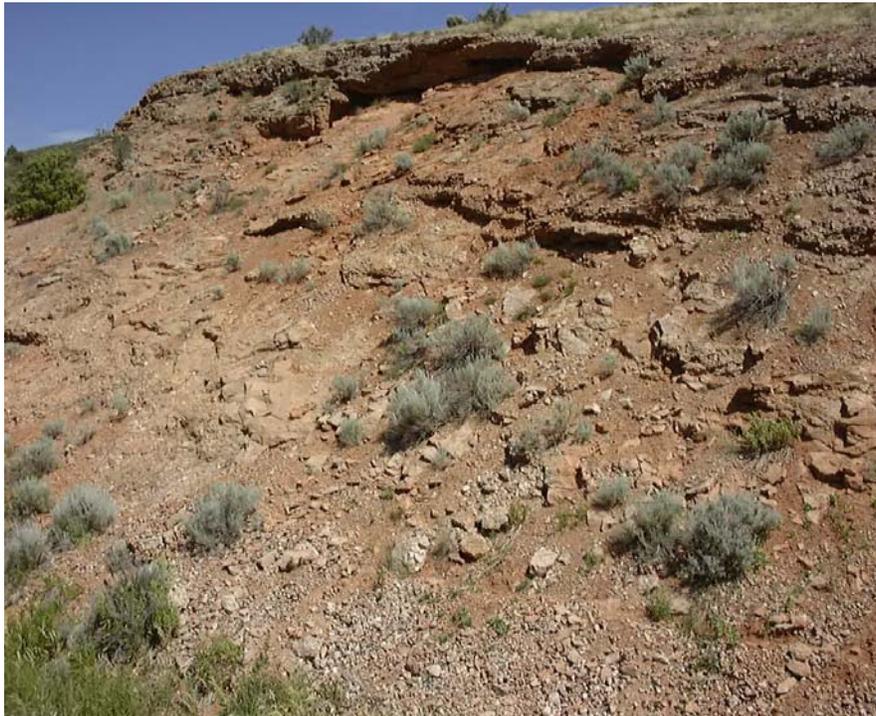
Figure 1-5. Wasatch Formation.

The geology of the Echo Creek Watershed consists of Tertiary and Cretaceous aged formations of sandstone, shale and quartzite conglomerates. The three dominant geologic units are the Wasatch formation, Echo Canyon conglomerate and the Henefer formation. The Wasatch formation (Figure 1-5) is comprised of red sandstone, siltstone, shale and conglomerate. The Echo Canyon conglomerate (Figure 1-6) is a red, massively bedded, pebble to boulder conglomerate. The conglomerate deposits of these two units are weakly cemented with highly erodible shale and sandstone lenses. The soils in the watershed are mostly rocky soils derived from these two conglomerates. The Henefer formation (Figure 1-7) is a tan and gray course-grained to conglomerate sandstone, inter-bedded with gray mudstone and shale. The Henefer formation also contributes erodible shale to the formation of clayey and loamy soils. Alluvium and colluvium deposits are found along the stream channels and valley bottoms that are susceptible to erosion and head cutting. The erodible nature of the geology of the watershed further exacerbates the sedimentation problem of Echo Creek and its tributaries.

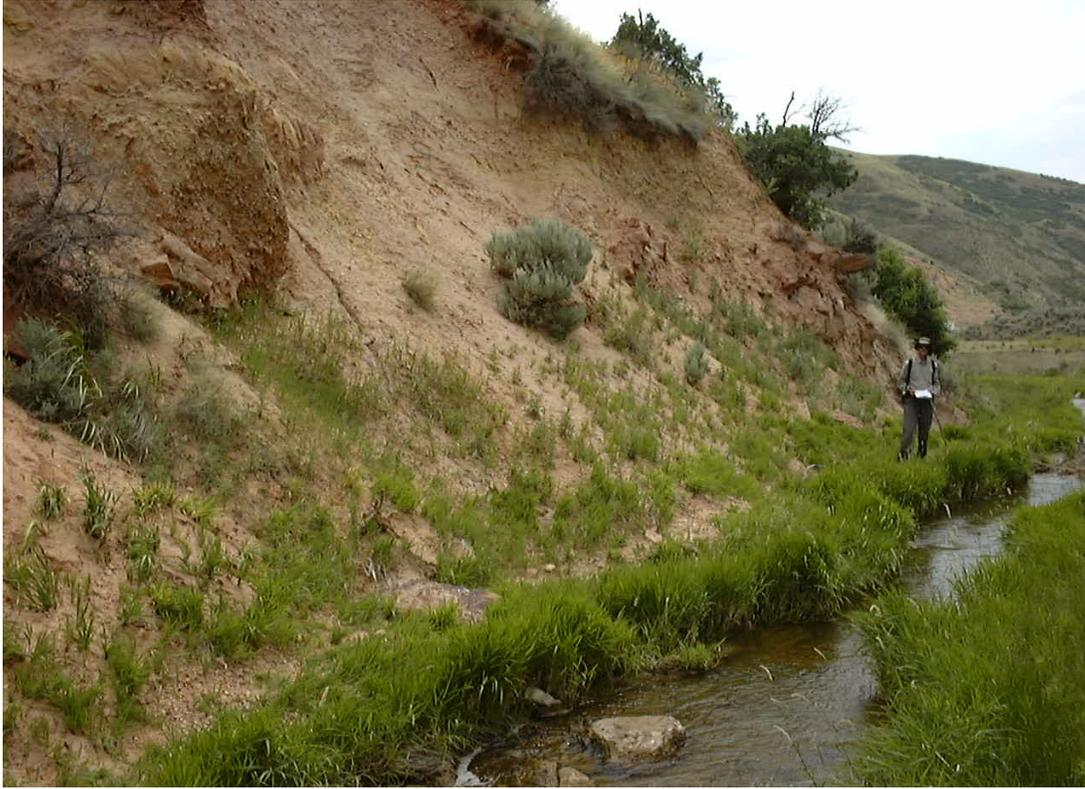
Figure 1-6. Echo Canyon Conglomerate formation.

In the lower part of the watershed the valley floor is flanked by massive red and tan colored cliffs formed by the Echo Canyon conglomerate and Henefer formation respectively. Mid way up the watershed the topography transitions into the red colored Wasatch formation forming less dramatic cliffs and rolling hills.

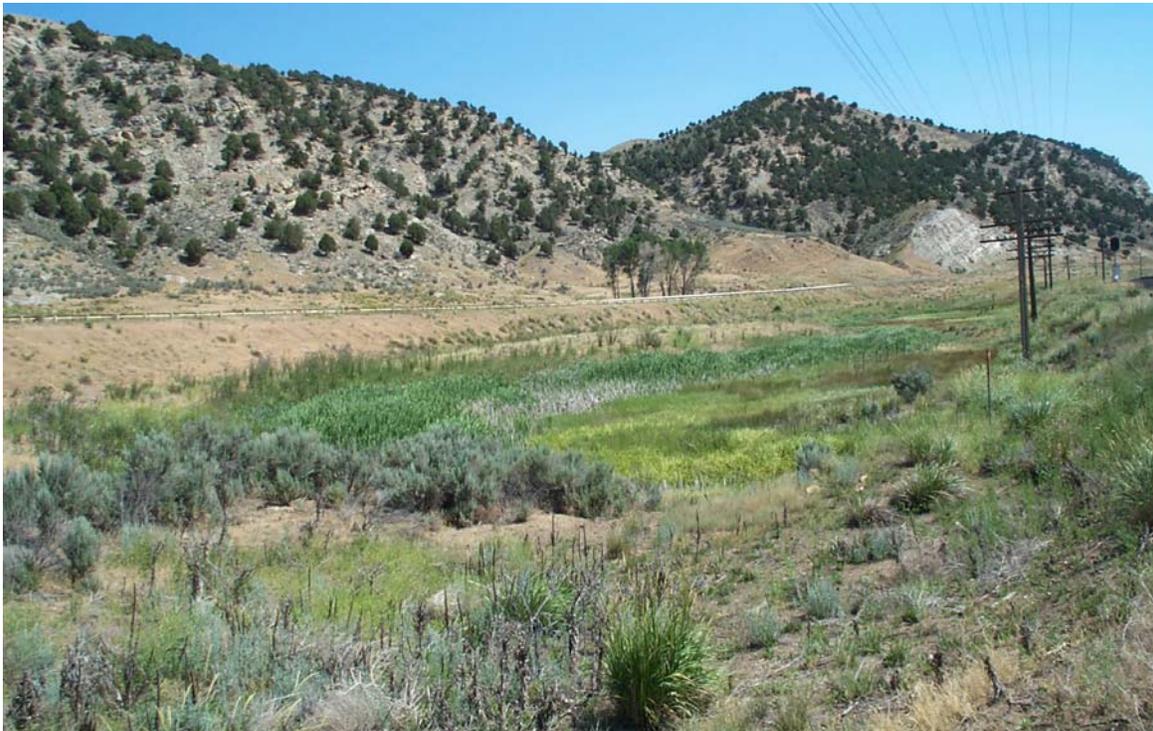
Figure 1-7. Henefer Formation.

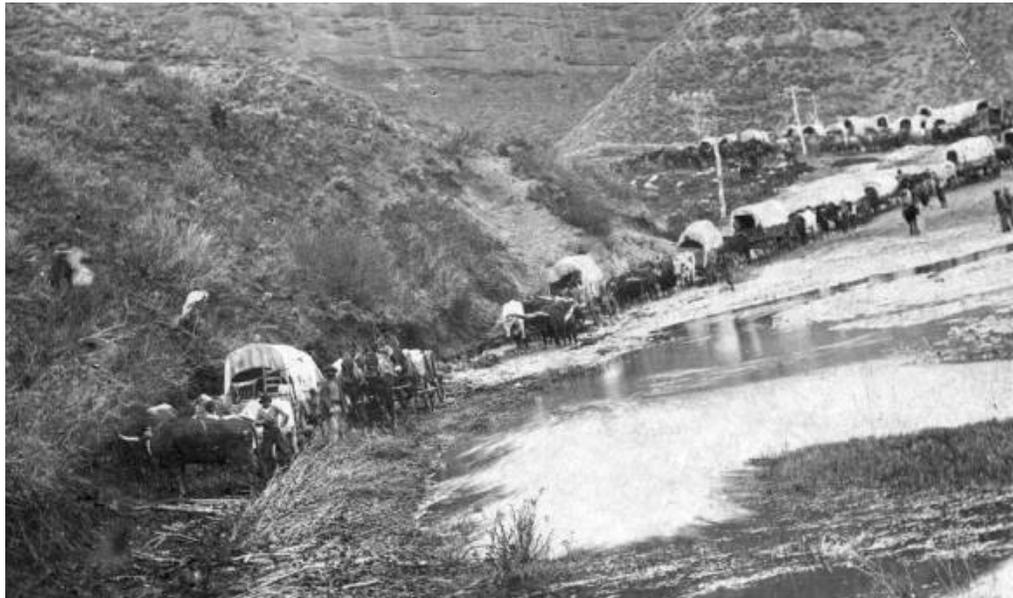
Figure 1-10: Wagon train in Echo Canyon in the 1860's. Willows were used to create a roadway for the wagons.

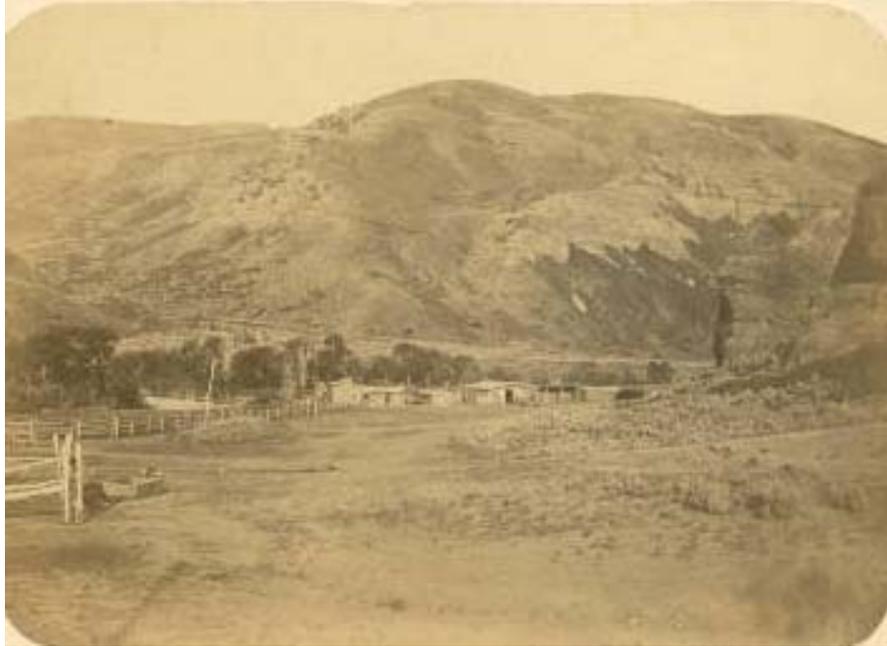
Figure 1-11: Settlement at the mouth of Echo Canyon. A large stand of cottonwoods can be seen along the stream.

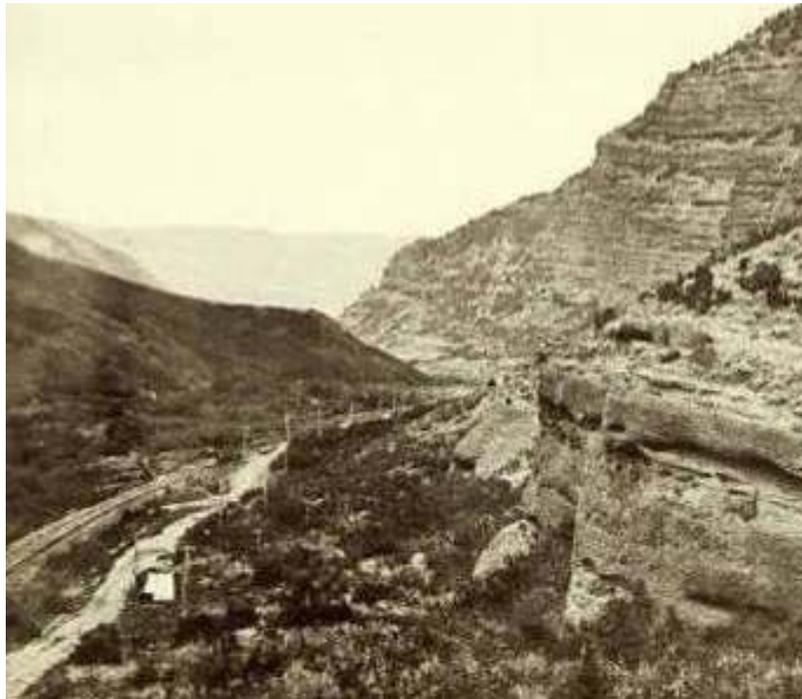
Figure 1-12: Echo Canyon 1872. Note the riparian vegetation covering the valley floor.

The purpose of these historic photos is to show that large woody riparian vegetation did flourish along Echo Creek. Presently, Echo Creek is devoid of this type of vegetation along most of its length. The absence of deep rooted woody vegetation has led in part to severe streambank erosion.

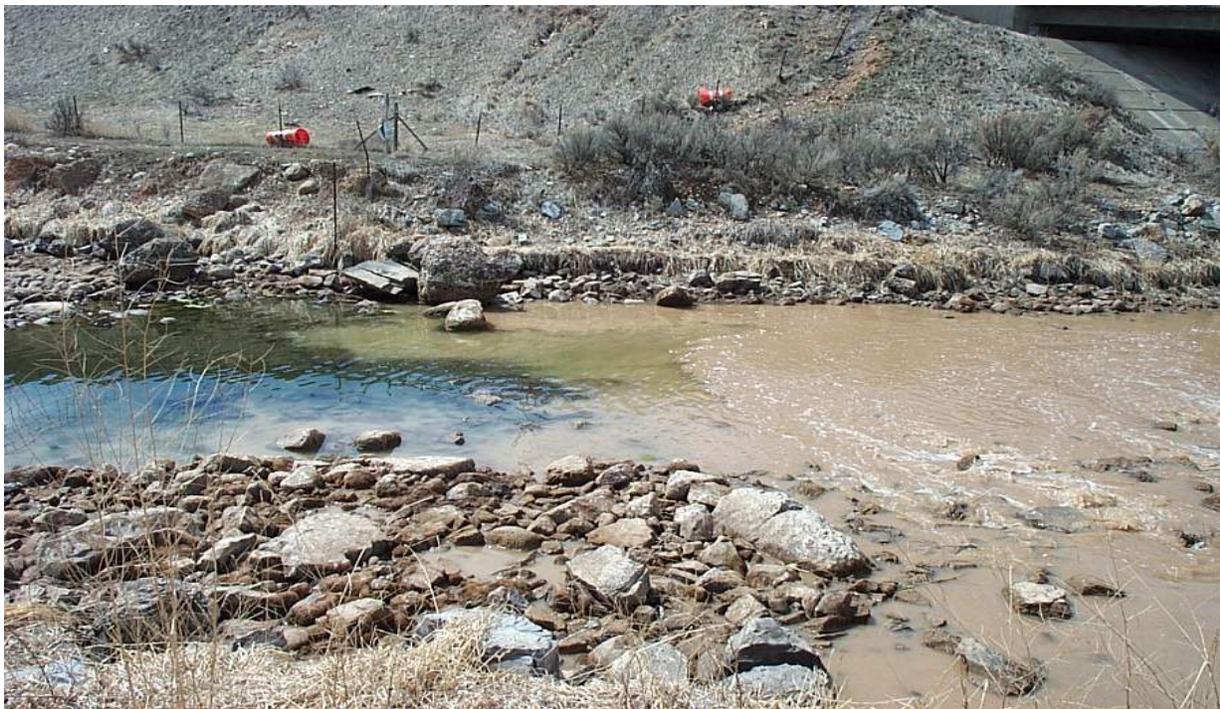
Figure 2-1: Echo Creek (right) flowing into the Weber River, March 2002.

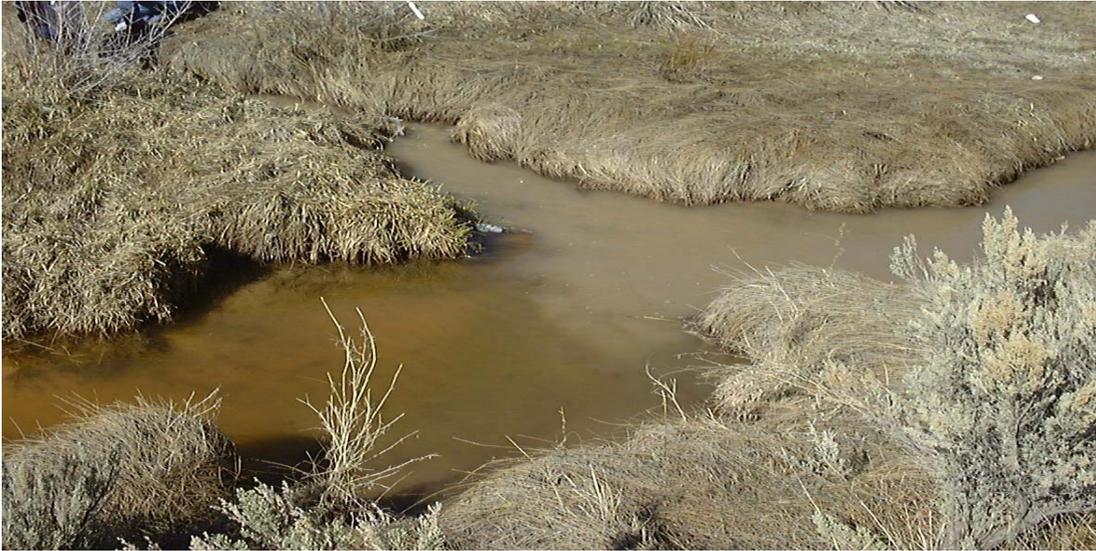
Figure 4-2: Confluence of Echo Creek (clear) and Rees Creek (turbid). Rees Creek has long been a major contributor of sediment to Echo Creek.

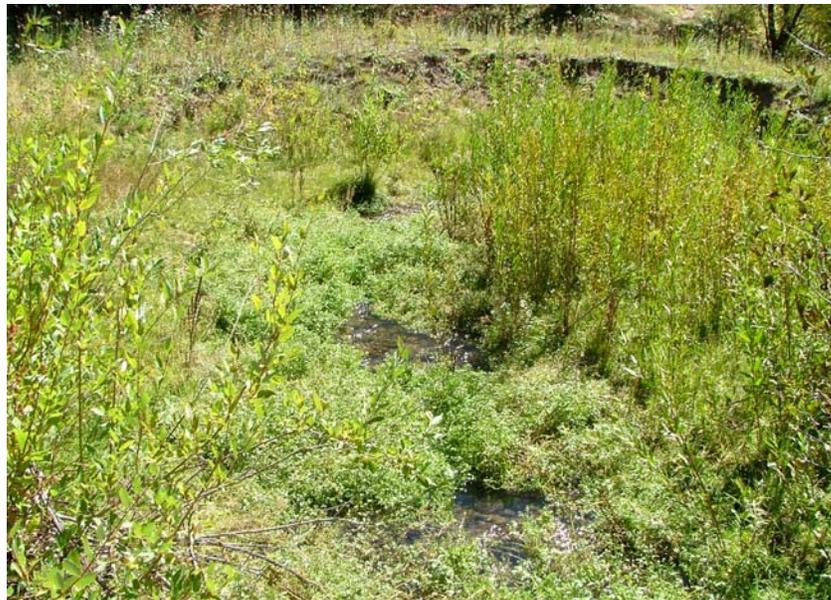
Figure 7-1: Natural re-establishment of willows on Sawmill Creek.

As identified in the Echo Creek Stream Visual Assessment Protocol report (SVAP) the main channel of Echo Creek has marginal to poor riparian habitat conditions. Marginal riparian habitat conditions are located on reaches that encompass much of the mid and lower sections of Echo Creek down to its confluence with the Weber River. This portion of the stream corridor has been impacted by stream alteration and weed spraying resulting in a loss of woody riparian vegetation typically associated with this type of stream. Poor riparian habitat is common along the main stem of Echo Creek. In a number of these areas stream alteration has virtually eliminated all the riparian habitat. The stream has been channelized into a cement canal to facilitate the construction of Interstate 80. Woody riparian vegetation should be re-established along the majority of the main channel of Echo Creek. The SVAP will be used to identify specific locations. The Summit Soil Conservation District, whose district includes the Echo Watershed, has a water jet stinger available for use. The water jet stinger is a tool for planting dormant non-rooted plant cuttings, such as willows. The stinger uses a jet of water to bore a hole into the stream bank in which the cutting is planted. The stinger also allows the cutting to be planted into the water table in order to maximize growing success of the cuttings.
