# JORDAN RIVER WATERSHED *E. COLI* TMDL

Appendices

UTAH DEPARTMENT *of*  
ENVIRONMENTAL QUALITY

# Appendix A: Big Cottonwood Creek Assessment Unit-1 *E. coli* TMDL

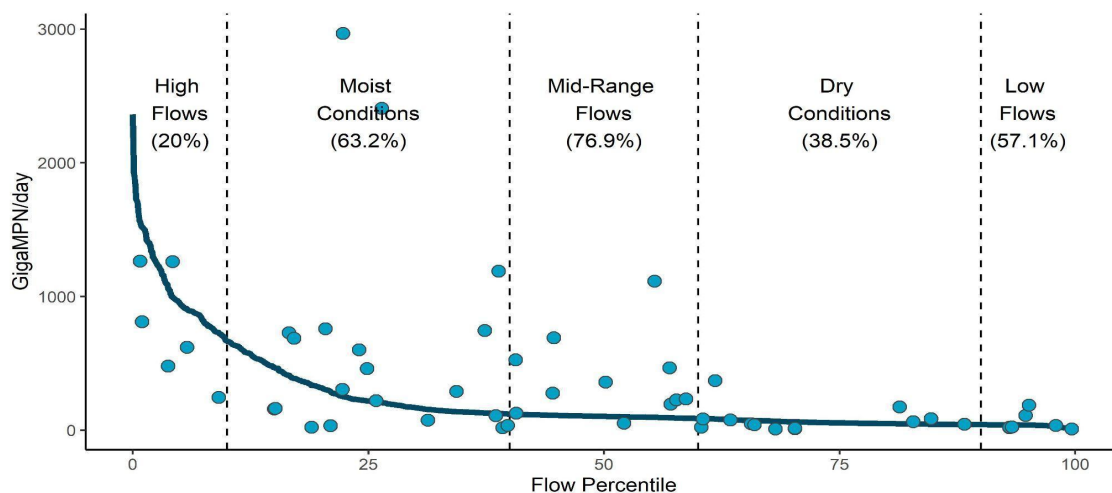
Using this site’s corresponding *E. coli* and flow data, the LDC shows exceedances occurring at all flow regimes (Figure A-8). Exceedances of the TMDL threshold (solid line) in high-to low-flow conditions indicate the potential for multiple sources of *E. coli* in the AU. These sources include point sources (low-flow conditions), onsite septic systems (dry flows), and riparian areas and impervious stormwater sources (mid-range). Upland stormwater and bank erosion are likely sources for the higher flow conditions. The percent of *E. coli* loading measurements that exceed the TMDL in each flow regime is provided in parentheses under each flow-regime label in Figure A-8. Load reductions are needed

primarily in the mid-range flow regimes, indicating both point and nonpoint source *E. coli* loading in Big Cottonwood Creek-1 AU.

**Figure A-8. Load duration curve for Big Cottonwood Creek at 300 West (4992972).**

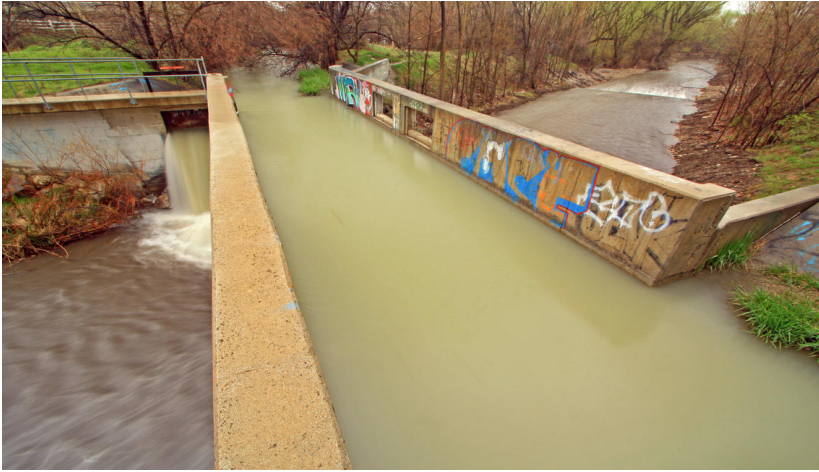
**Figure B-2. Jordan and Salt Lake City Canal crossing Little Cottonwood Creek (USGS 2011).**

During the irrigation season (April–October), exchange agreements allow Salt Lake City to use high-quality mountain stream water to address municipal demands, while local agricultural producers switch to using lower quality Utah Lake/Jordan River water for irrigation (SLCo 2017). Salt Lake City diverts Utah Lake/Jordan River water from the Jordan River Narrows through both the East Jordan Canal and Jordan and Salt Lake Canal into Little Cottonwood Creek to fulfill these exchange agreements (Figure B-2).

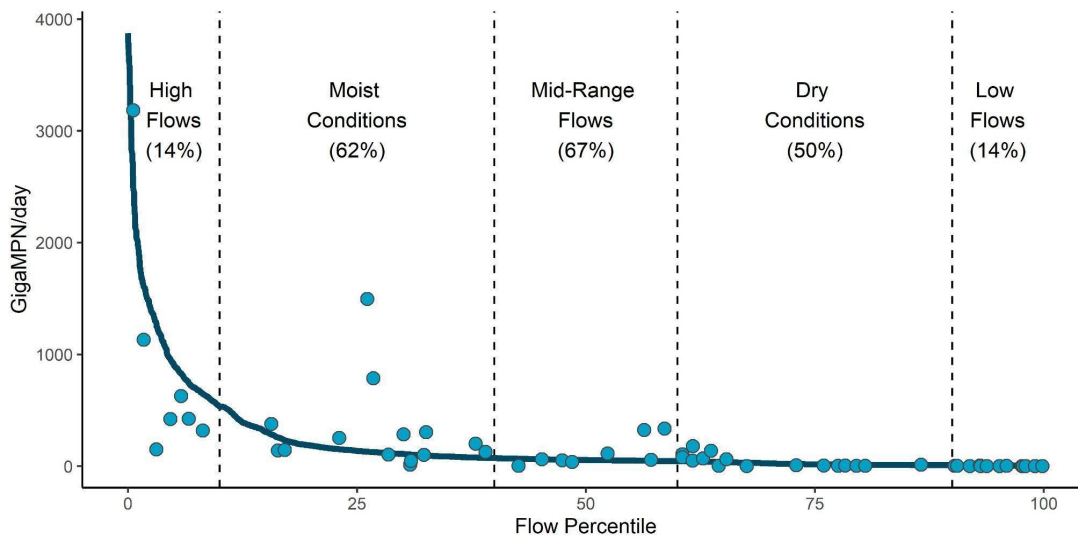
Using this site’s corresponding *E. coli* and flow data, the LDC shows exceedances occurring at all flow regimes (Figure B-9). Exceedances of the TMDL threshold (solid line) in high to low-flow conditions indicate the potential for multiple sources of *E. coli* in the AU. These sources include point sources (low-flow conditions), onsite septic systems (dry flows), and riparian areas and impervious stormwater sources (mid-range). Upland stormwater and bank erosion are likely sources during higher flow conditions. The necessary load reduction by flow regime is provided in parentheses under each flow-regime label in Figure

B-9. Most of the reductions are needed in the mid-range flow regimes at 67%, indicating that Little Cottonwood Creek is dominated by both point and nonpoint source delivery methods of *E. coli* loading.

**Figure B-9. Load duration curve for Little Cottonwood Creek at 300 West (4993590).**

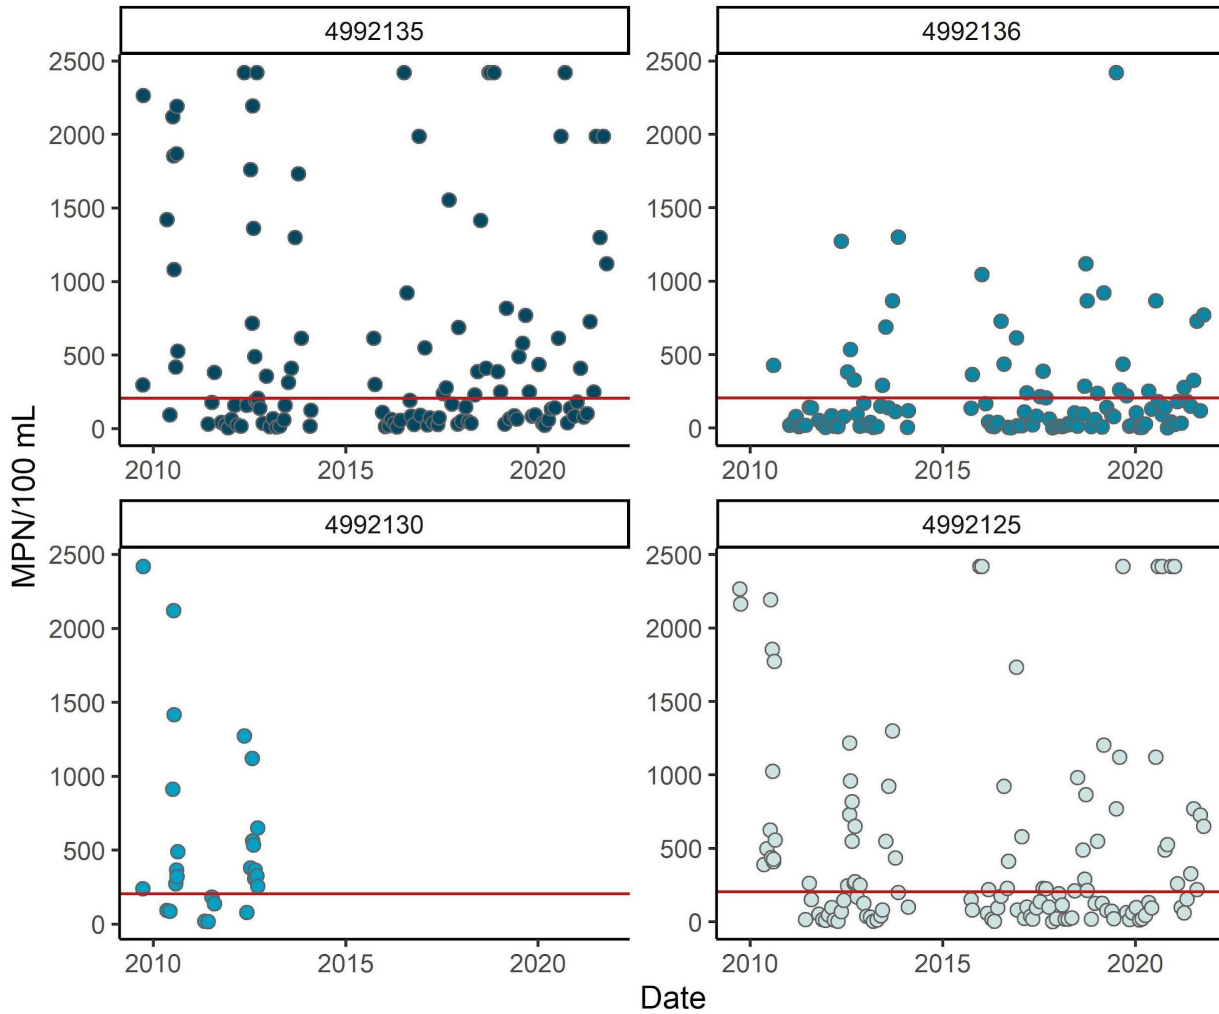
**Figure E-4. *E. coli* concentrations at each routine monitoring location through time within the Emigration Creek Lower Assessment Unit. The red line denotes the geometric mean criterion of 206 MPN/100 mL. Sites are ordered downstream (upper left panel) to upstream (lower right panel).**

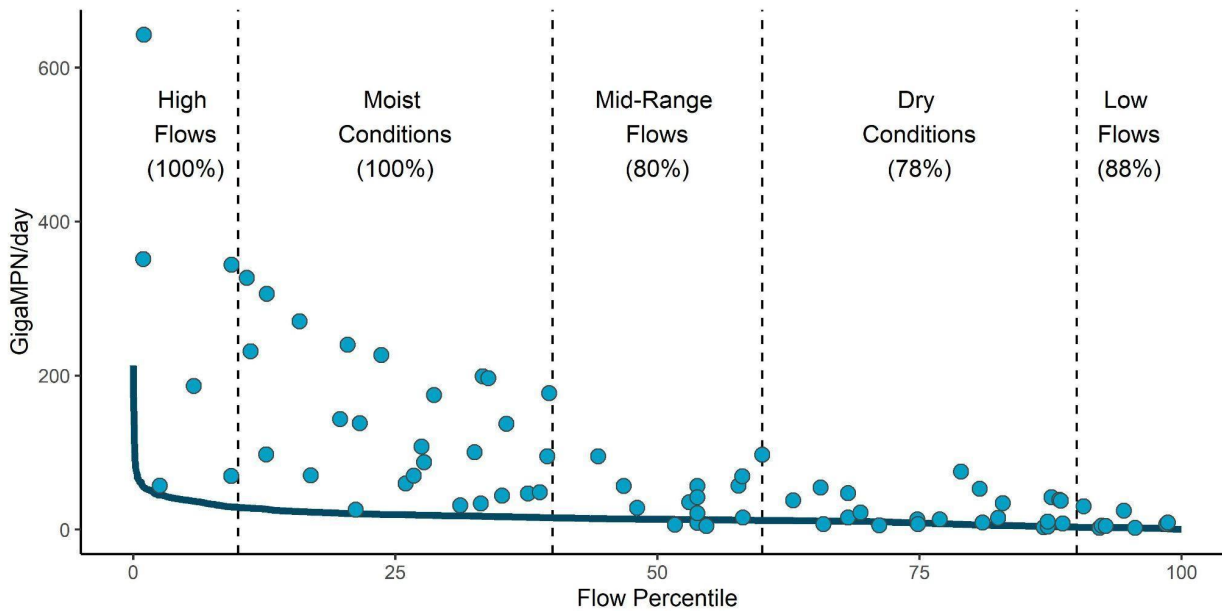
**Figure G-8. Load duration curve for Midas Creek at Jordan River (4994420).**
