SECOND FIVE-YEAR REVIEW REPORT FOR
KENNECOTT (SOUTH ZONE) SUPERFUND
ALTERNATIVE SITE
SALT LAKE COUNTY & TOOELE COUNTY, UTAH

Utah Department of Environmental Quality
Division of Environmental Response & Remediation
Salt Lake City, Utah

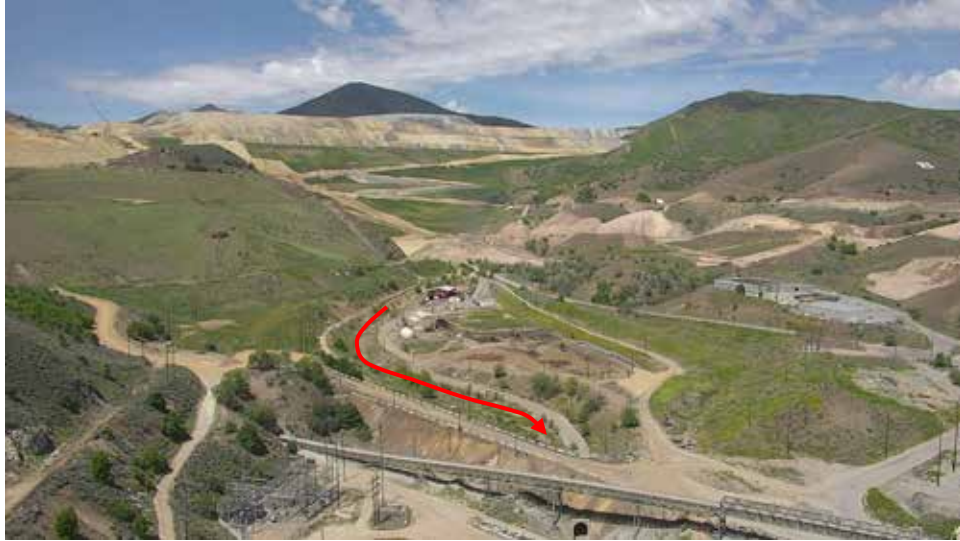
Photo 1 - Pictured is an aerial view of Bingham Canyon with the Bingham Canyon Waste Rock Dump in the background, KCC Precipitation Plant footprint in the middle of the frame, and Tunnel 5490 and the old Bingham Mine Ore Conveyor in the foreground. The footprint of the historic Yellow Cake Plant (OU11) is located on the northern hillside (in the upper right quadrant) and is now the site of material warehouses for RTKC. Bingham Creek (red arrow) is located along the southern boundary of the Precipitation Plant and is directed to the Large Bingham Reservoir.

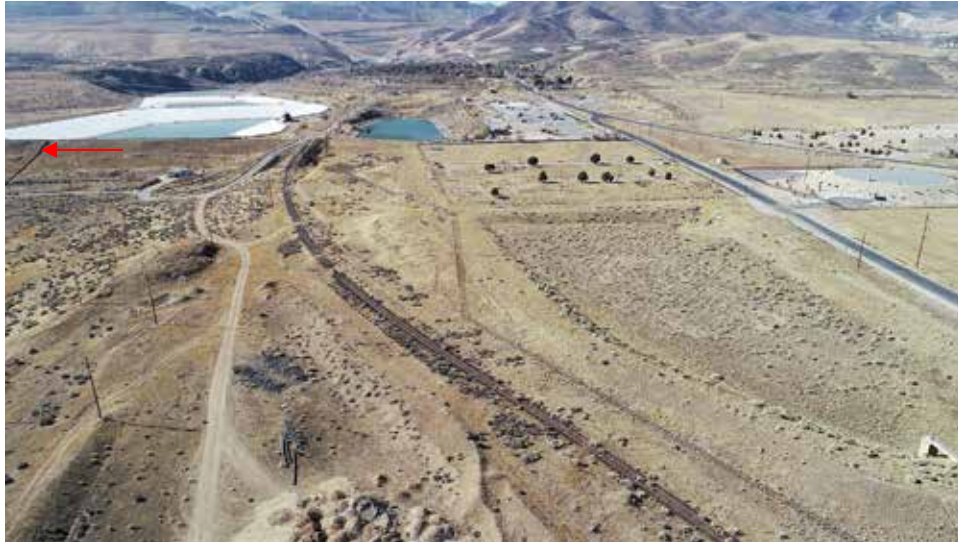
Photo 3 - Pictured is the Bingham Reservoir Complex near the mouth of Bingham Canyon. More info on the Bingham Reservoirs is provided in the photos for OU4. Bingham Creek reappears near the base of the Large Bingham Reservoir spillway (red arrow).

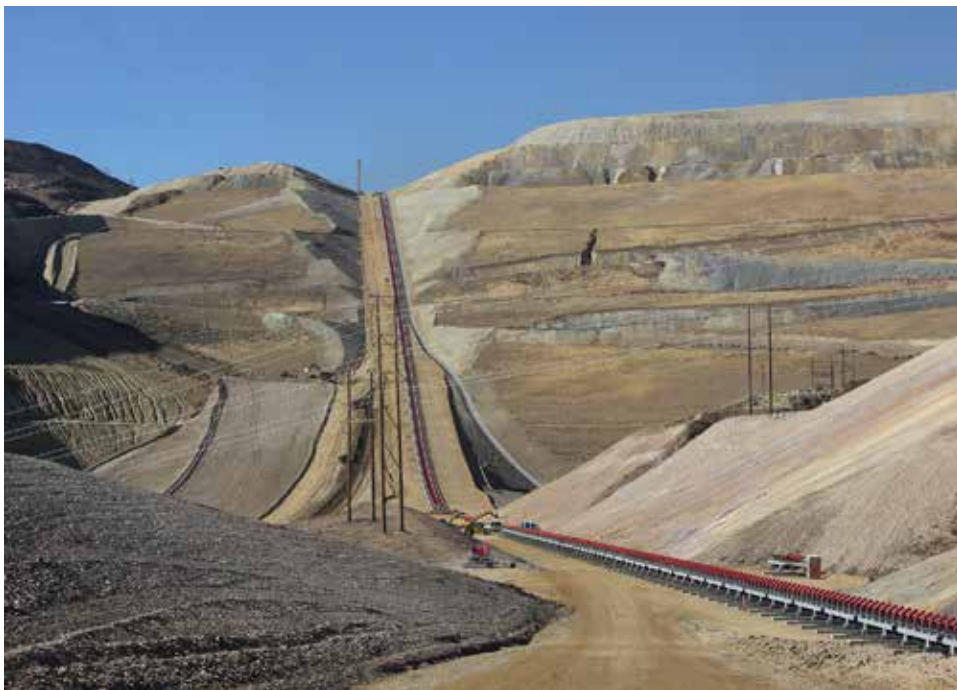
Photo 4 - Nearly completed, the new Bingham Mine Ore Conveyor runs from the Bingham Mine Pit Crusher to the Copperton Concentrator. The conveyor is bedded on waste rock. Material removed was used to recontour the base of the Bingham Canyon Waste Rock Dump with new storm water sediment capture basins.

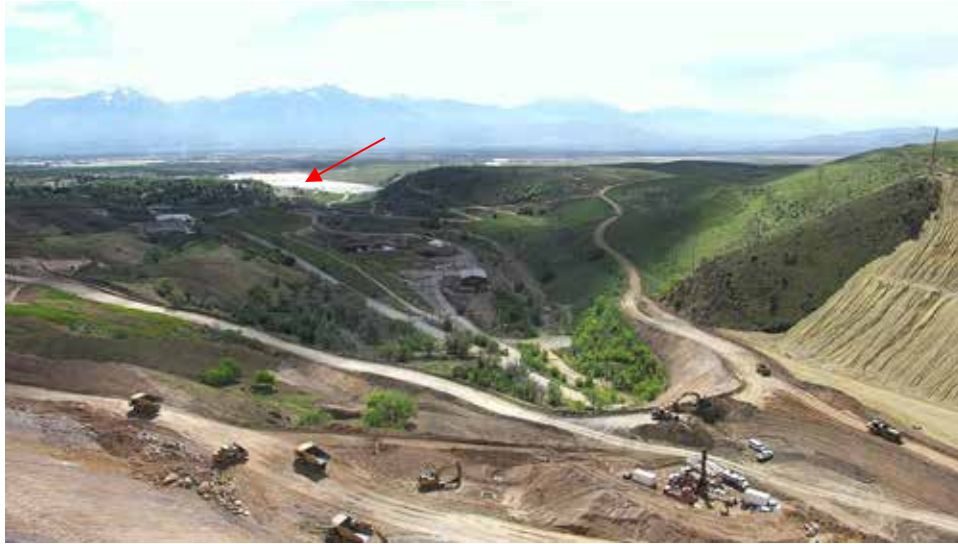
Photo 5 - Pictured is the eastern extent of Bingham Canyon from the Bingham Canyon Waste Rock Dump. New storm water sediment retention basins were under construction at the base of the Bingham Canyon Waste Rock Dump. The KCC Precipitation Plant is in the middle of the frame, and the Large Bingham Reservoir (red arrow) is in the background (center left) with the Town of Copperton is out of frame in the upper left quadrant.

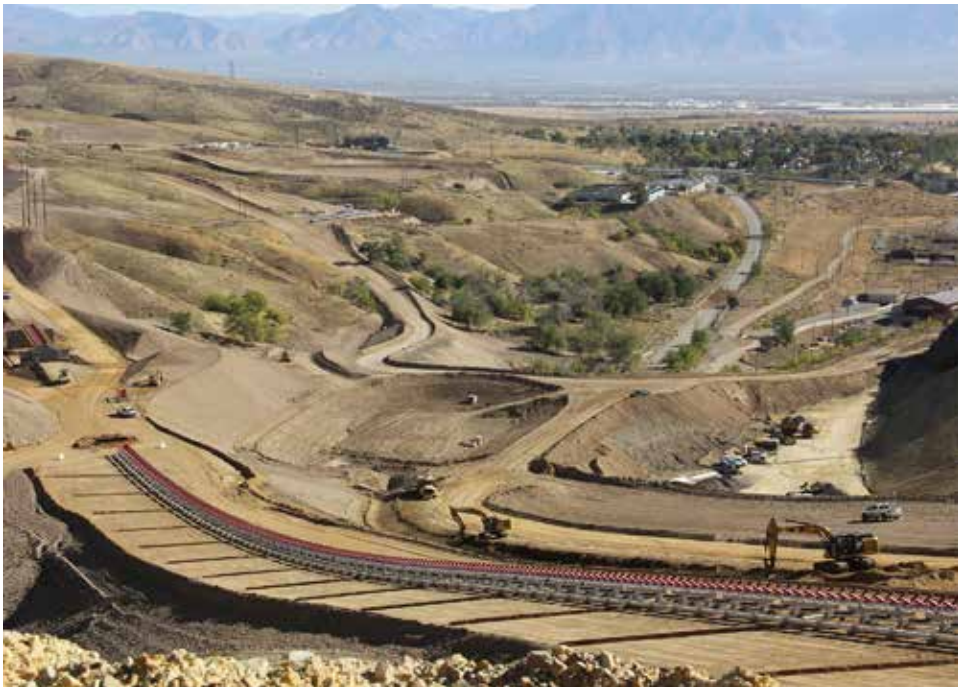
Photo 6 - Pictured is another view of the new Bingham Mine Ore Conveyor under construction. The conveyor begins to traverse laterally along the embankment of the Bingham Canyon Waste Rock Dump (view is east/northeast). Storm water sediment basins were still under construction. The KCC Precipitation Plant is just out of frame in the upper right quadrant.

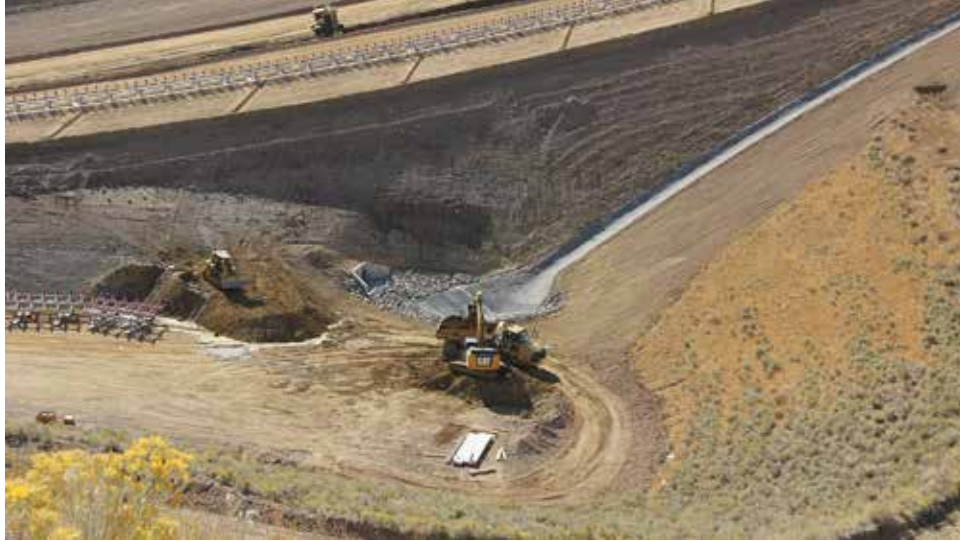
Photo 7 - Pictured adjacent to the new Bingham Mine Ore Conveyor is a concrete lined storm water down-drain and the first of storm water sediment basin at the base of the Bingham Canyon Waste Rock Dump. Storm water will be distributed to successive lower basins to dissipate flow, energy and to distribute volume.

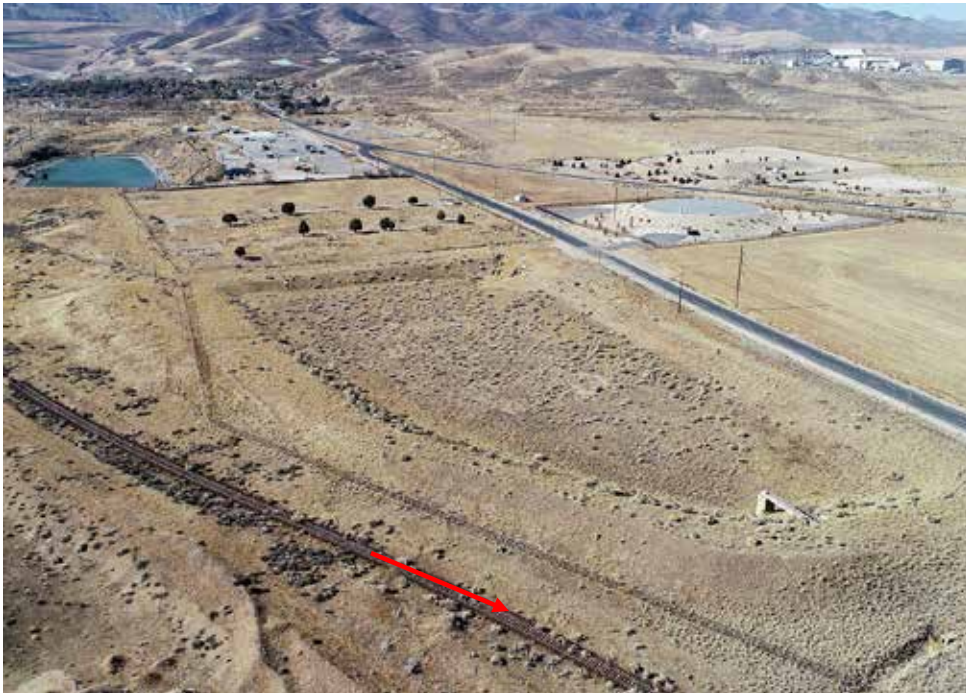
Photo 8 - Pictured is the Cemetery Pond which was previously cleaned up during the Bingham Creek Phase II removal action. Water from the OU2 Zone A RO plant can be directed to this pond as needed. The Cemetery Pond is well vegetated and generally does not contain water. In the foreground is a section of the 1960s Denver Rio Grande (DRG) Rail Corridor (red arrow, part of OU24).

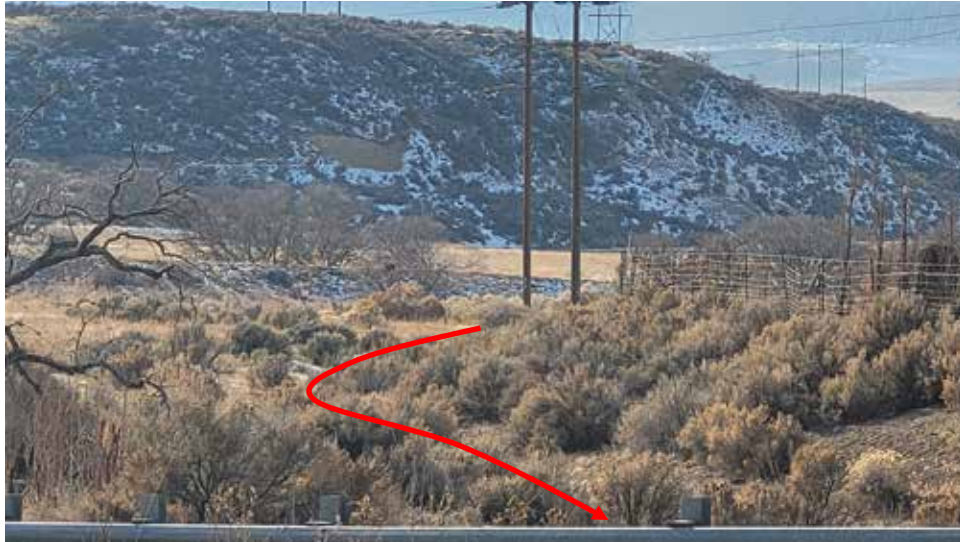
Photo 9 -- Pictured from SH-111 is the Bingham Creek Channel (red arrow), the view is to the west. The Channel is well vegetated with sage brush, rabbit brush, and grasses.

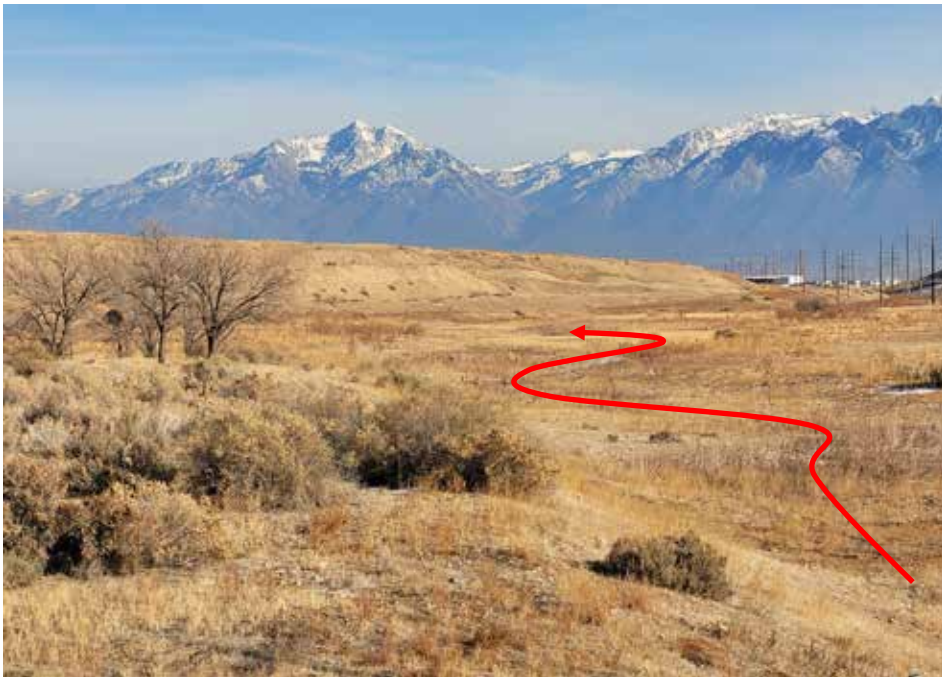
Photo 10 - Pictured is the Bingham Creek Channel (red arrow) looking east from SH-111. From this point the Channel's cut shallows and the floodplain widens. Both the Channel and floodplain are well vegetated with grasses and a few pockets of scrub oak, sage brush, and rabbit brush. Surfaces of both the Channel and floodplain are stable.

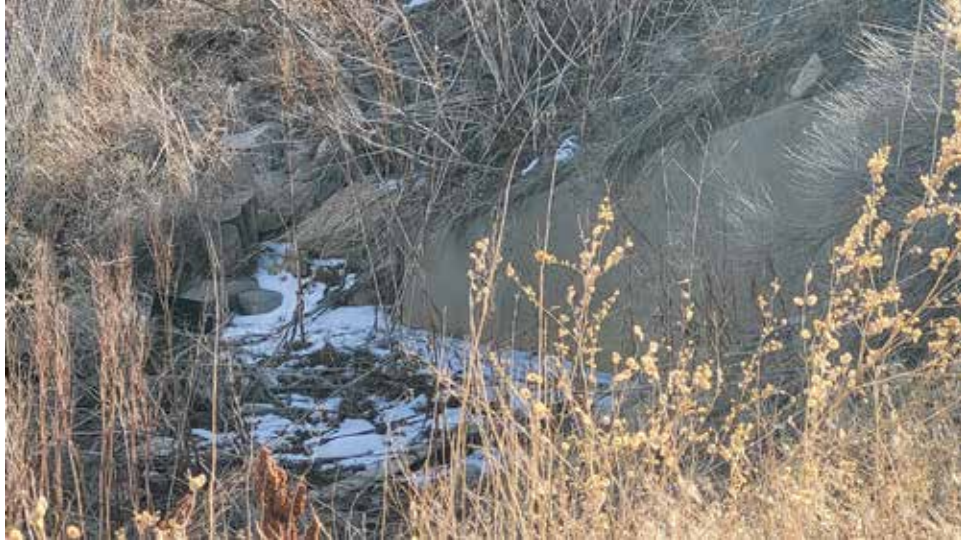
Photo 11 - Pictured is the culvert outlet for Bingham Creek where it flows under SH-111. The Outlet area is well vegetated and no water was observed. Some general solid waste debris (garbage) was observed around the outlet area.

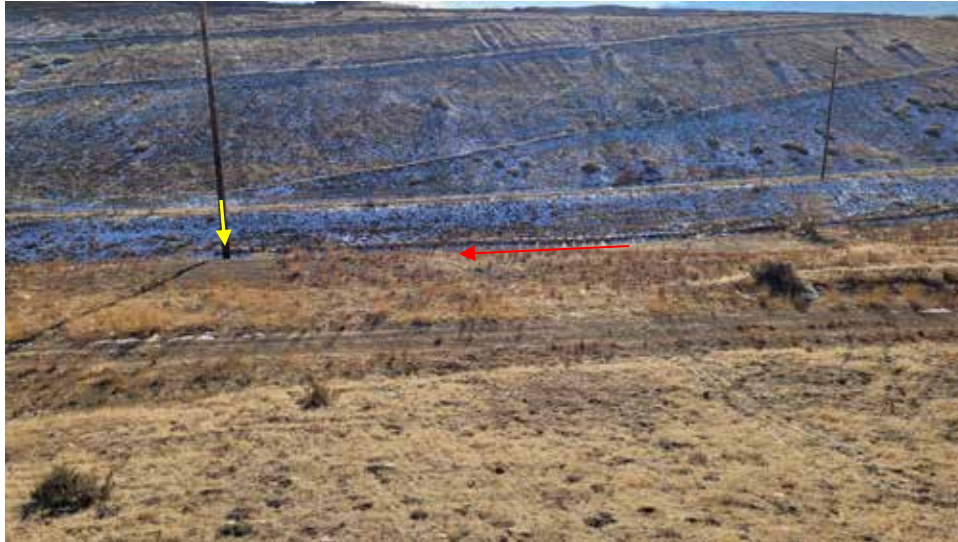
Photo 13 - Pictured is the Bingham Creek Channel (red arrow) and floodplain between the TJL (background) and the Bingham Creek Channel's northern embankment (the photo vantage point). Stones along the channel (parallel to red arrow) were placed during the Bingham Creek Phase II removal action to stabilize the soils. Soils around the utility pole (yellow arrow) have lead concentrations just below the surface of approximately 1,400 milligrams per kilogram (mg/kg).

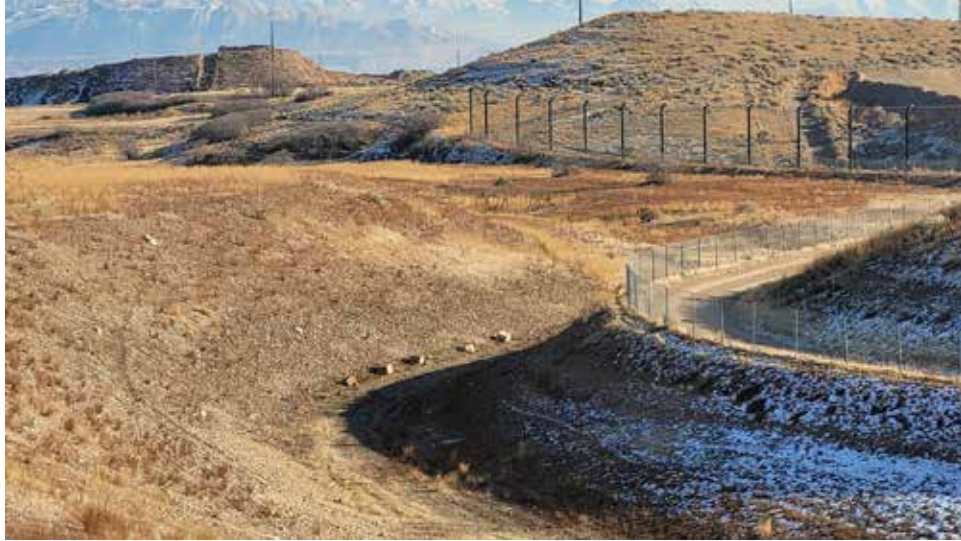
Photo 15 - Pictured is the “Big Bend” of Bingham Creek. This location is topographically below the western extent of the Bingham Flats area. Here the Channel is restricted by the footprint of TjL (fence line). Soils contain gravel and limited water (mostly from rain) falls on this area. Thus, revegetation has not been successful here. Soils in the Floodplain and embankments are stable, no erosion was observed.

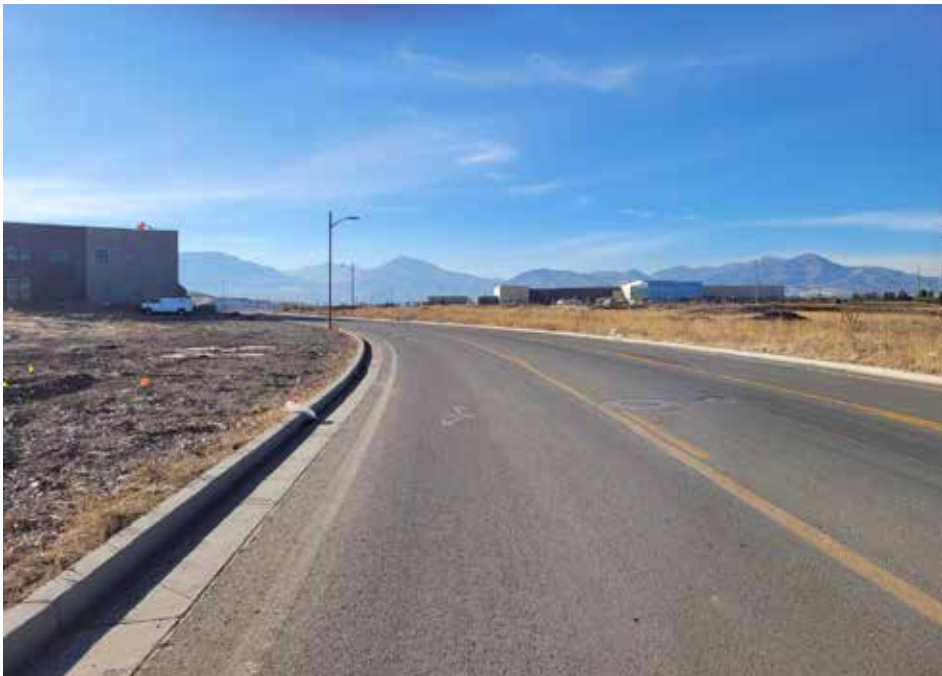
Photo 16 - Pictured is a portion of the western extent of the Bingham Flats Oquirrh Park area, a commercial/industrial development in the LHM - Daybreak Communities. New construction is taken place along the southern side of the road (left). In the background to the right is eBay's data center. LHM - Daybreak Communities controls land use changes in this area.

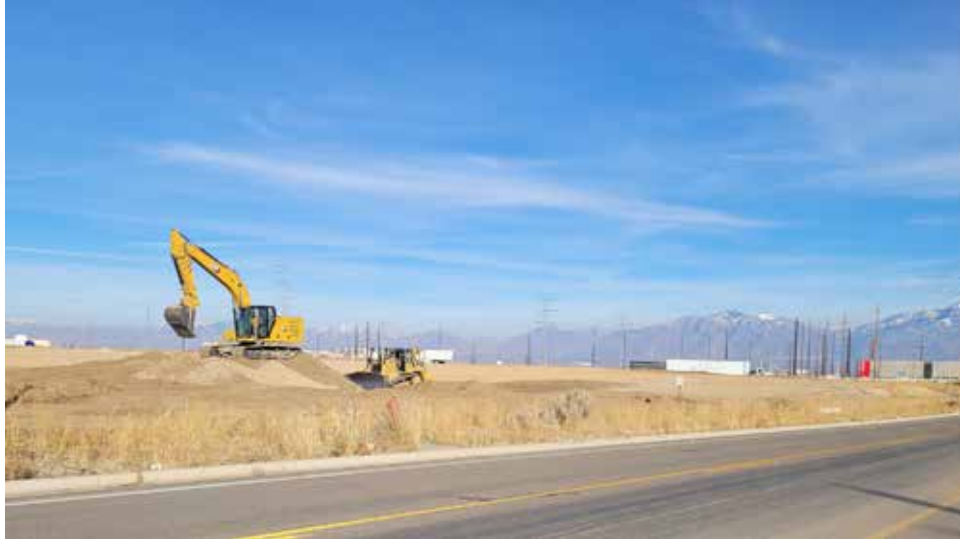
Photo 17 - In the Bingham Flats area new construction was observed to the north of the location in Photo 16. Prior to sale, the Bingham Flats area was assessed by RTKC in the 1990s and further cleanup work was performed in 2016 to address soils above the (Kennecott Unrestricted Action Levels (KUALs) for arsenic and lead.

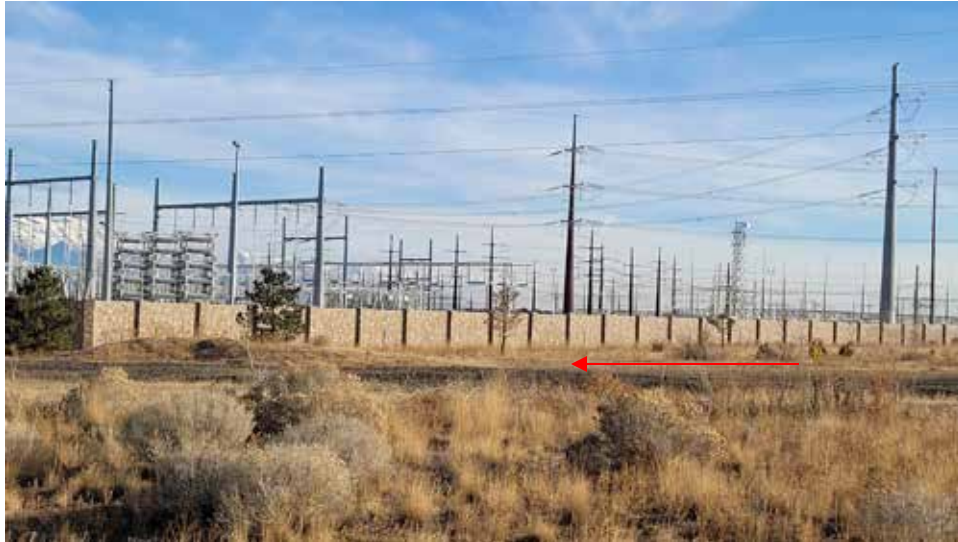
Photo 19 - Pictured in the central portion of Bingham Flats is a Rocky Mountain Power substation. The historic 1960s DRG Rail Corridor (red arrow, foreground) still has slag (not leachable) as rail bedding in place. The rail corridor is subject to ICs created by the City of West Jordan and Salt Lake County Health Department. The power substation has been in place since prior to the Bingham Creek Phase II cleanup.

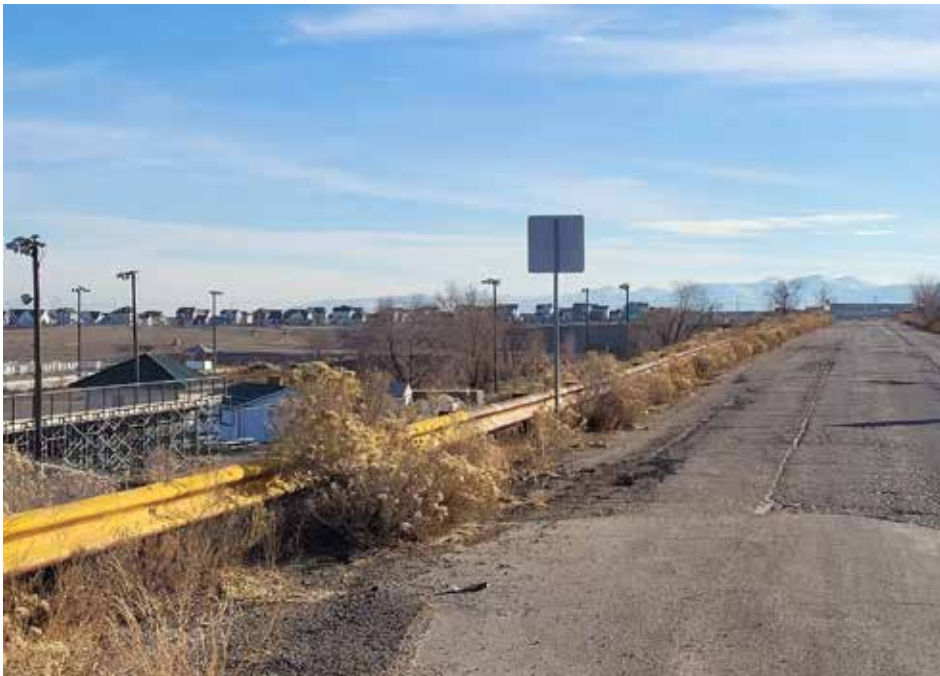
Photo 20 - Pictured from approximately 5000 West is Salt Lake County (SLCO) Parks & Recreation's (P&R) Welby Gravel Pit redevelopment project. In the foreground to the left is the SLCO BMX bike recreation facility and in background before the houses is the Welby Pit redevelopment project, Bingham Creek Channel and floodplain. Interstate Brick, a commercial entity located in the eastern extent of the Bingham Flats area is located out of frame to the right.

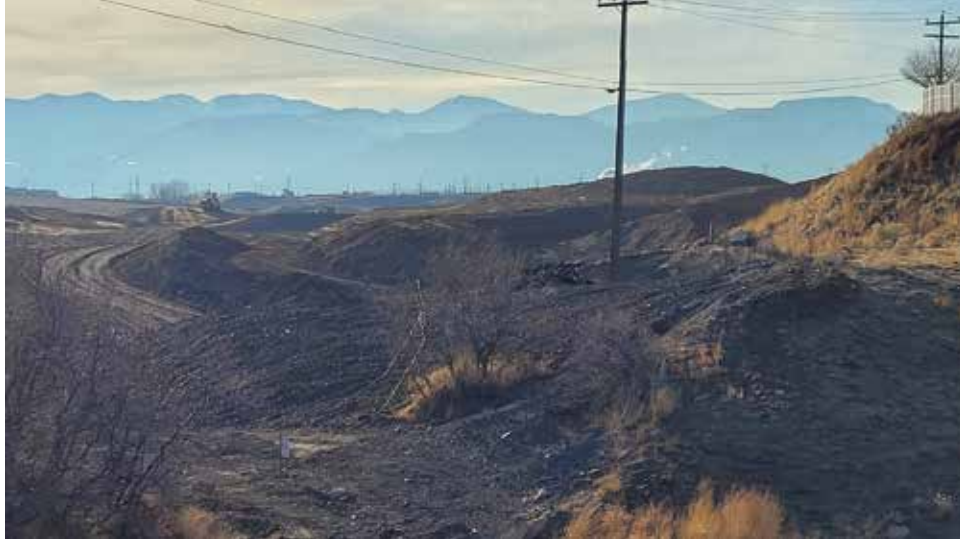
Photo 21 - Pictured is the northeastern extent of SLCO P&R's Welby Gravel Pit redevelopment project, the view is southwesterly from 4800 West. The historic Bingham Creek Channel traversed this site in the background. The vegetated hillside (right) leads up to residential homes.

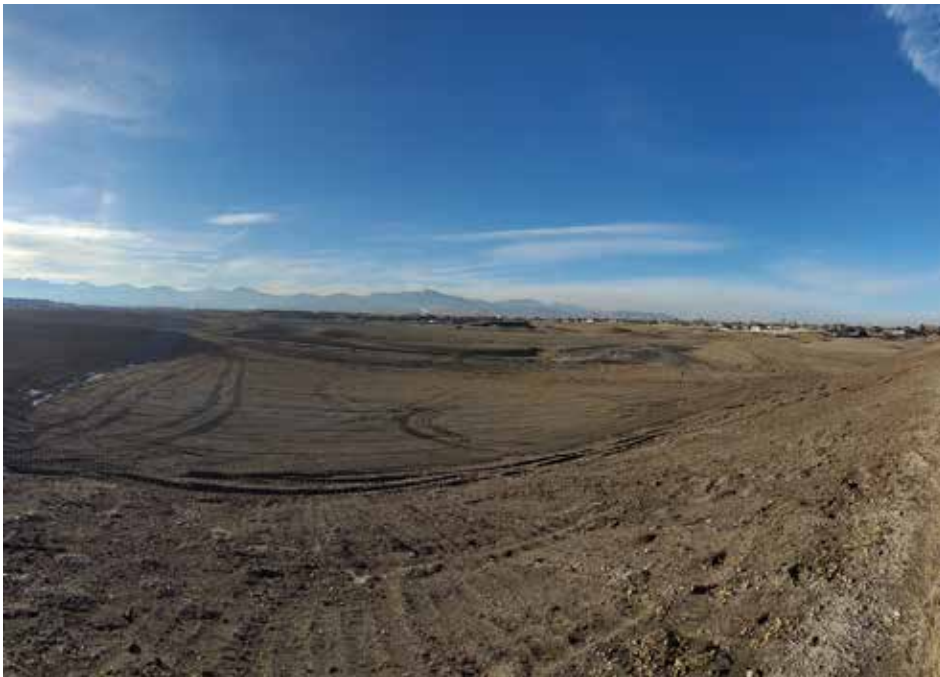
Photo 22 - Pictured is a broad overview of SLCO P&R's Welby Gravel Pit redevelopment project, the view is northwesterly from 4800 West. Based on current land topography, the historic Bingham Creek Channel is not observable. Eventually a graded channel will be maintained for flood control capacity.

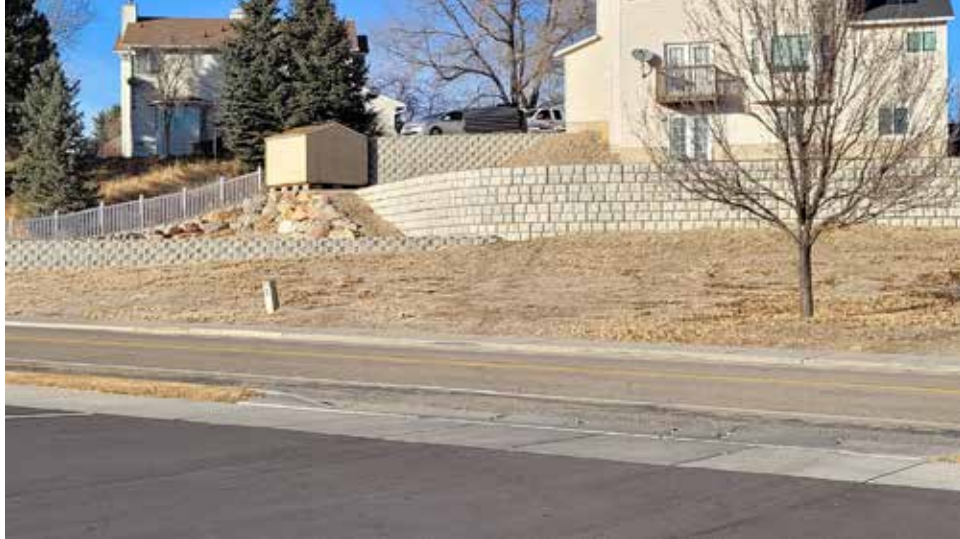
Photo 23 - Pictured is the western end of South Jordan City's Bingham Creek Trailhead park on Skye Drive. Located north of Skye Drive and the park is a residential neighborhood built prior to the Bingham Creek Phase II cleanup. Recent hillside stabilization work was observed (stone walls). South Jordan City will be contacted to ascertain the extent of soil excavation during the project. This hillside had a historical irrigation ditch which conveyed waters from Bingham Creek to the historically farmed land where the houses now are located.

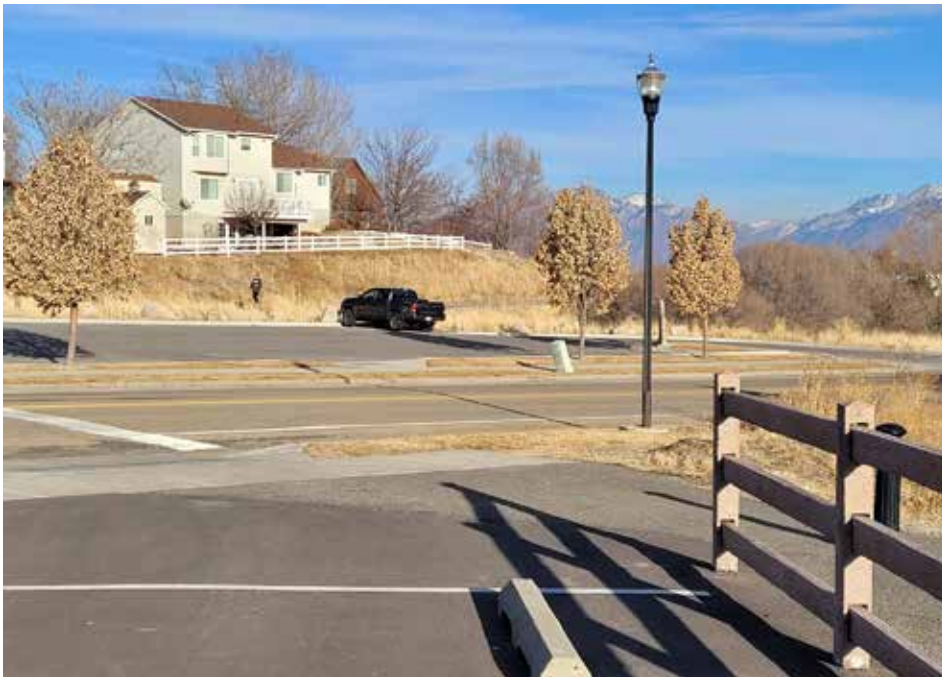
Photo 24 - Pictured is South Jordan City's parking lot for their Bingham Creek Trailhead park adjacent to Skye Drive. This area was the subject of an RTKC removal action prior to the previous FYR in 2016. The parking lot and trail were found in good condition.

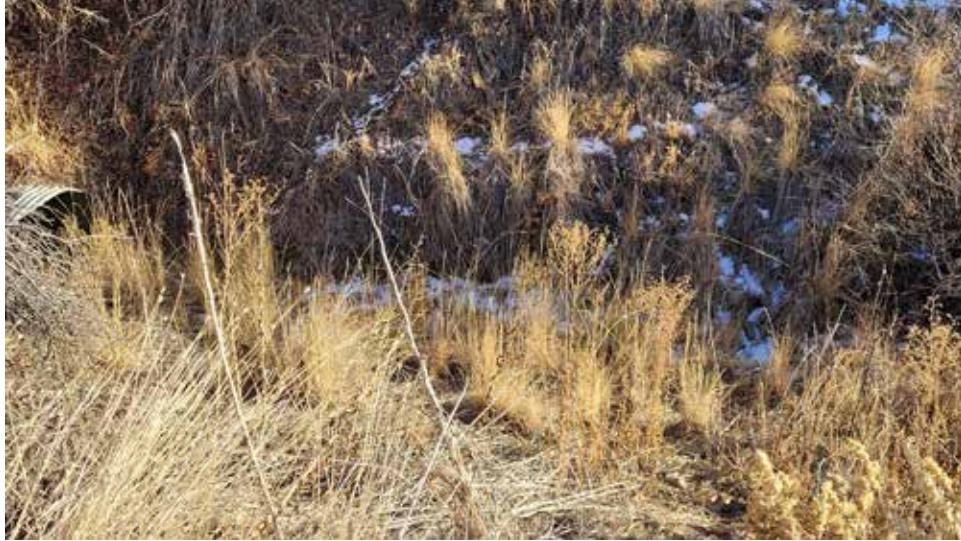
Photo 25 - Pictured just west of Skye Drive is the Bingham Creek Channel, the culvert underlies Skye Drive. Vegetative cover in the Channel has not changed since the previous FYR. No water was observed in the Channel nor was any erosion observed along the Channel. The Channel in this location is well incised and narrow.

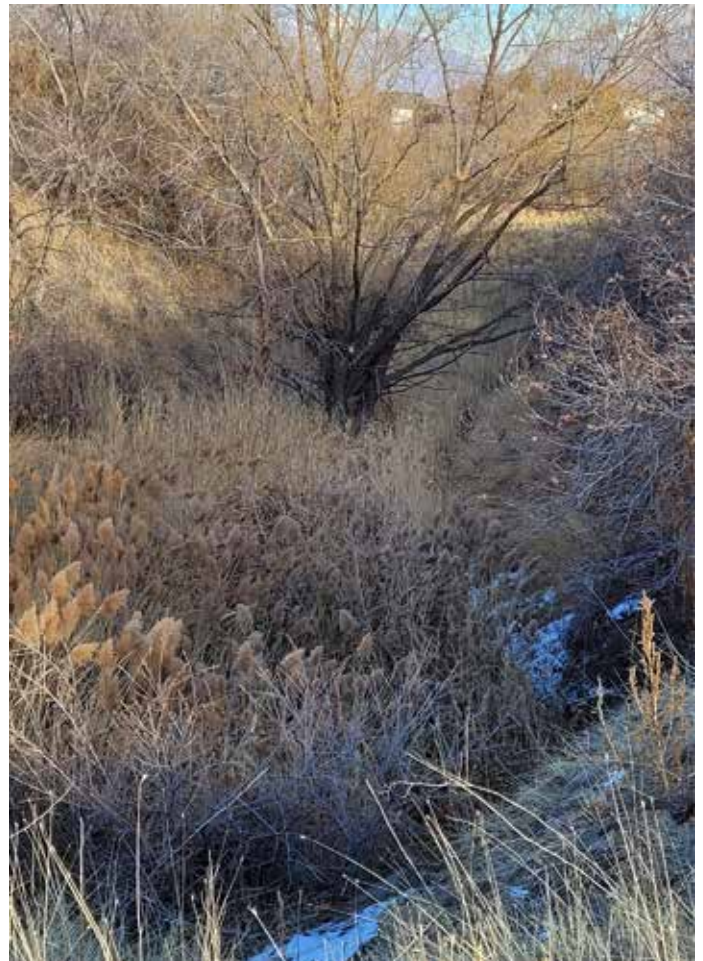
Photo 26 - Pictured just east (downgradient) from Skye Drive is the Bingham Creek Channel. The Channel is well vegetated and has not changed since the previous FYR. No water was observed in the Channel nor was any erosion observed along the Channel. The Channel in this location is well incised and narrow.

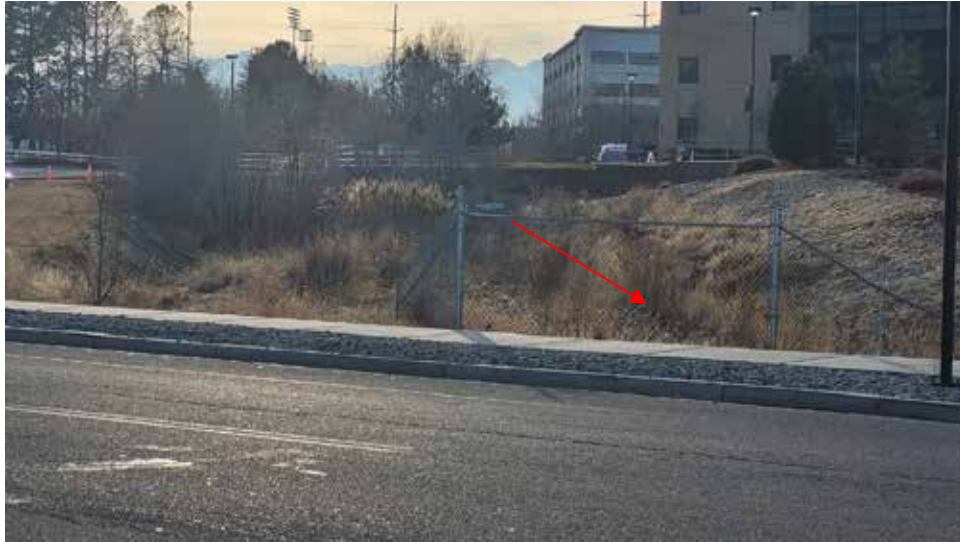
Photo 29 - Pictured upgradient and west of 3400 West is the Bingham Creek Channel (red arrow). The Channel flows northeast, just north of the Jordan Valley Hospital (and was part of the Bingham Creek Phase II cleanup in the 1990s). The Channel was well vegetated, a condition that has not changed since the last FYR. A project by UDOT to reconstruct Bangerter Highway managed Bingham Creek soils under the City of West Jordan's IC in the vicinity and the Channel was revegetated as part of the project.

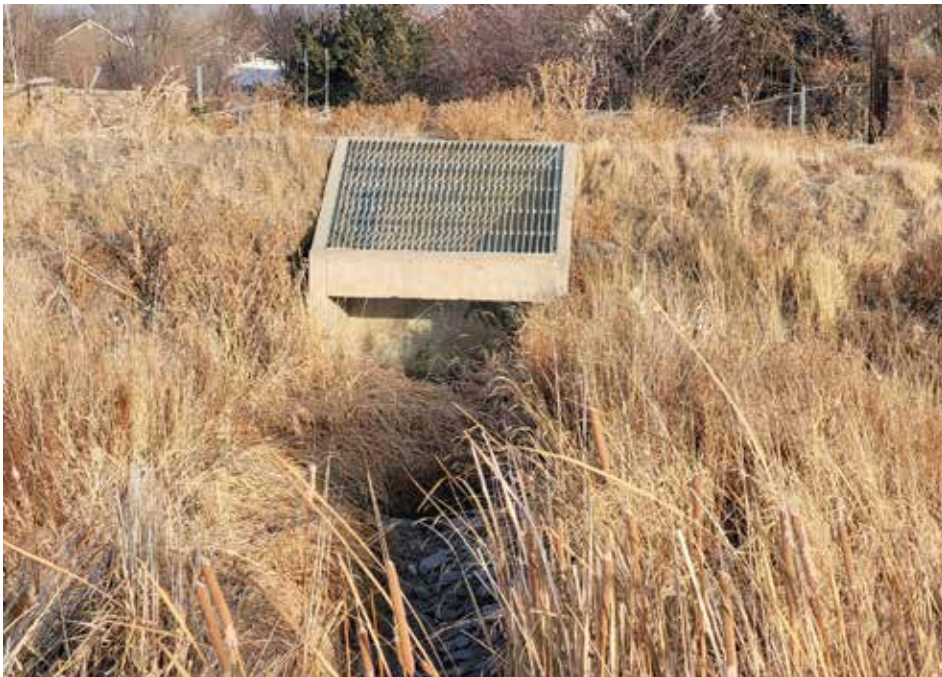
Photo 30 - Pictured east and downgradient of 3400 West is the Bingham Creek Channel. The pictured grated box directs flow in the Channel past the Welby Canal. No water was observed in the Channel nor was any erosion observed along the Channel and around the Canal.

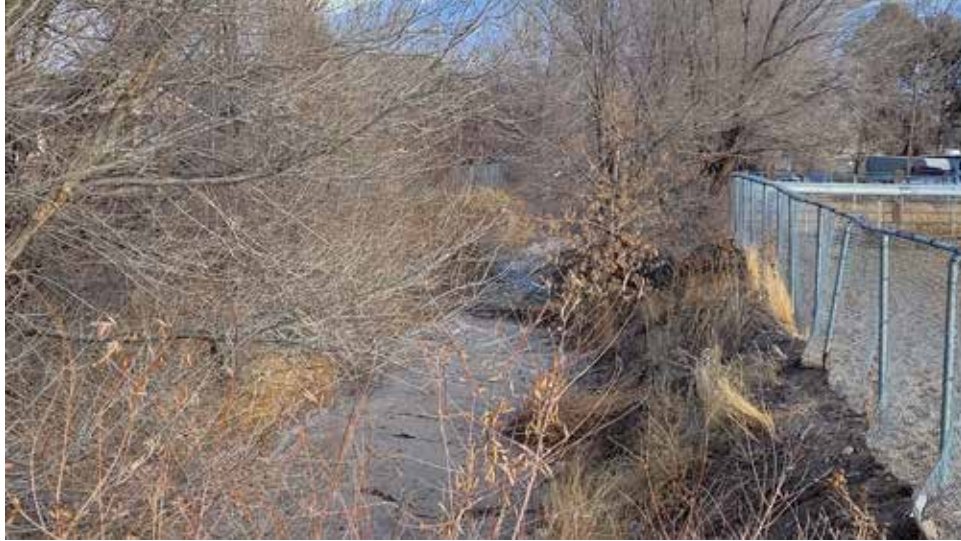
Photo 31 - Pictured east and downgradient of 3200 West is the Bingham Creek Channel (south of Haun Drive) in West Jordan City. The Channel is cement lined in this location and bounded by residential parcels. No water was observed in the Channel nor was any evidence of erosion observed along the Channel. The tops of the Channel embankments were well vegetated with scrub oak, willows, grasses, and other weedy species.

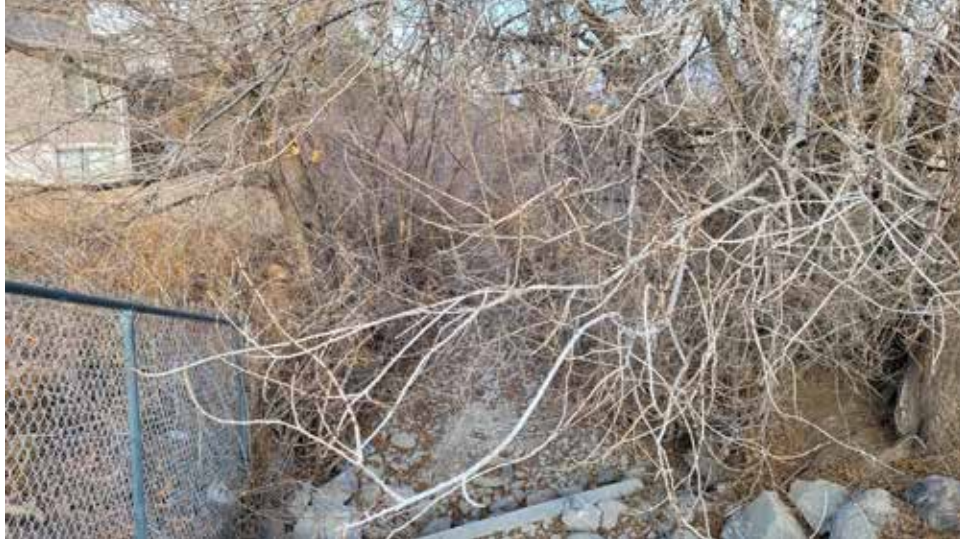
Photo 33 - Pictured northeast from 2700 West is the Bingham Creek Channel just below the culvert under 2700 West. The Channel has a soil and rock bottom, with a dense thicket of willows and grasses. The Channel acts as a boundary between the residential parcels to the north and the Glenmoore Golf Course to the south (to the right, not visible). No water or erosion was observed.

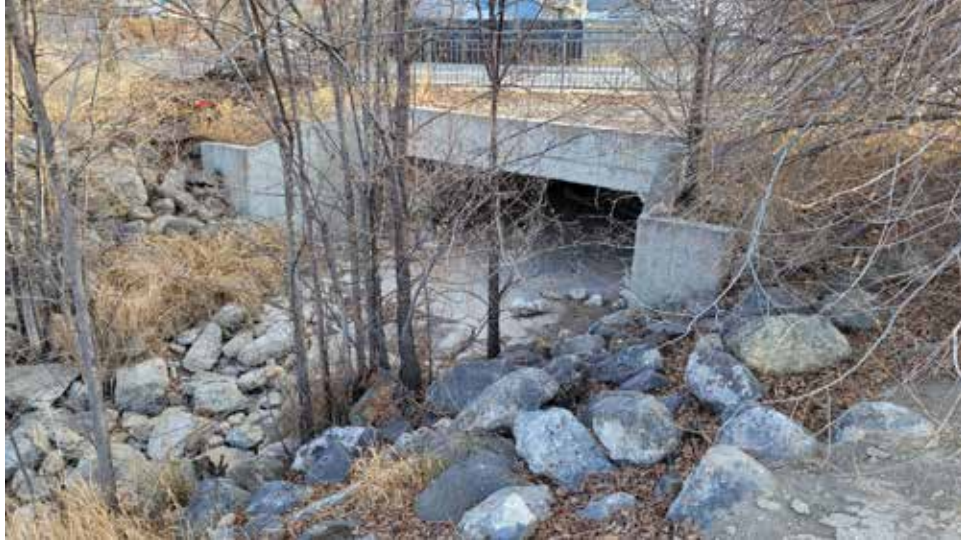
Photo 35 - Pictured north and downgradient of Sugar Factory Road is the Bingham Creek Channel and a box culvert under Sugar Factory Road. No water was observed in the Channel. The Channel below the culvert is well armored with large rock. Vegetation observed has not changed since the last FYR.

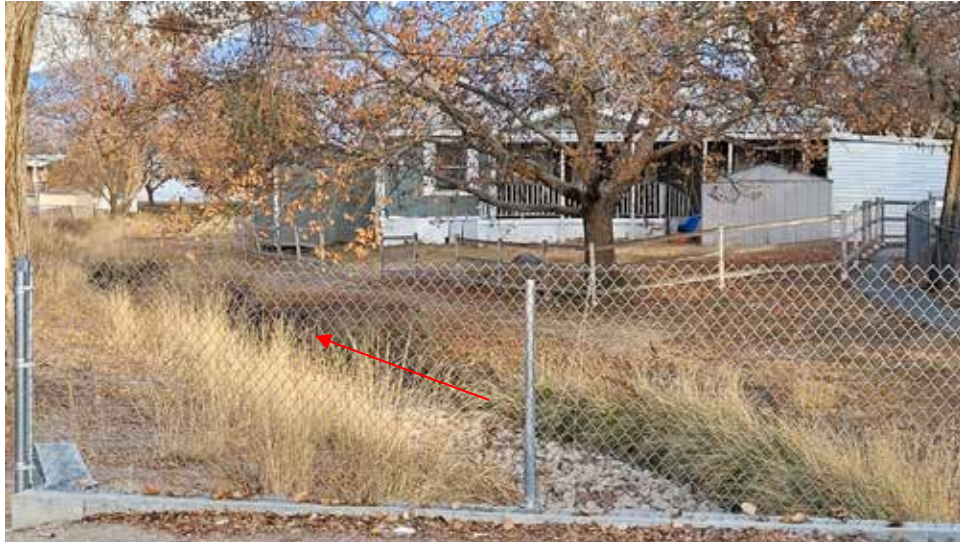
OU1

Photo 37 - Pictured east and downgradient of 1700 West (Redwood Road) is the Bingham Creek Channel (red arrow) as it enters the Brookside Mobile Home Park. The Channel characteristics have not changed since the last FYR. Most of the Channel is fairly incise and narrow with grass vegetation along the top of embankments. Some mobile home units have fences above the Channel.

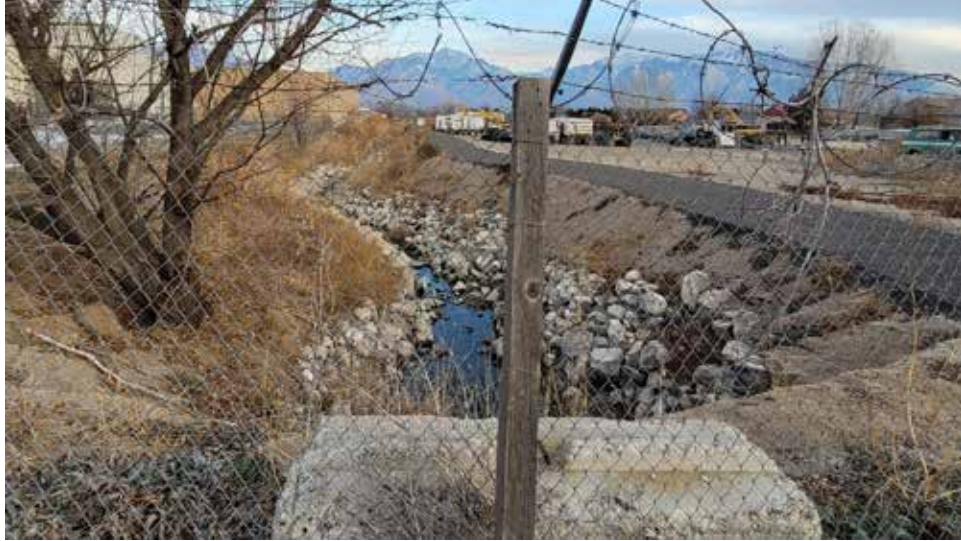
OU1

Photo 39 - Pictured east and downgradient of 1500 West is the Bingham Creek Channel. Under the City of West Jordan and Salt Lake County Health Department oversight, Salt Lake County Flood Control (SLCO FC) in 2019 redeveloped the Channel from 1500 West to 1300 West to enhance flood control capacity. Soils were retained onsite (under the paved access road) that were above the KUALs for arsenic and lead. The Channel is well armored and no erosion was observed, water was observed.

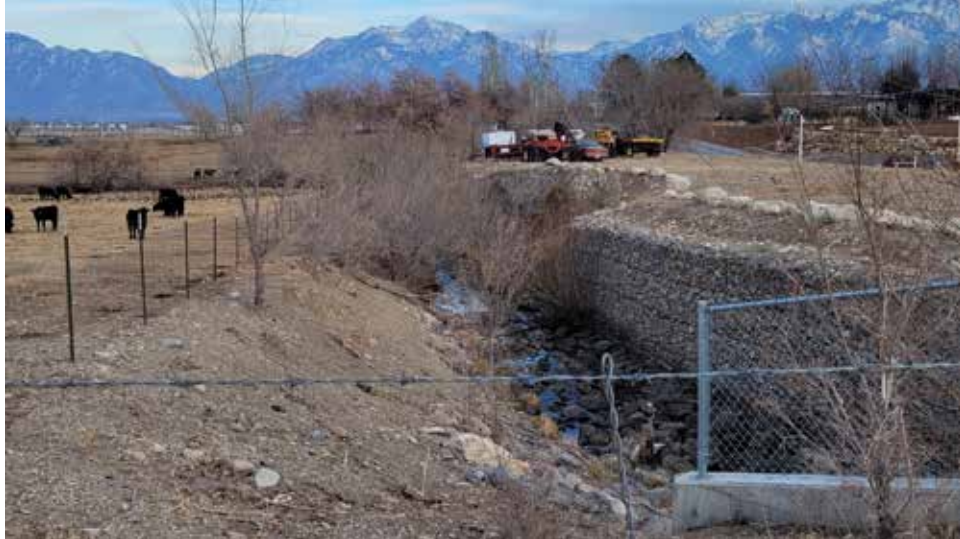
OU1

Photo 41 - Pictured east and downgradient of 1300 West is the Bingham Creek Channel. The Channel has not changed since the last FYR. The Channel begins a traverse through agricultural parcels (used for grazing). Further northeast the Channel runs through a buried culvert under an asphalt and paving business. Eventually Bingham Creek discharges into the Jordan River about 930 feet south of 7800 South. No erosion was observed along the Channel, the southern embankment has cribbing for stabilization, and water was observed.

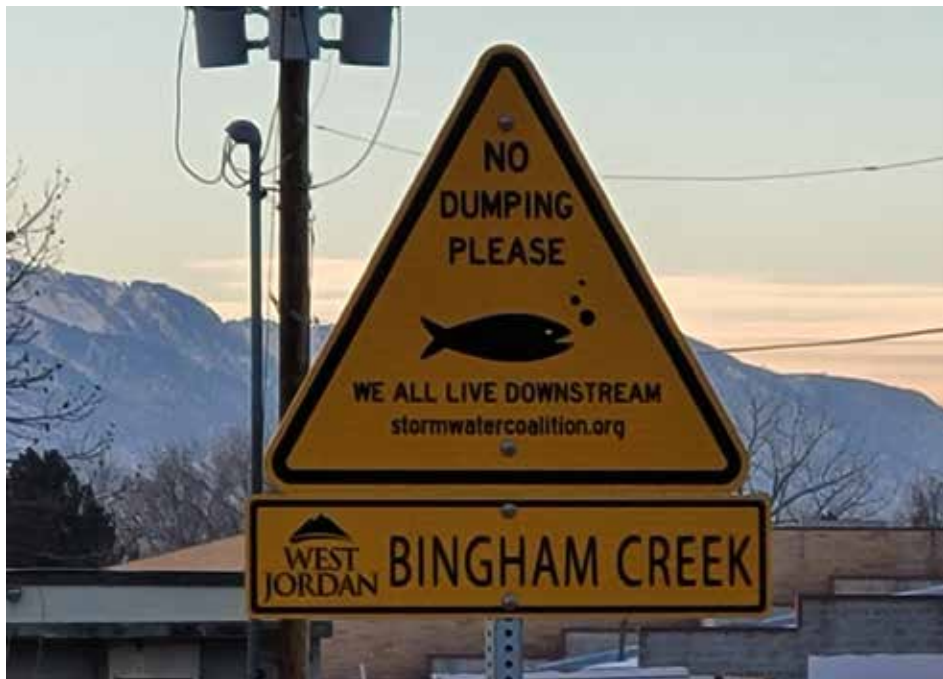
Photo 42 - Pictured is an example of signage the cities of West Jordan and South Jordan use to remind the public to not dump solid waste/garbage into Bingham Creek. Though enhanced with trails and parks, solid waste is dumped into sections of Bingham Creek. Rarely have fish been observed in the Channel, mallards have been observed in the past.

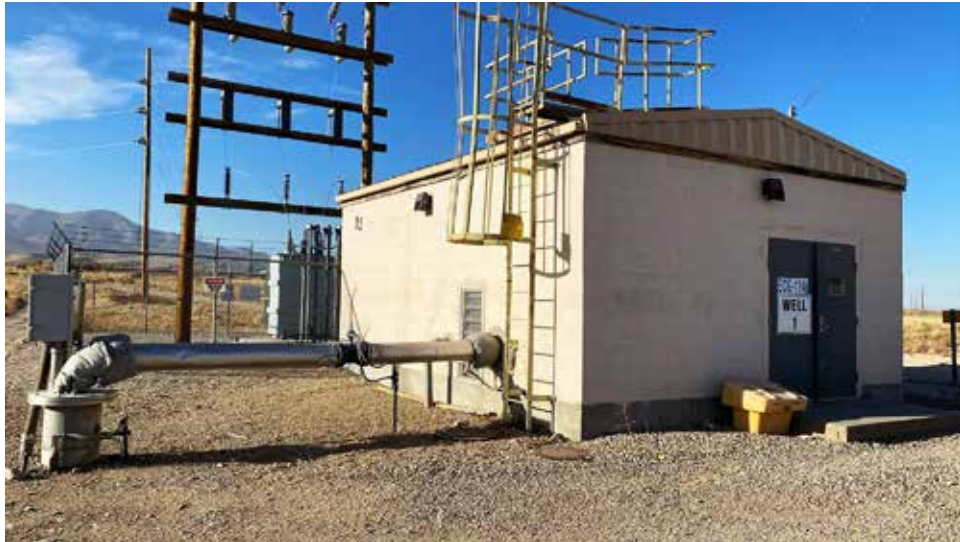
OU2

Photo 43 - Pictured is Acid Extraction Well #ECG1146. ECG1146 is the original extraction well, constructed by RTKC, in response to CERCLA and State NRD investigations. The building houses the well piping, and metering equipment. No leakage around the well head and casing (left side of the frame) was observed.

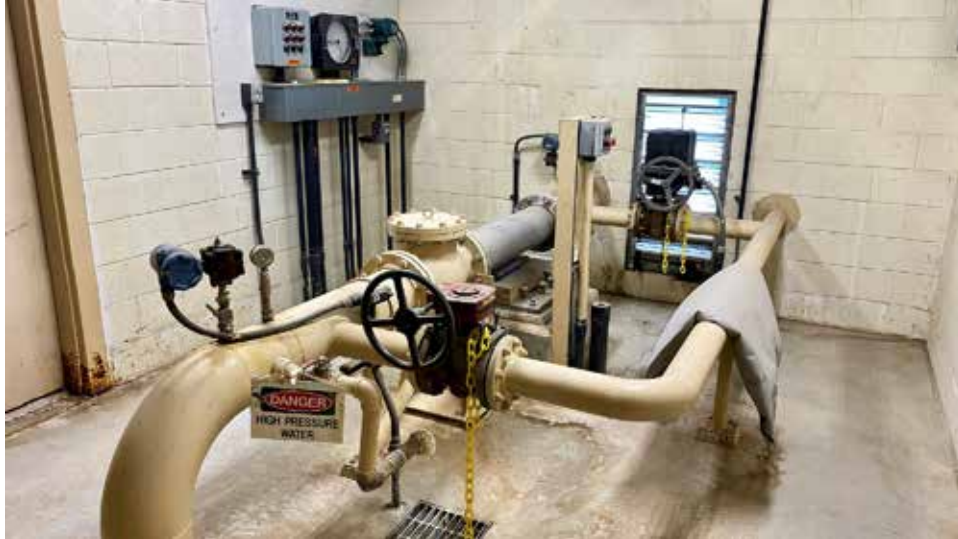
OU2

Photo 45 - Pictured is the well piping for Acid Extraction Well #ECG1146. No signs of leakage were observed.

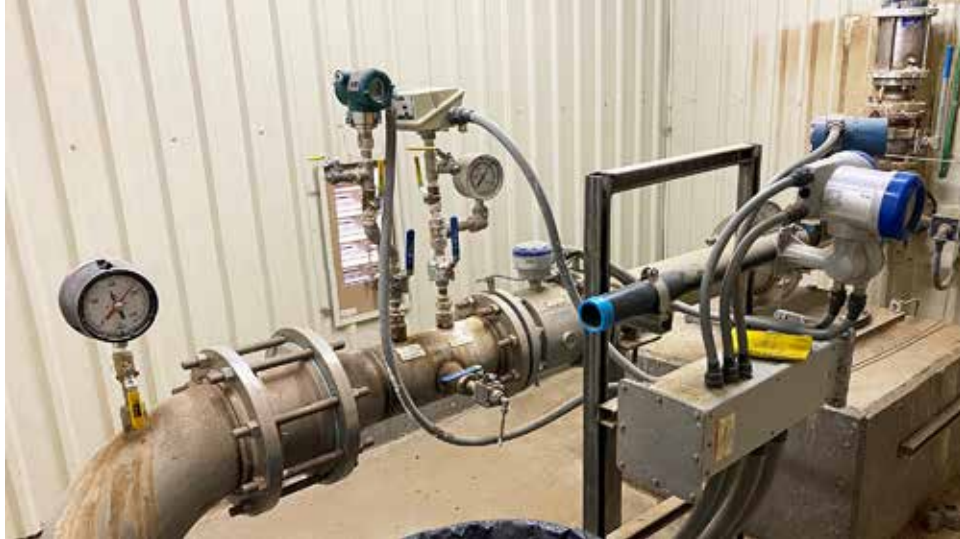
OU2

Photo 49 - Pictured is the well piping inside of well house for BSG2784. No signs of leakage were observed.

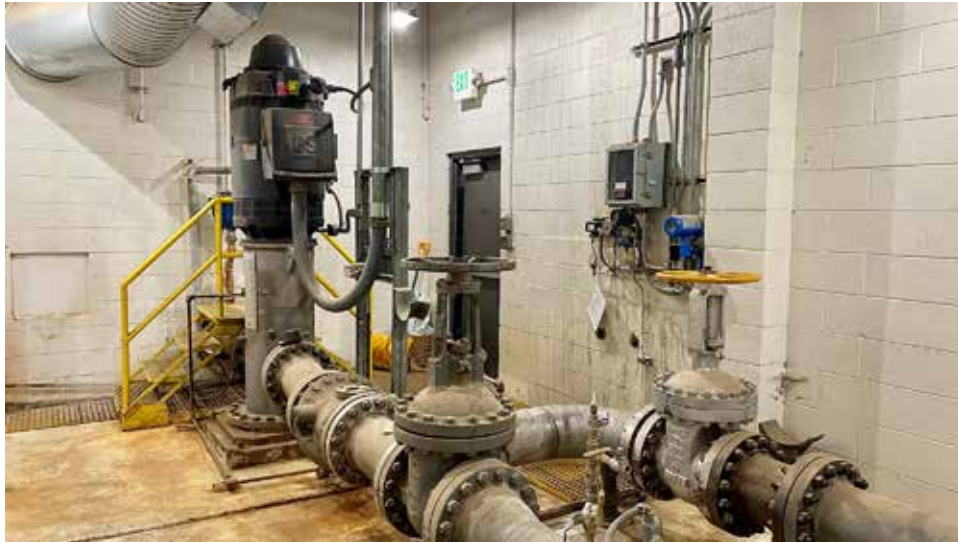
OU2

Photo 53 - Pictured is the well pump, piping and metering equipment for B2G1193. No signs of leakage were observed.
