SECOND FIVE-YEAR REVIEW REPORT FOR
KENNECOTT (SOUTH ZONE) SUPERFUND
ALTERNATIVE SITE
SALT LAKE COUNTY & TOOELE COUNTY, UTAH

Utah Department of Environmental Quality
Division of Environmental Response & Remediation
Salt Lake City, Utah

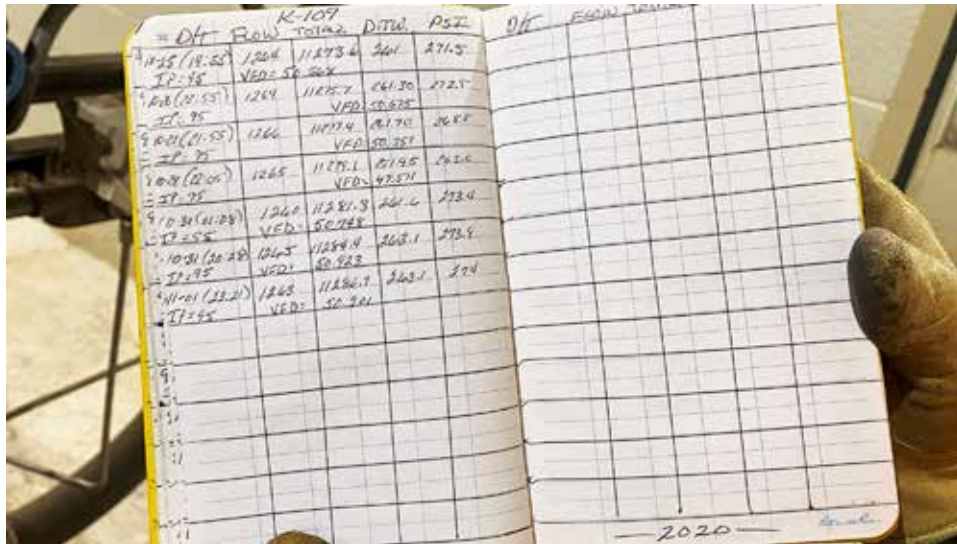
OU2

Photo 54 - Pictured is the well head, casing, and pipe, as well as the housing for Barrier Well #BFG1200 (or K109). No leaks were observed.

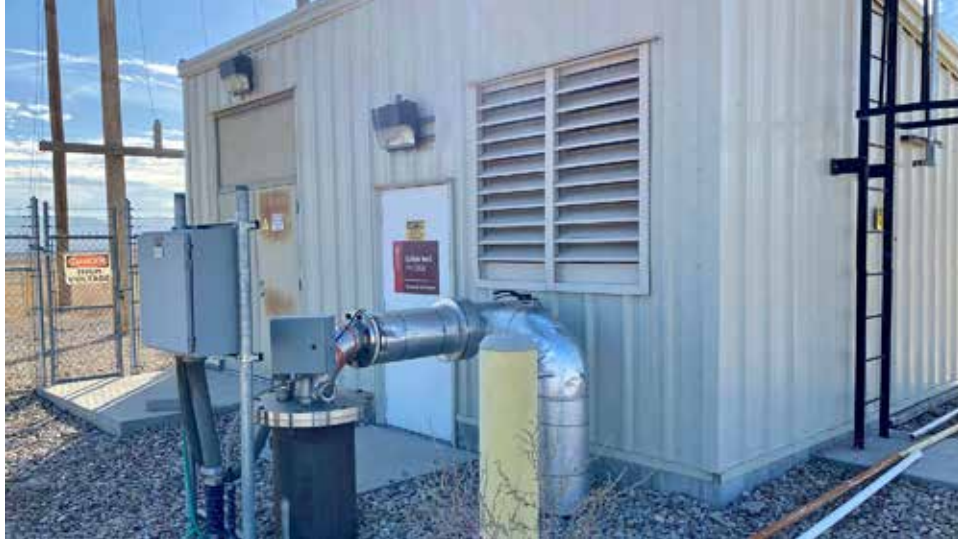
OU2

Photo 56 - Pictured is the well pump, piping and metering equipment for BFG1200. No signs of leakage were observed.

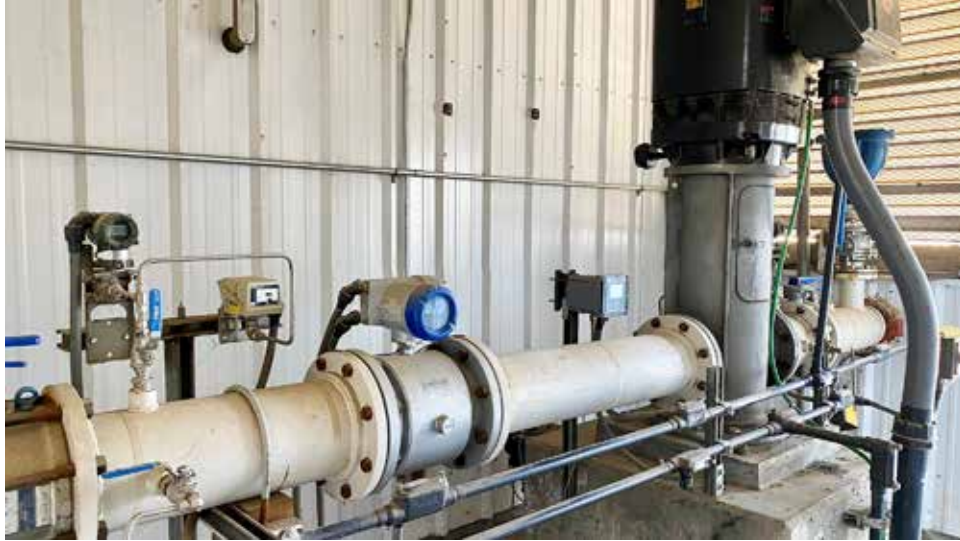
OU2

Photo 59 - Pictured is the well pump, piping and metering equipment for BSG2828. No signs of leakage were observed.

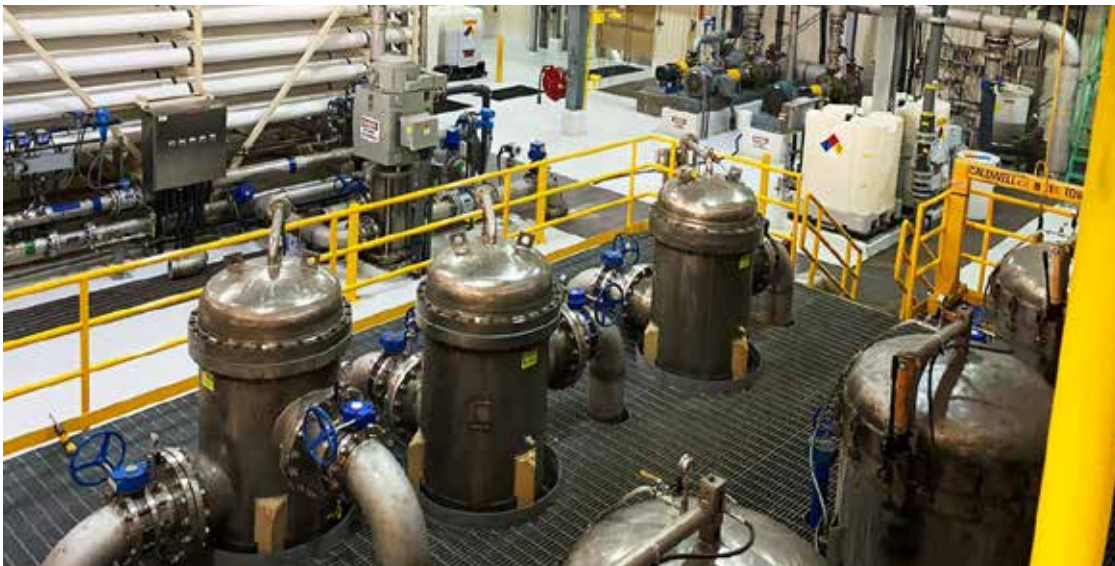
Photo 65 - Pictured are the feed water and finish water storage tanks for the Zone A RO plant. The feed water tanks store water from the barrier wells. Prior to entering the plant, the feed water is directed through UV disinfectant. Product water prior to leaving the plant is degasified to remove radon. Also pictured is the various piping to convey water. No leaks were observed.

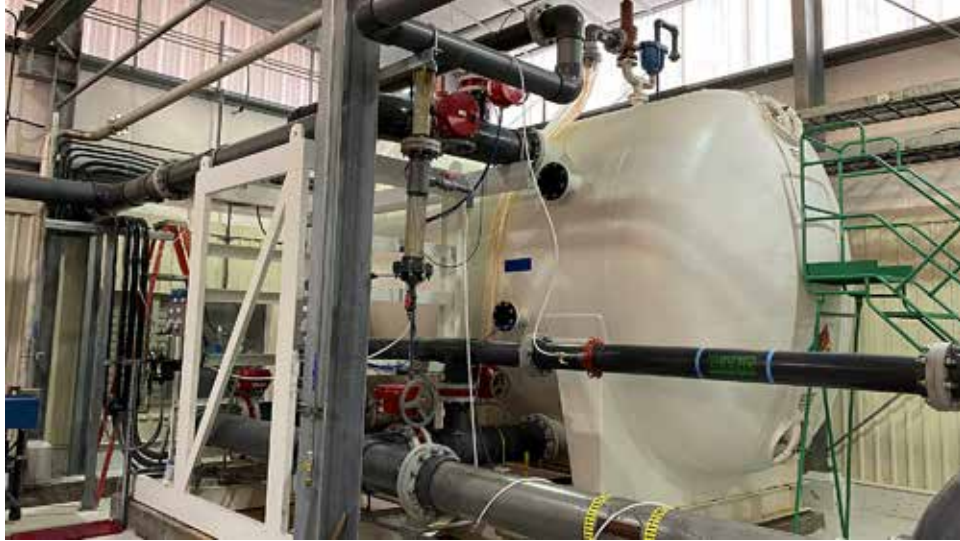
OU2

Photo 68 - Pictured are the two RO membrane treatment skids each capable of treating 1,500 gallons per minute (gpm). Each skid consists of two treatment stages, the concentrate or byproduct of the first stage becomes the feed water for the second stage. Each treatment skid is able maintained to have a recovery efficiency of approximately 75%. Each white PVC horizontal vessel holds 7 RO membrane units. No leaks were detected.

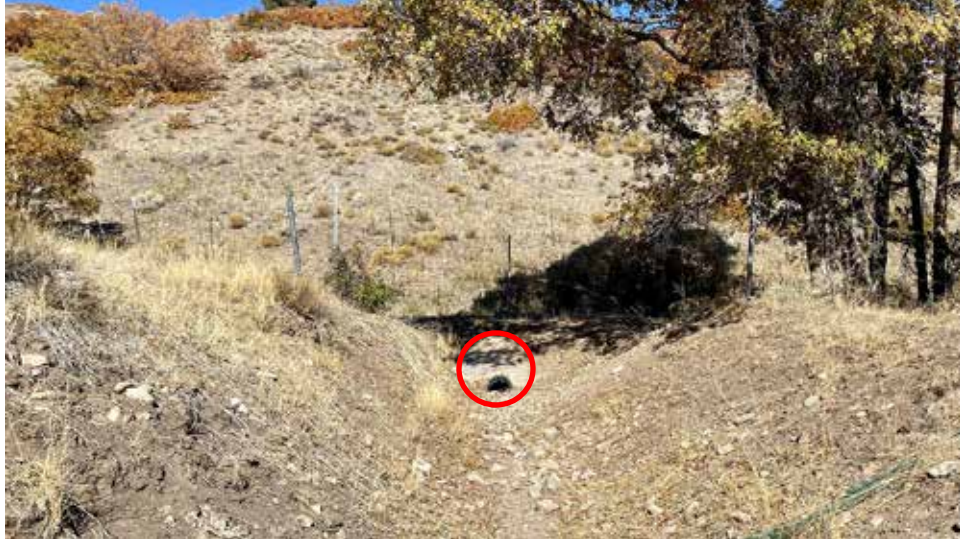
OU3

Photo 74 - Pictured is Yosemite Drainage just above the SLCO road in Butterfield Canyon. The Yosemite Drainage is incised along this lower stretch and has previously been impacted by releases of waste rock sediment from the South Waste Rock Dump located in the upper reach of the Yosemite Drainage. The Yosemite Drainage channel is well vegetated with sagebrush, rabbitbrush and grasses but the bottom is comprised of gravelly silt. No signs of recent erosion were observed.

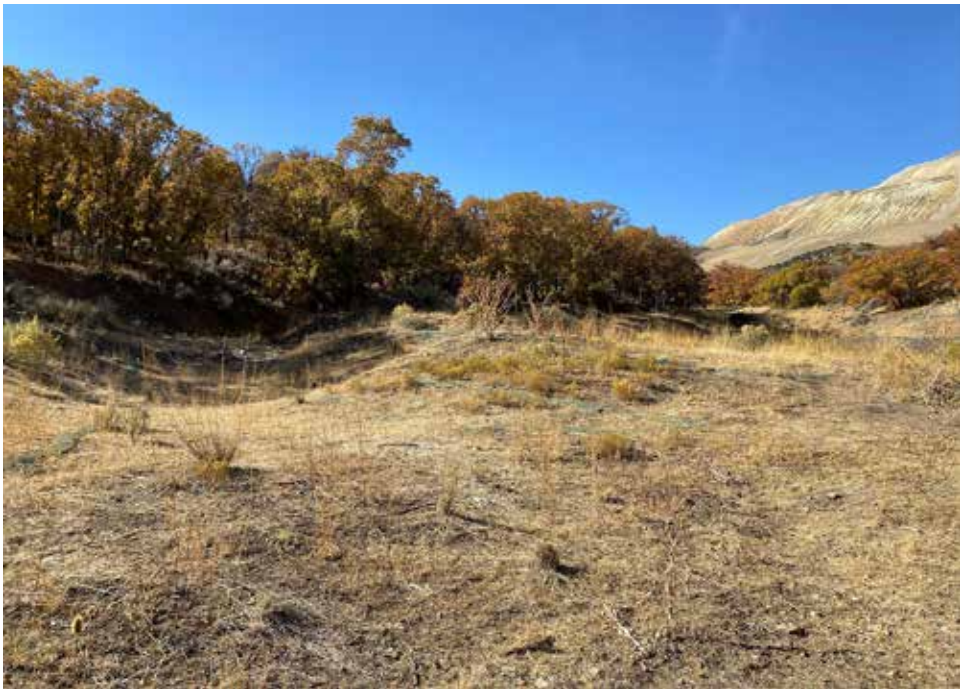
Photo 75 - Pictured south from the SLCO road (downgradient) is the culvert outlet that conveys storm water from the Yosemite Drainage into Butterfield Creek. The outlet (red circle) appeared stable and no signs of recent erosion were observed.

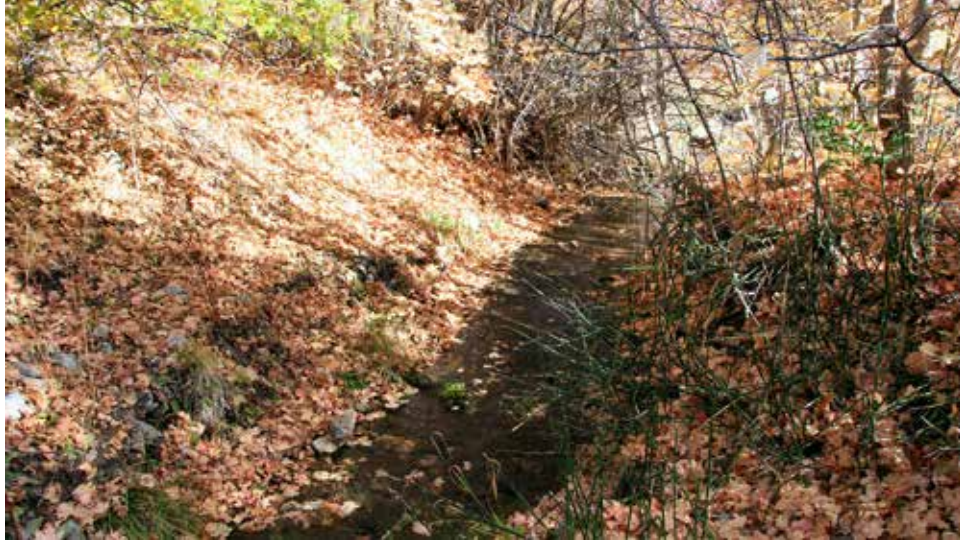
OU3

Photo 83 - Pictured is a segment of Butterfield Creek Channel in a thicket of scrub oak. The Channel runs through thickets of scrub oak and can have steep embankments which can be subject to erosion. No signs of recent erosion were observed. The thickets of scrub oak, cottonwoods, aspen can be dense, leading to a fair amount of leaf litter in the Creek Channel.

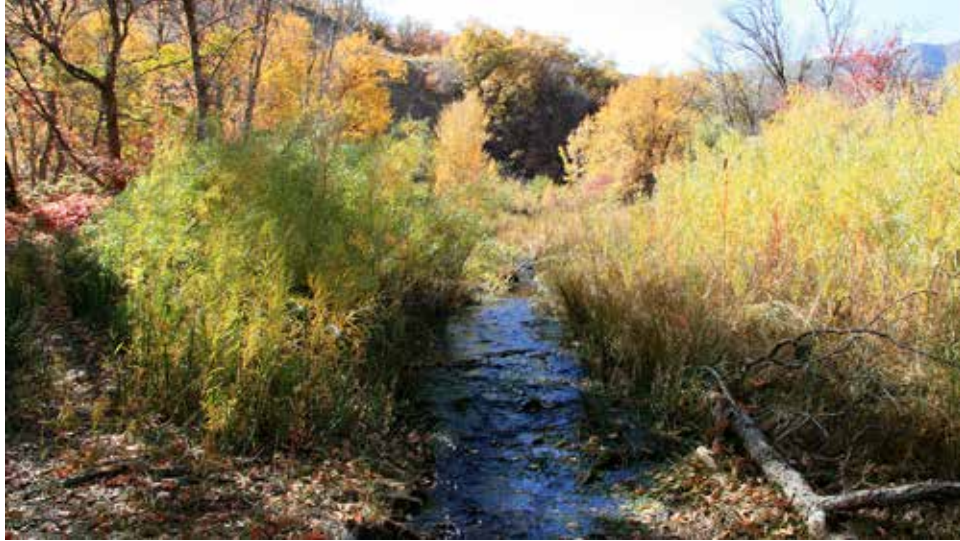
OU3

Photo 85 - Pictured is a segment of Butterfield Creek downgradient of the confluence with Olsen Drainage. The Channel is well vegetated by a dense a thicket of willows, tamarisk which prevents easy access. The Channel is fairly wider at this point and the flow is slower.

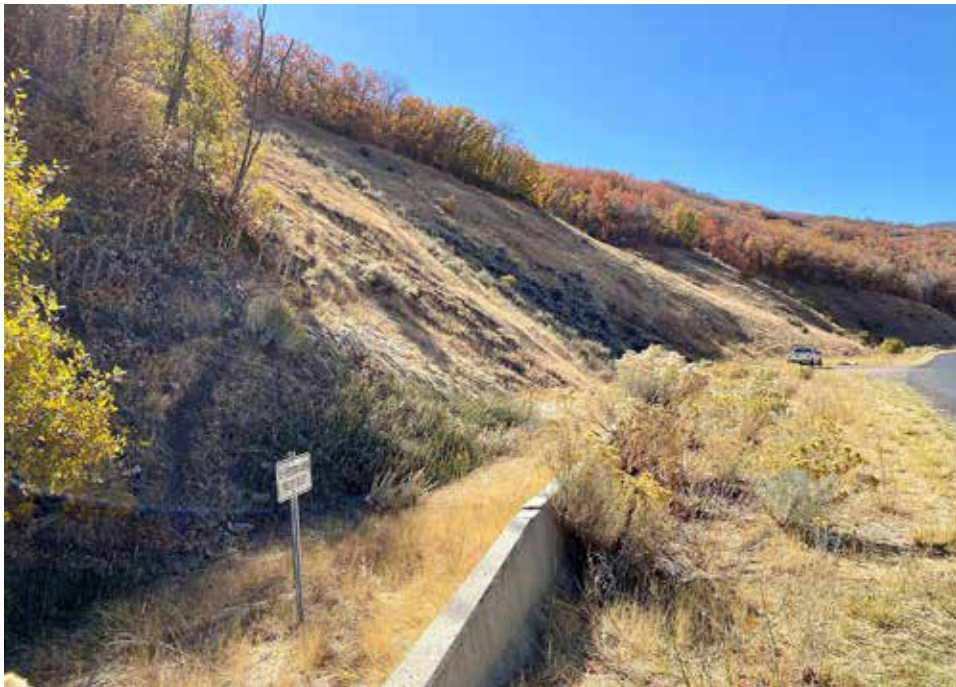
Photo 86 - Pictured is the lower area where waste rock previously located in the middle reach of Butterfield Canyon was removed from below Butterfield Mine Tunnel. The hillside surface is steep, with revegetation still in progress where the waste rock was removed. From the Canyon floor to the tree line demonstrates the vertical height of the waste rock previously located in the Canyon.

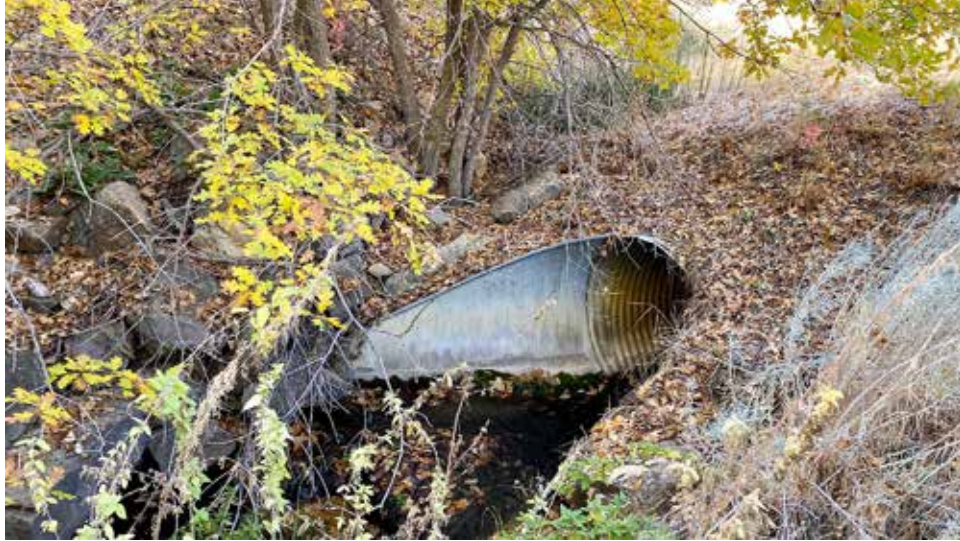
OU3

Photo 87 - Pictured is another segment of Butterfield Canyon. During a 2013 high intensity storm event a section of the Channel got eroded enough to compromise the integrity of SLCO road. To address this, SLCO installed larger culverts (as pictured) to manage future storm water runoff.

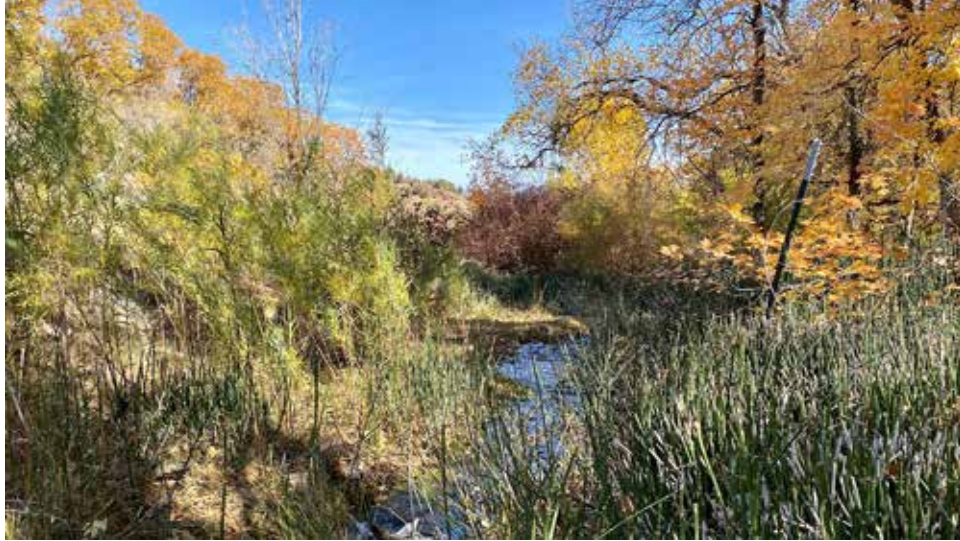
OU3

Photo 89 - Pictured is another segment of Butterfield Creek Channel. In addition to willows and grasses, other wetland plant species can be observed in the Channel. The aquatic and wetland plants do a great job stabilizing the embankments of the Channel and preventing erosion. The vegetation also serves as habitat to passerine bird species and small animals. Because water is not always available in the Creek, rarely are fish observed.

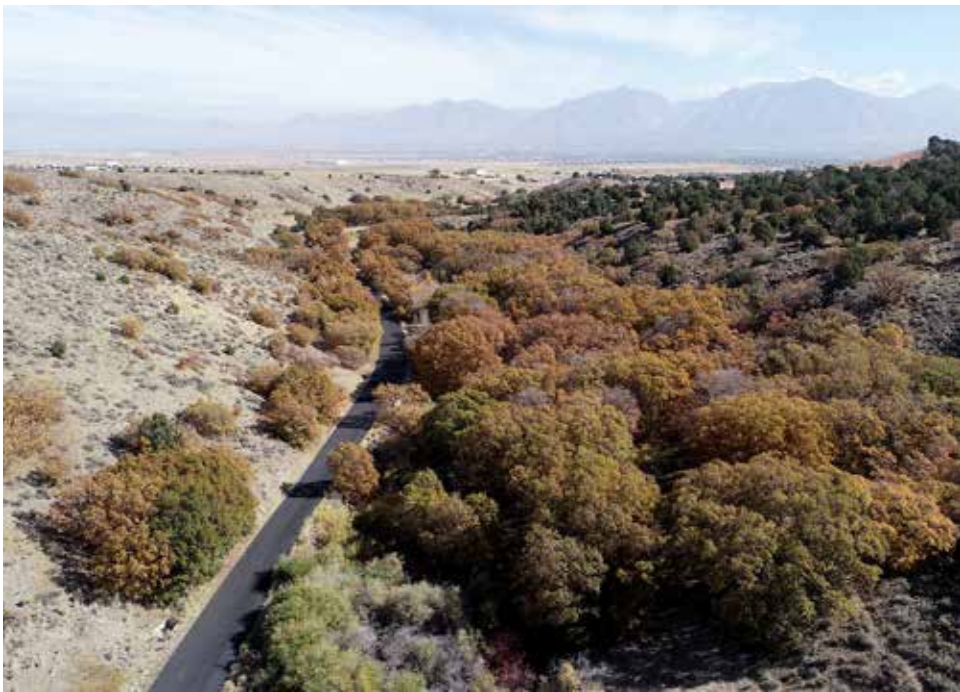
Photo 90 - Pictured is an aerial view of Butterfield Canyon below the confluence with Yosemite Drainage (out of frame to the lower left quadrant). Tailings located under the SLCO road has lead and arsenic concentrations above the KUAs. Butterfield Creek is under the canopy of scrub oak.

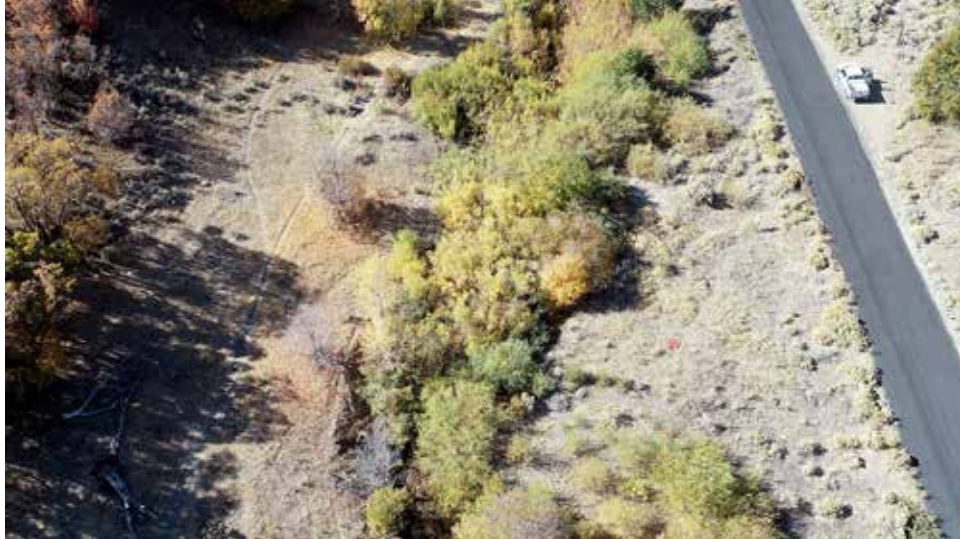
OU3

Photo 91 - Pictured is an aerial view of the confluence of Saints Rest Drainage and Butterfield Canyon, upgradient of the confluence with Yosemite Drainage. This area was impacted by waste rock sediment released during a 2013 intense storm event. Tailings located under the SLCO road contains lead and arsenic concentrations above the KUALs.

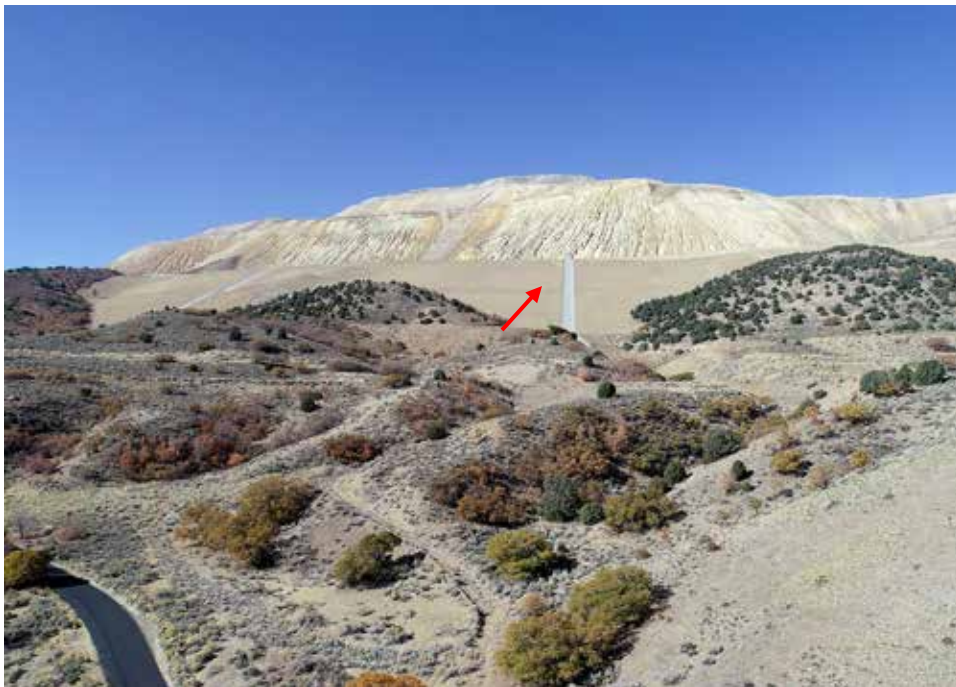
Photo 92 - Pictured is the Saints Rest Drainage above the SLCO Road in Butterfield Canyon, and the South Waste Rock Dump located in the upper reach. The new bench of waste rock (red arrow) is part of the reclamation project Kennecott is pursuing to increase stabilization of the South Waste Rock Dump and storm water containment capacity.

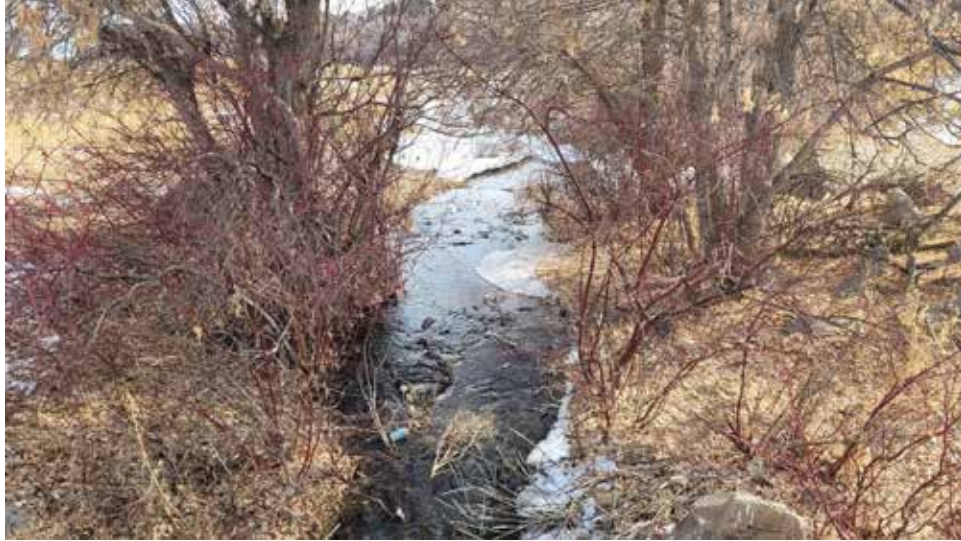
OU3

Photo 93 - Pictured is Butterfield Creek Channel downgradient of the SLCO Wild Burro Center access road at the mouth of Butterfield Canyon. The Channel is shallow in this location with large flat floodplain. No signs of recent erosion were observed.

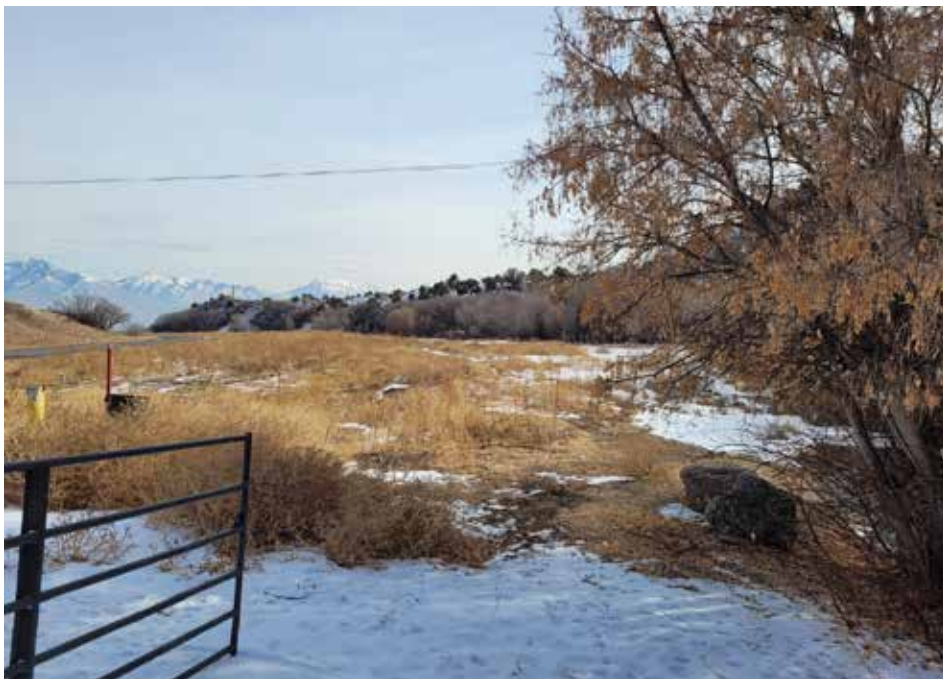
Photo 94 - Pictured is the vegetated (grasses) floodplain of Butterfield Creek (Butterfield Creek is to the right running under the tree canopy). A Kennecott groundwater monitoring well along the upper-lower left quadrant is visible (the yellow vertical casing). Often during high flows, Butterfield Creek floods the depicted parcel.

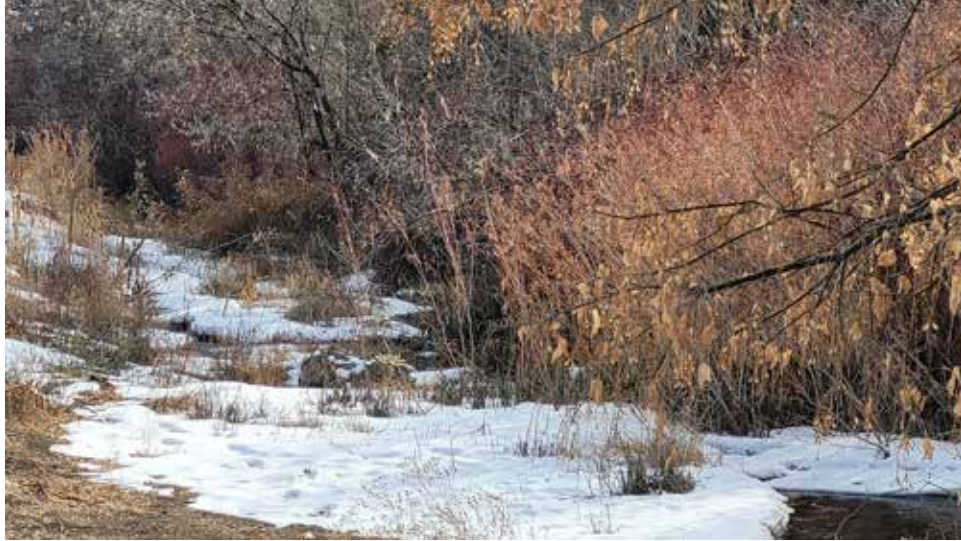
OU3

Photo 95 - Pictured is the Butterfield Creek Channel about 75 feet east of the SLCO Wild Burro Center access road. Flow in Butterfield Creek is slow enough during most of the year that erosional cuts are rare. No signs of recent erosion were observed.

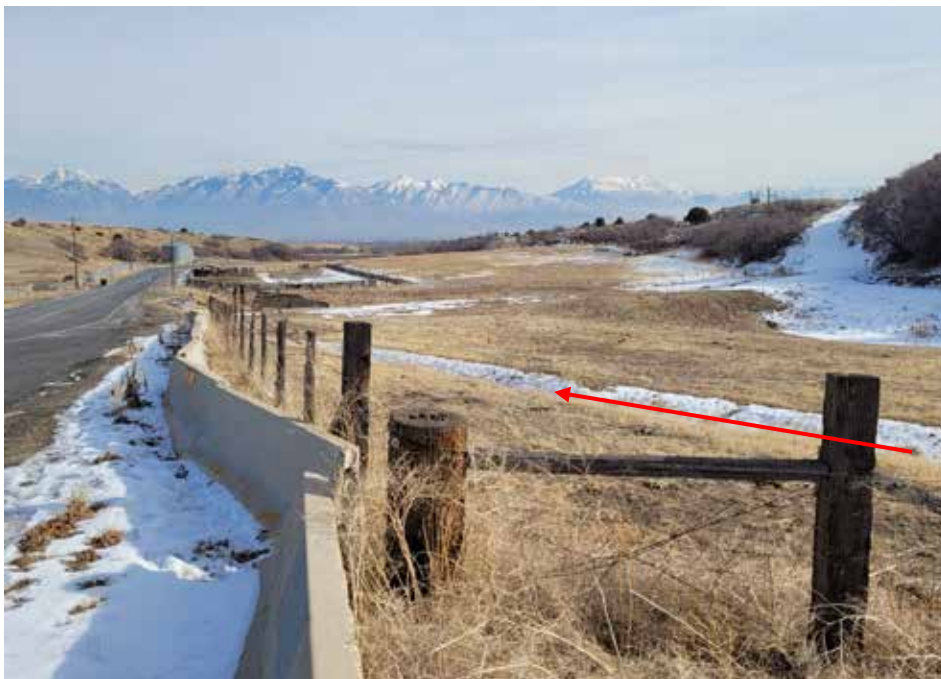
Photo 96 - Pictured is the western extent of Herriman Agricultural Lands beginning with parcel HAG001. Butterfield Creek (red arrow) generally parallels the SLCO road, crossing it as diverted to be used for irrigation further east (view is to the east). No land use changes were observed on the Herriman Agricultural (HAG) parcel #001.

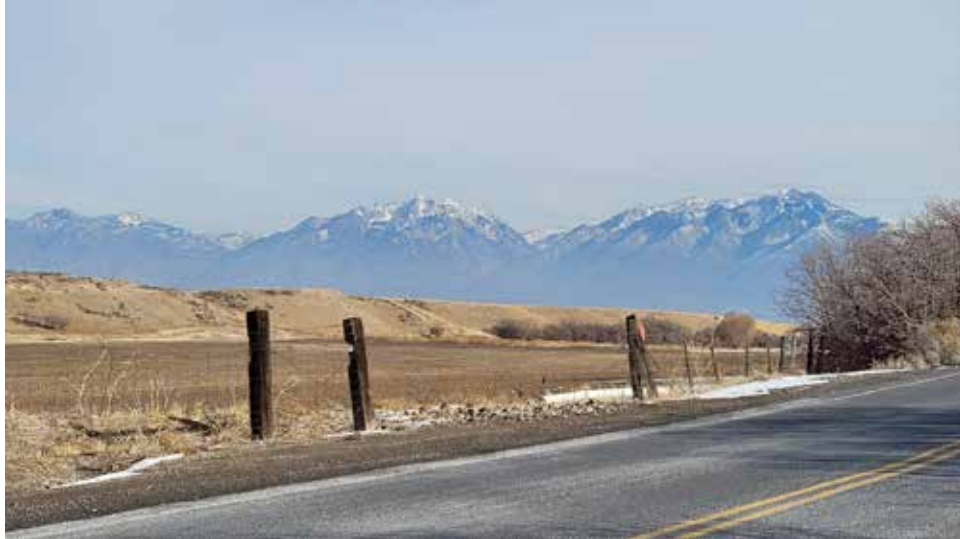
OU3

Photo 97 - Pictured is the eastern portion of HAG001 where RTKC performed removal action due to the release of waste rock sediment from a 2013 intense storm event. The ground surfaces were observed to be prepared for planting alfalfa during the inspection. HAG001 is part of a planned development, Olympia Hills, project.

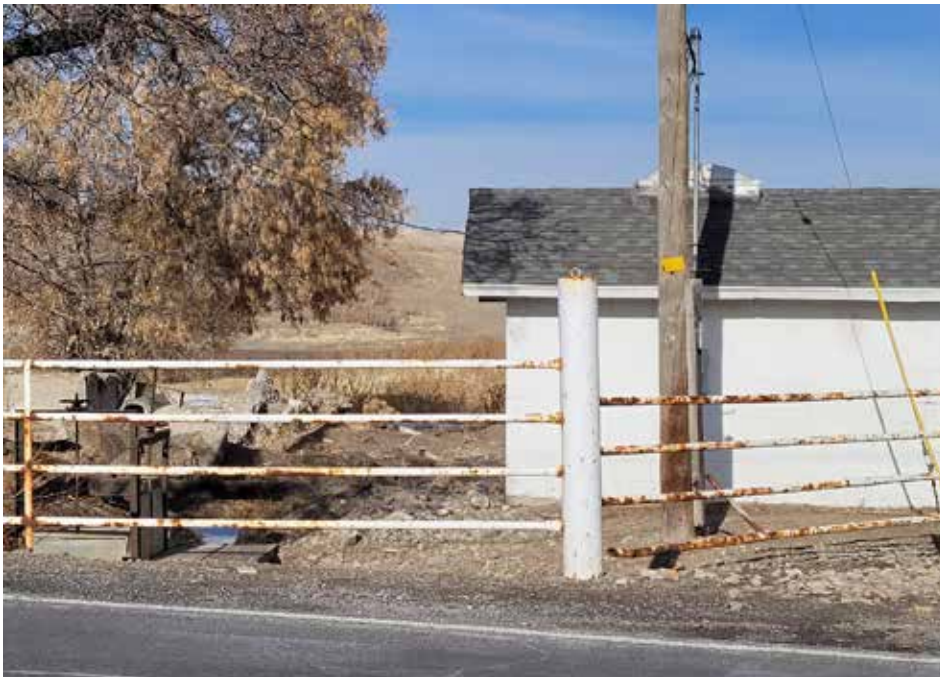
Photo 98 - Pictured is a diversion gate (lower left quadrant, behind the white metal fencing) for Butterfield Creek on parcel HAG007. The Creek is diverted into the Herriman Pipeline Company irrigation system for downstream customers use.

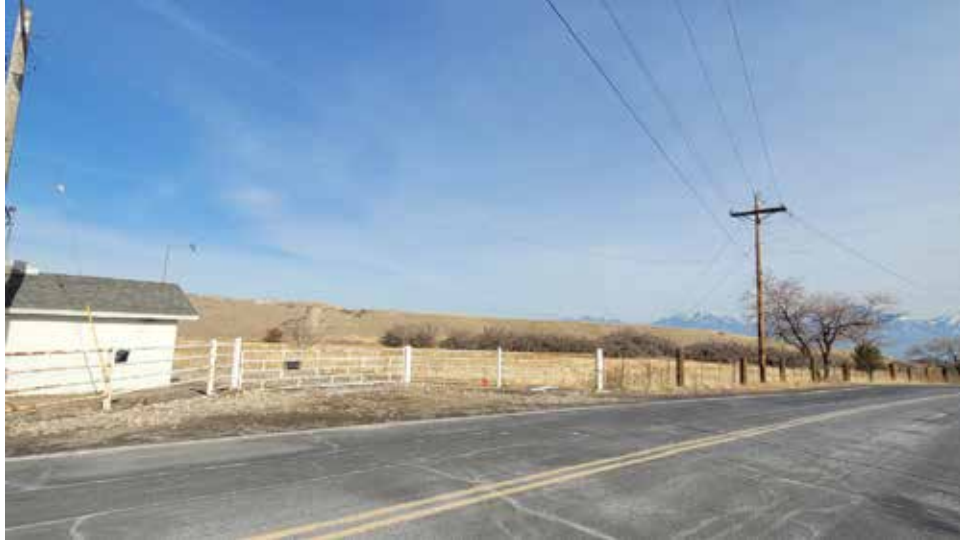
OU3

Photo 99 - Pictured is the western portion of HAG007 (behind the fencing to the left of the SLCO road). Though redevelopment has not been initiated here, HAG007 is undergoing redevelopment converting the agricultural land into residential lots under the oversight of the City of Herriman and their contaminated soils ordinance.

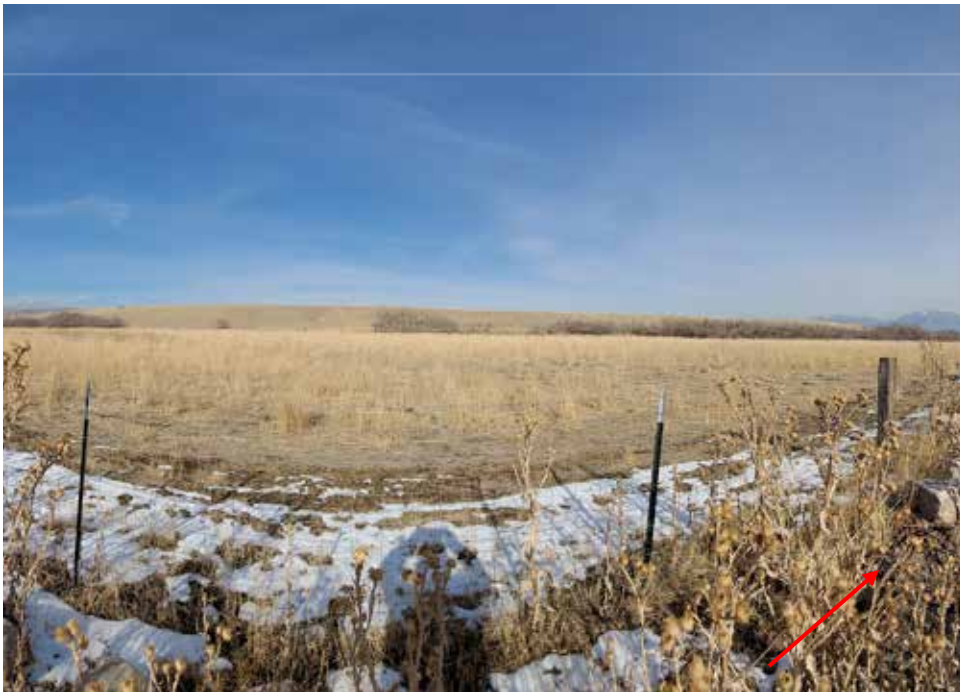
Photo 100 - Pictured is another segment of parcel HAG007. A portion of Butterfield Creek water is diverted into the ditch (red arrow) for irrigation use.

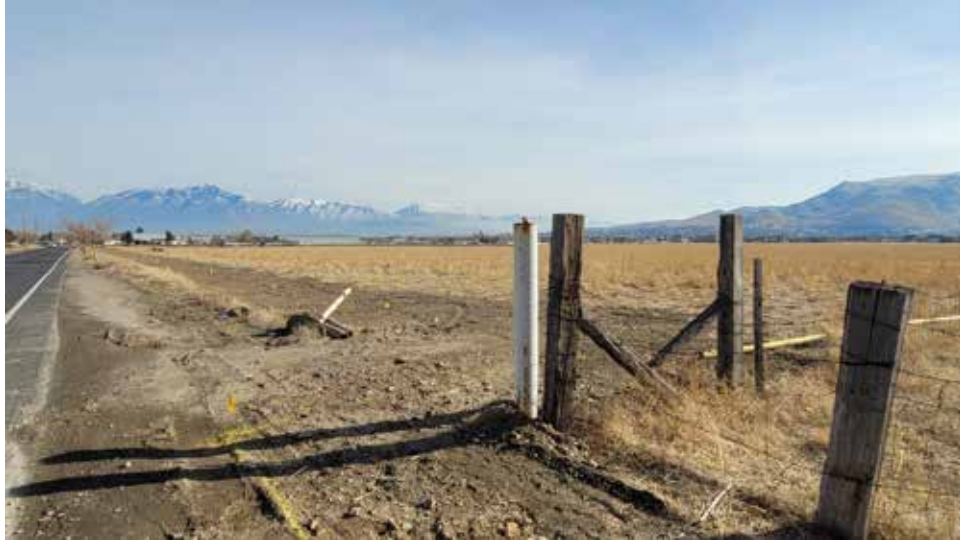
OU3

Photo 101 - Pictured is the northwestern corner of parcel HAG010. HAG010 is being redeveloped under the oversight of the City of Herriman and their contaminated soils ordinance.

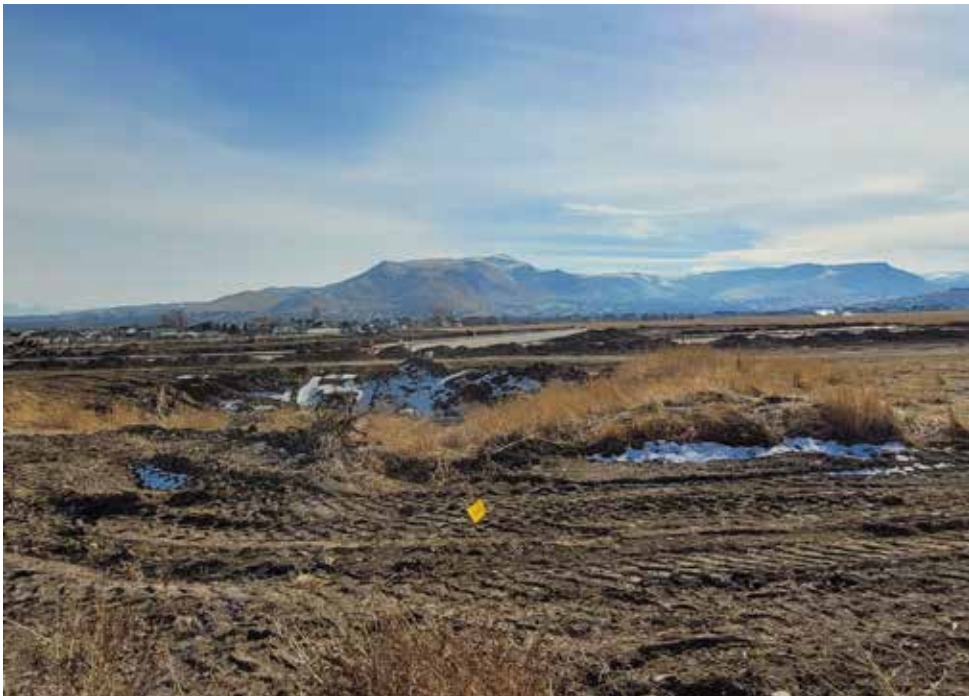
Photo 102 - Pictured is a northeast portion of parcel HAG010. Soil surfaces have been disturbed, evidence of the redevelopment work that is currently in progress.

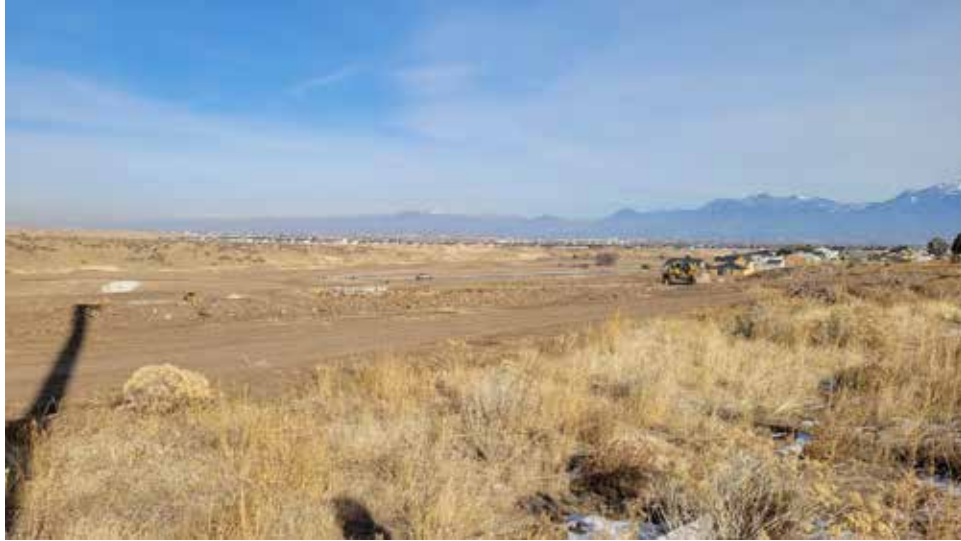
OU3

Photo 103 - Pictured is the eastern portion of HAG007 that is currently being redeveloped for residential use as part of the Hidden Oaks project. The redevelopment is under the oversight of the City of Herriman. Surfaces were disturbed, there were no distinctive soil stockpiles observed. A re-aligned Butterfield Creek was not yet distinguishable from the surrounding disturbed surfaces. Under the ordinance, soils with elevated arsenic and lead are being managed.

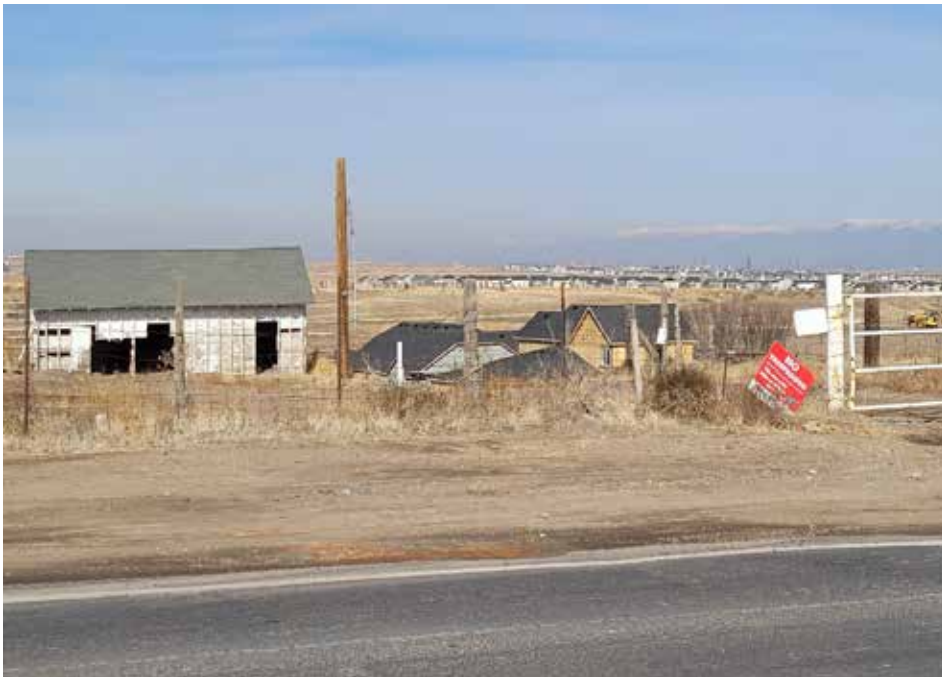
Photo 104 - Pictured is an eastern access point on HAG007, which is the proposed access point for the removal of the Bastian Ditch (OU5) located on a northern portion of HAG0007 under the SLCO Health Department oversight and their contaminated soils ordinance.

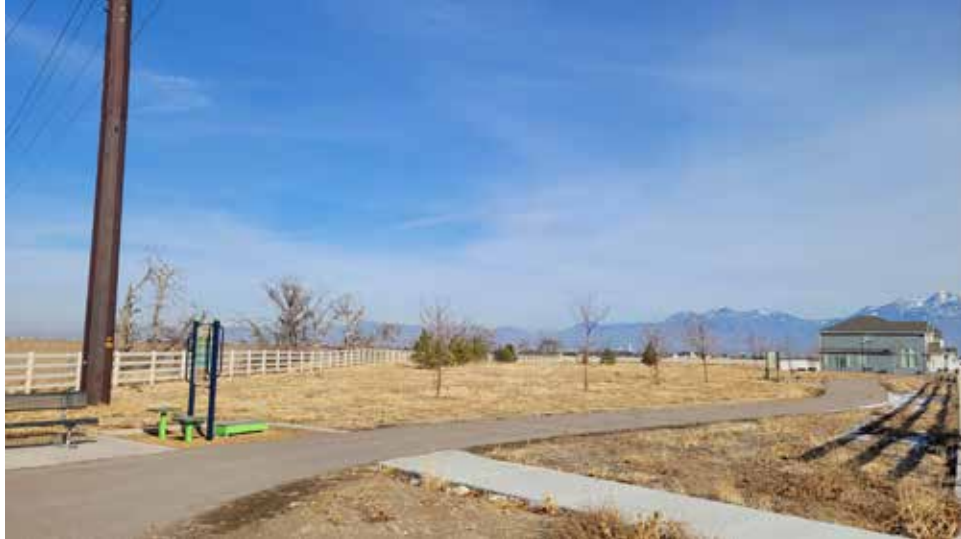
OU3

Photo 105 - Pictured is the neighborhood park created in the Blackhawk subdivision constructed in the early 2000s. Management of soils above the City of Herriman residential action level for arsenic and lead was done in compliance with the City of Herriman's contaminated soils ordinance. Some soils were encapsulated here in the park, as approved by the City of Herriman. Park surfaces were well vegetated and did not show any evidence of disturbance.

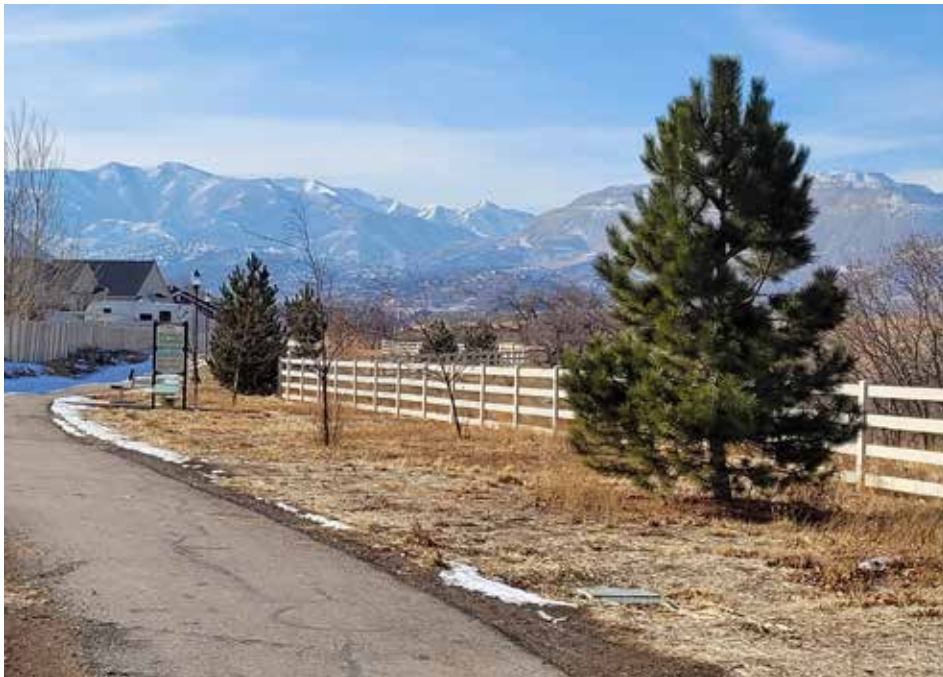
Photo 106 - Pictured is a portion of the established Blackhawk residential subdivision and park trail constructed while managing soils in compliance with the City of Herriman's contaminated soils ordinance. North of the fence line, parcel HAG007 is being redeveloped in compliance with the City of Herriman ordinance.

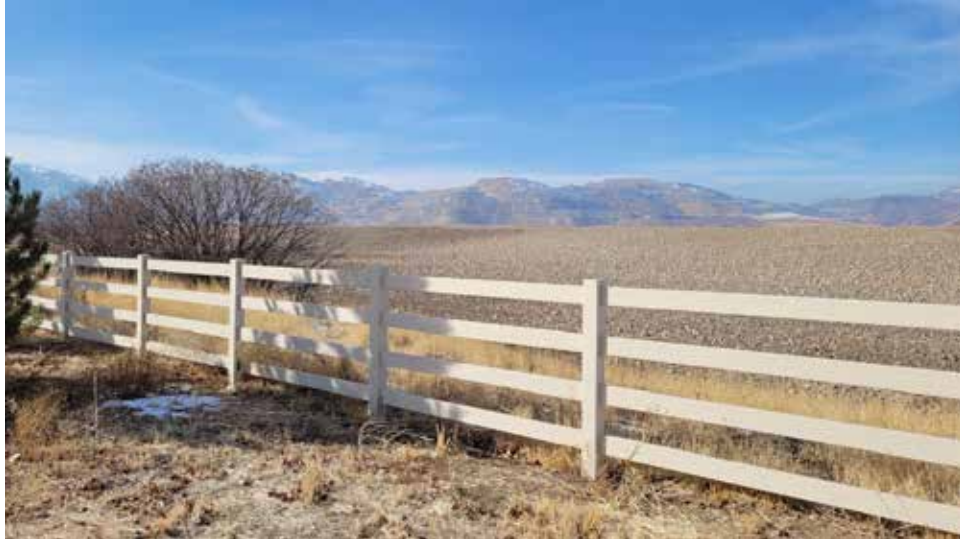
OU3

Photo 107 - As noted in Photo 106, north of the Blackhawk subdivision parcel HAG007 is being redeveloped. Soils are managed in compliance with the City of Herriman's ordinance. Surfaces and soils have been prepared to support the planned residential development, Hidden Oaks.

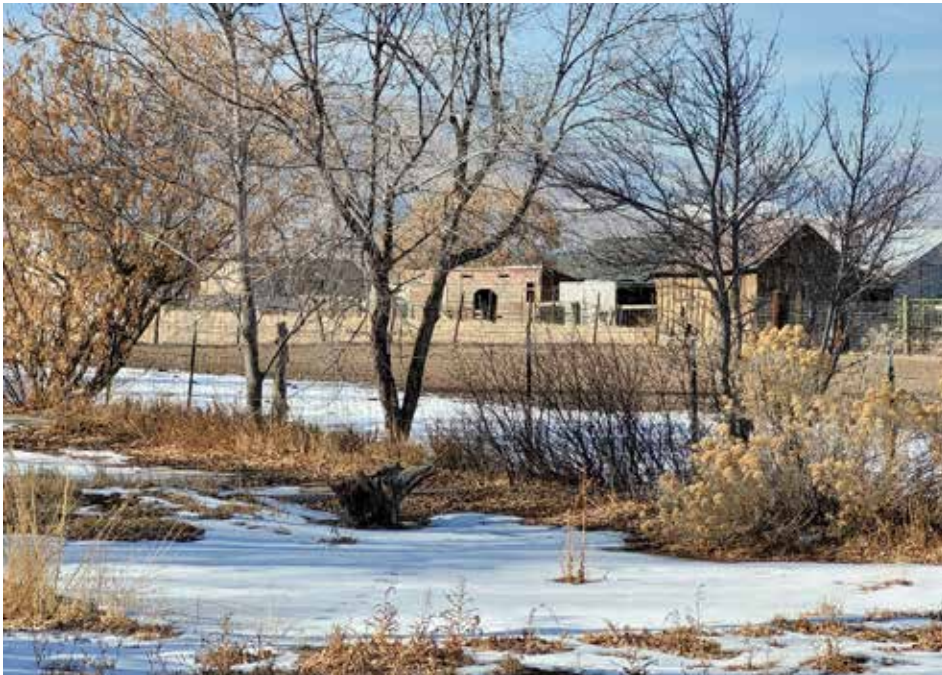
Photo 108 - Pictured is an example of a "pasture lot" in the historic residential section of Herriman. During the late 1990s removal action, EPA did not perform removal action on pasture lots. Pasture lots were determined by EPA not to have any exposure risk based on the then current land use. EPA determined that these pasture lots should be subject to the City of Herriman's contaminated soils ordinance if proposed for redevelopment.

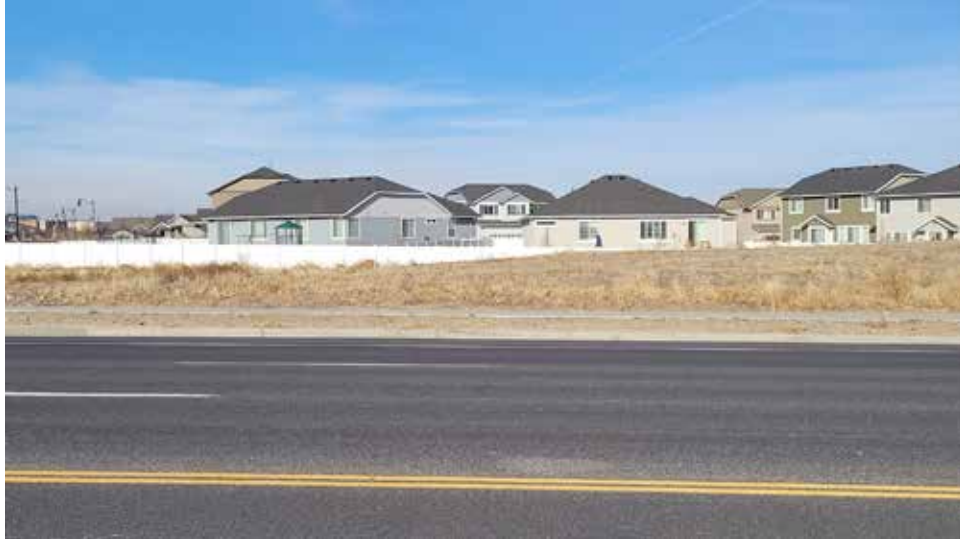
OU3

Photo 109 - Pictured is the western extent of the Tuscany Estates soils repository constructed (in the early 2000s) by the developer to manage soils removed from the residential development at Tuscany Estates (out of view to the south, current view is to the north). Soils on the Tuscany Estates site had lead concentrations greater than 1200 mg/kg and arsenic greater than 100 mg/kg. The repository parcel is subject to compliance with the City of Herriman ordinance if redeveloped. No signs of recent erosion were observed. The southern portion of the developed HAG031 parcel is located behind the white vinyl fence depicted in the background, north of the repository.

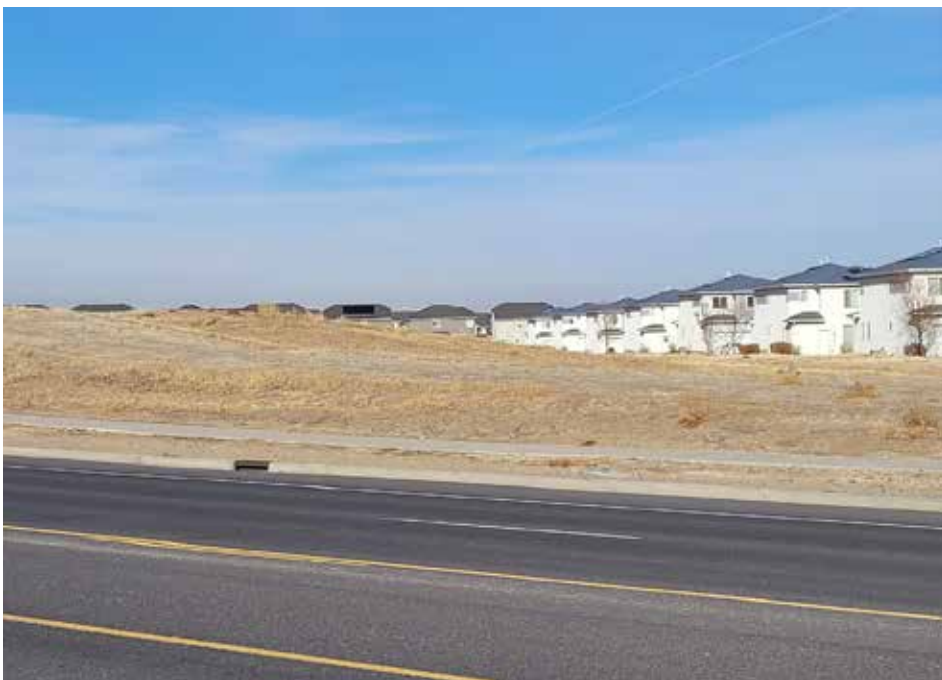
Photo 110 - Pictured is the eastern extent of Tuscany Estates soils repository. The repository parcel is subject to compliance with the City of Herriman ordinance if redeveloped. No signs of recent erosion were observed. The white sided homes to the right (east) are part of the Garbett Homes development on the adjacent parcel.

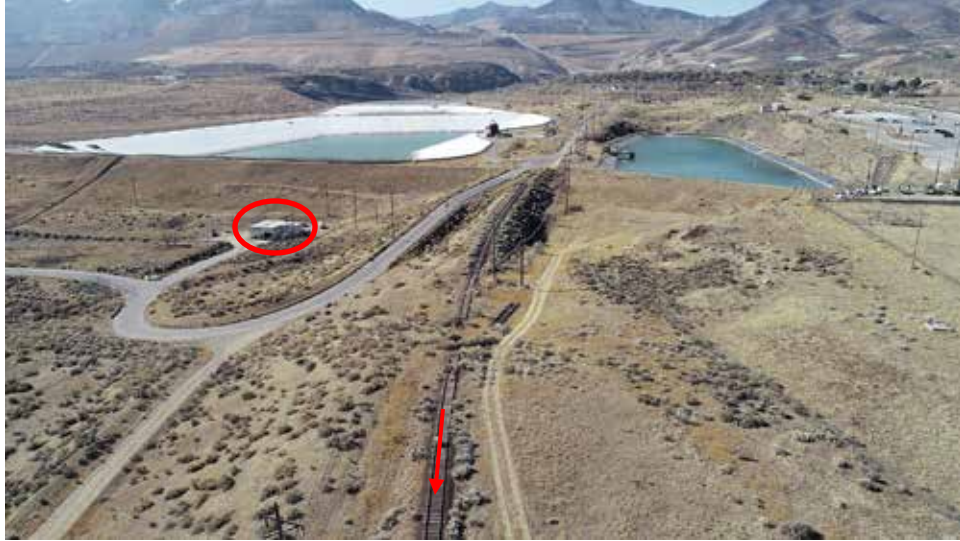
OU4

Photo 111 - Pictured is an aerial overview of the Bingham Reservoir complex (looking west). The Large Bingham Reservoir is the white-liner lined cells in the upper left quadrant of the photo. The Small Bingham Reservoir is to the right in the upper right quadrant of the photo. Both reservoirs are divided by 1960s DRG Rail Corridor (red arrow). The Cemetery Pond (OU1) is in the lower right quadrant. At the base of Large Bingham Reservoir is the Waste Water Disposal Pump Station (red circle).
