SECOND FIVE-YEAR REVIEW REPORT FOR
KENNECOTT (SOUTH ZONE) SUPERFUND
ALTERNATIVE SITE
SALT LAKE COUNTY & TOOELE COUNTY, UTAH

Utah Department of Environmental Quality
Division of Environmental Response & Remediation
Salt Lake City, Utah

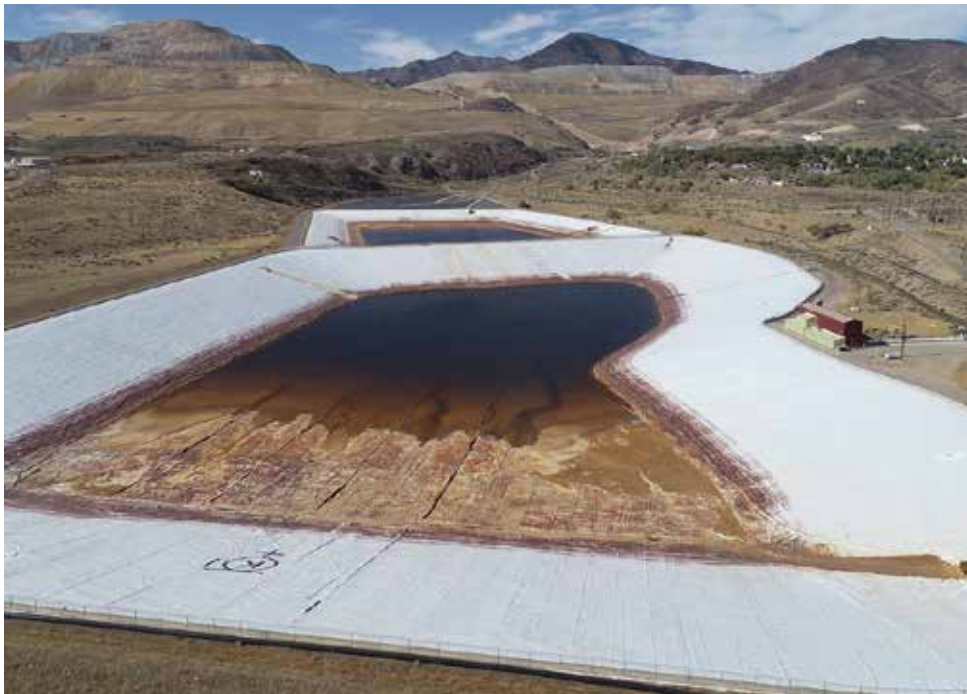
Photo 112 - Pictured is an aerial overview of the three cell Large Bingham Reservoir. Zone 2 (in the foreground), and Zone 1 are the principal holding cells while the Settlement Basin (third cell, black lined, furthest west) is used to remove large debris in flow from Bingham Canyon. The Large Bingham Reservoir has three liners (clay, 40-mil, and 60-mil HDPE) with leak detection and was reconstructed in the mid-1990s).

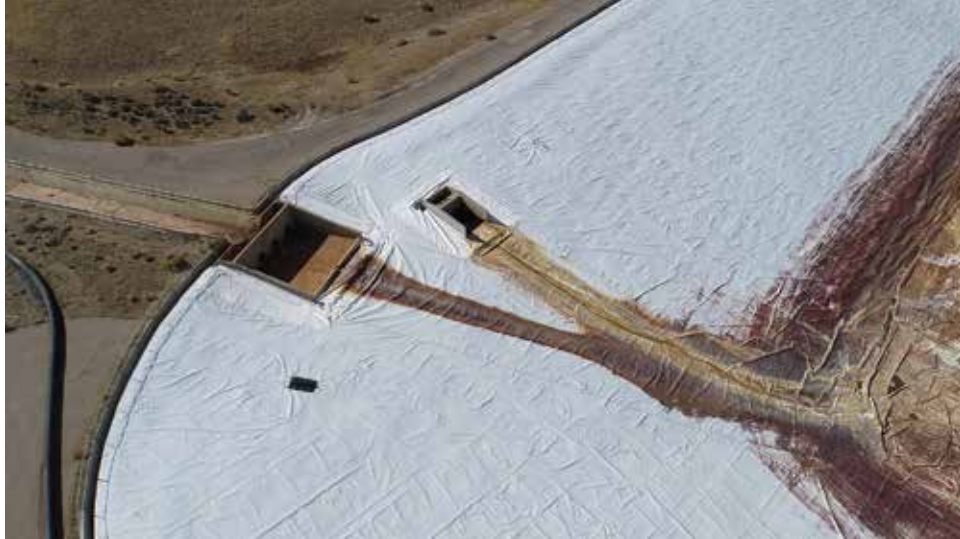
OU4

Photo 113 - Pictured is an outlet into Zone 2 from the Water Collection System (OU12). Staining is due to concentrations of iron in water managed in Large Bingham Reservoir. The liner did not have any observable tears.

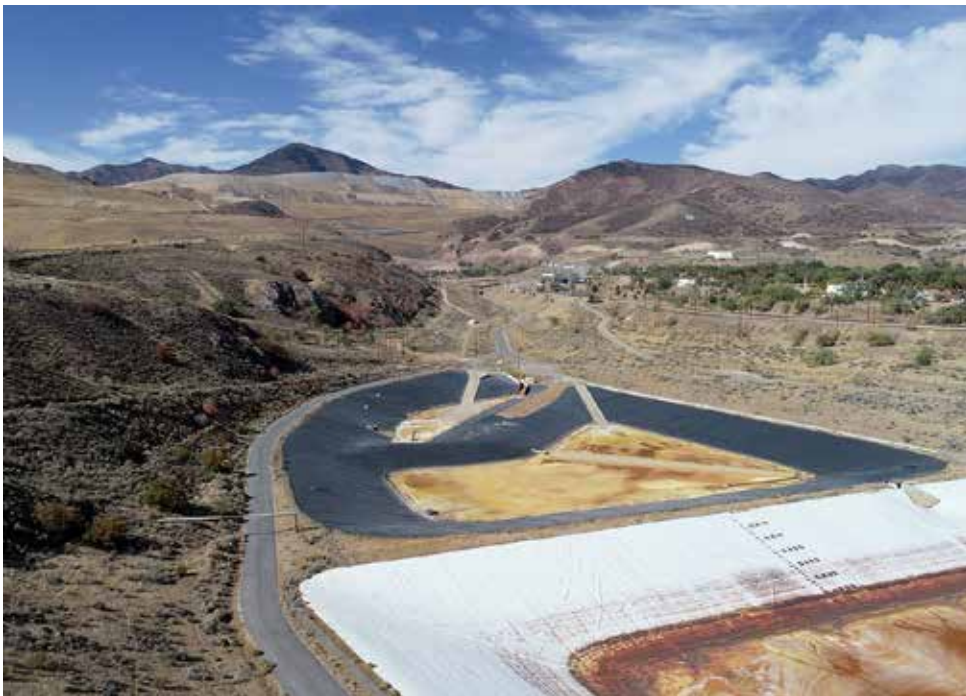
Photo 114 - Pictured is the Settlement Basin with its High-density polyethylene (HDPE) liner over a concrete base. The Settlement Basin captures debris and sediments from storm water runoff from Bingham Canyon to the west, and requires periodic maintenance to “muck out” the debris. Sediment is removed to RTKC’s onsite disposal areas around the Bingham Mine Waste Rock Dumps. The Town of Copperton is located to the north in the upper right quadrant of the photo.

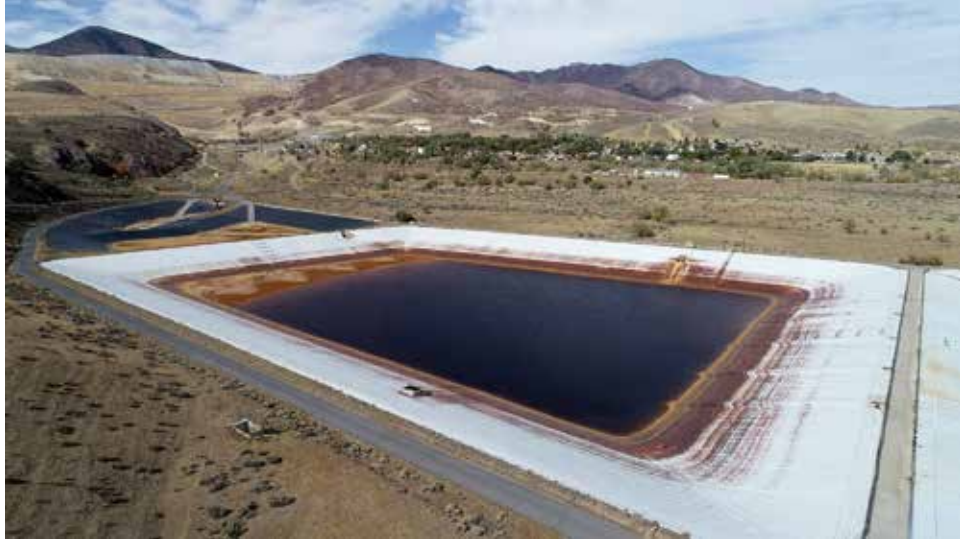
OU4

Photo 115 - Pictured is an aerial view of Zone 1 of the Large Bingham Reservoir.

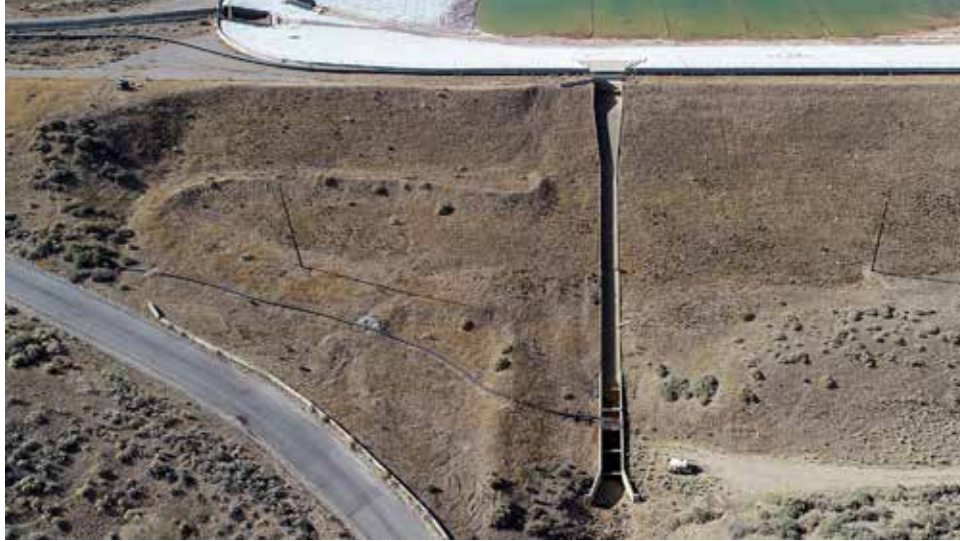
OU4

Photo 117 - Pictured is an aerial view of the Large Bingham Reservoir spillway in Zone 2. Since the 2016 FYR, the overflow channel has not been used. Bingham Creek (OU1) initiates east of the spillway. The spillway is cement lined and has an energy dissipater at its base. The dam for Zone 2 showed no signs of erosion or other destabilization.

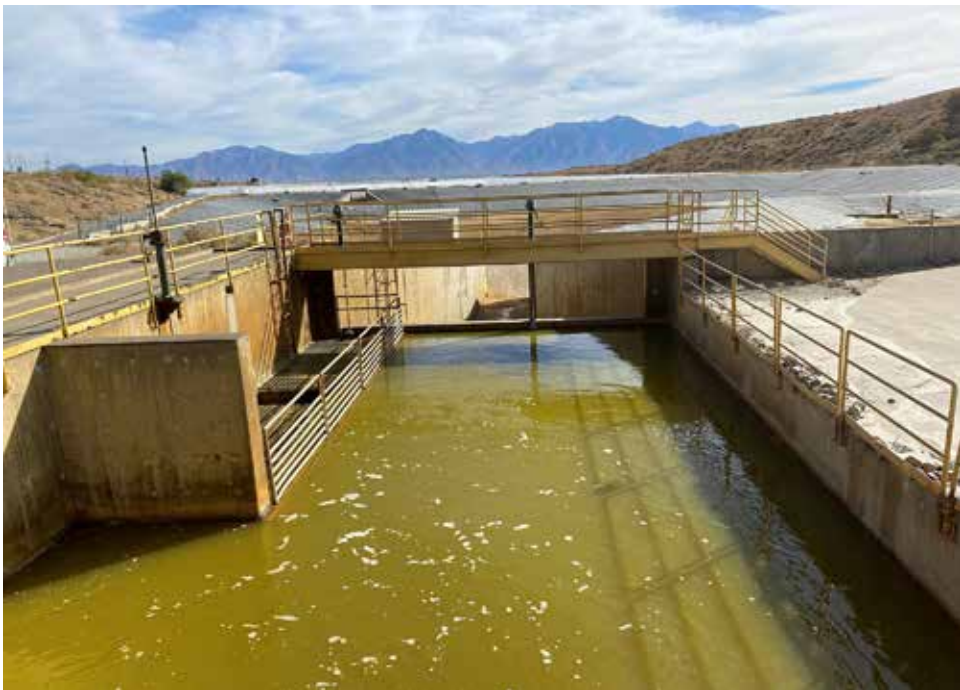
Photo 118 - Pictured is a collection box where captured alluvial groundwater from Bingham Canyon directed to the Large Bingham Reservoir can be routed to the Settlement Basin or one of the other two zones. The water here is a combination of circumneutral water and acid mine drainage.

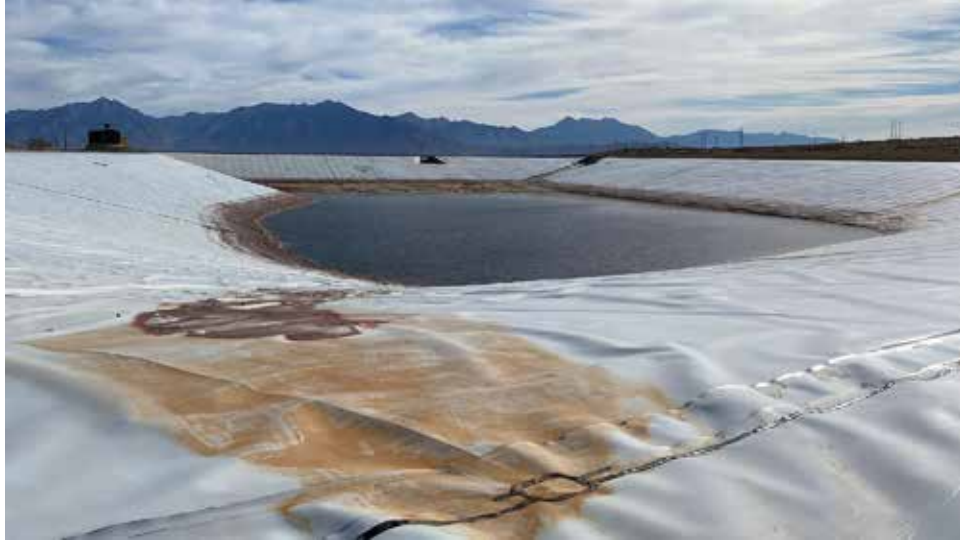
OU4

Photo 119 - Pictured is a section of the 60-mil HDPE liner on Zone 2. The liner has welded seams. Located between the 60-mil and 40-mil liner is the leak detection system. The DWQ GWPP specifies maintenance and best management practices to ensure the integrity of the two HDPE liners and the underlying clay liner.

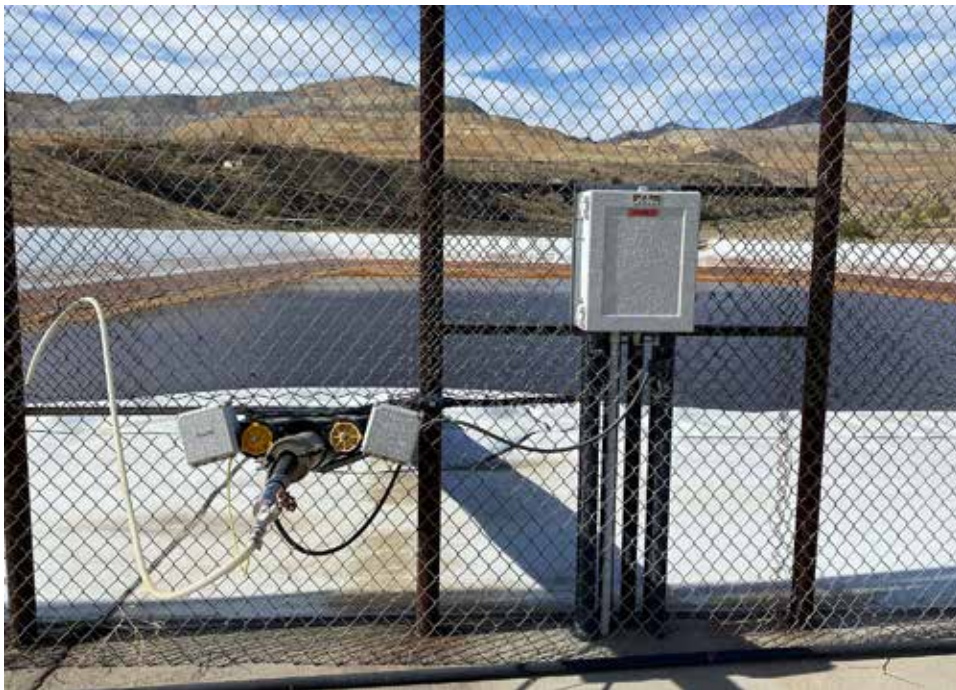
Photo 120 - Pictured is an example of leak detection equipment at the surface on Zone 1. The three portals on left can provide access to spaces between each of liners to assess for potential leaks with transducers. The box on the right along the fence houses a meter that provides data from strategically located probes between the liners.

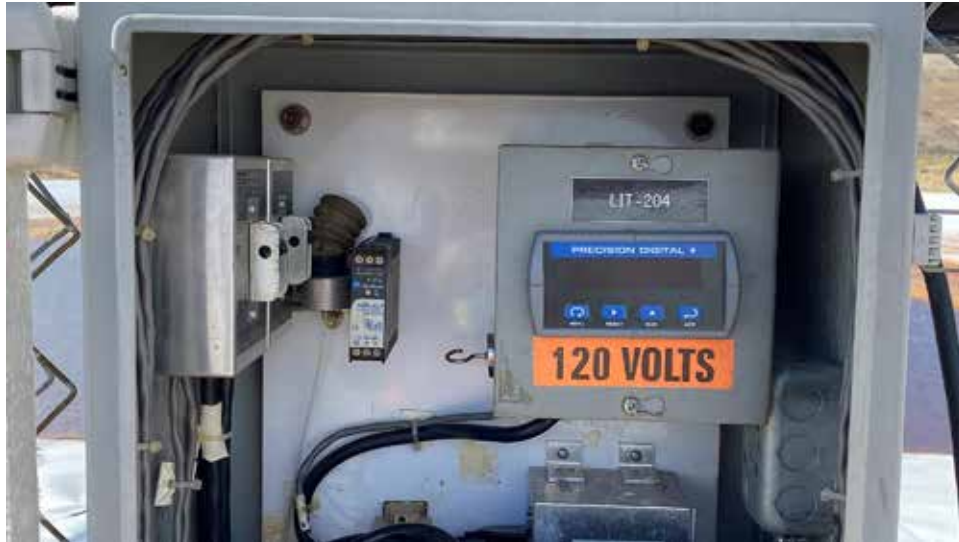
OU4

Photo 121 - Pictured is the metering equipment provides data from the probes located in sumps between the liners. The probes allow for the measurement of pressure and water levels in sumps.

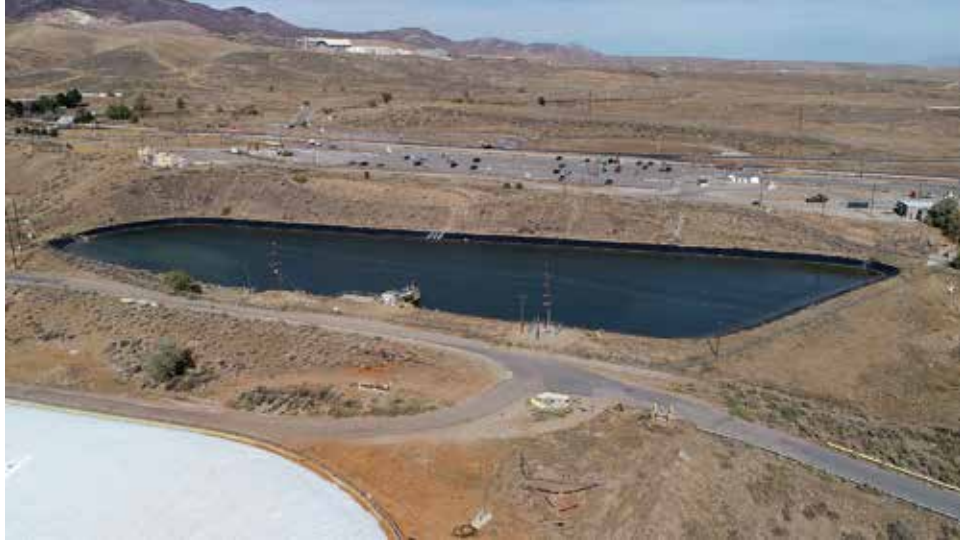
OU4

Photo 123 - Pictured is an aerial view of the lined Small Bingham Reservoir. Mine water is directed here which is more suitable for operational use. Soils around the Reservoir have a potential to have elevated arsenic and lead concentrations and other metals as observed by the iron staining between the two reservoirs (the white liner is Zone 2 of the Large Bingham Reservoir).

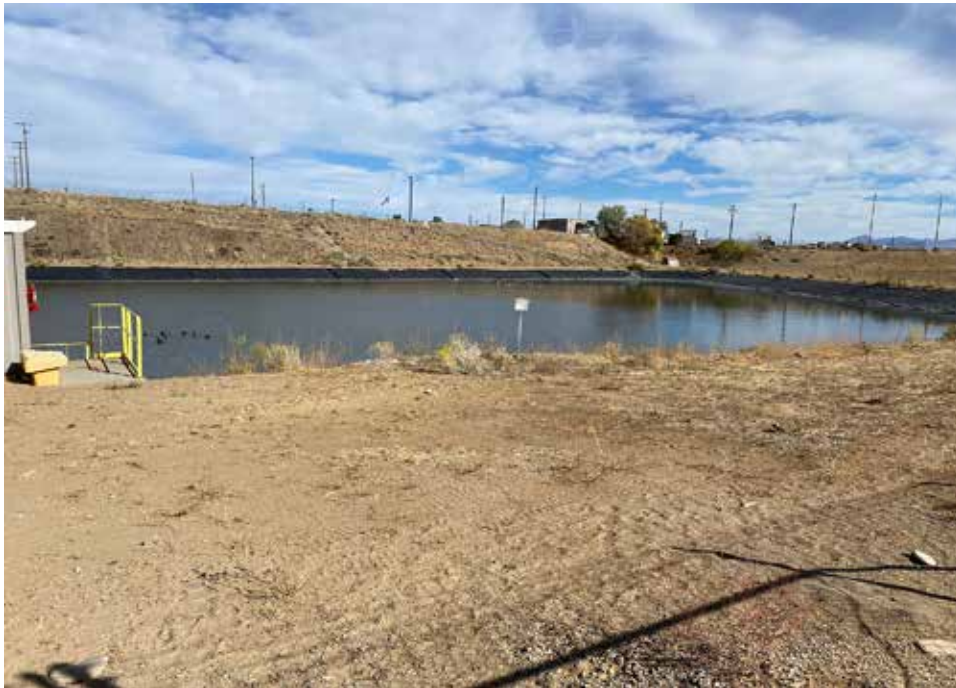
Photo 124 - Pictured is the surface of the water retained at the Small Bingham Reservoir. American Coots were observed on the water surface. Use by waterfowl is difficult to deter at this facility.

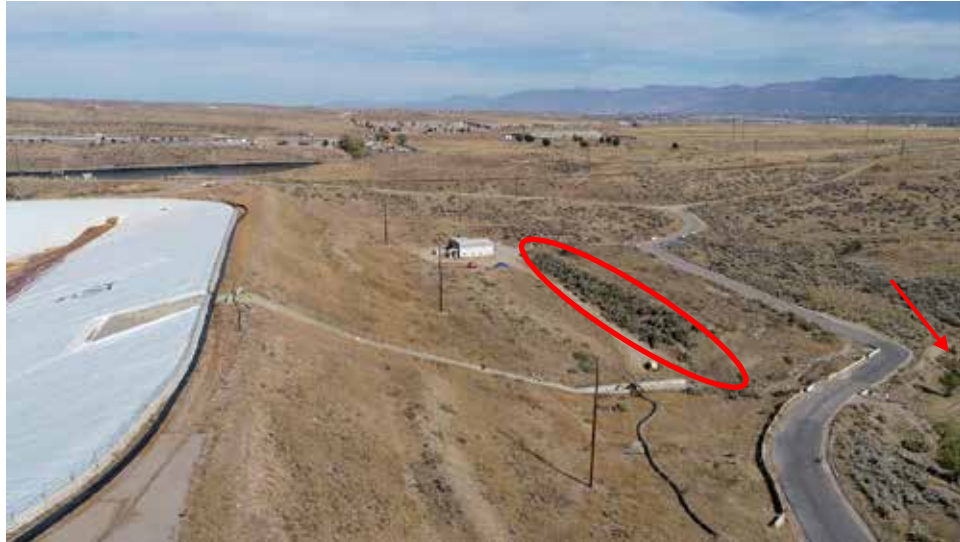
OU4

Photo 125 - Pictured is the eastern slope of Large Bingham Reservoir dam. At the base, is the Waste Water Disposal Pump Station (WWDPS, white sided building). The red circle surrounds the 1-acre parcel owned by ARCO-BP which is part of OU5. Secured by RTKC, the parcel has a soil pile with potential elevated metals concentrations. Bingham Creek (OU1) begins opposite the paved access road (red arrow).

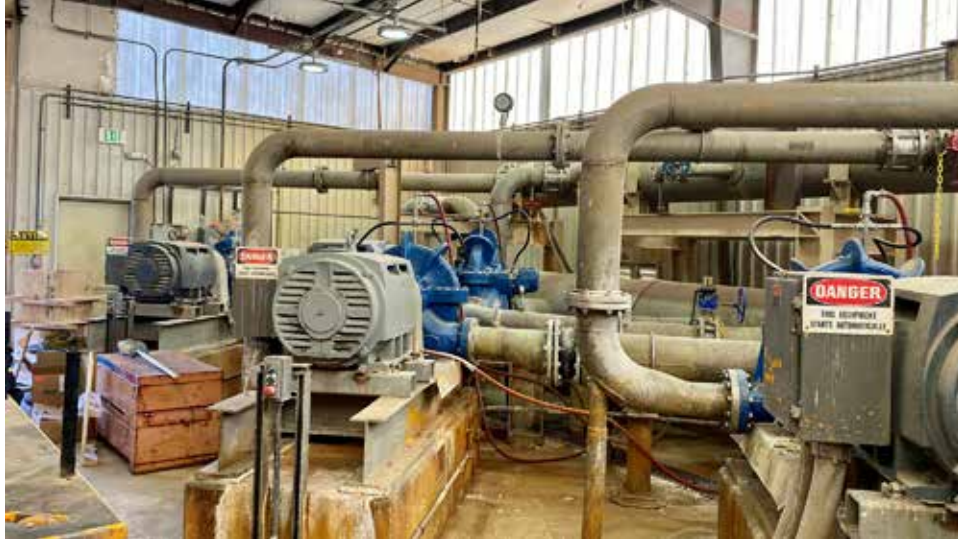
OU4

Photo 127 - Pictured is another view of the interior of WWDPS. No leaks were detected though there is evidence of past leaks which were observed during the last FYR. Mine water collected around the Kennecott South Zone is directed here and pumped to RTKC's Tailings Pipeline and North Tailings Impoundment (OU15) for disposal or recycling.

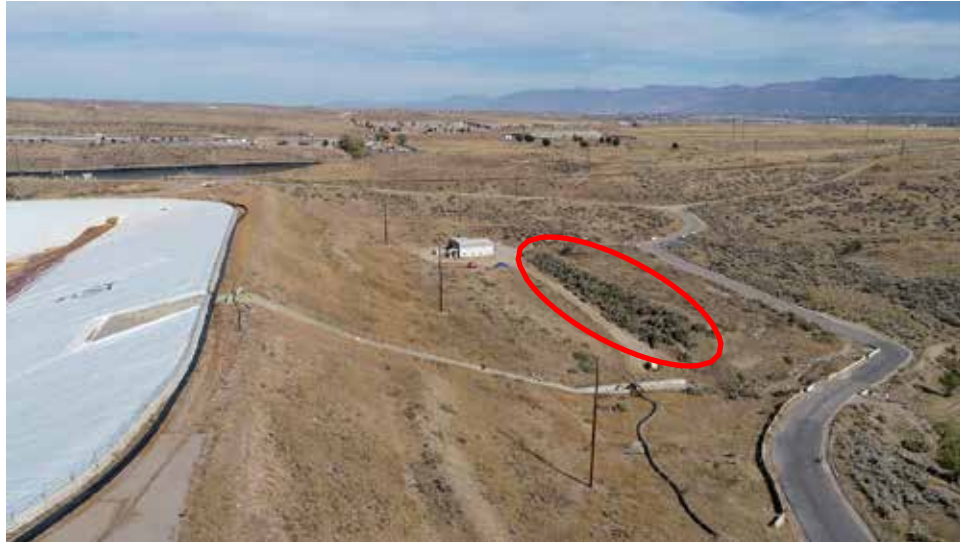
OU5

Photo 128 - Pictured at the base of RTKC's Zone 2 Large Bingham Reservoir, is a 1-acre parcel owned by ARCO-BP with a soil pile (red circle) that potentially contains lead and arsenic above the site KUALs. The parcel has not been characterized. RTKC secures access to the parcel by the general public. The soil pile is vegetated and is not eroding into Bingham Creek which is located out of frame to the right.

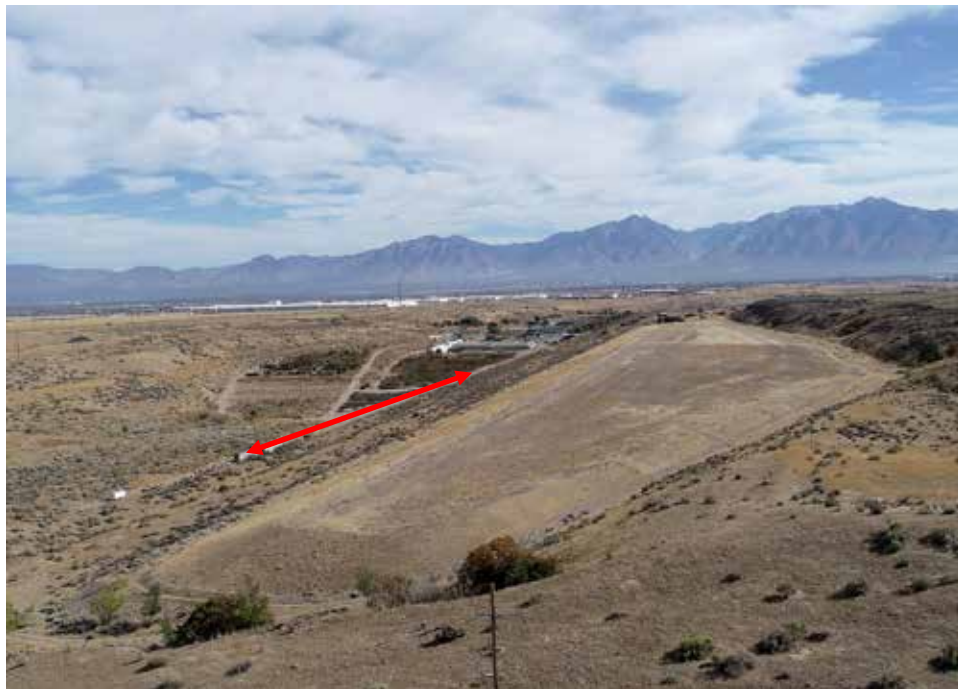
Photo 129 - Pictured is an aerial overview of the OU5 ARCO Tails Repository. South of dirt road (red arrow), the ARCO Tails site includes approximately 90-acres, on which is the depicted 41-acre ARCO Tails Repository. The Repository is well vegetated and stable, nothing has changed since the last FYR.

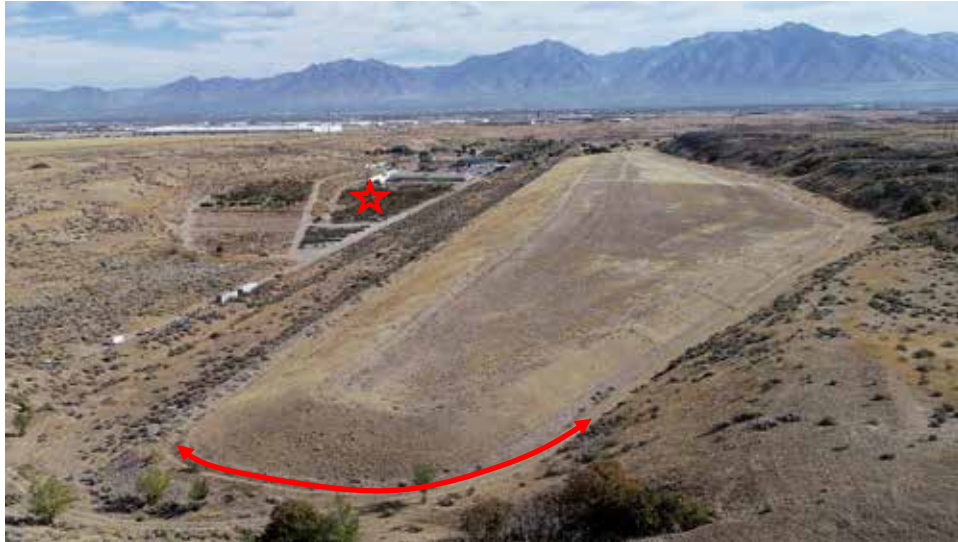
OU5

Photo 130 - Pictured is an aerial view of the 41-acre ARCO Tails Repository. Around the base on the southern side of the Repository is a rip-rap armored drainage ditch (red arrow) which directs storm water away from Repository surface to the west (red arrow). A similar channel on the eastern half of the Repository directs runoff east. No changes to the area were observed since last FYR. The red star denotes the site of Progressive Nursery which leases land north of Bingham Creek from Kennecott for their operations.

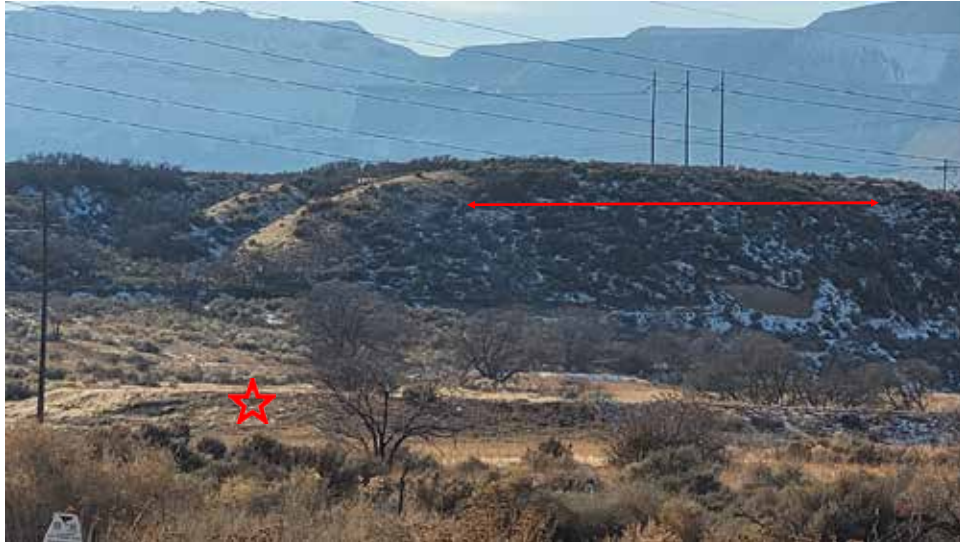
OU5

Photo 132 - Pictured from SH-111 is the storm water retention basin ARCO-BP maintains to manage storm water runoff from the Repository on its eastern end (red star). The basin appeared vegetated and stable with no erosion evidence. Along the hillside in the background is the historic footprint of the Bastian Ditch (red arrow) which was removed by ARCO-BP and placed into the 41-acre Repository. The hillside appeared to be vegetated and stable.

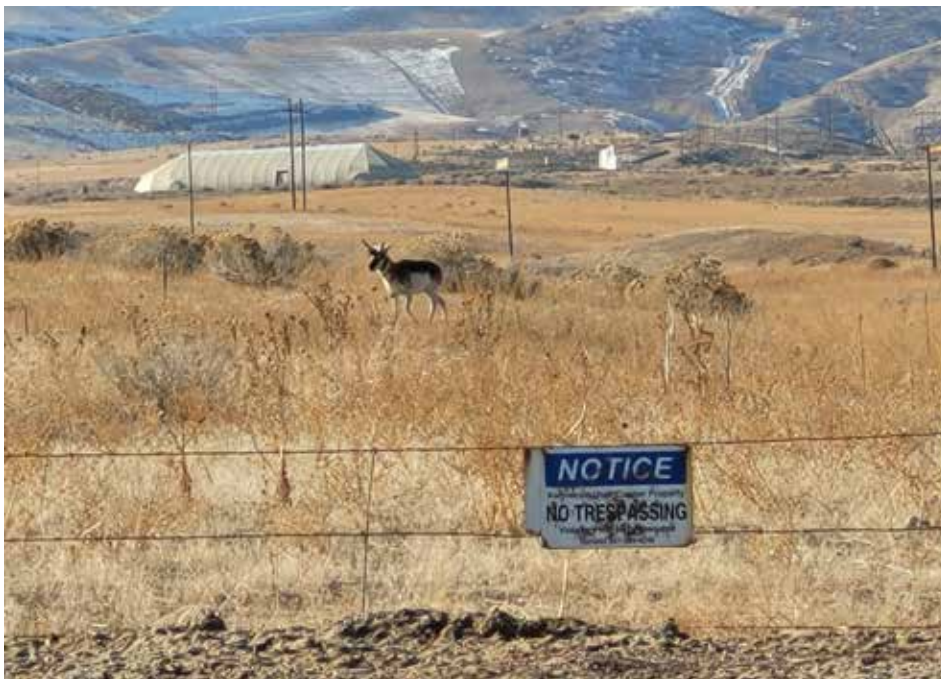
Photo 133 - Pictured south of the ARCO-BP land holding, Pronghorn Antelope were observed on RTKC's property in an area where RTKC previously removed the Bastian Ditch. This area is well vegetated with grasses, thistle, sage brush and rabbit brush. RTKC's property is generally secured with three, five and ten strand barbed-wire fencing with no trespassing signs as depicted.

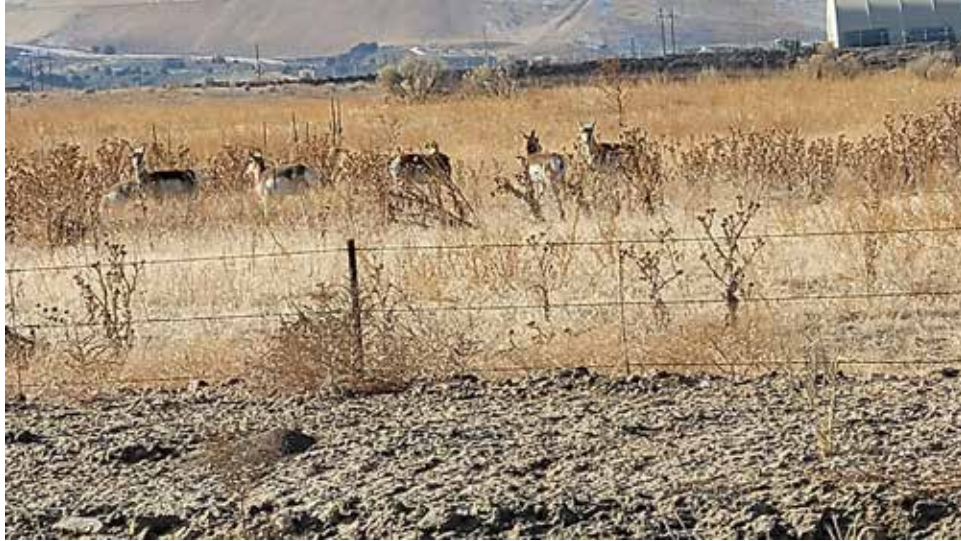
OU5

Photo 134 - The small herd of Pronghorn Antelope were observed during the inspection from SH-111. Except for the immediate shoulder of SH-111, the pictured surface of RTKC's property where they removed the Bastian Ditch is well vegetated. RTKC's perimeter fence is secure with no slack along the wires.

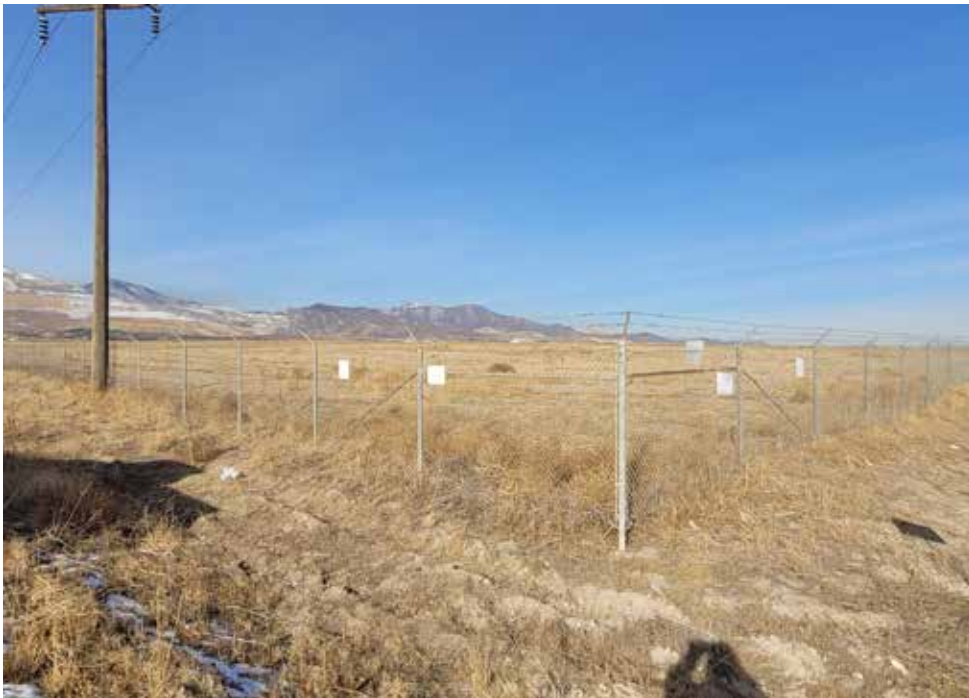
Photo 135 - Pictured from 11800 South is the southeast corner of South Valley Water Reclamation's facility, Lark Monofill. The eastern half of facility (behind the fence) includes portions of Bastian Ditch Drainage Area below surface. The land to the right of the fence is part of the planned Daybreak Community Western Village. South Valley Water Reclamation's Lark Monofill is undergoing redevelopment, which requires the management of mine waste (under the SLCO Health Department ordinance) associated with the Bastian Ditch. The Bastian Ditch historically traversed (north to south) the western portion of the facility.

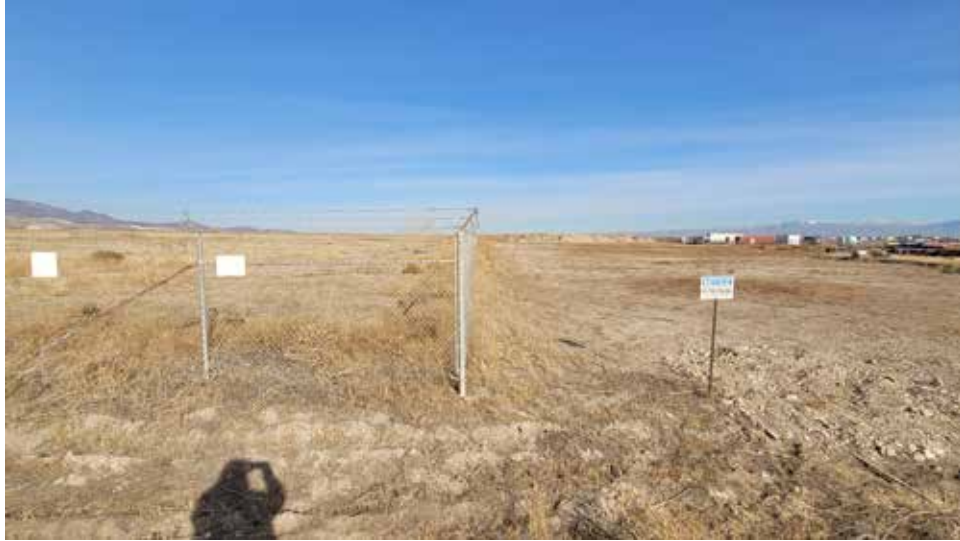
OU5

Photo 136 - Pictured is the eastern perimeter fence for the Lark Monofill facility, and the Western Village of the Daybreak Community. The fence line and adjacent land overlie the Bastian Ditch Drainage Area. Lead and arsenic concentrations in soils along the fence are above the site KUALs. Management of mine waste during the Lark Monofill redevelopment and Daybreak Communities West Village development is or will be done under the SLCO Health Department ordinance.

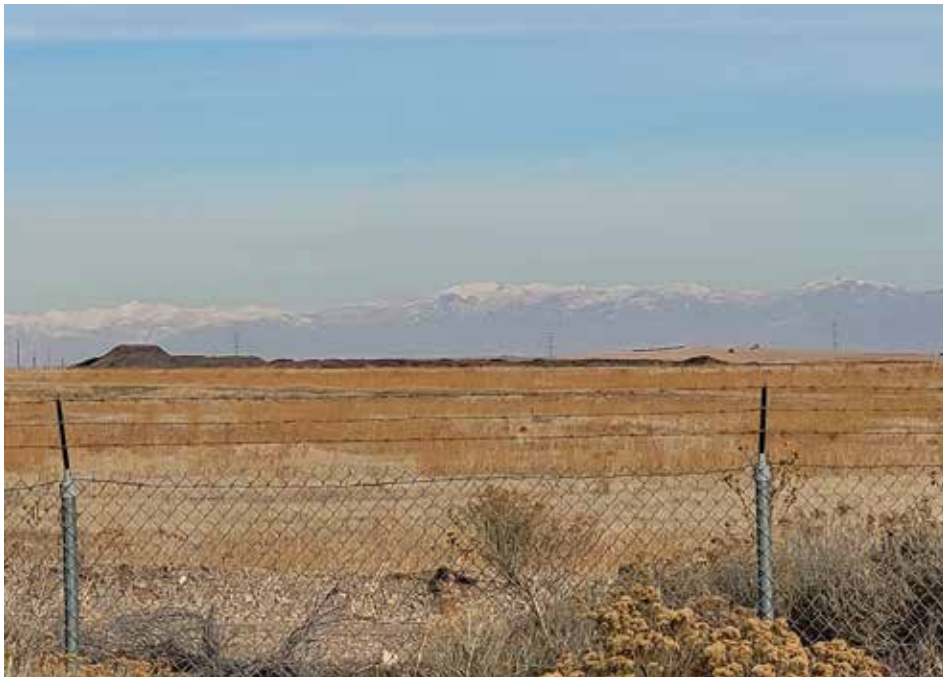
Photo 137 - Pictured from the southwest corner of the Lark Monofill facility and 11800 South (in the background) are stockpiles of biosolids being removed under oversight by the DWQ Biosolids program. The Bastian Ditch underlies the property north of the fence, which will be removed under the SLCO Health Department ordinance.

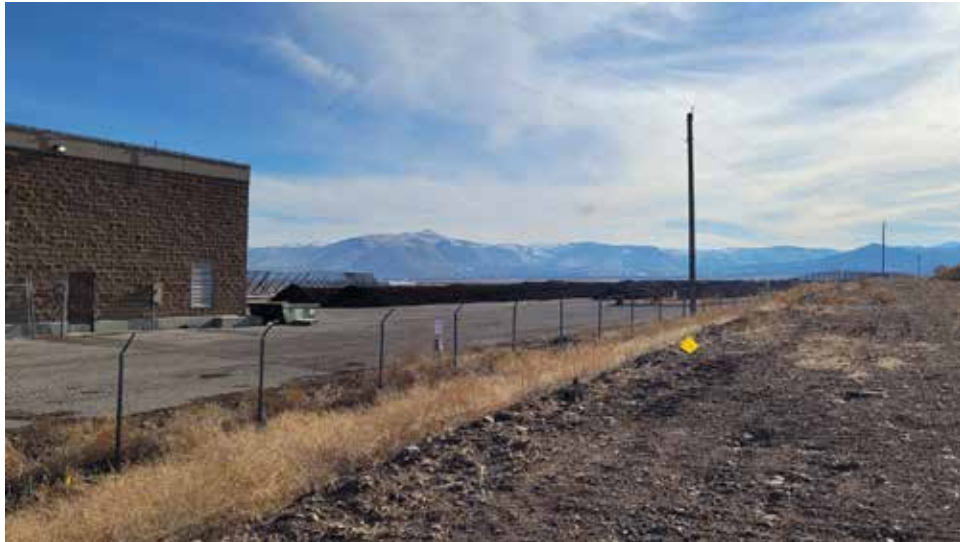
OU5

Photo 138 - Pictured from the northern portion of the Lark Monofill facility the biosolids being removed are undergoing drying prior to land application on site, under the oversight of DWQ. The biosolids are the piles of dark material in the background.

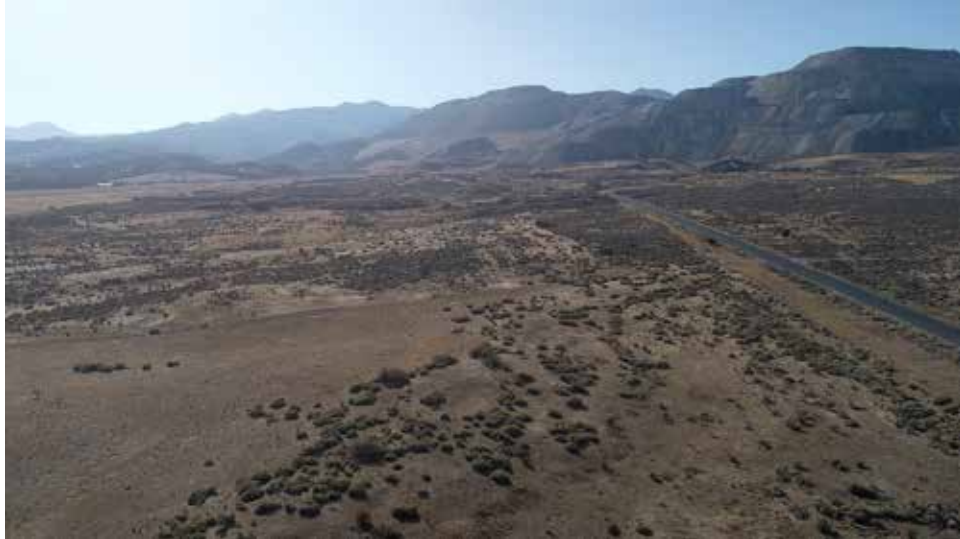
Photo 139 - Pictured is an aerial overview of the Lark Tails and Waste Rock site (OU6) east of SH-111 and south of 11800 South. In the upper right quadrant of the photo is the Bingham Mine Waste Rock Dumps. Generally, the OU6 area is undeveloped, with various vegetation types and variable surface topographies.

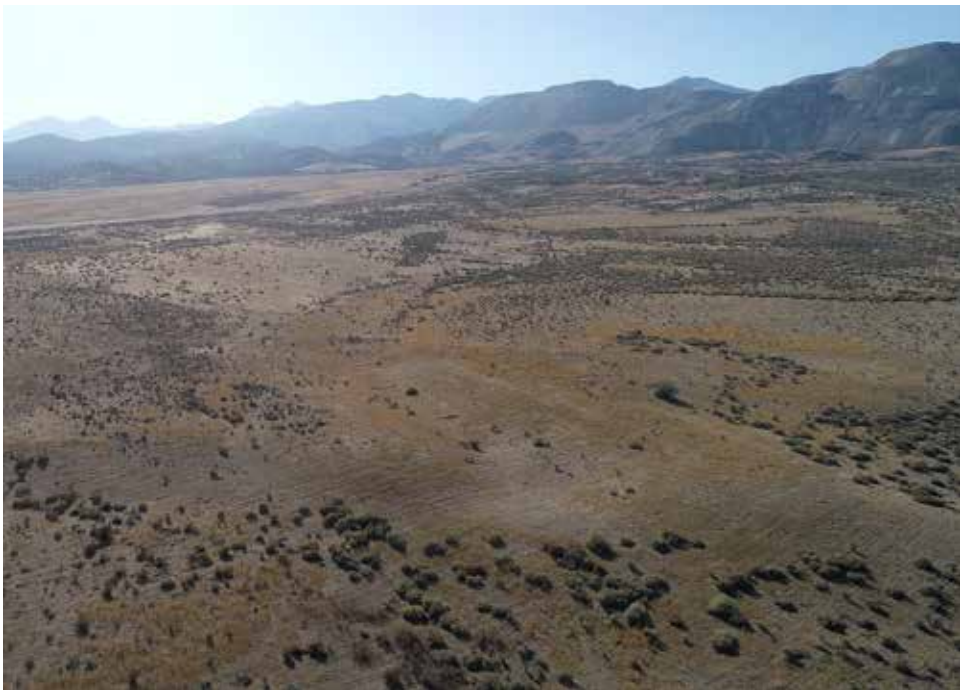
Photo 140 - Pictured is an aerial overview of OU6 west of SH-111. In the upper right quadrant is the Bingham Mine Waste Rock Dumps. Generally, the area is undeveloped, the land is owned by RTKC.

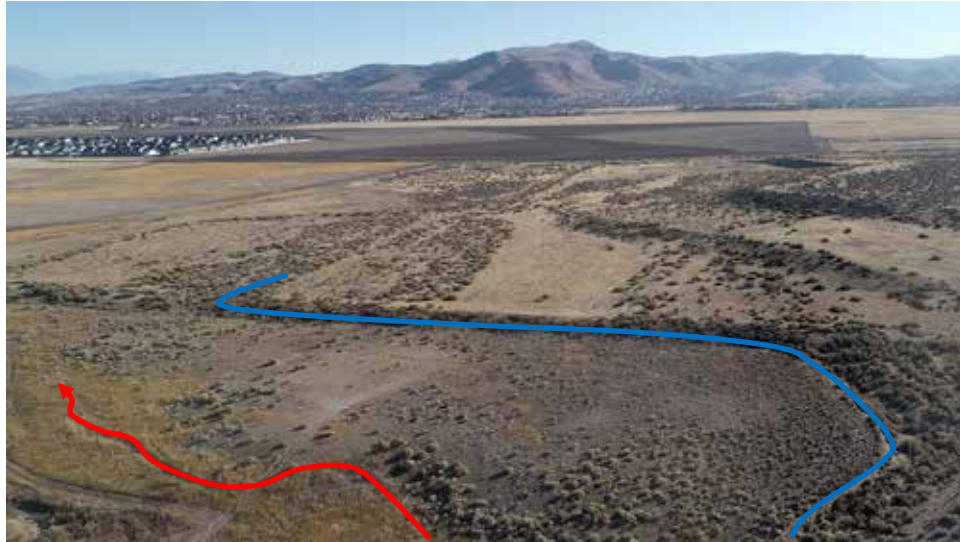
Photo 141 - Pictured is an aerial view of Midas Creek (red arrow) just east of SH-111 and its floodplain and the area comprising the Lark Tails (blue line) site which is where copper tailings are buried, the view is southeast. Edge Homes LLC is developing lands east and south of OU6 (visible in the upper left quadrant) more specifically east of the Southeast Tails Area. Soils and mine waste in OU6 can exceed the site KUALs for lead and potentially arsenic.

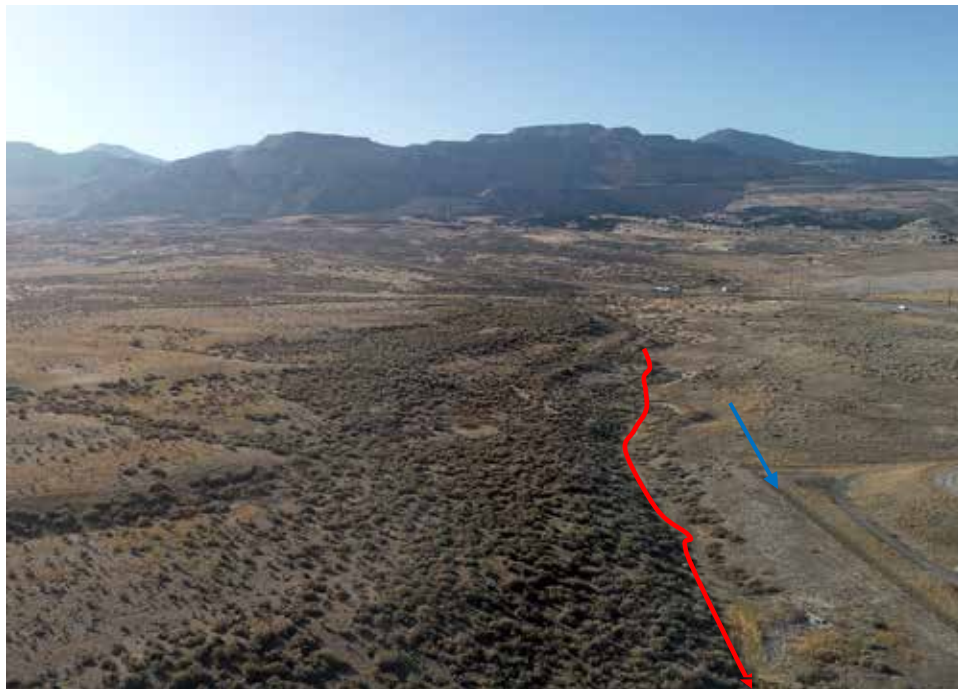
Photo 142 - Pictured is an aerial view of Midas Creek (red arrow) as it traverses east from SH-111. To the south of Midas Creek is the Lark Tails area. The Creek extends east from SH-111 and was crossed by the historic footprints of the Mascotte Ditch (OU6) and Bastian Ditch (OU5). The fence line (blue arrow) in the lower right quadrant encircles the new Herriman City water tank.

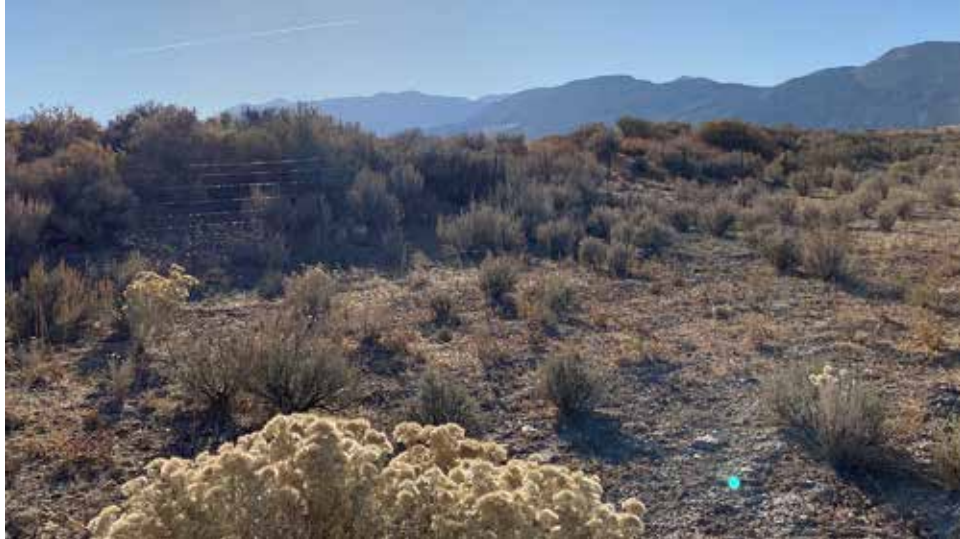
OU6

Photo 143 - Pictured is the Midas Creek Channel and floodplain south of the Herriman City water tank. Visible from the Channel is RTKC's perimeter fence around the Lark Tails area south of the Creek Channel. The fence is stable and comprised of ten strings of barbed-wire. The observable surfaces are well vegetated and stable, vegetation includes grasses, sage brush, rabbit brush and other weedy species. No erosion was observed.

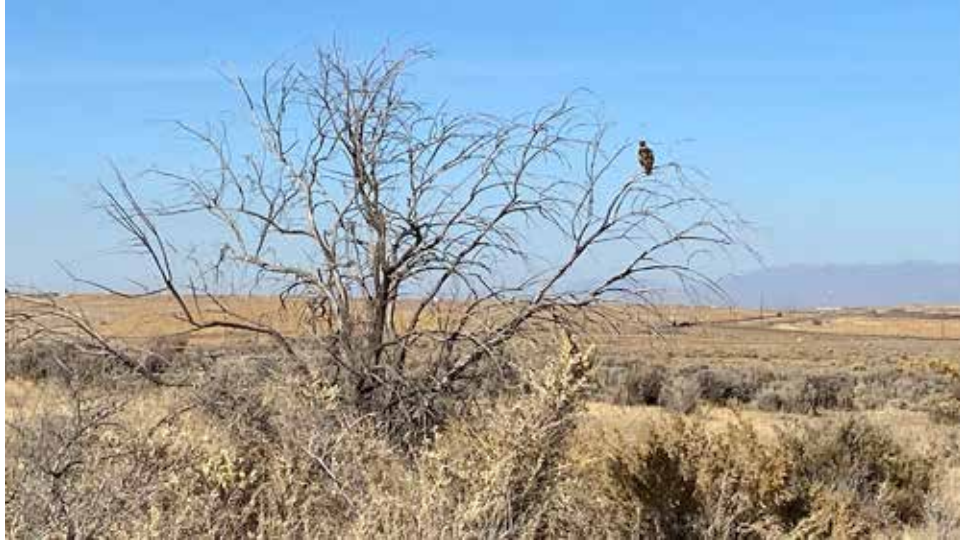
OU6

Photo 145 - Pictured is an example of some of the scrub oak, with clusters of sage and rabbit brush habitat located on portions of the western Lark Tails area. Perched in this scrub oak during the inspection was a Marsh Hawk.

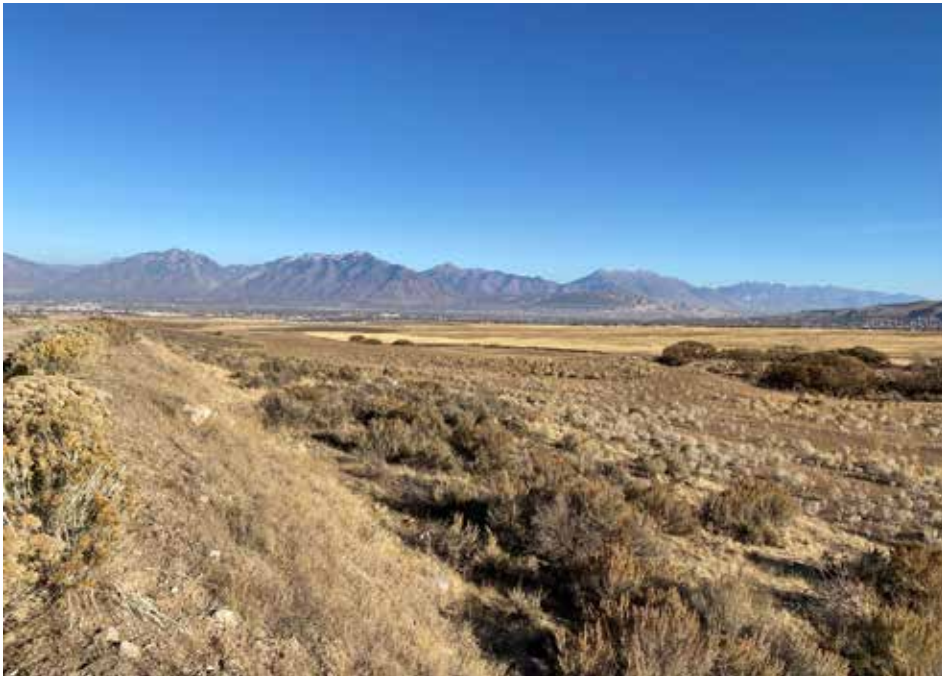
Photo 146 - Pictured is the southern portion of the Lark Waste Rock - Long Dump footprint which was previously remediated. In addition, Copper Creek Channel traverses west to east from SH-111 just south of the Long Dump. The Copper Creek Channel was fairly shallow if not flat. The area is well vegetated and has not changed since the last FYR. No erosion was observed.

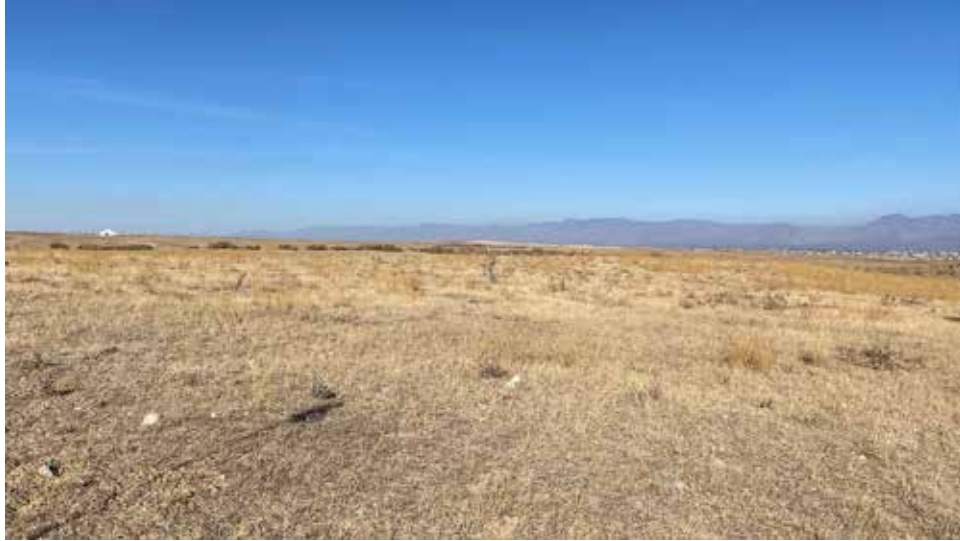
OU6

Photo 147 - Pictured is a section of the current surface grade in the area of the historic footprint of the motorcycle park once located in the Lark Tails area. The current surface is predominantly vegetated with grasses, is not eroding and has not changed since last FYR.

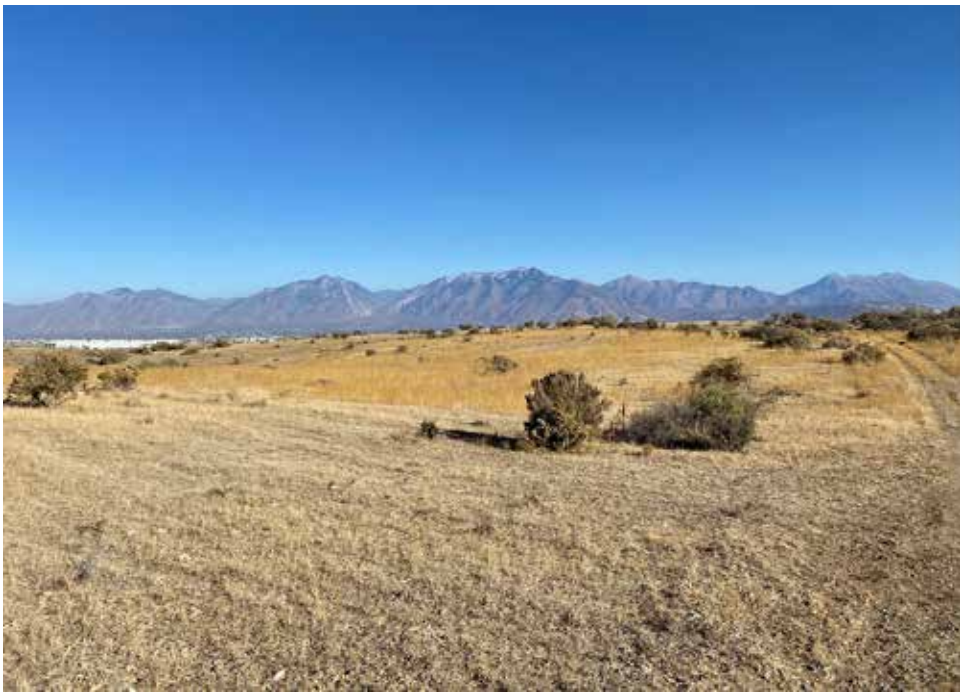
Photo 148 - Pictured is a section of the current surface in the area of the historic footprint of the motorcycle park once located in the Lark Tails area. The current surface is predominantly vegetated with grasses, is not eroding and has not changed since last FYR.

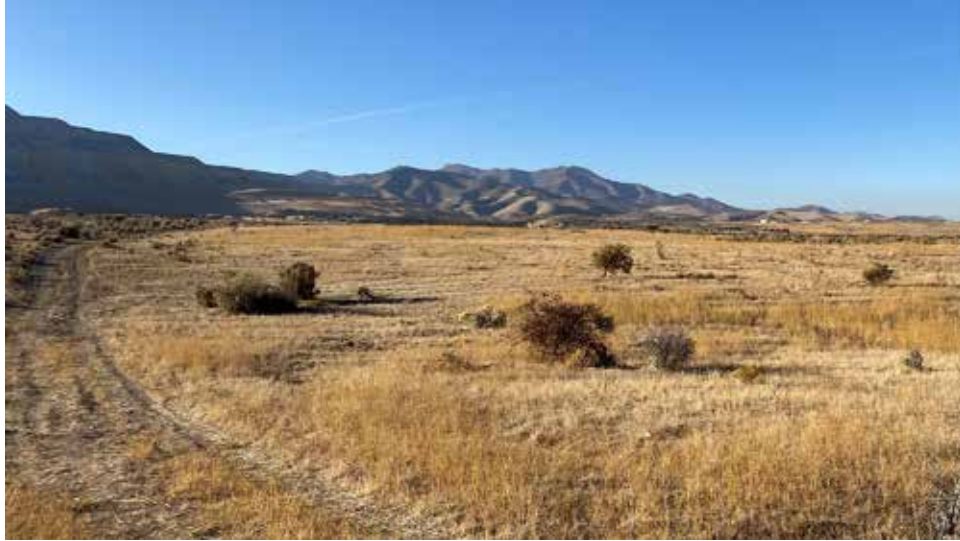
OU6

Photo 149 - Pictured is a section of the current surface in the eastern area of the historic footprint of the motorcycle park once located in the Lark Tails area. The current surface is predominantly vegetated with grasses, is not eroding and has not changed since last FYR. An access can be seen cut through the surface vegetation along its length, it is not frequently traversed.

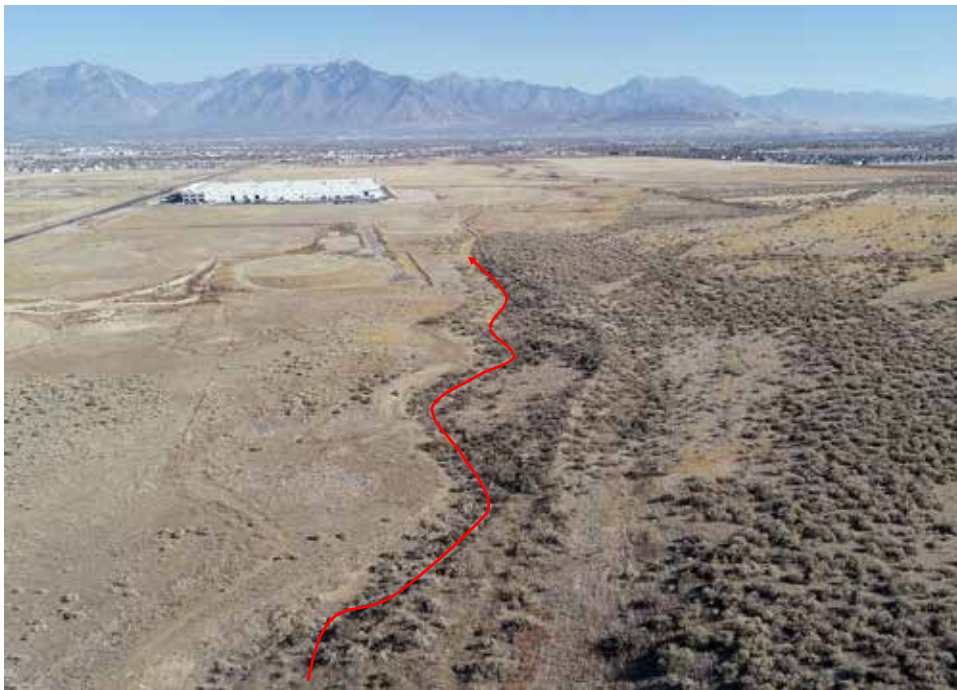
Photo 150 - Pictured is another aerial view of the Midas Creek Channel (red arrow) and floodplain, the Lark Tails area south of the Channel, the Herriman City water tank and further east Bullfrog Spas manufacturing plant in the upper left quadrant. The Herriman Water Tank and Bullfrog facility are the two most recent development projects in the area. Between these two facilities is the footprint of the historic Mascotte Ditch and Pond.
