SECOND FIVE-YEAR REVIEW REPORT FOR
KENNECOTT (SOUTH ZONE) SUPERFUND
ALTERNATIVE SITE
SALT LAKE COUNTY & TOOELE COUNTY, UTAH

Utah Department of Environmental Quality
Division of Environmental Response & Remediation
Salt Lake City, Utah

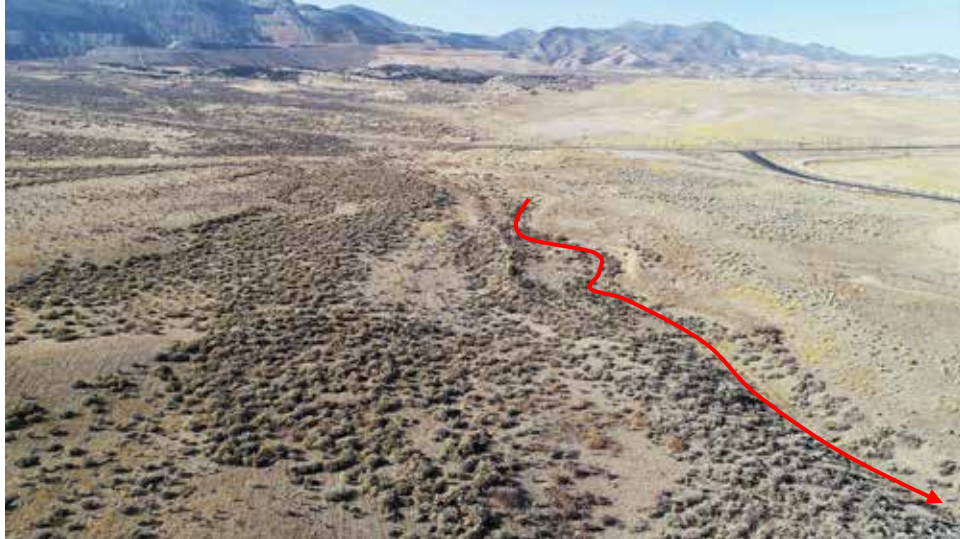
OU6

Photo 151 - Pictured is the western segment of the Midas Creek Channel (red arrow) with the intersection of 11800 South and SH- 111 in the upper right quadrant. In this general area, the Bastian Ditch (OU5) historically crossed Midas Creek. Midas Creek Channel is well vegetated along with its floodplain. It is stable and no erosion was observed.

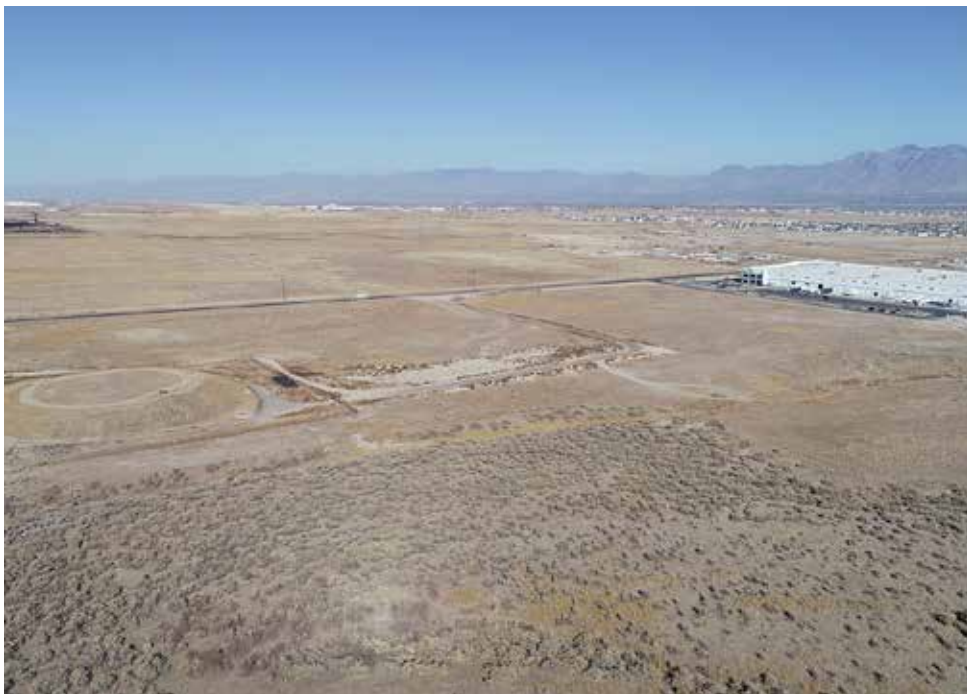
Photo 152 - Pictured is an aerial view of the Herriman City water tank and the area between the Herriman tank site and Bullfrog Spas. The road to the north is 11800 South where Jordan Valley Water Conservancy District constructed a pipeline under the SLCO Health Department IC.

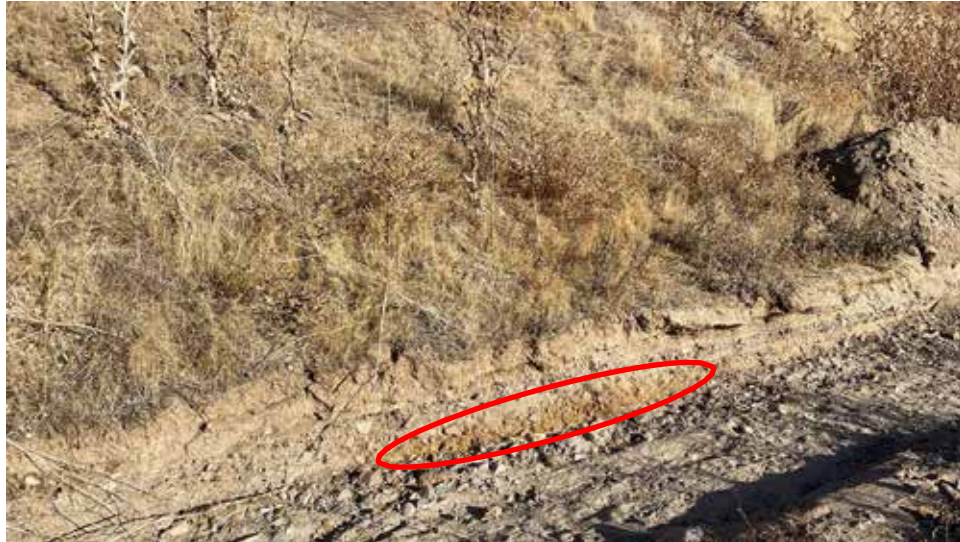
OU6

Photo 153 - Pictured is a section of the Midas Creek Channel located between Herriman City water tank and the Bullfrog Spa facility. The Channel shows some evidence of soils which could contain lead and arsenic above the KUALs (red circle). Generally, the Channel is shallow and narrow with a shallow high-water line (about 1 foot) based on surrounding vegetation.

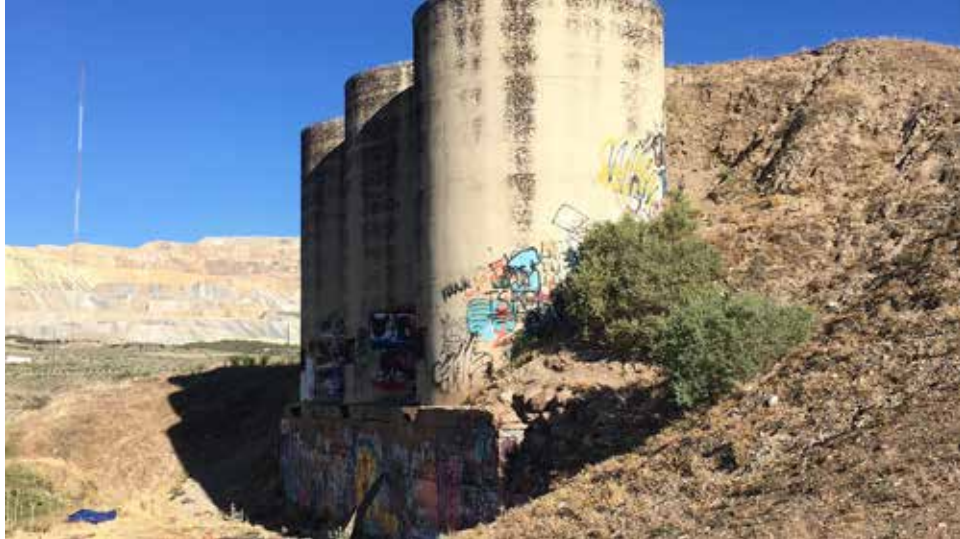
OU6

Photo 155 - Pictured is the Historic Midas Creek Silos removed since the last FYR. The Silos were used for storage by local farmers. Recently they became an attractive nuisance on RTKC's property as observed by the graffiti. RTKC removed the Silos between 2019-2020.

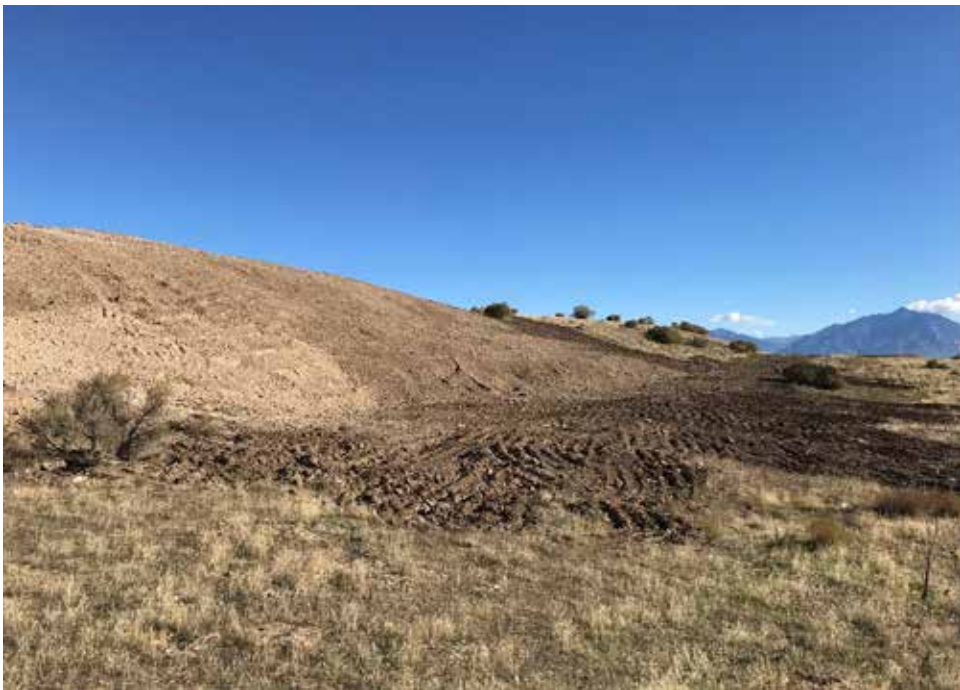
Photo 156 - Pictured is the post removal surface after the removal of the Midas Creek Silos and management of surrounding soils. The removal surface was contoured and ripped to facilitate revegetation efforts.

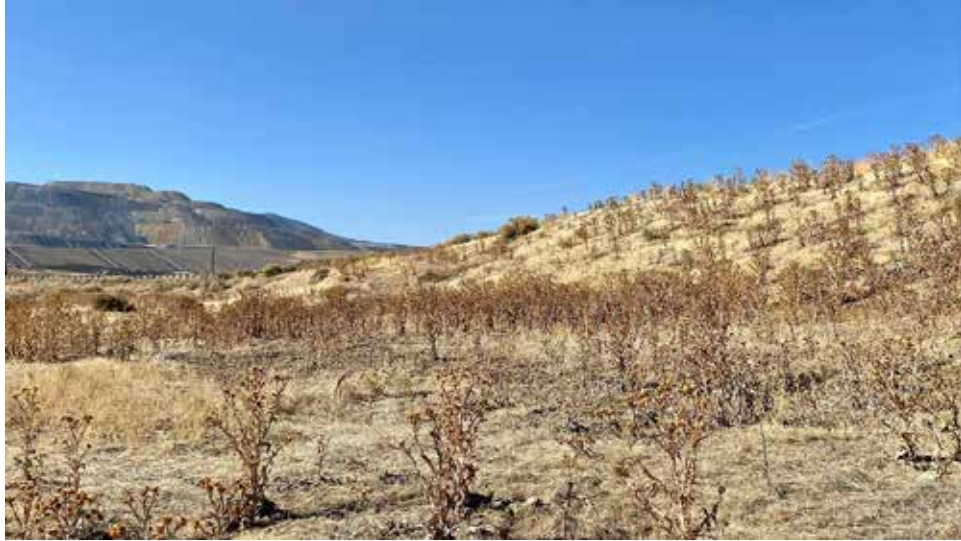
OU6

Photo 157 - Pictured is the post removal surface where the Midas Creek Silos once stood. Grasses and thistle have vegetated the surface soils.

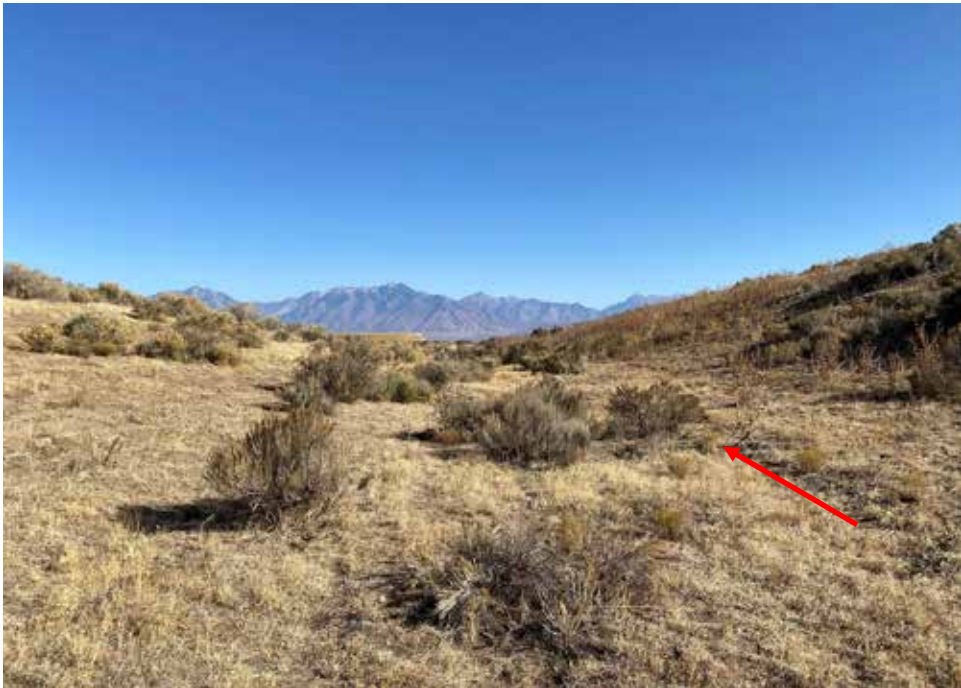
Photo 158 - Pictured is the Midas Creek Channel south of Midas Creek Silos removal area. The hillside to the right is the Lark Tails area. The Creek Channel is barely noticeable (red arrow).

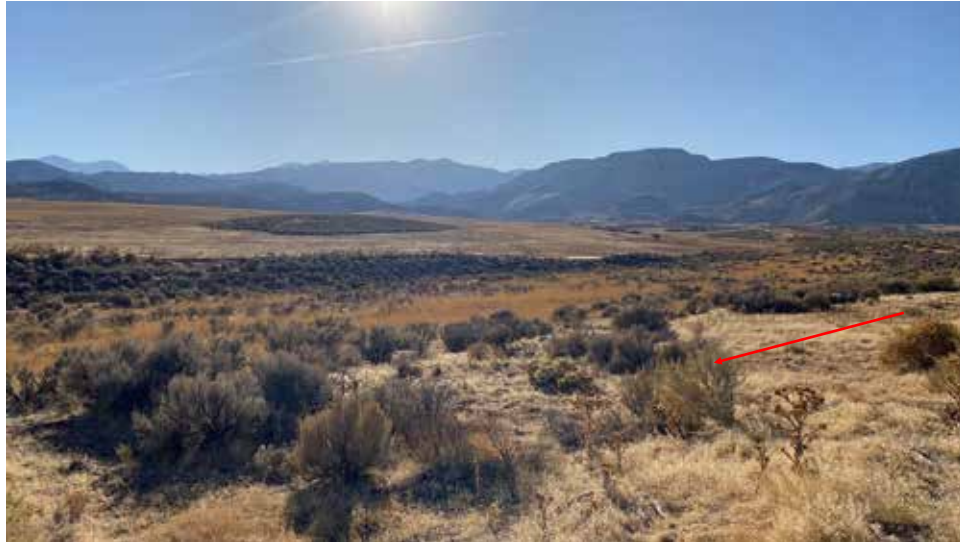
OU6

Photo 159 - Pictured south of the Lark Waste Rock area is the Copper Creek Channel. Barely observable, Copper Creek (red arrow) is an almost flat Channel which rarely has flowing water due to the limited precipitation that this area receives. Most precipitation infiltrates before it can flow on the surface.

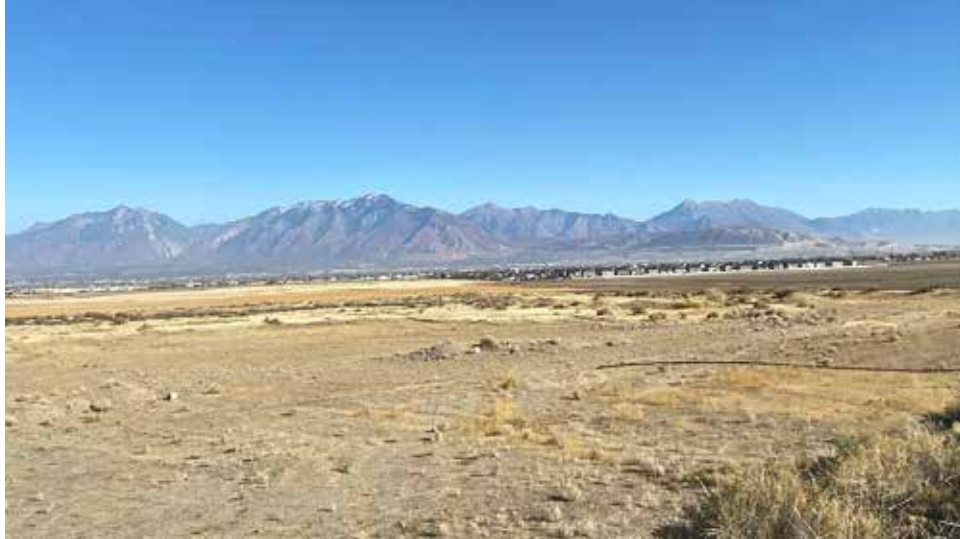
OU6

Photo 161 - Pictured is an aerial view of the eastern extent of OU6, east of the Lark Tails area and in the distance the Lone Tree historic area where soils had lead and arsenic concentrations greater than KUALs. East of RTKC's land holdings, SLR (Suburban Land Reserve) owns the land south of 11800 South and east of 6000 West, with a few land holdings more recently purchased by other third parties. This area is primed for redevelopment as noted by the homes in the distance (part of the Edge Homes LLC development).

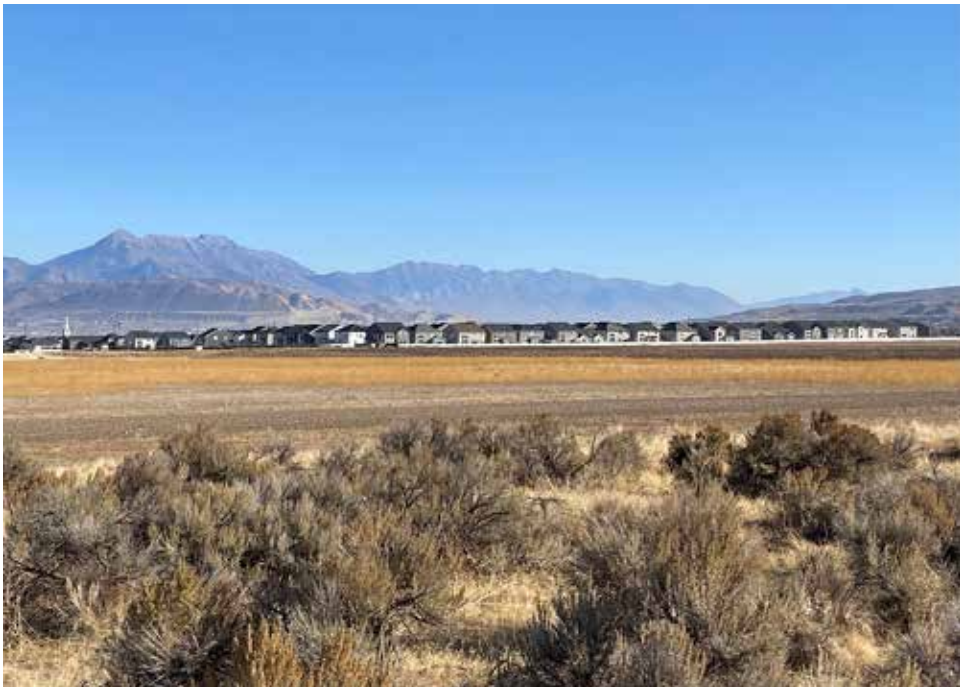
Photo 162 - Pictured is the Edge Homes subdivision located south of approximately 12600 South. This is the first of a series of housing developments planned for the area east of OU6 and RTKC's property.

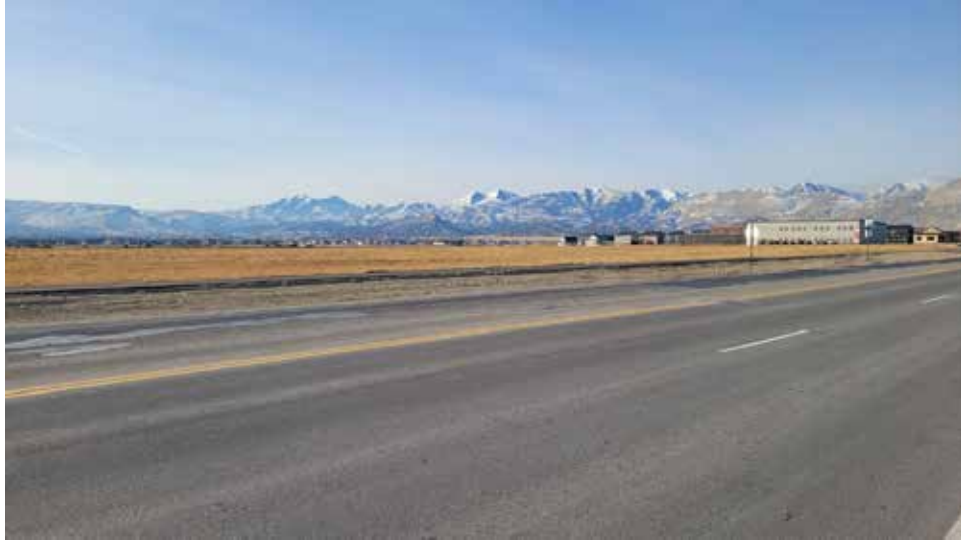
OU6

Photo 163 - Pictured west of 6000 West (Mustang Way) and south of 11800 South (the road pictured) is the planned Teton Village development underway by SOJO118 LLC. The Teton Village includes a planned trail along a portion of Midas Creek, west of 6000 West. The building in the upper right quadrant is an Advantage Arts Academy facility developed in compliance with the SLCO Health Department ordinance.

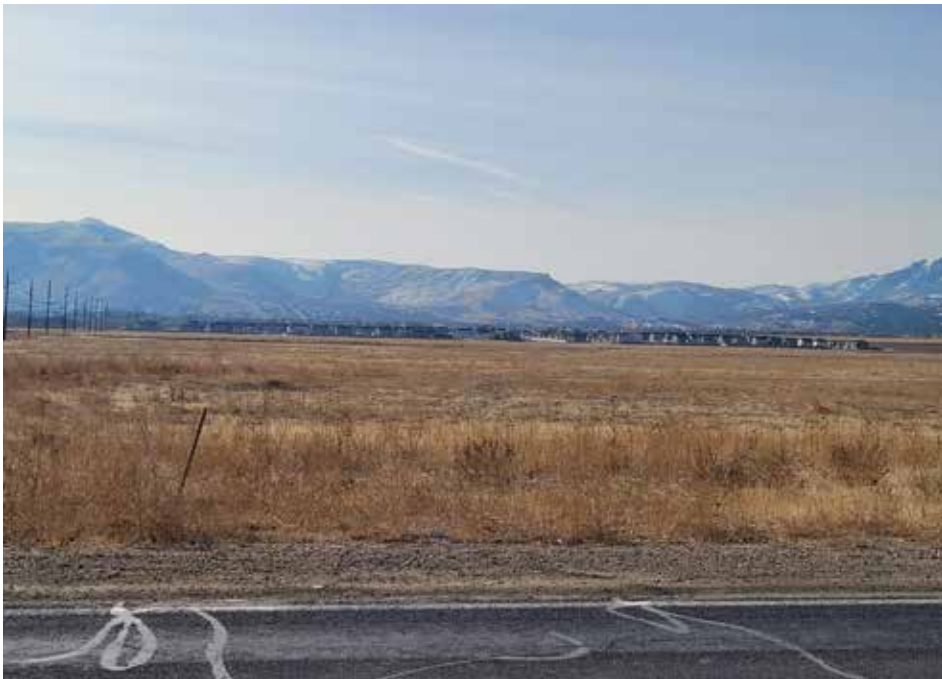
Photo 165 - Pictured from 11800 South (and west of Advantage Arts Academy) is the Bullfrog Spa manufacturing plant located north of the Midas Creek Channel. The facility was constructed (prior to 2013) in the vicinity of the historic Mascotte Ditch and Mascotte Pond (which were previously removed by RTKC as part of their response work in OU6).

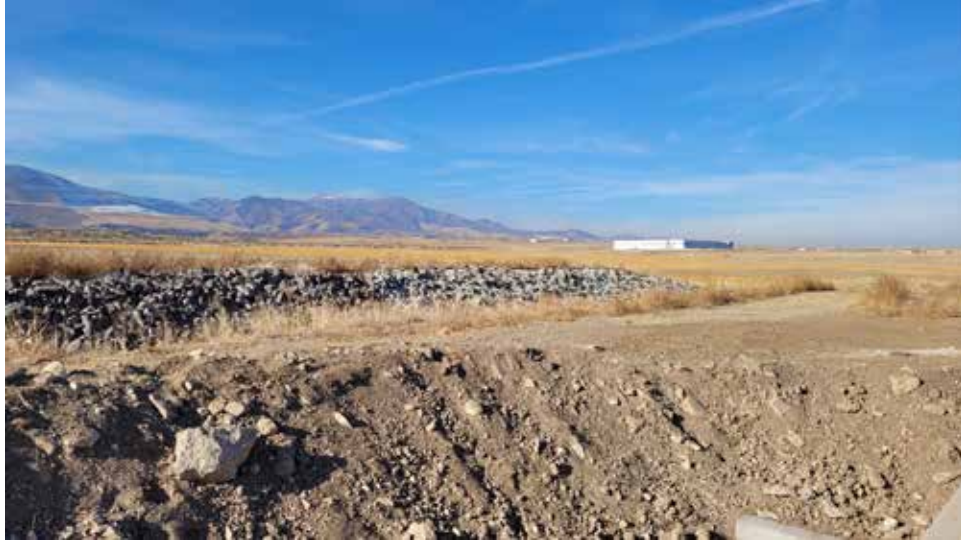
Photo 168 - Pictured is the site of a proposed development, Creek Ridge North, by Edge Homes LLC which is working through a site characterization as Copper Creek historically traversed the property. In the far distance is the Daybreak Communities development north of 11800 South.

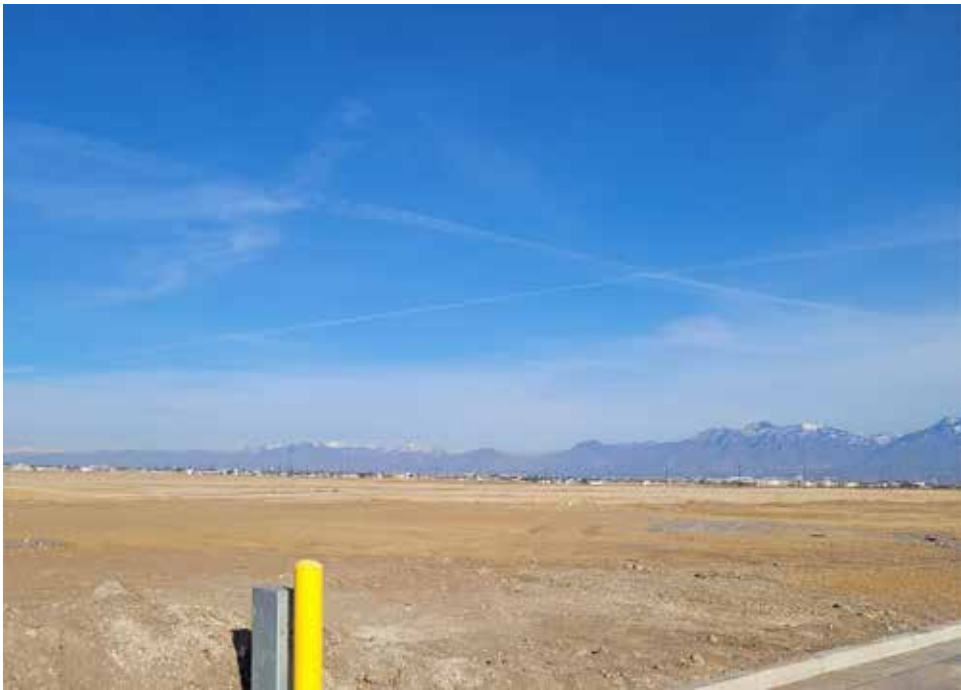
Photo 169 - Pictured is the Midas Creek Channel east of Mustang Way (6000 West). The Channel has had improvements made along its length. Previous characterization efforts over 20 years ago west of here detected some concentrations of lead and arsenic above the site KUALs. Previously no response action under CERCLA for OU6 was required east of 6000 West along Midas Creek because soils on average complied with the applicable land use action levels for open space in OU6.

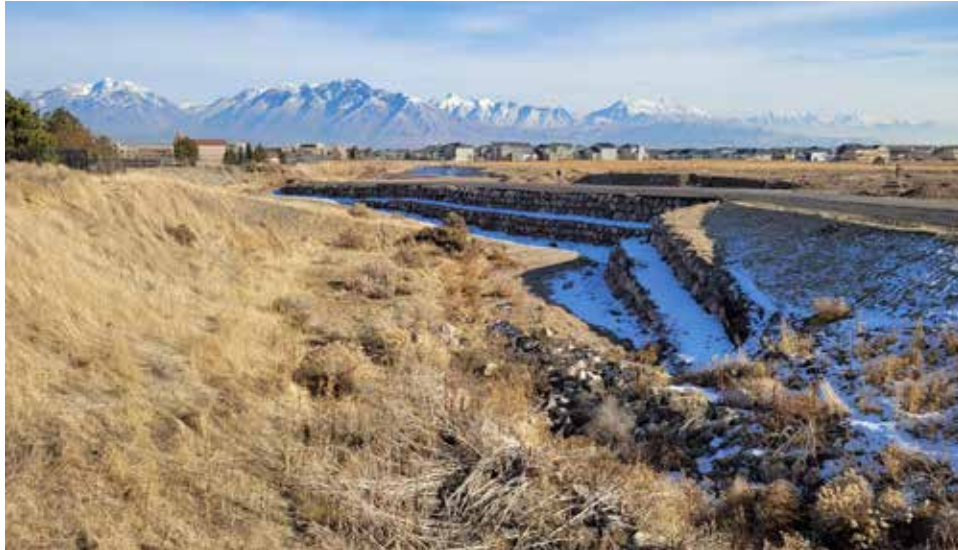
Photo 170 - Pictured is the Midas Creek Channel (red arrow) west of Mustang Way (6000 West). The Channel forms the southern boundary of the Teton Village development which includes a trail path for recreational use along the northern perimeter of the Channel. The development project was underway at the time of the inspection, and is subject to compliance with the SLCO Health Department ordinance.

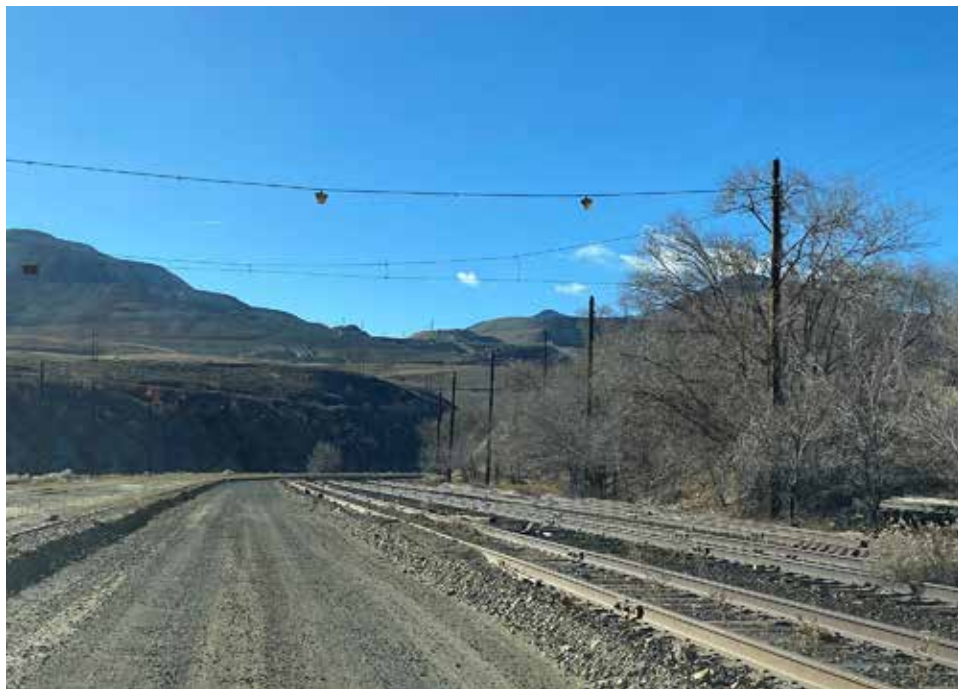
Photo 178 - Pictured is the western extent of the historic KCC Copperton Rail Yard with rail lines extending west into Bingham Canyon. The surrounding hillside and surfaces in the Yard could have soils, slag and other mine waste with lead and arsenic concentrations above the site KUALs. The Yard and rail lines are located below the Town of Copperton, which is out of frame to the right. The old Bingham Mine Ore Conveyor is in the background,

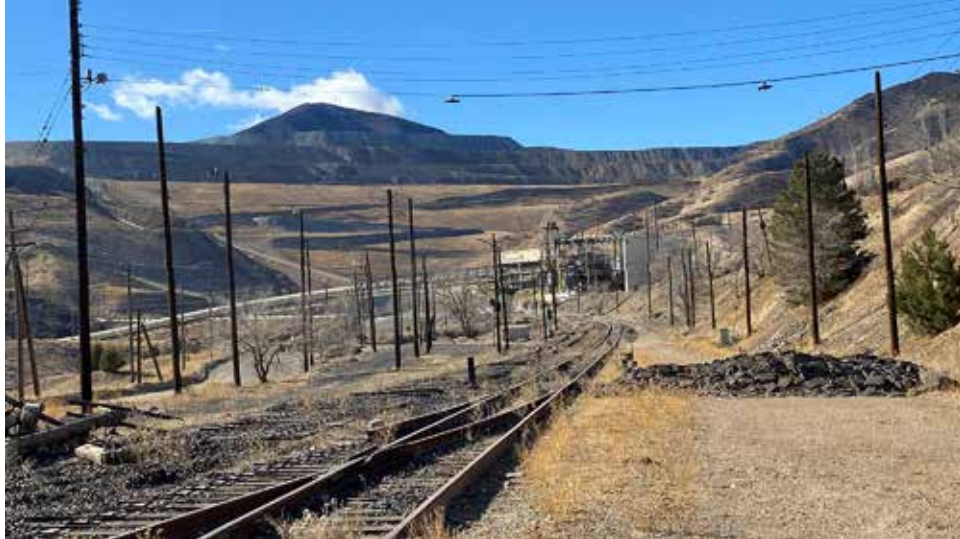
Photo 179 - Pictured is one of the tailings deposit areas (red star) evaluated previously by EPA in the Town of Copperton. The low topography area in the background past the rails could have soils and mine waste with lead and arsenic concentrations above the site KUALs. The area is undeveloped, partially vegetated and surfaces appeared stable. Previous sampling supported EPA's conclusion that soil did not exceed an applicable land use action level for open space.

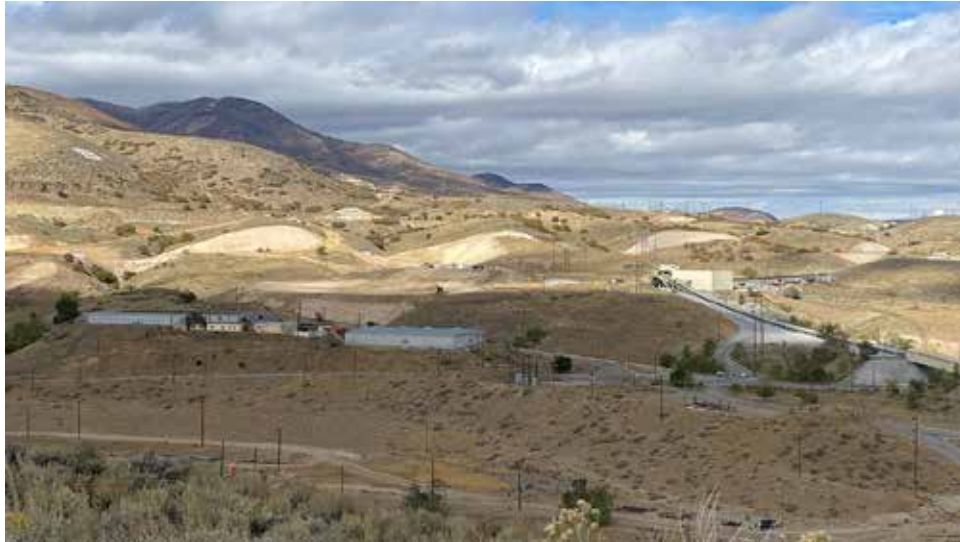
Photo 181 - Pictured in the foreground is the eastern portion of the historic KCC Precipitation Plant. Underlying this facility and the hillside to the north are soils associated with historic Lead Mine Mill which are known to have concentrations of lead and arsenic above the site KUALs. There is a about 20 vertical feet of metals impacted soils underneath the remaining active and decommissioned portions of the KCC Precipitation Plant.

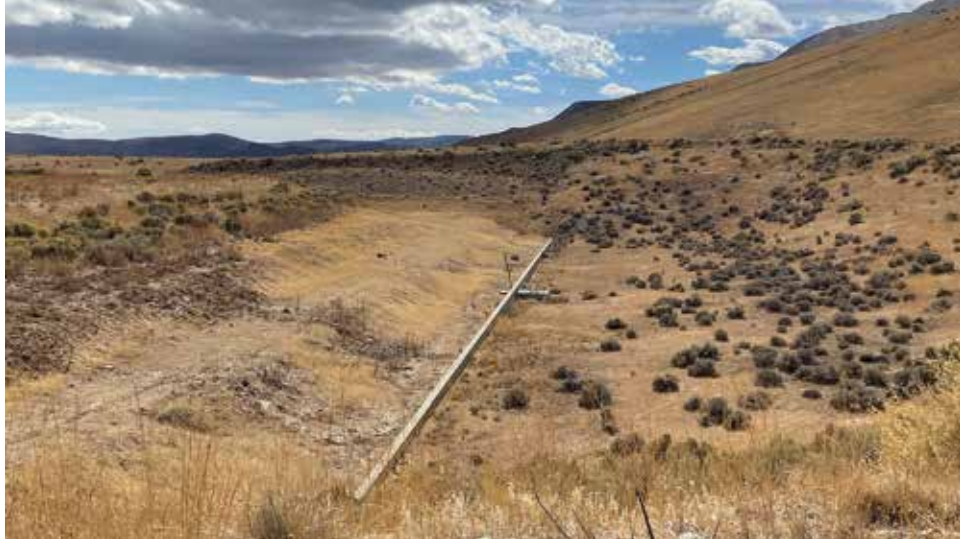
Photo 188 - Pictured upgradient of the Bluewater Repository is another view of the Bluewater 1 Upper Cutoff Wall. The Bluewater 1 Upper Cutoff Wall is used to capture alluvial groundwater prior to it flowing below the surface through the Bluewater Repository.

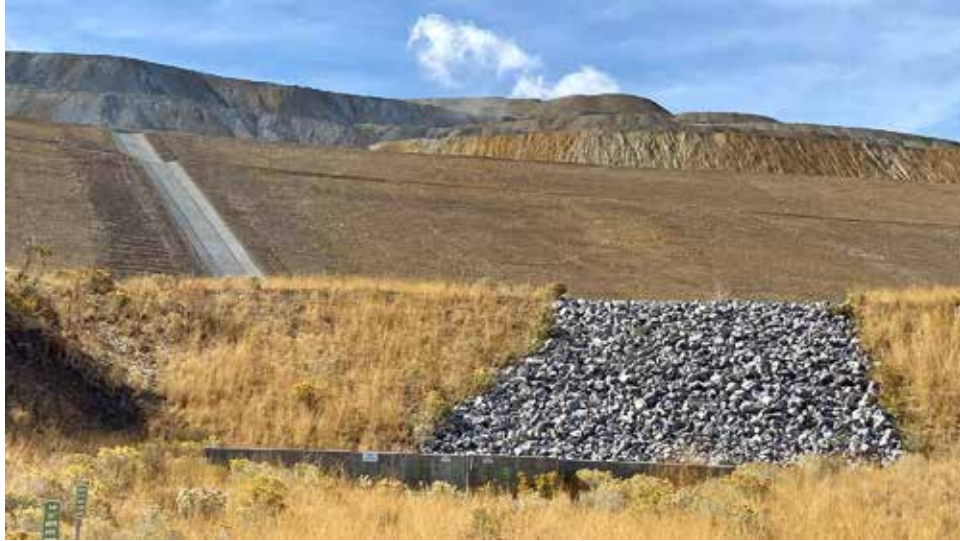
Photo 194 - Pictured is the sediment basin above the Midas 1 Cutoff Wall located at the base of reconstructed sediment basin as part of EWRE project. The Midas 1 Cutoff Wall and sediment basin embankment appeared to be in good condition with no sediment buildup.

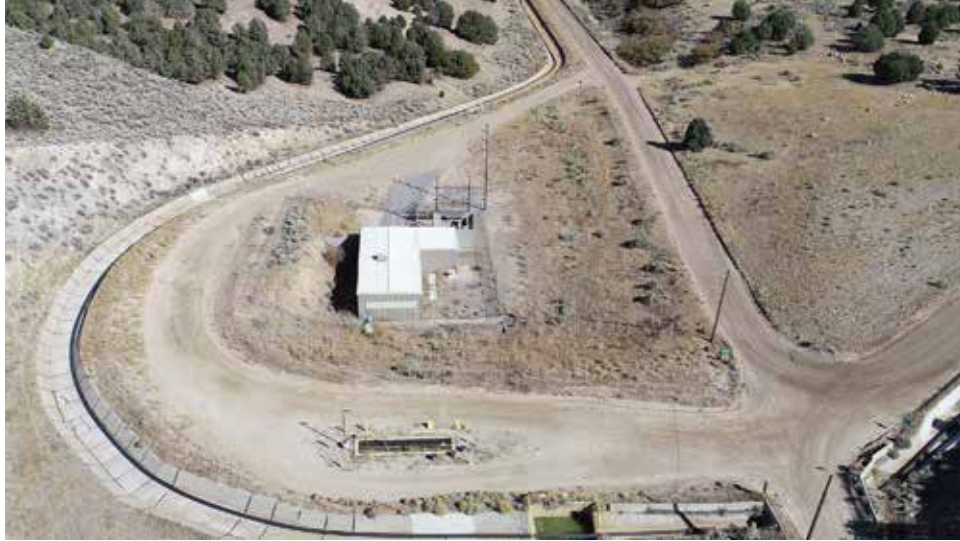
Photo 195 - Pictured is the Midas 2 Cutoff Wall located in the northern portion of the Midas drainage. The gravel bed is used to help dissipate the energy of storm water runoff from the upgradient sediment basin and to facilitate drainage to the cutoff wall surface water sump. The Midas 2 Cutoff Wall appeared to be in good condition.

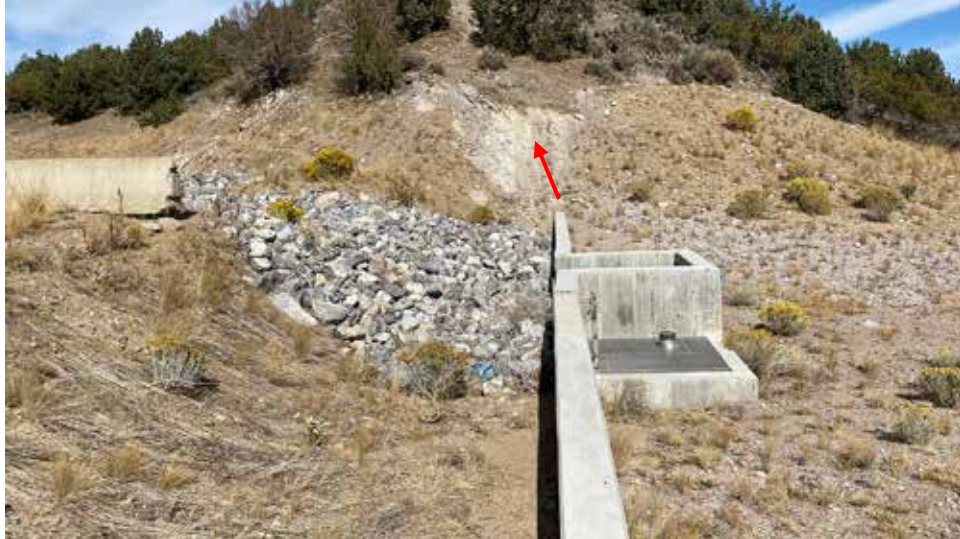
Photo 200 - Pictured is a close up of the Keystone Drainage cutoff wall located just below the spillway of the lower sediment basin depicted in photo #199. The Cutoff Wall appeared to be in good condition with no sediment buildup on the upgradient side of wall (left). The spillway is well armored. Notice the bedrock outcrop at the north end of the wall (red arrow) that the wall is keyed into.

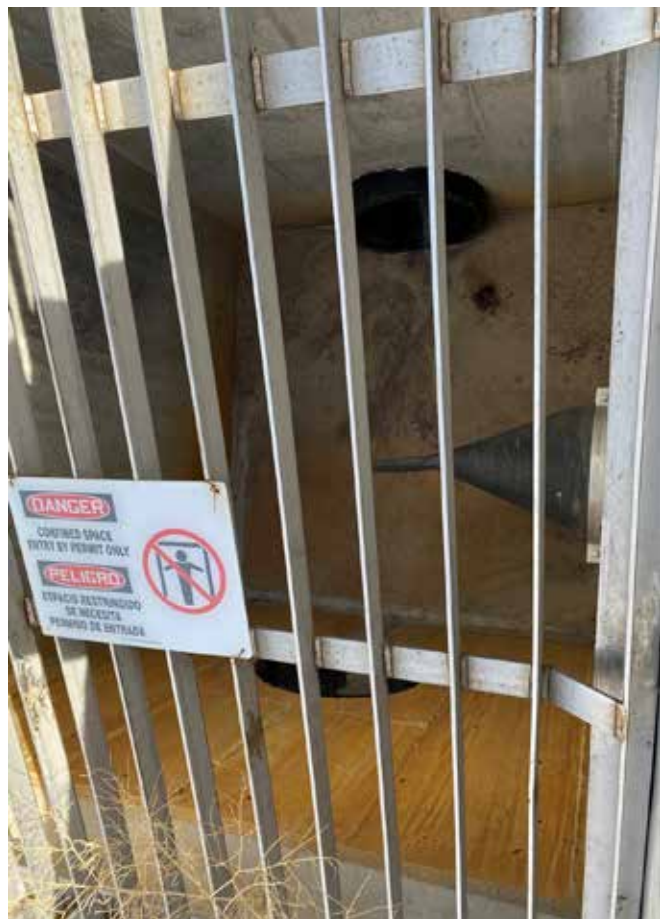
Photo 201 - Pictured is the surface storm water sump box at the Keystone Cutoff Wall. No water was observed and there is limited sediment buildup in the bottom of sump box.

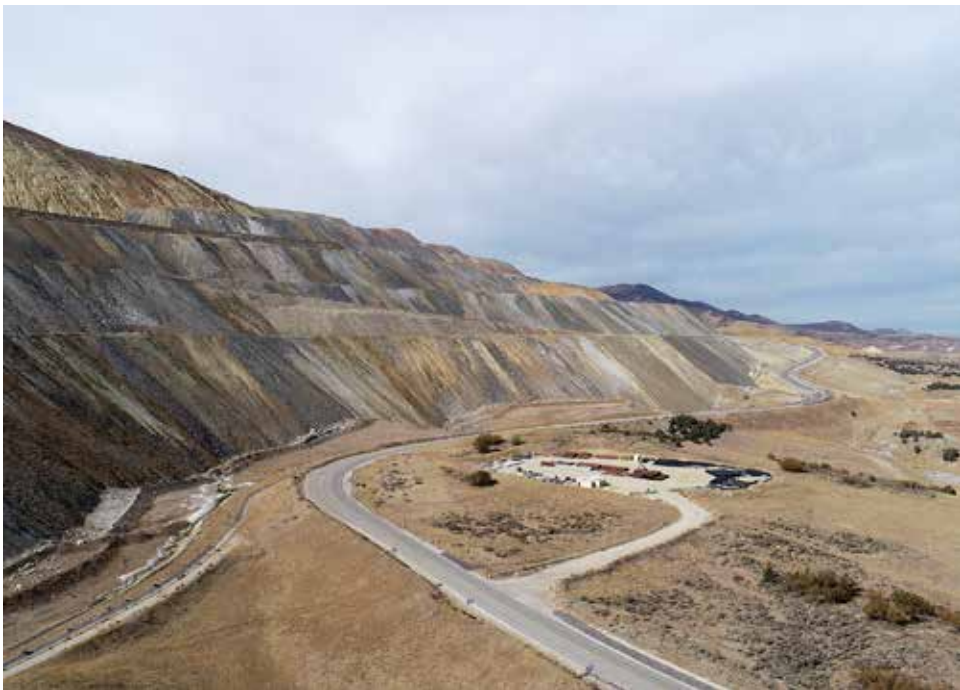
Photo 202 - Pictured is an aerial overview of the Copper 1 Cutoff Wall and upgradient sediment basin constructed as part of RTKC's EWRE project. Both the basin and cutoff wall were recently reconstructed and appeared to be in good condition. Revegetation efforts have been successful.

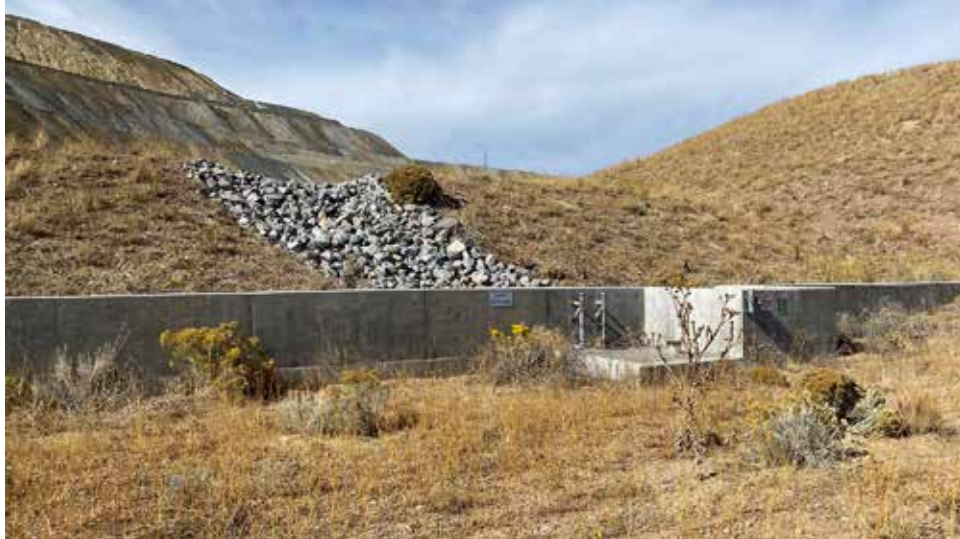
OU12

Photo 204 - Pictured is a closeup of the downgradient side of the Copper 1 Cutoff Wall. No sediment buildup or evidence of overtopping of the wall is apparent. The sediment basin spillway and wall are both in great condition having recently been constructed.

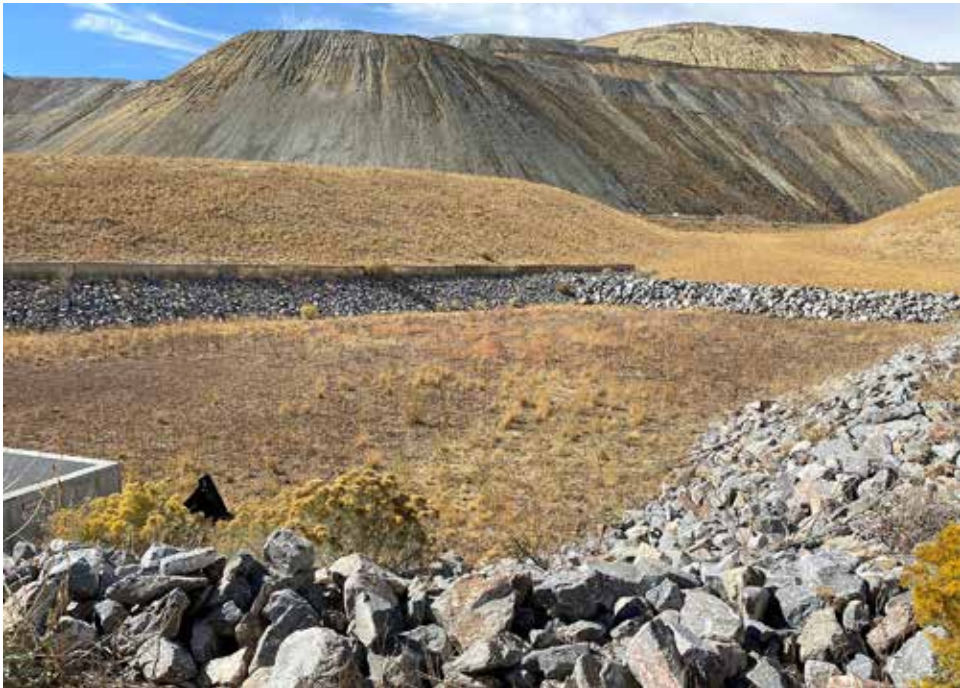
Photo 205 - Pictured is a closeup of the upgradient sediment basin above the Copper 1 Cutoff Wall. The vegetation and rip-rap are indicators that the basin is stable.

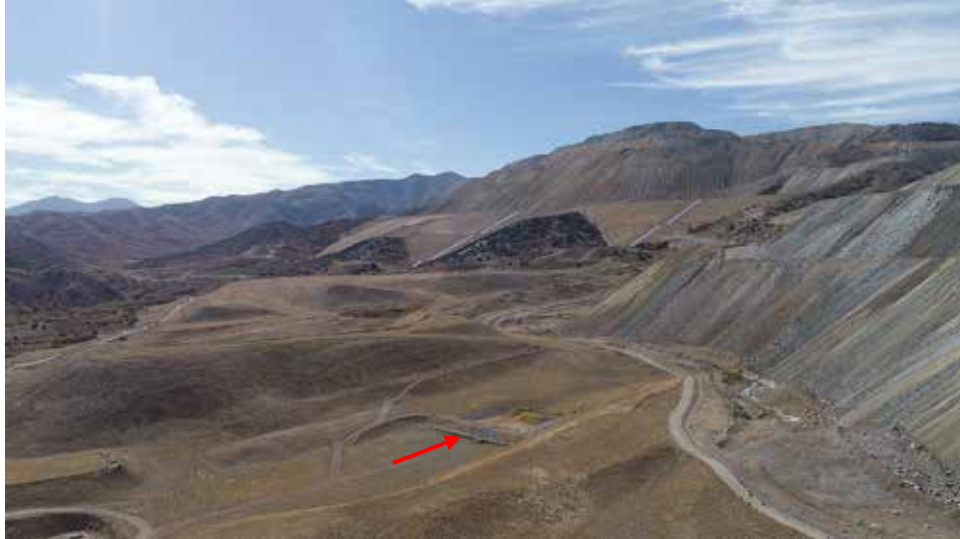
OU12

Photo 206 - Pictured is an aerial view of the reconstructed Copper 3 Cutoff Wall (red arrow). Observe the lateral distance from toe of Copper Drainage Eastside Waste Rock Dump (west, right, of the Copper 3 Cutoff Wall). No apparent erosion between the dump and the Wall is observable.

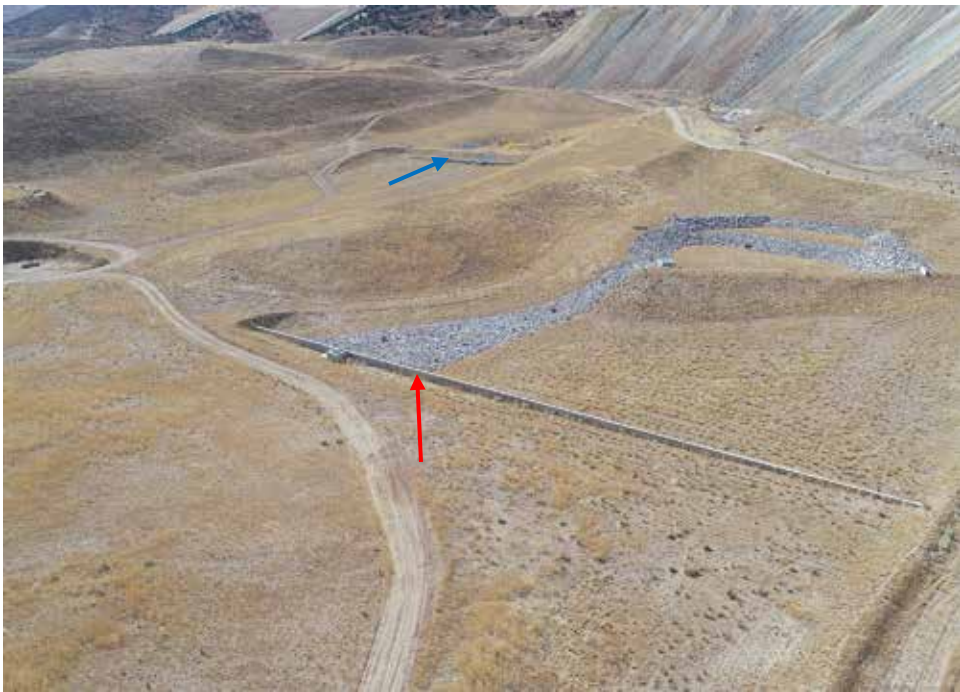
Photo 207 - Pictured is the Copper 2 Cutoff Wall (red arrow) and sediment basin recently reconstructed as part of the EWRE project. The Copper 3 Cutoff Wall is visible to the left in the background (blue arrow). Surfaces appear stable and revegetation efforts look good. No erosion is apparent.

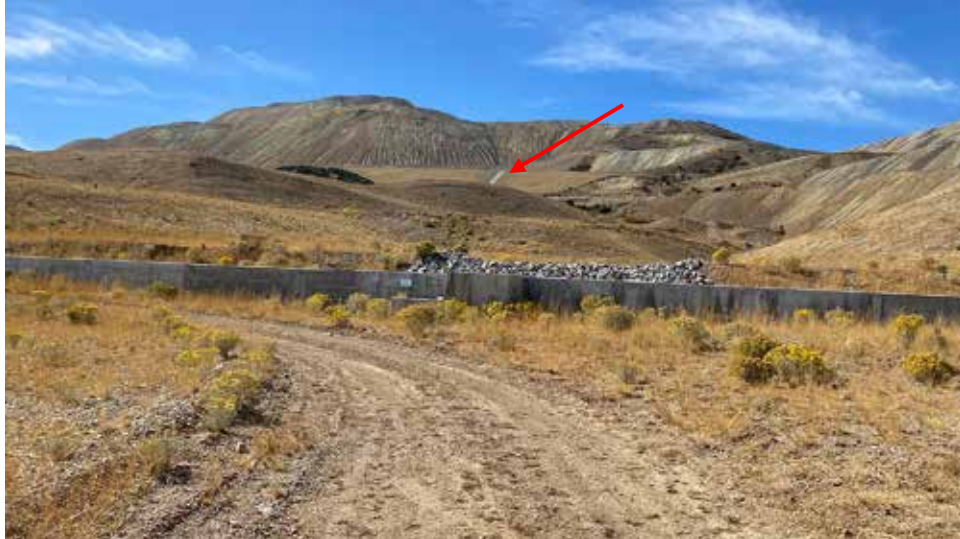
OU12

Photo 208 - Pictured is the reconstructed Copper 4 Cutoff Wall. The Copper Drainage contains the south extension of Bingham Mine Eastside Waste Rock Dumps. The Copper 4 Cutoff Wall appears to be in good condition with no evidence of over toping or recent storm water runoff issues. The waste rock dump in the background (red arrow) is the Yosemite Dump of the Bingham Mine Southside Waste Rock Dumps, located in the Yosemite Drainage above Butterfield Canyon.

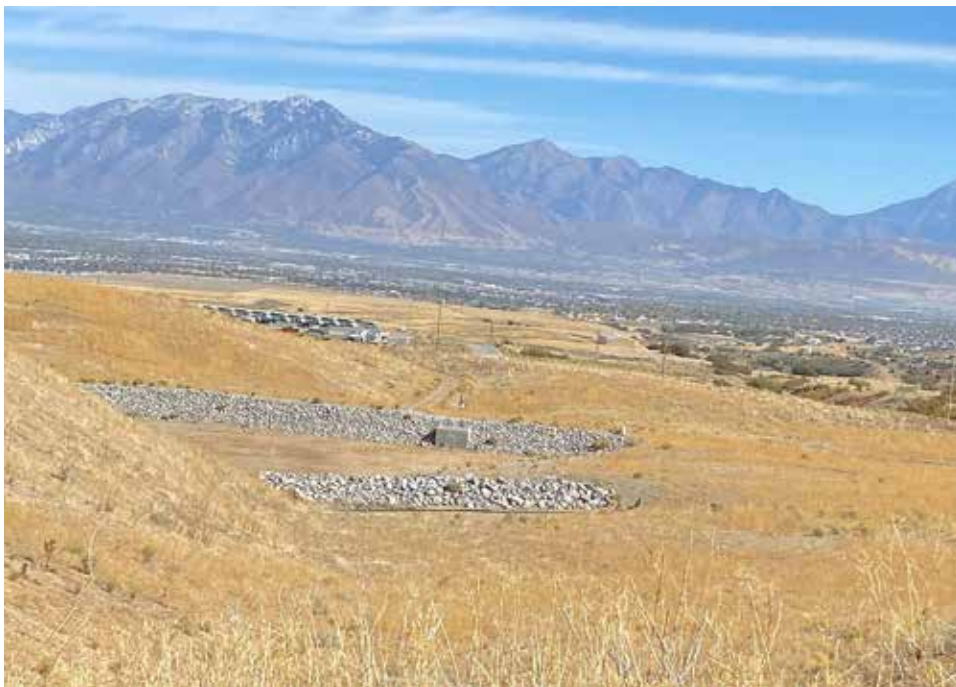
Photo 209 - Pictured is the storm water basin in the Copper 4 Drainage upgradient of the Copper 4 Cutoff Wall. Surfaces appear stable and well vegetated.

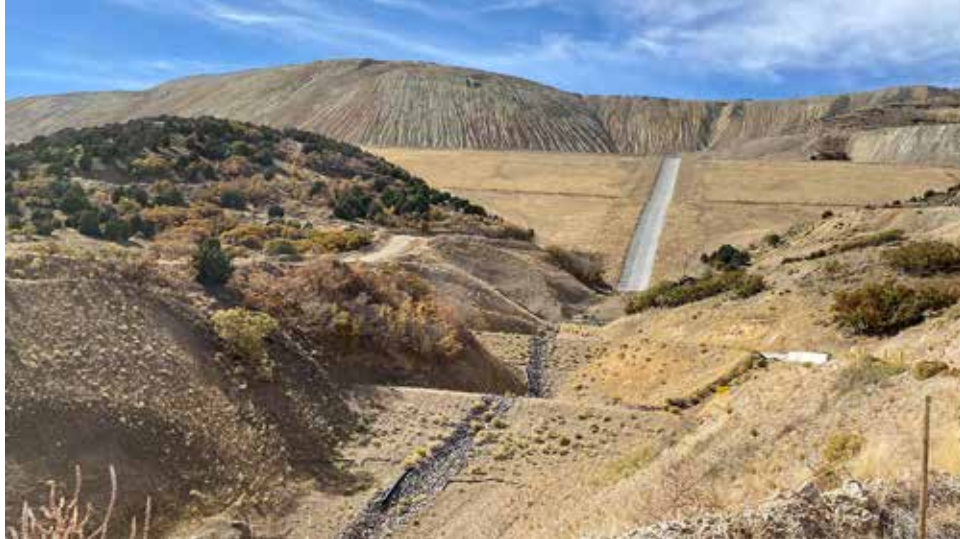
OU12

Photo 210 - Pictured is the Yosemite Drainage and the Bingham Mine Southside Waste Rock Dump. The South Waste Rock Reclamation (SWRR) project has resulted in a new waste rock bench Yosemite which is relaxed and revegetated in front of the older Southside Waste Rock Dump. The storm water down drain and new sediment basins are in place and appear to be in good condition. The SWRR project has expanded RTKC's ability to manage a 100-year 24-hour storm event.

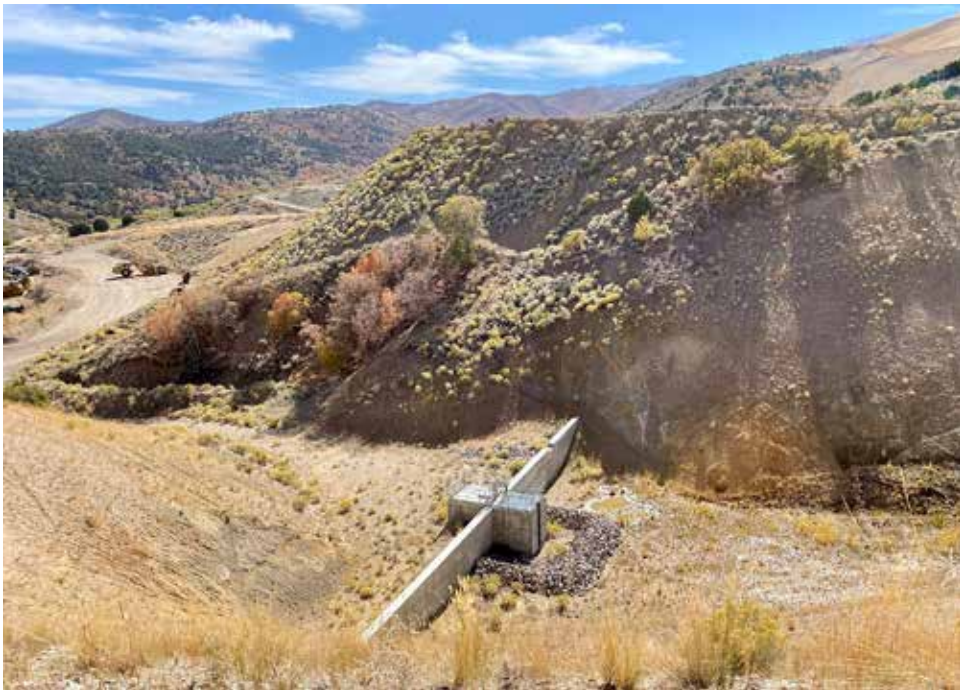
Photo 211 - Pictured is the reconstructed Yosemite Drainage Upper Cutoff Wall near the base of last newly constructed sediment basin in the Upper Drainage. The new cutoff wall has a higher vertical extension above the surface to assist with capturing storm water runoff. The Cutoff Wall, the debris/energy dissipater upgradient of Wall and the Wall's storm water sump all appear to be in good condition. Surfaces around wall are being revegetated.

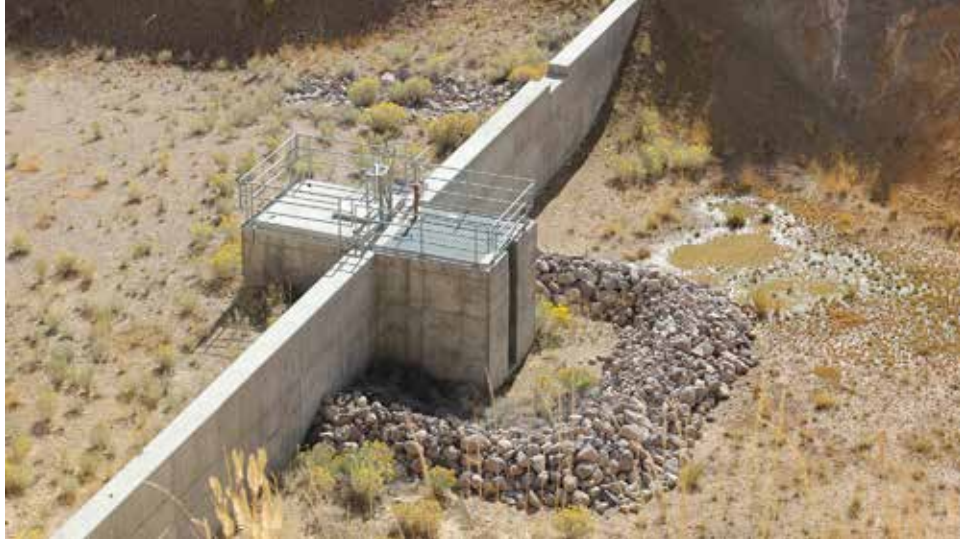
OU12

Photo 212 - Pictured is a close up of the Yosemite Drainage Upper Cutoff Wall. The ground surface is being revegetated. The new Wall is more robust compared to the previous cutoff wall which has been buried under the SWRR project's new bench of waste rock.

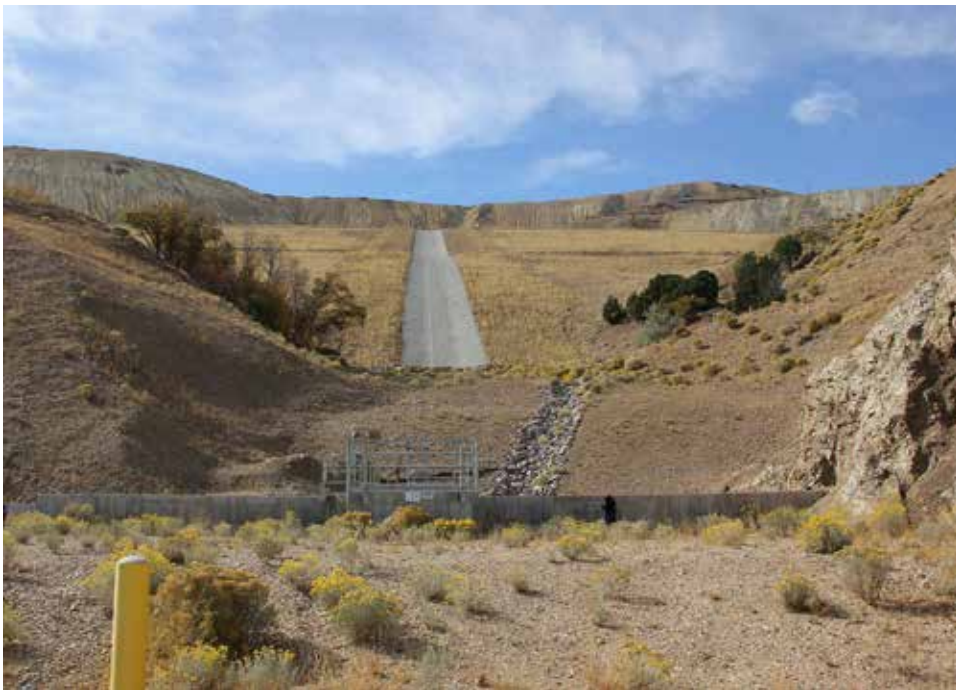
Photo 213 - Pictured is the downgradient side of the new Yosemite Drainage Upper Cutoff Wall and the SWRR project's relaxed bench of waste rock which has been revegetated. This view is helpful to understand the slopes of the Bingham Mine Southside Waste Rock Dumps. Even when relaxed the bench slopes are steep, so down drains and sediment basins are critical to prevent the release events as observed in 2013.
