SECOND FIVE-YEAR REVIEW REPORT FOR
KENNECOTT (SOUTH ZONE) SUPERFUND
ALTERNATIVE SITE
SALT LAKE COUNTY & TOOELE COUNTY, UTAH

Utah Department of Environmental Quality
Division of Environmental Response & Remediation
Salt Lake City, Utah

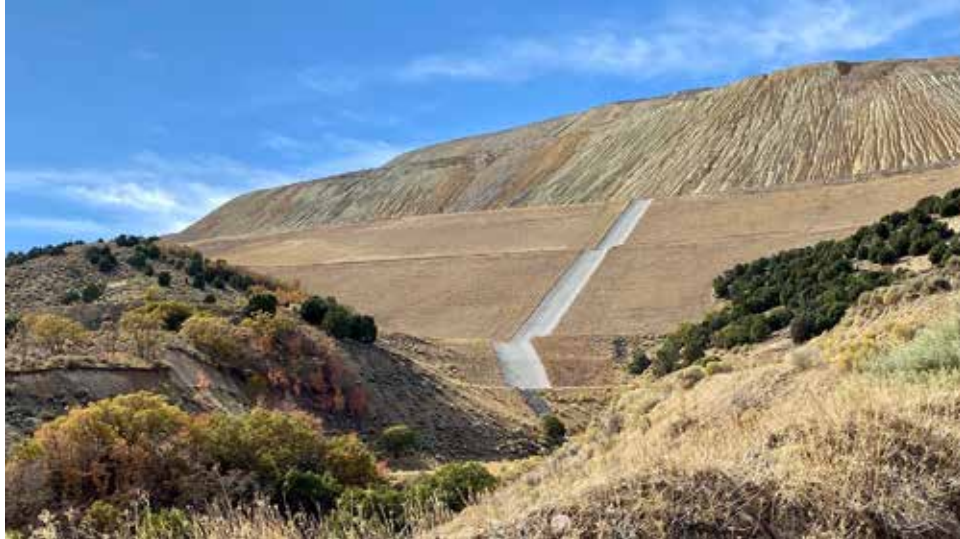
OU12

Photo 214 - Pictured is the Saints Rest Drainage and the SWRR project's new waste rock bench that has been relaxed and revegetated. The down drain from the top of the SWRR project's waste rock bench will prevent runoff erosion. The older Bingham Mine Southside Waste Rock Dump is located above the new SWRR project's bench. The SWRR project will stabilize the upper older dumps, minimize storm water infiltration and reduce the generation of acid mine drainage, and contain higher volumes of storm water.

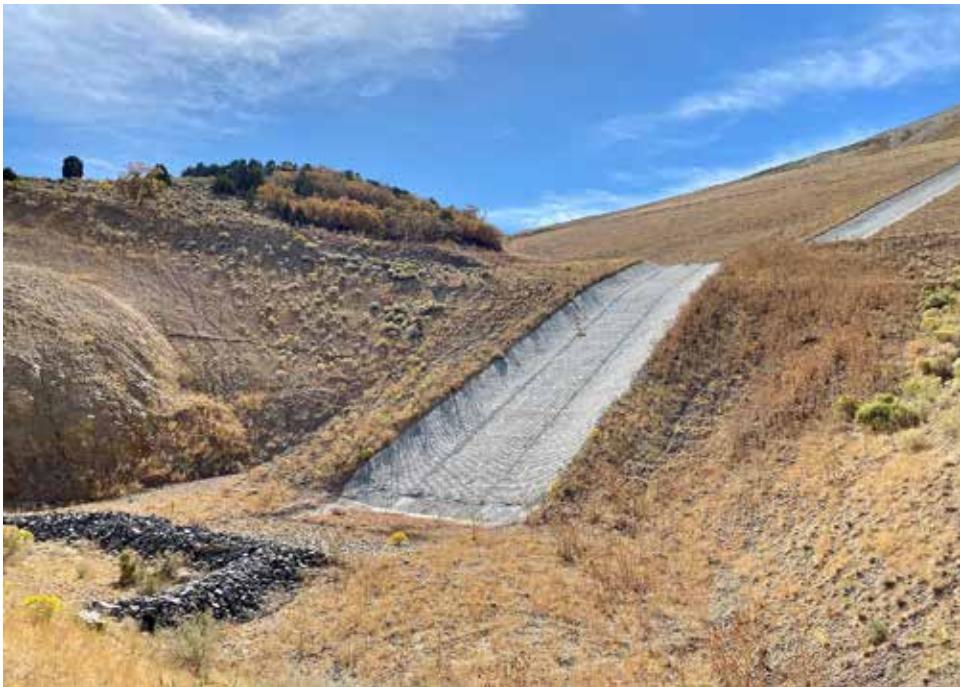
Photo 215 - Pictured at the base of the down drain in the Saints Rest Drainage is an energy dissipater in front of the Saints Rest Cutoff Wall storm water sump box. The down drain is constructed of interlocking concrete matts which limit vegetation growth. Revegetation efforts on the surrounding slopes appears to be successful. The SWRR project's new bench of waste rock and each down drain are constructed the same way.

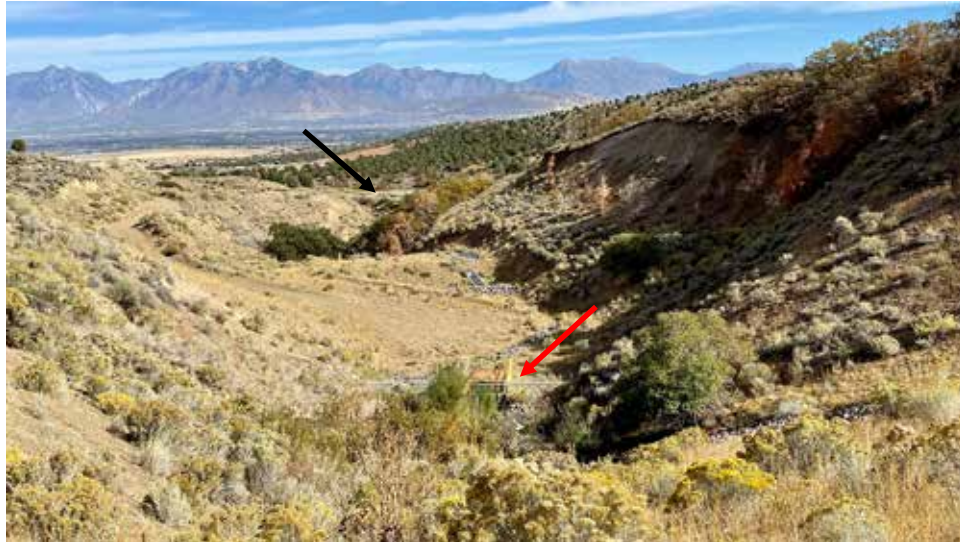
OU12

Photo 216 - Pictured is the Saints Rest Cutoff Wall (red arrow) and secondary storm water basin down gradient of the Wall. Further in the distance is the Water Collection Pipeline Road (black arrow) which forms a secondary basin to prevent storm water runoff from migrating off site. Surfaces are well vegetated.

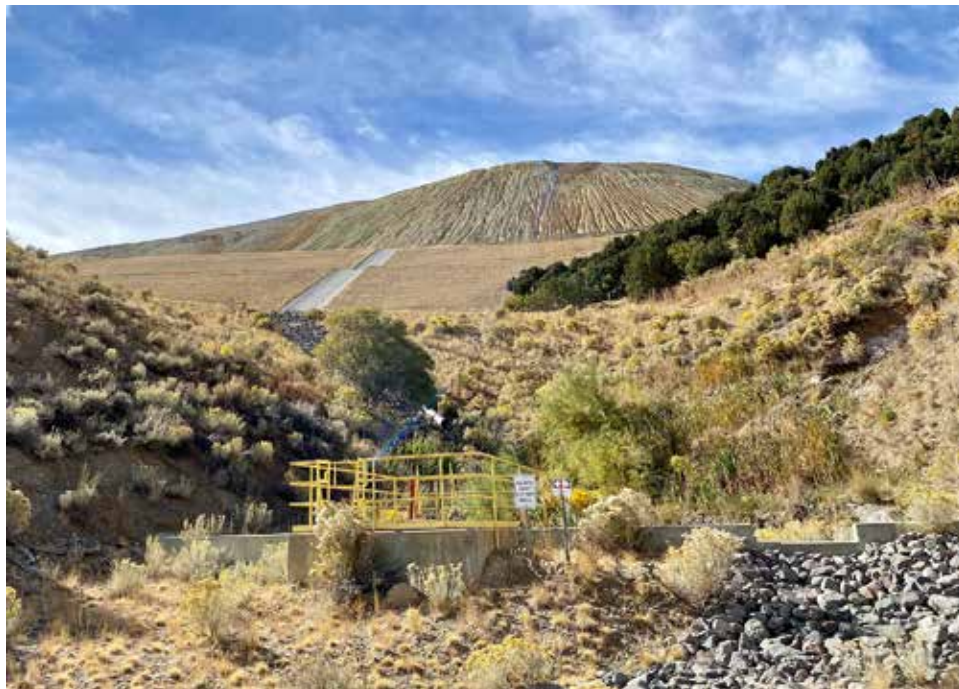
Photo 217 - Pictured is the Saints Rest Drainage Cutoff Wall. The SWRR project did not require the replacement of the Saints Rest Cutoff Wall.

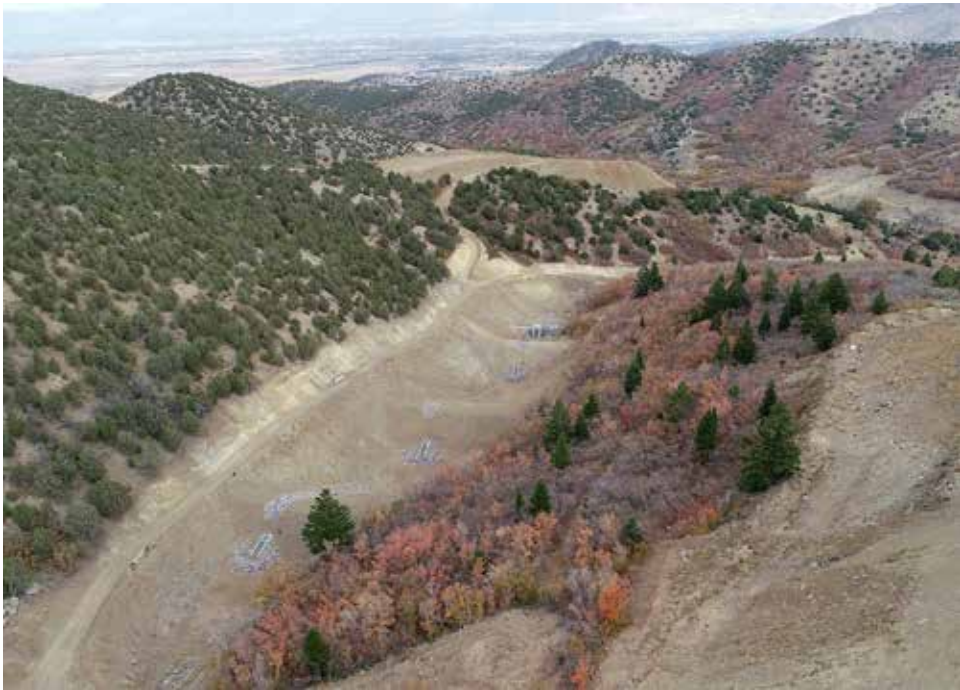
Photo 219 - Pictured is an aerial overview of the Butterfield 1 Drainage looking southeast toward Butterfield Canyon. The series of newly constructed sediment basins will contain a 100-year 24-hour storm water runoff event. The disturbed surface on the south embankment (right side of the photo) has had vegetation removed to prepare the surface for the relaxation of the SWRR project's new waste rock bench.

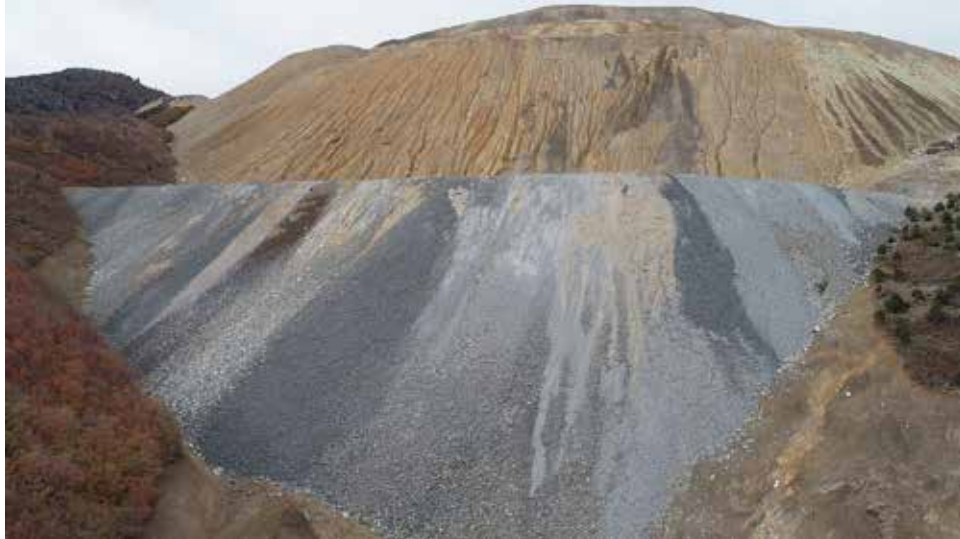
OU12

Photo 220 - Pictured is the SWRR project's new bench of waste rock in the Butterfield I Drainage. Once relaxed, the bench will have a down drain installed and be revegetated. The new bench of waste rock is distinguished by the grey color of the un-oxidized waste rock.

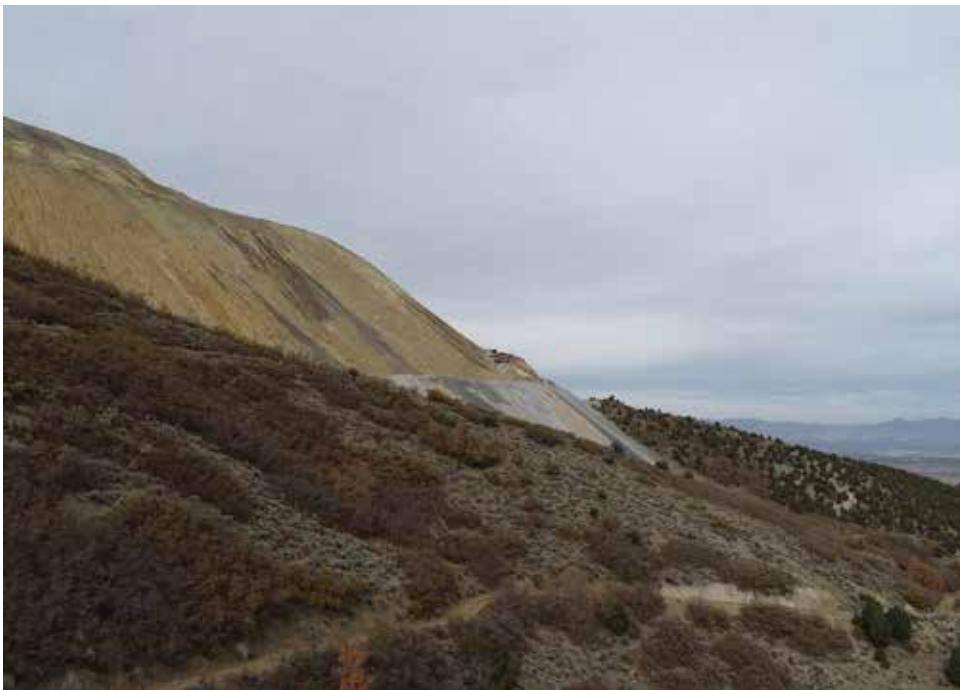
Photo 221 - Pictured from the adjacent drainage, the SWRR project's new bench of waste rock in the Butterfield 1 Drainage is distinctly visible (grey rock) in comparison to the older Bingham Mine Southside Waste Rock Dump upgradient. The new bench will stabilize the upper dump and the sediment basins below will help contain debris.

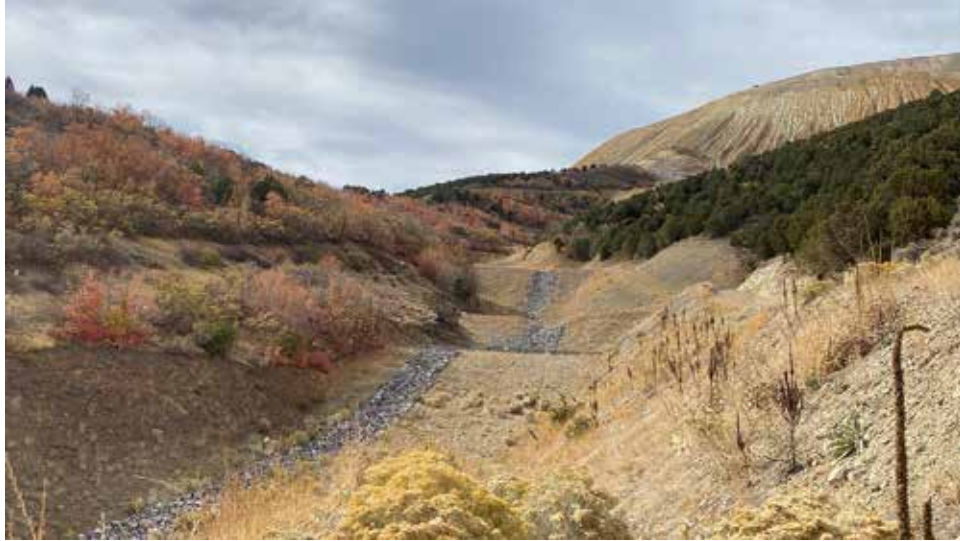
OU12

Photo 222 - Pictured from the reconstructed Butterfield 1 Cutoff Wall, the spillways of the newly constructed storm water runoff basins are visible. The slopes of the basins appear to be stable and are being revegetated.

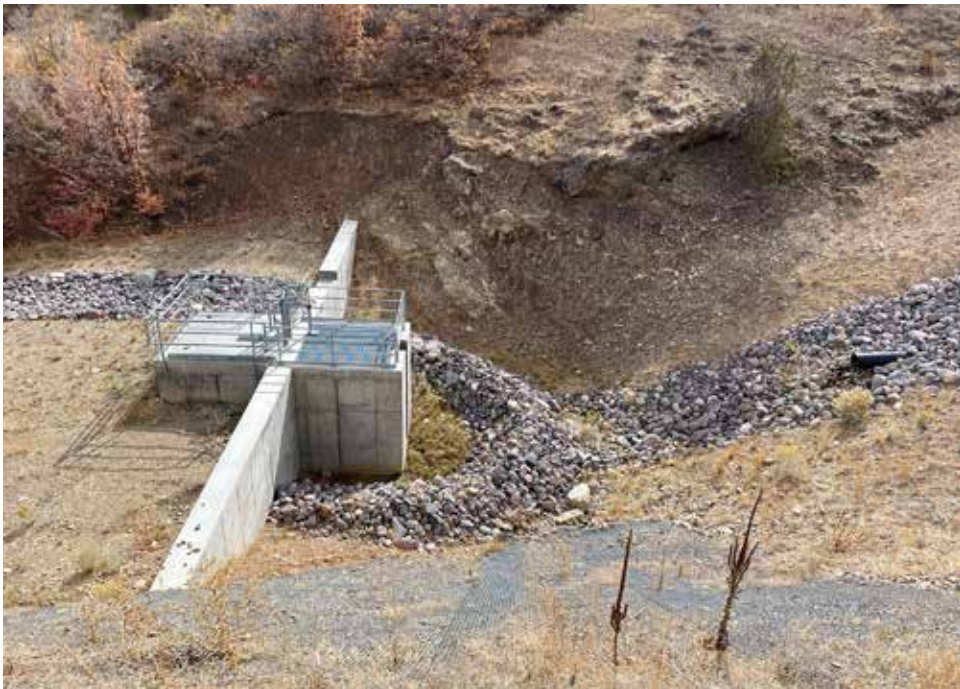
Photo 223 - Pictured is the new Butterfield I Drainage Cutoff Wall. Designed to receive storm water from the upgradient sediment basin, the new Wall, the storm water sump box and energy dissipator all appear to be in good condition as does the armored spillway of the lower sediment basin.

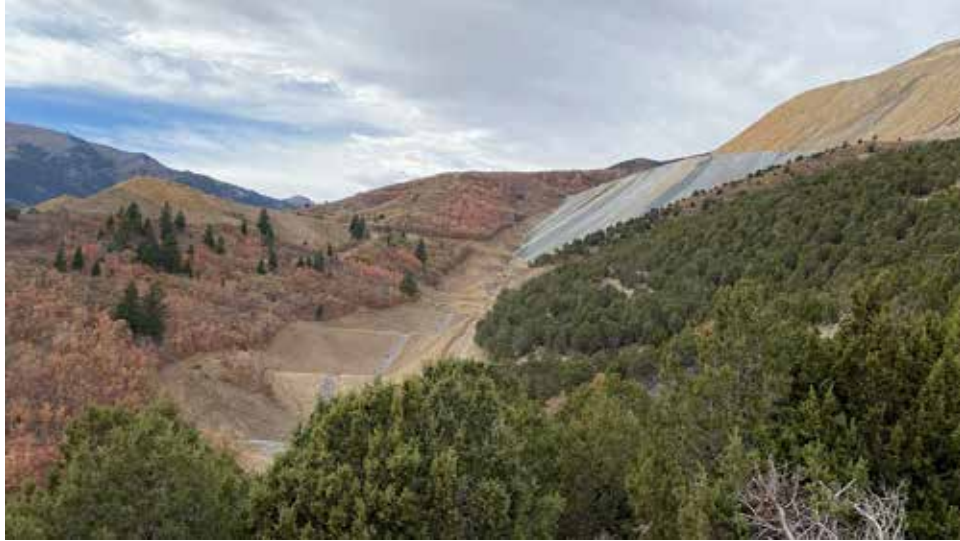
OU12

Photo 224 - Pictured is an aerial overview of the Olsen Drainage and the SWRR project's new bench of waste rock (grey, un-oxidized rock). The new bench of waste rock has yet to be relaxed and revegetated. Below the bench, as denoted by the individual armored spillways, are a series of newly constructed sediment basins to capture storm water runoff.

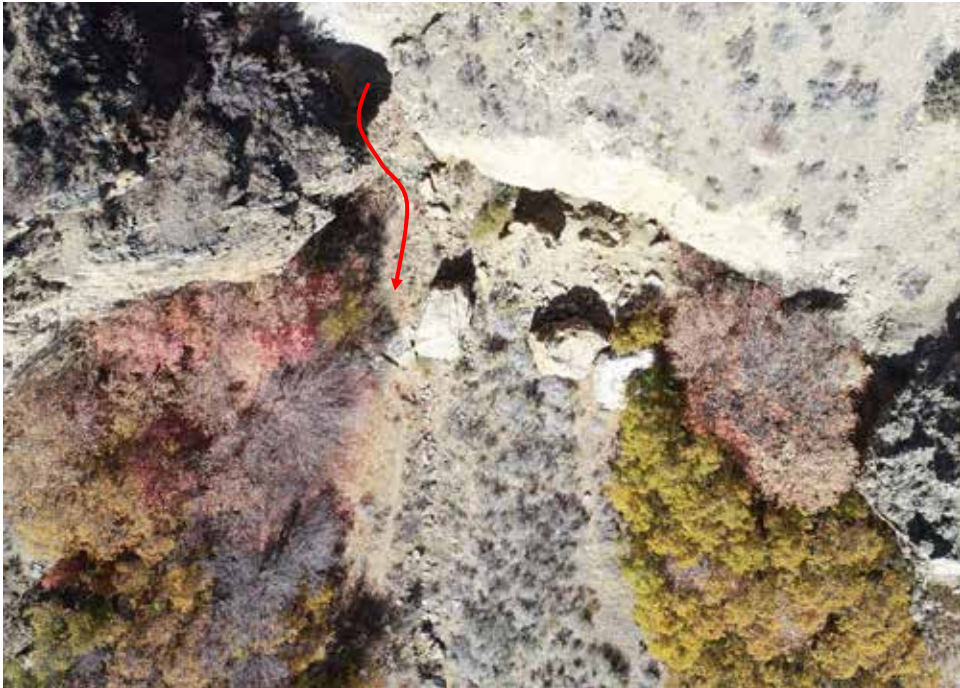
Photo 225 - Pictured is an aerial view of the Olsen Drainage outlet into Butterfield Canyon. From above, the drainage appears to have minimal stormwater runoff sediment along the drainage channel (red arrow).

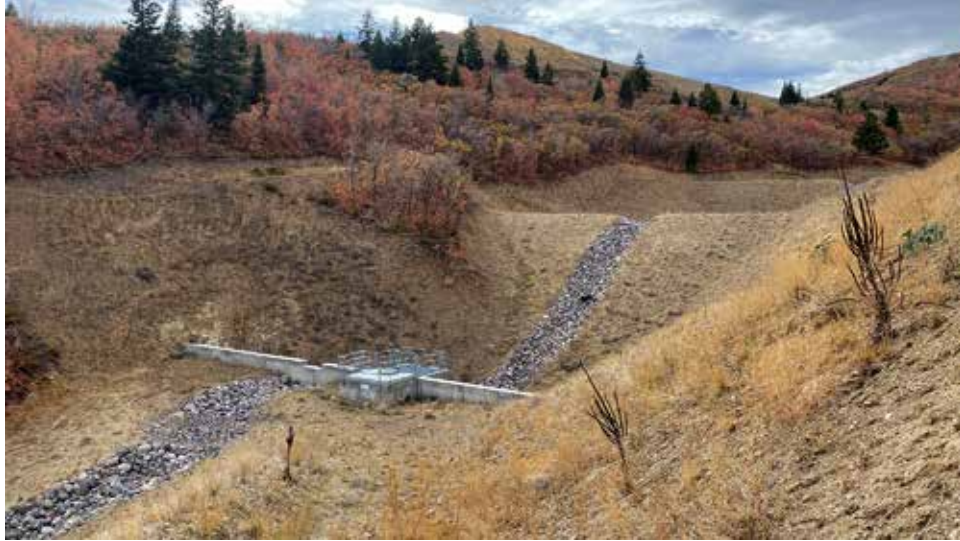
OU12

Photo 226 - Pictured is the new Olsen Drainage Cutoff Wall. The Wall and sediment basin spillway all look good and the surrounding surfaces are revegetating well.

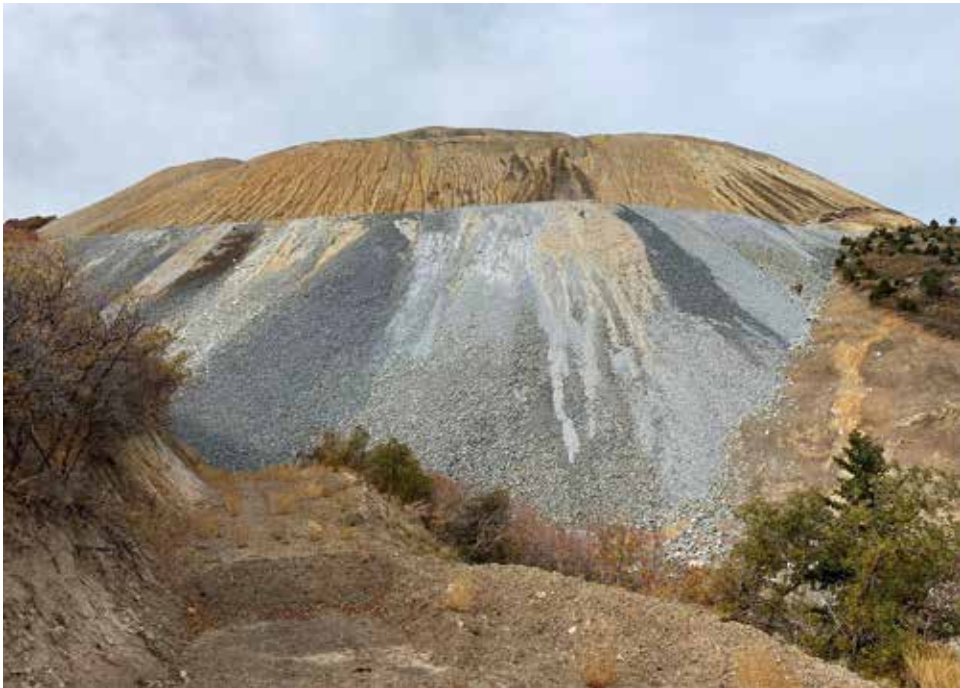
Photo 227 - Pictured from above the sediment basins in the upper Olsen Drainage is the SWRR project's new bench of waste rock. Above the bench is the older Southside Waste Rock Dump in Olsen that will be stabilized by the new bench. Once relaxed, the new bench will be revegetated and have a down drain constructed to direct storm water runoff away from vegetated slopes of the bench.

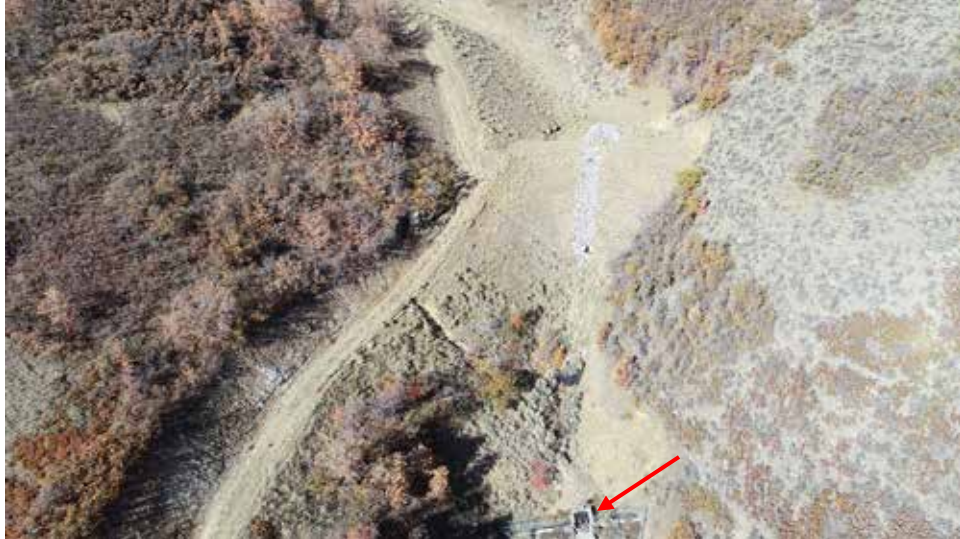
OU12

Photo 228 - Pictured is an aerial over of the Queen Mine and Blackjack Gulch Drainage and the new upper cutoff wall (red arrow). Upper portions of Blackjack Gulch have waste rock deposits associated with the Queen Mine.

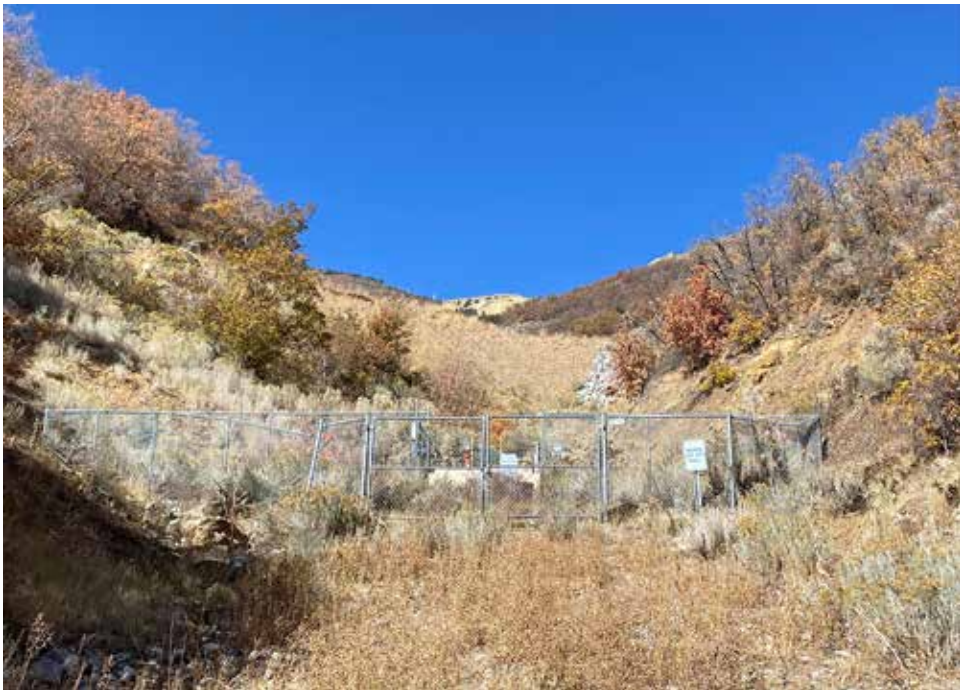
Photo 229 - Pictured is the downgradient slope of the Blackjack Gulch or Queen Cutoff Wall. Established for some time, the surfaces around the Wall are well vegetated. The Queen Cutoff Wall captures alluvial groundwater flow in the Blackjack Gulch Drainage as do all the cutoff walls.

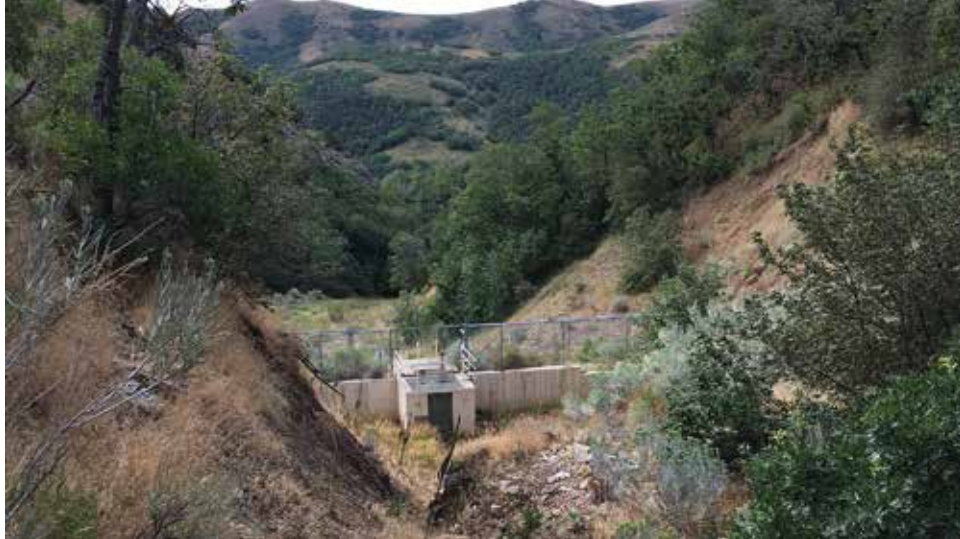
OU12

Photo 230 - Pictured is the upper reach of Blackjack Gulch with an upgradient view of the Queen Cutoff Wall. The Cutoff Wall appears to be in good condition with no evidence of sediment buildup around the storm water sump box. The Blackjack Gulch Drainage around the Queen Cutoff Wall is narrow, constricting and steep.

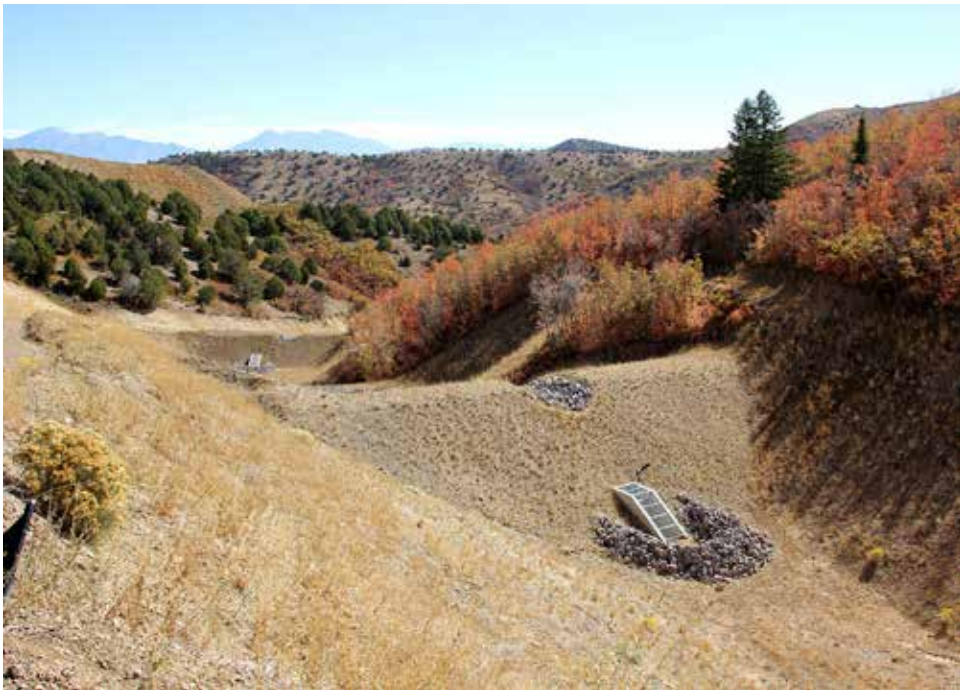
Photo 231 - Pictured below the Queen Mine and waste rock dumps are the newly constructed sediment basins in upper Blackjack gulch. The basins are designed with robust dams and energy dissipaters to capture and manage storm water runoff from a 100-year 24-hour storm event. Surfaces have been revegetated.

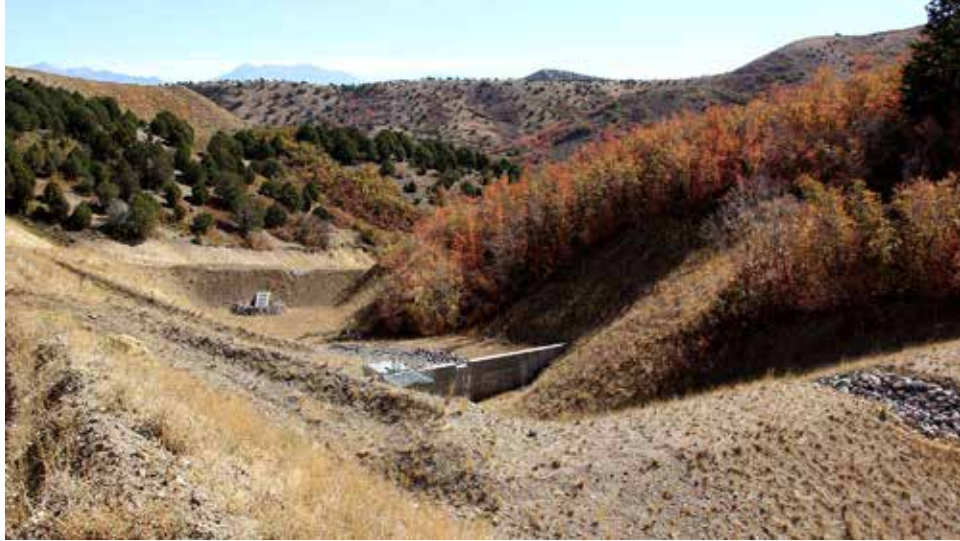
OU12

Photo 232 - Pictured is the new Blackjack Gulch Upper Cutoff Wall situated between the first and second new sediment basins. The new cutoff wall is located closer to the Queen Mine Waste Dumps and will capture alluvial groundwater and storm water runoff before the lower and original Queen Cutoff Wall.

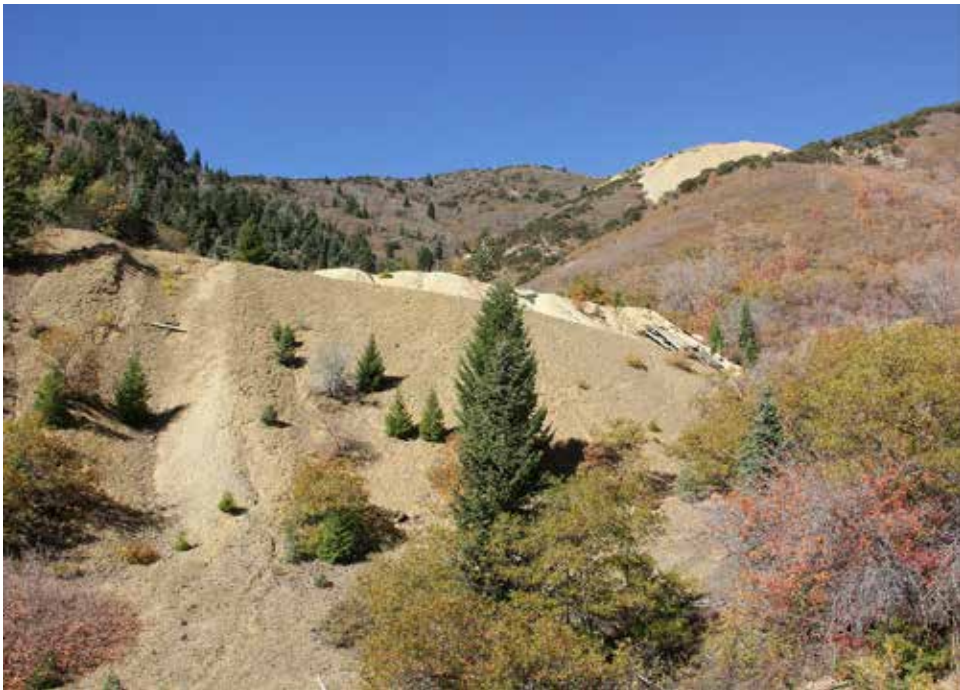
Photo 233 - Pictured is the first of a series of waste rock dumps located around the historic Queen Mine and Mill, and Tunnel footprints. This western dump in upper Blackjack Gulch is the site of Queen Mine Mill (historically located on top of the dump). The waste rock dump has historically shown evidence of erosion.

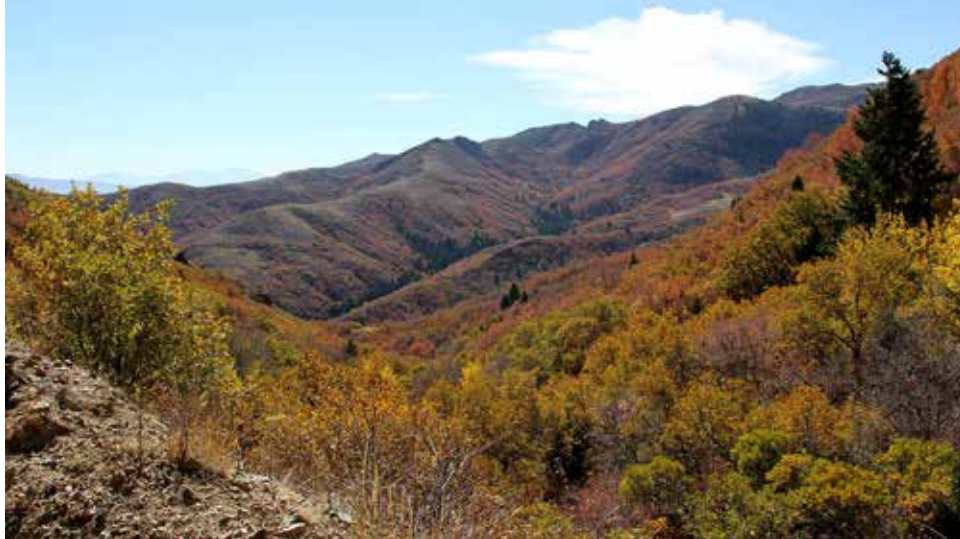
OU12

Photo 234 - Pictured from the Queen Mine footprint is the Blackjack Gulch Drainage looking south toward Butterfield Canyon. Blackjack Gulch is the last drainage of the Bingham Mine Southside Waste Rock Dump drainages. The SWRR project is enhancing the management of alluvial groundwater and storm water runoff in these drainages to prevent release events like the high intensity storm in 2013.

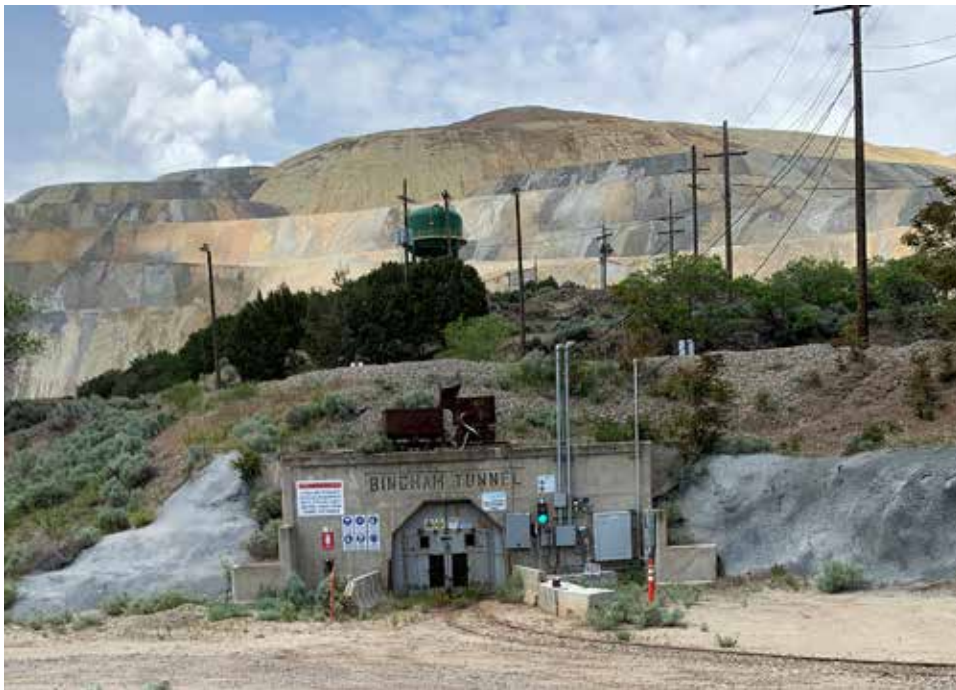
Photo 235 - Pictured is the New Bingham Tunnel portal. The Tunnel extends west into the Bingham Mine underground workings. As part of the EWRE project, RTKC increased stability of structural supports along the Tunnel to ensure it could support the weight of the new bench of waste rock placed as part of EWRE project. The Tunnel portal is secured by RTKC.

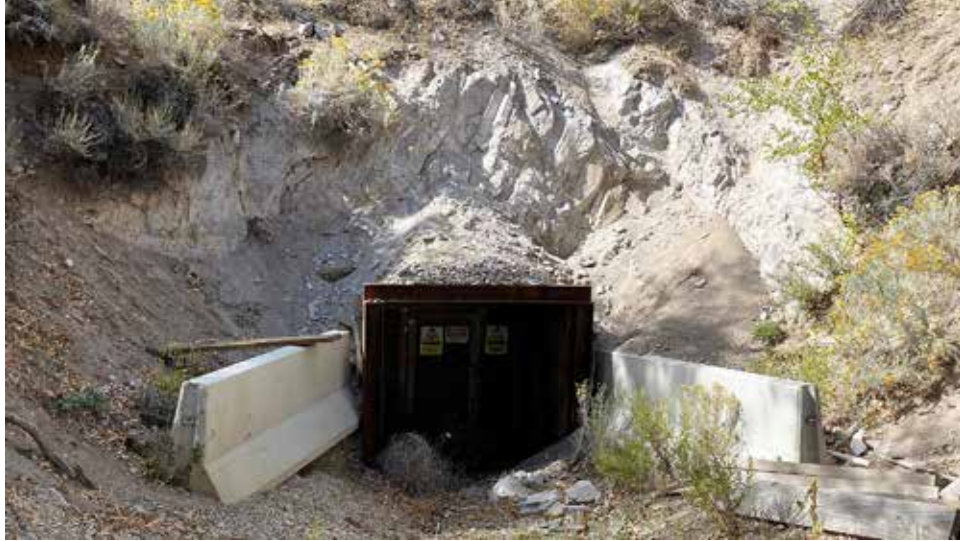
OU12

Photo 235 - Pictured is the Mascotte Tunnel portal below the Keystone Drainage. The Mascotte Tunnel is secured by RTKC. Water from the Tunnel is piped to the Water Collection Pipeline and directed to the Large Bingham Reservoir (OU4).

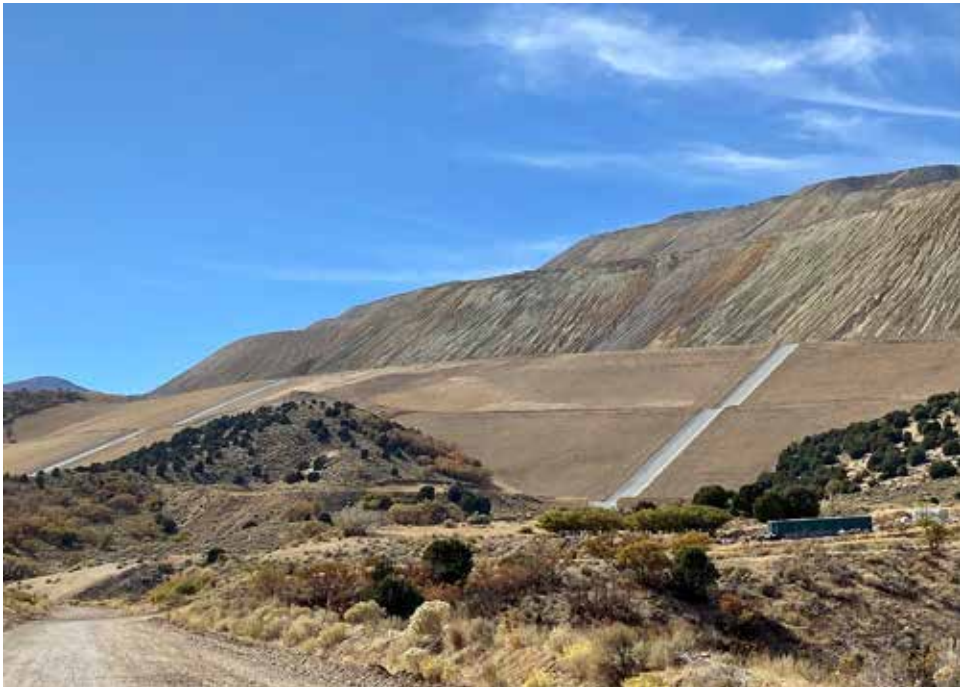
Photo 236 - As an overview of the SWRR project, pictured are the Yosemite and Saints Rest drainages and respective benches of waste rock that have been relaxed and revegetated. Comparative to the older, angle of repose waste rock dumps located above the new bench, the new bench is designed to minimize water infiltration and stabilize the historic upper dumps.

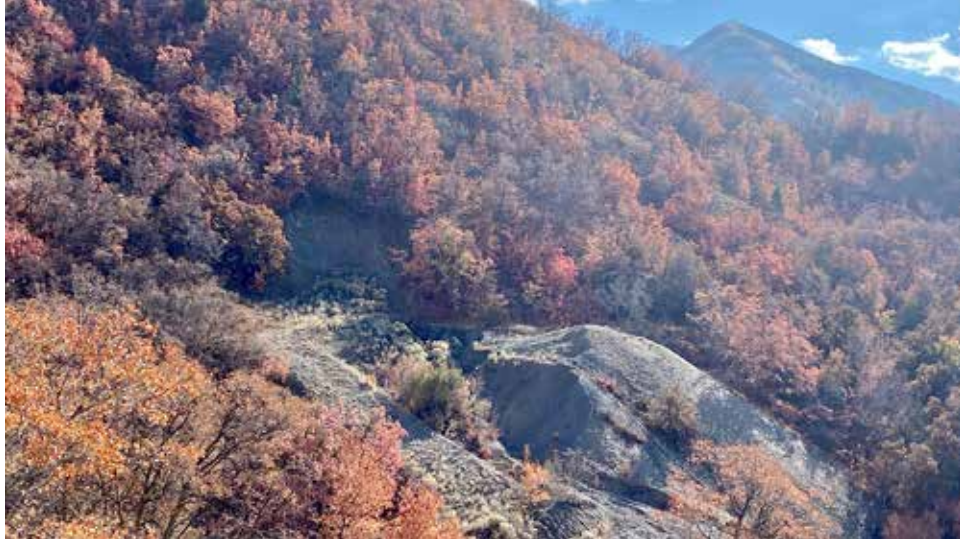
OU18

Photo 237 - Pictured is an aerial overview of the Bingham West Dip Tunnel and rock dump located on the western face of the Oquirrh Mountains south of Pine Canyon, in Tooele County. The Tunnel portal has collapsed and the rock dump is not well vegetated and showing evidence of erosion. The Tunnel is well inside RTKC's property line and the site is not easily accessible by the general public.

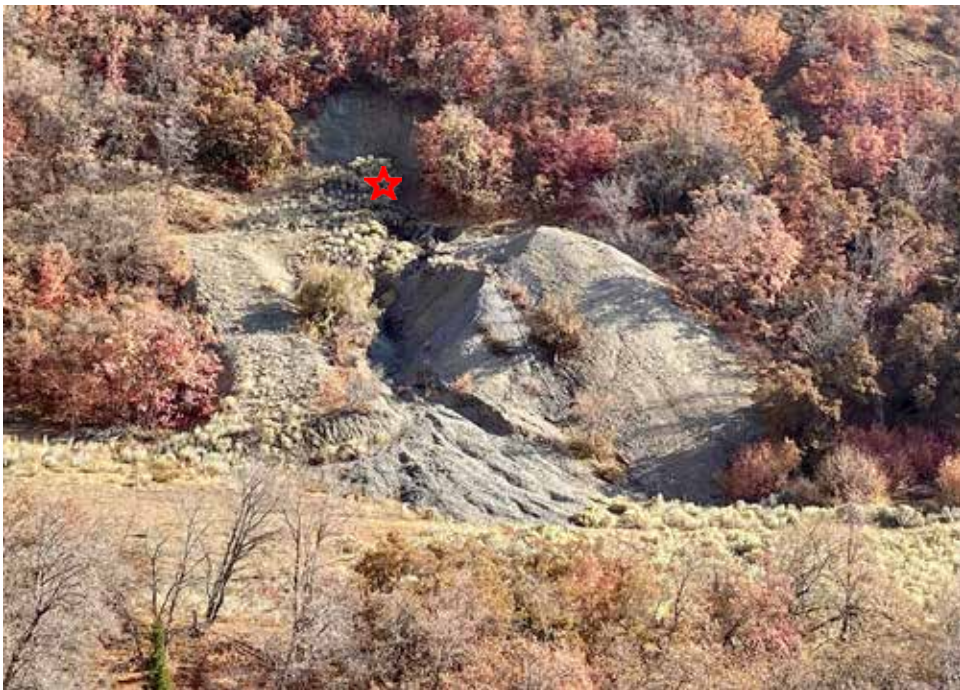
Photo 238 - Pictured is the Bingham West Dip Tunnel and rock dump which shows evidence of erosion along its surface. The material in the rock dump has sloughed to the base of the dump, but has not migrated past the base onto the surrounding downgradient surface. The collapsed Tunnel portal is marked by the red star.

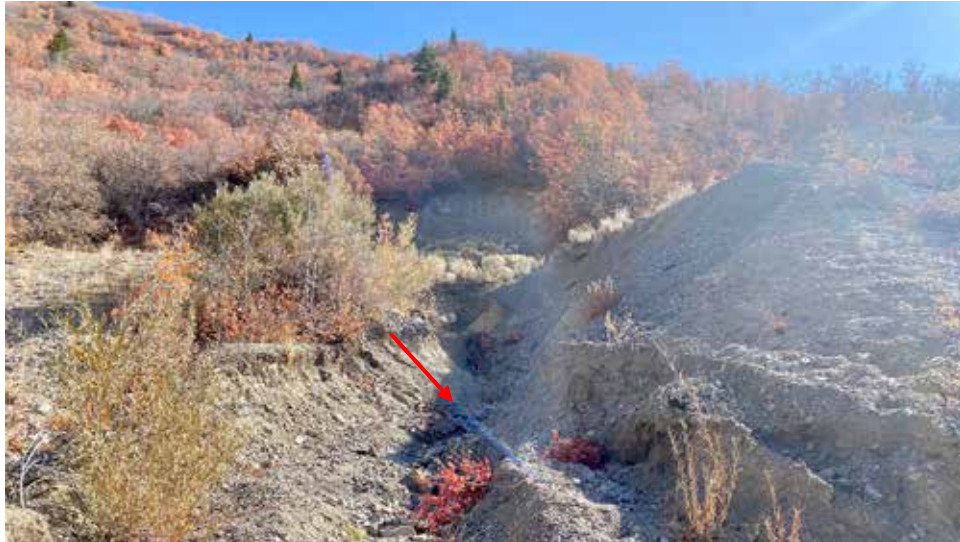
OU18

Photo 239 - Pictured north of the rock dump is an HDPE pipe used to convey water from the Tunnel around the dump to prevent further erosion. The pipe is delineated by the red arrow. Also pictured is a closeup of the fairly incised erosional gully on the dump surface.

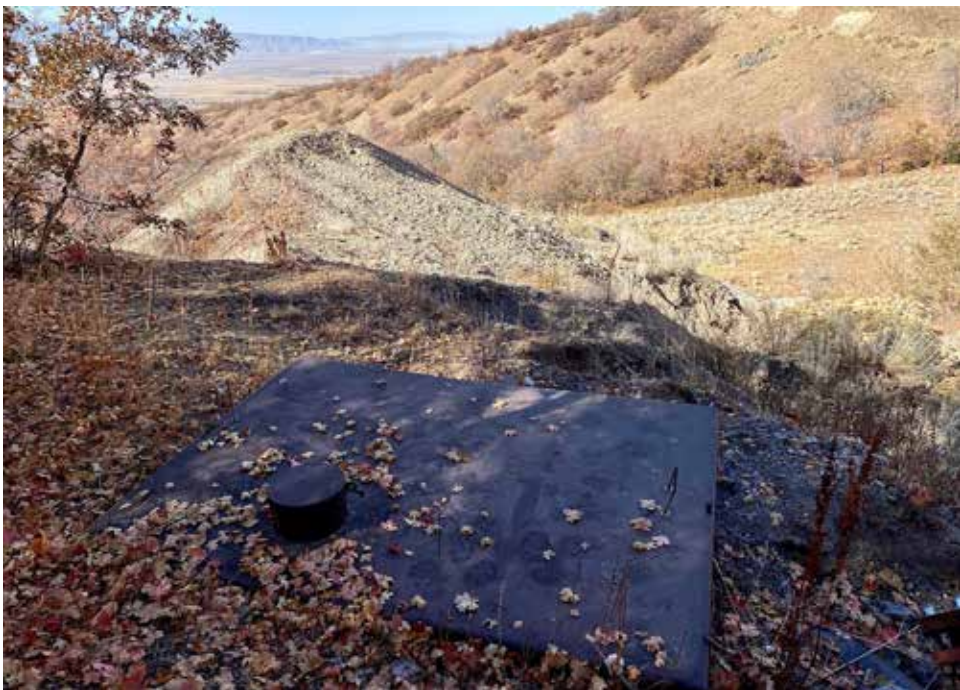
Photo 240 - Pictured is the Bingham West Dip Tunnel sump box located outside of the collapsed Tunnel. Water collected along the Tunnel is directed to the sump and piped downgradient of the rock dump (visible in the upper left quadrant). The rock dump contains a gravelly mixture of angular rock, silts and sands. Concentrations of arsenic and potentially lead are above the site KUALs.

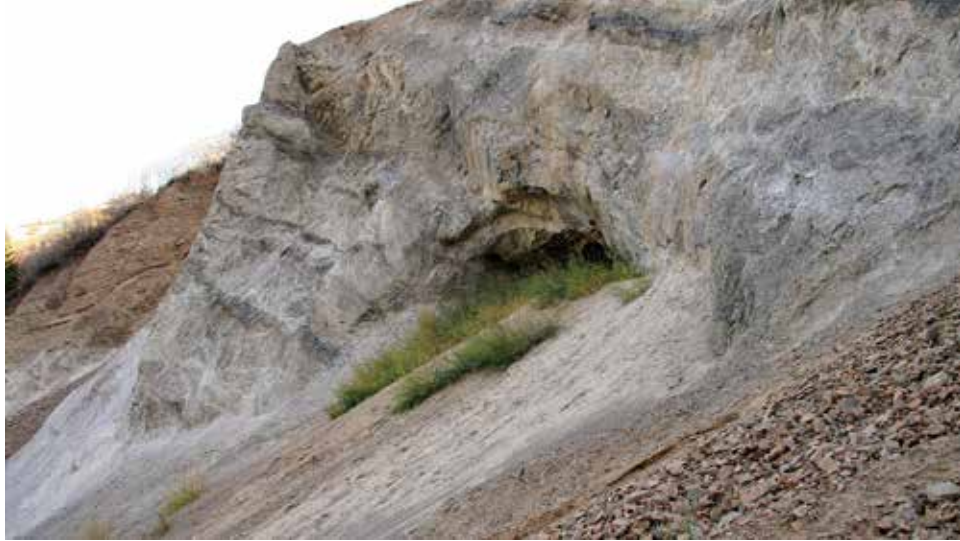
OU18

Photo 241 - Pictured is the Copper Boy Tunnel portal located just below the Oquirrh Mountain ridgeline crest. The Tunnel was drilled into the surrounding rock outcrop. Tunnel discharge appears to support localized grasses. Surrounding soils and rock can have arsenic and lead concentrations above the site KUALs.

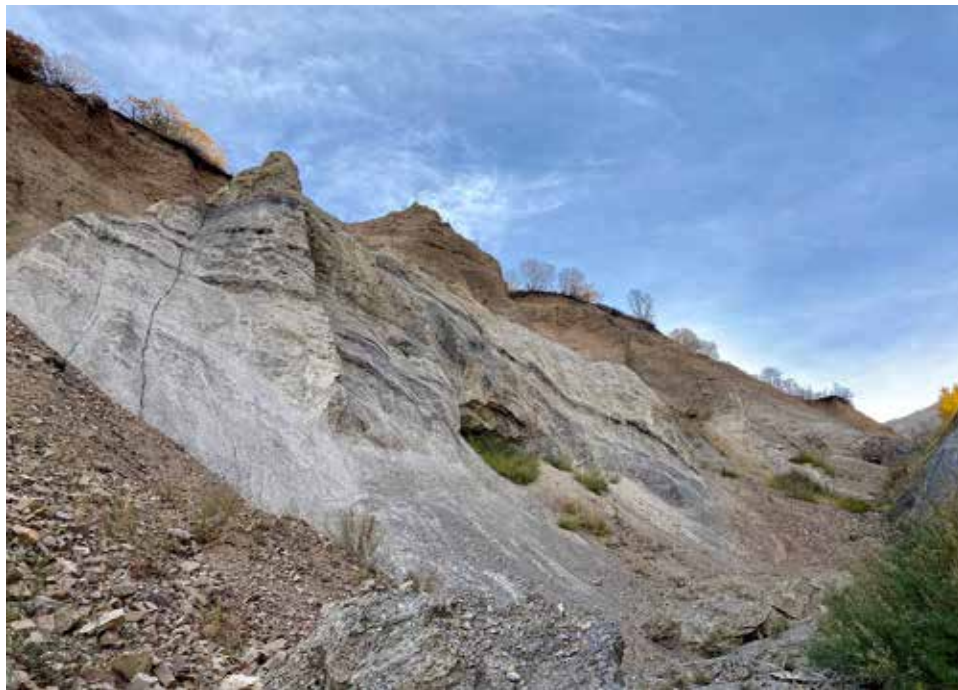
Photo 242 - Pictured is the Copper Boy Tunnel portal from a downgradient vantage point. The Tunnel is located well inside RTKC's property, in an inaccessible location. The Tunnel area is unlikely to be redeveloped based on slope grades and location.

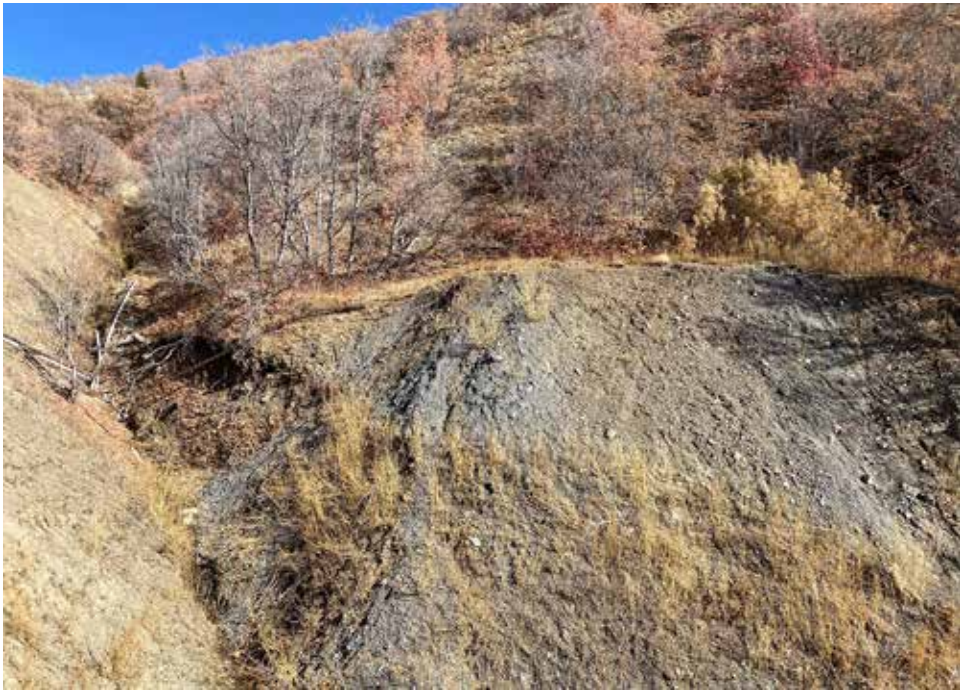
Photo 243 - Pictured above the Copper Boy Tunnel is another portal (red star) which is higher up the drainage. This second portal is similar to the first as it's in a secure area, well within RTKC's property and unlikely to be developed or trespassed upon.

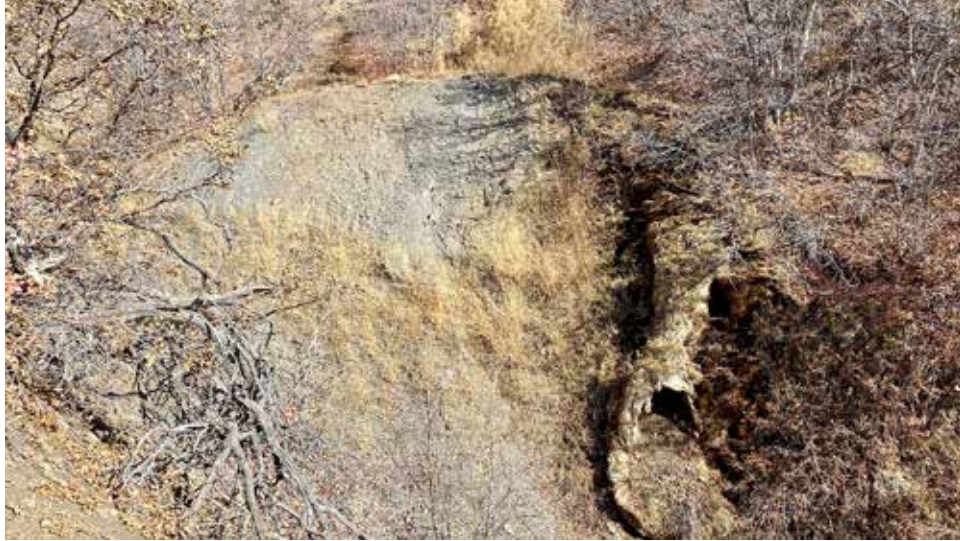
OU18

Photo 244 - Pictured is the Helen B Tunnel and rock dump located below the visible Oquirrh Mountain ridgeline. The rock dump has some evidence of erosional gullies. The rock dump is not well vegetated which may be due to its angular rock composition, limited water, chemical composition or a combination of all three.

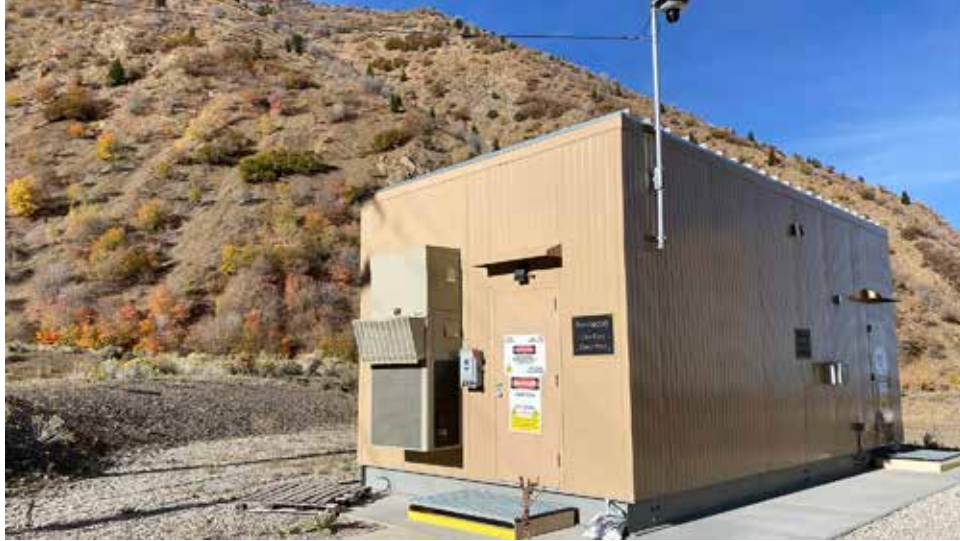
OU20

Photo 255 - Pictured is RTKC's pump house and adit to the underground Carr Fork mine workings. The pump and associated pipes are used to dewater the Carr Fork workings.

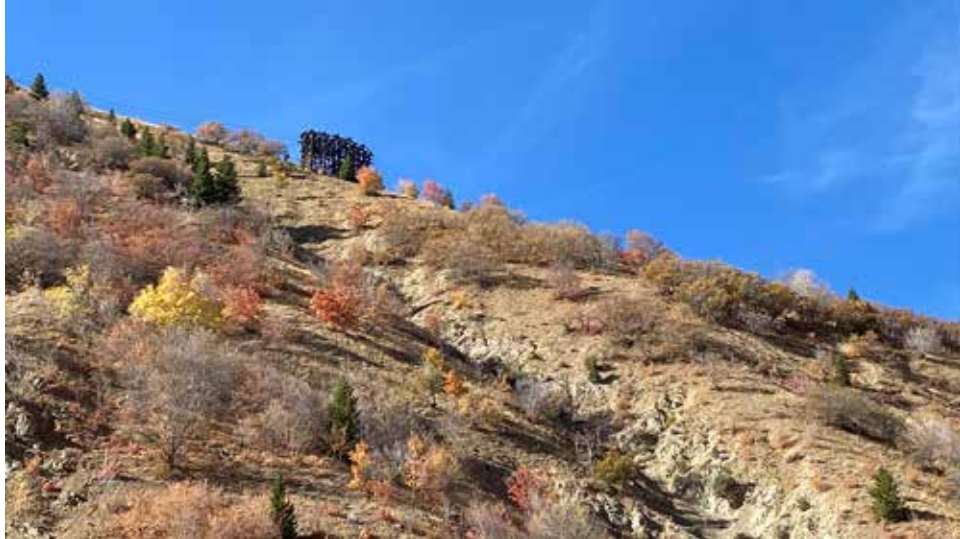
OU20

Photo 259 - Pictured is the Pine Canyon Rail and Tunnel and the HDPE discharge pipe directing water to the historic cement lined canal. The HDPE pipe is actually located in the canal, and is sized above the water production capacity of the Tunnel. Observed at the Tunnel portal, the rail line extends into the Tunnel, but it is far from operational. The Tunnel portal and surrounding surfaces were stable.

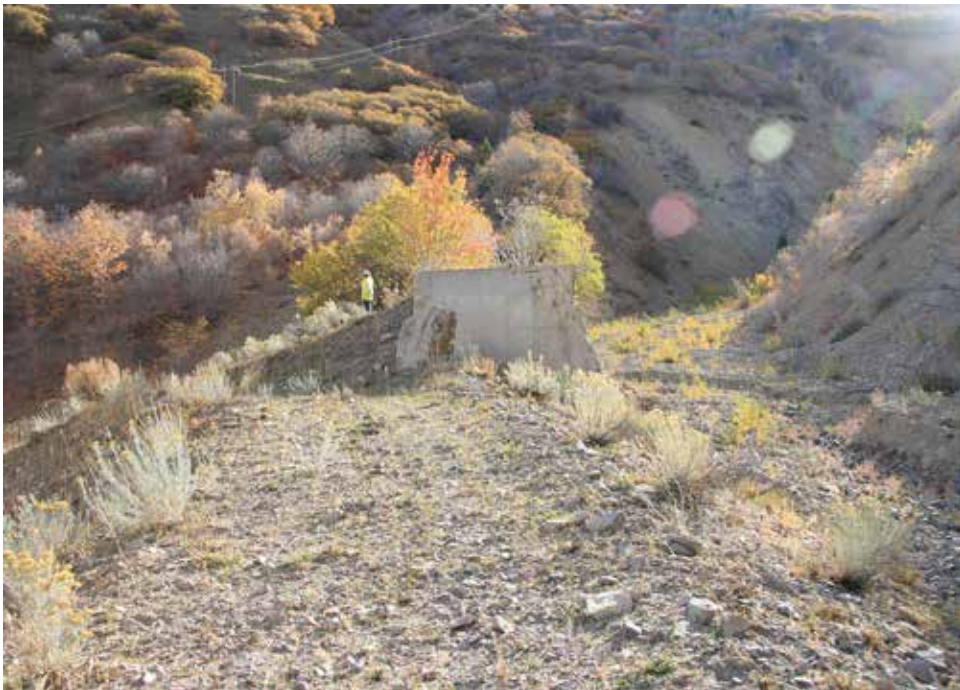
Photo 260 - Pictured above the south slope of Pine Canyon is a support structure for the historical aerial crane which was used to convey ore from the Carr Fork workings and the Bingham Mine District to the International Smelter located at the mouth of Pine Canyon. The south slope is relatively steep with erosional gullies.
