SECOND FIVE-YEAR REVIEW REPORT FOR
KENNECOTT (SOUTH ZONE) SUPERFUND
ALTERNATIVE SITE
SALT LAKE COUNTY & TOOELE COUNTY, UTAH

Utah Department of Environmental Quality
Division of Environmental Response & Remediation
Salt Lake City, Utah

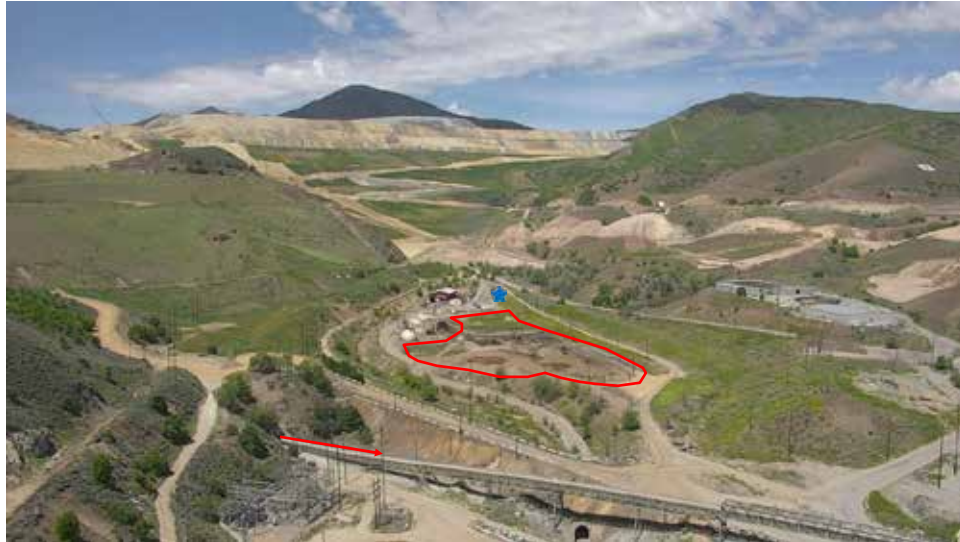
OU24

Photo 264 - Pictured is the upper reach of Pine Canyon from the historical foundation seen in photo 261. Canyon surfaces are stable and well vegetated, except right around the Pine Canyon Tunnel portal and Carr Fork adit. Storm water runoff has not been observed to carry sediment, and is managed under a storm water permit in the downgradient sediment basins. Side slopes in Pine Canyon remain steep with variable vegetation. Soils can exceed the arsenic, and potentially the lead site KUALs.

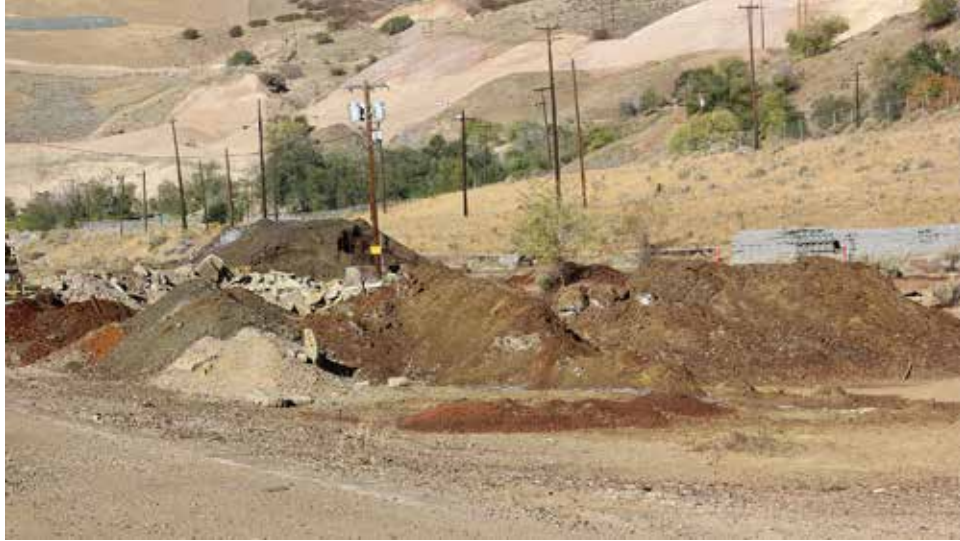
OU24

Photo 301 - Pictured are stockpiles of soil and other unknown material. Much of the KCC Precipitation Plant facility was demolished and encapsulated on site in the early 2000s. The historic Lead Mine Mill footprint is also buried in the area depicted along the base of the northern hillside (upper right quadrant). The area depicted has over approximately 20 feet of soil with concentrations of lead and arsenic above the site KUALs.

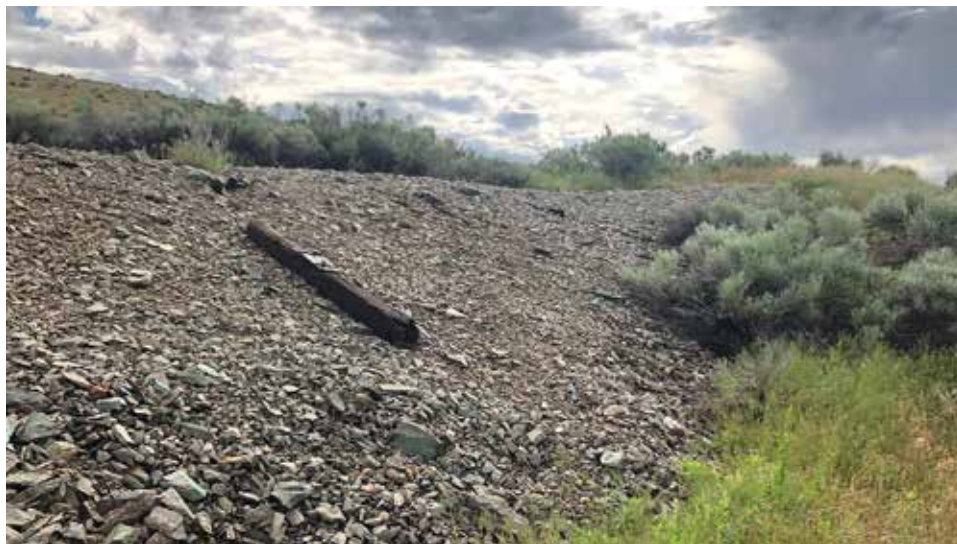
OU24

Photo 305 - Pictured prior to removal is the ore dump situated alongside the historic B&G Rail corridor. The dump consisted on angular rock of variable sizes and was not supportive of vegetative growth along much of its surface.

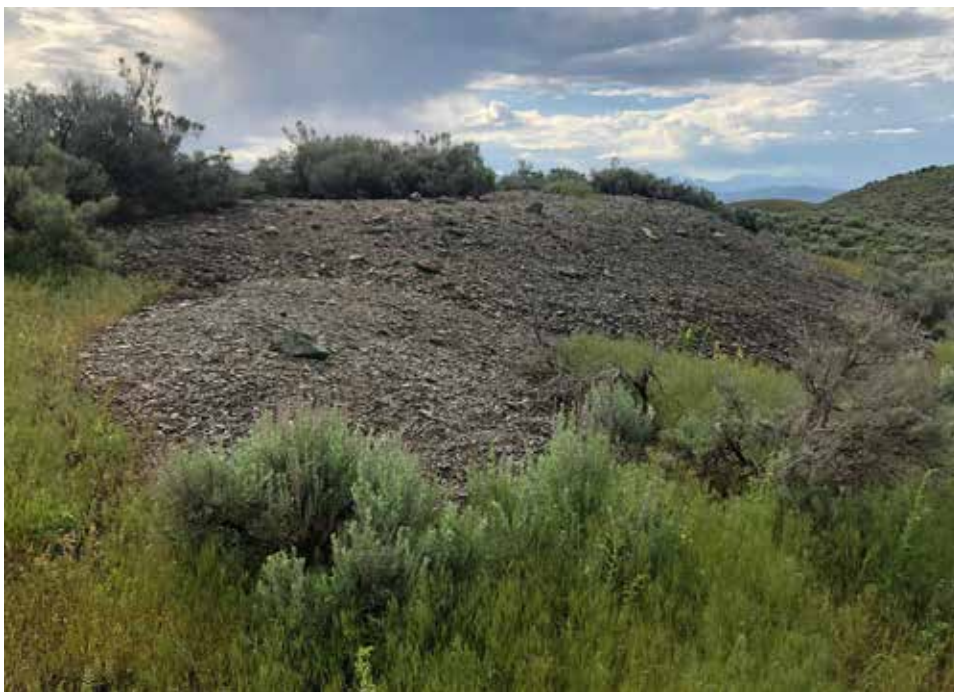
Photo 306 - Pictured prior to removal is another section of the B&G Rail Corridor ore dump. Some angular rock and large rock fragments were oxidized and green in color, indicative of a higher copper or manganese content.

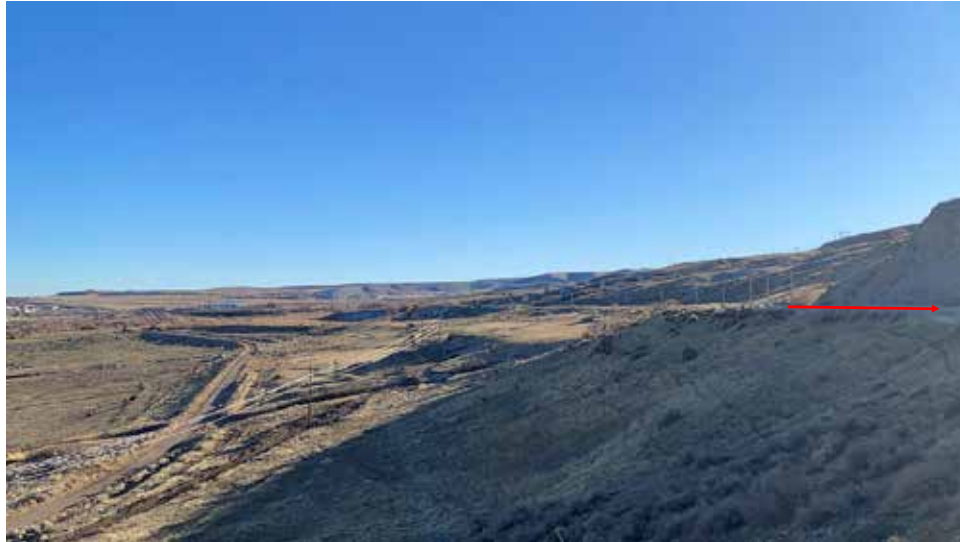
OU24

Photo 311 - Pictured is another aerial view of the B&G Rail Corridor and the post removal surface of the historic ore dump (red arrow). Revegetation will take time since the area is not actively irrigated.

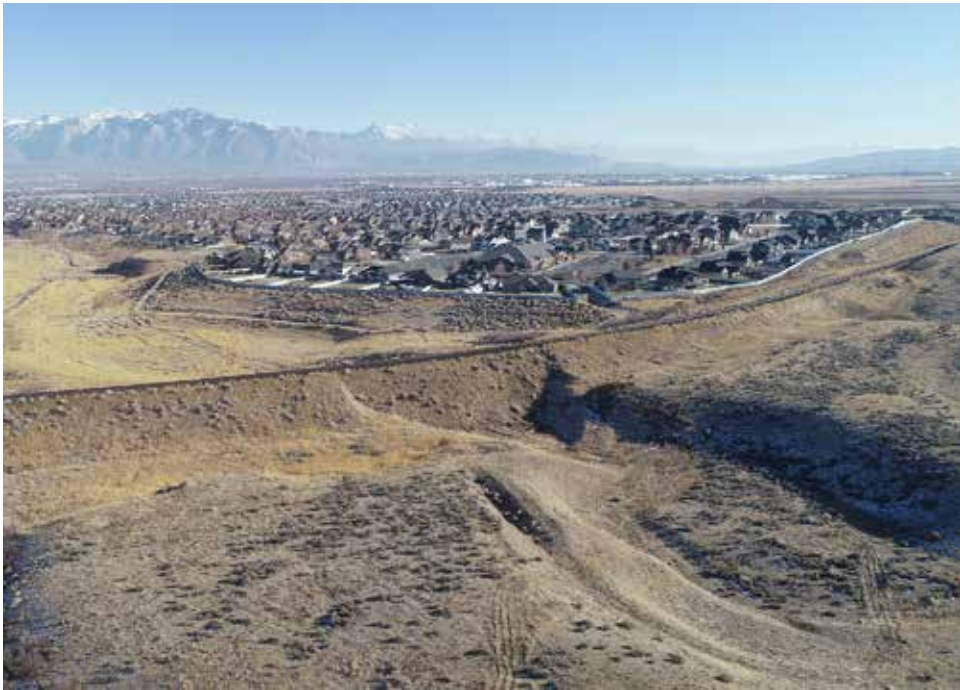
Photo 314 - Pictured is the Copperton High Line Rail Corridor near 4800 South. The Copperton High Line Rail Corridor has been removed in some locations pursuant to an approved soil management work plan under CERCLA oversight

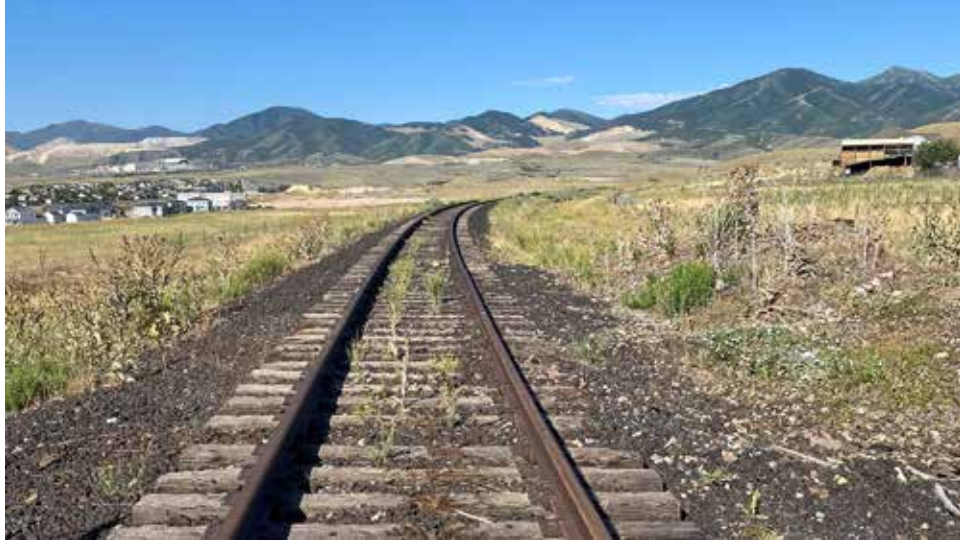
OU24

Photo 317 - Pictured is the Copperton High Line Rail Corridor running parallel to the southern boundary of Gateway-Little Valley development site. The development will reportedly not encroach onto the Rail Corridor.

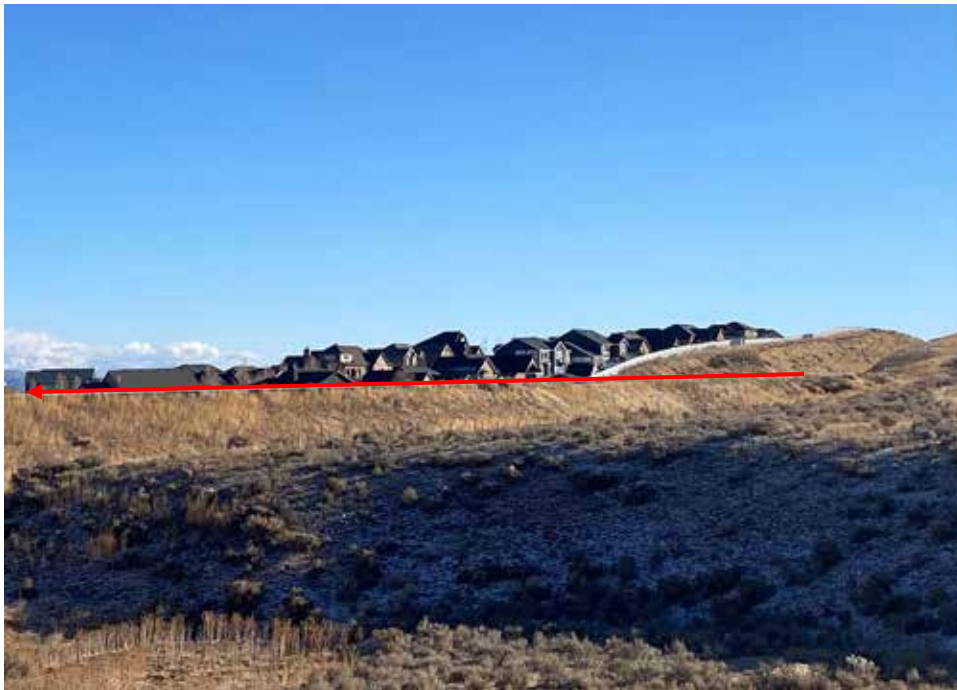
Photo 318 - Pictured is a section of the Copperton High Line Rail Corridor near 7800 South. Notice the rail bed material (which is slag). The Copperton High Line Rail Corridor (in areas where it was removed) had slag, slag sediment and soils with arsenic and lead concentrations above the site KUALs.

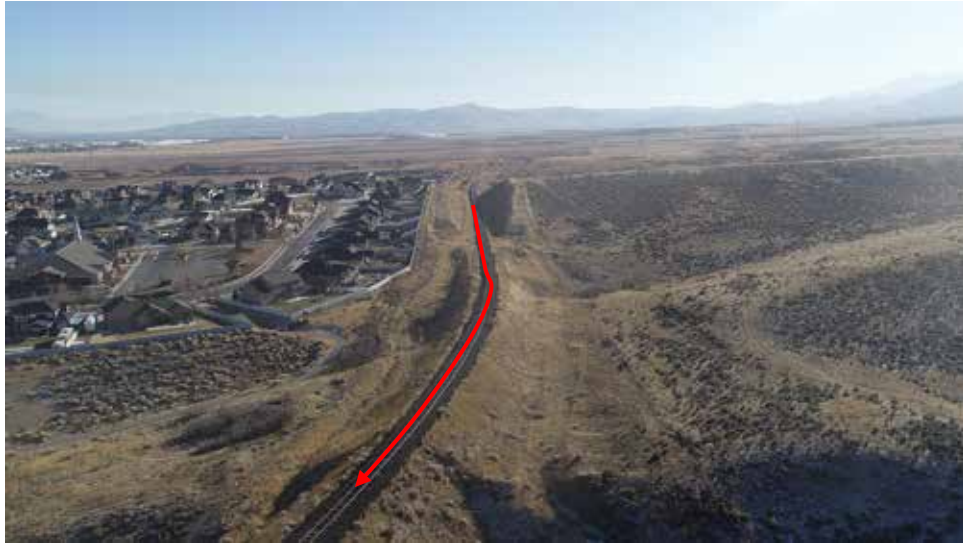
OU24

Photo 319 - Pictured from Clay Hollow, the Copperton High Line Rail Corridor (red arrow) is located just west of RTKC's property line. The Sycamores residential development is located just east of RTKC's property line. A fence line along RTKC's property secures access to the Rail Corridor.

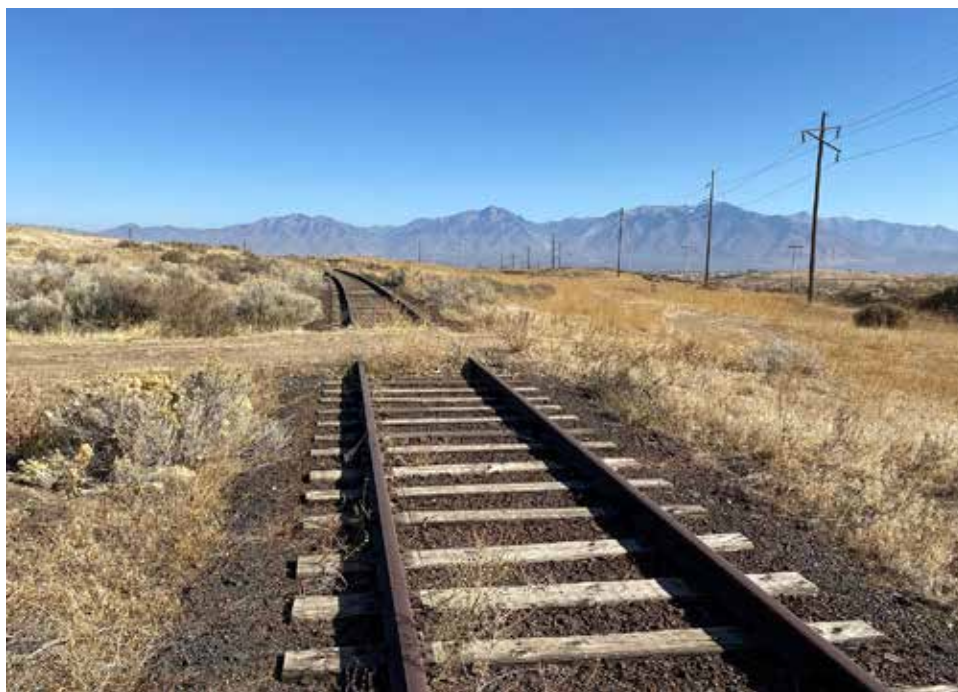
Photo 322 - Pictured is another view of the Copperton High Line Rail Corridor located along the southern perimeter of the Gateway-Little Valley Development project. The Rail Corridor is intact through this section.

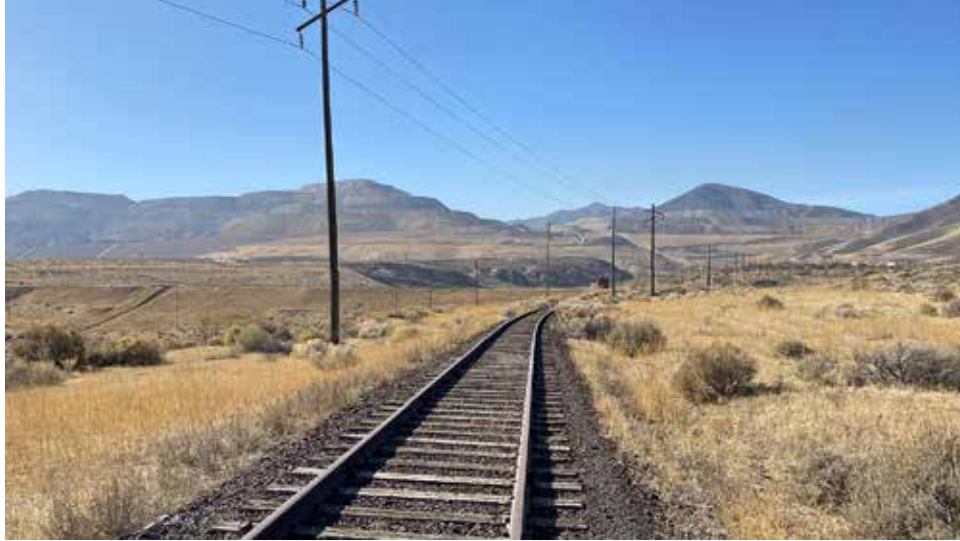
OU24

Photo 323 - Pictured is a section of the 1960s Denver Rio Grande (DRG) Rail Corridor on RTKC property east of the Town of Copperton, UT. Typical of many of the site rail corridors, the rail bed is comprised of slag. Soils and slag can have concentrations of arsenic and lead above the site KUALs.

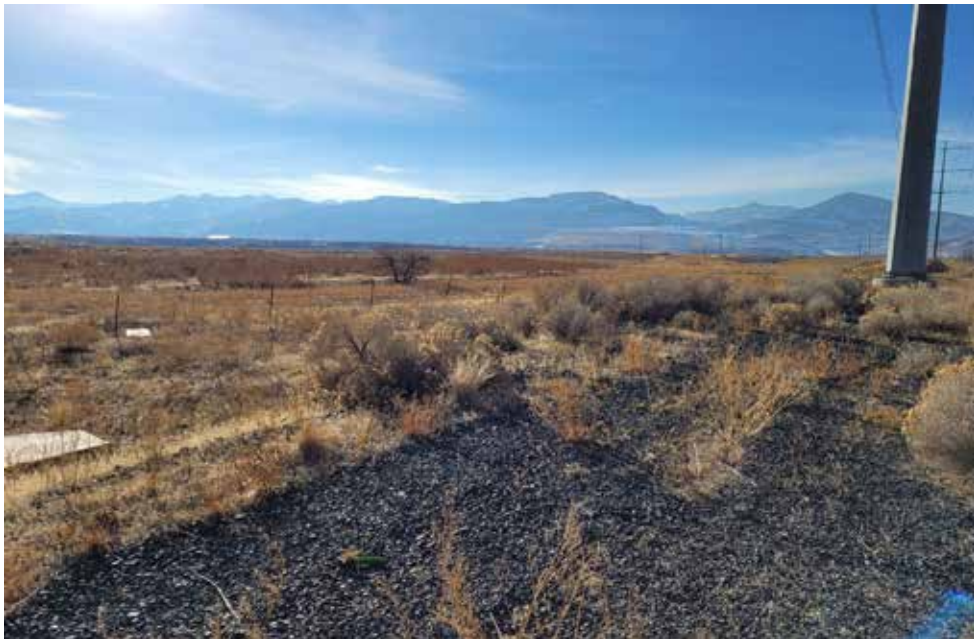
Photo 326 - Pictured is a section of the 1960s DRG Rail Corridor at approximately 7000 West and Old Bingham Highway (looking east). The historic rail bed (slag) is in place and contains concentrations of arsenic and lead above the site KUALs. The historic rail bed has been converted into the alignment of Rocky Mountain Power's Mona transmission line.

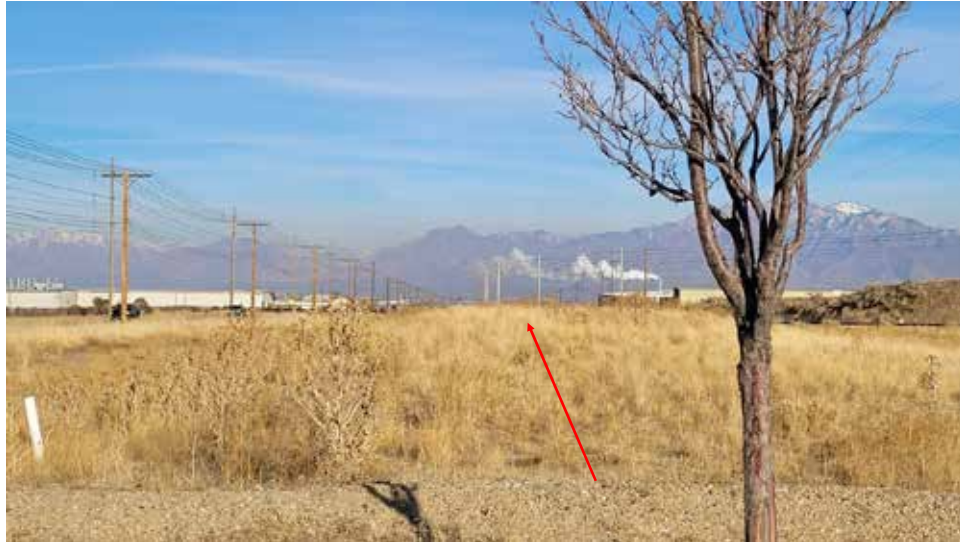
OU24

Photo 327 - Pictured is a section of the 1960s DRG Rail Corridor at approximately 7000 West and Old Bingham Highway (looking west). The historic rail bed (slag) is in place and contains concentrations of arsenic and lead above the site KUALs. The historic rail bed has been converted into the alignment of Rocky Mountain Power's Mona transmission line as evidence by the poles.

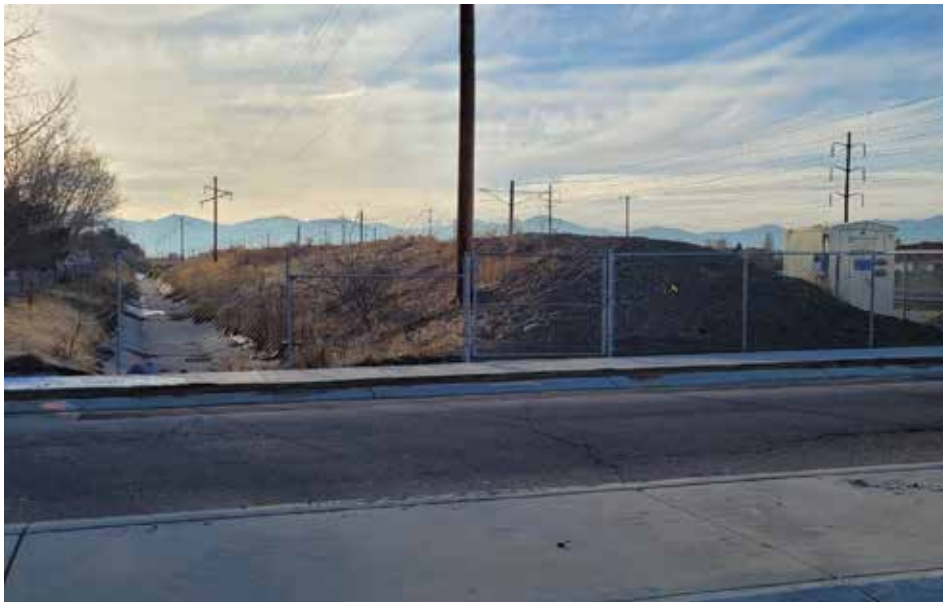
Photo 328 - Pictured is the eastern extent of the 1960s DRG Rail Corridor in place near 5600 West. The rail bed is vegetated here, perhaps indicative of soil being placed over the rail bed since typically rail bedding material (slag) is not supportive of vegetation.

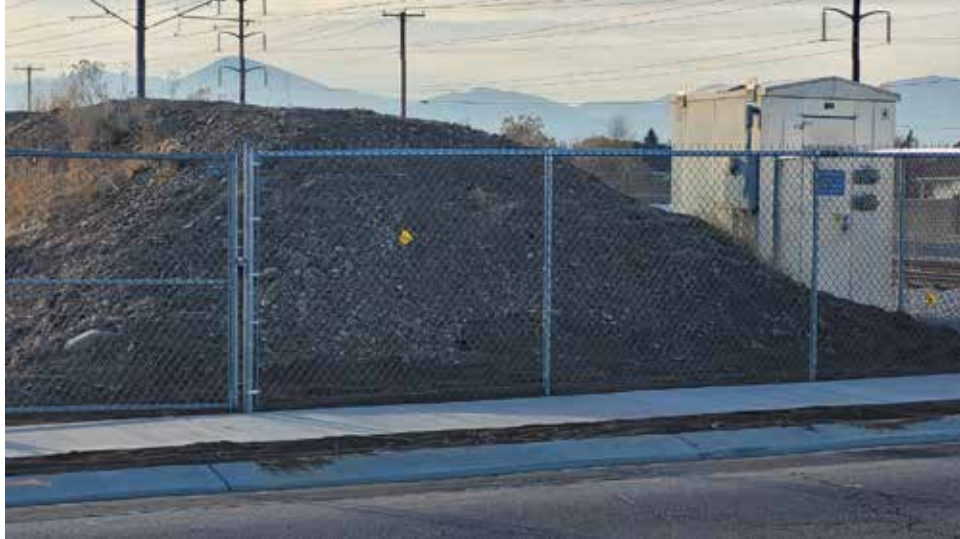
OU24

Photo 329 - Pictured is the sound barrier/soils repository UTA constructed from 4700 West to 4500 West along the Mid Jordan Trax Line. The repository is where they placed slag and soils in excess of the OU1 Commercial Lead Land Use Action Level of 2000 mg/kg excavated during the conversion of the 1960s DRG Rail Corridor into the UTA Mid Jordan Trax Line. The pictured section of the repository was recently reconstructed to support the installation of sidewalk, along Wasatch Meadows Drive, in compliance with the City of West Jordan's contaminated soils ordinance.

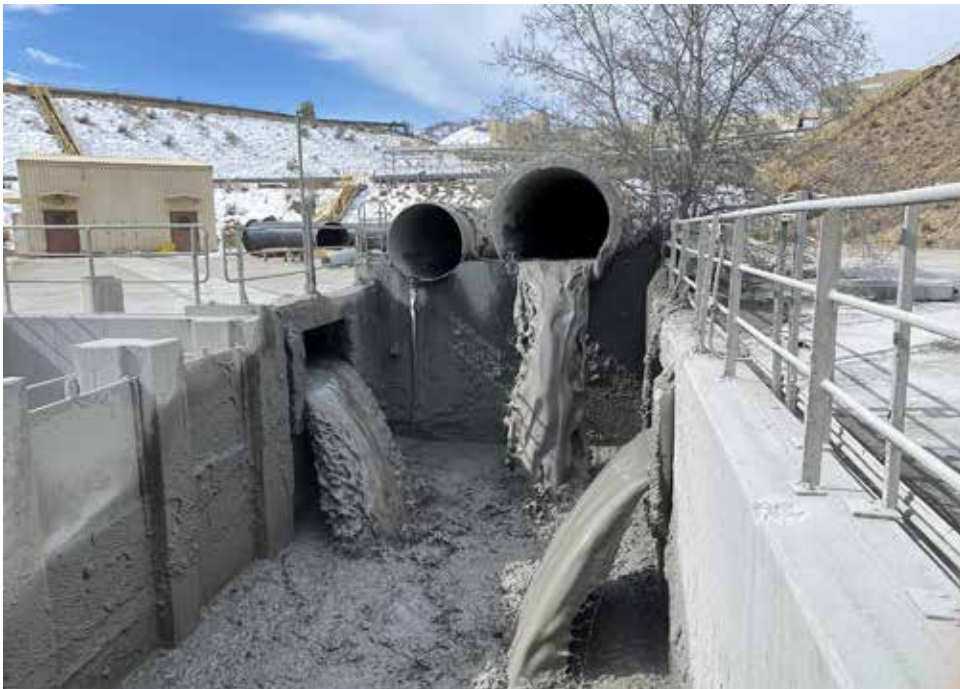
Photo 336 - Pictured is drop box NP-5 located along the tailings conveyance infrastructure. This is the first of two drop boxes where lime can be added to the tailings slurry to neutralize aqueous pH.
