# **Appendix I**

## **Site Inspection Photos and Observations**

**I. OU3 Herriman Agricultural Properties**

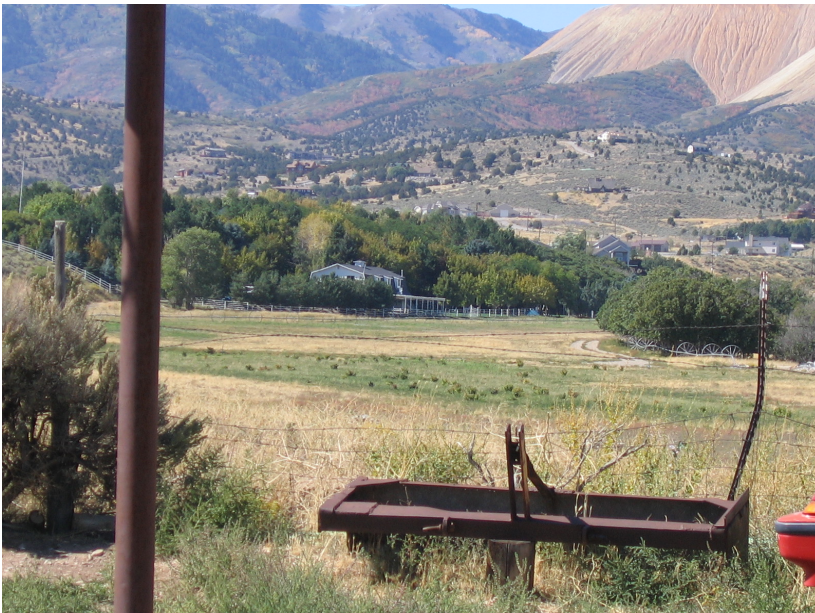
**Figure No. 2:** Pictured is Butterfield Creek drainage (channel is off to the right side of frame near sprinkler equipment) looking west back towards Butterfield Canyon and waste rock dumps.

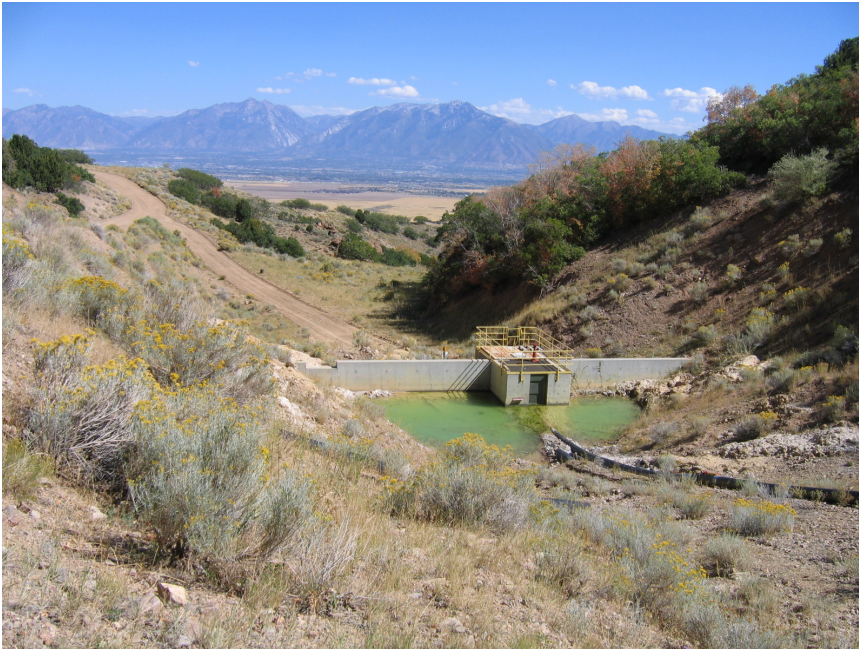
**Figure No. 12:** Pictured is the Yosemite drainage cut-off wall located approximately 100 yards down gradient of the sediment traps near the base of the waste rock dump.

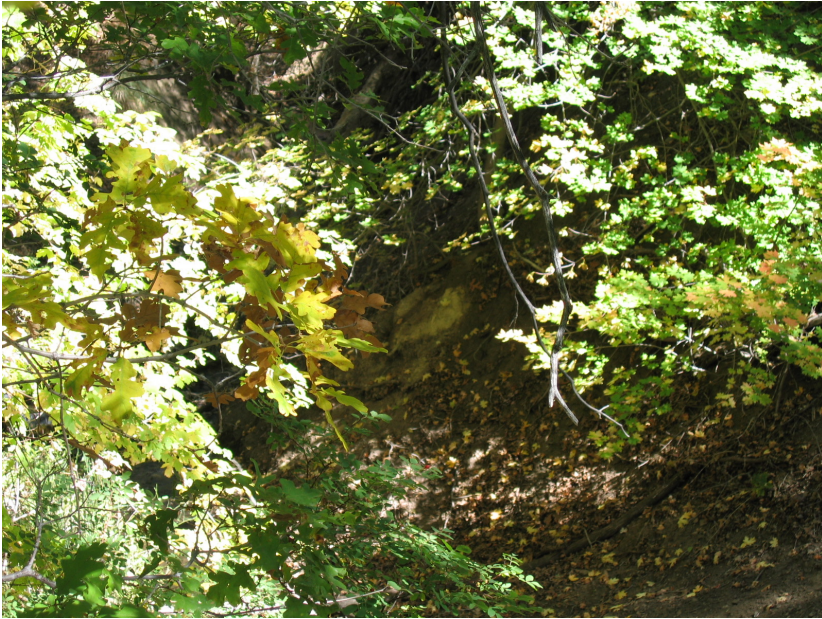
**Figure No. 13:** Pictured is Butterfield Creek channel, up-gradient of the Yosemite drainage confluence.

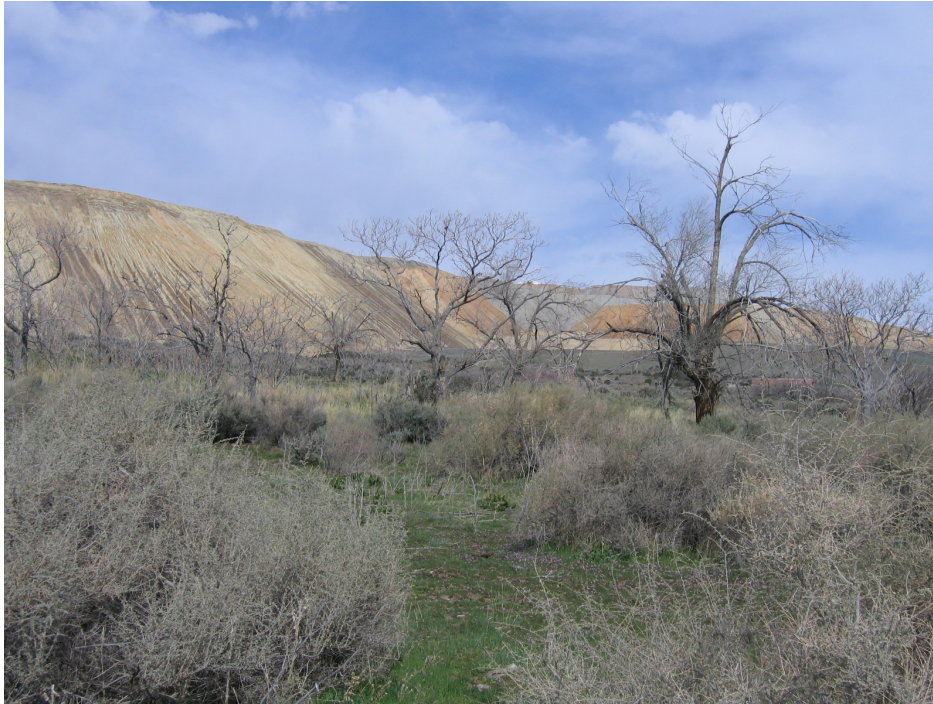
**Figure No. 31:** Pictured is the first of two photos of the lower town site of Lark, near the removal area for the Long Dump.

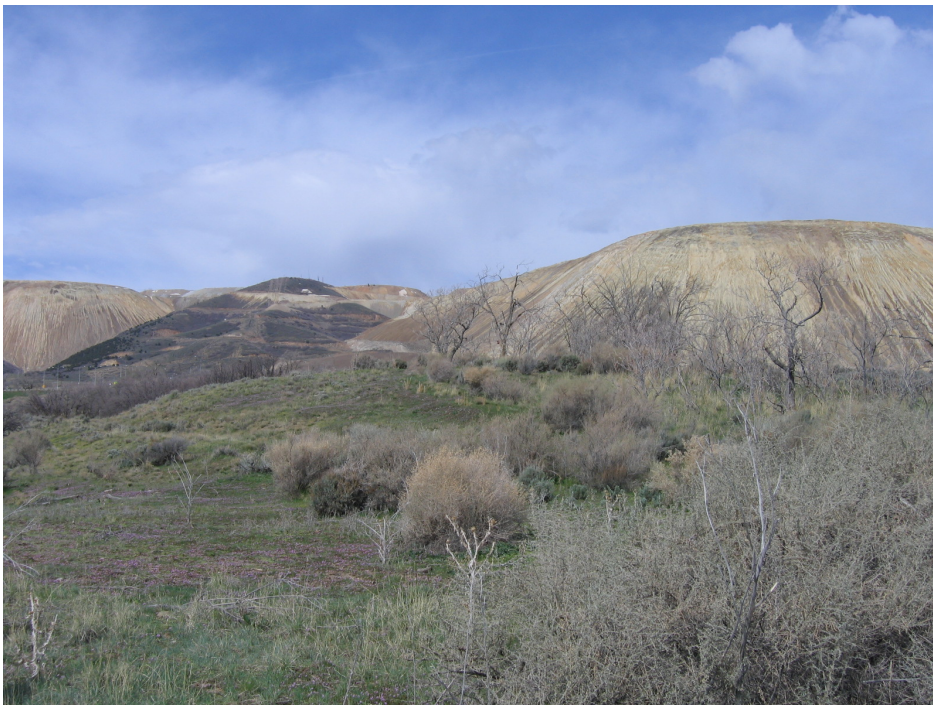
**Figure No. 32:** Pictured is the second photo of two showing segments of the lower town site of Lark, near the removal area for the Long Dump.

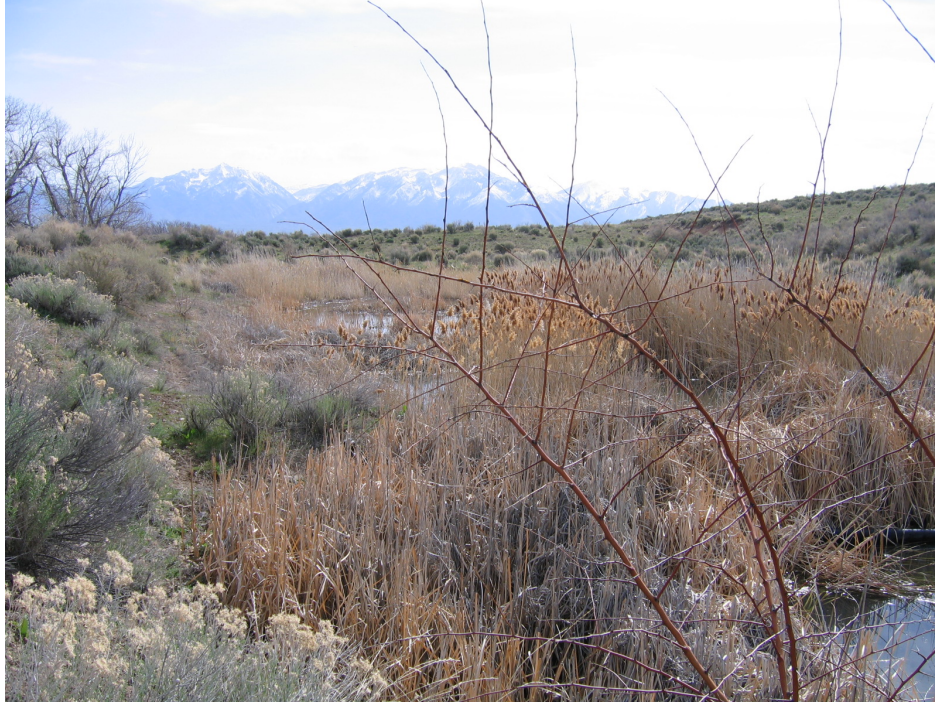
**Figure No. 35:** Pictured are the ponds of the Experimental Wetlands in Lark, near the removal site of the Long Dump and near the historic site of Lower Lark. The seep feeding the wetlands is out of the frame to the rear right.

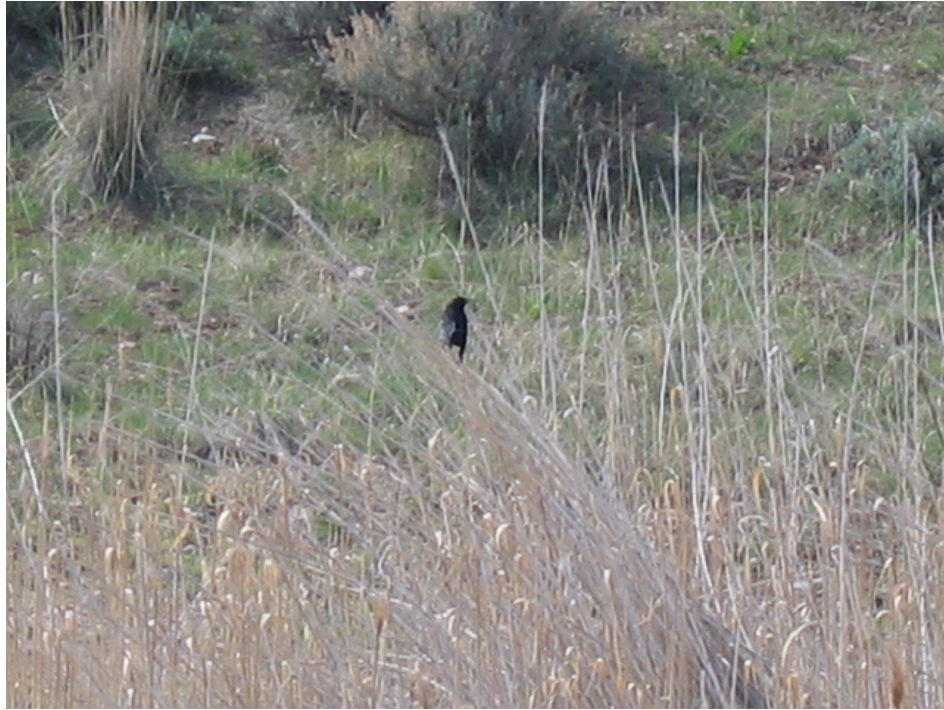
**Figure No. 37:** Close-up of the black bird pictured in Figure No. 39.

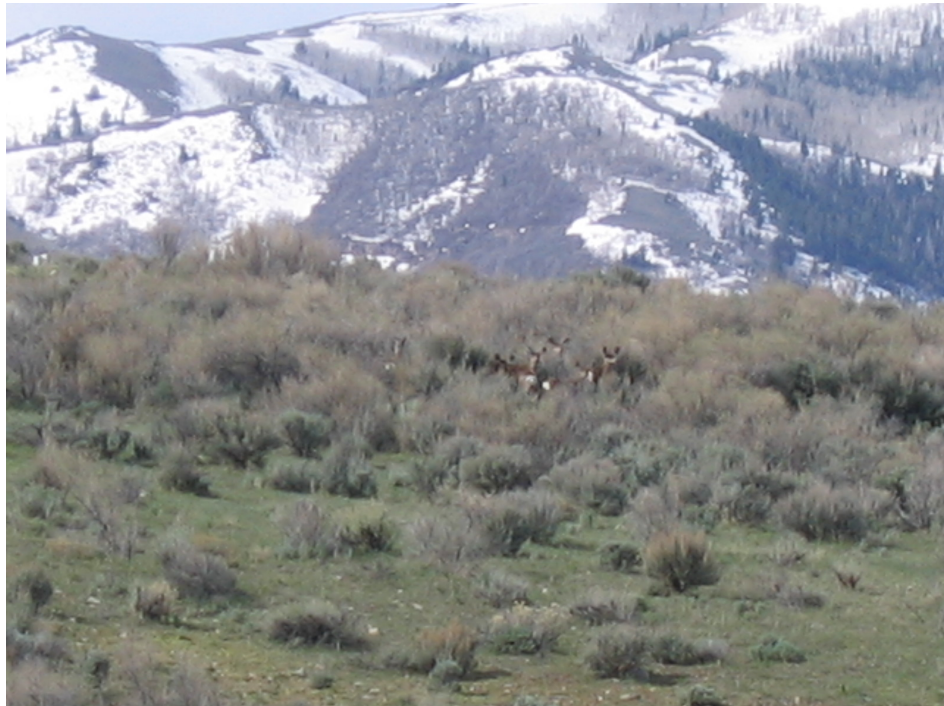
**Figure No. 38:** Deer were observed in the area of the Long Dump site not far from the Lark Experimental Wetlands.

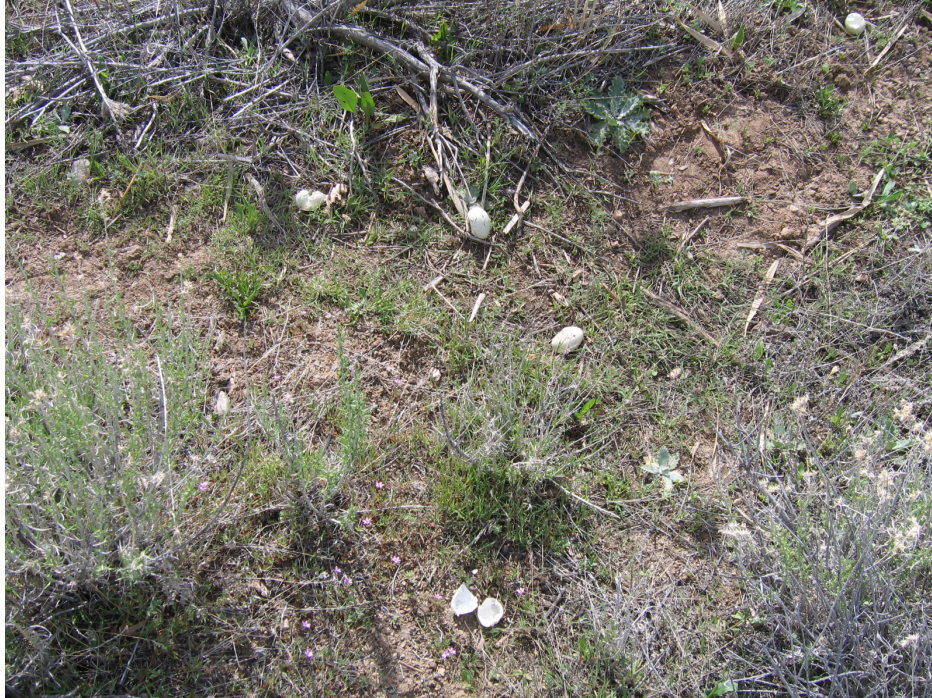
**Figure No. 39:** Though the situation of these eggs, whether the young hatched or these eggs underwent predation, mallard use of the ponds was observed (two mallards actually were spooked from the ponds).

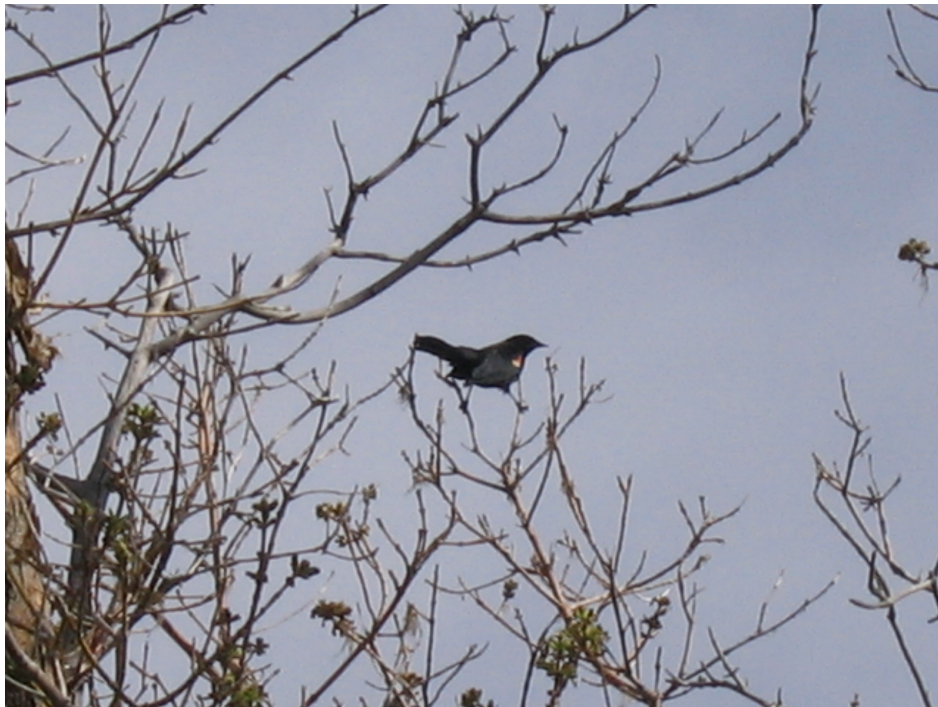
**Figure No. 40:** Other red-wing blackbirds were observed in the cottonwoods or elm trees in the vicinity of the wetlands.

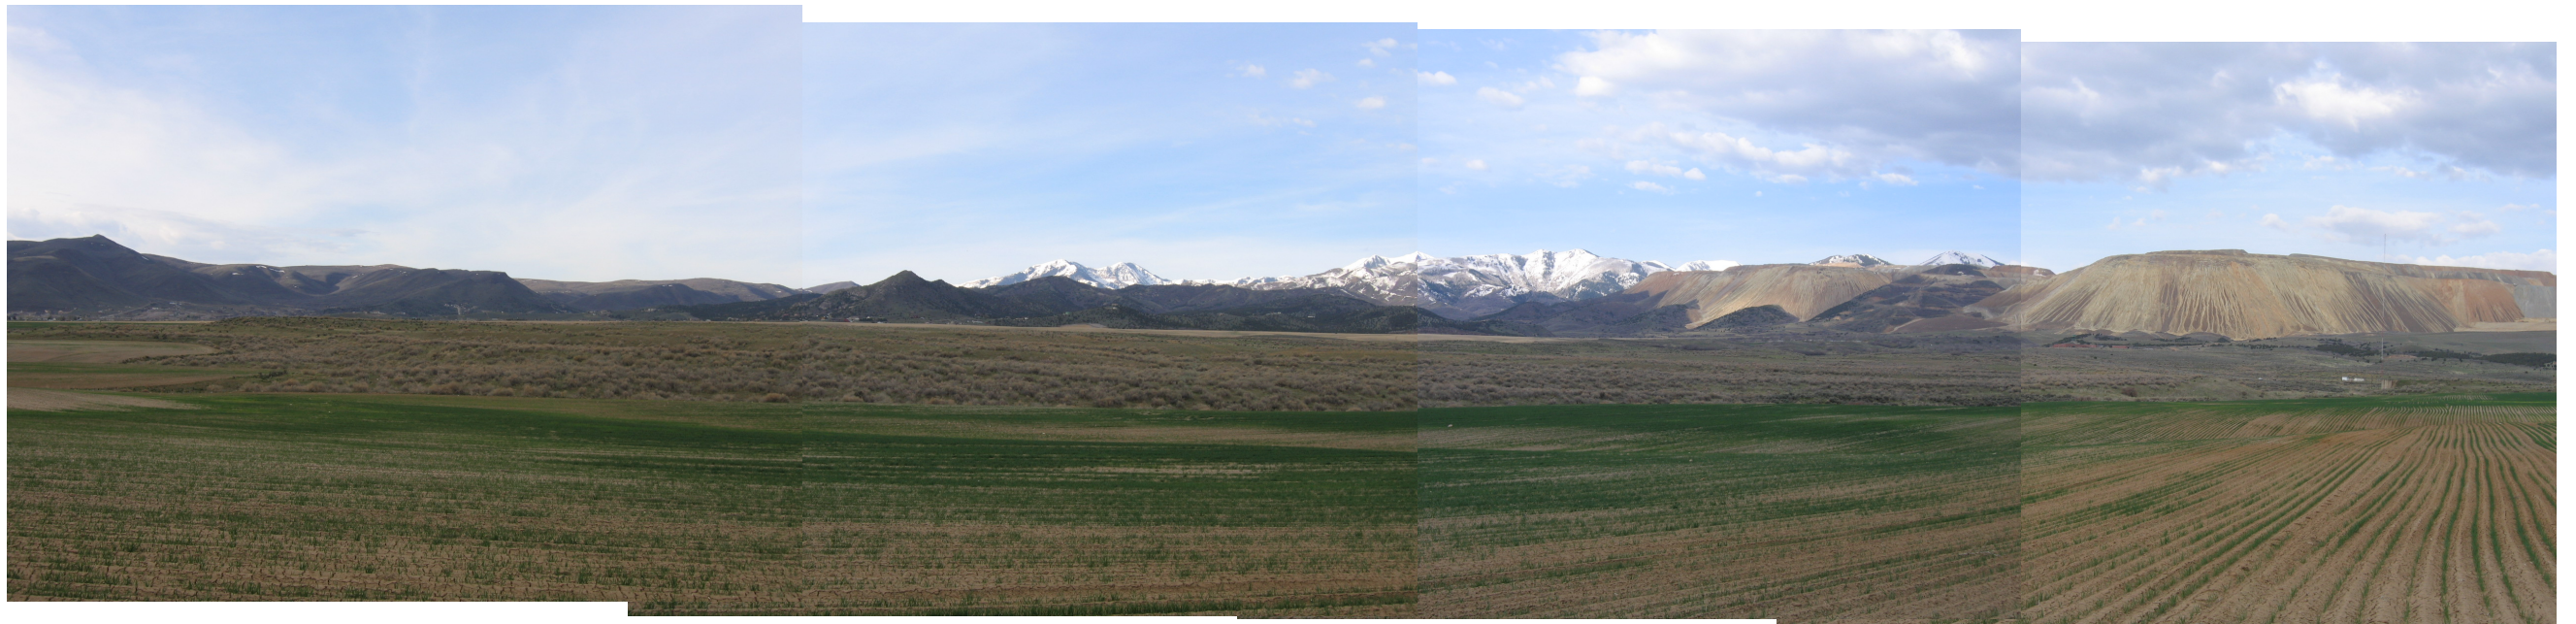
**Figure No. 46:** Pictured is a panorama of the Lark Tailings reclamation area from the site of the Mascotte Pond. On the eastern most end (left) is the southeastern turn of the Lark Tailings Area. Midas Creek flows in the draw located between the farm land in the foreground and the tailings area (where the sage brush is located) in the middle of the panorama. In the western frame (right side) is the Midas Creek Silos area with the white shed and aerial on the western side of Rt. 111. In the background (by about 4 to 5 miles) are the foothills of the Traverse Mountains and Butterfield Canyon is located near the southern extent of the Eastside Waste Rock Dumps of the Bingham Canyon Pit. Off in the distance to the southwest of Midas Creek Silos area (near the base of the tallest Bingham Canyon Waste Rock dump) a reader can just make out the red brick buildings of USSRM in the old town of Lark.

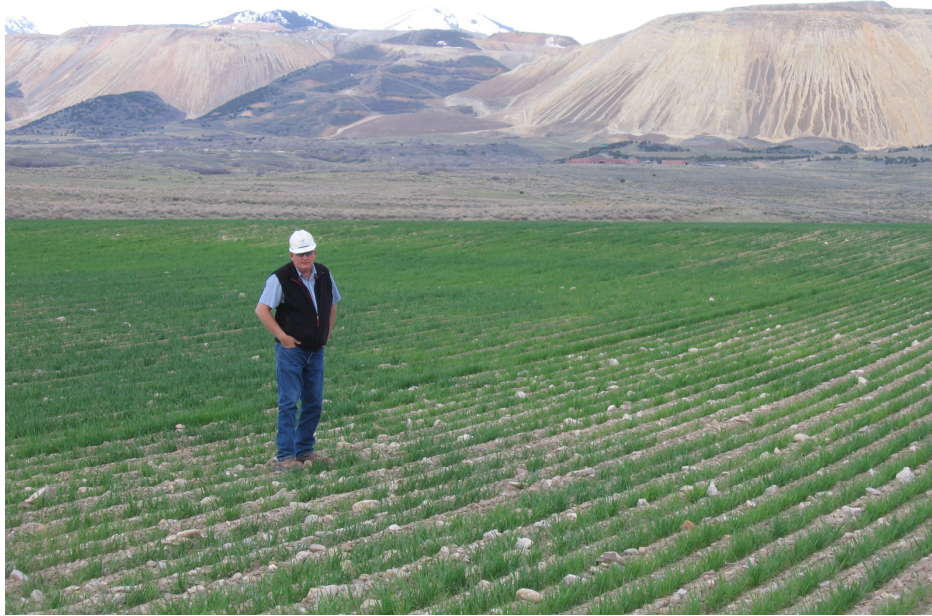
**Figure No. 47:** Pictured Mr. Brian Vinton standing in the area where once was located the Mascotte Ponds. In the distance is the USSRM buildings in the old town site of Lark, near the base of the 1000 foot high Bingham Canyon Waste Rock dumps (Copper Gulch and Notch are between the two waste rock dumps, the area vegetated). The Mascotte Pond site was cleaned up and has subsequently been returned to farm land.

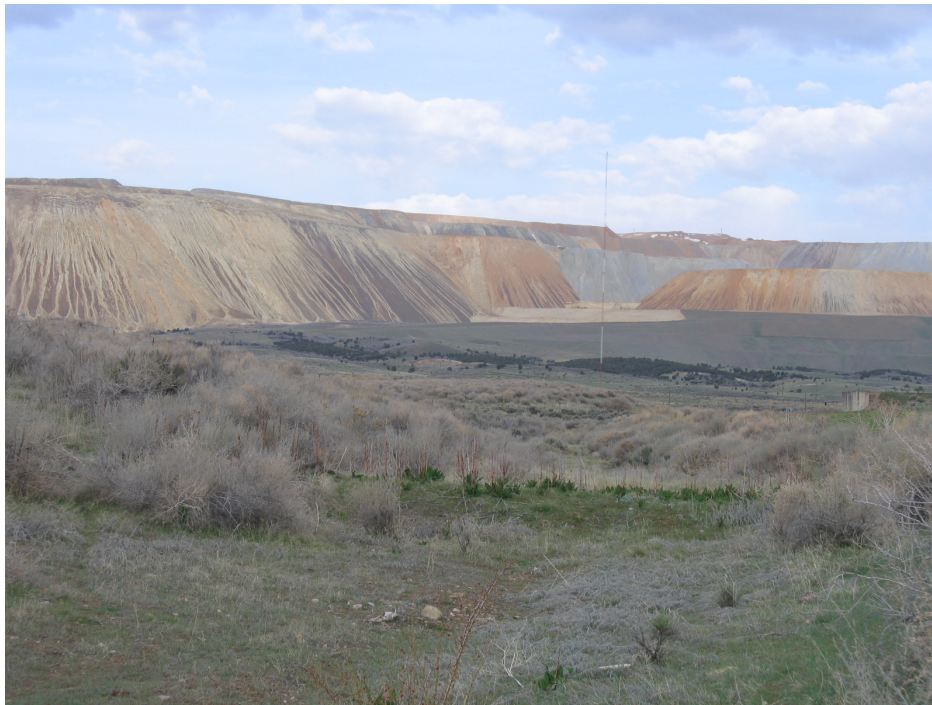
**Figure No. 48:** Pictured is Midas Creek channel near the base of the northern boundary of the Lark Tailings reclamation area. Midas Creek Silos area is in the distance along the right side of the frame.

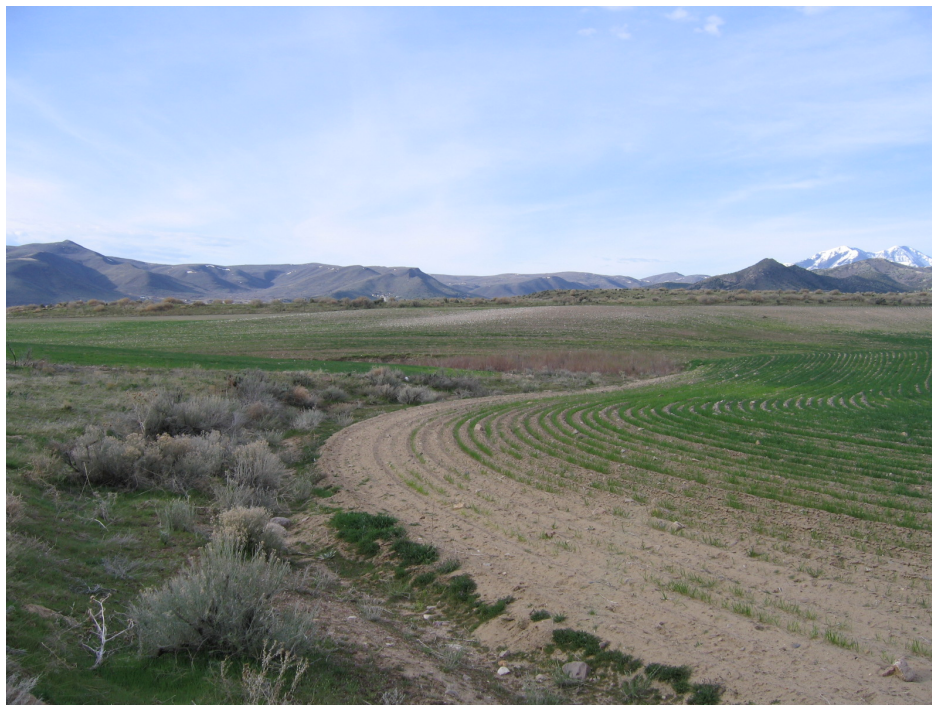
**Figure No. 50:** Pictured is the south trending Midas Creek at its South Bend stretch. The sage brush covered hill in the distance is the Lark Tailings reclamation area.

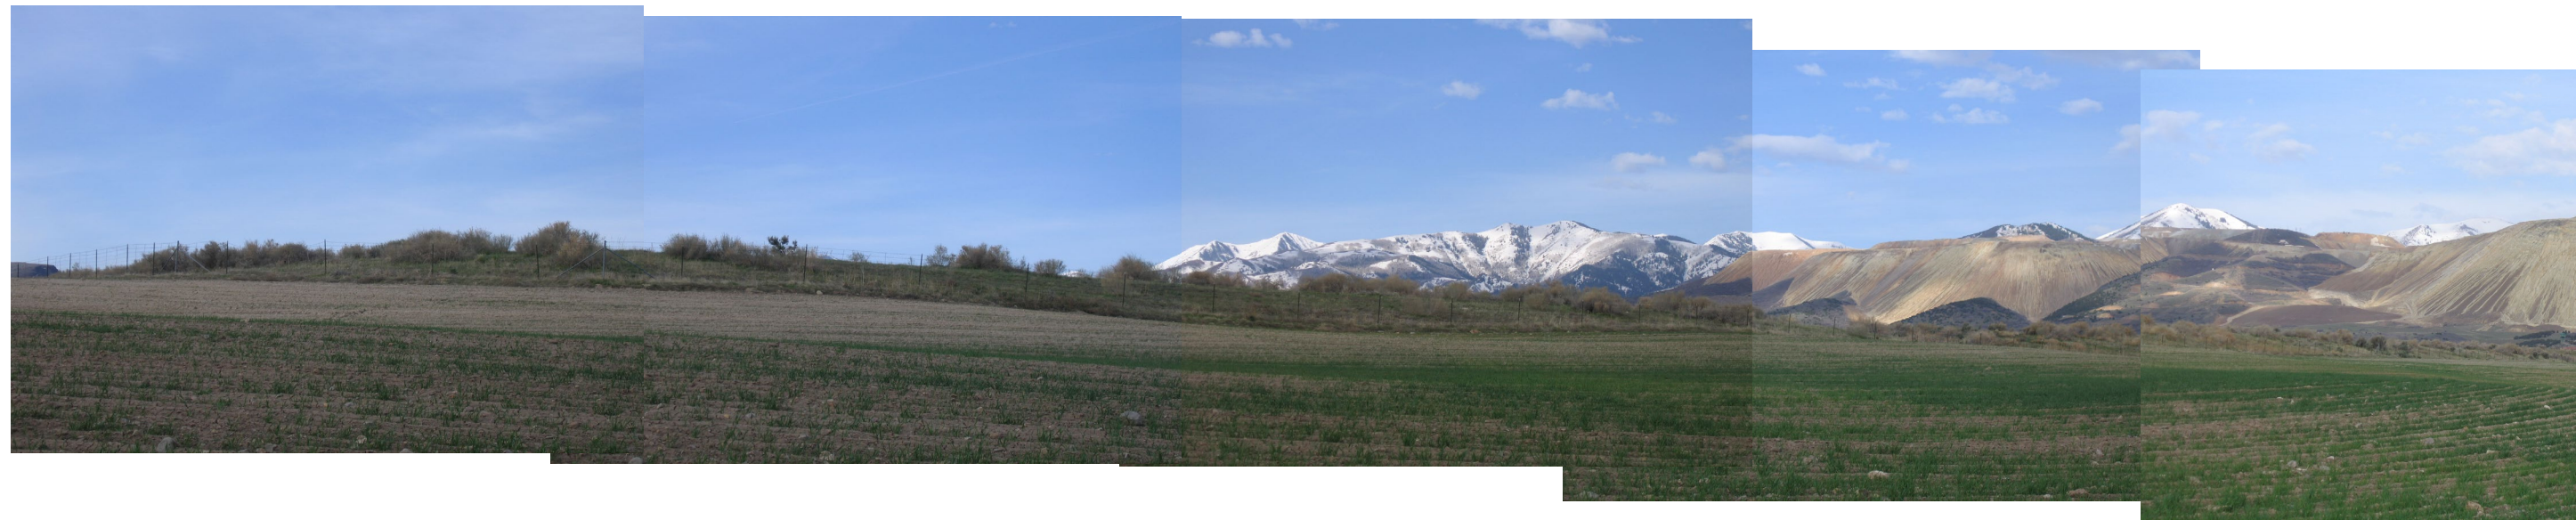
**Figure No. 51:** Pictured is the generally trending eastern boundary of the Lark Tailings reclamation area. In the left side of the panorama the tailings area begins to turn south. Farming in this area is right up near to the site fence. Though dry farmed, the adjacent land to the tailings area is supportive for agricultural activities.

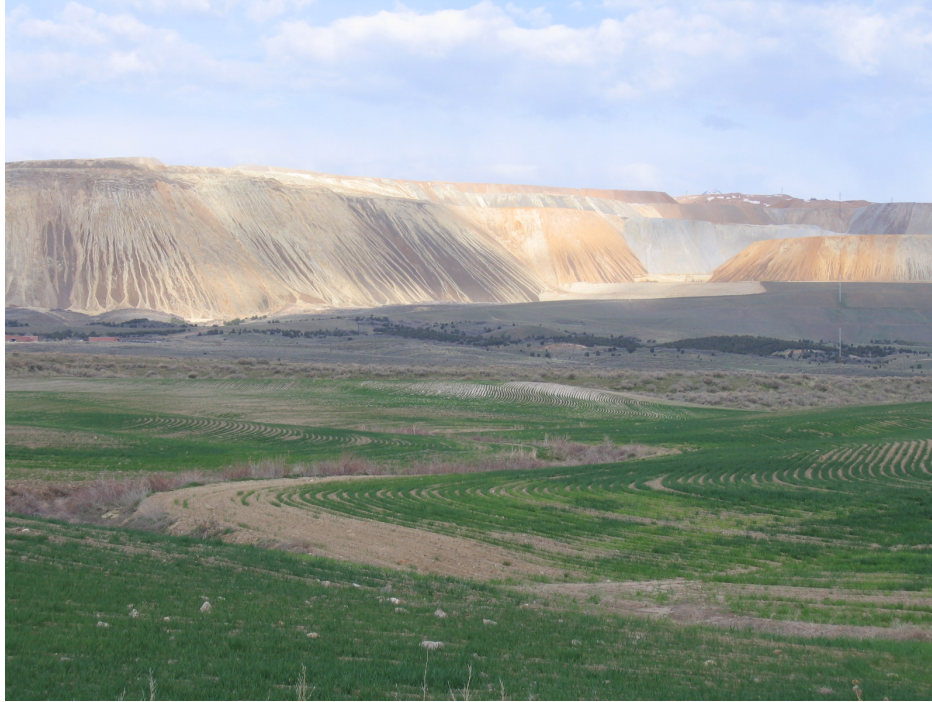
**Figure No. 52:** Pictured is Midas Creek channel from the Kennecott Land haul road coming into the site from Daybreak (north of 11800 South). The sage brush covered hill in the near distance is the eastern/southeastern trending boundary of the Lark Tailings reclamation area.

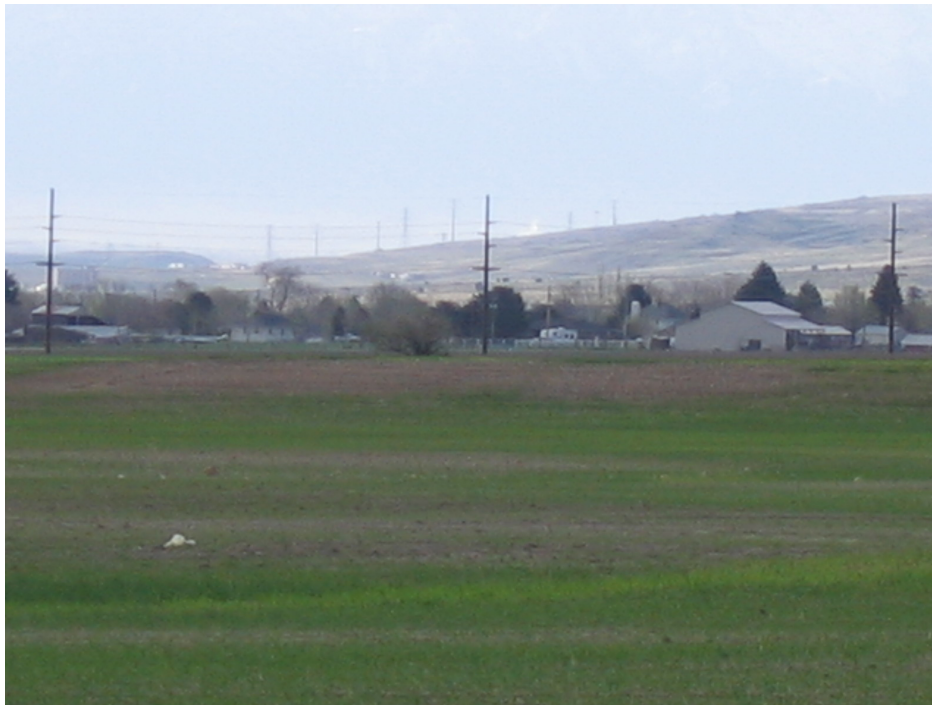
**Figure No. 53:** Located approximately 0.5 miles from the Southeast corner of the Lark Tailings reclamation area is a location entitled Lone Tree (note the lone tree immediately to the left of the distant power line) that was characterized on a minimal level and received some spot removals (as related by Mr. Brian Vinton during the April 23<sup>rd</sup> tour). This site is located near 6000 West. Photo was taken from the Kennecott haul road.

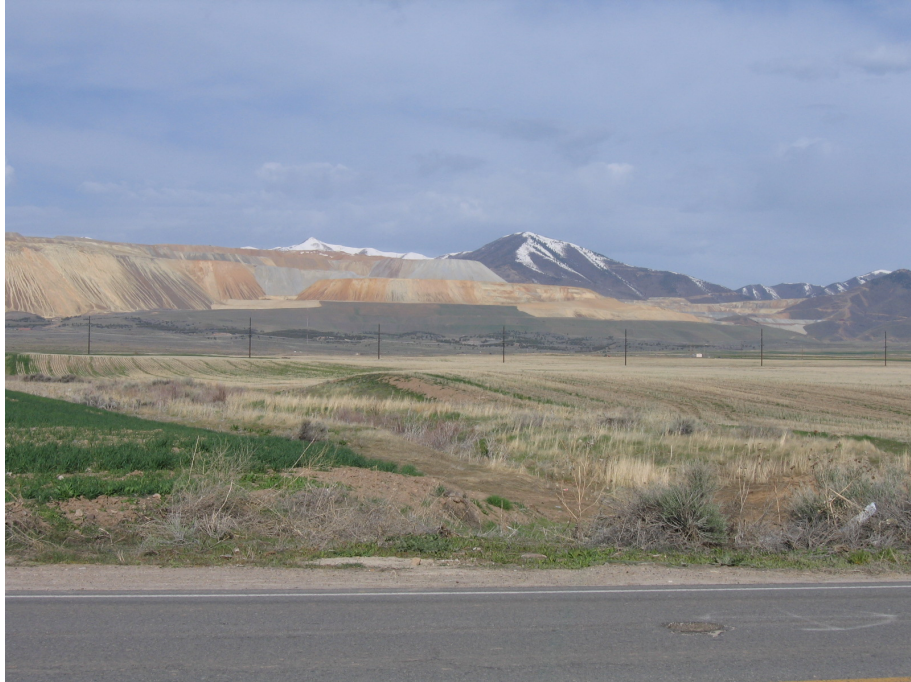
**Figure No. 54:** Pictured is the crossing of Midas Creek at 6000 West. Midas Creek continues East by Southeast until it converges with Copper Creek approximately at 5600 West and 12000 South. The power lines in the distance are approximately  $\frac{1}{2}$  mile east of the Lark Tailings reclamation site Southeast Area (subject of Figure No. 61.)

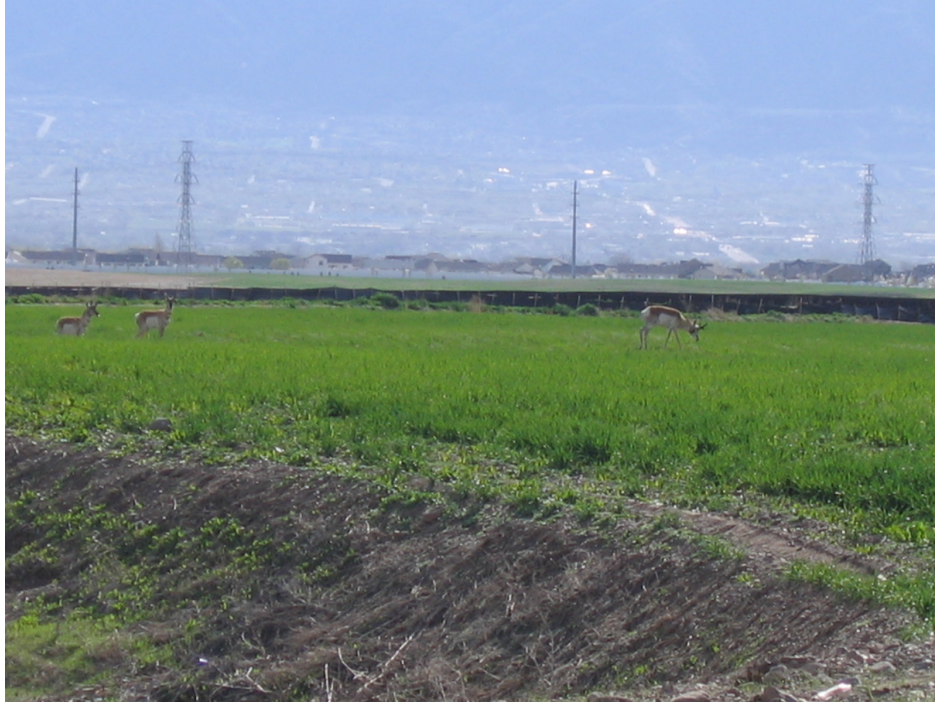
**Figure No. 56:** Pictured are three antelope in the pasture lot noted in Figure No. 58. Midas Creek follows the alignment of the black silt fencing in the distance.

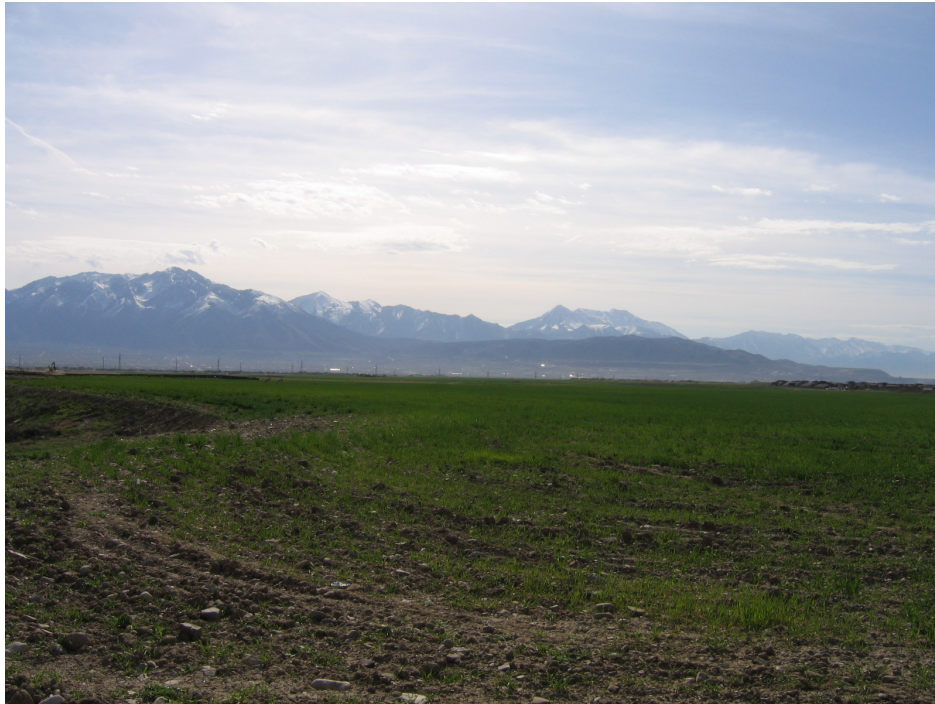
**Figure No. 57:** Pictured is the area (off in the distance) where Midas Creek and Copper Creek converge (Midas Creek roughly follows the black silt fencing on the left side of the frame). This area has been extensively farmed for many years; signs to the convergence of the creeks are almost invisible.

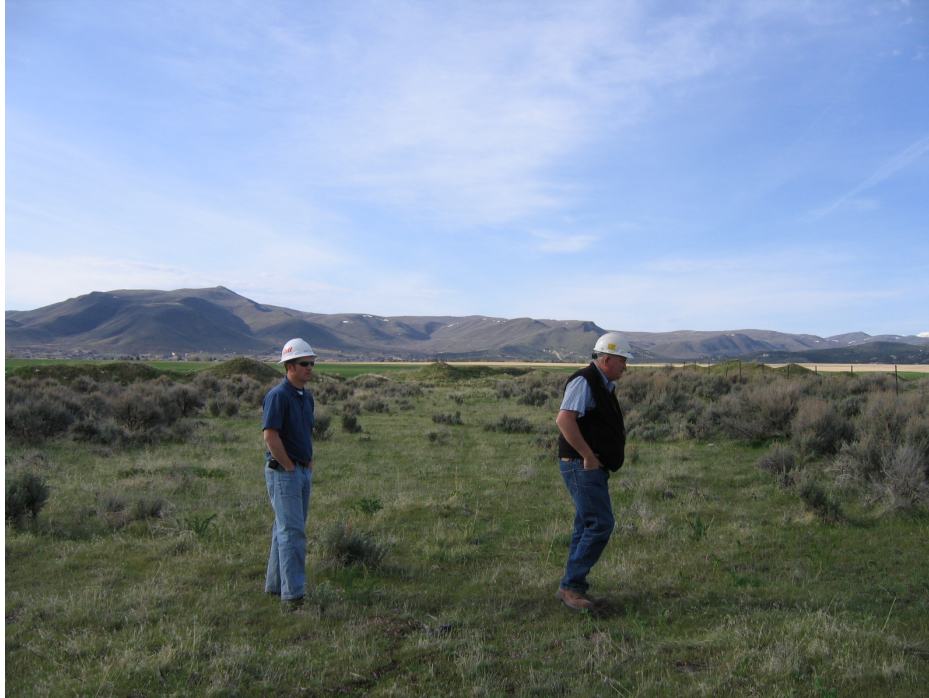
**Figure No. 59:** Pictured are Mr. Kelly Payne and Mr. Brian Vinton traversing through the Southeast Area of the Lark Tailings site. The fence surrounding the Lark Tailings reclamation area is visible along the right side of the frame.

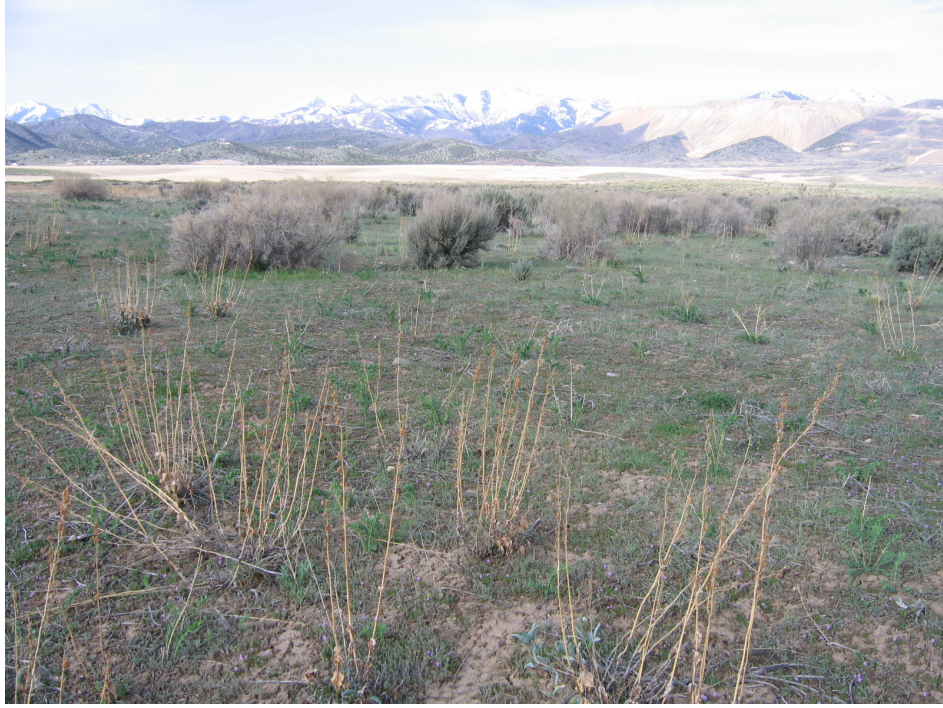
**Figure No. 61:** Pictured is the top surface of the Lark Tailings reclamation site looking towards the southwest (toward Butterfield Canyon from the Southeast corner area of the site). The vegetation pictured here is predominantly the same across the whole site.

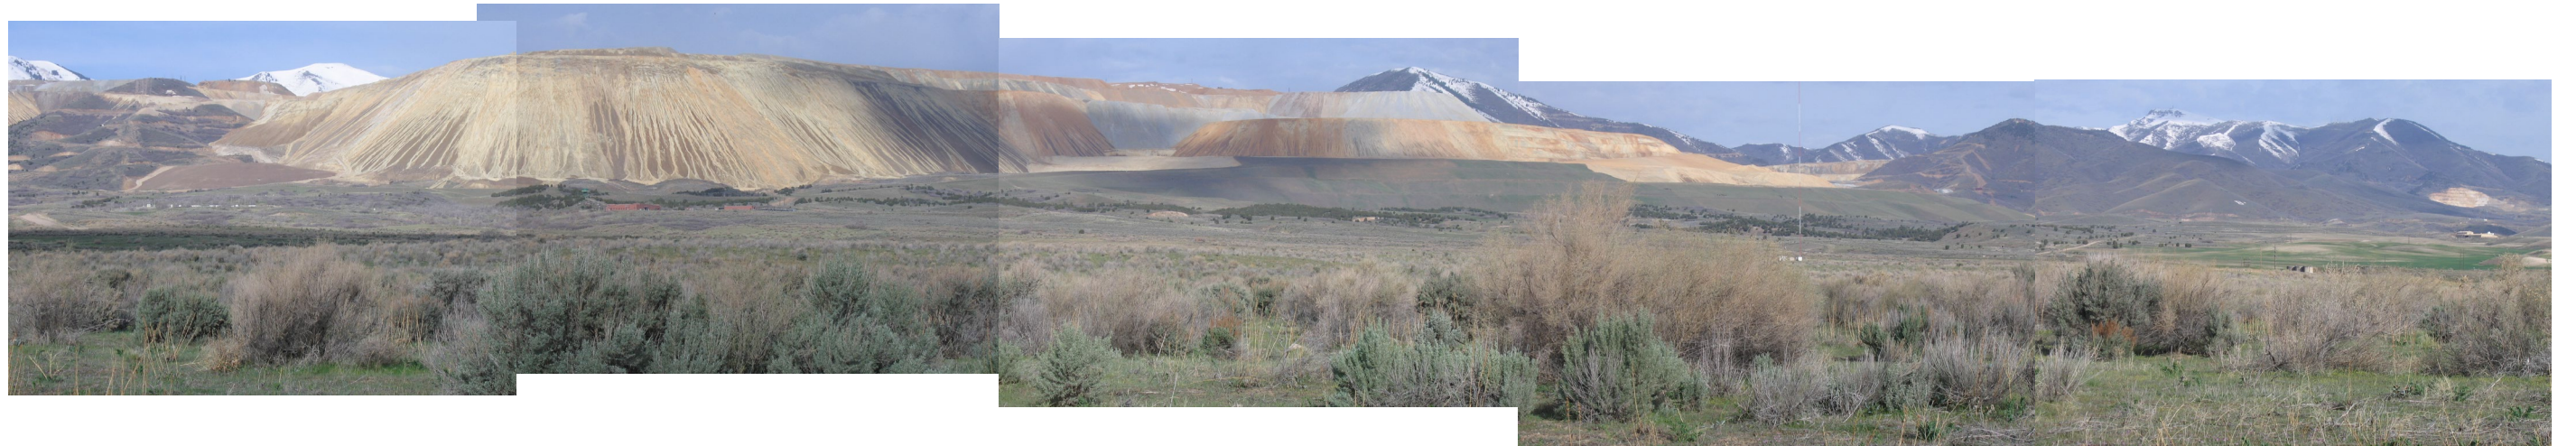
**Figure No. 63:** Pictured is the top surface of the Lark Tailings reclamation area from near the Southeast Corner. Visible in the distance right side of the panorama is the Midas Creek Silos area (right side of panorama), followed to the left by the white shed and aerial, and followed by the USSRM administration and warehouse buildings in the old town site of Lark. In the far distance are the Bingham Canyon Mine, Eastside Waste Rock Dumps

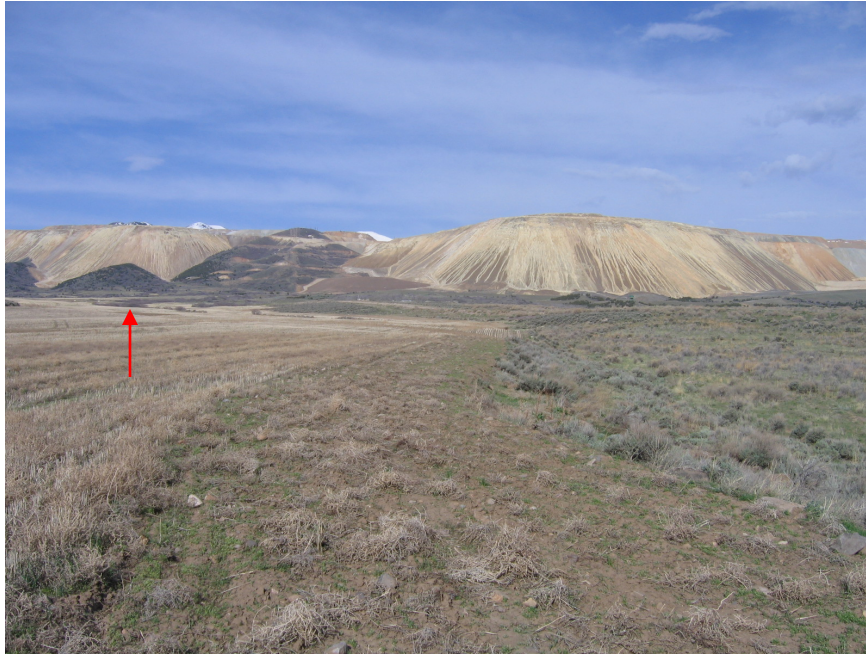
**Figure No. 64:** Pictured is the Copper Creek channel situated between farmed land and the Kennecott Land haul road. The southern boundary of the Lark Tailings reclamation area is approximately 600 feet to the north from this channel (off to the right out of the frame). In the distance is a tree line meandering south and west toward Copper Gulch (or Notch) area between the dumps of the Eastside Waste Rock Dumps of the Bingham Canyon Mine; the tree line follows Copper Creek (red arrow).

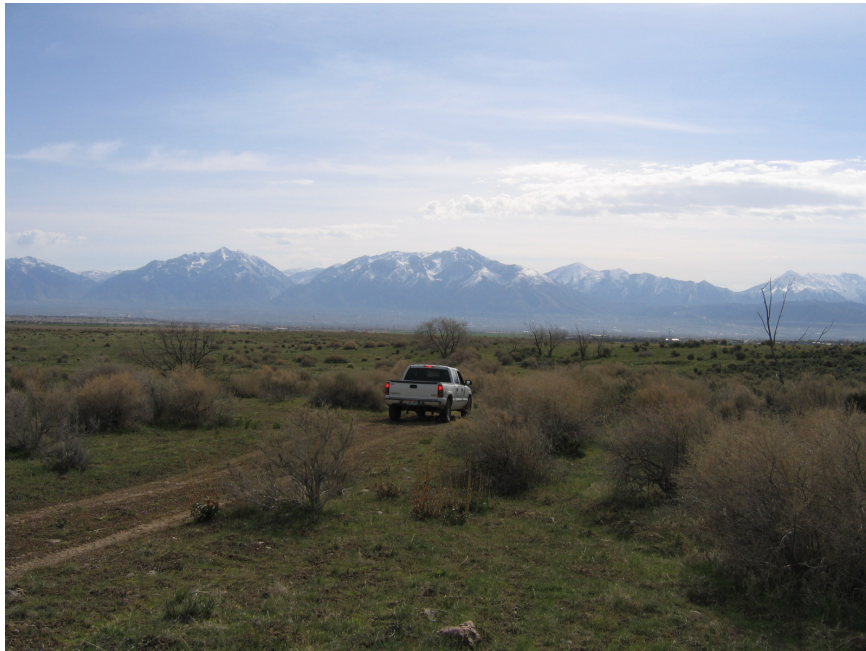
**Figure No. 65:** Near the southwestern boundary of the Lark Tailings reclamation area is the historic site of the Ohio Copper Company Mill No. 2&3. As part of the reclamation work the mill footings were removed and the area was reclaimed. The vegetation here is similar along the top of the reclaimed Lark Tailings.

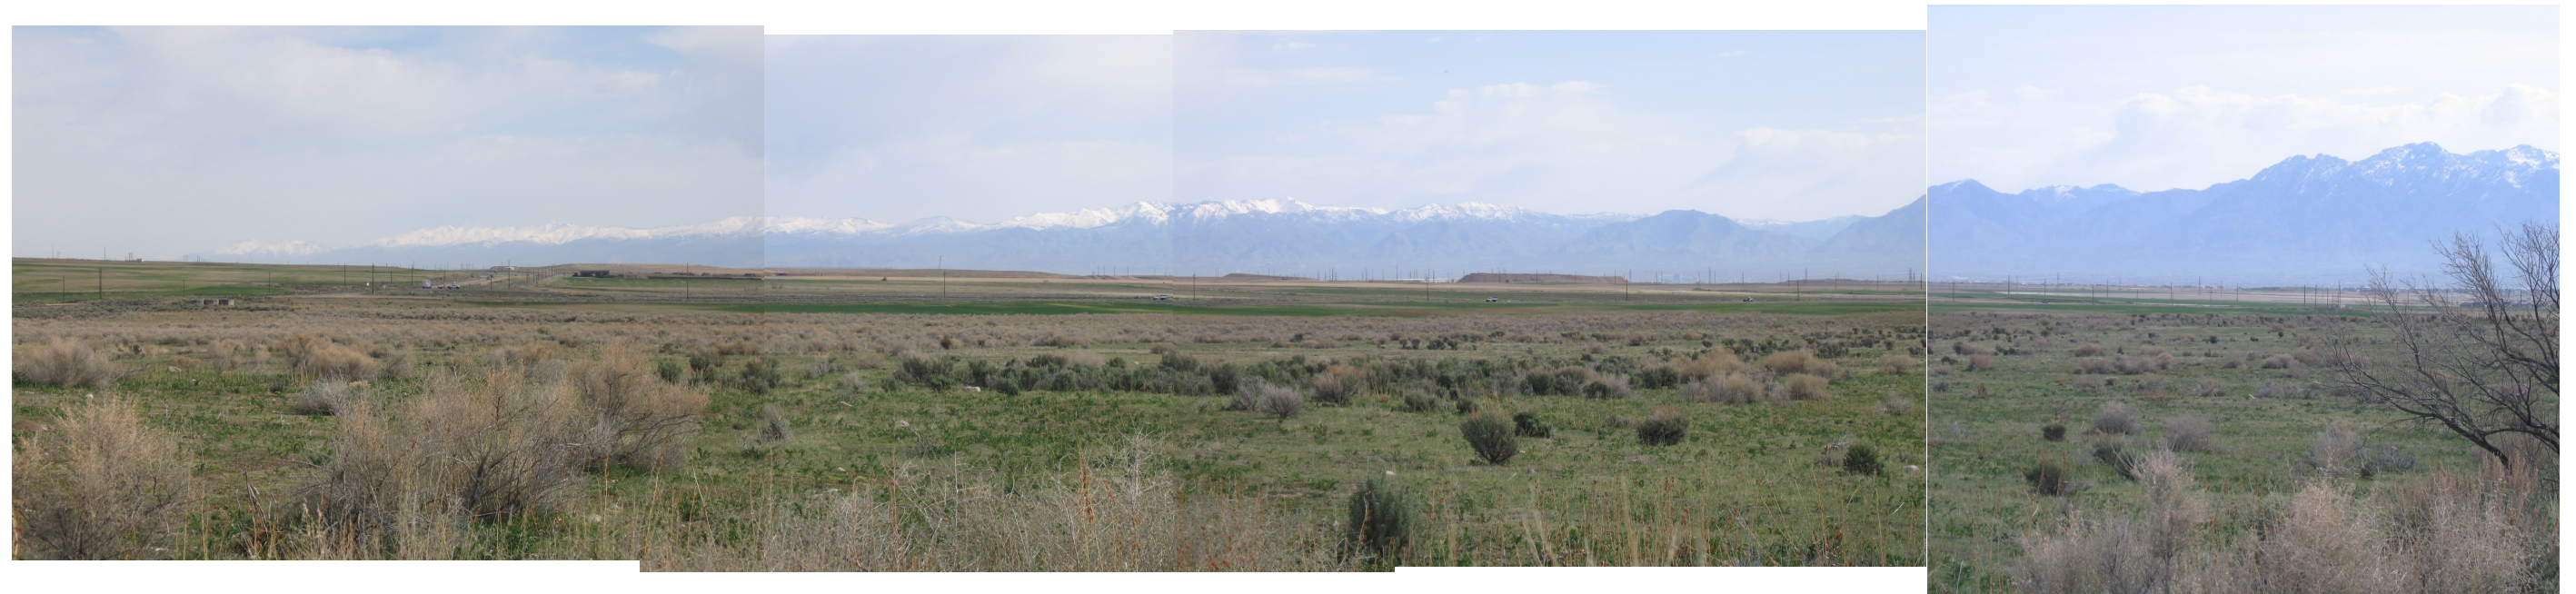
**Figure No. 66:** Pictured is the Lark Tailings reclamation area as viewed from the Ohio Copper Company No. 2&3 mill site (near the southwest corner); view is north by northeast. In the left side of the panorama is the Midas Creek Silos site. The visible road is 11800 South and the Mascotte Ditch and Midas Creek alignments follow the natural depressions in the near background flowing east from the Midas Creek Silos area. In the foreground is the area where the Ohio Copper Company disposed of the reworked mill tailings from Mill No. 1. As noted in Figures No. 49, 54, 61 and 66 the top surface of the Lark Tailings reclamation area is well vegetated but the jack rabbits in the area are eating the low lying grasses (natural predators are few, one coyote was observed during the site inspection). The area where Figure No. 66 was taken is out of this panorama's right side (east by southeast).

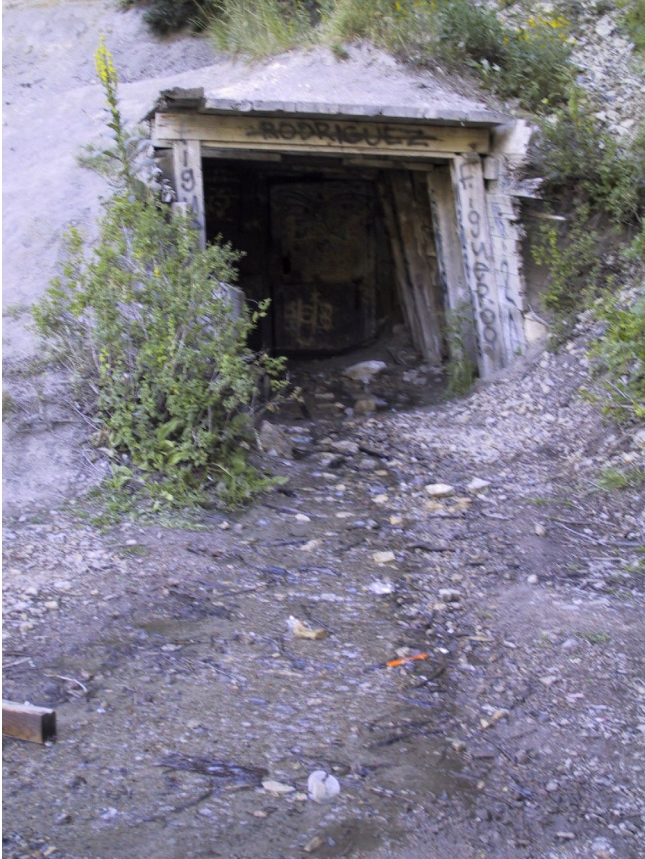
**Figure No. 68:** In 2005 the Water Supply Tunnel portal remained as historically left by the mine operators. Recessed from the portal front is a steel bulkhead door, which up till 2006 was used to prevent access to the tunnel.

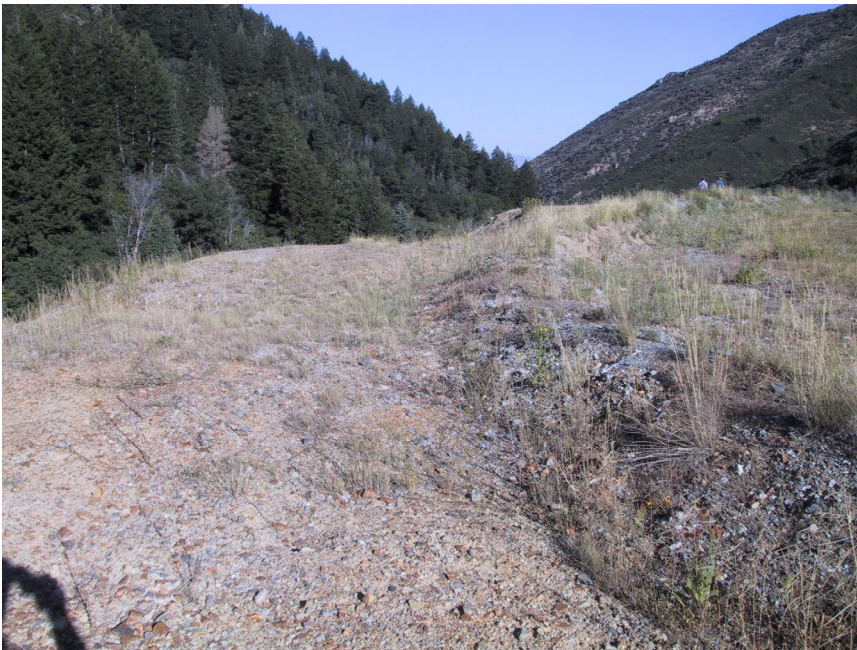
**Figure No. 69:** Pictured is the southern boundary of the Water Supply Tunnel Dump near the edge of the embankment. Note the vegetated berm entering the picture from the bottom right corner. Native grasses and some shrubs have begun to voluntarily grow on the dump surface.
