# **Appendix I**

## **Site Inspection Photos and Observations**

**I. OU3 Herriman Agricultural Properties**

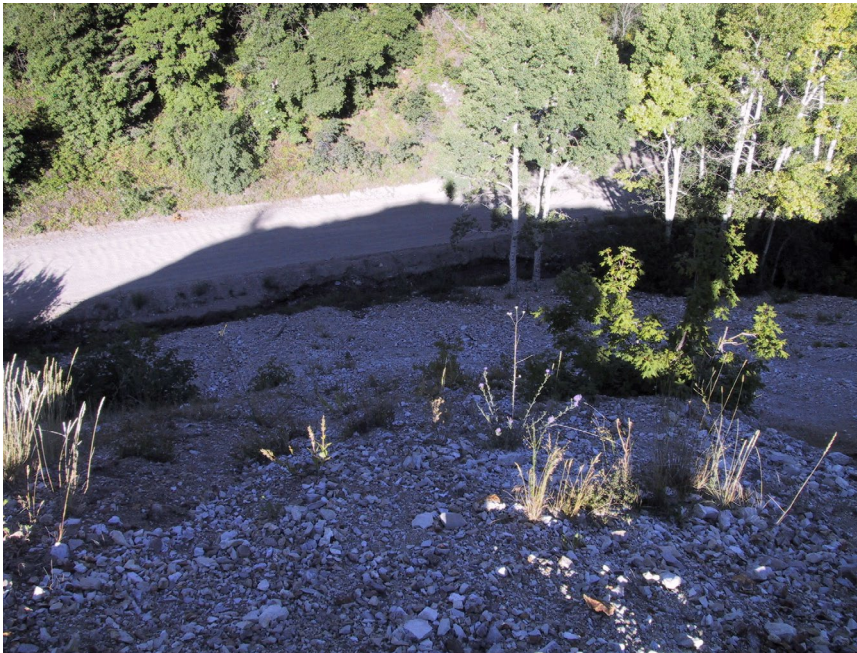
**Figure No. 70:** From on top of the Water Supply Tunnel Dump's southern embankment looking down to the Tooele County road, Middle Canyon Creek is visible as the dark line near the road base. The grasses and trees pictured here are from voluntary seeding.

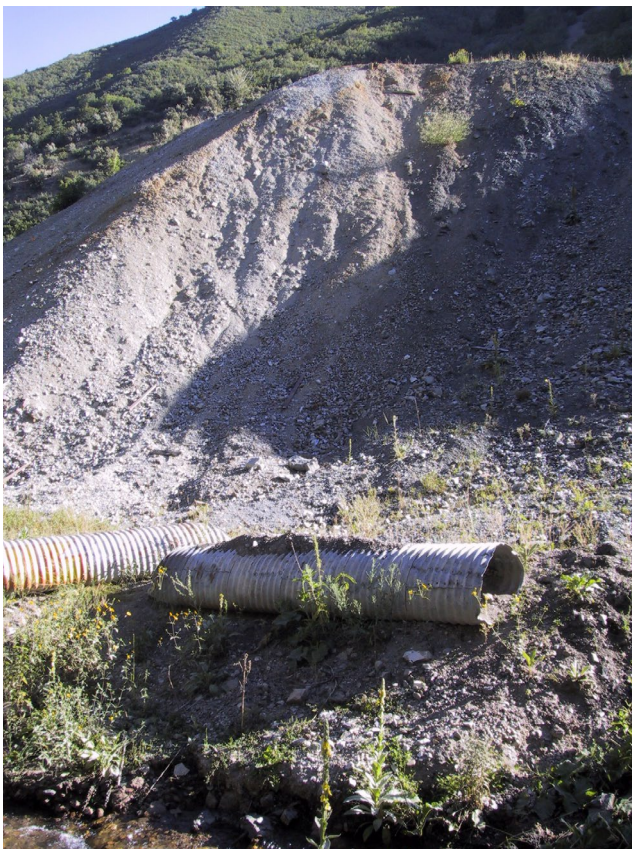
**Figure No. 71:** Pictured is the Water Supply Tunnel Dump and Middle Canyon Creek from the Tooele County road.

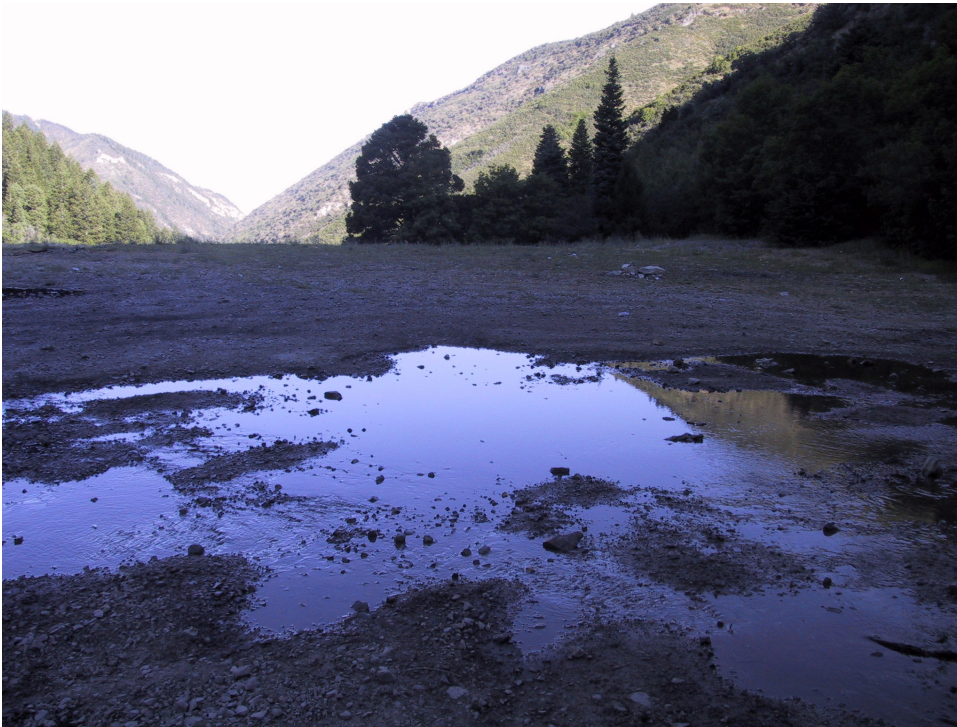
**Figure No. 72:** Pictured is the Water Supply Tunnel Dump top surface with surface water discharging from the tunnel. In the distance is Middle Canyon viewed to the west. The drainage pipe from the top of the Dump is located near the conifer trees pictured in the shade.

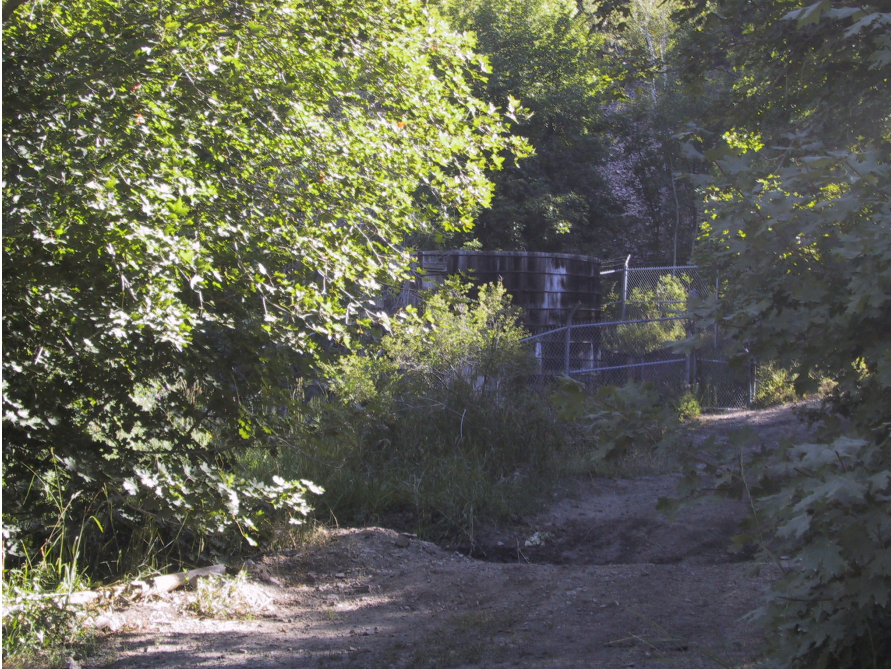
**Figure No. 74:** Pictured is the water storage tank and collection point for the local irrigation company's diversion structure off of Middle Canyon Creek (which is located in the depression visually separating the access road to the tank. The western slope of the Water Supply Tunnel Dump is barely visible through the trees just to the right of the tank.

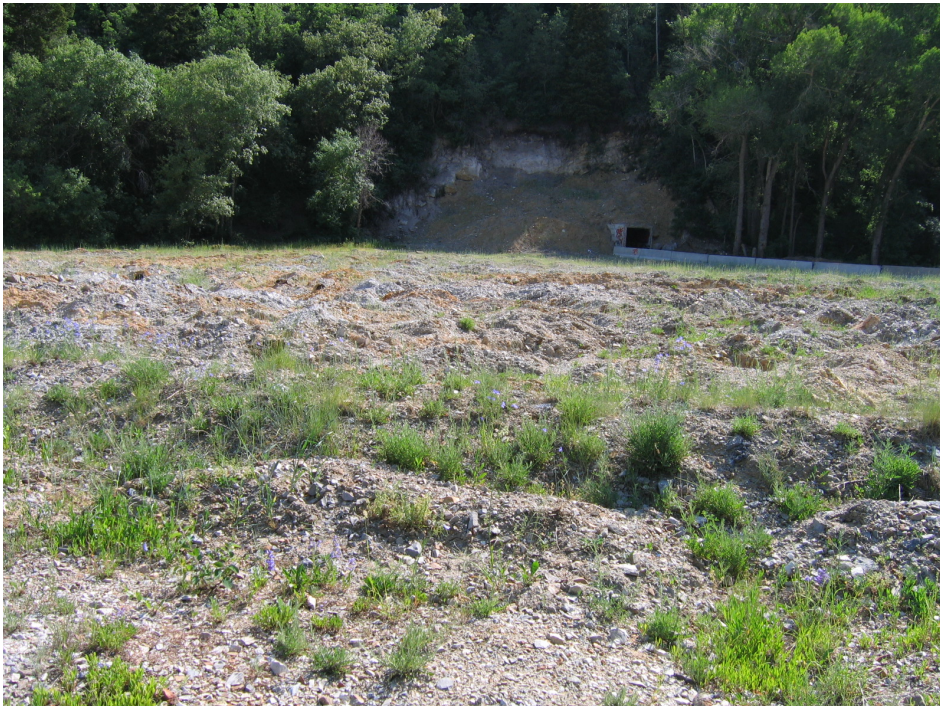
**Figure No. 78:** Pictured is the top surface of the Water Supply Tunnel Dump looking back toward the tunnel portal from the edge of the southern embankment. Along with the grasses seeded on the surface, many voluntary species were observed in the stands of vegetation.

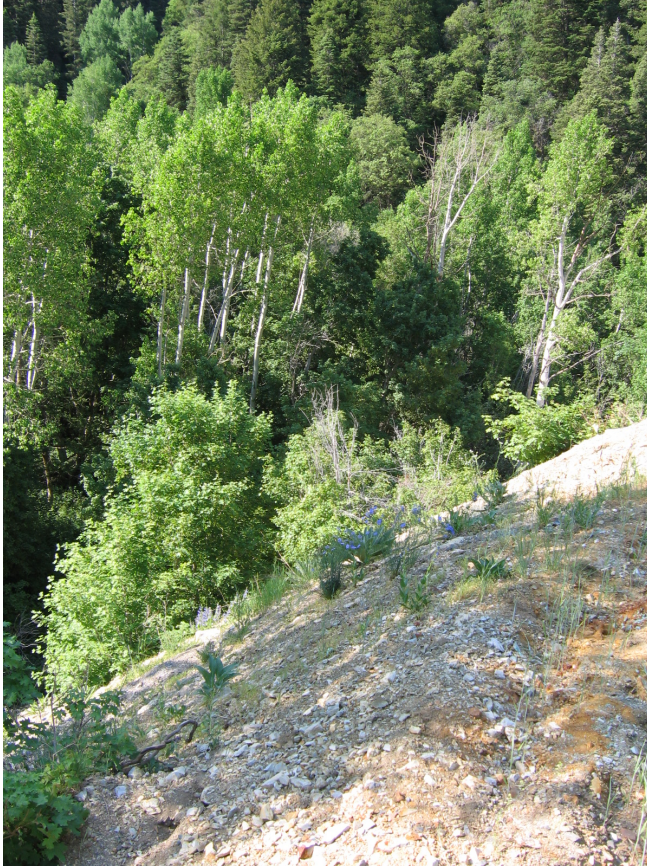
**Figure No. 80:** Pictured is the southern embankment of the Water Supply Tunnel Dump from along its top edge. The stands of vegetation are entirely voluntary in this location.

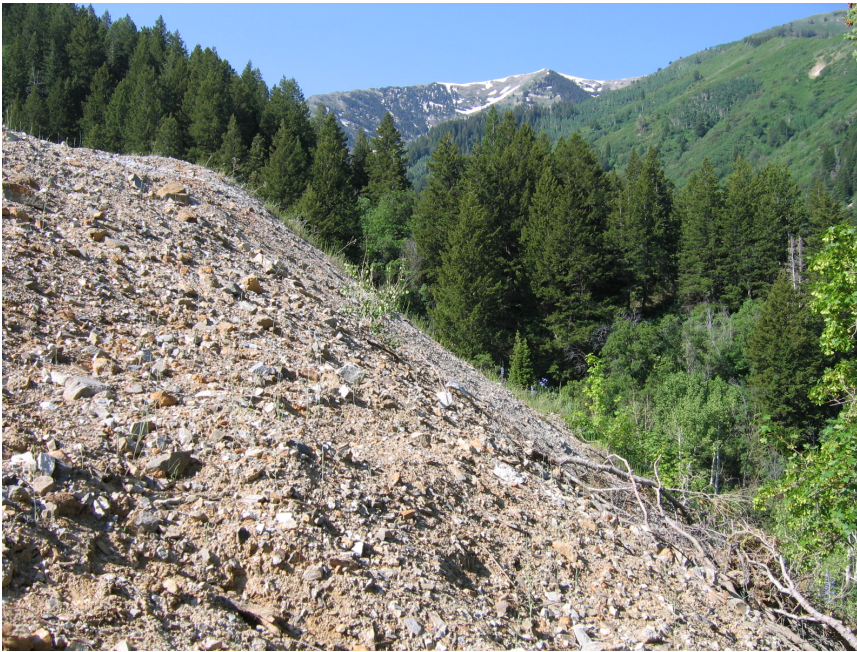
**Figure No. 81:** Pictured is the western embankment slope of the Water Supply Tunnel Dump taken from the reconstructed drainage channel from the top surface. Some of the slopes along the Dump have seen the successful introduction of voluntary vegetation species, more so than other slopes.

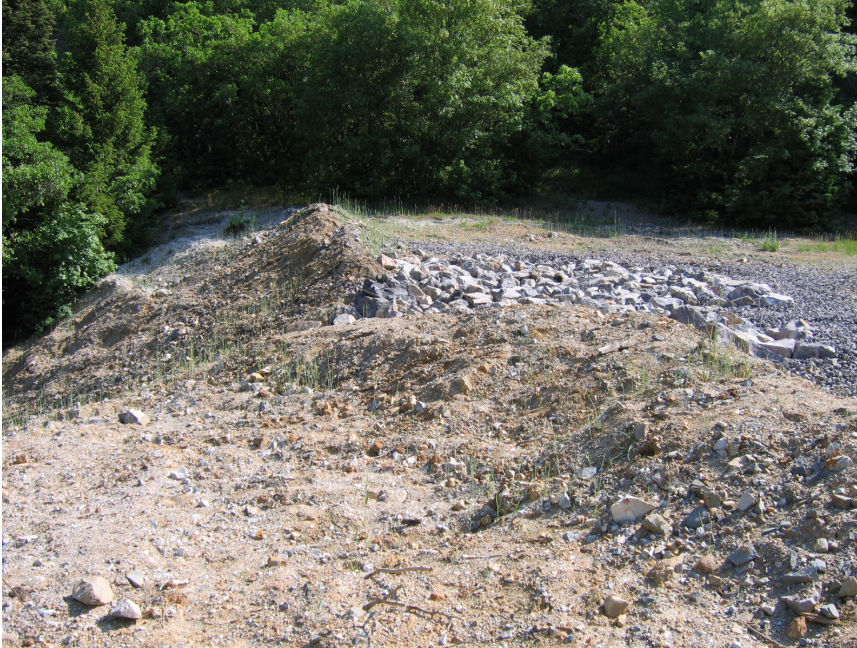
**Figure No. 82:** Pictured is the top section of the reconstructed drainage channel and capture area along the top edge of the western slope of the Water Supply Tunnel Dump. Top to bottom this drainage channel is significantly armored with rip-rap to protect it against undercutting. Note the water directional berm as part of the water control structures on top of the Dump.

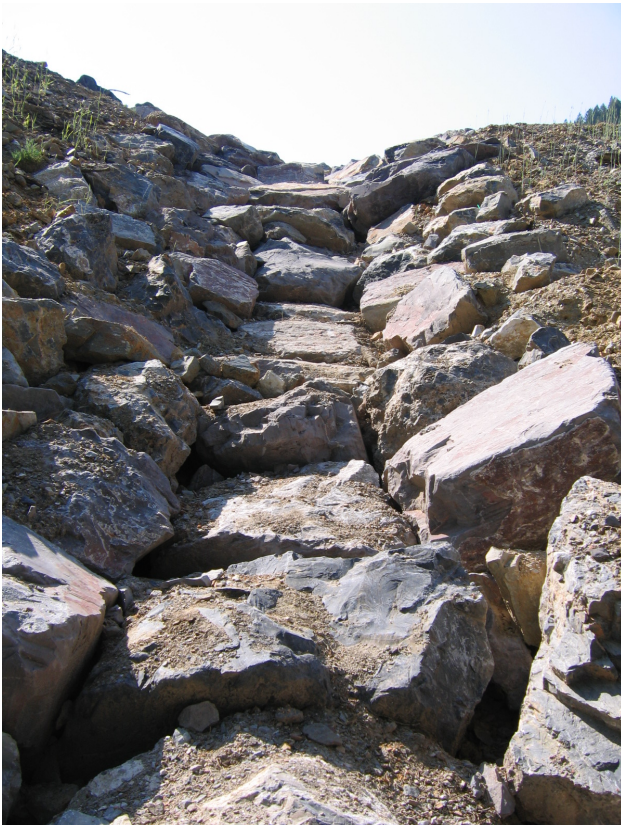
**Figure No. 83:** Pictured is a close-up of the drainage channel and its rip-rap near the top of the Water Supply Tunnel Dump. This channel was assessed to be stable for the limited water it potentially will receive draining from the top surface of the Water Supply Tunnel Dump.

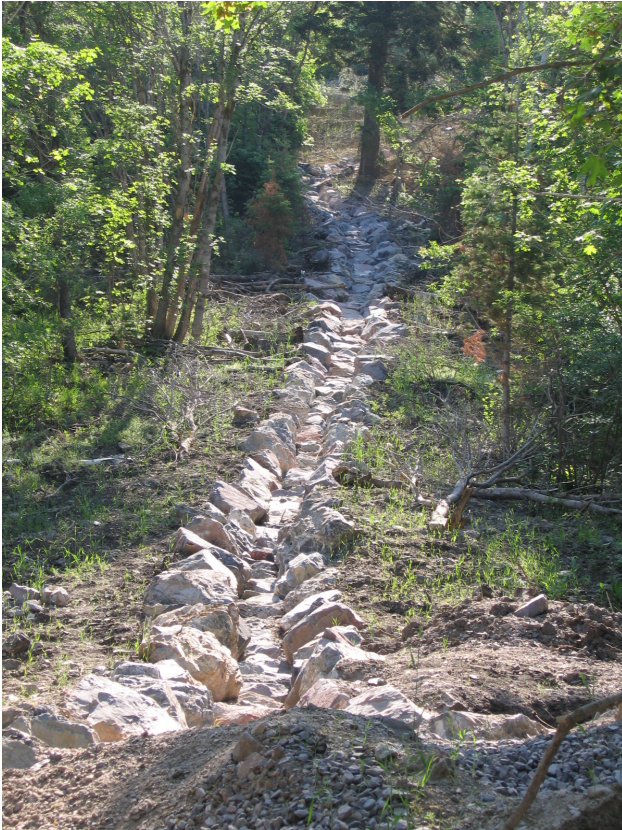
**Figure No. 84:** Pictured is the reconstructed drainage channel taken from the base of the channel near the water tank and irrigation system. Water from this channel is delivered to Middle Canyon Creek. Vegetative success near and along the base of the Water Supply Tunnel Dump is the best along the western and eastern slopes of the Dump.

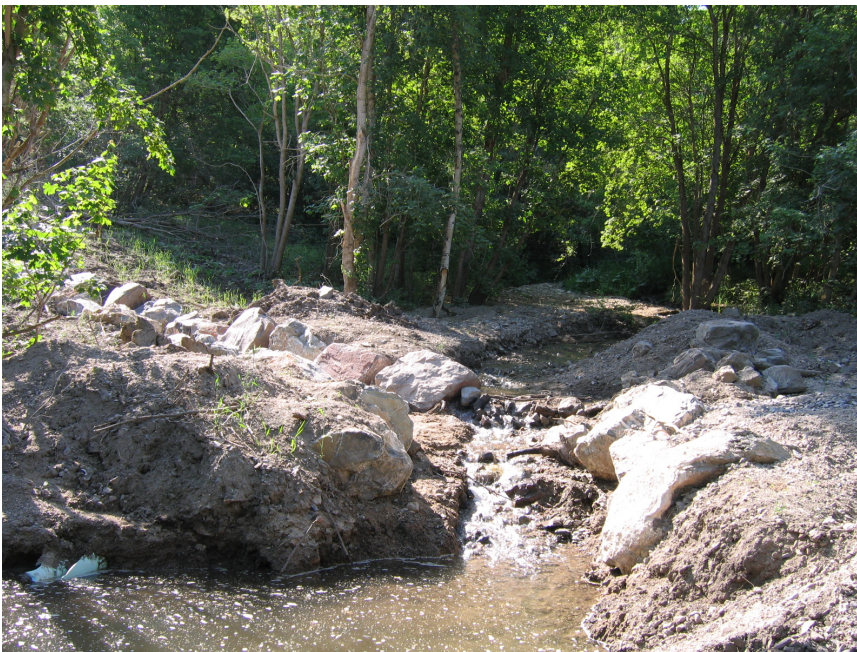
**Figure No. 85:** Pictured is the confluence of the drainage channel from the Water Supply Tunnel Dump and Middle Canyon Creek near the base of the western slope of the Dump.

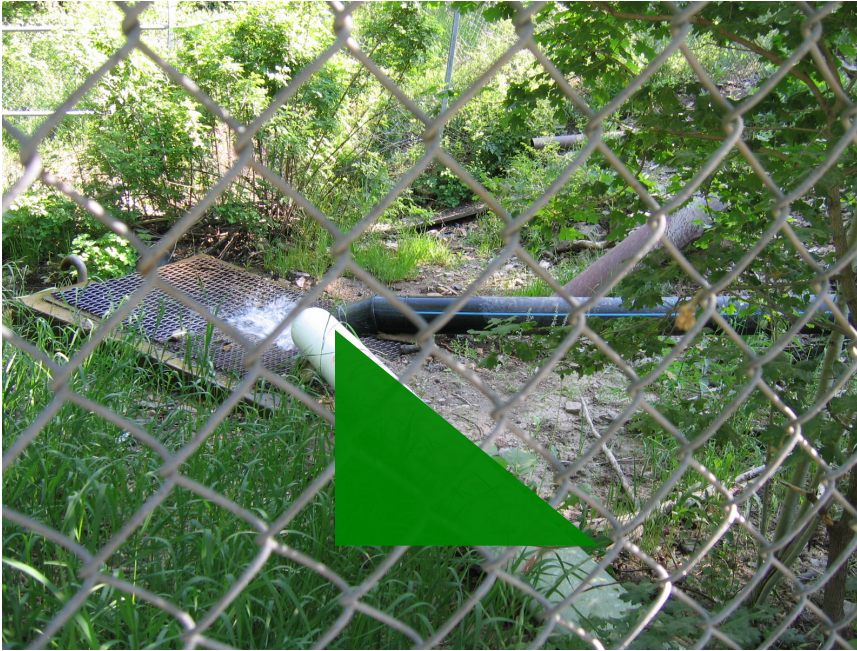
**Figure No. 86:** Pictured is the black HDPE pipe directing water from the Water Supply Tunnel straight into the local irrigation company's collection point off of Middle Canyon Creek. The green triangle is inserted in the frame to cover some publicly inappropriate graffiti on the white PVC pipe.
